Visual Site Inspection Report

Project Name	H-600 Pipeline Spread H	AFE	124300138	Spread	H-600 Pipeline Spread H
Contractor	Precision			Report #	18038
Inspector	Logan Box			Date/Time	12/14/2020 4:31 PM
Permit #	TBD	Inspection Type	VA SWPP	Station Begin	13415+51
State	VA	Inspection Area	Partial	Station End	13525+99
County	Franklin	Ground	Wet	Temperature (°F)	43.00
Municipality	N/A	Weather	Light Rain	Rain Gauge (in)	1.20
				Rain Accumulation Time (days)	1.00

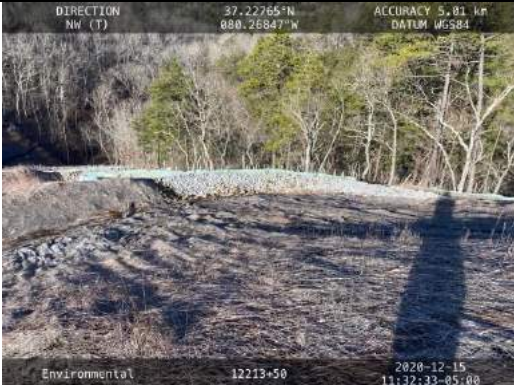
GPS Location	See photo for GPS coordinates		GPS Location	See photo for GPS coordinates	
Field Station#	12213+50		Field Station#	12210+00	
Pic 3 Desc.	Permanent Waterbar with rock weir outlet.		Pic 4 Desc.	Stabilized row with acceptable vegetative coverage across LOD

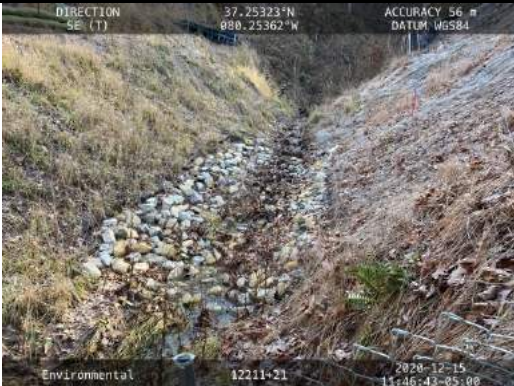
GPS Location	See photo for GPS coordinates		GPS Location	See photo for GPS coordinates	
Field Station#	12211+21		Field Station#	12212+00	
Pic 5 Desc.	Rip rap lines drain channel.		Pic 6 Desc.	Permanent restoration with acceptable vegetation across LOD

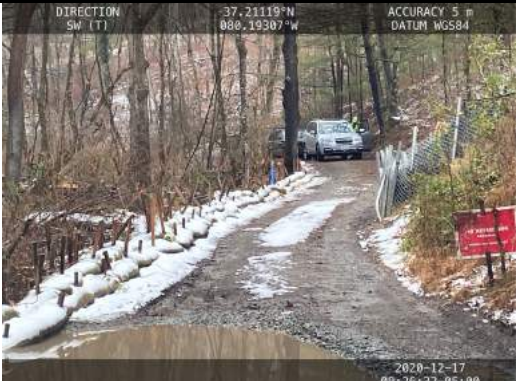
GPS Location	See photo		GPS Location	See photo	
Field Station#	12544+06		Field Station#	12544+54	
Pic 5 Desc.	MVP ROW crossing on Yellow Finch Road		Pic 6 Desc.	Stream S-EF20a, facing northeast, downstream

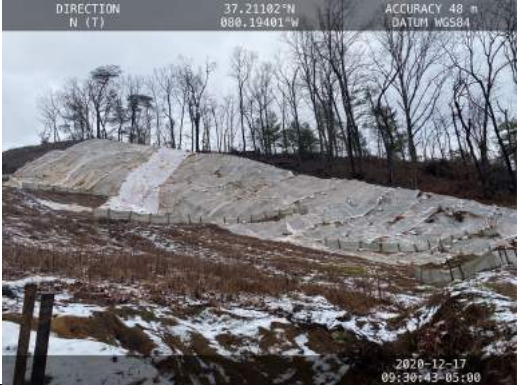
GPS Location	See photo		GPS Location	See photo	
Field Station#	12543+00		Field Station#	12529+00	
Pic 7 Desc.	Plastic sheeting intact and secure on stockpiles nearest to Yellow Finch Road.		Pic 8 Desc.	Plastic sheeting approximately 1500 feet from Yellow Finch Road is intact and secure.

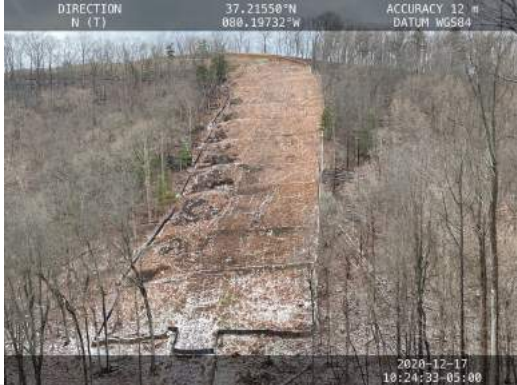
GPS Location	See photo		GPS Location	See photo	
Field Station#	12517+00		Field Station#	12519+70	
Pic 9 Desc.	Slope on coming in side of stream S-EF19 is stable.		Pic 10 Desc.	There is one tree in the buffer zone of stream S-EF19 that is over 3 inches.

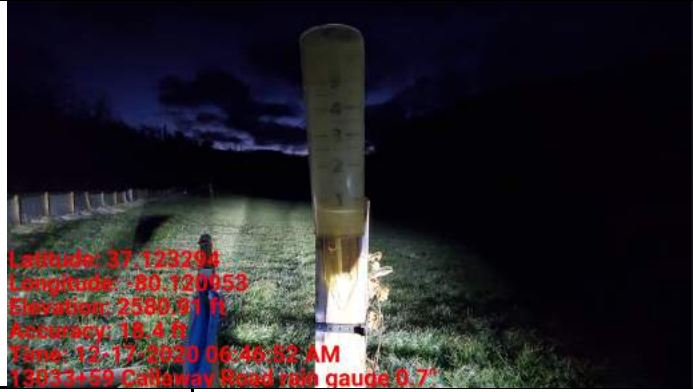
<p>Latitude: 37.123294 Longitude: -80.120053 Elevation: 2580.51 ft Accuracy: 15.4 ft Time: 12-17-2020 06:45:52 AM 13033+59 Callaway Road rain gauge 0.7"</p>

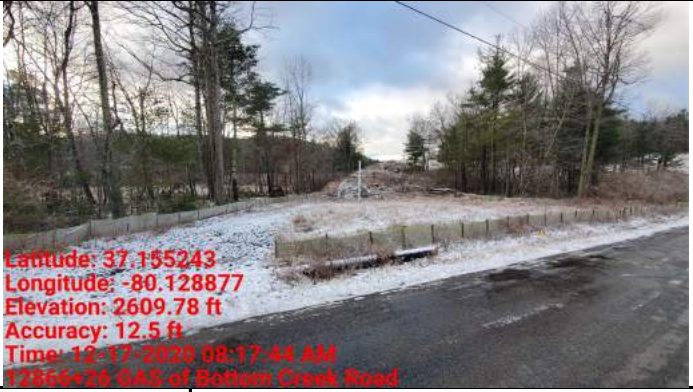
<p>Latitude: 37.155243 Longitude: -80.128877 Elevation: 2609.78 ft Accuracy: 12.5 ft Time: 12-17-2020 08:17:44 AM 12866+26 GAS of Bottom Creek Road</p>			
GPS Location	See pic for GPS location		GPS Location	See pic for GPS location	
Field Station#	13033+59		Field Station#	12866+26	
Pic 1 Desc.	Callaway Road rain gauge. 0.7" total precipitation.		Pic 2 Desc.	GAS of the Bottom Creek Road crossing.

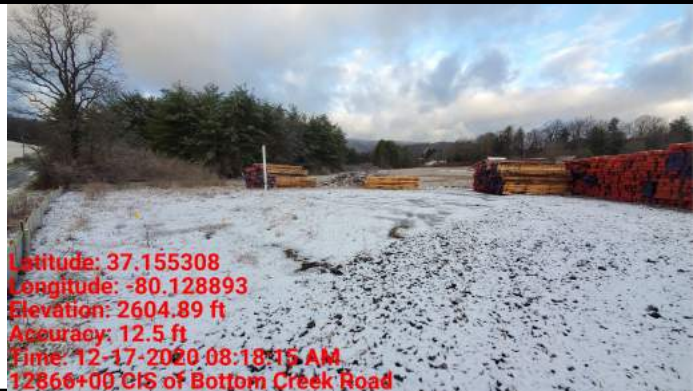
<p>Latitude: 37.155308 Longitude: -80.128893 Elevation: 2604.89 ft Accuracy: 12.5 ft Time: 12-17-2020 08:18:15 AM 12866+00 CIS of Bottom Creek Road</p>

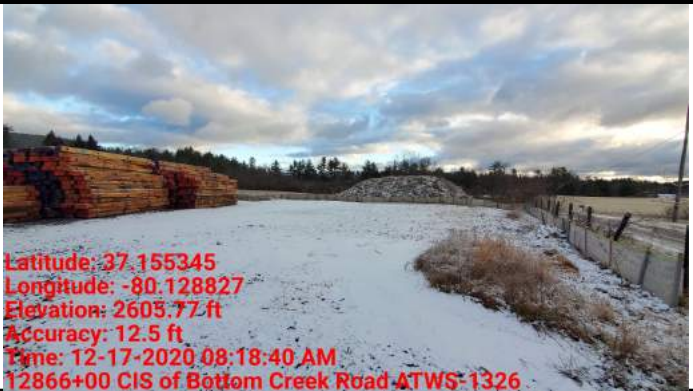
<p>Latitude: 37.155345 Longitude: -80.128827 Elevation: 2605.77 ft Accuracy: 12.5 ft Time: 12-17-2020 08:18:40 AM 12866+00 CIS of Bottom Creek Road ATWS-1326</p>

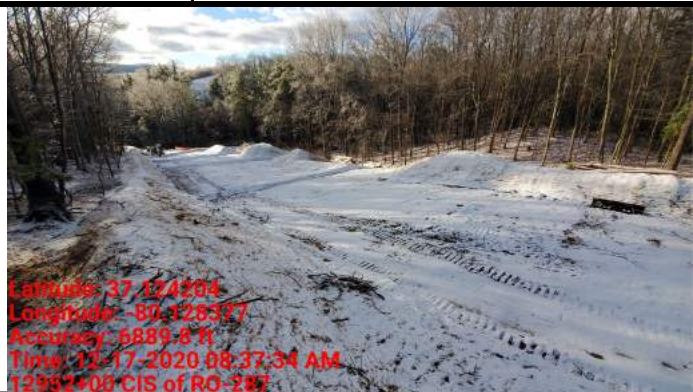
<p>Latitude: 37.124204 Longitude: -80.126377 Elevation: 6889.8 ft Accuracy: 68.8 ft Time: 12-17-2020 08:37:34 AM 12952+00 CIS of RO-287</p>

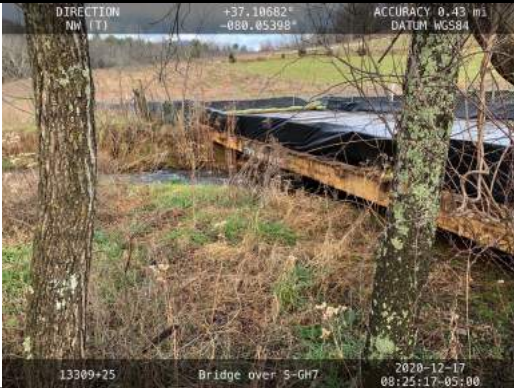
GPS Location	See photo for gps location data.		GPS Location	See photo for gps location data.	
Field Station#	13309+25		Field Station#	13309+09	
Pic 5 Desc.	Photo shows the downstream side of the bridge over stream S-GH7.		Pic 6 Desc.	Photo shows stream S-GH7 upstream from the bridge.

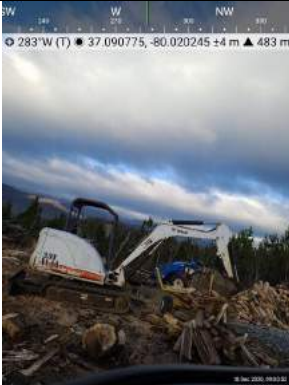
GPS Location	00000	GPS Location	00000		
Field Station#	13437+75	Field Station#	13496+32		
Pic 1 Desc.	Observed area where land owner continues to cut fire wood on row , no issues observed at the time of inspection		Pic 2 Desc.	Row photo taken by the EI showing vegetation and ECDs in place and functioning

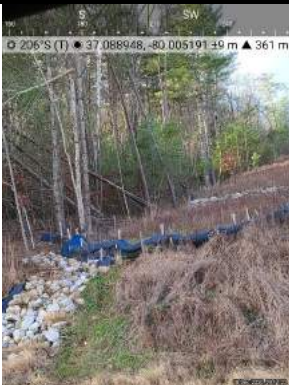
GPS Location	0000	GPS Location	00000		
Field Station#	13496+32	Field Station#	13525+25		
Pic 3 Desc.	Observed rock lined channel at road crossing. No issues observed at the time of inspection		Pic 4 Desc.	The EI monitored vegetation growth and ECDs throughout, no environmental issues observed at time of inspection

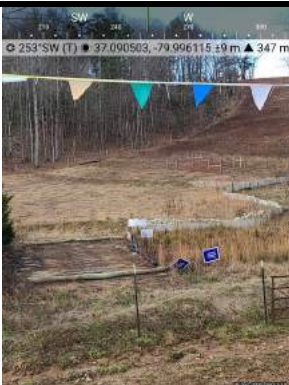
GPS Location	0000	GPS Location	0000		
Field Station#	13525+25	Field Station#	13500+48		
Pic 5 Desc.	The EI monitored equipment bridge and ECDs throughout travels today. No issues observed at the time of inspection		Pic 6 Desc.	Vegetation observation photo facing down row from stream crossing.
