# Visual Site Inspection Report

<b>Project Name</b>	H-600 Pipeline Spread H	<b>AFE</b>	124300138	<b>Spread</b>	H-600 Pipeline Spread H
<b>Contractor</b>	Precision			<b>Report #</b>	18327
<b>Inspector</b>	Stephen Bendele			<b>Date/Time</b>	12/21/2020 12:36 PM
<b>Permit #</b>	TBD	<b>Inspection Type</b>	VA SWPP	<b>Station Begin</b>	12638+24
<b>State</b>	VA	<b>Inspection Area</b>	Partial	<b>Station End</b>	12865+00
<b>County</b>	Roanoke	<b>Ground</b>	Frozen	<b>Temperature (°F)</b>	36.00
<b>Municipality</b>	N/A	<b>Weather</b>	Sunny	<b>Rain Gauge (in)</b>	0.00
				<b>Rain Accumulation Time (days)</b>	0.00

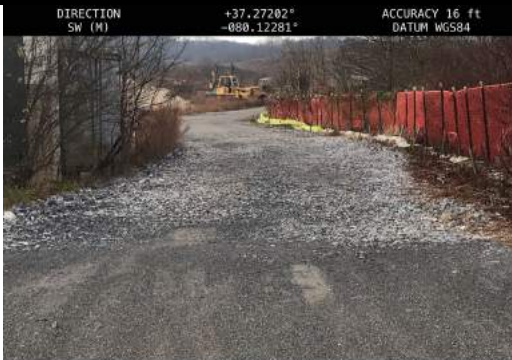
<p>DIRECTION SW (M) +37.27202° -080.12281° ACCURACY 16 ft DATUM WGS84</p> <p>MVP-LY-049_122120 Condition of rock entrance 2020-12-21 09:15:19-05:00</p>

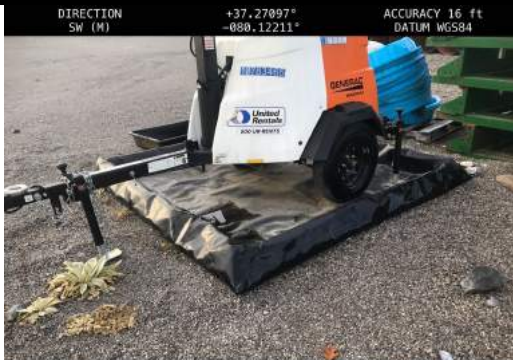
<p>DIRECTION SW (M) +37.27097° -080.12211° ACCURACY 16 ft DATUM WGS84</p> <p>MVP-LY-049_122120 Condition of containment 2020-12-21 09:16:58-05:00</p>			
GPS Location	MVP-LY-049 See photo for gps data		GPS Location	MVP-LY-049 See photo for gps data	
Field Station#	+0		Field Station#	+0	
Pic 1 Desc.	Condition of north rock entrance. No sediment on stone. Looking SW.		Pic 2 Desc.	Condition of containment under light plant. Free of stormwater. Looking SW.

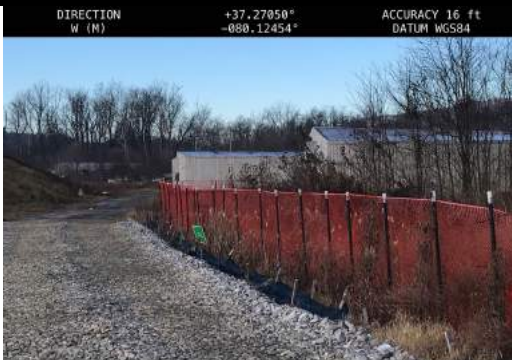
<p>DIRECTION W (M) +37.27050° -080.12454° ACCURACY 16 ft DATUM WGS84</p> <p>MVP-LY-049_122120 Condition of CFS &amp; safety fence 2020-12-21 09:25:15-05:00</p>

GPS Location	MVP-LY-049 See photo for gps data		GPS Location	MVP-LY-049 See photo for gps data	
Field Station#	+0		Field Station#	+0	
Pic 3 Desc.	Condition of compost filter sock and safety fence along feature W-CV21A. No impacts. Looking W.		Pic 4 Desc.	Landowner soil disturbance along compost filter sock and feature W-CV21B. Area not stabilized. No impacts. Looking SW.

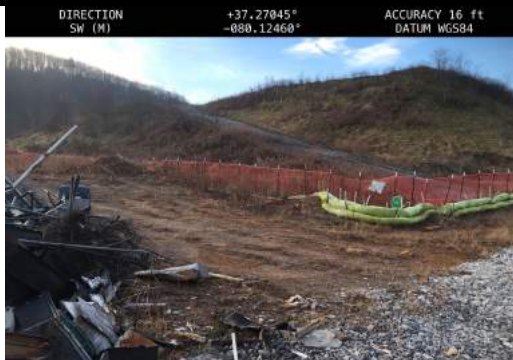
<p>DIRECTION SW (M) +37.27045° -080.12460° ACCURACY 16 ft DATUM WGS84</p> <p>MVP-LY-049_122120 Landowner disturbance along CFS &amp; feature 2020-12-21 09:25:25-05:00</p>

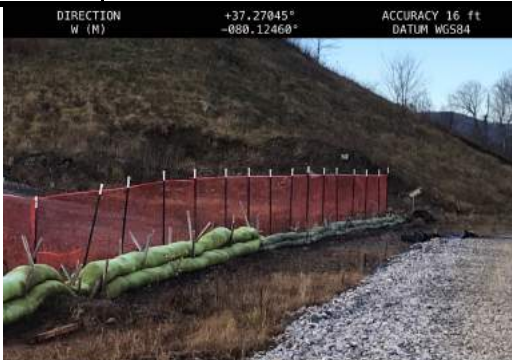
<p>DIRECTION W (M) +37.27045° -080.12460° ACCURACY 16 ft DATUM WGS84</p> <p>MVP-LY-049_122120 Landowner disturbance within 66' of feature 2020-12-21 09:25:34-05:00</p>

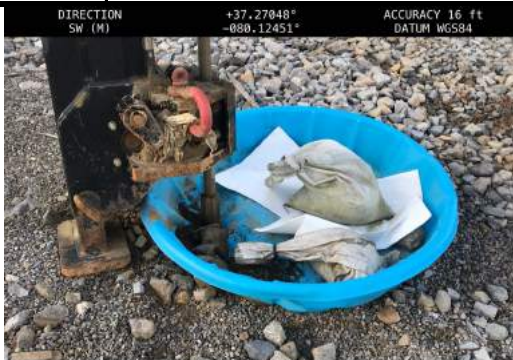
<p>DIRECTION SW (M) +37.27048° -080.12451° ACCURACY 16 ft DATUM WGS84</p> <p>MVP-LY-049_122120 Containment under stored equipment 2020-12-21 09:27:08-05:00</p>			
GPS Location	MVP-LY-049 See photo for gps data		GPS Location	MVP-LY-049 See photo for gps data	
Field Station#	+0		Field Station#	+0	
Pic 5 Desc.	Landowner soil disturbance within 66' and 120' of feature. Area not stabilized. No impacts. Looking W.		Pic 6 Desc.	Condition of containment under stored equipment. Looking SW.

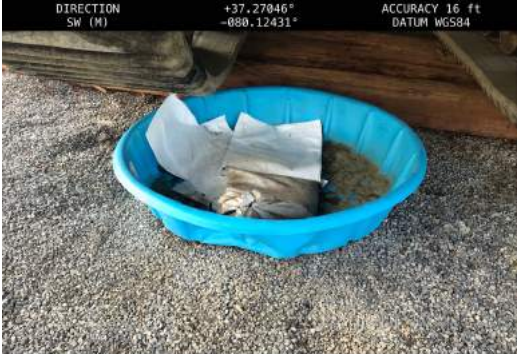
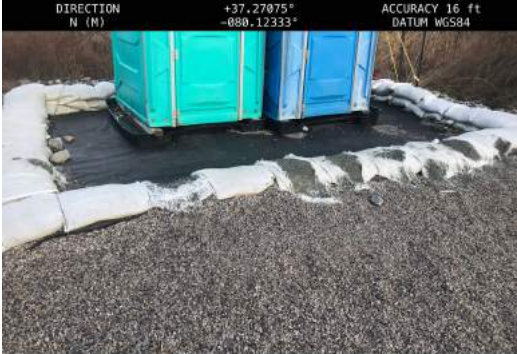
<b>GPS Location</b>	MVP-LY-049 See photo for gps data		<b>GPS Location</b>	MVP-LY-049 See photo for gps data	
<b>Field Station#</b>	+0		<b>Field Station#</b>	+0	
<b>Pic 7 Desc.</b>	Condition of containment under stored equipment. Looking SW		<b>Pic 8 Desc.</b>	Condition of trays and containment under toilets. Looking N.

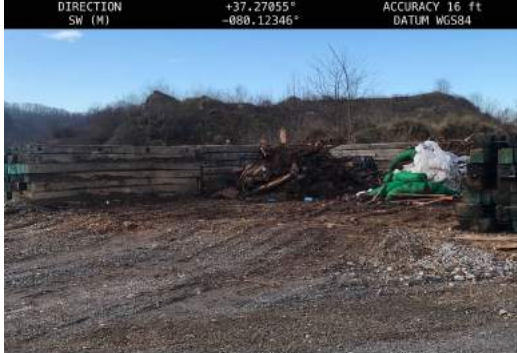
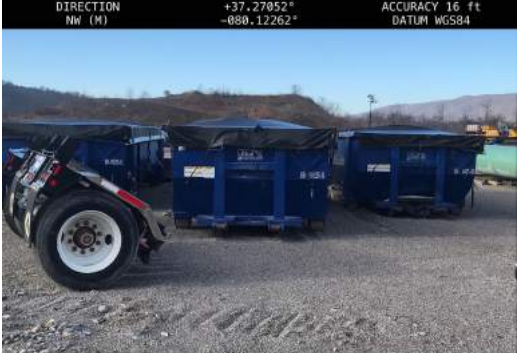
<b>GPS Location</b>	MVP-LY-049 See photo for gps data		<b>GPS Location</b>	MVP-LY-049 See photo for gps data	
<b>Field Station#</b>	+0		<b>Field Station#</b>	+0	
<b>Pic 9 Desc.</b>	Condition of temporary trash transfer pit. Debris inside boundary of pit. Looking W.		<b>Pic 10 Desc.</b>	No fluids or deposits around hazardous waste dumpsters. Looking NW.

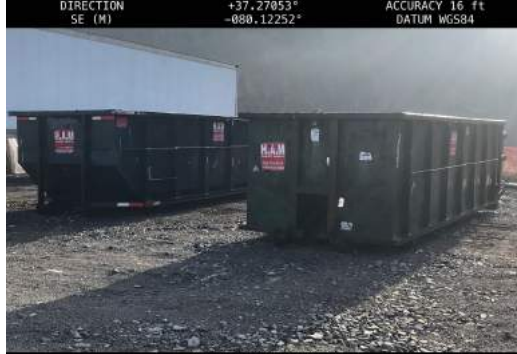
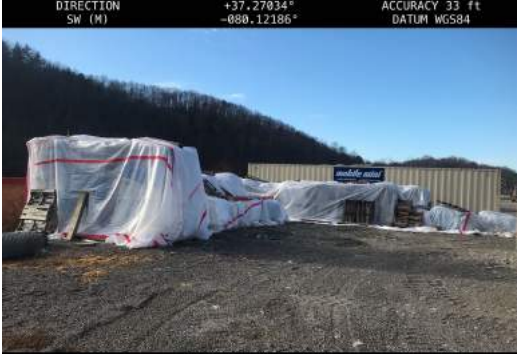
<b>Field Station#</b>	+0		<b>Field Station#</b>	+0	
<b>Pic 11 Desc.</b>	No loose trash around south dumpsters. Looking SE.		<b>Pic 12 Desc.</b>	Restoration supplies covered and protected from the elements. Looking SW.

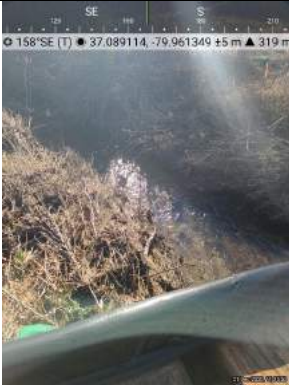
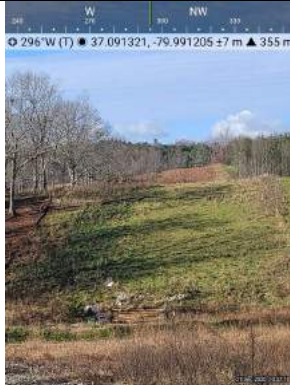
<b>GPS Location</b>	00000	<b>GPS Location</b>	00000		
<b>Field Station#</b>	13643+67	<b>Field Station#</b>	13539+39		
<b>Pic 1 Desc.</b>	Stream observation photo facing downstream, no environmental issues observed at the time of inspection		<b>Pic 2 Desc.</b>	Vegetation observation photo facing down row from stream/wetland , good coverage and ECDs in place and functioning

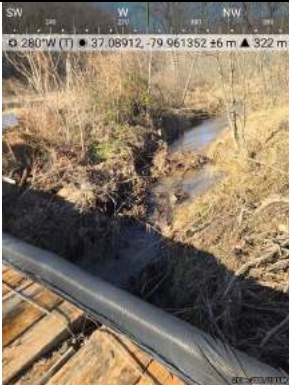
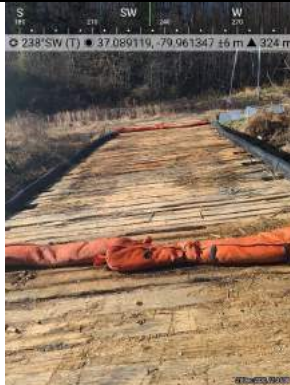
<b>GPS Location</b>	00000	<b>GPS Location</b>	00000		
<b>Field Station#</b>	13643+67	<b>Field Station#</b>	13643+67		
<b>Pic 3 Desc.</b>	Stream observation photo facing upstream, no environmental issues observed at the time of inspection		<b>Pic 4 Desc.</b>	Observed equipment bridge and protection, no issues observed at the time of inspection

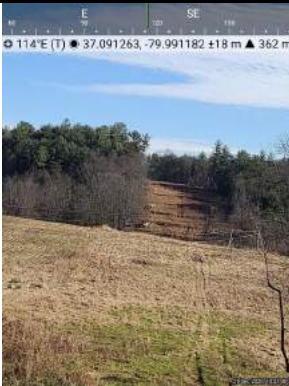
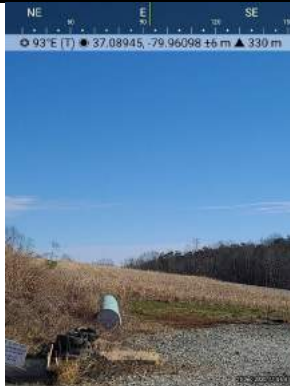
<b>Field Station#</b>	13541+82	<b>Field Station#</b>	13644+99		
<b>Pic 5 Desc.</b>	Vegetation observation photo facing up row from stream crossing showing good coverage		<b>Pic 6 Desc.</b>	Monitored vegetation growth during routine inspection today.

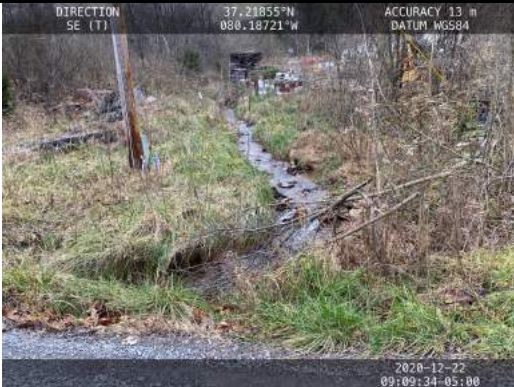
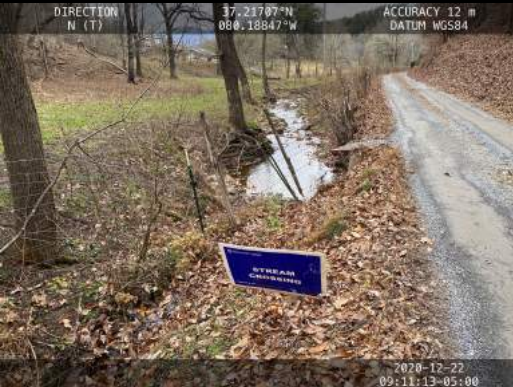
<b>GPS Location</b>	See photo		<b>GPS Location</b>	See photo	
<b>Field Station#</b>	12544+06		<b>Field Station#</b>	12544+06	
<b>Pic 1 Desc.</b>	Stream S-KL32, facing southeast, upstream from Yellow Finch Road		<b>Pic 2 Desc.</b>	Stream S-EF20b, facing north, downstream from Yellow Finch Road

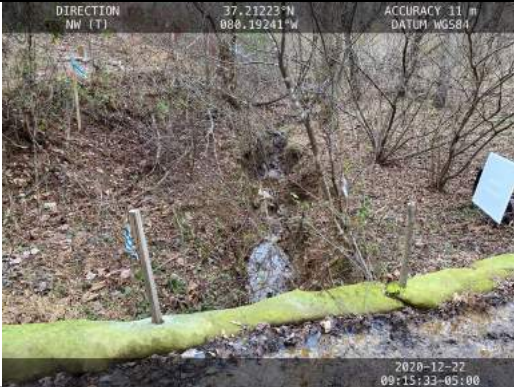
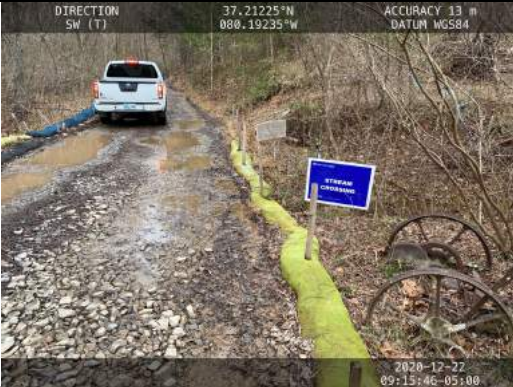
<b>GPS Location</b>	See photo		<b>GPS Location</b>	See photo	
<b>Field Station#</b>	12544+06		<b>Field Station#</b>	12544+06	
<b>Pic 3 Desc.</b>	Stream S-EF54, facing northwest, upstream from Yellow Finch Road		<b>Pic 4 Desc.</b>	Stream S-EF54 crossing on Yellow Finch, facing southwest

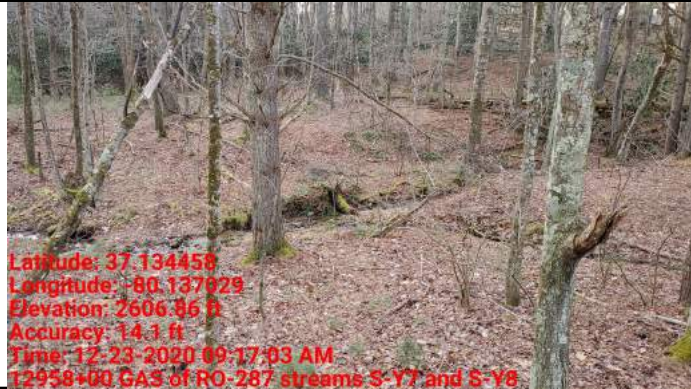
<p>Latitude: 37.134458 Longitude: -80.137929 Elevation: 2606.86 ft Accuracy: 14.1 ft Time: 12-23-2020 09:17:03 AM 12958+00 GAS of RO-287 streams S-Y7 and S-Y8</p>		  <p>Latitude: 37.134824 Longitude: -80.137781 Elevation: 2603.44 ft Accuracy: 25.9 ft Time: 12-23-2020 09:23:07 AM 12956+00 CIS of RO-287 sediment trap</p>

<b>GPS Location</b>	See pic for GPS location		<b>GPS Location</b>	See pic for GPS location	
<b>Field Station#</b>	12958+00		<b>Field Station#</b>	12956+00	
<b>Pic 3 Desc.</b>	Streams S-Y7 and S-Y8, where they merge on the downstream side of the project.		<b>Pic 4 Desc.</b>	Sediment trap on the CIS of access RO-287.

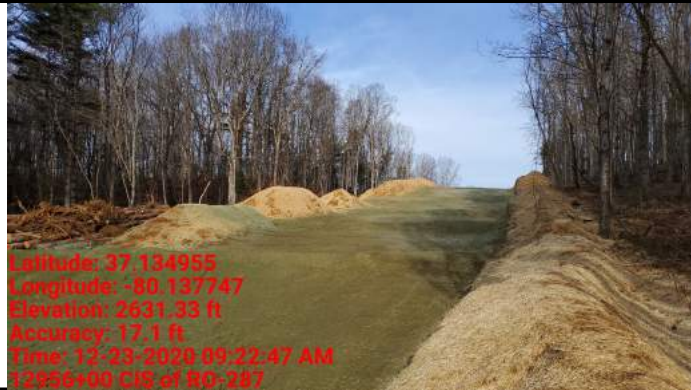
<p>Latitude: 37.134955 Longitude: -80.137747 Elevation: 2631.33 ft Accuracy: 17.1 ft Time: 12-23-2020 09:22:47 AM 12956+00 CIS of RO-287</p>		  <p>Latitude: 37.134840 Longitude: -80.137543 Elevation: 2656.87 ft Accuracy: 15.1 ft Time: 12-23-2020 09:22:26 AM 12956+00 CIS of RO-287</p>			
<b>GPS Location</b>	See pic for GPS location		<b>GPS Location</b>	See pic for GPS location	
<b>Field Station#</b>	12956+00		<b>Field Station#</b>	12956+00	
<b>Pic 5 Desc.</b>	Stabilized ROW on the CIS of RO-287. EarthGuard, straw mulch, and Curlex ECB applied.		<b>Pic 6 Desc.</b>	GAS of RO-287 has been stabilized with curlex from 12961+00 to 12966+00 approximately.

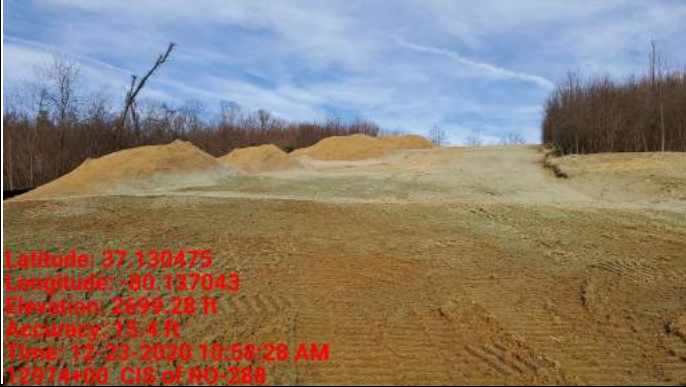
<p>Latitude: 37.130475 Longitude: -80.137043 Elevation: 2699.28 ft Accuracy: 15.4 ft Time: 12-23-2020 10:58:28 AM 12974+00 CIS of RO-288</p>

<p>Latitude: 37.137418 Longitude: -80.133882 Elevation: 2699.6 ft Accuracy: 209.6 ft Time: 12-23-2020 10:57:48 AM 12974+00 CIS of RO-288</p>		
GPS Location	See pic for GPS location		GPS Location	See pic for GPS location	
Field Station#	12974+00		Field Station#	12974+00	
Pic 7 Desc.	CIS of access road RO-288 stabilized with EarthGuard hydromulch. Soil piles and waterbars have ECB applied.		Pic 8 Desc.	GAS of access road RO-288 stabilized with EarthGuard hydromulch. Soil piles have straw mulch and waterbars have ECB applied.

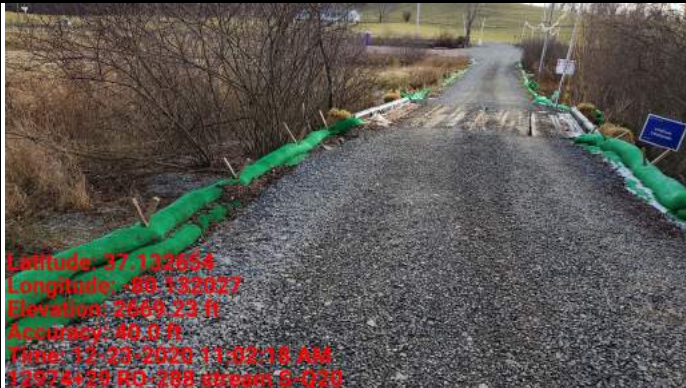
<p>Latitude: 37.132654 Longitude: -80.132927 Elevation: 2469.23 ft Accuracy: 80.0 ft Time: 12-23-2020 11:02:38 AM 12974+29 RO-288 stream S-Q20</p>

GPS Location	See pic for GPS location		GPS Location	See pic for GPS location	
Field Station#	12974+29		Field Station#	12994+20	
Pic 9 Desc.	Access road RO-288 at stream S-Q20.		Pic 10 Desc.	GAS of the US-221 road crossing. Well stabilized with vegetation.

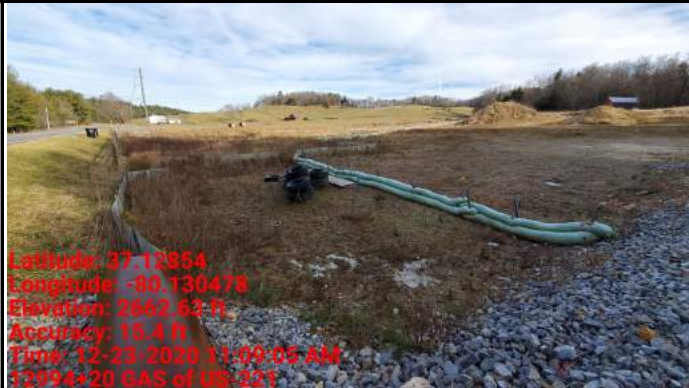
<p>Latitude: 37.12854 Longitude: -80.130478 Elevation: 2462.62 ft Accuracy: 18.4 ft Time: 12-23-2020 11:09:05 AM 12994+20 GAS of US-221</p>

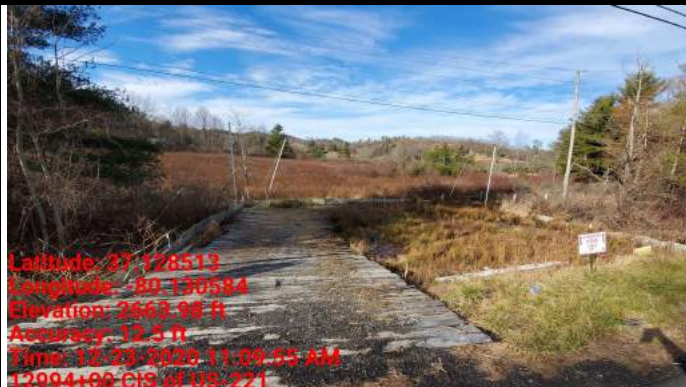
<p>Latitude: 37.128513 Longitude: -80.130584 Elevation: 2663.98 ft Accuracy: 12.5 ft Time: 12-23-2020 11:04:03 AM 12994+00 CIS of US-221</p>

<p>Latitude: 37.125917 Longitude: -80.125454 Elevation: 3711.94 ft Accuracy: 12.5 ft Time: 12-23-2020 11:27:18 AM 13012+40 CIS of the BRP motorway</p>		
GPS Location	See pic for GPS location		GPS Location	See pic for GPS location	
Field Station#	12994+00		Field Station#	13012+40	
Pic 11 Desc.	CIS of the US-221 road crossing well stabilized with vegetation.		Pic 12 Desc.	CIS of the BRP motorway stabilized with substantial vegetation.

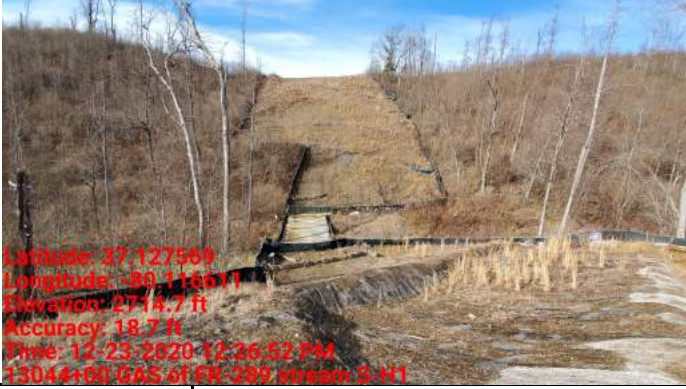
<b>GPS Location</b>	See pic for GPS location		<b>GPS Location</b>	See pic for GPS location	
<b>Field Station#</b>	13044+00		<b>Field Station#</b>	12974+29	
<b>Pic 15 Desc.</b>	Stream S-H1 on the GAS of access road FR-289.		<b>Pic 16 Desc.</b>	Geotech left after mats removed blown by wind leaving bare soil exposed to possible erosion. Added to punch list.

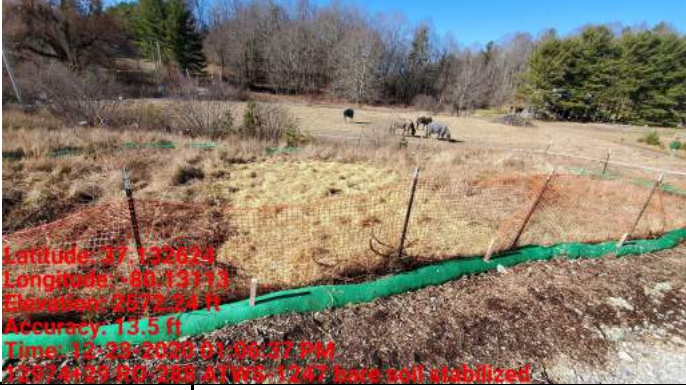
<b>GPS Location</b>	See pic for GPS location		<b>GPS Location</b>	See pic for GPS location	
<b>Field Station#</b>	12974+29		<b>Field Station#</b>	13115+50	
<b>Pic 17 Desc.</b>	Bare soil seeded and straw mulched, removed from punch list after completion.		<b>Pic 18 Desc.</b>	CIS of access FR-291 disturbed area stabilized with curlex ECB and straw mulch.

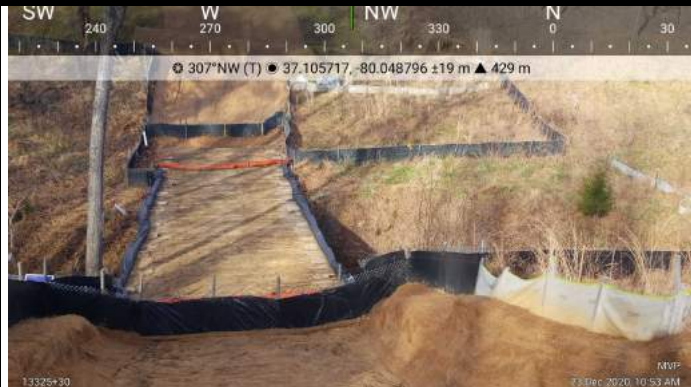
GPS Location	See Above		GPS Location	See Above	
Field Station#	13325+30		Field Station#	13329+00	
Pic 3 Desc.	Overview of Waterbody S-GH14. ECDs are functional and ROW is stable.		Pic 4 Desc.	ROW Overview. ECDs are functional and ROW is stable.

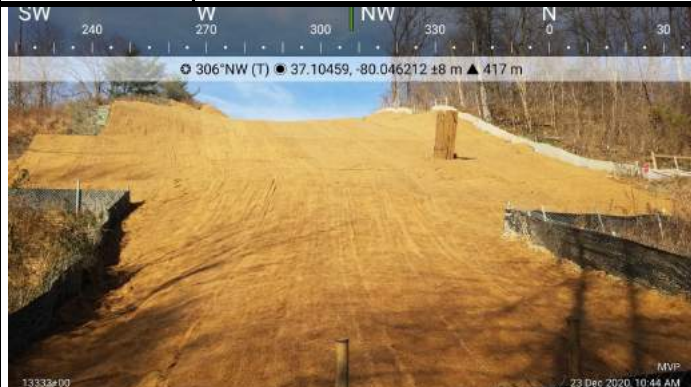
GPS Location	See Above		GPS Location	See Above	
Field Station#	13333+00		Field Station#	13334+17	
Pic 5 Desc.	ROW Overview. ECDs are functional and ROW is stable.		Pic 6 Desc.	Overview of Waterbody S-GH11. ECDs are functional and ROW is stable.

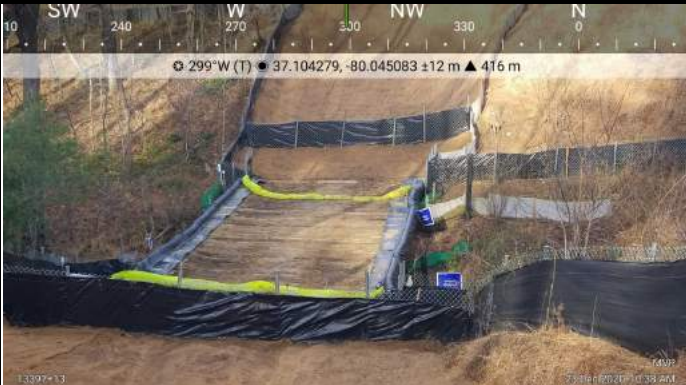
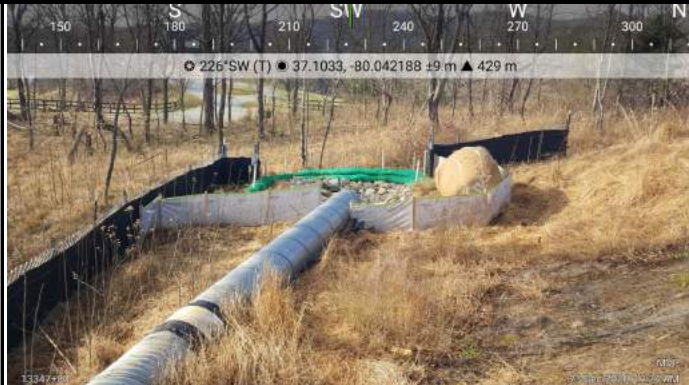
<b>GPS Location</b>	See Above		<b>GPS Location</b>	See Above	
<b>Field Station#</b>	13337+13		<b>Field Station#</b>	13347+80	
<b>Pic 7 Desc.</b>	Overview of Waterbody S-GH9. ECDs are functional and ROW is stable.		<b>Pic 8 Desc.</b>	Cleanwater diversion pipe outlet. ECDs are functional and ROW is stable.

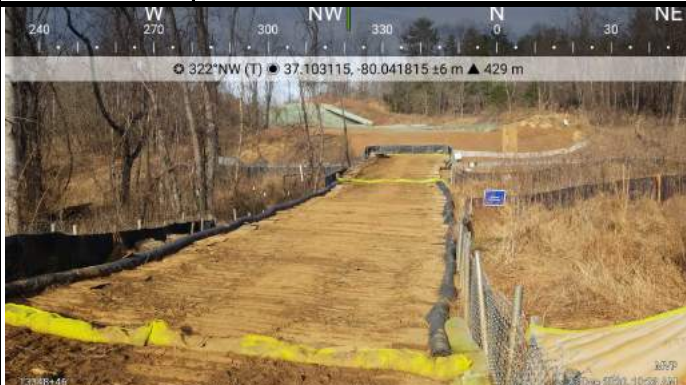
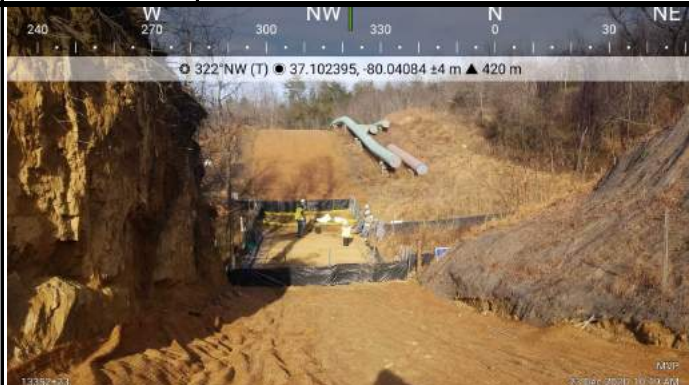
<b>GPS Location</b>	See Above		<b>GPS Location</b>	See Above	
<b>Field Station#</b>	13348+46		<b>Field Station#</b>	13352+23	
<b>Pic 9 Desc.</b>	Waterbody S-RR08. ECDs are functional and ROW is stable.		<b>Pic 10 Desc.</b>	Environmental Crews working on general maintenance (cleaning bridge) at Waterbody S-RR09. ECDs are functional.

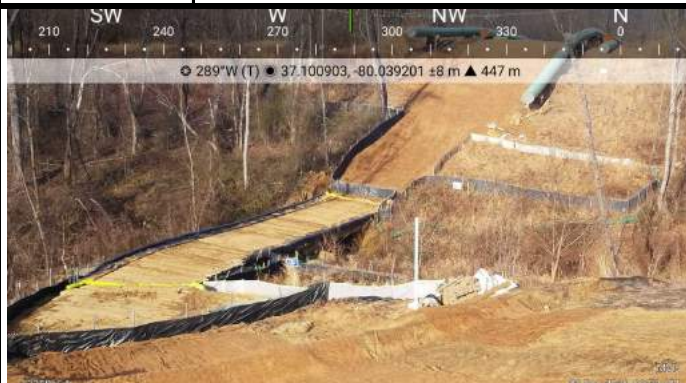
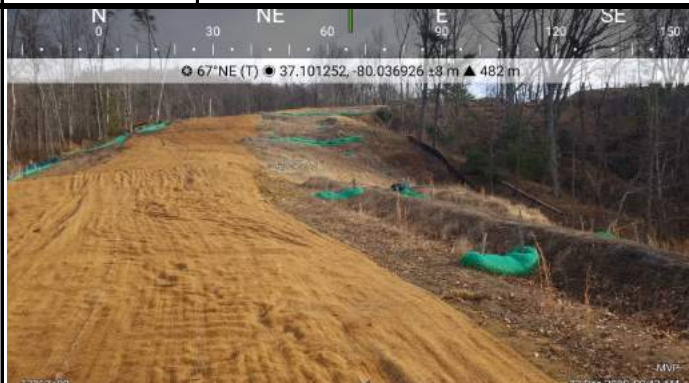
<b>GPS Location</b>	See Above		<b>GPS Location</b>	See Above	
<b>Field Station#</b>	13358+64		<b>Field Station#</b>	13367+00	
<b>Pic 11 Desc.</b>	Waterbody S-RR11. ECDs are functional and ROW is stable.		<b>Pic 12 Desc.</b>	ROW Overview. ECDs are functional and ROW is stable.

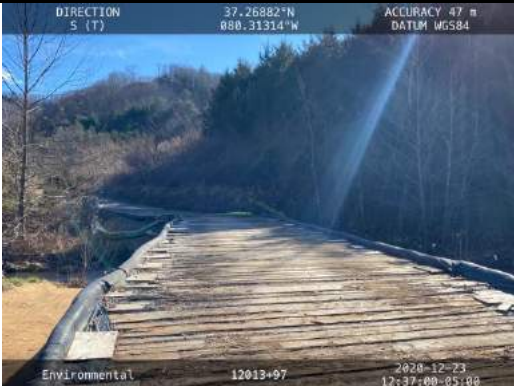
<b>Pic 5 Desc.</b>	Bridge and ECDs crossing S-G36 are in acceptable condition.		<b>Pic 6 Desc.</b>	Stabilized ROW with acceptable vegetative coverage across LOD

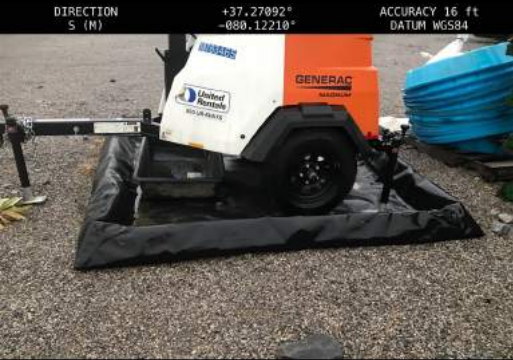
<b>GPS Location</b>	MVP-LY-049 See photo for gps data	<b>GPS Location</b>	MVP-LY-049 See photo for gps data		
<b>Field Station#</b>	+0	<b>Field Station#</b>	+0		
<b>Pic 1 Desc.</b>	Condition of rock entrance on center drive. No sediment on stone. Looking SE.	<b>Pic 2 Desc.</b>	Condition of containment under light plant. Free of stormwater. Looking S.

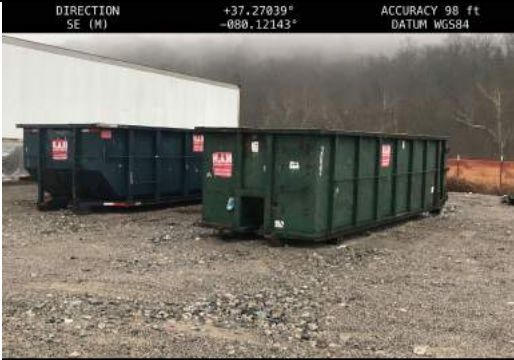
<b>GPS Location</b>	MVP-LY-049 See photo for gps data	<b>GPS Location</b>	MVP-LY-049 See photo for gps data		
<b>Field Station#</b>	+0	<b>Field Station#</b>	+0		
<b>Pic 3 Desc.</b>	No loose trash around south dumpsters. Looking SE.	<b>Pic 4 Desc.</b>	No deposits or fluids around hazardous waste dumpsters. Looking NW.

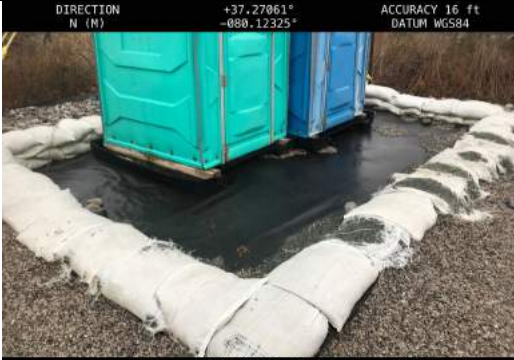
<b>Field Station#</b>	+0	<b>Field Station#</b>	+0		
<b>Pic 5 Desc.</b>	Condition of trays and containment under toilets. Looking NE.	<b>Pic 6 Desc.</b>	Condition of temporary trash transfer pit. Debris inside boundary of the pit. Looking W.

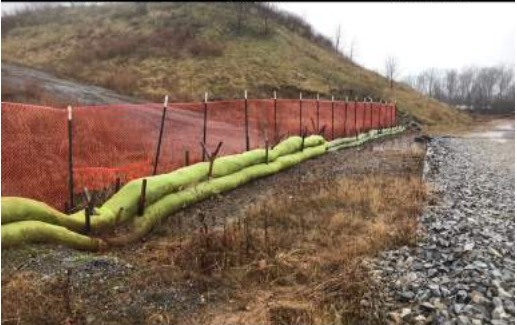
MVP-LY-049_122420 Landowner disturbance along CFS 6 feature 2020-12-24 09:02:09-05:00		MVP-LY-049_122420 Landowner disturbance within 66' of feature 2020-12-24 09:02:18-05:00			
<b>GPS Location</b>	MVP-LY-049 See photo for gps data		<b>GPS Location</b>	MVP-LY-049 See photo for gps data	
<b>Field Station#</b>	+0		<b>Field Station#</b>	+0	
<b>Pic 13 Desc.</b>	Landowner soil disturbance along compost filter sock and feature W-CV21B. Area not stabilized. No impacts. Looking S.		<b>Pic 14 Desc.</b>	Landowner soil disturbance within 66' and 120' of feature W-CV21B. Area not stabilized. No impacts. Looking SW.	
DIRECTION NE (M) +37.27035° -080.12486° ACCURACY 16 ft DATUM WGS84

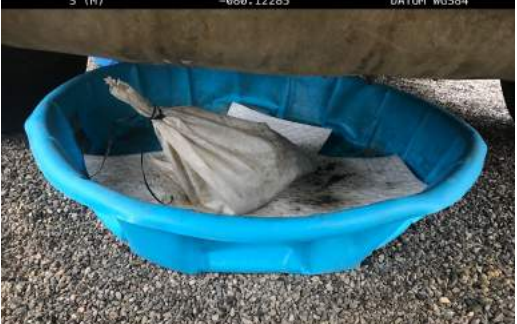
MVP-LY-049_122420 Landowner disturbance along feature 2020-12-24 09:02:49-05:00		MVP-LY-049_122420 Containment under stored vehicle 2020-12-24 09:04:53-05:00			
<b>GPS Location</b>	MVP-LY-049 See photo for gps data		<b>GPS Location</b>	MVP-LY-049 See photo for gps data	
<b>Field Station#</b>	+0		<b>Field Station#</b>	+0	
<b>Pic 15 Desc.</b>	Landowner soil disturbance along feature W-CV21A. Looking NE.		<b>Pic 16 Desc.</b>	Condition of containment under stored vehicle. Looking S.	
DIRECTION NE (M) +37.27009° -080.12263° ACCURACY 16 ft DATUM WGS84   		DIRECTION E (M) +37.27101° -080.12006° ACCURACY 16 ft DATUM WGS84

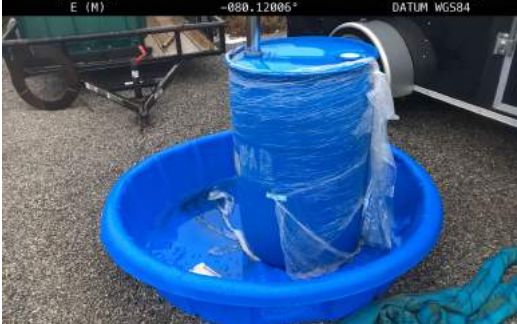
MVP-LY-049_122420 Containment under stored vehicle 2020-12-24 09:08:36-05:00		MVP-LY-049_122420 Barrel of toilet chemical in 2020-12-24 09:10:22-05:00			
<b>GPS Location</b>	MVP-LY-049 See photo for gps data		<b>GPS Location</b>	MVP-LY-049 See photo for gps data	
<b>Field Station#</b>	+0		<b>Field Station#</b>	+0

<b>Pic 17 Desc.</b>	Condition of containment under stored vehicle. Looking NE.		<b>Pic 18 Desc.</b>	Condition of containment under barrel of toilet chemical. Free of stormwater. Looking E.

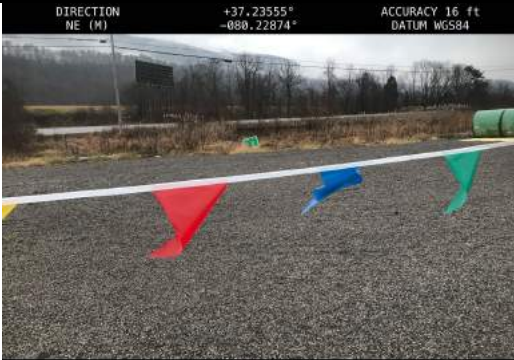
<p>DIRECTION NE (M) +37.23555° -080.22874° ACCURACY 16 ft DATUM WGS84</p> <p>MVP-PY-006_122420 Condition of buffer flagging 2020-12-24 07:56:05-05:00</p>

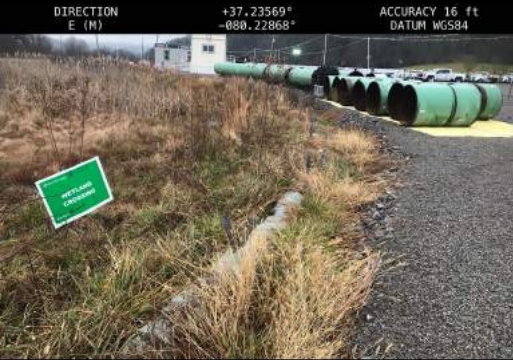
<p>DIRECTION E (M) +37.23569° -080.22868° ACCURACY 16 ft DATUM WGS84</p> <p>MVP-PY-006_122420 Condition of CFS &amp; signage at feature 2020-12-24 07:56:24-05:00</p>			
<b>GPS Location</b>	MVP-PY-006 See photo for gps data		<b>GPS Location</b>	MVP-PY-006 See photo for gps data	
<b>Field Station#</b>	+0		<b>Field Station#</b>	+0	
<b>Pic 1 Desc.</b>	Condition of buffer flagging for feature W-008. Looking NE.		<b>Pic 2 Desc.</b>	Condition of compost filter sock and signage for feature W-008. Looking E.

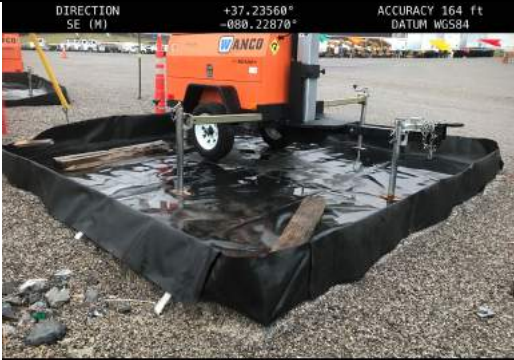
<p>DIRECTION SE (M) +37.23560° -080.22870° ACCURACY 164 ft DATUM WGS84</p> <p>MVP-PY-006_122420 Condition of containment 2020-12-24 07:56:52-05:00</p>

<b>GPS Location</b>	MVP-PY-006 See photo for gps data		<b>GPS Location</b>	MVP-PY-006 See photo for gps data	
<b>Field Station#</b>	+0		<b>Field Station#</b>	+0	
<b>Pic 3 Desc.</b>	Condition of containment under light plant. Free of stormwater. Looking SE.		<b>Pic 4 Desc.</b>	Condition of west rock entrance. No sediment on stone. Looking SW.

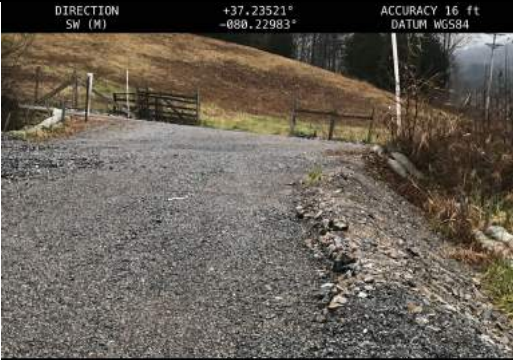
<p>DIRECTION SW (M) +37.23521° -080.22983° ACCURACY 16 ft DATUM WGS84</p> <p>MVP-PY-006_122420 Condition of rock entrance 2020-12-24 07:58:06-05:00</p>

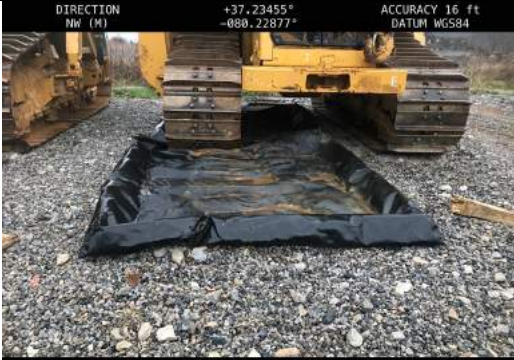
<p>DIRECTION NW (M) +37.23455° -080.22877° ACCURACY 16 ft DATUM WGS84</p> <p>MVP-PY-006_122420 Containment under stored equipment 2020-12-24 08:01:57-05:00</p>

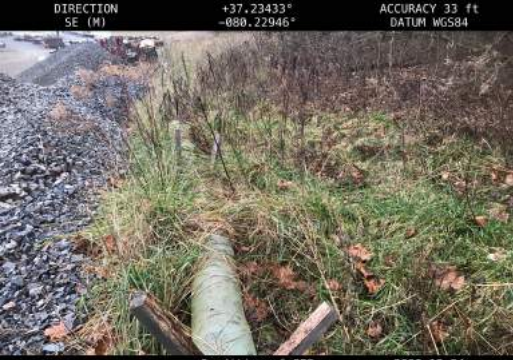
<p>DIRECTION SE (M) +37.23433° -080.22946° ACCURACY 33 ft DATUM WGS84</p> <p>MVP-PY-006_122420 Condition of CFS along LOD 2020-12-24 08:04:44-05:00</p>			
<b>GPS Location</b>	MVP-PY-006 See photo for gps data		<b>GPS Location</b>	MVP-PY-006 See photo for gps data	
<b>Field Station#</b>	+0		<b>Field Station#</b>	+0	
<b>Pic 5 Desc.</b>	Condition of containment under stored equipment. Looking NW.		<b>Pic 6 Desc.</b>	Condition of compost filter sock along north LOD. Looking SE.

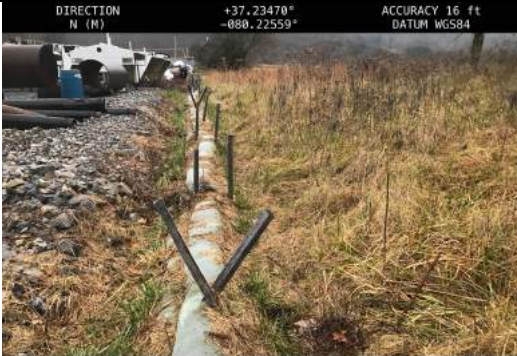
<b>GPS Location</b>	MVP-PY-006 See photo for gps data	<b>GPS Location</b>	MVP-PY-006 See photo for gps data		
<b>Field Station#</b>	+0	<b>Field Station#</b>	+0		
<b>Pic 7 Desc.</b>	Condition of compost filter sock along east LOD. Looking N.	<b>Pic 8 Desc.</b>	No deposits or fluids around hazardous waste dumpsters west of the mechanics building. Looking E.

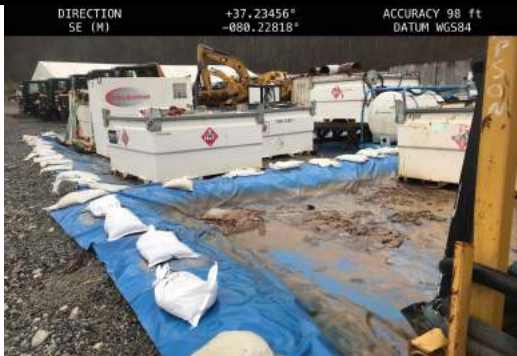
<b>GPS Location</b>	MVP-PY-006 See photo for gps data	<b>GPS Location</b>	MVP-PY-006 See photo for gps data		
<b>Field Station#</b>	+0	<b>Field Station#</b>	+0		
<b>Pic 9 Desc.</b>	Condition of containments. Free of stormwater. Looking SE.	<b>Pic 10 Desc.</b>	Condition of trays and containment under toilets. Looking NE.

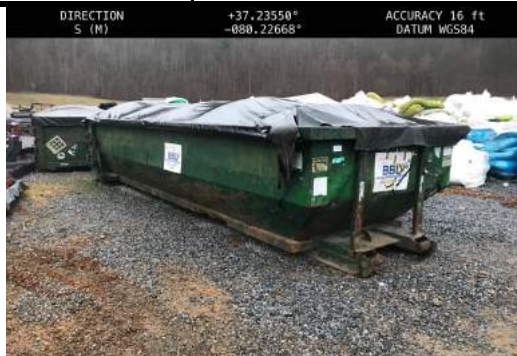
<b>Field Station#</b>	+0	<b>Field Station#</b>	+0		
<b>Pic 11 Desc.</b>	No fluids or deposits around hazardous waste dumpsters. Looking S.	<b>Pic 12 Desc.</b>	No loose trash around dumpsters. Looking SE.

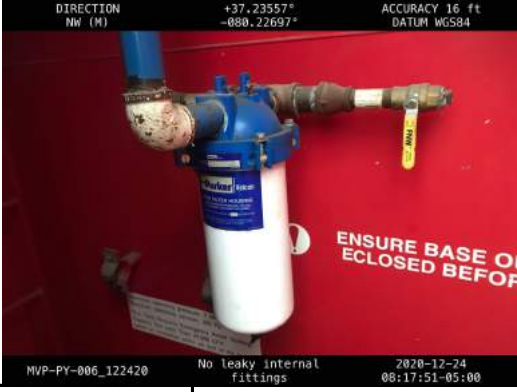
<b>Pic 17 Desc.</b>	Off Road Fuel unit no leaky internal fittings. Looking NW.		<b>Pic 18 Desc.</b>	Blue Bulk Fuel tanks no leaky fittings or nozzles. Looking N.
