Visual Site Inspection Report

Project Name	H-600 Pipeline Spread H	AFE	124300138	Spread	H-600 Pipeline Spread H
Contractor	Precision			Report #	18508
Inspector	John Brcic			Date/Time	12/28/2020 12:01 PM
Permit #	TBD	Inspection Type	VA SWPP	Station Begin	12443+75
State	VA	Inspection Area	Partial	Station End	12544+06
County	Montgomery	Ground	Damp	Temperature (°F)	31.00
Municipality	N/A	Weather	Cloudy	Rain Gauge (in)	0.00
				Rain Accumulation Time (days)	2.00

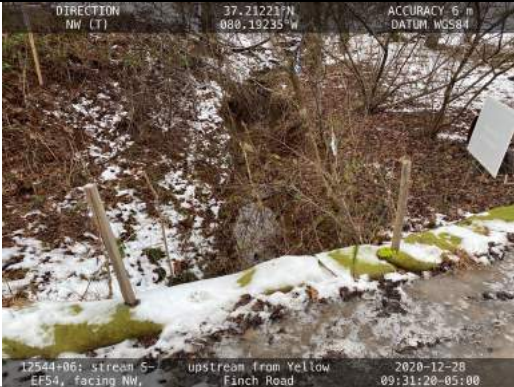
GPS Location	See photo		GPS Location	See photo	
Field Station#	12544+06		Field Station#	12544+54	
Pic 3 Desc.	Stream S-EF54, facing northwest, upstream from Yellow Finch Road		Pic 4 Desc.	Stream S-EF20a, facing northeast, downstream

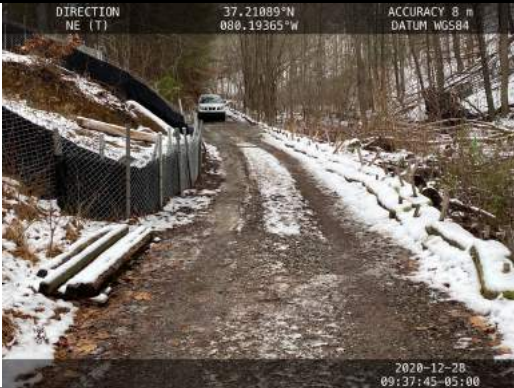
GPS Location	See photo		GPS Location	See photo	
Field Station#	12544+06		Field Station#	12543+00	
Pic 5 Desc.	MVP ROW crossing on Yellow Finch Road, facing northeast		Pic 6 Desc.	Plastic sheeting intact and secure on stockpiles nearest to Yellow Finch Road.

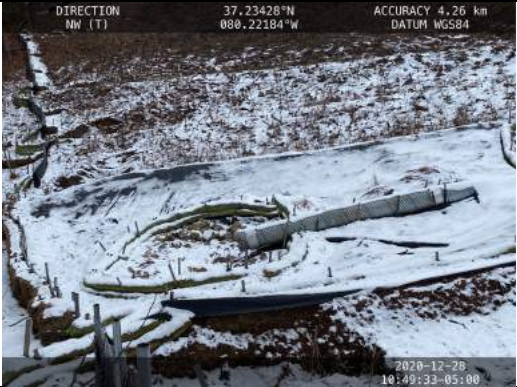
GPS Location	See photo		GPS Location	See photo	
Field Station#	12523+00		Field Station#	12503+70	
Pic 13 Desc.	Slope on going away side of stream S-EF19 is stable.		Pic 14 Desc.	Clean water diversion pipe outlet plunge pool in good repair, free of sediment.

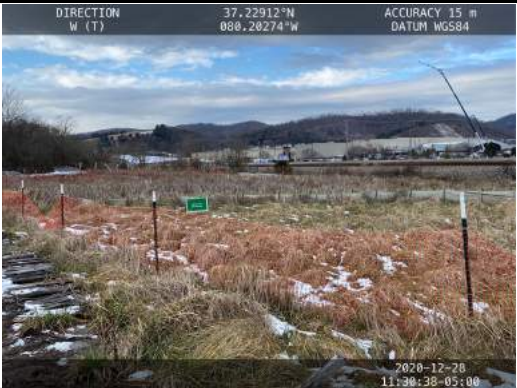
GPS Location	See photo		GPS Location	See photo	
Field Station#	12506+00		Field Station#	12460+75	
Pic 15 Desc.	Slope on going away side of clean water diversion pipe remains stable.		Pic 16 Desc.	Wetland W-KL58, facing west

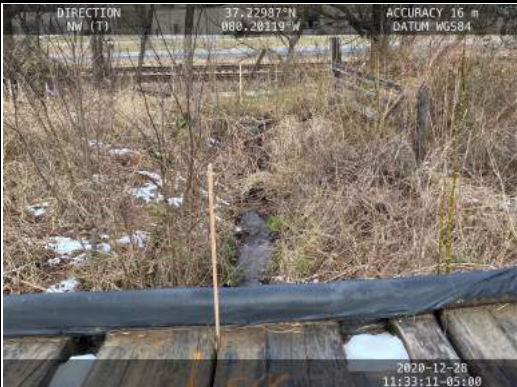
GPS Location	See photo		GPS Location	See photo	
Field Station#	12455+21		Field Station#	12444+94	
Pic 17 Desc.	Stream S-CD12, facing northwest, downstream		Pic 18 Desc.	Stream S-I1, facing southwest, upstream

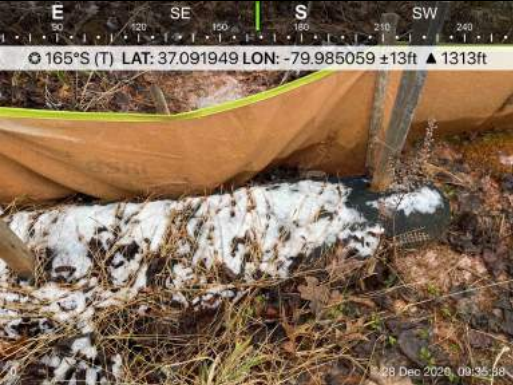
GPS Location	See photo		GPS Location	See photo	
Field Station#	13533+52		Field Station#	13560+00	
Pic 1 Desc.	Equipment bridge sideboard needs to be repaired.		Pic 2 Desc.	P1 has been damaged and needs to be replaced.

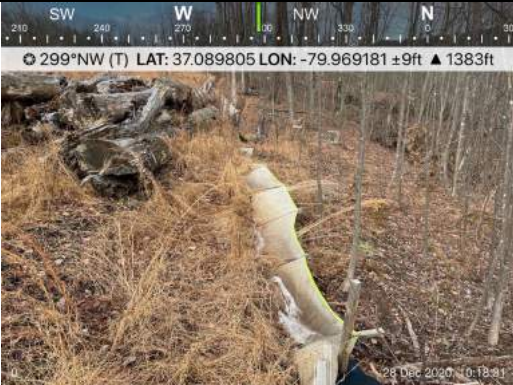
GPS Location	See photo		GPS Location	See photo	
Field Station#	13573+00		Field Station#	13600+00	
Pic 3 Desc.	P1 has been damaged and needs to be replaced.		Pic 4 Desc.	P1 has been damaged and needs to be replaced.

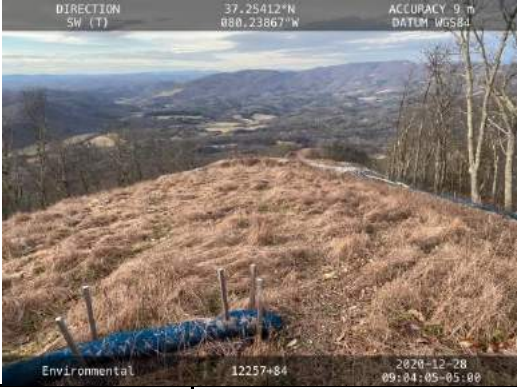
GPS Location	See photo for GPS coordinates		GPS Location	See photo for GPS coordinates	
Field Station#	12257+84		Field Station#	12255+00	
Pic 7 Desc.	Stabilized ROW with acceptable vegetative coverage across LOD		Pic 8 Desc.	Permanent water bars down stabilized hill side in acceptable condition with acceptable vegetation across LOD

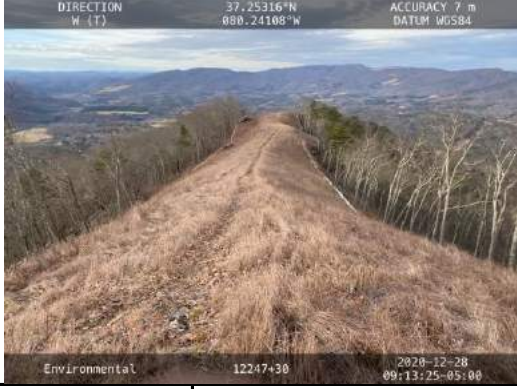
GPS Location	See photo for GPS coordinates		GPS Location	See photo for GPS coordinates	
Field Station#	12247+30		Field Station#	12240+00	
Pic 9 Desc.	Stabilized ROW with acceptable vegetation across LOD		Pic 10 Desc.	Stabilized hill with acceptable vegetation across LOD

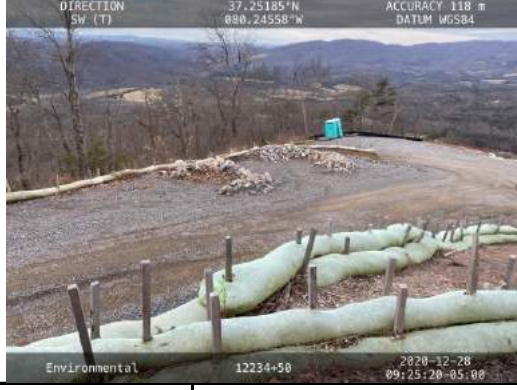
GPS Location	See photo for GPS coordinates		GPS Location	See photo for GPS coordinates	
Field Station#	12234+50		Field Station#	12234+06	
Pic 11 Desc.	Rock checks along side of MVP-MN-276.03 just before the switch back to prevent sediment from crossing and exiting the LOD.		Pic 12 Desc.	Portable toilets tied down and secured with secondary containment underneath

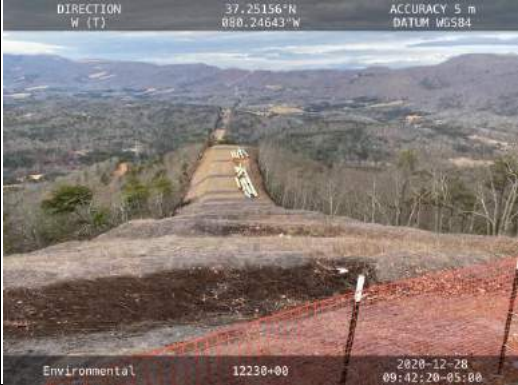
GPS Location	See photo for GPS coordinates		GPS Location	See photo for GPS coordinates	
Field Station#	12230+00		Field Station#	12192+66	
Pic 13 Desc.	Stabilized ROW with acceptable vegetative coverage across LOD		Pic 14 Desc.	Bridge and ECDs at S-C21 in acceptable condition

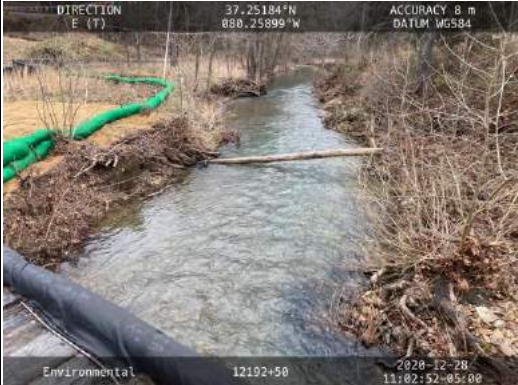
GPS Location	See photo for GPS coordinates		GPS Location	See photo for GPS coordinates	
Field Station#	12192+50		Field Station#	12198+90	
Pic 15 Desc.	Down stream of S-C21 in acceptable condition		Pic 16 Desc.	Access Road MVP-MN-275 in acceptable condition.	
Insert image here			Insert image here		
GPS Location			GPS Location		
Field Station#			Field Station#		
Pic 17 Desc.			Pic 18 Desc.

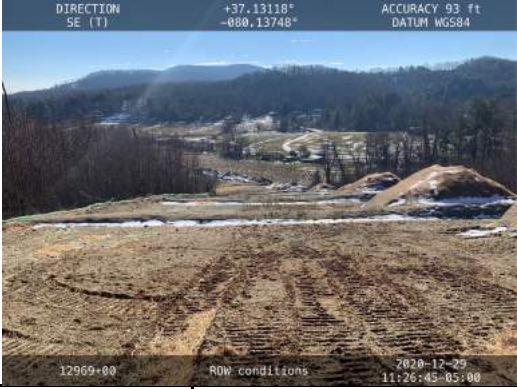
<p>DIRECTION SE (T) +37.13118° -080.13748° ACCURACY 93 ft DATUM WGS84</p> <p>12969+00 ROW conditions 2020-12-29 11:26:43-05:00</p>

<p>DIRECTION SE (T) +37.13049° -080.13717° ACCURACY 25 ft DATUM WGS84</p> <p>12975+00 ROW conditions 2020-12-29 11:31:29-05:00</p>			
GPS Location	See pic for GPS location		GPS Location	See pic for GPS location	
Field Station#	12969+00		Field Station#	12975+00	
Pic 13 Desc.	CIS of RO-288 stabilized with EarthGuard and no erosion issues found.		Pic 14 Desc.	GAS of RO-288 remains in compliance.

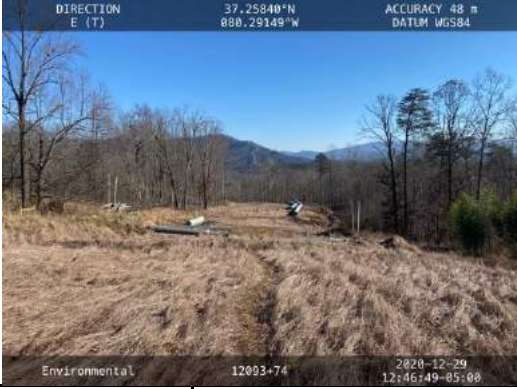
GPS Location	See photo for GPS coordinates		GPS Location	See photo for GPS coordinates	
Field Station#	12093+74		Field Station#	12098+44	
Pic 7 Desc.	Stabilized ROW with acceptable vegetative coverage across LOD		Pic 8 Desc.	Bridge and ECDs at S-MM13 in acceptable condition

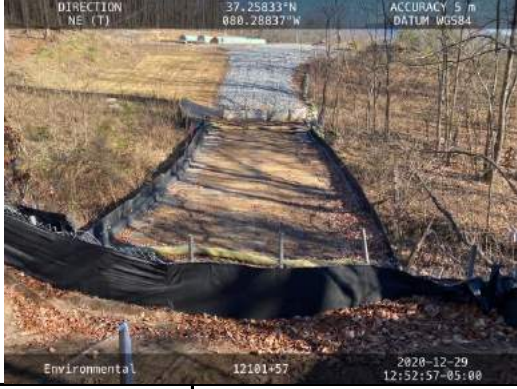
GPS Location	See photo for GPS coordinates		GPS Location	See photo for GPS coordinates	
Field Station#	12101+57		Field Station#	12108+41	
Pic 9 Desc.	Bridge and ECDs at S-MM11 in acceptable condition.		Pic 10 Desc.	Bridge and ECDs at S-F15 in acceptable condition.

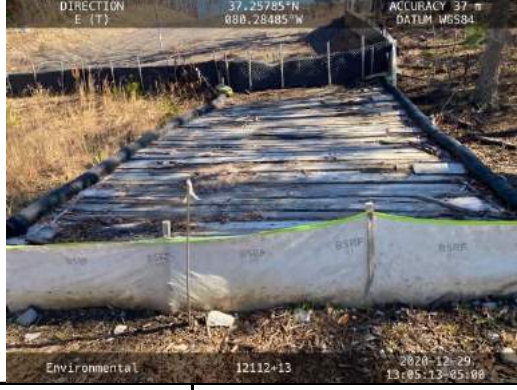
GPS Location	See photo for GPS coordinates		GPS Location	See photo for GPS coordinates	
Field Station#	12112+13		Field Station#	12116+45	
Pic 11 Desc.	Bridge and ECDs at S-F16A/B I'm acceptable condition		Pic 12 Desc.	Stabilized ROW with acceptable vegetation across LOD

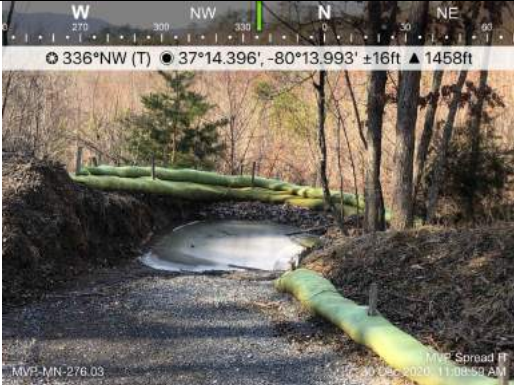
GPS Location	See Picture Watermark		GPS Location	See Picture Watermark	
Field Station#	12234+50		Field Station#	12234+50	
Pic 1 Desc.	Sump pit treatment along MVP-MN-276.03 is in good condition.		Pic 2 Desc.	Start of inspection area. CFS and ROW controls remain in good condition.

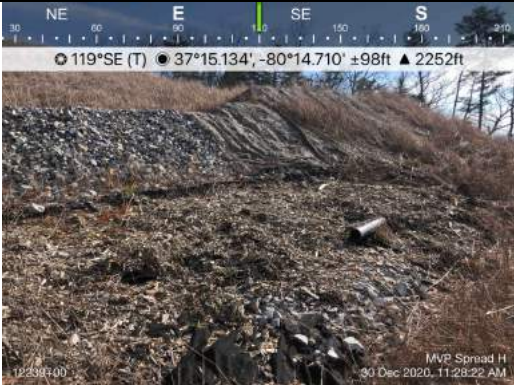
GPS Location	See Picture Watermark		GPS Location	See Picture Watermark	
Field Station#	12239+00		Field Station#	12283+00	
Pic 3 Desc.	Trench drain and waterbar/end treatment in good condition.		Pic 4 Desc.	Waterbar sump pit and end treatment in good condition.

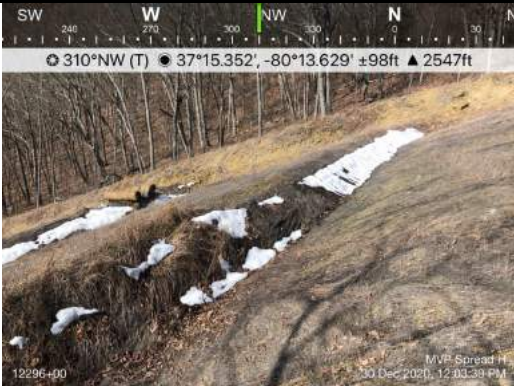
GPS Location	See Picture Watermark		GPS Location	See Picture Watermark	
Field Station#	12296+00		Field Station#	12300+00	
Pic 5 Desc.	Waterbars and end treatments on GAS Reese "V" are in good condition.		Pic 6 Desc.	Material stored on ROW remains stable and in good condition.

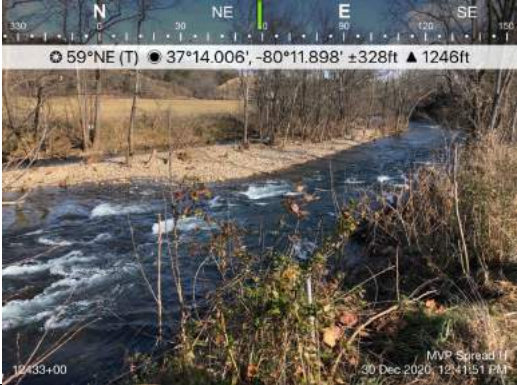
GPS Location	See Picture Watermark		GPS Location	See Picture Watermark	
Field Station#	12443+00		Field Station#	12443+25	
Pic 7 Desc.	Roanoke River (S-NN16) is in good condition, and the buffer zone remains undisturbed.		Pic 8 Desc.	CIS Route 11 controls are in good condition, and the ROW remains well vegetated.

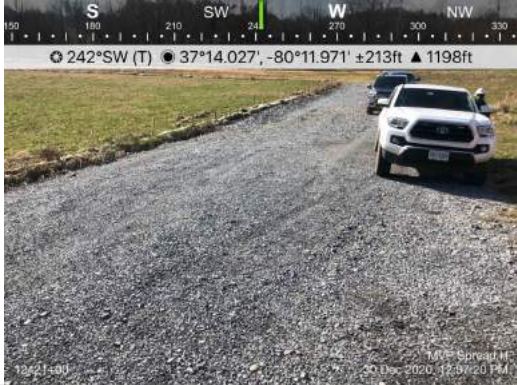
GPS Location	See Picture Watermark		GPS Location	See Picture Watermark	
Field Station#	12421+00		Field Station#	12429+00	
Pic 9 Desc.	Rock construction entrance is in good condition, and no tracked sediment was observed.		Pic 10 Desc.	CWD berm on CIS Roanoke River is in good condition.

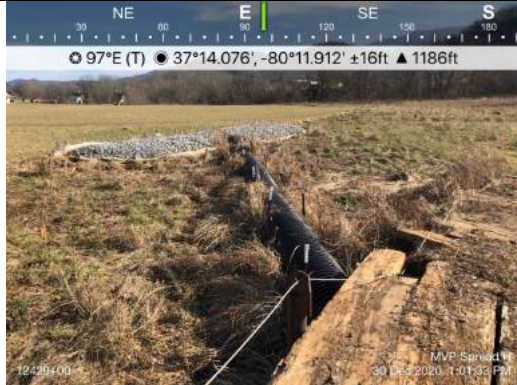
GPS Location	See Picture Watermark		GPS Location	See Picture Watermark	
Field Station#	12429+00		Field Station#	12420+00	
Pic 11 Desc.	CWD pipe and outlet are in good condition.		Pic 12 Desc.	Environmental crews maintaining BSRF on CIS railroad tracks.

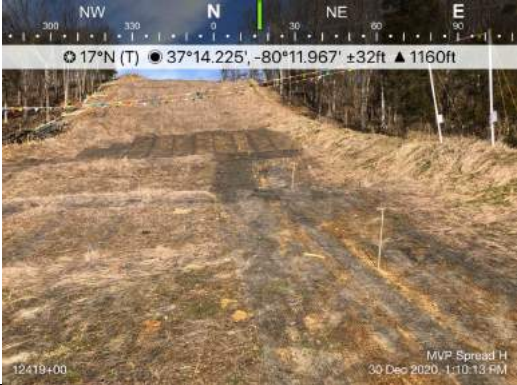
GPS Location	See Picture Watermark		GPS Location	See Picture Watermark	
Field Station#	12419+00		Field Station#	12409+00	
Pic 13 Desc.	ROW remains well stabilized with vegetation and erosion control matting.		Pic 14 Desc.	CWD pipe inlet is in good condition, and no accumulated sediment was observed.

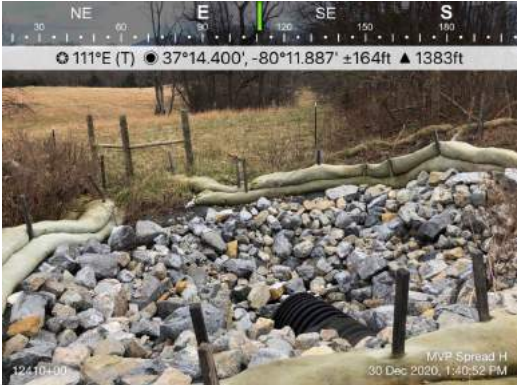
GPS Location	See Picture Watermark		GPS Location	See Picture Watermark	
Field Station#	12410+00		Field Station#	12380+00	
Pic 15 Desc.	CWD pipe outlet and plunge pool are in good condition.		Pic 16 Desc.	Stream S-NN19 is in good condition and the resource buffer remains undisturbed.

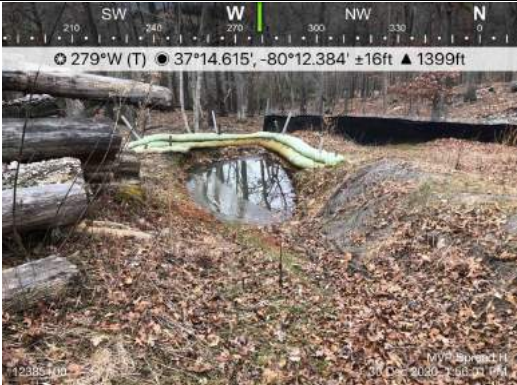
GPS Location	See Picture Watermark		GPS Location	See Picture Watermark	
Field Station#	12385+00		Field Station#	12409+50	
Pic 17 Desc.	Sump pit end treatment is in good condition.		Pic 18 Desc.	Sediment controls within MLV-27 area are in good condition.

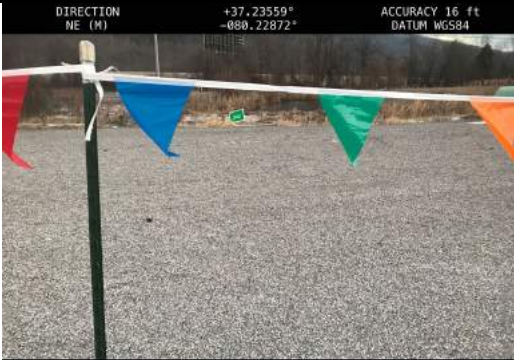
GPS Location	MVP-PY-006 See photo for gps data		GPS Location	MVP-PY-006 See photo for gps data	
Field Station#	+0		Field Station#	+0	
Pic 1 Desc.	Condition of buffer flagging for feature W-008. Looking NE.		Pic 2 Desc.	Condition of signage and compost filter sock along south edge of feature W-008. Looking E.

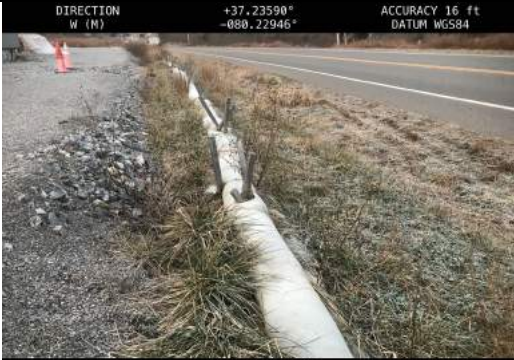
GPS Location	MVP-PY-006 See photo for gps data		GPS Location	MVP-PY-006 See photo for gps data	
Field Station#	+0		Field Station#	+0	
Pic 3 Desc.	Condition of compost filter sock along north LOD. Looking W.		Pic 4 Desc.	Condition of compost filter sock along west LOD. Looking SE.

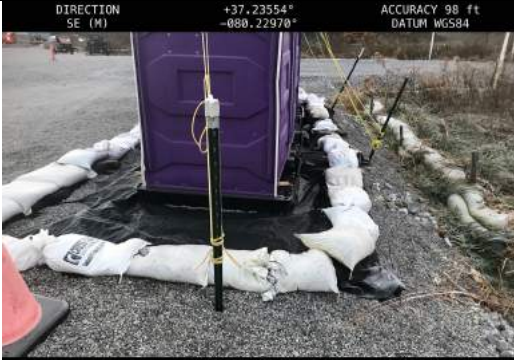
GPS Location	MVP-PY-006 See photo for gps data		GPS Location	MVP-PY-006 See photo for gps data	
Field Station#	+0		Field Station#	+0	
Pic 5 Desc.	Condition of trays and containment under toilets. Looking SE.		Pic 6 Desc.	Condition of west rock entrance. No sediment on stone. Looking SW.

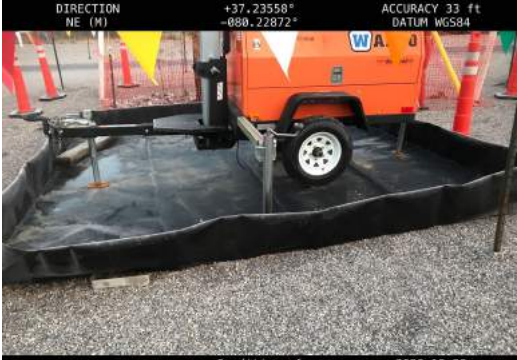
<p>DIRECTION NE (M) +37.23558° -080.22872° ACCURACY 33 ft DATUM WGS84</p> <p>MVP-PY-006_123020 Condition of containment 2020-12-30 07:30:05-05:00</p>

<p>DIRECTION W (M) +37.23572° -080.22678° ACCURACY 16 ft DATUM WGS84</p> <p>MVP-PY-006_123020 No leaky internal fittings 2020-12-30 07:48:45-05:00</p>			
GPS Location	MVP-PY-006 See photo for gps data		GPS Location	MVP-PY-006 See photo for gps data	
Field Station#	+0		Field Station#	+0	
Pic 7 Desc.	Condition of containment under light plant. Free of stormwater and ice. Looking NE.		Pic 8 Desc.	Blue Bulk Fuel tanks no leaky internal fittings. Looking W.

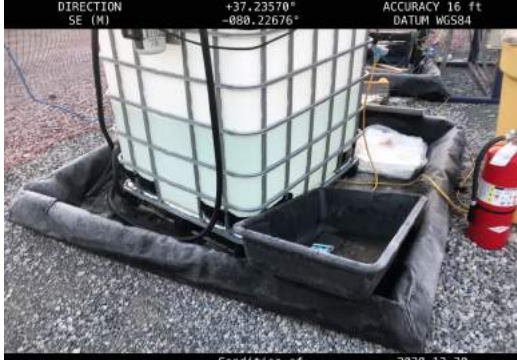
<p>DIRECTION SE (M) +37.23570° -080.22676° ACCURACY 16 ft DATUM WGS84</p> <p>MVP-PY-006_123020 Condition of containment 2020-12-30 07:49:18-05:00</p>

GPS Location	MVP-PY-006 See photo for gps data		GPS Location	MVP-PY-006 See photo for gps data	
Field Station#	+0		Field Station#	+0	
Pic 9 Desc.	Condition of containment under DEF container. Free of stormwater and ice. Looking SE.		Pic 10 Desc.	Secondary containment on site for tankers offloading fuel into Blue Bulk fuel tanks. Looking SW.

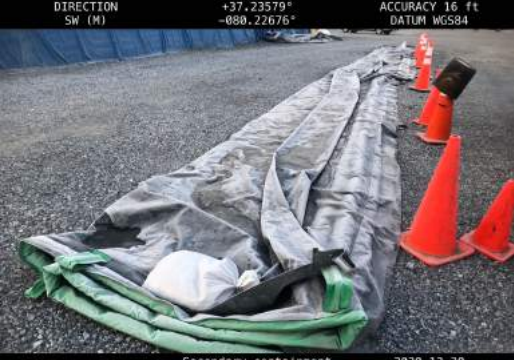
<p>DIRECTION SW (M) +37.23579° -080.22676° ACCURACY 16 ft DATUM WGS84</p> <p>MVP-PY-006_123020 Secondary containment on site for tankers 2020-12-30 07:49:36-05:00</p>

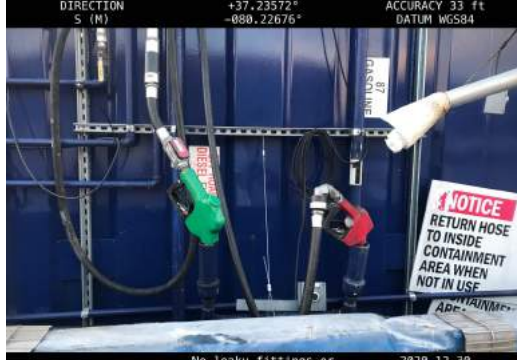
<p>DIRECTION S (M) +37.23572° -080.22676° ACCURACY 33 ft DATUM WGS84</p> <p>MVP-PU-006_123020 No leaky fittings or nozzles 2020-12-30 07:49:54-05:00</p>

<p>DIRECTION W (M) +37.23557° -080.22697° ACCURACY 33 ft DATUM WGS84</p> <p>MVP-PY-006_123020 Condition of containment 2020-12-30 07:50:22-05:00</p>			
GPS Location	MVP-PY-006 See photo for gps data		GPS Location	MVP-PY-006 See photo for gps data	
Field Station#	+0		Field Station#	+0	
Pic 11 Desc.	Blue Bulk Fuel tanks no leaky fittings or nozzles. Looking S.		Pic 12 Desc.	Off Road Fuel unit containment holding stormwater now frozen. Looking W.

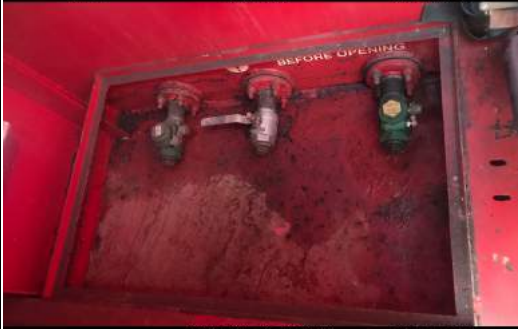
<div>MVP-PY-006_123020</div> <div>Condition of internal drip pan</div> <div>2020-12-30 07:51:11-05:00</div> </div>				<div> <div>DIRECTION W (M)</div> <div>+37.23563° -080.22693°</div> <div>ACCURACY 16 ft DATUM WGS84</div>

<div>MVP-PY-006_123020</div> <div>No leaky internal fittings</div> <div>2020-12-30 07:51:18-05:00</div> </div>	
GPS Location	MVP-PY-006 See photo for gps data		GPS Location	MVP-PY-006 See photo for gps data	
Field Station#	+0		Field Station#	+0	
Pic 13 Desc.	Off Road Fuel unit condition of internal drip pan. Looking SW.		Pic 14 Desc.	Off Road Fuel unit no leaky internal fittings. Looking W.	
<div> <div>DIRECTION S (M)</div> <div>+37.23562° -080.22691°</div> <div>ACCURACY 16 ft DATUM WGS84</div>

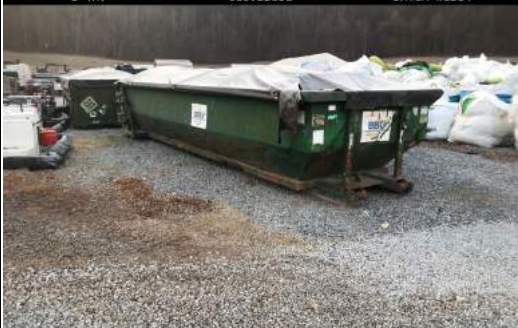
<div>MVP-PY-006_123020</div> <div>No deposits around hazardous waste ...</div> <div>2020-12-30 07:52:16-05:00</div> </div>				<div> <div>DIRECTION SE (M)</div> <div>+37.23550° -080.22653°</div> <div>ACCURACY 33 ft DATUM WGS84</div>

GPS Location	MVP-PY-006 See photo for gps data		GPS Location	MVP-PY-006 See photo for gps data	
Field Station#	+0		Field Station#	+0	
Pic 15 Desc.	No deposits around hazardous waste dumpsters. Looking S.		Pic 16 Desc.	No loose trash around dumpsters. Looking SE.	
<div> <div>DIRECTION NE (M)</div> <div>+37.23425° -080.22724°</div> <div>ACCURACY 33 ft DATUM WGS84</div>

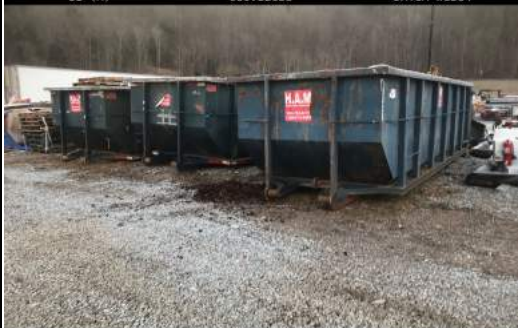
<div>MVP-PY-006_123020</div> <div>No loose trash around dumpsters</div> <div>2020-12-30 07:53:16-05:00</div> </div>

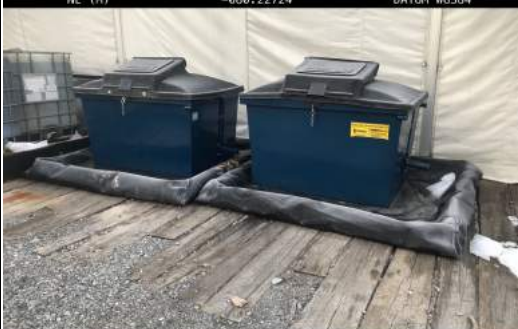
<div>MVP-PY-006_123020</div> <div>No deposits around hazardous waste ...</div> <div>2020-12-30 07:57:46-05:00</div> </div>				<div> <div>DIRECTION SE (M)</div> <div>+37.23456° -080.22793°</div> <div>ACCURACY 33 ft DATUM WGS84</div>

<div>MVP-PY-006_123020</div> <div>Condition of containment</div> <div>2020-12-30 08:02:37-05:00</div> </div>	
GPS Location	MVP-PY-006 See photo for gps data		GPS Location	MVP-PY-006 See photo for gps data	
Field Station#	+0		Field Station#	+0	
Pic 17 Desc.	No deposits or fluids around hazardous waste dumpsters west of mechanics building. Looking NE.		Pic 18 Desc.	Condition of containments. Holding stormwater now frozen. Looking SE.

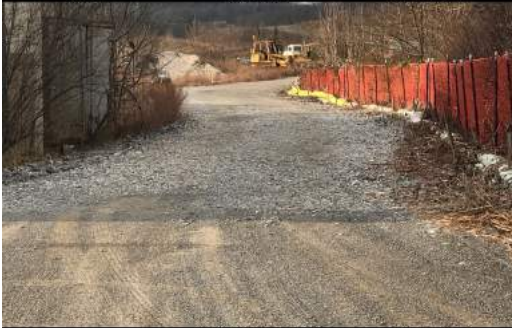
MVP-LY-049_123020 Condition of rock entrance 2020-12-30 08:56:34-05:00			DIRECTION SE (M) +37.27005° -080.12160° ACCURACY 164 ft DATUM WGS84

MVP-LY-049_123020 No loose trash around south dumpsters 2020-12-30 08:59:55-05:00	
GPS Location	MVP-LY-049 See photo for gps data		GPS Location	MVP-LY-049 See photo for gps data	
Field Station#	+0		Field Station#	+0	
Pic 1 Desc.	Condition of rock entrance on north drive. No sediment on stone. Looking SW.		Pic 2 Desc.	No loose trash around south dumpsters. Looking SE.	
	DIRECTION NW (M) +37.27056° -080.12252° ACCURACY 16 ft DATUM WGS84

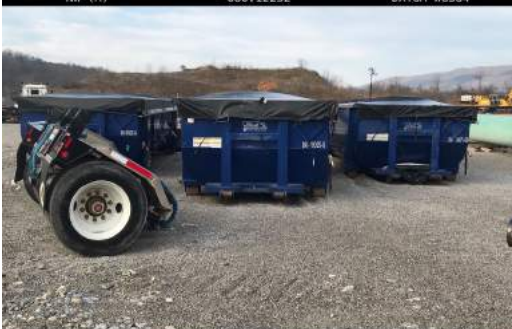
MVP-LY-049_123020 No deposits around hazardous waste 2020-12-30 09:01:22-05:00			DIRECTION W (M) +37.27078° -080.12362° ACCURACY 98 ft DATUM WGS84

GPS Location	MVP-LY-049 See photo for gps data		GPS Location	MVP-LY-049 See photo for gps data	
Field Station#	+0		Field Station#	+0	
Pic 3 Desc.	No fluids or deposits around hazardous waste dumpsters. Looking NW.		Pic 4 Desc.	Condition of temporary trash transfer pit. Debris inside boundary of pit. Looking W.	
	DIRECTION S (M) +37.27050° -080.12477° ACCURACY 33 ft DATUM WGS84

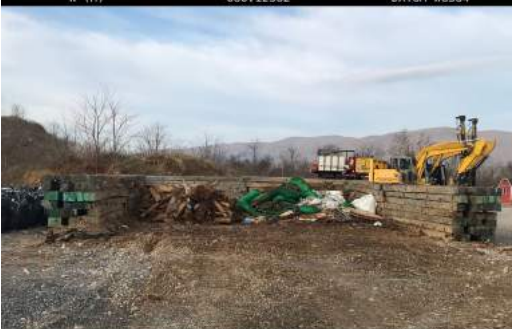
MVP-LY-049_123020 Condition of temporary trash 2020-12-30 09:02:18-05:00

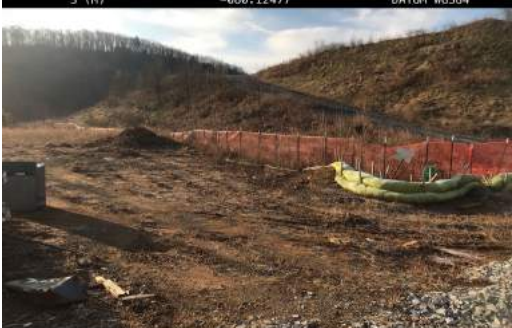
MVP-LY-049_123020 Landowner disturbance along CFS & feature 2020-12-30 09:08:37-05:00			DIRECTION W (M) +37.27045° -080.12469° ACCURACY 16 ft DATUM WGS84

MVP-LY-049_123020 Landowner disturbance within 66' of feature 2020-12-30 09:08:43-05:00	
GPS Location	MVP-LY-049 See photo for gps data		GPS Location	MVP-LY-049 See photo for gps data	
Field Station#	+0		Field Station#	+0	
Pic 5 Desc.	Landowner soil disturbance along compost filter sock and feature W-CV21B. Area not stabilized. No impacts. Looking S.		Pic 6 Desc.	Landowner soil disturbance within 66' and 120' of feature W-CV21B. Area not stabilized. No impacts. Looking W.

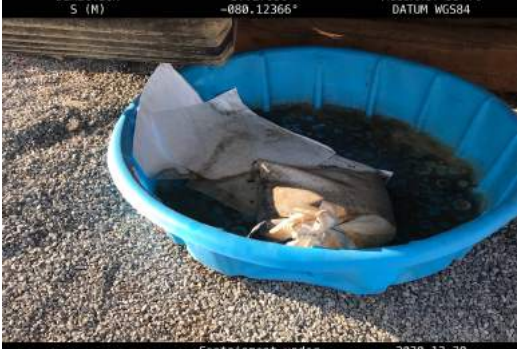
MVP-LY-049_123020 Containment under stored equipment 2020-12-30 09:26:03-05:00		MVP-LY-049_123020 Containment under stored equipment 2020-12-30 09:26:14-05:00			
GPS Location	MVP-LY-049 See photo for gps data		GPS Location	MVP-LY-049 See photo for gps data	
Field Station#	+0		Field Station#	+0	
Pic 13 Desc.	Condition of containment under stored equipment. Looking S.		Pic 14 Desc.	Condition of containment under stored equipment. Looking W.	
DIRECTION S (N) +37.27039° -080.12341° ACCURACY 164 ft DATUM WGS84

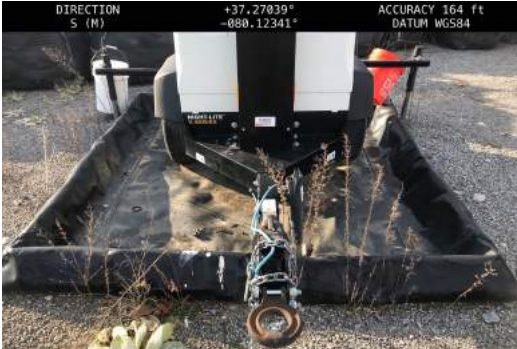
GPS Location	MVP-LY-049 See photo for gps data		GPS Location	MVP-LY-049 See photo for gps data	
Field Station#	+0		Field Station#	+0	
Pic 15 Desc.	Condition of containment under light plant. Looking S.		Pic 16 Desc.	Condition of trays and containment under toilets. Looking NE.	
DIRECTION S (N) +37.26966° -080.12210° ACCURACY 16 ft DATUM WGS84

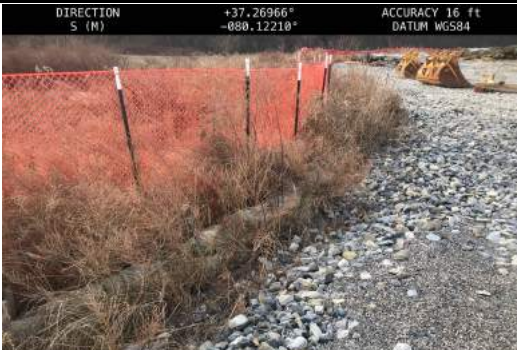
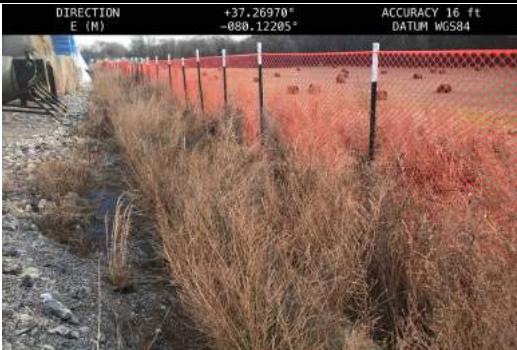
MVP-LY-049_123020 Condition of CFS & safety fence LOD 2020-12-30 09:30:11-05:00		MVP-LY-049_123020 Condition of CFS & safety fence LOD 2020-12-30 09:30:30-05:00			
GPS Location	MVP-LY-049 See photo for gps data		GPS Location	MVP-LY-049 See photo for gps data	
Field Station#	+0		Field Station#	+0	
Pic 17 Desc.	Condition of compost filter sock and safety fence along south LOD. Looking SW.		Pic 18 Desc.	Condition of compost filter sock and safety fence along south LOD. Looking E.

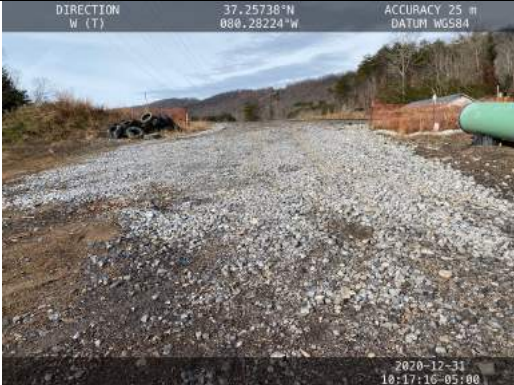
GPS Location	See photo		GPS Location	See photo	
Field Station#	12119+40		Field Station#	12121+33	
Pic 1 Desc.	RCE at Flatwoods Road in satisfactory condition.		Pic 2 Desc.	Stream S-C33, facing south, downstream

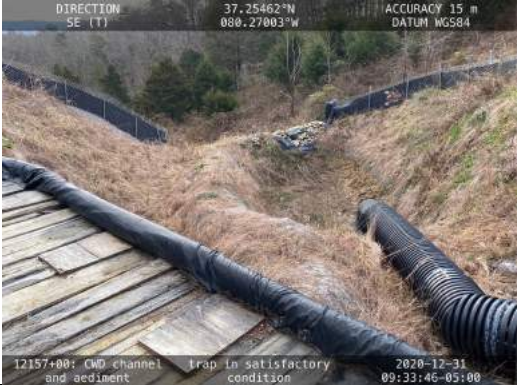
GPS Location	See photo		GPS Location	See photo	
Field Station#	12144+50		Field Station#	12157+00	
Pic 7 Desc.	Wetland W-C5, facing west		Pic 8 Desc.	Clean water diversion channel and sediment trap in satisfactory condition with no need for maintenance at this time.

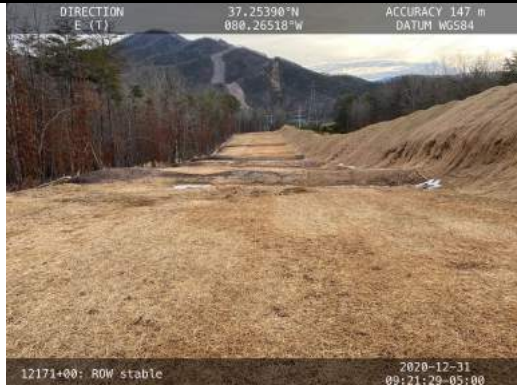
GPS Location	See photo		GPS Location	See photo	
Field Station#	12171+00		Field Station#	12190+85	
Pic 11 Desc.	ROW stable		Pic 12 Desc.	Bradshaw Road crossing in good condition.

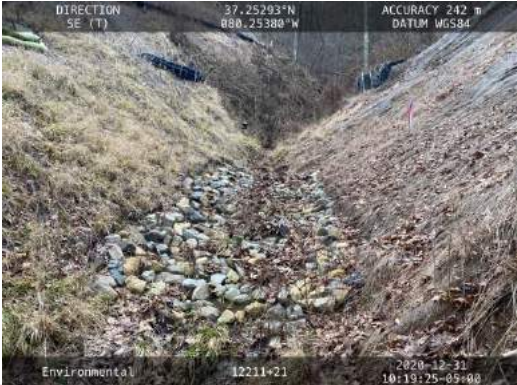
GPS Location	See photo		GPS Location	See photo	
Field Station#	12211+21		Field Station#	12213+27	
Pic 15 Desc.	The drainage feature at the bottom of the ravine between Bradshaw Road and Reese Mountain remains stable.		Pic 16 Desc.	Permanent restoration stable below the switchback on Reese Mountain.

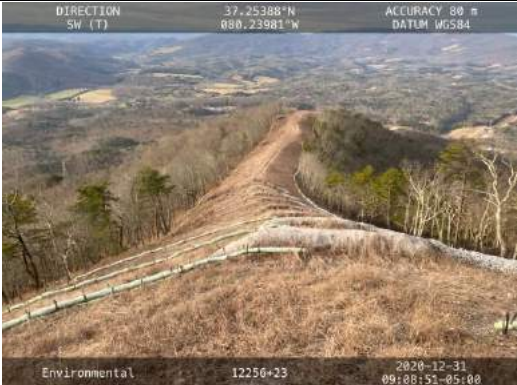
GPS Location	See photo		GPS Location	See photo	
Field Station#	12227+00		Field Station#	12256+23	
Pic 17 Desc.	ROW stable		Pic 18 Desc.	Permanent restoration stable over the top of Reese Mountain.

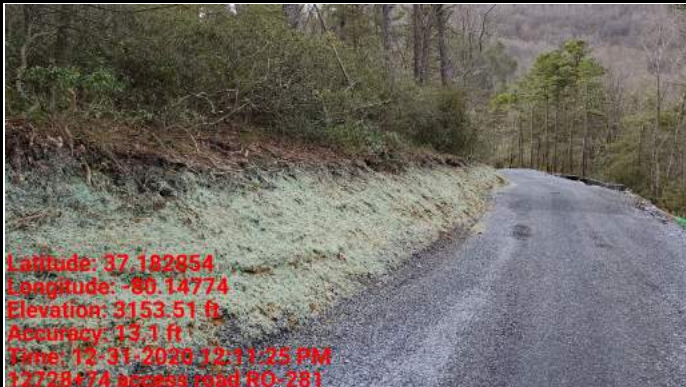
<p>DIRECTION NW (T) +37.15532° -80.12863° ACCURACY 16 ft DATUM WGS84 12866+00 West side of Bottom Creek Road 2020-12-31 10:05:10-05:00</p>		
GPS Location	See photo for gps location data.		GPS Location	See photo for gps location data.	
Field Station#	12728+74		Field Station#	12866+00	
Pic 17 Desc.	Photo shows the stabilized cut slope along RO-281.		Pic 18 Desc.	Photo shows the work space on the west side of Bottom Creek Road.
