Visual Site Inspection Report

Project Name	H-600 Pipeline Spread H	AFE	124300138	Spread	H-600 Pipeline Spread H
Contractor	Precision			Report #	16922
Inspector	John Brcic			Date/Time	11/16/2020 9:17 AM
Permit #	TBD	Inspection Type	VA SWPP	Station Begin	12865+00
State	VA	Inspection Area	Partial	Station End	13116+00
County	Franklin	Ground	Damp	Temperature (°F)	55.00
Municipality	N/A	Weather	Sunny	Rain Gauge (in)	0.00
				Rain Accumulation Time (days)	2.00

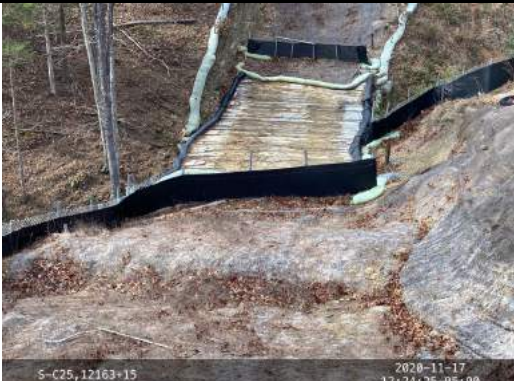
GPS Location	See photo GPS for location	GPS Location	See photo GPS for location		
Field Station#	12163+65	Field Station#	12163+15		
Pic 3 Desc.	Fabric detached from SSF was put on punch list for repair.	Pic 4 Desc.	Surrounding ECDs are in acceptable condition at S-C25.

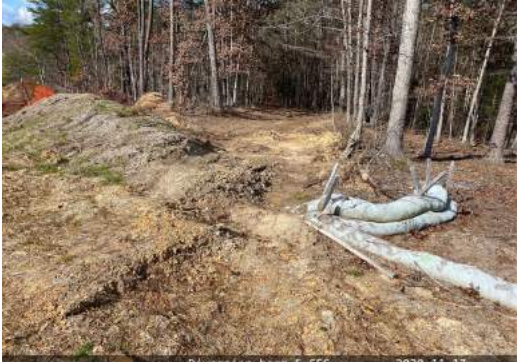
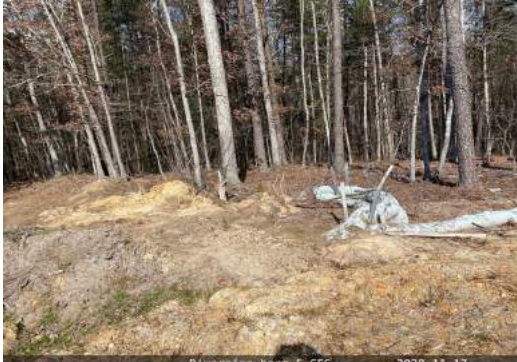
12170+67 Diversion berm & CFS damaged 2020-11-17 12:10:56-05:00		12170+00 Diversion berm & CFS damaged 2020-11-17 12:10:44-05:00			
GPS Location	See photo GPS for location		GPS Location	See photo GPS for location	
Field Station#	12170+00		Field Station#	12170+00	
Pic 7 Desc.	Diversion and CFS is damaged and has been added to the punch list for attention.		Pic 8 Desc.	Diversion and CFS is damaged and has been added to the punch list for attention.

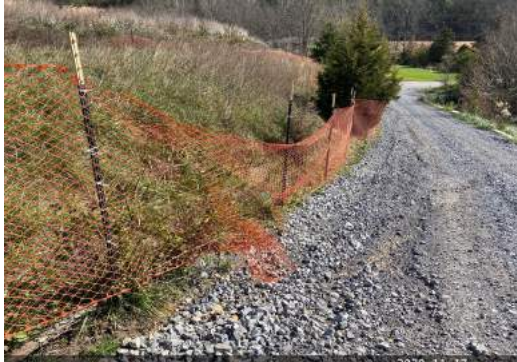
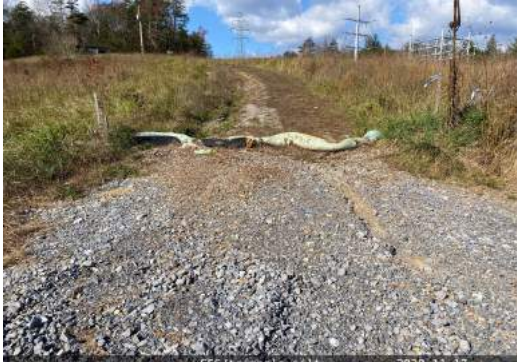
MVP-MN-274, 12188+34 Safety fence damaged 2020-11-17 11:50:41-05:00		MVP-MN-274, 12188+34 CFS/triangle silt dike damaged 2020-11-17 11:49:51-05:00			
GPS Location	See photo GPS for location		GPS Location	See photo GPS for location	
Field Station#	12188+34		Field Station#	12188+34	
Pic 9 Desc.	Safety fence is damaged and needs replacement. This issue has been added to the punch list.		Pic 10 Desc.	CFS and triangle silt dike are damaged and need replacement. This issue has been added to the punch list.

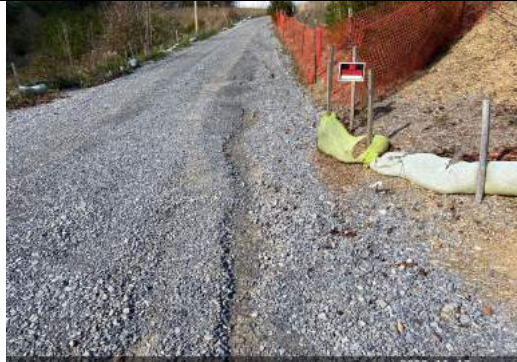
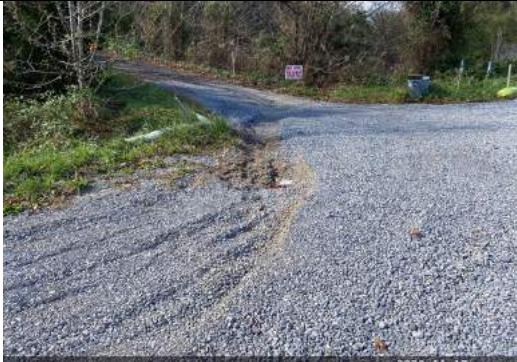
MVP-MN-274, 12188+34 Rilling/gully 2020-11-17 11:46:31-05:00		MVP-MN-274, 12188+34 Rilling/gully 2020-11-17 11:46:17-05:00			
GPS Location	See photo GPS for location		GPS Location	See photo GPS for location	
Field Station#	12188+34		Field Station#	12188+34	
Pic 11 Desc.	Rilling and gully identified for punch list at MVP-MN-274.		Pic 12 Desc.	Rilling and gully identified for punch list at MVP-MN-274.

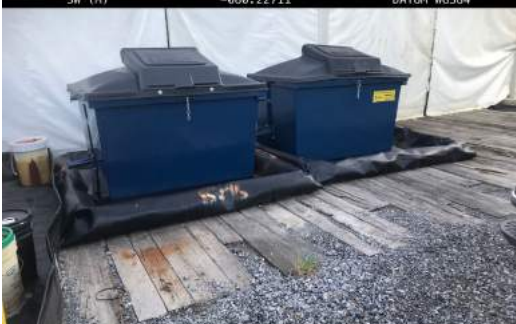
GPS Location	MVP-PY-006 See photo for gps data		GPS Location	MVP-PY-006 See photo for gps data	
Field Station#	+0		Field Station#	+0	
Pic 9 Desc.	Condition of containment. Free of stormwater. Looking SE.		Pic 10 Desc.	No deposits around hazardous waste dumpsters west of mechanics building. Looking SE.	
<div> <div>DIRECTION NW (M)</div> <div>+37.23538° -080.22659°</div> <div>ACCURACY 16 ft DATUM WGS84</div>

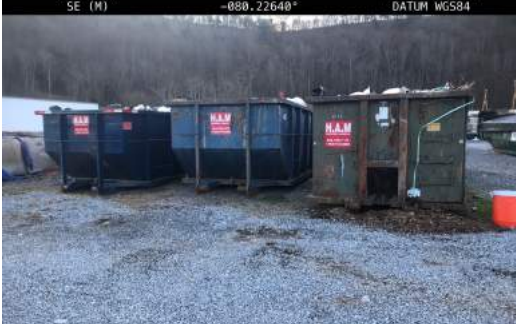
<div>MVP-PY-006_111720</div> <div>No loose trash around dumpsters</div> <div>2020-11-17 07:40:21-05:00</div> </div>			
GPS Location	MVP-PY-006 See photo for gps data		GPS Location	MVP-PY-006 See photo for gps data	
Field Station#	+0		Field Station#	+0	
Pic 11 Desc.	No deposits around hazardous waste dumpsters. Looking NW.		Pic 12 Desc.	No loose trash around dumpsters. Looking SE.

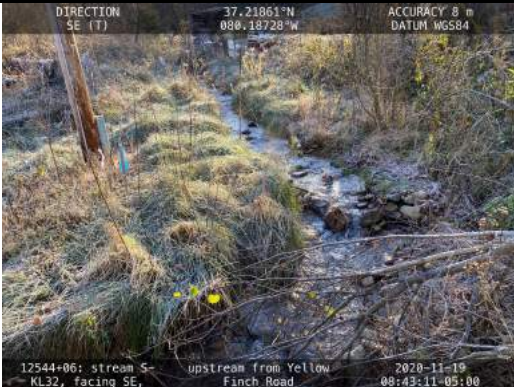
GPS Location	See photo		GPS Location	See photo	
Field Station#	12544+06		Field Station#	12544+06	
Pic 1 Desc.	Stream S-KL32, facing southeast, upstream from Yellow Finch Road		Pic 2 Desc.	Stream S-EF20b, facing south, upstream from Yellow Finch Road.

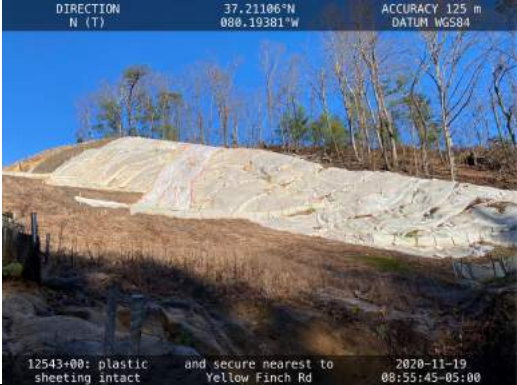
GPS Location	See photo		GPS Location	See photo	
Field Station#	12543+00		Field Station#	12529+00	
Pic 7 Desc.	Plastic sheeting on stockpiles nearest to Yellow Finch Road remains intact and secure.		Pic 8 Desc.	Plastic sheeting approximately 1500 feet from Yellow Finch Road is intact and secure.

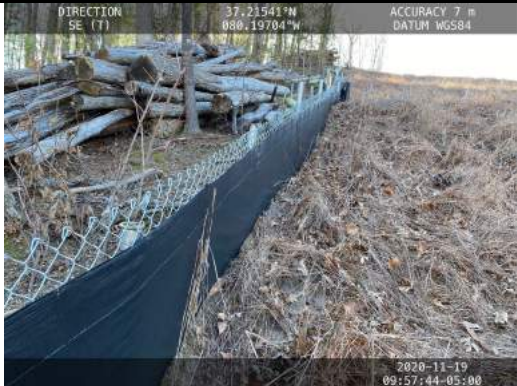
GPS Location	See photo		GPS Location	See photo	
Field Station#	12522+00		Field Station#	12517+00	
Pic 9 Desc.	Super silt fence is in satisfactory condition on the slope on the going away side of stream S-EF19.		Pic 10 Desc.	Slope on coming in side of stream S-EF19 remains stable.

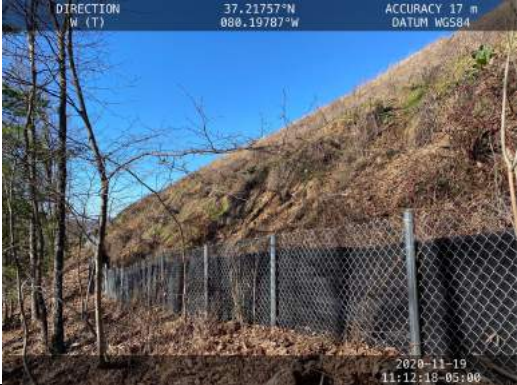
GPS Location	See photo	GPS Location	See photo	GPS Location	See photo
Field Station#	12512+00	Field Station#	12506+00	Field Station#	12484+00
Pic 13 Desc.	Super silt fence in good repair along the bottom of this fill slope.	Pic 14 Desc.	Clean water diversion berm has significant new vegetative cover after being re-stabilized this fall.	Pic 15 Desc.	Plastic sheeting over the "pig parts" excavation site is intact and secure.

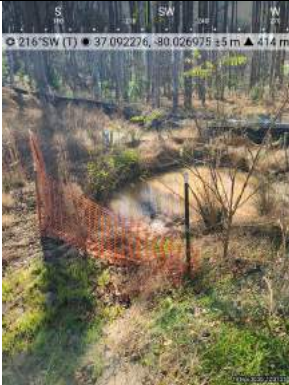
GPS Location	00000	GPS Location	0000		
Field Station#	13415+70	Field Station#	13416+00		
Pic 1 Desc.	Monitored sump pits and ECDs along my travel today doing SWPPP inspections		Pic 2 Desc.	Erosion blanket inspected and functioning on hill side above CAHAS #1

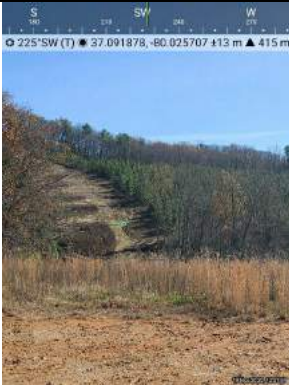
GPS Location	0000	GPS Location	0000		
Field Station#	13423+45	Field Station#	13497+50		
Pic 3 Desc.	Row photo showing vegetation growth outside of work space and ECDs in place and functioning on hill side .		Pic 4 Desc.	The EI observed soil segregation activities where Roberts Corrosion contractor worked on anode bed area. No environmental issues observed at the time of inspection.

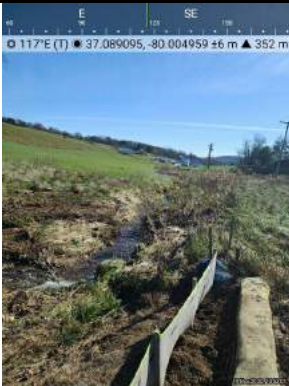
GPS Location	0000	GPS Location	0000		
Field Station#	13497+80	Field Station#	13497+80		
Pic 5 Desc.	Stream observation photo facing downstream while Roberts Corrosion worked on anode bed , no environmental issues observed at the time of inspection.		Pic 6 Desc.	Photo showing resource signs in place and ECDs along stream crossing

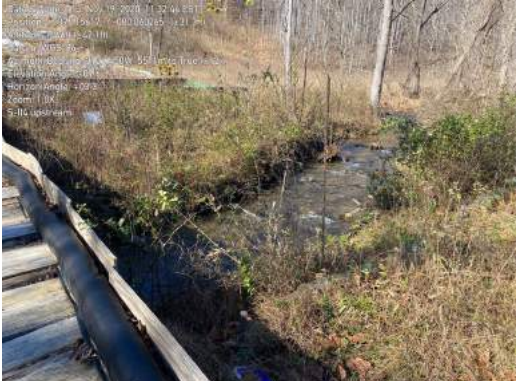
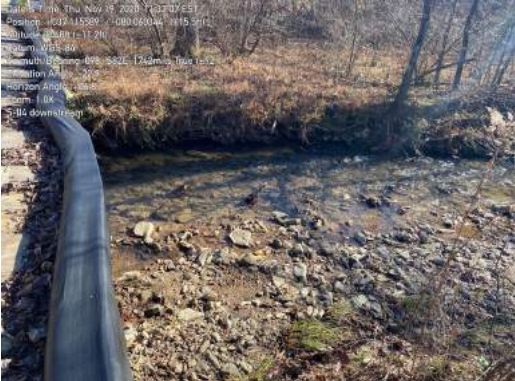
<p>Date & Time: Thu Nov 19, 2020 11:32:26 EST Position: 40.7115009, -80.0596771, 119.981 Altitude: 16470 to 32.361 Datum: WGS 84 Azimuth: Bearing: 064.564E, 1773mils, True is 12.1 Elevation Angle: +12.1 Horizon Angle: -93.0 Zoom: 1.0x Still: upstream</p>			
GPS Location	See photo for coordinates.		GPS Location	See photo for coordinates.	
Field Station#	13262+00		Field Station#	13261+00	
Pic 1 Desc.	MVP-FR-293.01, Flanders road crossing in acceptable condition.		Pic 2 Desc.	Bridge over S-II4 in acceptable condition.

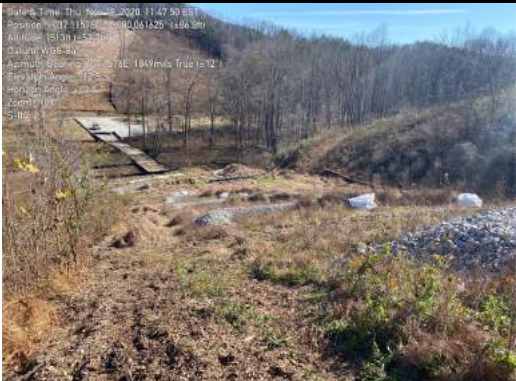
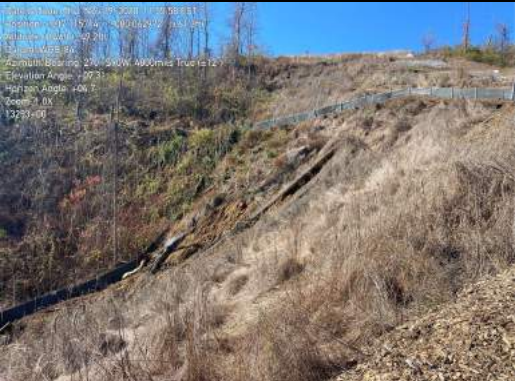
GPS Location	See photo for coordinates.		GPS Location	See photo for coordinates.	
Field Station#	13260+60		Field Station#	13260+60	
Pic 3 Desc.	S-II4, upstream, no changes noted, no environmental concerns.		Pic 4 Desc.	S-II4, downstream, stream bed and banks stable, no ROW impacts observed.

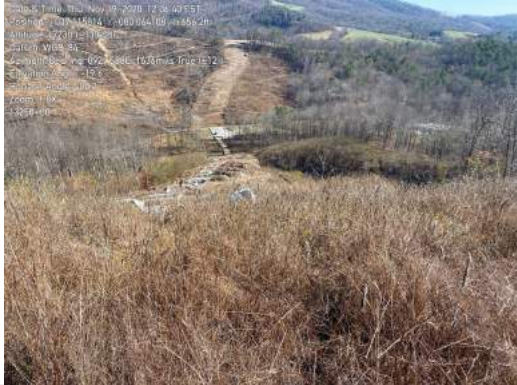
GPS Location	See photo for coordinates.		GPS Location	See photo for coordinates.	
Field Station#	13253+00		Field Station#	13253+00	
Pic 7 Desc.	SSF installed along bottom perimeter of slip material off ROW.		Pic 8 Desc.	SSF installed to divert water away from slip.

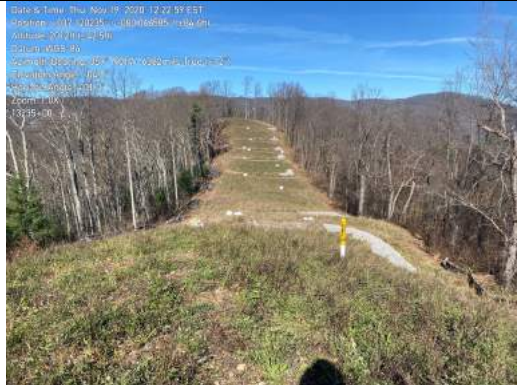
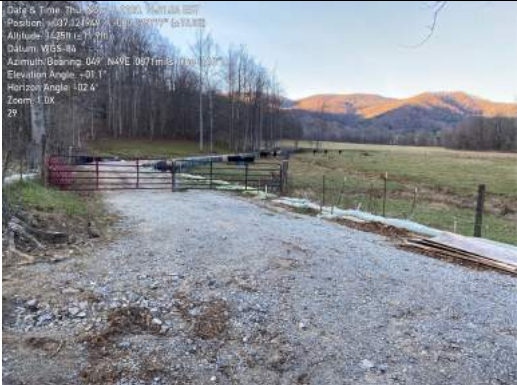
GPS Location	See photo for coordinates.		GPS Location	See photo for coordinates.	
Field Station#	13250+00		Field Station#	13250+00	
Pic 9 Desc.	ROW stable with acceptable vegetative cover across LOD.		Pic 10 Desc.	ROW stable with acceptable vegetative cover across LOD.

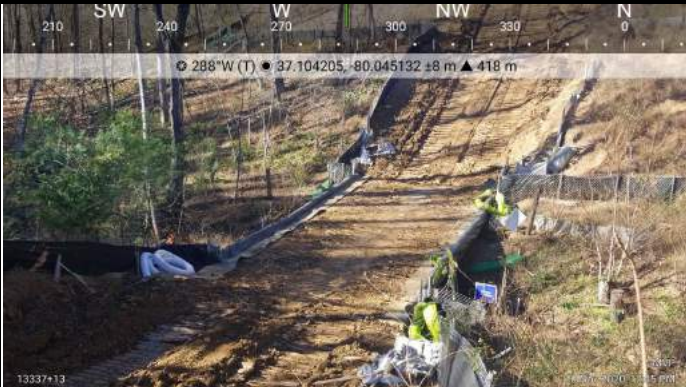
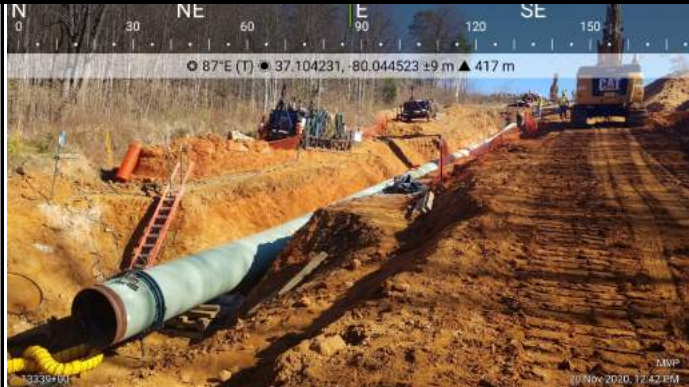
GPS Location	See Above	GPS Location	See Above		
Field Station#	13327+00	Field Station#	13334+17		
Pic 5 Desc.	Tie-in work. ECDs are functional. Crew will repair any nearby temp. waterbars and replace ECDs at end of day.	Pic 6 Desc.	Waterbody S-GH11. ECDs are functional. Crew will repair any nearby temp. waterbars and replace ECDs at end of day.

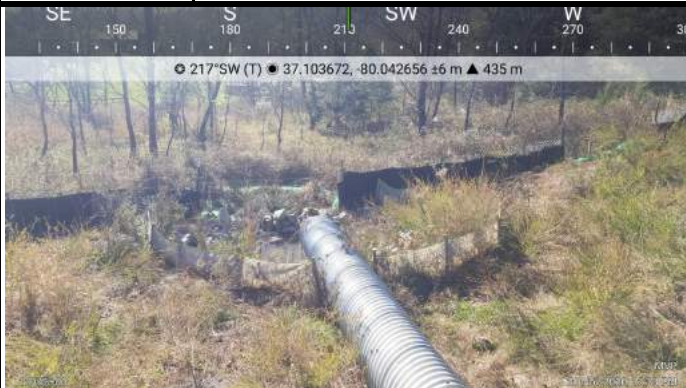
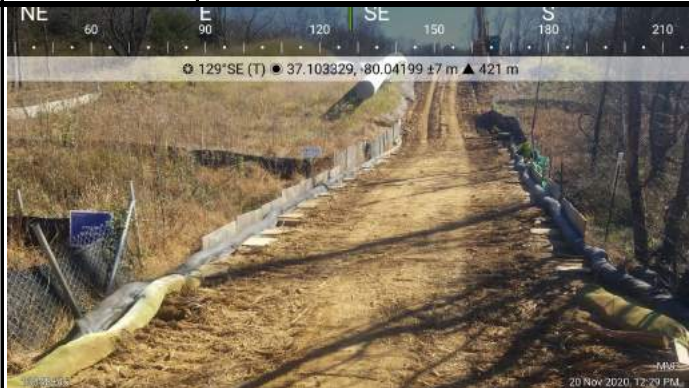
GPS Location	See Above		GPS Location	See Above	
Field Station#	13337+13		Field Station#	13339+00	
Pic 7 Desc.	Waterbody S-GH9. ECDs are functional. Crew will repair any nearby temp. waterbars and replace ECDs at end of day.		Pic 8 Desc.	Tie-in work. ECDs are functional. Crew will repair any nearby temp. waterbars and replace ECDs at end of day.

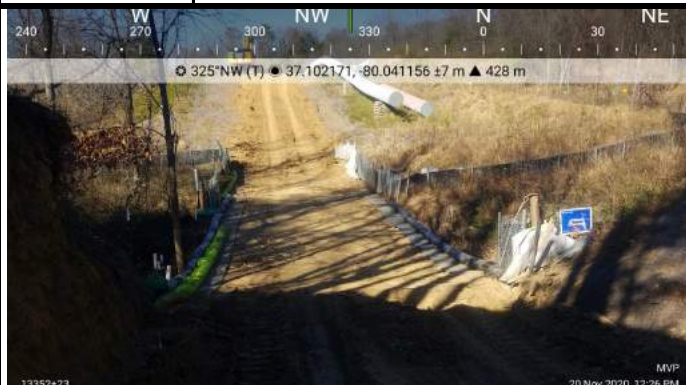
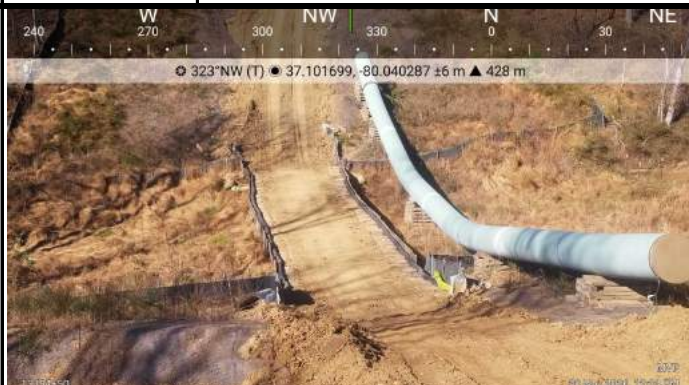
GPS Location	See Above		GPS Location	See Above	
Field Station#	13345+00		Field Station#	13348+46	
Pic 9 Desc.	Cleanwater diversion pipe outlet. ECDs are functional.		Pic 10 Desc.	Waterbody S-RR08. ECDs are functional. Crew will repair any nearby temp. waterbars and replace compost sock at end of day.

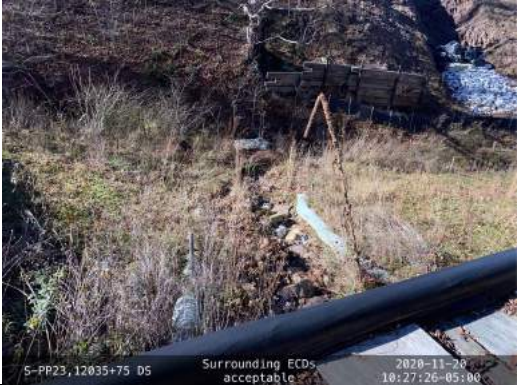
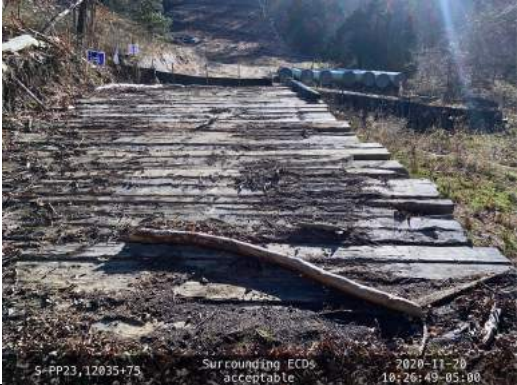
GPS Location	See photo GPS for location		GPS Location	See photo GPS for location	
Field Station#	12035+75		Field Station#	12035+75	
Pic 7 Desc.	S-PP23 is dry and it's surrounding ECDs are in acceptable condition.		Pic 8 Desc.	S-PP23 is dry and it's surrounding ECDs are in acceptable condition.

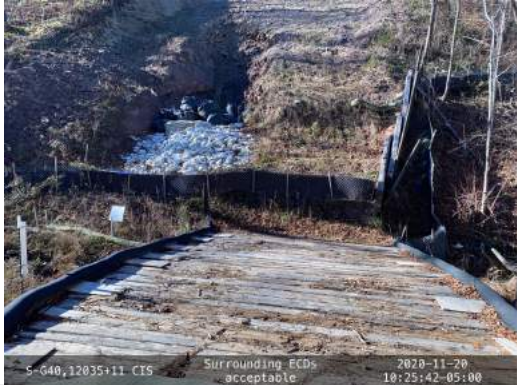
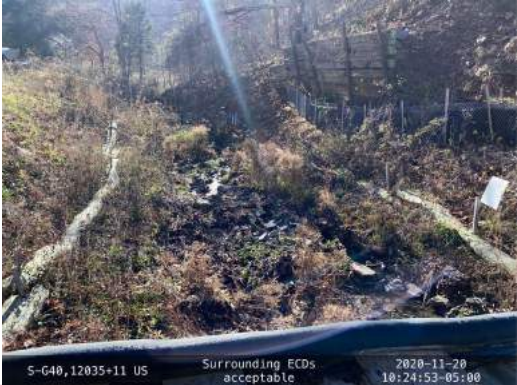
GPS Location	See photo GPS for location		GPS Location	See photo GPS for location	
Field Station#	12035+11		Field Station#	12035+11	
Pic 9 Desc.	S-G40 surrounding ECDs are in acceptable shape.		Pic 10 Desc.	S-G40 has no turbidity and bank ECDs are in acceptable condition.

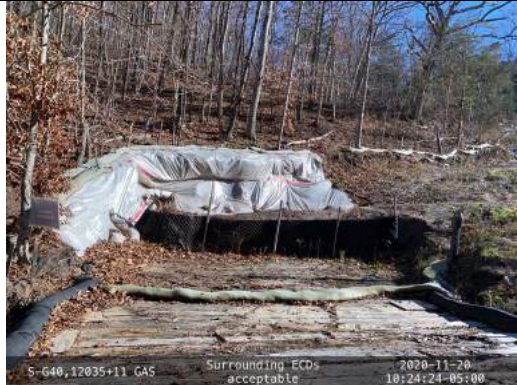
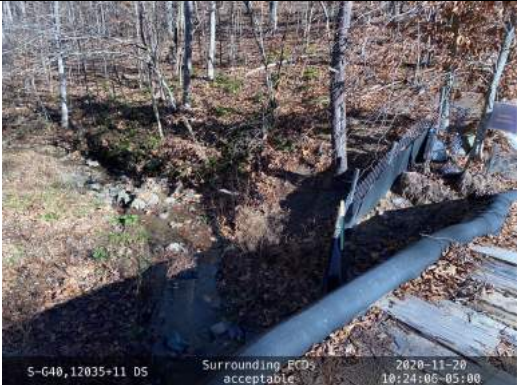
GPS Location	See photo GPS for location		GPS Location	See photo GPS for location	
Field Station#	12035+11		Field Station#	12035+11	
Pic 11 Desc.	S-G40 surrounding ECDs are in acceptable shape.		Pic 12 Desc.	S-G40 surrounding ECDs are in acceptable shape.

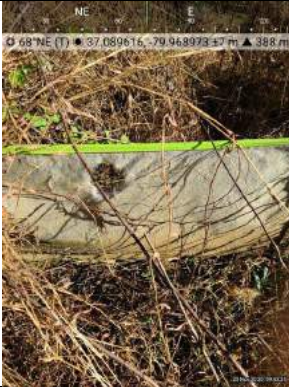
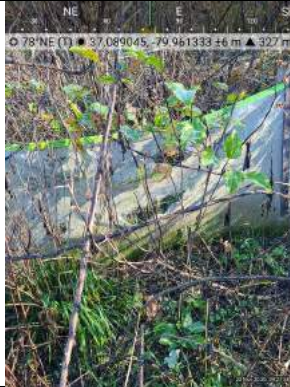
GPS Location	00000		GPS Location	00000	
Field Station#	13640+15		Field Station#	13643+54	
Pic 1 Desc.	P1 observed by the EI that requires maintenance repairs, documented and sent in to be added to the punch list		Pic 2 Desc.	P1 observed by the EI that requires maintenance repairs, documented and sent in to be added to the punch list

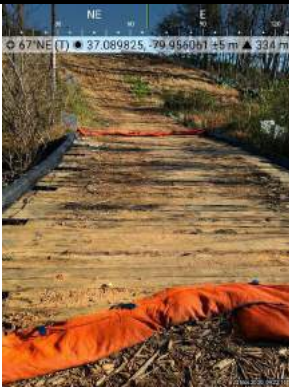
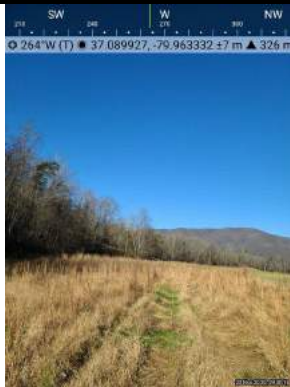
GPS Location	0000		GPS Location	000	
Field Station#	13659+03		Field Station#	13636+53	
Pic 3 Desc.	Monitored equipment bridge and protection, photo showing travel lane up hill from stream stabilized		Pic 4 Desc.	Vegetation observation photo facing up row from stream crossing showing good coverage .

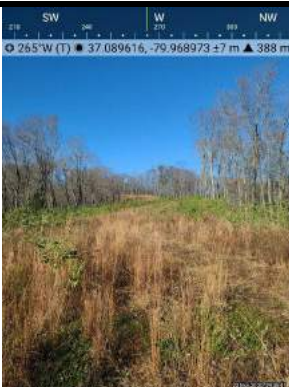
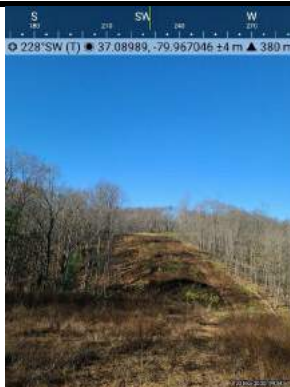
GPS Location	0000		GPS Location	0000	
Field Station#	13600+00		Field Station#	13622+45	
Pic 5 Desc.	Vegetation observation photo facing up row during routine inspection by the EI		Pic 6 Desc.	Vegetation observation photo facing up row during routine inspection by the EI

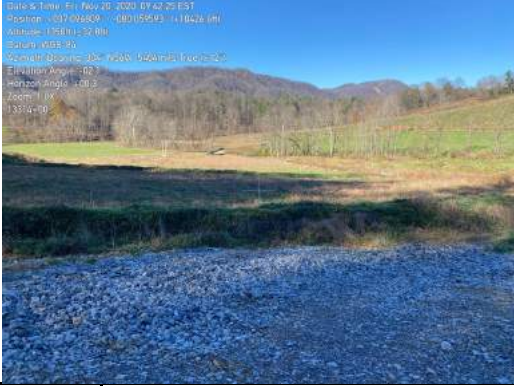
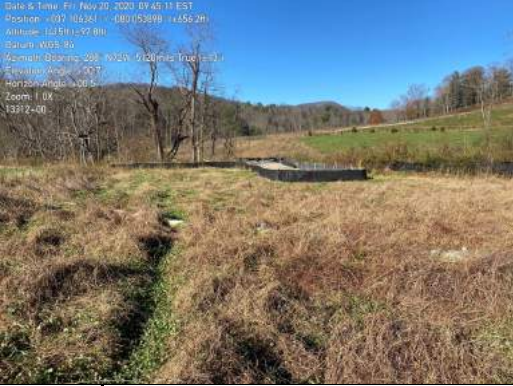
GPS Location	See photo for coordinates.		GPS Location	See photo for coordinates.	
Field Station#	13314+00		Field Station#	13312+00	
Pic 1 Desc.	ROW stable with acceptable vegetative cover; temporary waterbars and outlets functioning acceptably.		Pic 2 Desc.	ROW stable with acceptable vegetative cover.

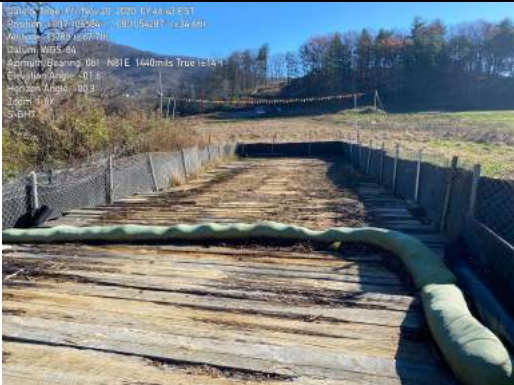
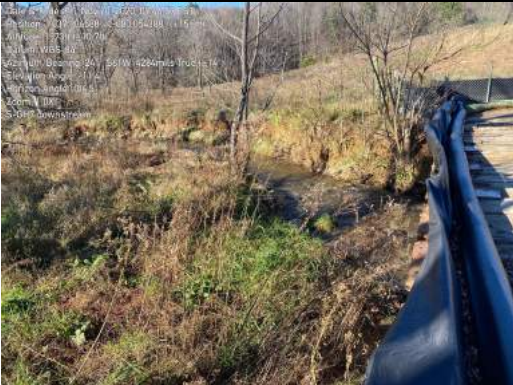
GPS Location	See photo for coordinates.		GPS Location	See photo for coordinates.	
Field Station#	13309+20		Field Station#	13309+09	
Pic 3 Desc.	Perimeter controls along S-GH7 in acceptable condition.		Pic 4 Desc.	S-GH7, downstream, no ROW impacts noted.

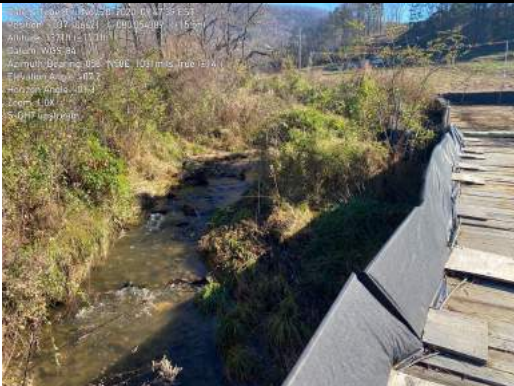
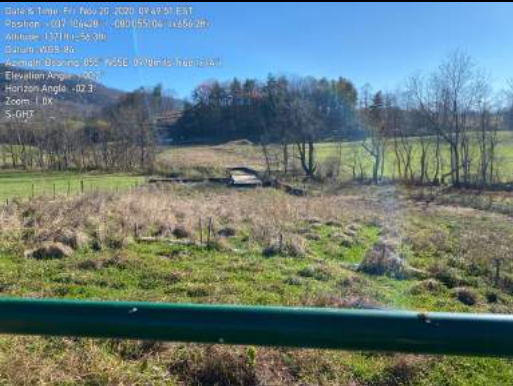
GPS Location	See photo for coordinates.		GPS Location	See photo for coordinates.	
Field Station#	13309+09		Field Station#	13306+00	
Pic 5 Desc.	S-GH7, upstream, no changes noted to stream bed or banks since last inspection, no turbidity noted.		Pic 6 Desc.	ROW stable with acceptable vegetative cover

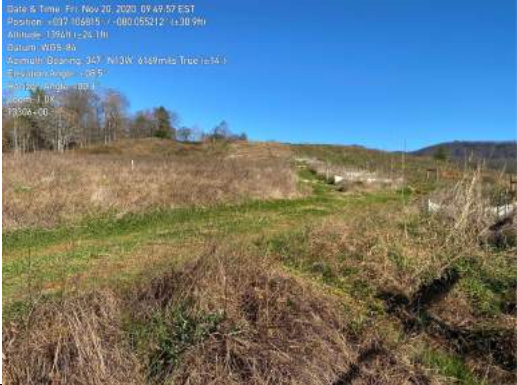
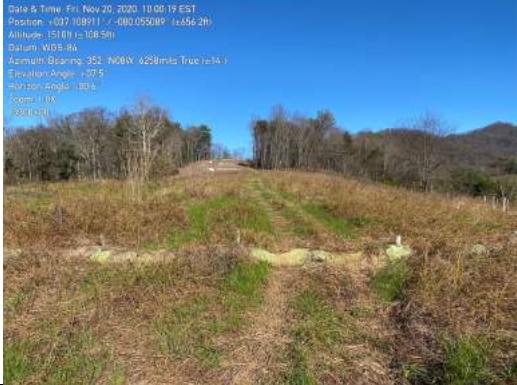
GPS Location	See photo for coordinates.		GPS Location	See photo for coordinates.	
Field Station#	13306+00		Field Station#	13300+00	
Pic 7 Desc.	ROW stable with acceptable vegetative cover, ATV tracks noted on ROW.		Pic 8 Desc.	ROW stable with acceptable vegetative cover, ATV tracks noted on ROW.	
<p>Field's Time: Fri, Nov 20, 2020 10:00:02 EST Position: +037.104425 / -080.058293 / +130.1m Altitude: 1260ft ±137.9ft Datum: WGS-84 Magnetic Bearing: 352.76°NW 600ftmils True (±14.1) Declination Angle: +02.5 Pitch Angle: +03.1 Zoom: 1.0X 13300+00</p>

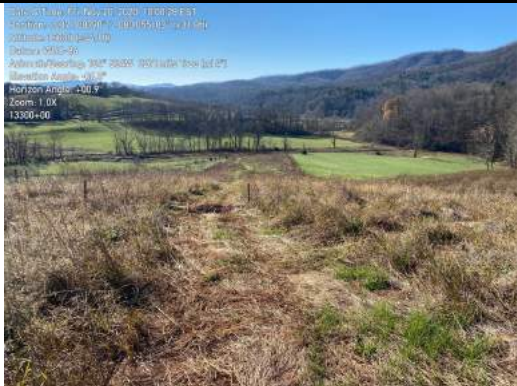
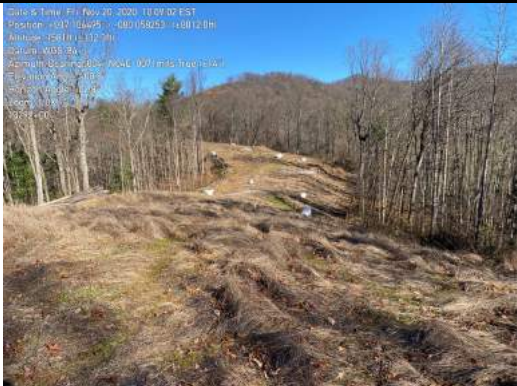
GPS Location	See photo for coordinates.		GPS Location	See photo for coordinates.	
Field Station#	13300+00		Field Station#	13292+00	
Pic 9 Desc.	ROW stable with acceptable vegetative cover.		Pic 10 Desc.	ROW stable with acceptable vegetative cover.	
<p>Field's Time: Fri, Nov 20, 2020 10:00:02 EST Position: +037.104425 / -080.058293 / +130.1m Altitude: 1260ft ±137.9ft Datum: WGS-84 Magnetic Bearing: 352.76°NW 600ftmils True (±14.1) Declination Angle: +02.5 Pitch Angle: +03.1 Zoom: 1.0X 13278+00</p>

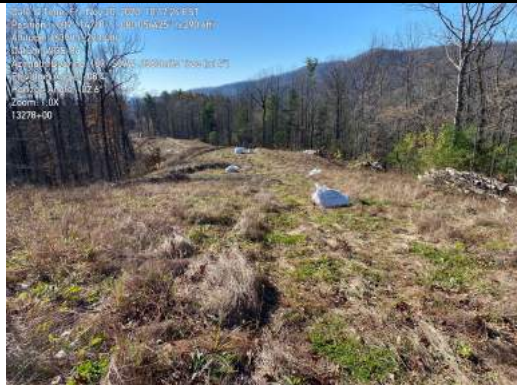
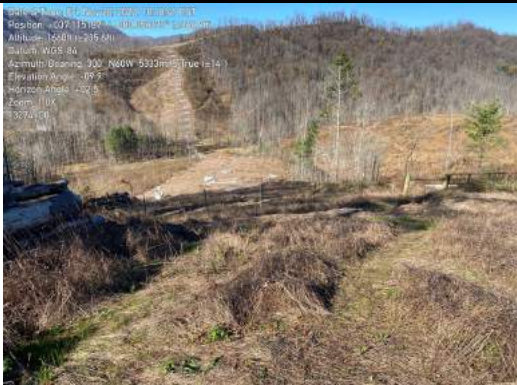
GPS Location	See photo for coordinates.		GPS Location	See photo for coordinates.	
Field Station#	13278+00		Field Station#	13274+00	
Pic 11 Desc.	ROW stable with acceptable vegetative cover.		Pic 12 Desc.	ROW stable with acceptable vegetative cover.
