Visual Site Inspection Report

Project Name	H-600 Pipeline Spread H	AFE	124300138	Spread	H-600 Pipeline Spread H
Contractor	Precision			Report #	17213
Inspector	Kaitlyn Ball			Date/Time	11/23/2020 1:40 PM
Permit #	TBD	Inspection Type	VA SWPP	Station Begin	12234+50
State	VA	Inspection Area	Partial	Station End	12443+75
County	Montgomery	Ground	Dry	Temperature (°F)	47.00
Municipality	N/A	Weather	Sunny	Rain Gauge (in)	0.10
				Rain Accumulation Time (days)	1.00

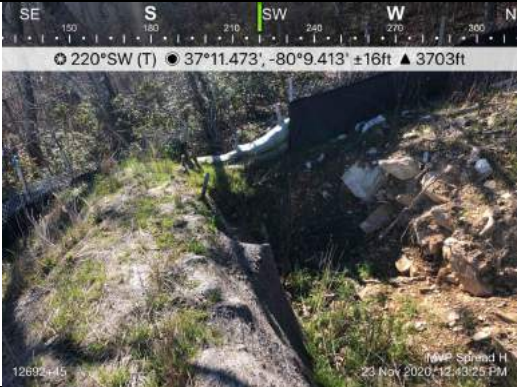
GPS Location	See Picture Watermark		GPS Location	See Picture Watermark	
Field Station#	12692+45		Field Station#	12701+00	
Pic 7 Desc.	Waterbar sump pit and end treatment in good condition and no maintenance is required.		Pic 8 Desc.	MVP-ATWS-955 is in good condition and no maintenance is needed.

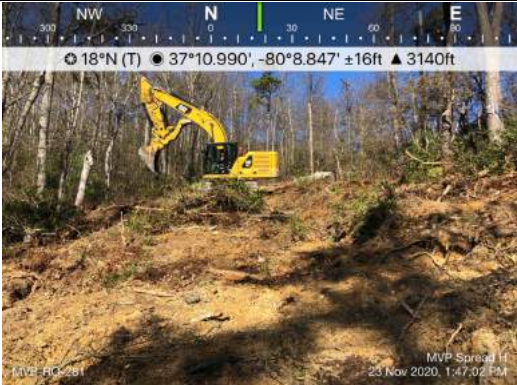
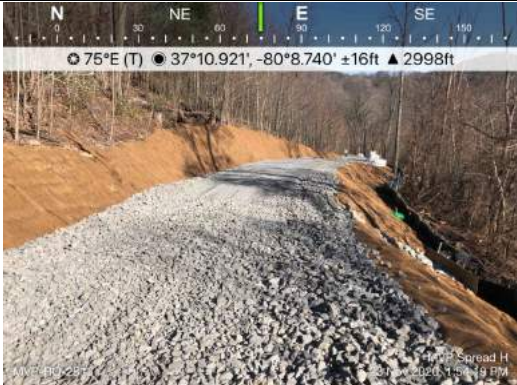
GPS Location	See Picture Watermark		GPS Location	See Picture Watermark	
Field Station#	12743+82		Field Station#	12743+82	
Pic 17 Desc.	Front end grubbing excavator. Environmental crews on-site installing CFS & SSF approx. 200 feet behind excavator.		Pic 18 Desc.	Completed section of MVP-RO-281 is stabilized with erosion control matting in all steep slope areas.

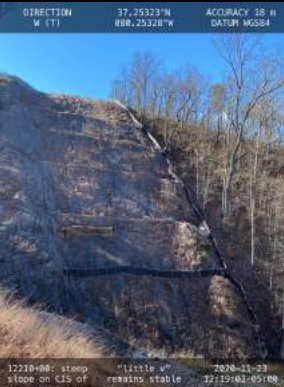
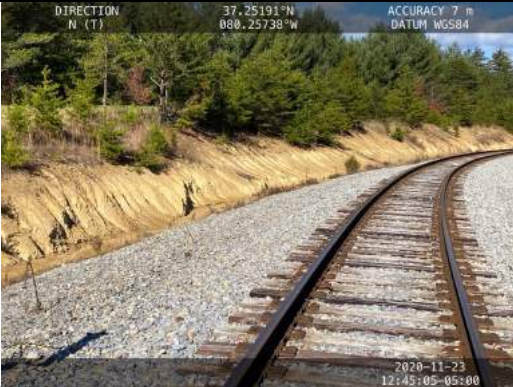
GPS Location	See photo		GPS Location	See photo	
Field Station#	12210+00		Field Station#	12197+00	
Pic 3 Desc.	The steep slope on the coming in side of the "little v" remains stable.		Pic 4 Desc.	Banks along the railroad tracks that cross MVP-MN-275 remain denuded with obvious rill and gully erosion continuing to occur.

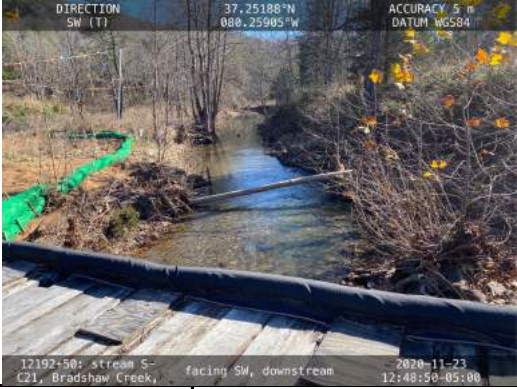
GPS Location	See photo		GPS Location	See photo	
Field Station#	12192+50		Field Station#	12184+00	
Pic 7 Desc.	Stream S-C21, Bradshaw Creek, facing southwest, downstream		Pic 8 Desc.	ROW on coming in side of Bradshaw Road is stable.

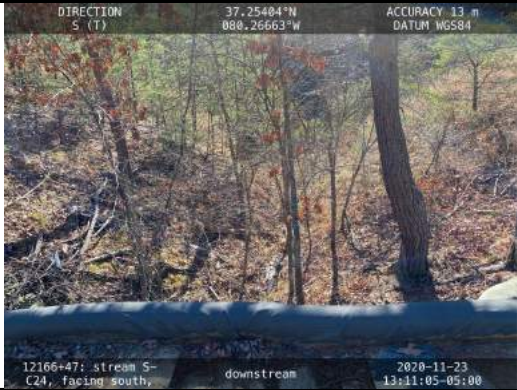
GPS Location	See photo		GPS Location	See photo	
Field Station#	12166+47		Field Station#	12163+05	
Pic 9 Desc.	Stream S-C24, facing south, downstream		Pic 10 Desc.	Stream S-C25, facing west

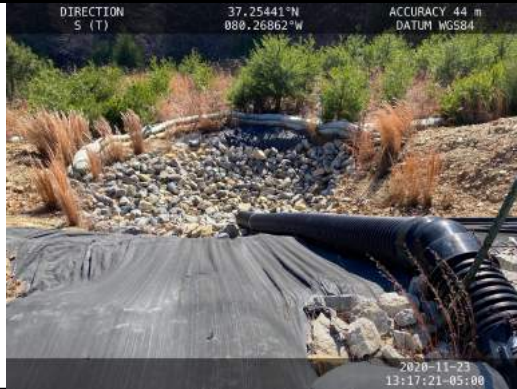
GPS Location	See photo		GPS Location	See photo	
Field Station#	12160+00		Field Station#	12157+00	
Pic 11 Desc.	Slope drains between access roads MVP-MN-273 and 274 remain in good repair.		Pic 12 Desc.	The temporary sediment trap and clean water diversion channel on the going away side of access road MVP-MN-273 in good repair.

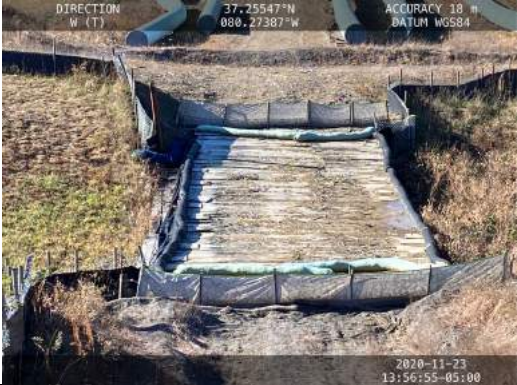
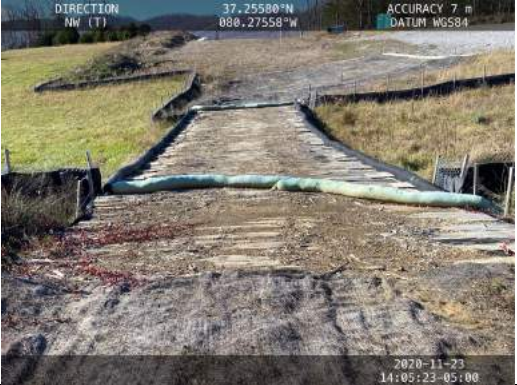
GPS Location	See photo		GPS Location	See photo	
Field Station#	12145+00		Field Station#	12140+00	
Pic 13 Desc.	Wetland W-C6, facing west		Pic 14 Desc.	Wetland W-C5, facing northwest

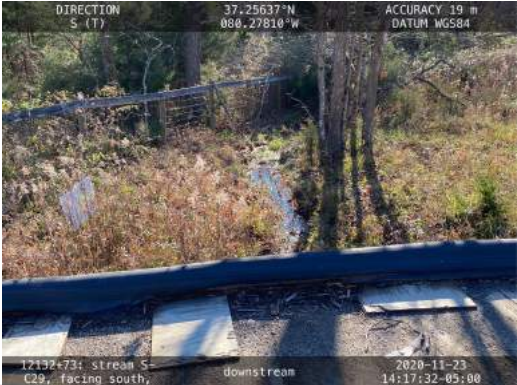
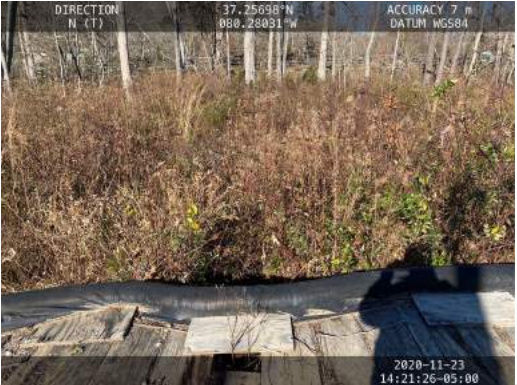
GPS Location	See photo		GPS Location	See photo	
Field Station#	12132+73		Field Station#	12125+65	
Pic 15 Desc.	Stream S-C29, facing southwest, downstream		Pic 16 Desc.	Stream S-MM31, facing north, upstream

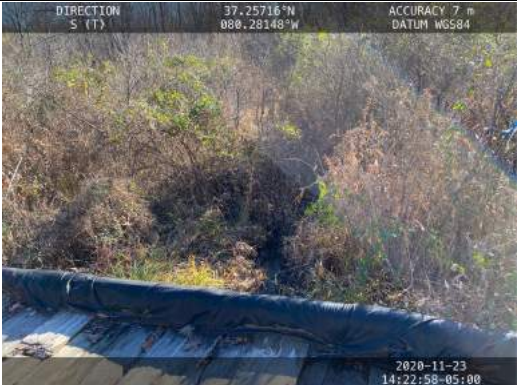
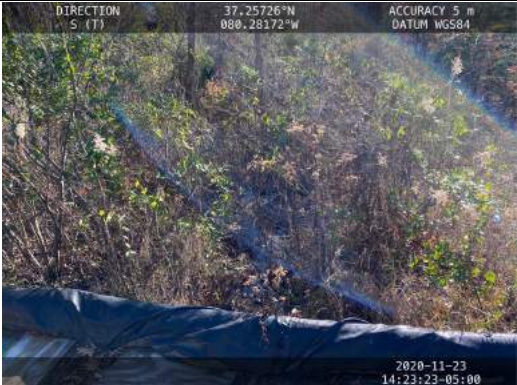
GPS Location	See photo		GPS Location	See photo	
Field Station#	12121+83		Field Station#	12121+33	
Pic 17 Desc.	Stream S-C36, facing south, downstream		Pic 18 Desc.	Stream S-C33, facing south, downstream

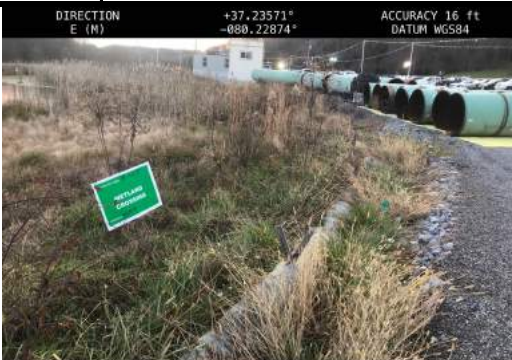
<p>DIRECTION E (M) +37.23571° -080.22874° ACCURACY 16 ft DATUM WGS84</p> <p>MVP-PY-006_112320 Condition of signage & CFS along feature 2020-11-23 07:23:57-05:00</p>			  <p>DIRECTION SE (M) +37.23553° -080.22697° ACCURACY 33 ft DATUM WGS84</p> <p>MVP-PY-006_112320 No fluid or deposits around hazardous ... 2020-11-23 07:26:45-05:00</p>	
GPS Location	MVP-PY-006 See photo for gps data		GPS Location	MVP-PY-006 See photo for gps data	
Field Station#	+0		Field Station#	+0	
Pic 5 Desc.	Condition of signage and compost filter sock along feature W-008. Looking E.		Pic 6 Desc.	No fluid or deposits around hazardous waste dumpsters. Looking SE.

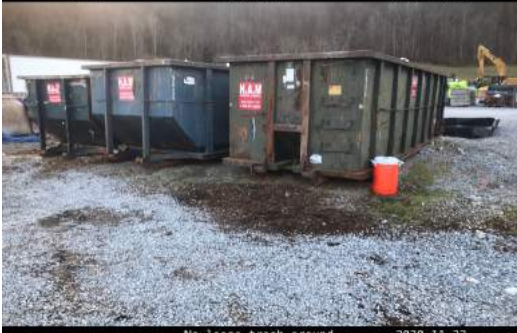
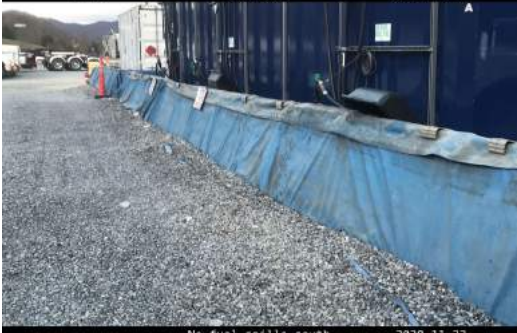
MVP-PY-006_112320 No loose trash around dumpsters 2020-11-23 07:27:19-05:00				MVP-PY-006_112320 No fuel spills south of tanks 2020-11-23 07:27:47-05:00	
GPS Location	MVP-PY-006 See photo for gps data		GPS Location	MVP-PY-006 See photo for gps data	
Field Station#	+0		Field Station#	+0	
Pic 7 Desc.	No loose trash around dumpsters. Looking SE.		Pic 8 Desc.	No fuel spills south of Blue Bulk fuel tanks. Looking W.	
DIRECTION SW (M) +37.23562° -080.22678° ACCURACY 16 ft DATUM WGS84

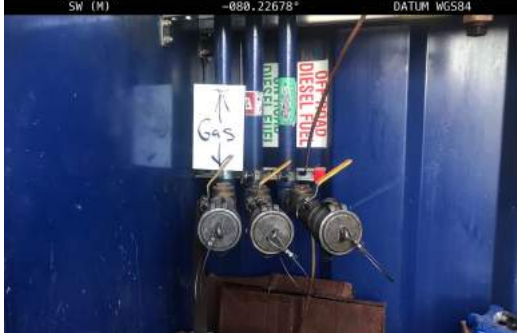
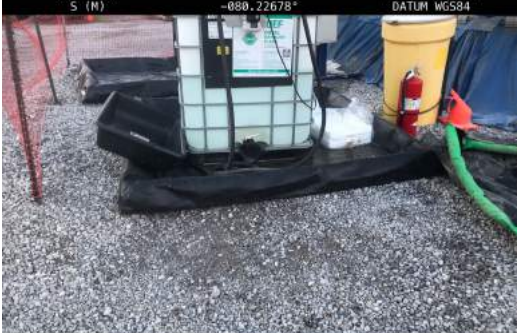
GPS Location	MVP-PY-006 See photo for gps data		GPS Location	MVP-PY-006 See photo for gps data	
Field Station#	+0		Field Station#	+0	
Pic 9 Desc.	Blue Bulk Fuel tanks no leaky internal fittings. Looking SW.		Pic 10 Desc.	Condition of containment under DEF tank. Looking S.	
DIRECTION W (M) +37.23566° -080.22677° ACCURACY 16 ft DATUM WGS84

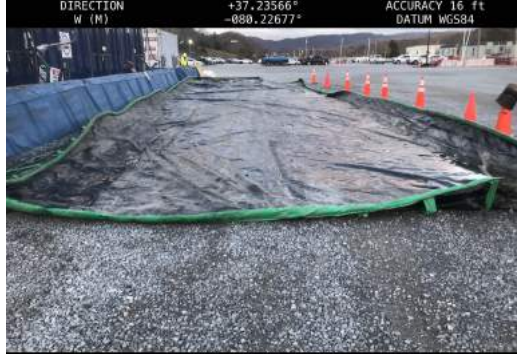
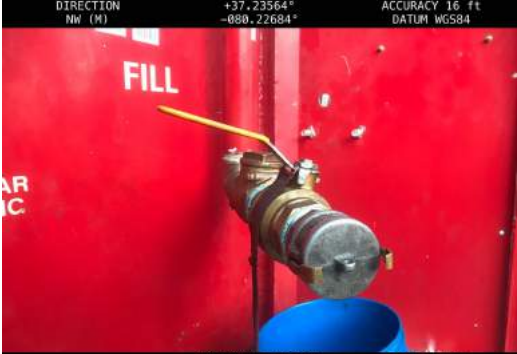
MVP-PY-006_112320 Secondary containment on site for tankers 2020-11-23 07:29:27-05:00				MVP-PY-006_112320 No leaky internal fittings 2020-11-23 07:30:53-05:00	
GPS Location	MVP-PY-006 See photo for gps data		GPS Location	MVP-PY-006 See photo for gps data	
Field Station#	+0		Field Station#	+0	
Pic 11 Desc.	Blue Bulk Fuel tanks Secondary containment spread waiting fuel delivery. Looking W.		Pic 12 Desc.	Off Road Fuel unit no leaky internal fittings. Looking NW.

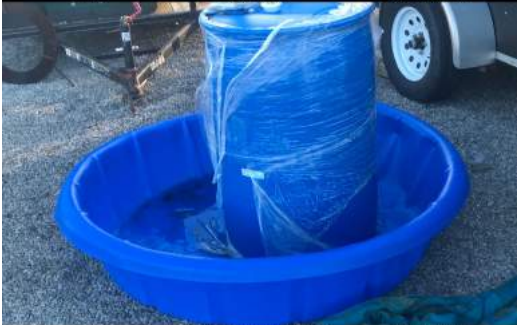
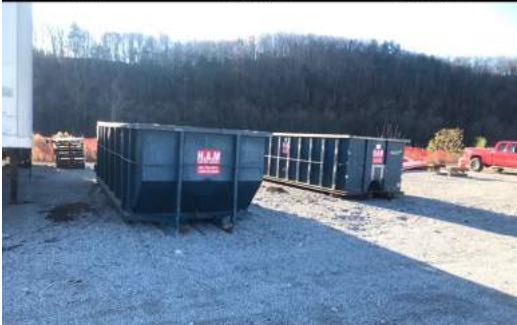
MVP-LY-049_112320 No loose trash around south dumpsters 2020-11-23 08:45:50-05:00			
GPS Location	MVP-LY-049 See photo for gps data		GPS Location	MVP-LY-049 See photo for gps data	
Field Station#	+0		Field Station#	+0	
Pic 7 Desc.	Barrel of Blue toilet chemical in containment. Looking E.		Pic 8 Desc.	No loose trash around south dumpsters. Looking SE.	
DIRECTION W (M) +37.27052° -080.12258° ACCURACY 16 ft DATUM WGS84

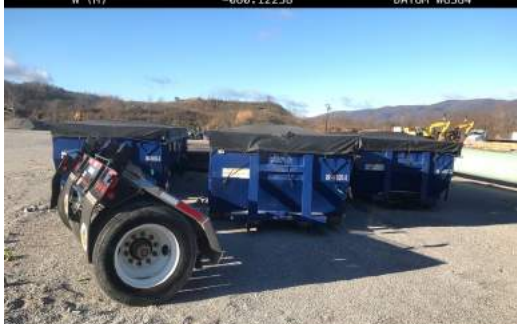
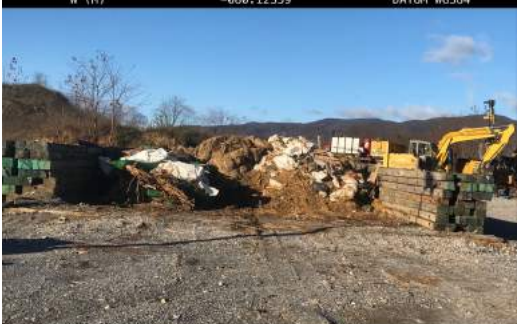
GPS Location	MVP-LY-049 See photo for gps data		GPS Location	MVP-LY-049 See photo for gps data	
Field Station#	+0		Field Station#	+0	
Pic 9 Desc.	No fluid or deposits around hazardous waste dumpsters. Looking W.		Pic 10 Desc.	Condition of temporary trash transfer pit. Debris inside boundary of pit. Looking W.	
DIRECTION SW (M) +37.27037° -080.12457° ACCURACY 16 ft DATUM WGS84

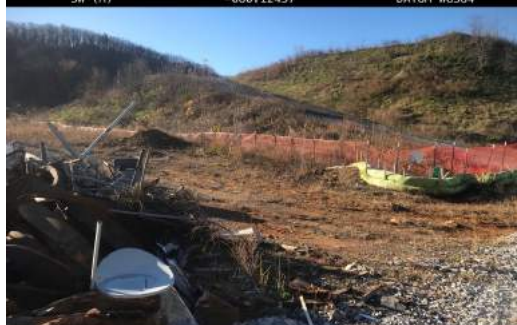
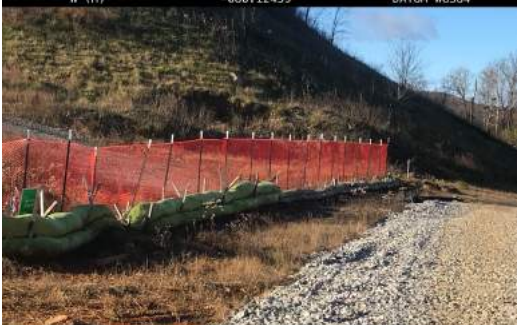
MVP-LY-049_112320 Landowner disturbance within 66' of feature 2020-11-23 08:50:27-05:00			
GPS Location	MVP-LY-049 See photo for gps data		GPS Location	MVP-LY-049 See photo for gps data	
Field Station#	+0		Field Station#	+0	
Pic 11 Desc.	Landowner soil disturbance along compost filter sock and feature W-CV21B. Area not stabilized. No impacts. Looking SW.		Pic 12 Desc.	Landowner soil disturbance within 66' and 120' of feature W-CV21B. Areas not stabilized. No impacts. Looking W.

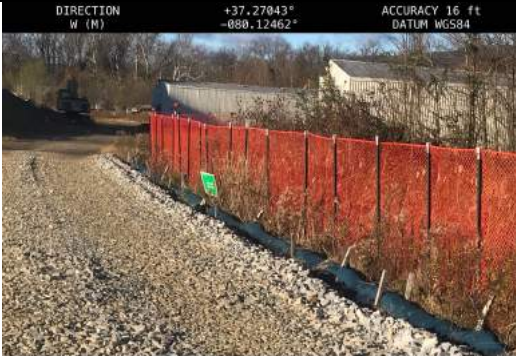
<p>DIRECTION SW (M) +37.27054° -080.12385° ACCURACY 16 ft DATUM WGS84</p> <p>MVP-LY-049_112320 Containment under stored equipment 2020-11-23 08:51:49-05:00</p>			
GPS Location	MVP-LY-049 See photo for gps data		GPS Location	MVP-LY-049 See photo for gps data	
Field Station#	+0		Field Station#	+0	
Pic 13 Desc.	Condition of compost filter sock and safety fence along feature W-CV21A. Looking W.		Pic 14 Desc.	Condition of containment under stored equipment. Looking SW.

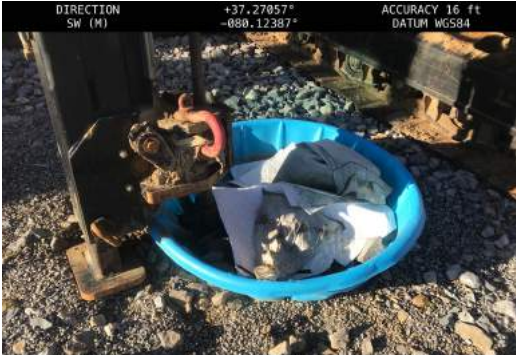
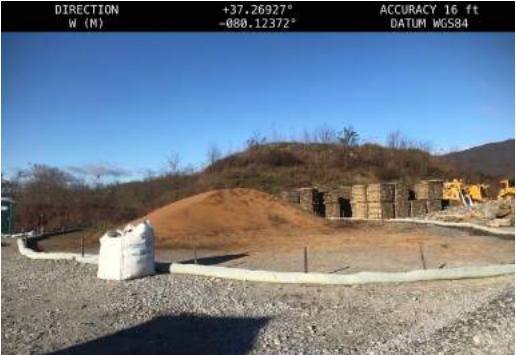
GPS Location	MVP-LY-049 See photo for gps data		GPS Location	MVP-LY-049 See photo for gps data	
Field Station#	+0		Field Station#	+0	
Pic 15 Desc.	Condition of containment under stored equipment. Looking SW.		Pic 16 Desc.	Condition of compost filter sock around sand pile. Looking W.

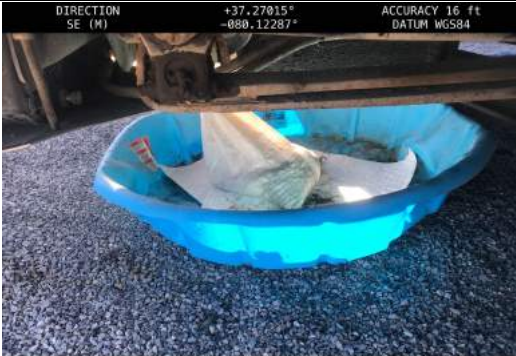
<p>DIRECTION E (M) +37.27003° -080.12295° ACCURACY 16 ft DATUM WGS84</p> <p>MVP-LY-049_112320 Containment under stored vehicle 2020-11-23 08:56:16-05:00</p>			
GPS Location	MVP-LY-049 See photo for gps data		GPS Location	MVP-LY-049 See photo for gps data	
Field Station#	+0		Field Station#	+0	
Pic 17 Desc.	Condition of containment under stored vehicle. Looking SE.		Pic 18 Desc.	Condition of containment under stored vehicle. Looking E.

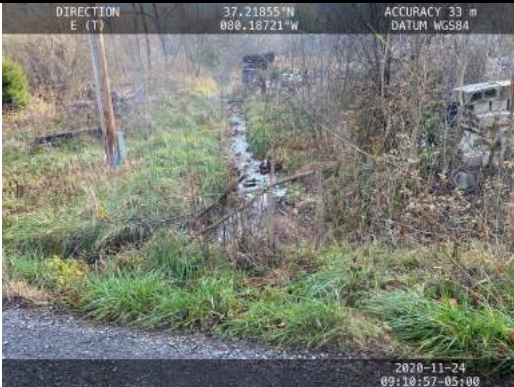
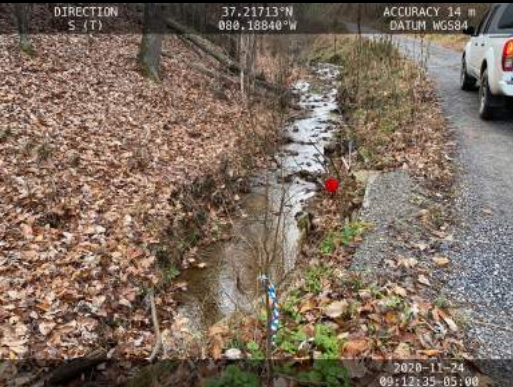
GPS Location	See photo		GPS Location	See photo	
Field Station#	12544+06		Field Station#	12544+06	
Pic 1 Desc.	Stream S-KL32, facing east, upstream from Yellow Finch Road		Pic 2 Desc.	Stream S-EF20b, facing south, upstream from Yellow Finch Road

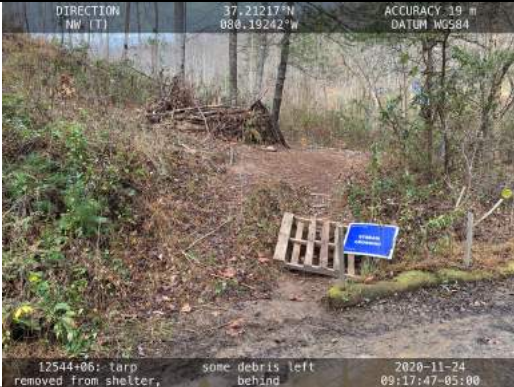
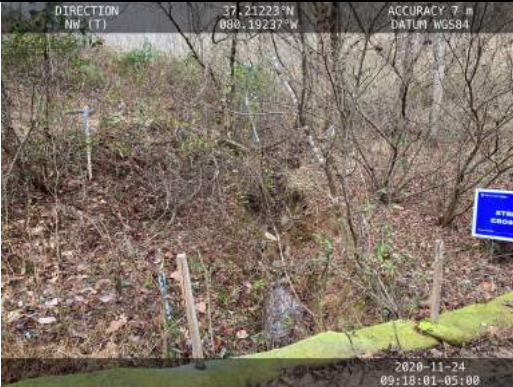
GPS Location	See photo		GPS Location	See photo	
Field Station#	12544+06		Field Station#	12544+06	
Pic 3 Desc.	Debris left behind where a protester shelter was removed recently.		Pic 4 Desc.	Stream S-EF54, facing northwest, upstream from Yellow Finch Road

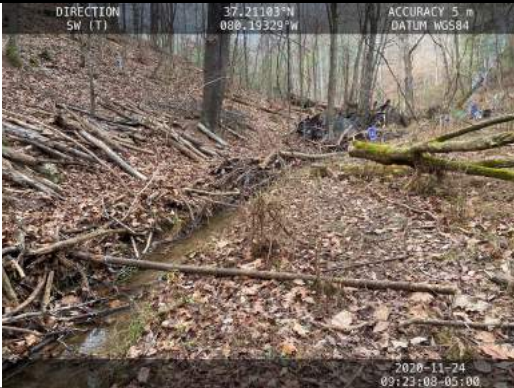
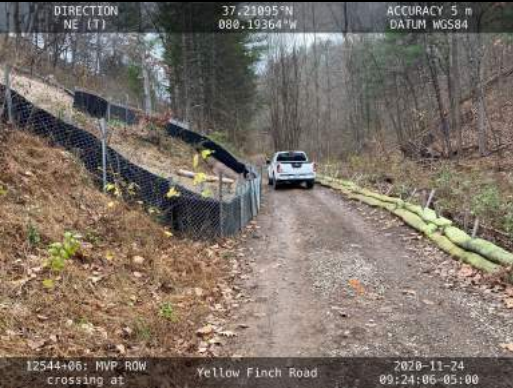
GPS Location	See photo		GPS Location	See photo	
Field Station#	12544+54		Field Station#	12544+06	
Pic 5 Desc.	Stream S-EF20a, facing southwest, upstream		Pic 6 Desc.	MVP ROW crossing at Yellow Finch Road

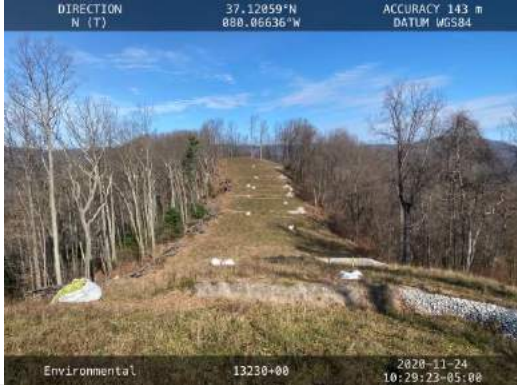
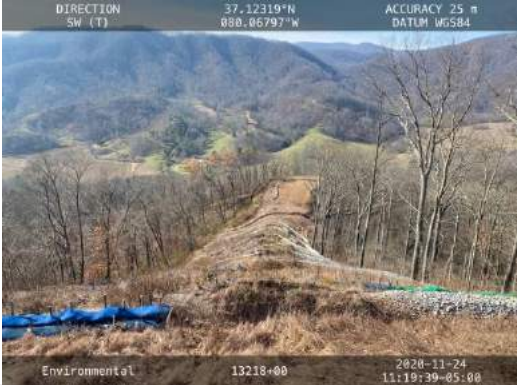
GPS Location	See photo for GPS coordinates		GPS Location	See photo for GPS coordinates	
Field Station#	13230+00		Field Station#	13218+00	
Pic 9 Desc.	Well vegetative cover across LOD		Pic 10 Desc.	Permanent water bars with Well vegetative cover across LOD.

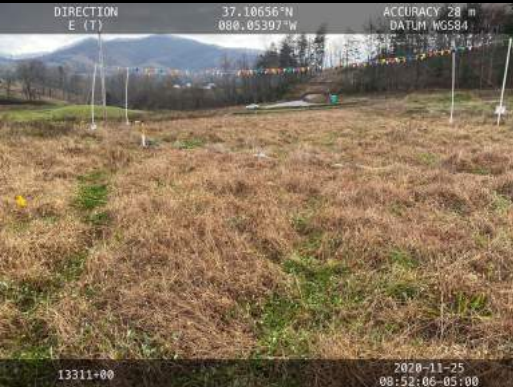
GPS Location	See photo		GPS Location	See photo	
Field Station#	13315+70		Field Station#	13311+00	
Pic 1 Desc.	Wades Gap Road crossing		Pic 2 Desc.	ROW stable where temporarily stabilized on coming in side of Wades Gap Road.

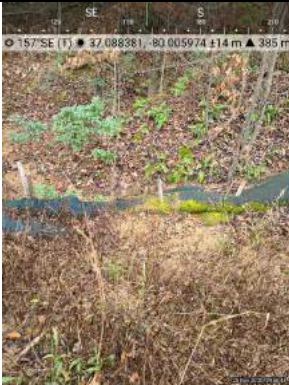
GPS Location	00000		GPS Location	00000	
Field Station#	13494+70		Field Station#	13493+00	
Pic 3 Desc.	CFS needs cleaned, sediment half height, discussed with the environmental crew to make repairs while in the area .		Pic 4 Desc.	Fallen tree caused CFS to be pulled up from the row, talked to the environmental crew to make repairs today while in the area.

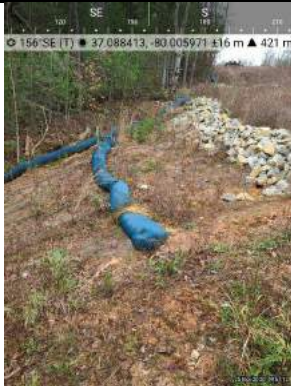
GPS Location	0000		GPS Location	0000	
Field Station#	13436+26		Field Station#	13494+70	
Pic 5 Desc.	Row photo up row from stream crossing showing ECDs in place and row stabilized, photo taken by the EI		Pic 6 Desc.	CFS needs cleaned, sediment half height, discussed with the environmental crew to make repairs while in the area .

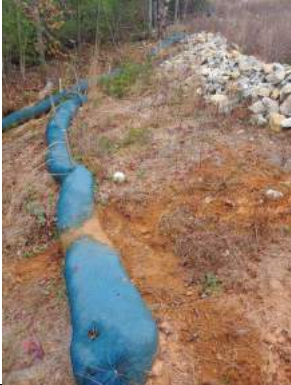
GPS Location	00000	GPS Location	00000		
Field Station#	13494+70	Field Station#	13494+70		
Pic 7 Desc.	Sediment removed from CFS and small wash repaired		Pic 8 Desc.	Sediment removed from CFS by the contractor.	
Insert image here			Insert image here		
GPS Location		GPS Location			
Field Station#		Field Station#			
Pic 9 Desc.			Pic 10 Desc.		
Insert image here			Insert image here		
GPS Location		GPS Location			
Field Station#		Field Station#			
Pic 11 Desc.			Pic 12 Desc.

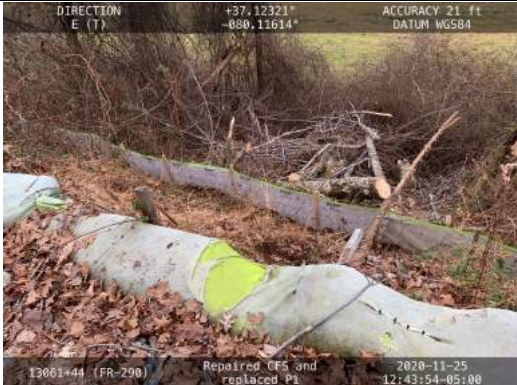
GPS Location	See photo for gps location data.		GPS Location	See photo for gps location data.	
Field Station#	13061+96		Field Station#	13061+44	
Pic 17 Desc.	Photo shows stream S-G27 downstream from the bridge.		Pic 18 Desc.	Photo shows the the repaired section of 12" CFS and the replaced section of P1 silt fence. Were previously damaged by a fallen tree.

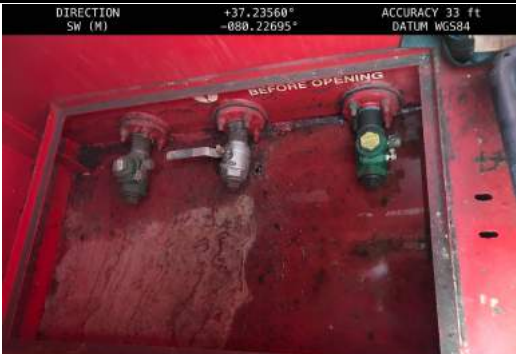
GPS Location	MVP-PY-006 see photo for gps data	GPS Location	MVP-PY-006 see photo for gps data		
Field Station#	+0	Field Station#	+0		
Pic 15 Desc.	Off Road Fuel unit containment holding some fluids. Looking SW.	Pic 16 Desc.	Blue Bulk Fuel tanks no leaky fittings or nozzles. Looking N.

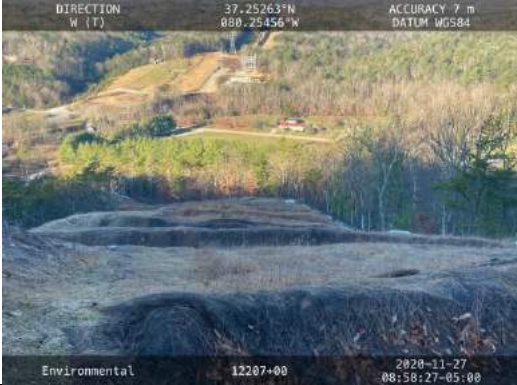
GPS Location	See photo for GPS coordinates		GPS Location	See photo for GPS coordinates	
Field Station#	12207+00		Field Station#	12213+00	
Pic 13 Desc.	Well vegetative cover across LOD.		Pic 14 Desc.	Small section of permanent restoration with a well vegetated cover.
