Visual Site Inspection Report

Project Name	H-600 Pipeline Spread H	AFE	124300138	Spread	H-600 Pipeline Spread H
Contractor	Precision			Report #	17462
Inspector	John Brcic			Date/Time	11/30/2020 2:45 PM
Permit #	TBD	Inspection Type	VA SWPP	Station Begin	12443+75
State	VA	Inspection Area	Partial	Station End	12544+06
County	Montgomery	Ground	Wet	Temperature (°F)	46.00
Municipality	N/A	Weather	Light Rain	Rain Gauge (in)	0.90
				Rain Accumulation Time (days)	2.00

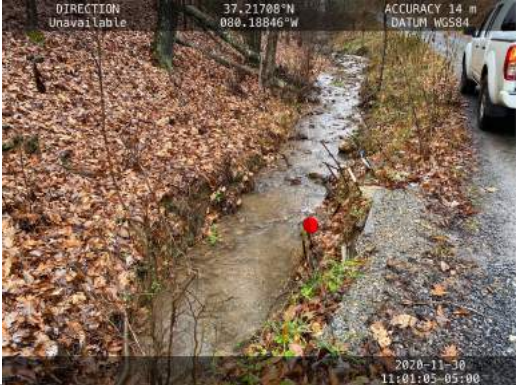
GPS Location	See photo		GPS Location	See photo	
Field Station#	12544+06		Field Station#	12544+06	
Pic 3 Desc.	Stream S-EF20b, facing south, upstream from Yellow Finch Road		Pic 4 Desc.	Stream S-EF53, facing northwest, upstream from Yellow Finch Road

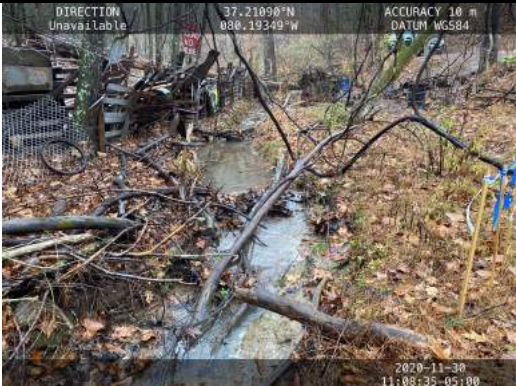
GPS Location	See photo		GPS Location	See photo	
Field Station#	12544+54		Field Station#	12544+54	
Pic 5 Desc.	Stream S-EF20a, facing southwest, upstream		Pic 6 Desc.	Stream S-EF20a, facing northeast, downstream

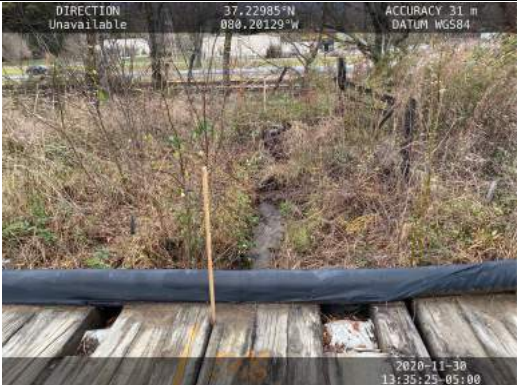
GPS Location	See photo		GPS Location	See photo	
Field Station#	12455+21		Field Station#	12444+94	
Pic 17 Desc.	Stream S-CD12, facing north, downstream		Pic 18 Desc.	Stream S-I1, facing west, upstream

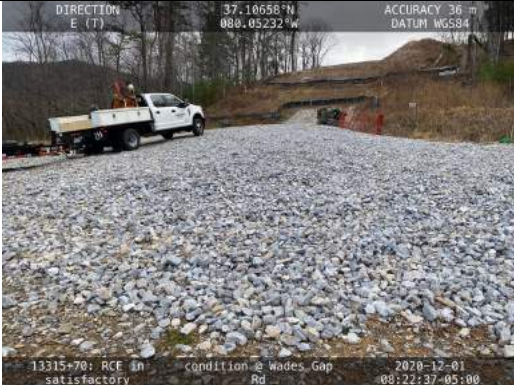
GPS Location	See photo		GPS Location	See photo	
Field Station#	13315+70		Field Station#	13313+00	
Pic 1 Desc.	RCE on coming in side of Wades Gap Road is in satisfactory condition.		Pic 2 Desc.	Temporarily stabilized ROW between stream S-GH7 and Wades Gap Road is well vegetated.

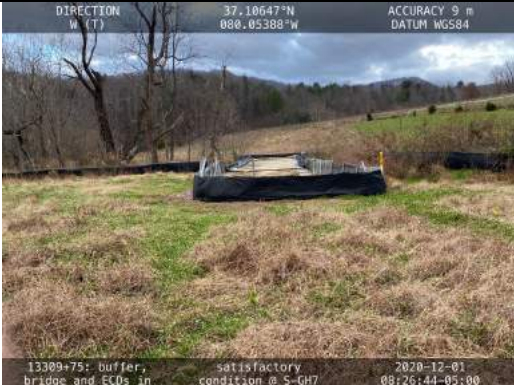
GPS Location	See photo		GPS Location	See photo	
Field Station#	13109+75		Field Station#	13109+09	
Pic 3 Desc.	The buffer zone, bridge and ECDs at stream S-GH7 are at good condition.		Pic 4 Desc.	Stream S-GH7, facing northeast, upstream

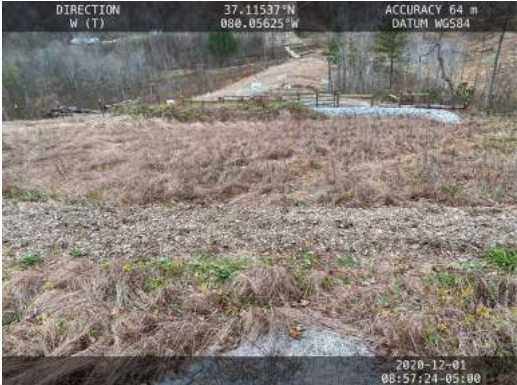
GPS Location	See photo		GPS Location	See photo	
Field Station#	13075+00		Field Station#	13071+00	
Pic 15 Desc.	ROW stable		Pic 16 Desc.	ROW stable

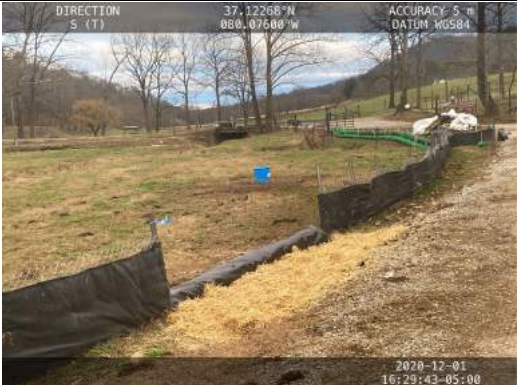
GPS Location	See photo		GPS Location	See photo	
Field Station#	13063+00		Field Station#	13185+40	
Pic 17 Desc.	Slope on going away side of the Flanders Road crossing remains stable.		Pic 18 Desc.	A foam silt dyke was replaced, CFS was replaced, and super silt fence repaired per MVP punch list item on MVP-MLV-AR-29.

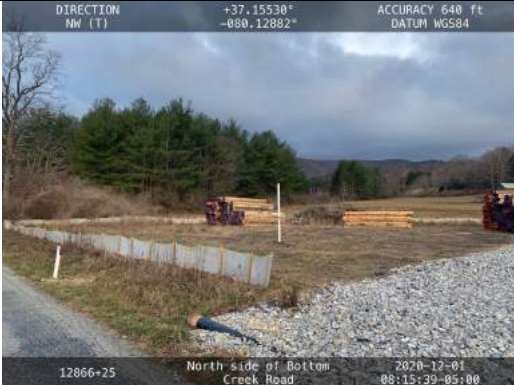
GPS Location	See photo for gps location data.		GPS Location	See photo for gps location data.	
Field Station#	12866+25		Field Station#	12957+38	
Pic 1 Desc.	Photo shows the work space on the west side of Bottom Creek Road.		Pic 2 Desc.	Photo shows the bridge over stream S-Z16 on access road RO-287. No issues were observed.

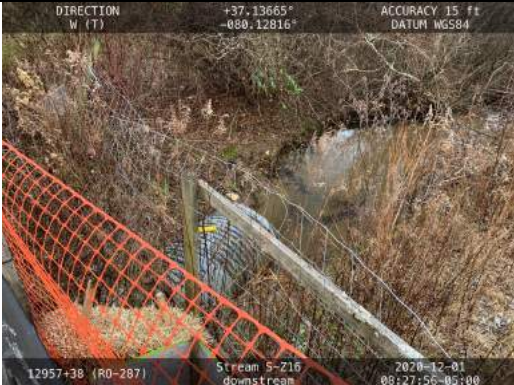
GPS Location	See photo for gps location data.		GPS Location	See photo for gps location data.	
Field Station#	12957+38		Field Station#	12957+38	
Pic 3 Desc.	Photo shows stream S-Z16 downstream from the bridge.		Pic 4 Desc.	Photo shows the bridge over stream S-Z17 on access road RO-287. No issues were observed.

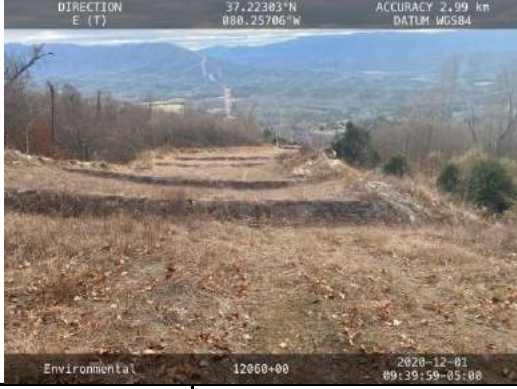
GPS Location	See photo for GPS coordinates		GPS Location	See photo for GPS coordinates	
Field Station#	12060+00		Field Station#	12062+00	
Pic 9 Desc.	Well vegetative cover across LOD		Pic 10 Desc.	Well vegetative cover across LOD

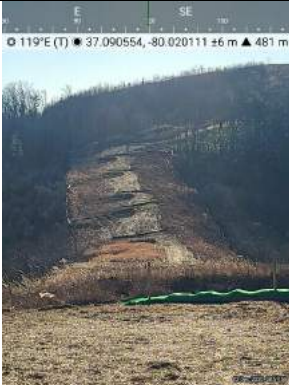
GPS Location	00000	GPS Location	0000		
Field Station#	1313440+00	Field Station#	13436+44		
Pic 1 Desc.	EI monitored ECDs and stabilization throughout areas of row today, no environmental issues observed at the time of inspection.		Pic 2 Desc.	EI Documented photo showing stabilized row and ECDs in place and functioning.

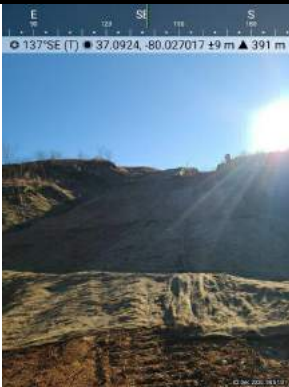
GPS Location	0000	GPS Location	0000		
Field Station#	13415+90	Field Station#	13496+98		
Pic 3 Desc.	EI monitored erosion control blanket of hill side near CAHAS#1 , no environmental issues observed at the time of inspection.		Pic 4 Desc.	Row photo taken by the EI showing ECDs in place and vegetation growth near stream crossing at CAHAS #2

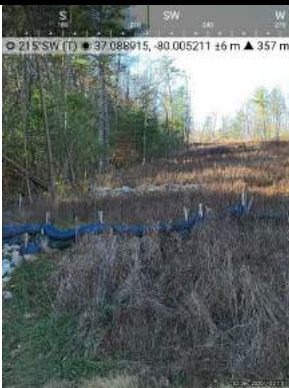
GPS Location	0000	GPS Location	0000		
Field Station#	13496+76	Field Station#	13497+10		
Pic 5 Desc.	Vegetation photo observation facing up row from CAHAS #2		Pic 6 Desc.	The EI monitored anode bed area and stabilization after recent work activities, no environmental issues observed at the time of inspection.

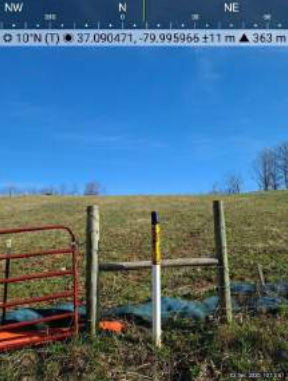
GPS Location	00000	GPS Location	0000		
Field Station#	13526+00	Field Station#	13543+32		
Pic 1 Desc.	Vegetation observation where cocklebur plants were mowed down by the land owner after land owner complaint, vegetation coverage was good in the area, no environmental issues		Pic 2 Desc.	The EI observed equipment bridge at stream crossing S-II9 , no environmental issues observed at the time of inspection

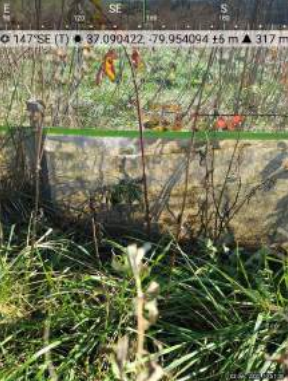
GPS Location	00000	GPS Location	00000		
Field Station#	13665+77	Field Station#	13658+47		
Pic 3 Desc.	EI observed damaged P1 that required maintenance, sent in to be added to the punch list		Pic 4 Desc.	EI observed damaged P1 that required maintenance, sent in to be added to the punch list

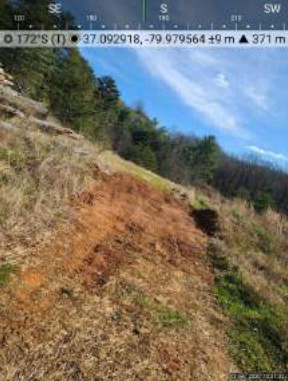
GPS Location	00000	GPS Location	0000		
Field Station#	13576+90	Field Station#	13576+00		
Pic 5 Desc.	The EI noticed during routine inspection that a breaker was damaged from a land owner accessing the row , documented and sent in to be added to the punch list for repairs and		Pic 6 Desc.	The EI noticed during routine inspection that a breaker was damaged from a land owner accessing the row , documented and sent in to be added to the punch list for repairs and

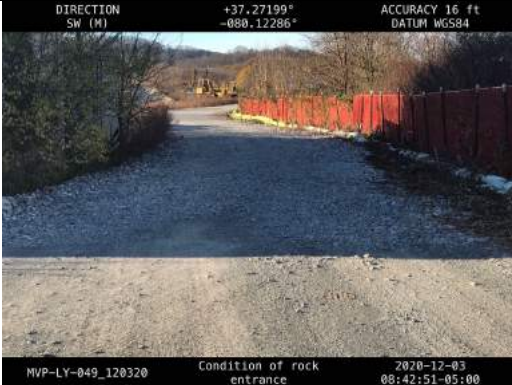
GPS Location	MVP-LY-049 See photo for gps data	GPS Location	MVP-LY-049 See photo for gps data		
Field Station#	+0	Field Station#	+0		
Pic 1 Desc.	Condition of rock entrance on north drive. No sediment on stone. Looking SW.	Pic 2 Desc.	Condition of compost filter sock and safety fence along north LOD. Looking W.

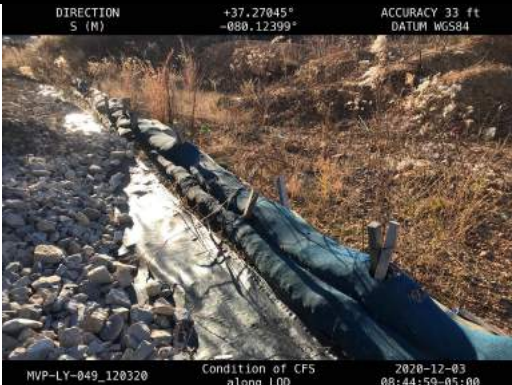
GPS Location	MVP-LY-049 See photo for gps data	GPS Location	MVP-LY-049 See photo for gps data		
Field Station#	+0	Field Station#	+0		
Pic 3 Desc.	Condition of compost filter sock and along west LOD. Looking S.	Pic 4 Desc.	Condition of compost filter sock and safety fence along feature W-CV21A. Looking W.

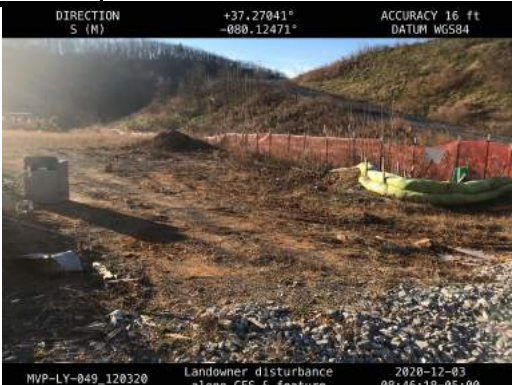
GPS Location	MVP-LY-049 See photo for gps data	GPS Location	MVP-LY-049 See photo for gps data		
Field Station#	+0	Field Station#	+0		
Pic 5 Desc.	Landowner soil disturbance along compost filter sock and feature W-CV21B. Area not stabilized. No impacts. Looking S.	Pic 6 Desc.	Landowner soil disturbance within 66' and 120' west of feature W-CV21B. Area not stabilized. Looking SW.

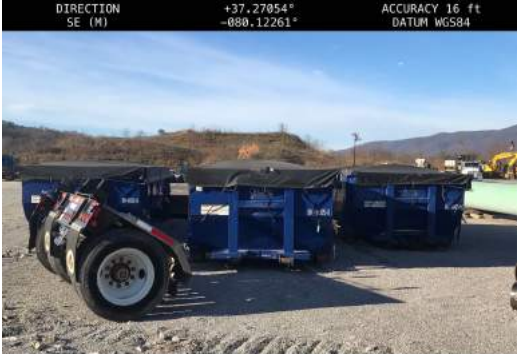
<p>DIRECTION SE (M) +37.27054° -080.12261° ACCURACY 16 ft DATUM WGS84</p> <p>MVP-LY-049_120320 No fluids or deposits around hazardous waste 2020-12-03 09:21:19-05:00</p>

<p>DIRECTION NW (M) +37.26926° -080.12375° ACCURACY 16 ft DATUM WGS84</p> <p>MVP-LY-049_120320 Condition of CF5 around sand pile 2020-12-03 09:23:46-05:00</p>			
GPS Location	MVP-LY-049 See photo for gps data		GPS Location	MVP-LY-049 See photo for gps data	
Field Station#	+0		Field Station#	+0	
Pic 13 Desc.	No fluids or deposits around hazardous waste dumpsters. Looking SE.		Pic 14 Desc.	Condition of compost filter sock around sand pile. Looking NW.

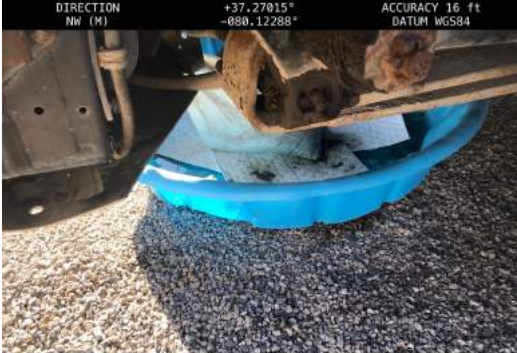
<p>DIRECTION NW (M) +37.27015° -080.12288° ACCURACY 16 ft DATUM WGS84</p> <p>MVP-LY-049_120320 Containment under stored vehicle 2020-12-03 09:26:24-05:00</p>

GPS Location	MVP-LY-049 See photo for gps data		GPS Location	MVP-LY-049 See photo for gps data	
Field Station#	+0		Field Station#	+0	
Pic 15 Desc.	Condition of containment under stored vehicle. Looking NW.		Pic 16 Desc.	Condition of containment under stored vehicle. Looking S.

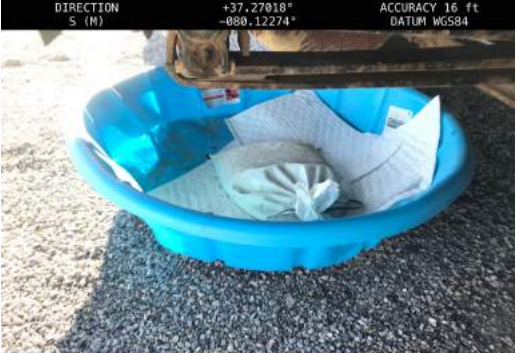
<p>DIRECTION S (M) +37.27018° -080.12274° ACCURACY 16 ft DATUM WGS84</p> <p>MVP-LY-049_120320 Containment under stored vehicle 2020-12-03 09:26:44-05:00</p>

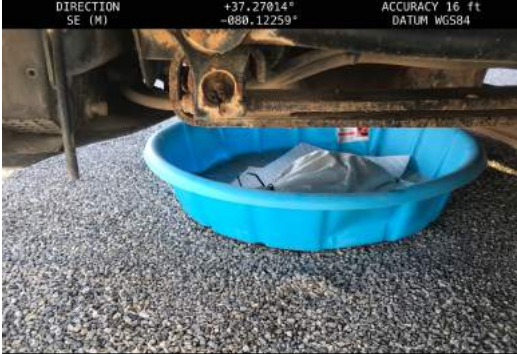
<p>DIRECTION SE (M) +37.27014° -080.12259° ACCURACY 16 ft DATUM WGS84</p> <p>MVP-LY-049_120320 Containment under stored vehicle 2020-12-03 09:27:10-05:00</p>

<p>DIRECTION NE (M) +37.27093° -080.12164° ACCURACY 16 ft DATUM WGS84</p> <p>MVP-LY-049_120320 Condition of containment 2020-12-03 09:29:15-05:00</p>			
GPS Location	MVP-LY-049 See photo for gps data		GPS Location	MVP-LY-049 See photo for gps data	
Field Station#	+0		Field Station#	+0	
Pic 17 Desc.	Condition of containment under stored vehicle. Looking SW.		Pic 18 Desc.	Condition of containment under generator. Free of stormwater. Looking NE.

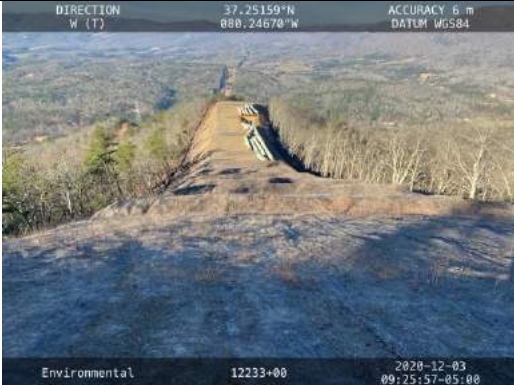
GPS Location	See photo for GPS coordinates		GPS Location	See photo for GPS coordinates	
Field Station#	12233+00		Field Station#	12217+23	
Pic 1 Desc.	Well vegetated and stabilized ROW.		Pic 2 Desc.	Water bar in well stabilized ROW working properly.

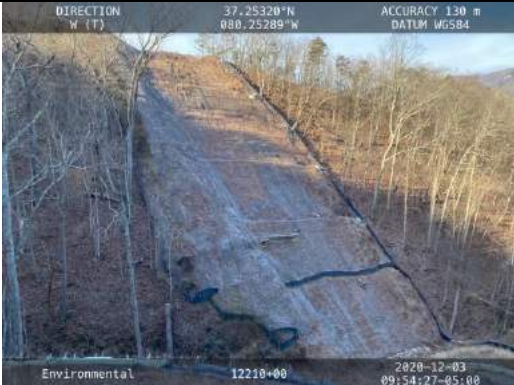
GPS Location	See photo for GPS coordinates		GPS Location	See photo for GPS coordinates	
Field Station#	12210+00		Field Station#	12212+50	
Pic 3 Desc.	Stabilized hill side with well vegetative coverage.		Pic 4 Desc.	Section of ROW where final restoration has taken place and is in acceptable condition.

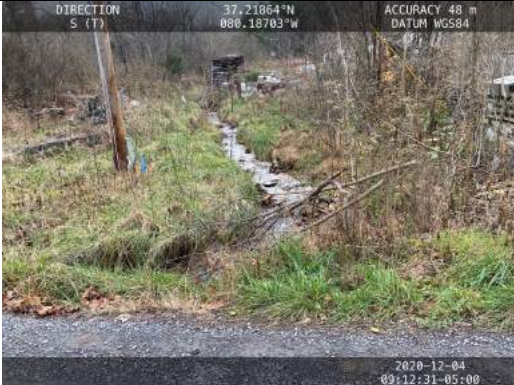
GPS Location	See photo		GPS Location	See photo	
Field Station#	12544+06		Field Station#	12544+06	
Pic 1 Desc.	Stream S-KL32, facing south, upstream from Yellow Finch Road		Pic 2 Desc.	Stream S-EF20b, facing north, upstream from Yellow Finch Road

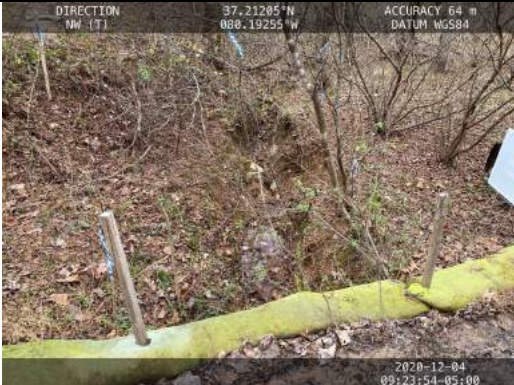
GPS Location	See photo		GPS Location	See photo	
Field Station#	12544+06		Field Station#	12544+06	
Pic 3 Desc.	Stream S-EF54, facing northwest, upstream		Pic 4 Desc.	MVP ROW crossing at Yellow Finch Road

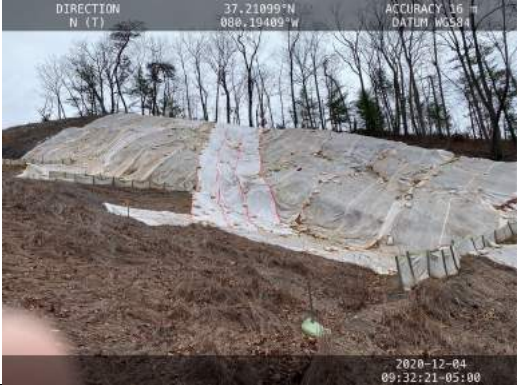
GPS Location	See photo		GPS Location	See photo	
Field Station#	12543+00		Field Station#	12536+00	
Pic 7 Desc.	Plastic sheeting on stockpiles nearest to Yellow Finch Road remains intact and secure.		Pic 8 Desc.	Fill slope remains stable.

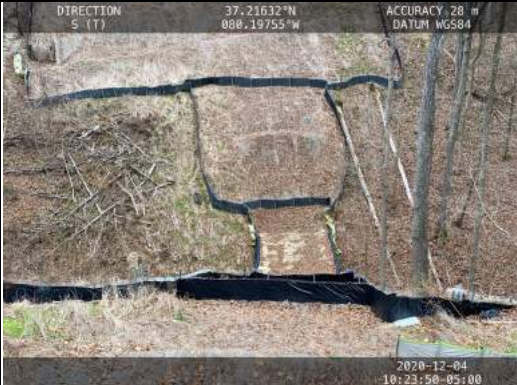
ert image here	
GPS Location	See photo		GPS Location	See photo	
Field Station#	12519+41		Field Station#	12522+00	
Pic 13 Desc.	Bridge, buffer zone, and ECDs are in satisfactory condition at stream S-EF19.		Pic 14 Desc.	Slope on the going away side stream S-EF19 remains stable.

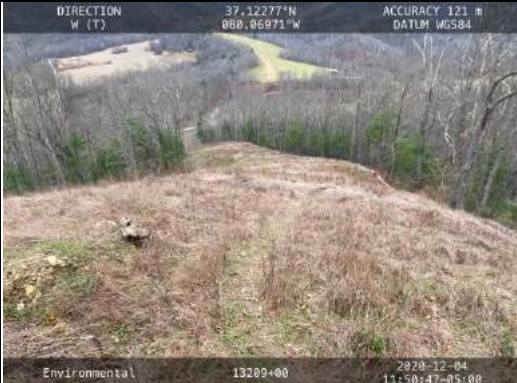
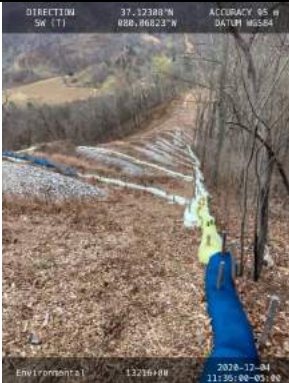
GPS Location	See photo for GPS coordinates		GPS Location	See photo for GPS coordinates	
Field Station#	13209+00		Field Station#	13216+00	
Pic 7 Desc.	Well vegetated coverage across LOD.		Pic 8 Desc.	Rock Weir outlets on permanent Waterbars with well vegetated coverage across the LOD.

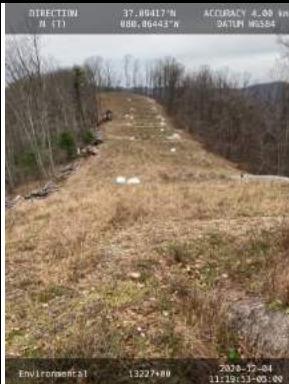
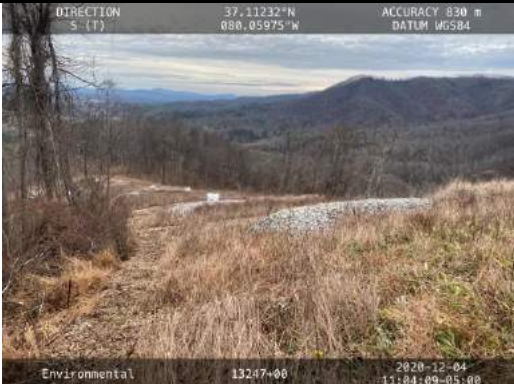
GPS Location	See photo for GPS coordinates		GPS Location	See photo for GPS coordinates	
Field Station#	13227+00		Field Station#	13247+00	
Pic 9 Desc.	Well vegetated coverage across LOD.		Pic 10 Desc.	Well vegetated ROW in acceptable condition.

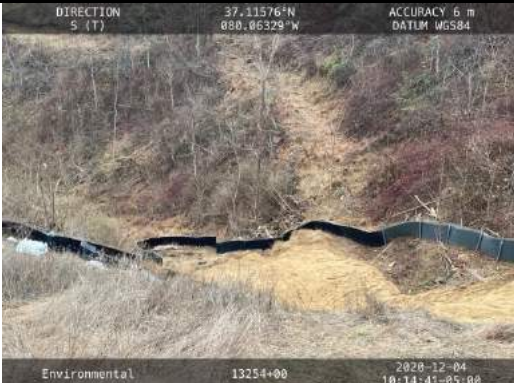
GPS Location	See photo for GPS coordinates		GPS Location	See photo for GPS coordinates	
Field Station#	13254+00		Field Station#	13254+00	
Pic 11 Desc.	Area where a slip has occurred and has been seeded and blanketed to prevent any further movement.		Pic 12 Desc.	SSF installed off ROW with land owner permission to keep sediment from exiting the LOD.
