<b>Project Name</b>		H-600 Pipeline Spread I		<b>AFE</b>	124300139	<b>Spread</b>	H-600 Pipeline Spread I	
<b>Contractor</b>		Precision				<b>Report #</b>	18921	
<b>Inspector</b>		Ben Farmer				<b>Date/Time</b>	1/11/2021 10:49 AM	
<b>Permit #</b>	TBD	<b>Inspection Type</b>	VA SWPP		<b>Station Begin</b>	15370+62		
<b>State</b>	VA	<b>Inspection Area</b>	Partial		<b>Station End</b>	15480+67		
<b>County</b>	Pittsylvania	<b>Ground</b>	Frozen		<b>Temperature (°F)</b>	36.00		
<b>Municipality</b>	Chatham	<b>Weather</b>	Cloudy		<b>Rain Gauge (in)</b>	0.00		
					<b>Rain Accumulation Time (days)</b>	0.00

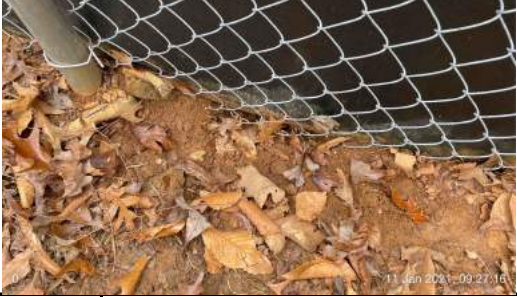
GPS Location	See photo				
Field Station#	15425+00				
Pic 5 Desc.	SSF has been undermined and needs to be keyed in.

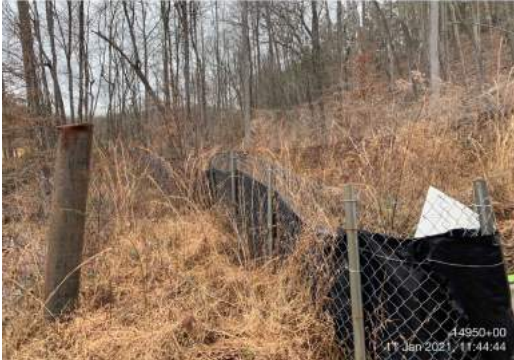
<b>GPS Location</b>	0	<b>GPS Location</b>	0		
<b>Field Station#</b>	14950+00	<b>Field Station#</b>	14950+00		
<b>Pic 1 Desc.</b>	Super silt fence in acceptable condition		<b>Pic 2 Desc.</b>	P1 silt fence in acceptable condition

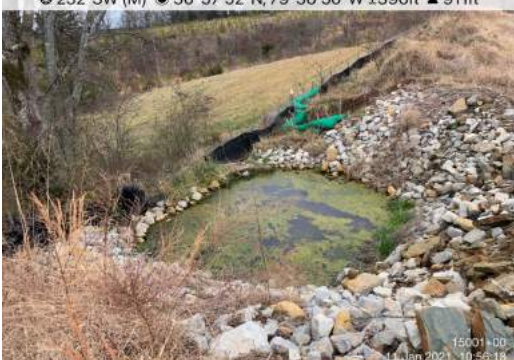
<b>GPS Location</b>	0	<b>GPS Location</b>	0		
<b>Field Station#</b>	15001+00	<b>Field Station#</b>	15028+00		
<b>Pic 5 Desc.</b>	Plunge pool in acceptable condition		<b>Pic 6 Desc.</b>	Equipment bridge in acceptable condition

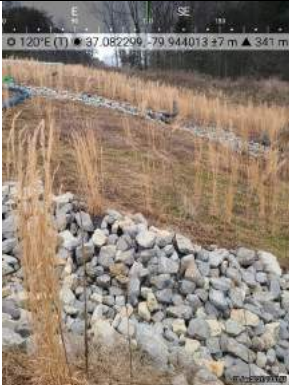
<b>GPS Location</b>	00000	<b>GPS Location</b>	000000		
<b>Field Station#</b>	13710+90	<b>Field Station#</b>	13710+10		
<b>Pic 1 Desc.</b>	Monitored rock lined channels and vegetation throughout today's travel. No environmental issues observed by the EI at the time of inspection.		<b>Pic 2 Desc.</b>	Observed sump pits and end treatment during today's inspection. No environmental issues observed at the time of inspection.

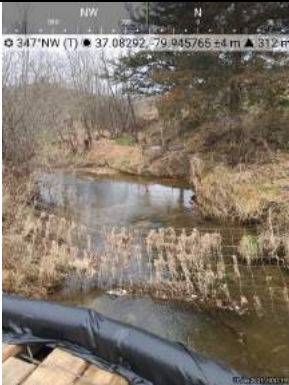
<b>GPS Location</b>	0000	<b>GPS Location</b>	0000		
<b>Field Station#</b>	13705+07	<b>Field Station#</b>	13719+00		
<b>Pic 3 Desc.</b>	Stream observation photo facing upstream, no environmental issues observed at time of inspection		<b>Pic 4 Desc.</b>	Monitored stabilization and vegetation growth today. No environmental issues observed at the of inspection.

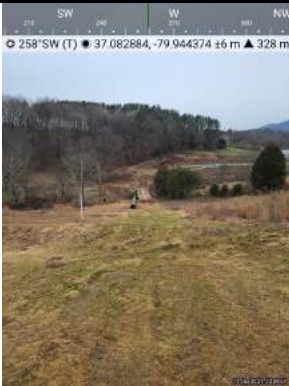
<b>GPS Location</b>	00000	<b>GPS Location</b>	0000		
<b>Field Station#</b>	13707+23	<b>Field Station#</b>	13705+07		
<b>Pic 5 Desc.</b>	The EI observed vegetation and stabilization during today's inspection, no issues at the time of inspection.		<b>Pic 6 Desc.</b>	Stream observation by the EI facing downstream.

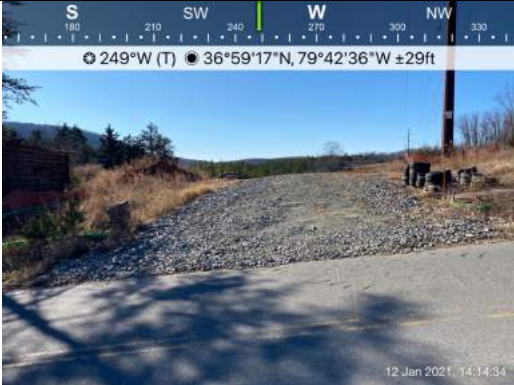
<b>GPS Location</b>	0	<b>GPS Location</b>	0		
<b>Field Station#</b>	14694+50	<b>Field Station#</b>	14689+36		
<b>Pic 1 Desc.</b>	Approximately 14694+50. Overview of road crossing and RCE. RCE installed and appears to be functioning correctly at time of inspection.		<b>Pic 2 Desc.</b>	Approximately 14689+36. Overview of stream crossing, equipment bridge and ECDs at stream S-H34.

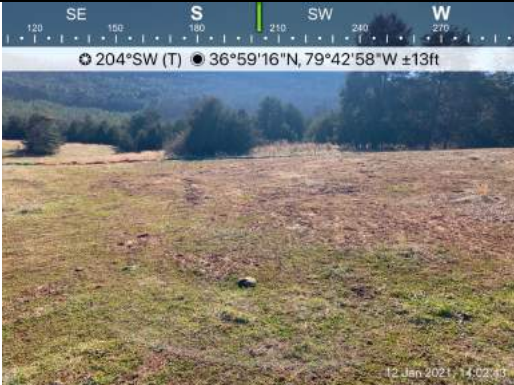
<b>GPS Location</b>	0	<b>GPS Location</b>	0		
<b>Field Station#</b>	14677+00	<b>Field Station#</b>	14673+10		
<b>Pic 3 Desc.</b>	Approximately 14677+00. Overview of ROW. ROW temporarily stabilized and has temporary vegetation growing.		<b>Pic 4 Desc.</b>	Approximately 14673+10. Overview of stream crossing, equipment bridge and ECDs at stream S-H37.

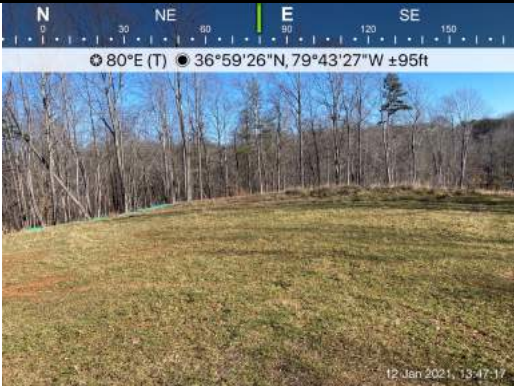
<b>Field Station#</b>	14651+00	<b>Field Station#</b>	14656+90		
<b>Pic 5 Desc.</b>	Approximately 14651+00. Overview of ROW. ROW temporarily stabilized and has temporary vegetation growing.		<b>Pic 6 Desc.</b>	Approximately 14656+90. Overview of stream crossing, equipment bridge and ECDs at stream S-H38.

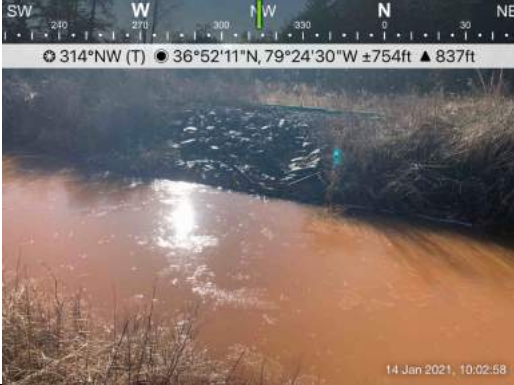
<b>GPS Location</b>	O	<b>GPS Location</b>	O		
<b>Field Station#</b>	15739+00	<b>Field Station#</b>	15722+00		
<b>Pic 1 Desc.</b>	Observing sump and end treatment	<b>Pic 2 Desc.</b>	Observing temporary vegetation,CWD outlet and ECD's

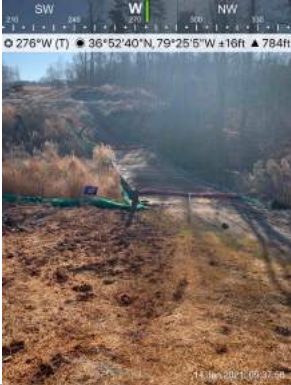
<b>GPS Location</b>	O	<b>GPS Location</b>	O		
<b>Field Station#</b>	15708+02	<b>Field Station#</b>	15707+00		
<b>Pic 3 Desc.</b>	Observing temporary stabilization, signage, buffer equipment crossing and ECD's	<b>Pic 4 Desc.</b>	Observing water bar, erosion control blanket and cfs checks.

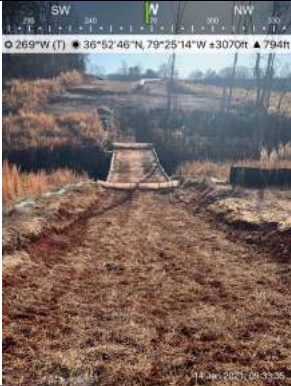
<b>GPS Location</b>	O	<b>GPS Location</b>	O		
<b>Field Station#</b>	15700+40	<b>Field Station#</b>	15696+00		
<b>Pic 5 Desc.</b>	Observing temporary stabilization, equipment crossing and ECD's	<b>Pic 6 Desc.</b>	Observing sump and end treatment

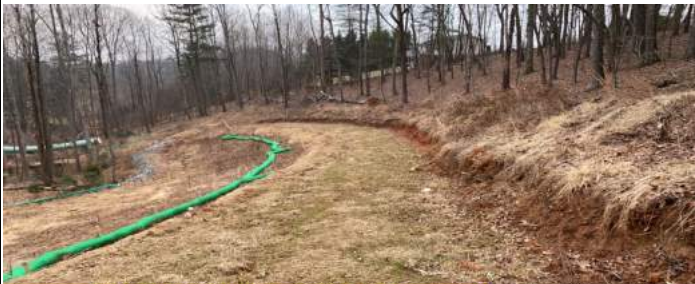
37°3'54" N 79°52'30" W 197°S COURSE 0° GPS 01.15.2021 10:42:31 1214 Bonbrook Mill Rd, Rocky Mount, VA 24151, United States Accur +/-79.1 Ft ALT 0 Ft			37°3'54" N 79°52'23" W 6°N COURSE 160° GPS 01.15.2021 10:48:30 1214 Bonbrook Mill Rd, Rocky Mount, VA 24151, United States Accur +/-213.3 Ft ALT 1189 Ft		
GPS Location	1	GPS Location	2		
Field Station#	14064+00	Field Station#	14072+00		
Pic 1 Desc.	Travel lane stabilized and vegetation growing. No issues observed.		Pic 2 Desc.	Plunge pool performing intended function.

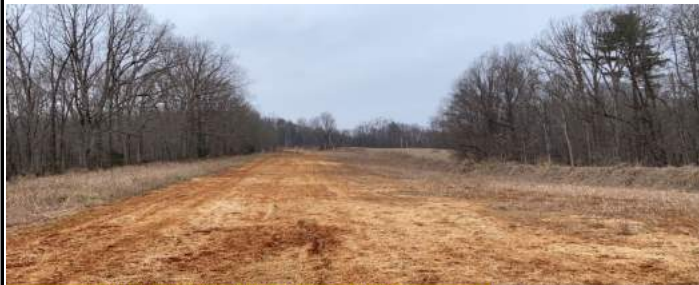
Pic 3 Desc.	Landowner was burning brush off ROW and caught spoil pile on fire. Area will need to be reseeded and stabilized.		Pic 4 Desc.	View of temporary stabilization along ROW. Little vegetative growth observed.

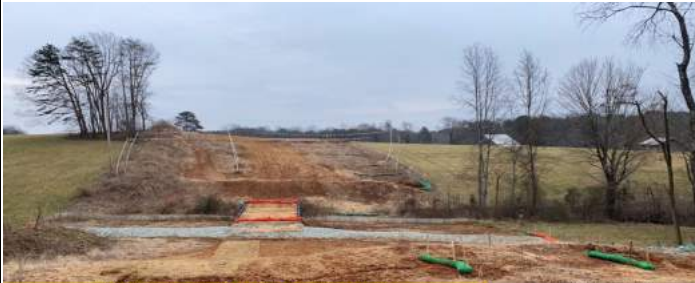
37°3'44" N 79°51'23" W 144°SE COURSE 52° GPS 01.15.2021 11:15:05 Rocky Mount, VA 24151, United States Accur +/-81.8 Ft ALT 1036 Ft			37°3'36" N 79°51'15" W 196°S COURSE 136° GPS 01.15.2021 11:31:33 Rocky Mount, VA 24151, United States Accur +/-89.5 Ft ALT 1059 Ft		
GPS Location	5	GPS Location	6		
Field Station#	14125+00	Field Station#	14136+00		
Pic 5 Desc.	View of temporary stabilization along ROW. Little vegetative growth observed. Some signs of erosion beginning to occur. Will monitor		Pic 6 Desc.	View of temporary stabilization along ROW. Little vegetative growth observed.

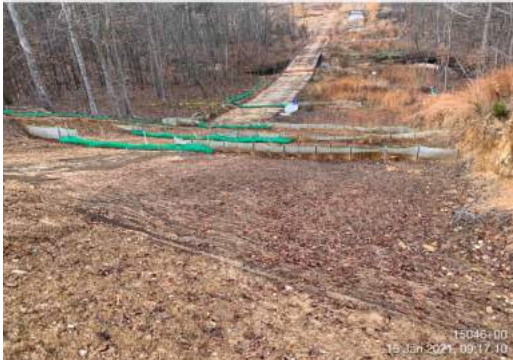
<p>258°W (M) 36°58'9"N, 79°36'19"W ±15285ft ▲ 876ft 15046+00 15 Jan 2021 09:17:10</p>

<p>165°S (M) 36°57'55"N, 79°36'26"W ±82ft ▲ 868ft 15021+00 15 Jan 2021 09:35:13</p>		
GPS Location	0		GPS Location	0	
Field Station#	15046+00		Field Station#	15021+00	
Pic 1 Desc.	P1 silt fence in acceptable condition		Pic 2 Desc.	Waterbar end treatment in acceptable condition

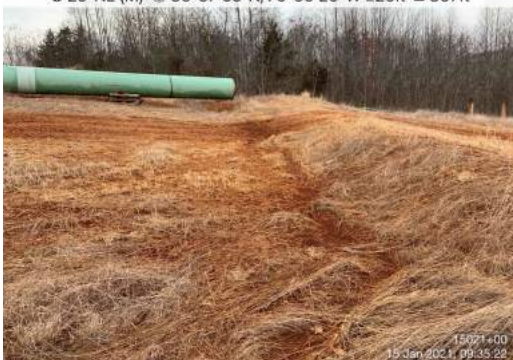
<p>29°NE (M) 36°57'55"N, 79°36'26"W ±26ft ▲ 867ft 15021+00 15 Jan 2021 09:35:22</p>

<p>357°N (M) 36°58'4"N, 79°38'19"W ±7726ft ▲ 883ft 15071+00 15 Jan 2021 10:02:01</p>		
GPS Location	0		GPS Location	0	
Field Station#	15021+00		Field Station#	15071+00	
Pic 3 Desc.	Waterbar in acceptable condition		Pic 4 Desc.	Equipment bridge in acceptable condition

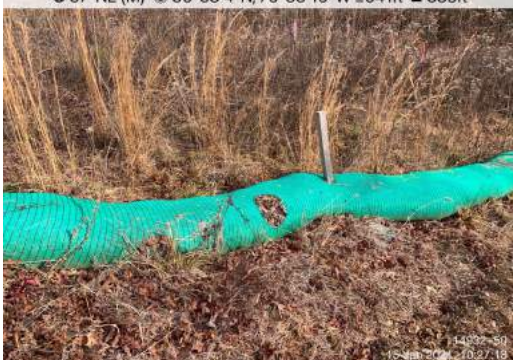
<p>57°NE (M) 36°58'4"N, 79°38'19"W ±541ft ▲ 883ft 14932+50 15 Jan 2021 10:27:18</p>

GPS Location	0		GPS Location	0	
Field Station#	14932+50		Field Station#	14930+00	
Pic 5 Desc.	CFS requiring maintenance		Pic 6 Desc.	Super silt fence requiring maintenance

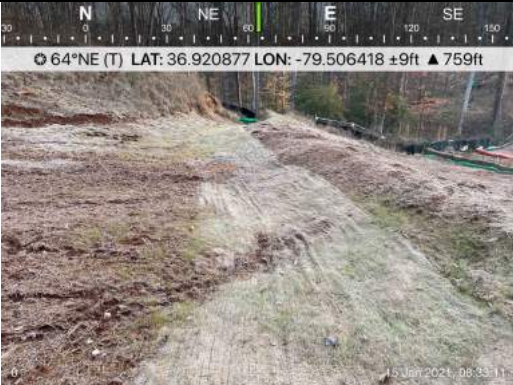
<b>GPS Location</b>	See photo	<b>GPS Location</b>	See photo		
<b>Field Station#</b>	15374+11	<b>Field Station#</b>	15383+00		
<b>Pic 3 Desc.</b>	P1 has been damaged and needs to be replaced.	<b>Pic 4 Desc.</b>	Waterbars are in good condition and functioning.

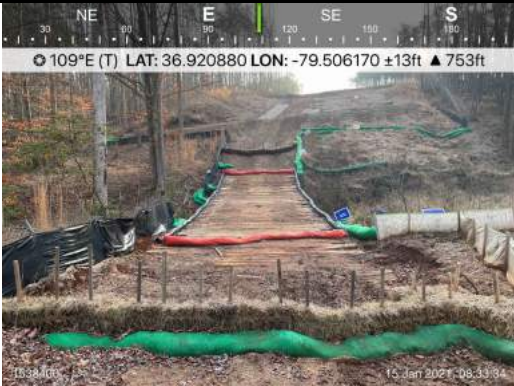
<b>GPS Location</b>	See photo	<b>GPS Location</b>	See photo		
<b>Field Station#</b>	15384+00	<b>Field Station#</b>	15400+00		
<b>Pic 5 Desc.</b>	Equipment bridge ECDs are in place and functioning.	<b>Pic 6 Desc.</b>	Topsoil berms remain stabilized.

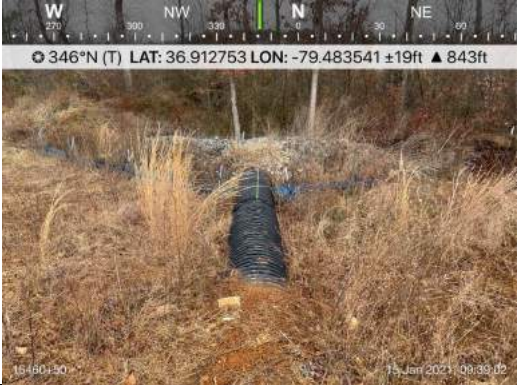
Insert image here	
<b>GPS Location</b>	See photo	<b>GPS Location</b>			
<b>Field Station#</b>	15460+50	<b>Field Station#</b>			
<b>Pic 7 Desc.</b>	CWDs are in good condition and functioning.	<b>Pic 8 Desc.</b>			
Insert image here		Insert image here			
<b>GPS Location</b>		<b>GPS Location</b>			
<b>Field Station#</b>		<b>Field Station#</b>			
<b>Pic 9 Desc.</b>		<b>Pic 10 Desc.</b>			
Insert image here		Insert image here			
<b>GPS Location</b>		<b>GPS Location</b>			
<b>Field Station#</b>		<b>Field Station#</b>			
<b>Pic 11 Desc.</b>		<b>Pic 12 Desc.</b>

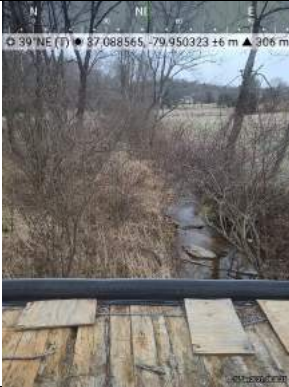
<b>GPS Location</b>	00000	<b>GPS Location</b>	00000		
<b>Field Station#</b>	13678+81	<b>Field Station#</b>	13678+81		
<b>Pic 1 Desc.</b>	Stream observation photo facing upstream during the EI's travel today, no environmental issues observed at the time of inspection.		<b>Pic 2 Desc.</b>	ECDs monitored at stream crossing, no environmental issues observed at time of inspection.

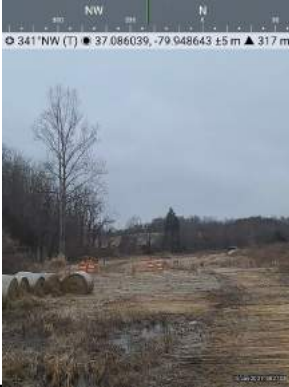
<b>GPS Location</b>	00000	<b>GPS Location</b>	00000		
<b>Field Station#</b>	13687+87	<b>Field Station#</b>	13678+81		
<b>Pic 3 Desc.</b>	Row showing equipment mats in place, vegetation observation.		<b>Pic 4 Desc.</b>	The EI conducted stream crossing observation facing downstream, no issues observed at the time of inspection

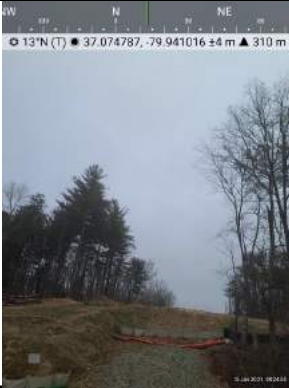
<b>GPS Location</b>	000000	<b>GPS Location</b>	00000		
<b>Field Station#</b>	13748+21	<b>Field Station#</b>	13748+21

<b>Pic 5 Desc.</b>	The EI monitored ECDs at road crossings during today's travel. No environmental issues observed at the time of inspection		<b>Pic 6 Desc.</b>	The EI monitored ECDs at road crossings during today's travel. No environmental issues observed at the time of inspection
