Visual Site Inspection Report

Project Name	H-600 Pipeline Spread I	AFE	124300139	Spread	H-600 Pipeline Spread I
Contractor	Precision	Report #	18042		
Inspector	Ben Farmer	Date/Time	12/14/2020 2:00 PM		
Permit #	TBD	Inspection Type	VA SWPP	Station Begin	15142+66
State	VA	Inspection Area	Partial	Station End	15260+00
County	Pittsylvania	Ground	Wet	Temperature (°F)	46.00
Municipality	Chatham	Weather	Heavy Rain	Rain Gauge (in)	1.40
				Rain Accumulation Time (days)	0.00

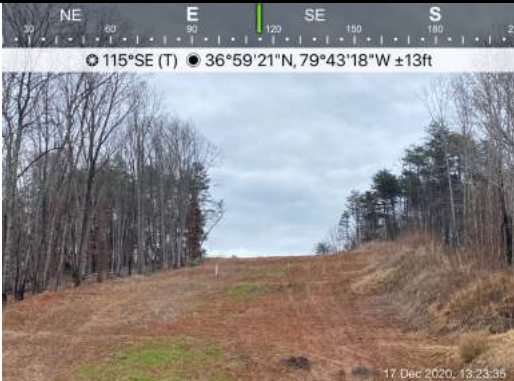
Pic 5 Desc.	Approximately 14660+00. Overview of ROW. ROW temporarily stabilized and has temporary vegetation growing.		Pic 6 Desc.	Approximately 14656+94. Overview of stream crossing, equipment bridge and ECDs at stream S-H38.
