Visual Site Inspection Report

Project Name	H-600 Pipeline Spread I	AFE	124300139	Spread	H-600 Pipeline Spread I
Contractor	Precision			Report #	18490
Inspector	John White			Date/Time	12/28/2020 8:00 AM
Permit #	TBD	Inspection Type	VA SWPP	Station Begin	15647+03
State	VA	Inspection Area	Full	Station End	15772+27
County	Pittsylvania	Ground	Frozen	Temperature (°F)	36.00
Municipality	Chatham	Weather	Cloudy	Rain Gauge (in)	1.40
				Rain Accumulation Time (days)	6.00

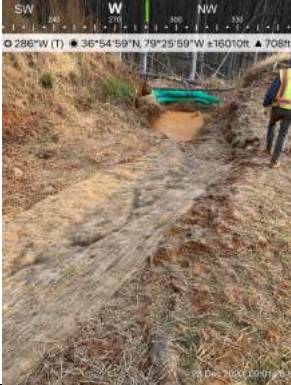
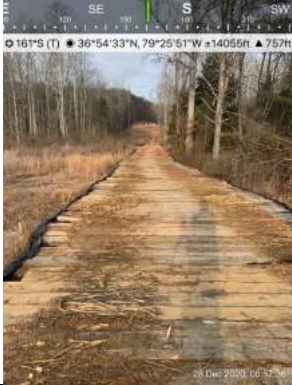
GPS Location	O	GPS Location	O		
Field Station#	15663+00	Field Station#	15671+00		
Pic 7 Desc.	Observing curlex, breaker, sump and end treatment	Pic 8 Desc.	Observing equipment crossing and ECD's.		
Insert image here		Insert image here			
GPS Location		GPS Location			
Field Station#		Field Station#			
Pic 9 Desc.		Pic 10 Desc.			
Insert image here		Insert image here			
GPS Location		GPS Location			
Field Station#		Field Station#			
Pic 11 Desc.		Pic 12 Desc.

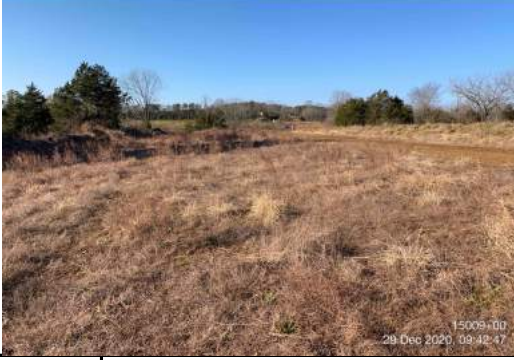
GPS Location	0	GPS Location	0		
Field Station#	15063+00	Field Station#	14983+00		
Pic 1 Desc.	P1 silt fence in acceptable condition	Pic 2 Desc.	Clean water diversion pipe requiring maintenance

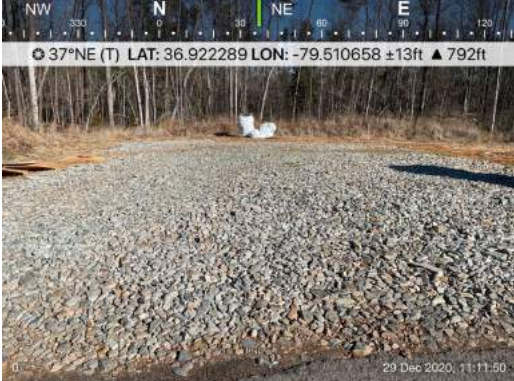
GPS Location	See photo		GPS Location	See photo	
Field Station#	15370+62		Field Station#	15373+00	
Pic 1 Desc.	RCEs in good condition at all road crossings.		Pic 2 Desc.	CFS in good condition and functioning.

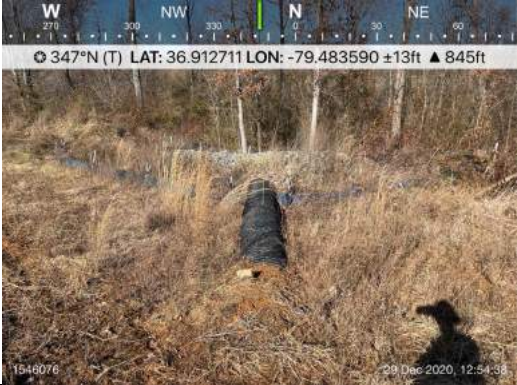
Insert image here	
GPS Location	See photo	GPS Location			
Field Station#	15460+76	Field Station#			
Pic 7 Desc.	CWDs are functioning throughout this section.	Pic 8 Desc.			
Insert image here		Insert image here			
GPS Location		GPS Location			
Field Station#		Field Station#			
Pic 9 Desc.		Pic 10 Desc.			
Insert image here		Insert image here			
GPS Location		GPS Location			
Field Station#		Field Station#			
Pic 11 Desc.		Pic 12 Desc.

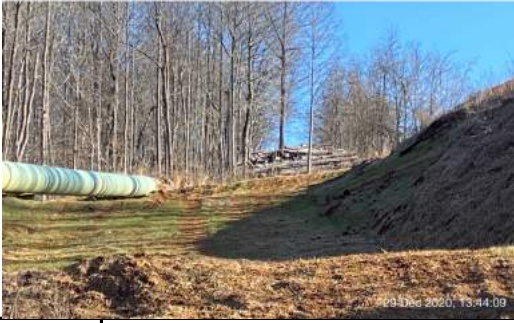
GPS Location	0	GPS Location	0	GPS Location	0
Field Station#	14603+00	Field Station#	14611+28	Field Station#	14614+00
Pic 1 Desc.	Approximately 14603+00. Overview of ROW. ROW temporarily stabilized and has temporary vegetation growing.

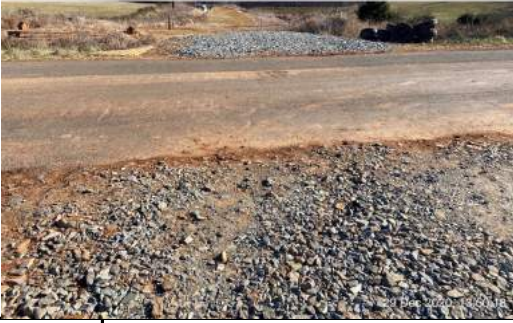
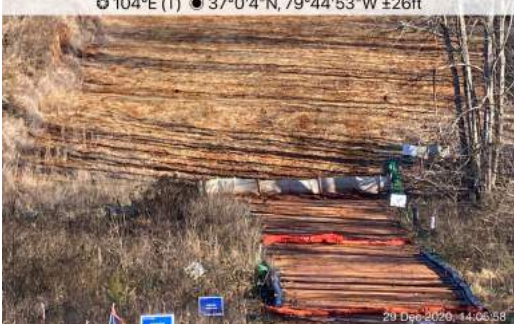
GPS Location	0	GPS Location	0	GPS Location	0
Field Station#	14599+24	Field Station#	14646+00	Field Station#	14646+00
Pic 4 Desc.	Approximately 14599+24. Overview of road crossing and RCEs. RCEs installed and appears to be functioning correctly at time of inspection.

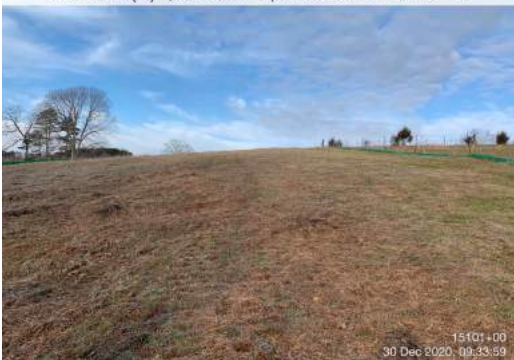
GPS Location	0	GPS Location	0		
Field Station#	15101+00	Field Station#	15092+00		
Pic 3 Desc.	Permanent vegetative stabilization in acceptable condition	Pic 4 Desc.	Temporary vegetative stabilization in acceptable condition

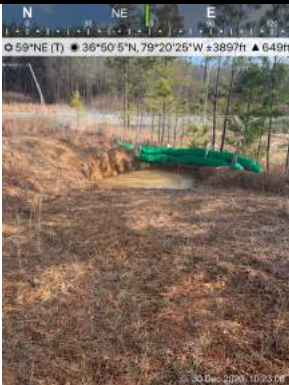
GPS Location	O	GPS Location	O		
Field Station#	21+00	Field Station#	15+70		
Pic 1 Desc.	Observing CFS that requires maintenance	Pic 2 Desc.	Observing p1 that requires

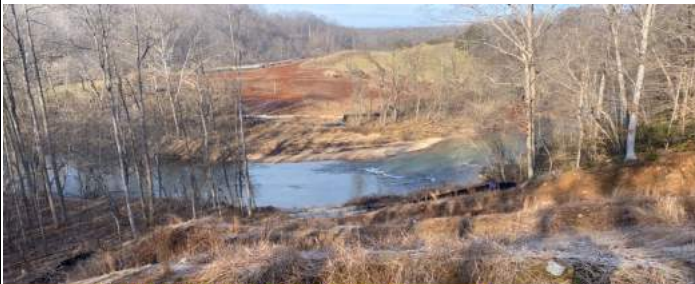
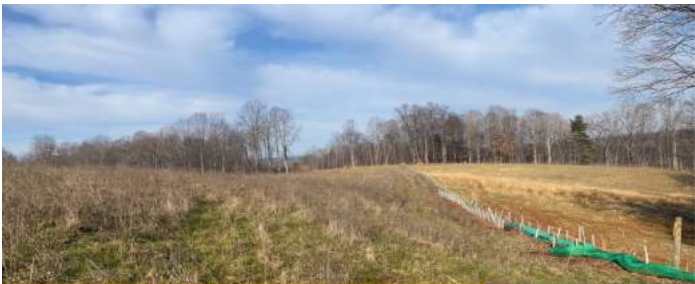
37°39' N 79°49'29" W 308°NW COURSE 271' GPS Glade Hill, VA 24092, United States 12.30.2020 10:30:50 Accur +/-74.2 Ft ALT 950 Ft			37°33' N 79°49'18" W 347°N COURSE 271' GPS Glade Hill, VA 24092, United States 12.30.2020 10:25:41 Accur +/-217.1 Ft ALT 950 Ft		
GPS Location	1		GPS Location	2	
Field Station#	14250+10		Field Station#	14259+00	
Pic 1 Desc.	View of ROW crossing at Blackwater River (S-F11). Water bars in place and functional.		Pic 2 Desc.	Contractor replaced perimeter CFS and P1 silt fence from previous punch list report.

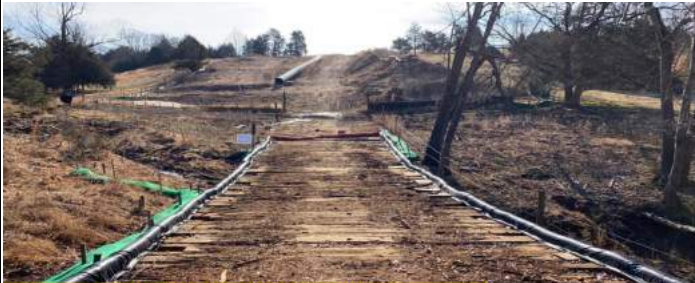
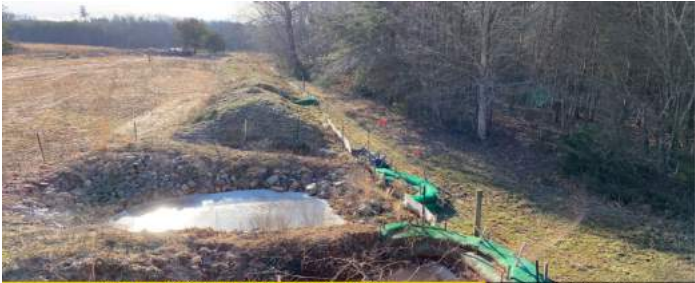
37°2'50" N 79°48'47" W 153°SE COURSE 257' GPS 955 Greenway Rd, Glade Hill, VA 24092, United States 12.30.2020 10:10:18 Accur +/-262.2 Ft ALT 1011 Ft			37°2'38" N 79°48'39" W 200°S COURSE 69' GPS 955 Greenway Rd, Glade Hill, VA 24092, United States 12.30.2020 10:02:44 Accur +/-39.8 Ft ALT 1062 Ft		
GPS Location	5		GPS Location	6	
Field Station#	14294+57		Field Station#	14306+00	
Pic 5 Desc.	Equipment bridge and surrounding ECDs in place and functional at S-F9.		Pic 6 Desc.	Plunge pool and surrounding ECDs in place and functional along perimeter of ROW.

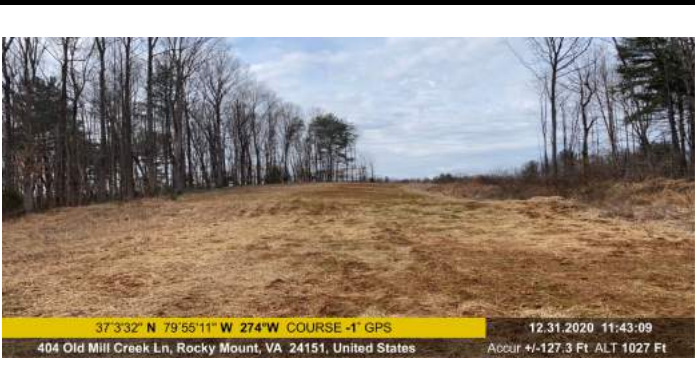
37°32'27" N 79°54'50" W 91°E COURSE 115° GPS 985 Iron Ridge Rd, Rocky Mount, VA 24151, United States 12.31.2020 11:34:20 Accur +/-43.9 Ft ALT 1028 Ft			37°3'32" N 79°55'11" W 274°W COURSE -1° GPS 404 Old Mill Creek Ln, Rocky Mount, VA 24151, United States 12.31.2020 11:43:09 Accur +/-127.3 Ft ALT 1027 Ft		
GPS Location	5	GPS Location	6		
Field Station#	13875+16	Field Station#	13856+00		
Pic 5 Desc.	Ditch subsidence continued to be observed CIS S-CD6.		Pic 6 Desc.	ROW stabilized GAS MVP-FR-303.01.

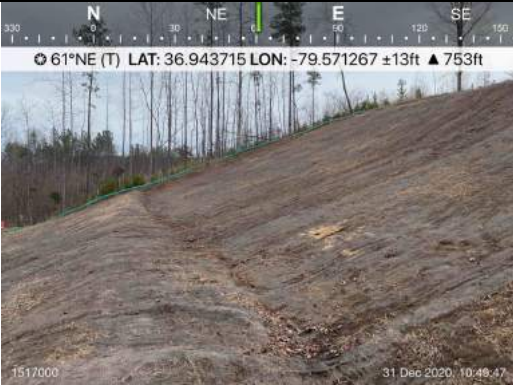
GPS Location	See photo		GPS Location	See photo	
Field Station#	15167+95		Field Station#	15170+00	
Pic 3 Desc.	Equipment bridge ECDs are in place and in good condition.		Pic 4 Desc.	Waterbars in good condition and functioning.

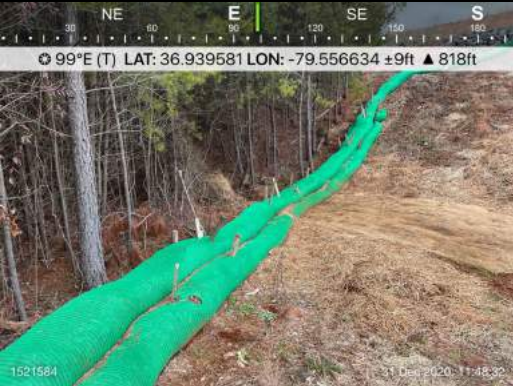
GPS Location	See photo		GPS Location	See photo	
Field Station#	15172+00		Field Station#	15215+84	
Pic 5 Desc.	Stockpiles remain stabilized.		Pic 6 Desc.	Perimeter CFS is in good condition throughout this section.
