Visual Site Inspection Report

Project Name	H-600 Pipeline Spread I	AFE	124300139	Spread	H-600 Pipeline Spread I
Contractor	Precision			Report #	16917
Inspector	Justin Burch			Date/Time	11/16/2020 8:23 AM
Permit #	TBD	Inspection Type	VA SWPP	Station Begin	14802+19
State	VA	Inspection Area	Full	Station End	14928+52
County	Franklin	Ground	Wet	Temperature (°F)	59.00
Municipality	N/A	Weather	Sunny	Rain Gauge (in)	5.00
				Rain Accumulation Time (days)	8.00

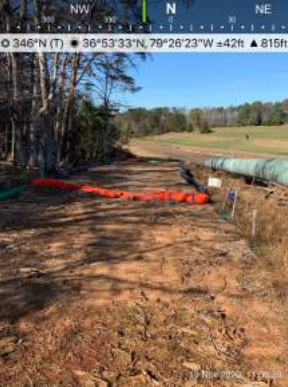
GPS Location	O	GPS Location	O		
Field Station#	15614+94	Field Station#	15616+00		
Pic 3 Desc.	Observing equipment crossing and ECD's.	Pic 4 Desc.	Observing temporary stabilization and signage

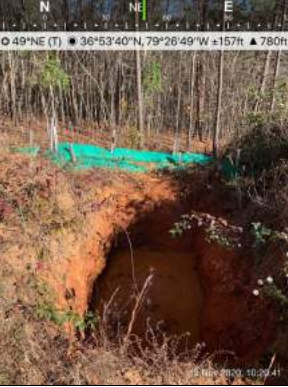
GPS Location	O	GPS Location	O		
Field Station#	15590+00	Field Station#	15592+00		
Pic 5 Desc.	Observing sump and end treatment	Pic 6 Desc.	Observing sump and end treatment.
