Visual Site Inspection Report

Project Name	H-600 Pipeline Spread I	AFE	124300139	Spread	H-600 Pipeline Spread I
Contractor	Precision			Report #	17441
Inspector	Justin Burch			Date/Time	11/30/2020 8:49 AM
Permit #	TBD	Inspection Type	VA SWPP	Station Begin	14928+52
State	VA	Inspection Area	Full	Station End	15063+85
County	Franklin/Pittsylvania	Ground	Wet	Temperature (°F)	57.00
Municipality	Chatham	Weather	Heavy Rain	Rain Gauge (in)	2.50
				Rain Accumulation Time (days)	7.00

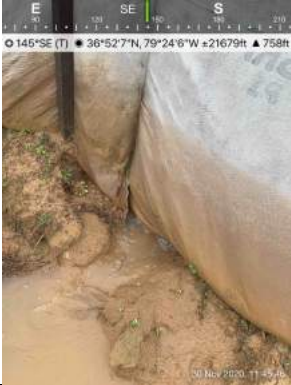
Insert image here		Insert image here	
GPS Location	O	GPS Location			
Field Station#	15776+00	Field Station#			
Pic 7 Desc.	Observing p1 that requires maintenance	Pic 8 Desc.			
Insert image here		Insert image here			
GPS Location		GPS Location			
Field Station#		Field Station#			
Pic 9 Desc.		Pic 10 Desc.			
Insert image here		Insert image here			
GPS Location		GPS Location			
Field Station#		Field Station#			
Pic 11 Desc.		Pic 12 Desc.

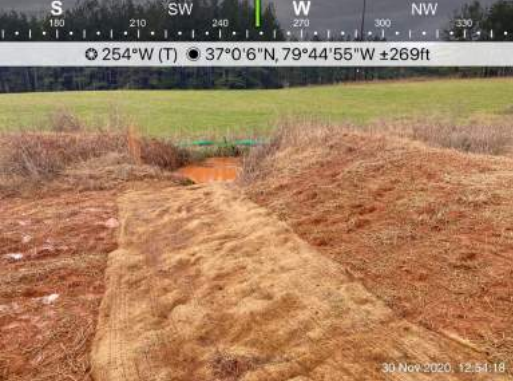
GPS Location	0	GPS Location	0		
Field Station#	14553+00	Field Station#	14565+00		
Pic 1 Desc.	Approximately 14553+00. Overview of ROW. ROW temporarily stabilized and has temporary vegetation growing.		Pic 2 Desc.	Approximately 14565+00. Overview of ROW. ROW temporarily stabilized and has temporary vegetation growing. Water bar and sump installed and appear to be functioning correctly.

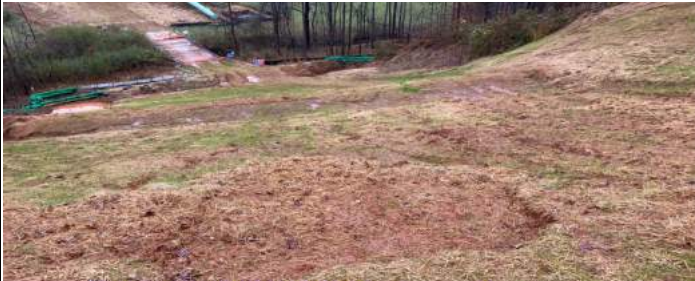
37°3'40" N 79°51'16" W 37°NE COURSE 286° GPS Rocky Mount, VA 24151, United States 11.30.2020 10:25:06 Accur +/-140.8 Ft ALT 1000 Ft			37°3'34" N 79°51'14" W 109°E COURSE 286° GPS Rocky Mount, VA 24151, United States 11.30.2020 10:20:32 Accur +/-919.2 Ft ALT 1000 Ft		
GPS Location	3		GPS Location	4	
Field Station#	14132+00		Field Station#	14139+50	
Pic 3 Desc.	Stabilize denuded area of ROW.		Pic 4 Desc.	CFS check full and undermining. Needs repaired.

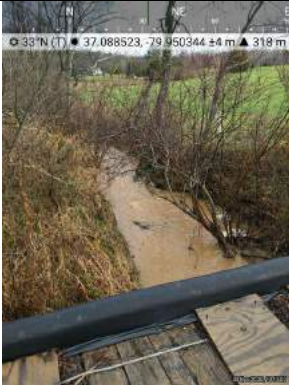
GPS Location	0000	GPS Location	0000		
Field Station#	13678+71	Field Station#	13678+71		
Pic 1 Desc.	Stream observation photo facing upstream during rain events, no environmental issues observed at time of inspection		Pic 2 Desc.	EI conducted stream observation photo facing downstream during rain event, no environmental issues observed at the time of inspection

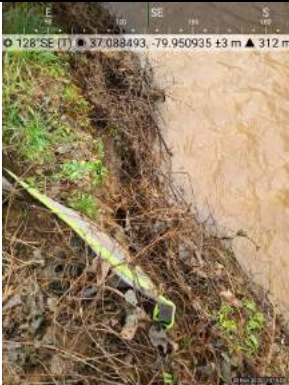
GPS Location	0000	GPS Location	0000		
Field Station#	13677+70	Field Station#	13747+00		
Pic 3 Desc.	Throughout the EI's travel today the EI noticed stream bank on the eve of row washing off more during rain events, recommended moving P1 further back on row, documented		Pic 4 Desc.	Monitored new vegetation growth on the coming in side of Green Level rd.

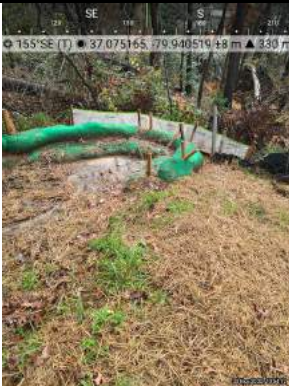
Pic 5 Desc.	ECDs checked and functioning properly during rain events.		Pic 6 Desc.	P1 requires maintenance, stakes broken. EI Documented and sent in to be added to the punch list

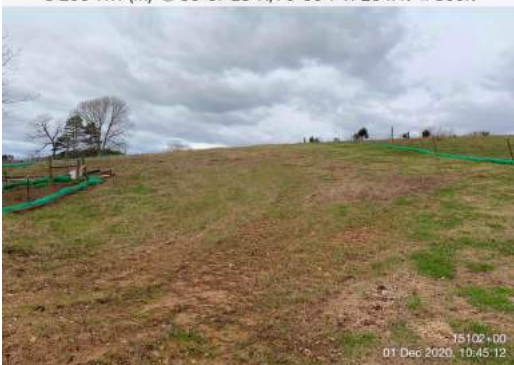
GPS Location	0	GPS Location	0		
Field Station#	15102+00	Field Station#	15142+00		
Pic 5 Desc.	Permanent vegetative stabilization in acceptable condition		Pic 6 Desc.	Equipment bridge in acceptable condition

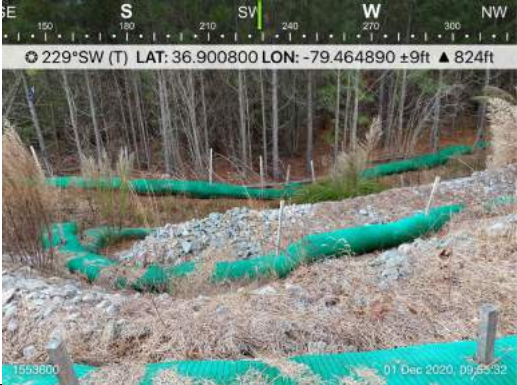
GPS Location	See photo	GPS Location	See photo		
Field Station#	15536+00	Field Station#	15546+70		
Pic 7 Desc.	CWDs in this area are in good condition and functioning.	Pic 8 Desc.	Waterbars are in good condition and functioning.		
Insert image here		Insert image here			
GPS Location		GPS Location			
Field Station#		Field Station#			
Pic 9 Desc.		Pic 10 Desc.			
Insert image here		Insert image here			
GPS Location		GPS Location			
Field Station#		Field Station#			
Pic 11 Desc.		Pic 12 Desc.

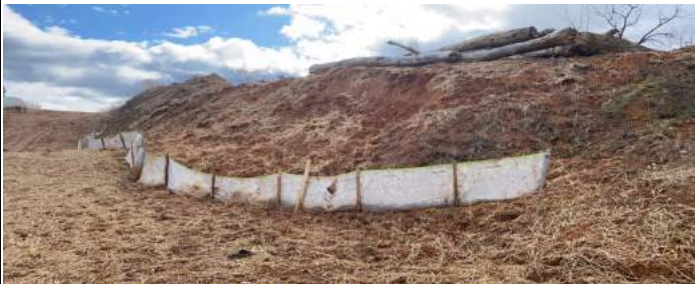
37°24'9" N 79°48'45" W 176°S COURSE 148° GPS Glade Hill, VA 24092, United States 12.01.2020 12:30:18 Accur +/-128.9 Ft ALT 1010 Ft			37°24'8" N 79°48'45" W 61°NE COURSE 188° GPS Glade Hill, VA 24092, United States 12.01.2020 12:30:52 Accur +/-104.6 Ft ALT 1006 Ft		
GPS Location	1	GPS Location	2		
Field Station#	14296+00	Field Station#	14296+50		
Pic 1 Desc.	Routine maintenance. Replace damaged panels of P1 silt fence from cattle damage.		Pic 2 Desc.	Routine maintenance. Replace damaged panels of P1 silt fence from cattle damage.

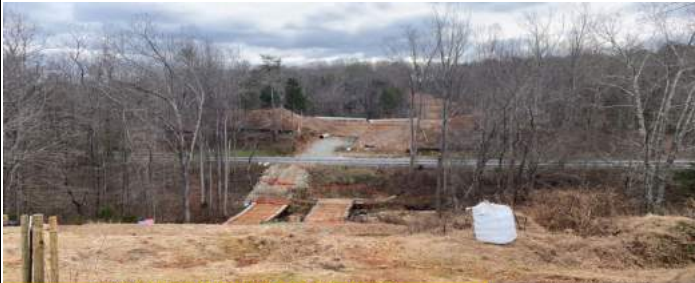
37°3'29" N 79°50'12" W 168°S COURSE 47° GPS 3175 Booker T Washington Hwy, Rocky Mount, VA 24151, United States 12.01.2020 11:17:39 Accur +/-67.9 Ft ALT 948 Ft			37°3'35" N 79°50'21" W 237°SW COURSE -1° GPS 3175 Booker T Washington Hwy, Rocky Mount, VA 24151, United States 12.01.2020 11:11:31 Accur +/-29.7 Ft ALT 945 Ft		
GPS Location	5	GPS Location	6		
Field Station#	14209+75	Field Station#	14194+00		
Pic 5 Desc.	ROW crossing RCE and equipment bridges at Hwy 122 in good condition at time of inspection.		Pic 6 Desc.	Contractor installed CFS J Hook per punch list item.

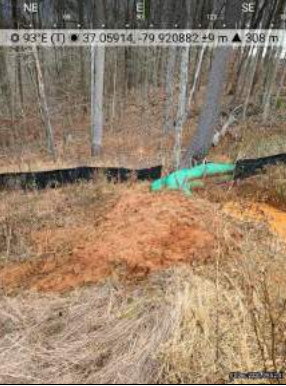
GPS Location	00000	GPS Location	00000		
Field Station#	13850+90	Field Station#	13814+20		
Pic 1 Desc.	Slope breaker observed and noticed sump pit was recently cleaned out and breaker needed to be stabilized, the EI added to the punch list to be addressed by the contractor.		Pic 2 Desc.	Top soil pile requires stabilization, added to the punch list

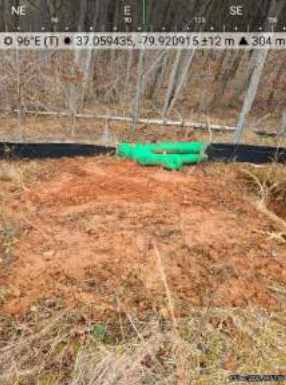
GPS Location	00000	GPS Location	00000		
Field Station#	13850+00	Field Station#	13825+13		
Pic 3 Desc.	Slope breaker observed and noticed sump pit was recently cleaned out and breaker needed to be stabilized, the EI added to the punch list to be addressed by the contractor.		Pic 4 Desc.	The EI noticed a area with erosion that required repair and stabilization, documented and added to the punch list for repair

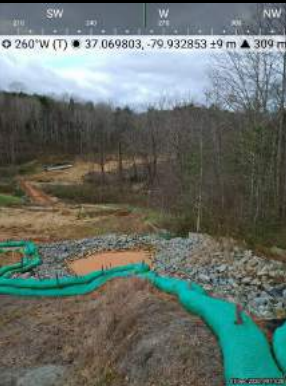
Pic 5 Desc.	The EI monitored sump pit and ECDs, no environmental issues observed at the time of inspection at this location		Pic 6 Desc.	Row photo taken by the EI during routine inspection today showing row stabilization and ECDs in place and functioning

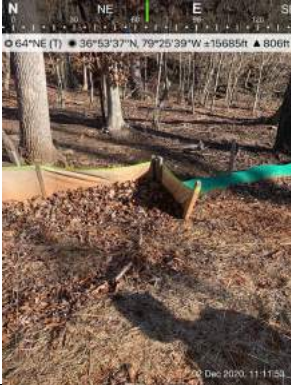
GPS Location	O	GPS Location	O		
Field Station#	15635+00	Field Station#	15635+00		
Pic 7 Desc.	Observing p1 that required maintenance.	Pic 8 Desc.	Observing the Contractor performing ECD maintenance.

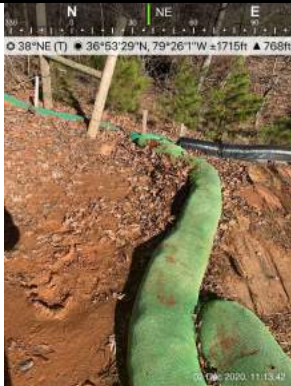
GPS Location	O	GPS Location	O		
Field Station#	15636+21	Field Station#	15636+21		
Pic 9 Desc.	Observing cfs that required maintenance.	Pic 10 Desc.	Observing the Contractor performing ECD maintenance.		
Insert image here		Insert image here			
GPS Location		GPS Location			
Field Station#		Field Station#			
Pic 11 Desc.		Pic 12 Desc.

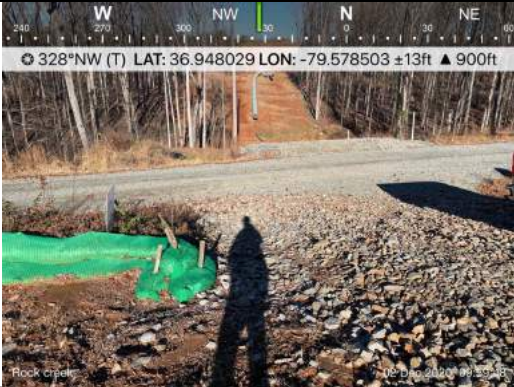
GPS Location	See photo		GPS Location	See photo	
Field Station#	15142+66		Field Station#	15169+47	
Pic 3 Desc.	RCE at Rockcreek Rd is in good condition.		Pic 4 Desc.	Equipment bridge ECDs are in place at S-C7.

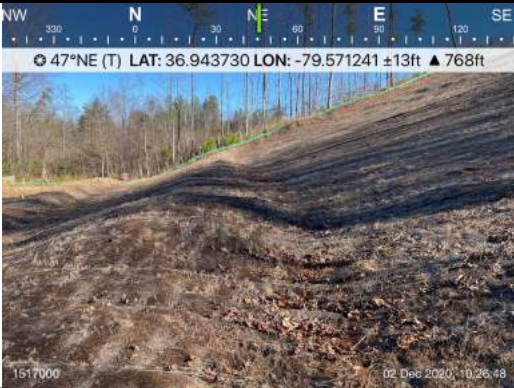
GPS Location	See photo		GPS Location	See photo	
Field Station#	15170+00		Field Station#	15174+00	
Pic 5 Desc.	Temporary waterbars in good condition and functioning throughout this section.		Pic 6 Desc.	Stockpiles are stabilized in this section of ROW.

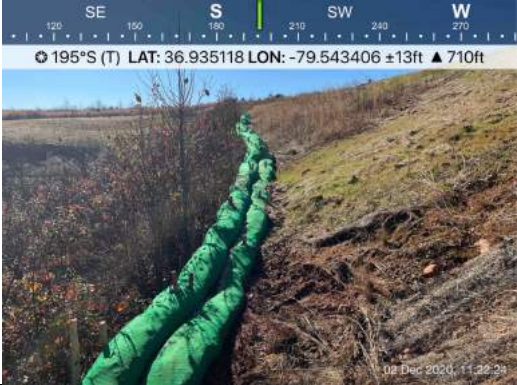
GPS Location	See photo	GPS Location			
Field Station#	15257+44	Field Station#			
Pic 7 Desc.	Perimeter CFS in good condition.	Pic 8 Desc.			
Insert image here		Insert image here			
GPS Location		GPS Location			
Field Station#		Field Station#			
Pic 9 Desc.		Pic 10 Desc.			
Insert image here		Insert image here			
GPS Location		GPS Location			
Field Station#		Field Station#			
Pic 11 Desc.		Pic 12 Desc.

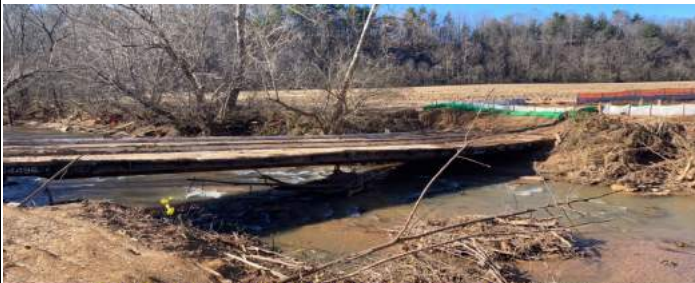
GPS Location	3	GPS Location	4		
Field Station#	13916+12	Field Station#	13892+45		
Pic 3 Desc.	Debris built up at S-II2 has largely dissipated from previous inspection. Equipment bridge in place at crossing and no issues observed.		Pic 4 Desc.	RCE at Iron Ridge Rd in good condition at time of inspection.

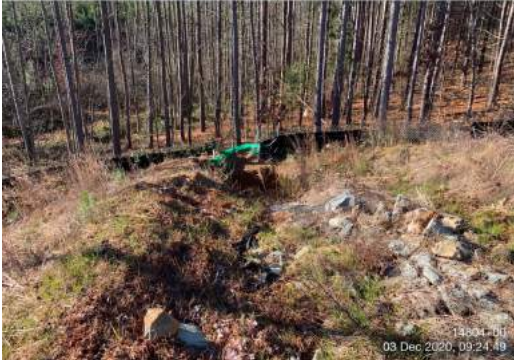
GPS Location	0	GPS Location	0		
Field Station#	14804+00	Field Station#	14816+00		
Pic 1 Desc.	Waterbar end treatment in acceptable condition	Pic 2 Desc.	P1 silt fence in acceptable condition

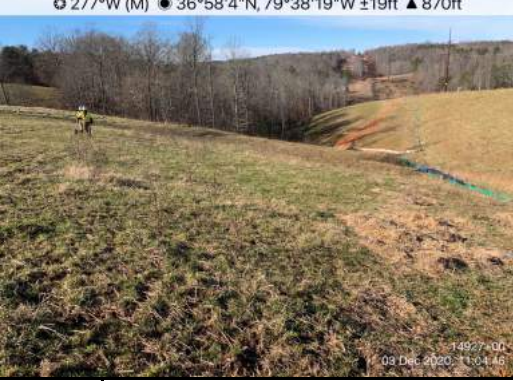
GPS Location	0	GPS Location	0		
Field Station#	14916+30	Field Station#	14927+00		
Pic 5 Desc.	Torn wattle on equipment bridge was repaired	Pic 6 Desc.	Permanent vegetative stabilization in acceptable condition

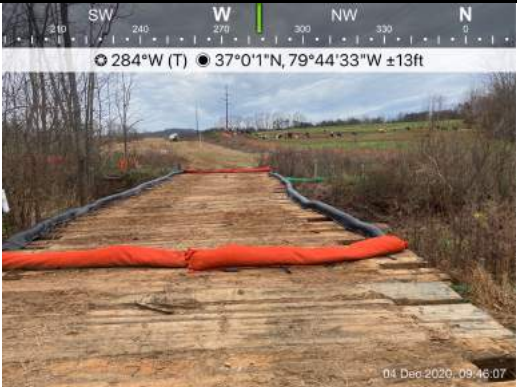
<p>GPS: 158°SE (T) 36°59'51"N, 79°44'18"W ±32ft</p> <p>04 Dec 2020, 09:53:07</p>	
GPS Location	0		GPS Location	0	
Field Station#	14582+85		Field Station#	14599+50	
Pic 1 Desc.	Approximately 14582+85. Overview of stream crossing, equipment bridge and ECDs at stream S-E17.		Pic 2 Desc.	Approximately 14599+50. Overview of road crossing and RCE. RCE installed and appears to be functioning correctly at time of inspection. Dirt in roadway from third party.

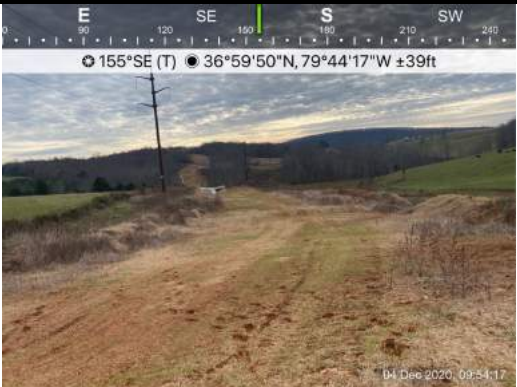
<p>GPS: 131°SE (T) 36°59'45"N, 79°44'7"W ±170ft</p> <p>04 Dec 2020, 09:55:36</p>	
GPS Location	0		GPS Location	0	
Field Station#	14603+00		Field Station#	14611+28	
Pic 3 Desc.	Approximately 14603+00. Overview of ROW. ROW temporarily stabilized and has temporary vegetation growing.		Pic 4 Desc.	Approximately 14611+28. Overview of stream crossing, equipment bridge and ECDs at stream S-E14.

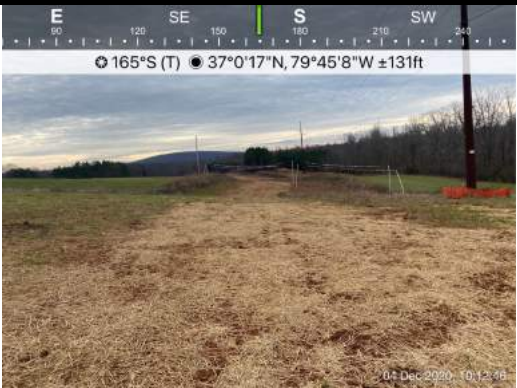
<p>GPS: 94°E (T) 37°0'4"N, 79°44'52"W ±13ft</p> <p>04 Dec 2020, 10:15:20</p>	
GPS Location	0		GPS Location	0	
Field Station#	14550+00		Field Station#	14568+10	
Pic 5 Desc.	Approximately 14550+00. Overview of ROW. ROW temporarily stabilized and has temporary vegetation growing.		Pic 6 Desc.	Approximately 14568+10. Overview of stream crossing, equipment bridge and ECDs at stream S-E18.

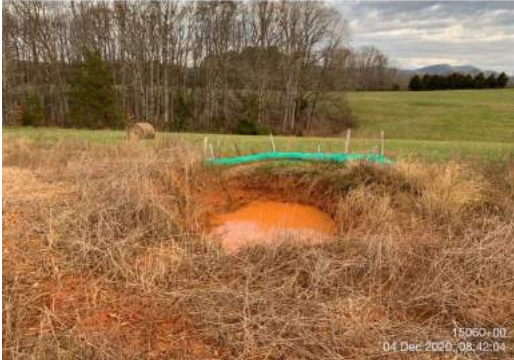
GPS Location	0	GPS Location	0		
Field Station#	15060+00	Field Station#	15060+00		
Pic 1 Desc.	Waterbar end treatment in acceptable condition		Pic 2 Desc.	Waterbar in acceptable condition

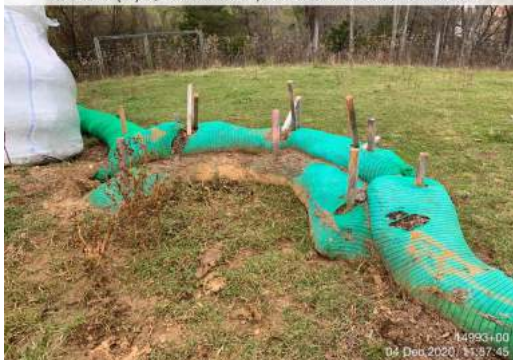
GPS Location	0	GPS Location	0		
Field Station#	14997+50	Field Station#	14993+00		
Pic 3 Desc.	CFS requires maintenance		Pic 4 Desc.	Waterbar end treatment requires maintenance; needs holes repaired and sediment removed

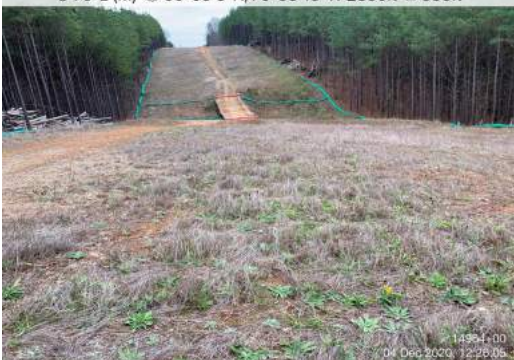
GPS Location	0	GPS Location	0		
Field Station#	15964+00	Field Station#	14933+00		
Pic 5 Desc.	Permanent vegetative stabilization in acceptable condition		Pic 6 Desc.	Equipment bridge in acceptable condition

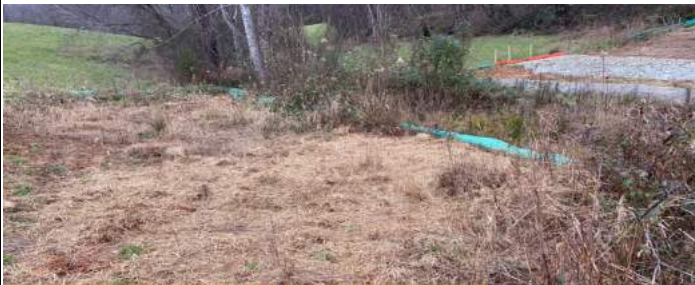
GPS Location	3	GPS Location	4		
Field Station#	14127+00	Field Station#	14131+50		
Pic 3 Desc.	Contractor stabilized denuded area of ROW per punch list item.		Pic 4 Desc.	Contractor stabilized denuded area of ROW per punch list item. RCE at Jones Mill Rd in good condition.

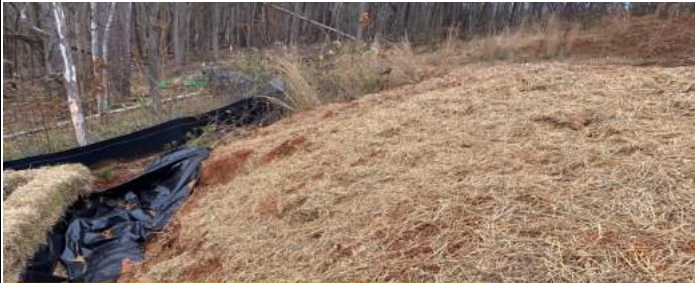
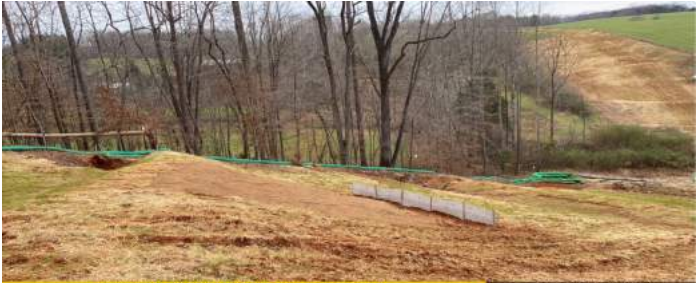
37°3'33" N 79°51'15" W 201°S COURSE 353° GPS 111-313 Jonesmill Ln, Rocky Mount, VA 24151, United States 12.04.2020 11:05:42 Accur +/-48.3 Ft ALT 1066 Ft			37°3'23" N 79°51'3" W 98°E COURSE 77° GPS Rocky Mount, VA 24151, United States 12.04.2020 11:12:07 Accur +/-247.7 Ft ALT 1001 Ft		
GPS Location	5	GPS Location	6		
Field Station#	14140+00	Field Station#	14156+00		
Pic 5 Desc.	Contractor stabilized denuded area of ROW per punch list item.		Pic 6 Desc.	Contractor repaired erosion per punch list item and installed Curlex and P1 silt fence to prevent further issues.

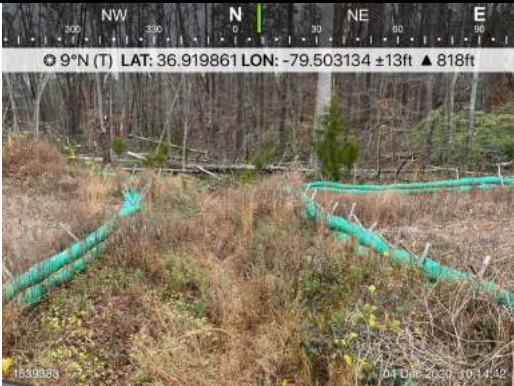
GPS Location	See photo		GPS Location	See photo	
Field Station#	15393+83		Field Station#	15460+76	
Pic 5 Desc.	CFS in good condition throughout this section of ROW		Pic 6 Desc.	CWDs in good condition and functioning.

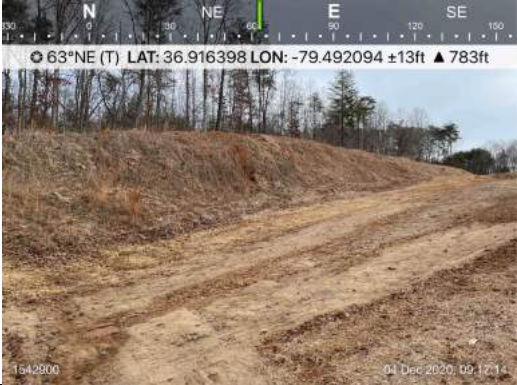
GPS Location	See photo	GPS Location	See photo		
Field Station#	15427+81	Field Station#	15429+00		
Pic 7 Desc.	Equipment bridge ECDs in place and functioning.	Pic 8 Desc.	Stockpiles remain stabilized.

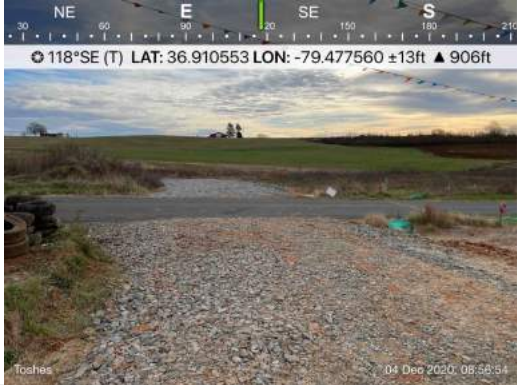
<p style="text-align: center;">Insert image here</p>			
GPS Location	See photo	GPS Location			
Field Station#	15480+50	Field Station#			
Pic 9 Desc.	RCEs in good condition at Toshes Rd. and Snowberry Rd.	Pic 10 Desc.			
<p style="text-align: center;">Insert image here</p>		<p style="text-align: center;">Insert image here</p>			
GPS Location		GPS Location			
Field Station#		Field Station#			
Pic 11 Desc.		Pic 12 Desc.

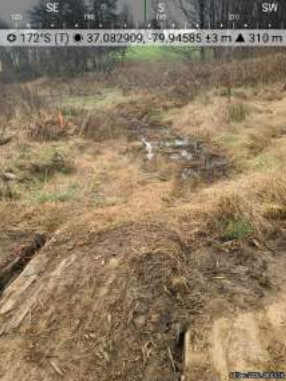
GPS Location	00000	GPS Location	00000		
Field Station#	13704+60	Field Station#	13729+90		
Pic 1 Desc.	EI observed a location where a land owner has been crossing the row with a ATV, documented that it was not project related		Pic 2 Desc.	EI noticed erosion beginning in the throat of a breaker, recommended installing erosion blanket , added to the punch list

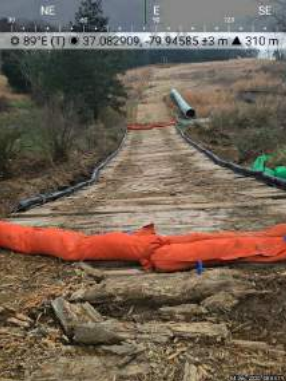
GPS Location	00000	GPS Location	0000		
Field Station#	13704+90	Field Station#	13700+00		
Pic 3 Desc.	EI monitored equipment bridges throughout the travel today		Pic 4 Desc.	Wire back silt fence requires maintenance, EI sent in to be added to the punch list

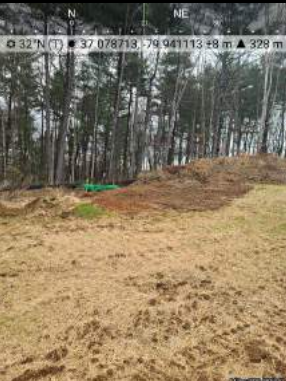
GPS Location	0000	GPS Location	0000		
Field Station#	13734+20	Field Station#	13696+03		
Pic 5 Desc.	EI monitored slope breakers and noticed where a sump pit was cleaned out, the breaker needs stabilized		Pic 6 Desc.	Photo taken by the EI showing equipment mats through a wetland area, no environmental issues observed.
