Visual Site Inspection Report

Project Name H-600 Pipeline Spread G		AFE 124300137	Spread H-600 Pipeline Spread G
Contractor Precision		Report # 20019	
Inspector Len Kruizenga		Date/Time 2/15/2021 8:48 AM	
Permit # TBD	Inspection Type VA SWPP	Station Begin	12005+00
State VA	Inspection Area Full	Station End	12005+00
County Giles	Ground Wet	Temperature (°F)	33.00
Municipality N/A	Weather Cloudy	Rain Gauge (in)	2.00
Rain Accumulation Time (days)			3.00

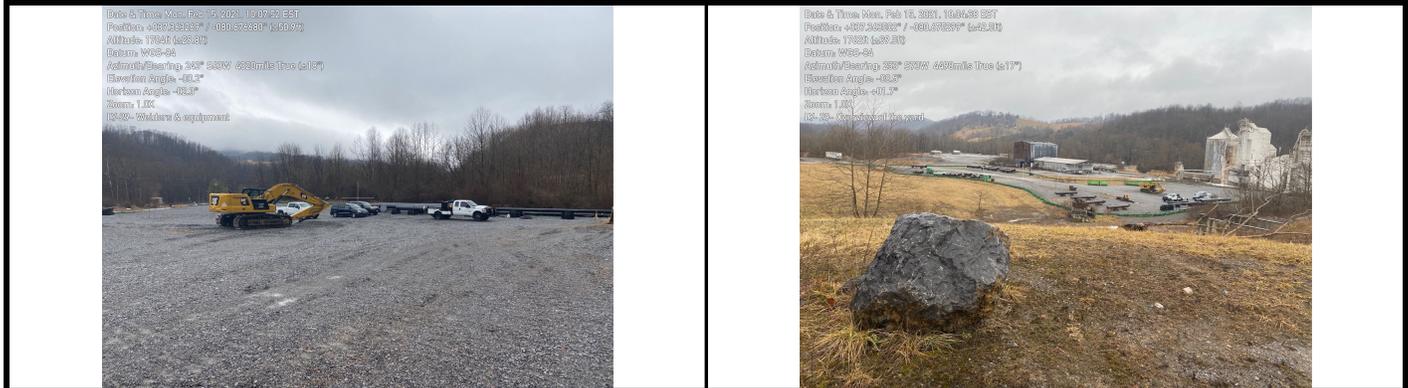
GPS Location	See photo GPS	GPS Location	See photo GPS
Field Station#	12005+00	Field Station#	12005+00
Pic 3 Desc.	LY29- Welders & track hoe	Pic 4 Desc.	LY29- Overview of the yard.

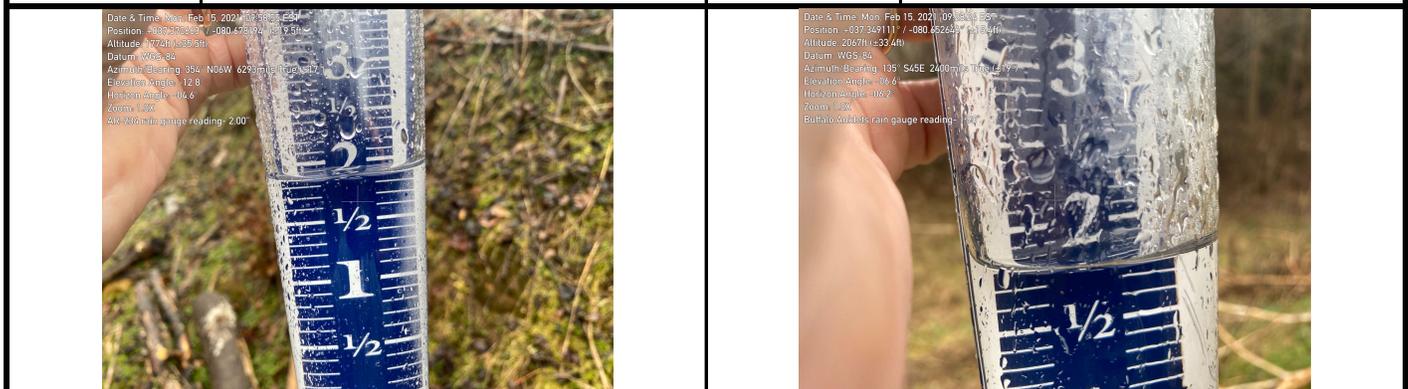
GPS Location	See photo GPS	GPS Location	See photo GPS
Field Station#	11671+00	Field Station#	12005+00
Pic 5 Desc.	AR-234.00 rain gauge reading- 2.00"	Pic 6 Desc.	Buffalo Anklets rain gauge reading- 1.90"

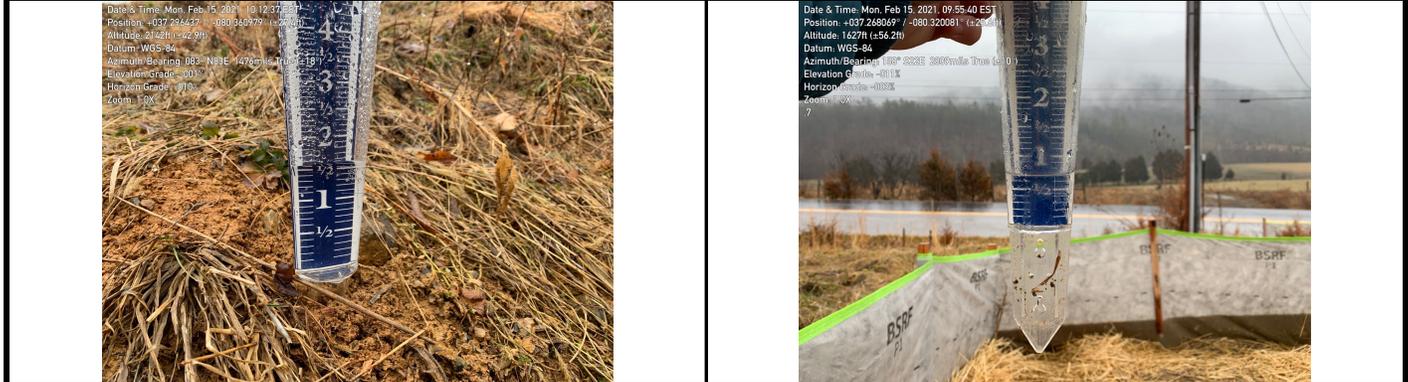
GPS Location	See pictures above for GPS coordinate	GPS Location	See pictures above for GPS coordinate
Field Station#	12005+00	Field Station#	12005+00
Pic 1 Desc.	1.6" of rain recorded	Pic 2 Desc.	.7" of rain recorded

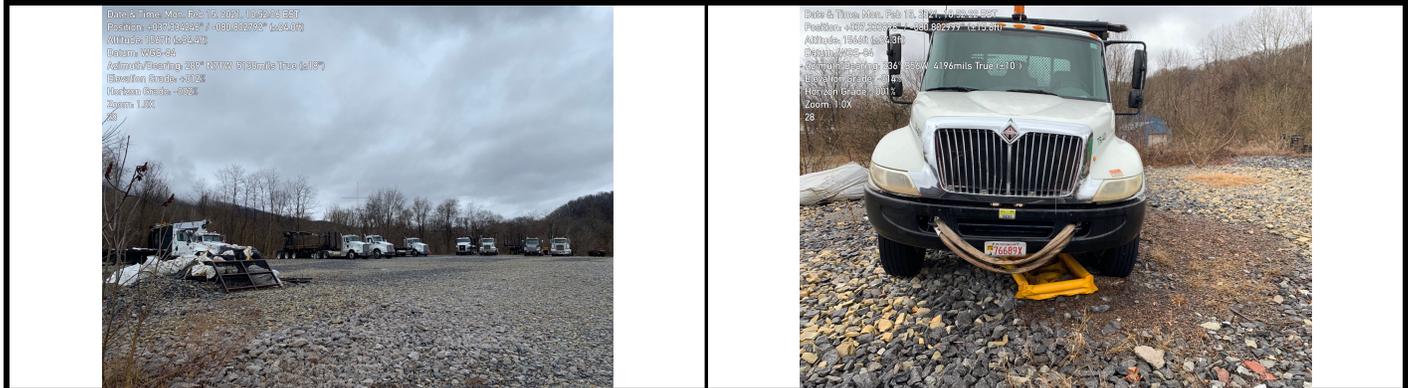
GPS Location	See pictures above for GPS coordinate	GPS Location	See pictures above for GPS coordinate
Field Station#	12005+00	Field Station#	12005+00
Pic 3 Desc.	ECD's and row conditions	Pic 4 Desc.	ECD's and row conditions

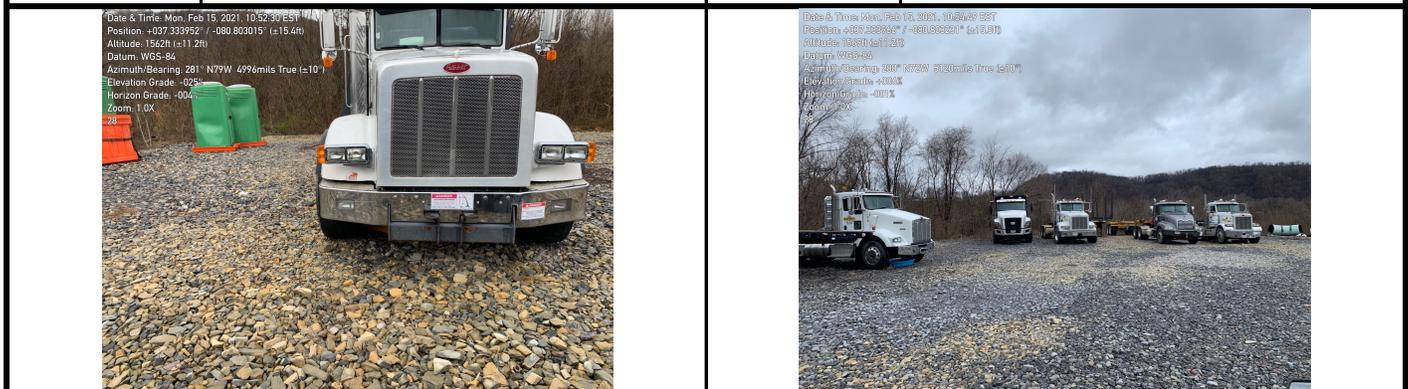
GPS Location	See pictures above for GPS coordinate	GPS Location	See pictures above for GPS coordinate
Field Station#	12005+00	Field Station#	12005+00
Pic 5 Desc.	ECD's and row conditions	Pic 6 Desc.	ECD's and row conditions

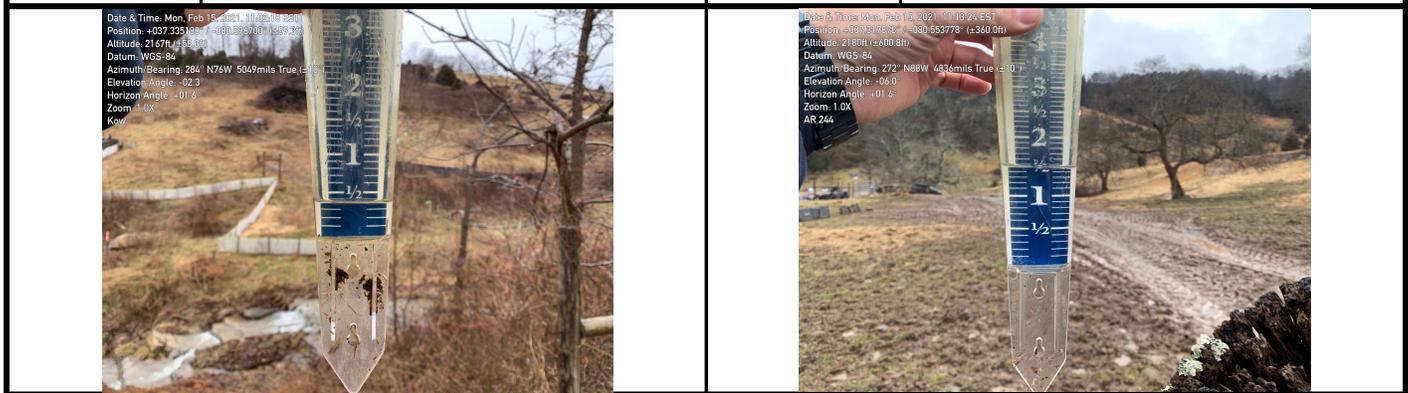
GPS Location	See photo for GPS location.	GPS Location	See photo for GPS location.
Field Station#	12005+00	Field Station#	12005+00
Pic 5 Desc.	Rain gauge at Kow Canp Road reads 0.4 inches.	Pic 6 Desc.	Rain gauge at AR 244 reads 1.4 inches.

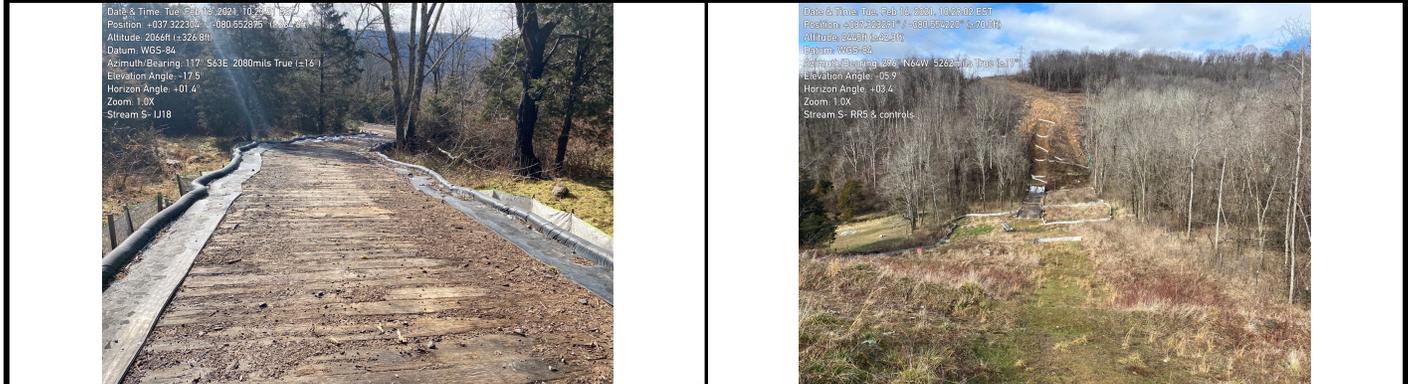
Field Station#	11023+88	Field Station#	11019+00
-----------------------	----------	-----------------------	----------

Pic 1 Desc.	Stream S-IJ18- Bridge and controls	Pic 2 Desc.	Stream S- RR5- controls
--------------------	------------------------------------	--------------------	-------------------------

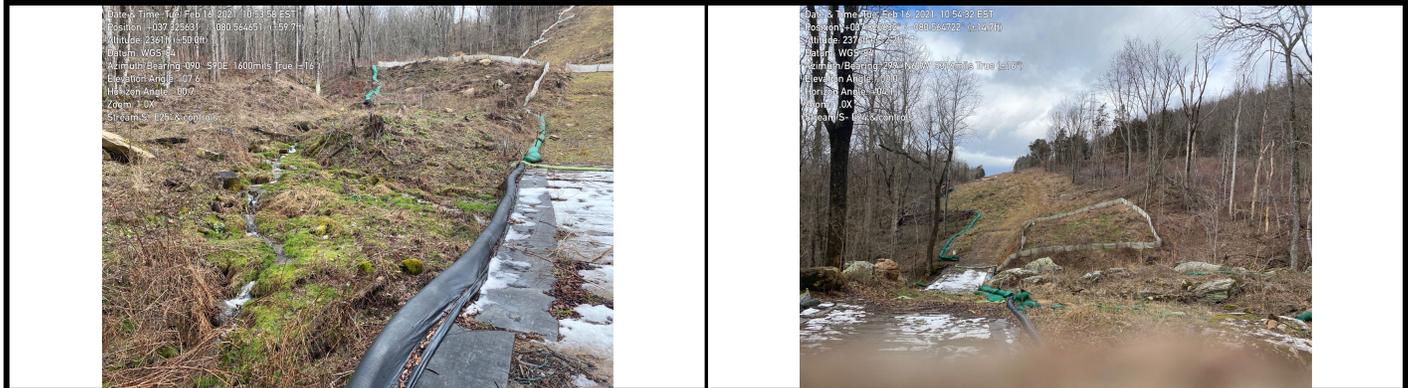
Field Station#	10986+00	Field Station#	10985+00
-----------------------	----------	-----------------------	----------

Pic 3 Desc.	Stream S- E25	Pic 4 Desc.	Stream S- E24- controls
--------------------	---------------	--------------------	-------------------------

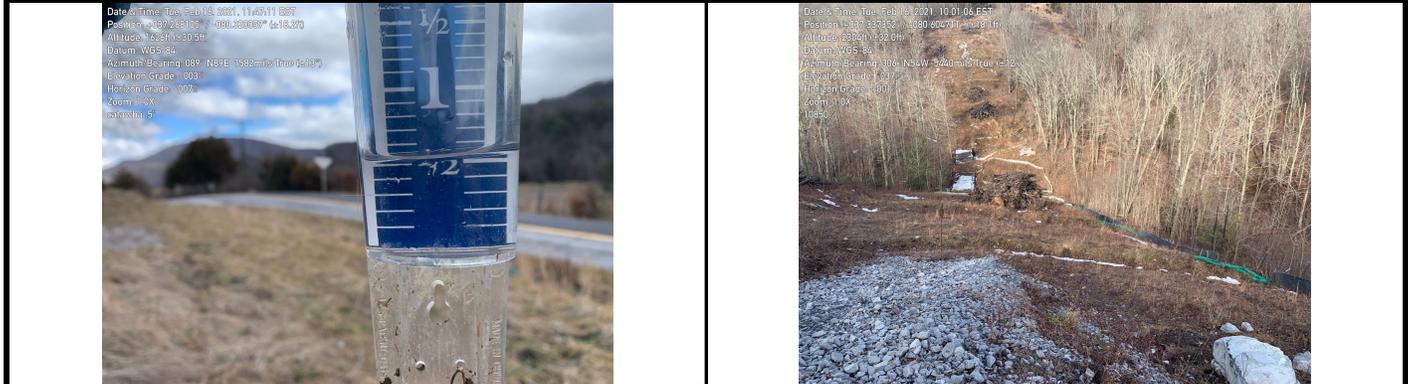
Field Station#	+1	Field Station#	10850+00
-----------------------	----	-----------------------	----------

Pic 1 Desc.	.5" of rain recorded	Pic 2 Desc.	ECDs and ROW conditions
--------------------	----------------------	--------------------	-------------------------

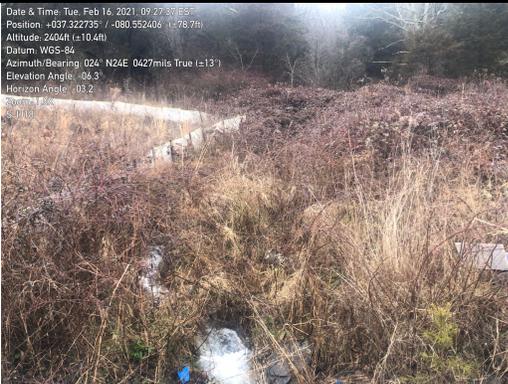
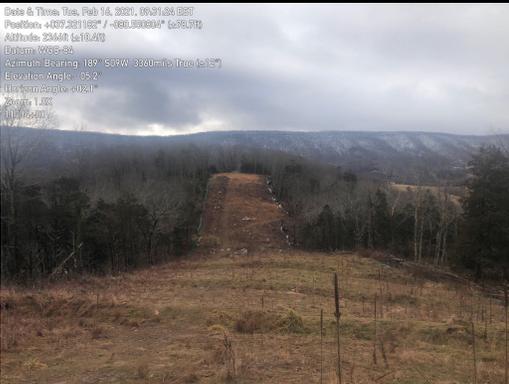
<p><small>Date & Time: Tue, Feb 16, 2021, 09:31:35 EST Position: +037.311637 / -080.553344 (-178.71) Altitude: 2348ft (-10.44) Datum: WGS-84 Azimuth/Bearing: 189° S09W 0360mils True (±13°) Elevation Angle: -05.2° Horizon Angle: -00.1° Zoom: 1.0X 11034+00</small></p>		
GPS Location	1	GPS Location	2	
Field Station#	11025+50	Field Station#	11034+00	
Pic 1 Desc.	S-IJ18 and controls.		Pic 2 Desc.	Section of RoW showing conditions and controls.

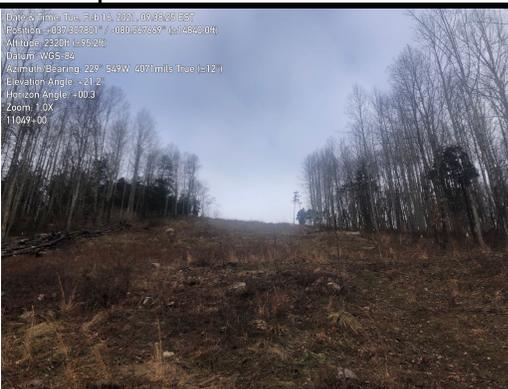
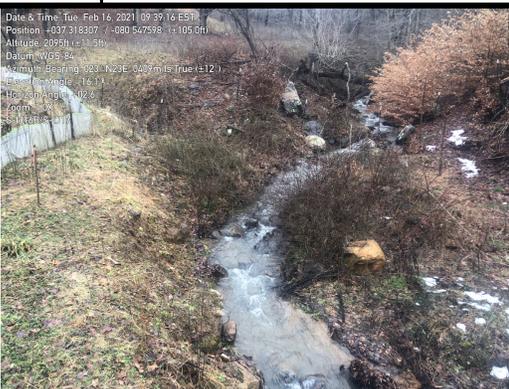
GPS Location	3	GPS Location	4	
Field Station#	11049+00	Field Station#	11050+10	
Pic 3 Desc.	Section of RoW showing conditions and controls.		Pic 4 Desc.	S-IJ16B/S-IJ17 and controls.

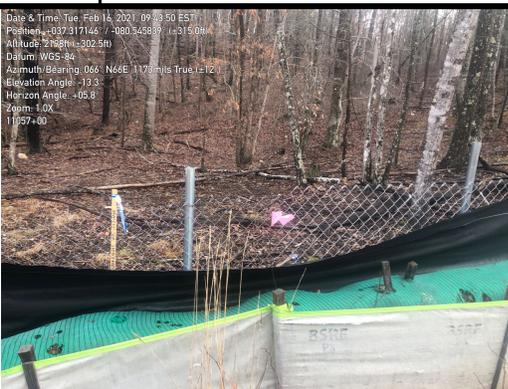
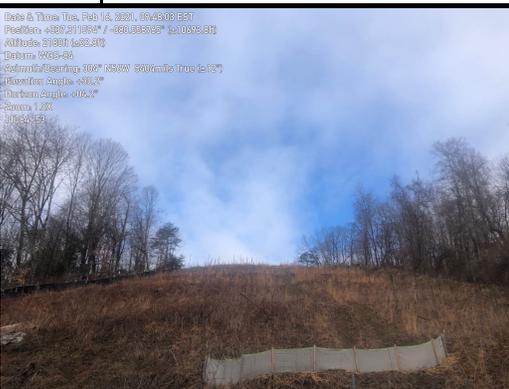
See photos for GPS coordinates.
 Performed SWPPP inspection from MP 208.78 to MP 209.56 as well as assessed AR 245.01.
 No major issues were identified.
 One location of minor wildlife/livestock damage to controls were identified. Lead EI Brian Shields, Utility Inspectors Mark Woodley and Billy Hayes as well as PPL Environmental Coordinator Mike Perry were notified and items added to the punch list.
 All other perimeter controls, ECDs and BMPs are functional.
 Vegetation or stabilization sufficient.
 No impact to sensitive resources observed.

<p><small>Date & Time: Tue, Feb 16, 2021, 09:40:08 EST Position: +037.317839 / -080.553344 (-178.71) Altitude: 2180ft (-10.52) Datum: WGS-84 Azimuth/Bearing: 006° N06W 5000mils True (±13°) Elevation Angle: -03.2° Horizon Angle: -00.2° Zoom: 1.0X 11064+53</small></p>		
GPS Location	5	GPS Location	6	
Field Station#	11057+00	Field Station#	11064+53	
Pic 5 Desc.	Minor wildlife damage to controls.		Pic 6 Desc.	Section of RoW showing conditions and controls.

E&S BMPs	Compliance Level	Corrective Action	Corrective Time Frame	Date Repaired
Compost Filter Sock	Communication	Repair holes in CFS	24 Hours	
Equipment Bridge	Acceptable			
Housekeeping	Acceptable			
Sensitive Resource Buffer	Acceptable			
Silt Fence (Filter Fabric Fence)	Acceptable			
Silt Fence (Reinforce Filter Fence)	Communication	Re attach SSF to chain link	24 Hours	
Temporary Diversion Berm	Acceptable			
Vegetative Stabilization (Temporary)	Acceptable

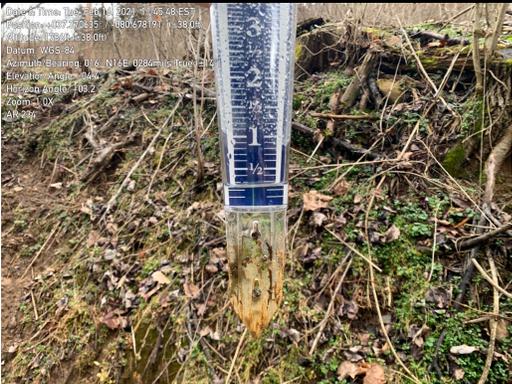
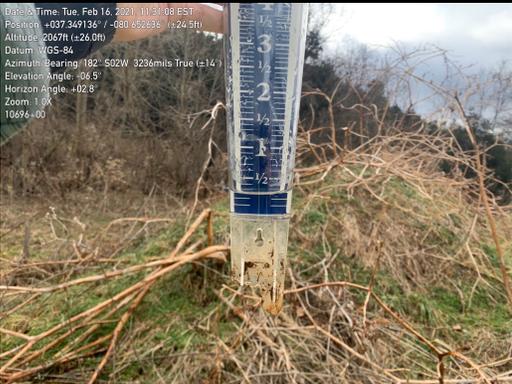
<p><small>Date & Time: Tue, Feb 16, 2021 11:31:08 EST Position: +037.349136 / -080.652636 (-24.5ft) Altitude: 2067ft (+26.0ft) Datum: WGS-84 Azimuth/Bearing: 0.1° S02W 323mils True (±14.1) Elevation Angle: -06.5° Horizon Angle: -02.8° Zoom: 1.0x 10696.00</small></p>		GPS Location	See photo for GPS location.	GPS Location	See photo for GPS location.
Field Station#	12005+00	Field Station#	10696+00	Pic 1 Desc.	Rain gauge at Access Road 234 reads 0.3 inches.	Pic 2 Desc.	Rain gauge at Buffalo Anklets Road reads 0.3 inches.

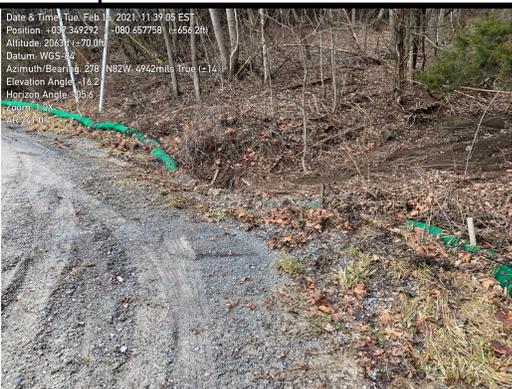
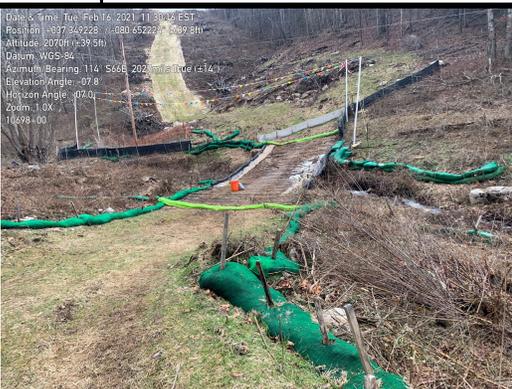
Field Station#	12005+00	Field Station#	10698+00	Pic 3 Desc.	CFS along AR 241.01 need cleaned. Item added to punch list.	Pic 4 Desc.	Sensitive resource buffer in place at stream S-G32.

E&S BMPs	Compliance Level	Corrective Action	Corrective Time Frame	Date Repaired
Compost Filter Sock	Communication	Clean out CFS	Addressed	2/16/2021
Equipment Bridge	Acceptable			
Flume Pipe	Acceptable			
Erosion Control Blanket	Acceptable			
Housekeeping	Acceptable			
Roadside Ditch	Acceptable			
Sensitive Resource Buffer	Acceptable			
Rock Construction Entrance	Acceptable			
Silt Fence (Filter Fabric Fence)	Acceptable

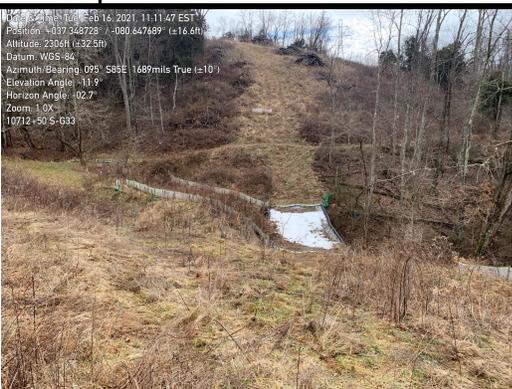
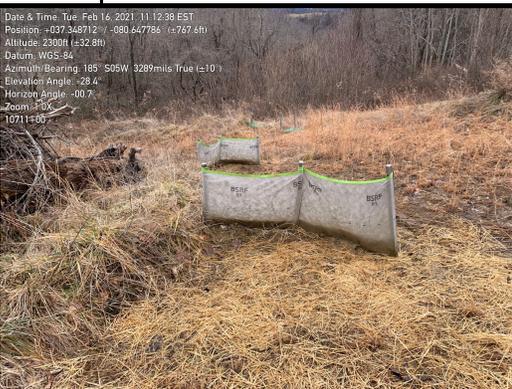
<p><small>Date & Time: Tue, Feb 16, 2021 11:12:38 EST Position: +037.349712 / -080.647786 (-16.6ft) Altitude: 2300ft (+32.5ft) Datum: WGS-84 Azimuth/Bearing: 185° S05W 3289mils True (±10.1) Elevation Angle: -28.4° Horizon Angle: -00.7° Zoom: 1.0x 10711.00</small></p>		GPS Location	See photo for GPS location.	GPS Location	See photo for GPS location.
Field Station#	10712+50	Field Station#	10711+00	Pic 5 Desc.	Sensitive resource buffer in place at stream S-G33.	Pic 6 Desc.	Priority one silt fence checks in place.

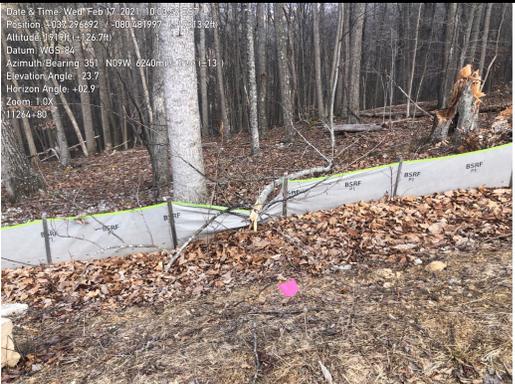
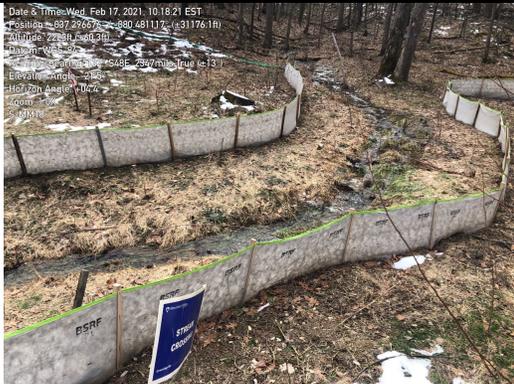
<p>Date & Time: Wed, Feb 17, 2021, 10:18:21 EST Position: +39.237373° / +80.481172° (+31176.1ft) Altitude: 2283.6ft (+696.3m) Datum: WGS 84 Azimuth/Bearing: 348° S48E 2347mils True (+13.1) Elevation Angle: +21.8° Horizon Angle: +02.7° Zoom: 1.0x SRN11</p>		
GPS Location	1	GPS Location	2		
Field Station#	11264+80	Field Station#	11292+80		
Pic 1 Desc.	P-1 silt fence damaged by fallen tree limb.		Pic 2 Desc.	S-MM18 and controls.

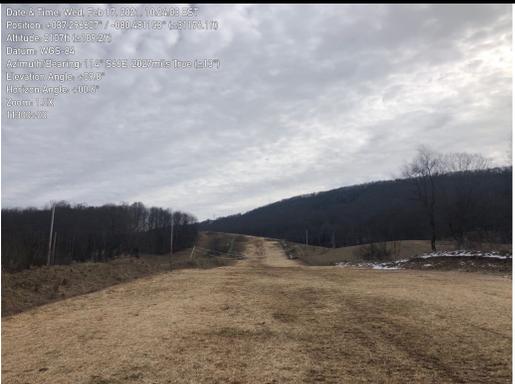
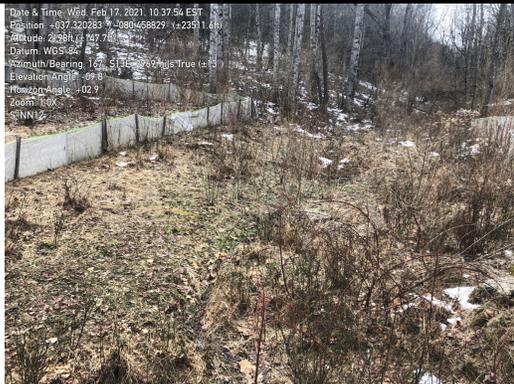
GPS Location	3	GPS Location	4		
Field Station#	11300+00	Field Station#	11327+85		
Pic 3 Desc.	Section of RoW showing conditions and controls.		Pic 4 Desc.	S-NN12 and controls.

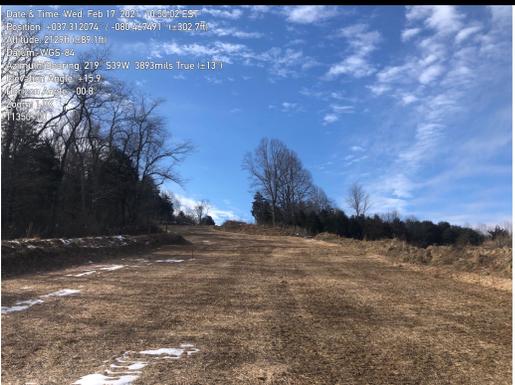
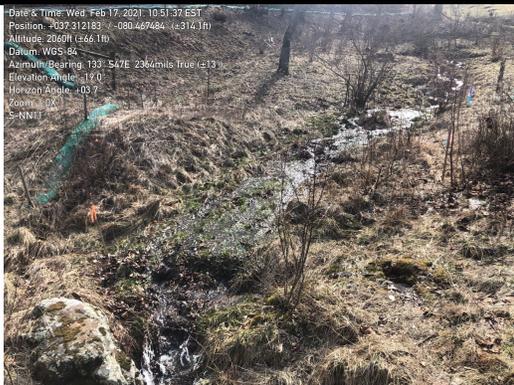
<p>Date & Time: Wed, Feb 17, 2021, 10:31:32 EST Position: +39.2312183° / +80.487484° (+3141.1ft) Altitude: 2060ft (+626.1m) Datum: WGS 84 Azimuth/Bearing: 133° S47E 2364mils True (+13.1) Elevation Angle: +17.0° Horizon Angle: +03.7° Zoom: 1.0x SRN11</p>		
GPS Location	5	GPS Location	6		
Field Station#	11350+00	Field Station#	11352+97		
Pic 5 Desc.	Section of RoW showing conditions and controls.		Pic 6 Desc.	S-NN11 and controls.

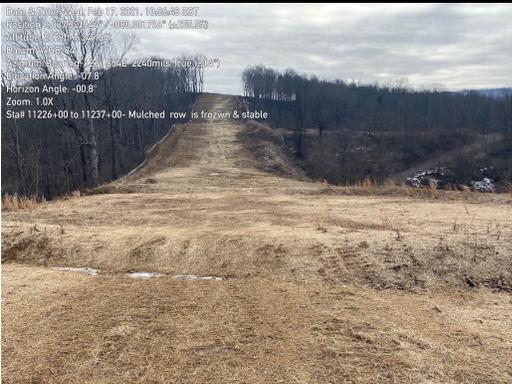
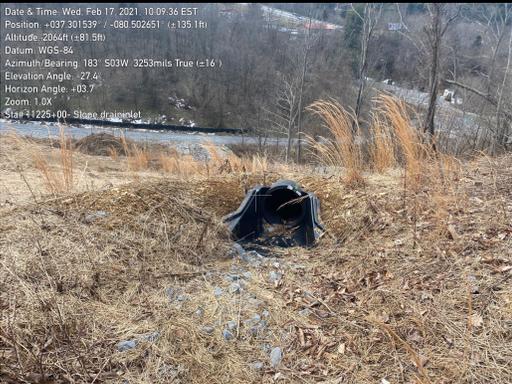
GPS Location	See photo GPS	GPS Location	See photo GPS
Field Station#	11226+00	Field Station#	11225+00	Pic 1 Desc.	Mulched row is stable	Pic 2 Desc.	Slope drain inlet.

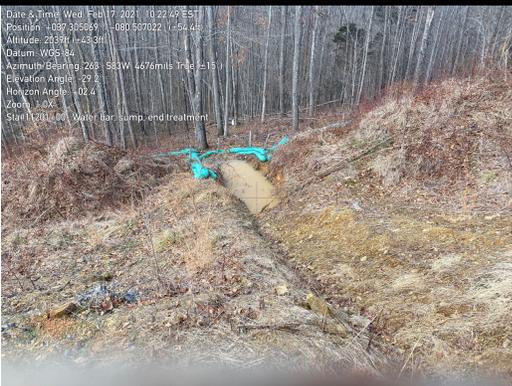
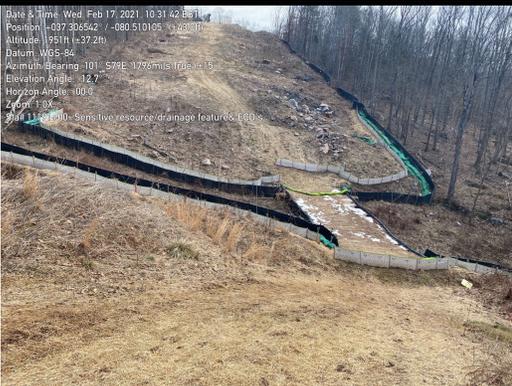
GPS Location	See photo GPS	GPS Location	See photo GPS
Field Station#	11201+00	Field Station#	11191+00	Pic 3 Desc.	Water bar, sump pit, end treatment.	Pic 4 Desc.	Sensitive resource area/ drainage feature and ECD's.

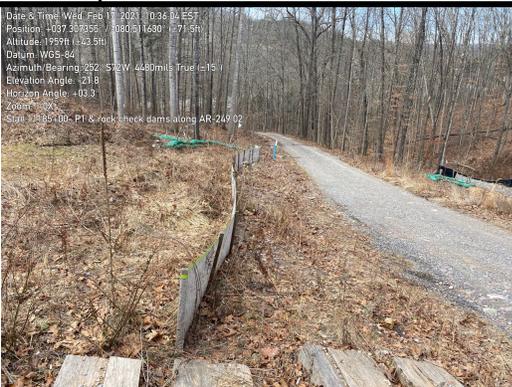
GPS Location	See photo GPS	GPS Location	See photo GPS
Field Station#	11185+00	Field Station#	11184+00	Pic 5 Desc.	P1 silt fence and rock check dams along AR-249.02	Pic 6 Desc.	CWD pipe and plunge pool.

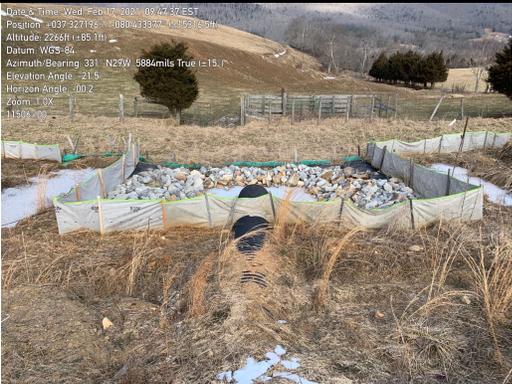
<p><small>Date & Time: Wed, Feb 17, 2021, 09:27:37 EST Position: +037.32719° / -080.43337° (-80.43337°) Altitude: 2264ft (+687m) Datum: WGS-84 Azimuth/Bearing: 331° N27W 5884mils True (+15.1°) Elevation Angle: -21.5° Horizon Angle: +00.2° Zoom: 1.0X 11506+00</small></p>

<p><small>Date & Time: Wed, Feb 17, 2021, 09:47:44 EST Position: +037.3281499° / -80.434591° (-80.434591°) Altitude: 2269ft (+691m) Datum: WGS-84 Azimuth/Bearing: 146° S34E 2596mils True (+15°) Elevation Angle: -04.4° Horizon Angle: +00.7° Zoom: 1.0X 11506+00</small></p>		
GPS Location	See photo for GPS location.	GPS Location	See photo for GPS location.	
Field Station#	11506+00	Field Station#	11506+00	
Pic 1 Desc.	Clean water diversion pipe and plunge pool in place.	Pic 2 Desc.	Clean water diversion pipe and clean water diversion berm in place.

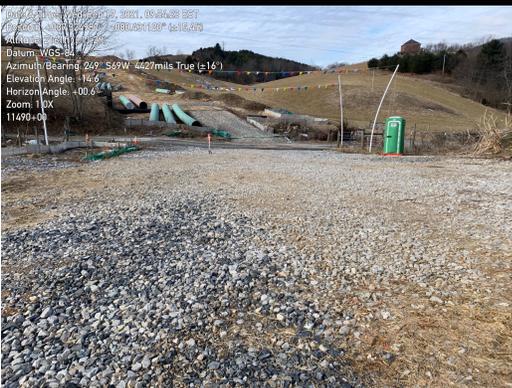
<p><small>Date & Time: Wed, Feb 17, 2021, 09:44:08 EST Position: +037.32719° / -080.43337° (-80.43337°) Altitude: 2264ft (+687m) Datum: WGS-84 Azimuth/Bearing: 269° S49W 4427mils True (+16°) Elevation Angle: +12.6° Horizon Angle: +00.6° Zoom: 1.0X 11490+00</small></p>

GPS Location	See photo for GPS location.	GPS Location	See photo for GPS location.	
Field Station#	11490+00	Field Station#	11436+00	
Pic 3 Desc.	RCE in place at Stevers Gap Road.	Pic 4 Desc.	Super silt fence fabric detached from chain link.

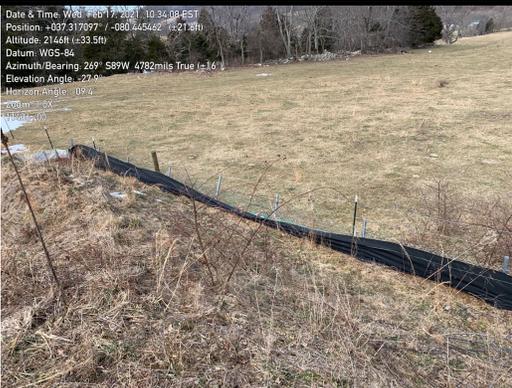
<p><small>Date & Time: Wed, Feb 17, 2021, 10:36:09 EST Position: +037.317897° / -080.445462° (-80.445462°) Altitude: 2146ft (+655m) Datum: WGS-84 Azimuth/Bearing: 269° S39W 4782mils True (+16°) Elevation Angle: -27.0° Horizon Angle: -09.4° Zoom: 1.0X 11436+00</small></p>

Conducted VA SWPPP inspection from MP 215 to MP 218.3.
 Since last inspection Precision Pipeline has conducted ECD maintenance and ECD upgrades where needed.
 No forward progress has been completed due to FERC shut down.
 Right of way has been stabilized using seed, mulch, and natural vegetation.
 Deficiencies located at station number;
 11436+00 - Super silt fence fabric detached from chain link.
 11437+50 - Hole in super silt fence fabric
 11406+75 - Broken P-1 stake.

E&S BMPs	Compliance Level	Corrective Action	Corrective Time Frame	Date Repaired
Broad-Based Dip	Acceptable			
Cleanwater Diversion Berm	Acceptable			
Cleanwater Diversion Pipe	Acceptable			
Compost Filter Sock	Acceptable			
Equipment Bridge	Acceptable			
Erosion Control Blanket	Acceptable			
Housekeeping	Acceptable			
Silt Fence (Filter Fabric Fence)	Communication	Repair broken stake	Addressed	2/17/2021
Silt Fence (Reinforced Filter Fabric Fence)	Communication	Repair hole and reattach to chain link	Addressed	2/17/2021

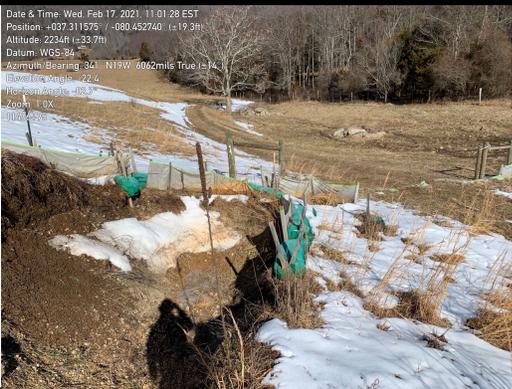
<p><small>Date & Time: Wed, Feb 17, 2021, 11:01:28 EST Position: +037.311975° / -080.452740° (-80.452740°) Altitude: 2234ft (+680m) Datum: WGS-84 Azimuth/Bearing: 324° N15W 6042mils True (+14°) Elevation Angle: -22.4° Horizon Angle: -23.4° Zoom: 1.0X 11406+75</small></p>

Pic 5 Desc.	Broken priority one silt fence stake.	Pic 6 Desc.	Triple barrier ECDs in place at off ROW karst feature.

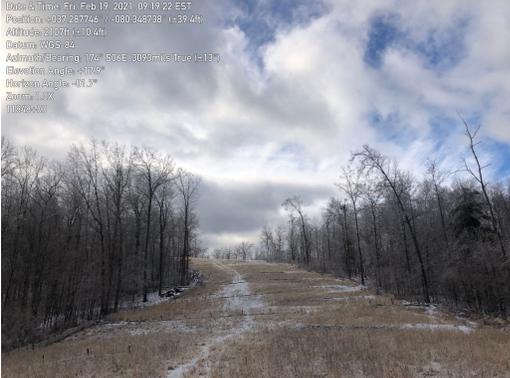
GPS Location 3		GPS Location 4			
Field Station# 11848+00		Field Station# 11863+65			
Pic 3 Desc. Section of restored RoW showing conditions and controls.		Pic 4 Desc. P-KL2 and controls.

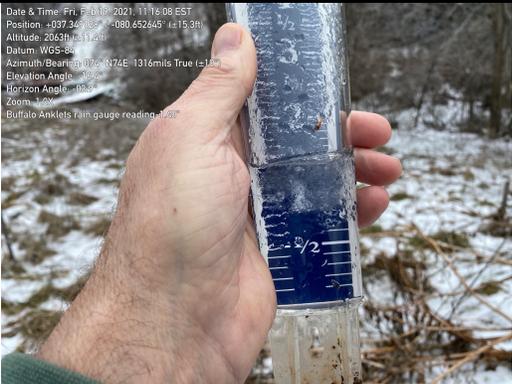
<p>Date & Time: Fri, Feb 19, 2021, 11:16:08 EST Position: +397.246337 / +880.652645 (+15.3in) Altitude: 2653ft (+807.9m) Datum: WGS-84 Azimuth/Bearing: 072° N74E 131&mits True (+15.1) Elevation Angle: +0.5° Horizon Angle: -0.5° Zoom: 1.0X Buffalo Anklets rain gauge reading-1.40"</p>

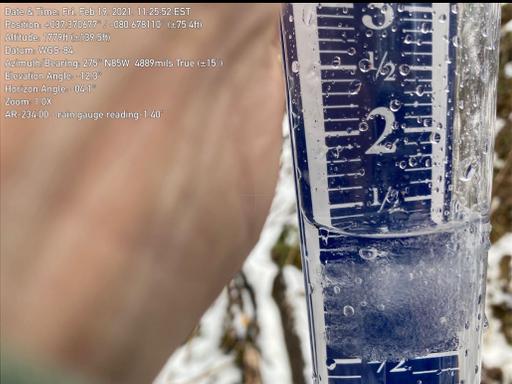
<p>Date & Time: Fri, Feb 19, 2021, 11:25:52 EST Position: +397.370297 / +880.678113 (+17.54in) Altitude: 2678ft (+815.9m) Datum: WGS-84 Azimuth/Bearing: 275° N85W 488&mits True (+15.1) Elevation Angle: +2.3° Horizon Angle: -0.6° Zoom: 1.0X AR-234.00 - rain gauge reading- 1.40"</p>		
GPS Location	See photo GPS	GPS Location	See photo GPS	
Field Station#	11671+00	Field Station#	12005+00	
Pic 1 Desc.	Buffalo Anklets rain gauge reading- 1.40"	Pic 2 Desc.	AR-234.00 rain gauge reading- 1.40"

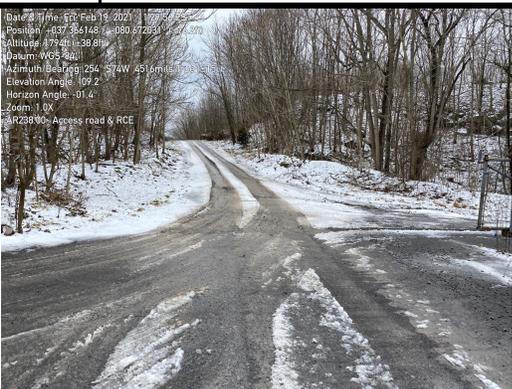
<p>Date & Time: Fri, Feb 19, 2021, 11:27:55 EST Position: +337.324148 / +880.572931 (+92.0in) Altitude: 1775ft (+540.6m) Datum: WGS-84 Azimuth/Bearing: 254° S74W 451&mits True (+15.1) Elevation Angle: +09.2° Horizon Angle: -01.4° Zoom: 1.0X AR238.00- Access road & RCE</p>

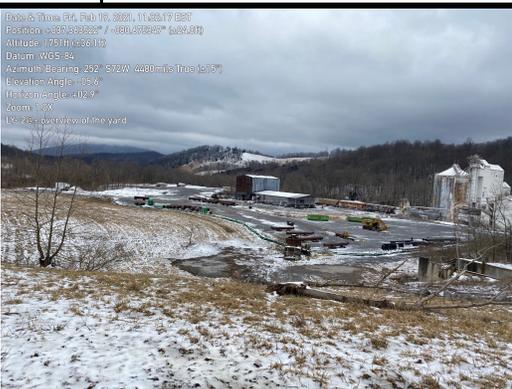
<p>Date & Time: Fri, Feb 19, 2021, 11:28:17 EST Position: +337.338222 / +880.572925 (+92.0in) Altitude: 1781ft (+543.1m) Datum: WGS-84 Azimuth/Bearing: 252° S72W 448&mits True (+15.1) Elevation Angle: +9.2° Horizon Angle: -02.7° Zoom: 1.0X LY29- post view of the yard</p>

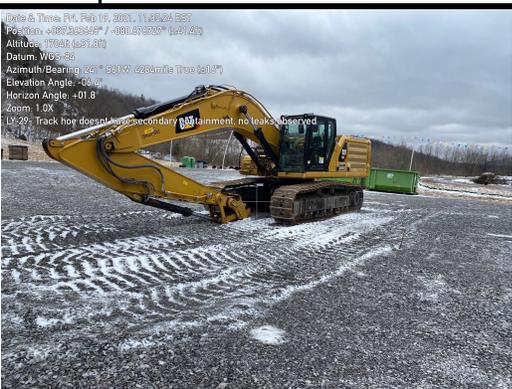
SWPPP inspection LY29:
 AR-238.00- Access road and RCE are in acceptable condition.
 CFS triple stack perimeter controls are in acceptable condition.
 Culvert and drainage feature are in acceptable condition.
 House keeping is acceptable.
 Waste management is acceptable.
 Overhead utility flagging is acceptable.
 There is a track hoe present in the yard, there is no secondary containment under machine and did not observe any fluid leaks.

<p>Date & Time: Fri, Feb 19, 2021, 11:29:22 EST Position: +337.333487 / +880.578227 (+92.0in) Altitude: 1782ft (+543.1m) Datum: WGS-84 Azimuth/Bearing: 321° S31W 438&mits True (+15.1) Elevation Angle: +0.6° Horizon Angle: +01.8° Zoom: 1.0X LY29- Track hoe doesn't have secondary containment, no leaks observed</p>

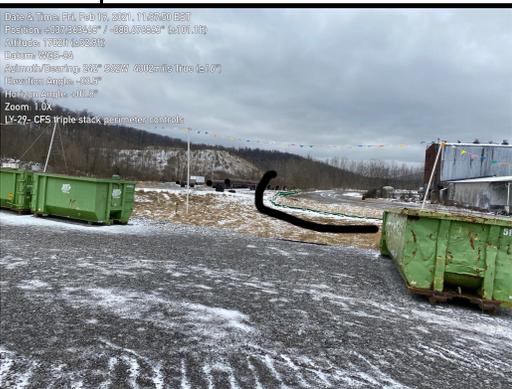
<p>Date & Time: Fri, Feb 19, 2021, 11:29:00 EST Position: +337.333487 / +880.578227 (+92.0in) Altitude: 1782ft (+543.1m) Datum: WGS-84 Azimuth/Bearing: 321° S31W 438&mits True (+15.1) Elevation Angle: +0.6° Horizon Angle: +01.8° Zoom: 1.0X LY29- CFS triple stack perimeter controls</p>		
GPS Location	See photo GPS	GPS Location	See photo GPS	
Field Station#	12005+00	Field Station#	12005+00	
Pic 5 Desc.	LY29- Track hoe in the yard.	Pic 6 Desc.	CFS triple stack perimeter controls & waste containers.

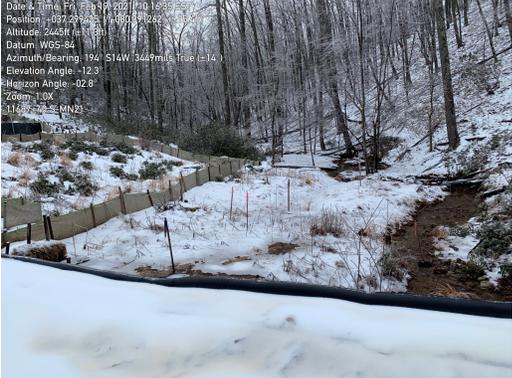
GPS Location	See photo for GPS location.	GPS Location	See photo for GPS location.	
Field Station#	11687+40	Field Station#	11704+10	
Pic 3 Desc.	Sensitive resource buffer in place at stream S-MN21.	Pic 4 Desc.	Sensitive resource buffer in place at stream S-MN22.

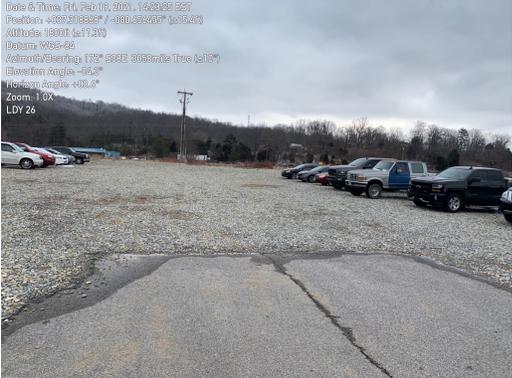
Pic 5 Desc.	RCE in place at employee parking lot.	Pic 6 Desc.	Secondary containment in place under fuel cell.
