# Visual Site Inspection Report

<b>Project Name</b> H-600 Pipeline Spread G		<b>AFE</b> 124300137	<b>Spread</b> H-600 Pipeline Spread G
<b>Contractor</b> Precision		<b>Report #</b> 20262	
<b>Inspector</b> Chris Burns		<b>Date/Time</b> 2/22/2021 8:10 AM	
<b>Permit #</b> TBD	<b>Inspection Type</b> VA SWPP	<b>Station Begin</b>	11023+80
<b>State</b> VA	<b>Inspection Area</b> Partial	<b>Station End</b>	11064+53
<b>County</b> Giles	<b>Ground</b> Wet	<b>Temperature (°F)</b>	45.00
<b>Municipality</b> N/A	<b>Weather</b> Light Rain	<b>Rain Gauge (in)</b>	0.00
			<b>Rain Accumulation Time (days)</b> 1.00

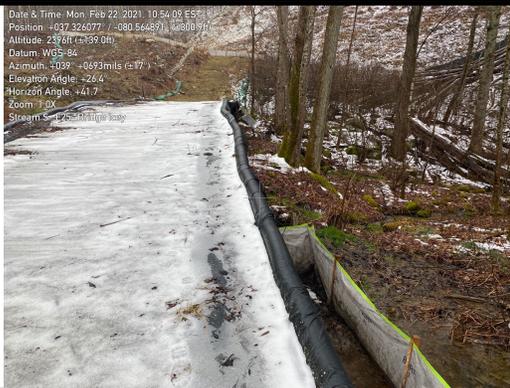
<b>Pic 3 Desc.</b>	Row overview.	<b>Pic 4 Desc.</b>	Stream S- E25, bridges are very icy and slippery.	
<p>Date &amp; Time: Mon, Feb 22, 2021, 11:17:08 EST            Position: +037.325399 / -080.578787 (-80.9658, 91)            Altitude: 2337ft (-1121ft)            Datum: WGS-84            Azimuth: -129 -2274mils (+17)            Elevation Angle: -24.7            Horizon Angle: +45.6            Zoom: 1.0X            Stream: S- E24 - Bridge icy</p>

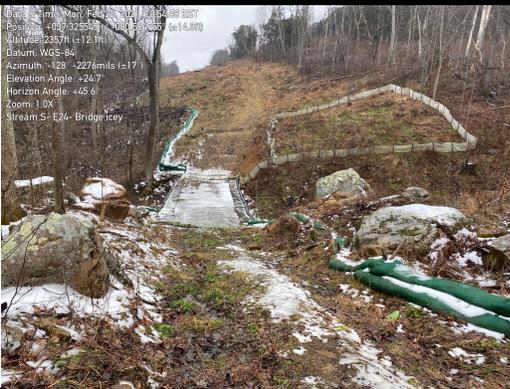
<b>Pic 5 Desc.</b>	Stream S- E24, bridge slippery, ECD's are in acceptable condition.	<b>Pic 6 Desc.</b>	Bridge over drainage feature.

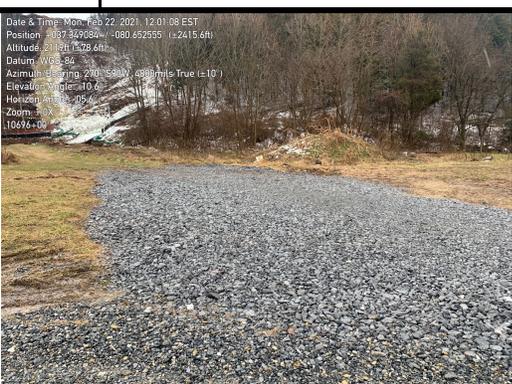
<b>Field Station#</b>	10696+00	<b>Field Station#</b>	10695+00	<b>Pic 5 Desc.</b>	RCE in place at Buffalo Anklets Road.	<b>Pic 6 Desc.</b>	CFS replaced. Was a communication item last inspection.

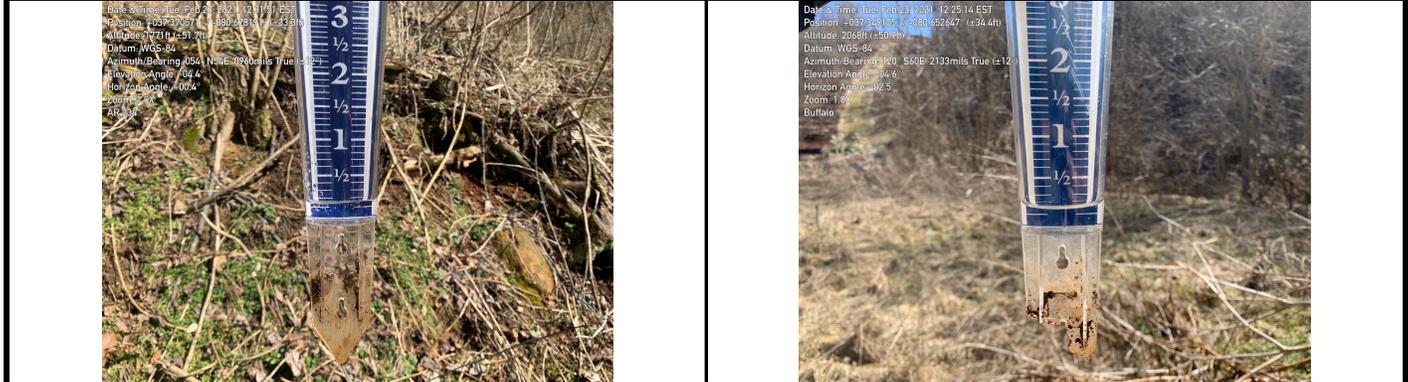
<b>Field Station#</b>	12005+00	<b>Field Station#</b>	10696+00
-----------------------	----------	-----------------------	----------

<b>Pic 1 Desc.</b>	Rain gauge at AR 234 reads 0.2 inches.	<b>Pic 2 Desc.</b>	Rain gauge at Buffalo Anklets Road reads 0.2 inches.
--------------------	--	--------------------	--

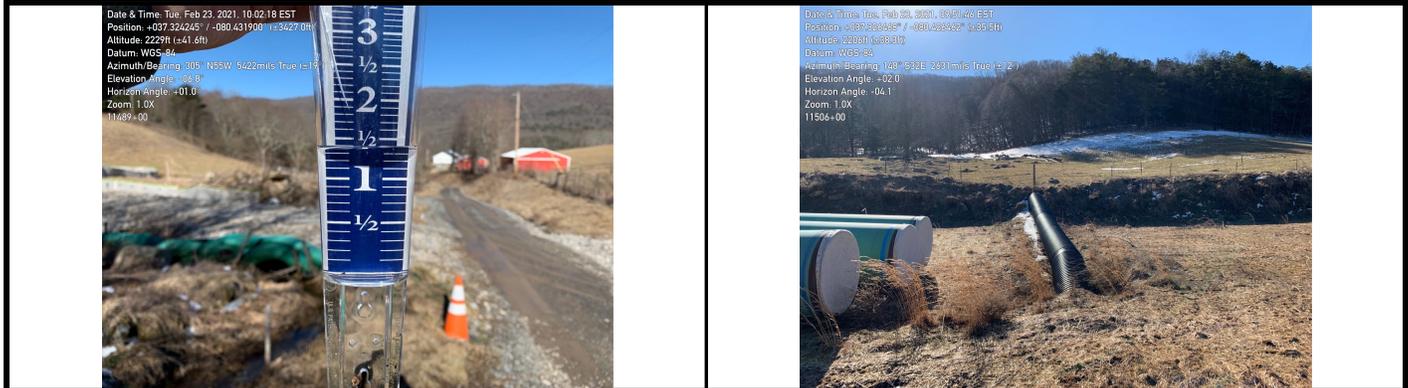
<b>Field Station#</b>	11489+00	<b>Field Station#</b>	11506+00
-----------------------	----------	-----------------------	----------

<b>Pic 3 Desc.</b>	Rain gauge at Stevers Gap Road reads 1.4 inches.	<b>Pic 4 Desc.</b>	Clean water diversion pipe and clean water diversion berm in place.
--------------------	--	--------------------	---

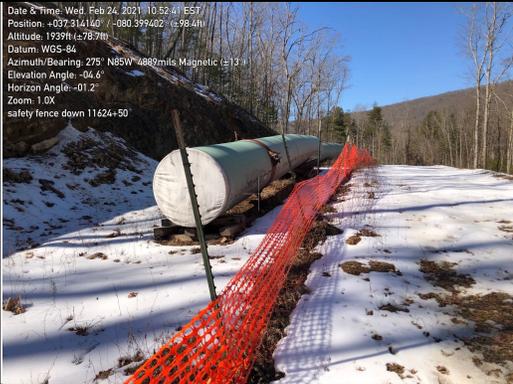
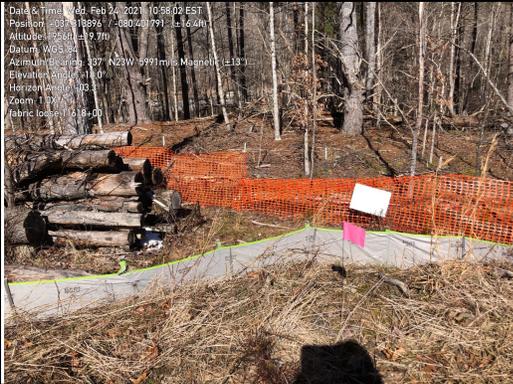
<b>GPS Location</b>	On photo	<b>GPS Location</b>	On photo
<b>Field Station#</b>	11624+50	<b>Field Station#</b>	11618+00
<b>Pic 7 Desc.</b>	Orange fence maintenance needed.	<b>Pic 8 Desc.</b>	Orange barricade fence maintenance needed

E&S BMPs	Compliance Level	Corrective Action	Corrective Time Frame	Date Repaired
Compost Filter Sock	Acceptable			
Equipment Bridge	Acceptable			
Rock Construction Entrance	Acceptable			
Sensitive Resource Buffer	Acceptable			
Silt Fence (Filter Fabric Fence)	Communication	Replace rotten P1	24 Hours	
Silt Fence (Reinforce Filter Fence)	Communication	Re-attach fabric to chain link SSF	24 Hours	
Waterbar	Acceptable			
Waterbar End Treatment	Acceptable			
Other - Explain in Comments	Communication	Repair orange safety fence	24 Hours

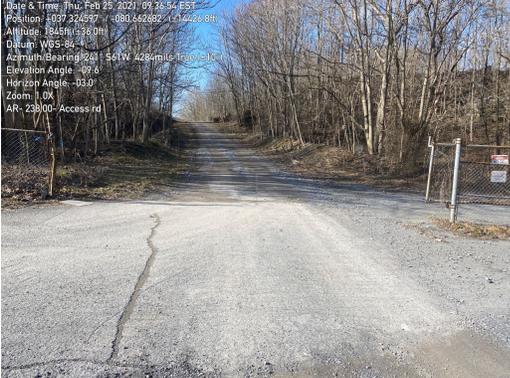
<p><small>Date &amp; Time: Thu, Feb 25, 2021, 09:38:52 EST Position: +037.326397, -080.662895, 1514628.0ft Altitude: 1845ft (+31.0ft) Datum: WGS-84 Azimuth/Bearing: 261.501W, 428.0mils True (+10°) Elevation Angle: -09.6° Horizon Angle: -03.0° Zoom: 1.0X LY-29- Access rd</small></p>

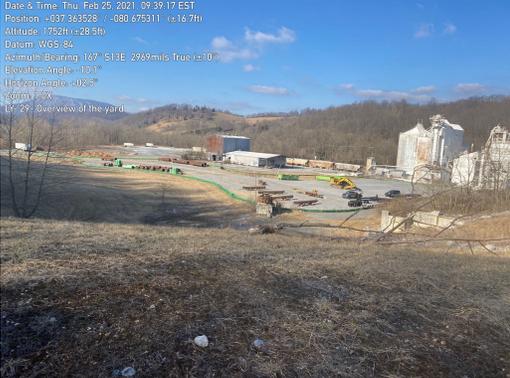
<p><small>Date &amp; Time: Thu, Feb 25, 2021, 09:39:17 EST Position: +037.363828, -080.675311, 1516176ft Altitude: 1825ft (+28.5ft) Datum: WGS-84 Azimuth/Bearing: 167.513E, 286.9mils True (+10°) Elevation Angle: -10.1° Horizon Angle: -02.5° Zoom: 1.0X LY-29- Overview of the yard</small></p>		
<b>GPS Location</b>	See photo GPS	<b>GPS Location</b>	See photo GPS	
<b>Field Station#</b>	12005+00	<b>Field Station#</b>	12005+00	
<b>Pic 1 Desc.</b>	AR-238.00- Access road serving LY29.		<b>Pic 2 Desc.</b>	LY29- Overview of the yard.

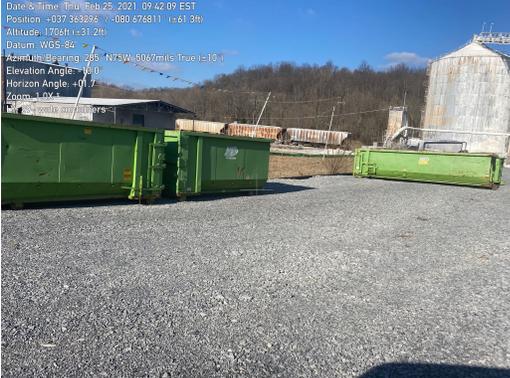
<p><small>Date &amp; Time: Thu, Feb 25, 2021, 09:42:09 EST Position: +037.363826, -080.674811, 1516130ft Altitude: 1796ft (+31.2ft) Datum: WGS-84 Azimuth/Bearing: 225.117SW, 508.7mils True (+10°) Elevation Angle: -11.0° Horizon Angle: -01.7° Zoom: 1.0X LY-29- Waste containers</small></p>

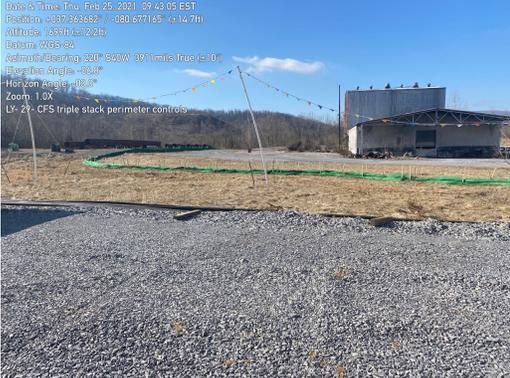
<p><small>Date &amp; Time: Thu, Feb 25, 2021, 09:43:05 EST Position: +037.363828, -080.677155, 1516176ft Altitude: 1838ft (+28.2ft) Datum: WGS-84 Azimuth/Bearing: 320° E32W, 391.1mils True (+10°) Elevation Angle: -03.0° Horizon Angle: -03.0° Zoom: 1.0X LY-29- CFS triple stack perimeter controls</small></p>

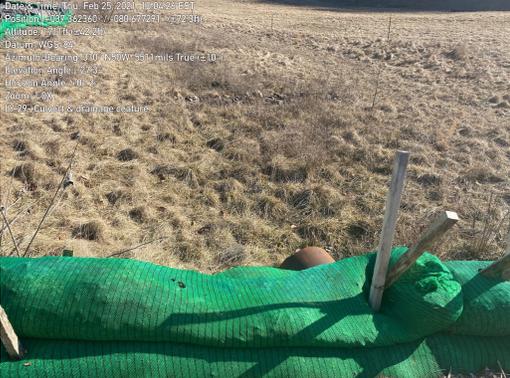
<p><small>Date &amp; Time: Thu, Feb 25, 2021, 10:06:25 EST Position: +037.362263, -080.676215, 1515920ft Altitude: 1795ft (+31.0ft) Datum: WGS-84 Azimuth/Bearing: 010.110W, 53.1mils True (+10°) Elevation Angle: -12.4° Horizon Angle: -01.7° Zoom: 1.25X LY-29- Culvert &amp; drainage feature</small></p>		
<b>GPS Location</b>	See photo GPS	<b>GPS Location</b>	See photo GPS

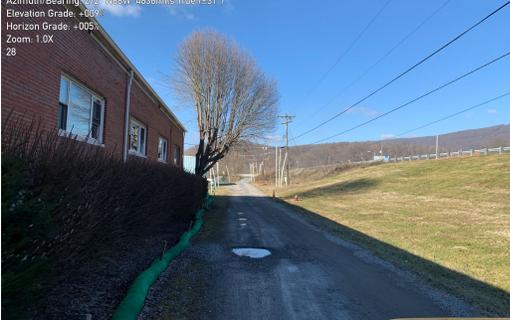
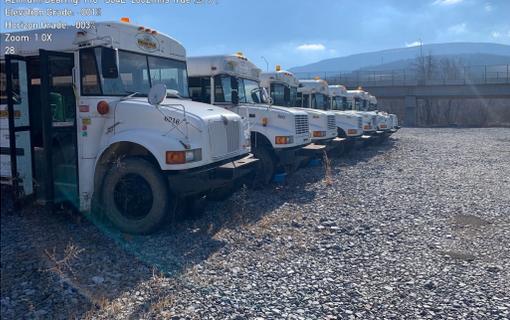
<b>Pic 5 Desc.</b>	ECD's and row conditions	<b>Pic 6 Desc.</b>	ECD's and row conditions

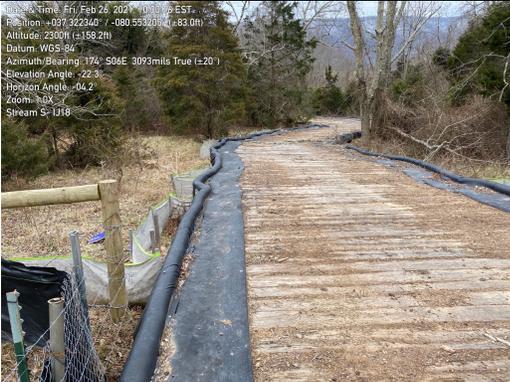
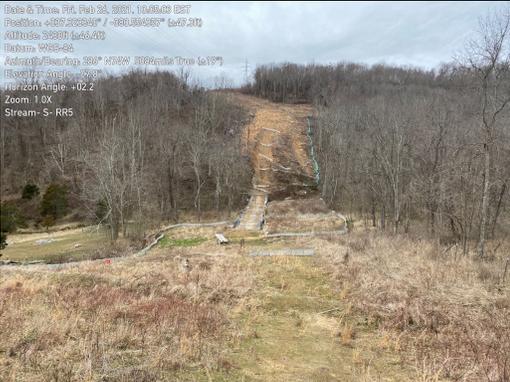
<b>GPS Location</b> See photo GPS		<b>GPS Location</b> See photo GPS			
<b>Field Station#</b> 11023+88		<b>Field Station#</b> 11019+00			
<b>Pic 1 Desc.</b> Stream S- IJ18 bridge and ECD's.		<b>Pic 2 Desc.</b> Stream S- RR5 bridge and ECD's.

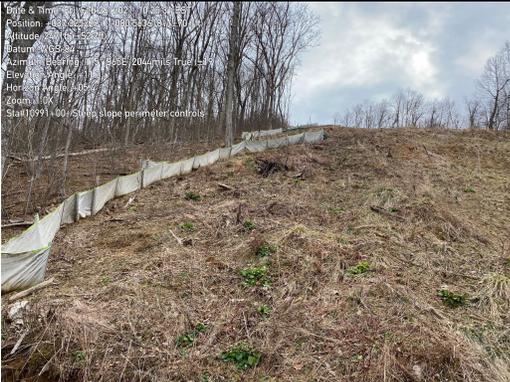
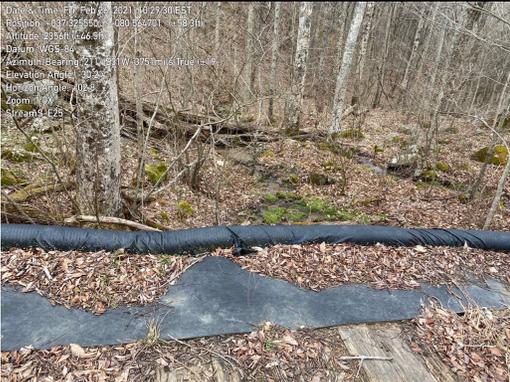
<b>GPS Location</b> See photo GPS		<b>GPS Location</b> See photo GPS			
<b>Field Station#</b> 10991+00		<b>Field Station#</b> 10986+00			
<b>Pic 3 Desc.</b> Steep slope perimeter controls.		<b>Pic 4 Desc.</b> Stream S- E25

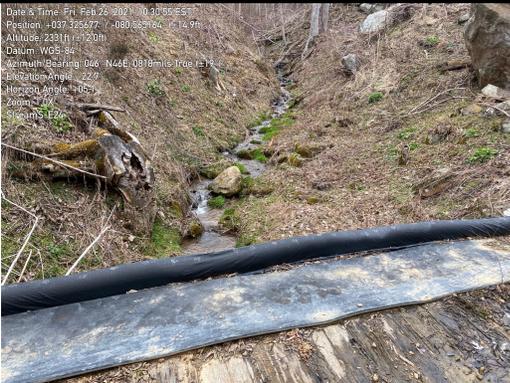
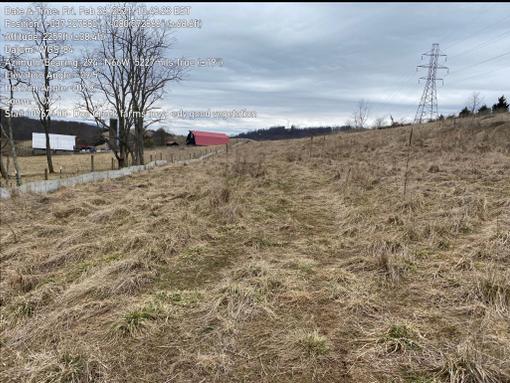
<b>GPS Location</b> See photo GPS		<b>GPS Location</b> See photo GPS			
<b>Field Station#</b> 10985+00		<b>Field Station#</b> 10962+00			
<b>Pic 5 Desc.</b> Stream S- E24		<b>Pic 6 Desc.</b> Doe Creek Farms row, vegetation is very good.

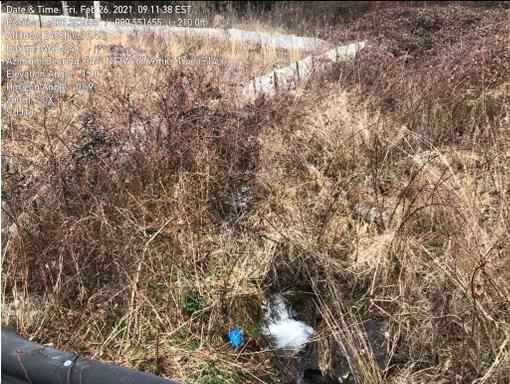
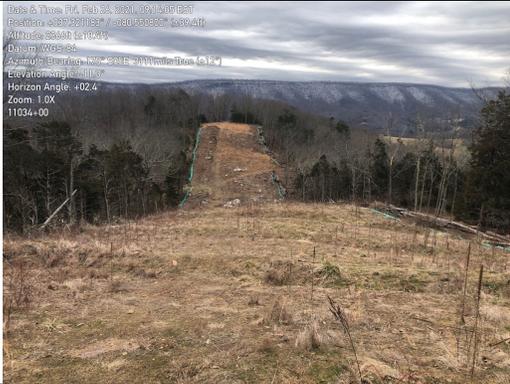
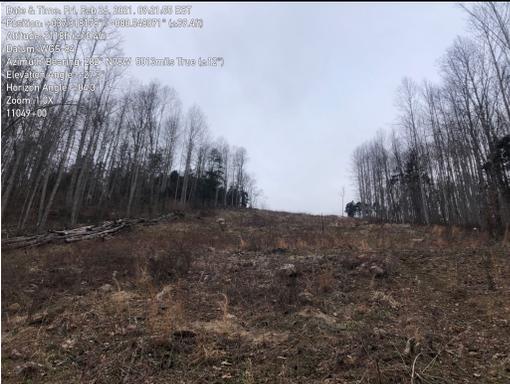
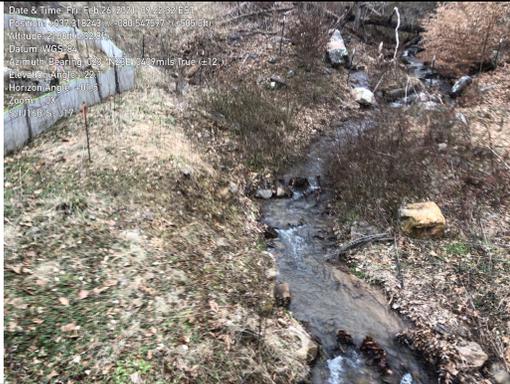
<b>GPS Location</b> 1		<b>GPS Location</b> 2					
<b>Field Station#</b> 11025+50		<b>Field Station#</b> 11034+00					
<b>Pic 1 Desc.</b> S-IJ18.		<b>Pic 2 Desc.</b> Section of RoW showing conditions and controls.					
<b>GPS Location</b> 3		<b>GPS Location</b> 4					
<b>Field Station#</b> 11049+00		<b>Field Station#</b> 11050+10					
<b>Pic 3 Desc.</b> Section of RoW showing conditions and controls.		<b>Pic 4 Desc.</b> S-IJ16B/S-IJ17 and controls.

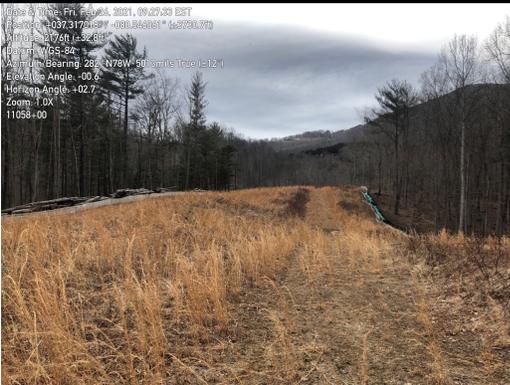
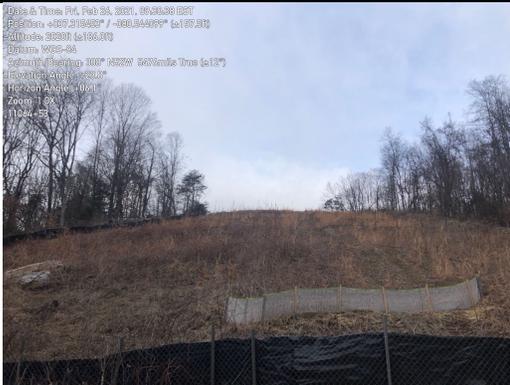
<b>GPS Location</b> 5		<b>GPS Location</b> 6					
<b>Field Station#</b> 11058+00		<b>Field Station#</b> 11064+53					
<b>Pic 5 Desc.</b> Section of RoW showing conditions and controls.		<b>Pic 6 Desc.</b> Section of RoW showing conditions and controls.

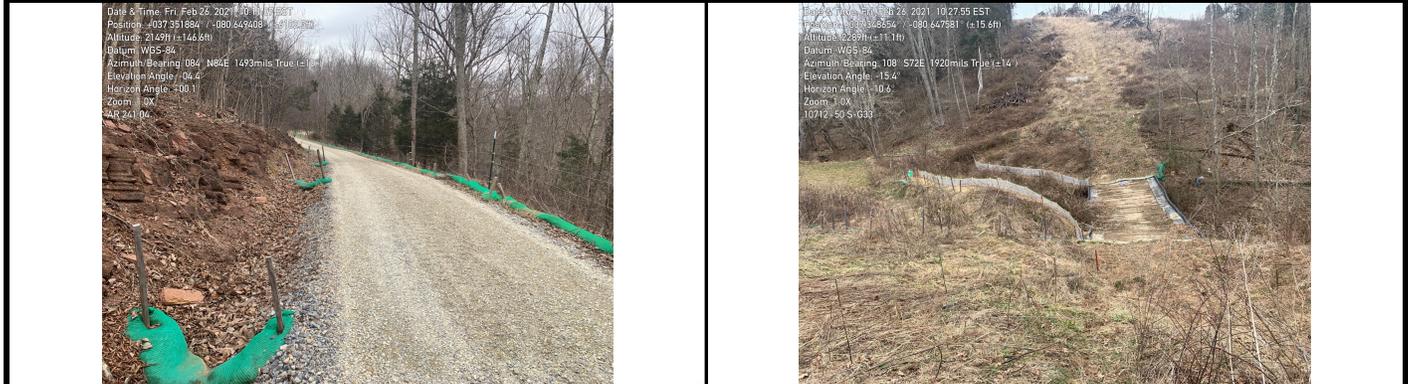
<b>GPS Location</b>	See photo for GPS location.	<b>GPS Location</b>	See photo for GPS location.
<b>Field Station#</b>	10710+00	<b>Field Station#</b>	10712+50
<b>Pic 1 Desc.</b>	Compost filter sock in place along access road 241.04.	<b>Pic 2 Desc.</b>	Sensitive resource buffer in place at stream S-G33.

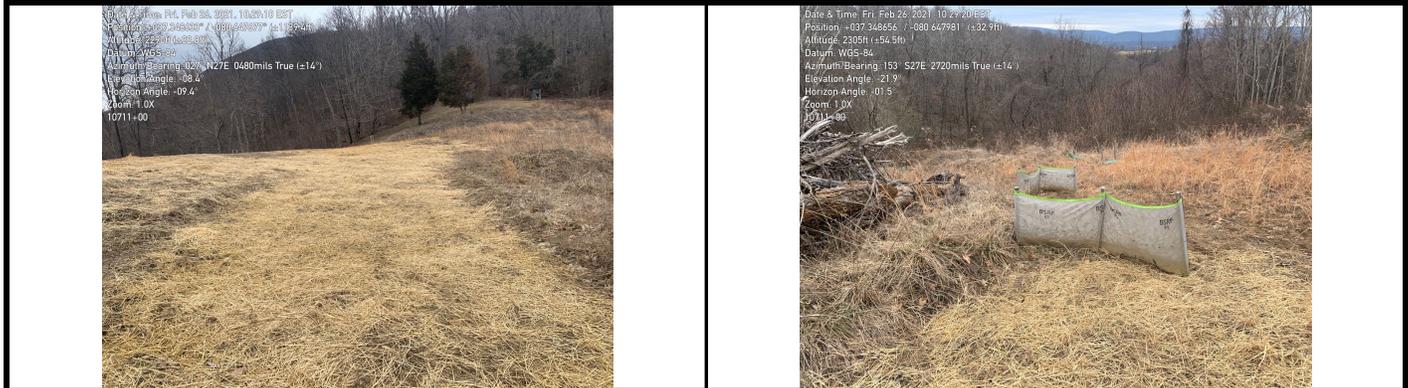
<b>GPS Location</b>	See photo for GPS location.	<b>GPS Location</b>	See photo for GPS location.
<b>Field Station#</b>	10711+00	<b>Field Station#</b>	10711+00
<b>Pic 3 Desc.</b>	Disturbed ROW stabilized with seed and mulch.	<b>Pic 4 Desc.</b>	Priority one silt fence checks in place.

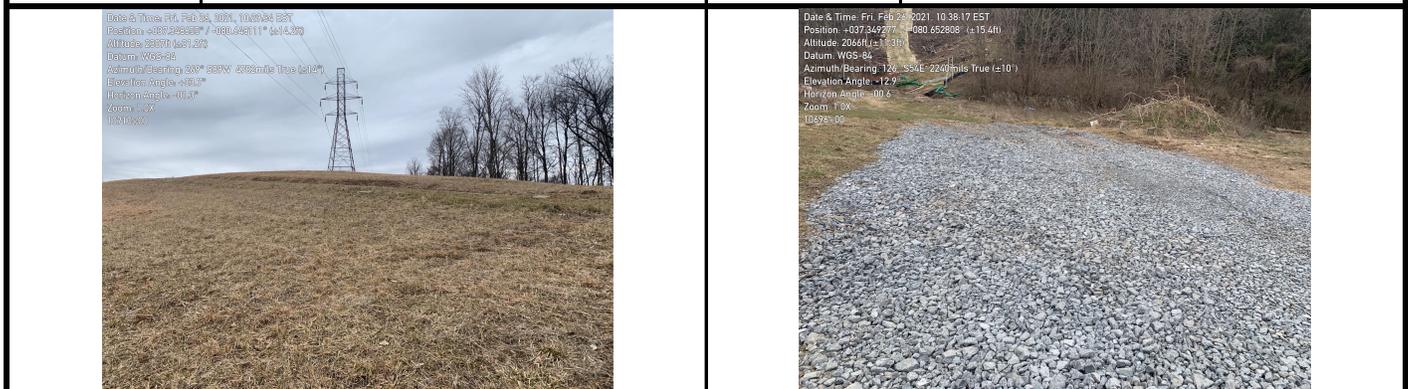
<b>GPS Location</b>	See photo for GPS location.	<b>GPS Location</b>	See photo for GPS location.
<b>Field Station#</b>	10710+00	<b>Field Station#</b>	10696+00
<b>Pic 5 Desc.</b>	ROW stabilized with natural vegetation growth.	<b>Pic 6 Desc.</b>	RCE in place at Buffalo Anklets Road.

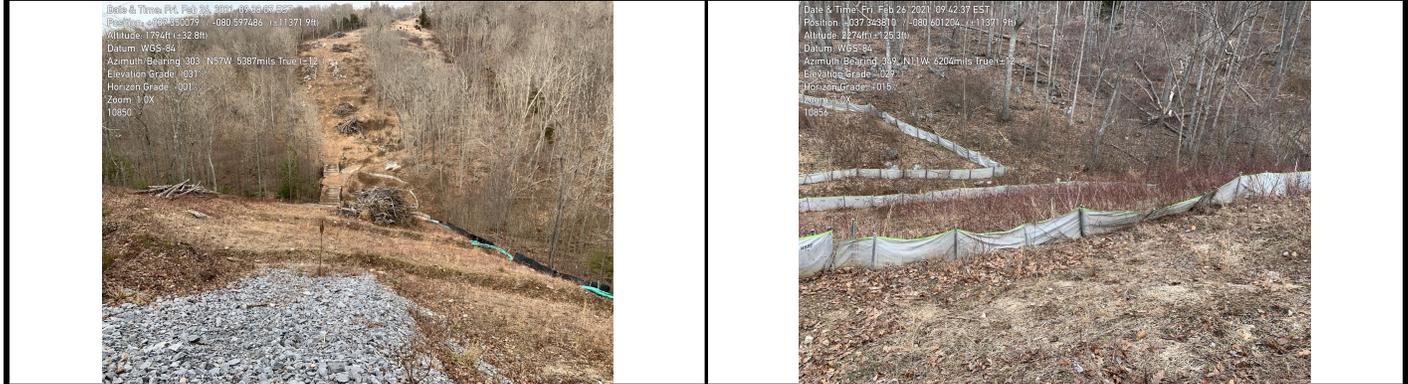
<b>Field Station#</b>	10850+00	<b>Field Station#</b>	10856+00
-----------------------	----------	-----------------------	----------

Arrived at LDY 26 for morning meeting  
 Performed SWPPP for MP 205 - MP 207  
 damaged ECD's observed during inspection  
 ROW conditions are stable and showing minimal signs of erosion  
 Damaged items added to the punch list

<b>Pic 1 Desc.</b>	ECD's and row conditions	<b>Pic 2 Desc.</b>	Damaged P1
--------------------	--------------------------	--------------------	------------

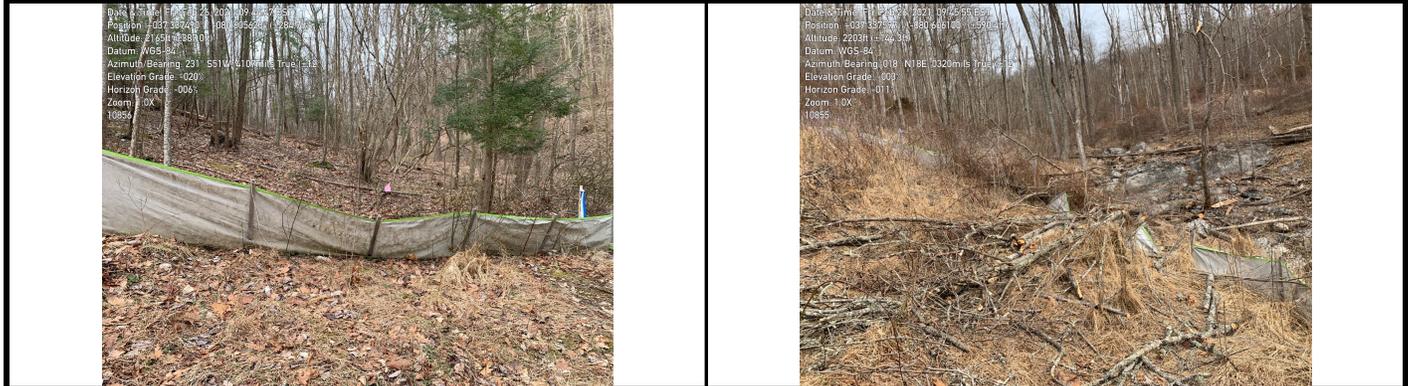
<b>Field Station#</b>	10856+00	<b>Field Station#</b>	10855+00
-----------------------	----------	-----------------------	----------

<b>Pic 3 Desc.</b>	Damaged P1	<b>Pic 4 Desc.</b>	Damaged P1
--------------------	------------	--------------------	------------

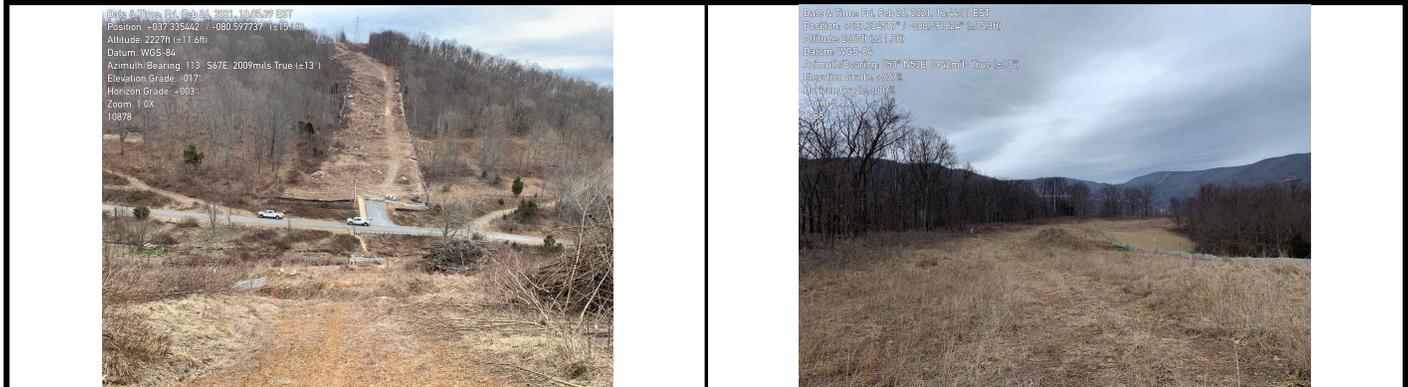
<b>Field Station#</b>	10878+00	<b>Field Station#</b>	108+98
-----------------------	----------	-----------------------	--------

<b>Pic 5 Desc.</b>	ECD's and row conditions	<b>Pic 6 Desc.</b>	ECD's and row conditions
--------------------	--------------------------	--------------------	--------------------------
