Visual Site Inspection Report

Project Name H-600 Pipeline Spread G		AFE 124300137	Spread H-600 Pipeline Spread G
Contractor Precision		Report # 19808	
Inspector Rob Robertson		Date/Time 2/8/2021 11:53 AM	
Permit # TBD	Inspection Type VA SWPP	Station Begin	11600+01
State VA	Inspection Area Full	Station End	11670+00
County Montgomery	Ground Frozen	Temperature (°F)	22.00
Municipality N/A	Weather Sunny	Rain Gauge (in)	0.00
			Rain Accumulation Time (days) 1.00

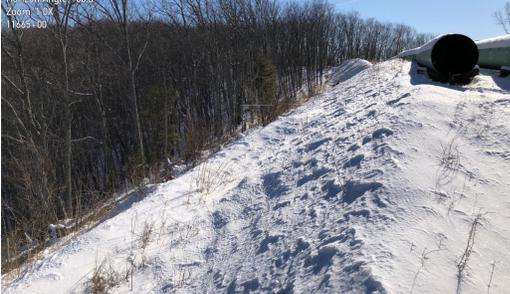
<p>Date & Time: Mon, Feb 08, 2021, 10:14:39 EST Position: -837.32390 / -680.375079 (-16.4ft) Altitude: 2298ft (+13.1ft) Datum: WGS-84 Azimuth/Bearing: 099.538E 1689mils Magnetic (+15.7) Elevation Angle: -09.9 Horizon Angle: -00.3 Zoom: 1.0X 11665+00</p>

GPS Location	On photo	GPS Location	On photo	GPS Location	On photo		
Field Station#	11665+00	Field Station#	11660+00	Field Station#	11650+00		
Pic 1 Desc.	ROW stable at top of Brush Mountain.	Pic 2 Desc.	Perimeter controls are in place.	Pic 3 Desc.	Perimeter ECDs are in place

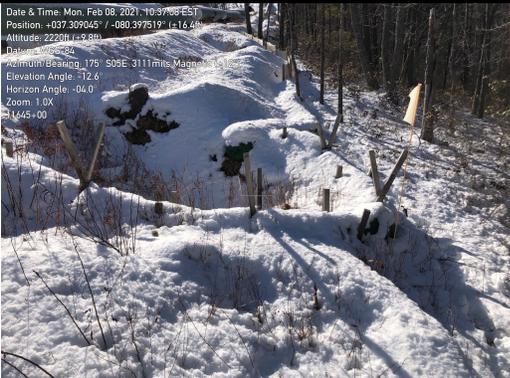
Pic 5 Desc.	End treatments and slope breakers are in place	Pic 6 Desc.	End treatments appear to be in good condition

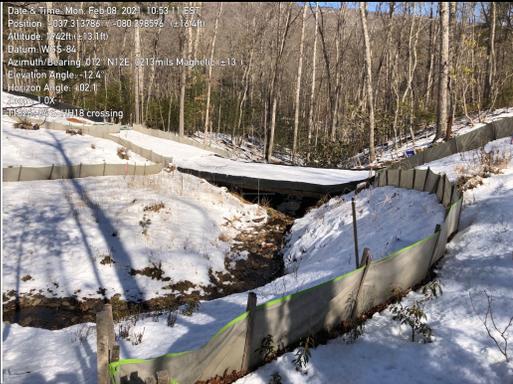
GPS Location	On photo
Field Station#	11626+04
Pic 7 Desc.	The S-HH18 crossing is currently stable

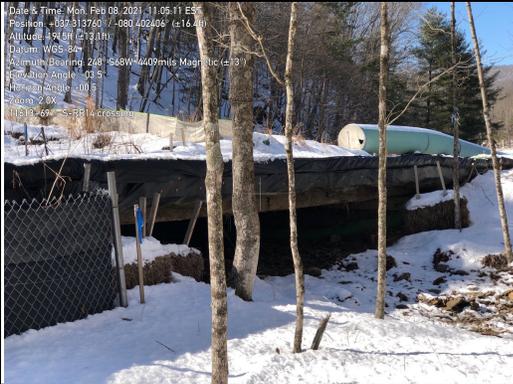
GPS Location	On photo
Field Station#	11614+20
Pic 8 Desc.	The S-RR14 crossing is stable Note; wrong station number on photo

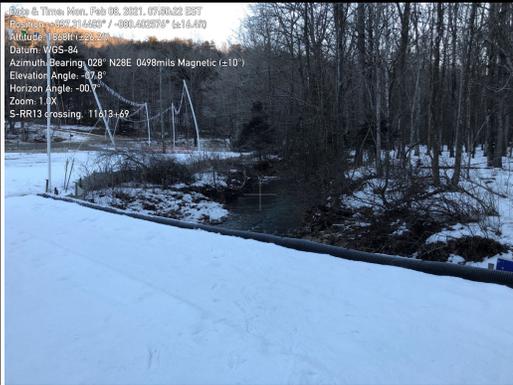
GPS Location	On photo
Field Station#	11613+69
Pic 9 Desc.	The S-RR13 crossing on access road MN-258.04 is stable

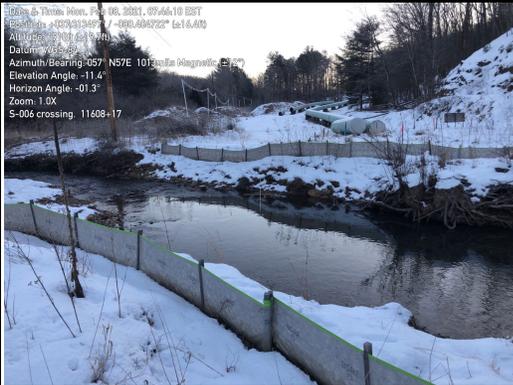
GPS Location	On photo
Field Station#	11608+17
Pic 10 Desc.	The S-006 crossing is currently stable

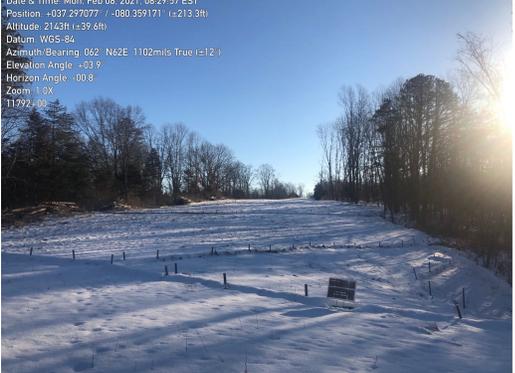
GPS Location	1		GPS Location	2	
Field Station#	11792+00		Field Station#	11818+00	
Pic 1 Desc.	Section of restored RoW showing conditions and controls.		Pic 2 Desc.	Section of restored RoW showing conditions and controls.	
	<p>Date & Time: Mon, Feb 08, 2021, 09:07:02 EST Position: -037.259839 / -080.383167 (+984.0ft) Altitude: 2153ft (+68.9ft) Datum: WGS-84 Azimuth/Bearing: 102. N28E 0696mils True (±12°) Elevation Angle: +08.5° Horizon Angle: -00.6° Zoom: 1.0X P-KL2</p>

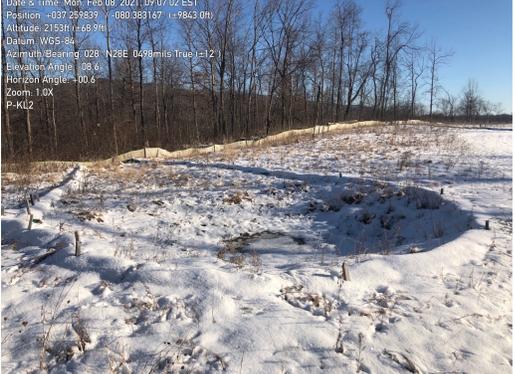
GPS Location	3		GPS Location	4	
Field Station#	11863+65		Field Station#	11874+00	
Pic 3 Desc.	P-KL2 and controls.		Pic 4 Desc.	Section of restored RoW showing conditions and controls.	
	<p>Date & Time: Mon, Feb 08, 2021, 09:18:39 EST Position: -037.252988 / -080.379293 (+660.5ft) Altitude: 2145ft (+103.1ft) Datum: WGS-84 Azimuth/Bearing: 105. S75E 1867mils True (±12°) Elevation Angle: +02.2° Horizon Angle: -01.0° Zoom: 1.0X 11886+00</p>

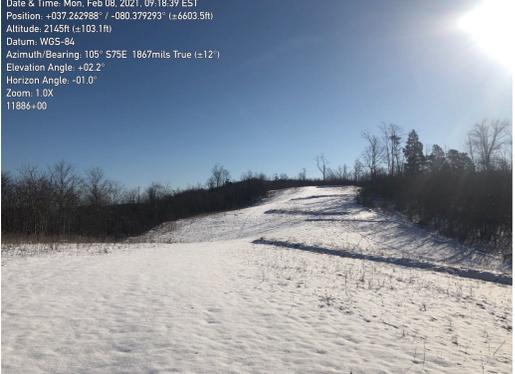
GPS Location	5		GPS Location	6	
Field Station#	11886+00		Field Station#	11899+00	
Pic 5 Desc.	Section of restored RoW showing conditions and controls.		Pic 6 Desc.	Section of restored RoW showing conditions and controls.

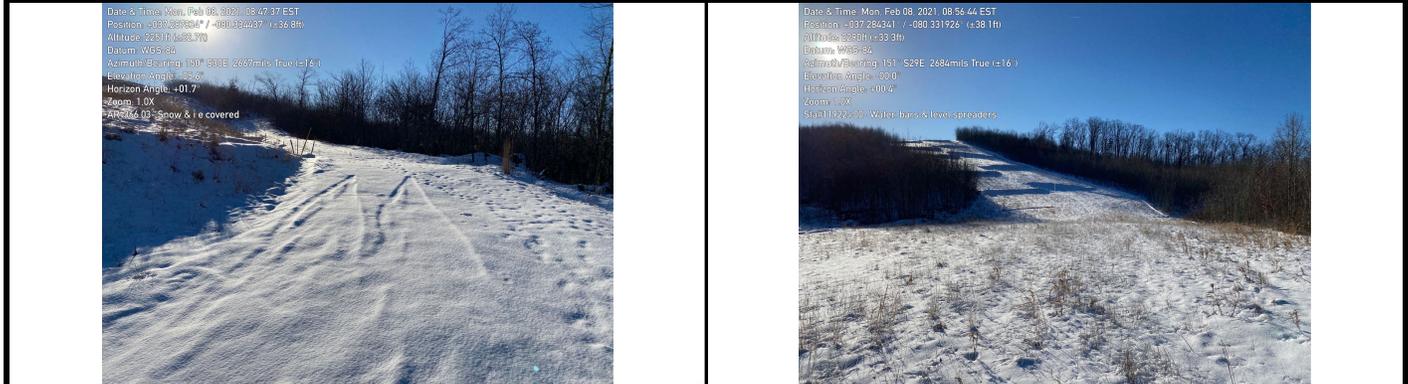
GPS Location	See photo GPS	GPS Location	See photo GPS
Field Station#	11900+00	Field Station#	11922+00
Pic 1 Desc.	AR-266.03 is snow & ice covered and slippery.	Pic 2 Desc.	Row, water bars, level spreaders.

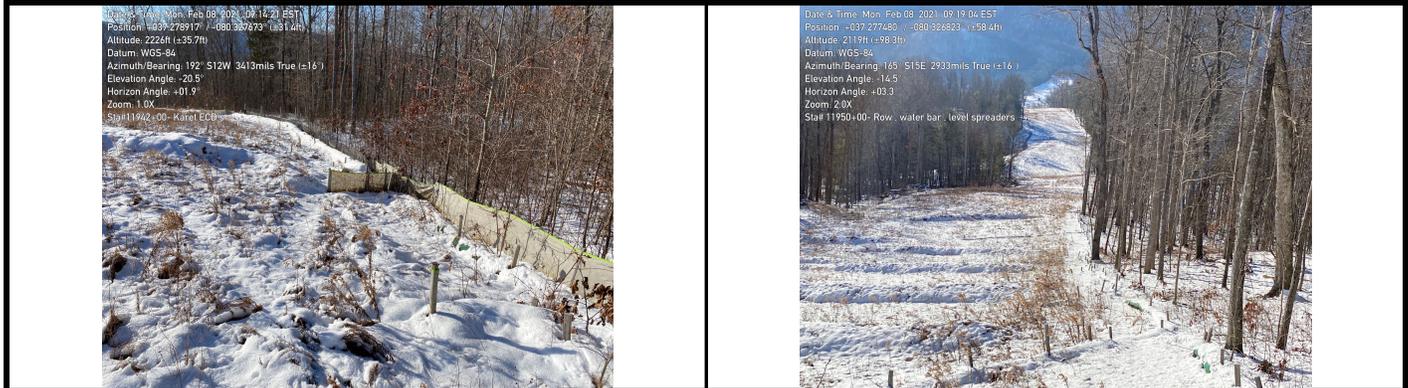
GPS Location	See photo GPS	GPS Location	See photo GPS
Field Station#	11942+00	Field Station#	11950+00
Pic 3 Desc.	Karst ECD's	Pic 4 Desc.	Row and controls

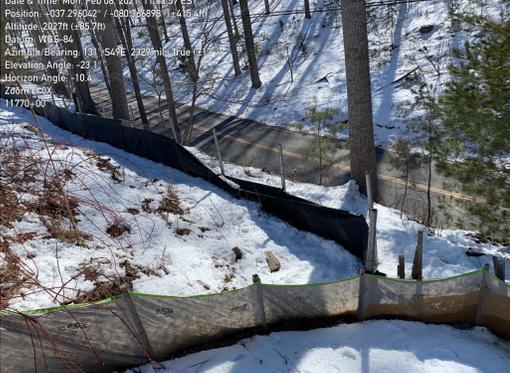
GPS Location	See photo for GPS location.		GPS Location	See photo for GPS location.
Field Station#	11775+00		Field Station#	11770+00
Pic 1 Desc.	Clean water drainage pipe not attached.		Pic 2 Desc.	Silt fence fabric detached from chain link.
<p>Date & Time: Mon, Feb 08, 2021, 11:01:47 EST Position: +037 291522 / -080 374251 (+61.0ft) Altitude: 2019ft (+61.2ft) Datum: WGS-84 Azimuth/Bearing: 225 S43W 3964mils True (+19.1) Elevation Angle: -19.2 Horizon Angle: -01.8 Zoom: 1.0X 11768+00</p>

Conducted VA SWPPP inspection from MP 221 to MP 223.8.
 Since last inspection Precision Pipeline has conducted ECD maintenance and ECD upgrades where needed.
 No forward progress has been completed due to FERC shut down.
 ROW has been stabilized using seed, mulch, and minor vegetation growth.
 Deficiencies located at station numbers;
 11768+00 and 11770+00 - reattach super silt fabric to chain link fencing.
 11775+00 - reattach clean water drainage pipe.

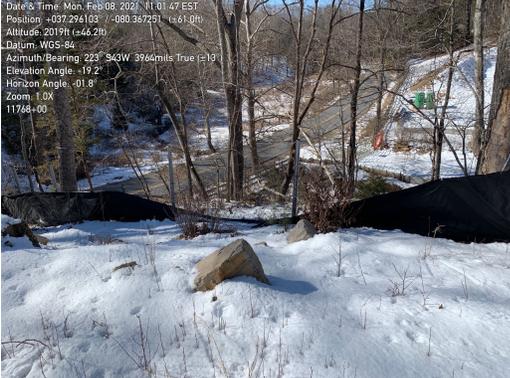
GPS Location	See photo for GPS location.		GPS Location	See photo for GPS location.
Field Station#	11768+00		Field Station#	11761+00
Pic 3 Desc.	Silt fence fabric detached from chain link.		Pic 4 Desc.	Priority one silt fence checks in place.
<p>Date & Time: Mon, Feb 08, 2021, 10:10:28 EST Position: +037 292271 / -080 026993 (+4630.3ft) Altitude: 2457ft (+748.0m) Datum: WGS-84 Azimuth/Bearing: 078 N75E 1333mils True (+13.1) Elevation Angle: -12.4 Horizon Angle: -06.0 Zoom: 1.0X 11704+10 S-MN22</p>

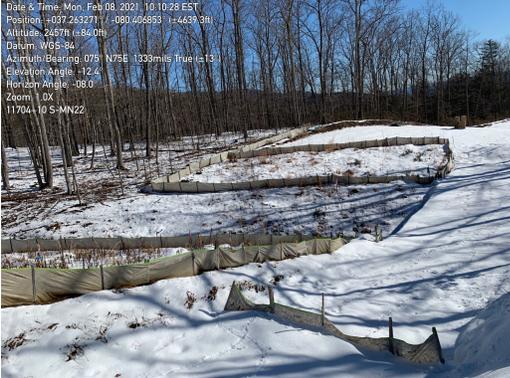
GPS Location	See photo for GPS location.		GPS Location	See photo for GPS location.
Field Station#	11704+10		Field Station#	11670+00
Pic 5 Desc.	Sensitive resource buffer in place at stream S-MN22.		Pic 6 Desc.	ECDs in place along LOD. ROW frozen and snow covered.

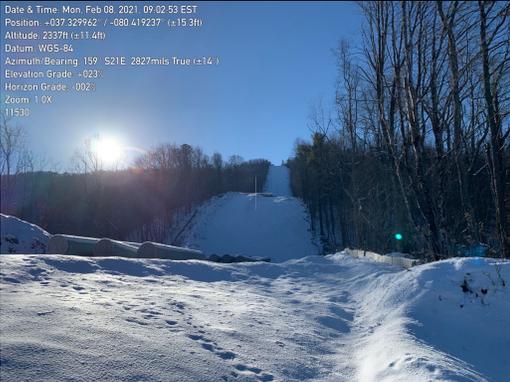
<p>Date & Time: Mon, Feb 08, 2021, 09:02:53 EST Position: +037.329362, -7-080.419237 (+15.3ft) Altitude: 2337ft (+11.4ft) Datum: WGS-84 Azimuth/Bearing: 159 S21E 2827mils True (+14.1) Elevation Grade: +023 Horizon Grade: +002 Zoom: 1.0X 11530</p>		<p>GPS Location See picture above for GPS coordinates</p> <p>Field Station# 11525+00</p> <p>Pic 1 Desc. ECD's and row conditions</p>		<p>GPS Location See picture above for GPS coordinates</p> <p>Field Station# 11530+00</p> <p>Pic 2 Desc. ECD's and row conditions</p>

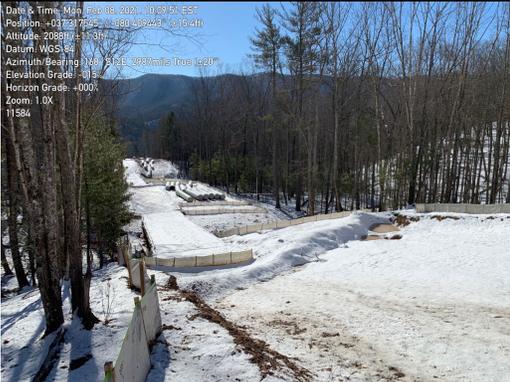
<p>Date & Time: Mon, Feb 08, 2021, 10:29:51 EST Position: +037.337792, -7-080.405442 (+15.4ft) Altitude: 2088ft (+11.3ft) Datum: WGS-84 Azimuth/Bearing: 168 S21E 3890mils True (+20.1) Elevation Grade: +015 Horizon Grade: +000 Zoom: 1.0X 11584</p>		<p>GPS Location See picture above for GPS coordinates</p> <p>Field Station# 11545+00</p> <p>Pic 3 Desc. ECD's and row conditions</p>		<p>GPS Location See picture above for GPS coordinates</p> <p>Field Station# 11584+00</p> <p>Pic 4 Desc. ECD's and row conditions</p>

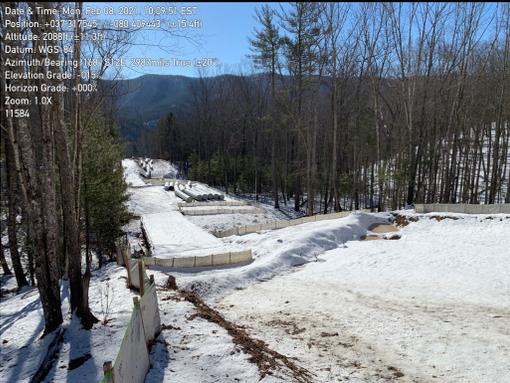
<p>Date & Time: Mon, Feb 08, 2021, 10:29:51 EST Position: +037.337792, -7-080.405442 (+15.4ft) Altitude: 2088ft (+11.3ft) Datum: WGS-84 Azimuth/Bearing: 168 S21E 3890mils True (+20.1) Elevation Grade: +015 Horizon Grade: +000 Zoom: 1.0X 11584</p>		<p>GPS Location See picture above for GPS coordinates</p> <p>Field Station# 11584+00</p> <p>Pic 5 Desc. ECD's and row conditions</p>		<p>GPS Location See picture above for GPS coordinates</p> <p>Field Station# 11584+00</p> <p>Pic 6 Desc. ECD's and row conditions</p>

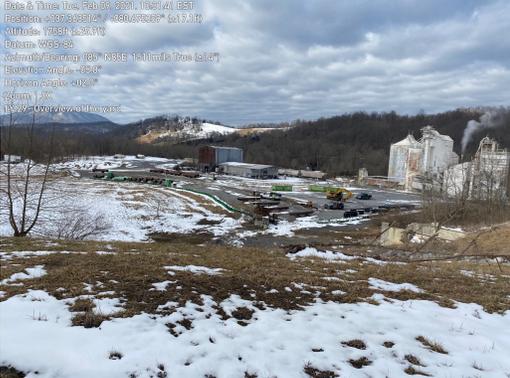
<p>Date & Time: Tue, Feb 09, 2021, 10:32:01 EST Position: +3373443.07 / +869.872109 / +1109.1171 Altitude: 1788ft (+553.7ft) Datum: WGS-84 Azimuth/Bearing: 180° N33E 1011mils True (+20°) Elevation Angle: -13.0° Horizon Angle: 0.0° Zoom: 1.0X LY29- Overview of the yard.</p>

GPS Location	See photo GPS	GPS Location	See photo GPS	GPS Location	See photo GPS		
Field Station#	12005+00	Field Station#	12005+00	Field Station#	12005+00		
Pic 1 Desc.	AR-238.00 access road RCE is snow and ice covered.	Pic 2 Desc.	LY29 overview of the yard.	Pic 3 Desc.	LY29- Roll off containers staged in the yard.

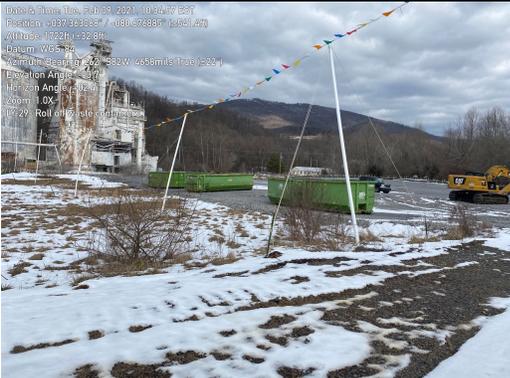
<p>Date & Time: Tue, Feb 09, 2021, 10:34:07 EST Position: +3373443.07 / +869.872109 / +1109.1171 Altitude: 1722ft (+523.8ft) Datum: WGS-84 Azimuth/Bearing: 174° S82W 4455mils True (+20°) Elevation Angle: -17.6° Horizon Angle: -0.6° Zoom: 1.0X LY29- Roll off containers.</p>

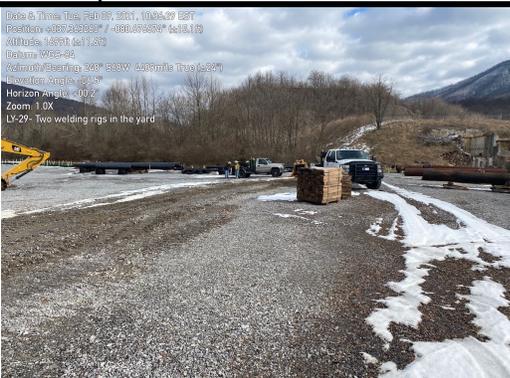
<p>Date & Time: Tue, Feb 09, 2021, 10:34:27 EST Position: +3373443.07 / +869.872109 / +1109.1171 Altitude: 1690ft (+517.9ft) Datum: WGS-84 Azimuth/Bearing: 343° S33W 4455mils True (+20°) Elevation Angle: -13.3° Horizon Angle: -10.2° Zoom: 1.0X LY29- Two welding rigs in the yard.</p>

GPS Location	See photo GPS	GPS Location	See photo GPS	GPS Location	See photo GPS		
Field Station#	12005+00	Field Station#	12005+00	Field Station#	12005+00		
Pic 5 Desc.	LY29- Welders and two welding rigs	Pic 6 Desc.	LY29- CFS triple stack perimeter controls.

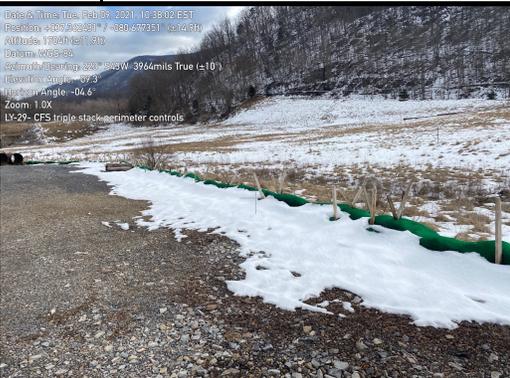
<p>Date & Time: Tue, Feb 09, 2021, 10:38:02 EST Position: +3373443.07 / +869.872109 / +1109.1171 Altitude: 1794ft (+662.3ft) Datum: WGS-84 Azimuth/Bearing: 220° S34W 3964mils True (+10°) Elevation Angle: -07.3° Horizon Angle: -04.6° Zoom: 1.0X LY29- CFS triple stack perimeter controls.</p>

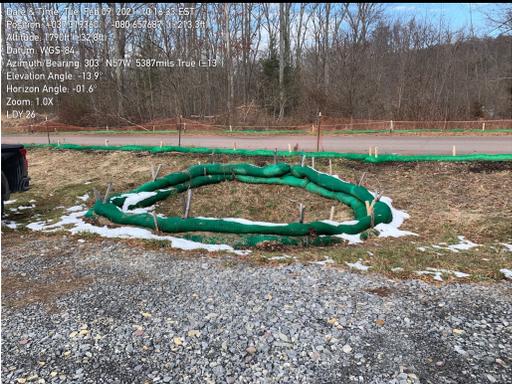
<p><small>Date & Time: Tue, Feb 09, 2021, 10:19:28 EST Position: 43879188587 / 4881658522 / 43879188587 Altitude: 1792ft (546.31m) Datum: WGS 84 Azimuth Bearing: 263° S83W 4462mits True (±10) Elevation Angle: -02.3° Horizon Angle: -01.4° Zoom: 1.0X LDY 26</small></p>		
GPS Location	See photo for GPS location.	GPS Location	See photo for GPS location.	
Field Station#	12005+00	Field Station#	12005+00	
Pic 1 Desc.	Triple stack cfs in place around drainage.	Pic 2 Desc.	Dumpsters being utilized for trash management.

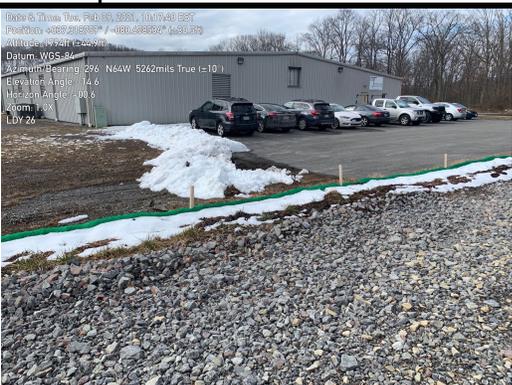
GPS Location	See photo for GPS location.	GPS Location	See photo for GPS location.	
Field Station#	12005+00	Field Station#	12005+00	
Pic 3 Desc.	18 inch compost filter sock in place along LOD.	Pic 4 Desc.	RCE in place at LDY 26 entrance.

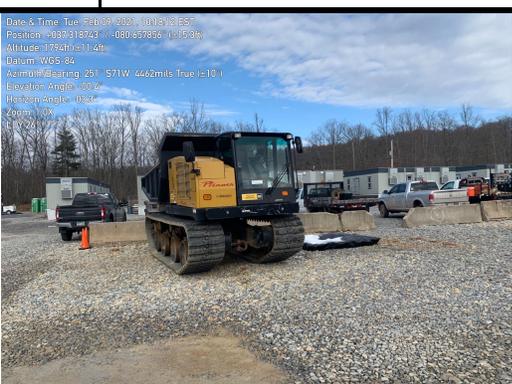
Pic 5 Desc.	Checked staged equipment for leaks.	Pic 6 Desc.	Secondary containment in place under fuel cell.

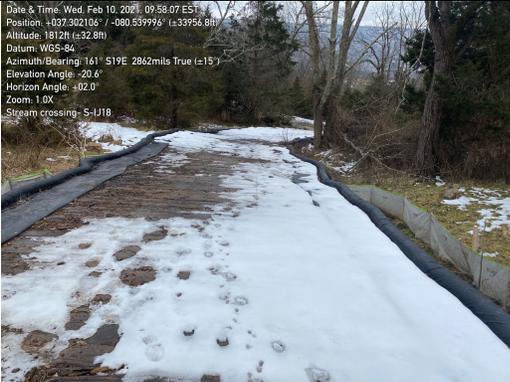
<p>Date & Time: Wed, Feb 10, 2021, 09:58:07 EST Position: +037.302104° / -080.539998° (+33956.8ft) Altitude: 1812ft (+32.8m) Datum: WGS-84 Azimuth/Bearing: 161° S19E 2862mils True (±15°) Elevation Angle: -20.6° Horizon Angle: +02.0° Zoom: 1.0X Staff: 10987+00 - Stream crossing - S-IJ18</p>

GPS Location	See photo GPS	GPS Location	See photo GPS	GPS Location	See photo GPS		
Field Station#	11023+88	Field Station#	11018+00	Field Station#	10989+00		
Pic 1 Desc.	Stream crossing S-IJ18	Pic 2 Desc.	Stream crossing S-RR5	Pic 3 Desc.	Perimeter controls on slope.

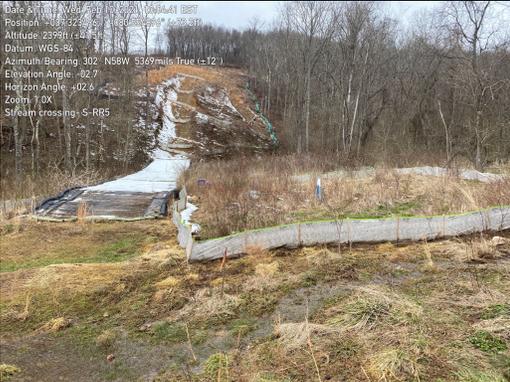
<p>Date & Time: Wed, Feb 10, 2021, 10:06:41 EST Position: +037.325628° / -080.564872° (+3864ft) Altitude: 2346ft (+38.8ft) Datum: WGS-84 Azimuth/Bearing: 302° NSW 5369mils True (±12°) Elevation Angle: -62.7° Horizon Angle: +02.8° Zoom: 1.0X Staff: 10985+00 - Stream crossing - S-RR5</p>

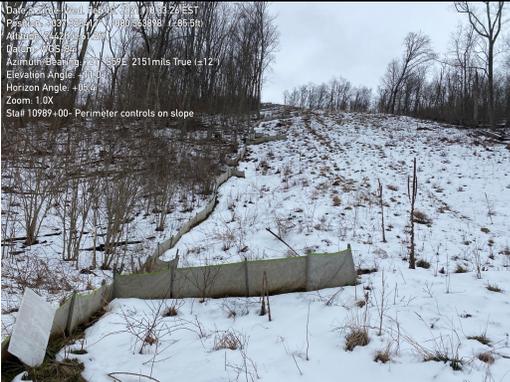
<p>Date & Time: Wed, Feb 10, 2021, 10:36:59 EST Position: +037.325628° / -080.564872° (+3864ft) Altitude: 2346ft (+38.8ft) Datum: WGS-84 Azimuth/Bearing: 096° N84E 1493mils True (±12°) Elevation Angle: -65.7° Horizon Angle: +01.5° Zoom: 1.0X Staff: 10986+00 - Perimeter controls on slope</p>

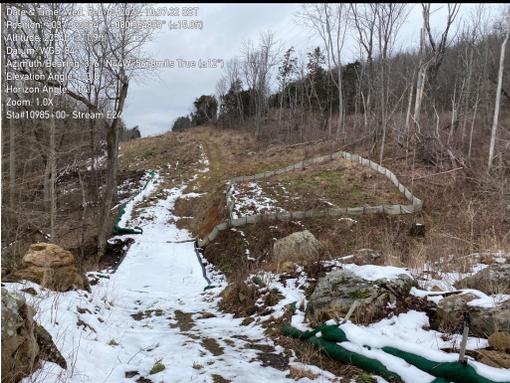
<p>Date & Time: Wed, Feb 10, 2021, 10:34:13 EST Position: +037.325628° / -080.564872° (+3864ft) Altitude: 2346ft (+38.8ft) Datum: WGS-84 Azimuth/Bearing: 309° NSW 5493mils True (±12°) Elevation Angle: -17.4° Horizon Angle: +02.9° Zoom: 1.0X Staff: 10985+00 - Stream E24</p>

Field Station#	10985+00	Field Station#	10964+00	Field Station#	10985+00		
Pic 5 Desc.	Stream S- E24- Bridge and ECD's.	Pic 6 Desc.	Drainage feature bridges bridge and ECD's.

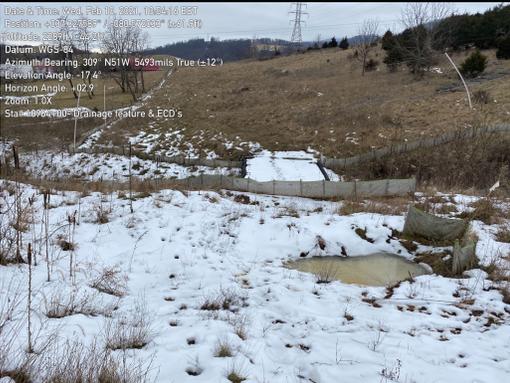
<p>Date & Time: Wed, Feb 10, 2021, 10:34:13 EST Position: +037.325628° / -080.564872° (+3864ft) Altitude: 2346ft (+38.8ft) Datum: WGS-84 Azimuth/Bearing: 309° NSW 5493mils True (±12°) Elevation Angle: -17.4° Horizon Angle: +02.9° Zoom: 1.0X Staff: 10985+00 - Drainage feature & ECD's</p>					
GPS Location	See photo GPS	GPS Location	See photo GPS	GPS Location	See photo GPS

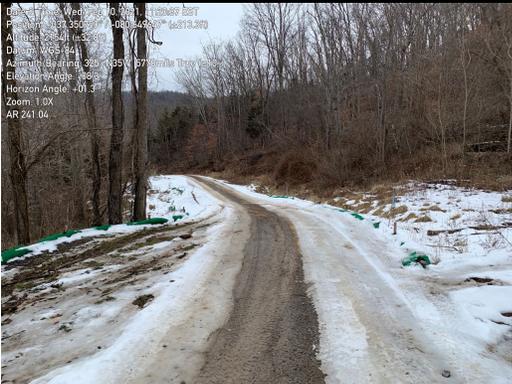
<p><small>Date & Time: Wed, Feb 10, 2021, 11:45:40 EST Position: +037.337120° / -080.623802° (±6999.5ft) Altitude: 2307ft (±141.1ft) Datum: WGS-84 Azimuth (Bearing): 115.565E 204mils True (±17°) Elevation Angle: -10.8° Horizon Angle: -01.3° Zoom: 1.0x 10712+50</small></p>		
GPS Location	See photo for GPS location.	GPS Location	See photo for GPS location.	
Field Station#	10711+00	Field Station#	10712+50	
Pic 1 Desc.	CFS in place along Access Road 241.04.	Pic 2 Desc.	Sensitive resource buffer in place at stream S-G33.

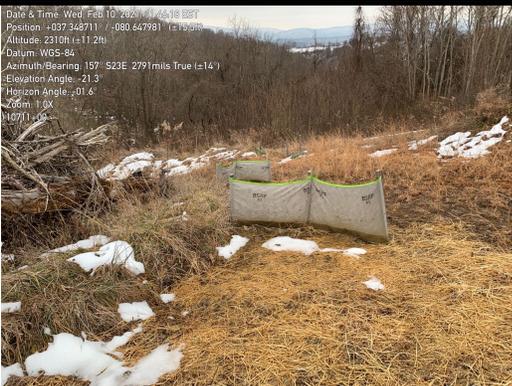
GPS Location	See photo for GPS location.	GPS Location	See photo for GPS location.	
Field Station#	10711+00	Field Station#	10710+00	
Pic 3 Desc.	Priority one silt fence checks in place.	Pic 4 Desc.	ROW stabilized with natural vegetation growth.

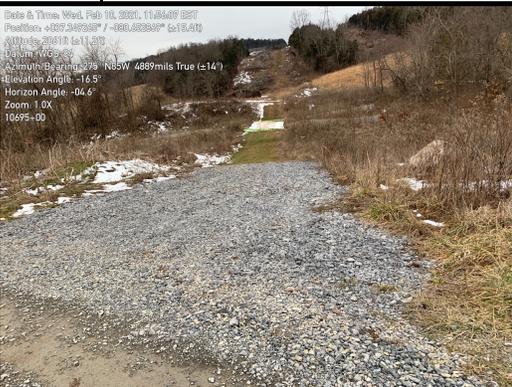
Pic 5 Desc.	Stabilized disturbed area with seed and mulch.	Pic 6 Desc.	RCE in place at Buffalo Anklets Road.

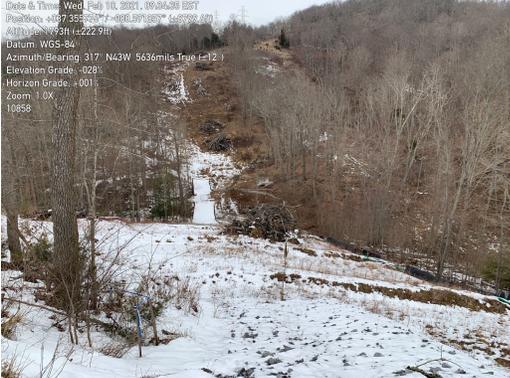
GPS Location	See picture above for GPS coordinates	GPS Location	See picture above for GPS coordinates	
Field Station#	10858+00	Field Station#	10864+00	
Pic 1 Desc.	ECD's and row conditions	Pic 2 Desc.	ECD's and row conditions

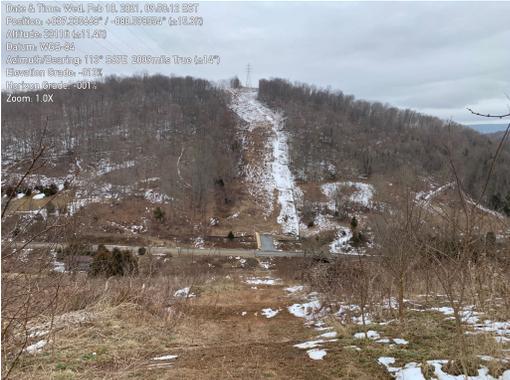
GPS Location	See picture above for GPS coordinates	GPS Location	See picture above for GPS coordinates	
Field Station#	10873+00	Field Station#	10888+00	
Pic 3 Desc.	ECD's and row conditions	Pic 4 Desc.	ECD's and row conditions

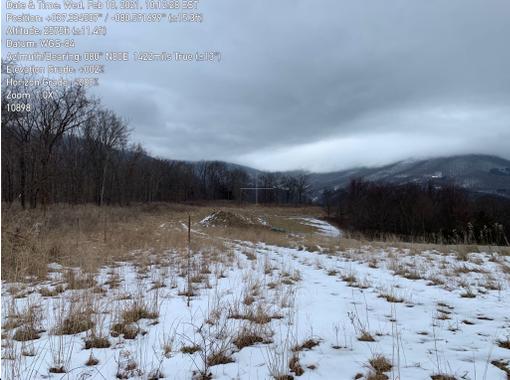
GPS Location	See picture above for GPS coordinates	GPS Location	See picture above for GPS coordinates	
Field Station#	10898+00	Field Station#	10923+00	
Pic 5 Desc.	ECD's and row conditions	Pic 6 Desc.	ECD's and row conditions

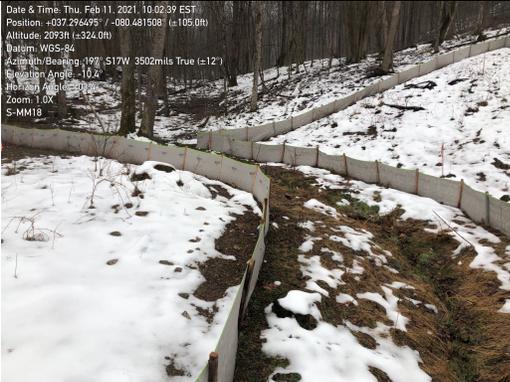
<p>GPS Location 1</p> <p>GPS Location 2</p>	
<p>Field Station# 11292+80</p>		<p>Field Station# 11329+00</p>		<p>Pic 1 Desc. S-MM18 and controls.</p> <p>Pic 2 Desc. Rilling causing water bar throat to gather sediment.</p>

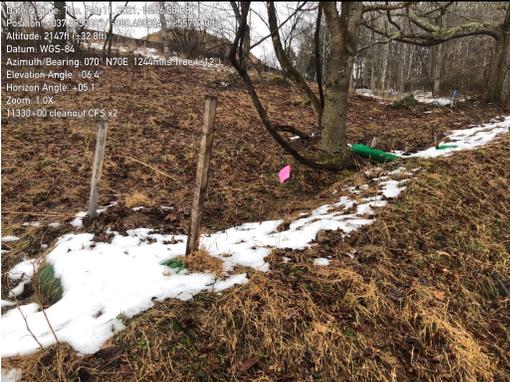
<p>GPS Location 3</p> <p>GPS Location 4</p>	
<p>Field Station# 11330+00</p>		<p>Field Station# 11333+00</p>		<p>Pic 3 Desc. CFS checks require cleaning.</p> <p>Pic 4 Desc. Rilling in waterbar throat and CFS checks require cleaning out/maintenance.</p>

E&S BMPs	Compliance Level	Corrective Action	Corrective Time Frame	Date Repaired
Cleanwater Diversion Berm	Acceptable			
Cleanwater Diversion Pipe	Acceptable			
Compost Filter Sock	Communication	Clean out checks	24 Hours	
Waterbar	Communication	Repair rills in throat	24 Hours	
Rock-lined Channel	Acceptable			
Sensitive Resource Buffer	Acceptable			
Silt Fence (Filter Fabric Fence)	Acceptable			
Silt Fence (Reinforce Filter Fence)	Acceptable			
Vegetative Stabilization (Temporary)	Communication	Stabilize repaired rills	24 Hours

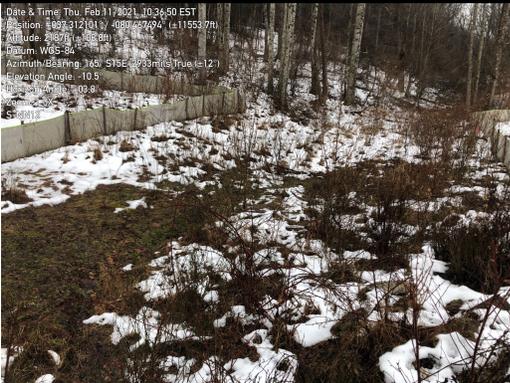
<p>GPS Location 5</p> <p>GPS Location 6</p>	
<p>Field Station# 11327+85</p>		<p>Field Station# 11352+97</p>		<p>Pic 5 Desc. S-NN12 and controls.</p> <p>Pic 6 Desc. S-NN11.</p>

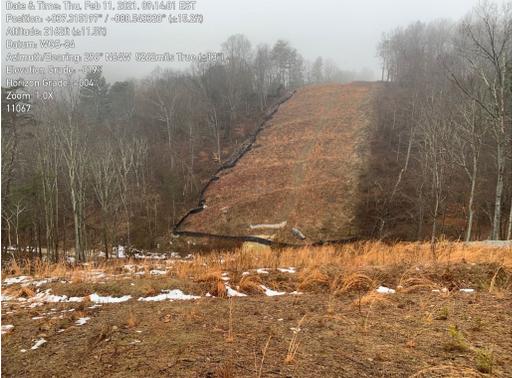
GPS Location	See pictures above for GPS coordinates		GPS Location	See pictures above for GPS coordinates
Field Station#	11067+00		Field Station#	11089+00
Pic 1 Desc.	ECD's and row conditions		Pic 2 Desc.	ECD's and row conditions

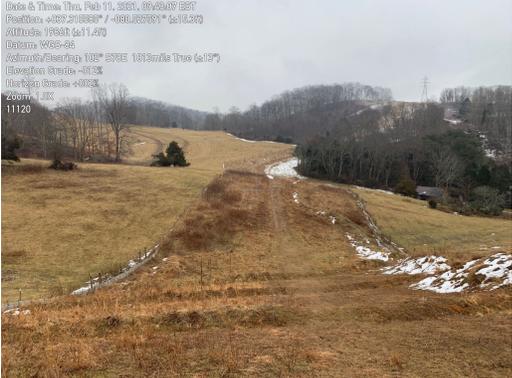
GPS Location	See pictures above for GPS coordinates		GPS Location	See pictures above for GPS coordinates
Field Station#	11120+00		Field Station#	11140+00
Pic 3 Desc.	ECD's and row conditions		Pic 4 Desc.	ECD's and row conditions

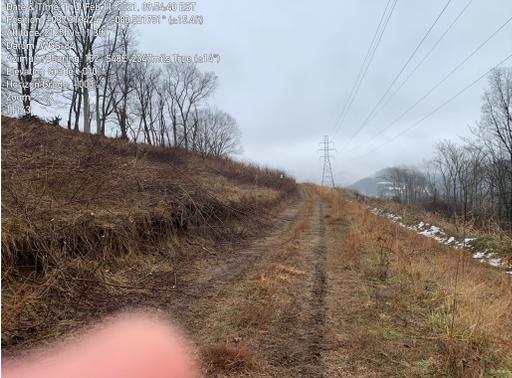
GPS Location	See pictures above for GPS coordinates		GPS Location	See pictures above for GPS coordinates
Field Station#	11143+00		Field Station#	11147+00
Pic 5 Desc.	Crews cutting the ROW		Pic 6 Desc.	ECD's and row conditions

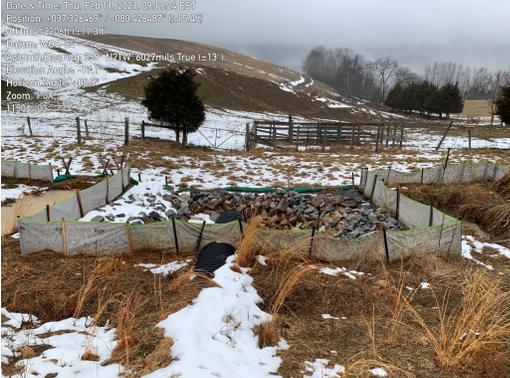
GPS Location See photo for GPS location.		GPS Location See photo for GPS location.		GPS Location See photo for GPS location.			
Field Station# 11506+00		Field Station# 11506+00		Field Station# 11488+00			
Pic 1 Desc. Clean water diversion pipe and plunge pool in place.		Pic 2 Desc. Clean water diversion pipe and clean water diversion berm in place.		Pic 3 Desc. RCE in place at Stevers Gap Road.

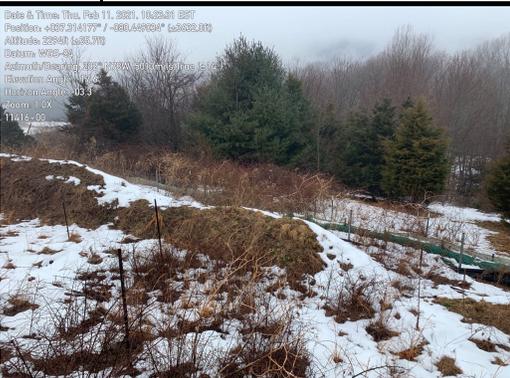
<p><small>Date & Time: Thu, Feb 11, 2021, 10:24:11 EST Position: +39.21477° / -88.48934° (+13.47) Altitude: 2394ft (+11.23) Datum: WGS-84 Azimuth/Bearing: 200° 00'W 400mils True (+13) Elevation Angle: -0.5 Horizon Angle: -0.5 Zoom: 1.0x 11416+00</small></p>

Conducted VA SWPPP inspection from MP 215 to MP 218.3.
 Since last inspection Precision Pipeline has conducted ECD maintenance and ECD upgrades where needed.
 No forward progress has been completed due to FERC shut down.
 Right of way has been stabilized using seed, mulch, and natural vegetation.
 Deficiency located at station number 11416+00 - Super silt fence fabric detached from chain link.

E&S BMPs	Compliance Level	Corrective Action	Corrective Time Frame	Date Repaired
Broad-Based Dip	Acceptable			
Cleanwater Diversion Berm	Acceptable			
Cleanwater Diversion Pipe	Acceptable			
Compost Filter Sock	Acceptable			
Equipment Bridge	Acceptable			
Housekeeping	Acceptable			
Plunge Pool	Acceptable			
Rock Construction Entrance	Acceptable			
Silt Fence (Reinforced Filter Fabric Fence)	Communication	Reattach SSF fabric to chain link	48 Hours

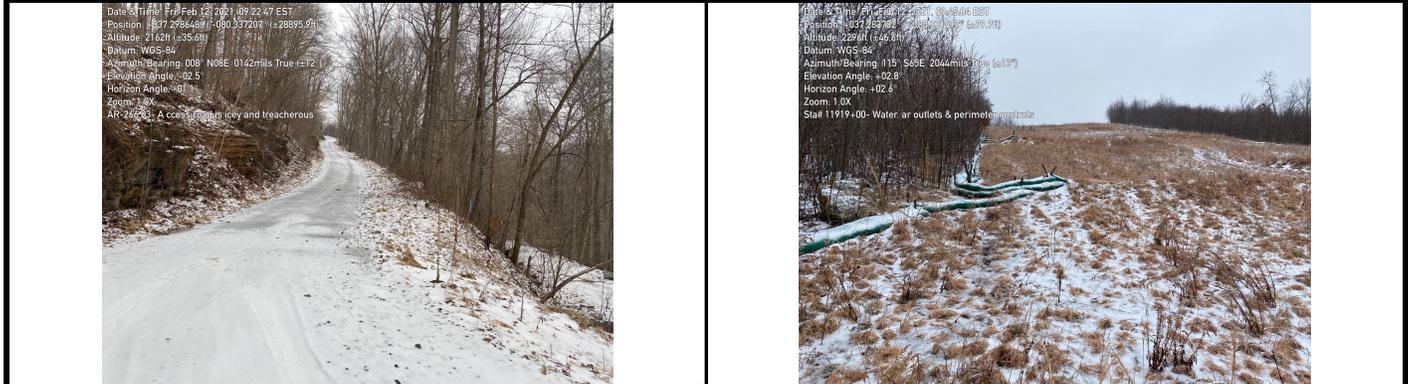
GPS Location	See photo GPS	GPS Location	See photo GPS
Field Station#	11900+00	Field Station#	11919+00
Pic 1 Desc.	AR-266.03 is ice covered and slippery.	Pic 2 Desc.	Water bar outlet's and perimeter controls.

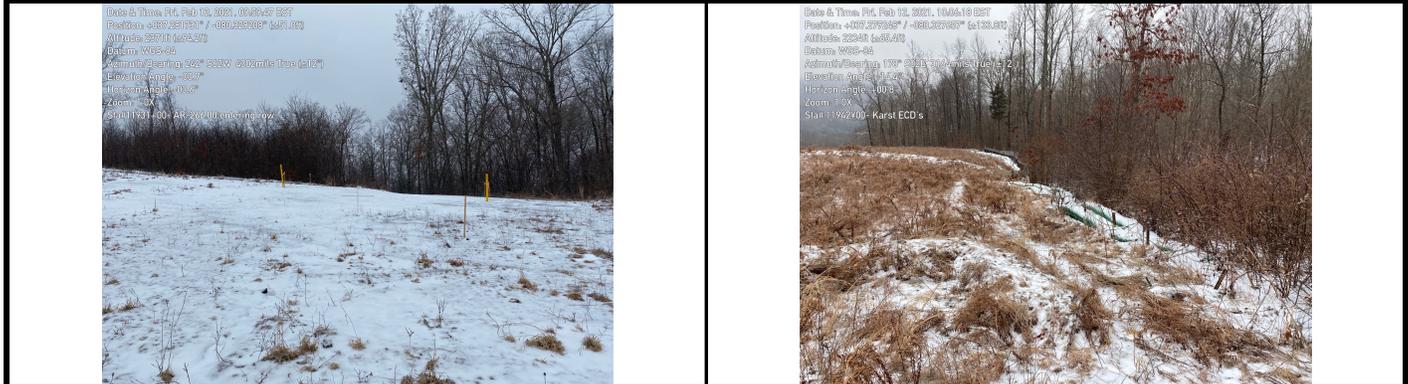
GPS Location	See photo GPS	GPS Location	See photo GPS
Field Station#	11931+00	Field Station#	11942+00
Pic 3 Desc.	AR-266.00 enters row.	Pic 4 Desc.	Karst ECD's.

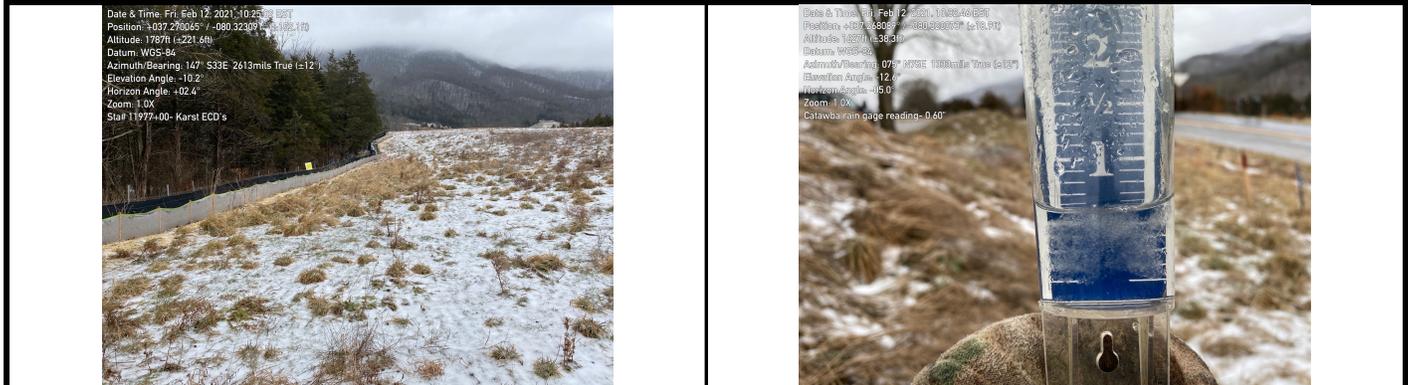
GPS Location	See photo GPS	GPS Location	See photo GPS
Field Station#	11977+00	Field Station#	11989+00
Pic 5 Desc.	Karst ECD's & signage.	Pic 6 Desc.	Catawba rain gauge reading-0.60"

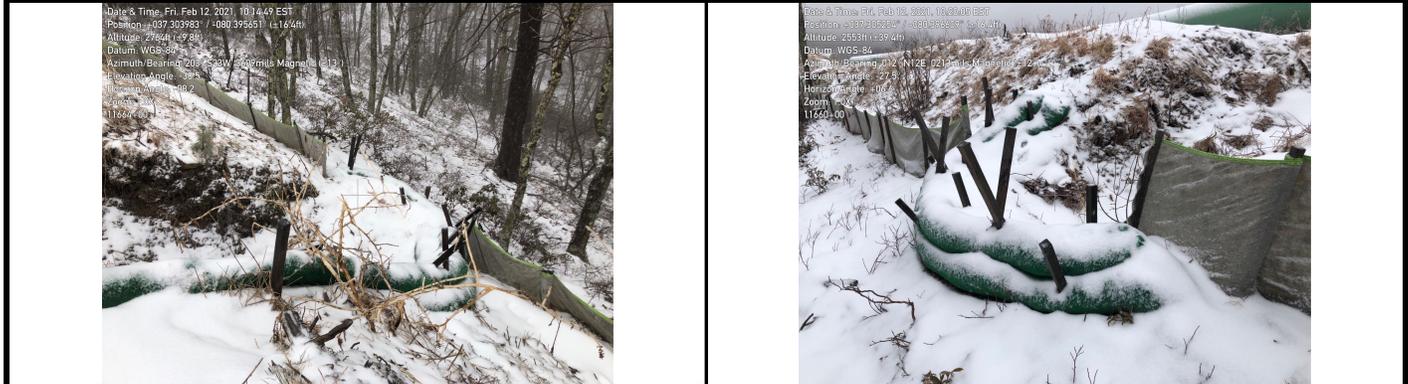
GPS Location	On photo	GPS Location	On photo
Field Station#	11664+00	Field Station#	11660+00
Pic 1 Desc.	Perimeter controls are in place and functional.	Pic 2 Desc.	Perimeter controls are in place and functioning.

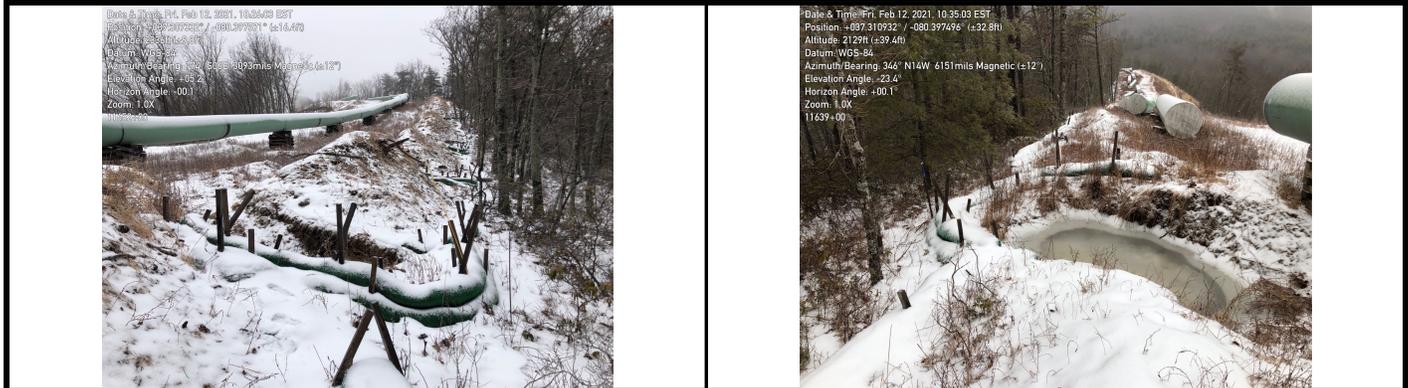
GPS Location	On photo	GPS Location	On photo
Field Station#	11652+00	Field Station#	11639+00
Pic 3 Desc.	Perimeter controls are in place and functional.	Pic 4 Desc.	Perimeter controls are in place and functional.

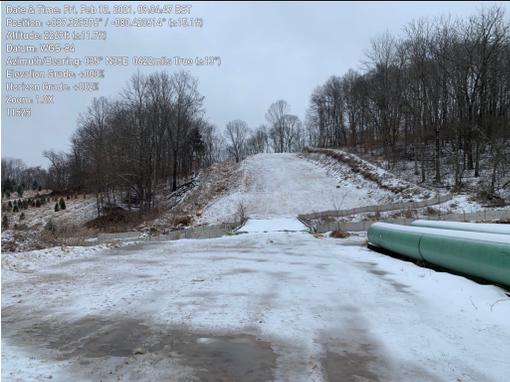
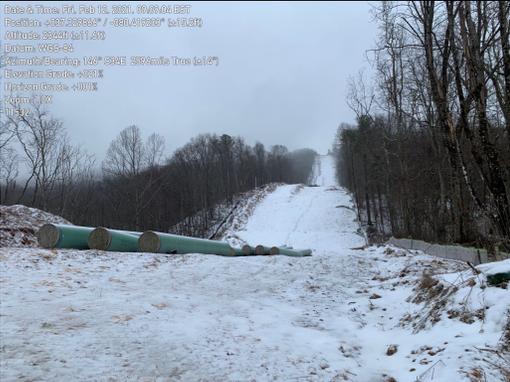
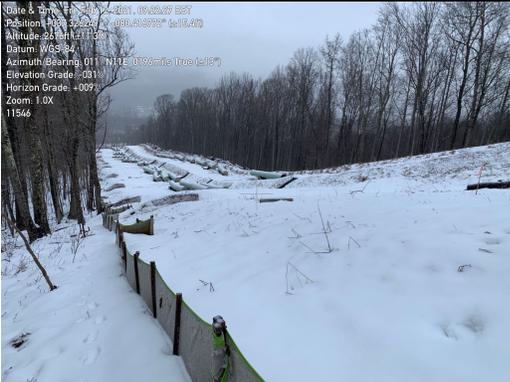
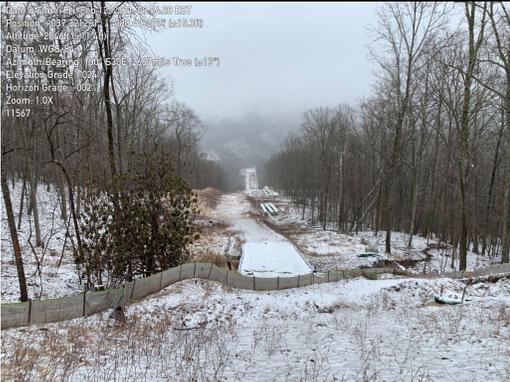
GPS Location		See picture above for GPS coordinates		GPS Location		See picture above for GPS coordinates	
Field Station#		11525+00		Field Station#		11532+00	
Pic 1 Desc.		ECD's and row conditions		Pic 2 Desc.		ECD's and row conditions	
GPS Location		See picture above for GPS coordinates		GPS Location		See picture above for GPS coordinates	
Field Station#		11546+00		Field Station#		11567+00	
Pic 3 Desc.		ECD's and row conditions		Pic 4 Desc.		ECD's and row conditions

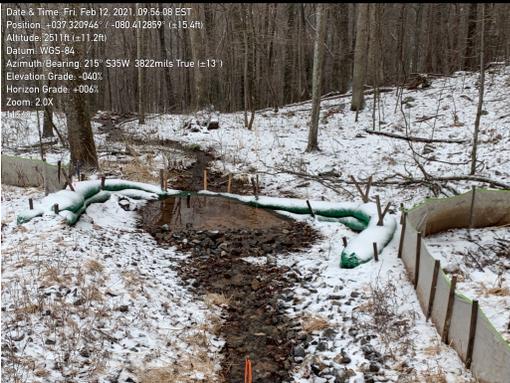
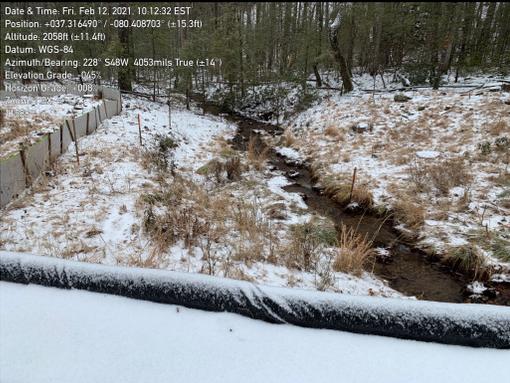
GPS Location		See picture above for GPS coordinates		GPS Location		See picture above for GPS coordinates	
Field Station#		11568+00		Field Station#		11588+00	
Pic 5 Desc.		ECD's and row conditions		Pic 6 Desc.		ECD's and row conditions

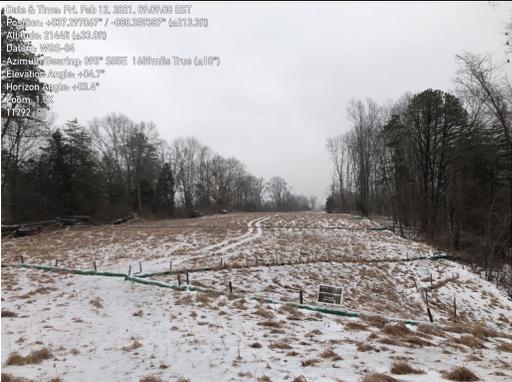
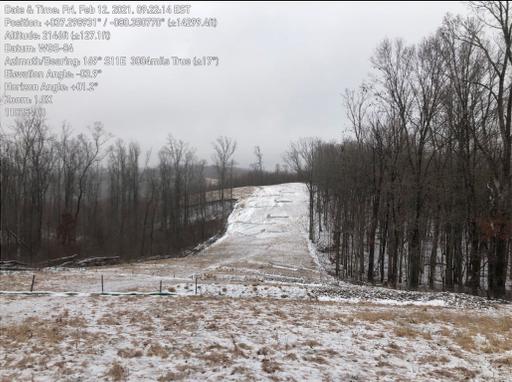
GPS Location 1		GPS Location 2			
Field Station# 11792+00		Field Station# 11825+00			
Pic 1 Desc. Section of restored RoW showing conditions and controls.		Pic 2 Desc. Section of restored RoW showing conditions and controls.

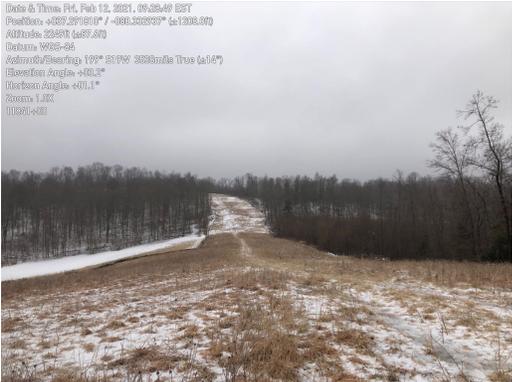
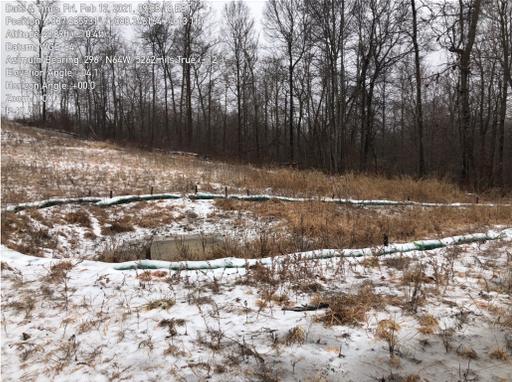
GPS Location 3		GPS Location 4			
Field Station# 11841+00		Field Station# 11863+65			
Pic 3 Desc. Section of restored RoW showing conditions and controls.		Pic 4 Desc. P-KL2 and controls.
