# Visual Site Inspection Report

<b>Project Name</b> H-600 Pipeline Spread G		<b>AFE</b> 124300137	<b>Spread</b> H-600 Pipeline Spread G
<b>Contractor</b> Precision		<b>Report #</b> 20845	
<b>Inspector</b> Chris Burns		<b>Date/Time</b> 3/8/2021 12:39 PM	
<b>Permit #</b> TBD	<b>Inspection Type</b> VA SWPP	<b>Station Begin</b>	11788+52
<b>State</b> VA	<b>Inspection Area</b> Partial	<b>Station End</b>	11899+99
<b>County</b> Montgomery	<b>Ground</b> Dry	<b>Temperature (°F)</b>	55.00
<b>Municipality</b> N/A	<b>Weather</b> Sunny	<b>Rain Gauge (in)</b>	0.00
			<b>Rain Accumulation Time (days)</b> 1.00

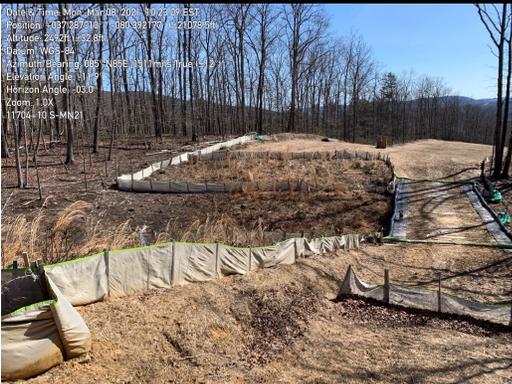
<p data-bbox="889 779 1104 905">Date &amp; Time: Mon, Mar 08, 2021, 12:16:05 EST Position: +037.25242, -080.37922, 2519 ft Altitude: 2388 ft (728 m) Datum: WGS 84 Azimuth Bearing: 099.938E, 103.9 mls True (±13°) Elevation Angle: -11.4 Horizon Angle: -02.3 Zoom: 1.0X 11761+00</p>			
<b>GPS Location</b>	See photo for GPS location.		<b>GPS Location</b>	See photo for GPS location.	
<b>Field Station#</b>	11704+10		<b>Field Station#</b>	11761+00	
<b>Pic 3 Desc.</b>	Sensitive resource buffer in place at stream S-MN22.		<b>Pic 4 Desc.</b>	Priority one silt fence checks in place.

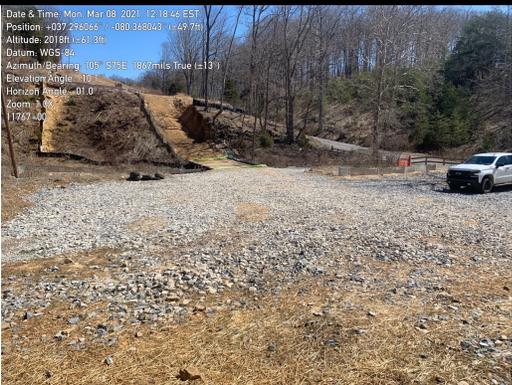
<b>GPS Location</b>	See photo for GPS location.		<b>GPS Location</b>	See photo for GPS location.	
<b>Field Station#</b>	11767+00		<b>Field Station#</b>	11778+00	
<b>Pic 5 Desc.</b>	RCE in place at MLV 26.		<b>Pic 6 Desc.</b>	Clean water diversion pipe inlet and clean water diversion berm in place.

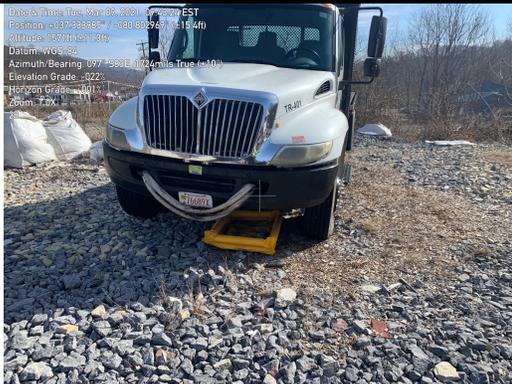
<b>GPS Location</b>	See picture above for GPS coordinates	<b>GPS Location</b>	See picture above for GPS coordinates	
<b>Field Station#</b>	12005+00	<b>Field Station#</b>	12005+00	
<b>Pic 3 Desc.</b>	ECD's and row conditions	<b>Pic 4 Desc.</b>	Secondary containment

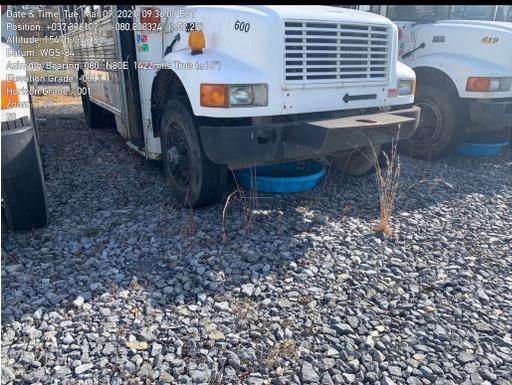
<b>GPS Location</b>	See picture above for GPS coordinates	<b>GPS Location</b>	See picture above for GPS coordinates	
<b>Field Station#</b>	12005+00	<b>Field Station#</b>	12005+00	
<b>Pic 5 Desc.</b>	Secondary containment	<b>Pic 6 Desc.</b>	ECD's and row conditions

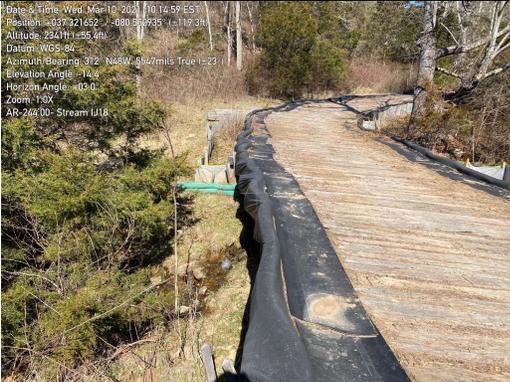
<b>GPS Location</b>	See photo GPS	<b>GPS Location</b>	See photo GPS	<b>GPS Location</b>	See photo GPS		
<b>Field Station#</b>	11023+88	<b>Field Station#</b>	11018+00	<b>Field Station#</b>	10989+00		
<b>Pic 1 Desc.</b>	Stream S- IJ18	<b>Pic 2 Desc.</b>	Row, controls, stream S-RR5	<b>Pic 3 Desc.</b>	Perimeter controls

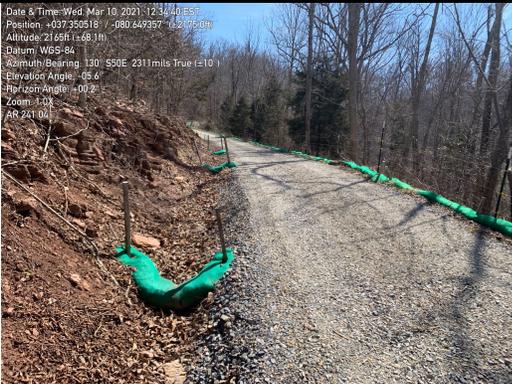
<b>GPS Location</b>	See photo for GPS location.		<b>GPS Location</b>	See photo for GPS location.	
<b>Field Station#</b>	10710+00		<b>Field Station#</b>	10712+50	
<b>Pic 1 Desc.</b>	Compost filter sock in place along access road 241.04.		<b>Pic 2 Desc.</b>	Sensitive resource buffer in place at stream S-G33.

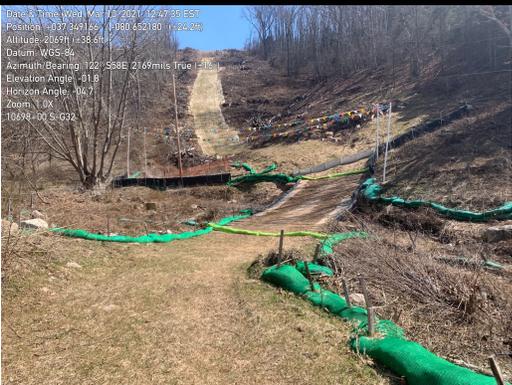
<b>GPS Location</b>	See photo for GPS location.		<b>GPS Location</b>	See photo for GPS location.	
<b>Field Station#</b>	10711+00		<b>Field Station#</b>	10711+00	
<b>Pic 3 Desc.</b>	ROW stabilized with seed and mulch.		<b>Pic 4 Desc.</b>	Priority one silt fence checks in place.	
<p>Date &amp; Time: Wed Mar 10 2021 12:47:30 EST  Position: +037.340150 / -080.652100 (-15.319101)  Altitude: 2055ft (+62.6m)  Datum: WGS-84  Azimuth/Bearing: 122 S58E 2169mils True (+10)  Elevation Angle: -01.8  Horizon Angle: -06.7  Zoom: 1.00  10698.00 S-G32</p>

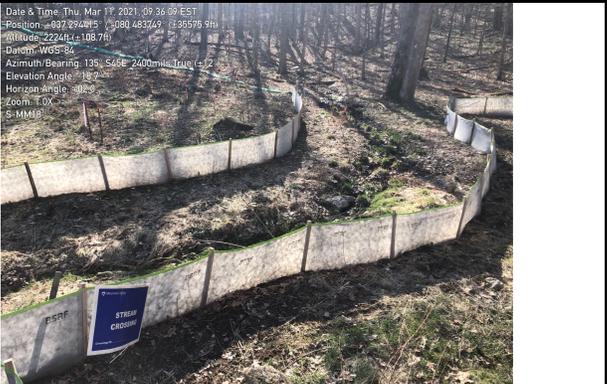
<b>GPS Location</b> 1	<b>GPS Location</b> 2				
<b>Field Station#</b> 11265+00	<b>Field Station#</b> 11292+80	<b>Pic 1 Desc.</b> Perimeter controls functional.	<b>Pic 2 Desc.</b> S-MM18 and controls.

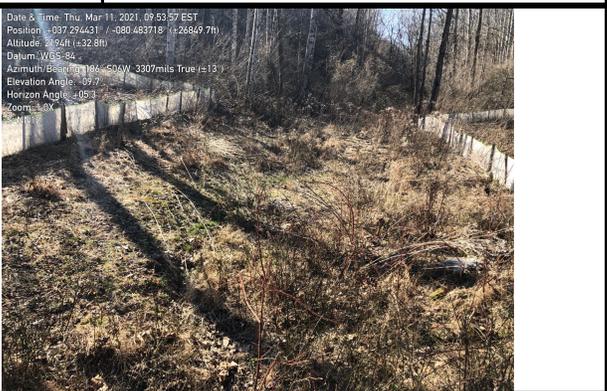
<b>Field Station#</b> 11300+00	<b>Field Station#</b> 11327+85	<b>Pic 3 Desc.</b> Section of RoW showing conditions and controls.	<b>Pic 4 Desc.</b> S-NN12 and controls.

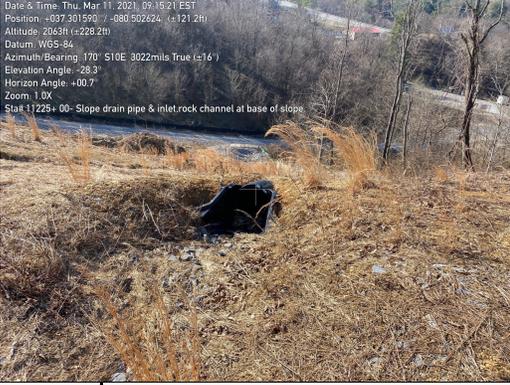
<p><small>Date &amp; Time: Thu, Mar 11, 2021, 09:15:21 EST Position: +037.301598 / -080.502624 (+121.2ft) Altitude: 2063ft (+223.2ft) Datum: WGS-84 Azimuth/Bearing: 170° S10E 3022mils True (+16°) Elevation Angle: -28.3° Horizon Angle: +00.7° Zoom: 1.0X Sta# 11225+00- Slope drain pipe &amp; inlet rock channel at base of slope.</small></p>

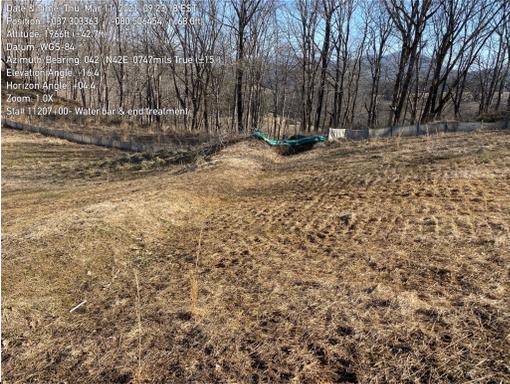
<p><small>Date &amp; Time: Thu, Mar 11, 2021, 09:23:05 EST Position: +037.303363 / -080.503024 (+98.0ft) Altitude: 1965ft (+152.7ft) Datum: WGS-84 Azimuth/Bearing: 042° N42E 0741mils True (+15°) Elevation Angle: -14.4° Horizon Angle: +00.4° Zoom: 1.0X Sta# 11207+00- Water bar &amp; end treatment.</small></p>

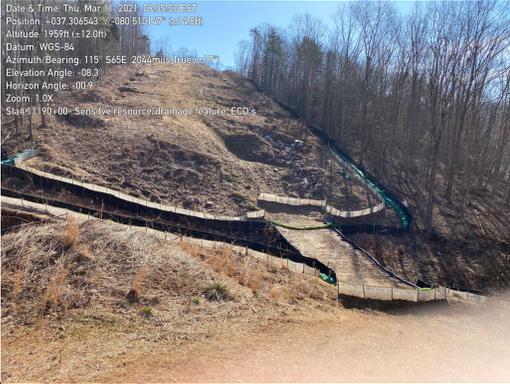
<p><small>Date &amp; Time: Thu, Mar 11, 2021, 09:35:05 EST Position: +037.306543 / -080.510125 (+210.8ft) Altitude: 1956ft (+12.0ft) Datum: WGS-84 Azimuth/Bearing: 115° S45E 2044mils True (+17°) Elevation Angle: -08.3° Horizon Angle: -00.9° Zoom: 1.0X Sta# 11190+00- Sensitive resource drainage feature ECD's.</small></p>

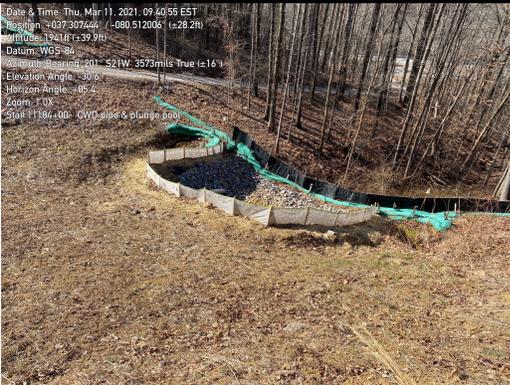
<p><small>Date &amp; Time: Thu, Mar 11, 2021, 09:40:55 EST Position: +037.307441 / -080.512005 (+28.2ft) Altitude: 1941ft (+39.9ft) Datum: WGS-84 Azimuth/Bearing: 201° S21W 3573mils True (+16°) Elevation Angle: -30.6° Horizon Angle: -05.4° Zoom: 1.0X Sta# 11184+00- CWD pipe &amp; plunge pool.</small></p>

<b>GPS Location</b>	See photo GPS	<b>GPS Location</b>	See photo GPS	<b>GPS Location</b>	See photo GPS		
<b>Field Station#</b>	11184+00	<b>Field Station#</b>	11177+00	<b>Field Station#</b>	11177+00		
<b>Pic 5 Desc.</b>	CWD pipe and plunge pool.	<b>Pic 6 Desc.</b>	The row is dry and in stable condition.

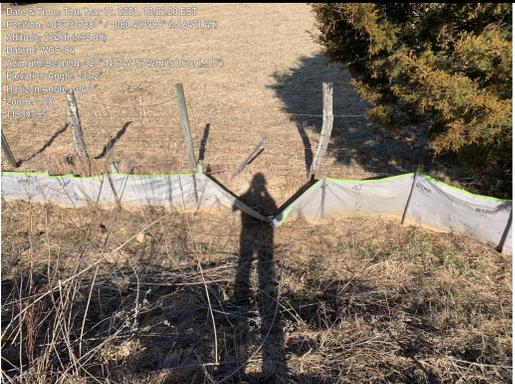
<p><small>Date &amp; Time: Thu, Mar 11, 2021, 10:02:20 EST Position: +037.3242327 / +080.4265337 (+15.31) Altitude: 2204ft (+671.0m) Datum: WGS-84 Azimuth/Bearing: 332 N28W 5902mils True (+18°) Elevation Angle: +13.7° Horizon Angle: +00.7° Zoom: 1.0X 11509+00</small></p>

Conducted VA SWPPP inspection from MP 215 to MP 218.3.  
 Since last inspection Precision Pipeline has conducted ECD maintenance and ECD upgrades where needed.  
 No forward progress has been completed due to FERC shut down.  
 Right of way has been stabilized using seed, mulch, and natural vegetation.  
 Deficiency located at station number 11509+55 - Broken priority one silt fence stake.

<p><small>Date &amp; Time: Thu, Mar 11, 2021, 10:05:14 EST Position: +037.3242327 / +080.4265337 (+15.31) Altitude: 2204ft (+671.0m) Datum: WGS-84 Azimuth/Bearing: 332 N28W 5902mils True (+18°) Elevation Angle: +18.4° Horizon Angle: +00.7° Zoom: 1.0X 11509+00</small></p>			
<b>GPS Location</b>	See photo for GPS location.		<b>GPS Location</b>	See photo for GPS location.	
<b>Field Station#</b>	11509+55		<b>Field Station#</b>	11506+00	
<b>Pic 1 Desc.</b>	Broke priority one silt fence stake.		<b>Pic 2 Desc.</b>	Clean water diversion pipe and plunge pool in place.

E&S BMPs	Compliance Level	Corrective Action	Corrective Time Frame	Date Repaired
Broad-Based Dip	Acceptable			
Cleanwater Diversion Berm	Acceptable			
Cleanwater Diversion Pipe	Acceptable			
Compost Filter Sock	Acceptable			
Equipment Bridge	Acceptable			
Housekeeping	Acceptable			
Plunge Pool	Acceptable			
Rock Construction Entrance	Acceptable			
Silt Fence (Filter Fabric Fence)	Communication	Repair broken stake.	Addressed	3/11/2021

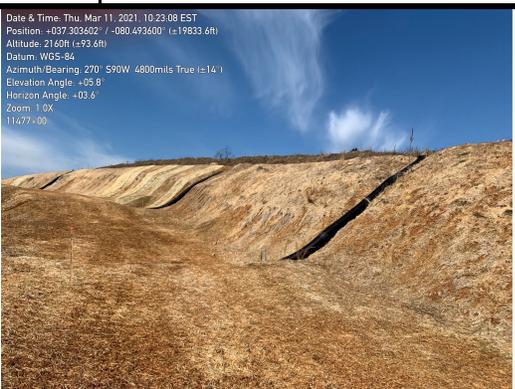
<b>GPS Location</b>	See photo for GPS location.		<b>GPS Location</b>	See photo for GPS location.	
<b>Field Station#</b>	11477+00		<b>Field Station#</b>	11380+00	
<b>Pic 5 Desc.</b>	Two-tone stabilized with ECB and slope drains in place.		<b>Pic 6 Desc.</b>	Triple barrier ECDs in place at off ROW karst feature.

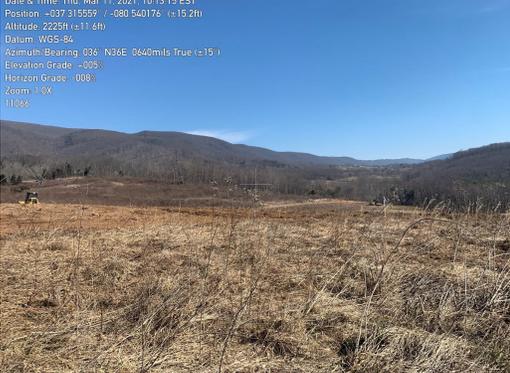
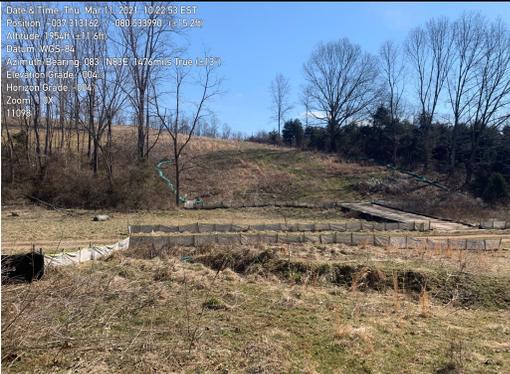
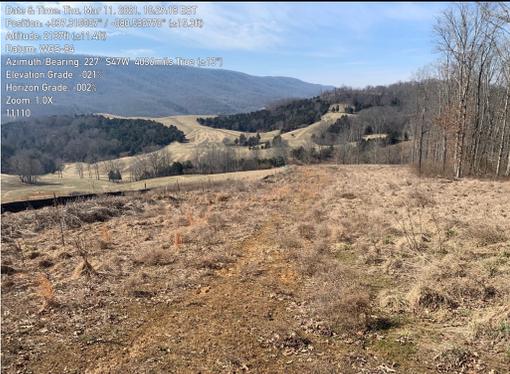
<b>GPS Location</b>	See picture above for GPS coordinates		<b>GPS Location</b>	See picture above for GPS coordinates			
<b>Field Station#</b>	11066+00		<b>Field Station#</b>	11069+00			
<b>Pic 1 Desc.</b>	ECD's and row conditions		<b>Pic 2 Desc.</b>	ECD's and row conditions			
<p>Date &amp; Time: Thu, Mar 11, 2021, 10:38:15 EST            Position: +037.31249° / -080.526532° (+15.21h)            Altitude: 1953ft (+11.4h)            Datum: WGS-84            Azimuth/Bearing: 281° N75W 4996mils True (+14.1)            Elevation Grade: +01%            Horizon Grade: +00%            Zoom: 1.0X            11126</p>

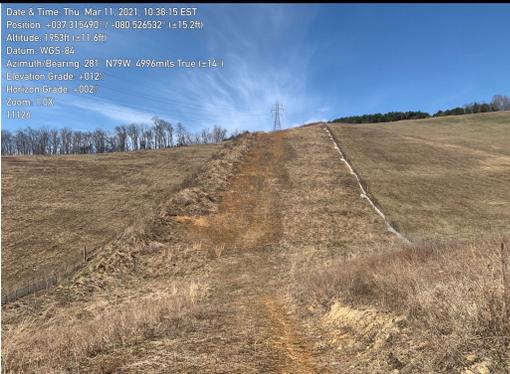
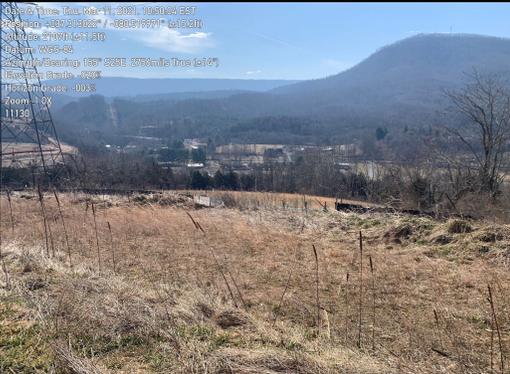
<b>GPS Location</b>	See picture above for GPS coordinates		<b>GPS Location</b>	See picture above for GPS coordinates			
<b>Field Station#</b>	11126+00		<b>Field Station#</b>	11130+00			
<b>Pic 5 Desc.</b>	ECD's and row conditions		<b>Pic 6 Desc.</b>	ECD's and row conditions

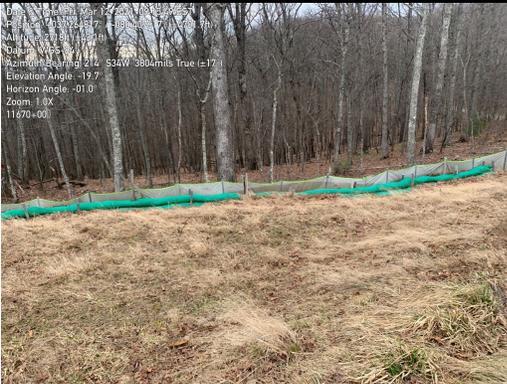
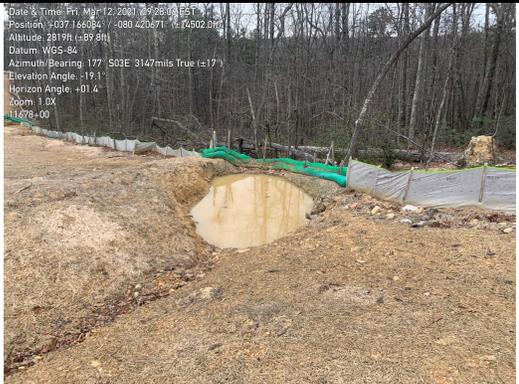
<p><small>Date &amp; Time: Fri, Mar 12, 2021, 12:28:03 EST Position: +0377146334 / -080426871 (-14502.0ft) Altitude: 2819ft (+89.8ft) Datum: WGS-84 Azimuth/Bearing: 177 S03E 3147mils True (+17) Elevation Angle: -19.1 Horizon Angle: -01.4 Zoom: 1.0X 11678+00</small></p>			
<b>GPS Location</b> See photo for GPS location.		<b>GPS Location</b> See photo for GPS location.			
<b>Field Station#</b> 11670+00		<b>Field Station#</b> 11678+00			
<b>Pic 1 Desc.</b> Triple stack compost filter sock and priority one silt fence in place along LOD.		<b>Pic 2 Desc.</b> Waterbar, sump pit and waterbar end treatment in place.

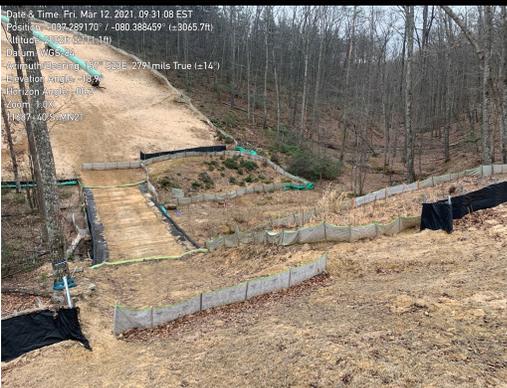
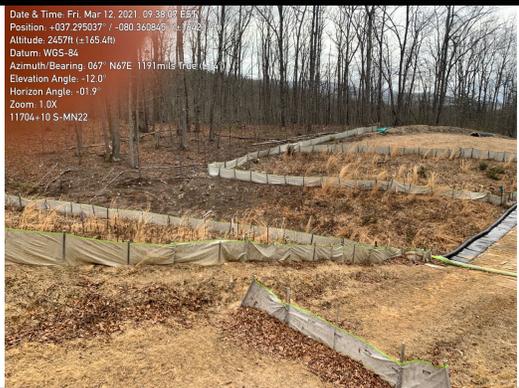
<p><small>Date &amp; Time: Fri, Mar 12, 2021, 09:38:02 EST Position: +037295037 / -080360840 (-117.2ft) Altitude: 2457ft (+75.4ft) Datum: WGS-84 Azimuth/Bearing: 067 N67E 1191mils True (+11) Elevation Angle: -12.0 Horizon Angle: -01.9 Zoom: 1.0X 11704+10 S-MN22</small></p>			
<b>GPS Location</b> See photo for GPS location.		<b>GPS Location</b> See photo for GPS location.			
<b>Field Station#</b> 11687+40		<b>Field Station#</b> 11704+10			
<b>Pic 3 Desc.</b> Sensitive resource buffer in place at stream S-MN21.		<b>Pic 4 Desc.</b> Sensitive resource buffer in place at stream S-MN22.

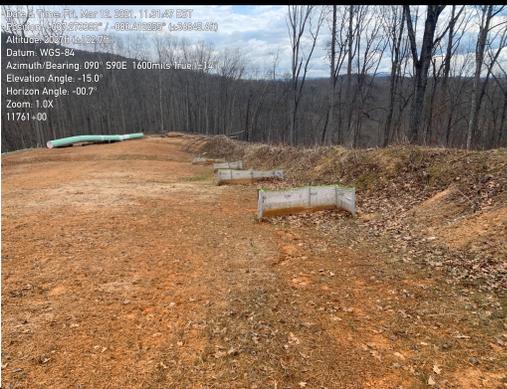
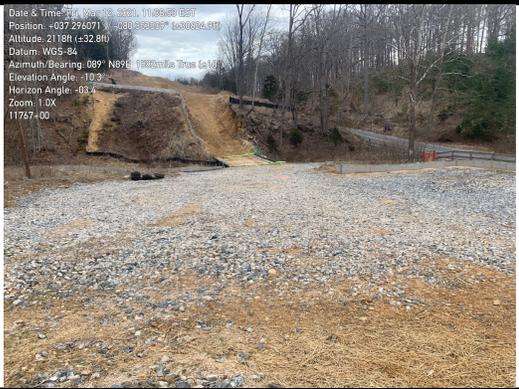
<b>GPS Location</b> See photo for GPS location.		<b>GPS Location</b> See photo for GPS location.			
<b>Field Station#</b> 11761+00		<b>Field Station#</b> 11767+00			
<b>Pic 5 Desc.</b> Priority one silt fence checks in place.		<b>Pic 6 Desc.</b> RCE in place at MLV 26.

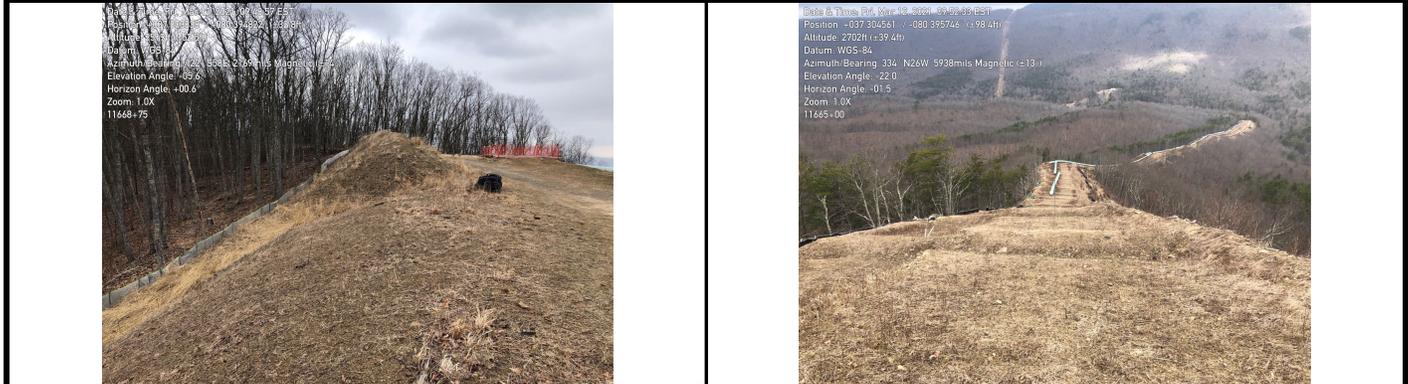
<b>GPS Location</b>	On photo	<b>GPS Location</b>	On photo
<b>Field Station#</b>	11668+75	<b>Field Station#</b>	11665+00
<b>Pic 1 Desc.</b>	Top of Brush Mountain is stable. ECDs are in place.	<b>Pic 2 Desc.</b>	Slope breakers are functional.

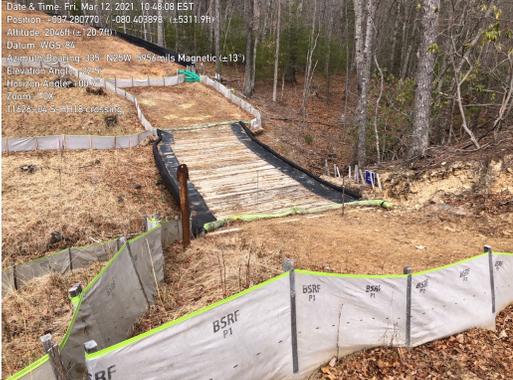
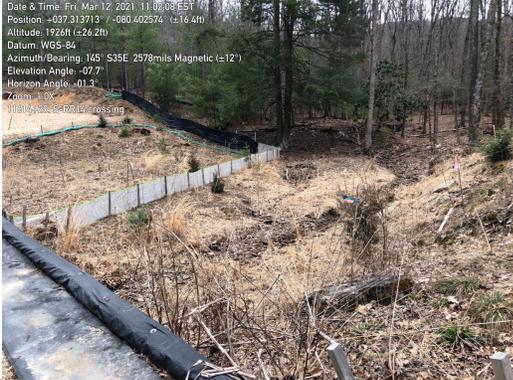
<b>GPS Location</b>	On photo	<b>GPS Location</b>	On photo
<b>Field Station#</b>	11626+04	<b>Field Station#</b>	11614+20
<b>Pic 7 Desc.</b>	The S-HH18 crossing is stable.	<b>Pic 8 Desc.</b>	The S-RR14 crossing is stable.

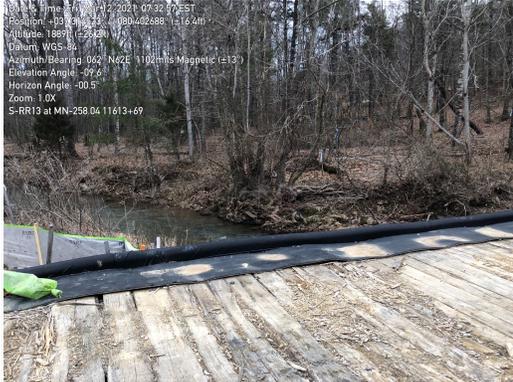
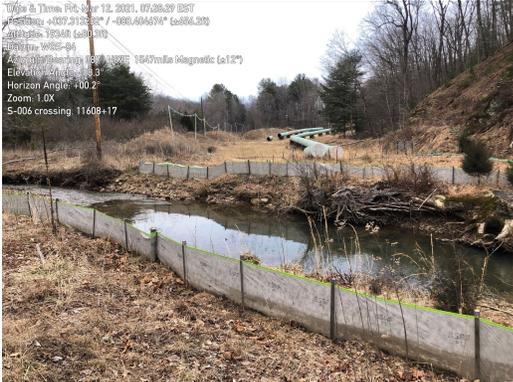
<b>GPS Location</b>	On photo	<b>GPS Location</b>	On photo
<b>Field Station#</b>	11613+69	<b>Field Station#</b>	11608+17
<b>Pic 9 Desc.</b>	The S-RR13 crossing at access road MN-258.04 is stable.	<b>Pic 10 Desc.</b>	The S-006 crossing is stable.

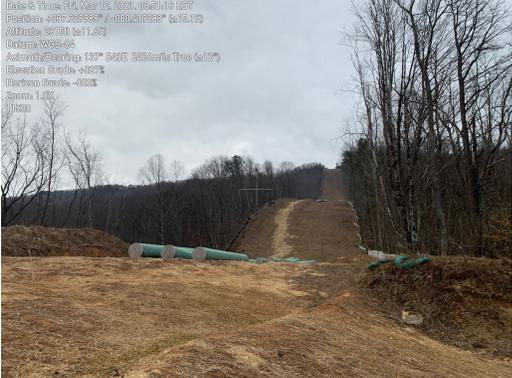
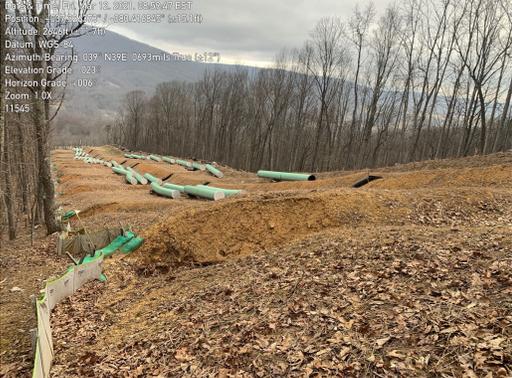
<b>GPS Location</b>	See picture above for GPS coordinates	<b>GPS Location</b>	See picture above for GPS coordinates	
<b>Field Station#</b>	11530+00	<b>Field Station#</b>	11545+00	
<b>Pic 1 Desc.</b>	ECD's and row conditions	<b>Pic 2 Desc.</b>	ECD's and row conditions

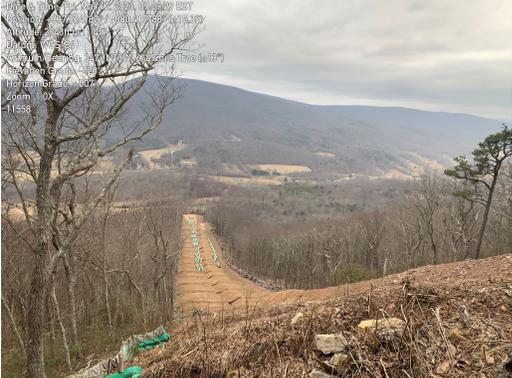
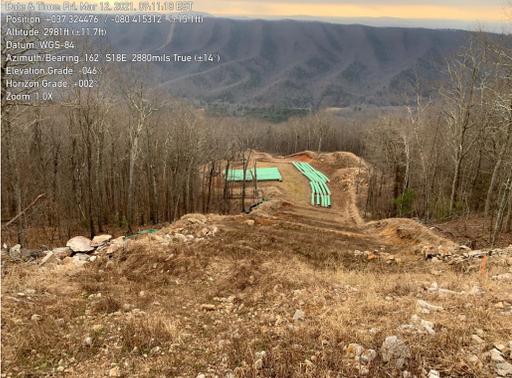
<b>GPS Location</b>	See picture above for GPS coordinates	<b>GPS Location</b>	See picture above for GPS coordinates	
<b>Field Station#</b>	11558+00	<b>Field Station#</b>	11550+00	
<b>Pic 3 Desc.</b>	ECD's and row conditions	<b>Pic 4 Desc.</b>	ECD's and row conditions

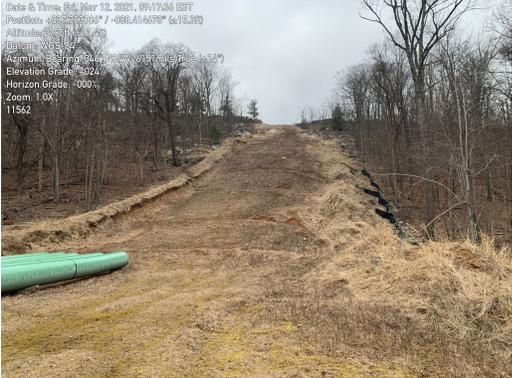
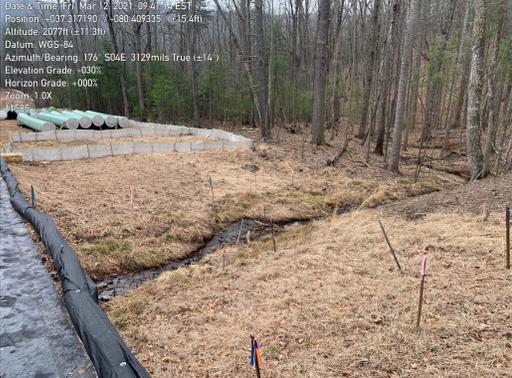
<b>GPS Location</b>	See picture above for GPS coordinates	<b>GPS Location</b>	See picture above for GPS coordinates	
<b>Field Station#</b>	11562+00	<b>Field Station#</b>	11585+00	
<b>Pic 5 Desc.</b>	ECD's and row conditions	<b>Pic 6 Desc.</b>	ECD's and row conditions
