Visual Site Inspection Report

Project Name H-600 Pipeline Spread H		AFE 124300138	Spread H-600 Pipeline Spread H
Contractor Precision		Report # 19370	
Inspector John Brcic		Date/Time 1/25/2021 11:05 AM	
Permit # TBD	Inspection Type VA SWPP	Station Begin 12119+17	
State VA	Inspection Area Partial	Station End 12284+75	
County Montgomery	Ground Damp	Temperature (°F) 37.00	
Municipality N/A	Weather Light Rain	Rain Gauge (in) 0.00	
			Rain Accumulation Time (days) 3.00

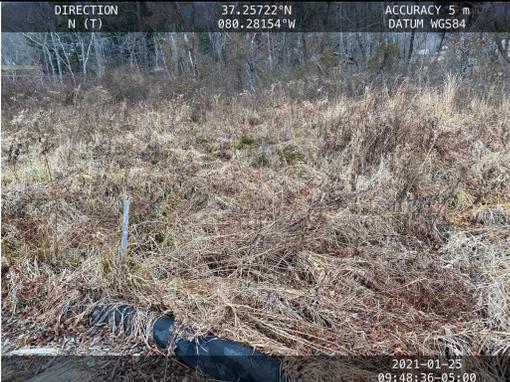
GPS Location	See photo		GPS Location	See photo	
Field Station#	12121+83		Field Station#	12125+65	
Pic 3 Desc.	Stream S-C36, facing north, upstream		Pic 4 Desc.	Stream S-MM31, facing north, upstream

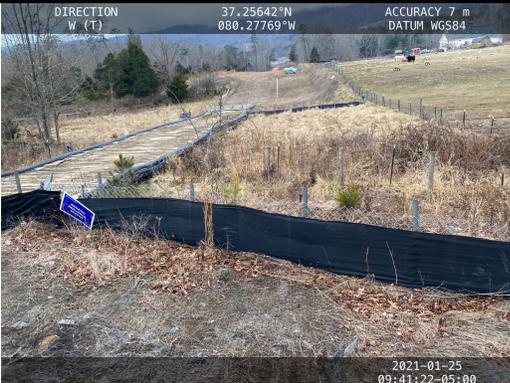
GPS Location	See photo		GPS Location	See photo	
Field Station#	12132+73		Field Station#	12157+00	
Pic 5 Desc.	Bridge, buffer zone and ECDs in satisfactory condition at stream S-C29.		Pic 6 Desc.	Clean water diversion channel and temporary sediment trap are in satisfactory condition and functioning properly.

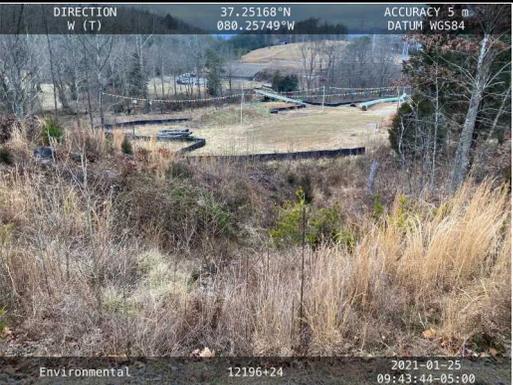
GPS Location	See photo	GPS Location	See photo
Field Station#	12192+50	Field Station#	12196+24
Pic 15 Desc.	Stream S-C21, Bradshaw Creek, facing south, downstream	Pic 16 Desc.	Stream S-0011, facing west, downstream

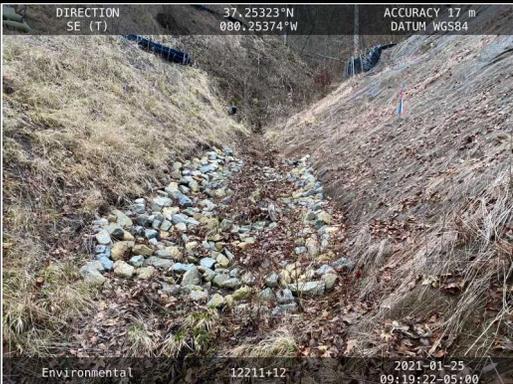
GPS Location	See photo	GPS Location	See photo
Field Station#	12211+12	Field Station#	12213+00
Pic 17 Desc.	The drainage feature in the bottom the ravine between Bradshaw Road and Reese Mountain remains stable.	Pic 18 Desc.	Permanent restoration between Bradshaw Road and Reese Mountain remains stable.

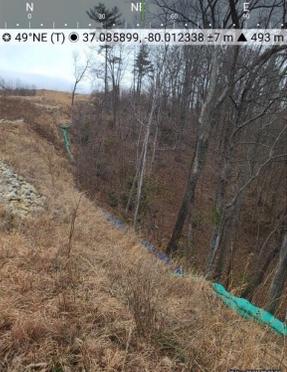
GPS Location	00000	GPS Location	00000	
Field Station#	13471+12	Field Station#	13462+00	
Pic 1 Desc.	During the EI's travel today the EI observed ECDs along the row boundary , no environmental issues observed at the time of inspection		Pic 2 Desc.	P1 damaged from wildlife, documented and sent in to be added to the punch list

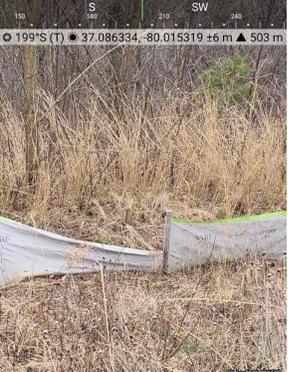
The EI noticed a section of P1 that was damaged from wildlife crossing the row , documented and sent in to be added to the punch list.

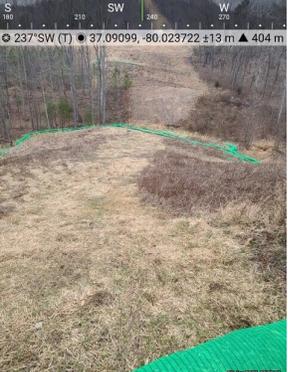
GPS Location	00000	GPS Location	00000	
Field Station#	13471+12	Field Station#	13488+24	
Pic 3 Desc.	During the EI's travel today the EI observed ECDs along the row boundary , no environmental issues observed at the time of inspection		Pic 4 Desc.	Row photo showing stabilization and ECDs in place and functioning.

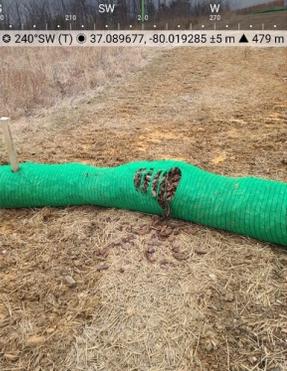
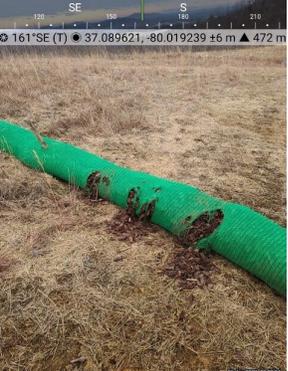
Throughout today's inspections the EI noticed a section of CFS that was damaged from land owner driving a ATV across, documented and sent in to be added to the punch list to be repaired by the contractor.

GPS Location	00000	GPS Location	00000	
Field Station#	13444+40	Field Station#	13444+40	
Pic 5 Desc.	CFS damaged from land owner driving a ATV over the CFS , Documented and sent in to be added to the punch list for repair		Pic 6 Desc.	CFS damaged from land owner driving a ATV over the CFS , Documented and sent in to be added to the punch list for repair

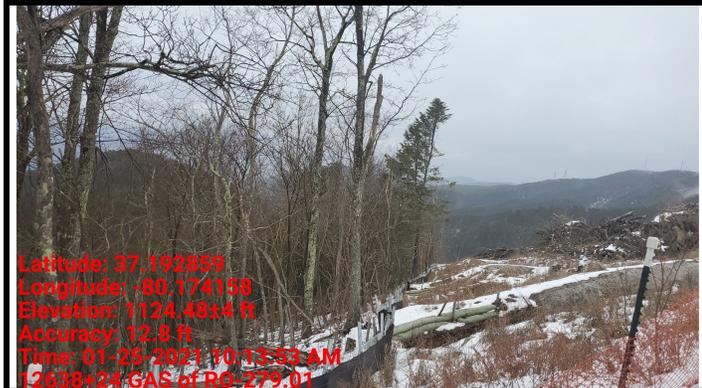
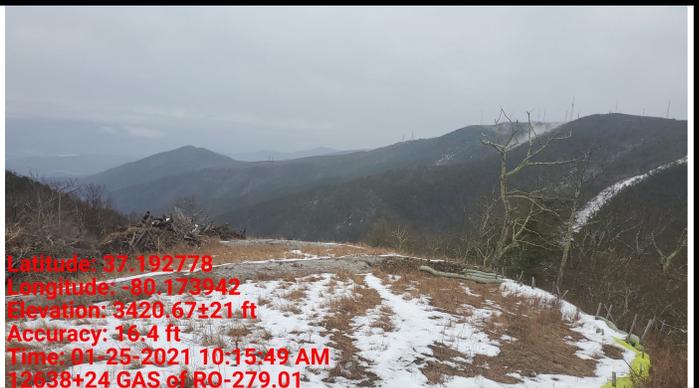
Pic 3 Desc.	ECD's and BMP's remain in compliance on the GAS of RO-279.01.
--------------------	---------------------------------------------------------------

Pic 4 Desc.	ECD's and BMP's remain in compliance on the GAS of RO-279.01.
--------------------	---------------------------------------------------------------

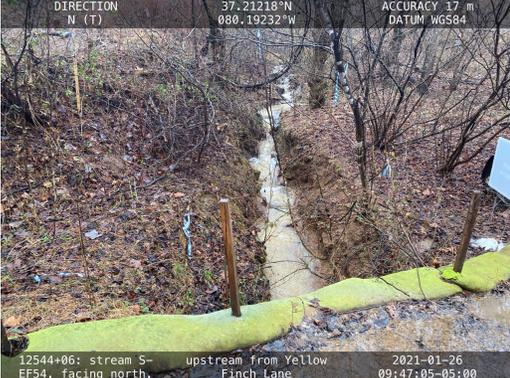
GPS Location	See photo	GPS Location	See photo		
Field Station#	12544+06	Field Station#	12544+06		
Pic 3 Desc.	Stream S-EF20b, facing northeast, downstream from Yellow Finch Lane crossing	Pic 4 Desc.	Stream S-EF54, facing north, upstream (turbid water observed)

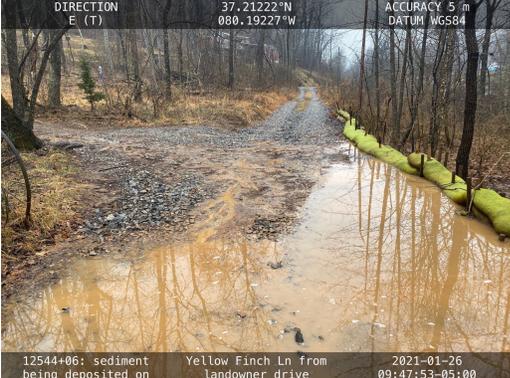
GPS Location	See photo	GPS Location	See photo		
Field Station#	12544+06	Field Station#	12544+56		
Pic 5 Desc.	Sediment being washed out of landowner driveway and deposited on Yellow Finch Lane.	Pic 6 Desc.	Stream S-EF20a, facing southwest, upstream

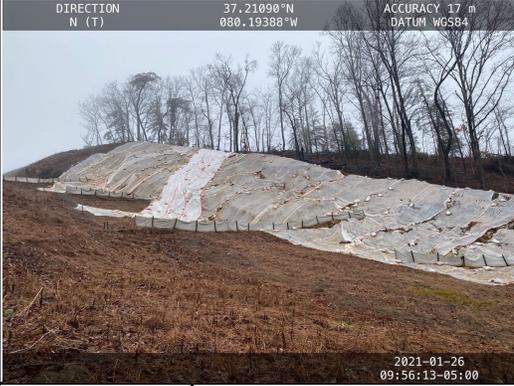
<p>DIRECTION S (T) 37.21388°N 080.19696°W ACCURACY 21 m DATUM WGS84 2021-01-26 10:21:23-05:00</p>	
GPS Location	See photo	GPS Location	See photo
Field Station#	12543+00	Field Station#	12529+00
Pic 7 Desc.	Plastic sheeting intact and secure on stockpiles nearest to Yellow Finch Lane.	Pic 8 Desc.	Plastic sheeting intact and secure approximately 1500 feet to the coming in side of Yellow Finch Lane.

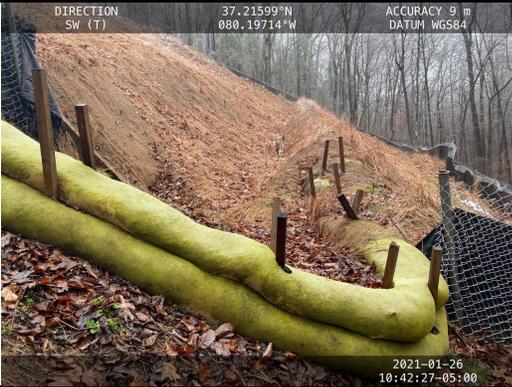
<p>DIRECTION SW (T) 37.21599°N 080.19714°W ACCURACY 9 m DATUM WGS84 2021-01-26 10:42:27-05:00</p>	
GPS Location	See photo	GPS Location	See photo
Field Station#	12519+41	Field Station#	1221+50
Pic 9 Desc.	Bridge, buffer zone and ECDs in satisfactory condition at stream S-EF19.	Pic 10 Desc.	Water bars in satisfactory condition and functioning properly on the slopes on both sides of stream S-EF19.

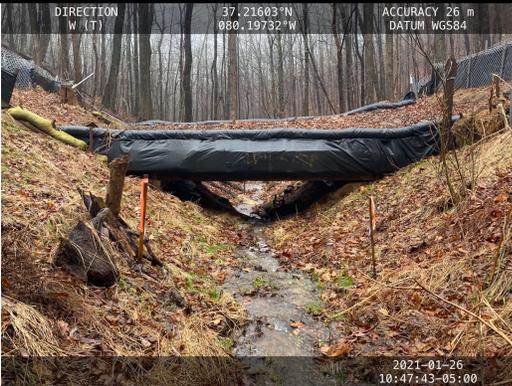
<p>DIRECTION W (T) 37.21603°N 080.19732°W ACCURACY 26 m DATUM WGS84 2021-01-26 10:47:43-05:00</p>	
GPS Location	See photo	GPS Location	See photo
Field Station#	12517+00	Field Station#	12519+41
Pic 11 Desc.	Slope stable on coming in side of stream S-EF19.	Pic 12 Desc.	Stream S-EF19, facing west, downstream

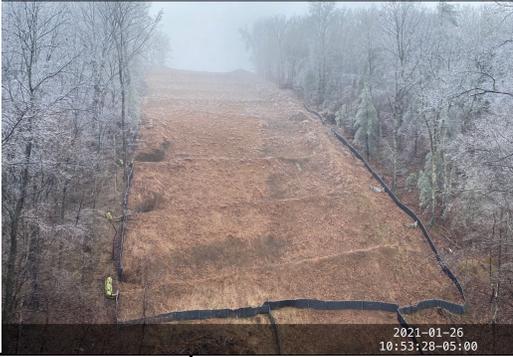
GPS Location	See photo	GPS Location	See photo
Field Station#	12523+00	Field Station#	12508+00
Pic 13 Desc.	Slope stable on going away side of stream S-EF19.	Pic 14 Desc.	Slope drains intact and functioning per design.
DIRECTION W (T) 37.21837°N 080.20010°W ACCURACY 48 m DATUM WGS84

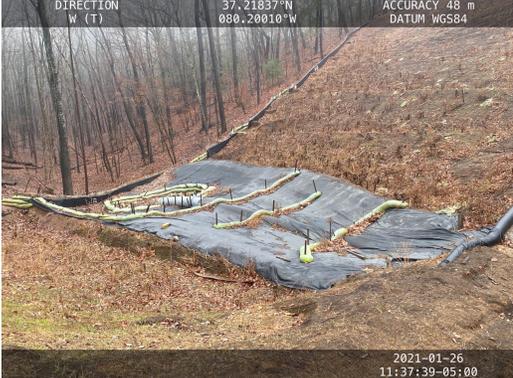
GPS Location	See photo	GPS Location	See photo
Field Station#	12503+70	Field Station#	12483+00
Pic 15 Desc.	Clean water diversion pipe in satisfactory condition and functioning properly.	Pic 16 Desc.	ROW stable through the area of the "pig parts" excavation site and clean water diversion channel.
DIRECTION NW (T) 37.23019°N 080.20138°W ACCURACY 21 m DATUM WGS84

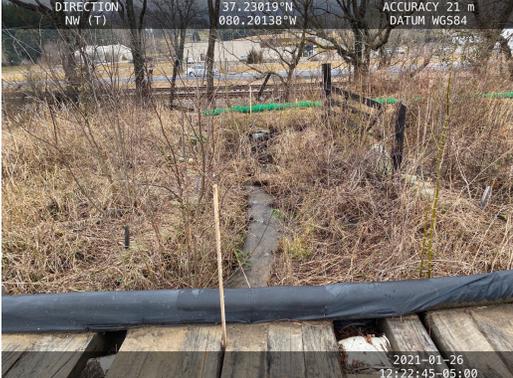
GPS Location	See photo	GPS Location	See photo
Field Station#	12455+21	Field Station#	12444+94
Pic 17 Desc.	Stream S-CD12, facing northwest, downstream	Pic 18 Desc.	Stream S-I1, facing northeast, downstream

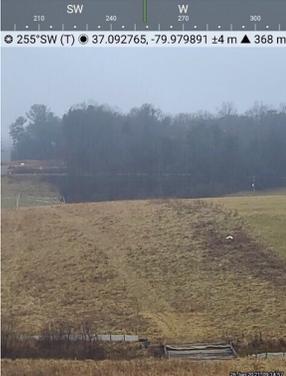
GPS Location	00000	GPS Location	0000	
Field Station#	13572+23	Field Station#	13643+00	
Pic 1 Desc.	The EI monitored permanent vegetation growth during today's inspections. No issues observed at the time of inspection.	Pic 2 Desc.	Saturated row photo taken during today's travel after recent rain events.

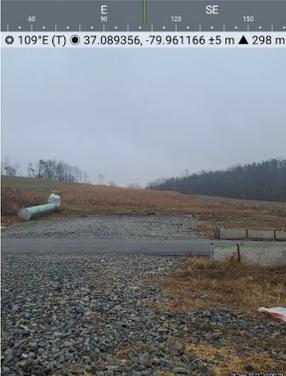
GPS Location	00000	GPS Location	00000	
Field Station#	13644+97	Field Station#	13643+53	
Pic 3 Desc.	Saturated row conditions showing vegetation during the EI's travel today.	Pic 4 Desc.	EI monitored ECDs and stream crossing, observed equipment bridge and protection, no issues observed at the time of inspection.

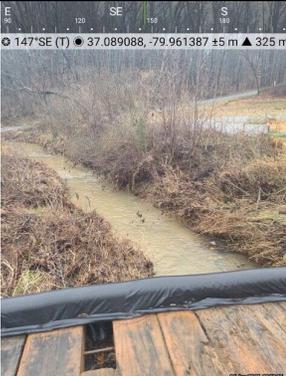
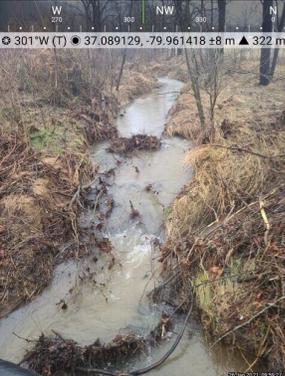
GPS Location	0000	GPS Location	0000	
Field Station#	13643+53	Field Station#	13643+53	
Pic 5 Desc.	Stream observation photo facing downstream after recent rain events. No environmental issues observed.	Pic 6 Desc.	Stream observation facing upstream after recent rain events. No environmental issues observed.

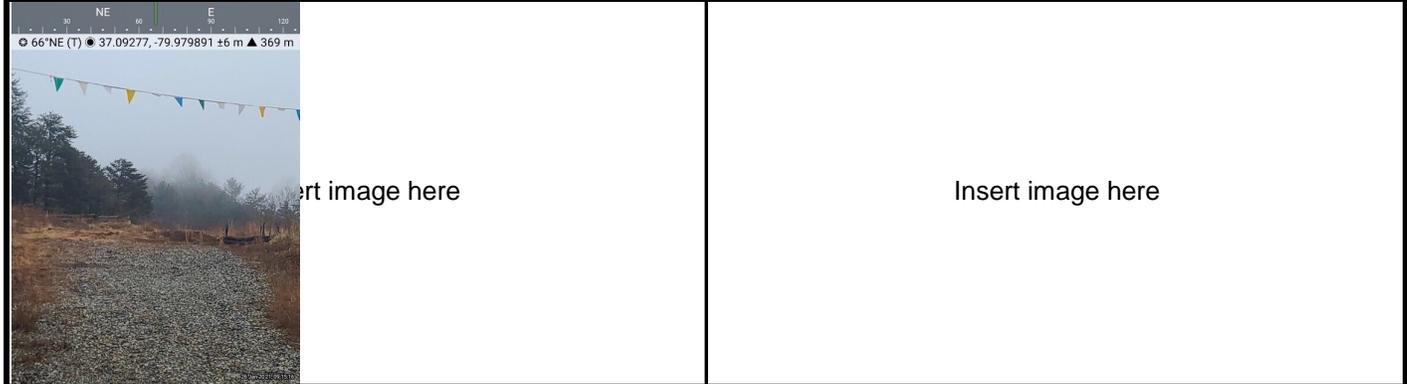
Pic 7 Desc.	Monitored RCEs at road crossings after recent rain events. No environmental issues observed at the time of inspection.	Pic 8 Desc.	
--------------------	------------------------------------------------------------------------------------------------------------------------	--------------------	--

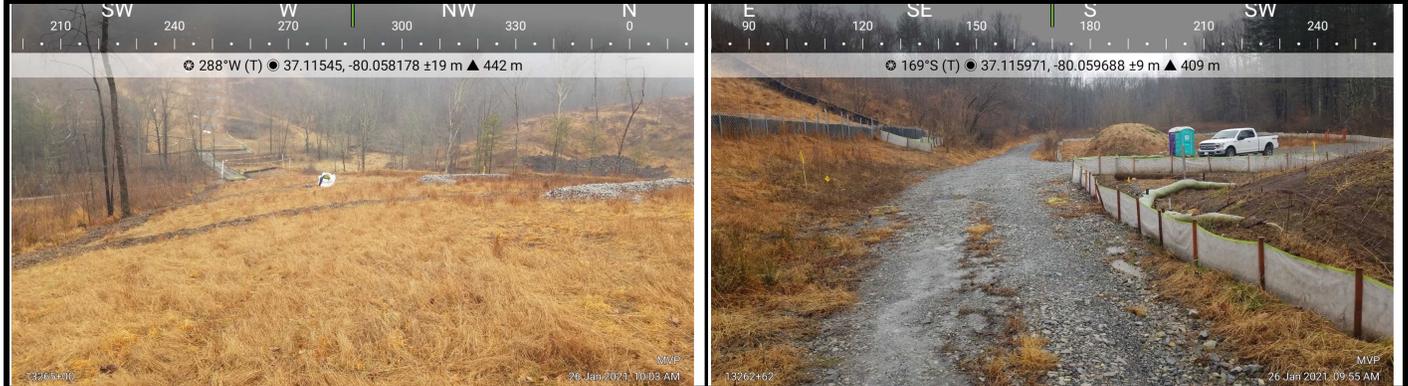
GPS Location See photo for coordinates.	GPS Location See photo for coordinates.
Field Station# 13265+00	Field Station# 13262+62
Pic 7 Desc. ROW stable with good vegetative cover across LOD.	Pic 8 Desc. MVP-FR-293.01, Flanders road in acceptable condition.

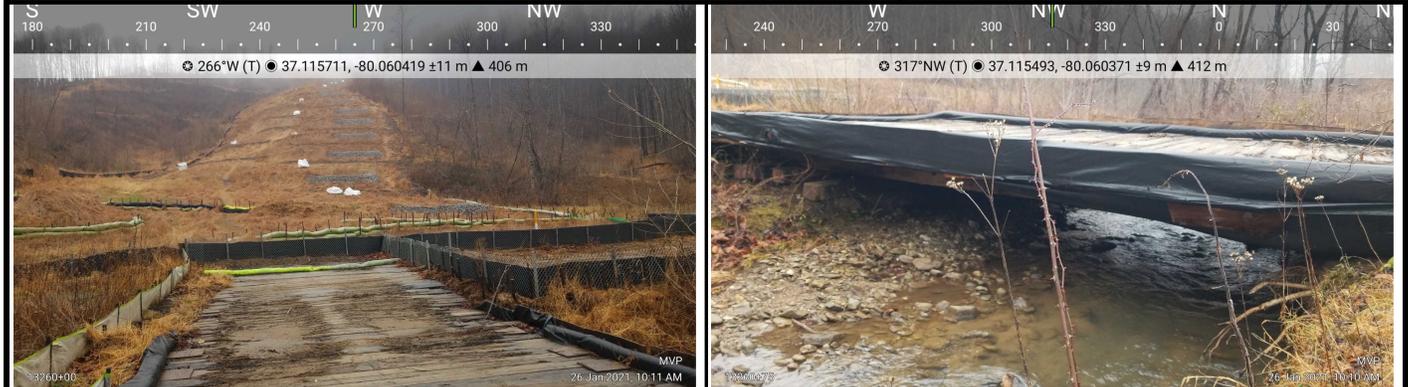
GPS Location See photo for coordinates.	GPS Location See photo for coordinates.
Field Station# 13260+00	Field Station# 13260+60
Pic 9 Desc. CIS S-II4, perimeter ECDs along stream crossing and LOD in acceptable condition.	Pic 10 Desc. S-II4, water level up, slight turbidity noted, bridge in acceptable condition.

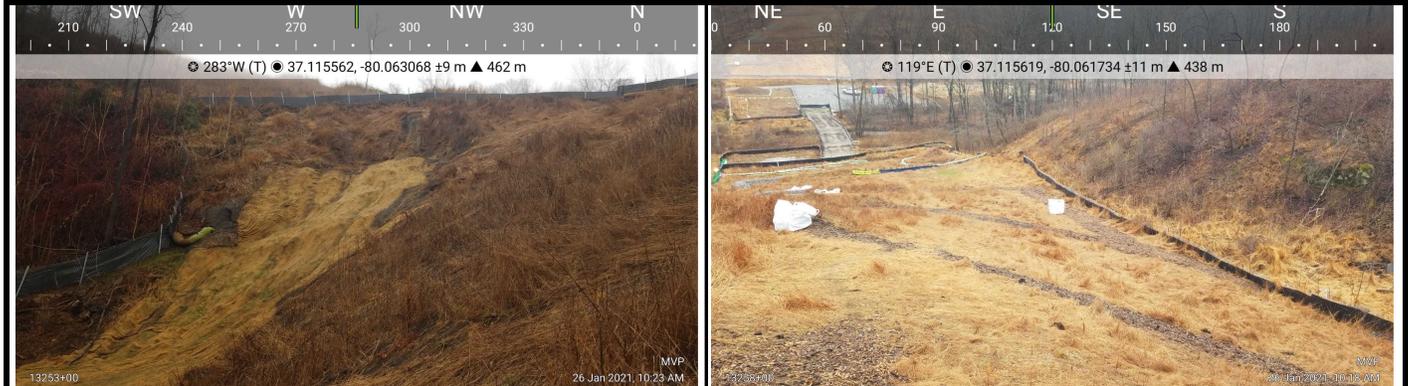
GPS Location See photo for coordinates.	GPS Location See photo for coordinates.
Field Station# 13253+00	Field Station# 13258+00
Pic 11 Desc. Previously documented and stabilized slip appeared stable. Sediment accumulation on a secondary control near toe on punch list.	Pic 12 Desc. ROW stable, with acceptable vegetative cover.

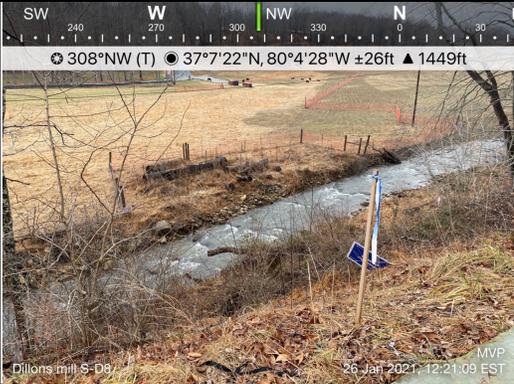
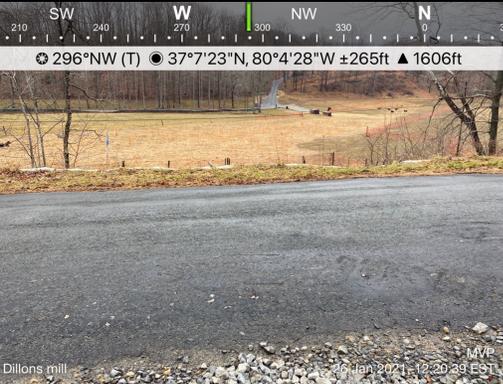
GPS Location See photo for coordinates.	
Field Station# 13197+50		Field Station# 13197+50		Pic 13 Desc. S-D8, no disturbance noted at stream crossing, water level up and with increased velocity.

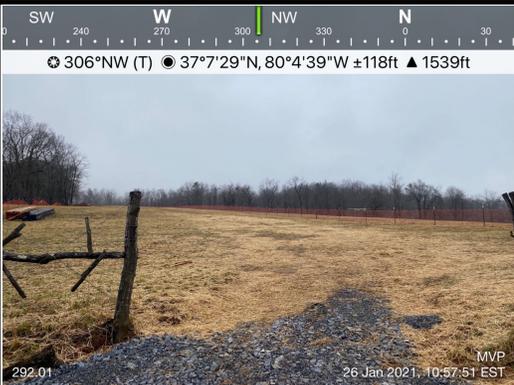
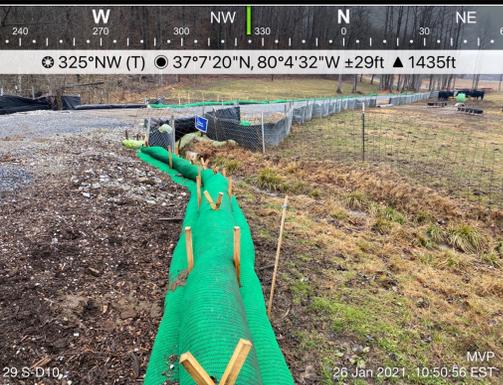
GPS Location See photo for coordinates.	
Field Station# 13185+40		Field Station# 13190+00		Pic 15 Desc. ROW stable.

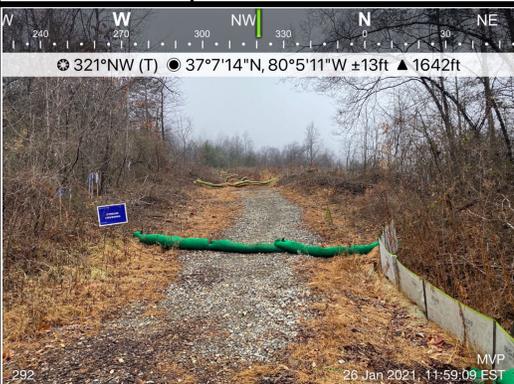
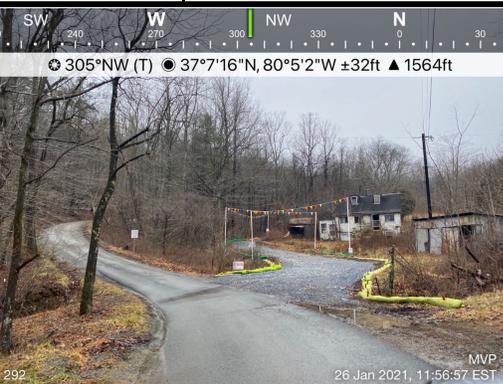
GPS Location See photo for coordinates.	
Field Station# 13142+00		Field Station# 13148+00		Pic 17 Desc. MVP-FR-292, ECDs in acceptable condition, no flow noted in S-D14.	
Pic 18 Desc. MVP-FR-292, access road and RCE in acceptable condition.		Pic 18 Desc. MVP-FR-292, access road and RCE in acceptable condition.

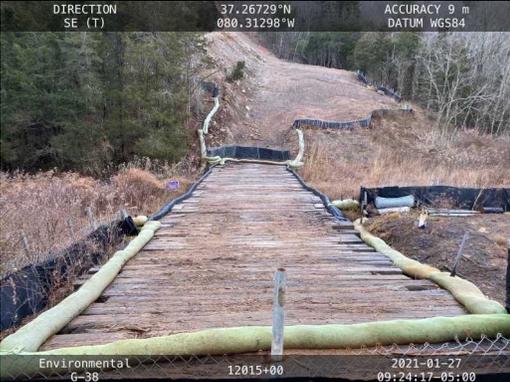
<p>DIRECTION SE (T) 37.26729°N 080.31298°W ACCURACY 9 m DATUM WGS84 Environmental G-38 12015+00 2021-01-27 09:24:17-05:00</p>			
GPS Location See photo		GPS Location See photo			
Field Station# 12008+53		Field Station# 12015+00			
Pic 1 Desc. Stream S-G36, facing southeast		Pic 2 Desc. Bridge, buffer zone and ECDs in satisfactory condition at stream S-G38.

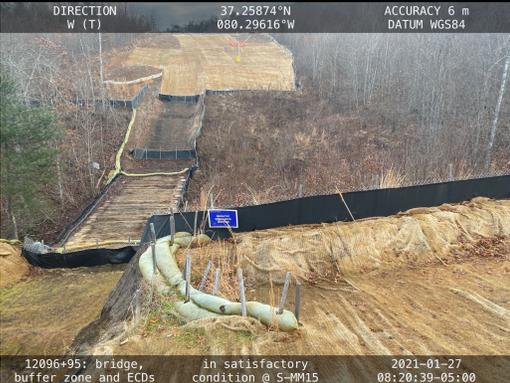
<p>DIRECTION W (T) 37.25874°N 080.29516°W ACCURACY 6 m DATUM WGS84 12096+95: bridge, buffer zone and ECDs in satisfactory condition @ S-MM15 2021-01-27 08:20:39-05:00</p>			
GPS Location See photo		GPS Location See photo			
Field Station# 12038+00		Field Station# 12076+95			
Pic 5 Desc. Clean water diversion pipe outlet plunge pool in satisfactory condition.		Pic 6 Desc. Bridge, buffer zone and ECDs in satisfactory condition at stream S-MM15.

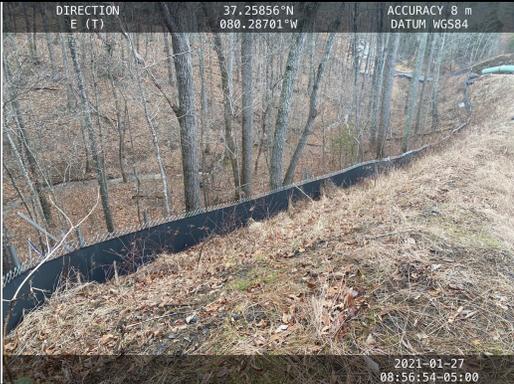
<p>DIRECTION E (T) 37.25817°N 080.28625°W ACCURACY 9 m DATUM WGS84 2021-01-27 08:59:55-05:00</p>	
GPS Location	See photo	GPS Location	See photo
Field Station#	12106+00	Field Station#	12108+00
Pic 13 Desc.	Perimeter super silt fence in good repair where the LOD parallels stream S-F15 for a short ways.	Pic 14 Desc.	Bridge, buffer zone and ECDs in satisfactory condition at stream S-F15.

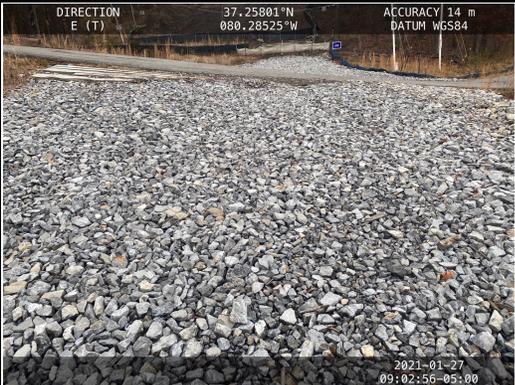
<p>DIRECTION E (T) 37.25801°N 080.28525°W ACCURACY 14 m DATUM WGS84 2021-01-27 09:02:56-05:00</p>	
GPS Location	See photo	GPS Location	See photo
Field Station#	12108+41	Field Station#	12109+62
Pic 15 Desc.	Stream S-F15, facing northwest, upstream	Pic 16 Desc.	Rock construction entrances on both sides of access road MVP-MN-271 are in good condition and free of sediment.

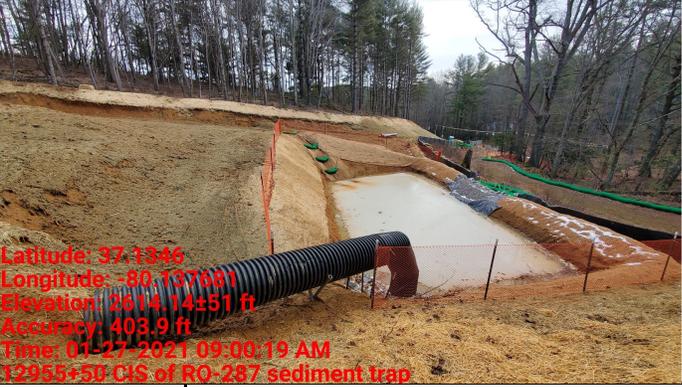
<p style="color: red; font-size: small;">Latitude: 37.13445 Longitude: -80.137739 Elevation: 2738.32±97 ft Accuracy: 121.1 ft Time: 01-27-2021 08:25:34 AM 12957+30 CIS of RO-287 stream S-Y7 and S-Y9 landowner's spring box</p>

<p style="color: red; font-size: small;">Latitude: 37.1346 Longitude: -80.137681 Elevation: 2614.14±51 ft Accuracy: 403.9 ft Time: 01-27-2021 09:00:19 AM 12955+50 CIS of RO-287 sediment trap</p>
GPS Location See pic for GPS location	GPS Location See pic for GPS location
Field Station# 12957+30	Field Station# 12955+50
Pic 1 Desc. Streams S-Y7, S-Y9 and landowner's spring box at RO-287.	Pic 2 Desc. Sediment trap on the CIS of RO-287.

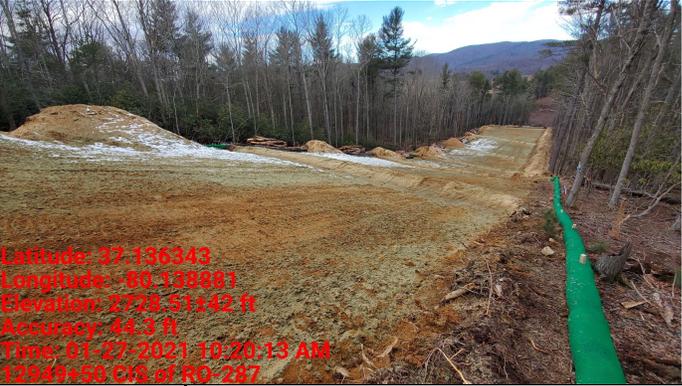
<p style="color: red; font-size: small;">Latitude: 37.13659 Longitude: -80.139099 Elevation: 2683.7±68 ft Accuracy: 24.0 ft Time: 01-27-2021 09:40:07 AM 12949+50 CIS of RO-287</p>

GPS Location See pic for GPS location	GPS Location See pic for GPS location
Field Station# 12949+50	Field Station# 12949+50
Pic 3 Desc. Waterbars, sumps and end treatments remain in compliance on the CIS of RO-287.	Pic 4 Desc. Stabilized ROW on the CIS of RO-287.

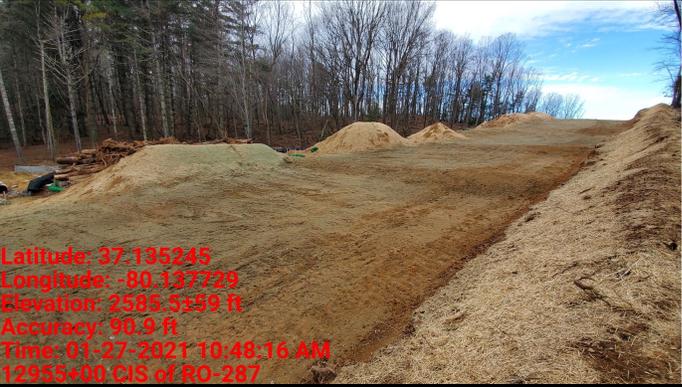
<p style="color: red; font-size: small;">Latitude: 37.135838 Longitude: -80.138484 Elevation: 2705.26±32 ft Accuracy: 181.6 ft Time: 01-27-2021 10:44:12 AM 12952+00 CIS of RO-287</p>

<p style="color: red; font-size: small;">Latitude: 37.135245 Longitude: -80.137729 Elevation: 2585.5±59 ft Accuracy: 90.9 ft Time: 01-27-2021 10:48:16 AM 12955+00 CIS of RO-287</p>
GPS Location See pic for GPS location	GPS Location See pic for GPS location
Field Station# 12952+00	Field Station# 12955+00
Pic 5 Desc. Stabilized ROW on the CIS of RO-287.	Pic 6 Desc. Stabilized ROW on the CIS of RO-287.

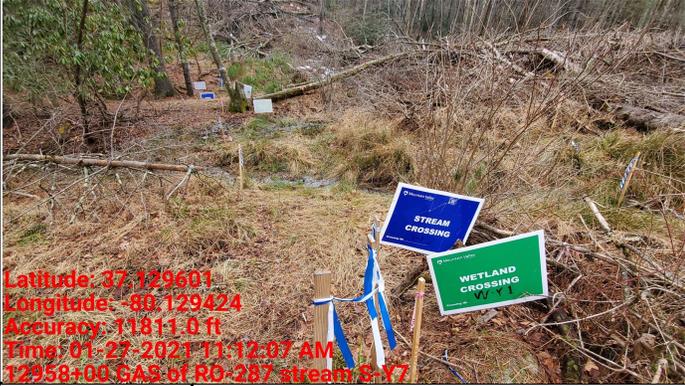
<p>Latitude: 37.129601 Longitude: -80.129424 Accuracy: 11811.0 ft Time: 01-27-2021 11:12:07 AM 12958+00 GAS of RO-287 stream S-Y7</p>

<p>Latitude: 37.134314 Longitude: -80.137427 Elevation: 2595.8170 ft Accuracy: 41.3 ft Time: 01-27-2021 11:13:49 AM 12958+50 GAS of RO-287 stream S-Y8</p>	
GPS Location	See pic for GPS location	GPS Location	See pic for GPS location
Field Station#	12958+00	Field Station#	12958+50
Pic 7 Desc.	Stream S-Y7 on the downstream side of the ROW.	Pic 8 Desc.	Stream S-Y8 on the downstream side of the ROW.

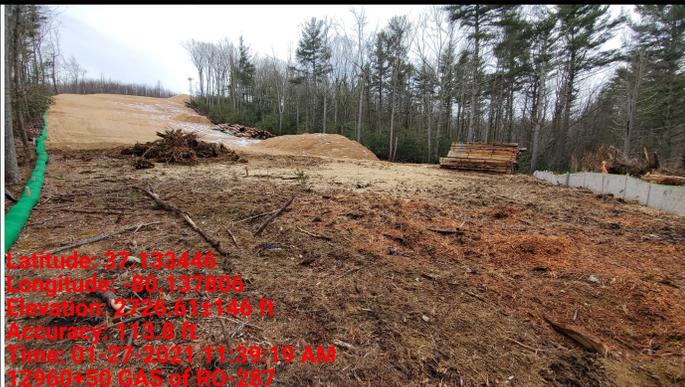
<p>Latitude: 37.134445 Longitude: -80.137896 Elevation: 2326.612148 ft Accuracy: 119.8 ft Time: 01-27-2021 11:39:19 AM 12960+50 GAS of RO-287</p>

Field Station#	12960+50	Field Station#	12970+50
Pic 9 Desc.	Current ROW conditions on the GAS of RO-287.	Pic 10 Desc.	No maintenance issues or impacts observed on the CIS of RO-288.

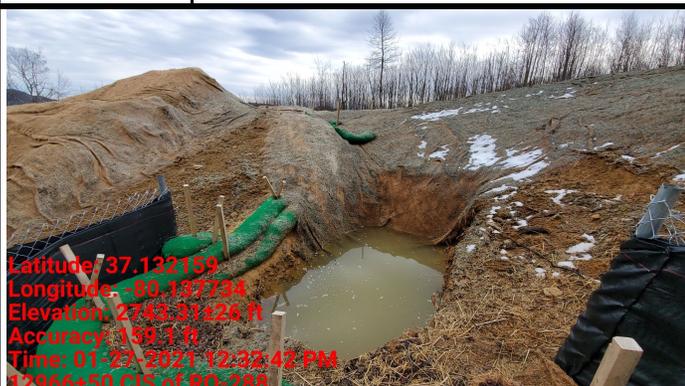
<p>Latitude: 37.132159 Longitude: -80.137734 Elevation: 2743.31826 ft Accuracy: 159.1 ft Time: 01-27-2021 12:35:42 PM 12966+50 CIS of RO-288</p>

<p>Latitude: 37.132513 Longitude: -80.137812 Elevation: 2798.37173 ft Accuracy: 282.5 ft Time: 01-27-2021 12:37:10 PM 12965+00 GAS of RO-287</p>	
GPS Location	See pic for GPS location	GPS Location	See pic for GPS location
Field Station#	12966+50	Field Station#	12965+00
Pic 11 Desc.	Waterbars, sumps and end treatments remain in compliance on the CIS of RO-288.	Pic 12 Desc.	No maintenance issues or impacts observed on the GAS of RO-287.

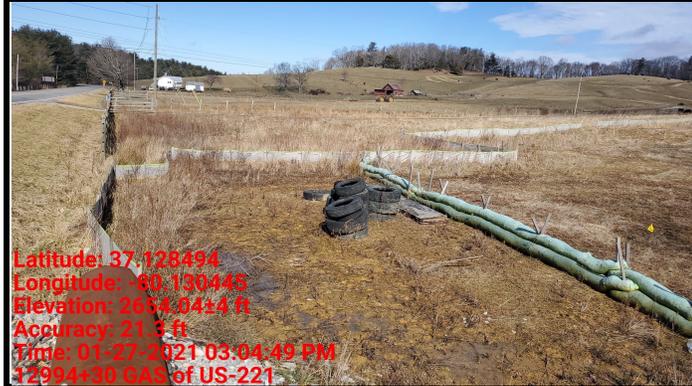
Pic 13 Desc.	GAS of the US-221 road crossing.
---------------------	----------------------------------

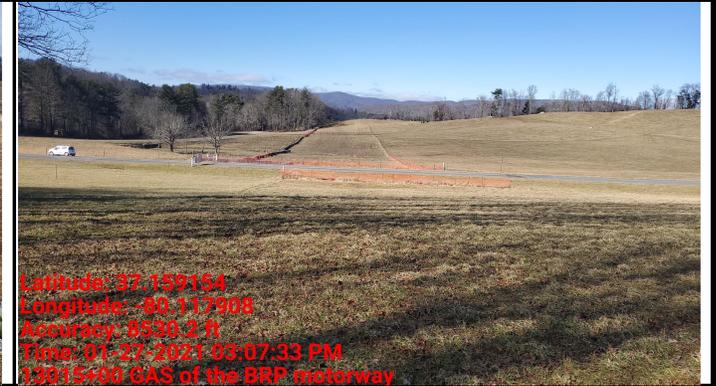
Pic 14 Desc.	The BRP motorway from the GAS.
---------------------	--------------------------------

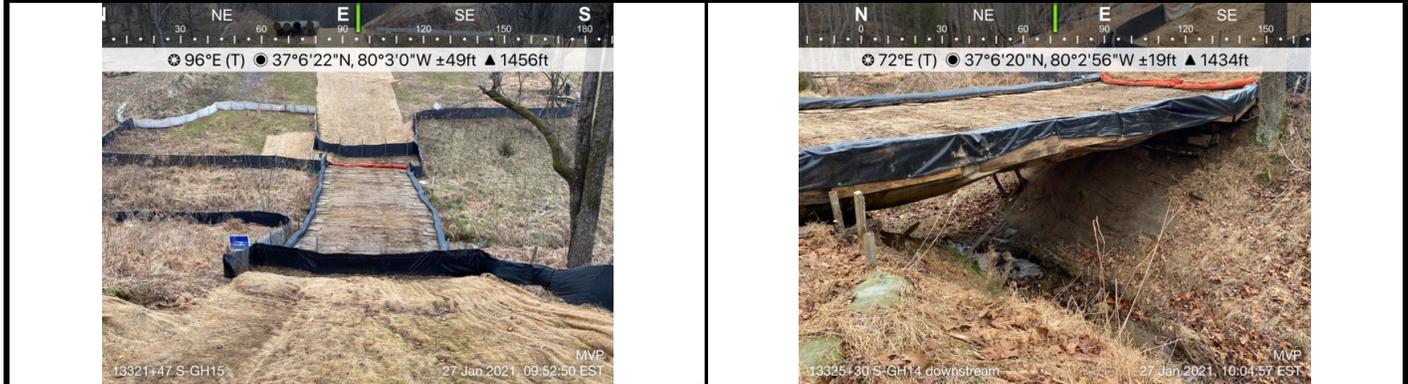
Field Station#	13321+47	Field Station#	13325+30
-----------------------	----------	-----------------------	----------

Pic 1 Desc.	Overview of Waterbody S-GH15. ECDs are functional and ROW is stable.	Pic 2 Desc.	Overview of Waterbody S-GH14. ECDs are functional and ROW is stable.
--------------------	----------------------------------------------------------------------	--------------------	----------------------------------------------------------------------

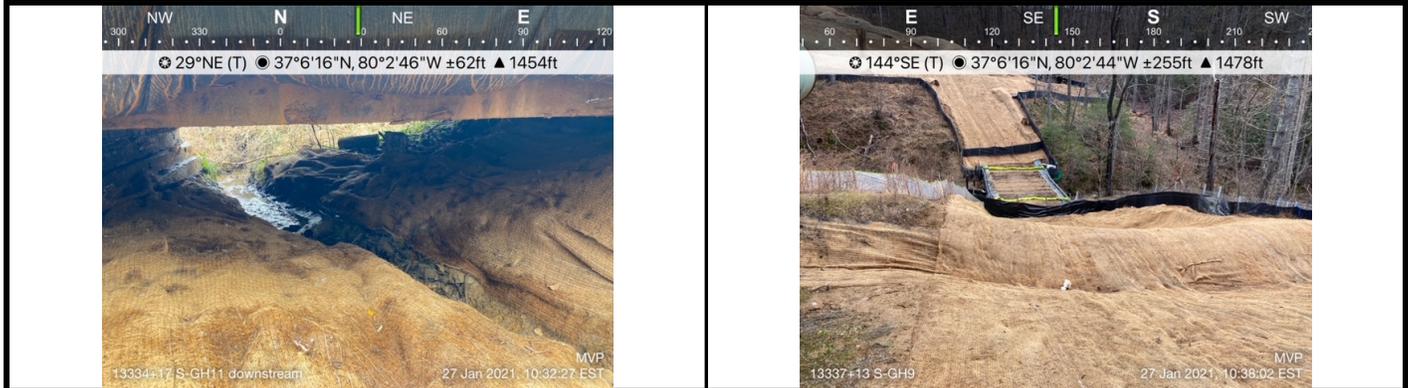
Field Station#	13334+17	Field Station#	13337+13
-----------------------	----------	-----------------------	----------

Pic 3 Desc.	Overview of Waterbody S-GH11. ECDs are functional and ROW is stable.	Pic 4 Desc.	Overview of Waterbody S-GH9. ECDs are functional and ROW is stable.
--------------------	----------------------------------------------------------------------	--------------------	---------------------------------------------------------------------

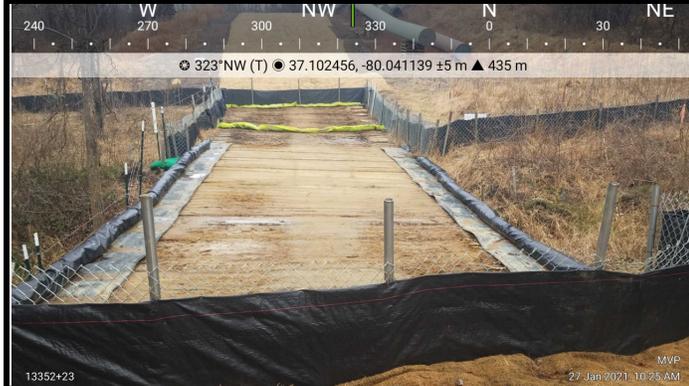
Field Station#	13352+23
-----------------------	----------

Pic 7 Desc.	Overview of Waterbody S-RR09. ECDs are functional and ROW is stable.
--------------------	----------------------------------------------------------------------

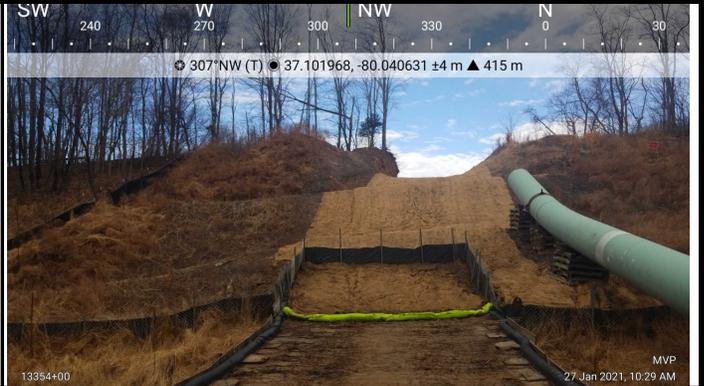
Field Station#	13354+00
-----------------------	----------

Pic 8 Desc.	ROW Overview. ECDs are functional and ROW is stable.
--------------------	------------------------------------------------------

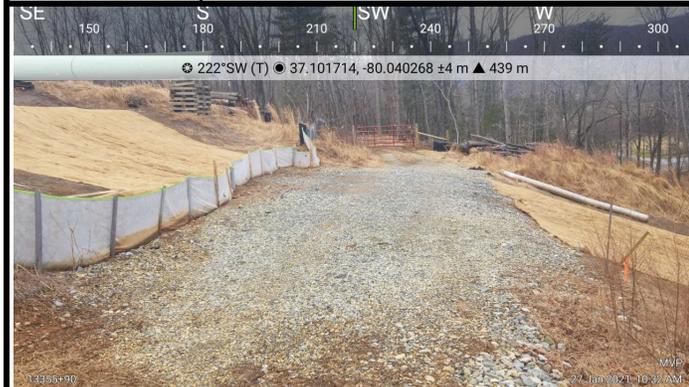
Field Station#	13355+90
-----------------------	----------

Pic 9 Desc.	Overview of private road crossing ROW. ECDs are functional and ROW is stable.
--------------------	-------------------------------------------------------------------------------

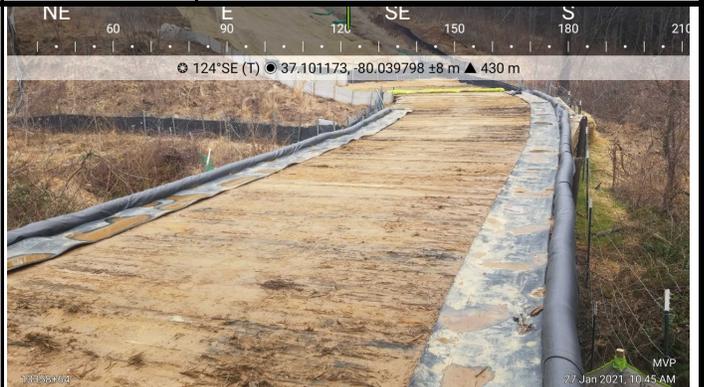
Field Station#	13358+64
-----------------------	----------

Pic 10 Desc.	Overview of Waterbody S-RR11. ECDs are functional and ROW is stable.
---------------------	----------------------------------------------------------------------

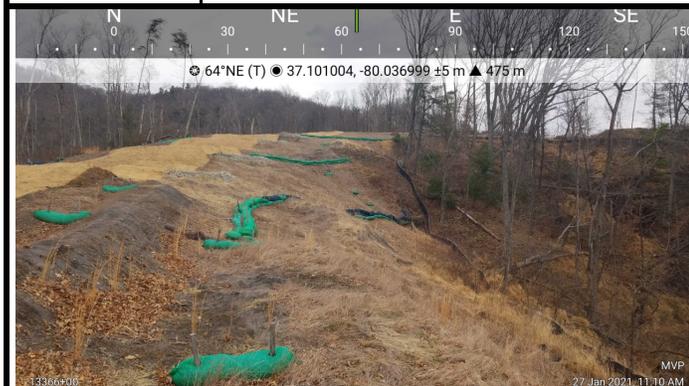
Field Station#	13366+00
-----------------------	----------

Pic 11 Desc.	ROW Overview. ECDs are functional and ROW is stable.
---------------------	------------------------------------------------------

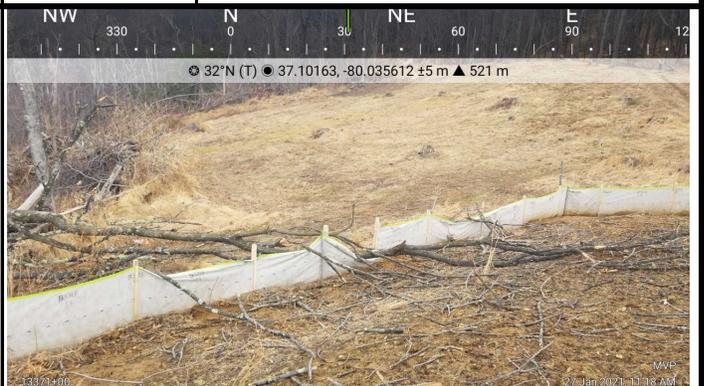
Field Station#	13371+00
-----------------------	----------

Four new internal 72 hour punchlist items were added today (see photos below): ST. 13370+50 - 13371+00, repair P1 silt fence where trees have fallen on the fence. ST. 13411+00, stabilize loose soils on slope. ST. 13415+00, repair P1 silt fence. ST. 13420+00 repair super silt fence.

Pic 12 Desc.	Internal 72 hour punchlist item: Repair P1 silt fence that trees have fallen on. Station 13370+50 - 13371+00.
---------------------	---------------------------------------------------------------------------------------------------------------

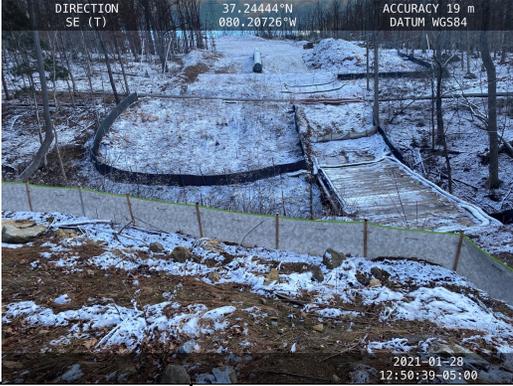
<p>DIRECTION W (T) 37.24431°N 080.20719°W ACCURACY 18 m DATUM WGS84 2021-01-28 12:51:35-05:00</p>	
GPS Location	See photo	GPS Location	See photo
Field Station#	12379+50	Field Station#	12380+04
Pic 7 Desc.	Bridge, buffer zone and ECDs in satisfactory condition at stream S-NN19.	Pic 8 Desc.	Stream S-NN19, facing west, downstream

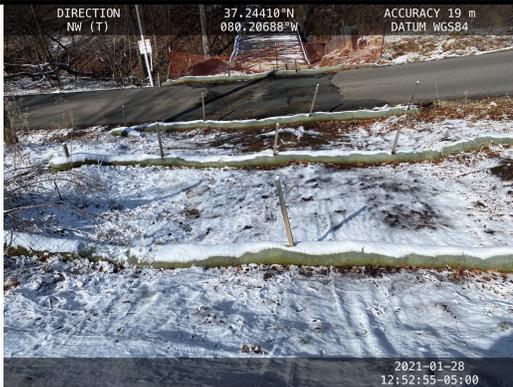
<p>DIRECTION SW (T) 37.24376°N 080.20649°W ACCURACY 12 m DATUM WGS84 2021-01-28 12:54:29-05:00</p>	
GPS Location	See photo	GPS Location	See photo
Field Station#	12380+75	Field Station#	12383+00
Pic 9 Desc.	Cannery Road crossing in satisfactory condition.	Pic 10 Desc.	Clean water diversion channel is well vegetated and stable.

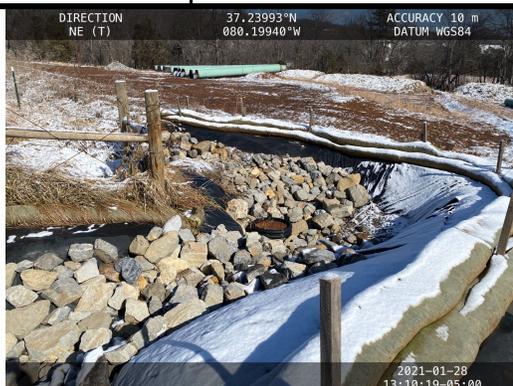
<p>DIRECTION W (T) 37.23340°N 080.20537°W ACCURACY 346 m DATUM WGS84 2021-01-28 13:19:59-05:00</p>	
GPS Location	See photo	GPS Location	See photo
Field Station#	12409+40	Field Station#	12417+00
Pic 11 Desc.	This clean water diversion pipe inlet on the coming in side of MLV-27 is in good condition and functioning properly.	Pic 12 Desc.	Waterbars are in satisfactory condition and functioning properly on the slope leading down to access road MVP-MN-279.

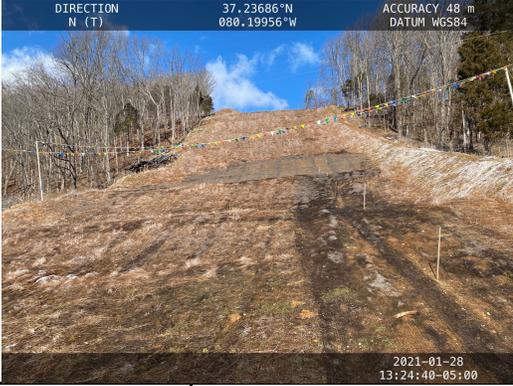
<p>DIRECTION W (T) 37.23655°N 080.19946°W ACCURACY 7 m DATUM WGS84 2021-01-28 13:25:13-05:00</p>	
GPS Location	See photo	GPS Location	See photo
Field Station#	12419+00	Field Station#	12423+00
Pic 13 Desc.	The slope on the coming in side of access road MVP-MN-279 remains stable.	Pic 14 Desc.	P1 silt fence in good condition on the coming in side of the railroad tracks next to MVP-MN-279.

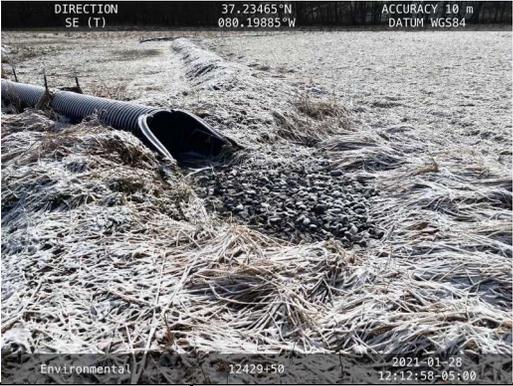
Pic 15 Desc.	The RCE on the going away side of access road MVP-MN-279 is in satisfactory condition and free of sediment.	Pic 16 Desc.	Clean water diversion pipe inlet is in satisfactory condition between access road MVP-MN-279 and the Roanoke River.

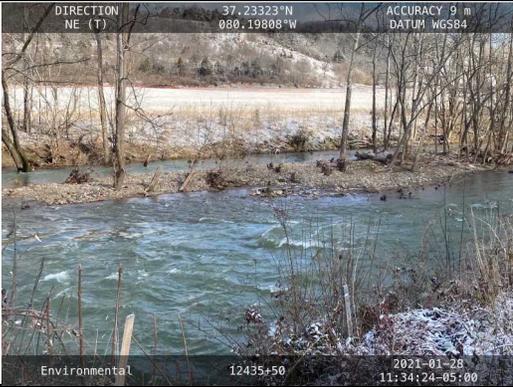
<p>DIRECTION W (T) 37.23242°N 080.19893°W ACCURACY 18 m DATUM WGS84 Environmental 12441+00 2021-01-28 11:36:10-05:00</p>	
GPS Location	See photo	GPS Location	See photo
Field Station#	12435+50	Field Station#	12441+00
Pic 17 Desc.	Stream S-NN16, Roanoke River, facing northeast from Lafayette Road	Pic 18 Desc.	ROW stable between Lafayette Road and Highway 11.

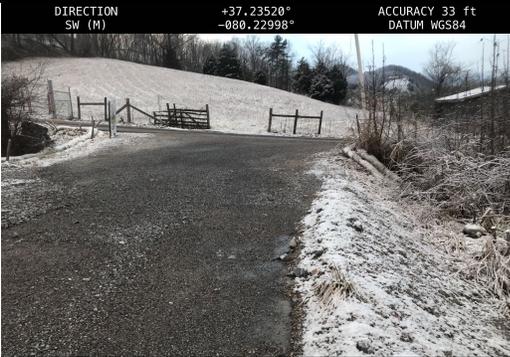
<p>DIRECTION SW (M) +37.23520° -080.22998° ACCURACY 33 ft DATUM WGS84</p> <p>MVP-PY-006_012821 Condition of west rock entrance 2021-01-28 07:48:08-05:00</p>

<p>DIRECTION N (M) +37.23543° -080.22965° ACCURACY 33 ft DATUM WGS84</p> <p>MVP-PY-006_012821 Condition of trays & containment 2021-01-28 07:48:47-05:00</p>			
GPS Location MVP-PY-006 See photo for gps data		GPS Location MVP-PY-006 See photo for gps data			
Field Station# +0		Field Station# +0			
Pic 1 Desc. Condition of west rock entrance. No sediment on stone. Looking SW.		Pic 2 Desc. Condition of trays and containment under toilets. Looking N.

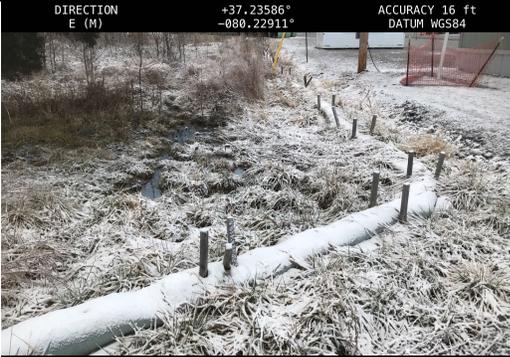
<p>DIRECTION E (M) +37.23586° -080.22911° ACCURACY 16 ft DATUM WGS84</p> <p>MVP-PY-006_012821 Condition of CFS LOD 2021-01-28 07:50:21-05:00</p>

GPS Location MVP-PY-006 See photo for gps data		GPS Location MVP-PY-006 See photo for gps data			
Field Station# +0		Field Station# +0			
Pic 3 Desc. Condition of compost filter sock along north LOD. Looking E.		Pic 4 Desc. Condition of compost filter sock and signage along feature W-CV21B. Looking E.

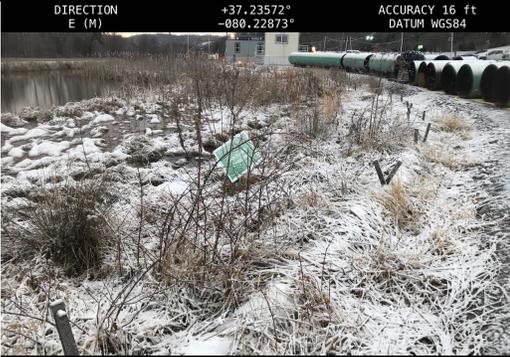
<p>DIRECTION E (M) +37.23572° -080.22873° ACCURACY 16 ft DATUM WGS84</p> <p>MVP-PY-006_012821 Condition of signage & CFS at feature 2021-01-28 07:51:13-05:00</p>

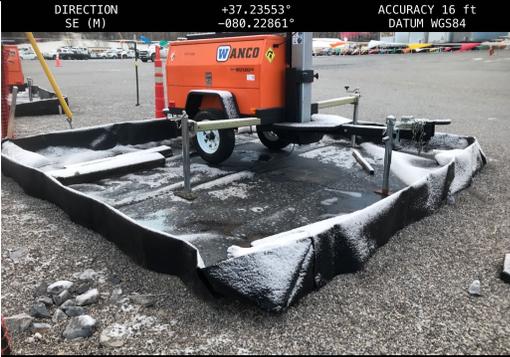
<p>DIRECTION SE (M) +37.23553° -080.22861° ACCURACY 16 ft DATUM WGS84</p> <p>MVP-PY-006_012821 Condition of containment 2021-01-28 07:51:52-05:00</p>

<p>DIRECTION SE (M) +37.23451° -080.22847° ACCURACY 98 ft DATUM WGS84</p> <p>MVP-PY-006_012821 Condition of containment 2021-01-28 07:54:22-05:00</p>			
GPS Location MVP-PY-006 See photo for gps data		GPS Location MVP-PY-006 See photo for gps data			
Field Station# +0		Field Station# +0			
Pic 5 Desc. Condition of containment under light plant. Looking SE.		Pic 6 Desc. Condition of containment. Holding stormwater and ice. Looking SE.

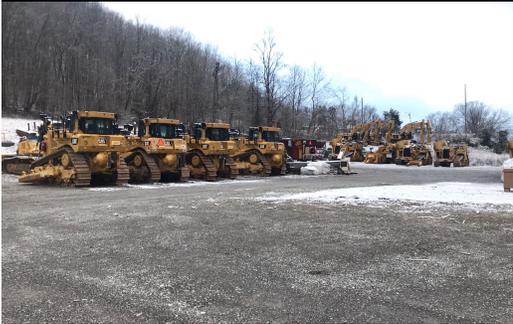
<p>MVP-PY-006_012821 Check stored equipment for new ... 2021-01-28 07:54:43-05:00</p>		<p>DIRECTION SE (M) +37.23448° ACCURACY 16 ft -080.22854° DATUM WGS84</p>

GPS Location	MVP-PY-006 See photo for gps data	GPS Location	MVP-PY-006 See photo for gps data
Field Station#	+0	Field Station#	+0
Pic 7 Desc.	Check stored equipment for new leaks. No new fluid leaks found. Looking SW.	Pic 8 Desc.	Condition of containment under stored equipment. Looking SE.

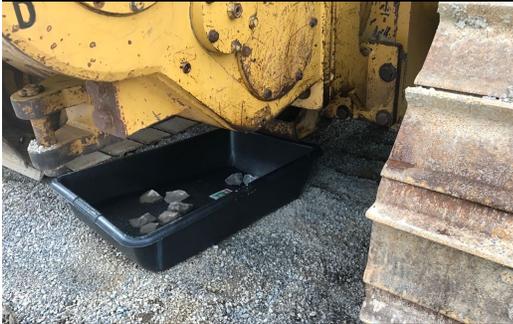
<p>MVP-PY-006_012821 Containment under stored equipment 2021-01-28 08:01:40-05:00</p>	
-------------------------------------------------------------------------------------------------------------------------------------------------------------------------------------------------------------------------------------------------------------------------	--	---------------------------------------------------------------------------------------------------------------------------------------------------------------------------------------------------------------------------------------------------------------------------	--

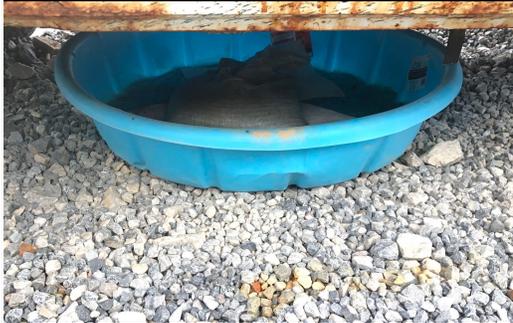
<p>MVP-PY-006_012821 Containment under stored vehicle 2021-01-28 08:06:24-05:00</p>		<p>DIRECTION NE (M) +37.23415° ACCURACY 16 ft -080.22713° DATUM WGS84</p>

GPS Location	MVP-PY-006 See photo for gps data	GPS Location	MVP-PY-006 See photo for gps data
Field Station#	+0	Field Station#	+0
Pic 9 Desc.	Condition of containment under stored vehicle. Looking NE.	Pic 10 Desc.	No deposits or fluids around hazardous waste dumpsters west of the mechanics building. Looking NE.

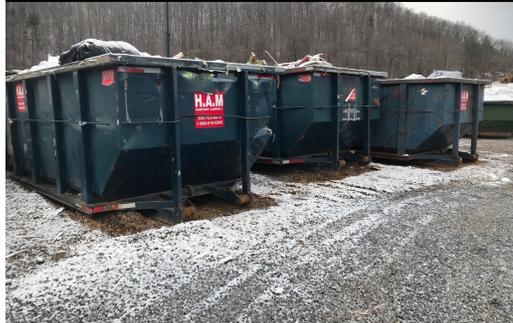
<p>MVP-PY-006_012821 No loose trash around dumpsters 2021-01-28 08:09:52-05:00</p>		<p>DIRECTION SW (M) +37.23554° ACCURACY 16 ft -080.22668° DATUM WGS84</p>

GPS Location	MVP-PY-006 See photo for gps data	GPS Location	MVP-PY-006 See photo for gps data
Field Station#	+0	Field Station#	+0
Pic 11 Desc.	No loose trash around dumpsters. Looking SW.	Pic 12 Desc.	No deposits or fluids around hazardous waste dumpsters. Looking SW.

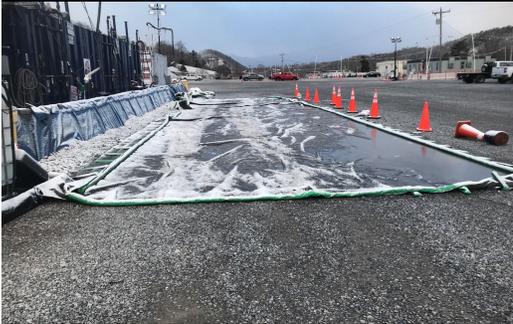
<p>MVP-PY-006_012821 Secondary containment on site for tankers 2021-01-28 08:10:49-05:00</p>	<p>DIRECTION W (M) +37.23571° -080.22678° ACCURACY 16 ft DATUM WGS84</p>

GPS Location MVP-PY-006 See photo for gps data	GPS Location MVP-PY-006 See photo for gps data
Field Station# +0	Field Station# +0
Pic 13 Desc. Secondary containment on site for tankers offloading fuel. Looking W.	Pic 14 Desc. Blue Bulk Fuel tanks no leaky internal fittings. Looking W.

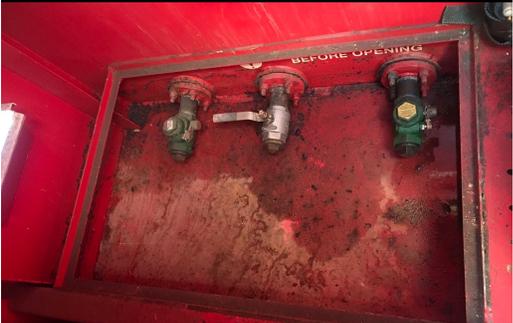
<p>MVP-PY-006_012821 Condition of internal drip pan 2021-01-28 08:14:00-05:00</p>
-----------------------------------------------------------------------------------------------------------------------------------------------------------------------------------------------------------------------------------------	------------------------------------------------------------------------------------------------------------------------------------------------------------------------------------------------------------------------------------------------

GPS Location MVP-PY-006 See photo for gps data	GPS Location MVP-PY-006 See photo for gps data
Field Station# +0	Field Station# +0
Pic 15 Desc. Blue Bulk Fuel tanks containment holding stormwater and ice. Looking N.	Pic 16 Desc. Off Road Fuel unit condition of internal drip pan. Looking W.

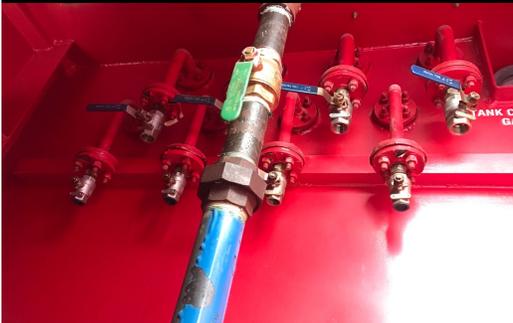
<p>MVP-PY-006_012821 No leaky internal fittings 2021-01-28 08:14:07-05:00</p>	<p>DIRECTION NE (M) +37.23558° -080.22681° ACCURACY 16 ft DATUM WGS84</p>

GPS Location MVP-PY-006 See photo for gps data	GPS Location MVP-PY-006 See photo for gps data
Field Station# +0	Field Station# +0
Pic 17 Desc. Off Road Fuel unit no leaky internal fittings. Looking NW.	Pic 18 Desc. Restoration supplies covered and protected from the elements. Looking NE.
