Visual Site Inspection Report

Project Name H-600 Pipeline Spread H		AFE 124300138	Spread H-600 Pipeline Spread H
Contractor Precision		Report # 19370	
Inspector John Brcic		Date/Time 1/25/2021 11:05 AM	
Permit # TBD	Inspection Type VA SWPP	Station Begin 12119+17	
State VA	Inspection Area Partial	Station End 12284+75	
County Montgomery	Ground Damp	Temperature (°F) 37.00	
Municipality N/A	Weather Light Rain	Rain Gauge (in) 0.00	
			Rain Accumulation Time (days) 3.00

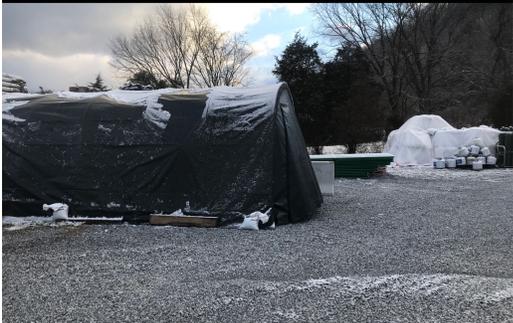
<p>MVP-PY-006_012821 Restoration supplies covered 2021-01-28 08:16:05-05:00</p>
---------------------------------------------------------------------------------------------------------------------------------------------------------------------------------------------------------------------------------------------	------------------------------------------------------------------------------------------------------------------------------------------------------------------------------------------------------------------------------------------------

GPS Location MVP-PY-006 See photo for gps data	GPS Location MVP-PY-006 See photo for gps data
Field Station# +0	Field Station# +0
Pic 17 Desc. Off Road Fuel unit no leaky internal fittings. Looking NW.	Pic 18 Desc. Restoration supplies covered and protected from the elements. Looking NE.

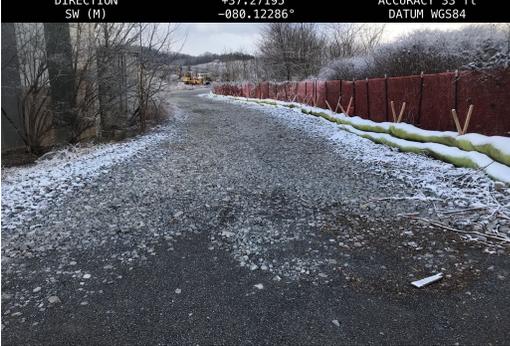
<p>DIRECTION SW (M) +37.27195° -080.12286° ACCURACY 33 ft DATUM WGS84</p> <p>MVP-LY-049_012821 Condition of rock entrance 2021-01-28 08:52:15-05:00</p>

<p>DIRECTION SW (M) +37.27045° -080.12460° ACCURACY 16 ft DATUM WGS84</p> <p>MVP-LY-049_012821 Landowner disturbance along feature 2021-01-28 09:13:55-05:00</p>			
GPS Location MVP-LY-049 See photo for gps data		GPS Location MVP-LY-049 See photo for gps data			
Field Station# +0		Field Station# +0			
Pic 1 Desc. Condition of north rock entrance. No sediment on stone. Looking SW.		Pic 2 Desc. Landowner soil disturbance along north edge of feature W-CV21A. Looking SW.

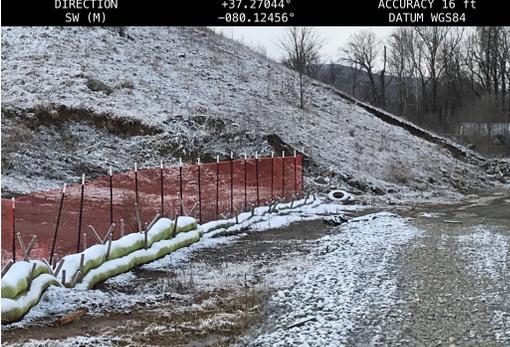
<p>DIRECTION SW (M) +37.27044° -080.12456° ACCURACY 16 ft DATUM WGS84</p> <p>MVP-LY-049_012821 Landowner disturbance within 66' of feature 2021-01-28 09:14:23-05:00</p>

GPS Location MVP-LY-049 See photo for gps data		GPS Location MVP-LY-049 See photo for gps data			
Field Station# +0		Field Station# +0			
Pic 3 Desc. Landowner soil disturbance within 66' and 120' west of feature W-CV21B. Areas not stabilized. No impacts. Looking SW.		Pic 4 Desc. Landowner soil disturbance along compost filter sock and feature W-CV21B. Area not stabilized. No impacts. Looking S.

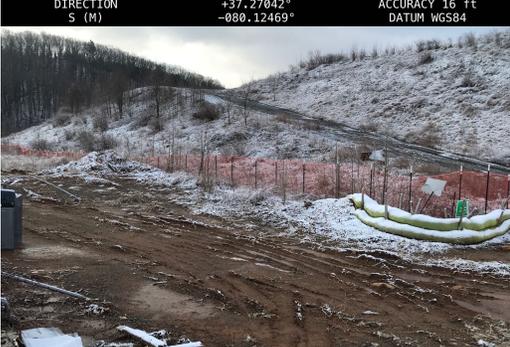
<p>DIRECTION S (M) +37.27042° -080.12469° ACCURACY 16 ft DATUM WGS84</p> <p>MVP-LY-049_012821 Landowner disturbance along CFS & feature 2021-01-28 09:14:58-05:00</p>

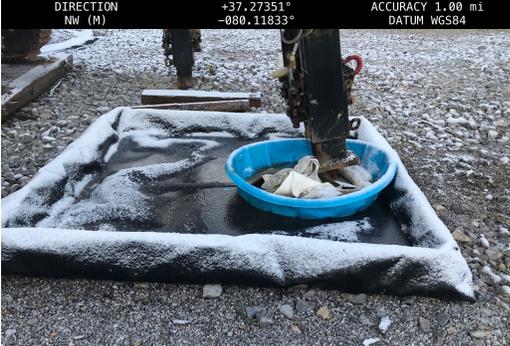
<p>DIRECTION NW (M) +37.27351° -080.11833° ACCURACY 1.00 mi DATUM WGS84</p> <p>MVP-LY-049_012821 Containment under stored equipment 2021-01-28 09:17:36-05:00</p>

<p>DIRECTION S (M) +37.27055° -080.12384° ACCURACY 16 ft DATUM WGS84</p> <p>MVP-LY-049_012821 Containment under stored equipment 2021-01-28 09:17:43-05:00</p>			
GPS Location MVP-LY-049 See photo for gps data		GPS Location MVP-LY-049 See photo for gps data			
Field Station# +0		Field Station# +0			
Pic 5 Desc. Condition of containment under stored equipment. Looking NW.		Pic 6 Desc. Condition of containment under stored equipment. Looking S.

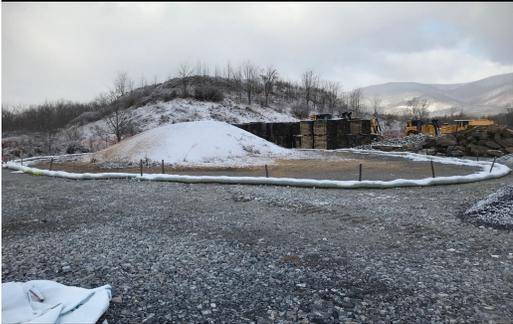
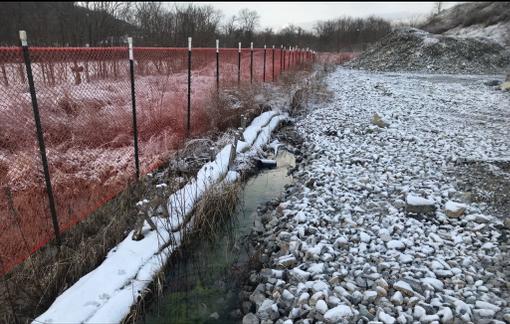
MVP-LY-049_012821 Condition of CFS around sand pile 2021-01-28 09:20:11-05:00		MVP-LY-049_012821 Condition of CFS & safety fence 2021-01-28 09:22:11-05:00			
GPS Location	MVP-LY-049 See photo for gps data		GPS Location	MVP-LY-049 See photo for gps data	
Field Station#	+0		Field Station#	+0	
Pic 7 Desc.	Condition of compost filter sock around sand pile. Looking W.		Pic 8 Desc.	Condition of compost filter sock and safety fence along south LOD. Looking W.	
DIRECTION SE (M) +37.26905° -080.12348° ACCURACY 16 ft DATUM WGS84

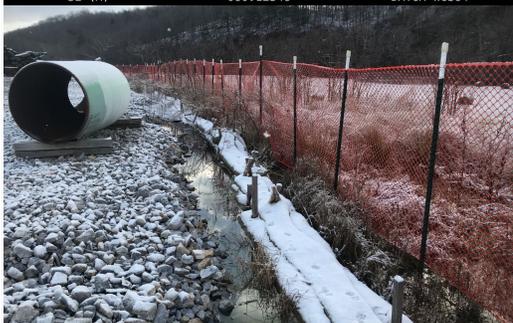
MVP-LY-049_012821 Condition of CFS & safety fence 2021-01-28 09:22:16-05:00		MVP-LY-049_012821 Condition of containment under ... 2021-01-28 09:25:12-05:00

GPS Location	MVP-LY-049 See photo for gps data		GPS Location	MVP-LY-049 See photo for gps data	
Field Station#	+0		Field Station#	+0	
Pic 9 Desc.	Condition of compost filter sock and safety fence along south LOD. Looking SE.		Pic 10 Desc.	Condition of containment under stored vehicle. Looking N.	
DIRECTION N (M) +37.26984° -080.12252° ACCURACY 98 ft DATUM WGS84

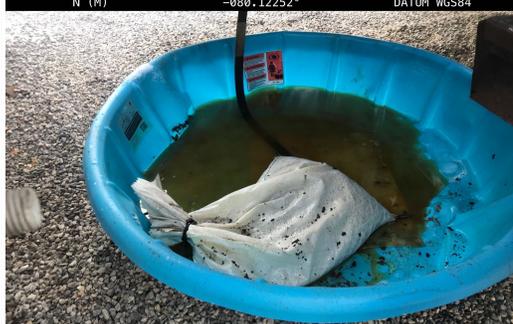
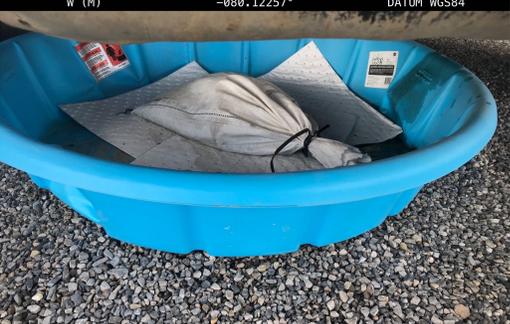
MVP-LY-049_012821 Containment under stored vehicle 2021-01-28 09:25:41-05:00		MVP-LY-049_012821 Containment under stored vehicle 2021-01-28 09:26:02-05:00			
GPS Location	MVP-LY-049 See photo for gps data		GPS Location	MVP-LY-049 See photo for gps data	
Field Station#	+0		Field Station#	+0	
Pic 11 Desc.	Condition of containment under stored vehicle. Looking N.		Pic 12 Desc.	Condition of containment under stored vehicle. Looking W.

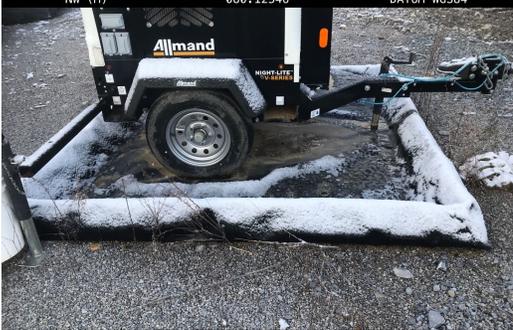
<p>DIRECTION NW (M) +37.27039° -080.12346° ACCURACY 16 ft DATUM WGS84</p> <p>MVP-LY-049_012821 Condition of containment 2021-01-28 09:28:41-05:00</p>

GPS Location MVP-LY-049 See photo for gps data	GPS Location MVP-LY-049 See photo for gps data
Field Station# +0	Field Station# +0
Pic 13 Desc. Condition of containment under light plant. Free of stormwater. Looking NW.	Pic 14 Desc. Debris inside boundary of pit. Looking NW.

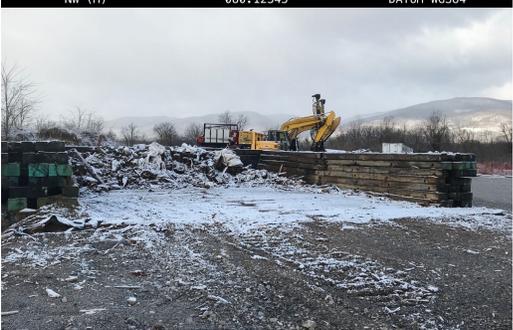
<p>DIRECTION NW (M) +37.27042° -080.12345° ACCURACY 16 ft DATUM WGS84</p> <p>MVP-LY-049_012821 Condition of temporary trash 2021-01-28 09:28:49-05:00</p>
-----------------------------------------------------------------------------------------------------------------------------------------------------------------------------------------------------------------------------------------	----------------------------------------------------------------------------------------------------------------------------------------------------------------------------------------------------------------------------------------------

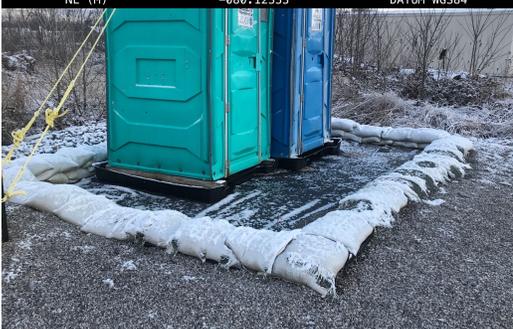
<p>DIRECTION NE (M) +37.27067° -080.12333° ACCURACY 33 ft DATUM WGS84</p> <p>MVP-LY-049_012821 Condition of trays & containment 2021-01-28 09:29:55-05:00</p>

GPS Location MVP-LY-049 See photo for gps data	GPS Location MVP-LY-049 See photo for gps data
Field Station# +0	Field Station# +0
Pic 15 Desc. Condition of trays and containment under toilets. Looking NE.	Pic 16 Desc. No deposits or fluids around hazardous waste dumpsters. Looking NW.

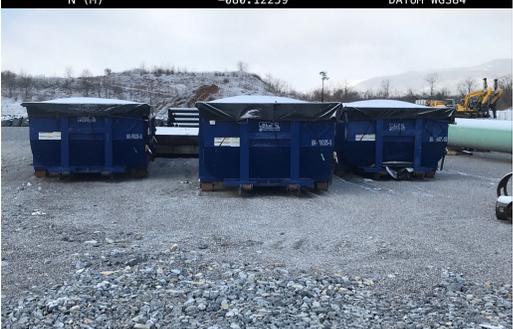
<p>DIRECTION N (M) +37.27055° -080.12259° ACCURACY 16 ft DATUM WGS84</p> <p>MVP-LY-049_012821 No deposits around hazardous waste 2021-01-28 09:31:01-05:00</p>
------------------------------------------------------------------------------------------------------------------------------------------------------------------------------------------------------------------------------------------------------	----------------------------------------------------------------------------------------------------------------------------------------------------------------------------------------------------------------------------------------------------

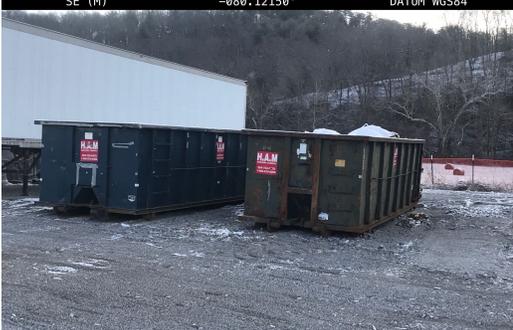
<p>DIRECTION SE (M) +37.27036° -080.12150° ACCURACY 33 ft DATUM WGS84</p> <p>MVP-LY-049_012821 No loose trash around south dumpsters 2021-01-28 09:32:03-05:00</p>

GPS Location MVP-LY-049 See photo for gps data	GPS Location MVP-LY-049 See photo for gps data
Field Station# +0	Field Station# +0
Pic 17 Desc. No loose trash around south dumpsters. Looking SE.	Pic 18 Desc. Restoration supplies covered and protected from the elements. Looking S.

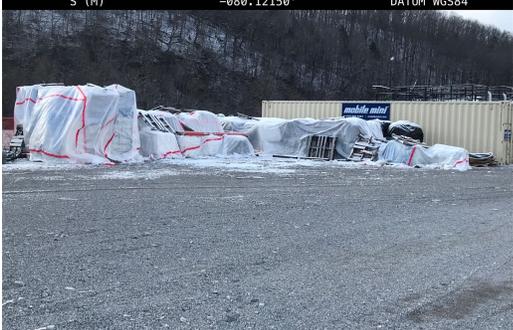
<p>DIRECTION S (M) +37.27033° -080.12150° ACCURACY 33 ft DATUM WGS84</p> <p>MVP-LY-049_012821 Restoration supplies covered 2021-01-28 09:32:23-05:00</p>
--------------------------------------------------------------------------------------------------------------------------------------------------------------------------------------------------------------------------------------------------------	-----------------------------------------------------------------------------------------------------------------------------------------------------------------------------------------------------------------------------------------------

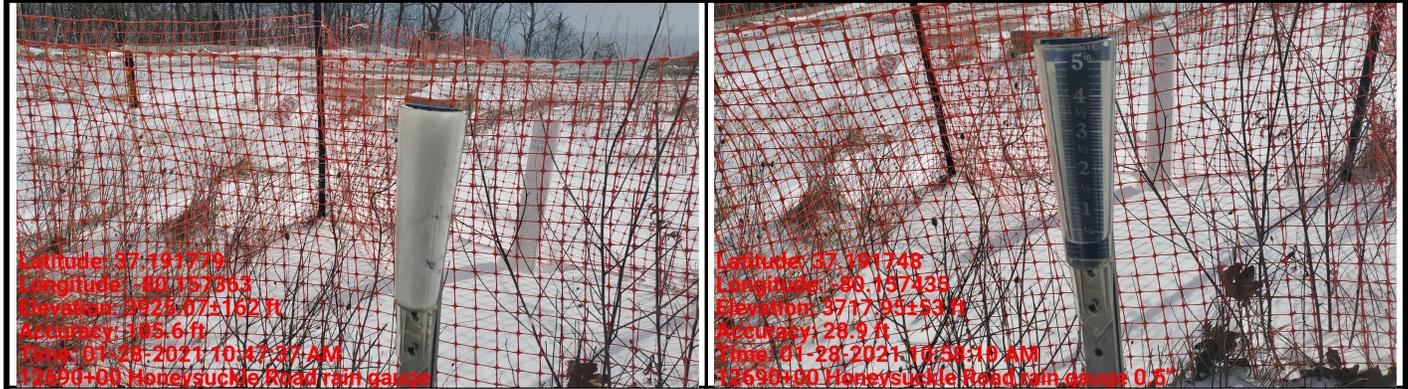
GPS Location See pic for GPS location	GPS Location See pic for GPS location
Field Station# 12690+00	Field Station# 12690+00
Pic 1 Desc. Honeysuckle Road rain gauge.	Pic 2 Desc. 0.5" total precipitation after melting snow and ice.

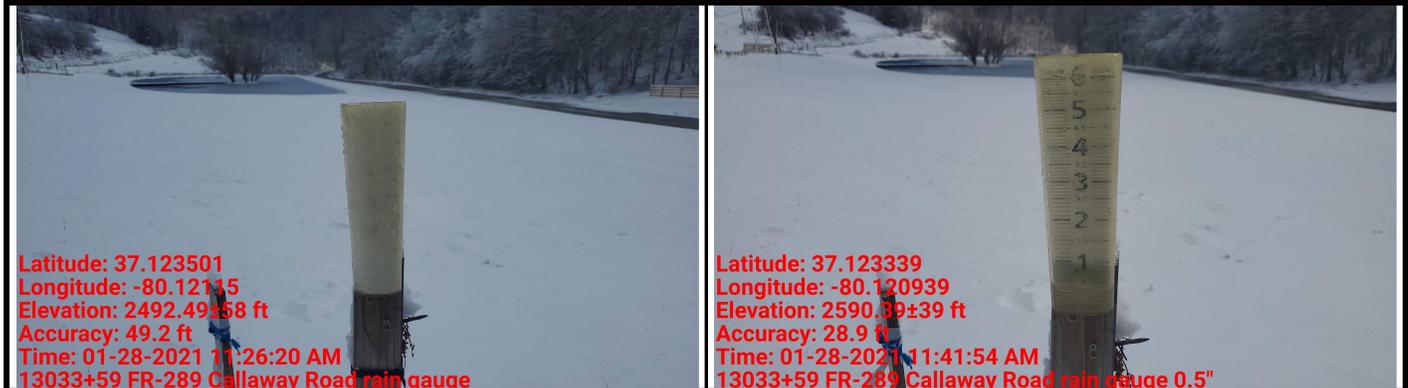
GPS Location See pic for GPS location	GPS Location See pic for GPS location
Field Station# 13033+59	Field Station# 13033+59
Pic 3 Desc. Callaway Road rain gauge.	Pic 4 Desc. 0.5" total precipitation after melting snow and ice.

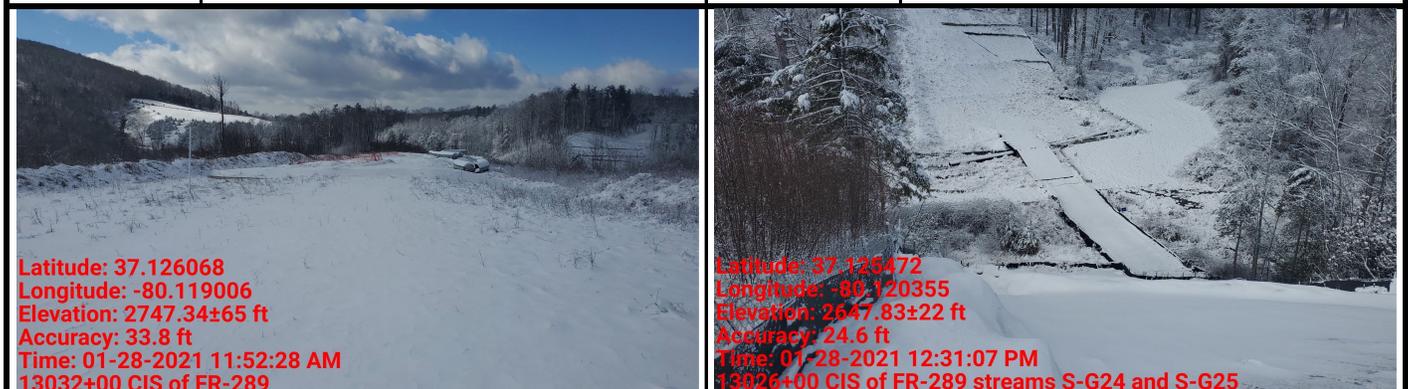
GPS Location See pic for GPS location	GPS Location See pic for GPS location
Field Station# 13032+00	Field Station# 13026+00
Pic 5 Desc. Current ROW conditions on the CIS of FR-289.	Pic 6 Desc. Streams S-G24 and S-G25 on the GAS of the BRP.

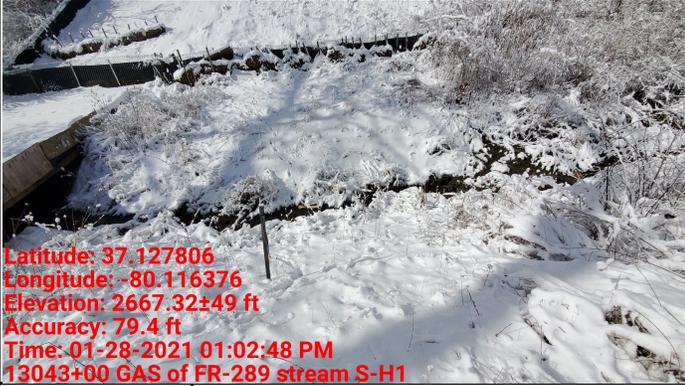
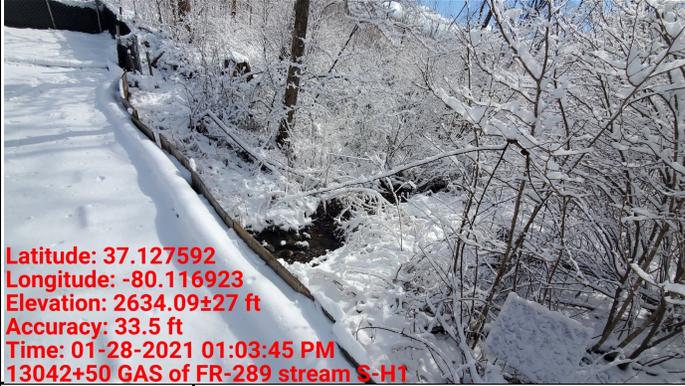
<p>Latitude: 37.127592 Longitude: -80.116923 Elevation: 2634.09±27 ft Accuracy: 33.5 ft Time: 01-28-2021 01:03:45 PM 13042+50 GAS of FR-289 stream S-H1</p>
GPS Location See pic for GPS location	GPS Location See pic for GPS location
Field Station# 13043+00	Field Station# 13042+50
Pic 7 Desc. Stream S-H1 upstream of the equipment bridge.	Pic 8 Desc. Stream S-H1 downstream of the equipment bridge.

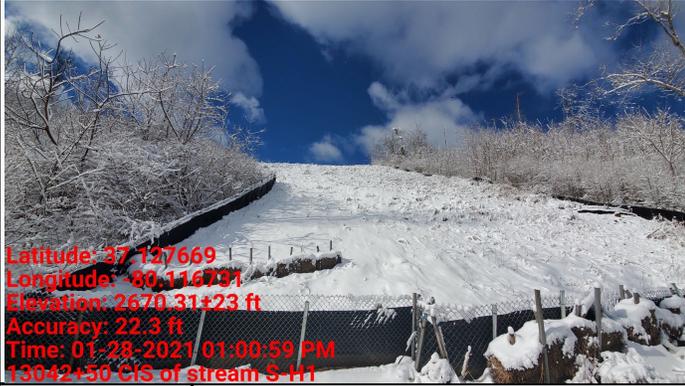
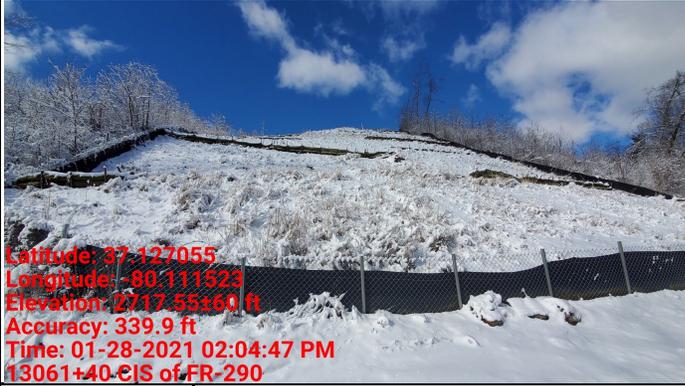
Field Station# 13042+50	Field Station# 13061+40
Pic 9 Desc. Slope on the CIS of stream S-H1	Pic 10 Desc. Slope on the CIS of FR-290.

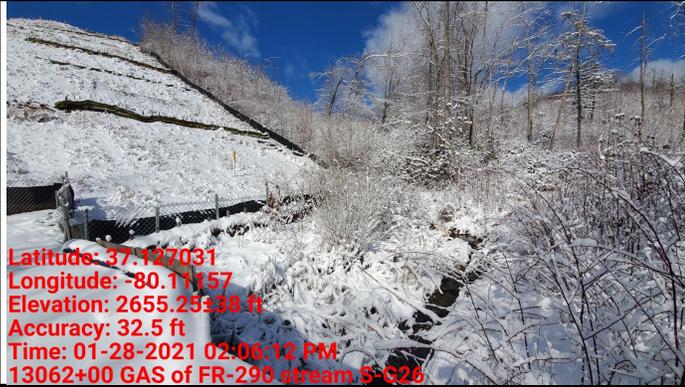
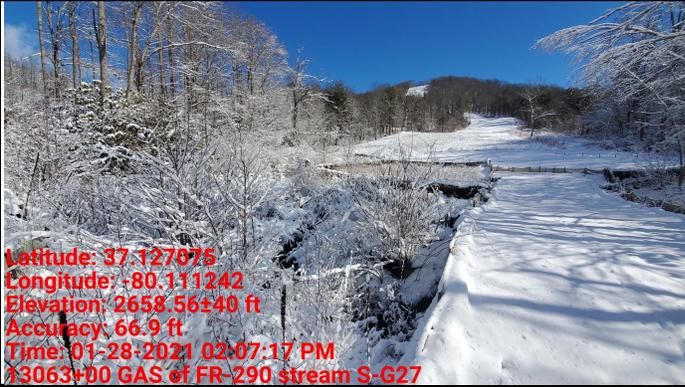
<p>Latitude: 37.127075 Longitude: -80.111242 Elevation: 2658.56±40 ft Accuracy: 66.9 ft Time: 01-28-2021 02:07:17 PM 13063+00 GAS of FR-290 stream S-G27</p>
GPS Location See pic for GPS location	GPS Location See pic for GPS location
Field Station# 13062+00	Field Station# 13063+00
Pic 11 Desc. Stream S-G26 on the GAS of FR-290.	Pic 12 Desc. Stream S-G27 on the GAS of FR-290.

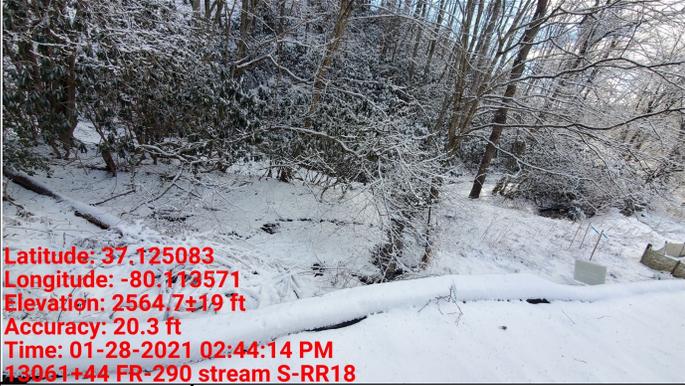
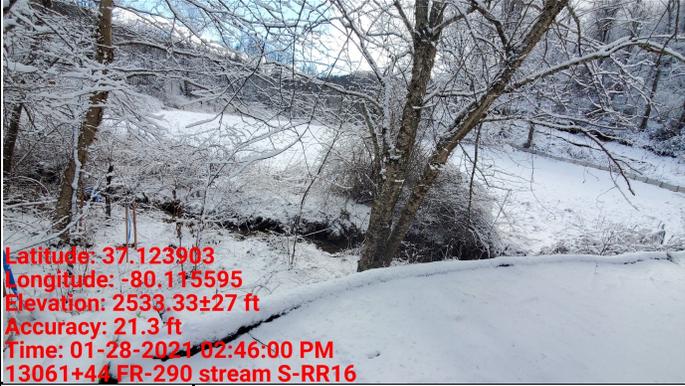
<p>Latitude: 37.123903 Longitude: -80.115595 Elevation: 2533.33±27 ft Accuracy: 21.3 ft Time: 01-28-2021 02:46:00 PM 13061+44 FR-290 stream S-RR16</p>	
GPS Location	See pic for GPS location	GPS Location	See pic for GPS location
Field Station#	13061+44	Field Station#	13061+44
Pic 13 Desc.	Stream S-RR18 on access road FR-290.	Pic 14 Desc.	Stream S-RR16 on access road FR-290.

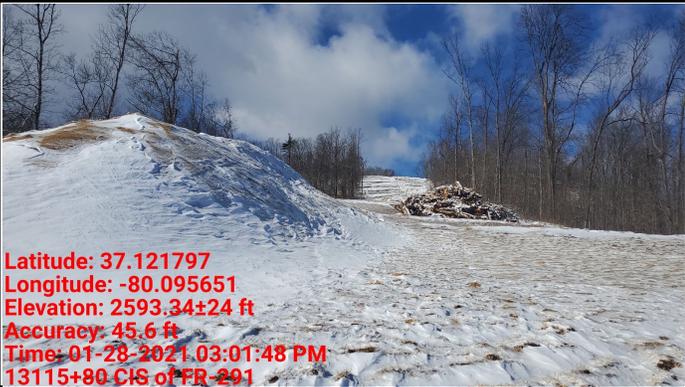
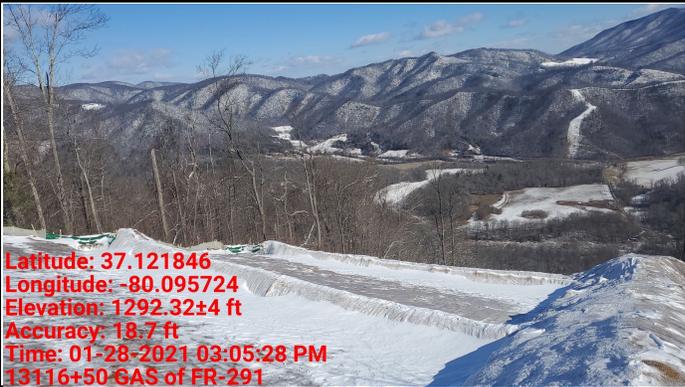
Field Station#	13115+80	Field Station#	13116+50
Pic 15 Desc.	Stabilized ROW on the CIS of FR-291.	Pic 16 Desc.	Stabilized ROW on the GAS of FR-291.

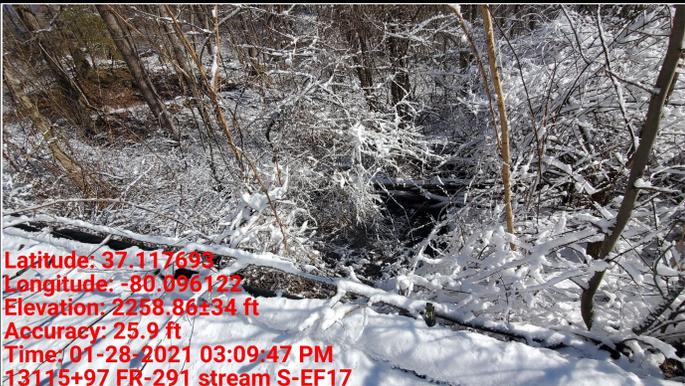
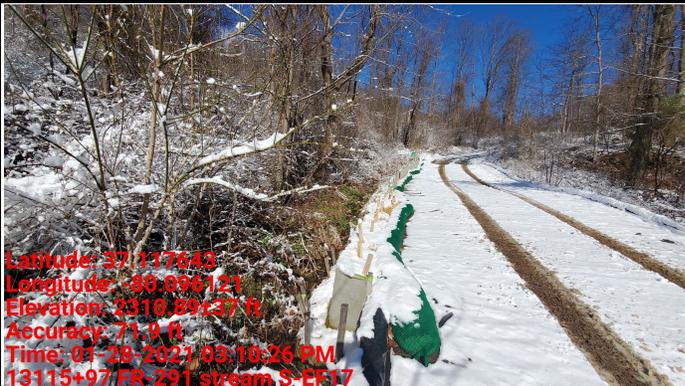
<p>Latitude: 37.117643 Longitude: -80.096121 Elevation: 2310.89±37 ft Accuracy: 71.9 ft Time: 01-28-2021 03:10:26 PM 13115+97 FR-291 stream S-EF17</p>	
GPS Location	See pic for GPS location	GPS Location	See pic for GPS location
Field Station#	13115+97	Field Station#	13115+97
Pic 17 Desc.	Downstream side of stream S-EF17.	Pic 18 Desc.	Upstream side of stream S-EF17 along FR-291.

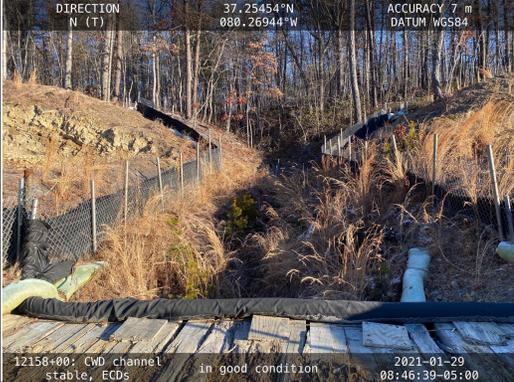
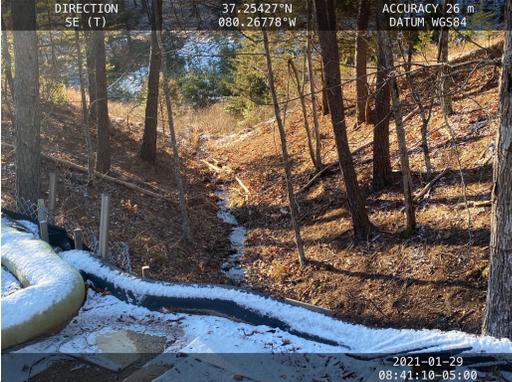
GPS Location	See photo	GPS Location	See photo
Field Station#	12158+00	Field Station#	12163+05
Pic 7 Desc.	Clean water diversion channel well vegetated and stable, ECDs in satisfactory condition.	Pic 8 Desc.	Stream S-C25, facing southeast, downstream

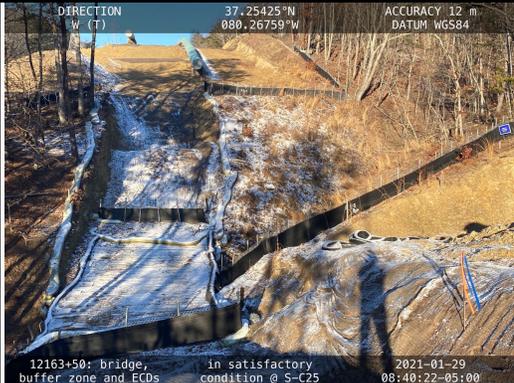
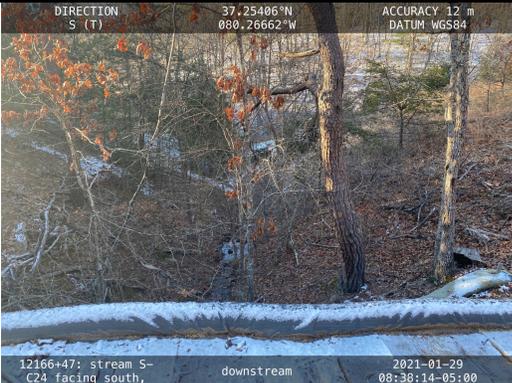
GPS Location	See photo	GPS Location	See photo
Field Station#	12163+50	Field Station#	12166+47
Pic 9 Desc.	Bridge, buffer zone and ECDs in satisfactory condition at stream S-C25.	Pic 10 Desc.	Stream S-C24, facing south, downstream

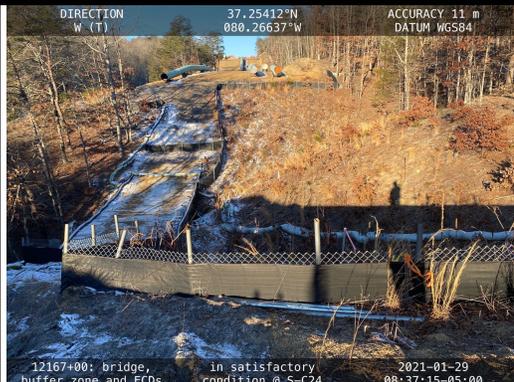
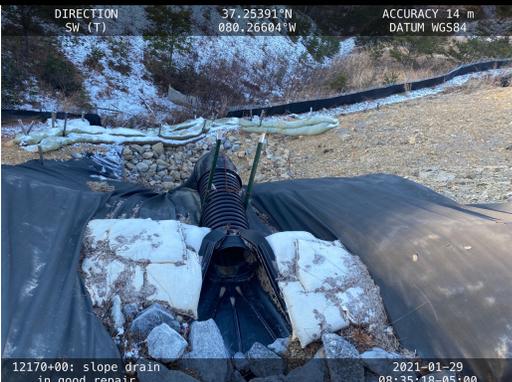
GPS Location	See photo	GPS Location	See photo
Field Station#	12167+00	Field Station#	12170+00
Pic 11 Desc.	Bridge, buffer zone and ECDs in satisfactory condition at stream S-C24.	Pic 12 Desc.	Slope drain in satisfactory condition.

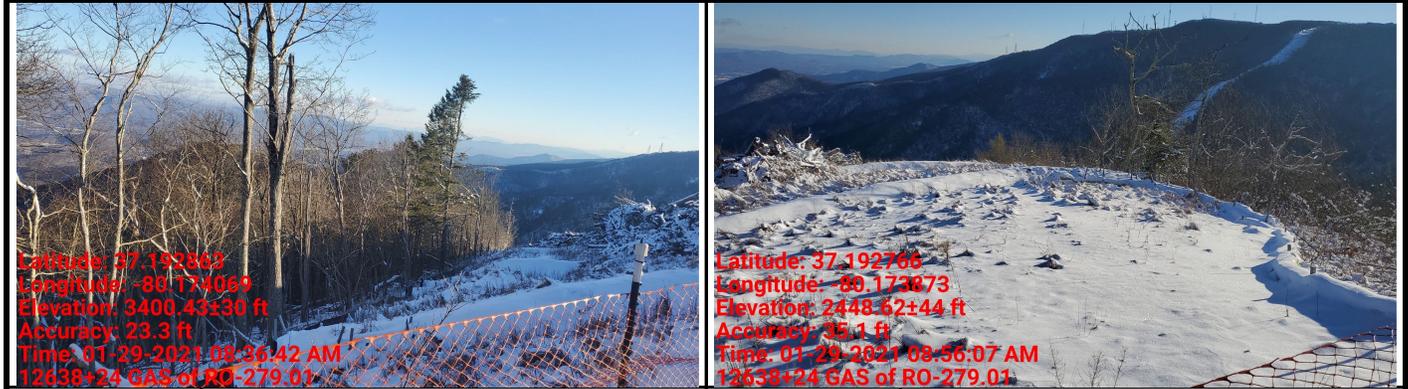
GPS Location	See pic for GPS location	GPS Location	See pic for GPS location
Field Station#	12638+24	Field Station#	12638+24
Pic 1 Desc.	GAS of RO-279.01 edge of ROW.	Pic 2 Desc.	GAS of RO-279.01 edge of ROW.

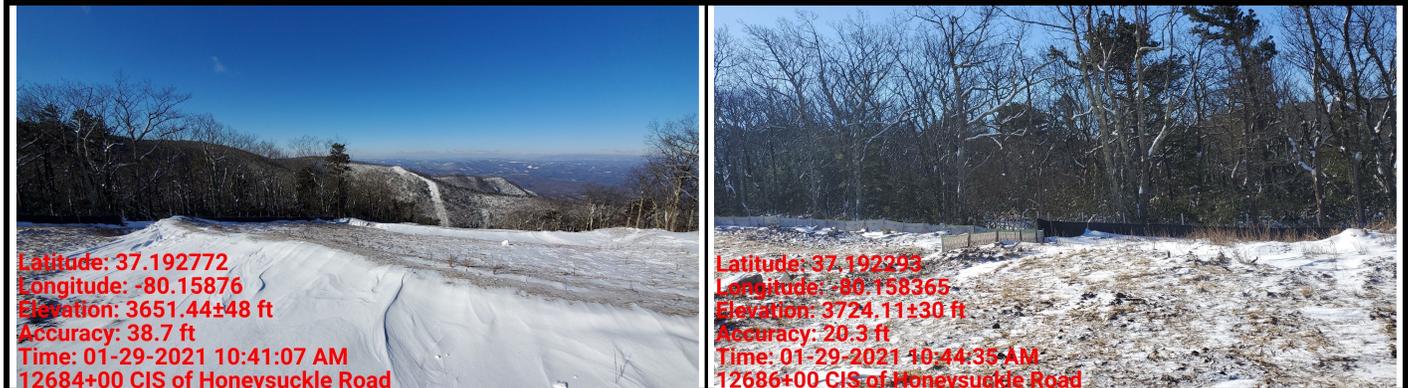
GPS Location	See pic for GPS location	GPS Location	See pic for GPS location
Field Station#	12684+00	Field Station#	12686+00
Pic 3 Desc.	Waterbars, sumps and end treatments remain in acceptable condition on the CIS of Honeysuckle Road.	Pic 4 Desc.	Perimeter P1 and SSF remain in acceptable condition on the CIS of Honeysuckle Road.

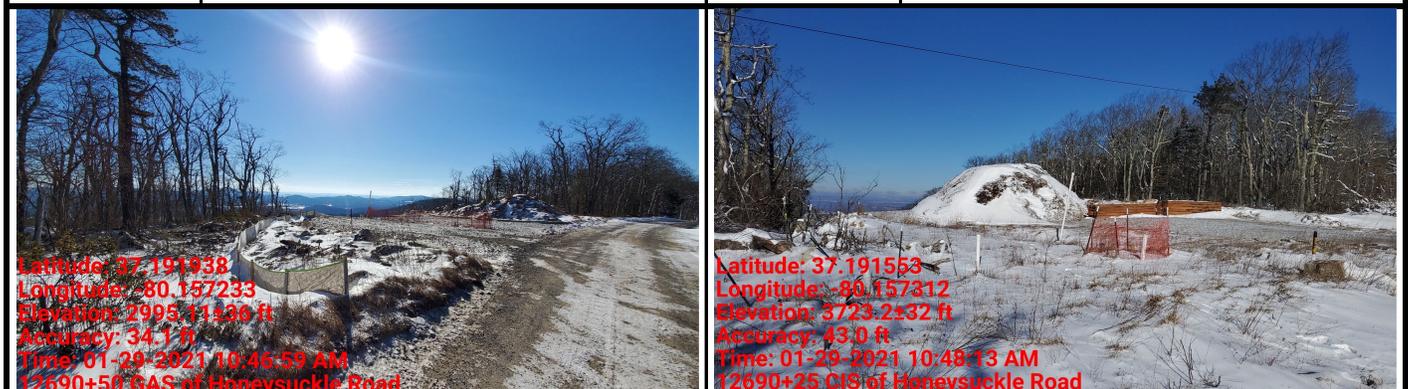
GPS Location	See pic for GPS location	GPS Location	See pic for GPS location
Field Station#	12690+50	Field Station#	12690+25
Pic 5 Desc.	GAS of Honeysuckle Road and RCE.	Pic 6 Desc.	CIS of Honeysuckle Road and RCE.

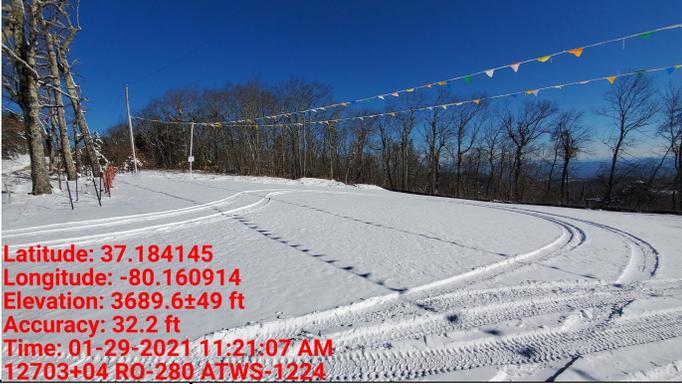
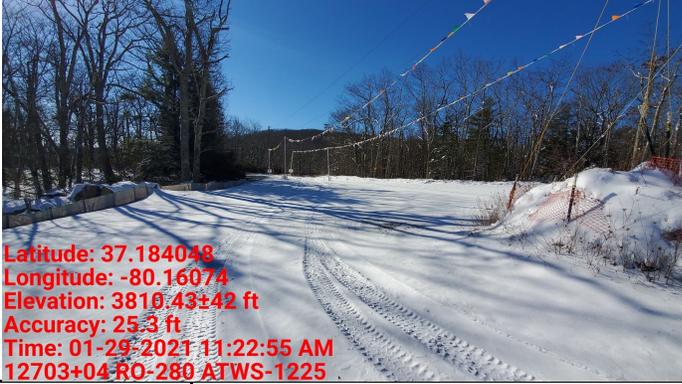
<p>Latitude: 37.184048 Longitude: -80.16074 Elevation: 3810.43±42 ft Accuracy: 25.3 ft Time: 01-29-2021 11:22:55 AM 12703+04 RO-280 ATWS-1225</p>	
GPS Location	See pic for GPS location	GPS Location	See pic for GPS location
Field Station#	12703+04	Field Station#	12703+04
Pic 7 Desc.	ATWS at Honeysuckle and access road RO-280.	Pic 8 Desc.	ATWS at Honeysuckle and access road RO-280.

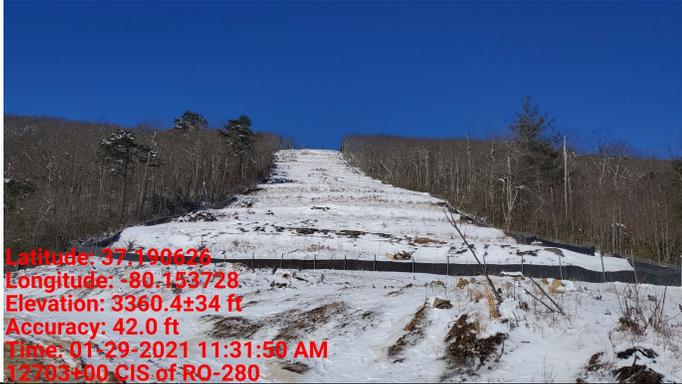
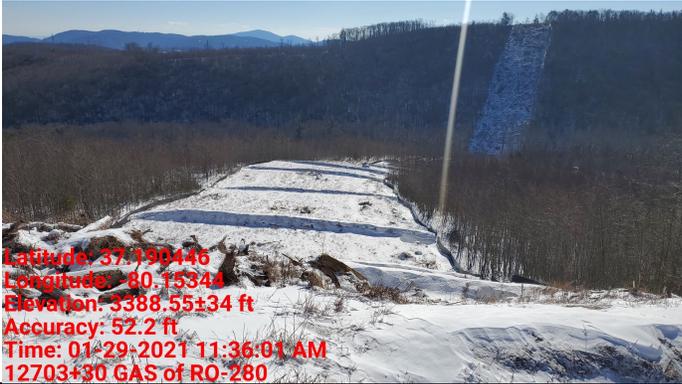
Field Station#	12703+00	Field Station#	12703+30
Pic 9 Desc.	Slope on the GAS of Honeysuckle and the CIS of RO-280.	Pic 10 Desc.	GAS of RO-280 remains in acceptable condition. No maintenance issues or impacts observed.

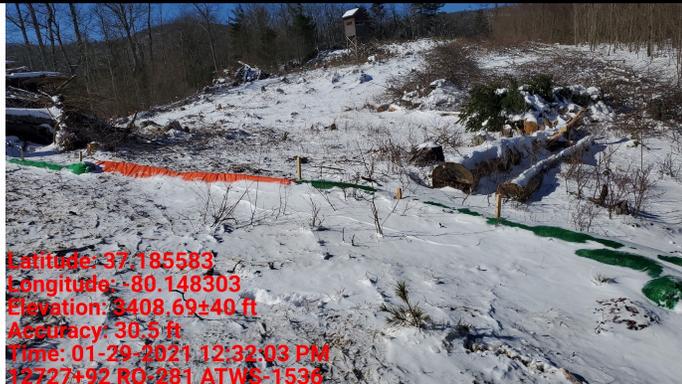
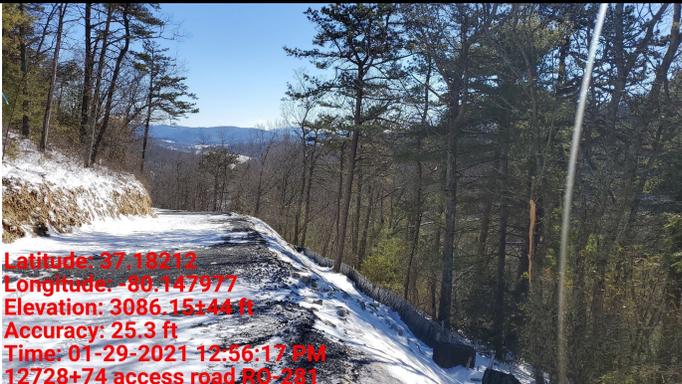
<p>Latitude: 37.18212 Longitude: -80.147977 Elevation: 3086.15±44 ft Accuracy: 25.3 ft Time: 01-29-2021 12:56:17 PM 12728+74 access road RO-281</p>	
GPS Location	See pic for GPS location	GPS Location	See pic for GPS location
Field Station#	12727+92	Field Station#	12728+74
Pic 11 Desc.	Edge of the ATWS and undisturbed ROW on RO-281.	Pic 12 Desc.	ECD's and BMP's along access road RO-281 remain in acceptable condition.

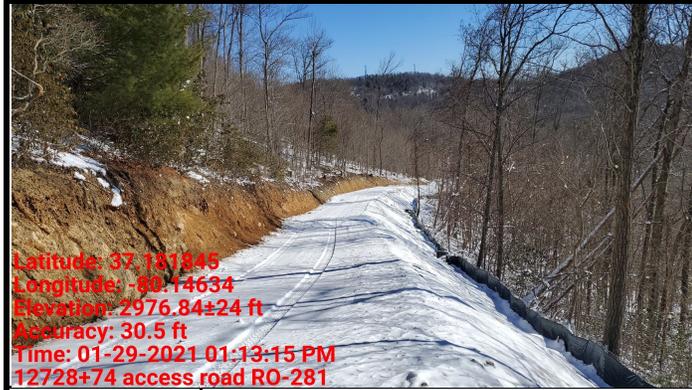
Pic 13 Desc.	ECD's and BMP's along access road RO-281 remain in acceptable condition.
---------------------	--------------------------------------------------------------------------

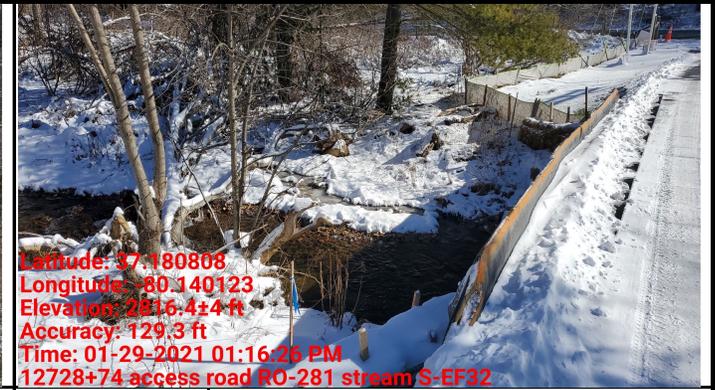
Pic 14 Desc.	No issues or impacts observed at stream S-EF32 along access road RO-281.
---------------------	--------------------------------------------------------------------------

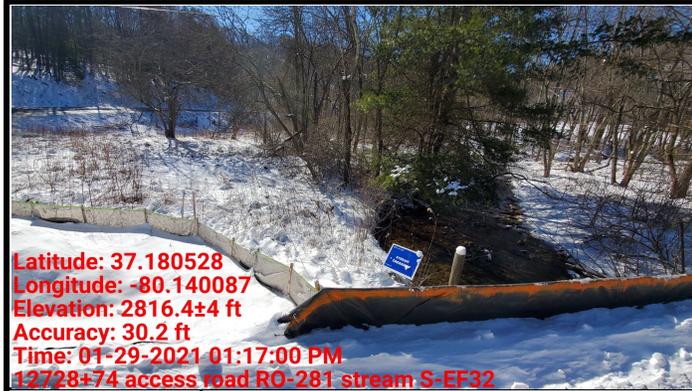
Pic 15 Desc.	No issues or impacts observed at stream S-EF32 along access road RO-281.
---------------------	--------------------------------------------------------------------------

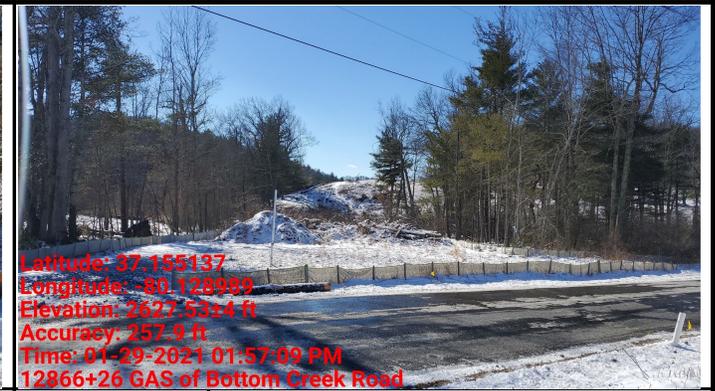
Pic 16 Desc.	GAS of Bottom Creek road remains in compliance.
---------------------	-------------------------------------------------

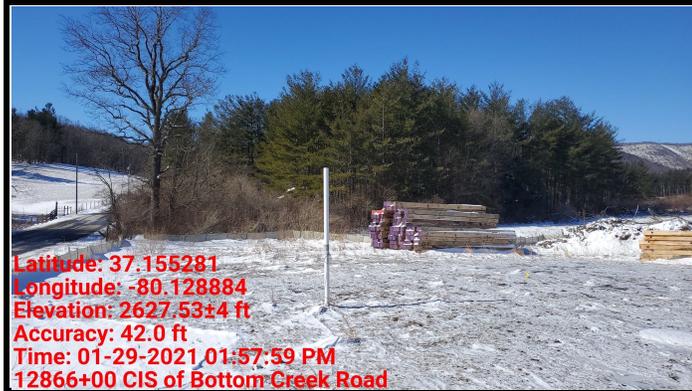
Pic 17 Desc.	ROW remains stabilized and in acceptable condition.
---------------------	-----------------------------------------------------

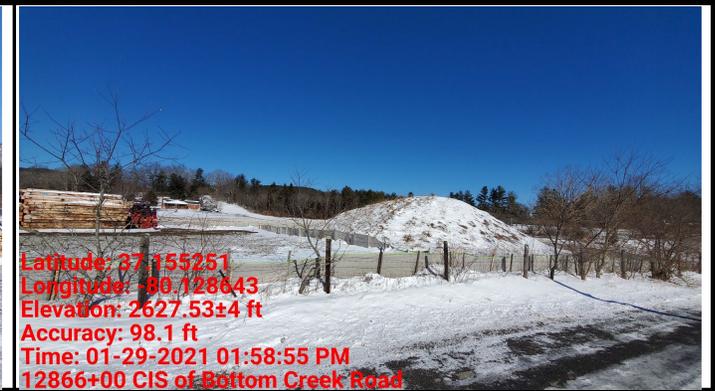
Pic 18 Desc.	No maintenance issues or impacts observed on the CIS of Bottom Creek Road.
---------------------	----------------------------------------------------------------------------

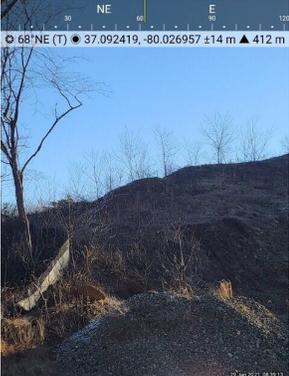
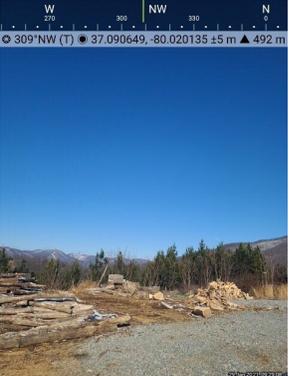
GPS Location	00000
GPS Location	0000	GPS Location	00000	Field Station#	13415+77
Pic 1 Desc.	During the EI's travel today the EI monitored ECDs along row edge inside a work space near CAHAS#1 , no environmental issues observed at the time of inspection.		Pic 2 Desc.	Observed area where a land owner has been cutting fire wood on row, no leaks or spill noticed at time of inspection, will continue to monitor the area.

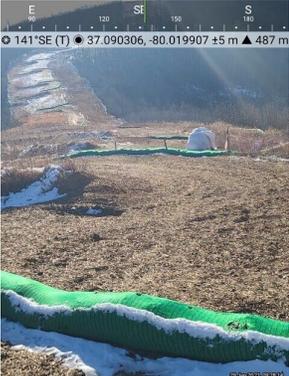
GPS Location	00000
GPS Location	0000	GPS Location	00000	Field Station#	13438+12
Pic 3 Desc.	Row conditions were frozen , monitored CFS across the row with no environmental issues observed.		Pic 4 Desc.	The EI monitored sump pits and ECDs installed at CAHAS#1 crossing, no issue observed at the time of inspection.

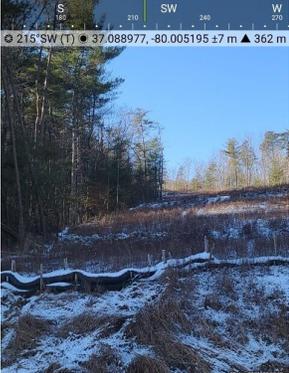
Pic 5 Desc.	CAHAS #2 crossing, the EI monitored vegetation and ECDs as Row conditions were frozen .		Pic 6 Desc.	Observed stream crossing where equipment bridge was removed during maintenance repairs, no environmental issues observed at the time of inspection.
