Visual Site Inspection Report

Project Name H-600 Pipeline Spread H		AFE 124300138	Spread H-600 Pipeline Spread H
Contractor Precision		Report # 19600	
Inspector Dawn McCullough		Date/Time 2/1/2021 2:54 PM	
Permit # TBD	Inspection Type VA SWPP	Station Begin 13141+65	
State VA	Inspection Area Partial	Station End 13316+21	
County Franklin	Ground Frozen	Temperature (°F) 37.00	
Municipality N/A	Weather Cloudy	Rain Gauge (in) 0.60	
			Rain Accumulation Time (days) 1.00

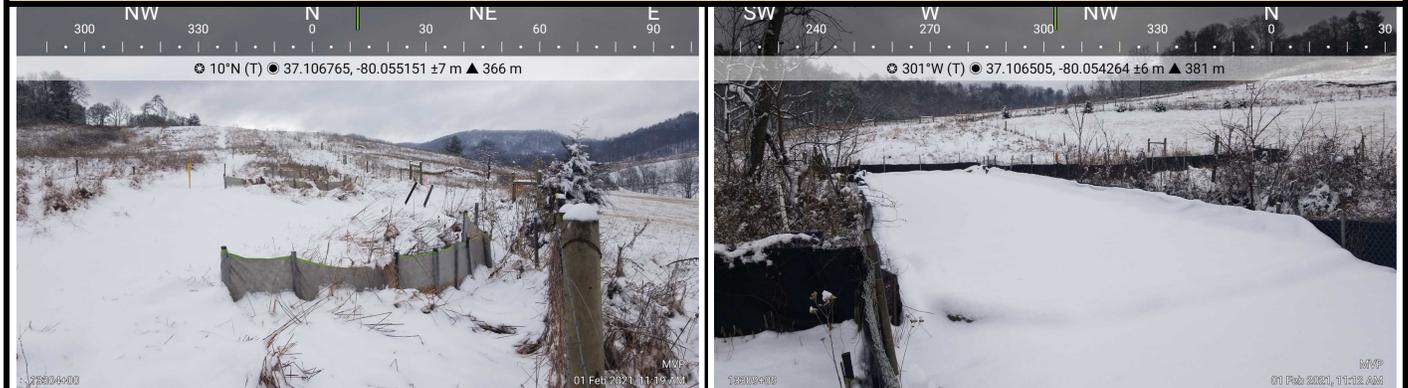
Field Station#	13304+00	Field Station#	13309+09
-----------------------	----------	-----------------------	----------

Pic 1 Desc.	ROW stable, snow covered, ground frozen.	Pic 2 Desc.	No observable issues at equipment crossing over S-GH7.
--------------------	--	--------------------	--

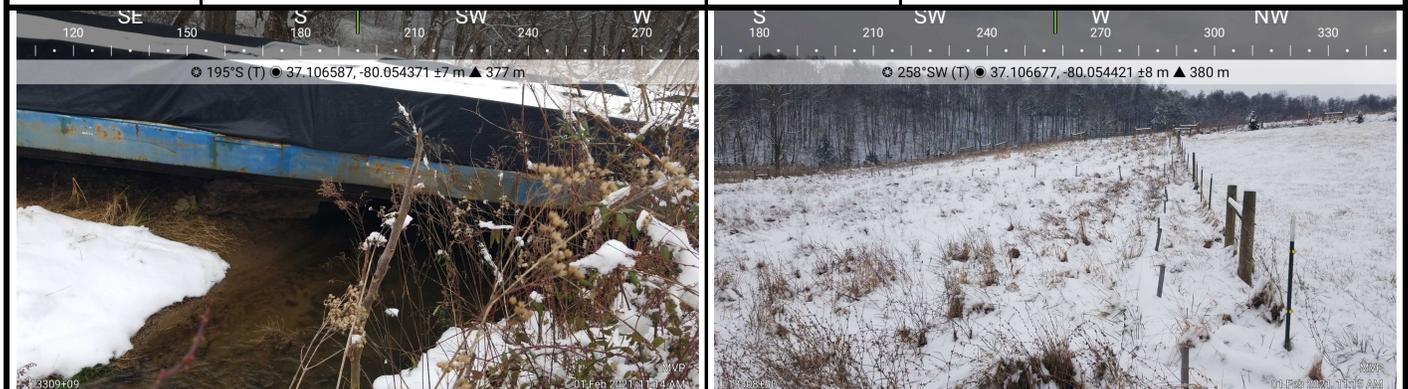
Field Station#	13309+09	Field Station#	13308+50
-----------------------	----------	-----------------------	----------

Pic 3 Desc.	S-GH7, bridge in acceptable condition, water flowing unobstructed under bridge.	Pic 4 Desc.	ROW stable, ECDs snow covered.
--------------------	---	--------------------	--------------------------------

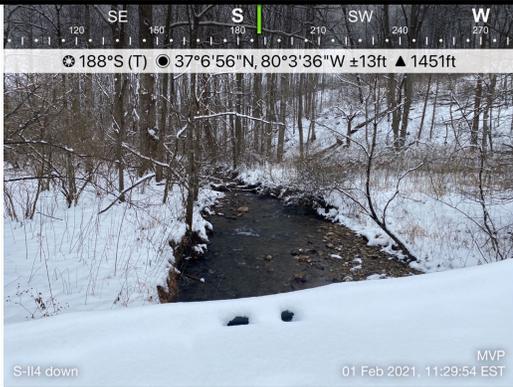
GPS Location	See photo for coordinates.
Field Station#	13261+00	GPS Location	See photo for coordinates.	Pic 7 Desc.	Perimeter controls in acceptable condition along S-II4, ROW stable and snow covered.
Pic 8 Desc.		Pic 8 Desc.	S-II4, upstream, no environmental concerns noted at stream crossing.

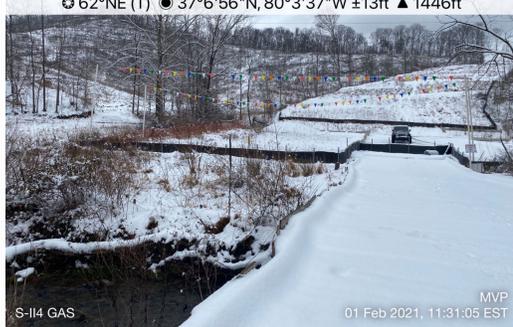
GPS Location	See photo for coordinates.
Field Station#	13260+60	Field Station#	13260+60	Pic 9 Desc.	S-II4, downstream, no changes noted to stream bed or banks.
Pic 10 Desc.		Pic 10 Desc.	S-II4, water flowing clear.

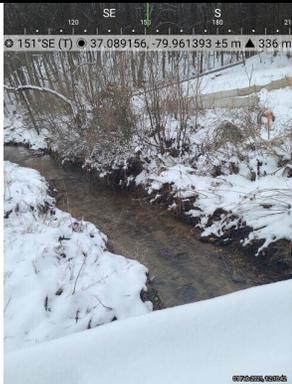
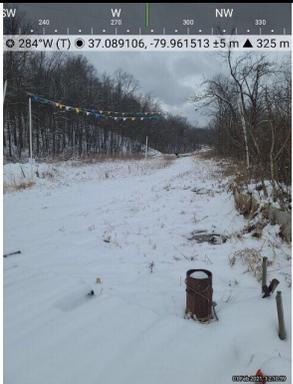
GPS Location	00000	GPS Location	0000	
Field Station#	12643+53	Field Station#	13643+00	
Pic 1 Desc.	Stream observation photo facing downstream, no environmental issues observed at time of inspection		Pic 2 Desc.

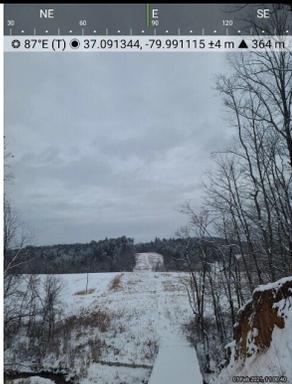
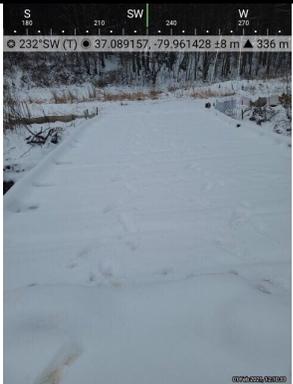
GPS Location	0000	GPS Location	0000	
Field Station#	13541+89	Field Station#	13643+53	
Pic 3 Desc.	Row photo showing snow accumulation from recent snow events		Pic 4 Desc.

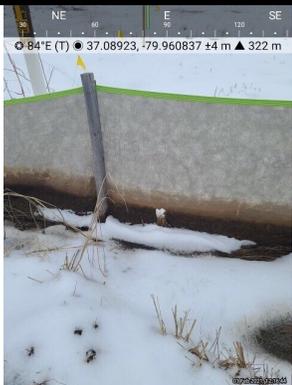
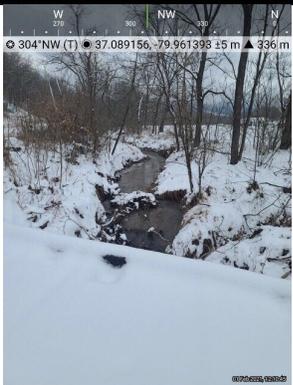
Throughout today's inspections the EI noticed a section of P1 was damaged from wildlife, documented and sent in to be added to the punch list.

GPS Location	0000	GPS Location	0000	
Field Station#	13644+90	Field Station#	13643+53	
Pic 5 Desc.	P1 damaged from wildlife, requires maintenance, documented and sent in to be added to the punch list		Pic 6 Desc.

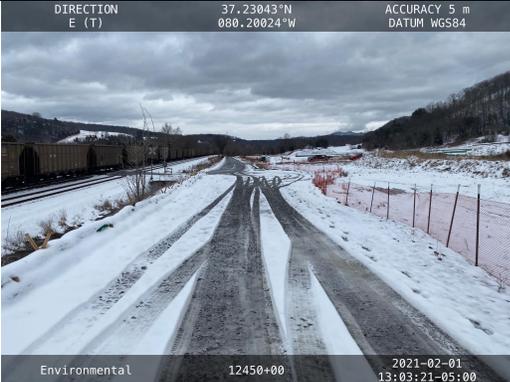
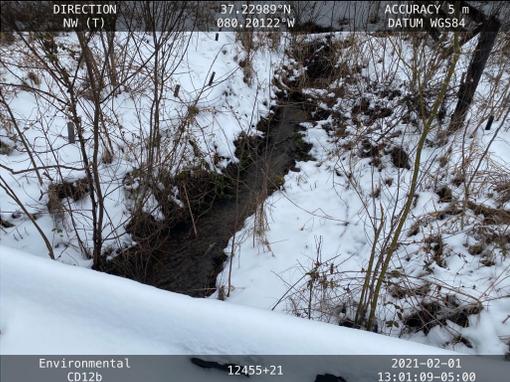
<p>DIRECTION NW (T) 37.22989°N 080.20122°W ACCURACY 5 m DATUM WGS84 Environmental CD12b 12455+21 2021-02-01 13:01:09-05:00</p>			
GPS Location See photo		GPS Location See photo			
Field Station# 12450+00		Field Station# 12455+21			
Pic 1 Desc. RCE on access road MVP-MLV-AR-28		Pic 2 Desc. S-CD12b down stream

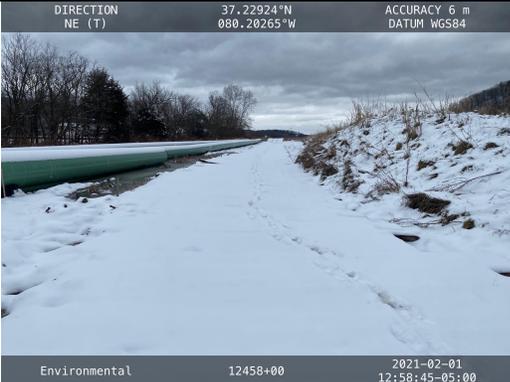
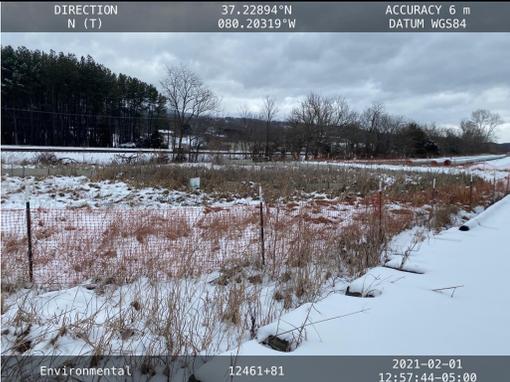
<p>DIRECTION N (T) 37.22894°N 080.20319°W ACCURACY 6 m DATUM WGS84 Environmental 12461+81 2021-02-01 12:57:44-05:00</p>			
GPS Location See photo		GPS Location See photo			
Field Station# 12458+00		Field Station# 12461+81			
Pic 3 Desc. ROW covered in snow		Pic 4 Desc. W-KL58 in acceptable condition

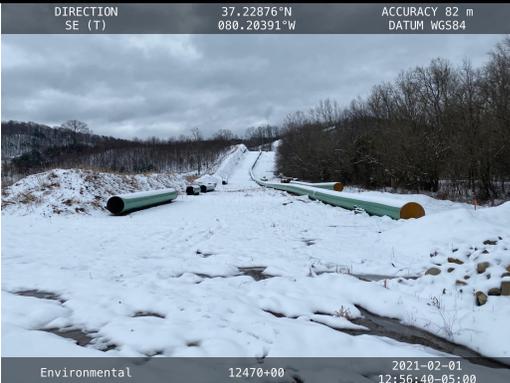
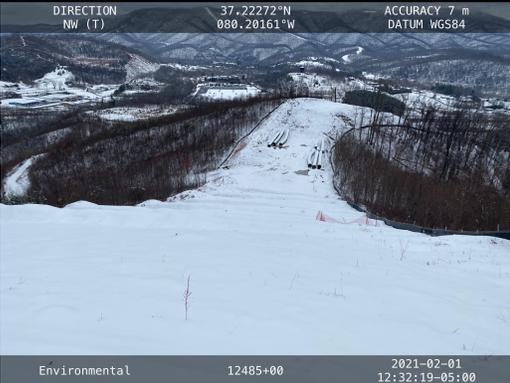
<p>DIRECTION NW (T) 37.22272°N 080.20161°W ACCURACY 7 m DATUM WGS84 Environmental 12485+00 2021-02-01 12:32:19-05:00</p>			
GPS Location See photo		GPS Location See photo			
Field Station# 12470+00		Field Station# 12485+00			
Pic 5 Desc. Stabilized ROW covered in snow		Pic 6 Desc. Stabilized slope covered in snow

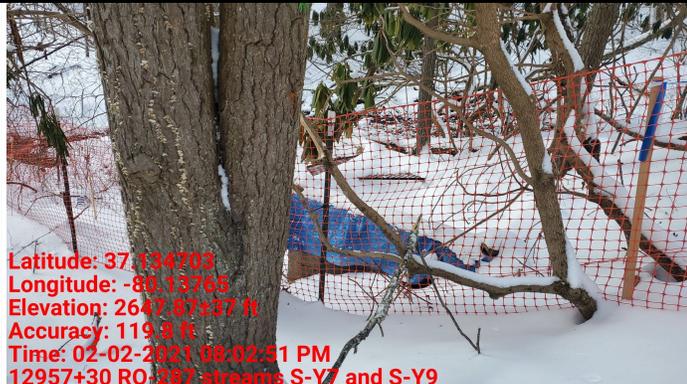
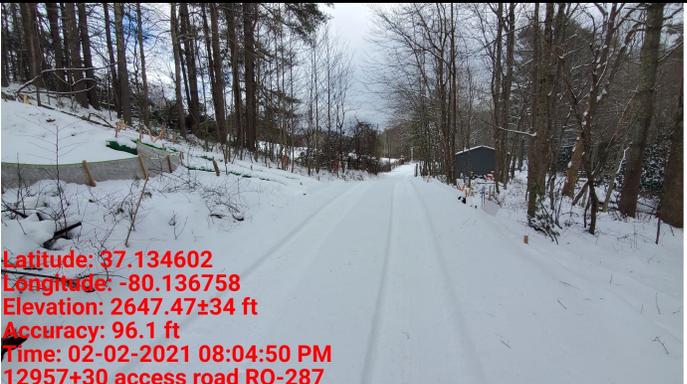
Pic 1 Desc. Landowner's spring box at RO-287.

Pic 2 Desc. Access road RO-287 at the ROW.

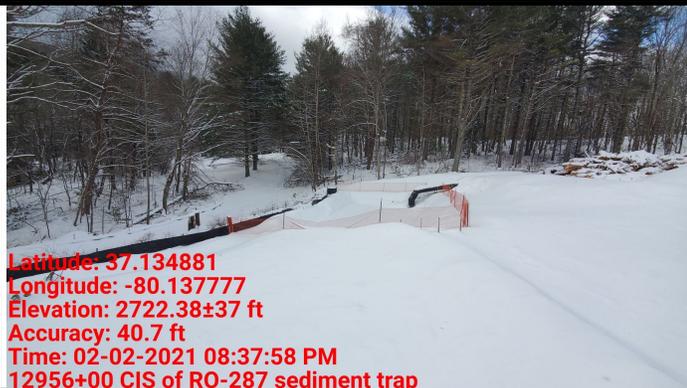
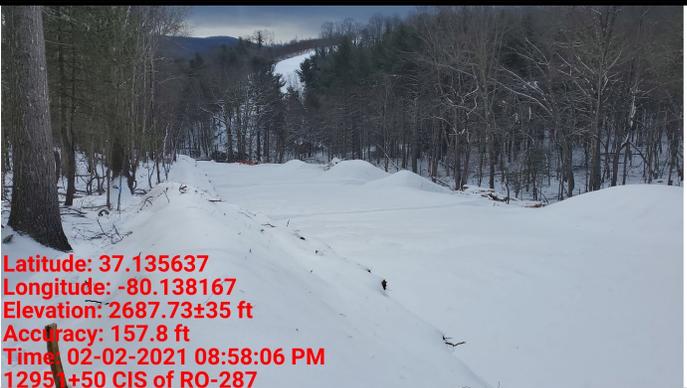
Pic 3 Desc. Sediment trap on the CIS of RO-287.

Pic 4 Desc. Current ROW conditions on the CIS of RO-287.

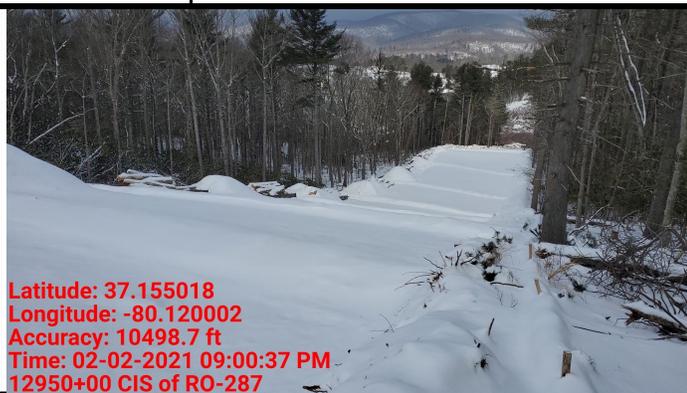
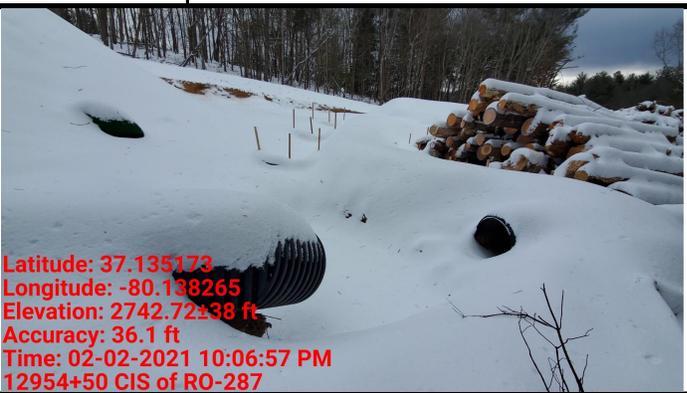
Pic 5 Desc. Current ROW conditions on the CIS of RO-287.

Pic 6 Desc. Sumps and drain pipe on the CIS of RO-287.

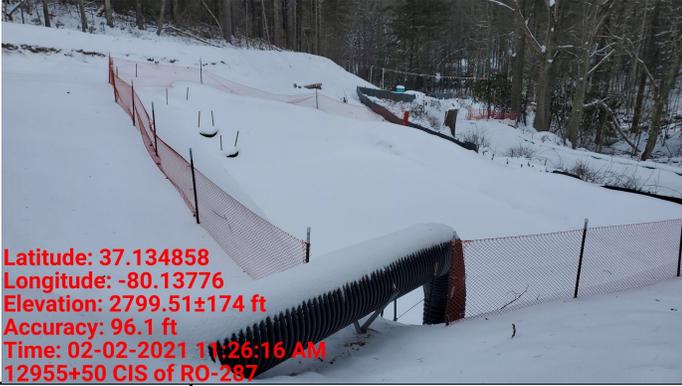
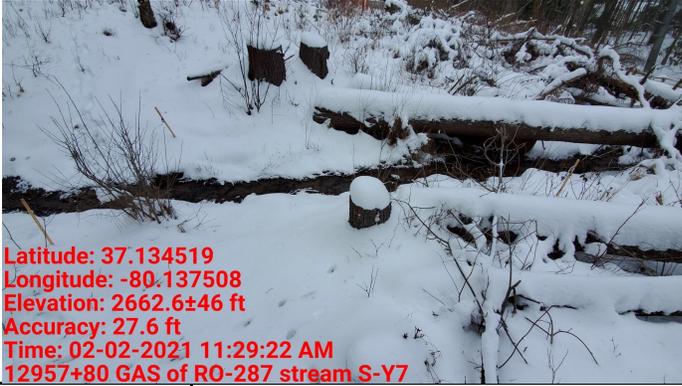
<p>Latitude: 37.134519 Longitude: -80.137508 Elevation: 2662.6±46 ft Accuracy: 27.6 ft Time: 02-02-2021 11:29:22 AM 12957+80 GAS of RO-287 stream S-Y7</p>		
GPS Location		See pic for GPS location		GPS Location	
See pic for GPS location		See pic for GPS location			
Field Station#		12955+50		Field Station#	
		12957+80			
Pic 7 Desc.		Sediment trap on the CIS of RO-287.		Pic 8 Desc.	
				Stream S-Y7 on the GAS of RO-287.

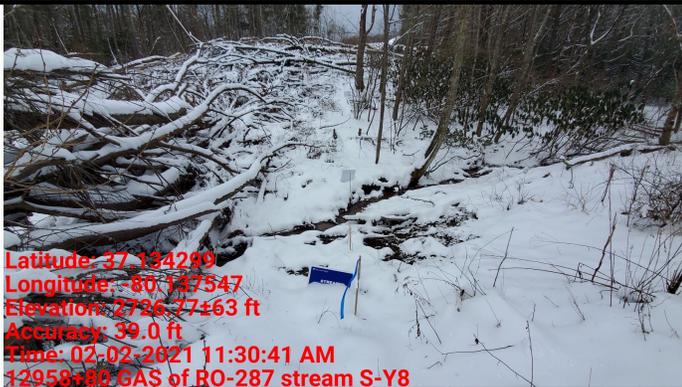
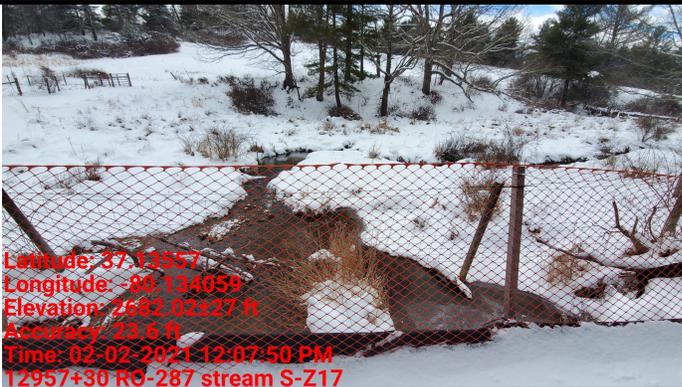
GPS Location		See pic for GPS location		GPS Location	
See pic for GPS location		See pic for GPS location			
Field Station#		12958+80		Field Station#	
		12957+30			
Pic 9 Desc.		Stream S-Y8 on the GAS of RO-287.		Pic 10 Desc.	
				Stream S-Z17 along RO-287.

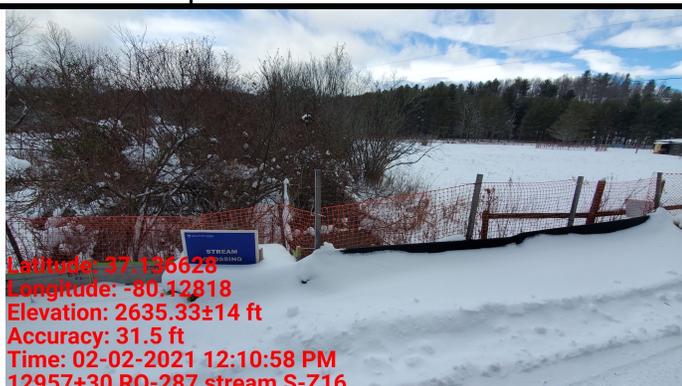
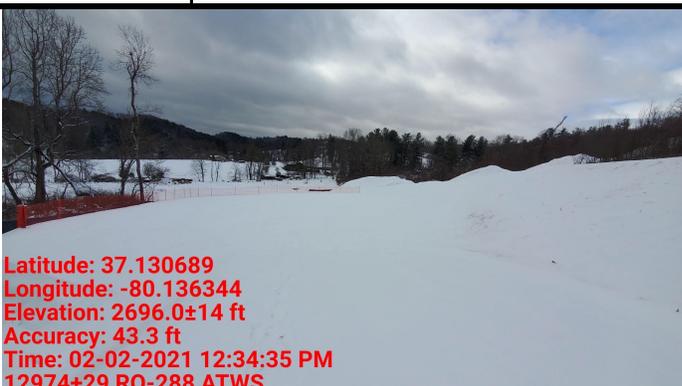
<p>Latitude: 37.130689 Longitude: -80.136344 Elevation: 2696.0±14 ft Accuracy: 43.3 ft Time: 02-02-2021 12:34:35 PM 12974+29 RO-288 ATWS</p>		
GPS Location		See pic for GPS location		GPS Location	
See pic for GPS location		See pic for GPS location			
Field Station#		12957+30		Field Station#	
		12974+29			
Pic 11 Desc.		Stream S-Z16 along access road RO-287.		Pic 12 Desc.	
				ATWS at RO-288 and the ROW.

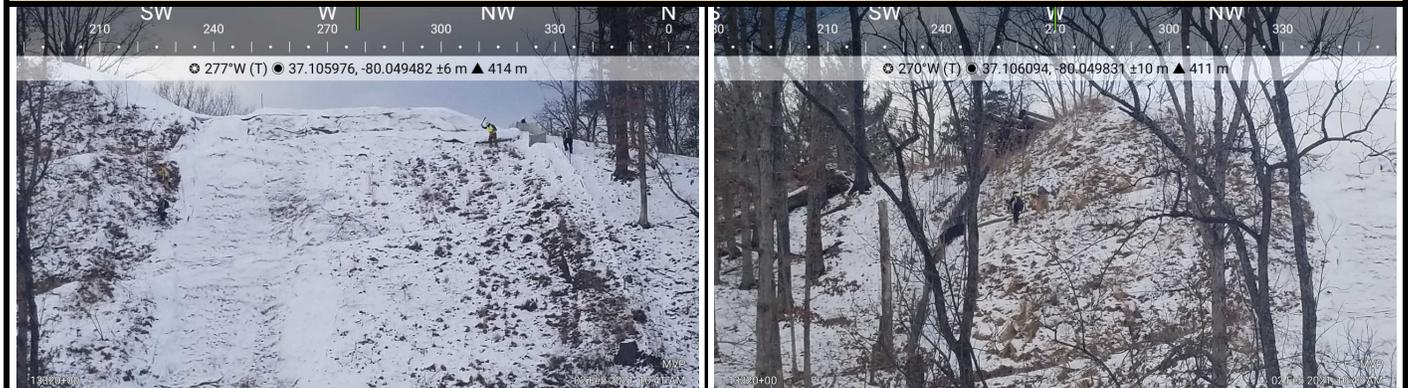
Field Station#	13320+00	Field Station#	13320+00
-----------------------	----------	-----------------------	----------

Pic 1 Desc.	Precision environmental crews working on clearing brush and small trees.	Pic 2 Desc.	Precision environmental crews working on clearing brush and small trees.
--------------------	--	--------------------	--

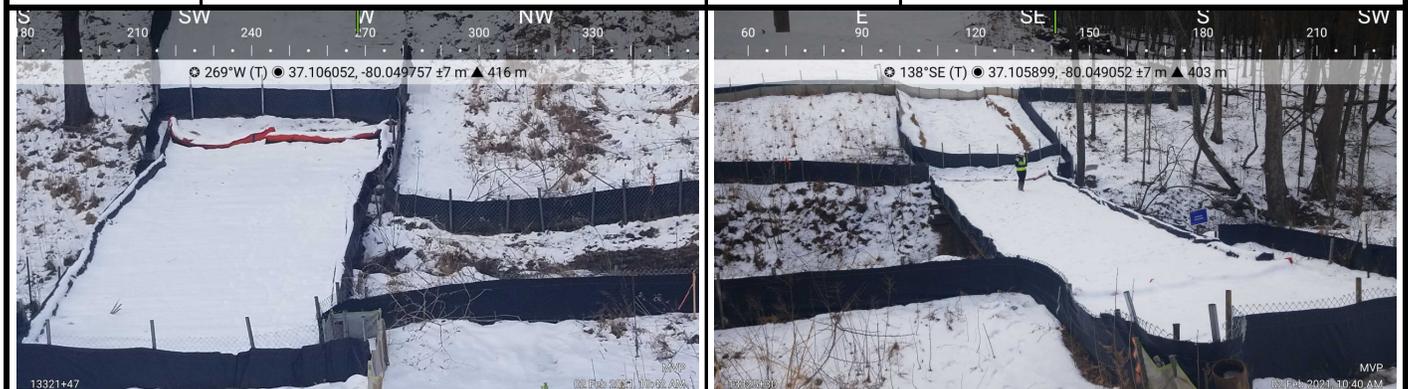
Field Station#	13321+47	Field Station#	13325+30
-----------------------	----------	-----------------------	----------

Pic 3 Desc.	Overview of Waterbody S-GH15. ECDs are functional and ROW is stable.	Pic 4 Desc.	Overview of Waterbody S-GH14. ECDs are functional and ROW is stable.
--------------------	--	--------------------	--

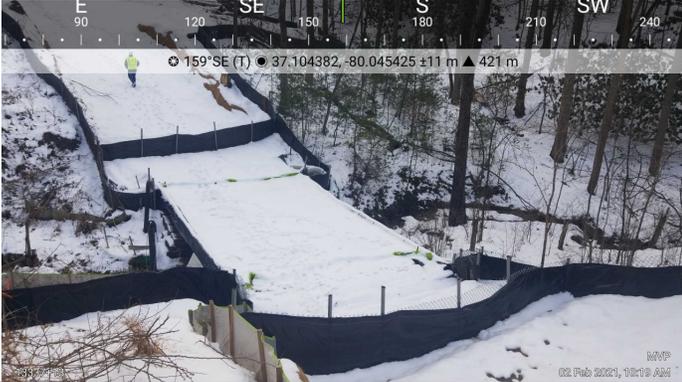
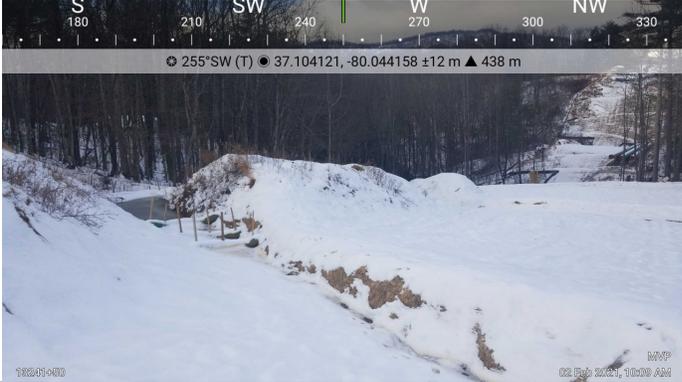
GPS Location	See Above	GPS Location	See Above
Field Station#	13337+13	Field Station#	13341+50
Pic 7 Desc.	Overview of Waterbody S-GH9. ECDs are functional and ROW is stable.	Pic 8 Desc.	ROW Overview. ECDs are functional and ROW is stable.

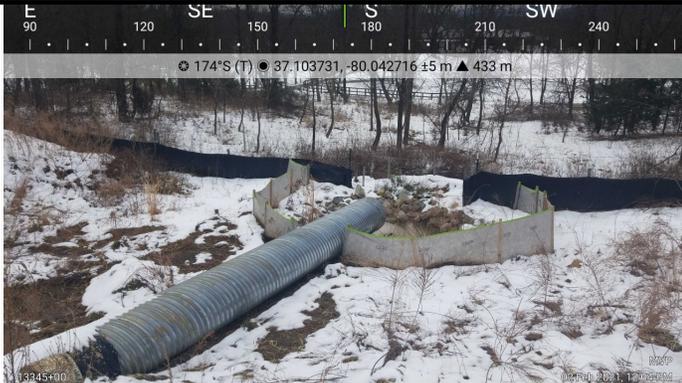
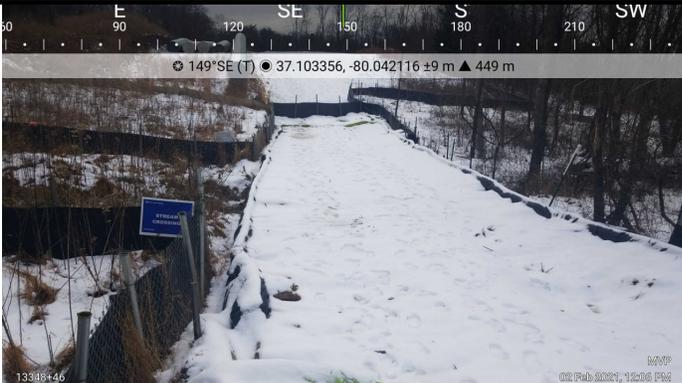
GPS Location	See Above	GPS Location	See Above
Field Station#	13345+00	Field Station#	13348+46
Pic 9 Desc.	ROW Overview. ECDs are functional and ROW is stable.	Pic 10 Desc.	Overview of Waterbody S-RR08. ECDs are functional and ROW is stable.

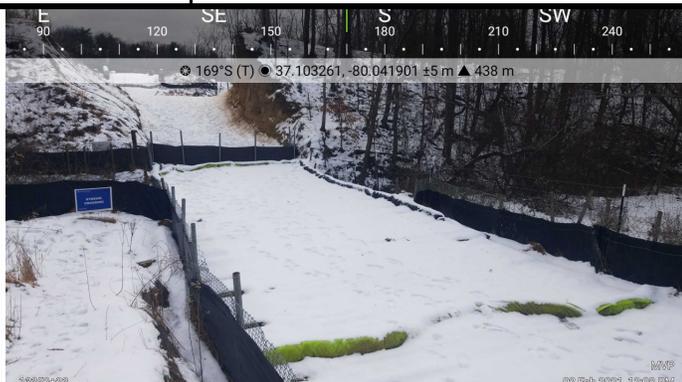
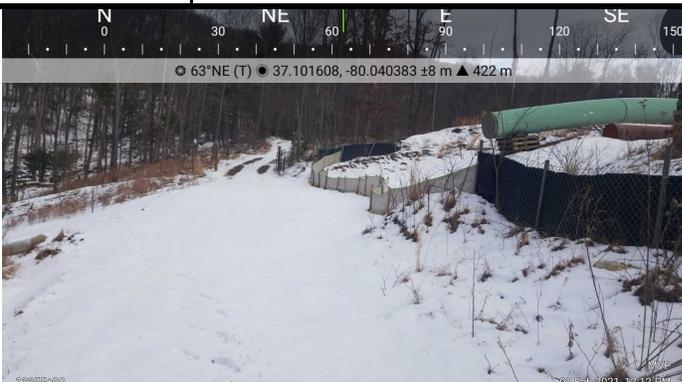
GPS Location	See Above	GPS Location	See Above
Field Station#	13352+23	Field Station#	13355+90
Pic 11 Desc.	Overview of Waterbody S-RR09. ECDs are functional and ROW is stable.	Pic 12 Desc.	Overview of private road crossing ROW. ECDs are functional and ROW is stable.

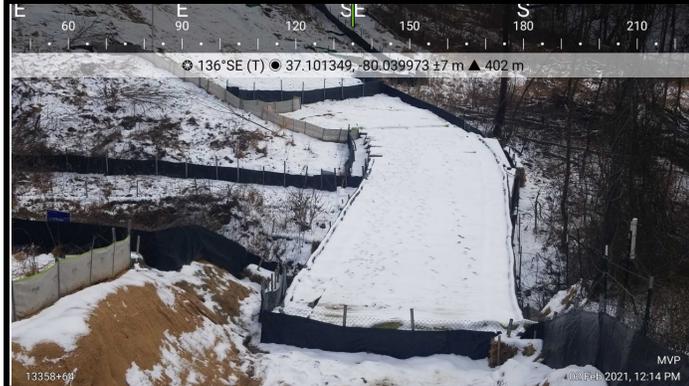
GPS Location	See Above
Field Station#	13358+64
Pic 13 Desc.	Overview of Waterbody S-RR11. ECDs are functional and ROW is stable.

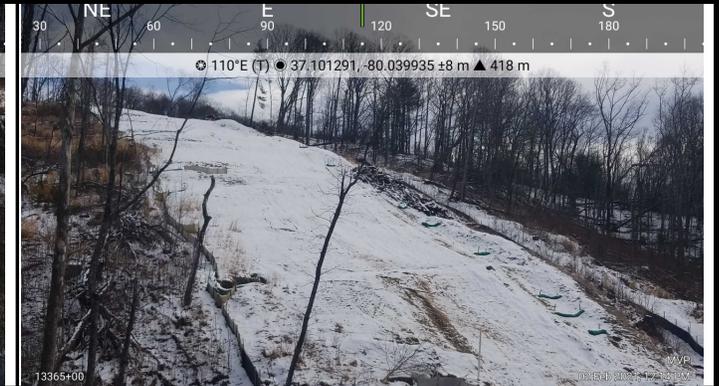
GPS Location	See Above
Field Station#	13365+00
Pic 14 Desc.	ROW Overview. ECDs are functional and ROW is stable.

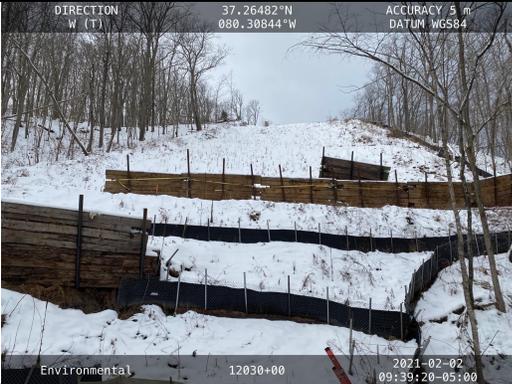
<p>DIRECTION W (T) 37.26482°N 080.30844°W ACCURACY 5 m DATUM WGS84 Environmental 12030+00 2021-02-02 09:39:20-05:00</p>	
GPS Location	See photo	GPS Location	See photo
Field Station#	12032+51	Field Station#	12030+00
Pic 7 Desc.	Down stream of S-G39 in acceptable condition with no sign of impact.	Pic 8 Desc.	Stabilized ROW in acceptable condition with snow coverage

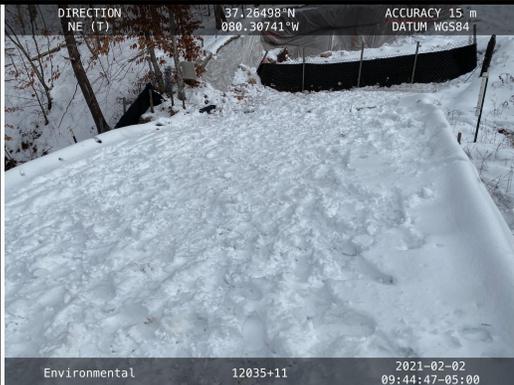
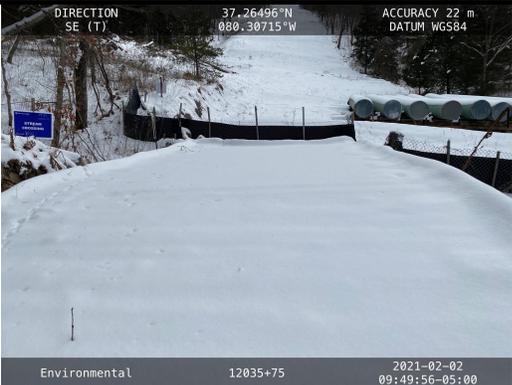
Pic 9 Desc.	Bridge and ECDs at S-G40 in acceptable condition	Pic 10 Desc.	Bridge and ECDs at S-PP23 in acceptable condition

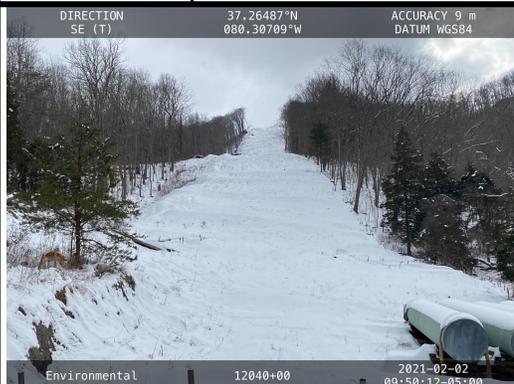
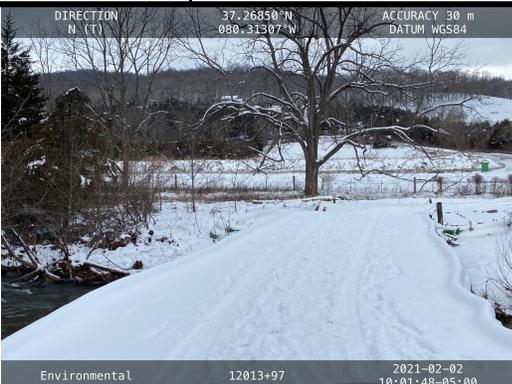
<p>DIRECTION N (T) 37.26850°N 080.31307°W ACCURACY 30 m DATUM WGS84 Environmental 12013+97 2021-02-02 10:01:48-05:00</p>	
GPS Location	See photo	GPS Location	See photo
Field Station#	12040+00	Field Station#	12013+97
Pic 11 Desc.	Stabilized Slope with layer of ice and snow.	Pic 12 Desc.	Bridge crossing S-G36 along access road 268 in acceptable condition

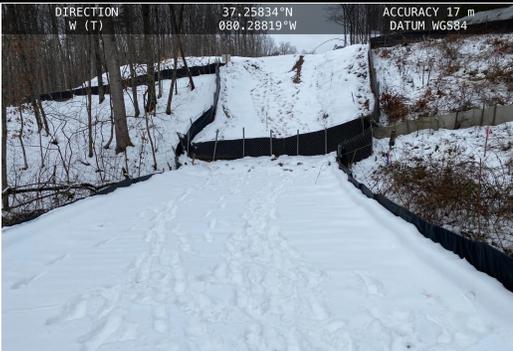
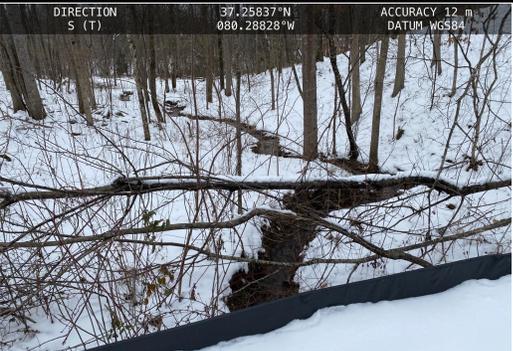
Environmental 12101+58 2021-02-02 10:55:47-05:00		Environmental 12101+57 2021-02-02 10:56:01-05:00	
GPS Location	See photo		
Field Station#	12101+58		
Pic 15 Desc.	Bridge and ECDs at S-MM11 is in acceptable condition		
Pic 16 Desc.	Down stream of S-MM11 in acceptable condition with no sign of impacts		
DIRECTION 37.25839°N ACCURACY 8 m E (T) 080.28810°W DATUM WGS84

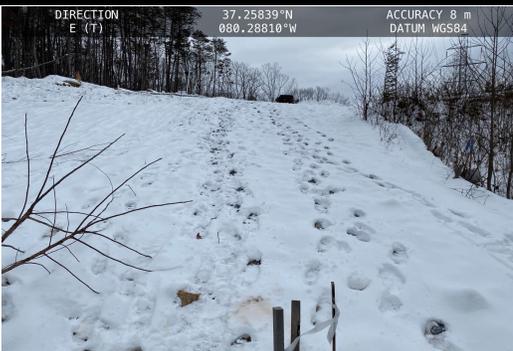
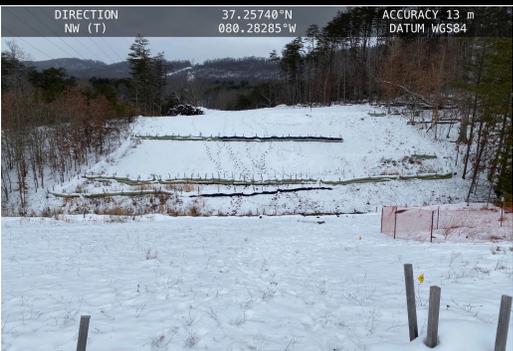
Environmental 12102+00 2021-02-02 10:56:16-05:00		Environmental 12117+00 2021-02-02 10:59:52-05:00	
GPS Location	See photo		
Field Station#	12102+00		
Pic 17 Desc.	RCE on the CIS of access road 270.01 covered with snow		
GPS Location	See photo		
Field Station#	12117+00		
Pic 18 Desc.	Stabilized ROW covered with snow and ice.

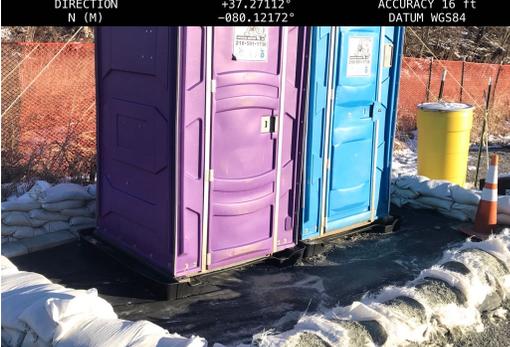
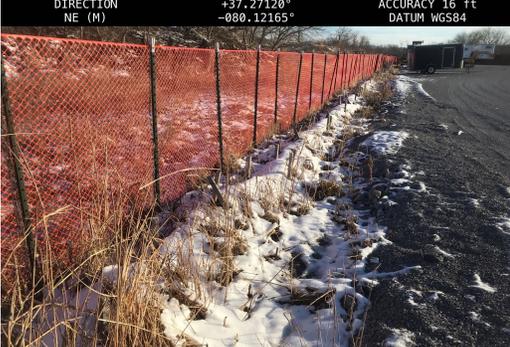
GPS Location MVP-LY-049 See photo for gps data		GPS Location MVP-LY-049 See photo for gps data			
Field Station# +0		Field Station# +0			
Pic 3 Desc. Condition of trays and containment under toilets. Looking NE.		Pic 4 Desc. Condition of compost filter sock and safety fence along north LOD. Looking NE.

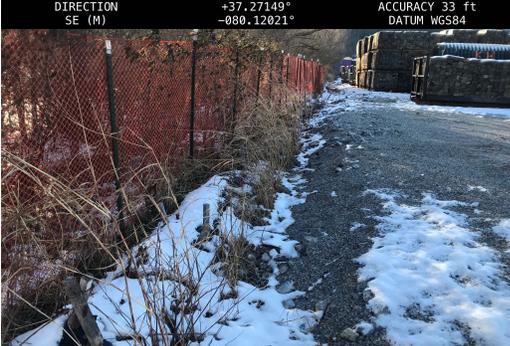
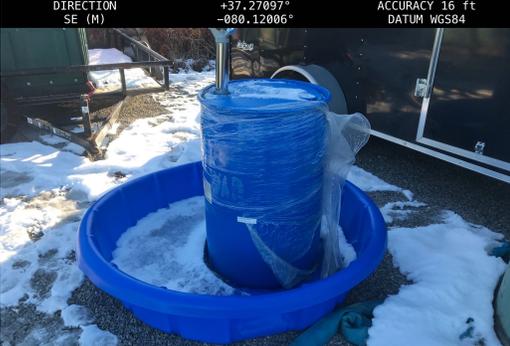
<p>DIRECTION SE (M) +37.27097° -080.12006° ACCURACY 16 ft DATUM WGS84</p> <p>MVP-LY-049_020321 Containment holding barrel of toilet ... 2021-02-03 08:36:22-05:00</p>			
GPS Location MVP-LY-049 See photo for gps data		GPS Location MVP-LY-049 See photo for gps data			
Field Station# +0		Field Station# +0			
Pic 5 Desc. Condition of compost filter sock and safety fence along east LOD. Looking SE.		Pic 6 Desc. Condition of containment holding barrel of toilet chemical. Holding snow and ice. Looking SE.

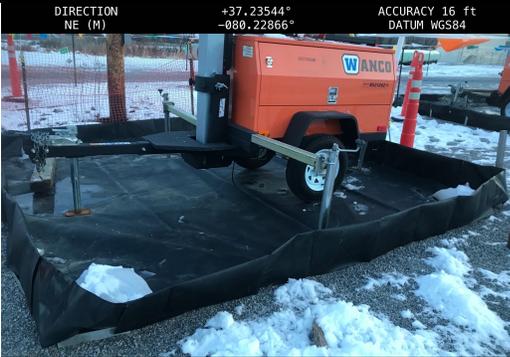
<p>DIRECTION E (M) +37.23573° -080.22873° ACCURACY 16 ft DATUM WGS84</p> <p>MVP-PY-006_020321 Condition of signage and CFS at feature 2021-02-03 07:23:42-05:00</p>			
GPS Location		MVP-PY-006 See photo for gps data		GPS Location	
Field Station#		+0		Field Station#	
Pic 1 Desc.		Condition of containment under light plant. Free of snow. Looking NE.		Pic 2 Desc.

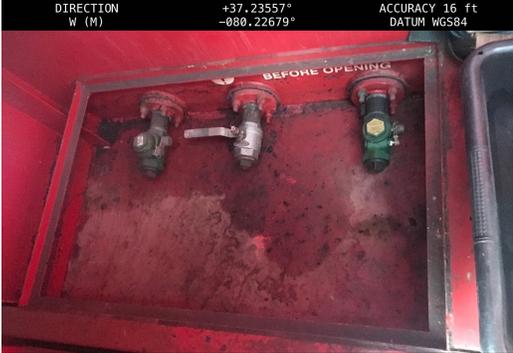
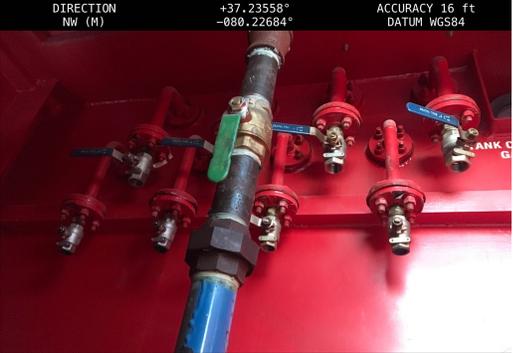
<p>DIRECTION NW (M) +37.23558° -080.22684° ACCURACY 16 ft DATUM WGS84</p> <p>MVP-PY-006_020321 No leaky internal fittings 2021-02-03 07:29:45-05:00</p>	
GPS Location	MVP-PY-006 See photo for gps data	GPS Location	MVP-PY-006 See photo for gps data
Field Station#	+0	Field Station#	+0
Pic 7 Desc.	Off Road Fuel unit condition of internal drip pan. Looking W.	Pic 8 Desc.	Off Road Fuel unit no leaky internal fittings. Looking NW.

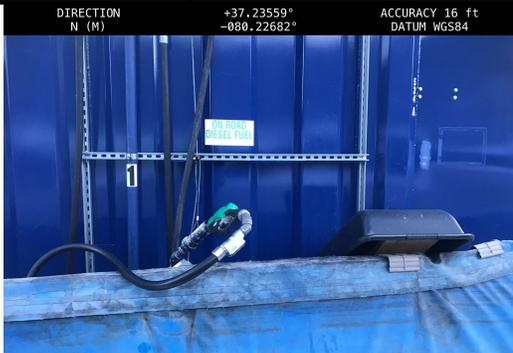
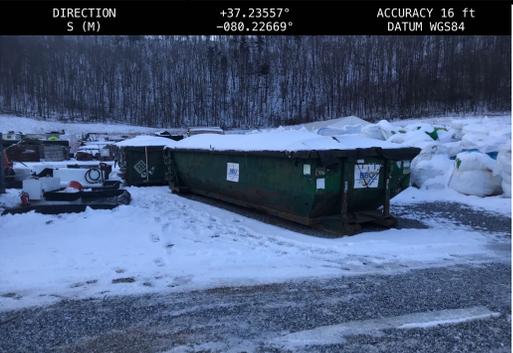
GPS Location	MVP-PY-006 See photo for gps data	GPS Location	MVP-PY-006 See photo for gps data
Field Station#	+0	Field Station#	+0
Pic 9 Desc.	Blue Bulk Fuel tanks no leaky fittings or nozzles. Looking N.	Pic 10 Desc.	No deposits or fluids around hazardous waste dumpsters. Looking SW.

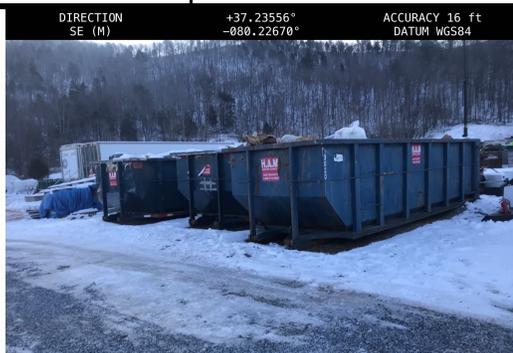
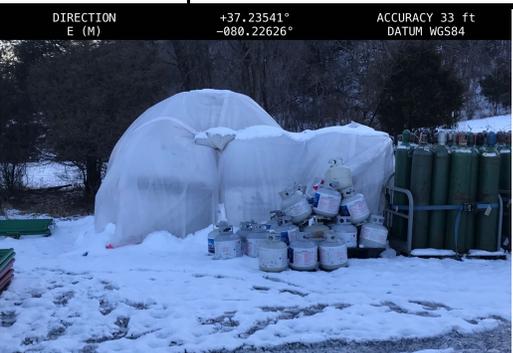
<p>DIRECTION E (M) +37.23541° -080.22626° ACCURACY 33 ft DATUM WGS84</p> <p>MVP-PY-006_020321 Restoration supplies covered 2021-02-03 07:33:45-05:00</p>	
GPS Location	MVP-PY-006 See photo for gps data	GPS Location	MVP-PY-006 See photo for gps data
Field Station#	+0	Field Station#	+0
Pic 11 Desc.	No loose trash around dumpsters. Looking SE.	Pic 12 Desc.	Restoration supplies covered and protected from the weather.

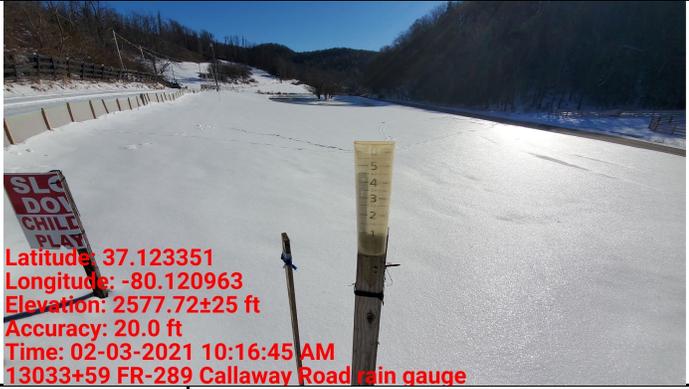
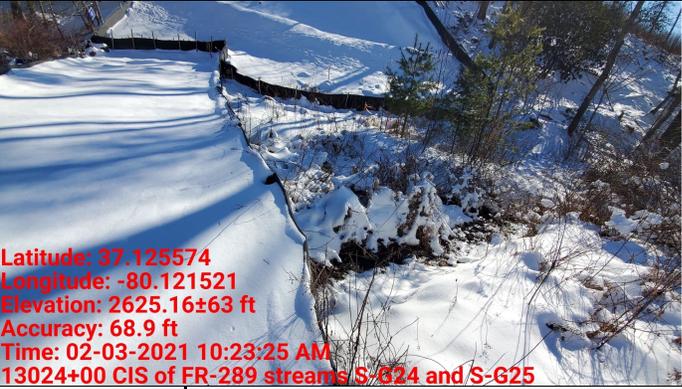
<p>Latitude: 37.125574 Longitude: -80.121521 Elevation: 2625.16±63 ft Accuracy: 68.9 ft Time: 02-03-2021 10:23:25 AM 13024+00 CIS of FR-289 streams S-G24 and S-G25</p>	
GPS Location	See pic for GPS location	GPS Location	See pic for GPS location
Field Station#	13033+59	Field Station#	13024+00
Pic 1 Desc.	0.0" precipitation at Callaway Road.	Pic 2 Desc.	Streams S-G24 and S-G25 on the downstream side of the bridge.

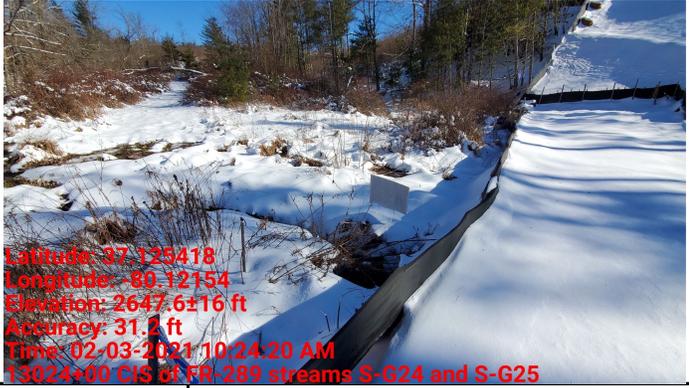
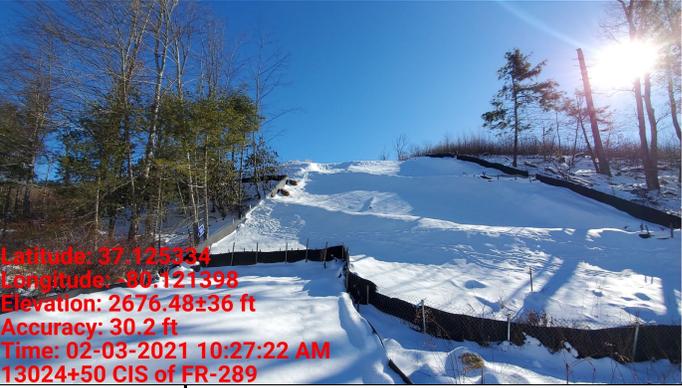
GPS Location	See pic for GPS location	GPS Location	See pic for GPS location
Field Station#	13024+00	Field Station#	13024+50
Pic 3 Desc.	Streams S-G24 and S-G25 on the upstream side of the bridge.	Pic 4 Desc.	Slope on the GAS of the stream crossings.

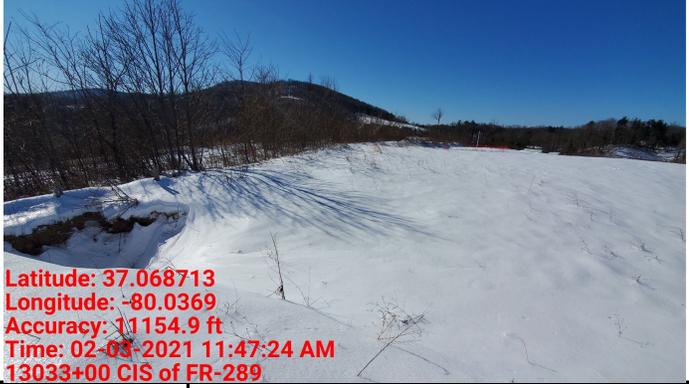
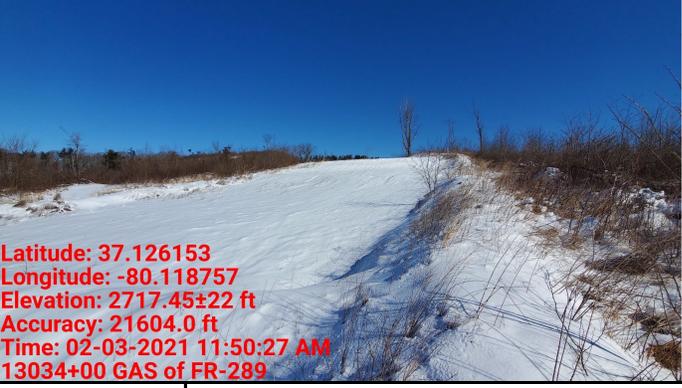
<p>Latitude: 37.126153 Longitude: -80.118757 Elevation: 2717.45±22 ft Accuracy: 21604.0 ft Time: 02-03-2021 11:50:27 AM 13034+00 GAS of FR-289</p>	
GPS Location	See pic for GPS location	GPS Location	See pic for GPS location
Field Station#	13033+00	Field Station#	13034+00
Pic 5 Desc.	Current ROW conditions on the CIS of FR-289	Pic 6 Desc.	Current ROW conditions on the GAS of FR-289.

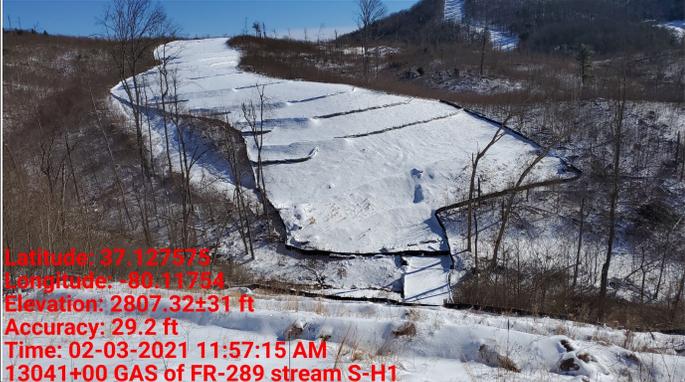
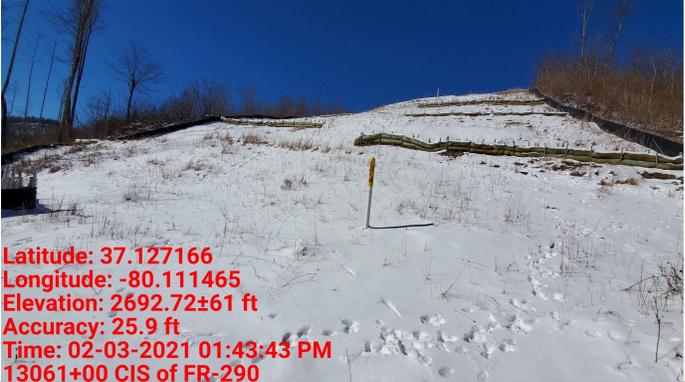
<p>Latitude: 37.127166 Longitude: -80.111465 Elevation: 2692.72±61 ft Accuracy: 25.9 ft Time: 02-03-2021 01:43:43 PM 13061+00 CIS of FR-290</p>	
GPS Location	See pic for GPS location	GPS Location	See pic for GPS location
Field Station#	13041+00	Field Station#	13061+00
Pic 7 Desc.	Stream S-H1 on the GAS of FR-289.	Pic 8 Desc.	Slope on the CIS of FR-290.

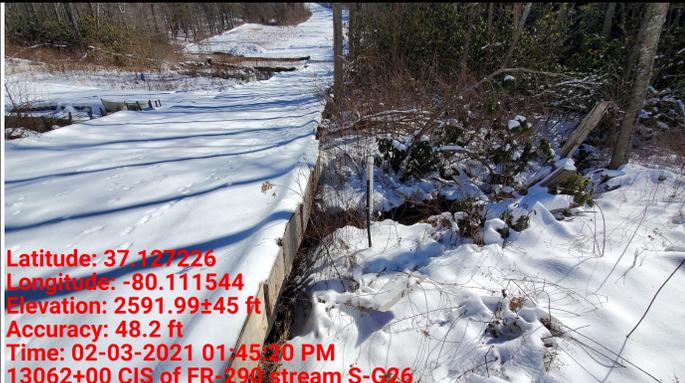
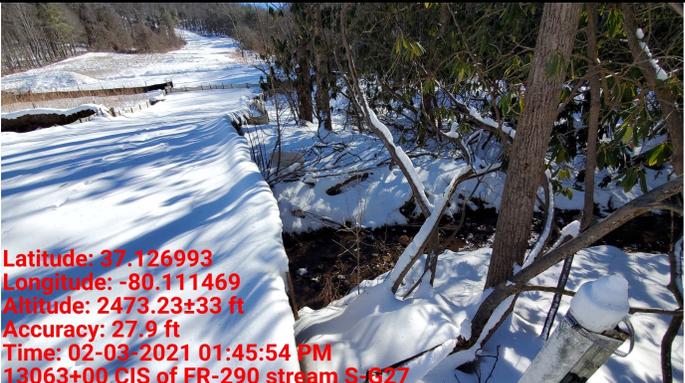
Field Station#	13062+00	Field Station#	13063+00
Pic 9 Desc.	Downstream side of stream S-G26 on the GAS of FR-290.	Pic 10 Desc.	Downstream side of stream S-G27 on the GAS of FR-290.

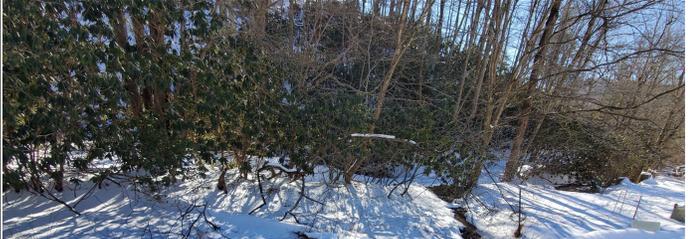
<p data-bbox="99 443 456 579"> Latitude: 37.125104 Longitude: -80.113458 Elevation: 2598.13±23 ft Accuracy: 17.4 ft Time: 02-03-2021 02:24:26 PM 13061+44 FR-290 stream S-RR18 </p>

<p data-bbox="797 443 1154 579"> Latitude: 37.123834 Longitude: -80.115749 Elevation: 2597.8±24 ft Accuracy: 20.7 ft Time: 02-03-2021 02:28:36 PM 13061+44 FR-290 stream S-RR16 </p>				
GPS Location See pic for GPS location	GPS Location See pic for GPS location				
Field Station# 13061+44	Field Station# 13061+44				
Pic 13 Desc. Stream crossing S-RR18 along access road FR-290.	Pic 14 Desc. Stream crossing S-RR16 along access road FR-290.

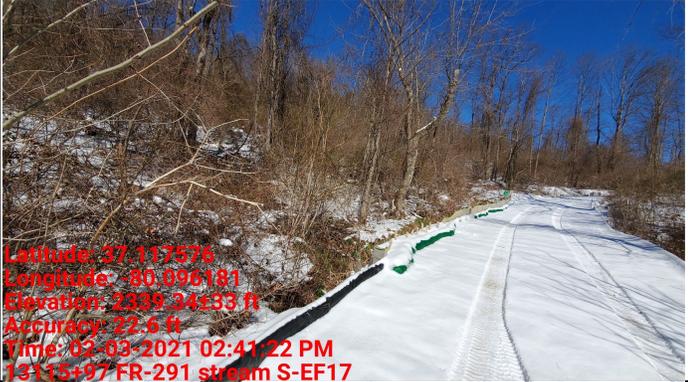
GPS Location See pic for GPS location	GPS Location See pic for GPS location				
Field Station# 13115+97	Field Station# 13117+00				
Pic 15 Desc. Access road FR-291 at stream S-EF17.	Pic 16 Desc. Current ROW conditions on the GAS of FR-291.

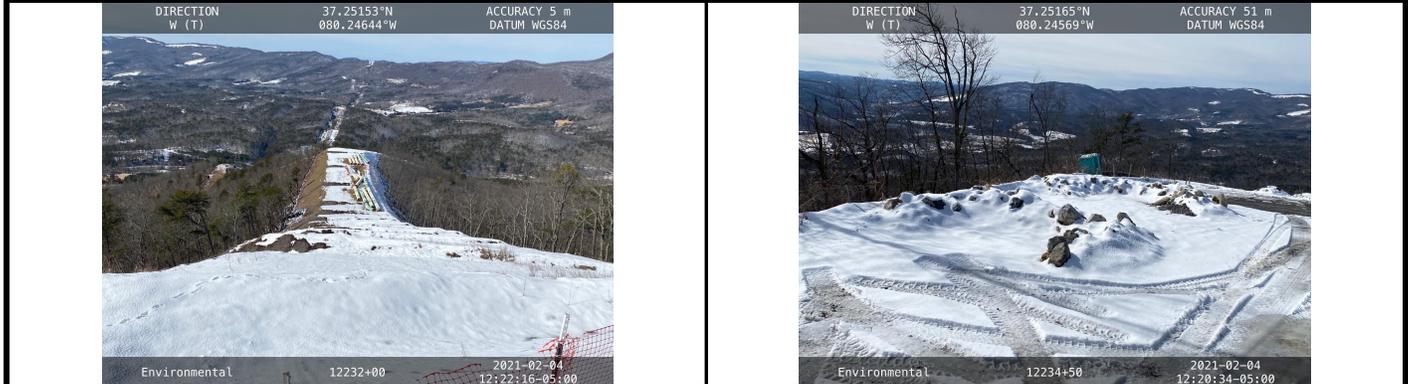
Field Station#	12232+00	Field Station#	12234+50
-----------------------	----------	-----------------------	----------

Pic 1 Desc.	Stabilized ROW covered with snow and ice	Pic 2 Desc.	Rock checks in acceptable condition
--------------------	--	--------------------	-------------------------------------

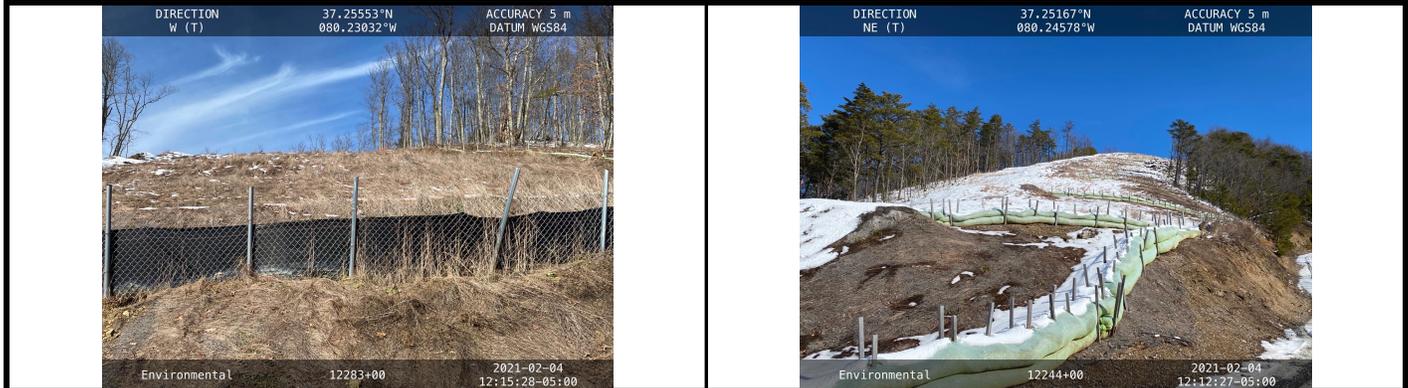
Field Station#	12283+00	Field Station#	12244+00
-----------------------	----------	-----------------------	----------

Pic 3 Desc.	Stabilized slope with acceptable vegetation across LOD	Pic 4 Desc.	Stabilized slope with a thin layer of snow and ice
--------------------	--	--------------------	--

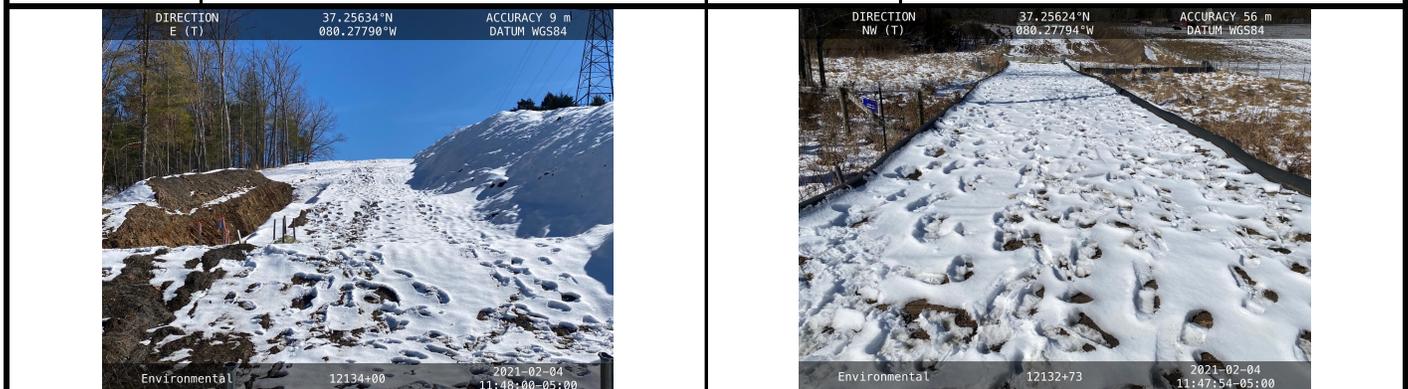
Field Station#	12134+00	Field Station#	12132+73
-----------------------	----------	-----------------------	----------

Pic 5 Desc.	Stabilized slope with snow and ice coverage	Pic 6 Desc.	Bridge and ECDs crossing S-C29 in acceptable condition
--------------------	---	--------------------	--

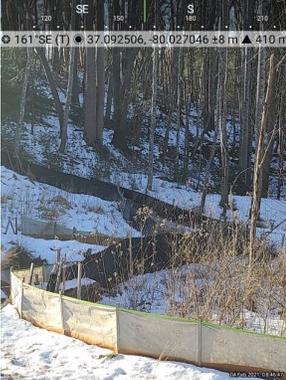
GPS Location	00000	GPS Location	00000	
Field Station#	13415+79	Field Station#	13437+75	
Pic 1 Desc.	During the EI's inspection today the EI monitored ECDs along the row edge, no issues observed at the time of inspection.		Pic 2 Desc.	EI monitored location on row where land owner continues cutting fire wood, no leaks or spills noticed at time of inspection

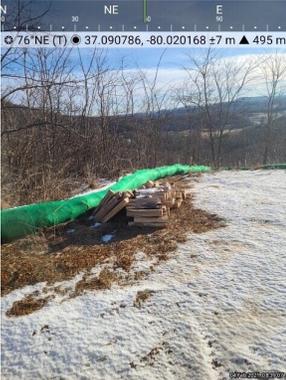
GPS Location	00000	GPS Location	00000	
Field Station#	13437+75	Field Station#	13496+76	
Pic 3 Desc.	EI monitored location on row where land owner continues cutting fire wood, no leaks or spills noticed at time of inspection		Pic 4 Desc.	EI monitored ECDs and vegetation at CAHAS #2 crossing. No environmental issues observed at time of inspection.

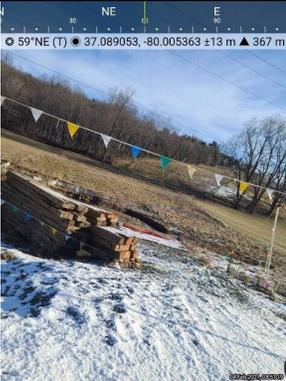
Over head power ribbon was down at CAHAS #2 crossing the EI Documented and sent in to be added to the punch list for repair by the contractor.

GPS Location	0000	GPS Location	0000	
Field Station#	13497+77	Field Station#	13498+00	
Pic 5 Desc.	EI noticed over head power ribbon was down, documented and sent in to be added to the punch list for repair.		Pic 6 Desc.	EI noticed stream bank S-IJ10 continues to wash during rain events causing erosion control blanket to be damaged, recommend installing new blanket and moving R1

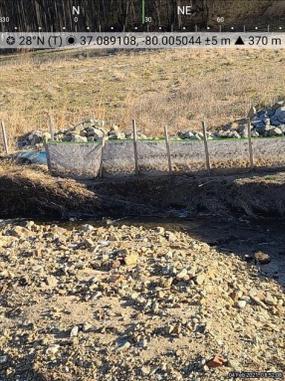
Throughout today's inspections the EI noticed stream bank S-IJ10 wash continuing to wash causing erosion blanket to be damaged , EI recommended installing new erosion blanket and moving the P1 back further on row to prevent being washed into the stream , documented and sent in to be added to the punch list.
