Visual Site Inspection Report

Project Name H-600 Pipeline Spread H		AFE 124300138	Spread H-600 Pipeline Spread H
Contractor Precision		Report # 19600	
Inspector Dawn McCullough		Date/Time 2/1/2021 2:54 PM	
Permit # TBD	Inspection Type VA SWPP	Station Begin 13141+65	
State VA	Inspection Area Partial	Station End 13316+21	
County Franklin	Ground Frozen	Temperature (°F) 37.00	
Municipality N/A	Weather Cloudy	Rain Gauge (in) 0.60	
			Rain Accumulation Time (days) 1.00

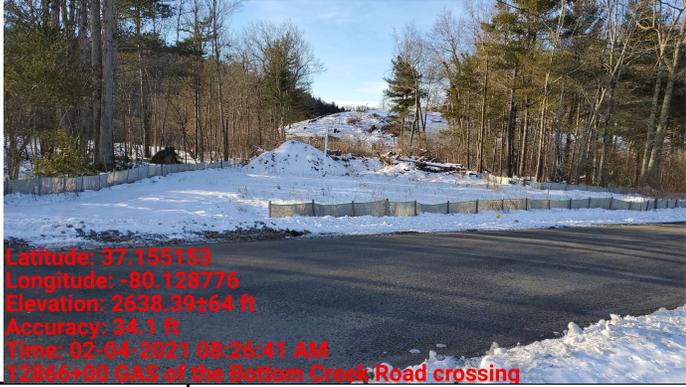
<p>Latitude: 37.155171 Longitude: -80.128608 Elevation: 2627.46±4 ft Accuracy: 53.5 ft Time: 02-04-2021 08:27:50 AM 12866+00 CIS of the Bottom Creek Road crossing</p>	
GPS Location	See pic for GPS location	GPS Location	See pic for GPS location
Field Station#	12866+00	Field Station#	12866+00
Pic 1 Desc.	The GAS of the Bottom Creek Road crossing.	Pic 2 Desc.	CIS of the Bottom Creek Road crossing.

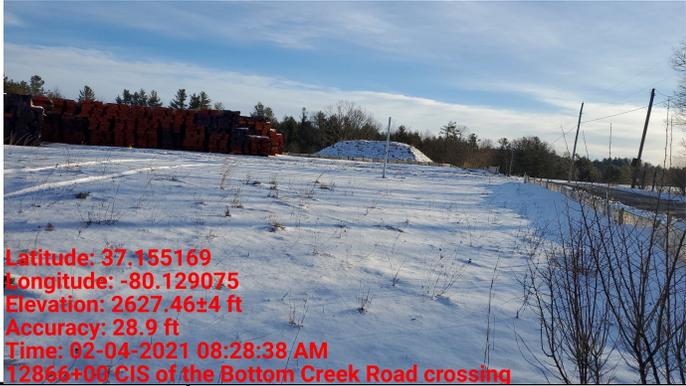
GPS Location	See pic for GPS location	GPS Location	See pic for GPS location
Field Station#	12866+00	Field Station#	12728+74
Pic 3 Desc.	CIS of the Bottom Creek Road crossing ATWS.	Pic 4 Desc.	Access road RO-281 at stream S-EF32.

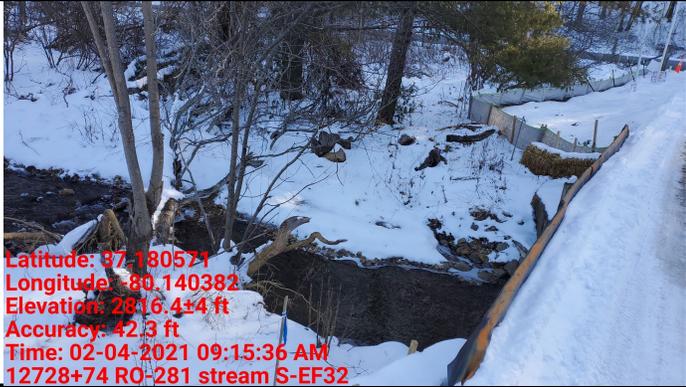
<p>Latitude: 37.180568 Longitude: -80.140375 Elevation: 2816.4±4 ft Accuracy: 64.6 ft Time: 02-04-2021 09:15:49 AM 12728+74 RO-281 stream S-EF32</p>	
GPS Location	See pic for GPS location	GPS Location	See pic for GPS location
Field Station#	12728+74	Field Station#	12728+74
Pic 5 Desc.	Stream S-EF32 along access road RO-281.	Pic 6 Desc.	Stream S-EF32 along access road RO-281.

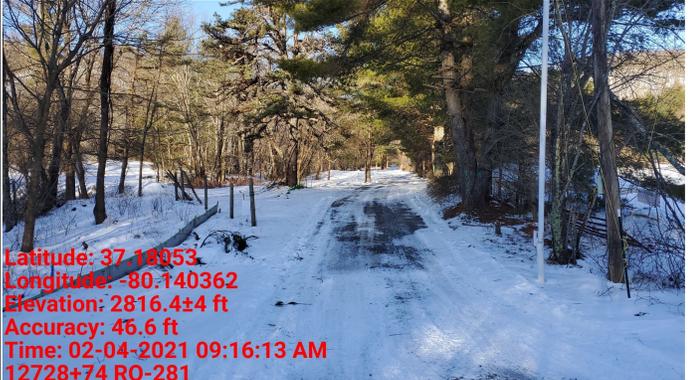
<p data-bbox="797 443 1485 579">Latitude: 37.192654 Longitude: -80.158868 Elevation: 3725.82±34 ft Accuracy: 29.2 ft Time: 02-04-2021 09:08:37 AM 12684+00 CIS of Honeysuckle Road looking towards GAS of RO-27</p>				
GPS Location See pic for GPS location	GPS Location See pic for GPS location				
Field Station# 12728+74	Field Station# 12684+00				
Pic 7 Desc. Access road RO-281.	Pic 8 Desc. The GAS of RO-279.01 from the CIS of Honeysuckle Road.

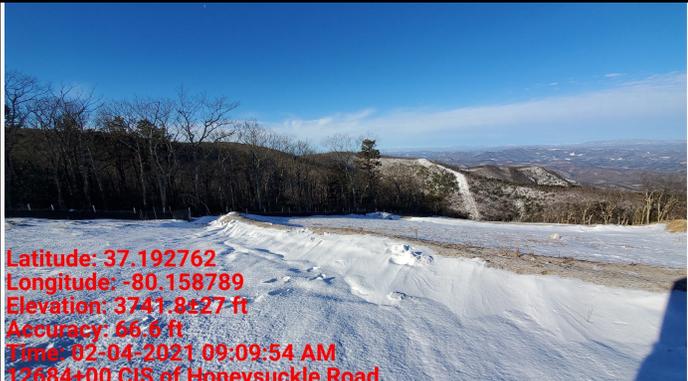
GPS Location See pic for GPS location	GPS Location See pic for GPS location				
Field Station# 12684+00	Field Station# 12690+50				
Pic 9 Desc. Waterbars, sumps and end treatments remain in compliance on the CIS of Honeysuckle Road.	Pic 10 Desc. GAS of Honeysuckle Road RCE.

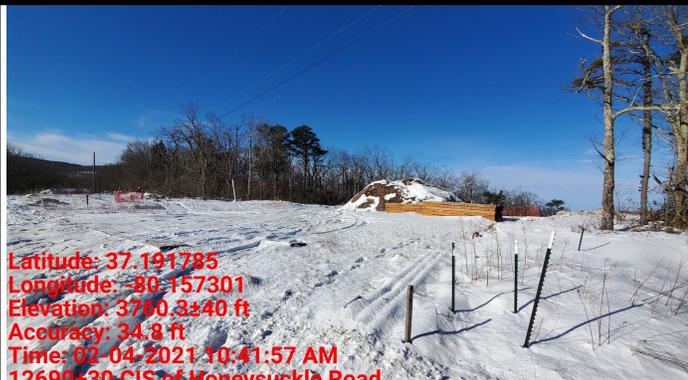
<p data-bbox="797 1598 1128 1734">Latitude: 37.183943 Longitude: -80.160849 Elevation: 3758.6±9 ft Accuracy: 35.1 ft Time: 02-04-2021 10:48:52 AM 12703+04 RO-280 ATWS-1225</p>				
GPS Location See pic for GPS location	GPS Location See pic for GPS location				
Field Station# 12690+30	Field Station# 12703+04				
Pic 11 Desc. CIS of Honeysuckle Road RCE.	Pic 12 Desc. ATWS-1225 at RO-280 and Honeysuckle Road

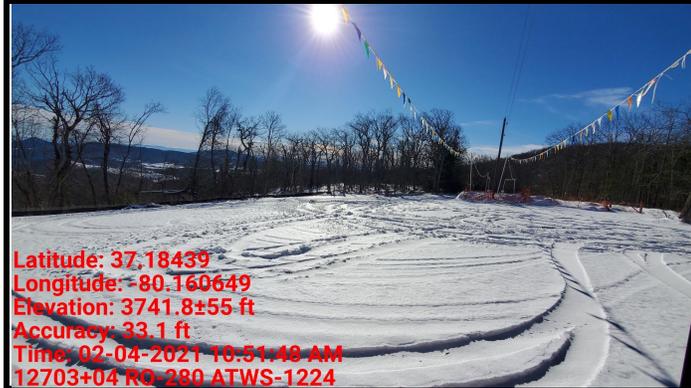
Pic 13 Desc.	ATWS-1224 at RO-280 and Honeysuckle Road
---------------------	--

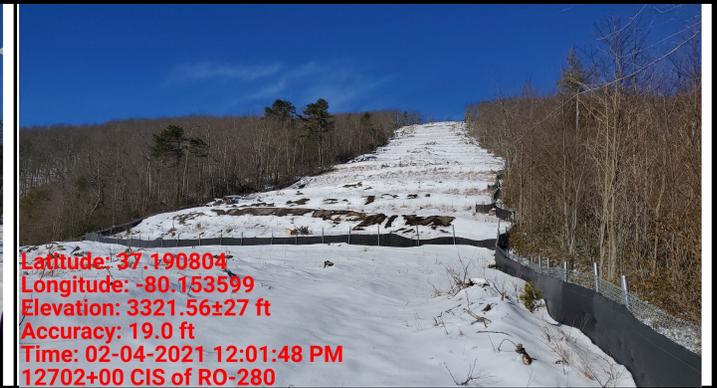
Pic 14 Desc.	CIS of access RO-280 and the GAS of Honeysuckle Road.
---------------------	---

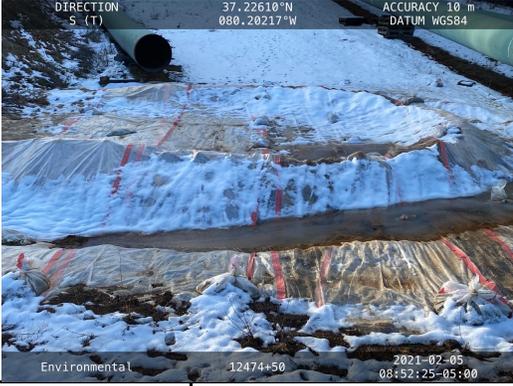
<p>DIRECTION N (T) 37.22465°N 080.20644°W ACCURACY 2.98 km DATUM WGS84 Environmental 12482+67 2021-02-05 08:48:35-05:00</p>		
GPS Location	See photo		GPS Location	See photo
Field Station#	12474+50		Field Station#	12482+67
Pic 15 Desc.	Plastic covering the unknown substance area.		Pic 16 Desc.	Access Road MVP-MLV-AR-28

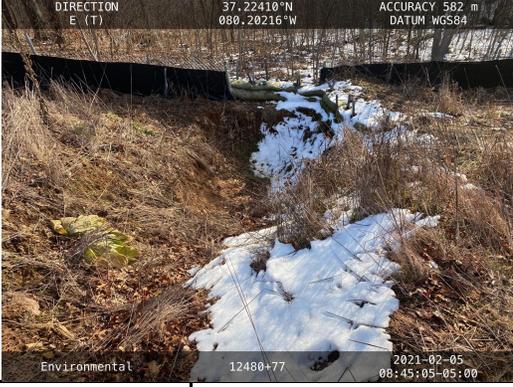
<p>DIRECTION S (T) 37.22361°N 080.20219°W ACCURACY 83 m DATUM WGS84 Environmental 12485+00 2021-02-05 08:42:12-05:00</p>		
GPS Location	See photo		GPS Location	See photo
Field Station#	12480+77		Field Station#	12485+00
Pic 17 Desc.	Waterbar outlet in acceptable condition		Pic 18 Desc.	Stabilized ROW covered with snow
