# Visual Site Inspection Report

<b>Project Name</b> H-600 Pipeline Spread H		<b>AFE</b> 124300138	<b>Spread</b> H-600 Pipeline Spread H
<b>Contractor</b> Precision		<b>Report #</b> 20563	
<b>Inspector</b> John Brcic		<b>Date/Time</b> 3/1/2021 1:48 PM	
<b>Permit #</b> TBD	<b>Inspection Type</b> VA SWPP	<b>Station Begin</b> 12443+75	
<b>State</b> VA	<b>Inspection Area</b> Partial	<b>Station End</b> 12544+06	
<b>County</b> Montgomery	<b>Ground</b> Wet	<b>Temperature (°F)</b> 50.00	
<b>Municipality</b> N/A	<b>Weather</b> Light Rain	<b>Rain Gauge (in)</b> 1.20	
<b>Rain Accumulation Time (days)</b>			3.00

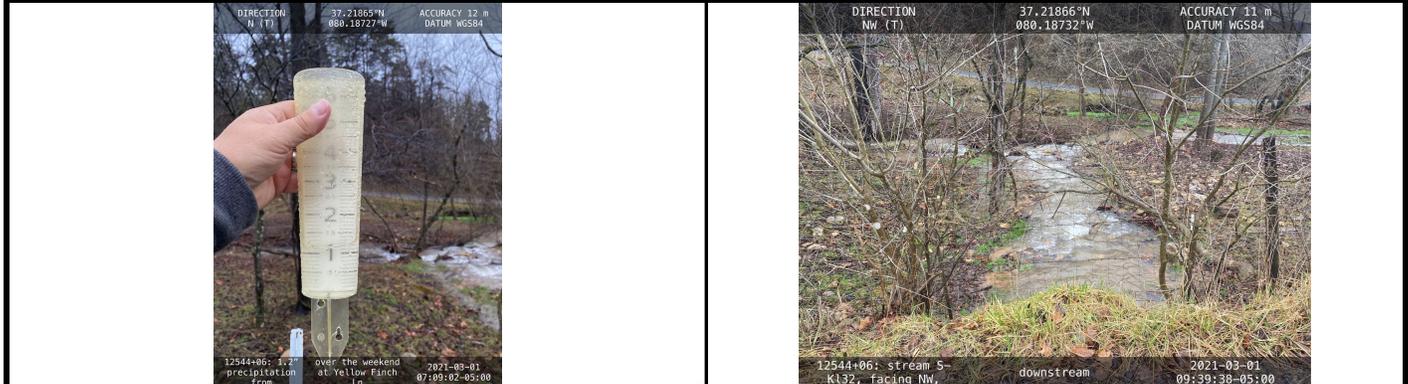
<b>Pic 1 Desc.</b>	1.2 inches of precipitation at Yellow Finch Lane from this passed weekend.	<b>Pic 2 Desc.</b>	Stream S-KL32, facing northwest, downstream from Yellow Finch Lane
--------------------	--	--------------------	--

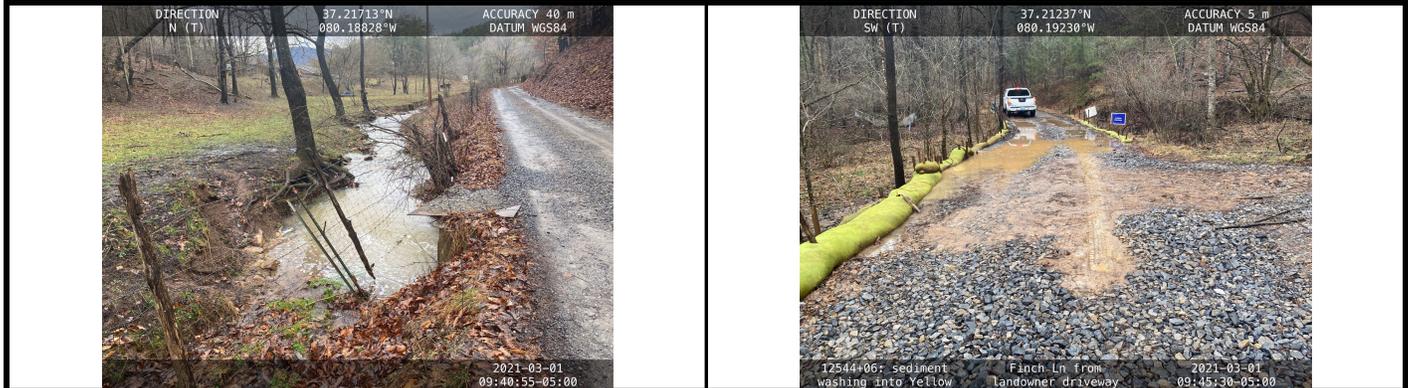
<b>Pic 3 Desc.</b>	Stream S-EF20b, facing north, downstream from Yellow Finch Lane	<b>Pic 4 Desc.</b>	Sediment continues to wash out of landowner's driveway into Yellow Finch Lane.
--------------------	---	--------------------	--

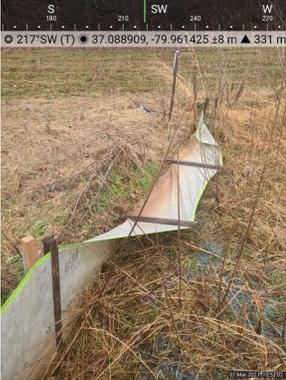
Throughout today's inspections the EI noticed a section of P1 that has been weathered and stakes broken causing the P1 to be down, documented and sent in to be added to the punch list for repair.

<b>GPS Location</b>	00000	<b>GPS Location</b>	00000	
<b>Field Station#</b>	13642+89	<b>Field Station#</b>	13643+54	
<b>Pic 1 Desc.</b>	During the EI's travel today the EI noticed a section of P1 required maintenance due to being weathered and stakes broken , documented and sent in to be added to the		<b>Pic 2 Desc.</b>	Stream observation photo facing upstream during routine inspection today. No issues observed at the time of inspection.

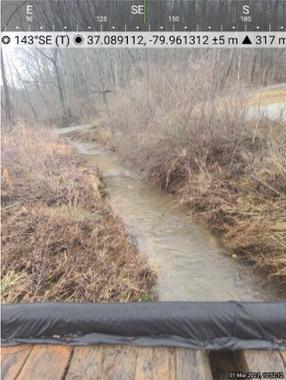
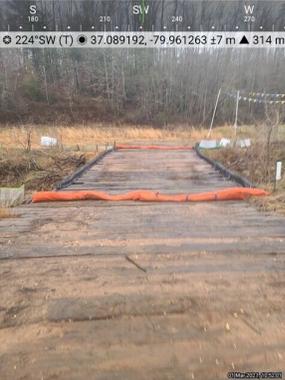
<b>GPS Location</b>	0000	<b>GPS Location</b>	00000	
<b>Field Station#</b>	13643+54	<b>Field Station#</b>	13643+70	
<b>Pic 3 Desc.</b>	Stream observation photo facing downstream during routine inspection today.		<b>Pic 4 Desc.</b>	Monitored equipment bridge and protection as light rain events continued. No issues observed at the time of inspection.

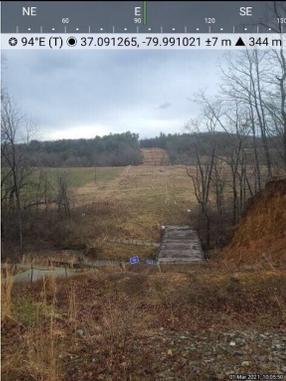
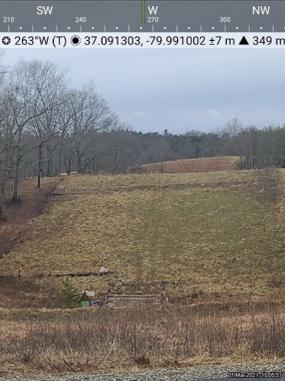
<b>Field Station#</b>	13543+00	<b>Field Station#</b>	13541+50	
<b>Pic 5 Desc.</b>	EI monitored equipment bridge and ECDs above stream cordng during light rain events today.no issues observed at the time of inspection		<b>Pic 6 Desc.</b>	Row photo taken during light rain showers today showing vegetation. No issues observed at the time of inspection.

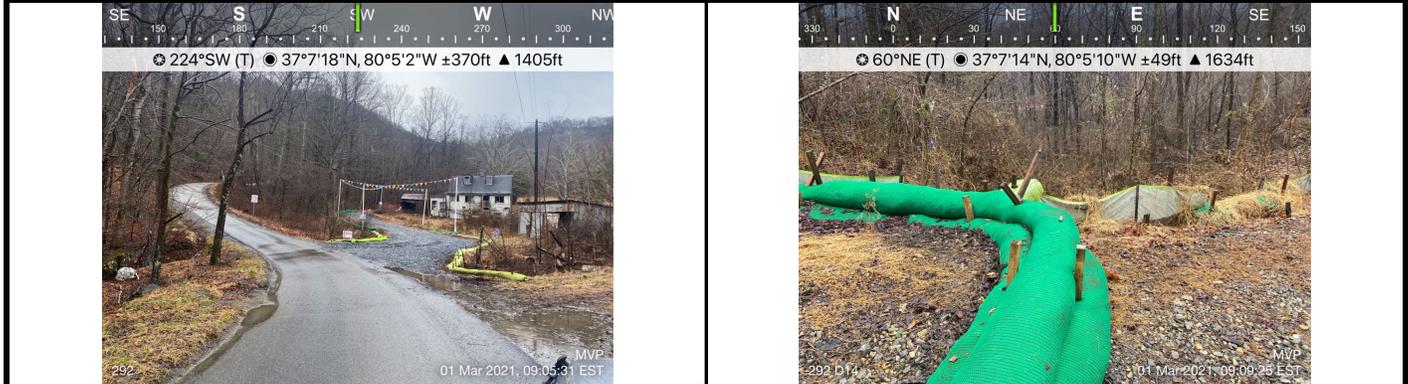
<b>Pic 1 Desc.</b>	MVP-FR-292, RCE and access road in acceptable condition.	<b>Pic 2 Desc.</b>	No waterbar flowing out of S-D14 across MVP-FR-292.
--------------------	--	--------------------	---

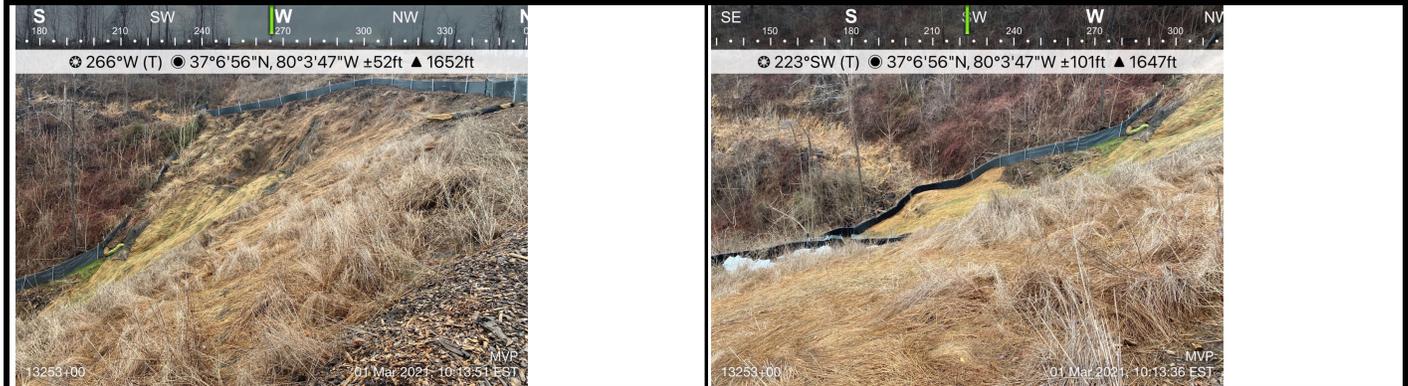
<b>GPS Location</b>	See photo for coordinates.	<b>GPS Location</b>	See photo for coordinates.
<b>Field Station#</b>	13253+00	<b>Field Station#</b>	13253+00
<b>Pic 11 Desc.</b>	Slip appeared stable, curlex remained in place.	<b>Pic 12 Desc.</b>	Slip appeared stable, perimeter controls functioning acceptably.

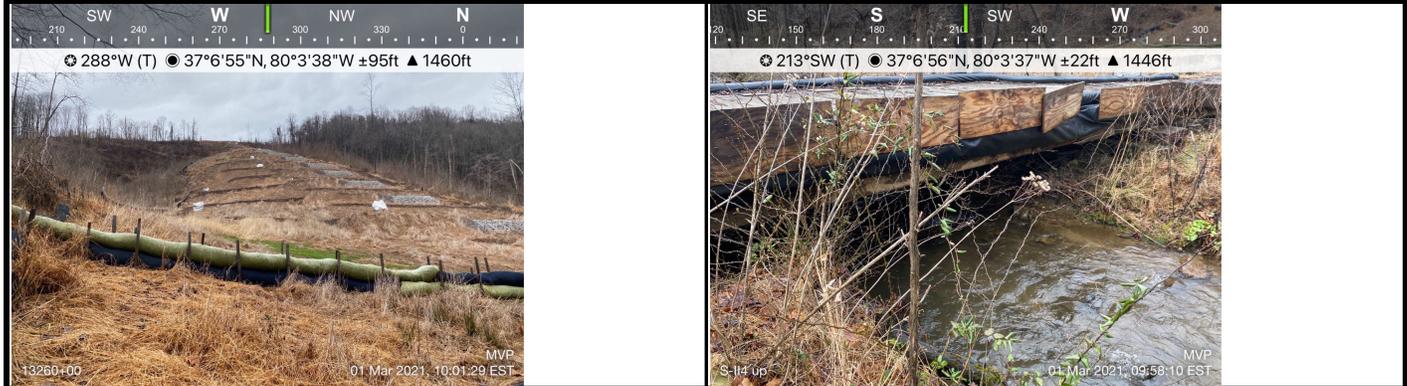
<b>GPS Location</b>	See photo for coordinates.	<b>GPS Location</b>	See photo for coordinates.
<b>Field Station#</b>	13260+00	<b>Field Station#</b>	13260+60
<b>Pic 13 Desc.</b>	ROW stable, no issues noted with level spreaders or permanent waterbar berms, dead or dormant vegetation noted across LOD.	<b>Pic 14 Desc.</b>	S-II4, upstream side of equipment bridge, slight turbidity noted in stream.

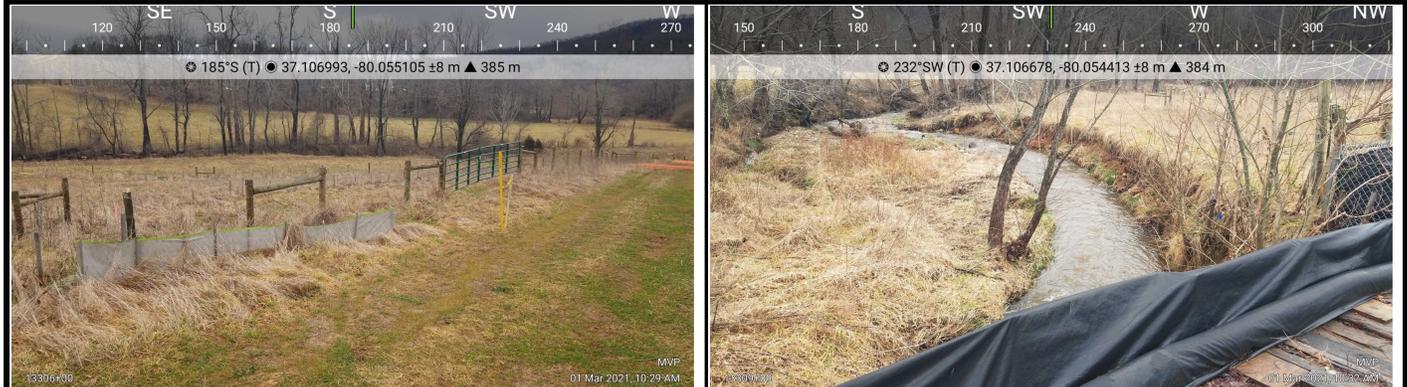
<b>GPS Location</b>	See photo for coordinates.	<b>GPS Location</b>	See photo for coordinates.
<b>Field Station#</b>	13306+00	<b>Field Station#</b>	13309+09
<b>Pic 15 Desc.</b>	ROW stable in agricultural area, vegetative cover noted across LOD.	<b>Pic 16 Desc.</b>	S-GH7, downstream, slight turbidity noted, stream banks appeared stable.

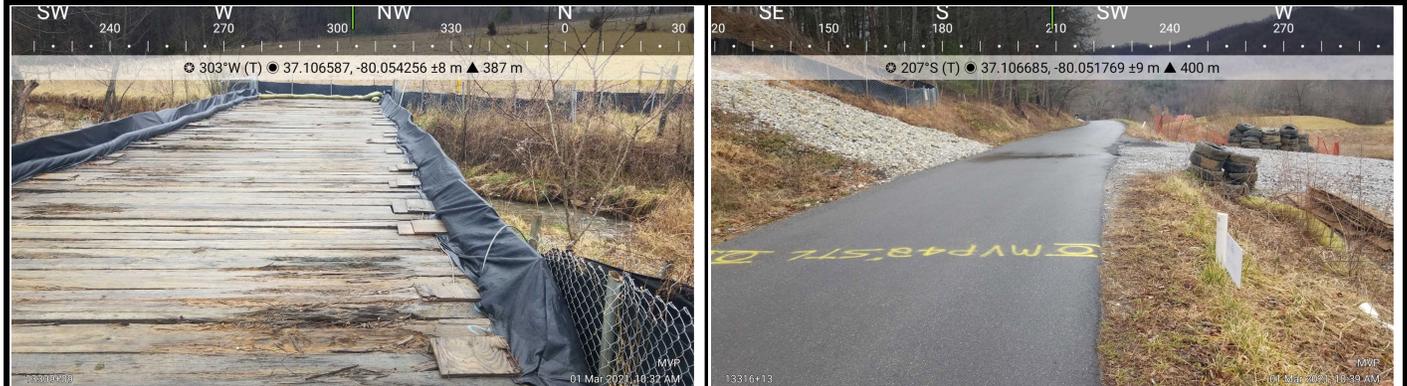
<b>GPS Location</b>	See photo for coordinates.	<b>GPS Location</b>	See photo for coordinates.
<b>Field Station#</b>	13309+09	<b>Field Station#</b>	13316+13
<b>Pic 17 Desc.</b>	Bridge across S-GH7 in acceptable condition.	<b>Pic 18 Desc.</b>	Wades Gap road crossing, road crossing was clean of sediment, RCEs were in acceptable condition.

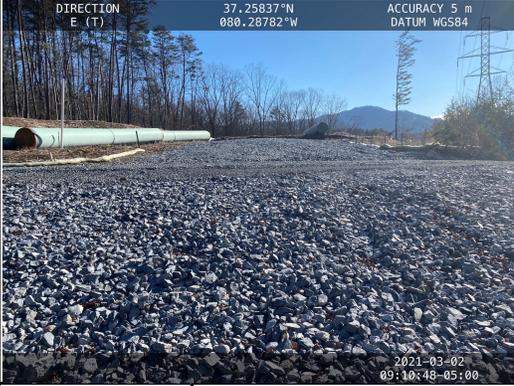
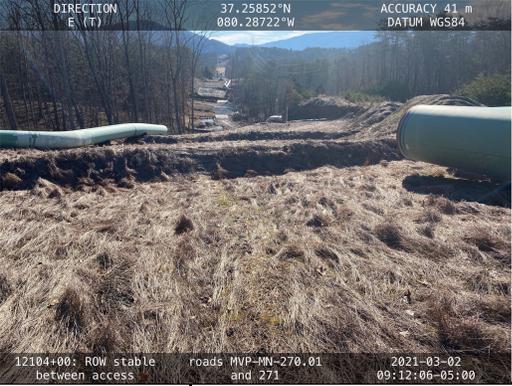
<b>GPS Location</b>	See photo	<b>GPS Location</b>	See photo
<b>Field Station#</b>	12102+69	<b>Field Station#</b>	12104+00
<b>Pic 13 Desc.</b>	RCEs on both sides of Half Acre Rock Road, MVP-MN-270.01, are in satisfactory condition.	<b>Pic 14 Desc.</b>	ROW stable between access roads MVP-MN-270.01 and 271.

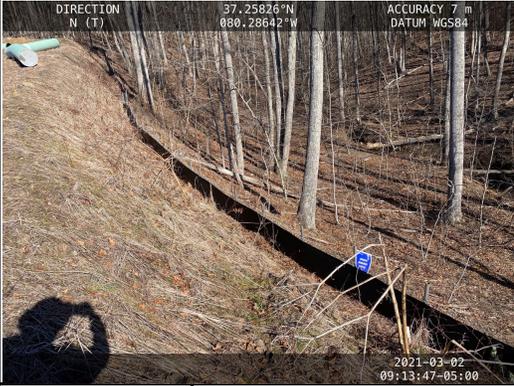
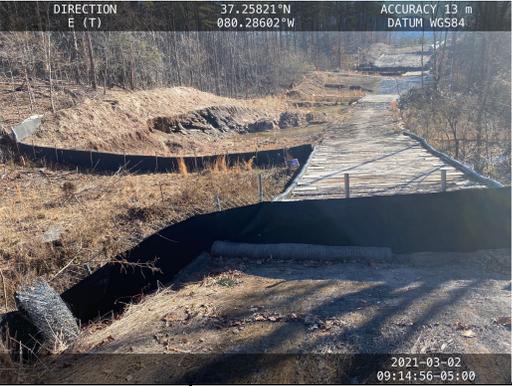
<b>GPS Location</b>	See photo	<b>GPS Location</b>	See photo
<b>Field Station#</b>	12107+00	<b>Field Station#</b>	12108+41
<b>Pic 15 Desc.</b>	Perimeter super silt fence in satisfactory condition.	<b>Pic 16 Desc.</b>	Bridge, buffer zone and ECDs in satisfactory condition at stream S-F15.

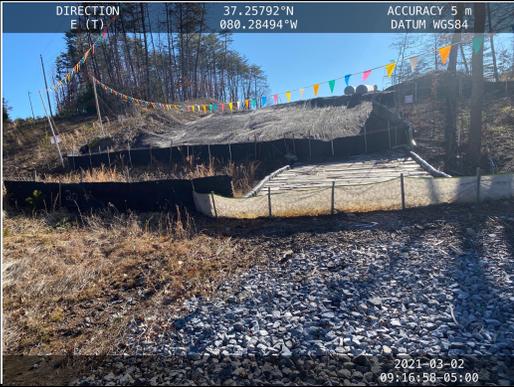
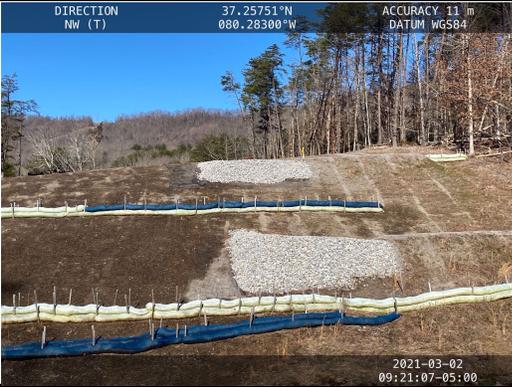
<b>GPS Location</b>	See photo	<b>GPS Location</b>	See photo
<b>Field Station#</b>	12112+13	<b>Field Station#</b>	12116+50
<b>Pic 17 Desc.</b>	Bridge, buffer zone and ECDs in satisfactory condition at stream S-F16.	<b>Pic 18 Desc.</b>	Permanent restoration on the coming in side of Flatwoods Road has minimal vegetative cover, but remains stable with erosion control blanket

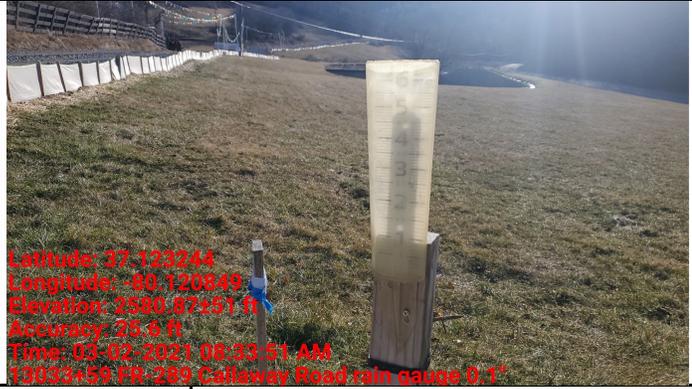
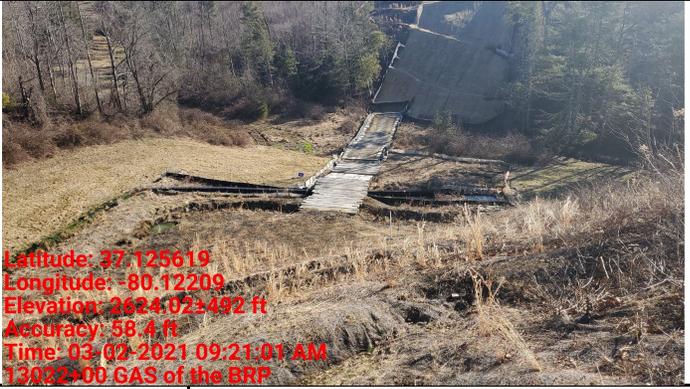
<p>Latitude: 37.125619 Longitude: -80.12209 Elevation: 2624.02±492 ft Accuracy: 58.4 ft Time: 03-02-2021 09:21:01 AM 13022+00 GAS of the BRP</p>	
<b>GPS Location</b>	See pic for GPS location	<b>GPS Location</b>	See pic for GPS location
<b>Field Station#</b>	13033+59	<b>Field Station#</b>	13022+00
<b>Pic 1 Desc.</b>	Callaway Road rain gauge. 0.1"	<b>Pic 2 Desc.</b>	Streams S-G24 and S-G25 on the GAS of the BRP.

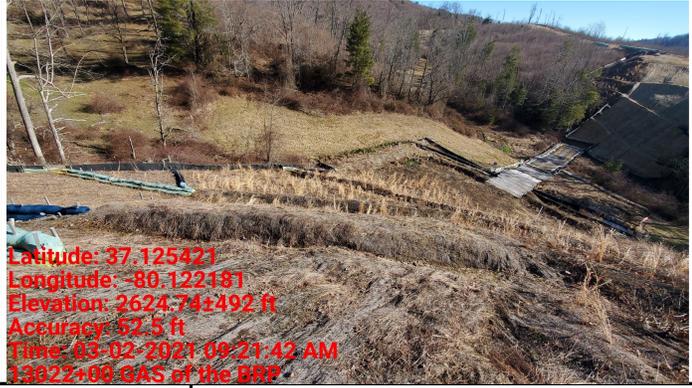
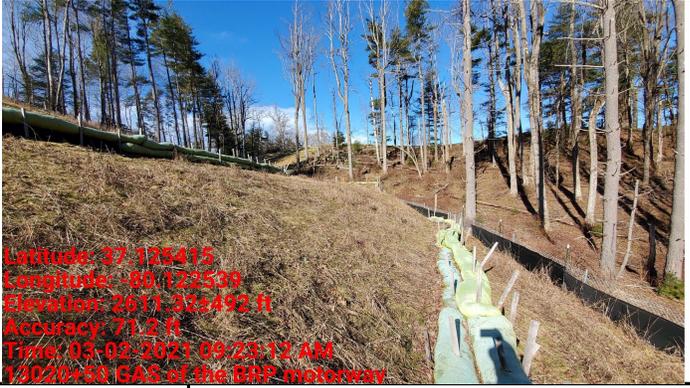
<b>Field Station#</b>	13022+00	<b>Field Station#</b>	13020+50
<b>Pic 3 Desc.</b>	Boundary of the BRP property.	<b>Pic 4 Desc.</b>	Current ROW conditions on the GAS of the BRP motorway.

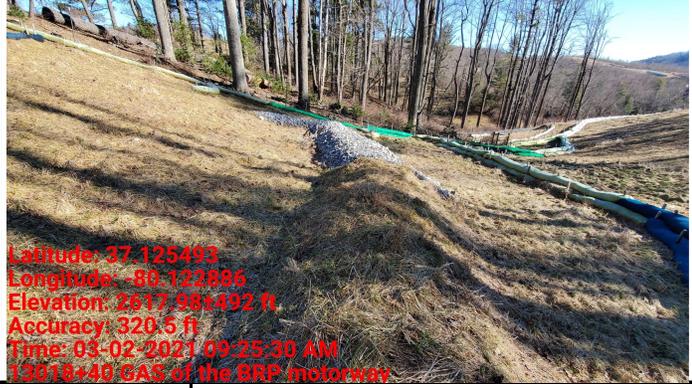
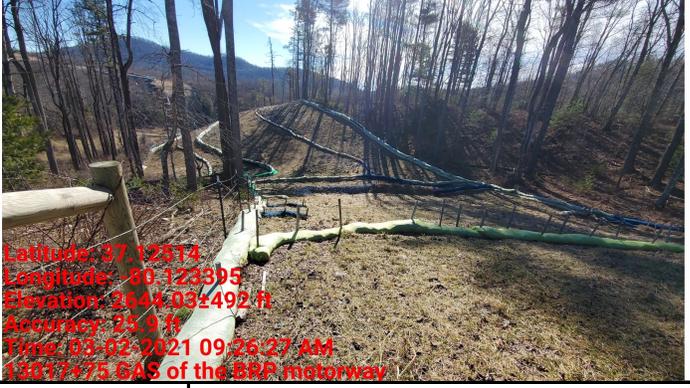
<p>Latitude: 37.12514 Longitude: -80.123395 Elevation: 2644.03±492 ft Accuracy: 75.9 ft Time: 03-02-2021 09:26:27 AM 13017+75 GAS of the BRP motorway</p>	
<b>GPS Location</b>	See pic for GPS location	<b>GPS Location</b>	See pic for GPS location
<b>Field Station#</b>	13018+40	<b>Field Station#</b>	13017+75
<b>Pic 5 Desc.</b>	Permanent Slope Breaker and Rock Level Spreader on the GAS of the BRP motorway.	<b>Pic 6 Desc.</b>	Current ROW conditions on the GAS of the BRP motorway in the wooded portion.

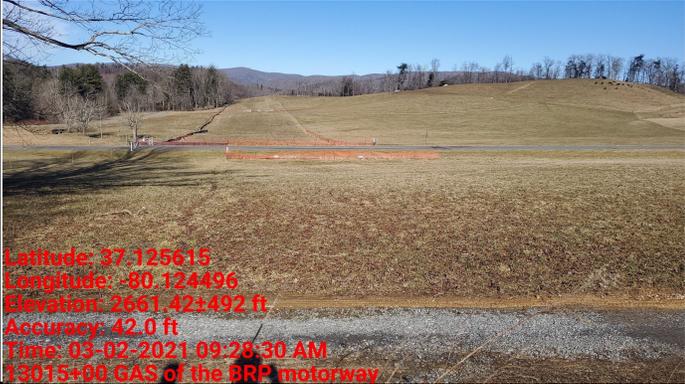
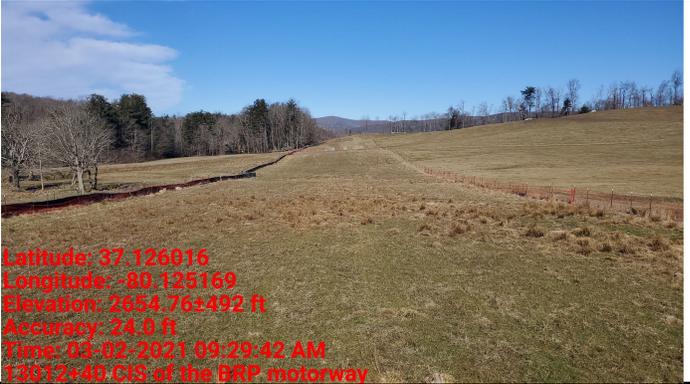
<p>Latitude: 37.126016 Longitude: -80.125169 Elevation: 2654.76+492 ft Accuracy: 24.0 ft Time: 03-02-2021 09:29:42 AM 13012+40 CIS of the BRP motorway</p>		
<b>GPS Location</b>	See pic for GPS location		<b>GPS Location</b>	See pic for GPS location	
<b>Field Station#</b>	13015+00		<b>Field Station#</b>	13012+40	
<b>Pic 7 Desc.</b>	Current ROW conditions on the GAS of the BRP motorway.		<b>Pic 8 Desc.</b>	No issues or impacts observed on the CIS of the BRP motorway.

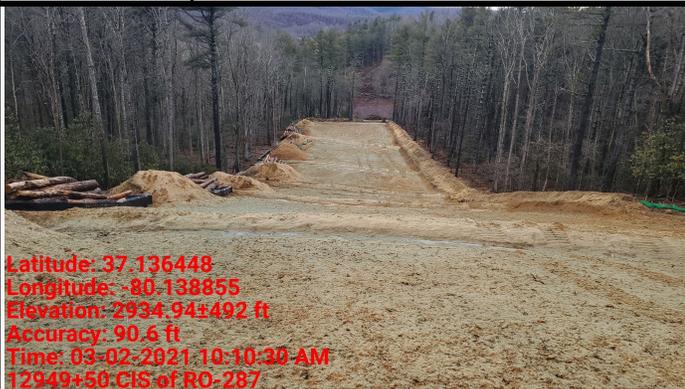
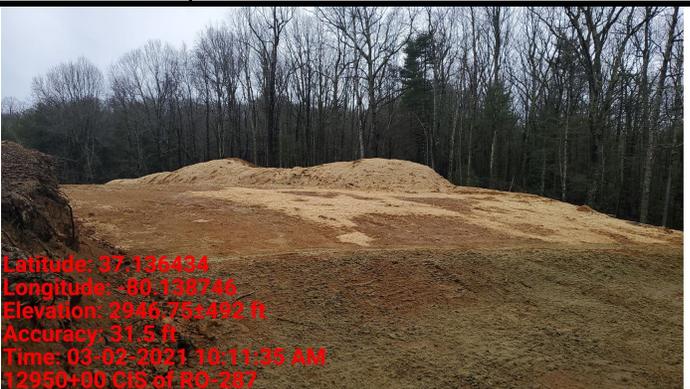
<b>GPS Location</b>	See pic for GPS location		<b>GPS Location</b>	See pic for GPS location	
<b>Field Station#</b>	12949+50		<b>Field Station#</b>	12950+00	
<b>Pic 9 Desc.</b>	ROW remains stabilized with EarthGuard hydromulch.		<b>Pic 10 Desc.</b>	No erosion issues or impacts observed on the CIS of RO-287.

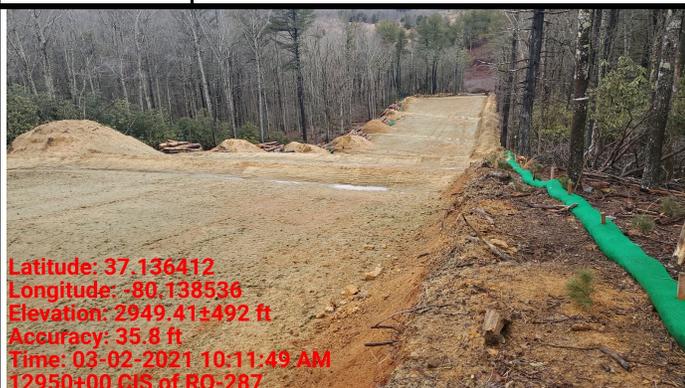
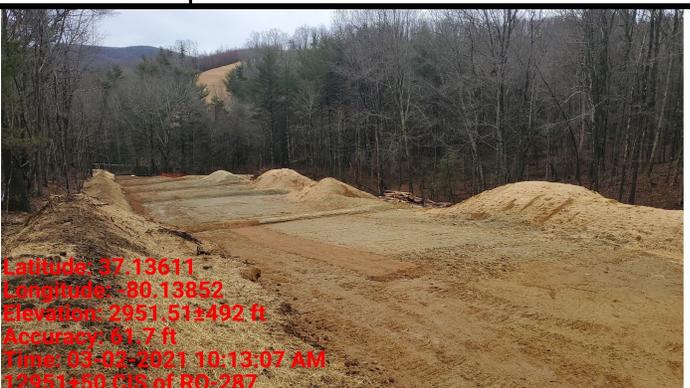
<p>Latitude: 37.13611 Longitude: -80.13852 Elevation: 2951.51+492 ft Accuracy: 61.7 ft Time: 03-02-2021 10:13:07 AM 12951+50 CIS of RO-287</p>		
<b>GPS Location</b>	See pic for GPS location		<b>GPS Location</b>	See pic for GPS location	
<b>Field Station#</b>	12950+00		<b>Field Station#</b>	12951+50	
<b>Pic 11 Desc.</b>	Current ROW conditions on the GAS of stream S-IJ43.		<b>Pic 12 Desc.</b>	Current ROW conditions on the CIS of RO-287.

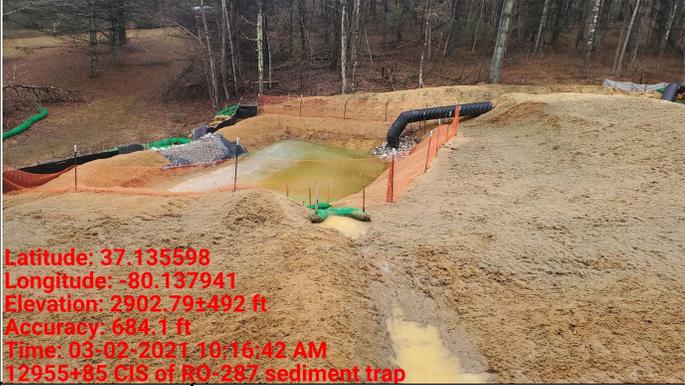
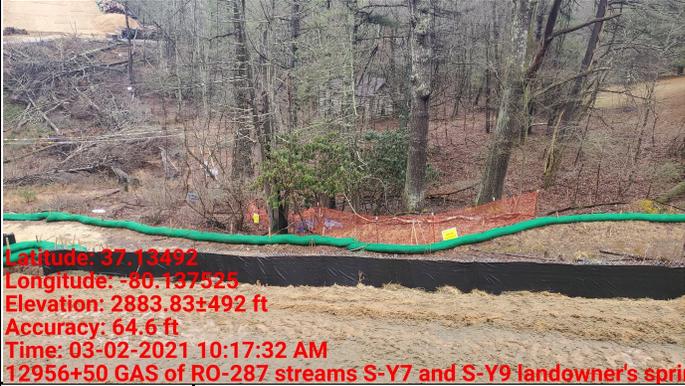
<p><b>Latitude:</b> 37.13492 <b>Longitude:</b> -80.137525 <b>Elevation:</b> 2883.83±492 ft <b>Accuracy:</b> 64.6 ft <b>Time:</b> 03-02-2021 10:17:32 AM <b>12956+50 GAS of RO-287 streams S-Y7 and S-Y9 landowner's spring</b></p>	
<b>GPS Location</b>	See pic for GPS location	<b>GPS Location</b>	See pic for GPS location
<b>Field Station#</b>	12955+85	<b>Field Station#</b>	12956+50
<b>Pic 13 Desc.</b>	Sediment trap on the CIS of RO-287.	<b>Pic 14 Desc.</b>	Streams on the GAS of RO-287 and the landowner's spring box.

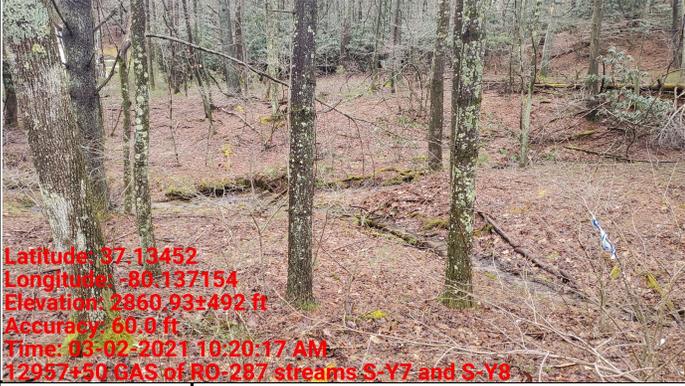
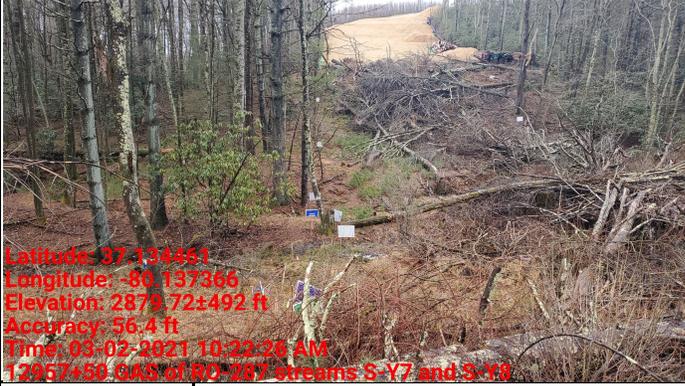
<b>GPS Location</b>	See pic for GPS location	<b>GPS Location</b>	See pic for GPS location
<b>Field Station#</b>	12957+50	<b>Field Station#</b>	12957+50
<b>Pic 15 Desc.</b>	Streams S-Y7 and S-Y8 on the downstream of the ATWS.	<b>Pic 16 Desc.</b>	Streams S-Y7 and S-Y8 on the downstream of the ROW.

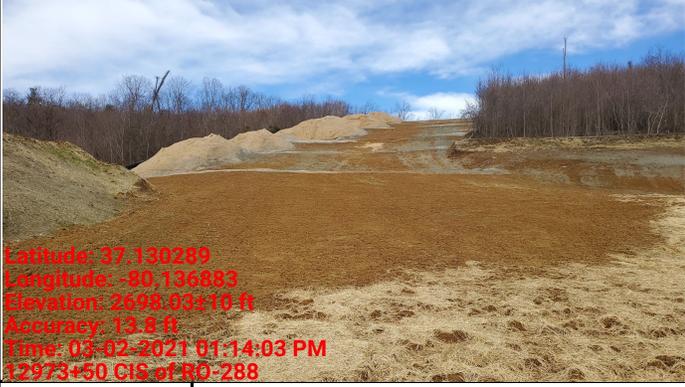
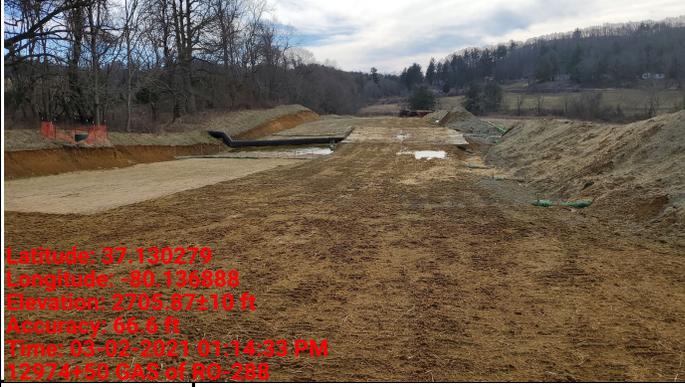
<p><b>Latitude:</b> 37.130279 <b>Longitude:</b> -80.136888 <b>Elevation:</b> 2705.87±110 ft <b>Accuracy:</b> 65.4 ft <b>Time:</b> 03-02-2021 01:14:33 PM <b>12974+50 GAS of RO-288</b></p>	
<b>GPS Location</b>	See pic for GPS location	<b>GPS Location</b>	See pic for GPS location
<b>Field Station#</b>	12973+50	<b>Field Station#</b>	12974+50
<b>Pic 17 Desc.</b>	Slope on the CIS of RO-288	<b>Pic 18 Desc.</b>	Current conditions of the ROW on the GAS of RO-288.

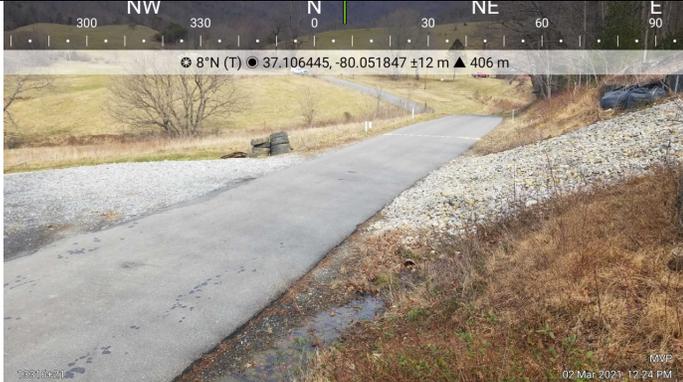
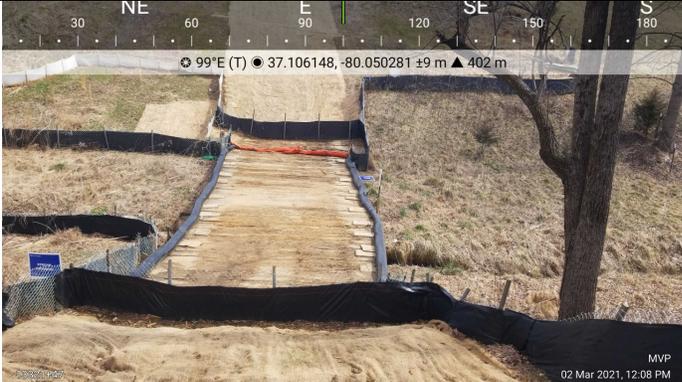
<b>GPS Location</b> See Above	<b>GPS Location</b> See Above
<b>Field Station#</b> 13316+21	<b>Field Station#</b> 13321+47
<b>Pic 1 Desc.</b> Overview of Wades Gap Road ROW crossing. ECDs are functional and ROW is stable.	<b>Pic 2 Desc.</b> Overview of Waterbody S-GH15. ECDs are functional and ROW is stable.

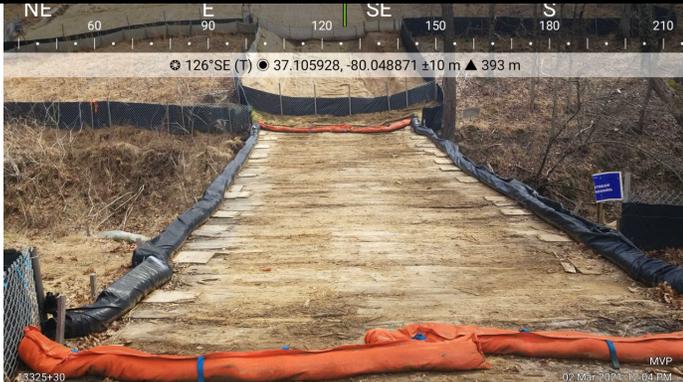
<b>GPS Location</b> See Above	<b>GPS Location</b> See Above
<b>Field Station#</b> 13325+30	<b>Field Station#</b> 13332+00
<b>Pic 3 Desc.</b> Overview of Waterbody S-GH14. ECDs are functional and ROW is stable.	<b>Pic 4 Desc.</b> ROW Overview. ECDs are functional and ROW is stable.

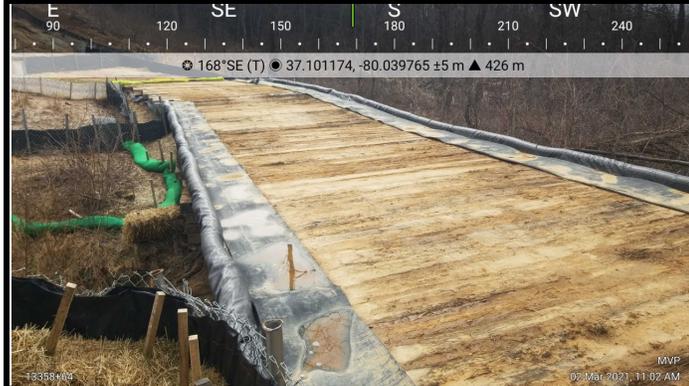
<b>GPS Location</b>	See Above
<b>Field Station#</b>	13358+64
<b>Pic 13 Desc.</b>	Overview of Waterbody S-RR11. ECDs are functional and ROW is stable.

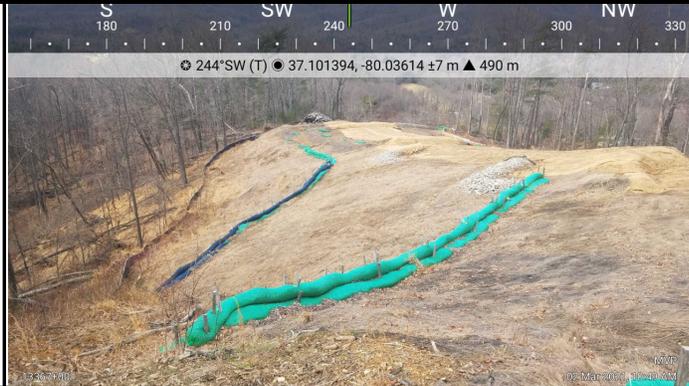
<b>GPS Location</b>	See Above
<b>Field Station#</b>	13367+00
<b>Pic 14 Desc.</b>	ROW Overview. ECDs are functional and ROW is stable.

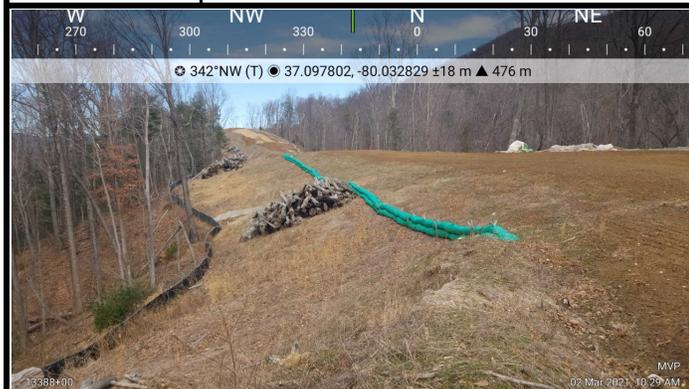
<b>GPS Location</b>	See Above
<b>Field Station#</b>	13388+00
<b>Pic 15 Desc.</b>	ROW Overview. ECDs are functional and ROW is stable.

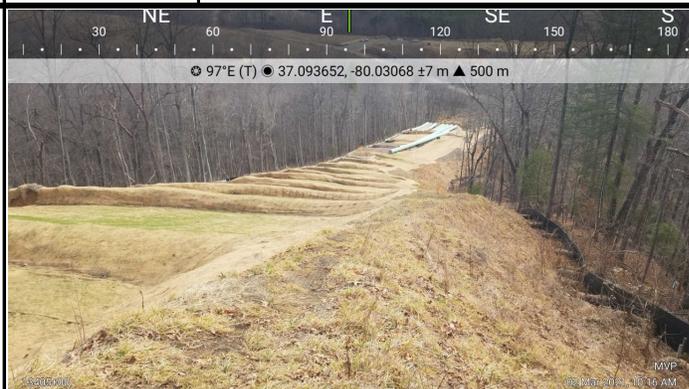
<b>GPS Location</b>	See Above
<b>Field Station#</b>	13405+00
<b>Pic 16 Desc.</b>	ROW Overview. ECDs are functional and ROW is stable.

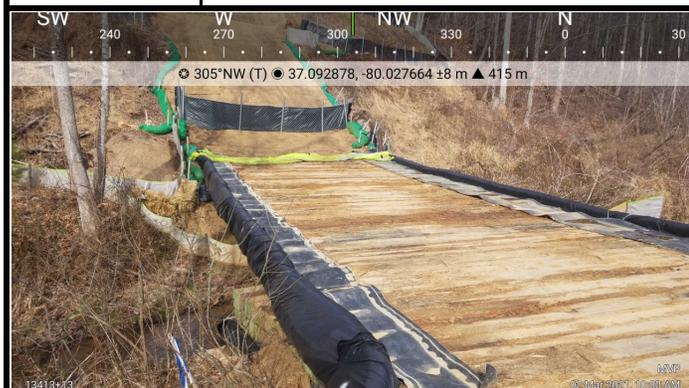
<b>GPS Location</b>	See Above
<b>Field Station#</b>	13413+13
<b>Pic 17 Desc.</b>	Overview of Waterbody S-IJ1. ECDs are functional and ROW is stable.

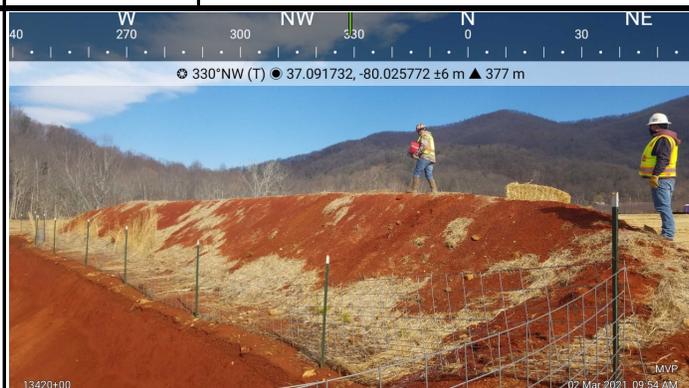
<b>GPS Location</b>	See Above
<b>Field Station#</b>	13420+00
<b>Pic 18 Desc.</b>	Environmental crews working on ECD/BMP maintenance.

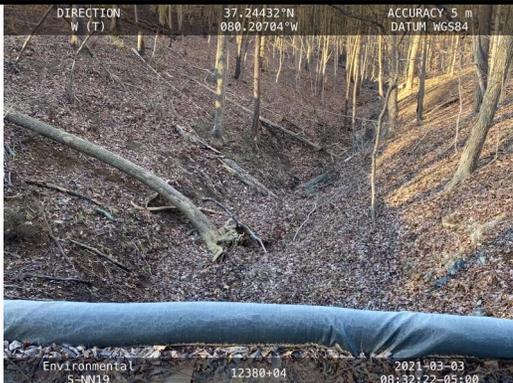
<p>DIRECTION W (T) 37.24432°N 080.20704°W ACCURACY 5 m DATUM WGS84 Environmental S-NN19 12380+04 2021-03-03 08:32:22-05:00</p>

<b>Pic 9 Desc.</b>	Stream S-NN19, facing west, downstream	<b>Pic 10 Desc.</b>	Bridge is in good condition over the clean water diversion channel on the going away side of Cannery Road.

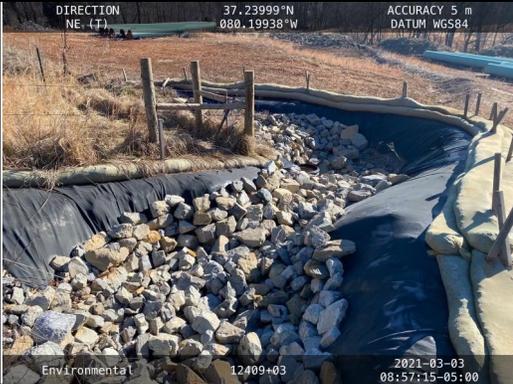
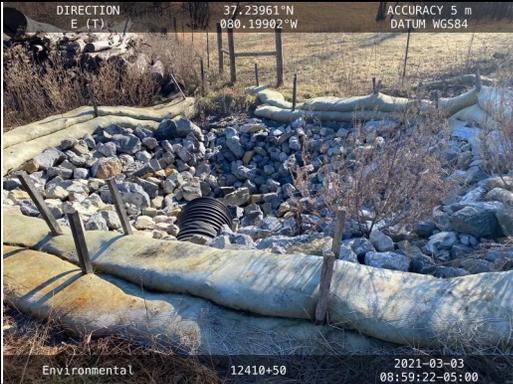
<b>GPS Location</b>	See photo	<b>GPS Location</b>	See photo
<b>Field Station#</b>	12409+03	<b>Field Station#</b>	12410+50
<b>Pic 13 Desc.</b>	Clean water diversion pipe inlet in satisfactory condition.	<b>Pic 14 Desc.</b>	Clean water diversion pipe outlet plunge pool free of sediment and functioning properly.

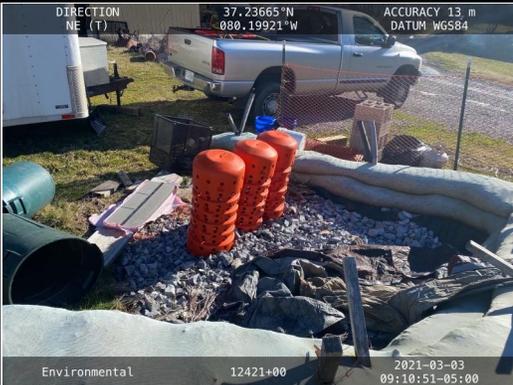
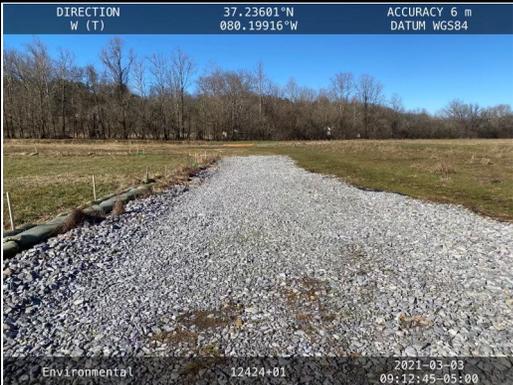
<b>GPS Location</b>	See photo	<b>GPS Location</b>	See photo
<b>Field Station#</b>	12421+00	<b>Field Station#</b>	12424+00
<b>Pic 15 Desc.</b>	Clean water diversion pipe inlet is in satisfactory condition near the chicken coop on the CIS in side of access road MVP-MN-279.	<b>Pic 16 Desc.</b>	RCE in satisfactory condition on the going away side of access road MVP-MN-279.

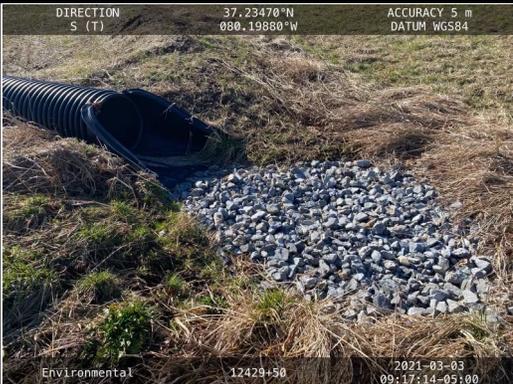
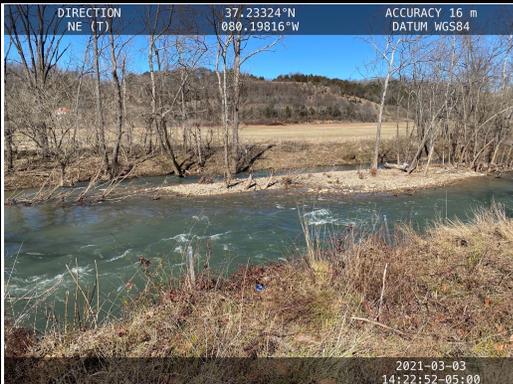
<b>GPS Location</b>	See photo	<b>GPS Location</b>	See photo
<b>Field Station#</b>	12429+50	<b>Field Station#</b>	12435+50
<b>Pic 17 Desc.</b>	Clean water diversion pipe inlet is in satisfactory condition between MVP-MN-279 and Roanoke River.	<b>Pic 18 Desc.</b>	Stream S-NN16, Roanoke River, facing northeast from Lafayette Road

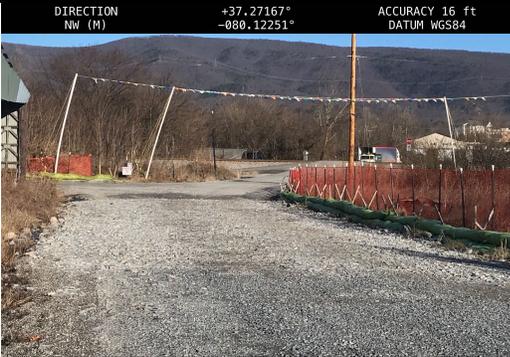
<p>DIRECTION: NW (M) +37.27167° -080.12251° ACCURACY 16 ft DATUM WGS84</p> <p>MVP-LY-049_030321 Condition of rock entrance 2021-03-03 08:25:00-05:00</p>

<p>DIRECTION: N (M) +37.27105° -080.12189° ACCURACY 16 ft DATUM WGS84</p> <p>MVP-LY-049_030321 Condition of CFS &amp; safety fence 2021-03-03 08:27:14-05:00</p>		<p><b>GPS Location</b> MVP-LY-049 See photo for gps data</p> <p><b>Field Station#</b> +0</p> <p><b>Pic 1 Desc.</b> Condition of rock entrance on center drive. No sediment on stone surface. Looking NW.</p>		<p><b>GPS Location</b> MVP-LY-049 See photo for gps data</p> <p><b>Field Station#</b> +0</p> <p><b>Pic 2 Desc.</b> Condition of compost filter sock and safety fence along east side of drive. Looking N.</p>

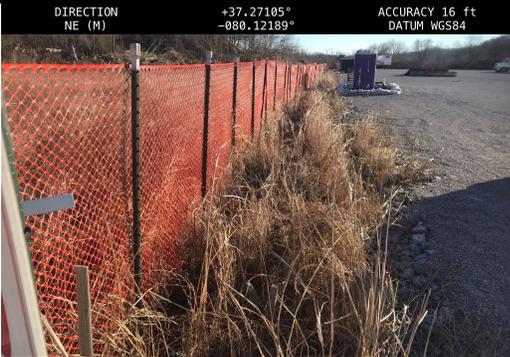
<p>DIRECTION: NE (M) +37.27105° -080.12189° ACCURACY 16 ft DATUM WGS84</p> <p>MVP-LY-049_030321 Condition of CFS &amp; safety fence 2021-03-03 08:27:19-05:00</p>

<p>DIRECTION: NE (M) +37.27107° -080.12168° ACCURACY 16 ft DATUM WGS84</p> <p>MVP-LY-049_030321 Condition of trays &amp; containment 2021-03-03 08:27:58-05:00</p>		<p><b>GPS Location</b> MVP-LY-049 See photo for gps data</p> <p><b>Field Station#</b> +0</p> <p><b>Pic 3 Desc.</b> Condition of compost filter sock and safety fence along north LOD. Looking NE.</p>		<p><b>GPS Location</b> MVP-LY-049 See photo for gps data</p> <p><b>Field Station#</b> +0</p> <p><b>Pic 4 Desc.</b> Condition of trays and containment under toilets. Looking NE.</p>

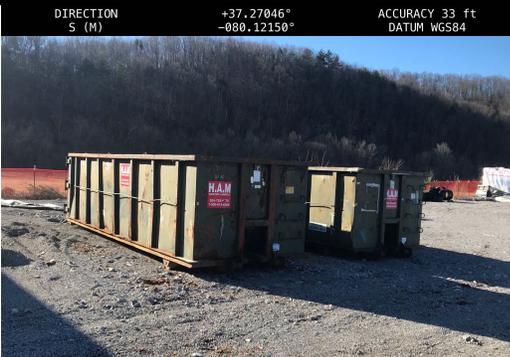
<p>DIRECTION: S (M) +37.27046° -080.12150° ACCURACY 33 ft DATUM WGS84</p> <p>MVP-LY-049_030321 No loose trash around south dumpsters 2021-03-03 08:51:45-05:00</p>

<p>DIRECTION: SW (M) +37.27751° -080.12529° ACCURACY 253 ft DATUM WGS84</p> <p>MVP-LY-049_030321 Restoration supplies covered 2021-03-03 08:53:44-05:00</p>		<p><b>GPS Location</b> MVP-LY-049 See photo for gps data</p> <p><b>Field Station#</b> +0</p> <p><b>Pic 5 Desc.</b> No loose trash around south dumpsters or in the yard. Looking S.</p>		<p><b>GPS Location</b> MVP-LY-049 See photo for gps data</p> <p><b>Field Station#</b> +0</p> <p><b>Pic 6 Desc.</b> Restoration supplies covered and protected from the weather. Looking SW.</p>

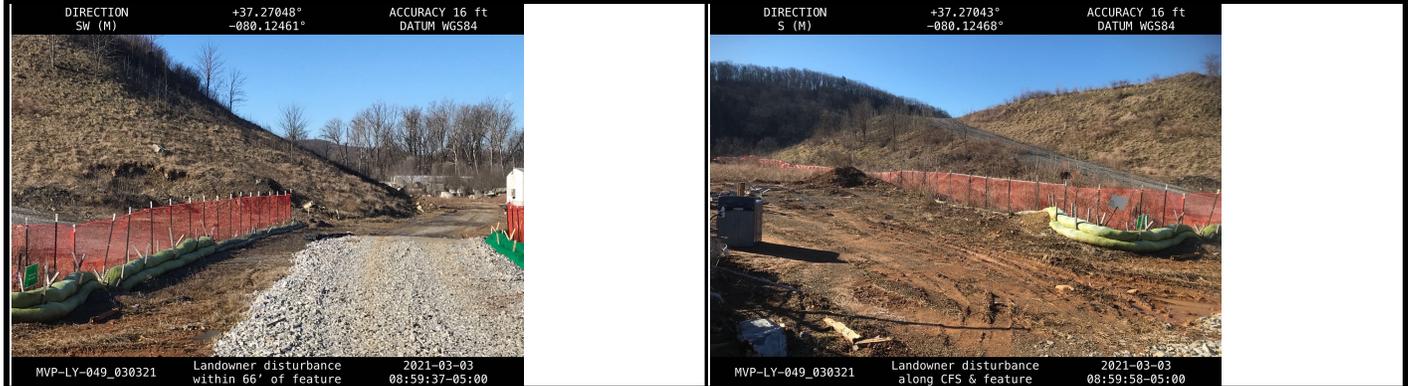
<b>GPS Location</b>	MVP-LY-049 See photo for gps data	<b>GPS Location</b>	MVP-LY-049 See photo for gps data
<b>Field Station#</b>	+0	<b>Field Station#</b>	+0
<b>Pic 13 Desc.</b>	Landowner soil disturbance within 66' and 120' west of feature W-CV21B. Areas not stabilized. No impacts. Looking SW.	<b>Pic 14 Desc.</b>	Landowner soil disturbance along compost filter sock and feature W-CV21B. Area not stabilized. No impact. Looking S.

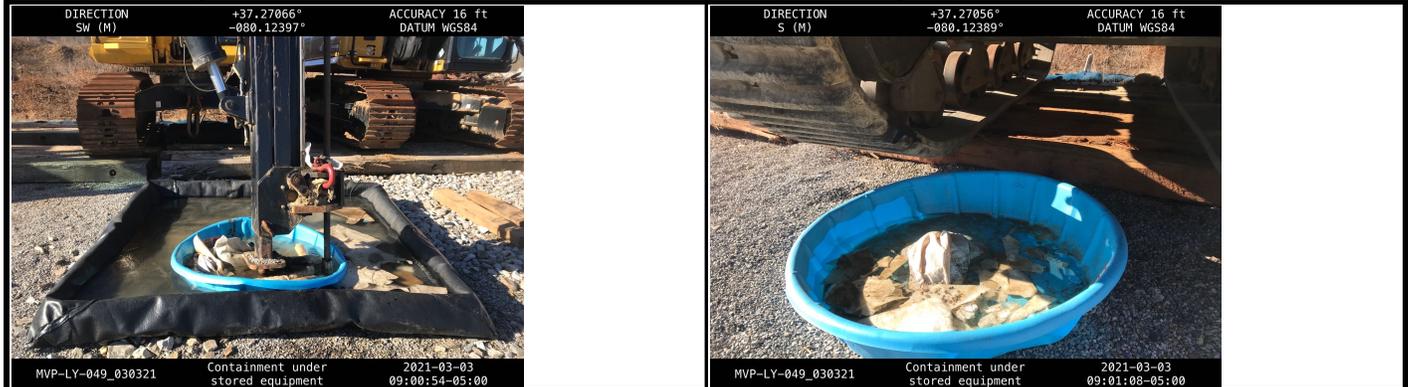
<b>GPS Location</b>	MVP-LY-049 See photo for gps data	<b>GPS Location</b>	MVP-LY-049 See photo for gps data
<b>Field Station#</b>	+0	<b>Field Station#</b>	+0
<b>Pic 15 Desc.</b>	Condition of containment under stored equipment. Looking SW.	<b>Pic 16 Desc.</b>	Condition of containment under stored equipment. Looking S.

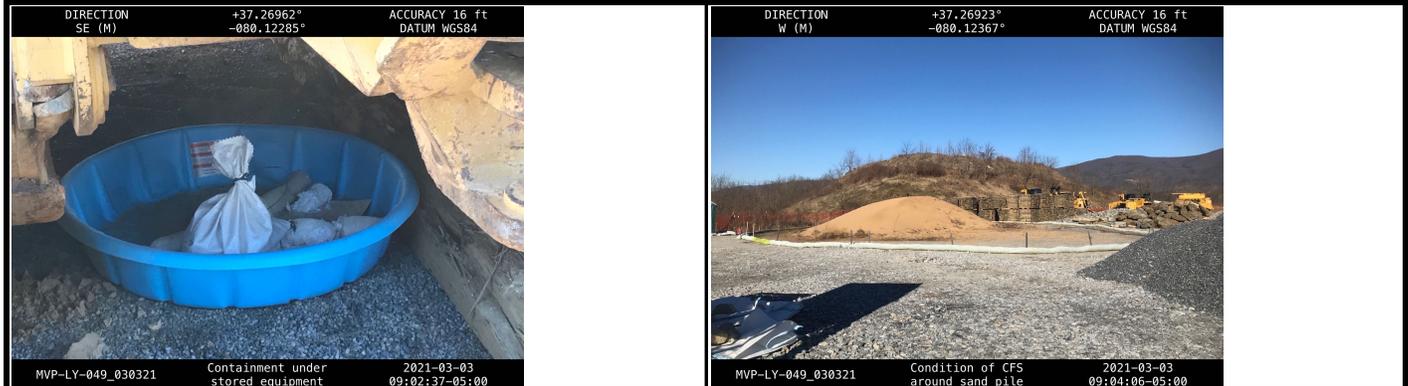
<b>GPS Location</b>	MVP-LY-049 See photo for gps data	<b>GPS Location</b>	MVP-LY-049 See photo for gps data
<b>Field Station#</b>	+0	<b>Field Station#</b>	+0
<b>Pic 17 Desc.</b>	Condition of containment under stored equipment. Looking SE.	<b>Pic 18 Desc.</b>	Condition of compost filter sock around sand pile. Looking W.

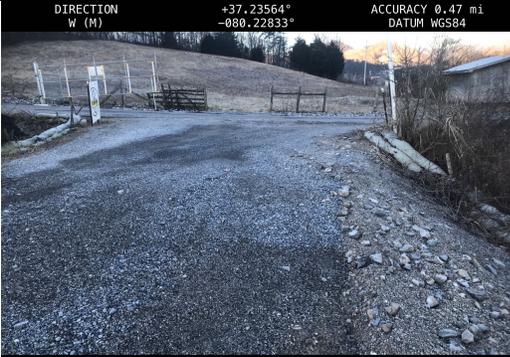
<p>DIRECTION W (M) +37.23564° -080.22633° ACCURACY 0.47 mi DATUM WGS84</p> <p>MVP-PY-006_030321 Condition of rock entrance 2021-03-03 07:28:56-05:00</p>

<p>DIRECTION E (M) +37.23582° -080.22694° ACCURACY 33 ft DATUM WGS84</p> <p>MVP-PY-006_030321 Condition of CFS &amp; signage at feature 2021-03-03 07:32:03-05:00</p>			
<b>GPS Location</b> MVP-PY-006 See photo for gps data		<b>GPS Location</b> MVP-PY-006 See photo for gps data			
<b>Field Station#</b> +0		<b>Field Station#</b> +0			
<b>Pic 1 Desc.</b> Condition of west rock entrance. No sediment on stone and no stone on roadway. Looking W.		<b>Pic 2 Desc.</b> Condition of compost filter sock and signage for feature W-008. Looking E.

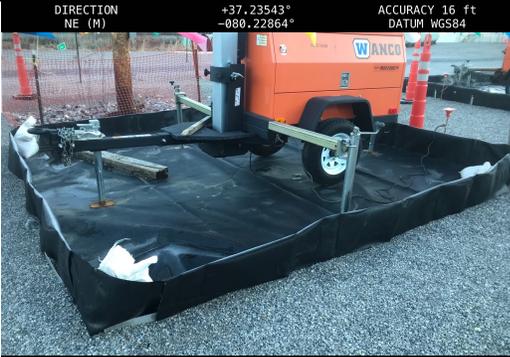
<p>DIRECTION NE (M) +37.23543° -080.22864° ACCURACY 16 ft DATUM WGS84</p> <p>MVP-PY-006_030321 Condition of containment 2021-03-03 07:33:08-05:00</p>

<b>GPS Location</b> MVP-PY-006 See photo for gps data		<b>GPS Location</b> MVP-PY-006 See photo for gps data			
<b>Field Station#</b> +0		<b>Field Station#</b> +0			
<b>Pic 3 Desc.</b> Condition of containment under light plant. Free of stormwater. Looking NE.		<b>Pic 4 Desc.</b> No fluids or deposits around hazardous waste dumpsters. Looking S.

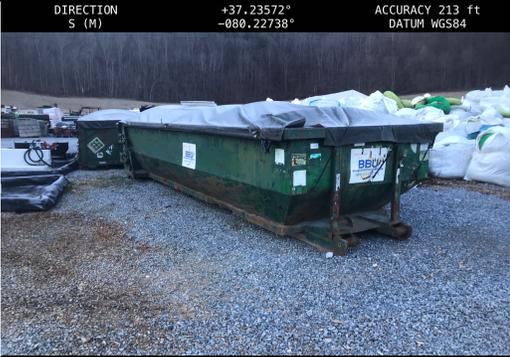
<p>DIRECTION S (M) +37.23572° -080.22738° ACCURACY 213 ft DATUM WGS84</p> <p>MVP-PY-006_030321 No fluids around hazardous waste ... 2021-03-03 07:35:49-05:00</p>

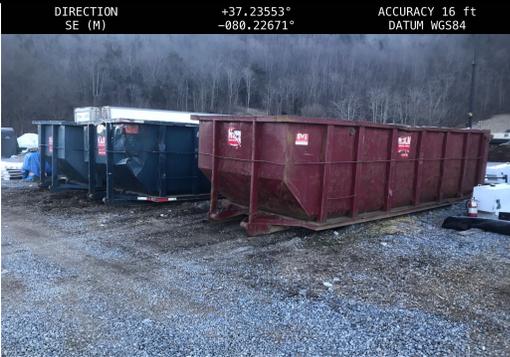
<p>DIRECTION SE (M) +37.23553° -080.22671° ACCURACY 16 ft DATUM WGS84</p> <p>MVP-PY-006_030321 No loose trash around dumpsters 2021-03-03 07:35:52-05:00</p>

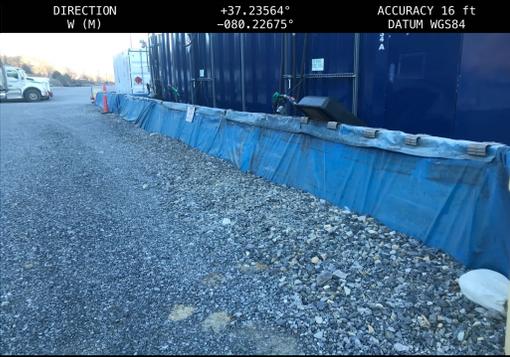
<p>DIRECTION W (M) +37.23564° -080.22675° ACCURACY 16 ft DATUM WGS84</p> <p>MVP-PY-006_030321 No fuel spills south of tanks 2021-03-03 07:36:07-05:00</p>			
<b>GPS Location</b> MVP-PY-006 See photo for gps data		<b>GPS Location</b> MVP-PY-006 See photo for gps data			
<b>Field Station#</b> +0		<b>Field Station#</b> +0			
<b>Pic 5 Desc.</b> No loose trash around dumpsters or in the yard. Looking SE.		<b>Pic 6 Desc.</b> No fuel spills south of the Blue Bulk fuel tanks. Looking W.

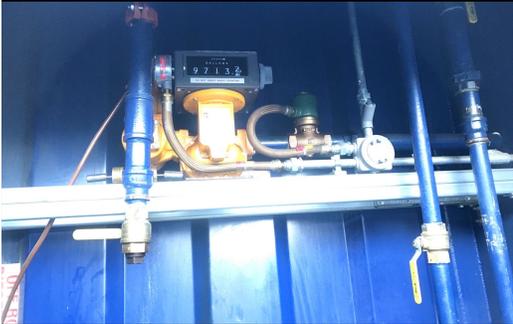
<p>DIRECTION W (M) +37.23566° -080.22678° ACCURACY 16 ft DATUM WGS84</p> <p>MVP-PY-006_030321 No leaky internal fittings 2021-03-03 07:36:58-05:00</p>

<b>GPS Location</b> MVP-PY-006 See photo for gps data	<b>GPS Location</b> MVP-PY-006 See photo for gps data
<b>Field Station#</b> +0	<b>Field Station#</b> +0
<b>Pic 7 Desc.</b> Blue Bulk Fuel tanks no leaky internal fittings. Looking W.	<b>Pic 8 Desc.</b> Condition of containment under DEF container. Free of stormwater. Looking S.

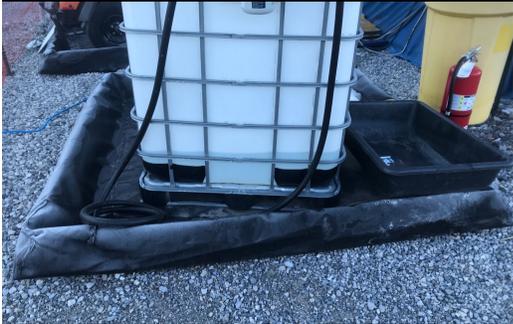
<p>DIRECTION S (M) +37.23564° -080.22679° ACCURACY 33 ft DATUM WGS84</p> <p>MVP-PY-006_030321 Condition of containment 2021-03-03 07:37:32-05:00</p>
--	---

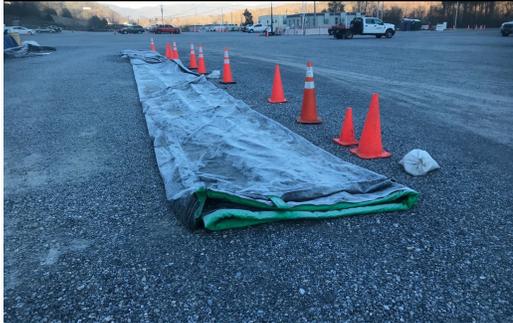
<p>DIRECTION W (M) +37.23569° -080.22678° ACCURACY 16 ft DATUM WGS84</p> <p>MVP-PY-006_030321 Secondary containment on site for tankers 2021-03-03 07:37:39-05:00</p>

<b>GPS Location</b> MVP-PY-006 See photo for gps data	<b>GPS Location</b> MVP-PY-006 See photo for gps data
<b>Field Station#</b> +0	<b>Field Station#</b> +0
<b>Pic 9 Desc.</b> Secondary containment on site for tankers offloading fuel. Looking W.	<b>Pic 10 Desc.</b> Off Road Fuel unit condition of containment. Holding stormwater with a sheen. Looking W.
