# Visual Site Inspection Report

<b>Project Name</b> H-600 Pipeline Spread H		<b>AFE</b> 124300138	<b>Spread</b> H-600 Pipeline Spread H
<b>Contractor</b> Precision		<b>Report #</b> 20563	
<b>Inspector</b> John Brcic		<b>Date/Time</b> 3/1/2021 1:48 PM	
<b>Permit #</b> TBD	<b>Inspection Type</b> VA SWPP	<b>Station Begin</b> 12443+75	
<b>State</b> VA	<b>Inspection Area</b> Partial	<b>Station End</b> 12544+06	
<b>County</b> Montgomery	<b>Ground</b> Wet	<b>Temperature (°F)</b> 50.00	
<b>Municipality</b> N/A	<b>Weather</b> Light Rain	<b>Rain Gauge (in)</b> 1.20	
<b>Rain Accumulation Time (days)</b>			3.00

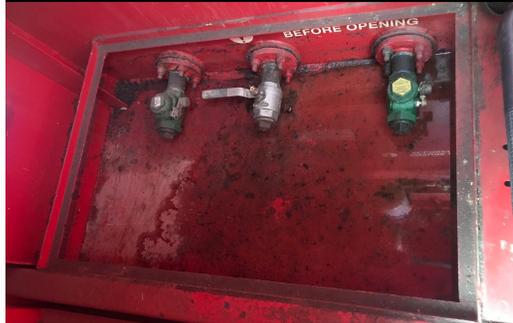
<p>DIRECTION W (M) +37.23557° -080.22699° ACCURACY 33 ft DATUM WGS84</p> <p>MVP-PY-006_030321 Condition of internal drip pan 2021-03-03 07:39:18-05:00</p>

<b>GPS Location</b> MVP-PY-006 See photo for gps data	<b>GPS Location</b> MVP-PY-006 See photo for gps data
<b>Field Station#</b> +0	<b>Field Station#</b> +0
<b>Pic 11 Desc.</b> Off Road Fuel unit condition of internal drip pan. Looking W.	<b>Pic 12 Desc.</b> Off Road Fuel unit no leaky internal fittings. Looking NW.

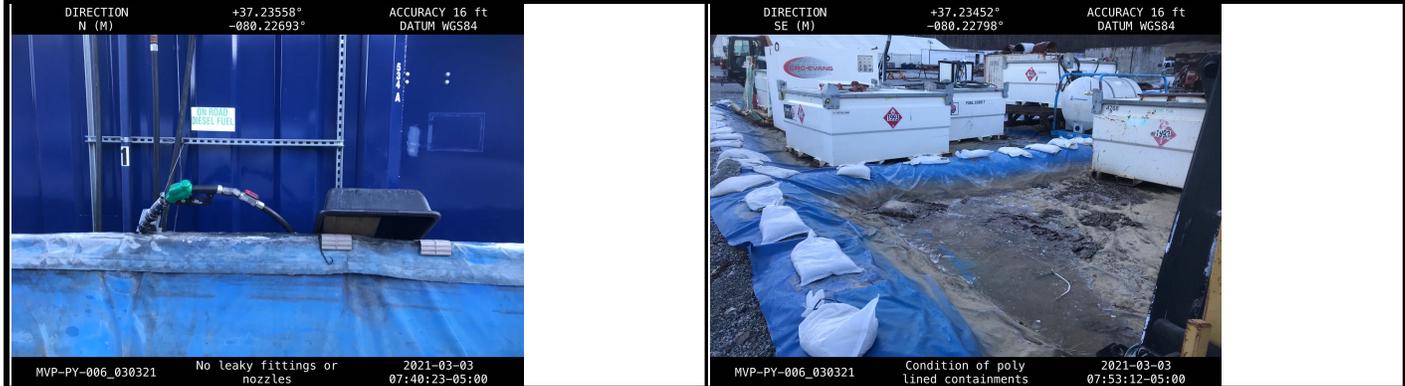
<b>GPS Location</b>	MVP-PY-006 See photo for gps data	<b>GPS Location</b>	MVP-PY-006 See photo for gps data
<b>Field Station#</b>	+0	<b>Field Station#</b>	+0
<b>Pic 13 Desc.</b>	Blue Bulk Fuel tanks no leaky fittings or nozzles. Drip pans in place for use in refueling. Looking N	<b>Pic 14 Desc.</b>	Condition of poly lined containments. Free of stormwater. Looking SE.

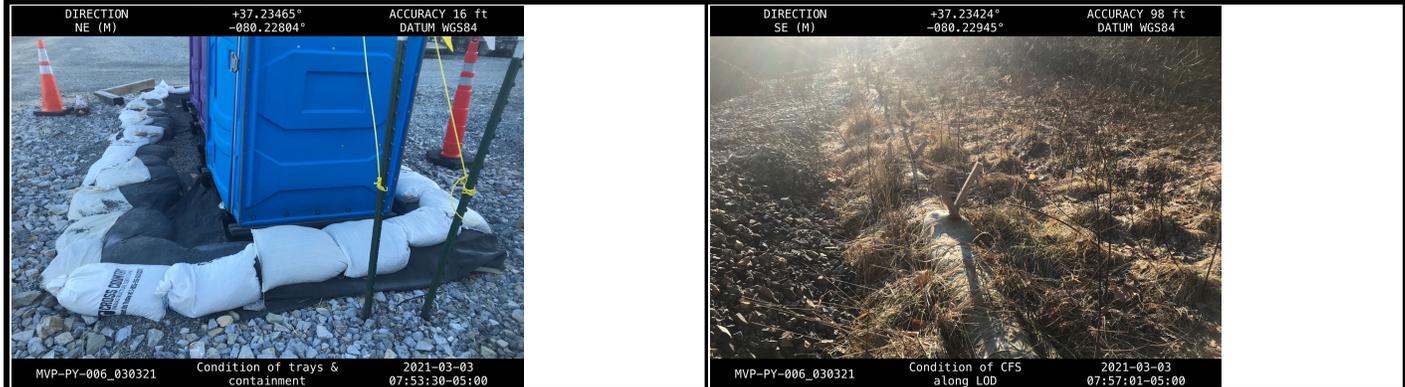
<b>GPS Location</b>	MVP-PY-006 See photo for gps data	<b>GPS Location</b>	MVP-PY-006 See photo for gps data
<b>Field Station#</b>	+0	<b>Field Station#</b>	+0
<b>Pic 15 Desc.</b>	Condition of trays and containment under toilets. Looking NE.	<b>Pic 16 Desc.</b>	Condition of compost filter sock along south LOD. Looking SE.

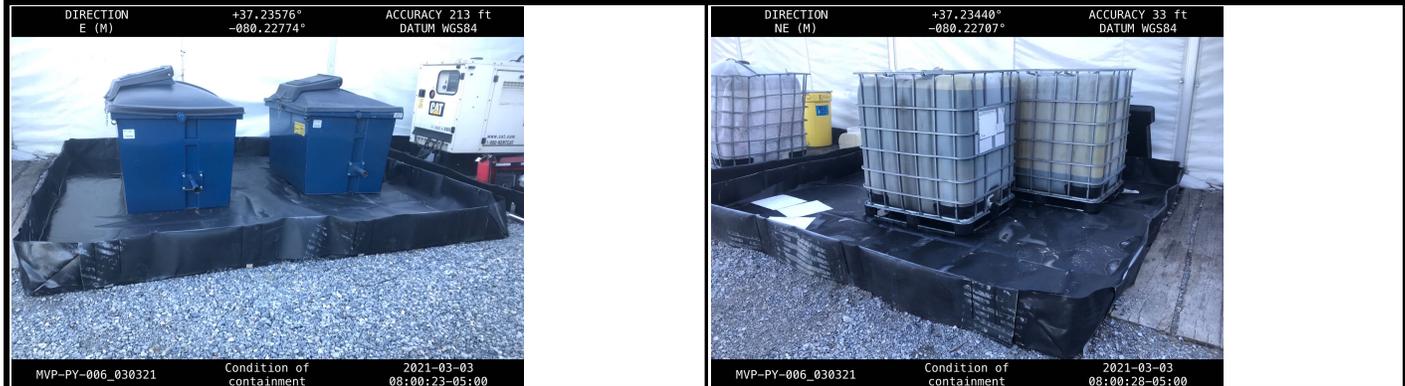
<b>GPS Location</b>	MVP-PY-006 See photo for gps data	<b>GPS Location</b>	MVP-PY-006 See photo for gps data
<b>Field Station#</b>	+0	<b>Field Station#</b>	+0
<b>Pic 17 Desc.</b>	Condition of containment holding hazardous waste dumpsters west of the mechanics building. Looking E.	<b>Pic 18 Desc.</b>	Condition of containment holding the used oil containers west of the mechanics building. Looking NE.

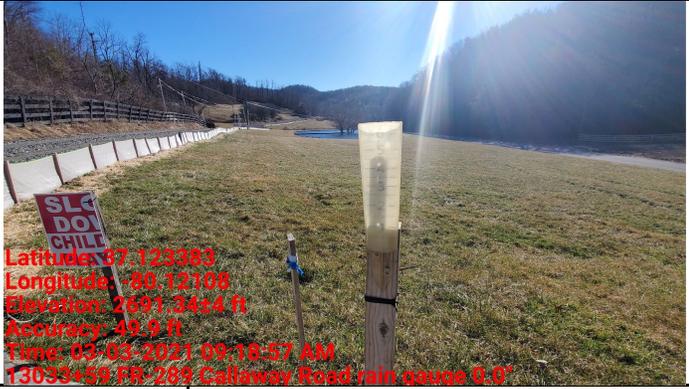
<p><b>Latitude:</b> 37.123383 <b>Longitude:</b> -80.12108 <b>Elevation:</b> 2691.34±4 ft <b>Accuracy:</b> 49.9 ft <b>Time:</b> 03-03-2021 09:18:57 AM <b>13033+59 FR-289 Callaway Road rain gauge 0.0"</b></p>

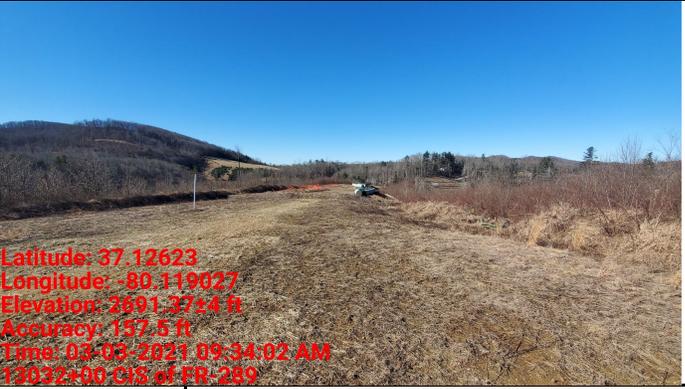
<p><b>Latitude:</b> 37.12623 <b>Longitude:</b> -80.119027 <b>Elevation:</b> 2691.37±4 ft <b>Accuracy:</b> 157.5 ft <b>Time:</b> 03-03-2021 09:34:02 AM <b>13032+00 CIS of FR-289</b></p>	
<b>GPS Location</b>	See pic for GPS location	<b>GPS Location</b>	See pic for GPS location
<b>Field Station#</b>	13033+59	<b>Field Station#</b>	13032+00
<b>Pic 1 Desc.</b>	0.0" total precipitation at Callaway Road.	<b>Pic 2 Desc.</b>	Current ROW conditions on the CIS of FR-289.

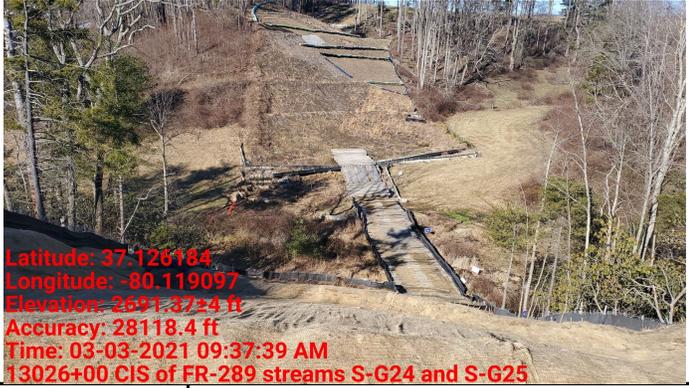
<p><b>Latitude:</b> 37.126184 <b>Longitude:</b> -80.119097 <b>Elevation:</b> 2691.37±4 ft <b>Accuracy:</b> 28118.4 ft <b>Time:</b> 03-03-2021 09:37:39 AM <b>13026+00 CIS of FR-289 streams S-G24 and S-G25</b></p>

<b>GPS Location</b>	See pic for GPS location	<b>GPS Location</b>	See pic for GPS location
<b>Field Station#</b>	13026+00	<b>Field Station#</b>	13024+50
<b>Pic 3 Desc.</b>	Streams S-G24 and S-G25 from the GAS.	<b>Pic 4 Desc.</b>	Waterbars, sumps and end treatments remain in acceptable condition.

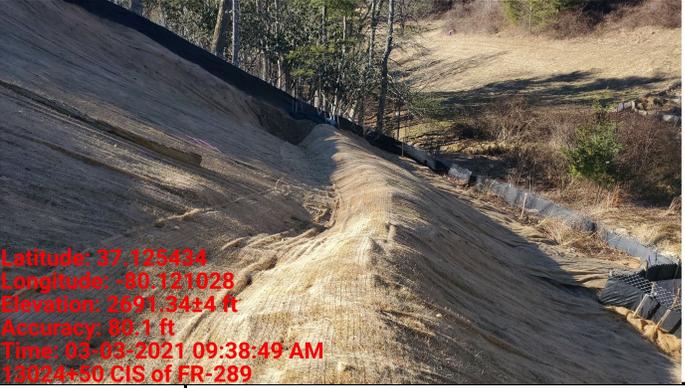
<p><b>Latitude:</b> 37.125434 <b>Longitude:</b> -80.121028 <b>Elevation:</b> 2691.34±4 ft <b>Accuracy:</b> 80.1 ft <b>Time:</b> 03-03-2021 09:38:49 AM <b>13024+50 CIS of FR-289</b></p>

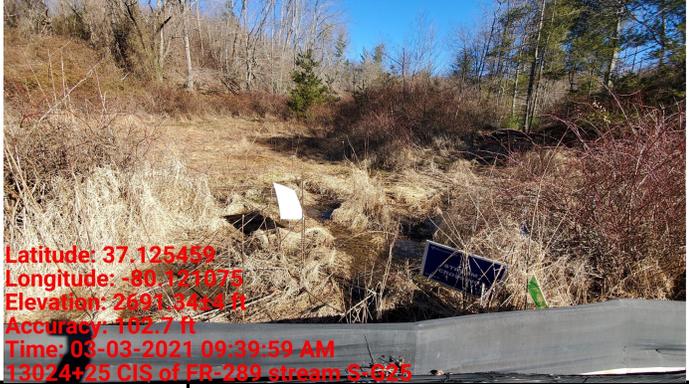
<p><b>Latitude:</b> 37.125459 <b>Longitude:</b> -80.121075 <b>Elevation:</b> 2691.34±4 ft <b>Accuracy:</b> 162.7 ft <b>Time:</b> 03-03-2021 09:39:59 AM <b>13024+25 CIS of FR-289 stream S-G25</b></p>

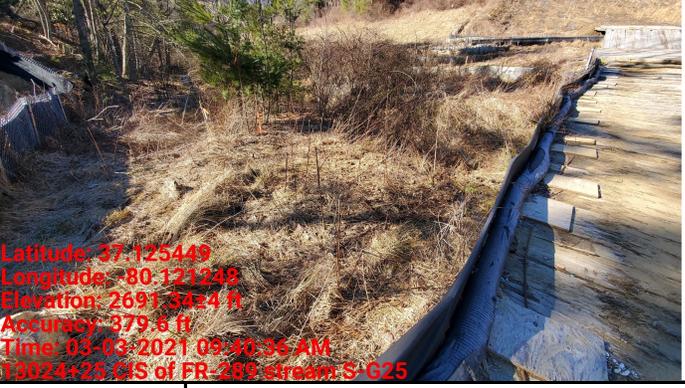
<p><b>Latitude:</b> 37.125449 <b>Longitude:</b> -80.121249 <b>Elevation:</b> 2691.34±4 ft <b>Accuracy:</b> 379.6 ft <b>Time:</b> 03-03-2021 09:40:36 AM <b>13024+25 CIS of FR-289 stream S-G25</b></p>	
<b>GPS Location</b>	See pic for GPS location	<b>GPS Location</b>	See pic for GPS location
<b>Field Station#</b>	13024+25	<b>Field Station#</b>	13024+25
<b>Pic 5 Desc.</b>	Stream S-G25 on the upstream side of the equipment bridge.	<b>Pic 6 Desc.</b>	Stream S-G25 on the downstream side of the equipment bridge.

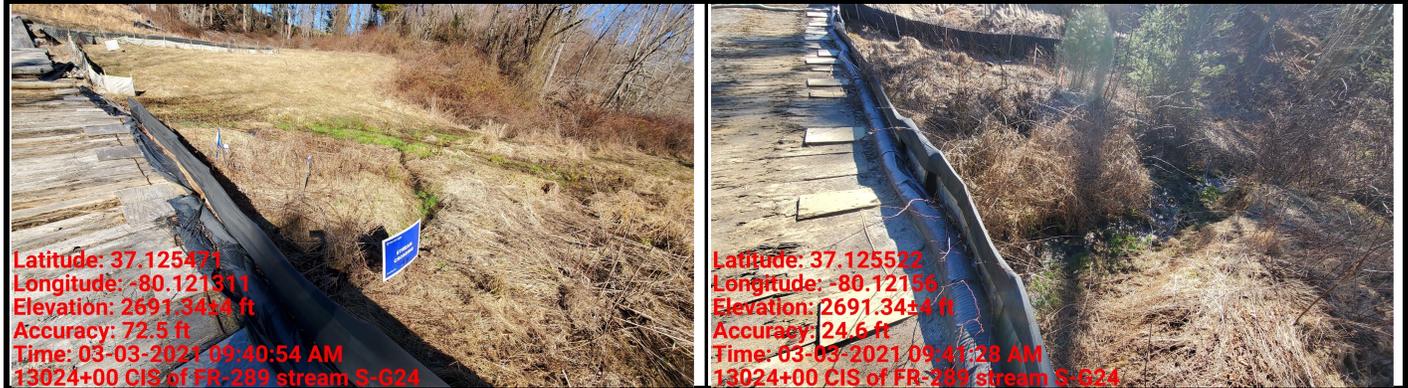
<b>GPS Location</b>	See pic for GPS location	<b>GPS Location</b>	See pic for GPS location
<b>Field Station#</b>	13024+00	<b>Field Station#</b>	13024+00
<b>Pic 7 Desc.</b>	Stream S-G24 on the upstream side of the equipment bridge.	<b>Pic 8 Desc.</b>	Stream S-G24 on the downstream side of the equipment bridge.

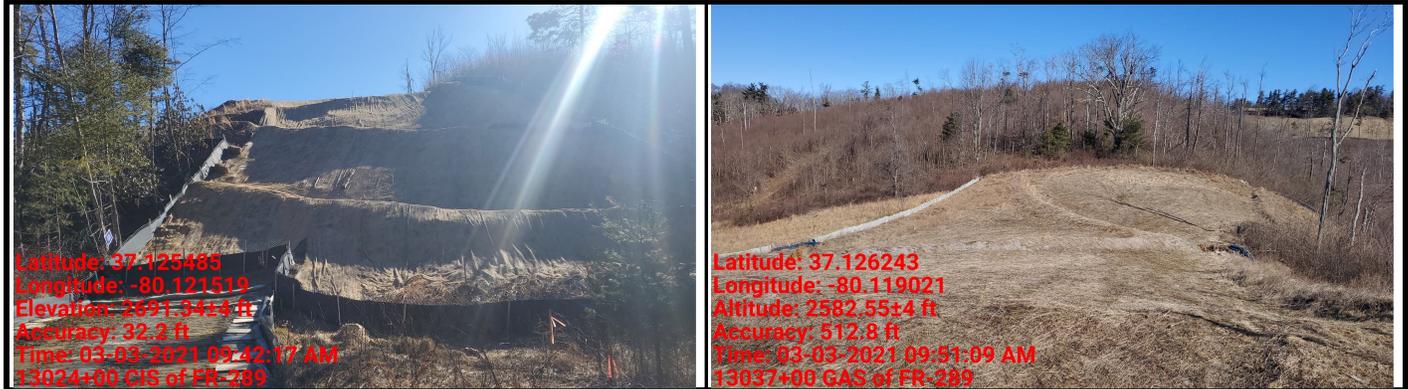
<b>GPS Location</b>	See pic for GPS location	<b>GPS Location</b>	See pic for GPS location
<b>Field Station#</b>	13024+00	<b>Field Station#</b>	13037+00
<b>Pic 9 Desc.</b>	Slope on the GAS of streams S-G24 and S-G25.	<b>Pic 10 Desc.</b>	Current ROW conditions on the GAS of FR-289.

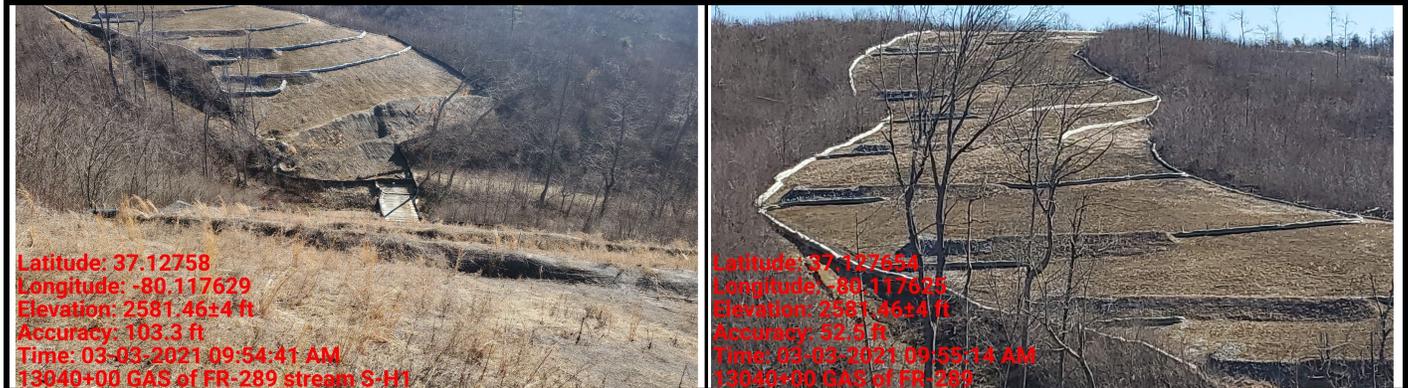
<b>GPS Location</b>	See pic for GPS location	<b>GPS Location</b>	See pic for GPS location
<b>Field Station#</b>	13040+00	<b>Field Station#</b>	13040+00
<b>Pic 11 Desc.</b>	Stream S-H1 on the GAS of FR-289.	<b>Pic 12 Desc.</b>	Current ROW conditions on the GAS of S-H1.

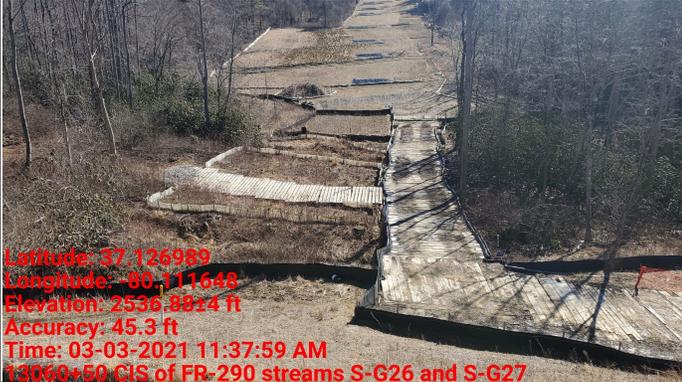
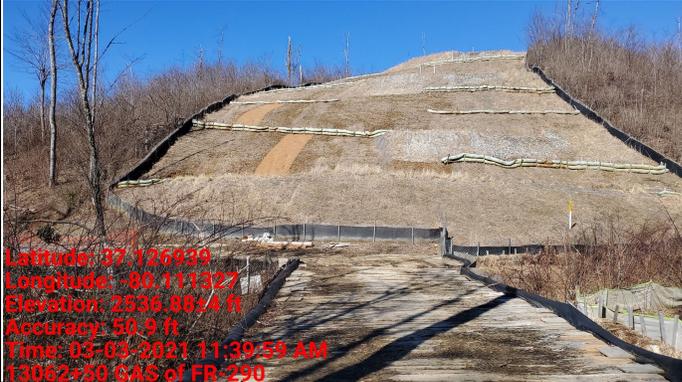
<b>GPS Location</b>	See pic for GPS location	<b>GPS Location</b>	See pic for GPS location
<b>Field Station#</b>	13060+50	<b>Field Station#</b>	13062+50
<b>Pic 13 Desc.</b>	Streams S-G26 and S-G27 from the CIS of FR-290.	<b>Pic 14 Desc.</b>	CIS of streams S-G26 and S-G27.

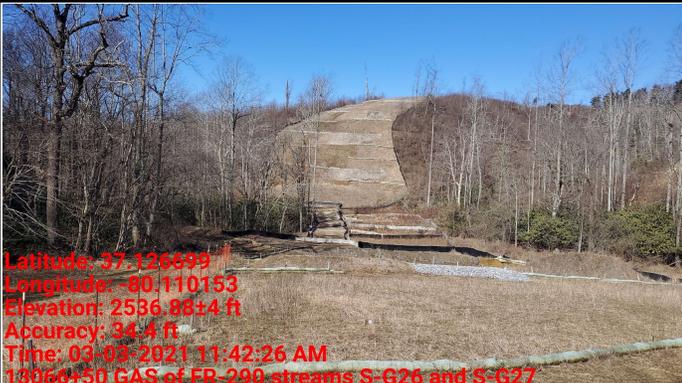
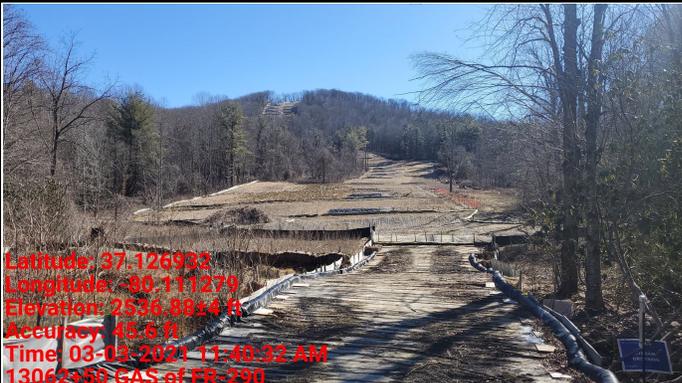
<b>GPS Location</b>	See pic for GPS location	<b>GPS Location</b>	See pic for GPS location
<b>Field Station#</b>	13066+50	<b>Field Station#</b>	13062+50
<b>Pic 15 Desc.</b>	Streams S-G26 and S-G27 from the GAS.	<b>Pic 16 Desc.</b>	GAS of FR-290

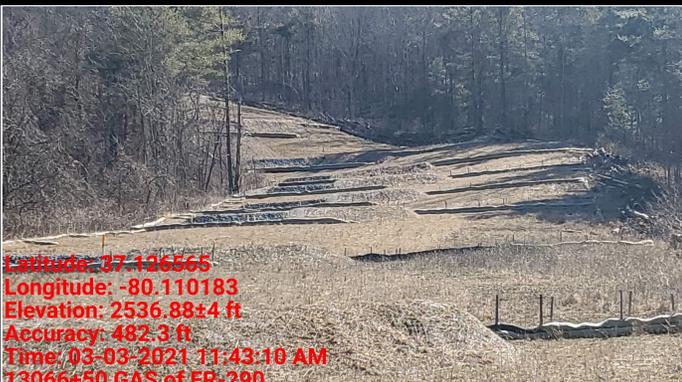
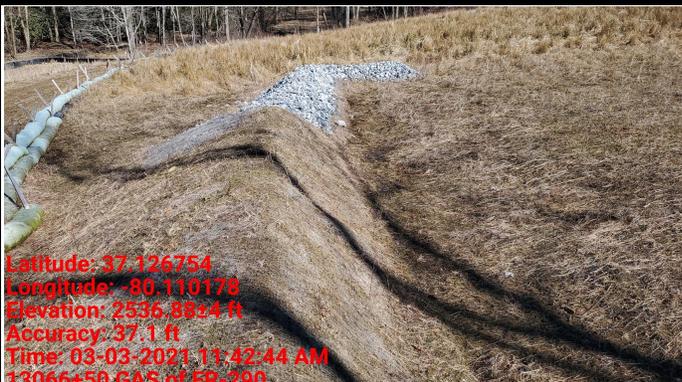
<b>GPS Location</b>	See pic for GPS location	<b>GPS Location</b>	See pic for GPS location
<b>Field Station#</b>	13066+50	<b>Field Station#</b>	13066+50
<b>Pic 17 Desc.</b>	Restored portion of the ROW on the GAS of FR-290.	<b>Pic 18 Desc.</b>	Permanent Slope Breaker and Rock Level Spreader on the GAS of FR-290.

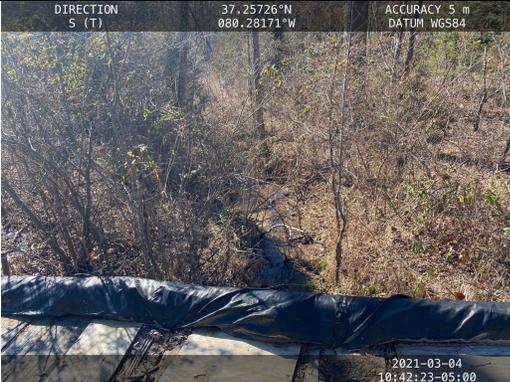
<p>DIRECTION S (T) 37.25719°N 080.28152°W ACCURACY 16 m DATUM WGS84 2021-03-04 10:41:54-05:00</p>			
<b>GPS Location</b> See photo		<b>GPS Location</b> See photo			
<b>Field Station#</b> 12121+33		<b>Field Station#</b> 12121+83			
<b>Pic 1 Desc.</b> Stream S-C33, facing south, downstream		<b>Pic 2 Desc.</b> Stream S-C83, facing south, downstream

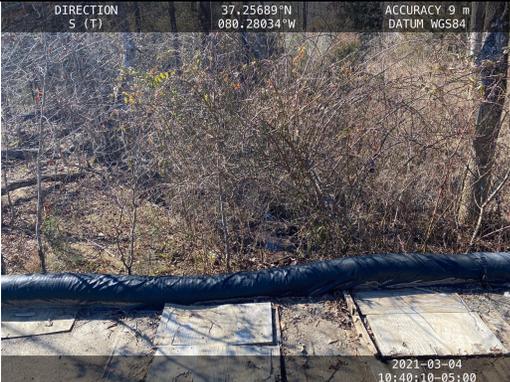
<b>Pic 3 Desc.</b> Stream S-C36, facing south, downstream		<b>Pic 4 Desc.</b> Slope was recently stabilized with erosion control blanket on the coming in side of access road MVP-MN-272.

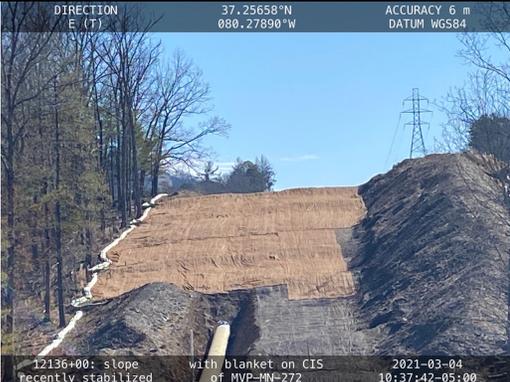
<p>DIRECTION E (T) 37.25658°N 080.27890°W ACCURACY 6 m DATUM WGS84 12136+00: slope recently stabilized with blanket on CIS of MVP-MN-272 2021-03-04 10:37:42-05:00</p>			
<b>GPS Location</b> See photo		<b>GPS Location</b> See photo			
<b>Field Station#</b> 12125+65		<b>Field Station#</b> 12136+00

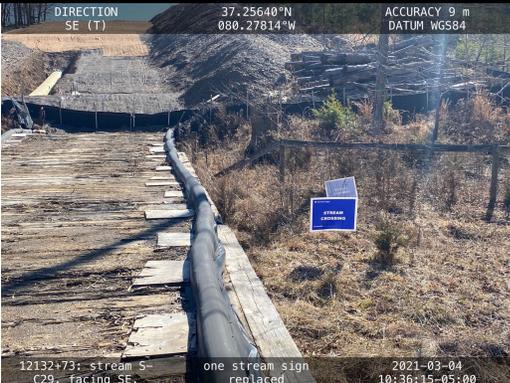
<p>DIRECTION SE (T) 37.25640°N 080.27814°W ACCURACY 9 m DATUM WGS84 12132+73: stream S-C29, facing SE, one stream sign replaced 2021-03-04 10:36:15-05:00</p>

<p>DIRECTION E (T) 37.25558°N 080.27437°W ACCURACY 14 m DATUM WGS84 2021-03-04 10:24:31-05:00</p>			
<b>GPS Location</b> See photo		<b>GPS Location</b> See photo			
<b>Field Station#</b> 12132+73		<b>Field Station#</b> 12143+59			
<b>Pic 5 Desc.</b> Stream S-C29, facing southeast. One stream sign replaced.		<b>Pic 6 Desc.</b> Wetland W-C5, facing east. Both wetland signs were replaced.

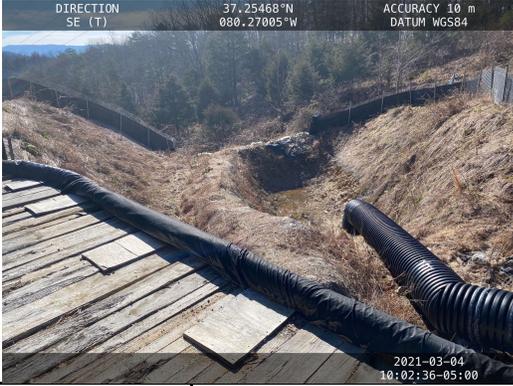
<p>DIRECTION SE (T) 37.25468°N 080.27005°W ACCURACY 10 m DATUM WGS84</p> <p>2021-03-04 10:02:36-05:00</p>	
<b>GPS Location</b>	See photo	<b>GPS Location</b>	See photo
<b>Field Station#</b>	12148+00	<b>Field Station#</b>	12157+00
<b>Pic 7 Desc.</b>	Small ravine between access roads MVP-MN-272 & 273 remains stable.	<b>Pic 8 Desc.</b>	Clean water diversion channel and temporary sediment trap are stable and functioning properly, and ECDs are in good repair.

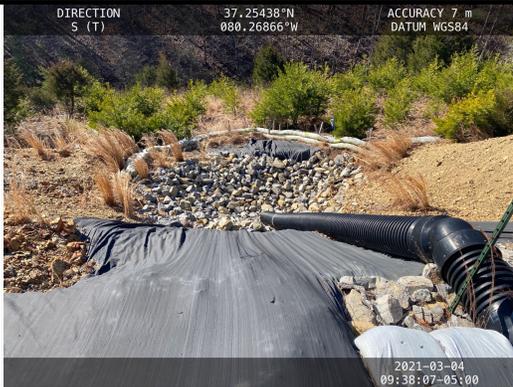
<b>GPS Location</b>	See photo	<b>GPS Location</b>	See photo
<b>Field Station#</b>	12160+00	<b>Field Station#</b>	12163+05
<b>Pic 9 Desc.</b>	Slope drain in good repair and functioning properly.	<b>Pic 10 Desc.</b>	Stream S-C25, facing east. One stream sign replaced.

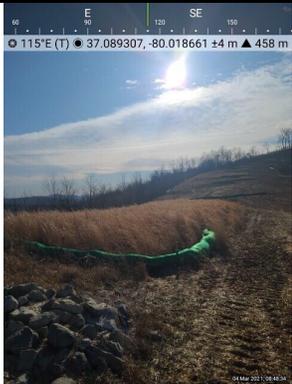
<b>GPS Location</b>	0000	<b>GPS Location</b>	00000		
<b>Field Station#</b>	13444+93	<b>Field Station#</b>	13446+04		
<b>Pic 1 Desc.</b>	Ecds in place around start of stream on row, good vegetation growth.		<b>Pic 2 Desc.</b>	Photo showing area where land owner has been crossing the row with ATV's, will continue to monitor the area.

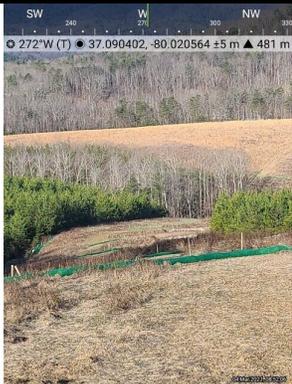
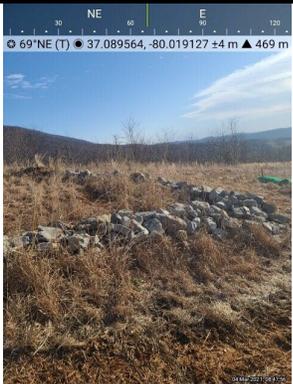
<b>GPS Location</b>	00000	<b>GPS Location</b>	00000		
<b>Field Station#</b>	13436+27	<b>Field Station#</b>	13450+00		
<b>Pic 3 Desc.</b>	Vegetation photo , ECDs in place and monitored during the EI's travel today.		<b>Pic 4 Desc.</b>	EI monitored rock checks on end of breakers while checking row conditions throughout.

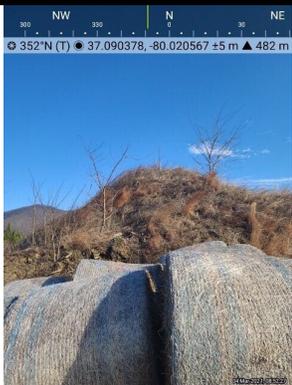
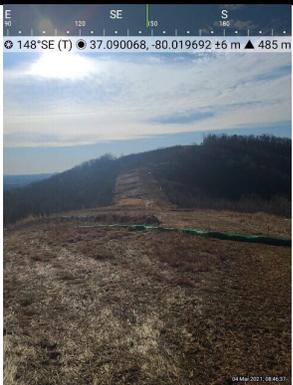
<b>GPS Location</b>	00000	<b>GPS Location</b>	00000		
<b>Field Station#</b>	13436+90	<b>Field Station#</b>	13440+12		
<b>Pic 5 Desc.</b>	EI monitored spoil pile stabilization and photo showing straw bales stock piled to be used to stabilize the row as needed .		<b>Pic 6 Desc.</b>	Row photo showing ECDs in place , row stabilization.

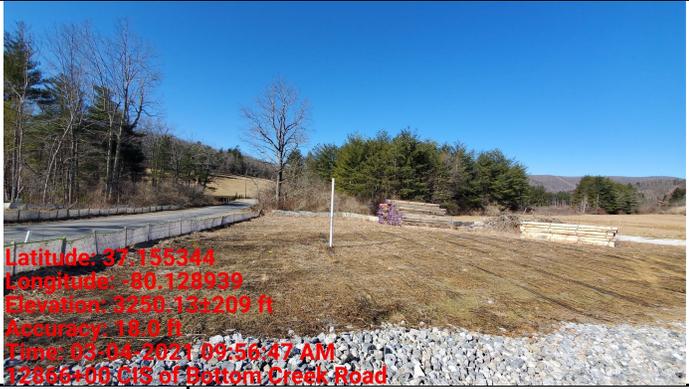
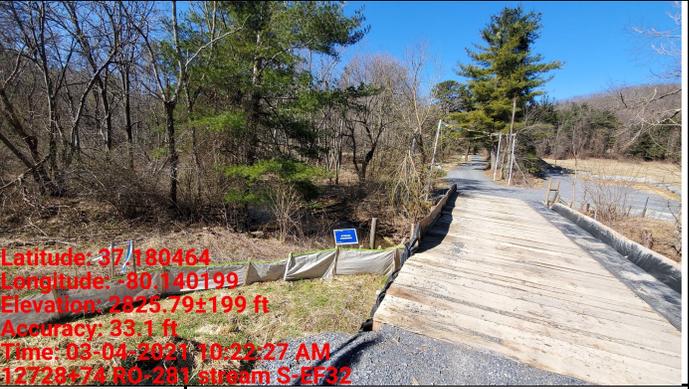
<p>Latitude: 37.180464 Longitude: -80.140199 Elevation: 2825.79±199 ft Accuracy: 33.1 ft Time: 03-04-2021 10:23:27 AM 12728+74 RO-281 stream S-EF32</p>	
<b>GPS Location</b>	See pic for GPS location	<b>GPS Location</b>	See pic for GPS location
<b>Field Station#</b>	12866+00	<b>Field Station#</b>	12728+74
<b>Pic 1 Desc.</b>	CIS of the Bottom Creek Road crossing.	<b>Pic 2 Desc.</b>	Downstream side of stream S-EF32.

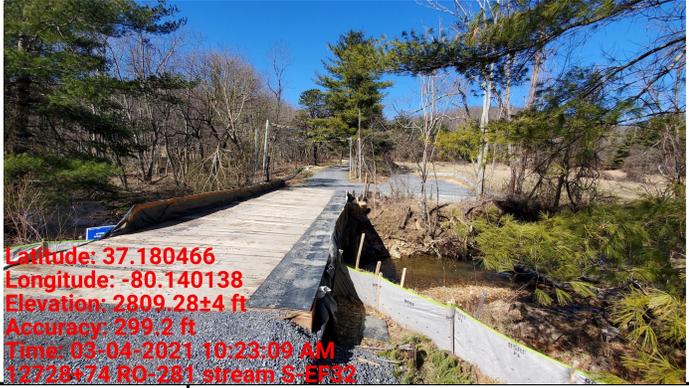
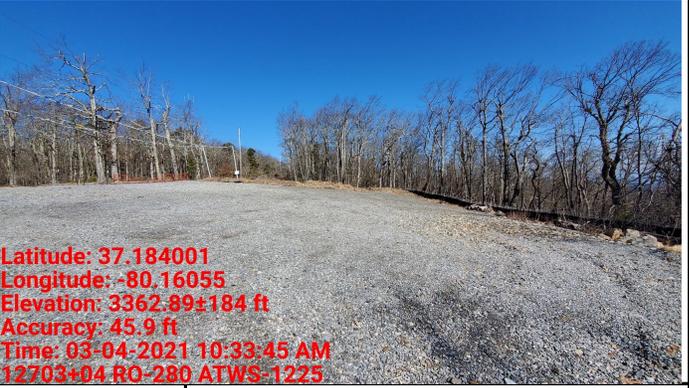
<b>Field Station#</b>	12728+74	<b>Field Station#</b>	12703+04
<b>Pic 3 Desc.</b>	Upstream side of stream S-EF32.	<b>Pic 4 Desc.</b>	Current conditions of the ATWS at Honeysuckle and RO-280.

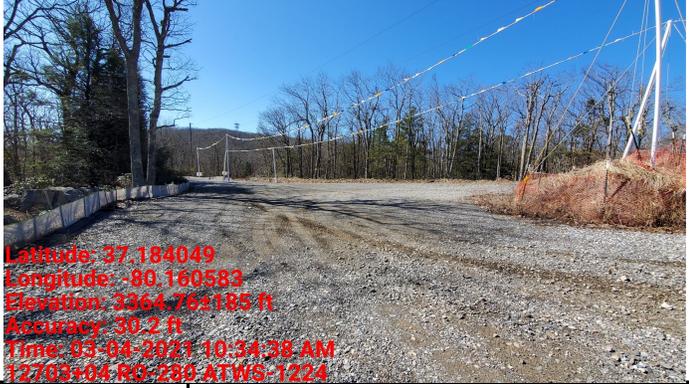
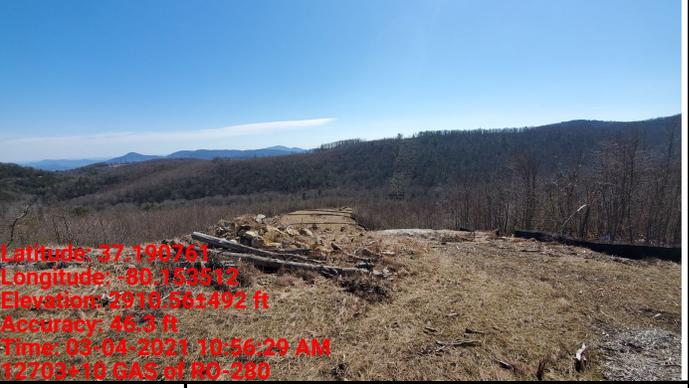
<p>Latitude: 37.190761 Longitude: -80.153512 Elevation: 2910.56±492 ft Accuracy: 46.3 ft Time: 03-04-2021 10:56:29 AM 12703+10 GAS of RO-280</p>	
<b>GPS Location</b>	See pic for GPS location	<b>GPS Location</b>	See pic for GPS location
<b>Field Station#</b>	12703+04	<b>Field Station#</b>	12703+10
<b>Pic 5 Desc.</b>	Current conditions of the ATWS at Honeysuckle and RO-280.	<b>Pic 6 Desc.</b>	Current conditions of the GAS of RO-280.

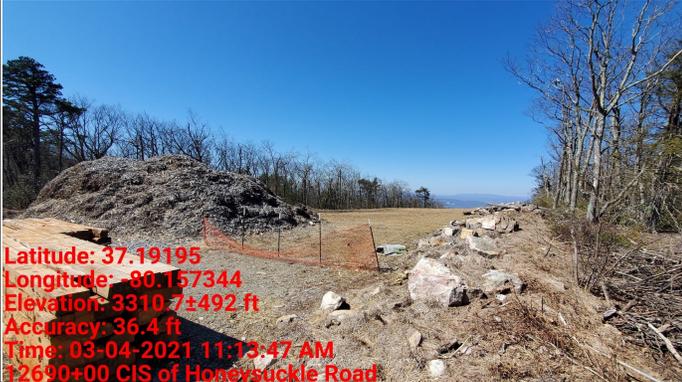
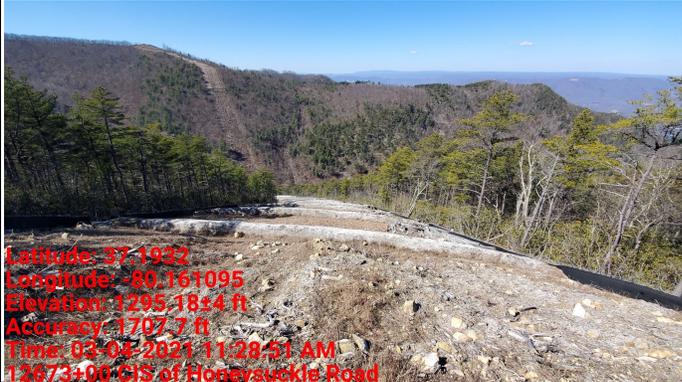
<b>GPS Location</b>	See pic for GPS location	<b>GPS Location</b>	See pic for GPS location
<b>Field Station#</b>	12690+00	<b>Field Station#</b>	127073+00
<b>Pic 7 Desc.</b>	ROW on the CIS of Honeysuckle Road	<b>Pic 8 Desc.</b>	Waterbars, sumps and end treatments remain in acceptable condition.

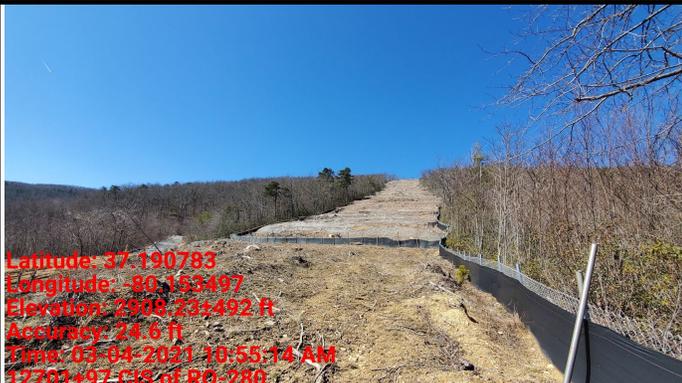
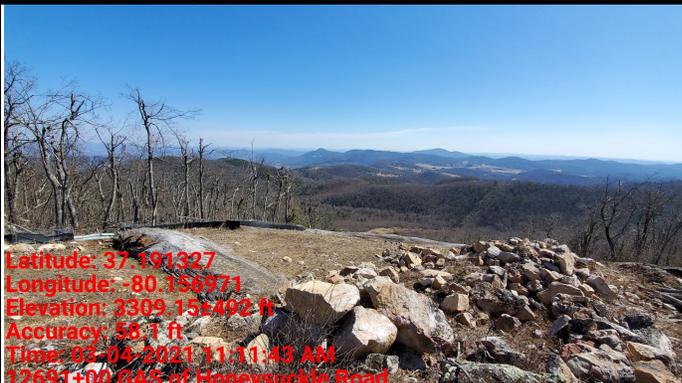
<b>GPS Location</b>	See pic for GPS location	<b>GPS Location</b>	See pic for GPS location
<b>Field Station#</b>	12701+97	<b>Field Station#</b>	12691+00
<b>Pic 9 Desc.</b>	Current conditions of the CIS of RO-280.	<b>Pic 10 Desc.</b>	No maintenance issues or impacts observed.

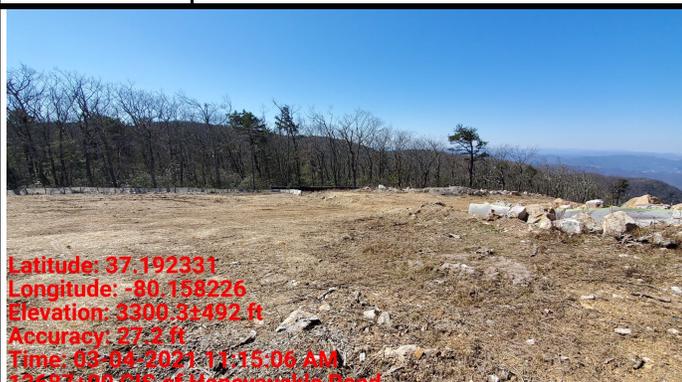
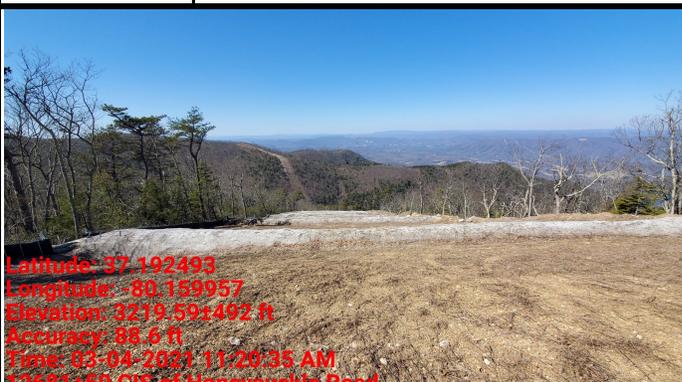
<b>GPS Location</b>	See pic for GPS location	<b>GPS Location</b>	See pic for GPS location
<b>Field Station#</b>	12687+00	<b>Field Station#</b>	12681+50
<b>Pic 11 Desc.</b>	ROW at the top of the slope on the CIS of Honeysuckle Road.	<b>Pic 12 Desc.</b>	Current ROW conditions on the CIS of Honeysuckle Road

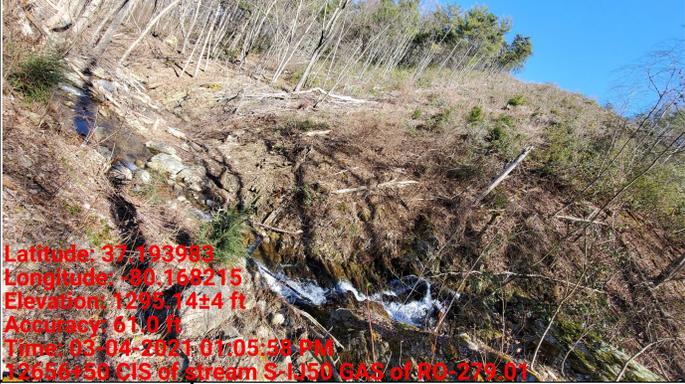
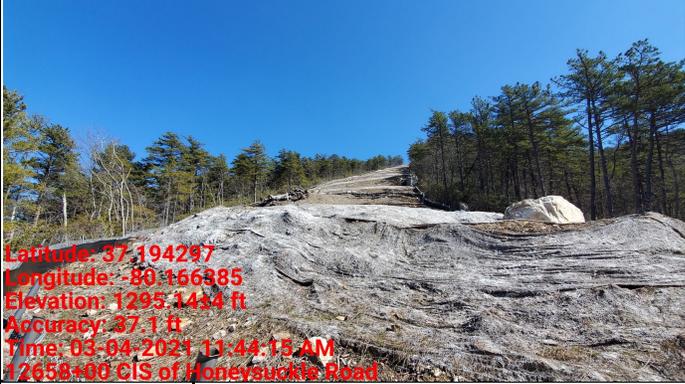
<p style="color: red; font-size: small;">Latitude: 37.194297 Longitude: -80.166385 Elevation: 1295.14±4 ft Accuracy: 37.1 ft Time: 03-04-2021 11:44:15 AM 12658+00 CIS of Honeysuckle Road</p>	
<b>GPS Location</b>	See pic for GPS location	<b>GPS Location</b>	See pic for GPS location
<b>Field Station#</b>	12656+50	<b>Field Station#</b>	12659+50
<b>Pic 13 Desc.</b>	No ground disturbance within 300' of stream.	<b>Pic 14 Desc.</b>	No maintenance issues or impacts observed on the GAS of stream S-IJ50.

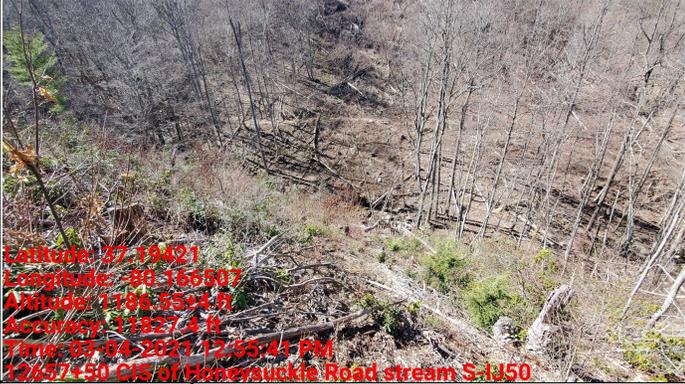
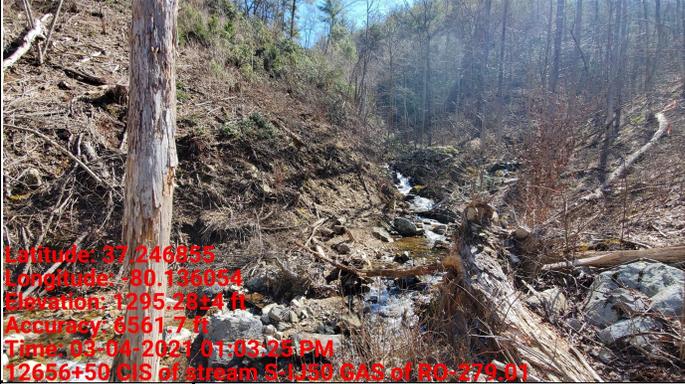
<b>GPS Location</b>	See pic for GPS location	<b>GPS Location</b>	See pic for GPS location
<b>Field Station#</b>	12657+50	<b>Field Station#</b>	12656+50
<b>Pic 15 Desc.</b>	Stream S-IJ50 from the GAS slope.	<b>Pic 16 Desc.</b>	Stream S-IJ50 from the CIS stream bank.

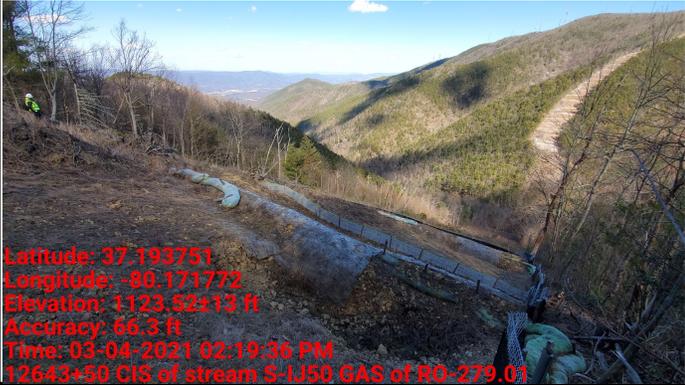
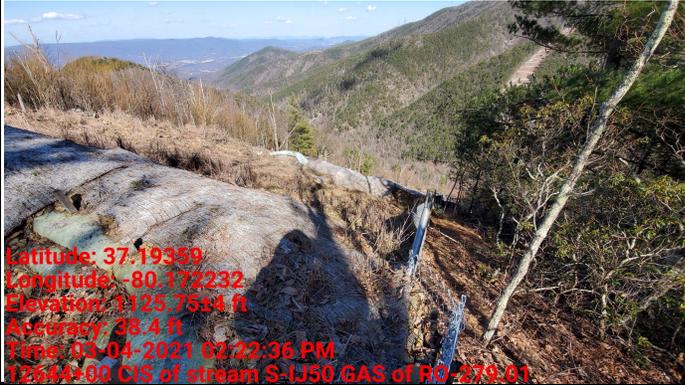
<p style="color: red; font-size: small;">Latitude: 37.19359 Longitude: -80.172232 Elevation: 1125.75±4 ft Accuracy: 38.4 ft Time: 03-04-2021 02:22:36 PM 12644+00 CIS of stream S-IJ50 GAS of RO-279.01</p>	
<b>GPS Location</b>	See pic for GPS location	<b>GPS Location</b>	See pic for GPS location
<b>Field Station#</b>	12643+50	<b>Field Station#</b>	12644+00
<b>Pic 17 Desc.</b>	Near the end of the cleared area. No maintenance issues or impacts were observed.	<b>Pic 18 Desc.</b>	Waterbars, sumps and end treatments remain in acceptable condition on the GAS of RO-279.01.

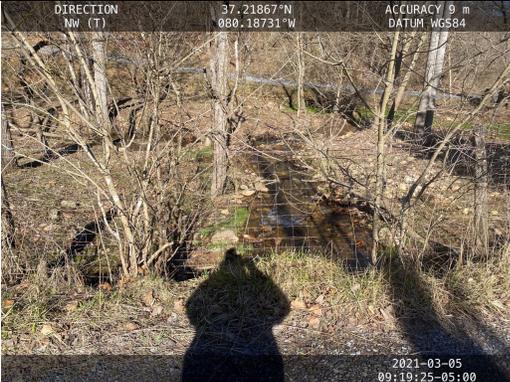
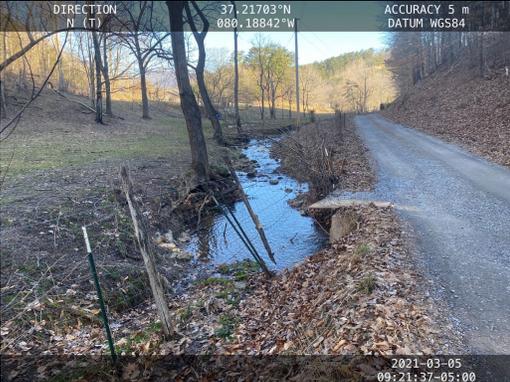
<b>GPS Location</b>	See photo		<b>GPS Location</b>	See photo	
<b>Field Station#</b>	12544+06		<b>Field Station#</b>	12544+06	
<b>Pic 1 Desc.</b>	Stream S-KL32, facing northwest, downstream from Yellow Finch Lane		<b>Pic 2 Desc.</b>	Stream S-EF20b, facing north, downstream from Yellow Finch Lane

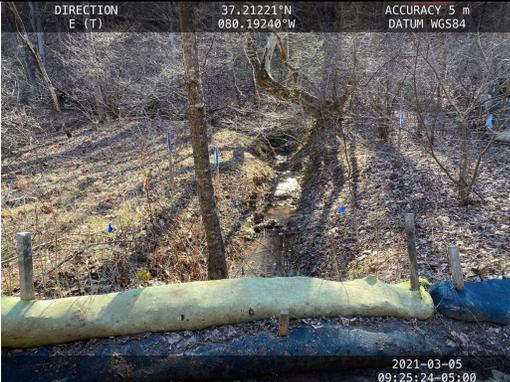
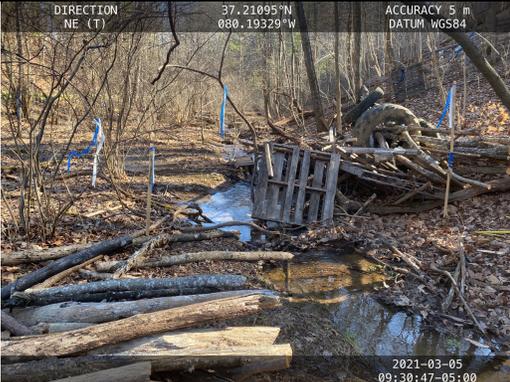
<b>GPS Location</b>	See photo		<b>GPS Location</b>	See photo	
<b>Field Station#</b>	12544+06		<b>Field Station#</b>	12544+54	
<b>Pic 3 Desc.</b>	Stream S-EF54, facing east, downstream from Yellow Finch Lane		<b>Pic 4 Desc.</b>	Stream S-EF20a, facing northeast, downstream

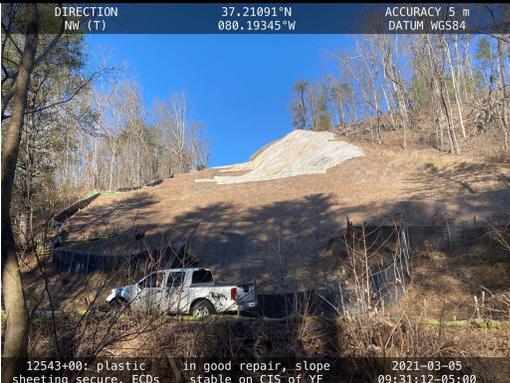
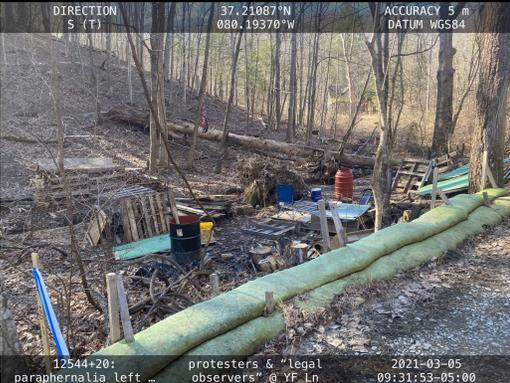
<b>GPS Location</b>	See photo		<b>GPS Location</b>	See photo	
<b>Field Station#</b>	12543+00		<b>Field Station#</b>	12544+20	
<b>Pic 5 Desc.</b>	Plastic sheeting secure, slope stable and ECDs in satisfactory condition on the coming in side of Yellow Finch Lane.		<b>Pic 6 Desc.</b>	Random paraphernalia left behind by protesters and "legal observers" on going away side of Yellow Finch Lane.

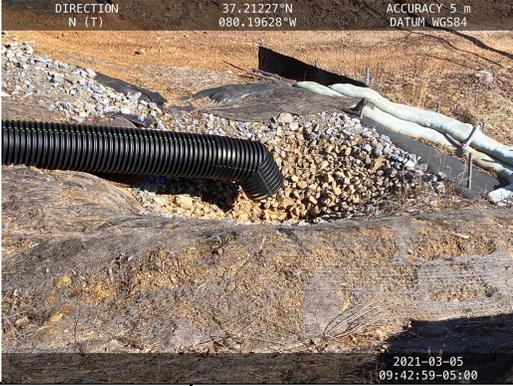
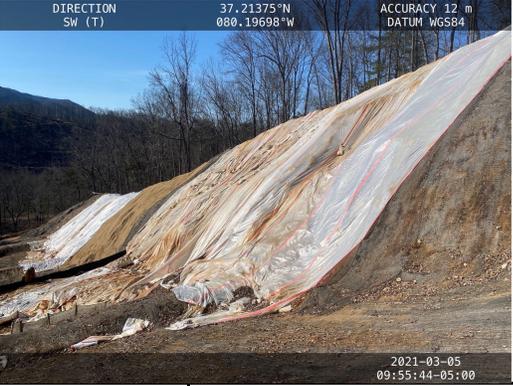
<p>DIRECTION SW (T) 37.21375°N 080.19698°W ACCURACY 12 m DATUM WGS84 2021-03-05 09:55:44-05:00</p>			
<b>GPS Location</b>	See photo		<b>GPS Location</b>	See photo	
<b>Field Station#</b>	12534+00		<b>Field Station#</b>	12529+00	
<b>Pic 7 Desc.</b>	Clean water diversion pipe outlet plunge pool in satisfactory condition.		<b>Pic 8 Desc.</b>	Plastic sheeting intact and secure on stockpiles approximately 1500 feet from Yellow Finch Lane.

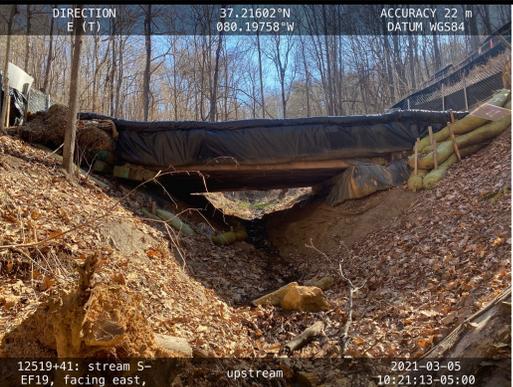
<p>DIRECTION E (T) 37.21602°N 080.19758°W ACCURACY 22 m DATUM WGS84 12519+41: stream S-EF19, facing east, upstream 2021-03-05 10:21:13-05:00</p>

<b>GPS Location</b>	See photo		<b>GPS Location</b>	See photo	
<b>Field Station#</b>	12524+00		<b>Field Station#</b>	12519+41	
<b>Pic 9 Desc.</b>	Super silt fence in satisfactory condition on the perimeter of the slope on the going away side of S-EF19.[		<b>Pic 10 Desc.</b>	Stream S-EF19, facing east, upstream

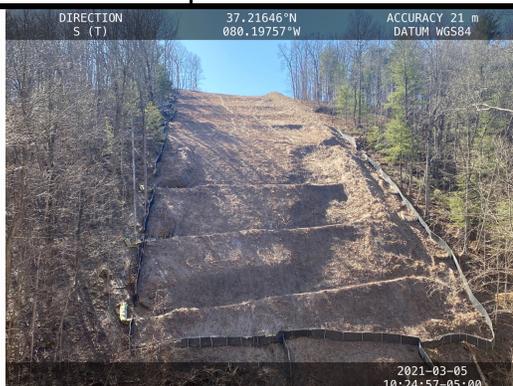
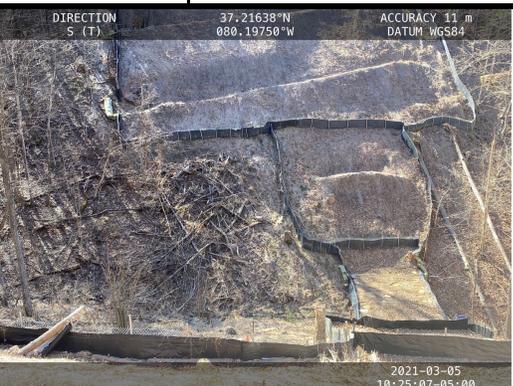
<p>DIRECTION S (T) 37.21638°N 080.19750°W ACCURACY 11 m DATUM WGS84 2021-03-05 10:25:07-05:00</p>			
<b>GPS Location</b>	See photo		<b>GPS Location</b>	See photo	
<b>Field Station#</b>	12523+00		<b>Field Station#</b>	12519+41	
<b>Pic 11 Desc.</b>	The slope on going away side of stream S-EF19 remains stable.		<b>Pic 12 Desc.</b>	The bridge, buffer zone and ECDs are in satisfactory condition at stream S-EF19.

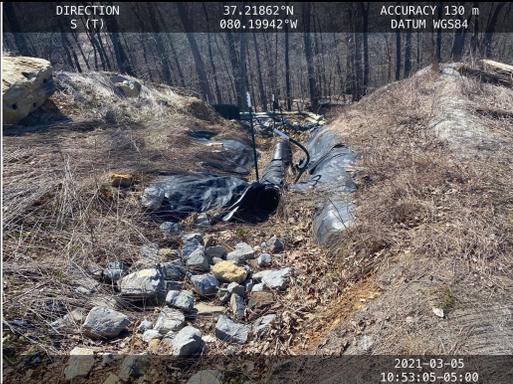
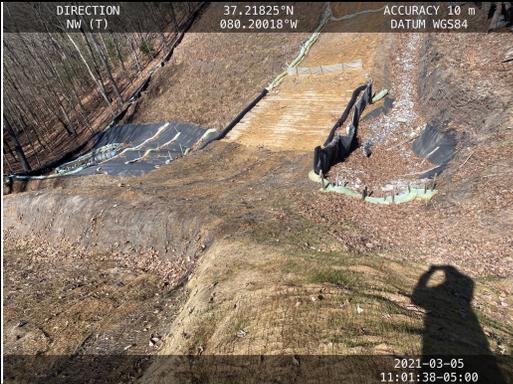
<b>GPS Location</b>	See photo		<b>GPS Location</b>	See photo	
<b>Field Station#</b>	12508+00		<b>Field Station#</b>	12503+70	
<b>Pic 13 Desc.</b>	Slope drain in satisfactory condition.		<b>Pic 14 Desc.</b>	Clean water diversion pipe and inlet and outlet in good repair.

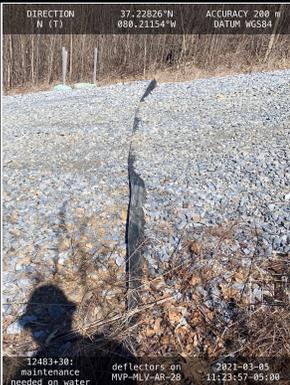
<b>GPS Location</b>	See photo		<b>GPS Location</b>	See photo	
<b>Field Station#</b>	12483+30		<b>Field Station#</b>	12455+21	
<b>Pic 15 Desc.</b>	Water deflectors in need of maintenance where they're being pushed over by gravel on access road MVP-MLV-AR-28.		<b>Pic 16 Desc.</b>	Stream S-CD12, facing northwest, downstream

E&S BMPs	Compliance Level	Corrective Action	Corrective Time Frame	Date Repaired
Compost Filter Sock	Acceptable			
Silt Fence (Filter Fabric Fence)	Acceptable			
Silt Fence (Reinforced Filter Fabric Fence)	Acceptable			
Cleanwater Diversion Pipe	Acceptable			
Plunge Pool	Acceptable			
Waterbar	Acceptable			
Waterbar End Treatment	Acceptable			
Sump Pit	Acceptable			
Water Deflector	Communication	MLV-AR-28	Addressed	3/5/2021

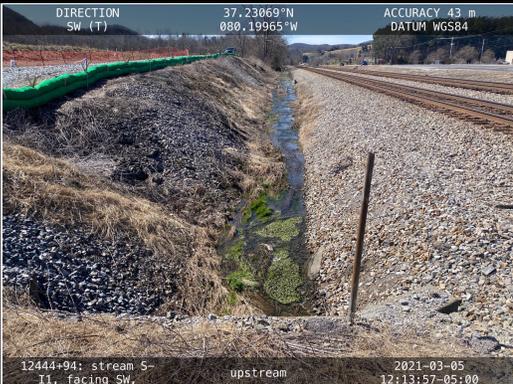
<b>GPS Location</b>	See photo		<b>GPS Location</b>	See photo	
<b>Field Station#</b>	12444+94		<b>Field Station#</b>	12483+30	
<b>Pic 17 Desc.</b>	Stream S-11, facing southwest, upstream		<b>Pic 18 Desc.</b>	Laborers cleared gravel off water deflectors on access road MVP-MLV-AR-28.

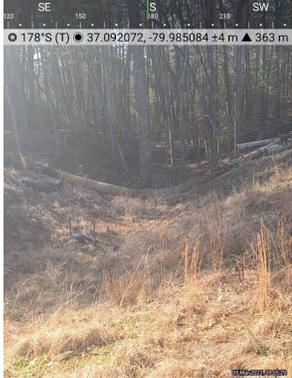
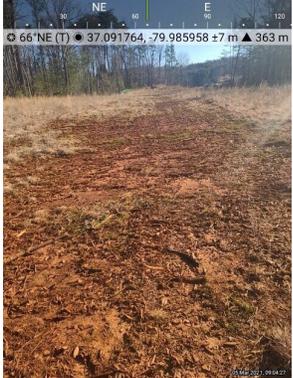
<b>GPS Location</b>	00000	<b>GPS Location</b>	00000	
<b>Field Station#</b>	13561+77	<b>Field Station#</b>	13555+30	
<b>Pic 1 Desc.</b>	Monitored ECDs in natural drain area, no environmental issues observed at the time of inspection.	<b>Pic 2 Desc.</b>	Photo showing area of row with sparse vegetation, no other environmental issues observed, will continue to monitor the area.

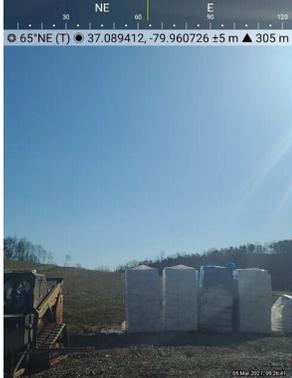
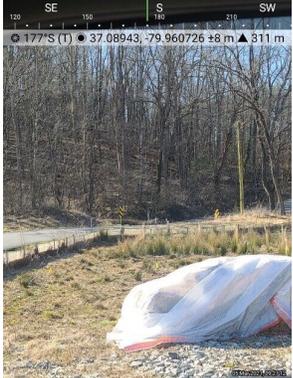
<b>GPS Location</b>	0000	<b>GPS Location</b>	00000	
<b>Field Station#</b>	13645+00	<b>Field Station#</b>	13643+23	
<b>Pic 3 Desc.</b>	Observed hydro seed materials stock piled at Leaning Oak rd, no environmental issues observed at the time of inspection.	<b>Pic 4 Desc.</b>	Throughout the EI's travel today the EI monitored ECDs near road crossings , ECDs were up to date and functioning properly.

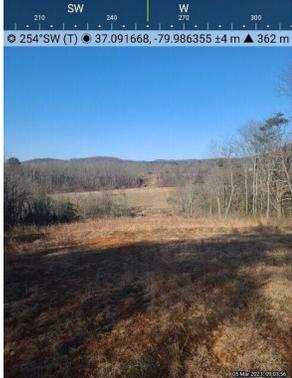
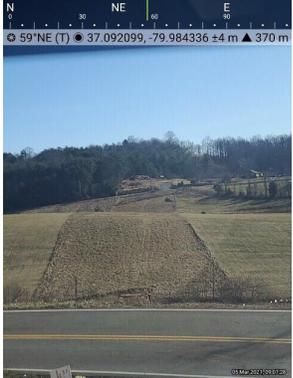
<b>Field Station#</b>	13560+00	<b>Field Station#</b>	13564+44	
<b>Pic 5 Desc.</b>	Row photo taken by the EI showing vegetation, no environmental issues observed at the time of inspection.	<b>Pic 6 Desc.</b>	Permanent vegetation area showing good coverage.

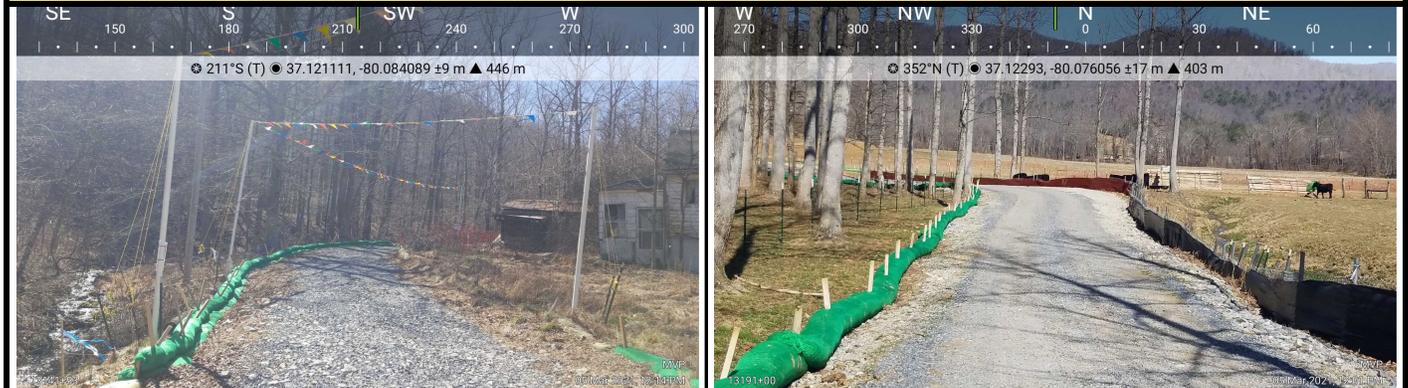
<b>GPS Location</b>	See photo for coordinates.	<b>GPS Location</b>	See photo for coordinates.
<b>Field Station#</b>	13141+53	<b>Field Station#</b>	13191+00
<b>Pic 1 Desc.</b>	MVP-FR-292, access road in acceptable condition.	<b>Pic 2 Desc.</b>	MVP-MLV-AR-29, access road in acceptable condition, ECDs in compliance.

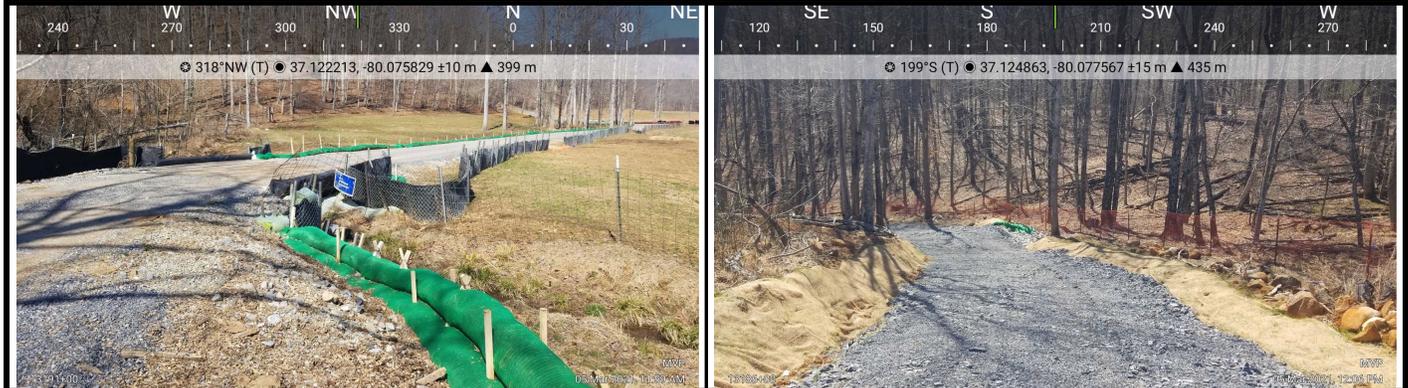
<b>GPS Location</b>	See photo for coordinates.	<b>GPS Location</b>	See photo for coordinates.
<b>Field Station#</b>	13191+00	<b>Field Station#</b>	13186+00
<b>Pic 3 Desc.</b>	MVP-MLV-AR-29, S-D10, typical cattle disturbance noted along stream.	<b>Pic 4 Desc.</b>	MVP-FR-292.01, access road in acceptable condition.
