# Visual Site Inspection Report

<b>Project Name</b> H-600 Pipeline Spread H		<b>AFE</b> 124300138	<b>Spread</b> H-600 Pipeline Spread H
<b>Contractor</b> Precision		<b>Report #</b> 20563	
<b>Inspector</b> John Brcic		<b>Date/Time</b> 3/1/2021 1:48 PM	
<b>Permit #</b> TBD	<b>Inspection Type</b> VA SWPP	<b>Station Begin</b> 12443+75	
<b>State</b> VA	<b>Inspection Area</b> Partial	<b>Station End</b> 12544+06	
<b>County</b> Montgomery	<b>Ground</b> Wet	<b>Temperature (°F)</b> 50.00	
<b>Municipality</b> N/A	<b>Weather</b> Light Rain	<b>Rain Gauge (in)</b> 1.20	
<b>Rain Accumulation Time (days)</b>			3.00

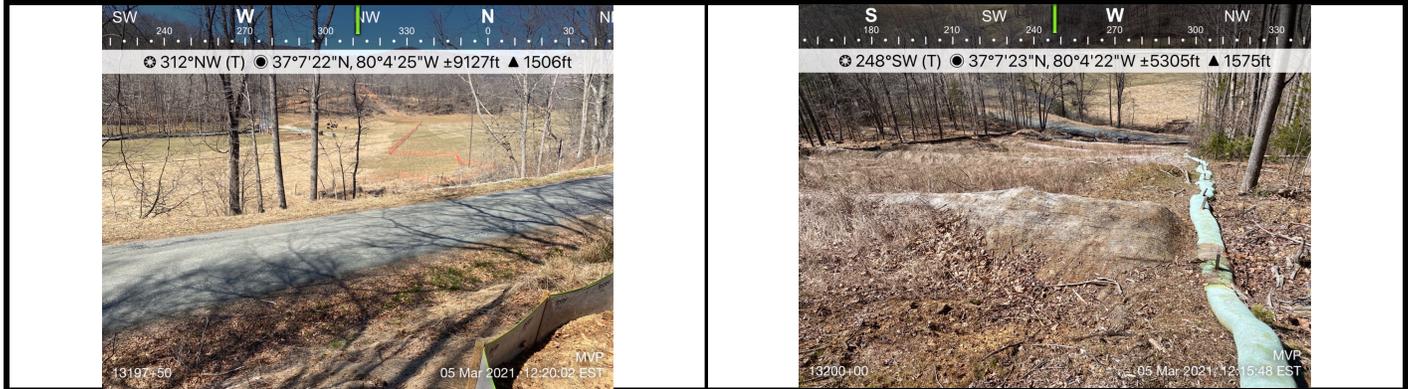
<b>GPS Location</b>	See photo for coordinates.	<b>GPS Location</b>	See photo for coordinates.
<b>Field Station#</b>	13197+50	<b>Field Station#</b>	13200+00
<b>Pic 5 Desc.</b>	Dillons Mill road crossing, no disturbance on the coming in side, road crossing clean.	<b>Pic 6 Desc.</b>	ROW stabilized, vegetative cover noted.

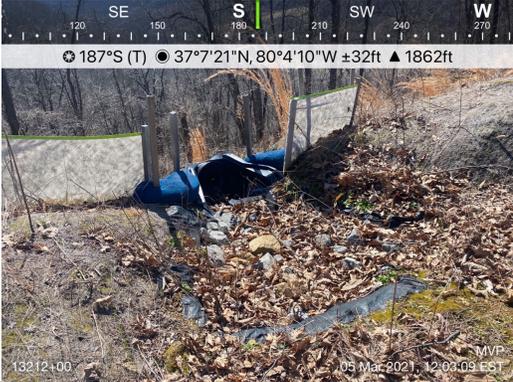
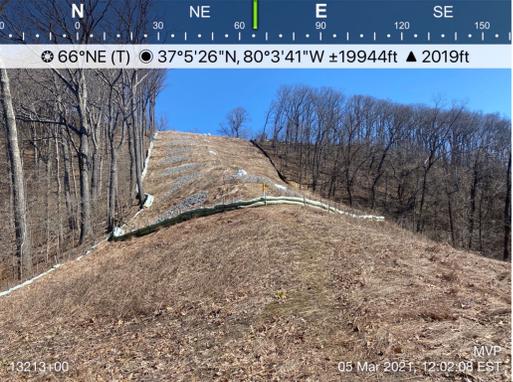
<p>66°NE (T) 37°5'26"N, 80°3'41"W ±19944ft ▲ 2019ft</p> <p>13213+00 05 Mar 2021 12:02:08 EST MVP</p>		<p><b>GPS Location</b> See photo for coordinates.</p> <p><b>Field Station#</b> 13212+00</p> <p><b>Pic 7 Desc.</b> Inlet clear of sediment and debris, ECDs in acceptable condition along side slope drain.</p>		<p><b>GPS Location</b> See photo for coordinates.</p> <p><b>Field Station#</b> 13213+00</p> <p><b>Pic 8 Desc.</b> ROW stable, vegetative cover noted across LOD.</p>

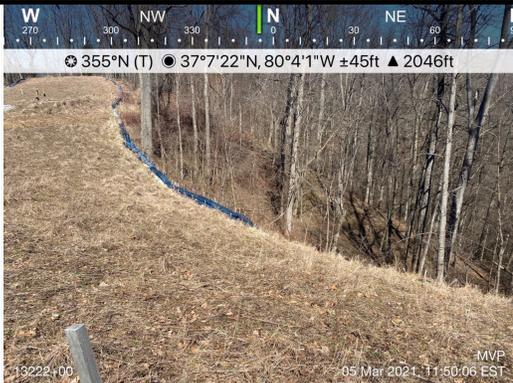
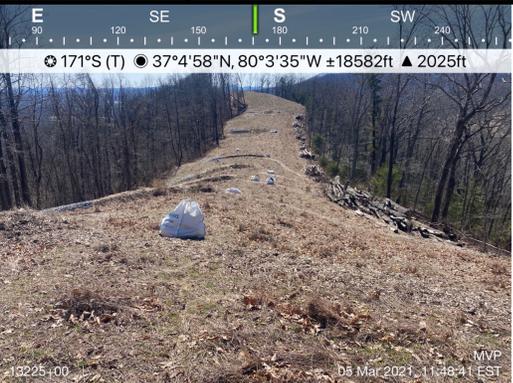
<p>171°S (T) 37°4'58"N, 80°3'35"W ±18582ft ▲ 2025ft</p> <p>13225+00 05 Mar 2021 11:38:41 EST MVP</p>		<p><b>GPS Location</b> See photo for coordinates.</p> <p><b>Field Station#</b> 13222+00</p> <p><b>Pic 9 Desc.</b> No notable movement on ROW at documented slip.</p>		<p><b>GPS Location</b> See photo for coordinates.</p> <p><b>Field Station#</b> 13225+00</p> <p><b>Pic 10 Desc.</b> ROW stable with vegetative cover across LOD.</p>

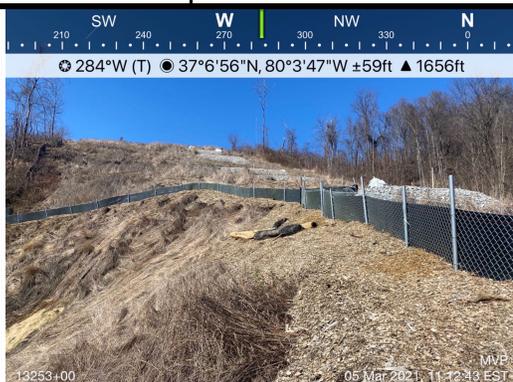
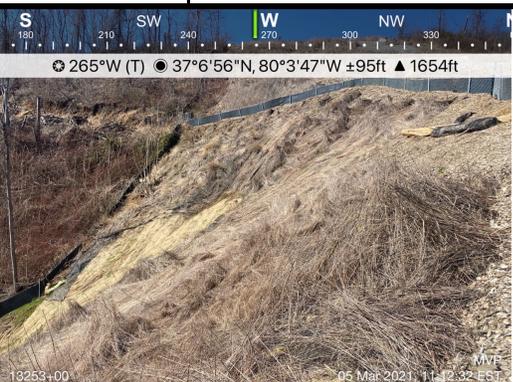
<p>265°W (T) 37°6'56"N, 80°3'47"W ±95ft ▲ 1654ft</p> <p>13253+00 05 Mar 2021 11:12:32 EST MVP</p>		<p><b>GPS Location</b> See photo for coordinates.</p> <p><b>Field Station#</b> 13253+00</p> <p><b>Pic 11 Desc.</b> SSF in good condition at the top of slip.</p>		<p><b>GPS Location</b> See photo for coordinates.</p> <p><b>Field Station#</b> 13253+00</p> <p><b>Pic 12 Desc.</b> Slip area appeared stable, no movement of the curlex noted, no sediment accumulation along perimeter controls.</p>

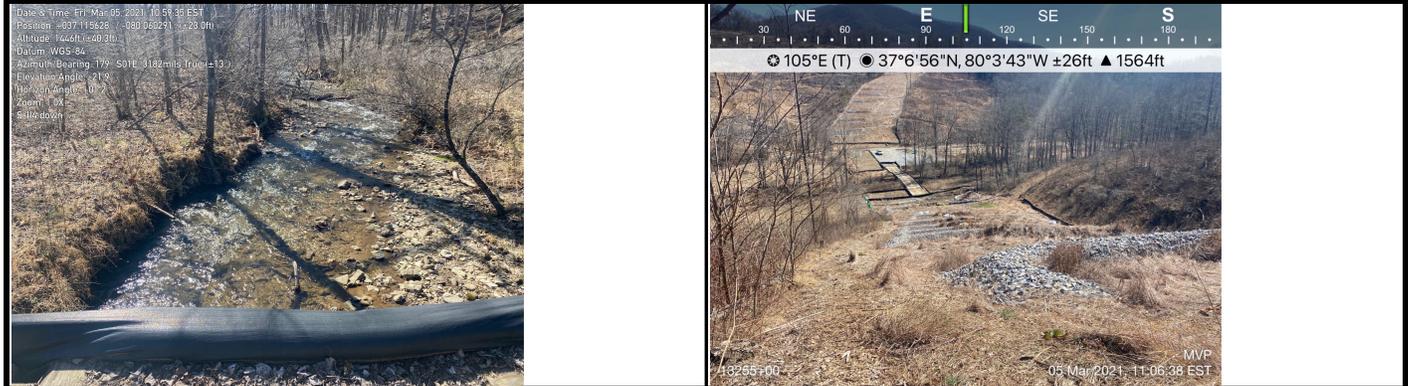
<b>GPS Location</b>	See photo for coordinates.	<b>GPS Location</b>	See photo for coordinates.
<b>Field Station#</b>	13260+60	<b>Field Station#</b>	13255+00
<b>Pic 13 Desc.</b>	S-II4, downstream, no turbidity observed, no changes noted to bed or banks.	<b>Pic 14 Desc.</b>	ROW stable with vegetative cover noted across LOD.

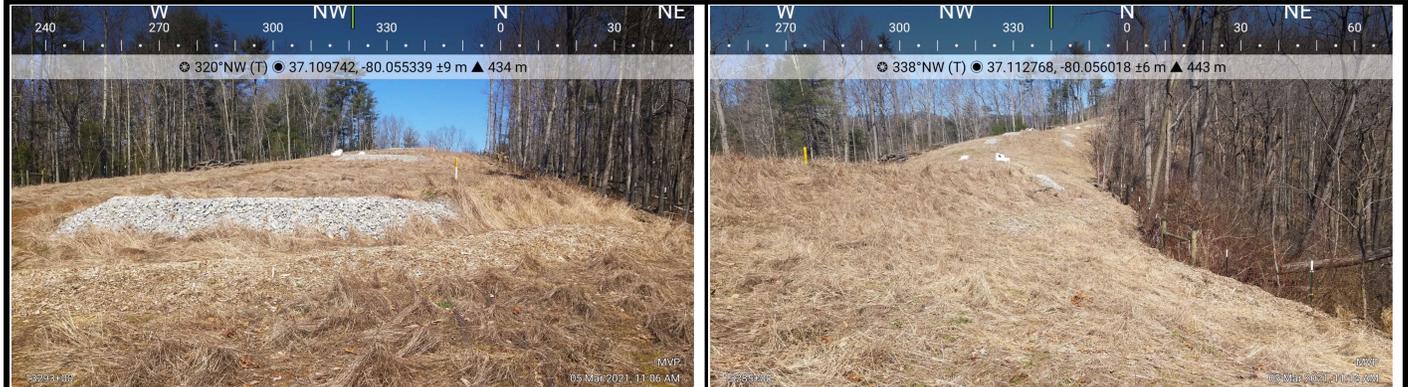
<b>GPS Location</b>	See photo for coordinates.	<b>GPS Location</b>	See photo for coordinates.
<b>Field Station#</b>	13293+00	<b>Field Station#</b>	13285+00
<b>Pic 15 Desc.</b>	ROW stable with vegetative cover noted across LOD.	<b>Pic 16 Desc.</b>	ROW stable with vegetative cover noted across LOD.

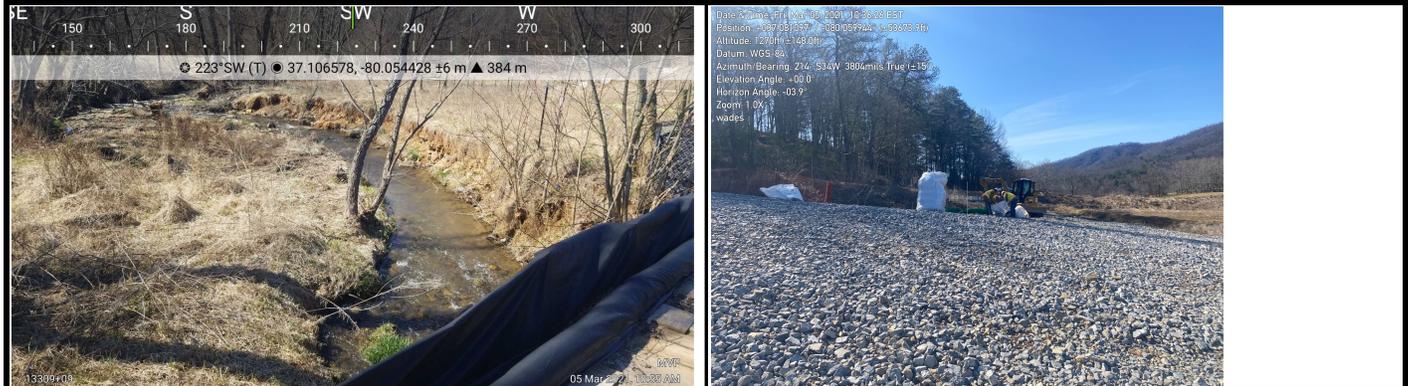
<b>GPS Location</b>	See photo for coordinates.	<b>GPS Location</b>	See photo for coordinates.
<b>Field Station#</b>	13309+09	<b>Field Station#</b>	13316+00
<b>Pic 17 Desc.</b>	S-GH7, downstream, no changes noted to stream bed or banks.	<b>Pic 18 Desc.</b>	PPL crew performing maintenance activity: replacing degrading CFS around soil pile.

E&S BMPs	Compliance Level	Corrective Action	Corrective Time Frame	Date Repaired
Cleanwater Diversion Berm	Acceptable			
Compost Filter Sock	Communication	Replace degrading CFS	Addressed	3/5/2021
Equipment Bridge	Acceptable			
Erosion Control Blanket	Acceptable			
Rock Construction Entrance	Acceptable			
Silt Fence (Filter Fabric Fence)	Acceptable			
Silt Fence (Reinforced Filter Fabric Fence)	Acceptable			
Waterbar	Acceptable			
Waterbar Outlet Protection	Acceptable
