# Visual Site Inspection Report

<b>Project Name</b> H-600 Pipeline Spread H		<b>AFE</b> 124300138	<b>Spread</b> H-600 Pipeline Spread H
<b>Contractor</b> Precision		<b>Report #</b> 21095	
<b>Inspector</b> John Brcic		<b>Date/Time</b> 3/15/2021 12:34 PM	
<b>Permit #</b> TBD	<b>Inspection Type</b> VA SWPP	<b>Station Begin</b> 12284+75	
<b>State</b> VA	<b>Inspection Area</b> Partial	<b>Station End</b> 12443+75	
<b>County</b> Montgomery	<b>Ground</b> Dry	<b>Temperature (°F)</b> 48.00	
<b>Municipality</b> N/A	<b>Weather</b> Cloudy	<b>Rain Gauge (in)</b> 0.00	
<b>Rain Accumulation Time (days)</b>			3.00

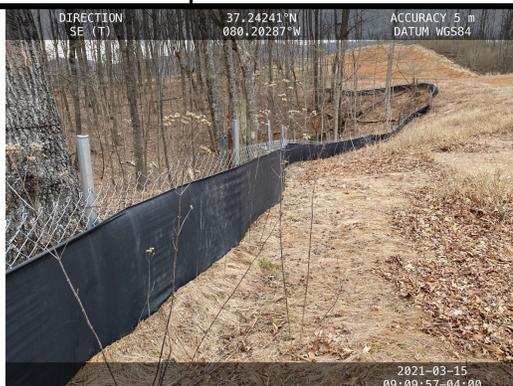
<p>DIRECTION SE (T) 37.24308°N 080.20378°W ACCURACY 6 m DATUM WGS84 2021-03-15 09:08:02-04:00</p>	
<b>GPS Location</b>	See photo	<b>GPS Location</b>	See photo
<b>Field Station#</b>	12383+00	<b>Field Station#</b>	12390+00
<b>Pic 9 Desc.</b>	Clean water diversion channel remains stable, ECDs in good repair.	<b>Pic 10 Desc.</b>	ROW stable

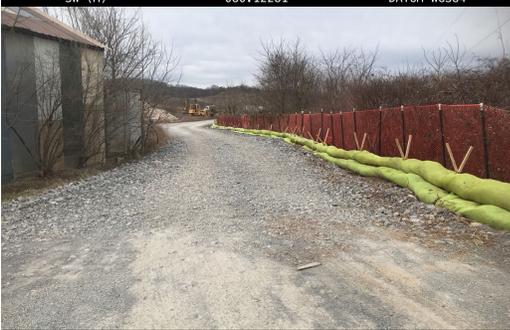
<p>DIRECTION SW (M) +37.27203° -080.12281° ACCURACY 33 ft DATUM WGS84</p> <p>MVP-LY-049_031521 Condition of rock entrance 2021-03-15 08:45:40-04:00</p>

<p>DIRECTION S (M) +37.27099° -080.12213° ACCURACY 16 ft DATUM WGS84</p> <p>MVP-LY-049_031521 Condition of containment 2021-03-15 08:48:13-04:00</p>			
<b>GPS Location</b> MVP-LY-049 See photo for gps data		<b>GPS Location</b> MVP-LY-049 See photo for gps data			
<b>Field Station#</b> +0		<b>Field Station#</b> +0			
<b>Pic 1 Desc.</b> Condition of north rock entrance. No sediment on stone. Looking SW.		<b>Pic 2 Desc.</b> Condition of containment under light plant. Free of stormwater. Looking S.

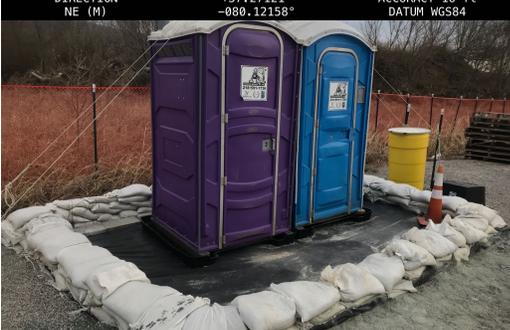
<p>DIRECTION NE (M) +37.27121° -080.12158° ACCURACY 16 ft DATUM WGS84</p> <p>MVP-LY-049_031521 Condition of trays &amp; containment 2021-03-15 08:49:04-04:00</p>

<b>GPS Location</b> MVP-LY-049 See photo for gps data		<b>GPS Location</b> MVP-LY-049 See photo for gps data			
<b>Field Station#</b> +0		<b>Field Station#</b> +0			
<b>Pic 3 Desc.</b> Condition of trays and containment. Looking NE.		<b>Pic 4 Desc.</b> Condition of containment holding barrel of toilet chemical. Free of stormwater. Looking E.

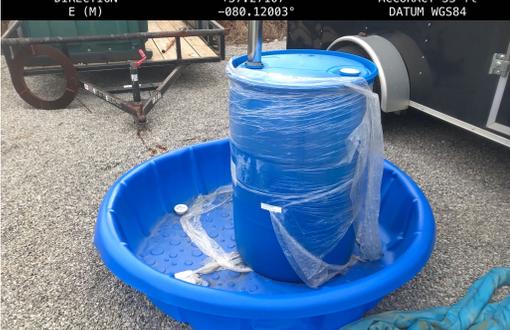
<p>DIRECTION E (M) +37.27107° -080.12003° ACCURACY 33 ft DATUM WGS84</p> <p>MVP-LY-049_031521 Condition of containment 2021-03-15 08:50:48-04:00</p>

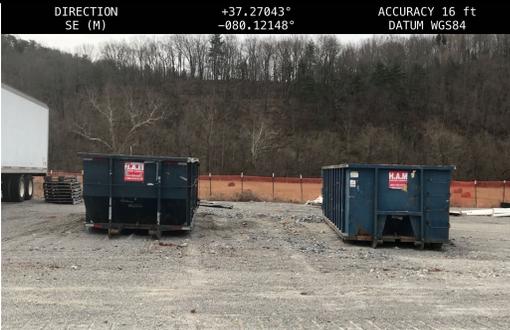
<p>DIRECTION SE (M) +37.27043° -080.12148° ACCURACY 16 ft DATUM WGS84</p> <p>MVP-LY-049_031521 No loose trash around south dumpsters 2021-03-15 09:04:04-04:00</p>

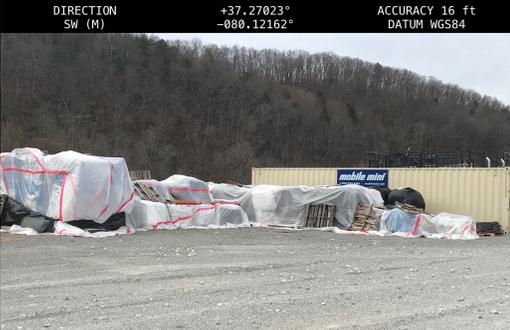
<p>DIRECTION Sw (M) +37.27023° -080.12162° ACCURACY 16 ft DATUM WGS84</p> <p>MVP-LY-049_031521 Restoration supplies covered 2021-03-15 09:04:21-04:00</p>			
<b>GPS Location</b> MVP-LY-049 See photo for gps data		<b>GPS Location</b> MVP-LY-049 See photo for gps data			
<b>Field Station#</b> +0		<b>Field Station#</b> +0			
<b>Pic 5 Desc.</b> No loose trash around south dumpsters. Looking SE.		<b>Pic 6 Desc.</b> Restoration supplies covered and protected from the weather. Looking SW.

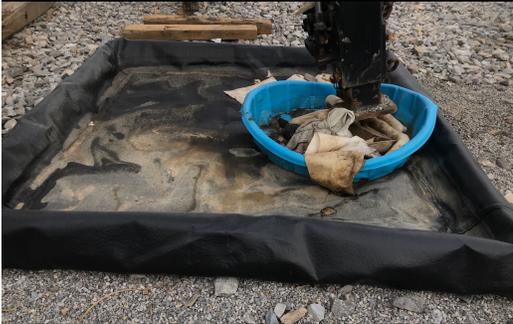
<p>MVP-LY-049_031521      Containment under stored equipment      2021-03-15 09:09:45-04:00</p>	<p>DIRECTION SW (M)      +37.27046° -080.12466°      ACCURACY 16 ft DATUM WGS84</p>

<b>GPS Location</b> MVP-LY-049 See photo for gps data	<b>GPS Location</b> MVP-LY-049 See photo for gps data
<b>Field Station#</b> +0	<b>Field Station#</b> +0
<b>Pic 13 Desc.</b> Condition of containment under stored equipment. Looking NW.	<b>Pic 14 Desc.</b> Landowner soil disturbance along north edge of feature W-CV21A. Area not stabilized. Looking SW.

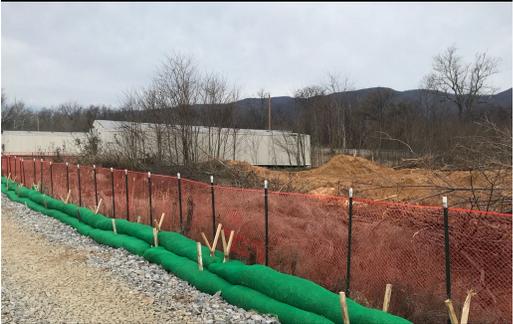
<p>MVP-LY-049_031521      Landowner disturbance along feature      2021-03-15 09:10:45-04:00</p>
---	---

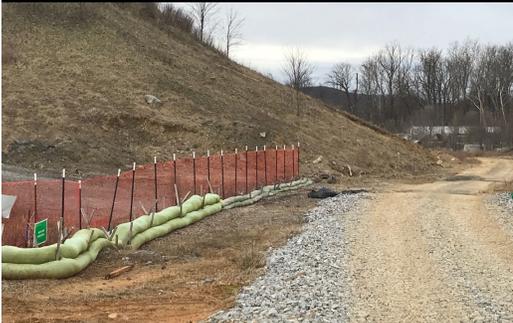
<p>MVP-LY-049_031521      Landowner disturbance within 66' of feature      2021-03-15 09:10:54-04:00</p>	<p>DIRECTION SE (M)      +37.27042° -080.12466°      ACCURACY 16 ft DATUM WGS84</p>

<b>GPS Location</b> MVP-LY-049 See photo for gps data	<b>GPS Location</b> MVP-LY-049 See photo for gps data
<b>Field Station#</b> +0	<b>Field Station#</b> +0
<b>Pic 15 Desc.</b> Landowner soil disturbance within 66' and 120' west of feature W-CV21B. Areas not stabilized. Looking SW.	<b>Pic 16 Desc.</b> Landowner soil disturbance along compost filter sock and feature W-CV21B. Area not stabilized. No impacts. Looking SE.

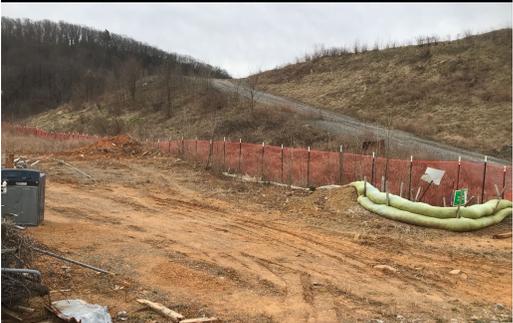
<p>MVP-LY-049_031521      Landowner disturbance along CFS &amp; feature      2021-03-15 09:11:10-04:00</p>
---	--

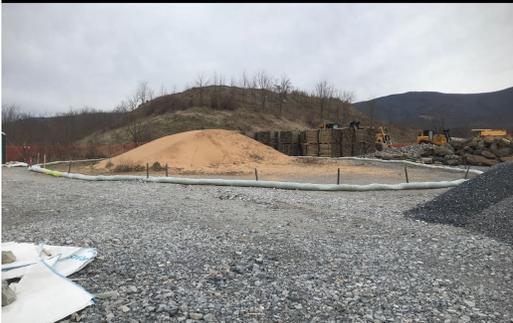
<p>MVP-LY-049_031521      Condition of CFS around sand pile      2021-03-15 09:13:20-04:00</p>	<p>DIRECTION E (M)      +37.26966° -080.12218°      ACCURACY 16 ft DATUM WGS84</p>

<b>GPS Location</b> MVP-LY-049 See photo for gps data	<b>GPS Location</b> MVP-LY-049 See photo for gps data
<b>Field Station#</b> +0	<b>Field Station#</b> +0
<b>Pic 17 Desc.</b> Condition of compost filter sock around sand pile. Looking NW.	<b>Pic 18 Desc.</b> Condition of compost filter sock and safety fence along south LOD. Looking E.

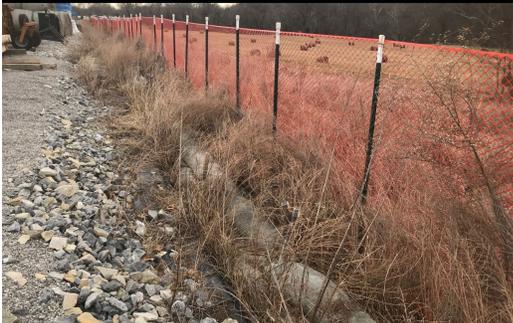
<p>MVP-LY-049_031521      Condition of CFS &amp; safety LOD      2021-03-15 09:17:30-04:00</p>
--	--

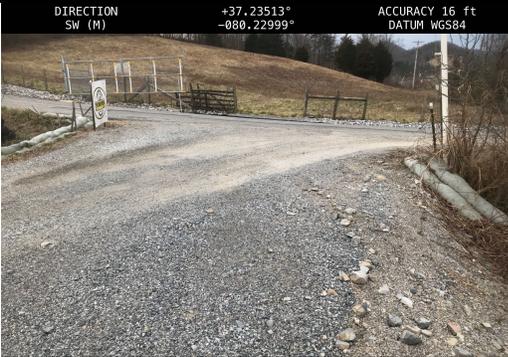
<p>DIRECTION Sw (M) +37.23513° -080.22999° ACCURACY 16 ft DATUM WGS84</p> <p>MVP-PY-006_031521 Condition of rock entrance 2021-03-15 07:52:04-04:00</p>

<p>DIRECTION E (M) +37.23580° -080.22767° ACCURACY 213 ft DATUM WGS84</p> <p>MVP-PY-006_031521 Condition of CFS along LOD 2021-03-15 07:56:33-04:00</p>	
<b>GPS Location</b> MVP-PY-006 See photo for gps data		<b>GPS Location</b> MVP-PY-006 See photo for gps data			
<b>Field Station#</b> +0		<b>Field Station#</b> +0			
<b>Pic 1 Desc.</b> Condition of the west rock entrance. No sediment on stone. No rock on roadway. Looking SW.		<b>Pic 2 Desc.</b> Condition of compost filter sock along south LOD. Looking E.

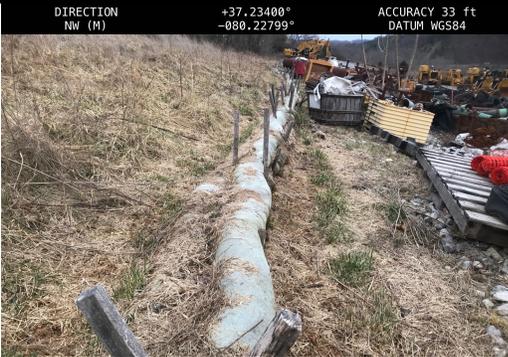
<p>DIRECTION NW (M) +37.23400° -080.22799° ACCURACY 33 ft DATUM WGS84</p> <p>MVP-PY-006_031521 Condition of CFS along LOD 2021-03-15 07:56:38-04:00</p>

<b>GPS Location</b> MVP-PY-006 See photo for gps data		<b>GPS Location</b> MVP-PY-006 See photo for gps data			
<b>Field Station#</b> +0		<b>Field Station#</b> +0			
<b>Pic 3 Desc.</b> Condition of compost filter sock along south LOD. Looking NW.		<b>Pic 4 Desc.</b> Condition of poly lined rock berm containments. Free of stormwater. Looking E.

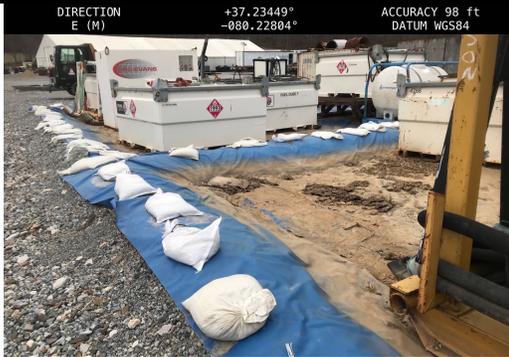
<p>DIRECTION E (M) +37.23449° -080.22804° ACCURACY 98 ft DATUM WGS84</p> <p>MVP-PY-006_031521 Condition of poly lined containments 2021-03-15 07:58:35-04:00</p>

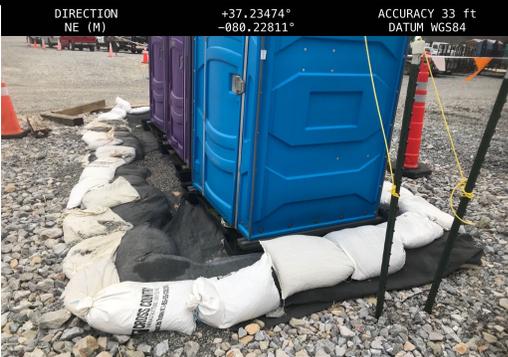
<p>DIRECTION NE (M) +37.23474° -080.22811° ACCURACY 33 ft DATUM WGS84</p> <p>MVP-PY-006_031521 Condition of trays &amp; containment 2021-03-15 07:58:53-04:00</p>

<p>DIRECTION E (M) +37.23419° -080.22716° ACCURACY 16 ft DATUM WGS84</p> <p>MVP-PY-006_031521 Condition of containment 2021-03-15 08:03:52-04:00</p>	
<b>GPS Location</b> MVP-PY-006 See photo for gps data		<b>GPS Location</b> MVP-PY-006 See photo for gps data			
<b>Field Station#</b> +0		<b>Field Station#</b> +0			
<b>Pic 5 Desc.</b> Condition of trays and containment under toilets. Looking NE.		<b>Pic 6 Desc.</b> Condition of containment under hazardous waste dumpsters west of the mechanics building. Free of fluids. Looking E.

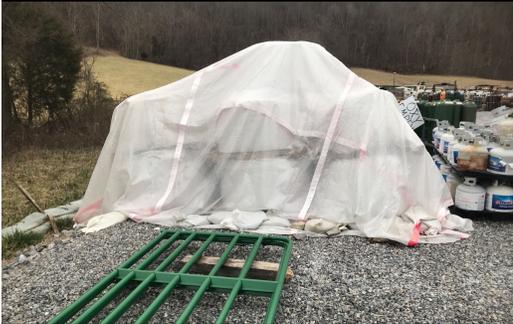
<p>MVP-PY-006_031521    Restoration supplies covered    2021-03-15 08:06:34-04:00</p>	<p>DIRECTION E (M)    +37.23569°    ACCURACY 16 ft -080.22711°    DATUM WGS84</p>

<b>GPS Location</b> MVP-PY-006 See photo for gps data	<b>GPS Location</b> MVP-PY-006 See photo for gps data
<b>Field Station#</b> +0	<b>Field Station#</b> +0
<b>Pic 7 Desc.</b> Restoration supplies covered and protected from the elements. Looking SE.	<b>Pic 8 Desc.</b> Secondary containment on site for tankers offloading fuel. Looking E.

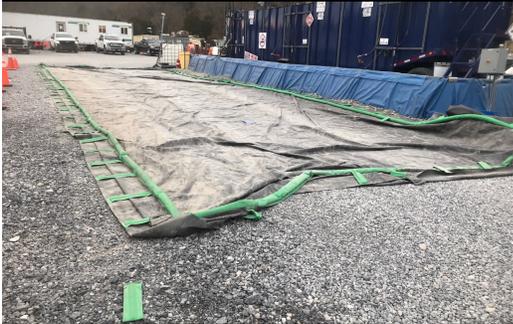
<p>MVP-PY-006_031521    Secondary containment on site for tankers    2021-03-15 08:08:11-04:00</p>
--	---

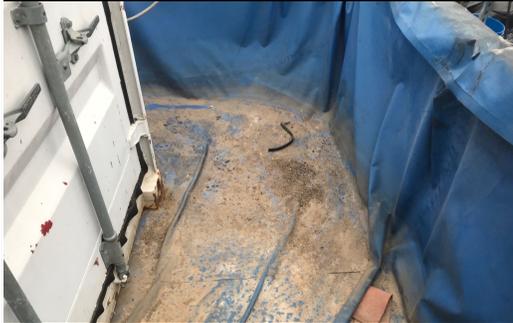
<p>MVP-PY-006_031521    Condition of containment    2021-03-15 08:08:38-04:00</p>	<p>DIRECTION W (M)    +37.23562°    ACCURACY 16 ft -080.22696°    DATUM WGS84</p>

<b>GPS Location</b> MVP-PY-006 See photo for gps data	<b>GPS Location</b> MVP-PY-006 See photo for gps data
<b>Field Station#</b> +0	<b>Field Station#</b> +0
<b>Pic 9 Desc.</b> Off Road Fuel unit condition of containment. Free of stormwater. Looking N.	<b>Pic 10 Desc.</b> Off Road Fuel unit no leaky internal fittings. Looking W.

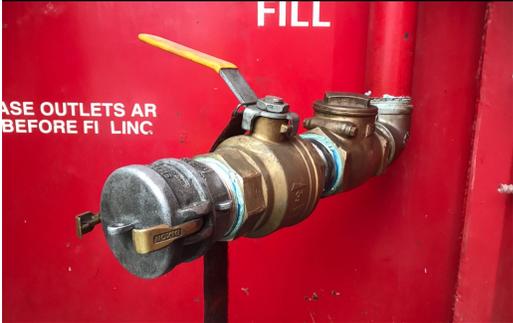
<p>MVP-PY-006_031521    No leaky internal fittings    2021-03-15 08:08:58-04:00</p>
--	---

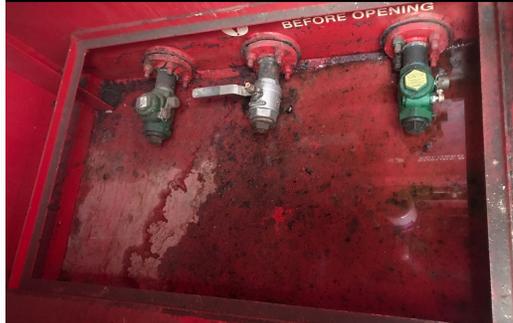
<p>MVP-PY-006_031521    Condition of internal drip pan    2021-03-15 08:09:04-04:00</p>	<p>DIRECTION N (M)    +37.23559°    ACCURACY 16 ft -080.22699°    DATUM WGS84</p>

<b>GPS Location</b> MVP-PY-006 See photo for gps data	<b>GPS Location</b> MVP-PY-006 See photo for gps data
<b>Field Station#</b> +0	<b>Field Station#</b> +0
<b>Pic 11 Desc.</b> Off Road Fuel unit condition of internal drip pan. Looking SW.	<b>Pic 12 Desc.</b> Blue Bulk Fuel tanks no leaky fittings or nozzles. Looking N.

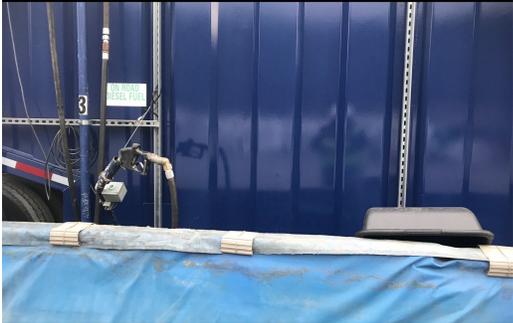
<p>MVP-PY-006_031521    No leaky fittings or nozzles    2021-03-15 08:09:49-04:00</p>
--	--

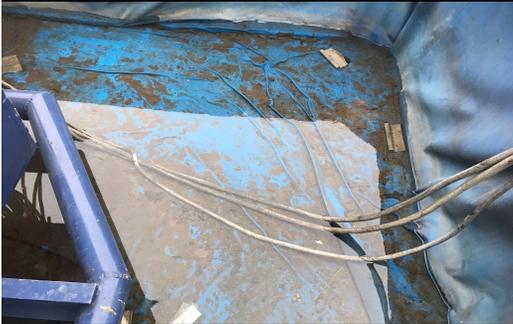
<p>MVP-PY-006_031521      Condition of containment      2021-03-15 08:10:20-04:00</p>	<p>DIRECTION W (M)      +37.23565°      ACCURACY 16 ft -080.22683°      DATUM WGS84</p>

<b>GPS Location</b> MVP-PY-006 See photo for gps data	<b>GPS Location</b> MVP-PY-006 See photo for gps data
<b>Field Station#</b> +0	<b>Field Station#</b> +0
<b>Pic 13 Desc.</b> Blue Bulk Fuel tanks condition of containment. Holding stormwater. Looking N.	<b>Pic 14 Desc.</b> Blue Bulk Fuel tanks no leaky internal fittings. Looking W.

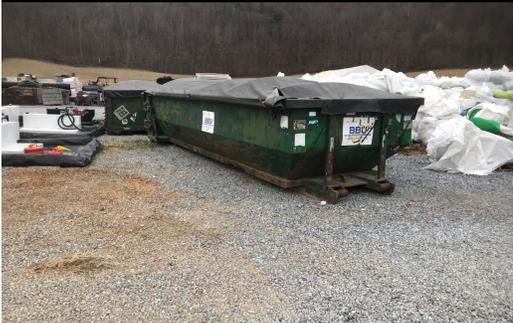
<p>MVP-PY-006_031521      No fluids around hazardous waste ...      2021-03-15 08:11:58-04:00</p>	<p>DIRECTION SE (M)      +37.23553°      ACCURACY 16 ft -080.22673°      DATUM WGS84</p>

<b>GPS Location</b> MVP-PY-006 See photo for gps data	<b>GPS Location</b> MVP-PY-006 See photo for gps data
<b>Field Station#</b> +0	<b>Field Station#</b> +0
<b>Pic 15 Desc.</b> No fluids or deposits around hazardous waste dumpsters. Looking S.	<b>Pic 16 Desc.</b> No loose trash around dumpsters or in the yard. Looking SE.

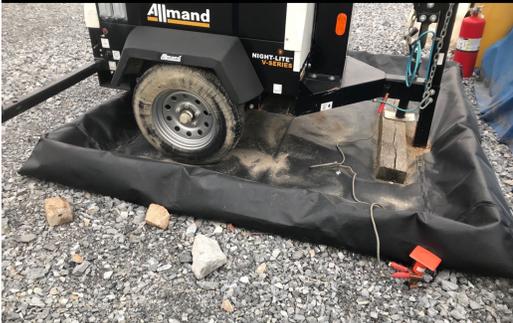
<p>MVP-PY-006_031521      Condition of containment      2021-03-15 08:13:08-04:00</p>	<p>DIRECTION E (M)      +37.23574°      ACCURACY 16 ft -080.22880°      DATUM WGS84</p>

<b>GPS Location</b> MVP-PY-006 See photo for gps data	<b>GPS Location</b> MVP-PY-006 See photo for gps data
<b>Field Station#</b> +0	<b>Field Station#</b> +0
<b>Pic 17 Desc.</b> Condition of containment under light plant. Free of stormwater. Looking N.	<b>Pic 18 Desc.</b> Condition of compost filter sock and signage for feature W-008. Looking E.

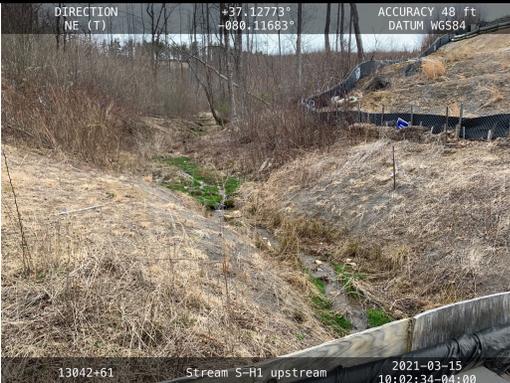
<b>Pic 5 Desc.</b>	Photo shows stream S-H1 upstream of the bridge.		<b>Pic 6 Desc.</b>	Photo shows stream S-H1 downstream of the bridge.

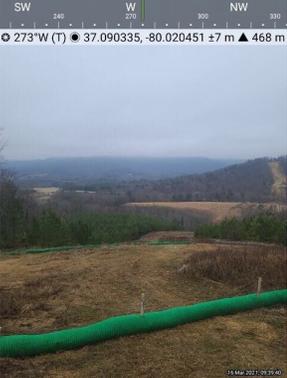
<p>NE E SE 100 84°E (T) ● 37.09234, -80.027198 ±17 m ▲ 408 m 13 Mar 2021 10:05:16</p>		
GPS Location	0000	GPS Location	0000		
Field Station#	13436+37	Field Station#	13415+90		
Pic 1 Desc.	Monitored all ECDs throughout inspection today , all CFS was in place and functioning		Pic 2 Desc.	Observed erosion control blanket on hill side , no environmental issues observed at the time of inspection.

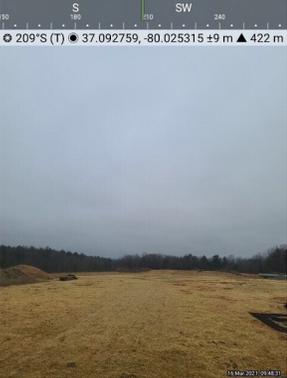
<p>SW W NW 300 261°W (T) ● 37.090474, -79.996035 ±4 m ▲ 349 m 13 Mar 2021 10:41:16</p>		
GPS Location	0000	GPS Location	0000		
Field Station#	13420+00	Field Station#	13525+91		
Pic 3 Desc.	Monitored stabilization in work space at CAHAS#1 . No environmental issues observed at the time of inspection,		Pic 4 Desc.	Inspected equipment bridge and protection, monitored ECDs and vegetation. O issues were observed at the time of inspection.

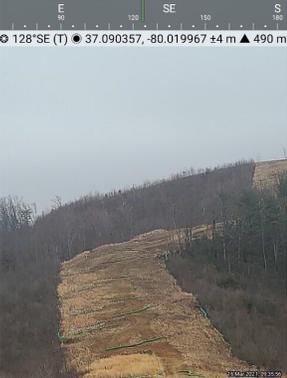
<p>S SW 240 197°S (T) ● 37.088945, -80.005189 ±9 m ▲ 370 m 13 Mar 2021 09:52:29</p>		
GPS Location	0000	GPS Location	0000		
Field Station#	13443+00	Field Station#	13496+67		
Pic 5 Desc.	Row photo showing slope breakers and CFS as well as vegetation, no environmental issues observed at the time of inspection. Will continue to monitor vegetation on travel lane		Pic 6 Desc.	CFS undermined at rd crossing at CAHAS#2 . Documented and added to the punch list for repair .

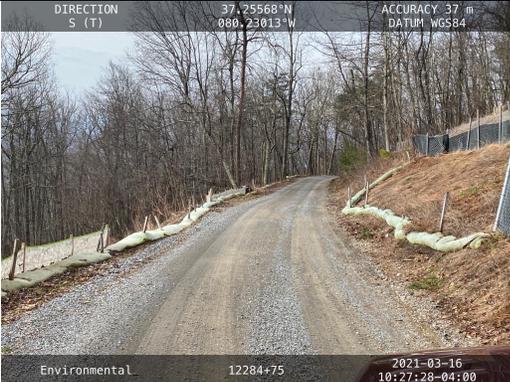
<p>DIRECTION NE (T) 37.25171°N 080.24578°W ACCURACY 17 m DATUM WGS84</p> <p>Environmental 12236+00 2021-03-16 10:31:48-04:00</p>		<p><b>GPS Location</b> See photo</p> <p><b>Field Station#</b> 12284+75</p> <p><b>Pic 1 Desc.</b> Access Road MVP-MN-276.03 crossing in acceptable condition</p>		<p><b>GPS Location</b> See photo</p> <p><b>Field Station#</b> 12236+00</p> <p><b>Pic 2 Desc.</b> Stabilized slope in acceptable condition</p>

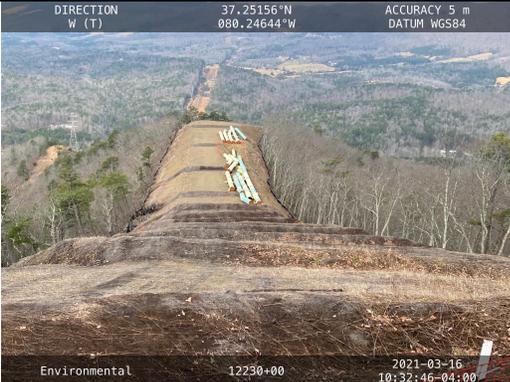
<p>DIRECTION W (T) 37.25341°N 080.26280°W ACCURACY 5 m DATUM WGS84</p> <p>Environmental 12175+00 2021-03-16 11:02:05-04:00</p>		<p><b>GPS Location</b> See photo</p> <p><b>Field Station#</b> 12230+00</p> <p><b>Pic 3 Desc.</b> Stabilized slope in acceptable condition</p>		<p><b>GPS Location</b> See photo</p> <p><b>Field Station#</b> 12175+00</p> <p><b>Pic 4 Desc.</b> Stabilized ROW in acceptable condition</p>

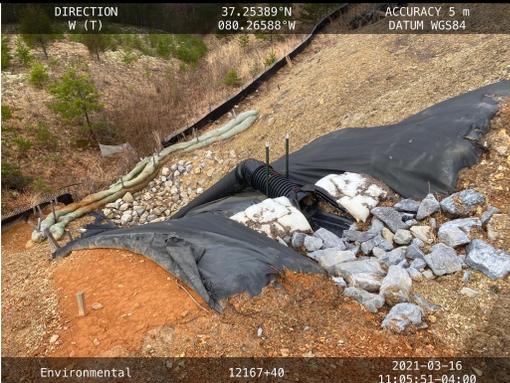
<p>DIRECTION Nw (T) 37.25391°N 080.26640°W ACCURACY 99 m DATUM WGS84</p> <p>Environmental S-C24 12166+47 2021-03-16 11:07:23-04:00</p>		<p><b>GPS Location</b> See photo</p> <p><b>Field Station#</b> 12167+40</p> <p><b>Pic 5 Desc.</b> Fill slope drain in acceptable condition</p>		<p><b>GPS Location</b> See photo</p> <p><b>Field Station#</b> 12166+47</p> <p><b>Pic 6 Desc.</b> Bridge and ECDs at stream crossing S-C24 in acceptable condition</p>

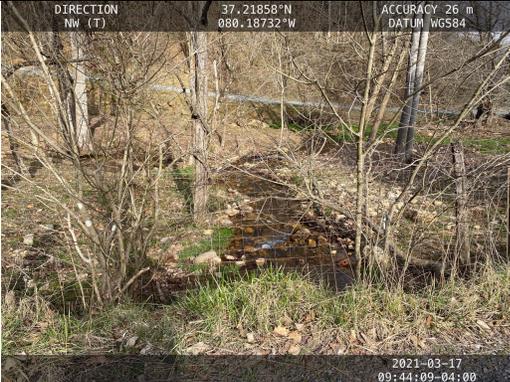
GPS Location		See photo		GPS Location	
Field Station#		12544+06		Field Station#	
Pic 1 Desc.		Stream S-KL32, facing northwest, downstream from Yellow Finch Lane		Pic 2 Desc.

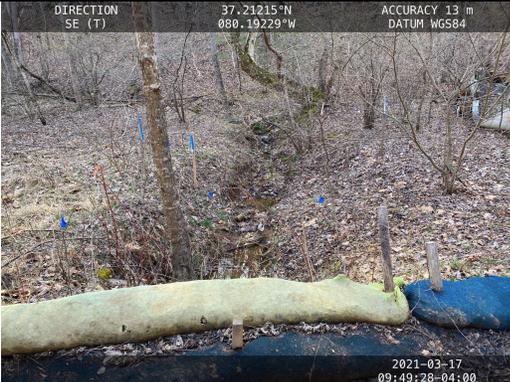
GPS Location		See photo		GPS Location	
Field Station#		12544+06		Field Station#	
Pic 3 Desc.		Stream S-EF54, facing southeast, downstream		Pic 4 Desc.

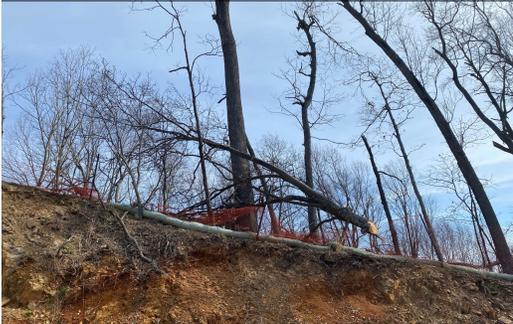
<p>12513+00: large limb left hanging on edge ROW by Enbridge tree trimming    2021-03-17 10:56:00-04:00</p>	<p>DIRECTION SW (T)    37.21772°N    ACCURACY 12 m 080.19789°W    DATUM WGS84</p>

<b>Pic 13 Desc.</b> A large limb was left in a precarious position hanging over the edge of MVP ROW by Enbridge tree trimmers.	<b>Pic 14 Desc.</b> Super silt fence perimeter controls in satisfactory condition along the bottom of this side slope.
--	--

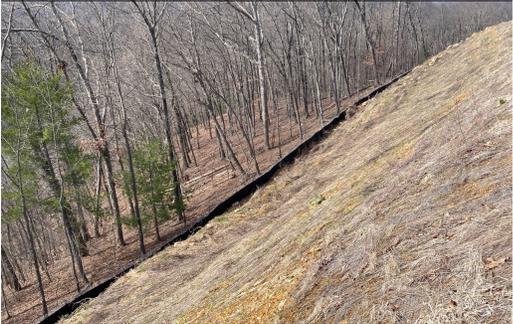
<p>12512+00: SSF perimeter controls in good repair at bottom of side slope    2021-03-17 10:57:07-04:00</p>
---	--

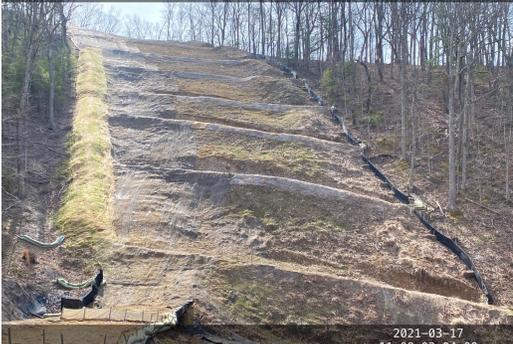
<b>Pic 15 Desc.</b> Slope stable on going away side of the clean water diversion pipe.	<b>Pic 16 Desc.</b> Water deflectors in satisfactory condition on access road MVP-MLV-AR-28.
--	--

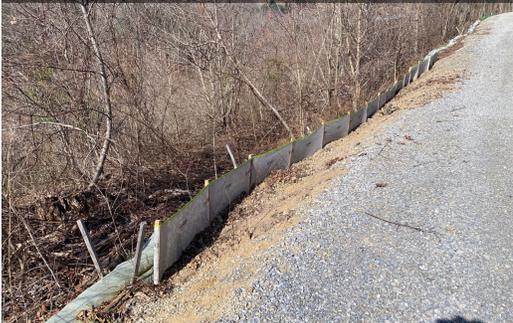
<p>12483+30: old P1 silt fence replaced replaced along MVP-MLV-AR-28    2021-03-17 11:27:13-04:00</p>	<p>DIRECTION NE (T)    37.22983°N    ACCURACY 12 m 080.20147°W    DATUM WGS84</p>

<b>Pic 17 Desc.</b> Old P1 silt fence was replaced alongside access road MVP-MLV-AR-28.	<b>Pic 18 Desc.</b> Old P1 silt fence was replaced around the going away side buffer zone of stream S-CD21.
---	---

Stations 12443+75 to 12544+06....Activity since last SWPPP inspection. The only remedial measures taken since the previous SWPPP inspection was the P1 silt fence replaced today along access road MVP-MLV-AR-28 and around the buffer zone on the going away side of stream S-CD12.

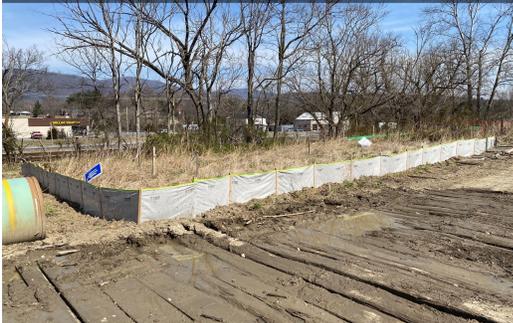
<p>12455+70: old P1 silt fence replaced on GAS buffer of stream S-CD12    2021-03-17 11:44:01-04:00</p>
--	--

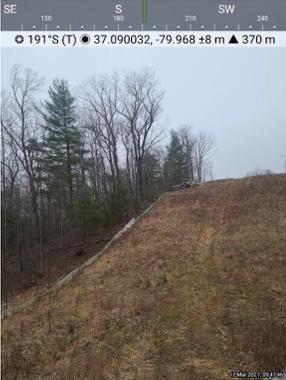
<b>GPS Location</b>	00000		<b>GPS Location</b>	0000	
<b>Field Station#</b>	13618+00		<b>Field Station#</b>	13590+00	
<b>Pic 1 Desc.</b>	EI monitored ECDs along side the row , checked vegetation growth throughout. No issues observed at the time of inspection		<b>Pic 2 Desc.</b>	Vegetation observation photo facing down row . No environmental issues observed at the time of inspection.

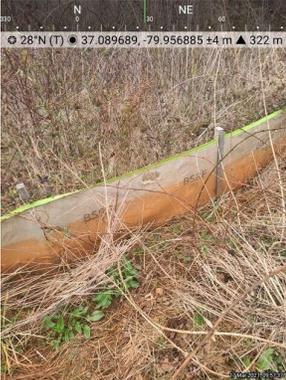
Throughout today's inspections the EI noted 4 locations where P1 required maintenance due to being weathered and torn, documented and sent in to be added to the punch list for repair.

<b>GPS Location</b>	00000		<b>GPS Location</b>	00000	
<b>Field Station#</b>	13656+72		<b>Field Station#</b>	13661+90	
<b>Pic 3 Desc.</b>	P1 requires maintenance due to being weathered and torn , documented and added to the punch list .		<b>Pic 4 Desc.</b>	P1 requires maintenance due to being weathered and torn , documented and added to the punch list .

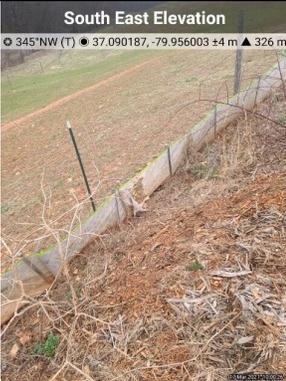
<b>Pic 5 Desc.</b>	P1 requires maintenance due to being weathered and torn , documented and added to the punch list .		<b>Pic 6 Desc.</b>	P1 requires maintenance due to being weathered and torn , documented and added to the punch list .

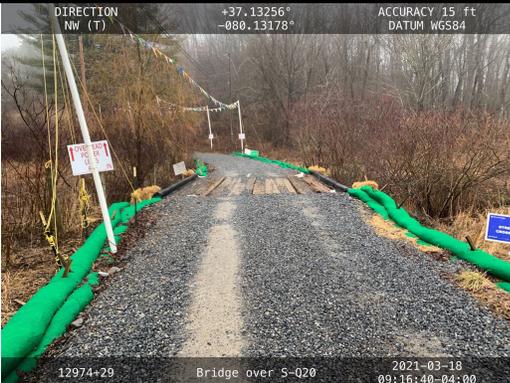
<b>Pic 5 Desc.</b>	Photo shows the bridge over stream S-Q20 on access road RO-288.		<b>Pic 6 Desc.</b>	Photo shows stream S-Q20 downstream of access road RO-288.

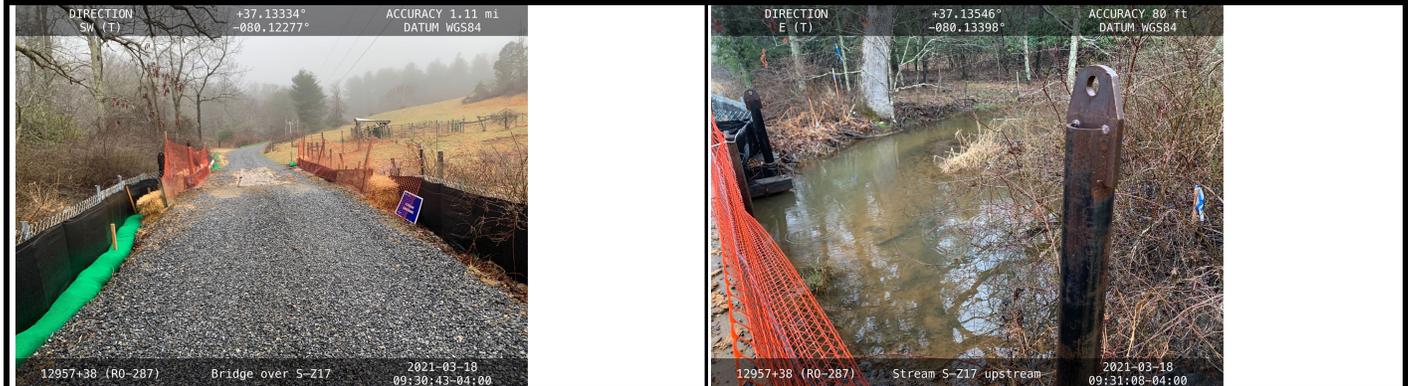
<b>GPS Location</b>	See photo for gps location data.	<b>GPS Location</b>	See photo for gps location data.
<b>Field Station#</b>	12957+38	<b>Field Station#</b>	12957+38
<b>Pic 11 Desc.</b>	Photo shows the bridge over stream S-Z17 on access road RO-287.	<b>Pic 12 Desc.</b>	Photo shows stream S-Z17 upstream of access road RO-287.

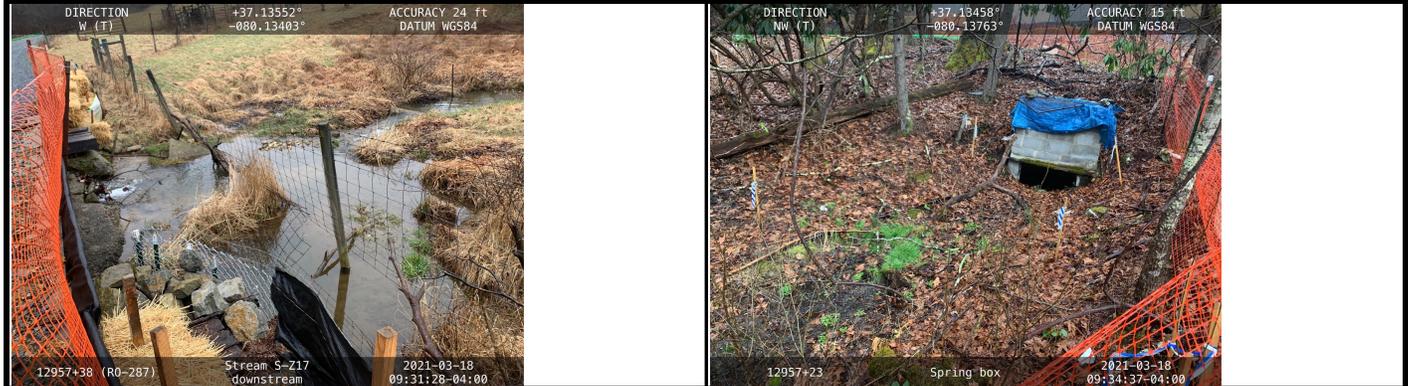
<b>GPS Location</b>	See photo for gps location data.	<b>GPS Location</b>	See photo for gps location data.
<b>Field Station#</b>	12957+38	<b>Field Station#</b>	12957+23
<b>Pic 13 Desc.</b>	Photo shows stream S-Z17 downstream of access road RO-287.	<b>Pic 14 Desc.</b>	Photo shows the spring box located near access road RO-287.

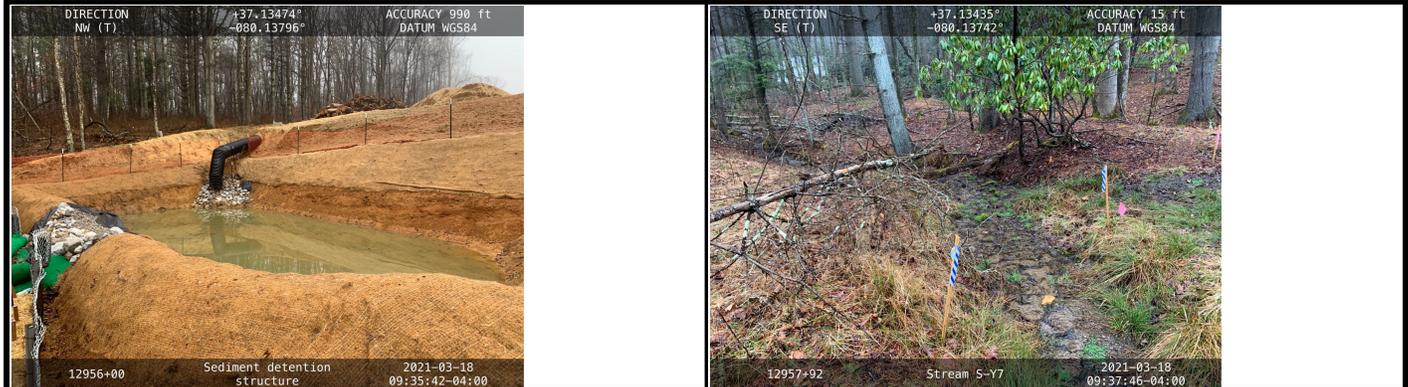
<b>GPS Location</b>	See photo for gps location data.	<b>GPS Location</b>	See photo for gps location data.
<b>Field Station#</b>	12956+00	<b>Field Station#</b>	12957+92
<b>Pic 15 Desc.</b>	Photo shows the sediment trap.	<b>Pic 16 Desc.</b>	Photo shows stream S-Y7 downstream of the ROW.

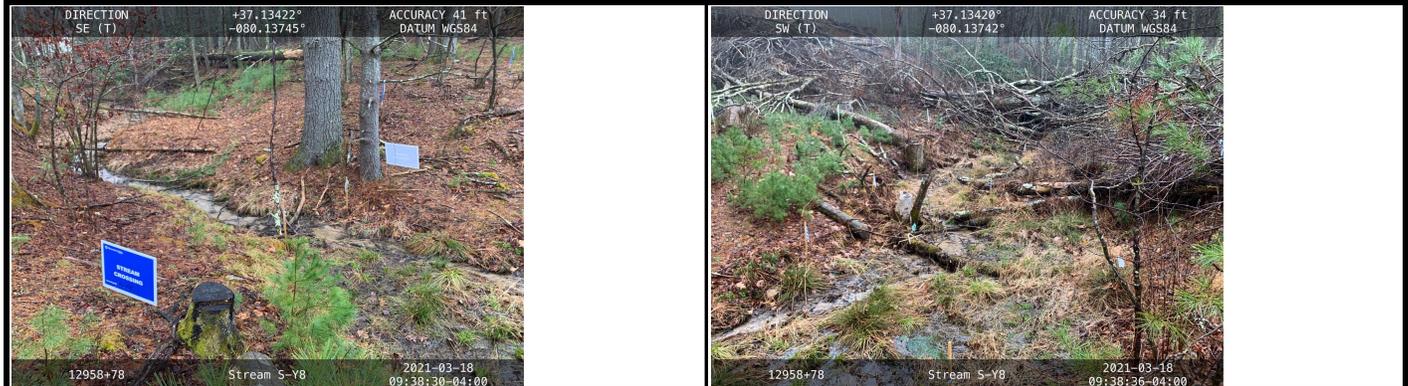
<b>GPS Location</b>	See photo for gps location data.	<b>GPS Location</b>	See photo for gps location data.
<b>Field Station#</b>	12958+78	<b>Field Station#</b>	12958+78
<b>Pic 17 Desc.</b>	Photo shows stream S-Y8 downstream from the ROW.	<b>Pic 18 Desc.</b>	Photo shows stream S-Y8 through the ROW.

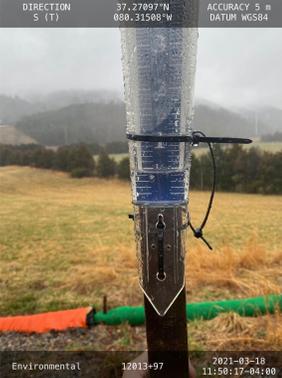
<b>GPS Location</b>	See photo	<b>GPS Location</b>	See photo		
<b>Field Station#</b>	12013+97	<b>Field Station#</b>	12040+00		
<b>Pic 1 Desc.</b>	Rain gauge totals for Catawba.5"	<b>Pic 2 Desc.</b>	Stabilized ROW in acceptable condition

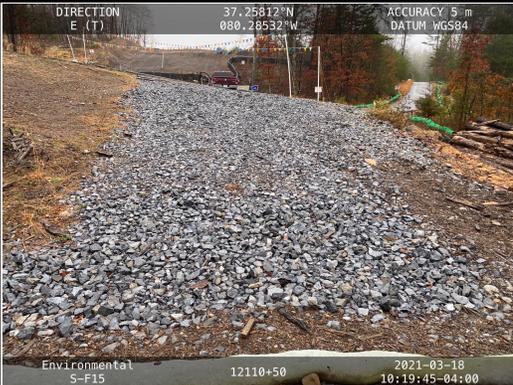
<b>Field Station#</b>	12110+50		<b>Field Station#</b>	12108+41	
<b>Pic 15 Desc.</b>	RCE on the cis of access road MVP-MN-271 in acceptable condition		<b>Pic 16 Desc.</b>	Bridge and ECDs crossing stream S-F15 in acceptable condition

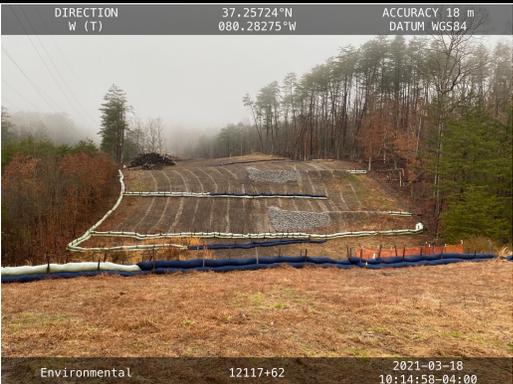
<p>DIRECTION W (T) 37.25724°N 080.28275°W ACCURACY 18 m DATUM WGS84 Environmental 12117+62 2021-03-18 10:14:58-04:00</p>			
<b>GPS Location</b>	See photo		<b>GPS Location</b>	See photo	
<b>Field Station#</b>	12112+13		<b>Field Station#</b>	12117+62	
<b>Pic 17 Desc.</b>	Bridge and ECDs crossing S-F16A/B in acceptable condition		<b>Pic 18 Desc.</b>	Stabilized ROW in acceptable condition

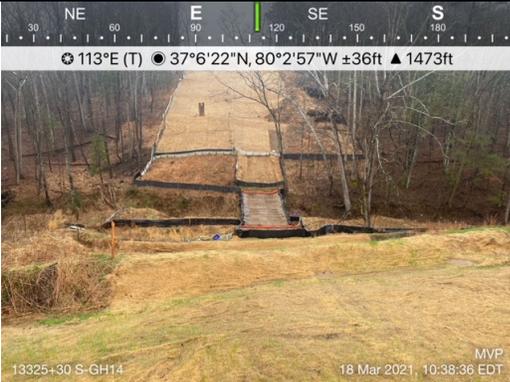
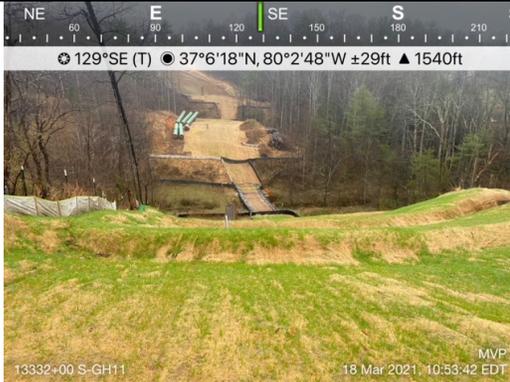
<b>GPS Location</b> See Above		<b>GPS Location</b> See Above			
<b>Field Station#</b> 13325+30		<b>Field Station#</b> 13332+00			
<b>Pic 3 Desc.</b> Overview of Waterbody S-GH14. ECDs are functional and ROW is stable.		<b>Pic 4 Desc.</b> ROW Overview. ECDs are functional and ROW is stable.

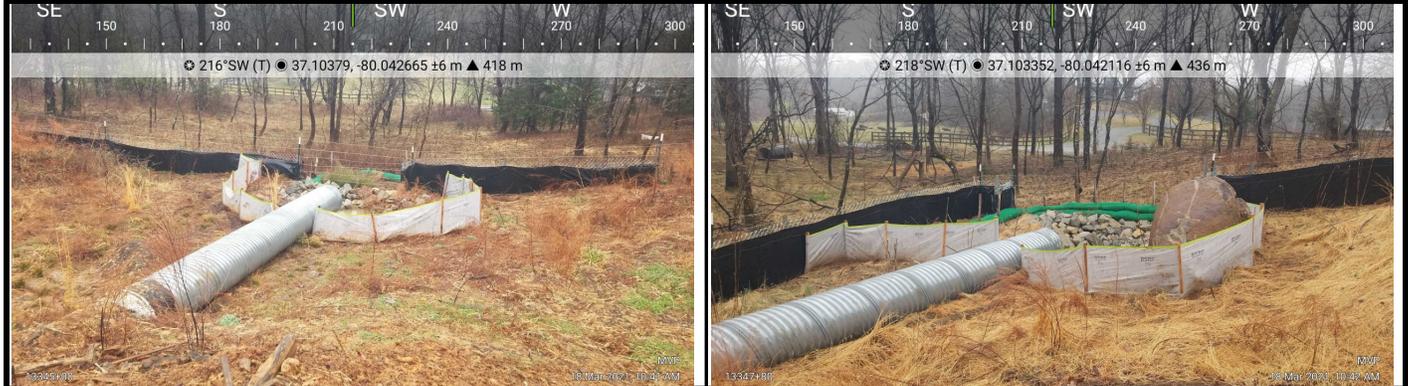
<b>GPS Location</b>	See Above	<b>GPS Location</b>	See Above
<b>Field Station#</b>	13345+00	<b>Field Station#</b>	13347+80
<b>Pic 7 Desc.</b>	ROW Overview. Cleanwater diversion pipe. ECDs are functional and ROW is stable.	<b>Pic 8 Desc.</b>	ROW Overview. Cleanwater diversion pipe. ECDs are functional and ROW is stable.

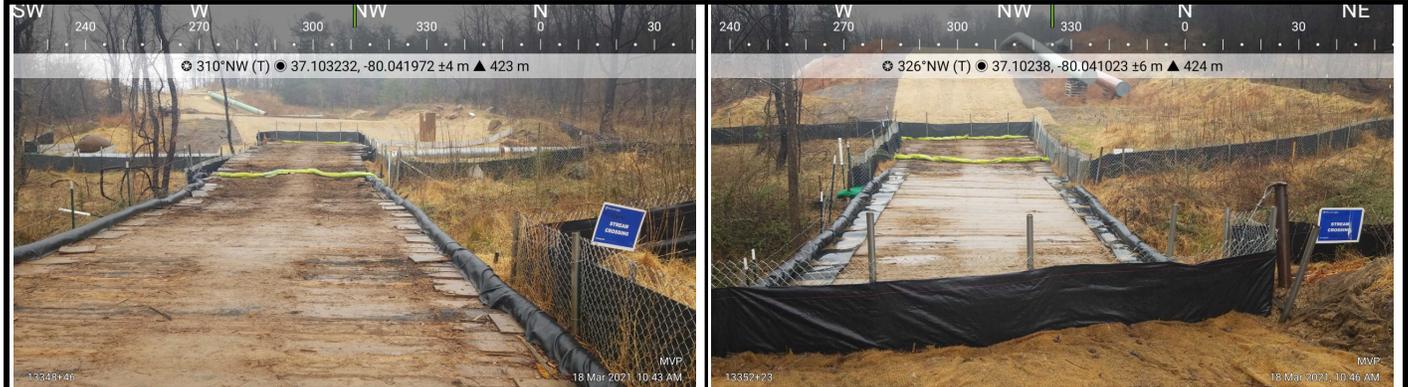
<b>GPS Location</b>	See Above	<b>GPS Location</b>	See Above
<b>Field Station#</b>	13348+46	<b>Field Station#</b>	13352+23
<b>Pic 9 Desc.</b>	Overview of Waterbody S-RR08. ECDs are functional and ROW is stable.	<b>Pic 10 Desc.</b>	Overview of Waterbody S-RR09. ECDs are functional and ROW is stable.

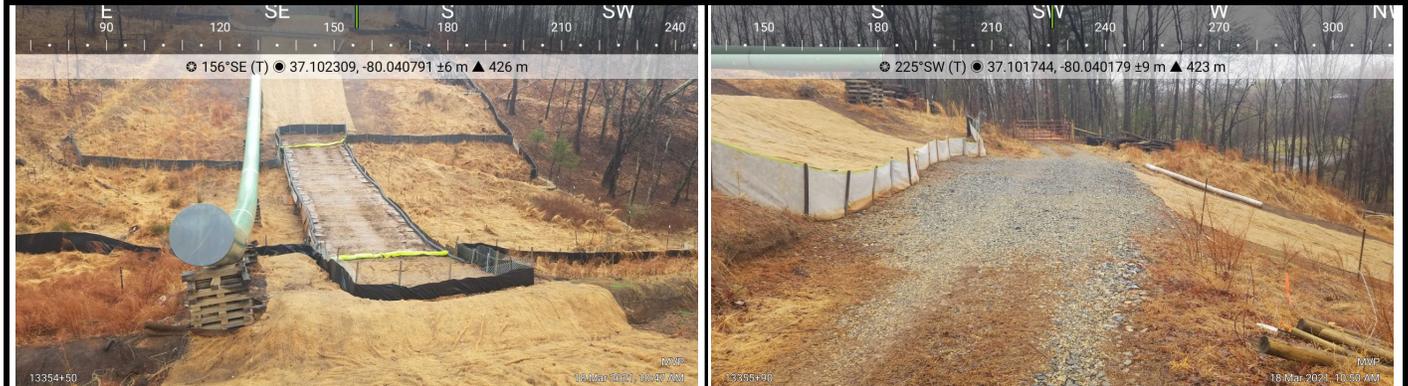
<b>GPS Location</b>	See Above	<b>GPS Location</b>	See Above
<b>Field Station#</b>	13354+50	<b>Field Station#</b>	13355+90
<b>Pic 11 Desc.</b>	ROW Overview. Bridge over "grassy swale". ECDs are functional and ROW is stable.	<b>Pic 12 Desc.</b>	Overview of private road crossing ROW. ECDs are functional and ROW is stable.

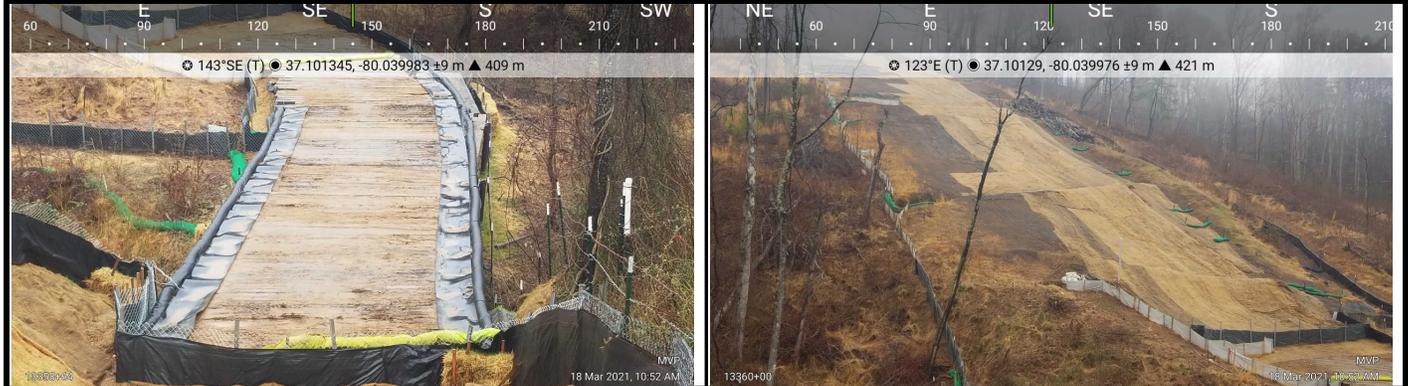
<b>GPS Location</b>	See Above	<b>GPS Location</b>	See Above
<b>Field Station#</b>	13358+64	<b>Field Station#</b>	13360+00
<b>Pic 13 Desc.</b>	Overview of Waterbody S-RR11. ECDs are functional and ROW is stable.	<b>Pic 14 Desc.</b>	ROW Overview. ECDs are functional and ROW is stable.

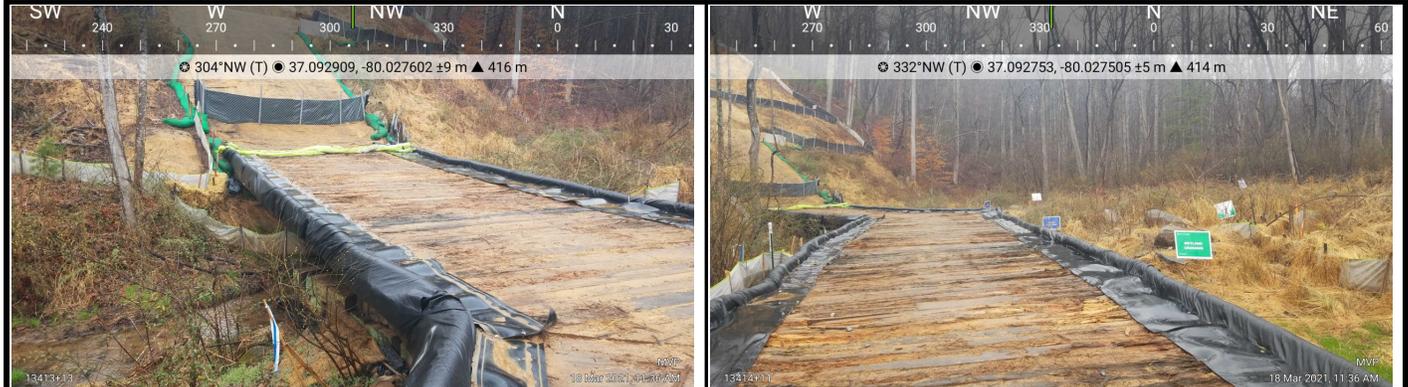
<b>GPS Location</b>	See Above	<b>GPS Location</b>	See Above
<b>Field Station#</b>	13413+13	<b>Field Station#</b>	13414+11
<b>Pic 15 Desc.</b>	Overview of Waterbody S-IJ1. ECDs are functional and ROW is stable.	<b>Pic 16 Desc.</b>	Overview of Wetland W-IJ1. ECDs are functional and ROW is stable.

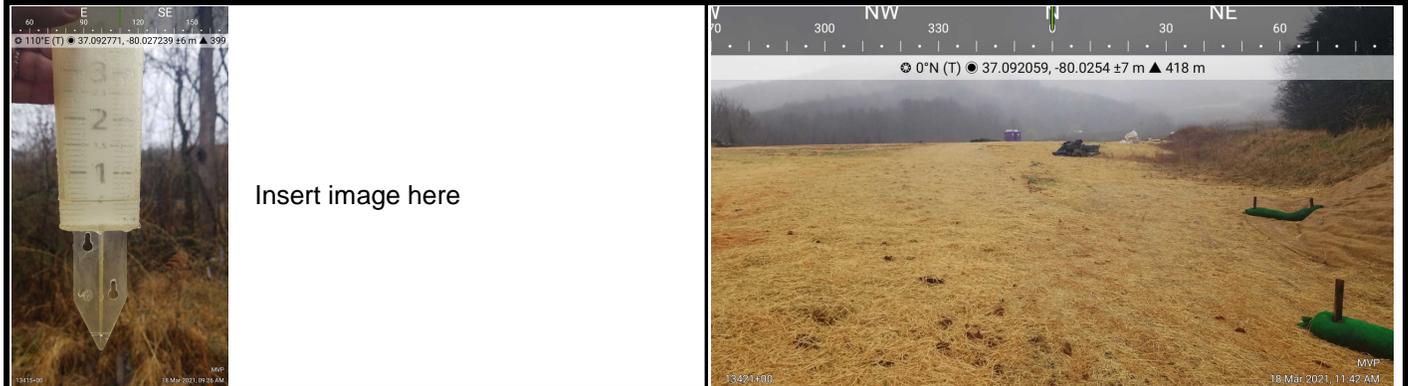
<b>GPS Location</b>	See Above	<b>GPS Location</b>	See Above
<b>Field Station#</b>	13415+00	<b>Field Station#</b>	13421+00
<b>Pic 17 Desc.</b>	Rain gauge at Cahas Mountain Road reads 0.5".	<b>Pic 18 Desc.</b>	ROW Overview. ECDs are functional and ROW is stable.

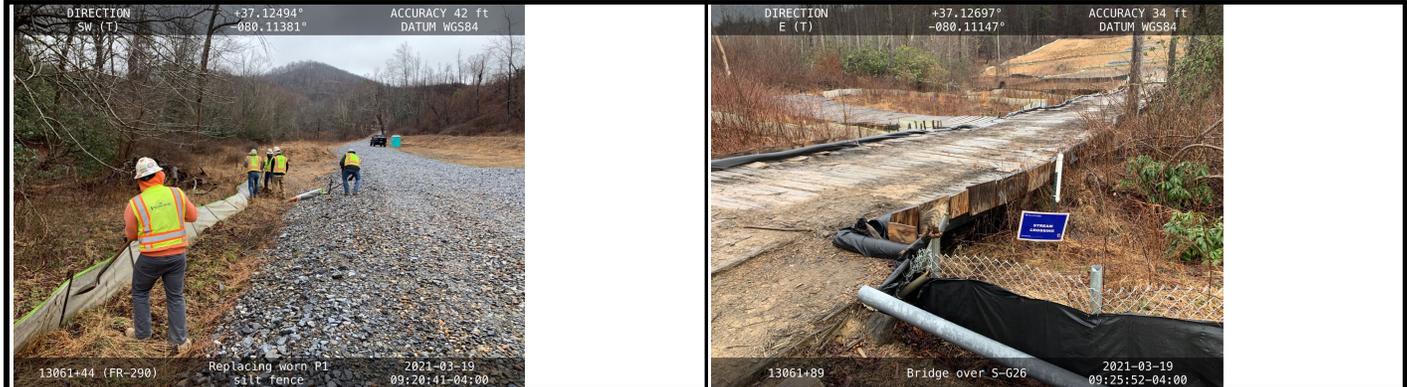
<b>GPS Location</b> See photo for gps location data.	<b>GPS Location</b> See photo for gps location data.
<b>Field Station#</b> 13061+44	<b>Field Station#</b> 13061+89
<b>Pic 9 Desc.</b> Photo shows the contractor replacing the P1 silt fence along FR-290.	<b>Pic 10 Desc.</b> Photo shows the bridge over stream S-G26.

13061+44 - worn P1 silt fence along FR-290 was replaced

The ROW from 13024+00 to 13044+00 and 13061+00 to 13064+00 remains in temporary stabilization. Worn P1 silt fence was observed along portions of access road FR-290. Precision's environmental crew replaced this section today. The restored portions of the ROW from 13044+00 to 13061+00 and 13064+00 to 13113+00 remains in compliance and no maintenance issues or impacts were observed. From 13113+00 to 13122+00 the ROW has been stabilized. No maintenance issues or impacts were found in the area.

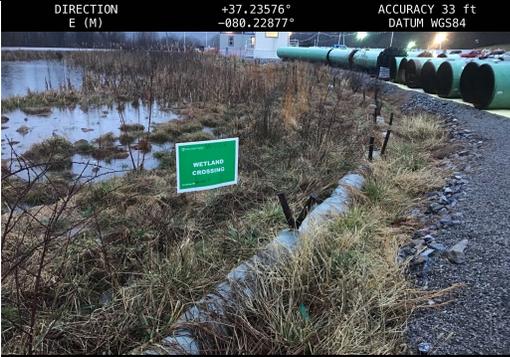
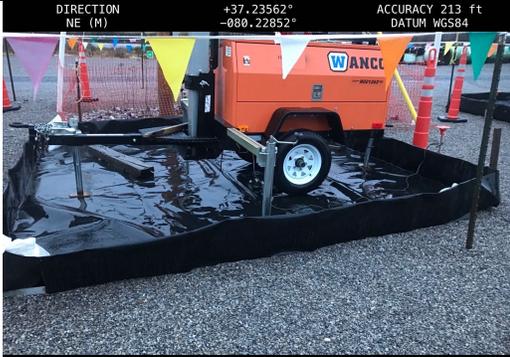
<p>DIRECTION NE (M) +37.23562° -080.22652° ACCURACY 213 ft DATUM WGS84</p> <p>MVP-PY-006_031921 Condition of containment 2021-03-19 07:27:58-04:00</p>			
<b>GPS Location</b> MVP-PY-006 See photo for gps data		<b>GPS Location</b> MVP-PY-006 See photo for gps data			
<b>Field Station#</b> +0		<b>Field Station#</b> +0			
<b>Pic 1 Desc.</b> Condition of compost filter sock and signage at feature W-008. Looking E.		<b>Pic 2 Desc.</b> Condition of containment under light plant. Containment holding stormwater. Looking NE.

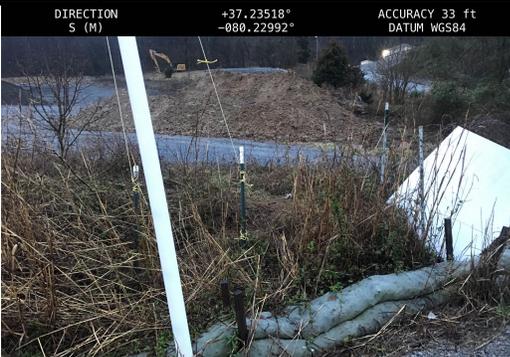
<p>DIRECTION S (M) +37.23518° -080.22992° ACCURACY 33 ft DATUM WGS84</p> <p>MVP-PY-006_031921 Condition of spoil pile 2021-03-19 07:29:14-04:00</p>

<b>GPS Location</b> MVP-PY-006 See photo for gps data		<b>GPS Location</b> MVP-PY-006 See photo for gps data			
<b>Field Station#</b> +0		<b>Field Station#</b> +0			
<b>Pic 3 Desc.</b> Condition of spoil pile on VDOT property adjacent to LOD. Spoil pile not stable. Looking S.		<b>Pic 4 Desc.</b> No fluids or deposits around hazardous waste dumpsters. Looking S.

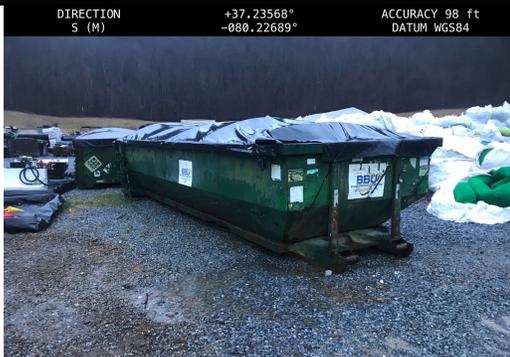
<p>DIRECTION S (M) +37.23568° -080.22689° ACCURACY 98 ft DATUM WGS84</p> <p>MVP-PY-006_031921 No fluids around hazardous waste ... 2021-03-19 07:31:47-04:00</p>

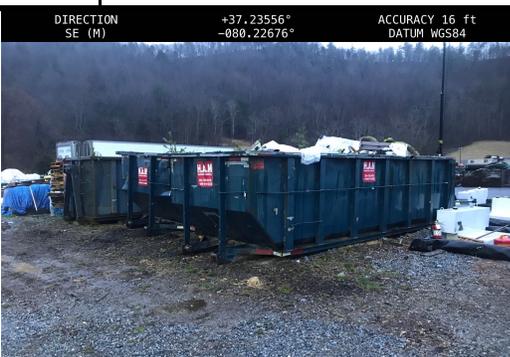
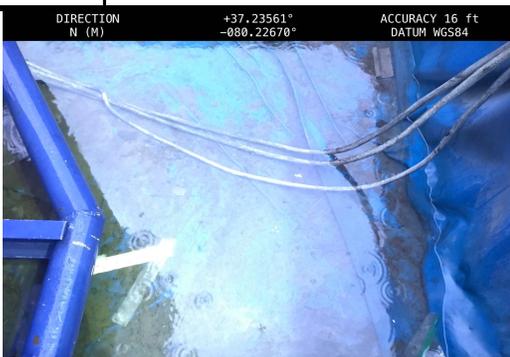
<p>DIRECTION N (M) +37.23561° -080.22670° ACCURACY 16 ft DATUM WGS84</p> <p>MVP-PY-006_031921 Condition of containment 2021-03-19 07:32:49-04:00</p>			
<b>GPS Location</b> MVP-PY-006 See photo for gps data		<b>GPS Location</b> MVP-PY-006 See photo for gps data			
<b>Field Station#</b> +0		<b>Field Station#</b> +0			
<b>Pic 5 Desc.</b> No loose trash around dumpsters or in the yard. Looking SE.		<b>Pic 6 Desc.</b> Blue Bulk Fuel tanks containment holding stormwater with sheen. Looking N.

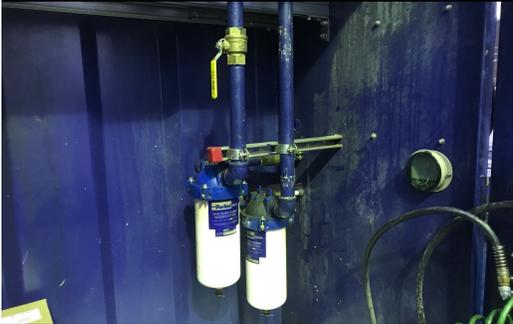
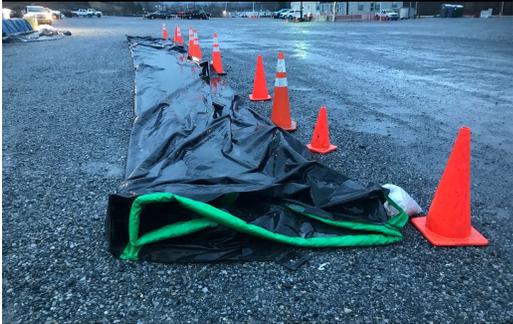
<p style="font-size: x-small; margin: 0;">MVP-PY-006_031921    Secondary containment on site for tankers    2021-03-19 07:33:49-04:00</p> </div>
<b>GPS Location</b> MVP-PY-006 See photo for gps data	<b>GPS Location</b> MVP-PY-006 See photo for gps data
<b>Field Station#</b> +0	<b>Field Station#</b> +0
<b>Pic 7 Desc.</b> Blue Bulk Fuel tanks no leaky internal fittings. Looking NW.	<b>Pic 8 Desc.</b> Secondary containment on site for tankers offloading fuel. Looking W.

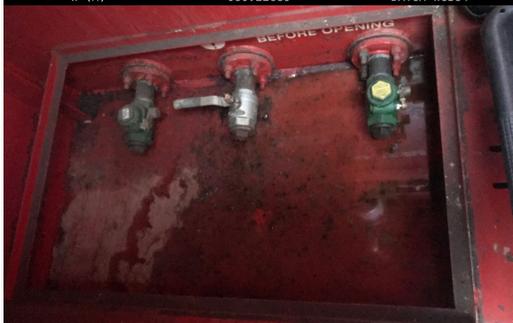
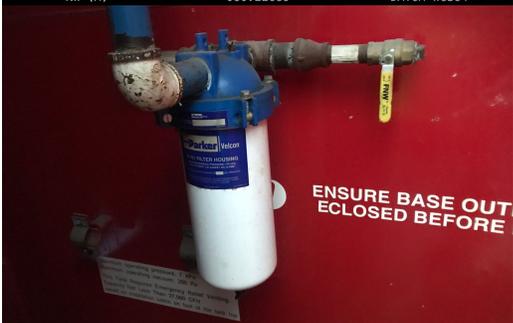
<p style="font-size: x-small; margin: 0;">MVP-PY-006_031921    No leaky internal fittings    2021-03-19 07:35:12-04:00</p> </div>
<b>GPS Location</b> MVP-PY-006 See photo for gps data	<b>GPS Location</b> MVP-PY-006 See photo for gps data
<b>Field Station#</b> +0	<b>Field Station#</b> +0
<b>Pic 9 Desc.</b> Off Road Fuel unit condition of internal drip pan. Looking W.	<b>Pic 10 Desc.</b> Off Road Fuel unit no leaky internal fittings. Looking NW.
