# Visual Site Inspection Report

<b>Project Name</b> H-600 Pipeline Spread H		<b>AFE</b> 124300138	<b>Spread</b> H-600 Pipeline Spread H
<b>Contractor</b> Precision		<b>Report #</b> 21095	
<b>Inspector</b> John Brcic		<b>Date/Time</b> 3/15/2021 12:34 PM	
<b>Permit #</b> TBD	<b>Inspection Type</b> VA SWPP	<b>Station Begin</b> 12284+75	
<b>State</b> VA	<b>Inspection Area</b> Partial	<b>Station End</b> 12443+75	
<b>County</b> Montgomery	<b>Ground</b> Dry	<b>Temperature (°F)</b> 48.00	
<b>Municipality</b> N/A	<b>Weather</b> Cloudy	<b>Rain Gauge (in)</b> 0.00	
<b>Rain Accumulation Time (days)</b>			3.00

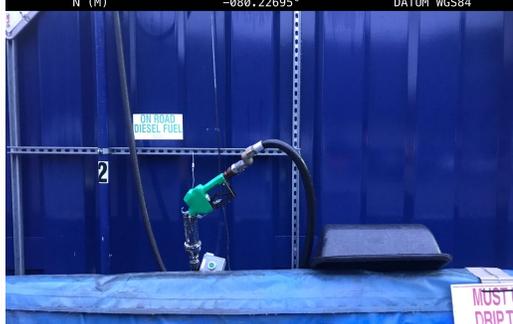
<p style="font-size: x-small; margin: 0;">MVP-PY-006_031921    No leaky fittings or nozzles    2021-03-19 07:36:05-04:00</p> </div>	<div style="border: 1px solid black; padding: 2px;"> <p style="font-size: small; margin: 0;">DIRECTION S (M)    +37.23555°    ACCURACY 16 ft -080.22610°    DATUM WGS84</p>

<p style="font-size: x-small; margin: 0;">MVP-PY-006_031921    Restoration supplies covered    2021-03-19 07:37:55-04:00</p> </div>
<b>GPS Location</b> MVP-PY-006 See photo for gps data	<b>GPS Location</b> MVP-PY-006 See photo for gps data
<b>Field Station#</b> +0	<b>Field Station#</b> +0
<b>Pic 11 Desc.</b> Blue Bulk Fuel tanks no leaky fittings or nozzles. Looking N.	<b>Pic 12 Desc.</b> Restoration supplies covered and protected from the weather. Looking S.

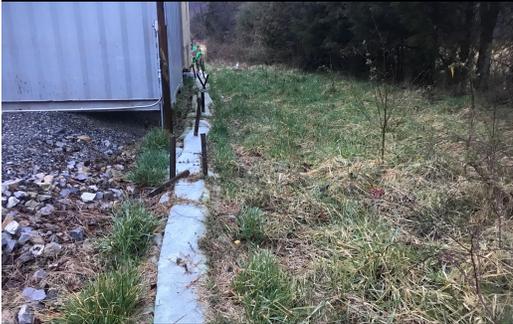
<p>MVP-PY-006_031921      Condition of CFS along east LOD      2021-03-19 07:38:26-04:00</p>	<p>DIRECTION S (M)      +37.23549°      ACCURACY 16 ft -080.22607°      DATUM WGS84</p>

<b>GPS Location</b> MVP-PY-006 See photo for gps data	<b>GPS Location</b> MVP-PY-006 See photo for gps data
<b>Field Station#</b> +0	<b>Field Station#</b> +0
<b>Pic 13 Desc.</b> Condition of compost filter sock along east LOD. Looking N.	<b>Pic 14 Desc.</b> Condition of compost filter sock along east LOD. Looking S.

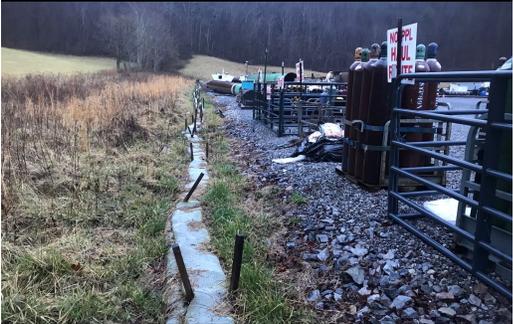
<p>MVP-PY-006_031921      Condition of CFS along east LOD      2021-03-19 07:38:42-04:00</p>
--	---

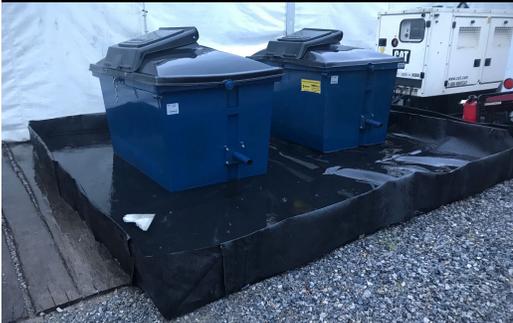
<p>MVP-PY-006_031921      Condition of containment      2021-03-19 07:40:22-04:00</p>	<p>DIRECTION NE (M)      +37.23416°      ACCURACY 33 ft -080.22779°      DATUM WGS84</p>

<b>GPS Location</b> MVP-PY-006 See photo for gps data	<b>GPS Location</b> MVP-PY-006 See photo for gps data
<b>Field Station#</b> +0	<b>Field Station#</b> +0
<b>Pic 15 Desc.</b> Condition of containment hold hazardous waste dumpsters west of mechanics building. Containment holding stormwater. Looking SE.	<b>Pic 16 Desc.</b> Condition of containment under stored vehicle. Looking NE.

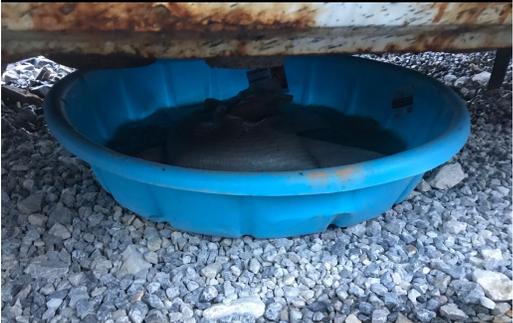
<p>MVP-PY-006_031921      Containment under stored vehicle      2021-03-19 07:41:29-04:00</p>
---	--

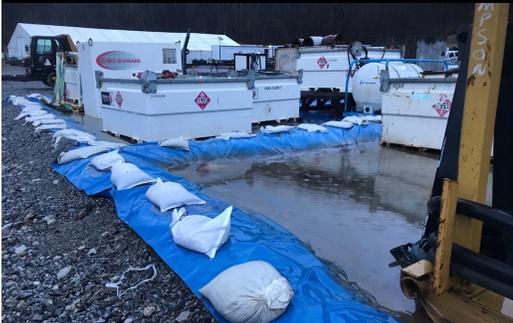
<p>MVP-PY-006_031921      Condition of poly lined containments      2021-03-19 07:42:17-04:00</p>	<p>DIRECTION NE (M)      +37.23463°      ACCURACY 16 ft -080.22800°      DATUM WGS84</p>

<b>GPS Location</b> MVP-PY-006 See photo for gps data	<b>GPS Location</b> MVP-PY-006 See photo for gps data
<b>Field Station#</b> +0	<b>Field Station#</b> +0
<b>Pic 17 Desc.</b> Condition of poly lined rock berm containments. Holding stormwater. Looking SE.	<b>Pic 18 Desc.</b> Condition of trays and containment under toilets. Looking NE.

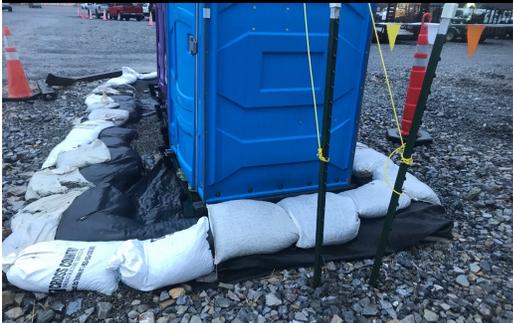
<p>MVP-PY-006_031921      Condition of trays &amp; containment      2021-03-19 07:42:31-04:00</p>
---	---

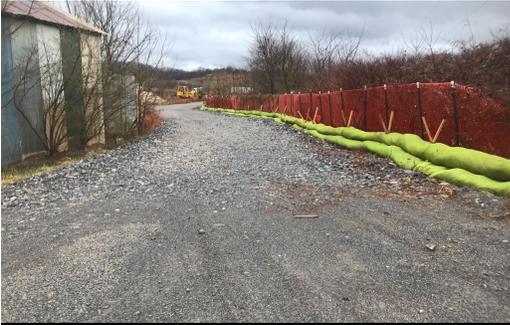
<p>MVP-LY-049_041921 Condition of rock entrance 2021-03-19 08:07:31-04:00</p>				<p>DIRECTION N (M) +37.27045° -080.12466° ACCURACY 16 ft DATUM WGS84</p>

<p>MVP-LY-049_031921 Landowner disturbance along feature 2021-03-19 08:10:51-04:00</p>	
<b>GPS Location</b> MVP-LY-049 See photo for gps data		<b>GPS Location</b> MVP-LY-049 See photo for gps data			
<b>Field Station#</b> +0		<b>Field Station#</b> +0			
<b>Pic 1 Desc.</b> Condition of rock entrance on north drive. No sediment on stone. Looking SW.		<b>Pic 2 Desc.</b> Landowner soil disturbance along north edge of feature W-CV21A. Area not stabilized. Looking NW.			
<p>DIRECTION NW (M) +37.27045° -080.12466° ACCURACY 16 ft DATUM WGS84</p>

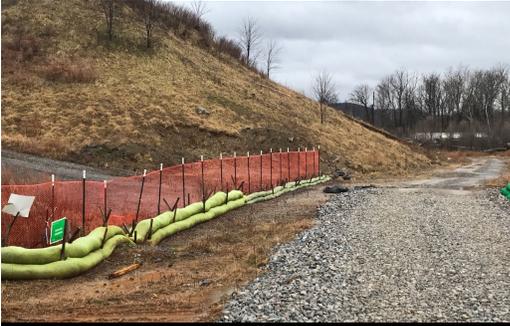
<p>MVP-LY-049_031921 Landowner disturbance within 66' of feature 2021-03-19 08:10:57-04:00</p>				<p>DIRECTION W (M) +37.27041° -080.12467° ACCURACY 16 ft DATUM WGS84</p>

<b>GPS Location</b> MVP-LY-049 See photo for gps data		<b>GPS Location</b> MVP-LY-049 See photo for gps data			
<b>Field Station#</b> +0		<b>Field Station#</b> +0			
<b>Pic 3 Desc.</b> Landowner soil disturbance within 66' and 120' west of feature W-CV21B. Areas not stabilized. Looking W.		<b>Pic 4 Desc.</b> Landowner soil disturbance along compost filter sock and feature W-CV21B. Area not stabilized. No impacts. Looking SW.			
<p>DIRECTION SW (M) +37.27047° -080.12390° ACCURACY 16 ft DATUM WGS84</p>

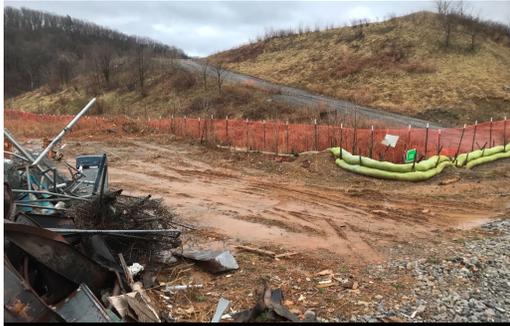
<p>MVP-LY-049_031921 Landowner disturbance along CFS &amp; feature 2021-03-19 08:11:04-04:00</p>

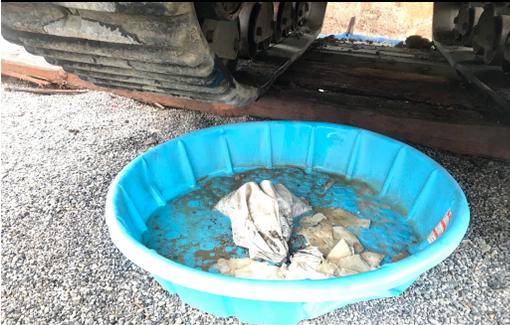
<p>MVP-LY-049_031921 Containment under stored equipment 2021-03-19 08:12:03-04:00</p>				<p>DIRECTION E (M) +37.26957° -080.12299° ACCURACY 16 ft DATUM WGS84</p>

<b>Pic 5 Desc.</b> Condition of containment under stored equipment. Looking SW.		<b>Pic 6 Desc.</b> Condition of containment under stored equipment. Looking E.

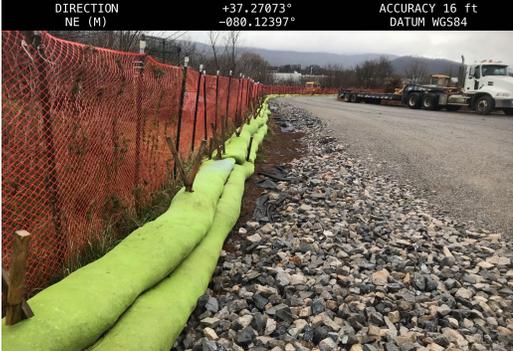
<p>DIRECTION NE (M) +37.27073° -080.12397° ACCURACY 16 ft DATUM WGS84</p> <p>MVP-LY-049_031921 Condition of CFS &amp; safety fence LOD 2021-03-19 08:13:04-04:00</p>

<p>DIRECTION W (M) +37.27073° -080.12397° ACCURACY 16 ft DATUM WGS84</p> <p>MVP-LY-049_031921 Condition of CFS &amp; safety fence LOD 2021-03-19 08:13:07-04:00</p>	
<b>GPS Location</b>	MVP-LY-049 See photo for gps data	<b>GPS Location</b>	MVP-LY-049 See photo for gps data
<b>Field Station#</b>	+0	<b>Field Station#</b>	+0
<b>Pic 7 Desc.</b>	Condition of compost filter sock and safety fence along north LOD. Looking NE.	<b>Pic 8 Desc.</b>	Condition of compost filter sock and safety fence along north LOD. Looking W.

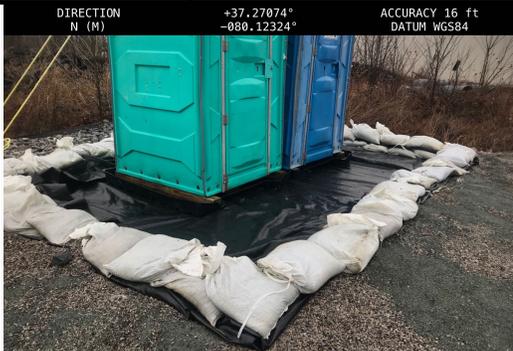
<p>DIRECTION N (M) +37.27074° -080.12324° ACCURACY 16 ft DATUM WGS84</p> <p>MVP-LY-049_031921 Condition of trays &amp; containment 2021-03-19 08:14:16-04:00</p>

<b>GPS Location</b>	MVP-LY-049 See photo for gps data	<b>GPS Location</b>	MVP-LY-049 See photo for gps data
<b>Field Station#</b>	+0	<b>Field Station#</b>	+0
<b>Pic 9 Desc.</b>	Condition of trays and containment under toilets. Looking NE.	<b>Pic 10 Desc.</b>	Condition of temporary trash transfer pit. Most debris has been removed. Looking W.

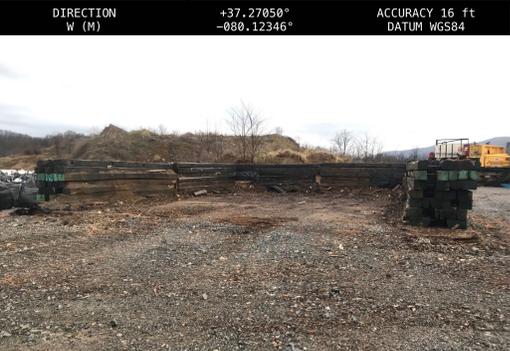
<p>DIRECTION W (M) +37.27050° -080.12346° ACCURACY 16 ft DATUM WGS84</p> <p>MVP-LY-049_031921 Condition of temporary trash ... 2021-03-19 08:15:50-04:00</p>

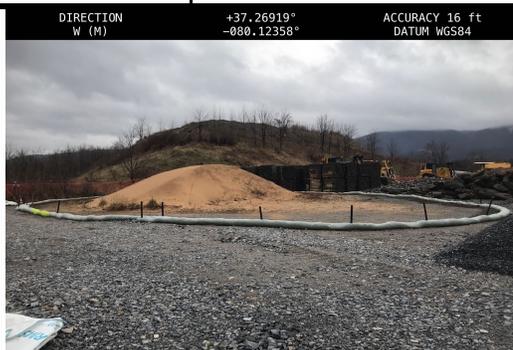
<p>DIRECTION W (M) +37.26919° -080.12358° ACCURACY 16 ft DATUM WGS84</p> <p>MVP-LY-049_031921 Condition of CFS around sand pile 2021-03-19 08:18:47-04:00</p>

<p>DIRECTION W (M) +37.27050° -080.12263° ACCURACY 16 ft DATUM WGS84</p> <p>MVP-LY-049_031921 No fluids around hazardous waste ... 2021-03-19 08:20:53-04:00</p>	
<b>GPS Location</b>	MVP-LY-049 See photo for gps data	<b>GPS Location</b>	MVP-LY-049 See photo for gps data
<b>Field Station#</b>	+0	<b>Field Station#</b>	+0
<b>Pic 11 Desc.</b>	Condition of compost filter sock around sand pile. Looking W.	<b>Pic 12 Desc.</b>	No fluids or deposits around hazardous waste dumpsters. Looking W.
