Visual Site Inspection Report

Project Name	H-600 Pipeline Spread H	AFE	124300138	Spread	H-600 Pipeline Spread H
Contractor	Precision			Report #	20859
Inspector	John Brcic			Date/Time	3/8/2021 1:22 PM
Permit #	TBD	Inspection Type	VA SWPP	Station Begin	12005+00
State	VA	Inspection Area	Partial	Station End	12119+17
County	Montgomery	Ground	Dry	Temperature (°F)	55.00
Municipality	N/A	Weather	Sunny	Rain Gauge (in)	0.00
				Rain Accumulation Time (days)	1.00

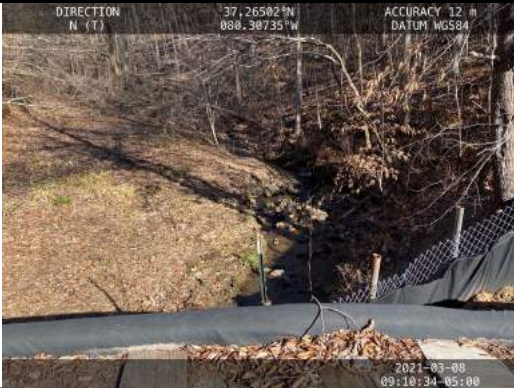
GPS Location	See photo		GPS Location	See photo	
Field Station#	12035+11		Field Station#	12035+75	
Pic 5 Desc.	Stream S-G40, facing north, downstream		Pic 6 Desc.	Stream S-PP23, facing southwest, downstream

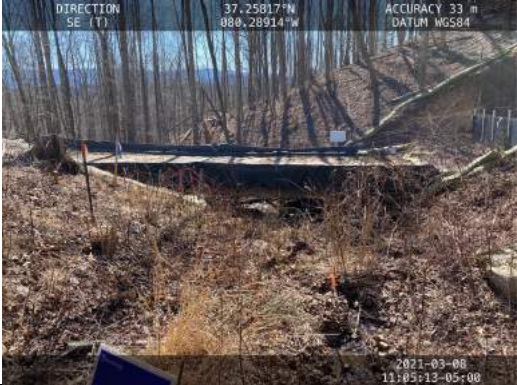
GPS Location	See photo		GPS Location	See photo	
Field Station#	12098+44		Field Station#	12101+57	
Pic 13 Desc.	Stream S-MM13, facing southeast, downstream		Pic 14 Desc.	Stream S-MM11, facing south, downstream

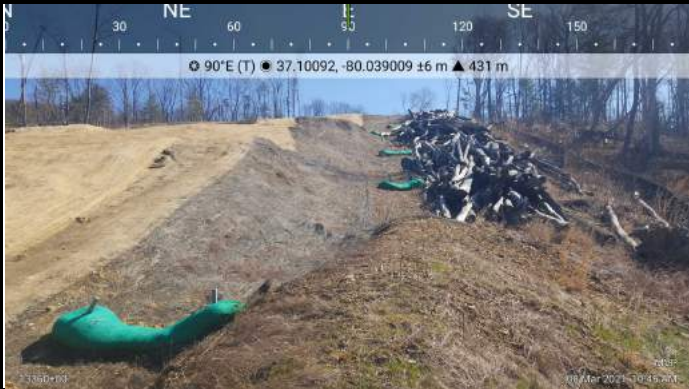
GPS Location	See Above		GPS Location	See Above	
Field Station#	13360+00		Field Station#	13396+00	
Pic 13 Desc.	ROW Overview. ECDs are functional and ROW is stable.		Pic 14 Desc.	ROW Overview. ECDs are functional and ROW is stable.

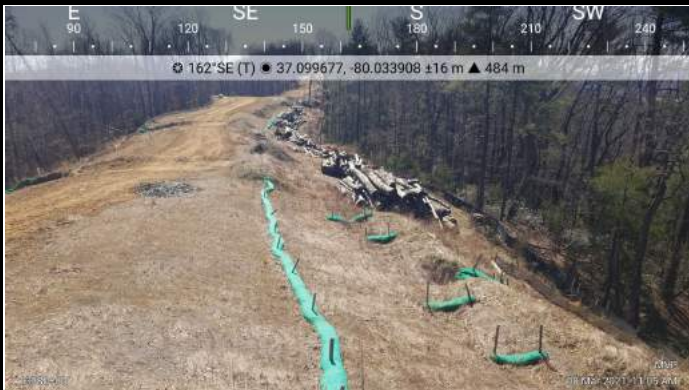
GPS Location	See Above		GPS Location	See Above	
Field Station#	13380+00		Field Station#	13413+01	
Pic 15 Desc.	ROW Overview. ECDs are functional and ROW is stable.		Pic 16 Desc.	Overview of Waterbody S-IJ1. ECDs are functional and ROW is stable.

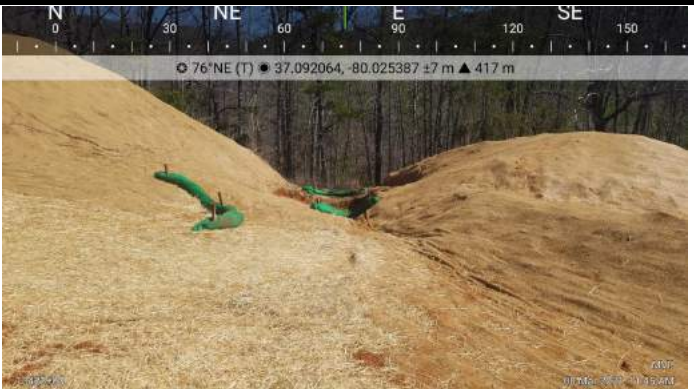
GPS Location	See Above		GPS Location	See Above	
Field Station#	13415+19		Field Station#	13422+00	
Pic 17 Desc.	Overview of Waterbody S-IJ3. ECDs are functional and ROW is stable.		Pic 18 Desc.	ROW Overview. ECDs are functional and ROW is stable.

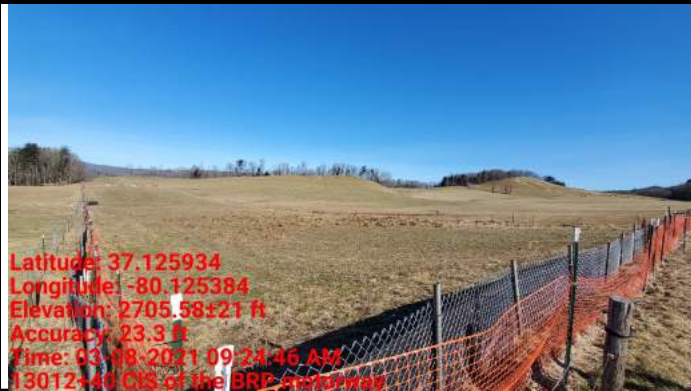
<p>Latitude: 37.125934 Longitude: -80.125384 Elevation: 2705.58±21 ft Accuracy: 23.3 ft Time: 03-08-2021 09:24:46 AM 13012+40 CIS of the BRP motorway</p>

Field Station#	13012+40		Field Station#	13012+80	
Pic 3 Desc.	Current conditions of the restored ROW on the CIS of the BRP Motorway.		Pic 4 Desc.	Current conditions of the restored ROW on the GAS of the BRP Motorway.

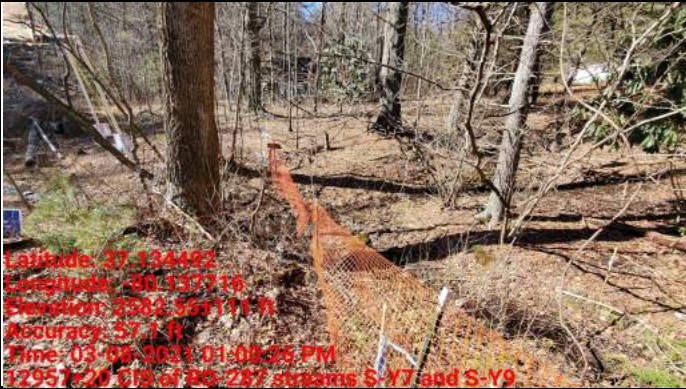
GPS Location	See pic for GPS location		GPS Location	See pic for GPS location	
Field Station#	12957+20		Field Station#	12958+00	
Pic 13 Desc.	Streams S-Y7 and S-Y9 on the upstream side of the ROW.		Pic 14 Desc.	Stream S-Y7 on the downstream side of the ROW.

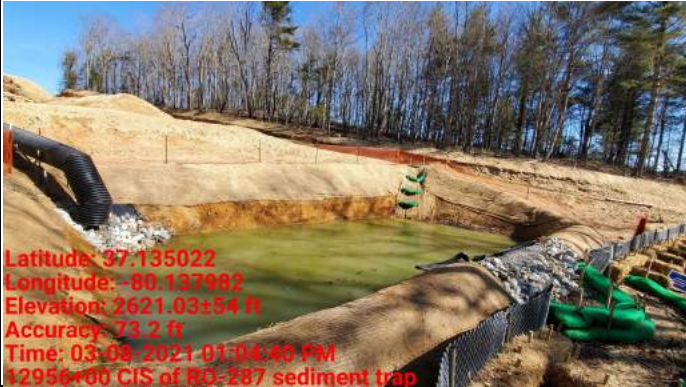
GPS Location	See pic for GPS location		GPS Location	See pic for GPS location	
Field Station#	12956+00		Field Station#	12957+30	
Pic 15 Desc.	Sediment trap on the CIS of RO-287.		Pic 16 Desc.	RO-287 at stream S-Z17.

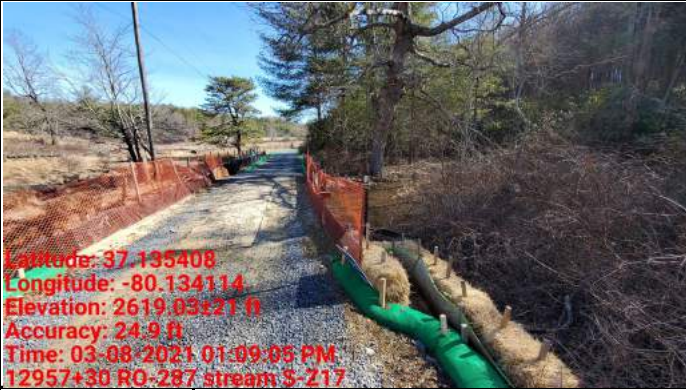
GPS Location	See pic for GPS location		GPS Location	See pic for GPS location	
Field Station#	12957+30		Field Station#	12957+30	
Pic 17 Desc.	RO-287 at stream S-Z17.		Pic 18 Desc.	RO-287 at stream S-Z16.

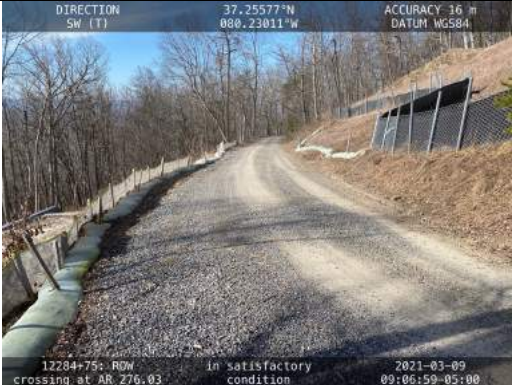
GPS Location	See photo		GPS Location	See photo	
Field Station#	12284+75		Field Station#	12298+00	
Pic 1 Desc.	ROW crossing on access road MVP-MN-276.03 in satisfactory condition.		Pic 2 Desc.	ROW stable through the "Big V".

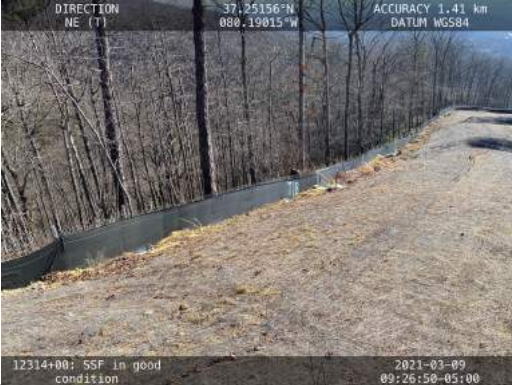
GPS Location	See photo		GPS Location	See photo	
Field Station#	12302+00		Field Station#	12314+00	
Pic 3 Desc.	ROW stable		Pic 4 Desc.	Super silt fence in satisfactory condition.

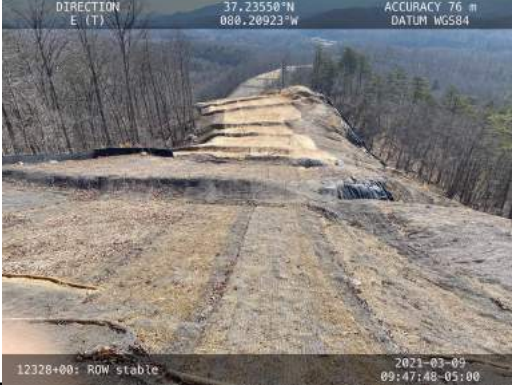
GPS Location	See photo		GPS Location	See photo	
Field Station#	12328+00		Field Station#	12328+50	
Pic 5 Desc.	ROW stable		Pic 6 Desc.	Slope drain in good repair.

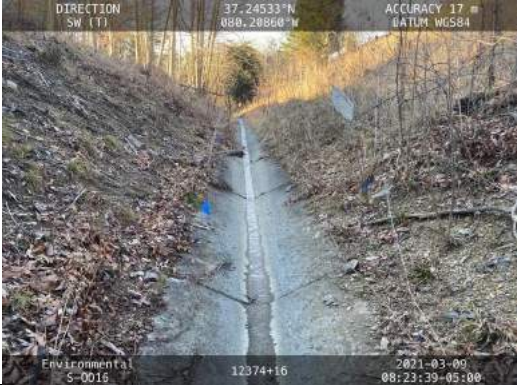
GPS Location	See photo		GPS Location	See photo	
Field Station#	12361+02		Field Station#	12374+16	
Pic 7 Desc.	Silt dyke on unused access road is in satisfactory condition.		Pic 8 Desc.	Stream S-0016, facing southwest, downstream

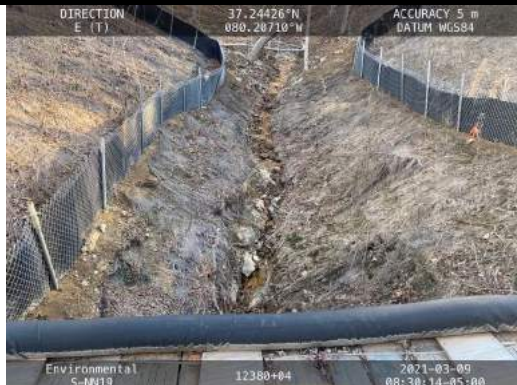
GPS Location	See photo		GPS Location	See photo	
Field Station#	12380+04		Field Station#	12409+03	
Pic 11 Desc.	Stream S-NN19, facing east, upstream		Pic 12 Desc.	Clean water diversion pipe inlet is free of sediment and in good condition.

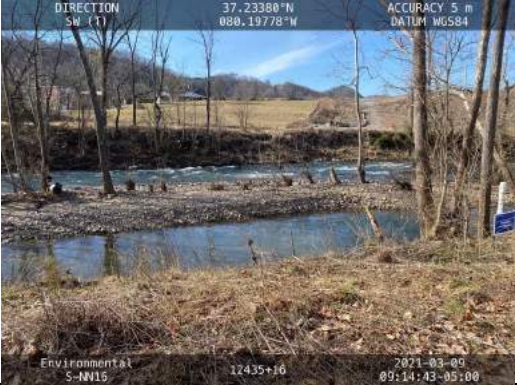
GPS Location	See photo		GPS Location	See photo	
Field Station#	12430+00		Field Station#	12435+16	
Pic 15 Desc.	Clean water diversion pipe outlet in good condition.		Pic 16 Desc.	Stream S-NN16, Roanoke River, facing southwest towards Lafayette Road.

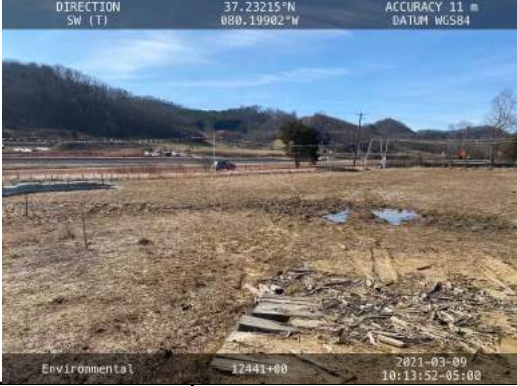
GPS Location	See photo		GPS Location	See photo	
Field Station#	12441+00		Field Station#	12437+70	
Pic 17 Desc.	ROW stable		Pic 18 Desc.	Slope stable on going away side of Lafayette Road.

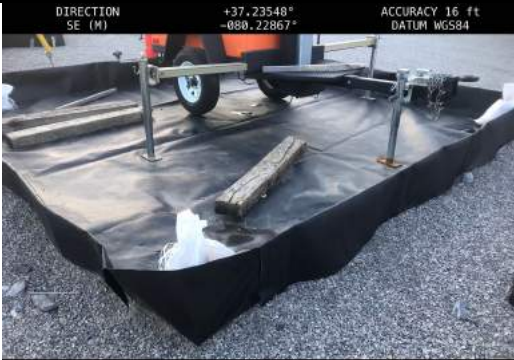
GPS Location	MVP-PY-006 See photo for gps data		GPS Location	MVP-PY-006 See photo for gps data	
Field Station#	+0		Field Station#	+0	
Pic 1 Desc.	Condition of containment under light plant. Free of stormwater. Looking SE.		Pic 2 Desc.	Condition of compost filter sock and signage at feature W-008. Looking E.

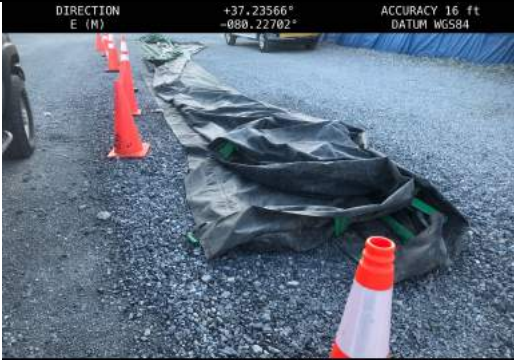
GPS Location	MVP-PY-006 See photo for gps data		GPS Location	MVP-PY-006 See photo for gps data	
Field Station#	+0		Field Station#	+0	
Pic 3 Desc.	Secondary containment on site for tankers offloading fuel. Looking E.		Pic 4 Desc.	Condition of containment under DEF container. Free of stormwater. Looking S.

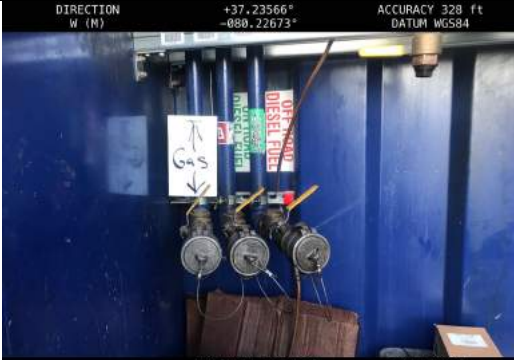
GPS Location	MVP-PY-006 See photo for gps data		GPS Location	MVP-PY-006 See photo for gps data	
Field Station#	+0		Field Station#	+0	
Pic 5 Desc.	Blue Bulk Fuel tanks no leaky internal fittings. Looking W.		Pic 6 Desc.	Off Road Fuel unit containment free of stormwater. Looking NE.

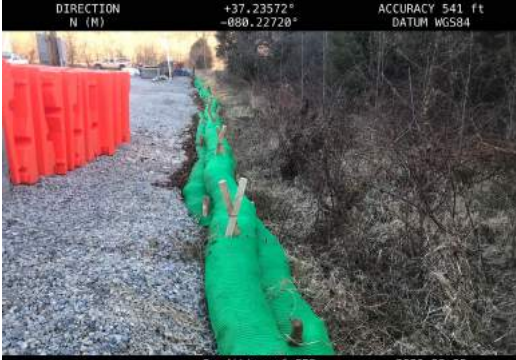
<p>DIRECTION N (N) +37.23572° -080.22720° ACCURACY 541 ft DATUM WGS84</p> <p>MVP-PY-006_030921 Condition of CFS along LOD 2021-03-09 07:45:39-05:00</p>

<p>DIRECTION S (N) +37.23570° -080.22619° ACCURACY 16 ft DATUM WGS84</p> <p>MVP-PY-006_030921 Condition of CFS along LOD 2021-03-09 07:45:45-05:00</p>			
GPS Location	MVP-PY-006 See photo for gps data		GPS Location	MVP-PY-006 See photo for gps data	
Field Station#	+0		Field Station#	+0	
Pic 13 Desc.	Condition of compost filter sock along east LOD. Looking N.		Pic 14 Desc.	Condition of compost filter sock along east LOD. Looking S.

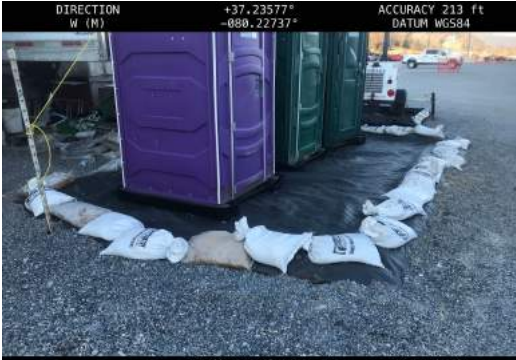
<p>DIRECTION W (N) +37.23577° -080.22737° ACCURACY 213 ft DATUM WGS84</p> <p>MVP-PY-006_030921 Condition of trays & containment 2021-03-09 07:46:33-05:00</p>

GPS Location	MVP-PY-006 See photo for gps data		GPS Location	MVP-PY-006 See photo for gps data	
Field Station#	+0		Field Station#	+0	
Pic 15 Desc.	Condition of trays and containment under toilets. Looking W.		Pic 16 Desc.	Condition of containment under hazardous waste dumpsters. No deposits, fluids and free of stormwater. Looking SE.

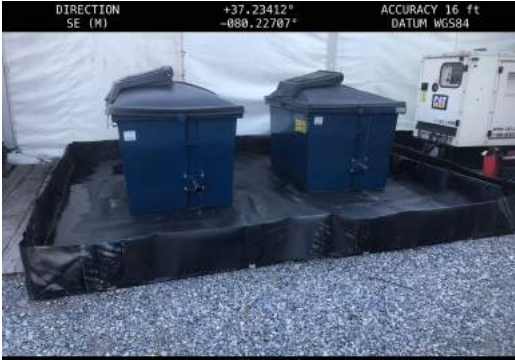
<p>DIRECTION SE (N) +37.23412° -080.22707° ACCURACY 16 ft DATUM WGS84</p> <p>MVP-PY-006_030921 Condition of containment 2021-03-09 07:58:28-05:00</p>

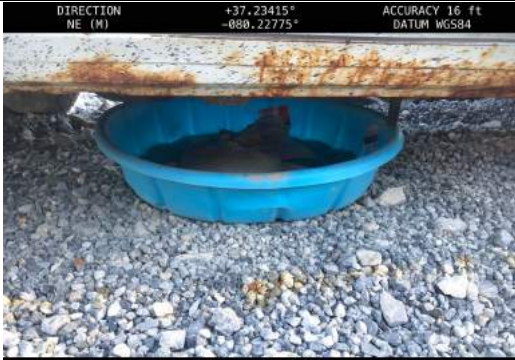
<p>DIRECTION NE (N) +37.23415° -080.22775° ACCURACY 16 ft DATUM WGS84</p> <p>MVP-PY-006_030921 Containment under stored vehicle 2021-03-09 07:59:36-05:00</p>			
GPS Location	MVP-PY-006 See photo for gps data		GPS Location	MVP-PY-006 See photo for gps data	
Field Station#	+0		Field Station#	+0	
Pic 17 Desc.	Condition of containment under used oil containers. No deposits, fluids or stormwater. Looking E.		Pic 18 Desc.	Condition of containment under stored vehicle. Looking NE.

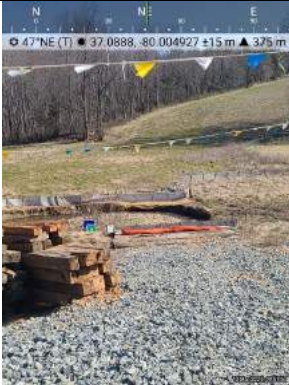
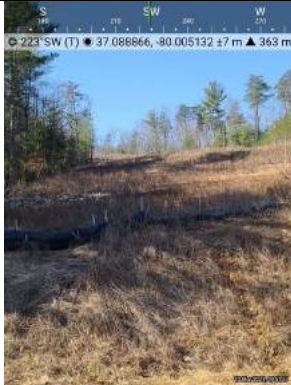
GPS Location	00000		GPS Location	0000	
Field Station#	13497+87		Field Station#	13496+76	
Pic 1 Desc.	Observed stream crossing problem land owner tract , monitored ECDs on stream banks, no issues observed at the time of inspection.		Pic 2 Desc.	Monitored ECDs and vegetation at CAHAS #2 crossing.

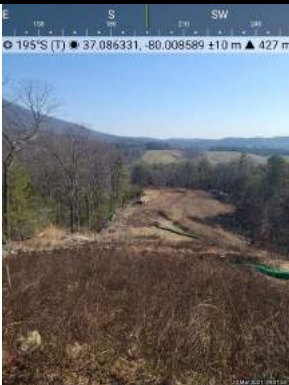
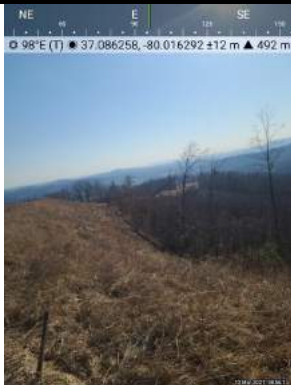
GPS Location	00000		GPS Location	00000	
Field Station#	13488+90		Field Station#	13460+21	
Pic 3 Desc.	Row photo showing vegetation, ECDs in place and functioning, no environmental issues observed at the time of inspection.		Pic 4 Desc.	Monitored ECDs and vegetation growth while checking row conditions throughout.

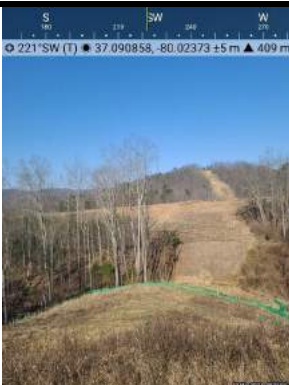
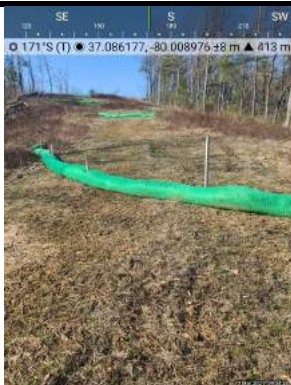
GPS Location	00000		GPS Location	0000	
Field Station#	13426+25		Field Station#	13488+00	
Pic 5 Desc.	Row photo showing vegetation and ECDs in place and functioning, no environmental issues observed at the time of inspection.		Pic 6 Desc.	Photo showing new vegetation growing in travel lane, ECDs in place and functioning.

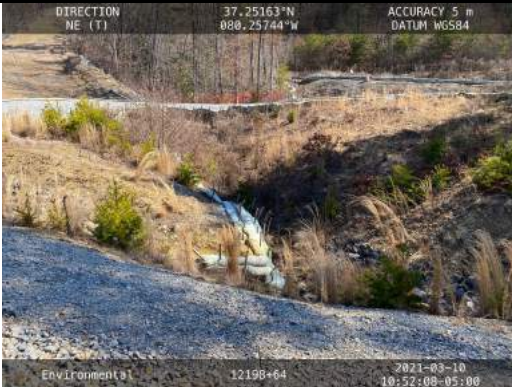
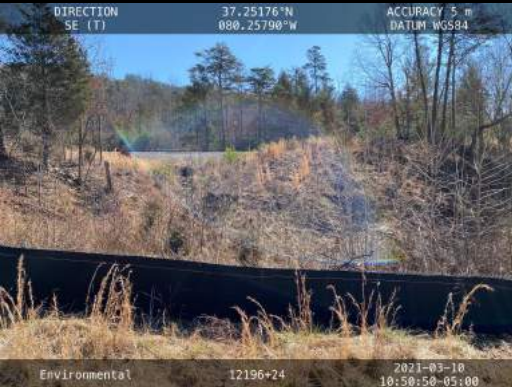
GPS Location	See photo		GPS Location	See photo	
Field Station#	12198+64		Field Station#	12196+24	
Pic 1 Desc.	Stream crossing S-OO11 on the E side of the rail road tracks in acceptable condition		Pic 2 Desc.	Stream crossing S-OO11 on west side of the railroad crossing in acceptable condition

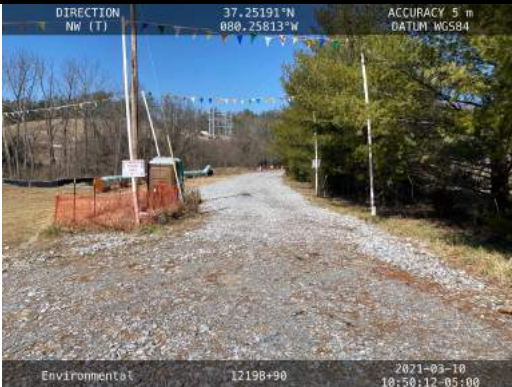
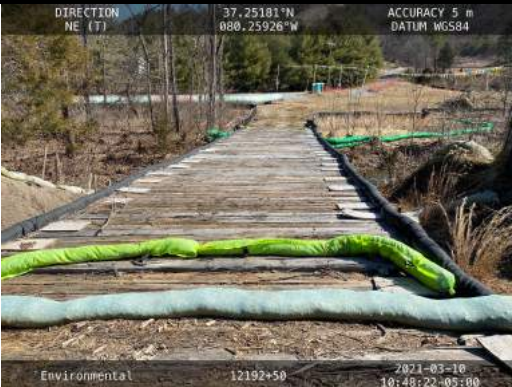
GPS Location	See photo		GPS Location	See photo	
Field Station#	12198+90		Field Station#	12192+50	
Pic 3 Desc.	Access Road MVP-MN-275 in acceptable condition		Pic 4 Desc.	Bridge and ECDs crossing S-C21 in acceptable condition

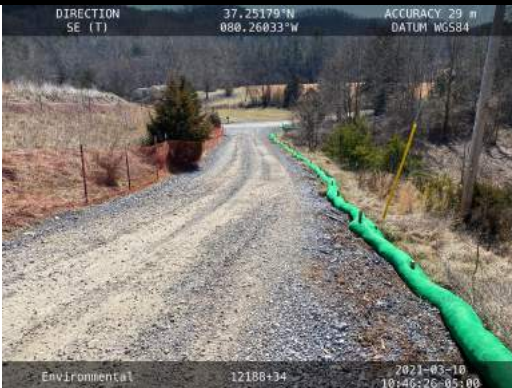
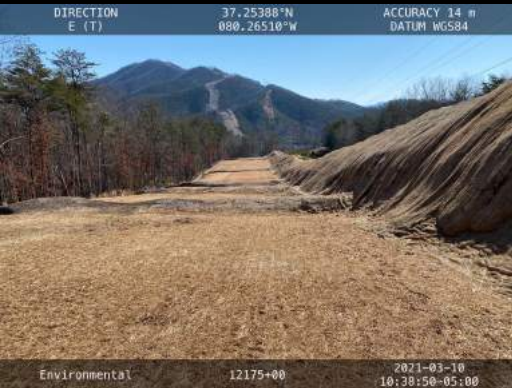
GPS Location	See photo		GPS Location	See photo	
Field Station#	12188+34		Field Station#	12175+00	
Pic 5 Desc.	Access Road MVP-MN-274 in acceptable condition		Pic 6 Desc.	Stabilized ROW in acceptable condition

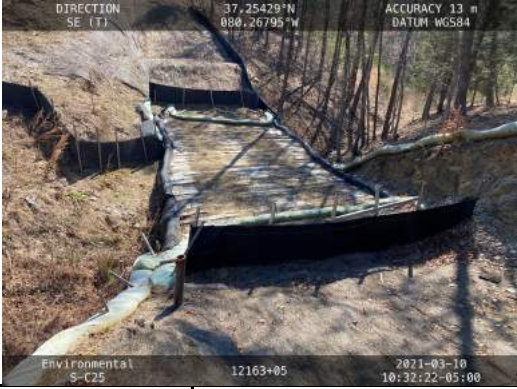
GPS Location	See photo		GPS Location	See photo	
Field Station#	12166+47		Field Station#	12163+05	
Pic 7 Desc.	Bridge and ECDs at stream crossing S-C24 in acceptable condition		Pic 8 Desc.	Bridge and ECDs at S-C25 in acceptable condition

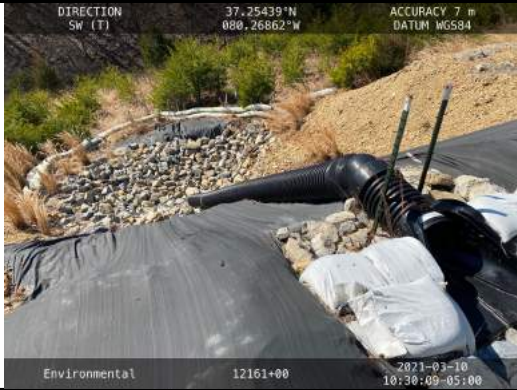
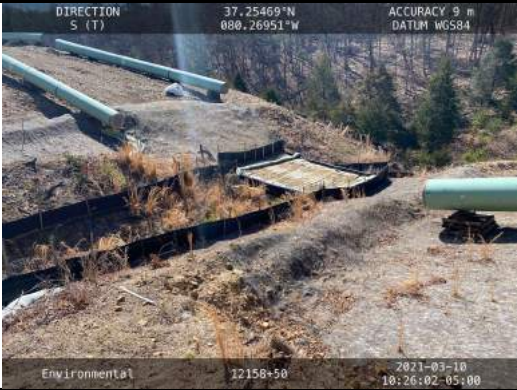
GPS Location	See photo		GPS Location	See photo	
Field Station#	12161+00		Field Station#	12158+50	
Pic 9 Desc.	Fill slope drain in acceptable condition		Pic 10 Desc.	Clean water crossing in acceptable condition

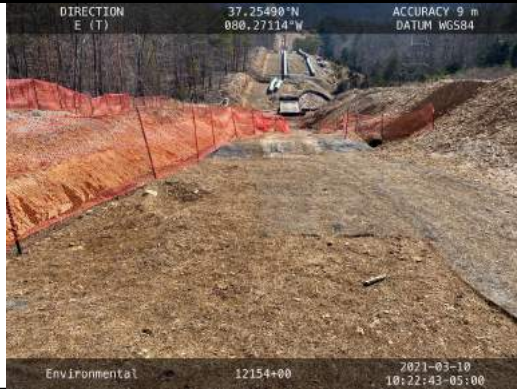
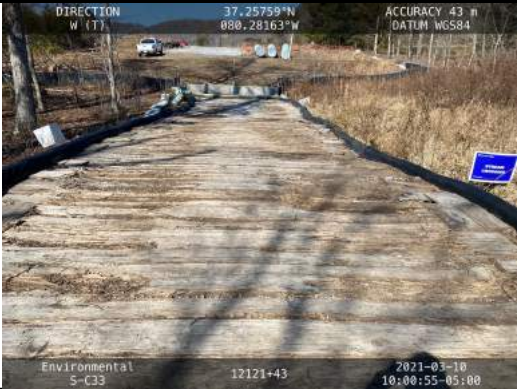
GPS Location	See photo		GPS Location	See photo	
Field Station#	12154+00		Field Station#	12121+43	
Pic 11 Desc.	Stabilized ROW in acceptable condition		Pic 12 Desc.	ECDs and bridge crossing S-C33 is in acceptable condition

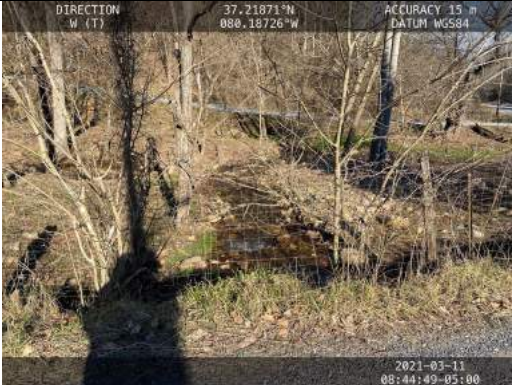
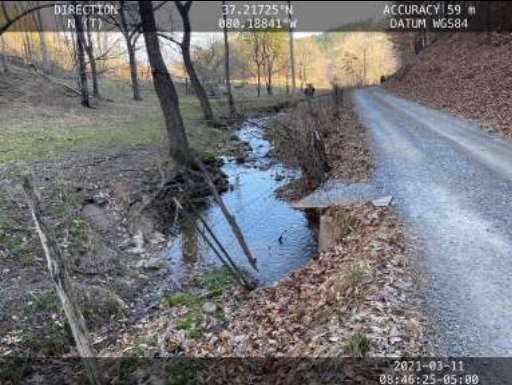
GPS Location	See photo		GPS Location	See photo	
Field Station#	12544+06		Field Station#	12544+06	
Pic 1 Desc.	Stream S-KL32, facing west, downstream from Yellow Finch Lane		Pic 2 Desc.	Stream S-EF20b, facing north, downstream from Yellow Finch Lane

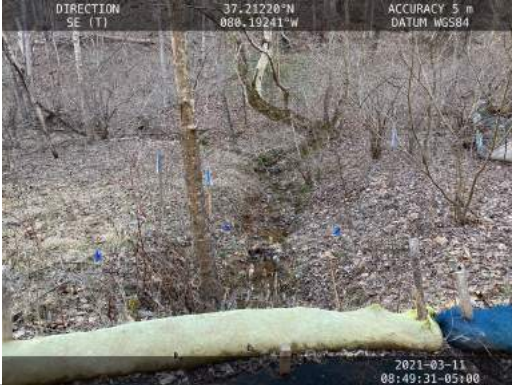
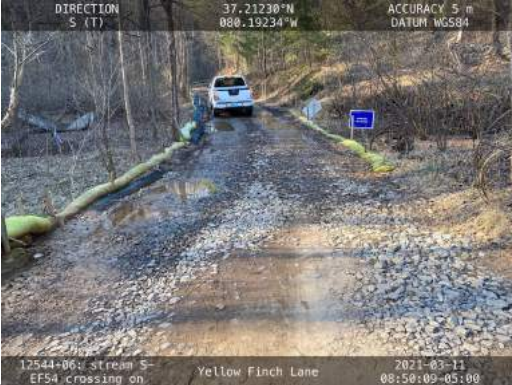
GPS Location	See photo		GPS Location	See photo	
Field Station#	12544+06		Field Station#	12544+06	
Pic 3 Desc.	Stream S-EF54, facing southeast, downstream from Yellow Finch Lane		Pic 4 Desc.	Yellow Finch Lane crossing over stream S-EF54.

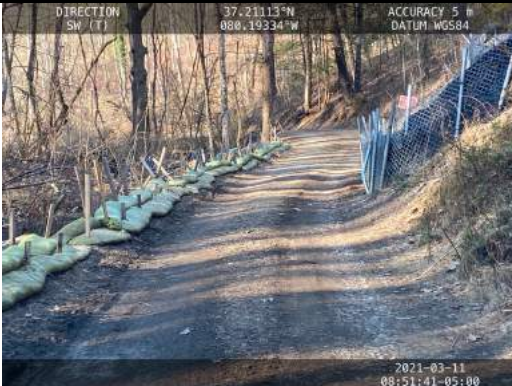
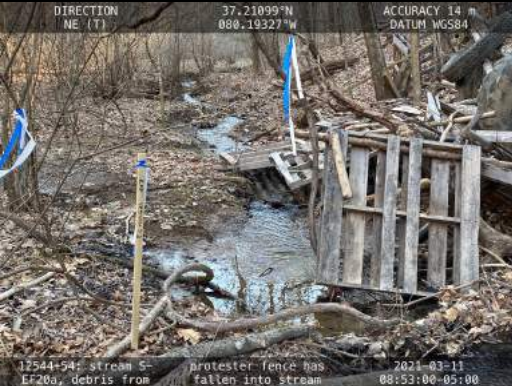
GPS Location	See photo		GPS Location	See photo	
Field Station#	12544+06		Field Station#	12544+54	
Pic 5 Desc.	MVP ROW crossing on Yellow Finch Lane.		Pic 6 Desc.	Pallets from protester barricade have fallen over stream S-EF20a outside, downstream of, MVP ROW.

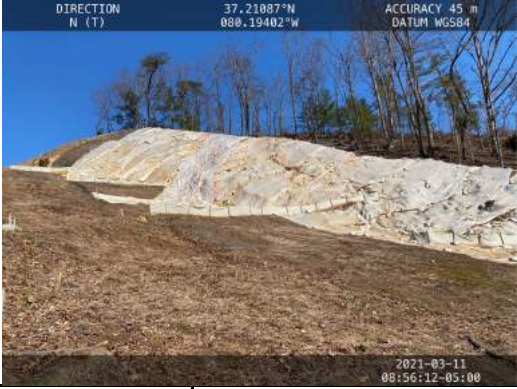
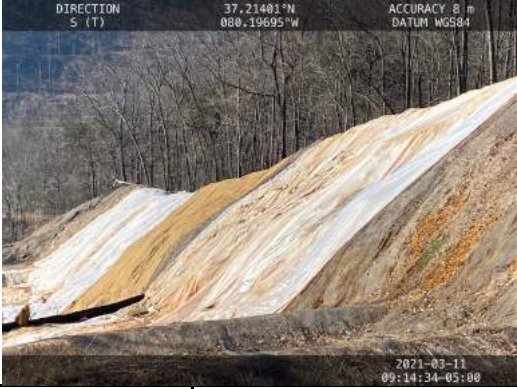
GPS Location	See photo		GPS Location	See photo	
Field Station#	12543+00		Field Station#	12529+00	
Pic 7 Desc.	Plastic sheeting remains secure on stockpiles nearest to Yellow Finch Lane.		Pic 8 Desc.	Plastic sheeting is secure on stockpiles approximately 1500 feet from Yellow Finch Lane.

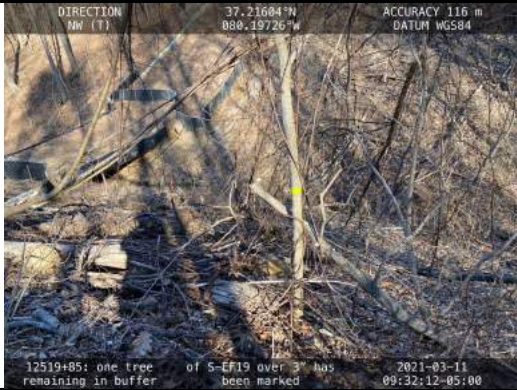
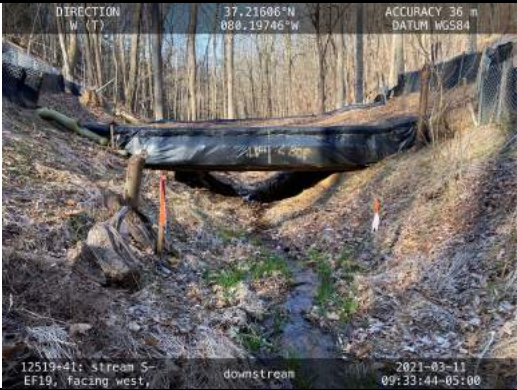
GPS Location	See photo		GPS Location	See photo	
Field Station#	12519+85		Field Station#	12519+41	
Pic 9 Desc.	1 tree remains in the buffer zone of stream S-EF19 that is in the 3" to 5" diameter size range.		Pic 10 Desc.	Stream S-EF19, facing west, downstream

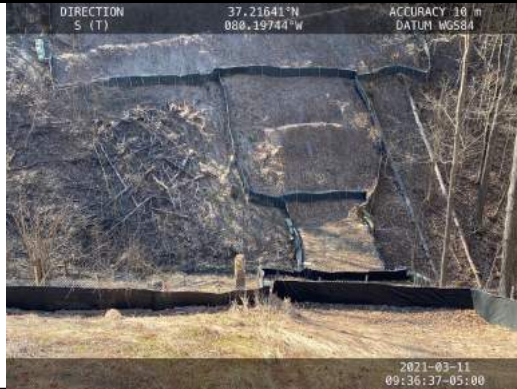
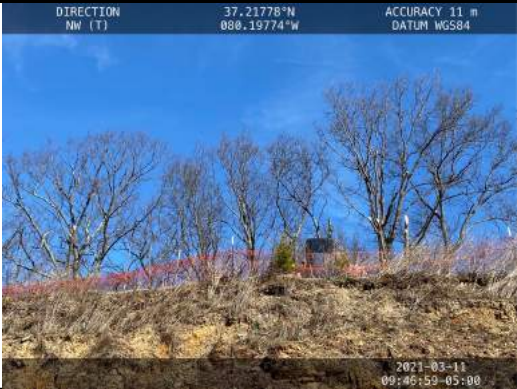
GPS Location	See photo		GPS Location	See photo	
Field Station#	12519+41		Field Station#	12512+00	
Pic 11 Desc.	The bridge, buffer zone and ECDs are in satisfactory condition at stream S-EF19.		Pic 12 Desc.	Enbridge had a crew trimming trees on their ROW adjacent to MVP ROW.

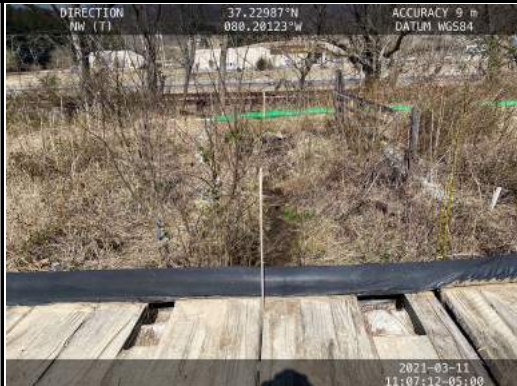
GPS Location	See photo		GPS Location	See photo	
Field Station#	12475+00		Field Station#	12455+21	
Pic 15 Desc.	ROW stable		Pic 16 Desc.	Stream S-CD12, facing northwest, downstream

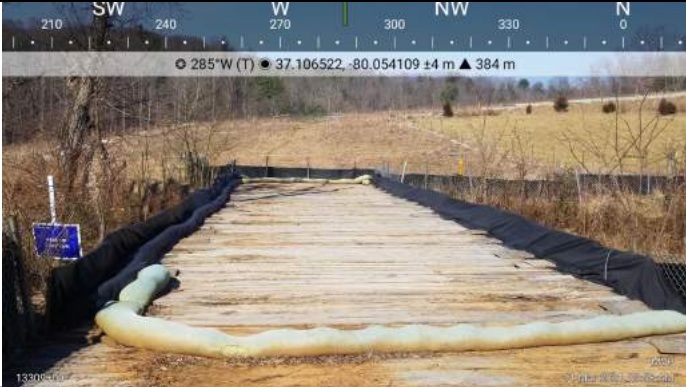
GPS Location	See photo for coordinates.		GPS Location	See photo for coordinates.	
Field Station#	13309+09		Field Station#	13306+00	
Pic 3 Desc.	S-GH7, bridge in acceptable condition at stream crossing, no impacts noted.		Pic 4 Desc.	ROW stable with acceptable vegetative cover across LOD.

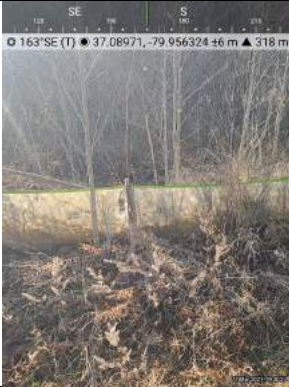
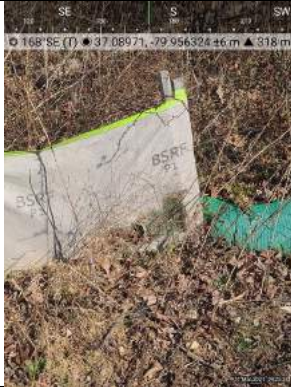
GPS Location	00000	GPS Location	00000		
Field Station#	13657+50	Field Station#	13658+70		
Pic 1 Desc.	P1 requires maintenance due to being weathered and torn, documented and sent in to be added to the punch list.		Pic 2 Desc.	P1 requires maintenance due to being weathered and torn, documented and sent in to be added to the punch list.

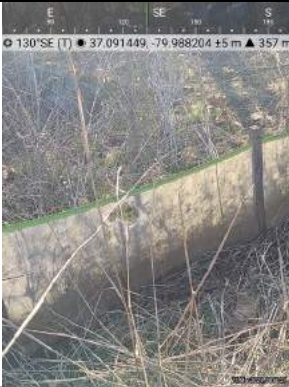
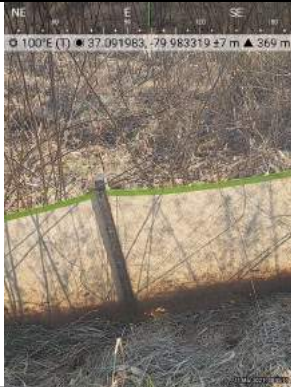
GPS Location	00000	GPS Location	00000		
Field Station#	13550+50	Field Station#	13564+75		
Pic 3 Desc.	P1 requires maintenance due to being weathered and torn, documented and sent in to be added to the punch list.		Pic 4 Desc.	P1 requires maintenance due to wildlife damage , documented and sent in to be added to the punch list.

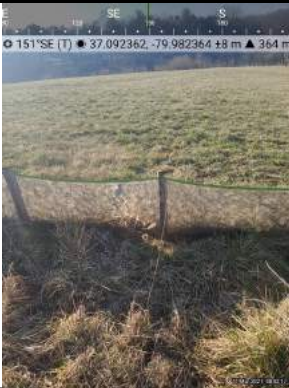
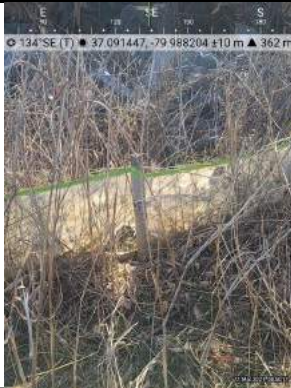
GPS Location	00000	GPS Location	00000		
Field Station#	13568+79	Field Station#	13550+50		
Pic 5 Desc.	P1 requires maintenance due to wildlife damage , documented and sent in to be added to the punch list.		Pic 6 Desc.	Additional photo showing P1 that requires maintenance due to wildlife damage , documented and sent in to be added to the punch list.

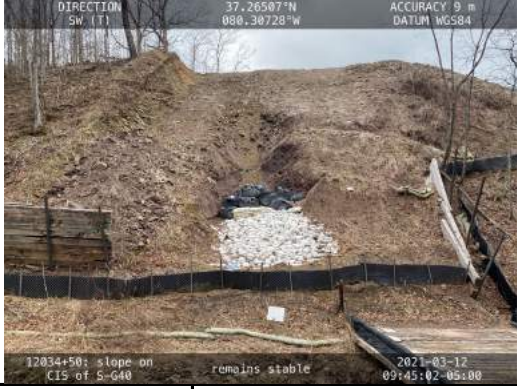
GPS Location	See photo		GPS Location	See photo	
Field Station#	12034+50		Field Station#	12035+75	
Pic 9 Desc.	The steep slope on the coming in side of stream S-G40 remains stable.		Pic 10 Desc.	Stream S-PP23, facing northeast, upstream

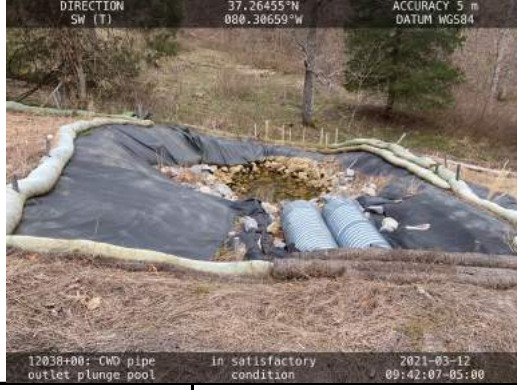
GPS Location	See photo		GPS Location	See photo	
Field Station#	12038+00		Field Station#	12045+00	
Pic 11 Desc.	Clean water diversion pipe outlet is in satisfactory condition.		Pic 12 Desc.	ROW stable

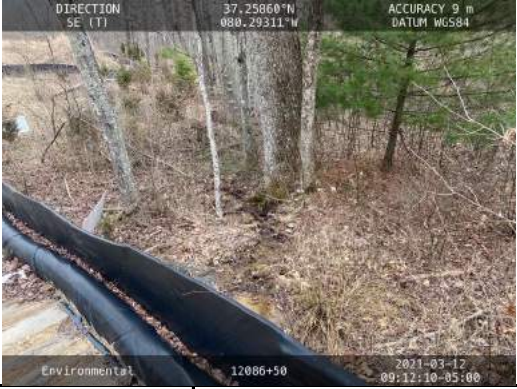
GPS Location	See photo		GPS Location	See photo	
Field Station#	12086+50		Field Station#	12086+50	
Pic 13 Desc.	Bridge and ECDs in satisfactory condition at stream S-MM14.		Pic 14 Desc.	Stream S-MM14, facing southeast, downstream

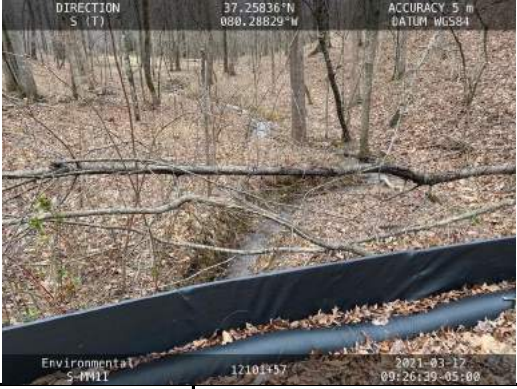
GPS Location	See photo		GPS Location	See photo	
Field Station#	12098+44		Field Station#	12101+57	
Pic 15 Desc.	Bridge and ECDs in satisfactory condition at stream S-MM13.		Pic 16 Desc.	Stream S-MM11, facing south, downstream

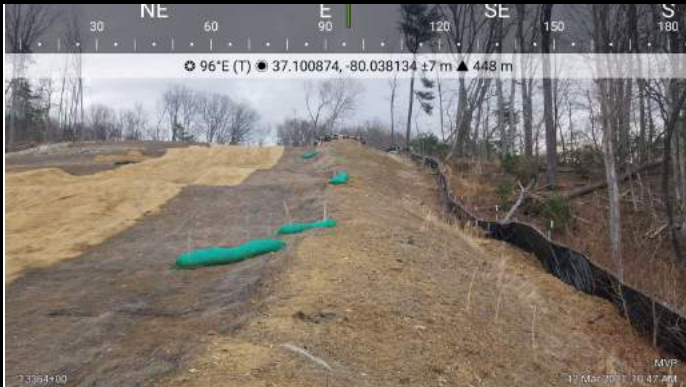
GPS Location	See Above		GPS Location	See Above	
Field Station#	13364+00		Field Station#	13370+00	
Pic 13 Desc.	ROW Overview. ECDs are functional and ROW is stable.		Pic 14 Desc.	ROW Overview. ECDs are functional and ROW is stable.

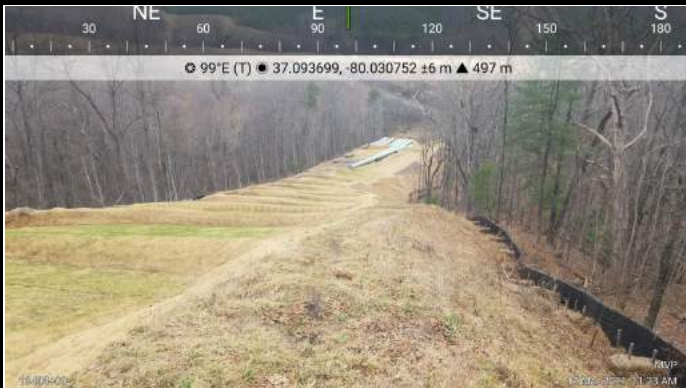
GPS Location	See Above		GPS Location	See Above	
Field Station#	13404+00		Field Station#	13413+01	
Pic 15 Desc.	ROW Overview. ECDs are functional and ROW is stable.		Pic 16 Desc.	Overview of Waterbody S-IJ1. ECDs are functional and ROW is stable.

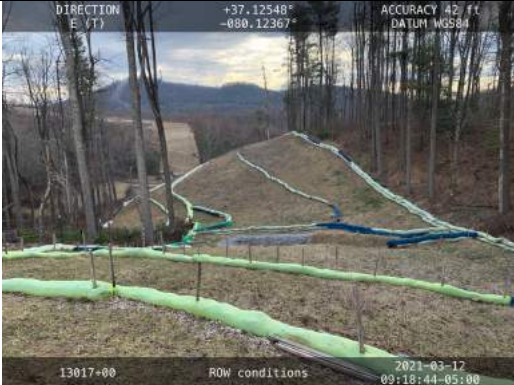
GPS Location	See pic for GPS location		GPS Location	See pic for GPS location	
Field Station#	13017+00		Field Station#	13012+75	
Pic 1 Desc.	Wooded portion of the BRP.		Pic 2 Desc.	GAS of the BRP motorway.

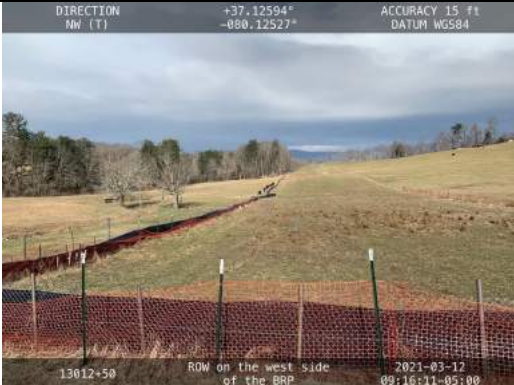
GPS Location	See pic for GPS location		GPS Location	See pic for GPS location	
Field Station#	13012+50		Field Station#	12994+00	
Pic 3 Desc.	CIS of the BRP motorway.		Pic 4 Desc.	CIS of the US-221 road crossing.

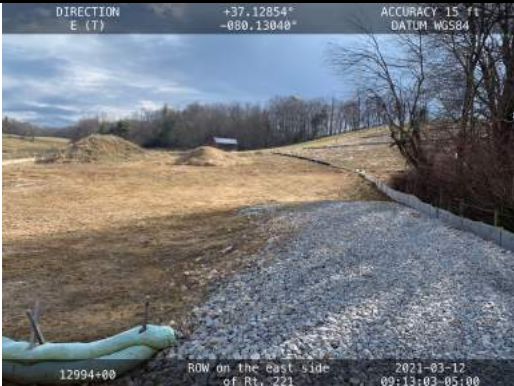
GPS Location	See pic for GPS location		GPS Location	See pic for GPS location	
Field Station#	12994+20		Field Station#	12957+50	
Pic 5 Desc.	GAS of the US-221 road crossing.		Pic 6 Desc.	Streams S-Y7 and S-Y8 on the GAS of RO-287.
