Visual Site Inspection Report

Project Name H-600 Pipeline Spread I		AFE 124300139	Spread H-600 Pipeline Spread I
Contractor Precision		Report # 19351	
Inspector John White		Date/Time 1/25/2021 9:47 AM	
Permit # TBD	Inspection Type VA SWPP	Station Begin 15584+23	
State VA	Inspection Area Full	Station End 15647+03	
County Pittsylvania	Ground Damp	Temperature (°F) 39.00	
Municipality Chatham	Weather Cloudy	Rain Gauge (in) 0.00	
Rain Accumulation Time (days)			6.00

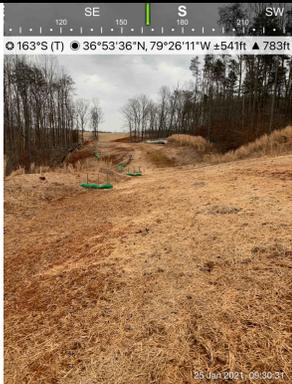
<p>GPS: 163°S (T) ● 36°53'36"N, 79°26'11"W ±541ft ▲ 783ft</p>

<p>GPS: 78°E (T) ● 36°53'38"N, 79°26'14"W ±541ft ▲ 781ft</p>	
GPS Location	O	GPS Location	O	
Field Station#	15630+00	Field Station#	15632+00	
Pic 1 Desc.	Observing temporary stabilization and ECD's	Pic 2 Desc.	Observing temporary stabilization, CWD outlet and ECD's

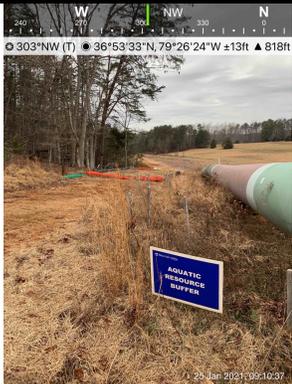
<p>GPS: 303°NW (T) ● 36°53'33"N, 79°26'24"W ±13ft ▲ 818ft</p>

<p>GPS: 298°NW (T) ● 36°53'33"N, 79°26'22"W ±13ft ▲ 820ft</p>	
GPS Location	O	GPS Location	O	
Field Station#	15615+00	Field Station#	15616+00	
Pic 3 Desc.	Observing temporary stabilization, signage, equipment crossing, buffer and ECD's	Pic 4 Desc.	Observing temporary stabilization and signage

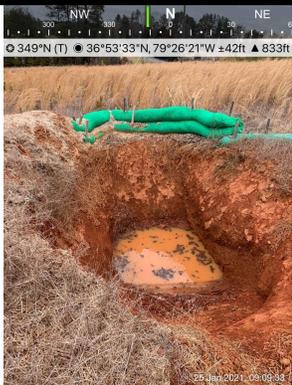
<p>GPS: 349°N (T) ● 36°53'33"N, 79°26'21"W ±42ft ▲ 833ft</p>

Field Station#	15617+00	Field Station#	15595+60	
Pic 5 Desc.	Observing sump and end treatment	Pic 6 Desc.	Observing temporary stabilization, signage, buffer, equipment crossing and ECD's

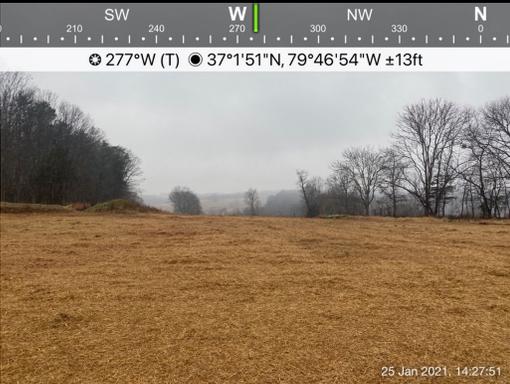
<p>GPS Location: 0 Field Station#: 14409+00 Pic 2 Desc.: Approximately 14409+00. Overview of ROW.</p>

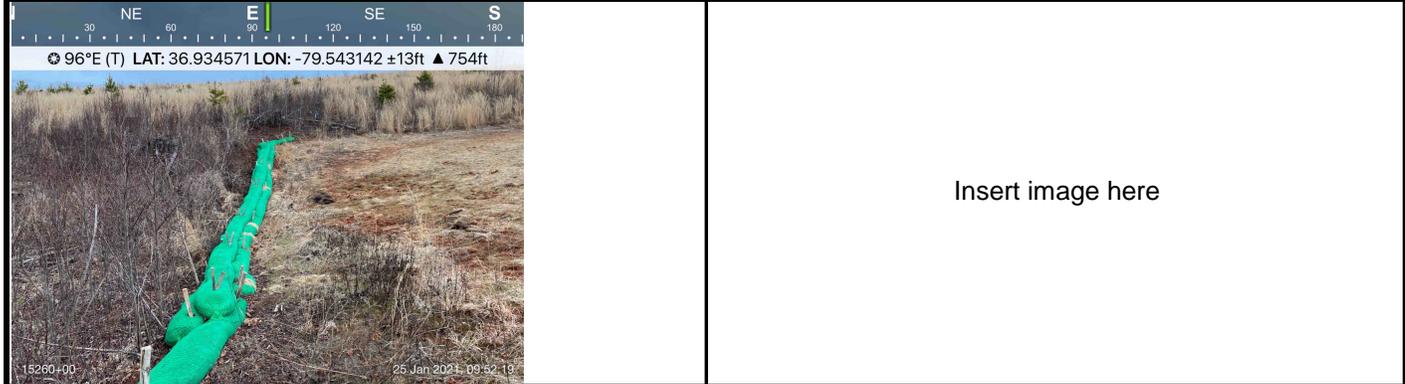
Pic 7 Desc.	Perimeter CFS in good condition throughout this section of ROW.	Pic 8 Desc.	
--------------------	---	--------------------	--

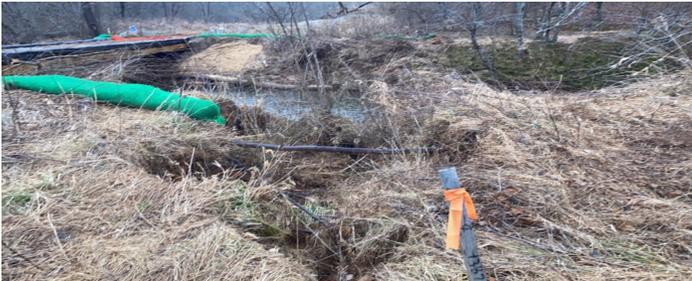
<p>37°32'7" N 79°54'50" W 116°SE COURSE 297' GPS 01.25.2021 10:41:04 Rocky Mount, VA 24151, United States Accur +/-113.6 Ft ALT 1029 Ft</p>

- Made note of condition of ditch subsidence CIS S-CD6 (pictured below)
- Walked ROW with environmental foreman checking on condition of ECDs and identifying potential environmental issues

<p>37°32'7" N 79°54'50" W 328°NW COURSE 292' GPS 01.25.2021 10:40:42 Accur +/-34.1 Ft ALT 1028 Ft</p>		
GPS Location 1		GPS Location 2			
Field Station# 13875+16		Field Station# 13875+16			
Pic 1 Desc. Ditch subsidence CIS S-CD6 has worsened from previous inspection		Pic 2 Desc. Stream bank of S-CD6 eroding at CIS bridge crossing.

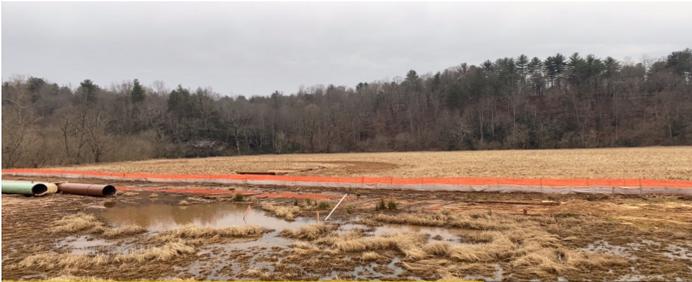
<p>37°30" N 79°54'32" W 324°NW COURSE 324' GPS 01.25.2021 10:17:32 Rocky Mount, VA 24151, United States Accur +/-49.2 Ft ALT 999 Ft</p>

Pic 3 Desc. Bridge mats still located in field off ROW between S-II2 and Iron Ridge Rd		Pic 4 Desc. View of stream S-II2 at ROW/bridge crossing

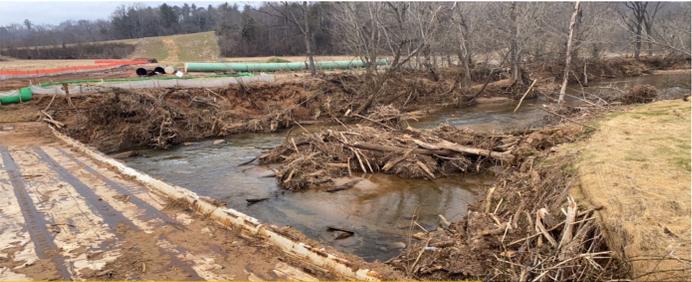
<p>37°2'57" N 79°54'30" W 20°N COURSE 298' GPS 01.25.2021 10:13:54 1770 Iron Ridge Rd, Rocky Mount, VA 24151, United States Accur +/-64.1 Ft ALT 1110 Ft</p>		
GPS Location 3		GPS Location 4			
Field Station# 13911+00		Field Station# 13915+51

- Light rain with wet ground conditions during inspection
- Rain began falling on ROW at approximately 9:00am
- Made note of condition of ROW crossing at S-II2 (pictured below)

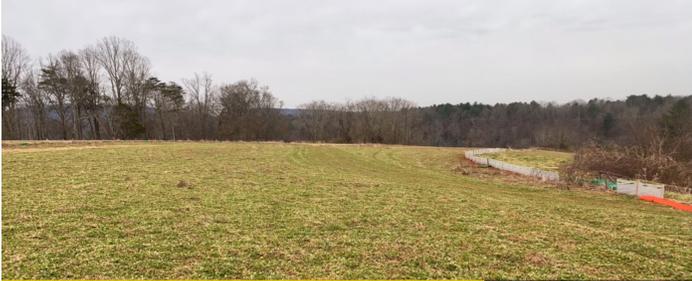
<p>37°3'12" N 79°54'34" W 233°SW COURSE 232' GPS 01.25.2021 10:23:54 1116 Iron Ridge Rd, Rocky Mount, VA 24151, United States Accur +/-43.9 Ft ALT 1112 Ft</p>

<p>37°2'53" N 79°53'43" W 295°NW COURSE 269' GPS 01.25.2021 09:56:18 184 Foggy Ridge Rd, Rocky Mount, VA 24151, United States Accur +/-30.5 Ft ALT 1111 Ft</p>		
GPS Location 5		GPS Location 6			
Field Station# 13898+00		Field Station# 13956+00			
Pic 5 Desc. View of ROW in final cleanup area GAS Iron Ridge Rd		Pic 6 Desc. View of ROW in temporary area CIS Foggy Ridge Rd

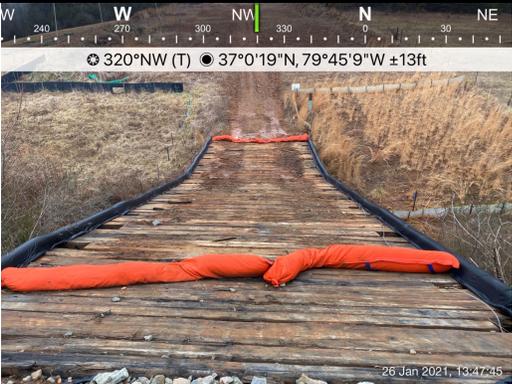
<p>GPS: 320°NW (T) ● 37°0'19"N, 79°45'9"W ±13ft 26 Jan 2021, 13:47:45</p>

<p>GPS: 96°E (T) ● 37°0'40"N, 79°45'15"W ±13ft 26 Jan 2021, 13:36:50</p>	GPS Location	0	GPS Location	0
Field Station#	14546+33	Field Station#	14524+00	Pic 1 Desc.	Approximately 14546+33. Overview of stream crossing, equipment bridge and ECDs at stream S-G17.	Pic 2 Desc.	Approximately 14524+00. Overview of road crossing and RCEs. RCEs installed and appears to be functioning correctly at time of inspection.

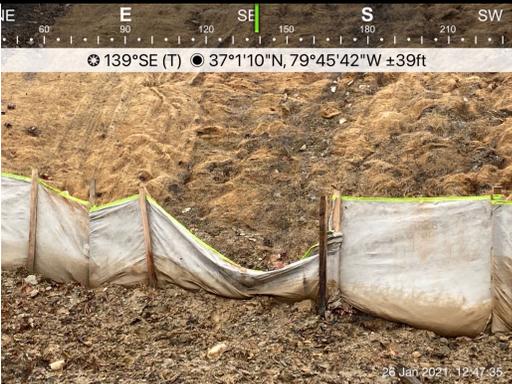
<p>GPS: 139°SE (T) ● 37°1'10"N, 79°45'42"W ±39ft 26 Jan 2021, 12:47:35</p>

<p>GPS: 283°W (T) ● 37°1'11"N, 79°45'43"W ±22ft 26 Jan 2021, 12:46:40</p>	GPS Location	0	GPS Location	0
Field Station#	14487+00	Field Station#	14486+25	Pic 3 Desc.	Approximately 14487+00. P-1 requires maintenance. P-1 appears to have been damaged by livestock.	Pic 4 Desc.	Approximately 14486+25. CFS requires maintenance. CFS damaged by livestock.

E&S BMPs	Compliance Level	Corrective Action	Corrective Time Frame	Date Repaired
Compost Filter Sock	Communication	Repair livestock damage and remove		
Equipment Bridge	Acceptable			
Rock Construction Entrance	Acceptable			
Sensitive Resource Buffer	Acceptable			
Sensitive Resource Signage	Acceptable			
Silt Fence (Filter Fabric Fence)	Communication	Repair livestock damage		
Silt Fence (Reinforce Filter Fence)	Communication	Repair damaged fabric		
Vegetative Stabilization (Temporary)	Acceptable			
Erosion Control Blanket	Acceptable

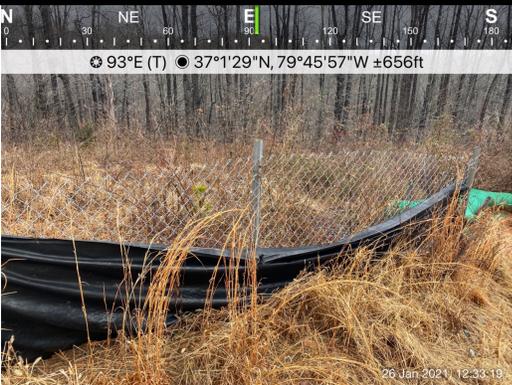
<p>GPS: 93°E (T) ● 37°1'29"N, 79°45'57"W ±656ft 26 Jan 2021, 12:33:19</p>

<p>GPS: 6°N (T) ● 37°1'35"N, 79°46'4"W ±114ft 26 Jan 2021, 12:27:10</p>	GPS Location	0	GPS Location	0
Field Station#	14458+00	Field Station#	14457+00	Pic 5 Desc.	Approximately 14458+00. SSF requires maintenance.	Pic 6 Desc.	Approximately 14457+00. Outlet requires maintenance.

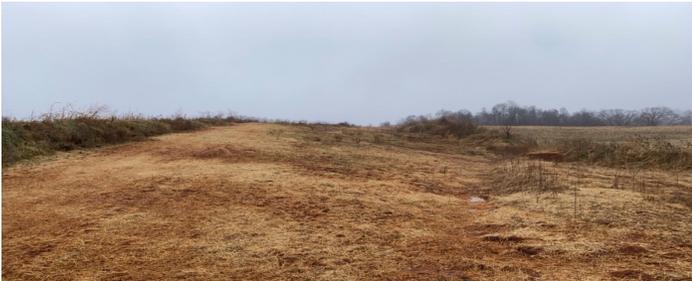
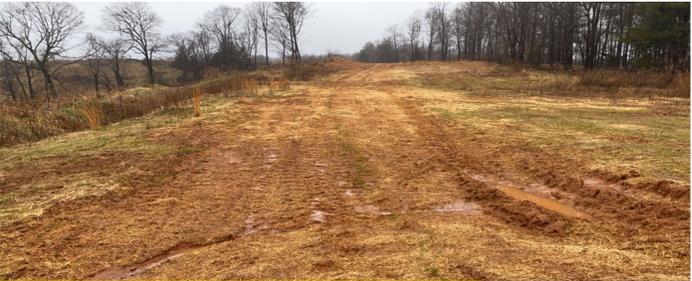
<small>37°30' N 79°53'31" W 359°N COURSE 28' GPS Rocky Mount, VA 24151, United States</small>			<small>01.26.2021 09:20:52 Accur +/-19.2 Ft ALT 1122 Ft</small>		
<small>37°36' N 79°53'17" W 322°NW COURSE 20' GPS Rocky Mount, VA 24151, United States</small>			<small>01.26.2021 09:27:17 Accur +/-54.2 Ft ALT 1123 Ft</small>		
GPS Location	1		GPS Location	2	
Field Station#	13970+00		Field Station#	13982+00	
Pic 1 Desc.	View of stabilized ROW in temporary area GAS Foggy Ridge Rd.		Pic 2 Desc.	Minor erosion occurring in throat of water bar. Will monitor area in subsequent inspections.

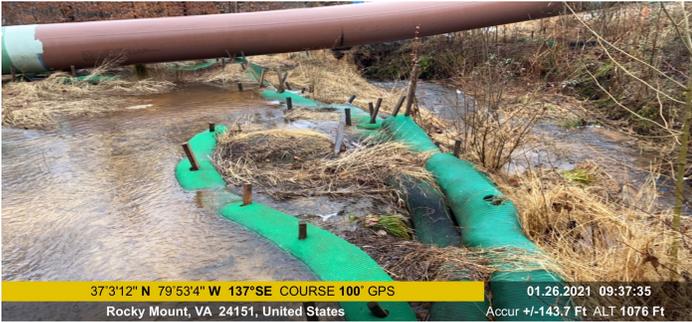
GPS Location	3		GPS Location	4	
Field Station#	13998+25		Field Station#	13999+00	
Pic 3 Desc.	CFS triple stack undermining at S-KL36		Pic 4 Desc.	View of water flowing into open ditch GAS S-KL36

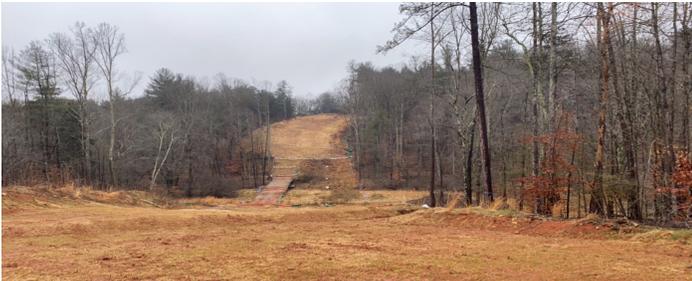
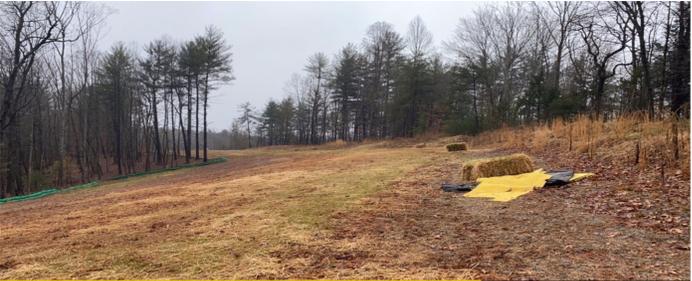
<small>37°34'3" N 79°52'45" W 225°SW COURSE 52' GPS 155 Sink Dr, Rocky Mount, VA 24151, United States</small>			<small>01.26.2021 11:01:55 Accur +/-71.6 Ft ALT 1173 Ft</small>		
<small>37°33'6" N 79°52'52" W 197°S COURSE 158' GPS 161 Price Ln, Rocky Mount, VA 24151, United States</small>			<small>01.26.2021 11:07:00 Accur +/-76.7 Ft ALT 1104 Ft</small>		
GPS Location	5		GPS Location	6	
Field Station#	14038+00		Field Station#	14029+00	
Pic 5 Desc.	View of stabilized ROW in temporary area GAS Bonbrook Mill RC1		Pic 6 Desc.	View of stabilized ROW in temporary area GAS Bonbrook Mill RC1

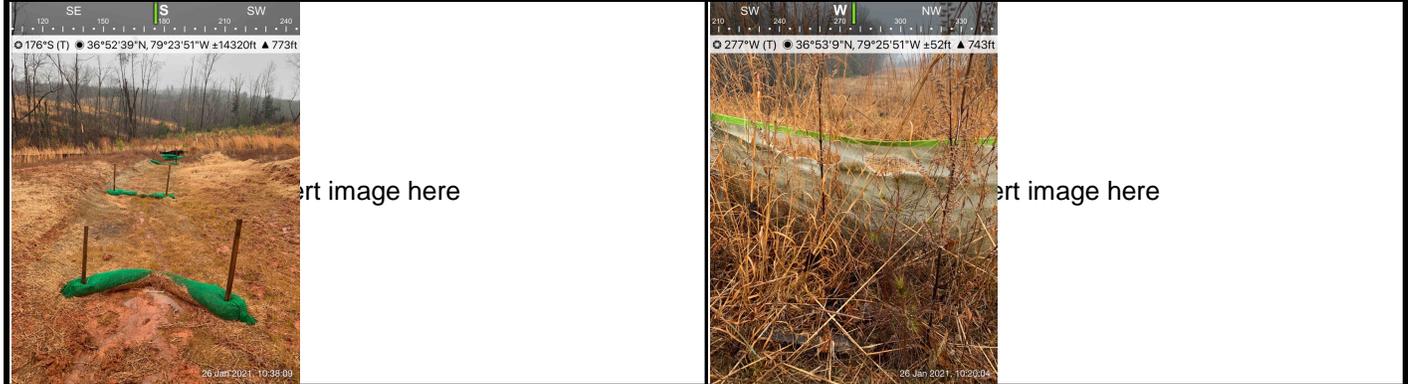
Pic 13 Desc.	Observing water bar, erosion control blanket and cfs checks	Pic 14 Desc.	Observing p1 that requires maintenance
---------------------	---	---------------------	--

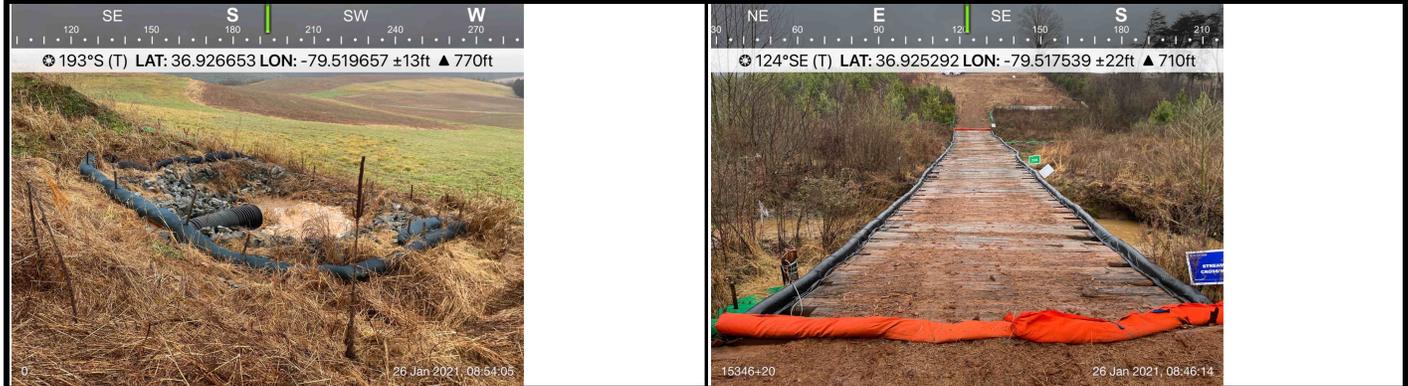
GPS Location	See photo	GPS Location	See photo
Field Station#	15338+00	Field Station#	15346+20
Pic 7 Desc.	CWD is functioning as intended.	Pic 8 Desc.	Equipment bridge ECDs are in place and functioning.

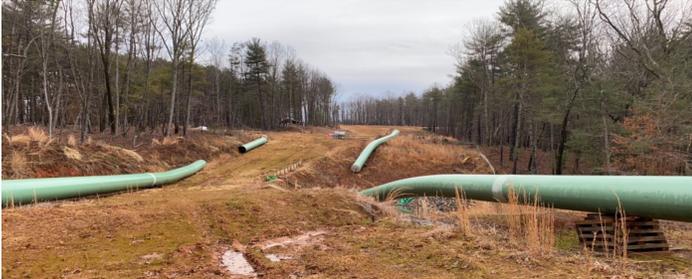
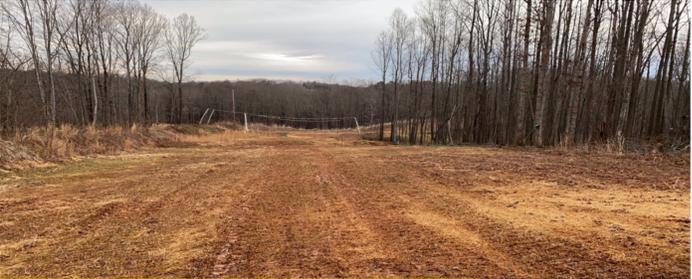
<small>37°3'54" N 79°52'24" W 110°E COURSE 0° GPS Rocky Mount, VA 24151, United States</small>			<small>37°3'52" N 79°52'12" W 86°E COURSE 99° GPS Wirtz, VA 24184, United States</small>		
<small>01.27.2021 09:01:43 Accur +/-53.2 Ft ALT 0 Ft</small>			<small>01.27.2021 09:06:33 Accur +/-125.9 Ft ALT 1175 Ft</small>		
GPS Location	1		GPS Location	2	
Field Station#	14069+00		Field Station#	14082+00	
Pic 1 Desc.	View of ROW in two-tone area. ECDs are in place and functional. ROW stabilized.		Pic 2 Desc.	ROW stabilized in temporary area. Limited vegetation observed.

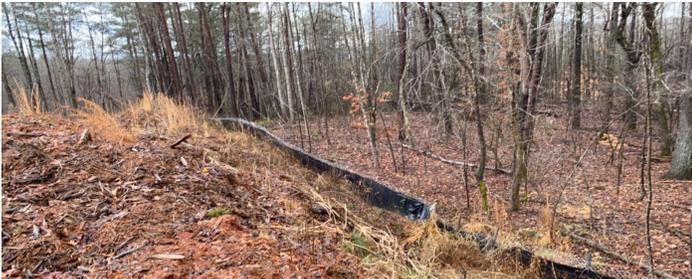
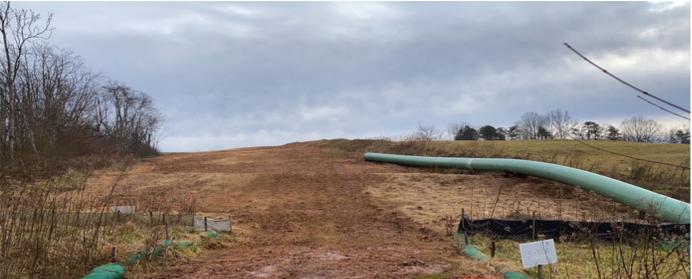
<small>37°3'33" N 79°51'16" W 259°W COURSE 53° GPS 110-312 Jonesmill Ln, Rocky Mount, VA 24151, United States</small>			<small>37°3'21" N 79°51'1" W 133°SE COURSE 358° GPS Rocky Mount, VA 24151, United States</small>		
<small>01.27.2021 09:35:15 Accur +/-136.1 Ft ALT 1068 Ft</small>			<small>01.27.2021 09:45:14 Accur +/-32.8 Ft ALT 946 Ft</small>		
GPS Location	5		GPS Location	6	
Field Station#	14139+50		Field Station#	14158+00	
Pic 5 Desc.	Perimeter SSF in place and functional.		Pic 6 Desc.	ROW stabilized in temporary area. Limited vegetation observed.

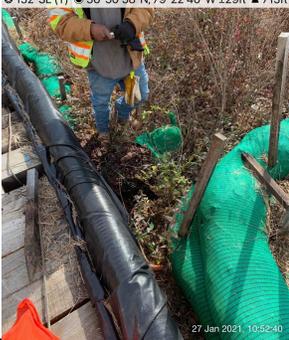
GPS Location	O	GPS Location	O	Field Station#	15934+00
Field Station#	15934+00	Field Station#	15878+08	Pic 3 Desc.	Observing the Contractor performing ECD maintenance
Pic 3 Desc.	Observing the Contractor performing ECD maintenance	Pic 4 Desc.	Observing CFS that required maintenance

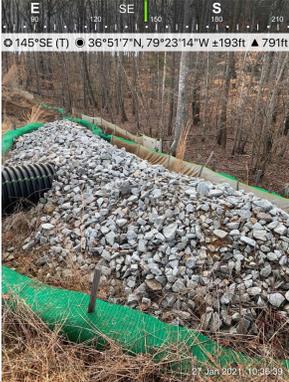
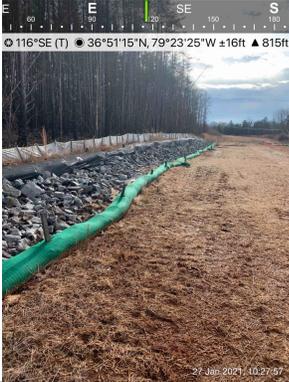
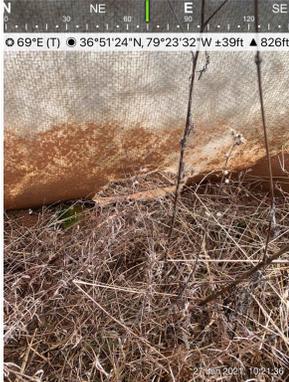
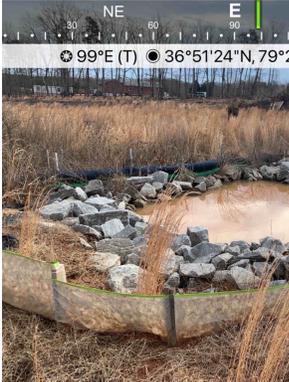
GPS Location O		GPS Location O		GPS Location O		GPS Location O	
Field Station# 15851+00		Field Station# 15836+00		Field Station# 15825+00		Field Station# 15825+00	
Pic 7 Desc. Observing CWD outlet and ECD's		Pic 8 Desc. Observing temporary stabilization, rock drain and ECD's		Pic 9 Desc. Observing p1 that requires maintenance		Pic 10 Desc. Observing plunge pool and ECD's

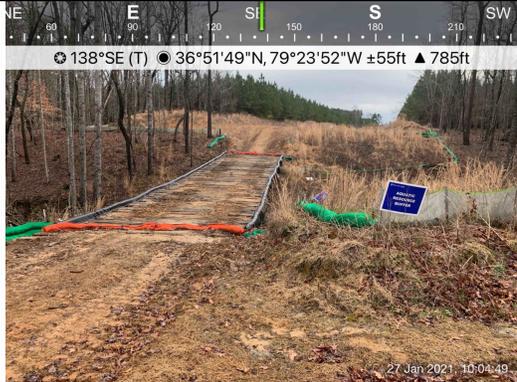
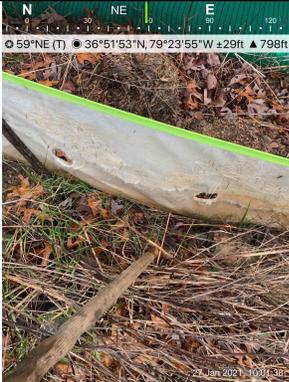
GPS Location O		GPS Location O		GPS Location O		GPS Location O	
Field Station# 15794+77		Field Station# 15777+00		Field Station# 15794+77		Field Station# 15777+00	
Pic 11 Desc. Observing temporary stabilization, equipment crossing, signage and ECD's		Pic 12 Desc. Observing p1 that requires maintenance		Pic 11 Desc. Observing temporary stabilization, equipment crossing, signage and ECD's		Pic 12 Desc. Observing p1 that requires maintenance

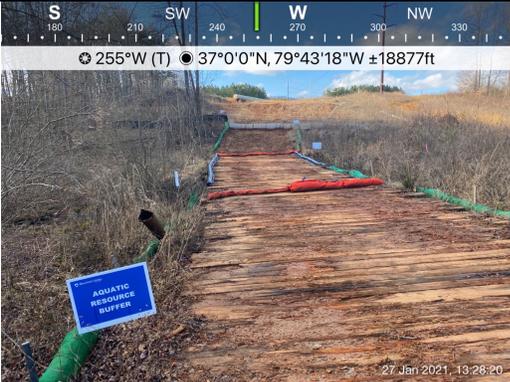
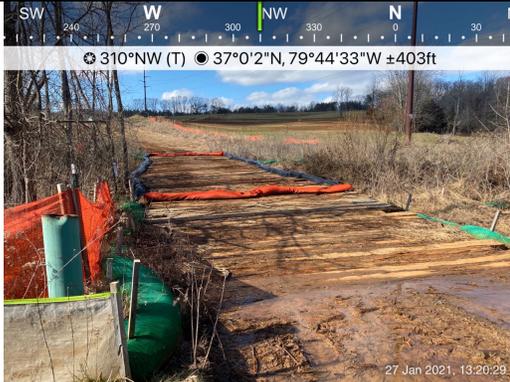
GPS Location	0	GPS Location	0
Field Station#	14568+10	Field Station#	14582+85
Pic 3 Desc.	Approximately 14568+10. Overview of stream crossing, equipment bridge and ECDs at stream S-E18.	Pic 4 Desc.	Approximately 14582+85. Overview of stream crossing, equipment bridge and ECDs at stream S-E17.

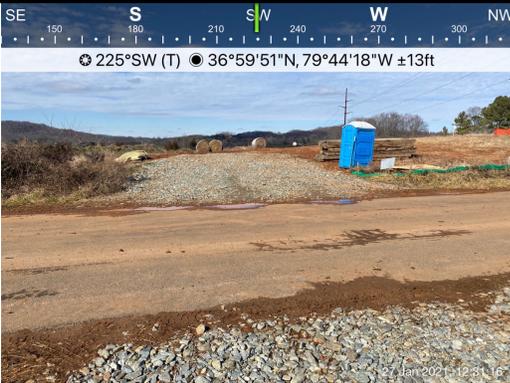
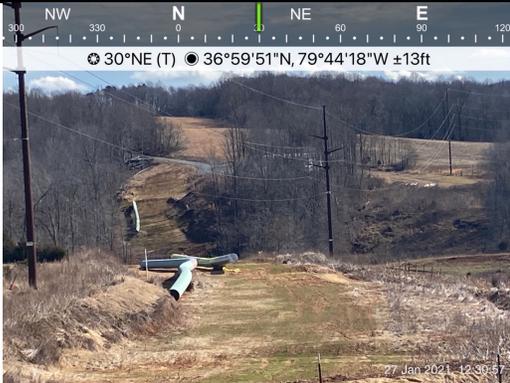
GPS Location	0	GPS Location	0
Field Station#	14599+00	Field Station#	14605+00
Pic 5 Desc.	Approximately 14599+00. Overview of road crossing and RCEs. RCEs installed and appears to be functioning correctly at time of inspection.	Pic 6 Desc.	Approximately 14605+00. Overview of ROW.

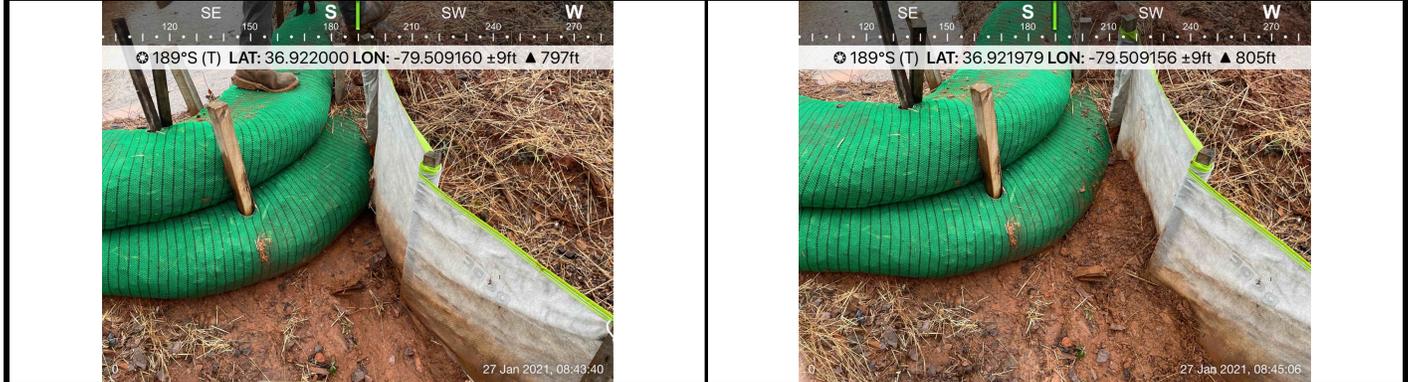
Field Station#	15377+00	Field Station#	15377+00
-----------------------	----------	-----------------------	----------

Pic 1 Desc.	CFS is undermined and needs to be keyed in.	Pic 2 Desc.	Environmental crew has corrected this issue
--------------------	---	--------------------	---

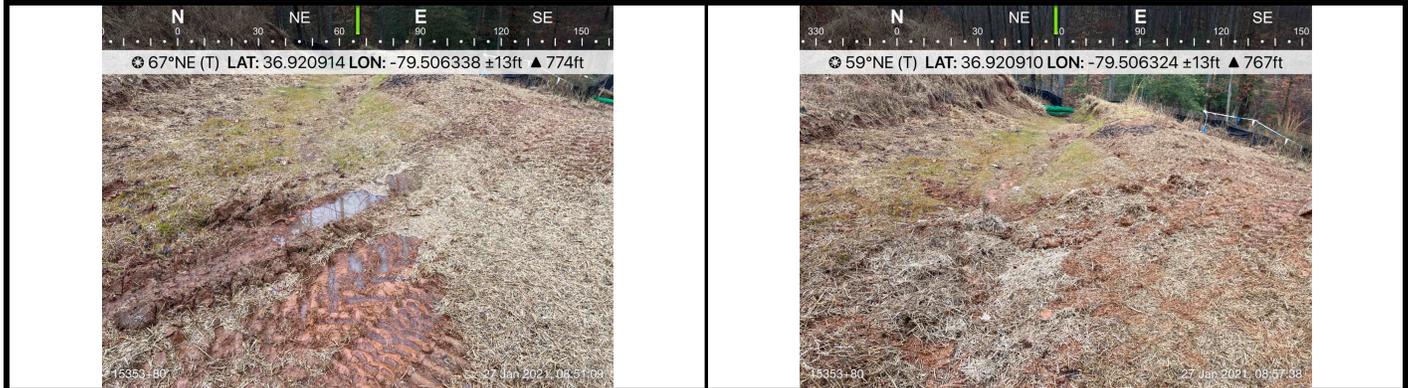
Field Station#	15353+80	Field Station#	15353+80
-----------------------	----------	-----------------------	----------

Pic 3 Desc.	Waterbar channel is obstructed and needs to be regraded	Pic 4 Desc.	Environmental crew has corrected this issue
--------------------	---	--------------------	---

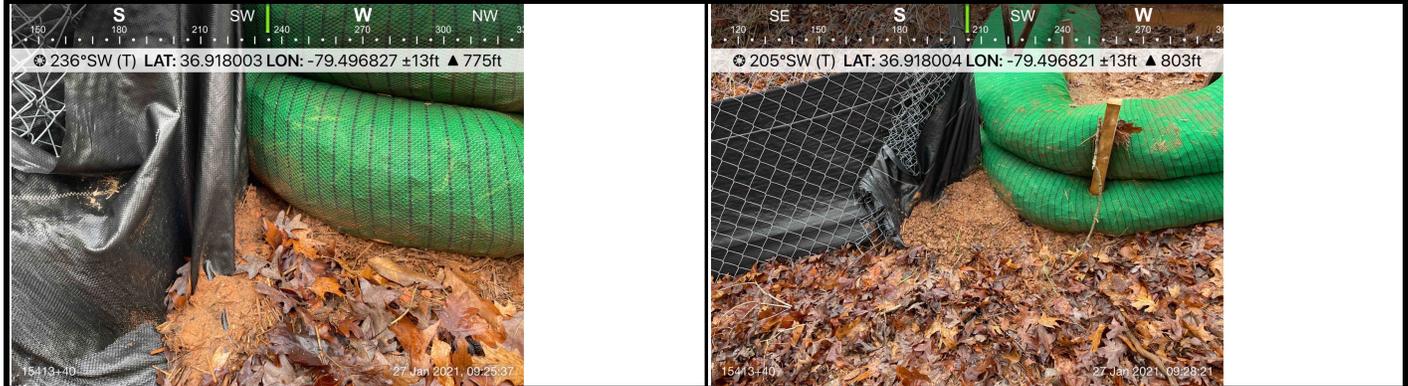
GPS Location	See photo	GPS Location	See photo
Field Station#	15413+40	Field Station#	15413+40
Pic 7 Desc.	CFS is undermined and needs to be keyed in.	Pic 8 Desc.	Environmental crew has corrected this issue

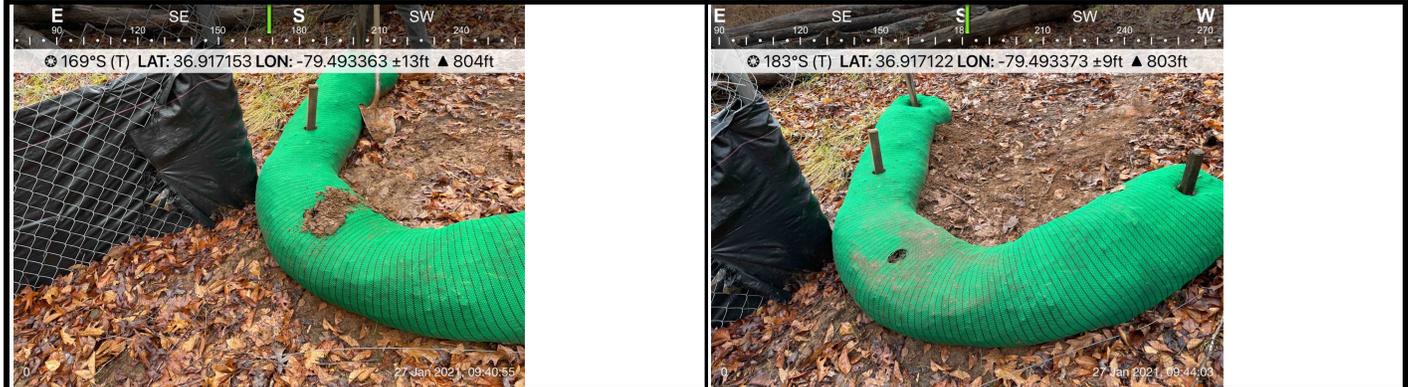
GPS Location	See photo	GPS Location	See photo
Field Station#	15424+00	Field Station#	15424+00
Pic 9 Desc.	CFS requires maintenance.	Pic 10 Desc.	Environmental crew has corrected this issue

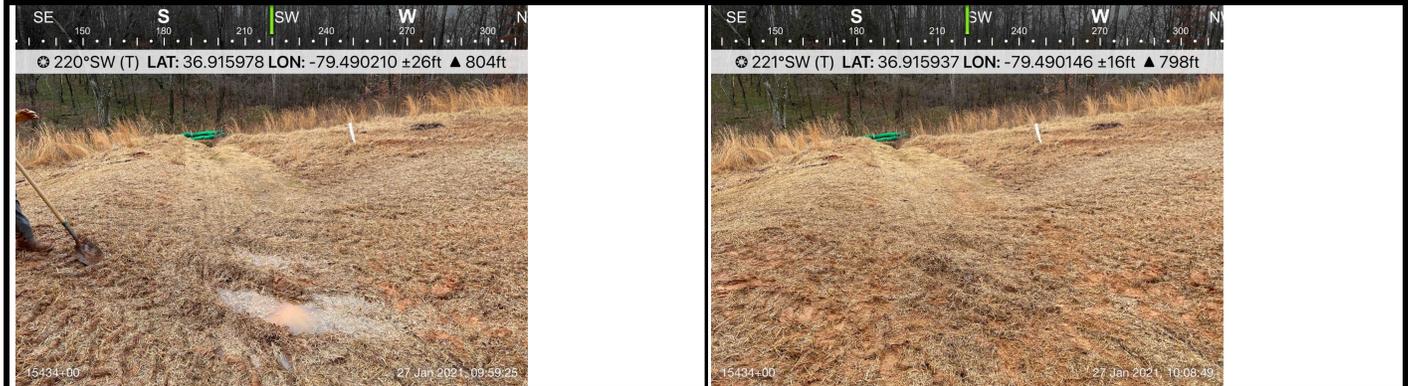
GPS Location	See photo	GPS Location	See photo
Field Station#	15434+00	Field Station#	15434+00
Pic 11 Desc.	Waterbar channel is obstructed and needs to be regraded	Pic 12 Desc.	Environmental crew has corrected this issue

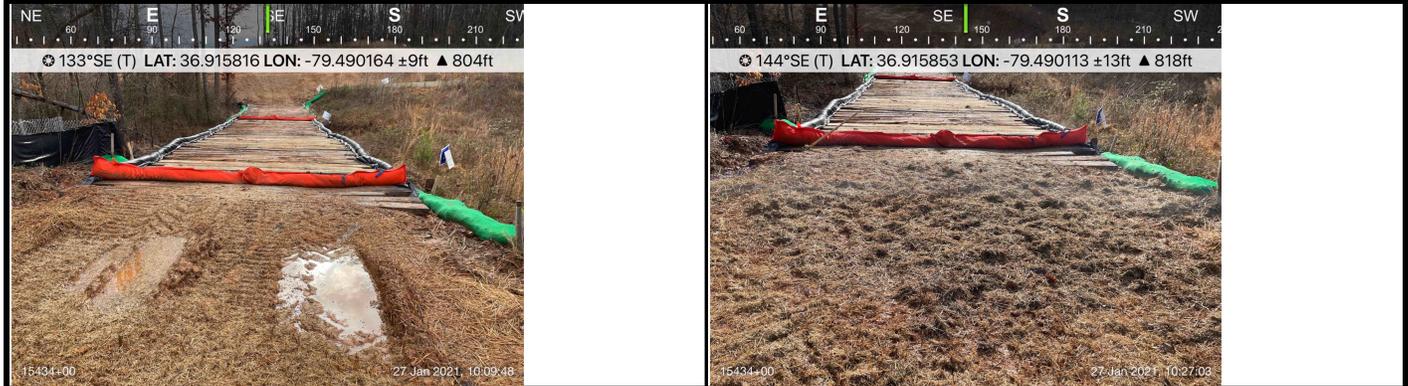
GPS Location	See photo	GPS Location	See photo
Field Station#	15434+50	Field Station#	15434+50
Pic 13 Desc.	Bridge approach is holding water and needs to be regraded.	Pic 14 Desc.	Environmental crew has corrected this issue

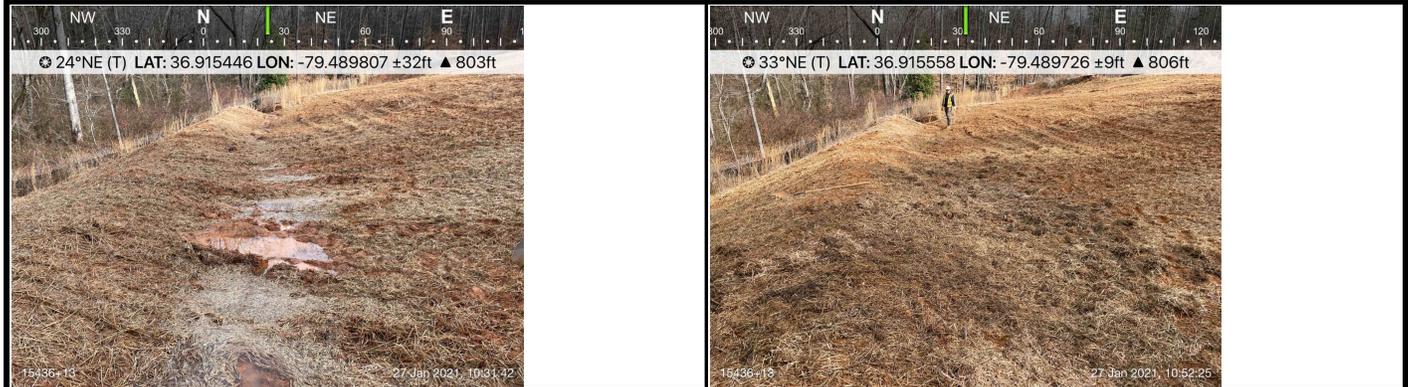
GPS Location	See photo	GPS Location	See photo
Field Station#	15436+13	Field Station#	15436+13
Pic 15 Desc.	Waterbar channel is obstructed and needs to be regraded	Pic 16 Desc.	Environmental crew has corrected this issue

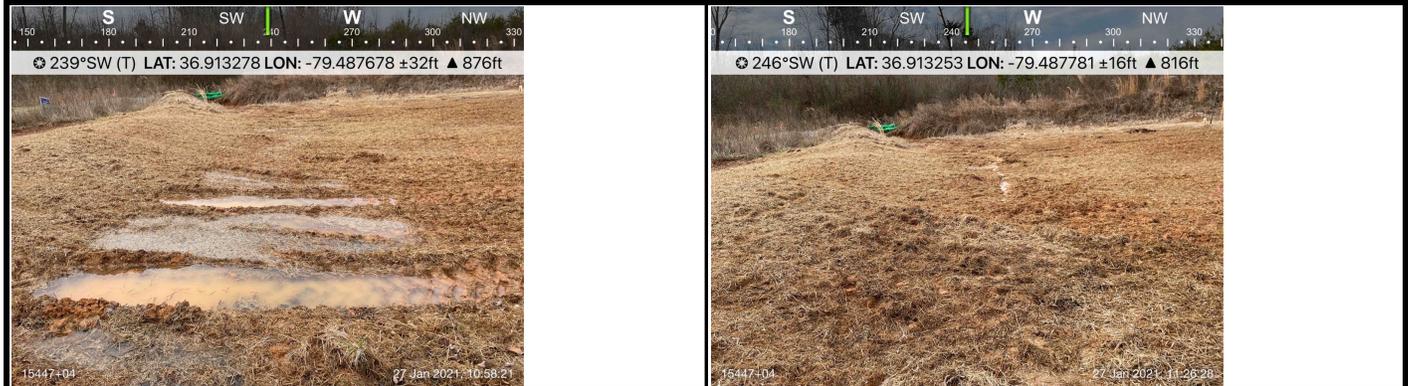
GPS Location	See photo	GPS Location	See photo
Field Station#	15447+04	Field Station#	15447+04
Pic 17 Desc.	Waterbar channel is obstructed and needs to be regraded	Pic 18 Desc.	Environmental crew has corrected this issue

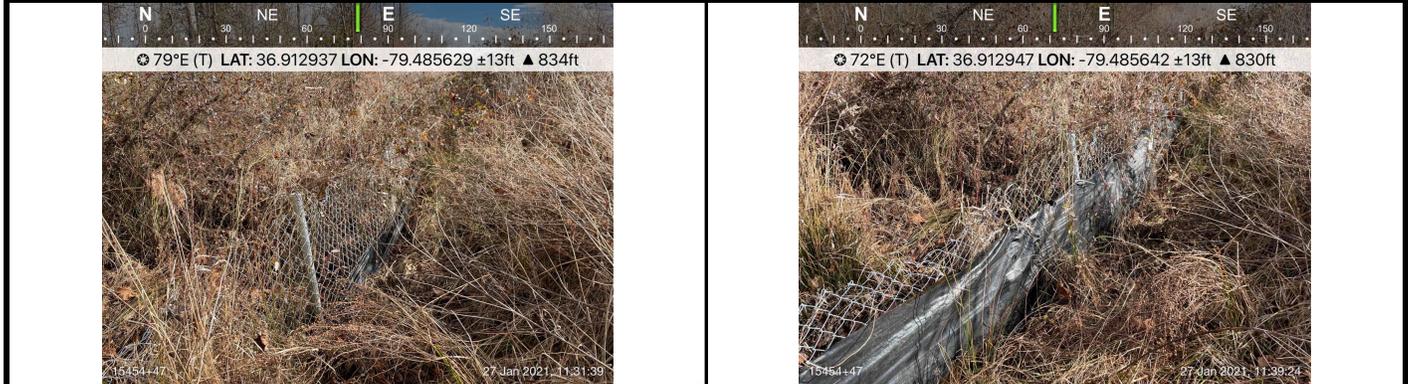
Field Station#	15454+47	Field Station#	15454+47
-----------------------	----------	-----------------------	----------

Pic 1 Desc.	SSF fabric needs to be reattached.	Pic 2 Desc.	Environmental crew has corrected this issue.
--------------------	------------------------------------	--------------------	--

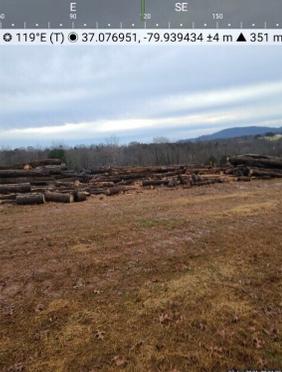
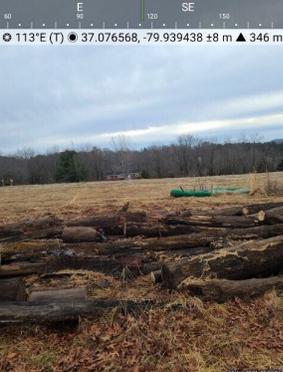
Throughout today's inspections the EI observed 2 areas where a land owner has moved the CFS from the edge of the LOD to access a log pile to cut fire wood inside the LOD . The EI recommended installing orange sock in the areas that were moved by the land owner. Documented and added to the punch list.

GPS Location	000000		GPS Location	00000	
Field Station#	13739+00		Field Station#	13739+00	
Pic 1 Desc.	Photo taken by the EI showing area where land owner has cut fire wood from log pile inside the LOD, will continue to monitor the area		Pic 2 Desc.	Photo showing CFS moved by land owner to access the row to cut fire wood, documented and sent in to be added to the punch list

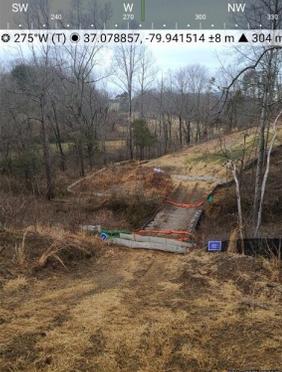
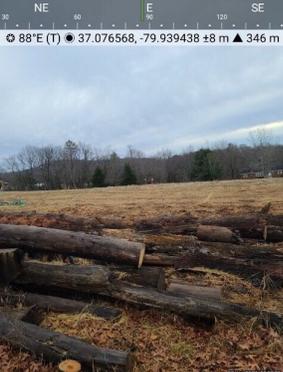
GPS Location	00000		GPS Location	00000	
Field Station#	13728+11		Field Station#	13739+00	
Pic 3 Desc.	The EI monitored equipment bridge and stabilization on hill side above stream crossing, no environmental issues observed at the time of inspection		Pic 4 Desc.	Photo showing CFS moved by land owner to access the row to cut fire wood, documented and sent in to be added to the punch list.

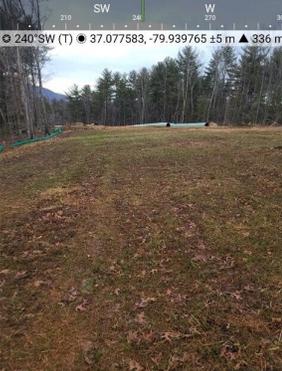
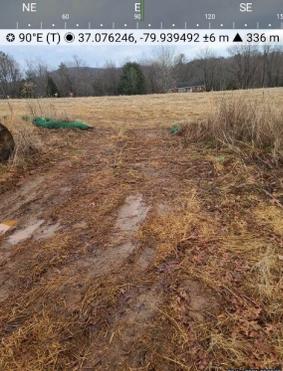
Field Station#	13738+37		Field Station#	13740+00	
Pic 5 Desc.	Vegetation observation photo taken by the EI showing new growth .		Pic 6 Desc.	Additional photo showing CFS moved by the land owner to access the row, documented and sent in to be added to the punch list.

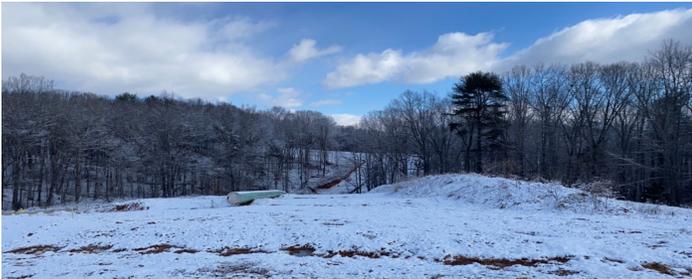
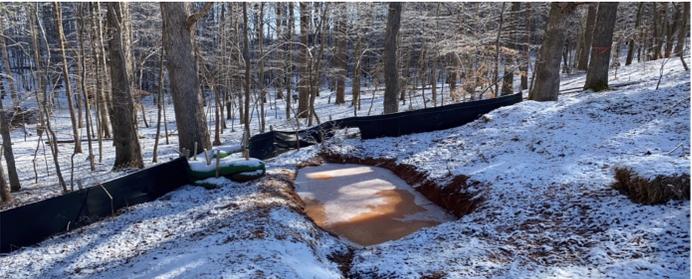
GPS Location	1	GPS Location	2
Field Station#	14173+00	Field Station#	14175+50
Pic 1 Desc.	ROW frozen and covered in snow during inspection	Pic 2 Desc.	Water in sumps frozen during inspection

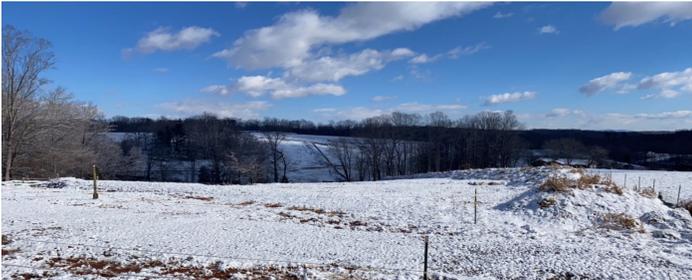
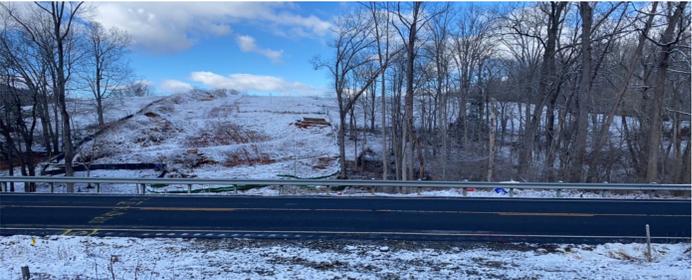
GPS Location	3	GPS Location	4
Field Station#	14185+00	Field Station#	14210+00
Pic 3 Desc.	ROW frozen and covered in snow during inspection	Pic 4 Desc.	ROW frozen and covered in snow during inspection

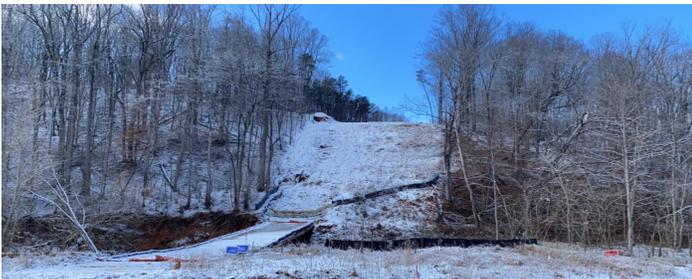
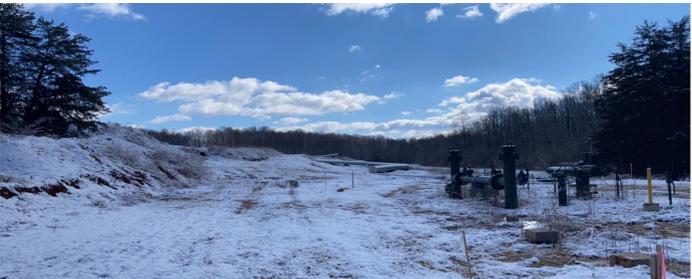
GPS Location	5	GPS Location	6
Field Station#	14233+00	Field Station#	14239+00
Pic 5 Desc.	ROW frozen and covered in snow during inspection	Pic 6 Desc.	ROW frozen and covered in snow during inspection

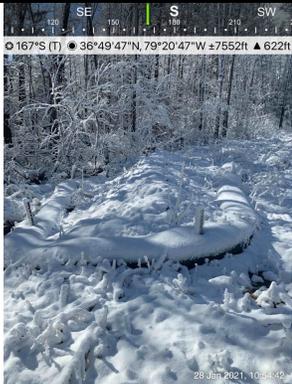
<p>GPS: 153°SE (T) ● 36°49'47"N, 79°20'45"W ±13ft ▲ 620ft 28 Jan 2021, 10:52:25</p>	
GPS Location	O		GPS Location	O	
Field Station#	16013+00		Field Station#	16016+36	
Pic 1 Desc.	Observing CWD outlet and ECD's		Pic 2 Desc.	Observing equipment crossing,buffer and stream

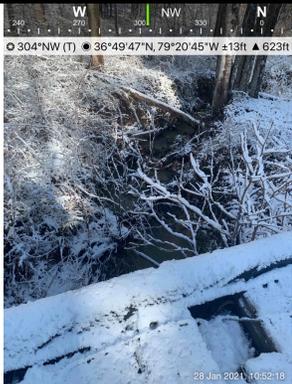
<p>GPS: 193°S (T) ● 36°49'48"N, 79°20'44"W ±55ft ▲ 610ft 28 Jan 2021, 10:51:39</p>	
GPS Location	O		GPS Location	O	
Field Station#	16016+36		Field Station#	16016+36	
Pic 3 Desc.	Observing side board and stream.		Pic 4 Desc.	Observing equipment crossing

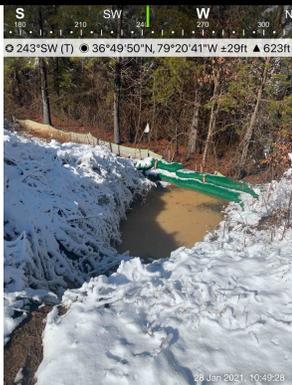
GPS Location	O		GPS Location	O	
Field Station#	16020+00		Field Station#	16022+00	
Pic 5 Desc.	Observing sump and end treatment		Pic 6 Desc.	Observing water bar and cfs check

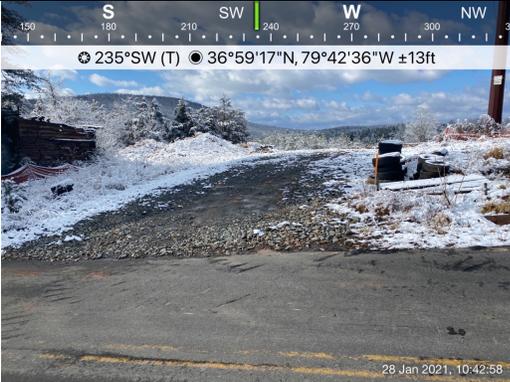
<p>GPS: 226°SW (T) ● 36°59'17"N, 79°42'38"W ±52ft 28 Jan 2021, 10:44:04</p>	
GPS Location	0	GPS Location	0
Field Station#	14694+50	Field Station#	14693+00
Pic 1 Desc.	Approximately 14694+50. Overview of road crossing and RCE. RCE installed and appears to be functioning correctly at time of inspection.	Pic 2 Desc.	Approximately 14693+00. Overview of ROW.

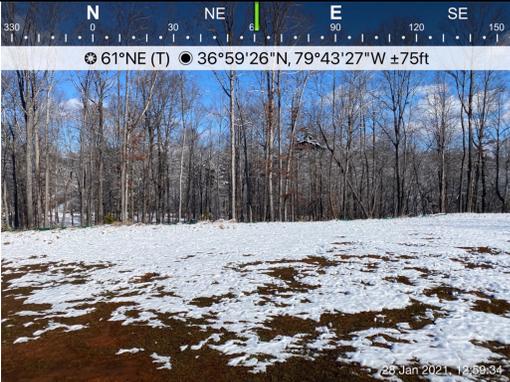
<p>GPS: 98°E (T) ● 36°59'41"N, 79°43'10"W ±17988ft 28 Jan 2021, 13:16:00</p>	
GPS Location	0	GPS Location	0
Field Station#	14651+75	Field Station#	14656+90
Pic 3 Desc.	Approximately 14651+75. Overview of ROW.	Pic 4 Desc.	Approximately 14656+90. Overview of stream crossing, equipment bridge and ECDs at stream S-H38.

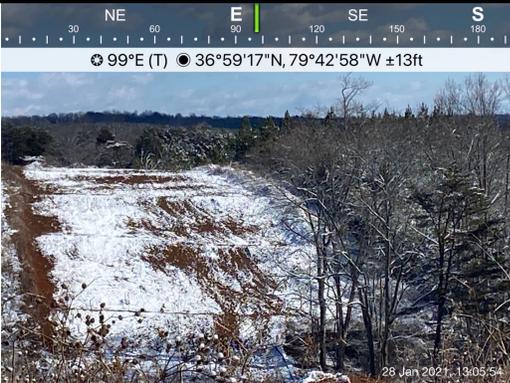
<p>GPS: 245°SW (T) ● 36°59'17"N, 79°42'58"W ±13ft 28 Jan 2021, 13:05:32</p>	
GPS Location	0	GPS Location	0
Field Station#	14684+00	Field Station#	14675+00
Pic 5 Desc.	Approximately 14684+00. Overview of ROW.	Pic 6 Desc.	Approximately 14675+00. Overview of ROW.

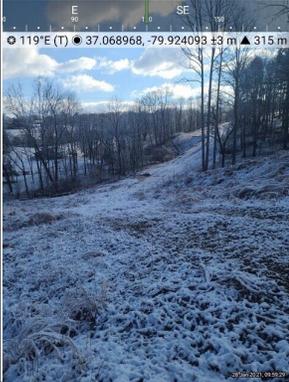
Insert image here		Insert image here	
GPS Location	0000	GPS Location			
Field Station#	13814+23	Field Station#			
Pic 7 Desc.	Row observation after overnight snow event, no environmental issues observed at time of inspection.		Pic 8 Desc.		
Insert image here		Insert image here			
GPS Location		GPS Location			
Field Station#		Field Station#			
Pic 9 Desc.		Pic 10 Desc.			
Insert image here		Insert image here			
GPS Location		GPS Location			
Field Station#		Field Station#			
Pic 11 Desc.		Pic 12 Desc.

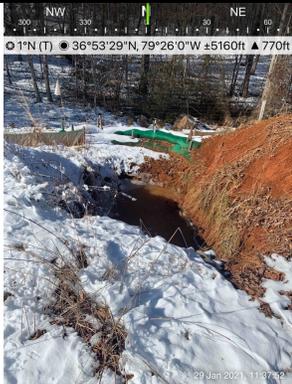
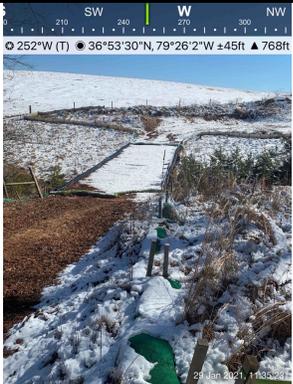
GPS Location	O		
GPS Location	O	GPS Location	O	Field Station#	15639+00		
Field Station#	15639+00	Field Station#	15636+45	Pic 1 Desc.	Observing sump and end treatment		
Pic 1 Desc.		Pic 2 Desc.		Pic 2 Desc.	Observing buffer, equipment crossing and ECD's		
Pic 2 Desc.		Pic 3 Desc.

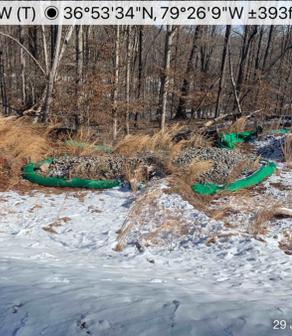
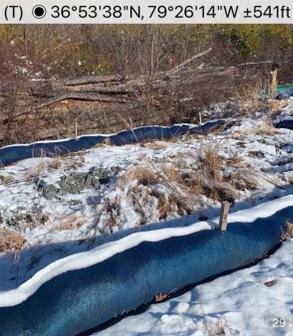
GPS Location	O	GPS Location	O	Field Station#	15636+00		
Field Station#	15636+00	Field Station#	15632+00	Pic 3 Desc.	Observing signage, buffer and ECD's		
Pic 3 Desc.		Pic 4 Desc.		GPS Location	O		
GPS Location	O	GPS Location	O	Field Station#	15631+00		
Field Station#	15631+00	Field Station#	15620+00	Pic 5 Desc.	Observing temporary vegetation, CWD outlet and ECD's		
Pic 5 Desc.		Pic 6 Desc.		Pic 6 Desc.	Observing CWD outlet and ECD's

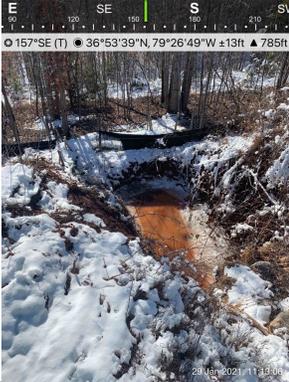
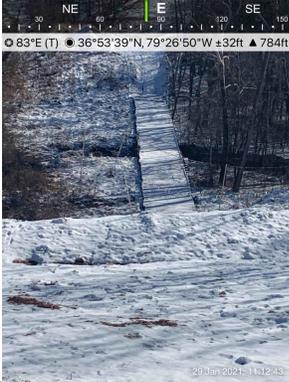
<p>ert image here</p>	
GPS Location O		GPS Location O			
Field Station# 15594+00		Field Station# 15595+60			
Pic 7 Desc. Observing sump and end treatment		Pic 8 Desc. Observing water bar,buffer, equipment crossing and ECD's

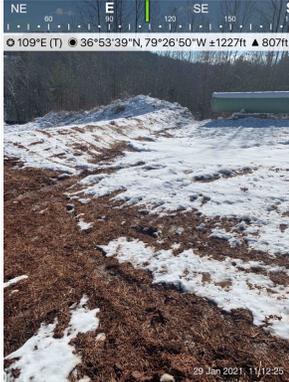
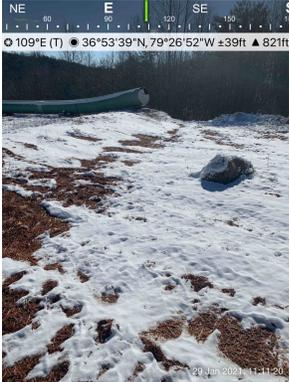
<p>ert image here</p>	
GPS Location O		GPS Location O			
Field Station# 15592+00		Field Station# 15591+00			
Pic 9 Desc. Observing water bar		Pic 10 Desc. Observing water bar			
Insert image here			Insert image here		
GPS Location		GPS Location			
Field Station#		Field Station#			
Pic 11 Desc.		Pic 12 Desc.

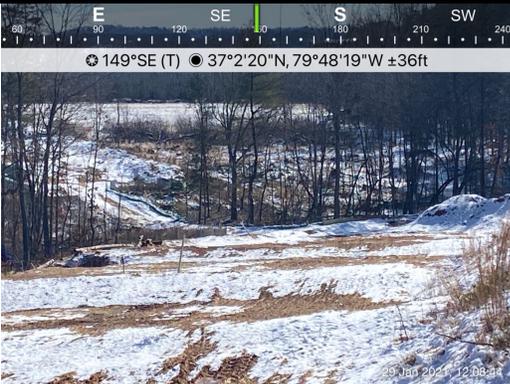
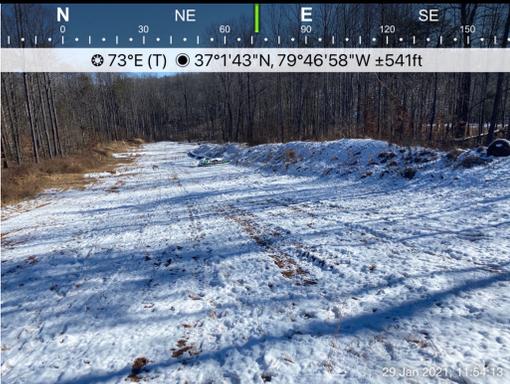
GPS Location	0	GPS Location	0		
Field Station#	14335+00	Field Station#	14415+00		
Pic 3 Desc.	Approximately 14335+00. Overview of ROW.		Pic 4 Desc.	Approximately 14415+00. Overview of ROW.

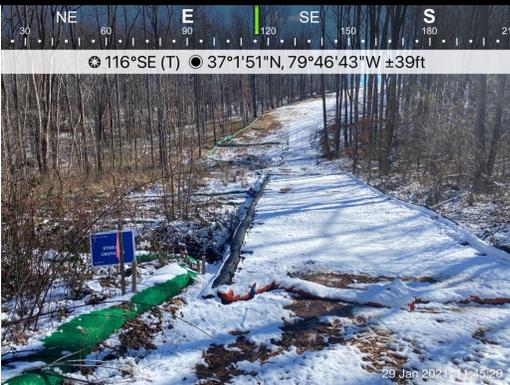
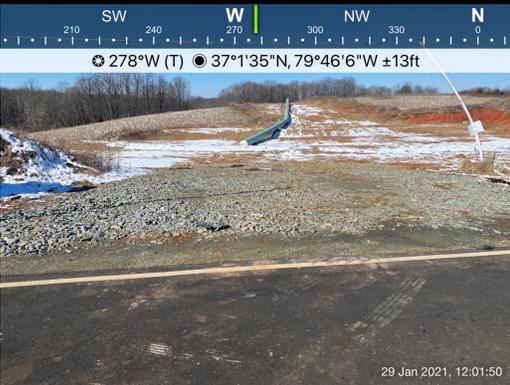
GPS Location	0	GPS Location	0		
Field Station#	14420+21	Field Station#	14454+00		
Pic 5 Desc.	Approximately 14420+21. Overview of stream crossing, equipment bridge and ECDs at stream S-GH36.		Pic 6 Desc.	Approximately 14454+00. Overview of road crossing and RCE. RCE installed and appears to be functioning correctly at time of inspection.
