Visual Site Inspection Report

Project Name H-600 Pipeline Spread I		AFE 124300139	Spread H-600 Pipeline Spread I
Contractor Precision		Report # 19583	
Inspector Justin Burch		Date/Time 2/1/2021 11:38 AM	
Permit # TBD	Inspection Type VA SWPP	Station Begin 14802+19	
State VA	Inspection Area Full	Station End 14928+52	
County Franklin	Ground Frozen	Temperature (°F) 45.00	
Municipality N/A	Weather Cloudy	Rain Gauge (in) 0.90	
Rain Accumulation Time (days)			6.00

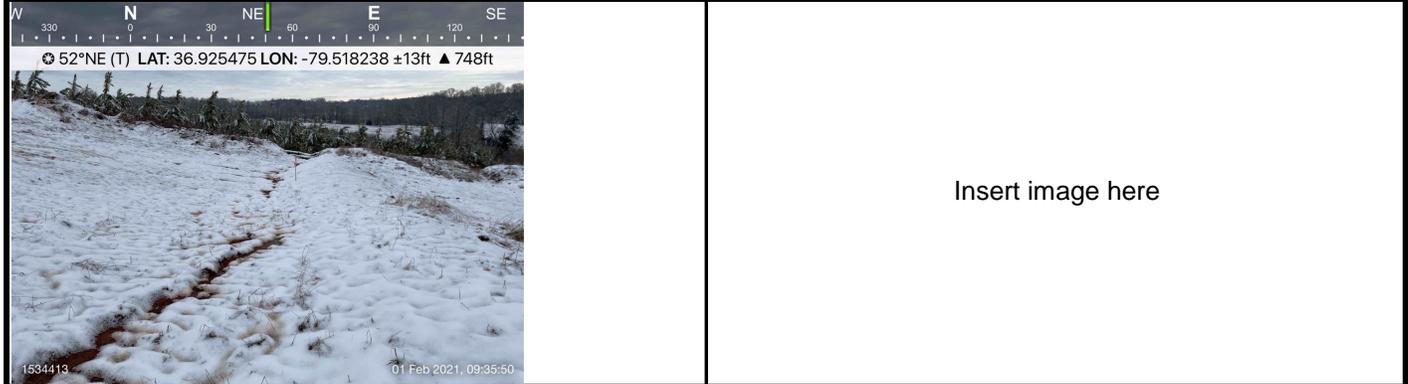
Field Station#	15344+13	Field Station#	
-----------------------	----------	-----------------------	--

Pic 7 Desc.	Waterbars are functioning as intended.	Pic 8 Desc.	
--------------------	--	--------------------	--

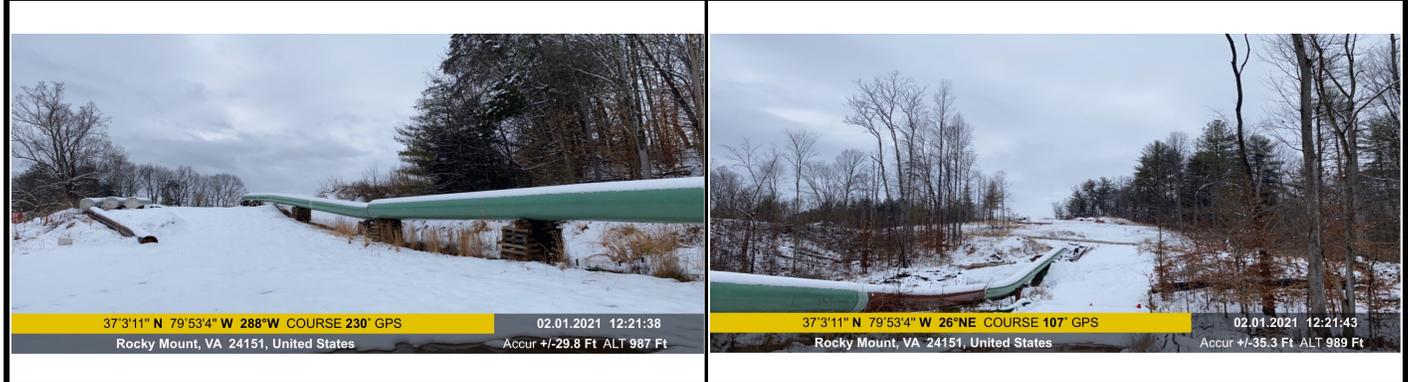
GPS Location	1	GPS Location	2
Field Station#	13995+00	Field Station#	14004+00
Pic 1 Desc.	Snowy ground conditions observed during inspection	Pic 2 Desc.	Snowy ground conditions observed during inspection

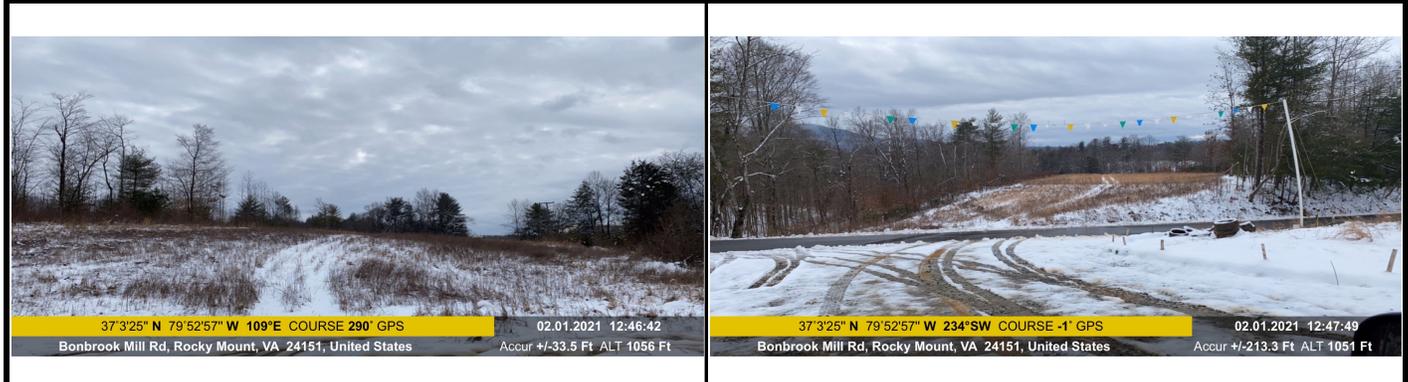
GPS Location	3	GPS Location	4
Field Station#	14011+00	Field Station#	14018+47
Pic 3 Desc.	Snowy ground conditions observed during inspection	Pic 4 Desc.	Snowy ground conditions observed during inspection

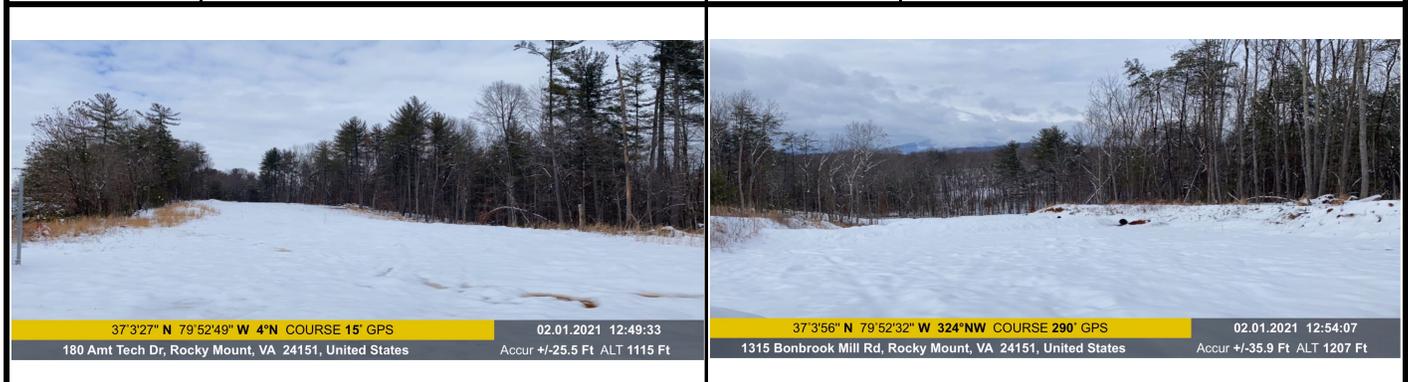
GPS Location	5	GPS Location	6
Field Station#	14026+00	Field Station#	14060+00
Pic 5 Desc.	Snowy ground conditions observed during inspection	Pic 6 Desc.	Snowy ground conditions observed during inspection

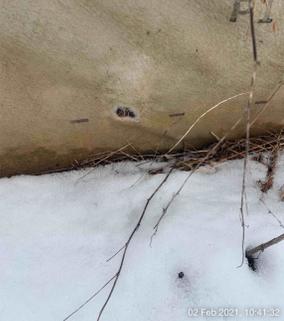
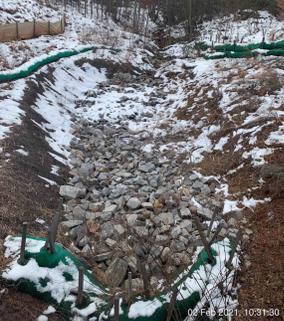
GPS Location O		GPS Location O			
Field Station# 15886+00		Field Station# 15860+00			
Pic 1 Desc. Observing p1 that requires maintenance		Pic 2 Desc. Observing rock lined channel and ECD's			
<p>South Elevation <small>19°N (T) ● 36°51'7"N, 79°23'14"W ±121ft ▲ 790ft</small></p>

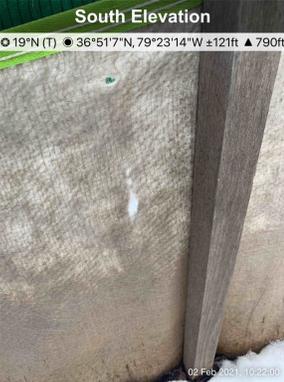
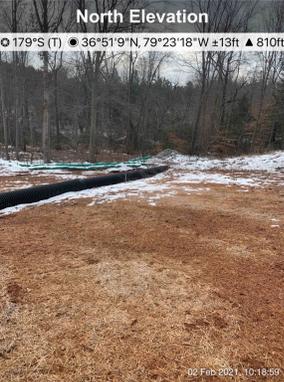
GPS Location O		GPS Location O			
Field Station# 15850+00		Field Station# 15839+00			
Pic 3 Desc. Observing p1 that requires maintenance		Pic 4 Desc. Observing CWD pipe and ECD's			
<p>West Elevation <small>103°E (T) ● 36°51'9"N, 79°23'19"W ±22ft ▲ 810ft</small></p>

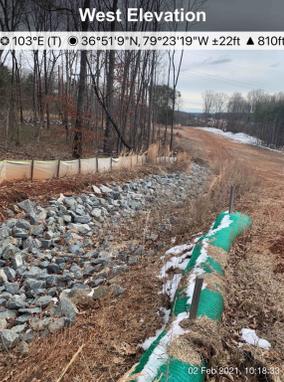
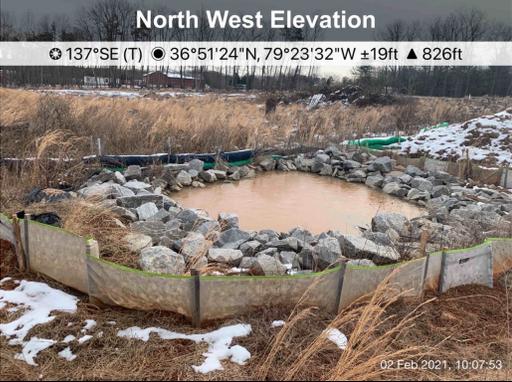
GPS Location O		GPS Location O			
Field Station# 15838+00		Field Station# 15825+00			
Pic 5 Desc. Observing rock drain and ECD's		Pic 6 Desc. Observing plunge pool and ECD's

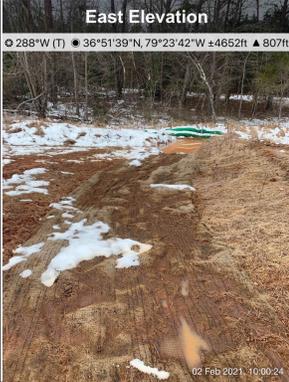
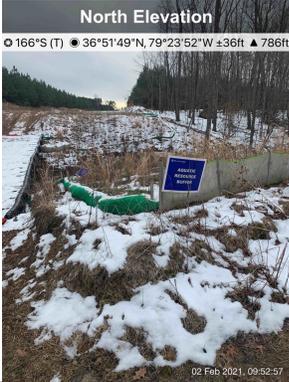
<p>North Elevation <small>166°S (T) ● 36°51'49"N, 79°23'52"W ±36ft ▲ 786ft</small> <small>02 Feb 2021, 09:52:57</small></p>		<p>ert image here</p>	
GPS Location ○		GPS Location ○					
Field Station# 15809+00		Field Station# 15794+20					
Pic 7 Desc. Observing water bar, erosion control blanket, sump and end treatment		Pic 8 Desc. Observing signage, buffer and ECD's

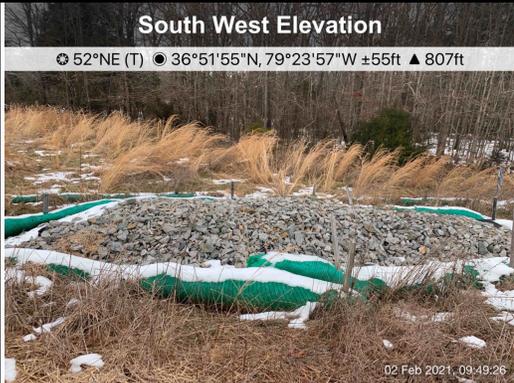
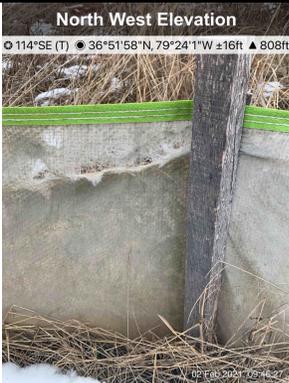
GPS Location ○		GPS Location ○					
Field Station# 15785+00		Field Station# 15780+50					
Pic 9 Desc. Observing CWD outlet and ECD's		Pic 10 Desc. Observing p1 that requires					
<p>Insert image here</p>			<p>Insert image here</p>				
GPS Location		GPS Location					
Field Station#		Field Station#					
Pic 11 Desc.		Pic 12 Desc.

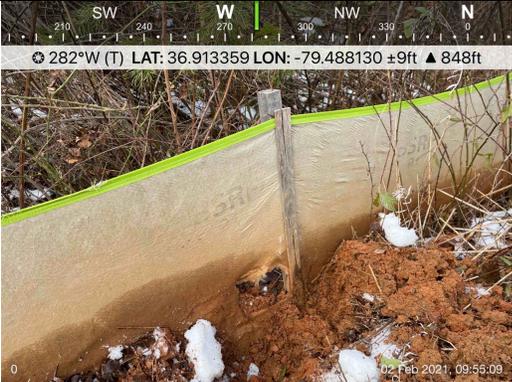
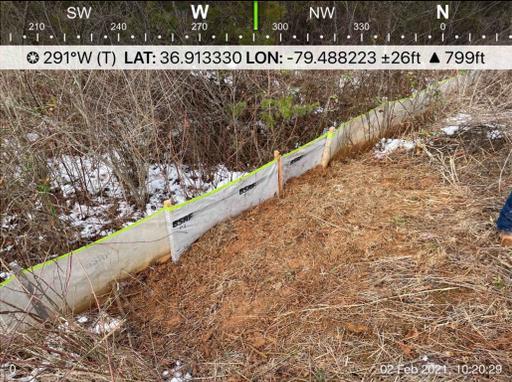
E&S BMPs	Compliance Level	Corrective Action	Corrective Time Frame	Date Repaired
Silt Fence (Filter Fabric Fence)	Communication	P1 has been damaged and needs to	Addressed	2/2/2021
Cleanwater Diversion Pipe	Acceptable			
Compost Filter Sock	Acceptable			
Equipment Bridge	Acceptable			
Rock Construction Entrance	Acceptable			
Silt Fence (Reinforced Filter Fabric Fence)	Acceptable

<p>GPS: 291°W (T) LAT: 36.913330 LON: -79.488223 ±26ft ▲ 799ft 02 Feb 2021 10:20:29</p>			
GPS Location See photo		GPS Location See photo			
Field Station# 15446+00		Field Station# 15446+00			
Pic 1 Desc. P1 has been damaged and needs to be replaced.		Pic 2 Desc. Environmental crew has corrected this issue.

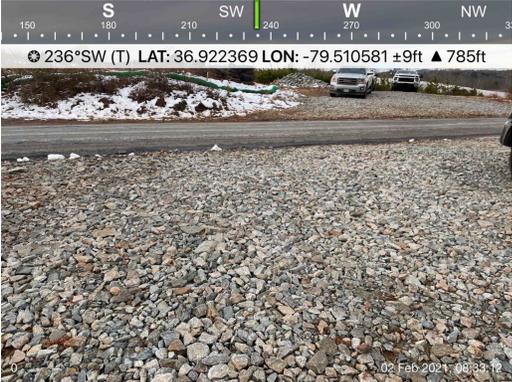
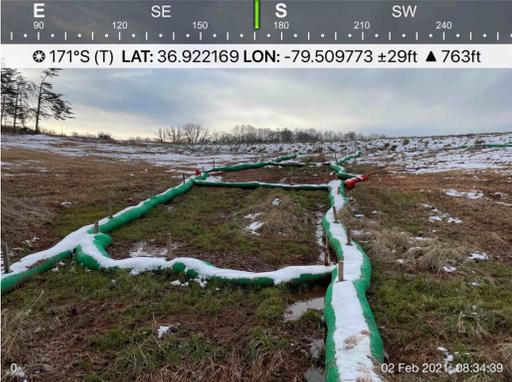
<p>GPS: 171°S (T) LAT: 36.922169 LON: -79.509773 ±29ft ▲ 763ft 02 Feb 2021 08:34:39</p>			
GPS Location See photo		GPS Location See photo			
Field Station# 15370+62		Field Station# 15373+00			
Pic 3 Desc. RCEs are in good condition at all road crossings.		Pic 4 Desc. CFS is in good condition and functioning throughout this section.

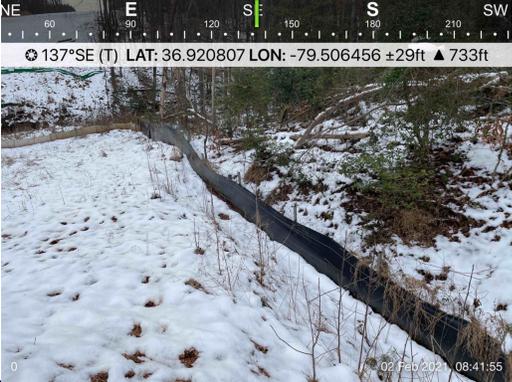
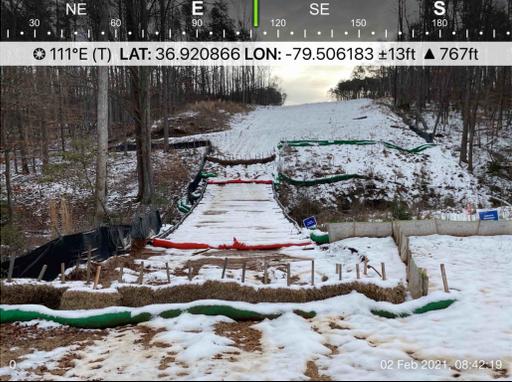
<p>GPS: 111°E (T) LAT: 36.920866 LON: -79.506183 ±13ft ▲ 767ft 02 Feb 2021 08:42:19</p>			
GPS Location See photo		GPS Location See photo			
Field Station# 15383+00		Field Station# 15384+74			
Pic 5 Desc. Perimeter SSF is in good condition.		Pic 6 Desc. Equipment bridge ECDs are in place and functioning at all stream and wetland crossings.

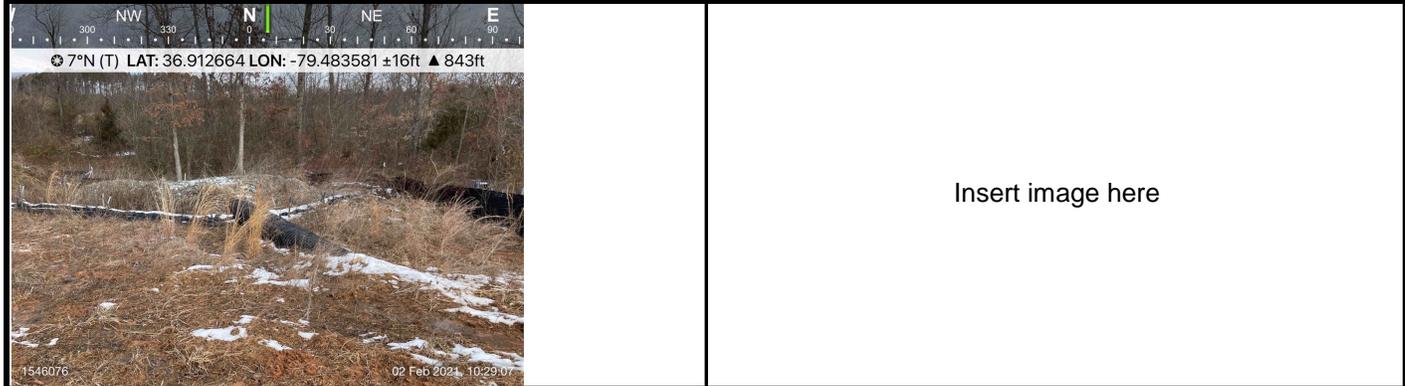
Field Station#	15460+00	Field Station#	
-----------------------	----------	-----------------------	--

Pic 7 Desc.	CWDs are functioning as intended.	Pic 8 Desc.	
--------------------	-----------------------------------	--------------------	--

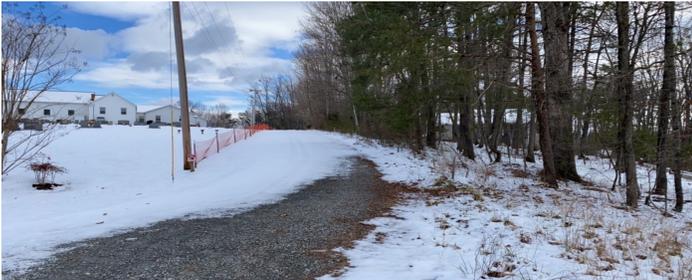
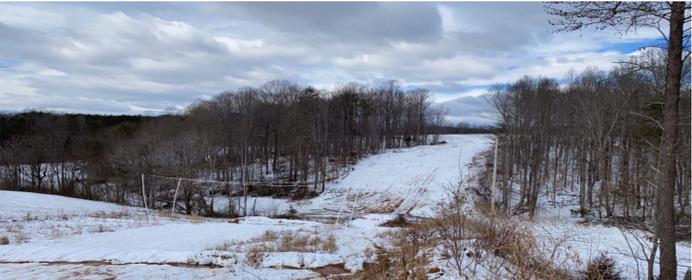
GPS Location	3	GPS Location	4
Field Station#	14072+87	Field Station#	13126+50
Pic 3 Desc.	Frozen/snowy ground conditions observed during inspection. RCE at MVP-FR-309.05 in good condition.	Pic 4 Desc.	Frozen/snowy ground conditions observed during inspection. Perimeter controls in place and functional.

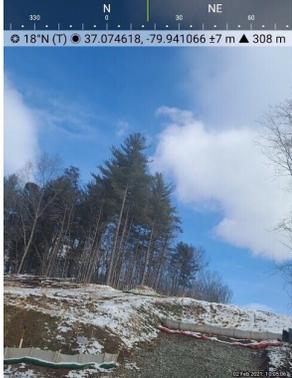
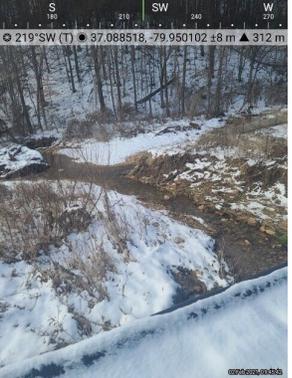
GPS Location	00000	GPS Location	0000	
Field Station#	13748+10	Field Station#	13678+71	
Pic 5 Desc.	EI checked ECDs at road crossing , no issue observed, all ECDs up to spec and functioning .	Pic 6 Desc.	Stream observation photo facing downstream. No environmental issue observed at time of inspection by the EI

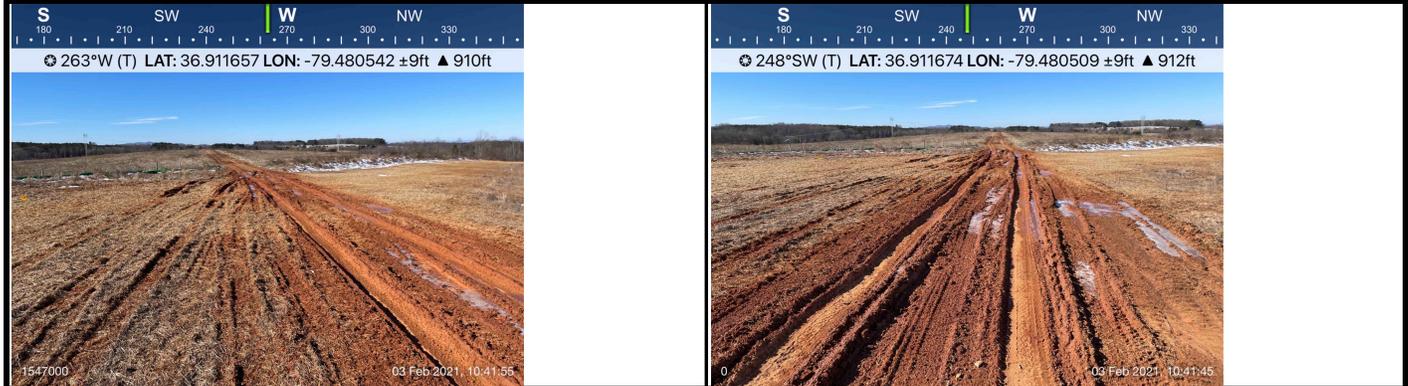
GPS Location	See photo	GPS Location	See photo
Field Station#	15470+00	Field Station#	15470+00
Pic 7 Desc.	3rd party has rutted farm road crossing ROW.	Pic 8 Desc.	3rd party has rutted farm road crossing ROW.

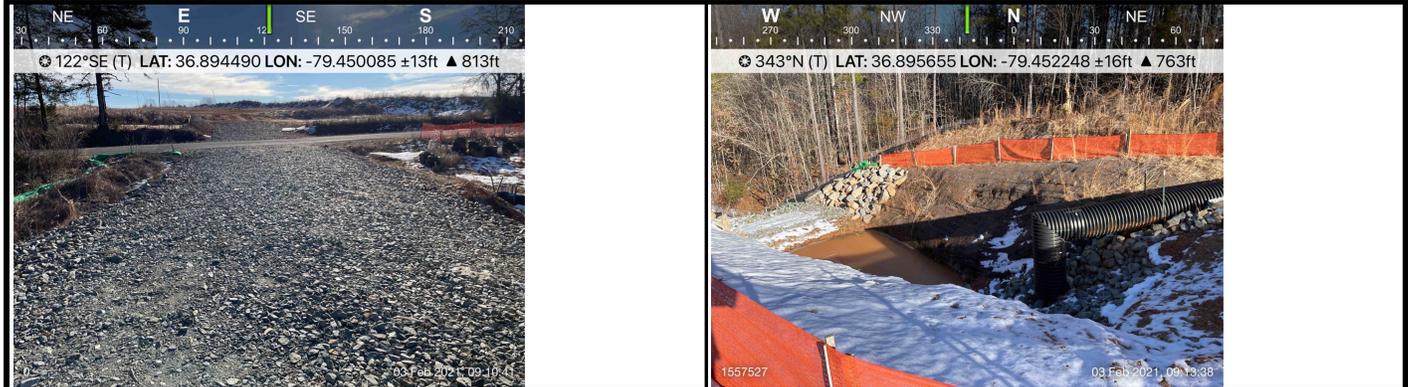
GPS Location	See photo	GPS Location	See photo
Field Station#	15584+00	Field Station#	15575+27
Pic 9 Desc.	RCEs in good condition at all road crossings.	Pic 10 Desc.	Slope drain is in good condition and functioning.

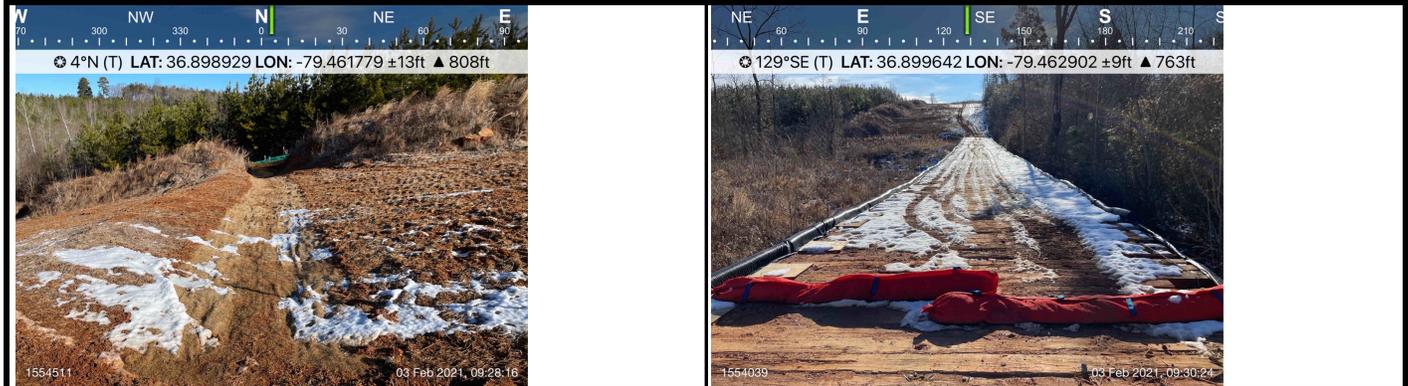
GPS Location	See photo	GPS Location	See photo
Field Station#	15545+11	Field Station#	15549+39
Pic 11 Desc.	Waterbars are in good condition.	Pic 12 Desc.	Equipment bridge ECDs in place and functioning.

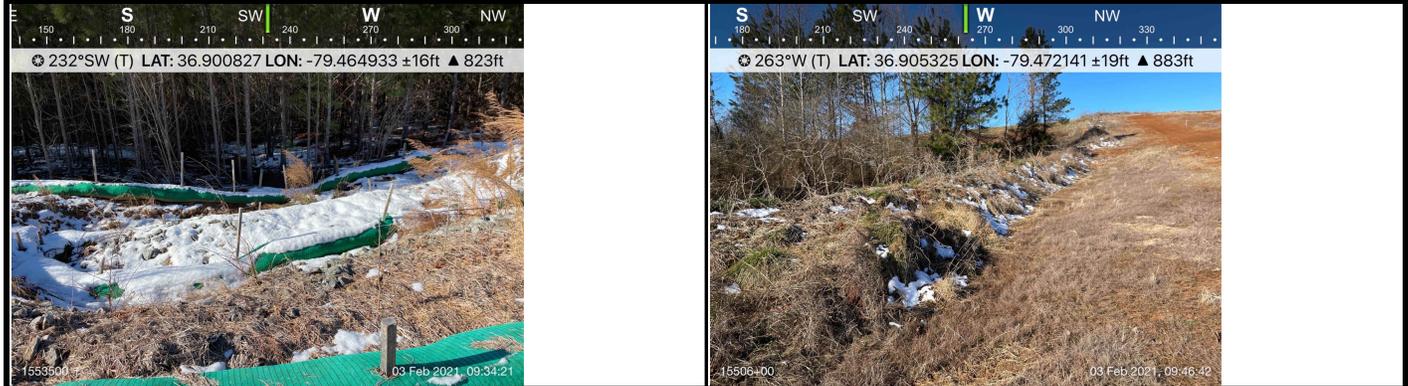
Field Station#	15535+00	Field Station#	15506+00
-----------------------	----------	-----------------------	----------

Pic 13 Desc.	CWDs functioning as intended.	Pic 14 Desc.	Stockpiles remain stabilized.
---------------------	-------------------------------	---------------------	-------------------------------

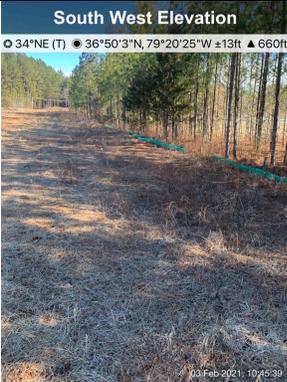
<p>South West Elevation <small>34°NE (T) 36°50'3"N, 79°20'25"W ±13ft ▲ 660ft</small> <small>03 Feb 2021, 10:45:39</small></p>	
GPS Location	O	GPS Location	O		
Field Station#	13+00	Field Station#	9+00		
Pic 1 Desc.	Observing sump and end treatment	Pic 2 Desc.	Observing temporary stabilization and CFS

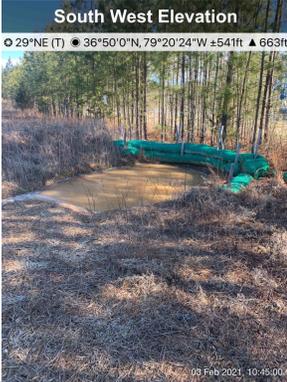
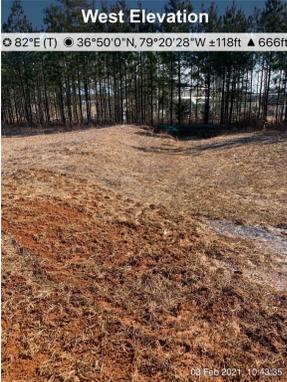
<p>West Elevation <small>82°E (T) 36°50'0"N, 79°20'28"W ±118ft ▲ 666ft</small> <small>03 Feb 2021, 10:43:35</small></p>		
GPS Location	O	GPS Location	O		
Field Station#	8+00	Field Station#	10+00		
Pic 3 Desc.	Observing temporary stabilization, sump and end treatment	Pic 4 Desc.	Observing water bar and temporary stabilization

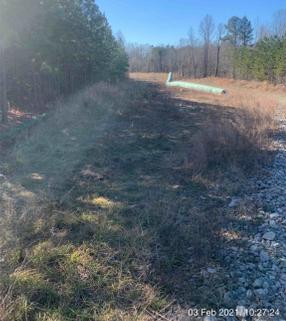
<p>03 Feb 2021 10:26:05</p>	
GPS Location		O		GPS Location		O	
Field Station#		6+00		Field Station#		11+50	
Pic 1 Desc.		Observing temporary vegetation		Pic 2 Desc.		Observing temporary vegetation and signage	
		<p>North East Elevation</p> <p>208°SW (T) ● 36°49'44"N, 79°20'39"W ±13ft ▲ 621ft</p>

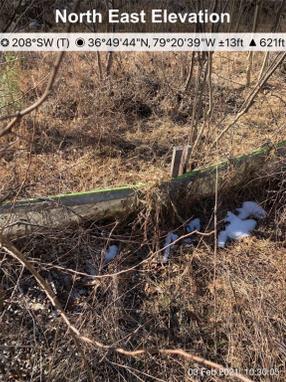
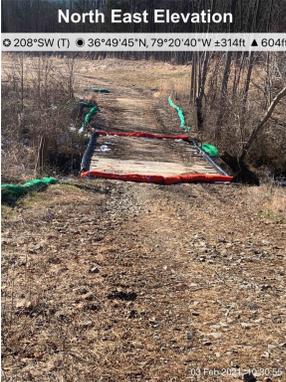
<p>03 Feb 2021 12:30:35</p>	
GPS Location		O		GPS Location		O	
Field Station#		12+15		Field Station#		12+65	
Pic 3 Desc.		Observing buffer and p1 that requires maintenance		Pic 4 Desc.		Observing equipment crossing and ECD's

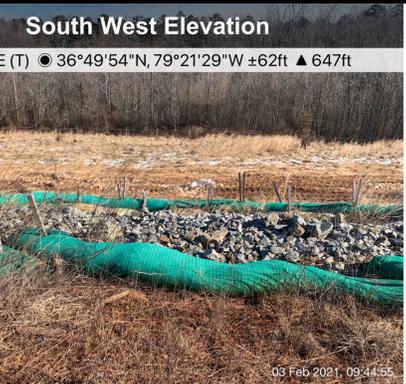
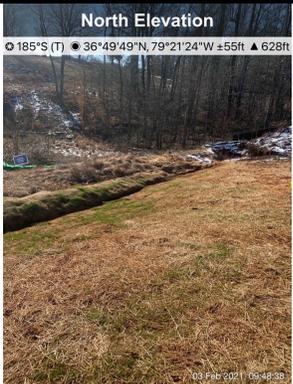
GPS Location	O		GPS Location	O	
Field Station#	15970+00		Field Station#	15974+50	
Pic 3 Desc.	Observing temporary vegetation,CWD outlet and ECD's		Pic 4 Desc.	Observing temporary stabilization,erosion control blanket,signage and buffer

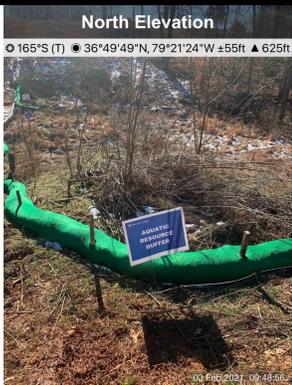
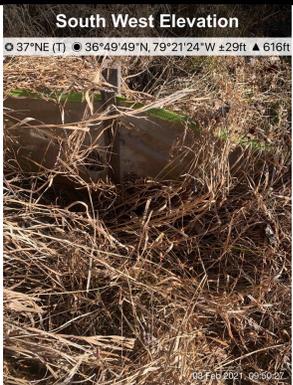
GPS Location	O		GPS Location	O	
Field Station#	15976+79		Field Station#	15977+00	
Pic 5 Desc.	Observing signage, buffer and ECD's		Pic 6 Desc.	Observing p1 that requires maintenance.

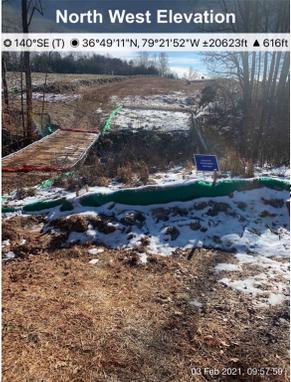
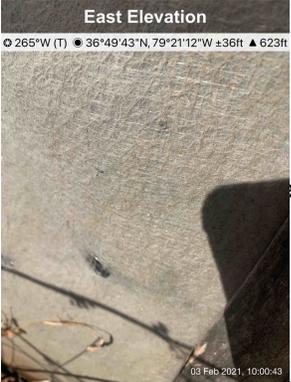
<p>East Elevation <small>265°W (T) 36°49'43"N, 79°21'12"W ±36ft ▲ 623ft</small> <small>03 Feb 2021, 10:00:43</small></p>		<p>ert image here</p>	
GPS Location O		GPS Location O			
Field Station# 15986+50		Field Station# 15987+81			
Pic 7 Desc. Observing temporary stabilization, equipment crossing, signage and buffer		Pic 8 Desc. Observing p1 that requires maintenance

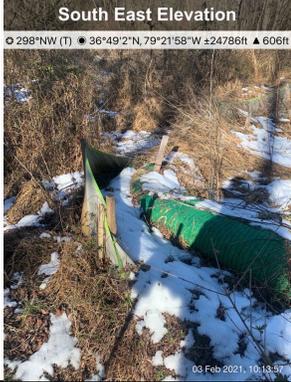
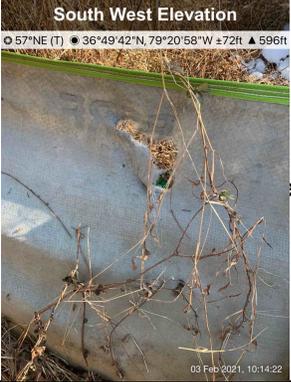
Pic 9 Desc. Observing p1 that requires maintenance		Pic 10 Desc. Observing p1 that requires maintenance

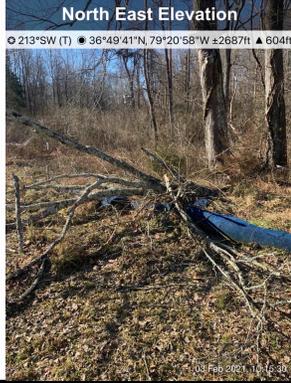
<p>North East Elevation <small>213°SW (T) 36°49'41"N, 79°20'58"W ±2687ft ▲ 604ft</small> <small>03 Feb 2021, 11:29:31</small></p>		<p>ert image here</p>		<p>Insert image here</p>	
GPS Location O		GPS Location			
Field Station# 16004+05		Field Station#			
Pic 11 Desc. Observing tree limbs that need to be removed from the CFS.		Pic 12 Desc.

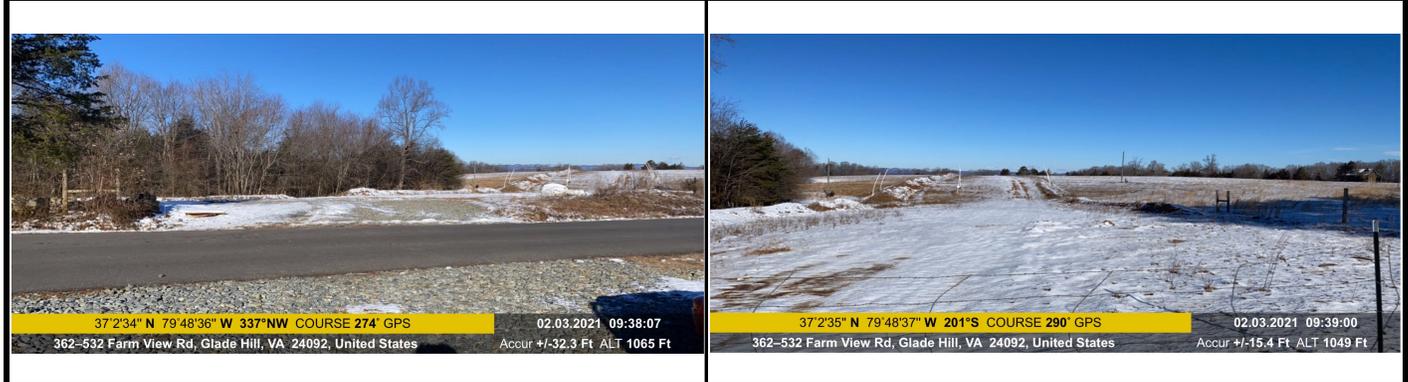
GPS Location 1	GPS Location 2
Field Station# 14311+57	Field Station# 14308+00
Pic 1 Desc. RCE at Farm View RD in good condition. Frozen/snowy ground conditions observed during inspection.	Pic 2 Desc. Frozen/snowy ground conditions observed during inspection.

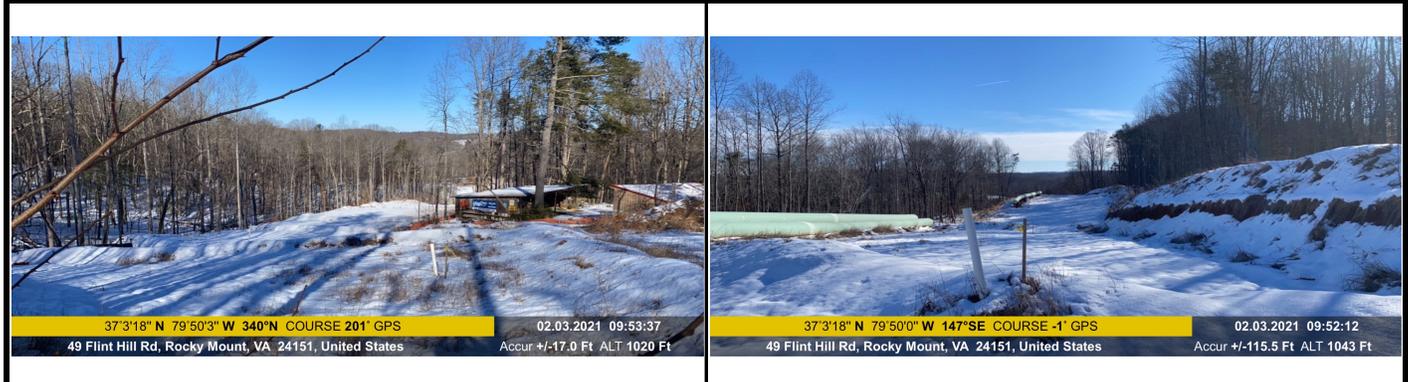
GPS Location 3	GPS Location 4
Field Station# 14217+00	Field Station# 14224+00
Pic 3 Desc. Frozen/snowy ground conditions observed during inspection.	Pic 4 Desc. Frozen/snowy ground conditions observed during inspection.

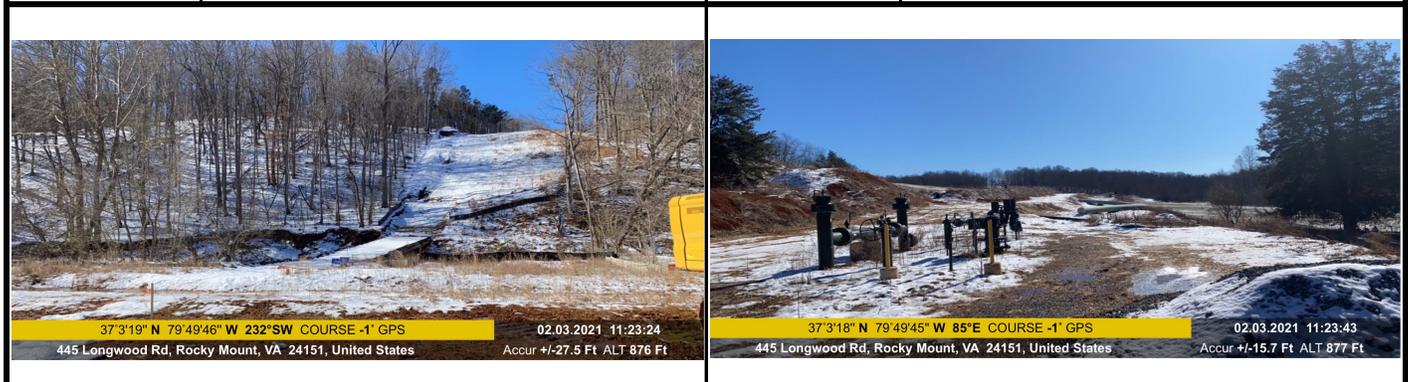
GPS Location 5	GPS Location 6
Field Station# 14230+00	Field Station# 14236+10
Pic 5 Desc. Frozen/snowy ground conditions observed during inspection.	Pic 6 Desc. Frozen/snowy ground conditions observed during inspection.

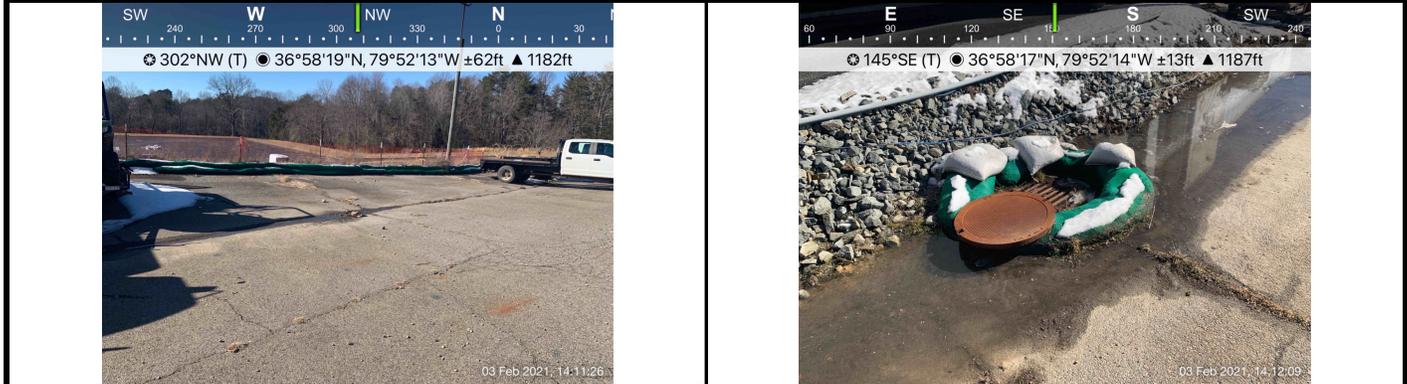
Pic 1 Desc.	Perimeter ECD's on west side of paved yard in good condition.	Pic 2 Desc.	Inlet protection for parking lot drain near storage building in acceptable condition.
--------------------	---	--------------------	---

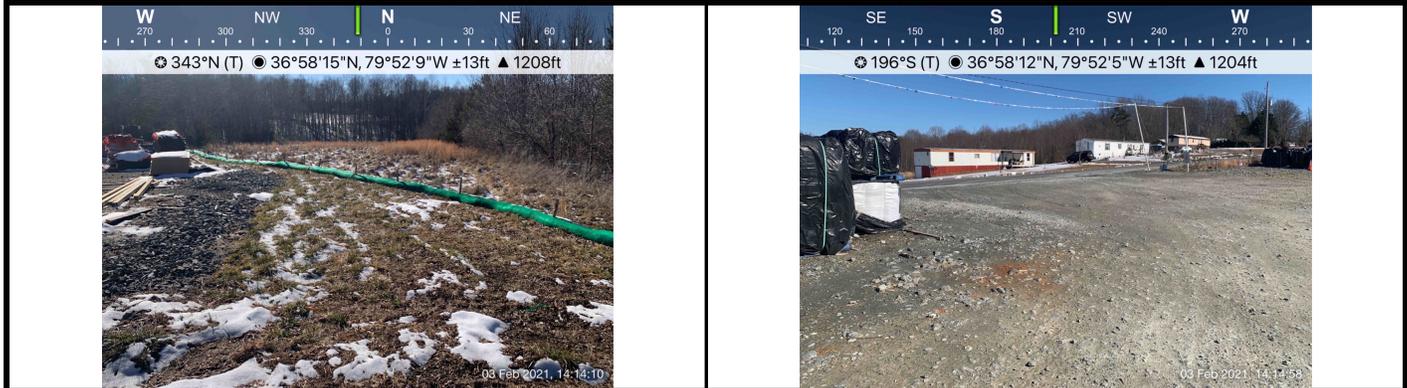
Pic 3 Desc.	Perimeter ECD's on north end of gravel yard in good condition.	Pic 4 Desc.	RCE at gravel yard in good condition.
--------------------	--	--------------------	---------------------------------------

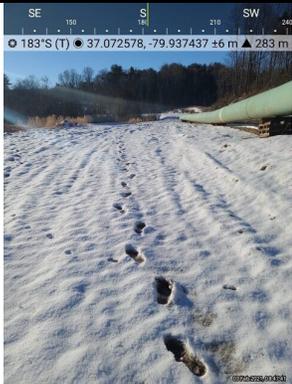
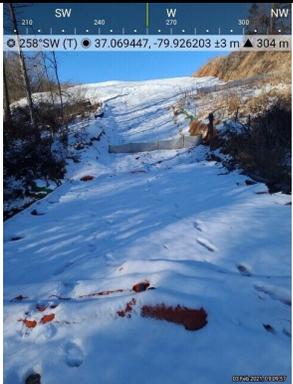
GPS Location	00000		GPS Location	00000
Field Station#	13762+12		Field Station#	13805+70
Pic 1 Desc.	Row photo taken by the EI during routine inspection showing snow covered row .		Pic 2 Desc.	The EI monitored equipment bridges and ECDs during routine inspection today, no environmental issues observed at the time of inspection.

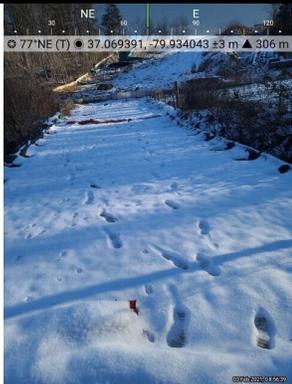
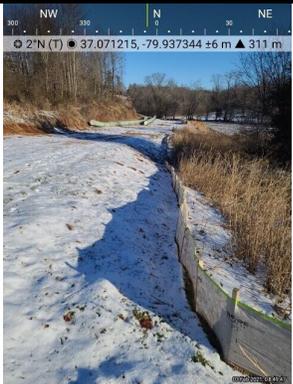
GPS Location	000000		GPS Location	00000
Field Station#	13781+62		Field Station#	13765+23
Pic 3 Desc.	Equipment bridge and protection inspected during travels throughout the row today.		Pic 4 Desc.	The EI inspected ECDs throughout the row travel today, no environmental issues observed at the time of inspection.

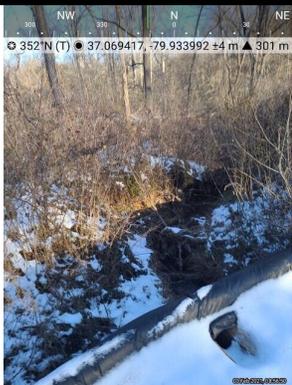
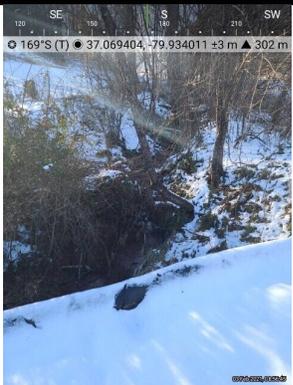
GPS Location	00000		GPS Location	00000
Field Station#	13805+70		Field Station#	13805+70
Pic 5 Desc.	Stream observation photo facing downstream during routine inspection today.		Pic 6 Desc.	Stream observation photo facing upstream during routine inspection today.

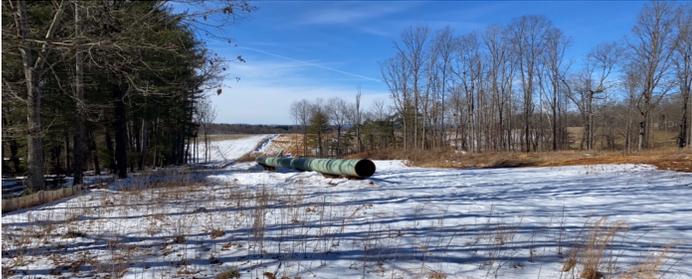
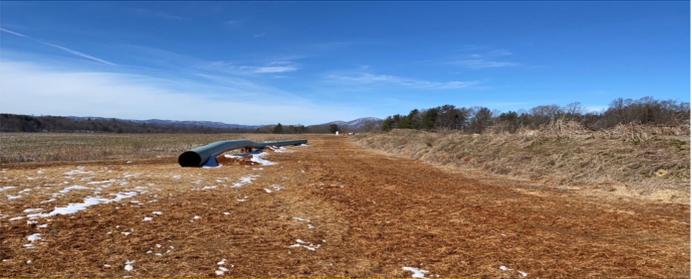
<p>37°25'1" N 79°53'44" W 283°W COURSE 218° GPS 02.04.2021 11:37:08 356 Foggy Ridge Rd, Rocky Mount, VA 24151, United States Accur +/-44.1 Ft ALT 1094 Ft</p>			<p>37°25'2" N 79°53'56" W 328°NW COURSE 288° GPS 02.04.2021 11:43:13 184 Foggy Ridge Rd, Rocky Mount, VA 24151, United States Accur +/-73.3 Ft ALT 1070 Ft</p>		
GPS Location	1		GPS Location	2	
Field Station#	13954+00		Field Station#	13943+00	
Pic 1 Desc.	ROW covered in snow in multiple locations in section during inspection.		Pic 2 Desc.	Temporary stabilized area CIS Foggy Ridge Rd. Area will be aerial seeded/stabilized.

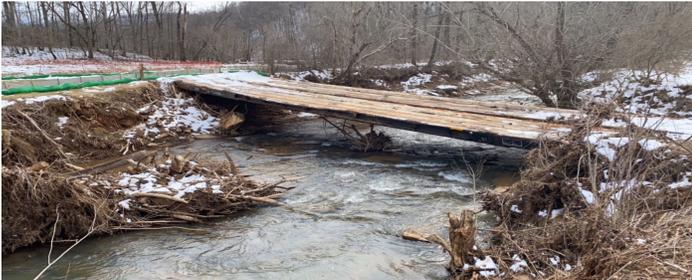
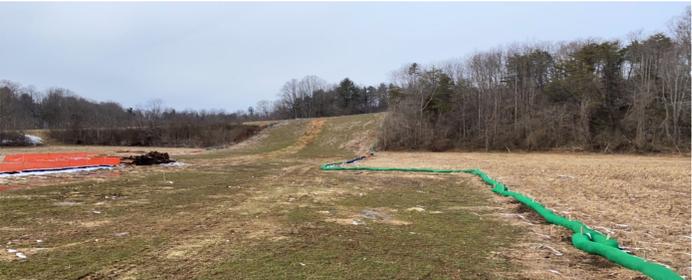
GPS Location	3		GPS Location	4	
Field Station#	13915+51		Field Station#	13912+48	
Pic 3 Desc.	View of S-II2 stream crossing from ROW. No new issues to report.		Pic 4 Desc.	Extra workspace in good condition. Perimeter controls in place and functional.

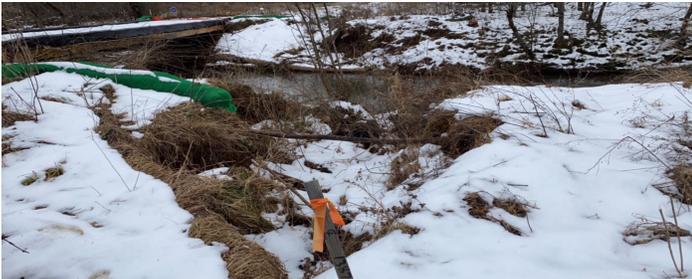
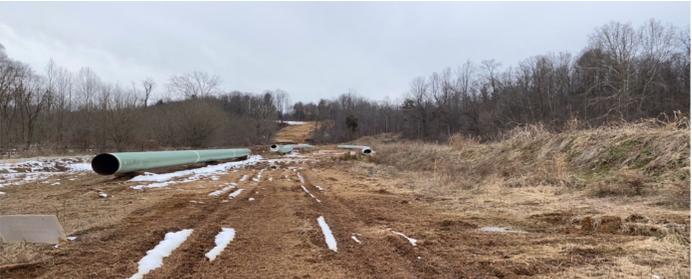
<p>37°3'27" N 79°54'50" W 98°E COURSE 151° GPS 02.04.2021 14:25:35 404 Old Mill Creek Ln, Rocky Mount, VA 24151, United States Accur +/-46.6 Ft ALT 1030 Ft</p>			<p>37°3'27" N 79°54'55" W 309°NW COURSE 69° GPS 02.04.2021 14:27:20 404 Old Mill Creek Ln, Rocky Mount, VA 24151, United States Accur +/-71.5 Ft ALT 1029 Ft</p>		
GPS Location	5		GPS Location	6	
Field Station#	13875+16		Field Station#	13866+00	
Pic 5 Desc.	View of ditch subsidence CIS S-CD6.		Pic 6 Desc.	ROW covered in snow in multiple locations in section during inspection.

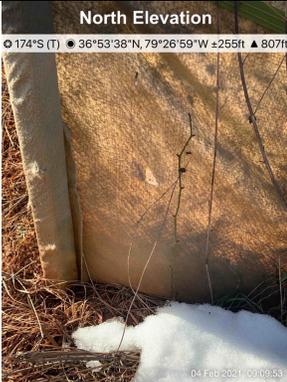
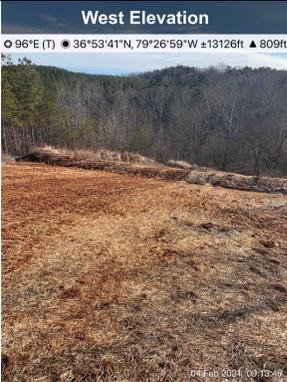
<p>West Elevation <small>96°E (T) ● 36°53'41"N, 79°26'59"W ±13126ft ▲ 809ft</small></p>			
GPS Location O		GPS Location O			
Field Station# 15884+00		Field Station# 15592+00			
Pic 1 Desc. Observing p1 that requires maintenance		Pic 2 Desc. Observing temporary stabilization and water bar.

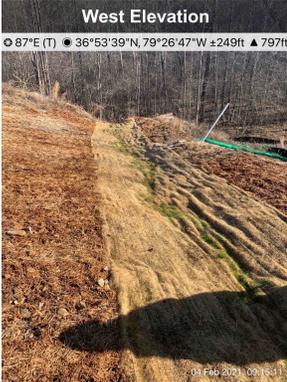
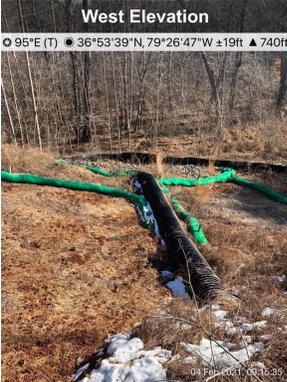
<p>West Elevation <small>95°E (T) ● 36°53'39"N, 79°26'47"W ±19ft ▲ 740ft</small></p>			
GPS Location O		GPS Location O			
Field Station# 15594+00		Field Station# 15595+00			
Pic 3 Desc. Observing temporary stabilization, water bar and erosion control blanket.		Pic 4 Desc. Observing CWD outlet and ECD's

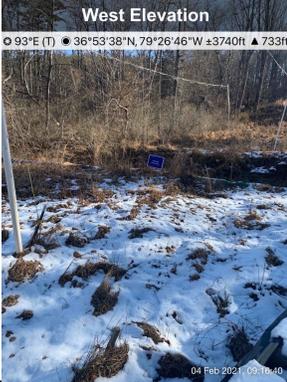
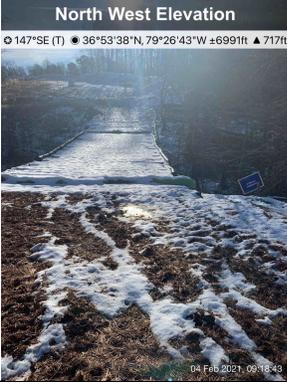
GPS Location O		GPS Location O			
Field Station# 15596+79		Field Station# 15600+12			
Pic 5 Desc. Observing buffer and signage		Pic 6 Desc. Observing equipment crossing, signage and ECD's

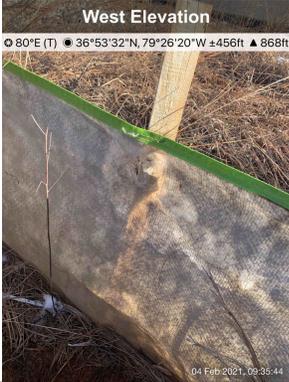
<p>West Elevation <small>80°E (T) 36°53'32"N, 79°26'20"W ±456ft ▲ 868ft</small></p>		<p>ert image here</p>	
GPS Location ○		GPS Location ○			
Field Station# 15630+00		Field Station# 15619+30			
Pic 7 Desc. Observing sump and end treatment		Pic 8 Desc. Observing p1 that requires maintenance

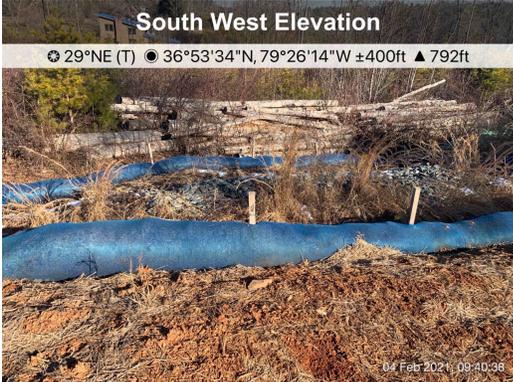
<p>South West Elevation <small>29°NE (T) 36°53'34"N, 79°26'14"W ±400ft ▲ 792ft</small></p>		<p>ert image here</p>	
GPS Location ○		GPS Location ○			
Field Station# 15619+30		Field Station# 15623+00			
Pic 9 Desc. Observing p1 that requires maintenance		Pic 10 Desc. Observing CWD outlet and ECD's

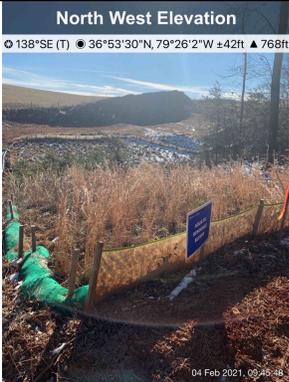
GPS Location ○		GPS Location ○			
Field Station# 15631+00		Field Station# 15635+95			
Pic 11 Desc. Observing CWD outlet and ECD's		Pic 12 Desc. Observing signage, buffer and ECD's

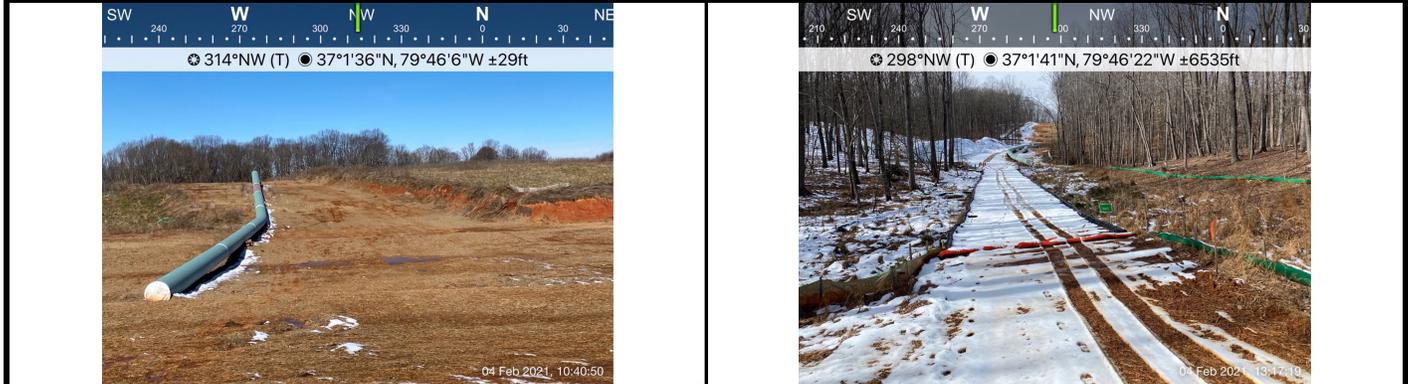
GPS Location	0	GPS Location	0
Field Station#	14450+00	Field Station#	14438+33
Pic 1 Desc.	Approximately 14450+00. Overview of ROW.	Pic 2 Desc.	Approximately 14438+33. Overview of stream crossing, equipment bridge and ECDs at stream S-GH44.

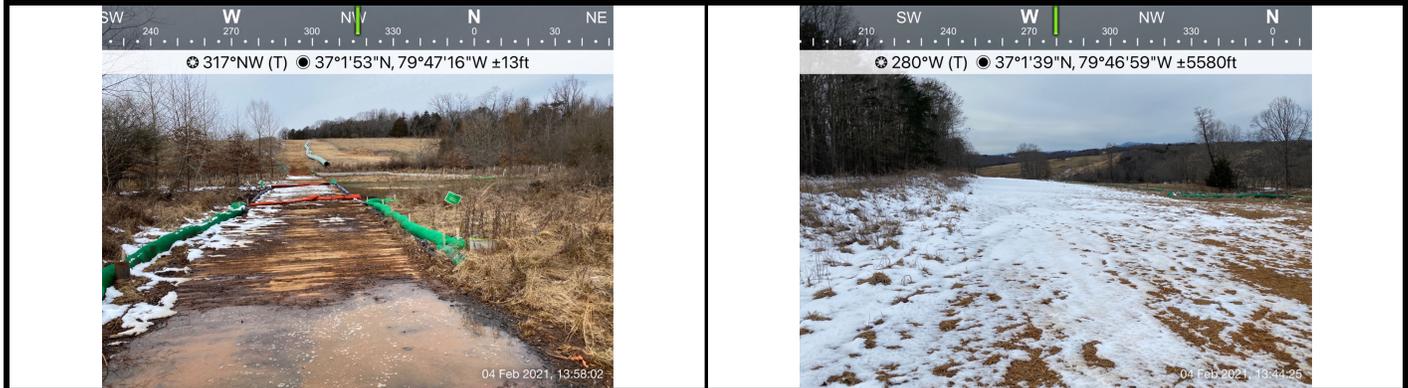
GPS Location	0	GPS Location	0
Field Station#	14391+50	Field Station#	14401+00
Pic 3 Desc.	Approximately 14391+50. Overview of stream crossing, equipment bridge and ECDs at stream S-A41.	Pic 4 Desc.	Approximately 14401+00. Overview of ROW.

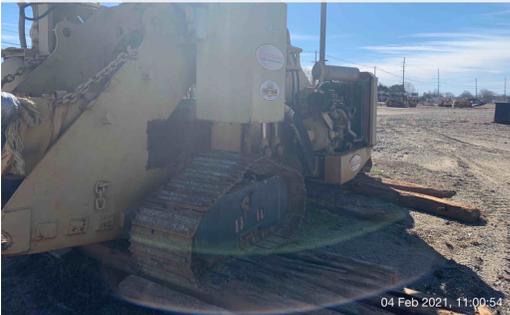
<p style="text-align: right; font-size: small;">04 Feb 2021, 11:08:14</p>			
GPS Location	O	GPS Location	O		
Field Station#	00+00	Field Station#	00+00		
Pic 1 Desc.	Observing staged equipment	Pic 2 Desc.	Observing staged equipment		
<p style="text-align: center;">North East Elevation</p> <p style="text-align: center;">☉ 223°SW (T) ● 36°41'19"N, 79°22'4"W ±213ft ▲ 731ft</p>

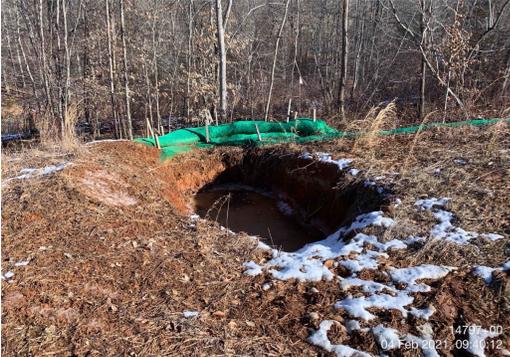
<p>275°W (M) 36°59'12"N, 79°41'44"W ±65ft ▲ 943ft 14738+00 04 Feb 2021, 10:21:43</p>		
GPS Location 0			GPS Location 0		
Field Station# 14797+00			Field Station# 14738+00		
Pic 1 Desc. Waterbar end treatment in acceptable condition			Pic 2 Desc. Waterbar in acceptable condition

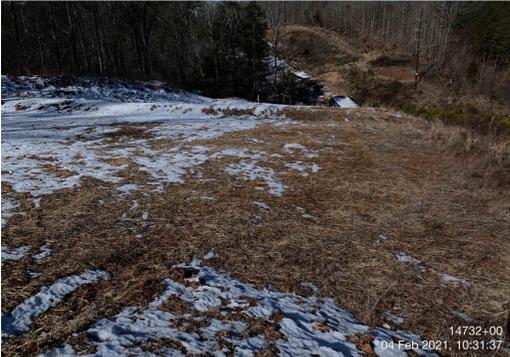
<p>302°NW (M) 36°59'15"N, 79°41'53"W ±469ft ▲ 829ft 14729+00 04 Feb 2021, 10:33:12</p>		
GPS Location 0			GPS Location 0		
Field Station# 14732+00			Field Station# 14729+00		
Pic 3 Desc. Temporary vegetative stabilization in acceptable condition			Pic 4 Desc. P1 silt fence in acceptable condition

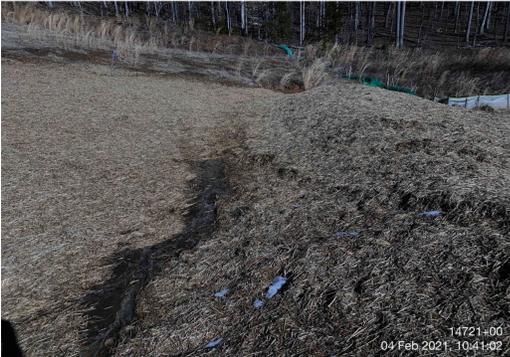
GPS Location 0			GPS Location 0		
Field Station# 14721+00			Field Station# 14701+00		
Pic 5 Desc. Waterbar in acceptable condition			Pic 6 Desc. Equipment bridge in acceptable condition

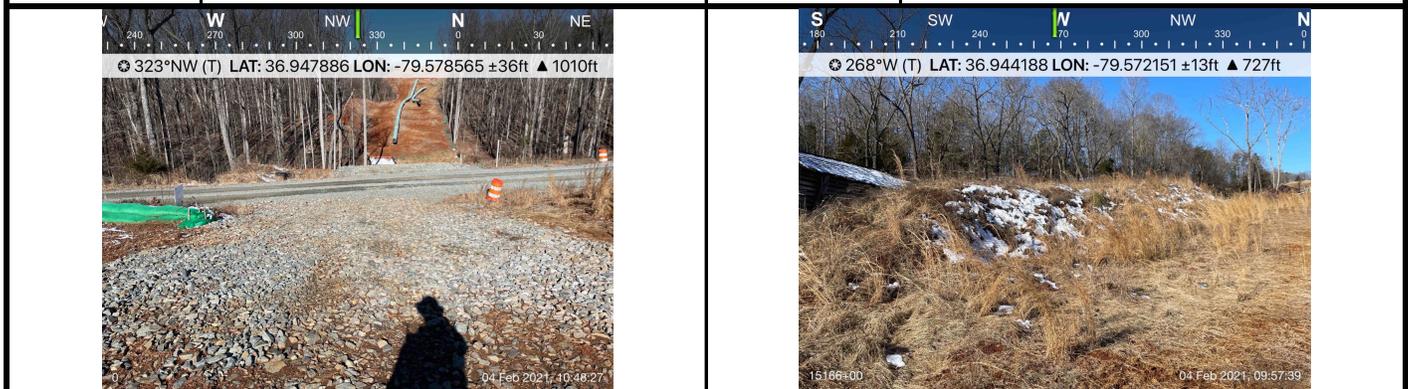
GPS Location	See photo	GPS Location	See photo
Field Station#	15142+66	Field Station#	15166+00
Pic 5 Desc.	RCE at Rockcreek Rd. is in good condition.	Pic 6 Desc.	Stockpiles remain stabilized.
