Visual Site Inspection Report

Project Name H-600 Pipeline Spread I		AFE 124300139	Spread H-600 Pipeline Spread I
Contractor Precision		Report # 19801	
Inspector Justin Burch		Date/Time 2/8/2021 9:14 AM	
Permit # TBD	Inspection Type VA SWPP	Station Begin 14928+52	
State VA	Inspection Area Full	Station End 15063+95	
County Franklin/Pittsylvania	Ground Frozen	Temperature (°F) 48.00	
Municipality Chatham	Weather Sunny	Rain Gauge (in) 0.60	
Rain Accumulation Time (days)			6.00

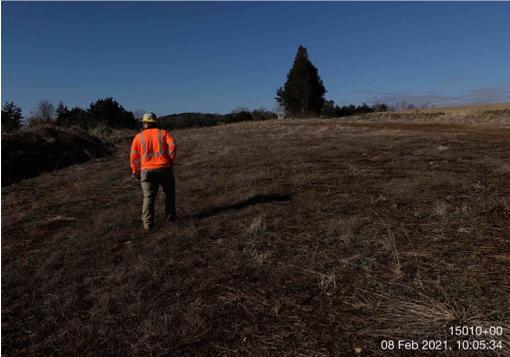
<p>175°S (M) ● 36°58'0"N, 79°37'50"W ±52ft ▲ 818ft 14951+00 08 Feb 2021, 10:41:00</p>				
GPS Location		0		GPS Location		0	
Field Station#		15010+00		Field Station#		14951+00	
Pic 3 Desc.		Temporary vegetative stabilization in acceptable condition		Pic 4 Desc.		Slope drain in acceptable condition

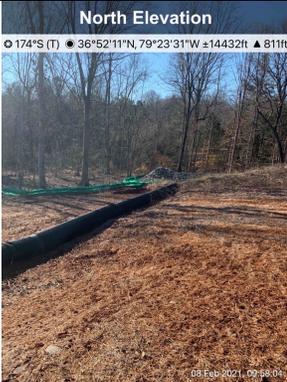
<p>South West Elevation <small>⊙ 44°NE (T) ● 36°51'14"N, 79°23'25"W ±16ft ▲ 813ft</small> <small>08 Feb 2021, 09:53:15</small></p>	
GPS Location	O		GPS Location	O	
Field Station#	15845+00		Field Station#	15836+00	
Pic 1 Desc.	Observing temporary stabilization,CWD outlet and ECD's		Pic 2 Desc.	Observing p1 that requires maintenance

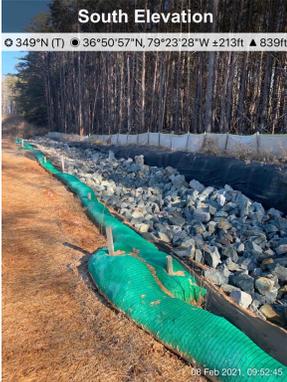
<p>West Elevation <small>⊙ 91°E (T) ● 36°51'24"N, 79°23'32"W ±42ft ▲ 832ft</small> <small>08 Feb 2021, 09:45:44</small></p>		
GPS Location	O		GPS Location	O	
Field Station#	15836+00		Field Station#	15825+00	
Pic 3 Desc.	Observing rock drain and ECD's		Pic 4 Desc.	Observing plunge pool and ECD's

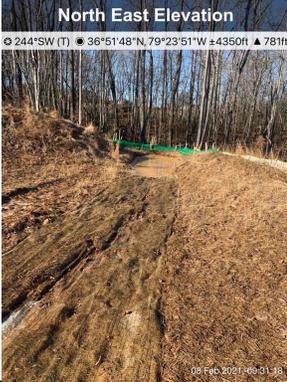
<p>North West Elevation <small>⊙ 137°SE (T) ● 36°51'49"N, 79°23'53"W ±209ft ▲ 782ft</small> <small>08 Feb 2021, 09:30:07</small></p>		
GPS Location	O		GPS Location	O	
Field Station#	15796+00		Field Station#	15794+77	
Pic 5 Desc.	Observing water bar, erosion control blanket, sump and end treatment		Pic 6 Desc.	Observing signage, equipment crossing,buffer and ECD's

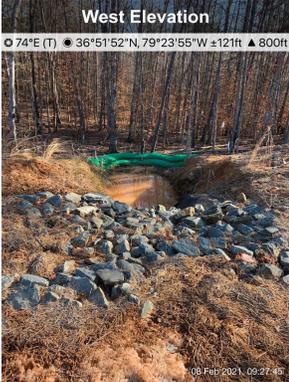
<p>South East Elevation 305°NW (T) 36°52'27"N, 79°23'44"W ±14432ft ▲ 804ft 08 Feb 2021, 09:28:33</p>		<p>ert image here</p>	
GPS Location ○		GPS Location ○			
Field Station# 15792+00		Field Station# 15787+00			
Pic 7 Desc. Observing rock drain, sump and end treatment		Pic 8 Desc. Observing safety fence that requires maintenance

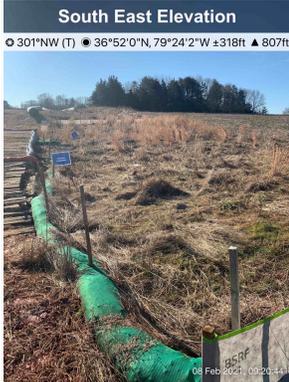
<p>North East Elevation 217°SW (T) 36°52'37"N, 79°23'39"W ±12608ft ▲ 819ft 08 Feb 2021, 09:17:47</p>		<p>ert image here</p>	
GPS Location ○		GPS Location ○			
Field Station# 15781+00		Field Station# 15775+00			
Pic 9 Desc. Observing buffer, signage, equipment crossing and ECD's		Pic 10 Desc. Observing temporary stabilization, sump and end treatment

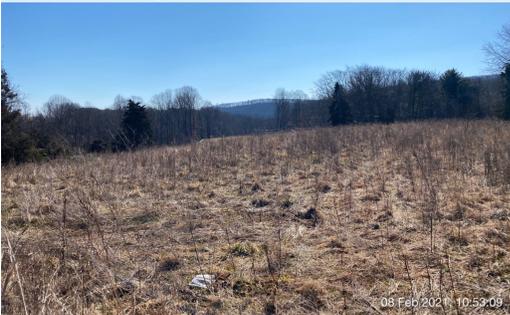
GPS Location	0	GPS Location	0	
Field Station#	14646+00	Field Station#	14633+00	
Pic 1 Desc.	Approximately 14646+00. Overview of ROW.		Pic 2 Desc.	Approximately 14633+00. Overview of ROW.

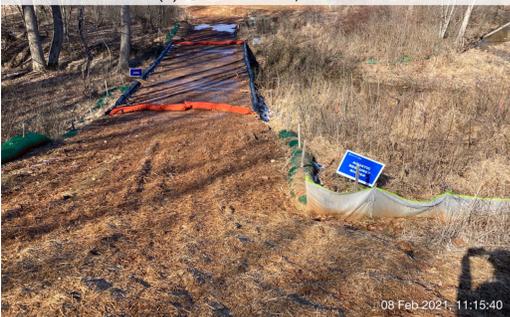
GPS Location	0	GPS Location	0	
Field Station#	14611+27	Field Station#	14599+50	
Pic 3 Desc.	Approximately 14611+27. Overview of stream crossing, equipment bridge and ECDs at stream S-E14.		Pic 4 Desc.	Approximately 14599+50. Overview of road crossing and RCEs.

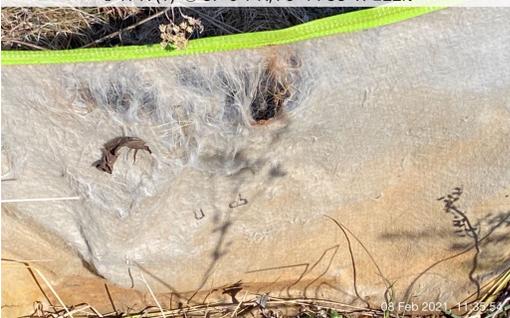
GPS Location	0	GPS Location	0	
Field Station#	14582+68	Field Station#	14568+10	
Pic 5 Desc.	Approximately 14582+68. P-1 requires maintenance.		Pic 6 Desc.	Approximately 14568+10. Overview of stream crossing, equipment bridge and ECDs at stream S-E18.

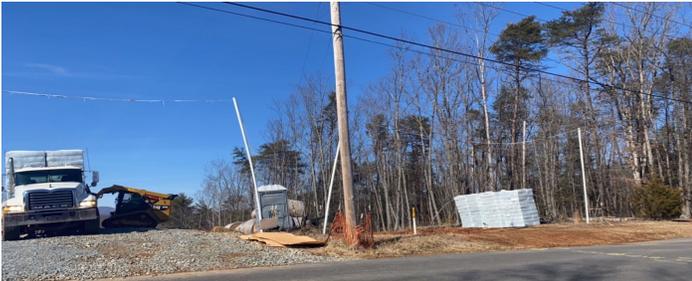
GPS Location	1	GPS Location	2
Field Station#	14062+17	Field Station#	14076+00
Pic 1 Desc.	Contractor staging stabilization materials at Bonbrook Mill RC2	Pic 2 Desc.	Routine maintenance. Replace row of P1 silt fence which has reached effective lifespan.

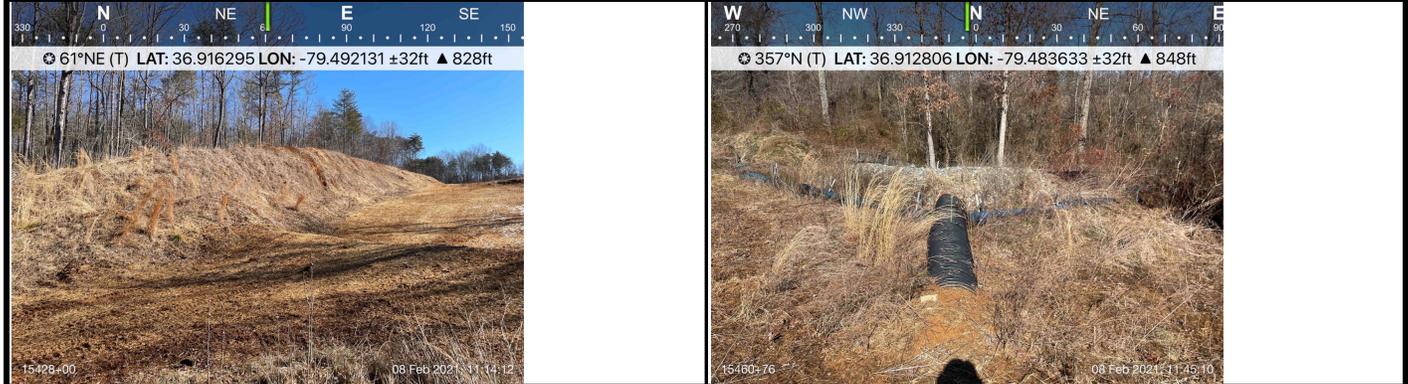
GPS Location	See photo	GPS Location	See photo
Field Station#	15428+00	Field Station#	15460+76
Pic 7 Desc.	Stockpiles remain stabilized.	Pic 8 Desc.	CWDs are functioning as intended.

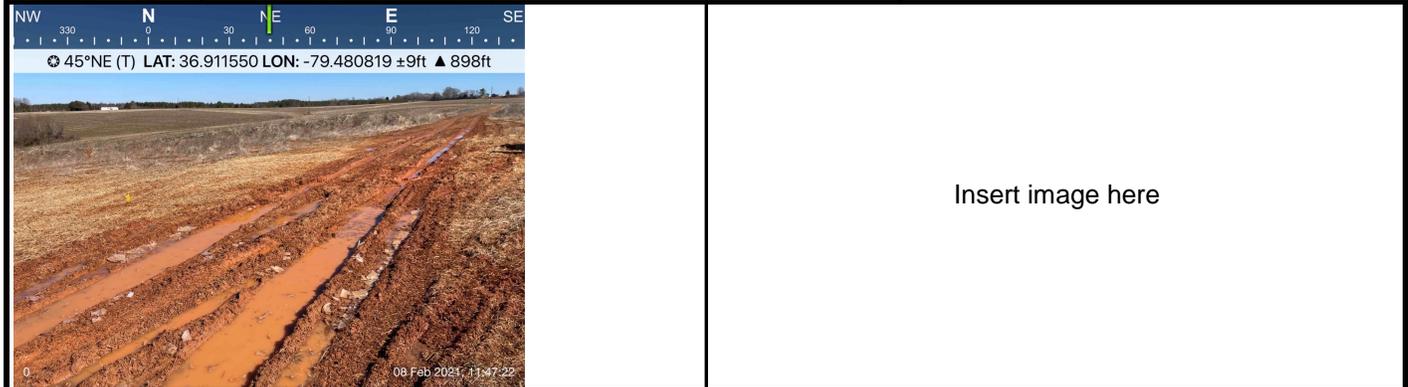
GPS Location	See photo	GPS Location	
Field Station#	15469+05	Field Station#	
Pic 9 Desc.	3rd party using MVP-PI-332.01.	Pic 10 Desc.

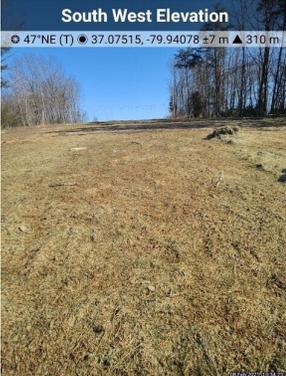
GPS Location	00000		GPS Location	00000	
Field Station#	13746+56		Field Station#	13746+00	
Pic 1 Desc.	The EI monitored areas of the row where hydro seed was recently applied, no issues observed at the time of inspection		Pic 2 Desc.	Photo taken by the EI showing row after hydro seed applied.

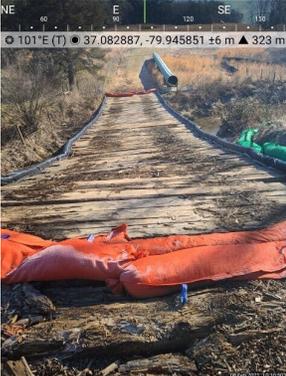
GPS Location	0000		GPS Location	00000	
Field Station#	13704+90		Field Station#	13704+90	
Pic 3 Desc.	The EI monitored ECDs and equipment bridge protection. No issues observed at the time of inspection.		Pic 4 Desc.	Stream observation photo facing downstream during routine inspection today.

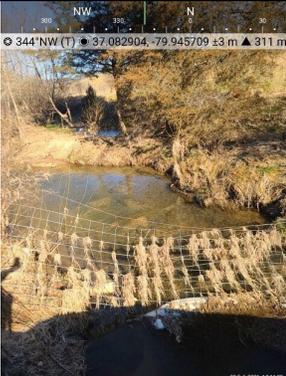
GPS Location	00000		GPS Location	0000	
Field Station#	13704+90		Field Station#	13705+12	
Pic 5 Desc.	Stream observation photo facing upstream during routine row inspection by the EI.		Pic 6 Desc.	Photo showing temporary vegetation area . No issues observed at the time of inspection.

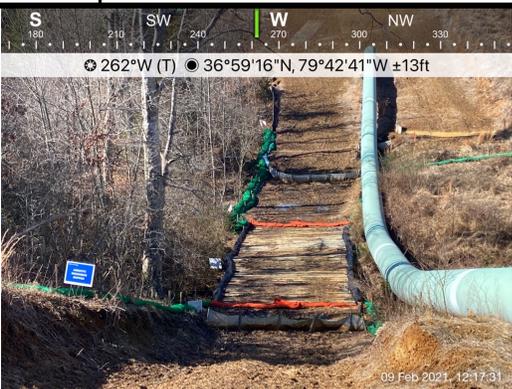
GPS Location	0	GPS Location	0	
Field Station#	14689+36	Field Station#	14676+00	
Pic 3 Desc.	Approximately 14689+36. Overview of stream crossing, equipment bridge and ECDs at stream S-H34.		Pic 4 Desc.	Approximately 14676+00. Overview of ROW.

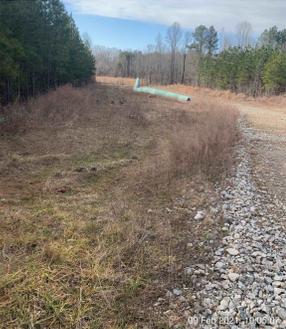
GPS Location		O		GPS Location	
		O			
Field Station#		6+00		Field Station#	
		6+00		11+50	
Pic 1 Desc.		Observing temporary vegetation		Pic 2 Desc.	
				Observing temporary vegetation and signage	
		<p>North Elevation</p> <p>185°S (T) ● 36°49'45"N, 79°20'40"W ±200ft ▲ 623ft</p>

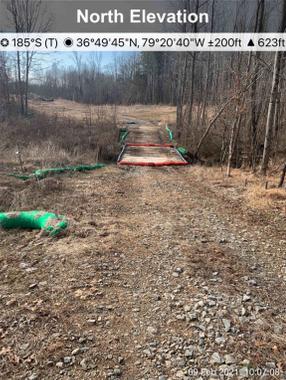
GPS Location		O		GPS Location	
		O			
Field Station#		12+65		Field Station#	
		12+65		19+00	
Pic 3 Desc.		Observing equipment crossing and ECD's		Pic 4 Desc.	
				Observing temporary stabilization and ECD's	
Insert image here			Insert image here		
GPS Location				GPS Location	
Field Station#				Field Station#

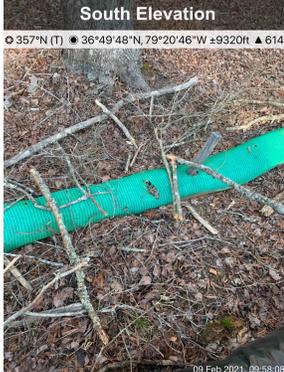
<p>South Elevation <small>11°N (T) 36°49'48"N, 79°20'45"W ±39ft ▲ 616ft</small> <small>09 Feb 2021, 10:01:10</small></p>	
GPS Location	O		GPS Location	O	
Field Station#	16016+45		Field Station#	16016+45	
Pic 1 Desc.	Observing CFS that required maintenance		Pic 2 Desc.	Observing CFS that received maintenance.

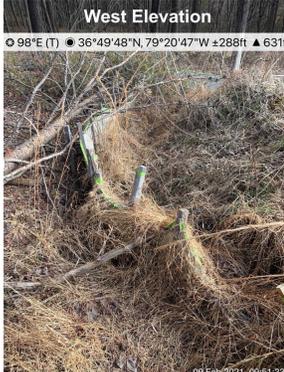
<p>North West Elevation <small>154°SE (T) 36°49'48"N, 79°20'46"W ±88ft ▲ 614ft</small> <small>09 Feb 2021, 09:54:05</small></p>	
GPS Location	O		GPS Location	O	
Field Station#	16015+50		Field Station#	16015+50	
Pic 3 Desc.	Observing p1 that requires maintenance		Pic 4 Desc.	Observing the Contractor performing ECD maintenance.

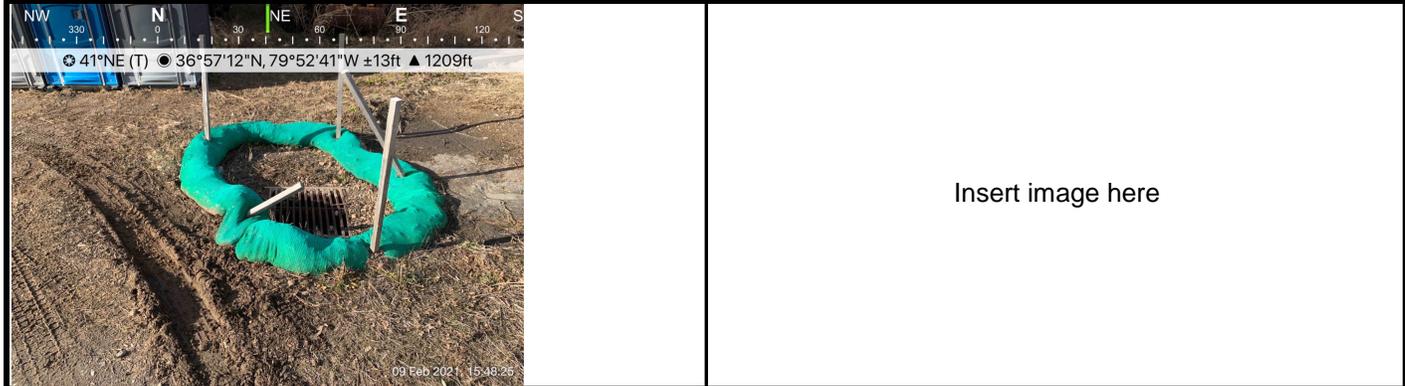
- The locations received .50" of rainfall since the last inspection.
- All perimeter ECD's were inspected and no issues were found.
- The inlet protection for the catch basin drains at LY-046 were in good condition. The catch basins at MVP-LY-033 and MVP-ANC-006 require maintenance. (See pics 5,6,and 7)

Pic 7 Desc.	Inlet protection for second catch basin at MVP-ANC-006 requires maintenance.	Pic 8 Desc.	
--------------------	--	--------------------	--

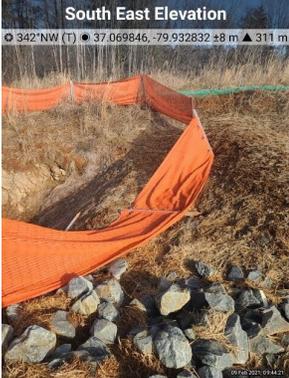
<p>South Elevation 15°N (T) • 37.063823, -79.921955 ±7 m ▲ 286 m</p>	
GPS Location	000000		GPS Location	00000	
Field Station#	13748+44		Field Station#	13834+70	
Pic 1 Desc.	Safety fence around large sump pit requires maintenance, stake blown over during high wind, added to the punch list for repair.		Pic 2 Desc.	P1 requires maintenance due to wildlife damage , EI Documented and sent in to be added to the punch list for repairs.

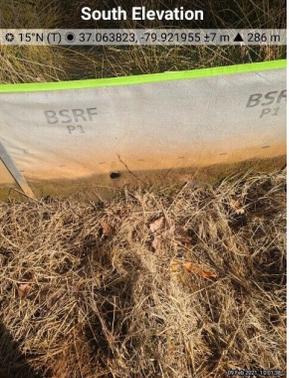
S-C14 stream buffer fence at STA# 13834+70 required maintenance due to wildlife damage at lower sections of P1 in 2 areas, the EI Documented and sent in to be added to the punch list for repairs by the contractor.

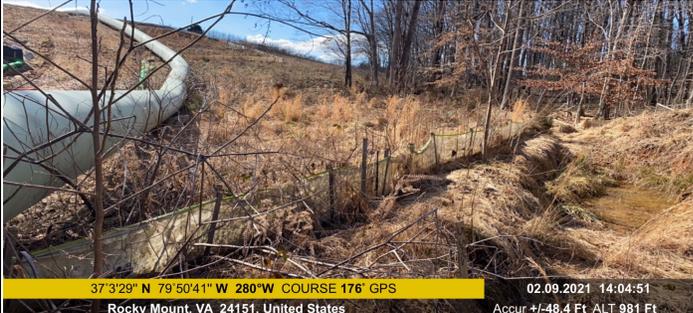
<p>37°3'29" N 79°50'41" W 280°W COURSE 176° GPS Rocky Mount, VA 24151, United States 02.09.2021 14:04:51 Accur +/-48.4 Ft ALT 981 Ft</p>	
GPS Location	1	GPS Location	2
Field Station#	14306+00	Field Station#	14176+50
Pic 1 Desc.	Routine maintenance. Replace damaged P1 silt fence from cattle damage.	Pic 2 Desc.	Routine maintenance. Replace entire row of P1 silt fence. Multiple holes in fabric at resource buffer.

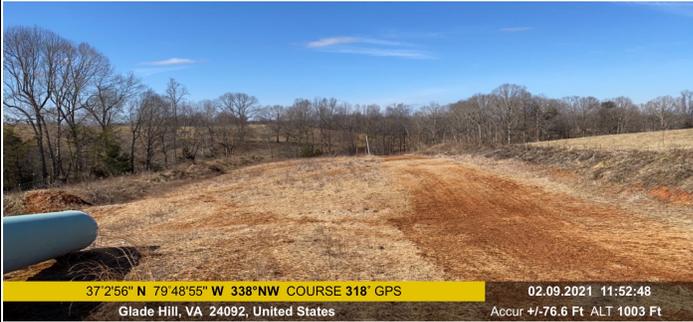
GPS Location	3	GPS Location	4
Field Station#	14308+00	Field Station#	14285+00
Pic 3 Desc.	Multiple bare or lightly vegetated areas along ROW that will be aerially seeded/stabilized.	Pic 4 Desc.	Multiple bare or lightly vegetated areas along ROW that will be aerially seeded/stabilized.

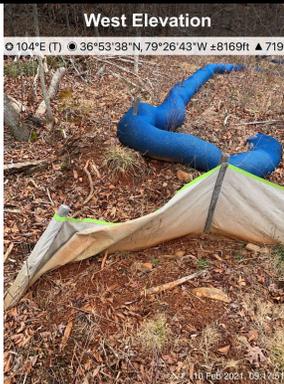
<p>West Elevation <small>107°E (T) 36°53'38"N, 79°26'45"W ±364ft ▲ 701ft</small></p>	
GPS Location	O		GPS Location	O	
Field Station#	15599+50		Field Station#	15596+00	
Pic 3 Desc.	Observing p1 that requires maintenance		Pic 4 Desc.	Observing equipment crossing, stream, buffer and signage

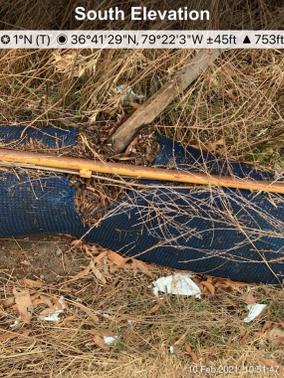
GPS Location O		GPS Location O			
Field Station# 00+00		Field Station# 00+00			
Pic 1 Desc. Observing stored materials		Pic 2 Desc. Observing CFS that requires maintenance			
<p>South West Elevation 28°NE (T) ● 36°41'30"N, 79°22'0"W ±213ft ▲ 746ft</p>

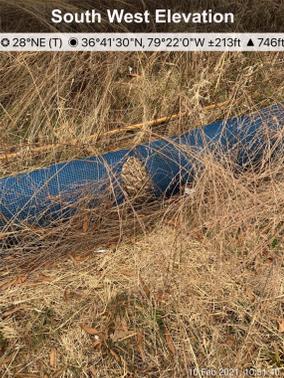
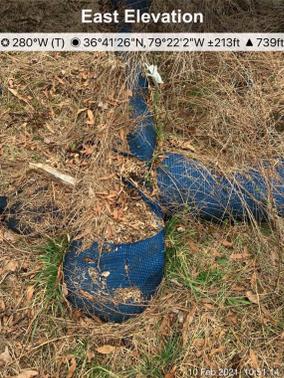
GPS Location O		GPS Location O			
Field Station# 00+00		Field Station# 00+00			
Pic 3 Desc. Observing CFS that requires maintenance		Pic 4 Desc. Observing CFS That Requires Maintenance			
<p>South East Elevation 312°NW (T) ● 36°41'21"N, 79°22'2"W ±269ft ▲ 734ft</p>

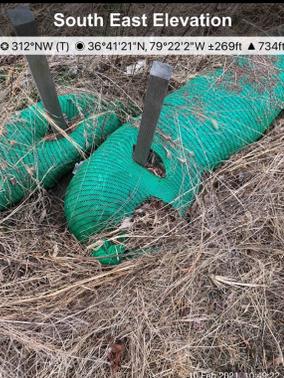
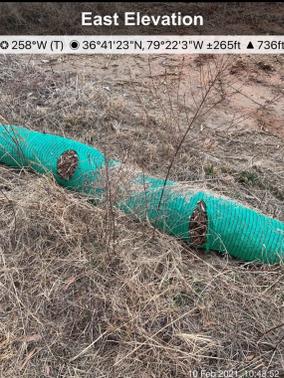
GPS Location O		GPS Location O			
Field Station# 00+00		Field Station# 00+00			
Pic 5 Desc. Observing CFS that requires maintenance		Pic 6 Desc. Observing CFS that requires maintenance

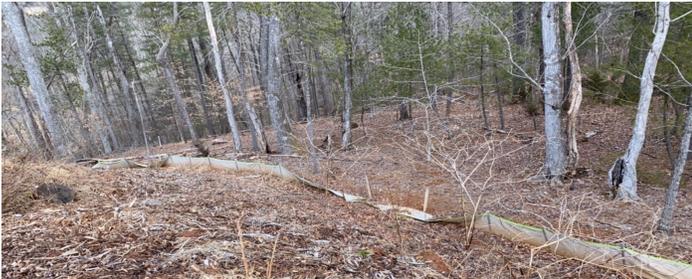
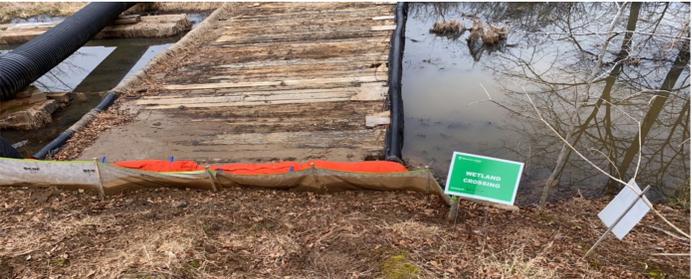
<p>37°3'16" N 79°54'36" W 23°NE COURSE 207' GPS 985 Iron Ridge Rd, Rocky Mount, VA 24151, United States 02.10.2021 10:26:43 Accur +/-93.5 Ft ALT 1126 Ft</p>			<p>37°3'19" N 79°54'38" W 28°NE COURSE -1' GPS 985 Iron Ridge Rd, Rocky Mount, VA 24151, United States 02.10.2021 10:32:53 Accur +/-188.4 Ft ALT 1135 Ft</p>		
GPS Location 1		GPS Location 2			
Field Station# 13892+00		Field Station# 13889+00			
Pic 1 Desc. Routine maintenance. Replace damaged P1 silt fence along perimeter of ROW.		Pic 2 Desc. Routine maintenance. Replace row of P1 silt fence which has reached effective lifespan.

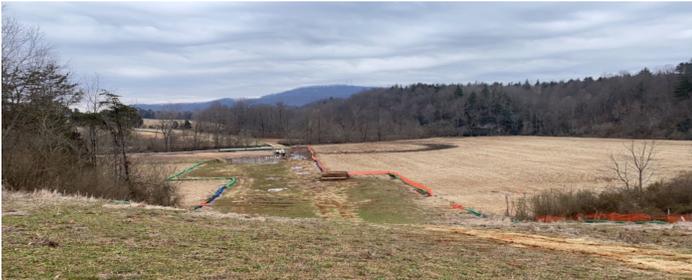
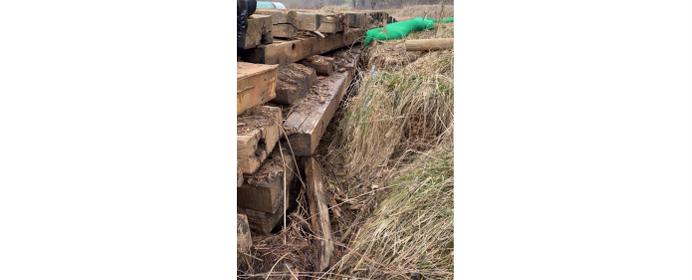
- Made note of condition of erosion/subsidence occurring CIS S-CD6. Condition continues to worsen.
- Made note of condition of bridge crossing of S-II2; no change in status from previous inspection

GPS Location 3		GPS Location 4			
Field Station# 13913+00		Field Station# 13875+16			
Pic 3 Desc. View of ROW CIS S-CD6. Bridge mats and wattles remain off ROW		Pic 4 Desc. Bank CIS S-CD6 continues to erode away at bridge mats

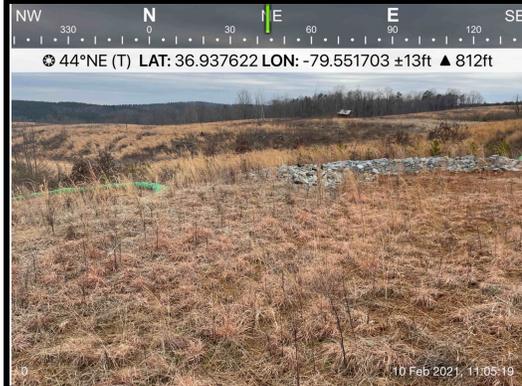
Pic 7 Desc.	Permanent waterbars are in good condition.	Pic 8 Desc.	Perimeter CFS is in good condition throughout this area.
--------------------	--	--------------------	--

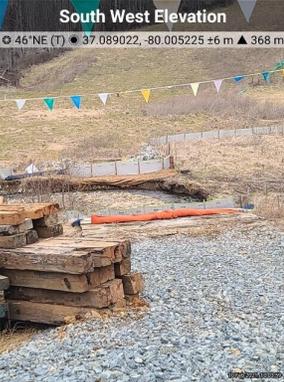
GPS Location 00000		GPS Location 0000		GPS Location 0000	
Field Station# 13496+76		Field Station# 13442+54		Field Station# 13442+54	
Pic 1 Desc. Vegetation photo , ECDs in place and functioning at road crossing .		Pic 2 Desc. Row photo taken by the EI during row inspection today , showing ECDs and water bars functioning . No issues observed at the time of inspection.		Pic 2 Desc. Row photo taken by the EI during row inspection today , showing ECDs and water bars functioning . No issues observed at the time of inspection.	
		<p>South West Elevation <small>46°NE (T) ● 37.089022, -80.005225 +6 m ▲ 368 m</small></p>

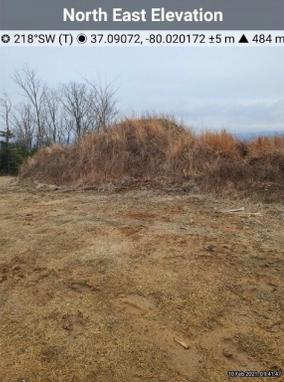
GPS Location 0000		GPS Location 0000		GPS Location 00000	
Field Station# 13498+00		Field Station# 13420+00		Field Station# 13420+00	
Pic 3 Desc. The EI observed area where stream bank was stabilized with erosion blanket recently and P1 moved back onto row to prevent being washed into the stream.		Pic 4 Desc. Work space monitored by the EI during row inspection.		Pic 4 Desc. Work space monitored by the EI during row inspection.	
		<p>North East Elevation <small>218°SW (T) ● 37.09072, -80.020172 +5 m ▲ 484 m</small></p>

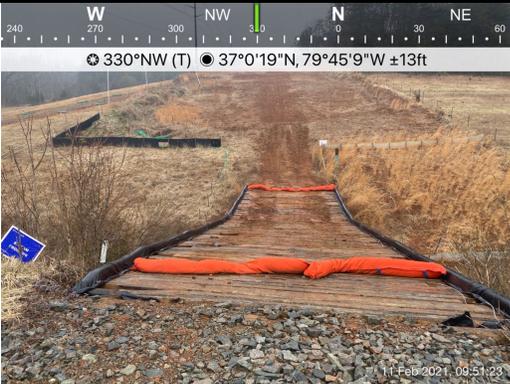
GPS Location	0	GPS Location	0		
Field Station#	14546+33	Field Station#	14529+00		
Pic 1 Desc.	Approximately 14546+33. Overview of stream crossing, equipment bridge and ECDs at stream S-G17.		Pic 2 Desc.	Approximately 14529+00. Overview of ROW.

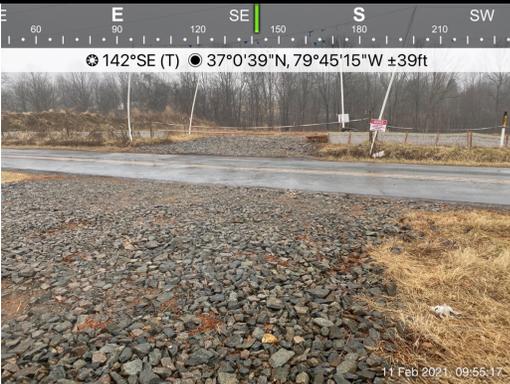
GPS Location	0	GPS Location	0		
Field Station#	14524+75	Field Station#	14522+50		
Pic 3 Desc.	Approximately 14524+75. Overview of road crossing and RCEs.		Pic 4 Desc.	Approximately 14522+50. Over of ROW and MVP-ATWS-528.

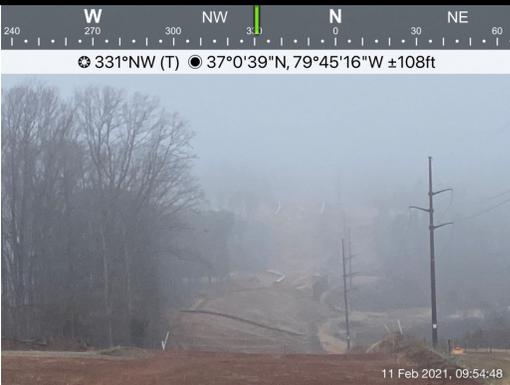
GPS Location	0	GPS Location	0		
Field Station#	14515+00	Field Station#	14457+00		
Pic 5 Desc.	Approximately 14515+00. Overview of ROW.		Pic 6 Desc.	Approximately 14457+00. Overview of ROW.

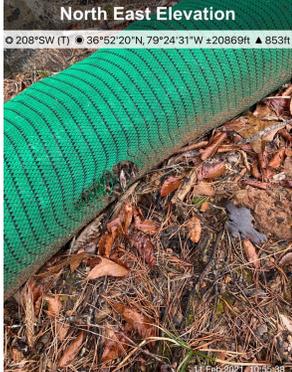
<p>North East Elevation <small>212°SW (T) ● 36°52'18"N, 79°24'26"W ±236ft ▲ 868ft</small></p>	GPS Location	O
Field Station#	15748+00		Field Station#	15748+00	
Pic 1 Desc.	Observing CFS that required maintenance		Pic 2 Desc.	Observing CFS that received maintenance

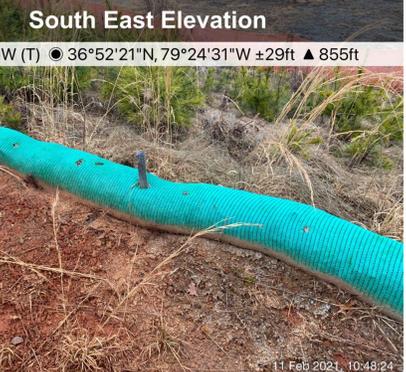
<p>South Elevation <small>357°N (T) ● 36°52'20"N, 79°24'31"W ±52ft ▲ 856ft</small></p>	GPS Location	O
Field Station#	15746+20		Field Station#	15746+20	
Pic 3 Desc.	Observing CFS that required maintenance		Pic 4 Desc.	Observing CFS that received maintenance

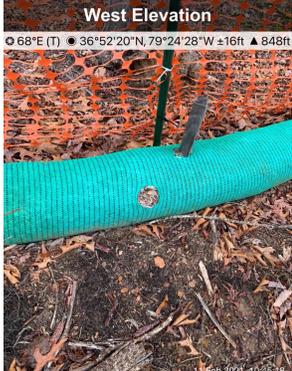
Field Station#	15746+00		Field Station#	15746+00	
Pic 5 Desc.	Observing CFS that required maintenance		Pic 6 Desc.	Observing CFS that received maintenance

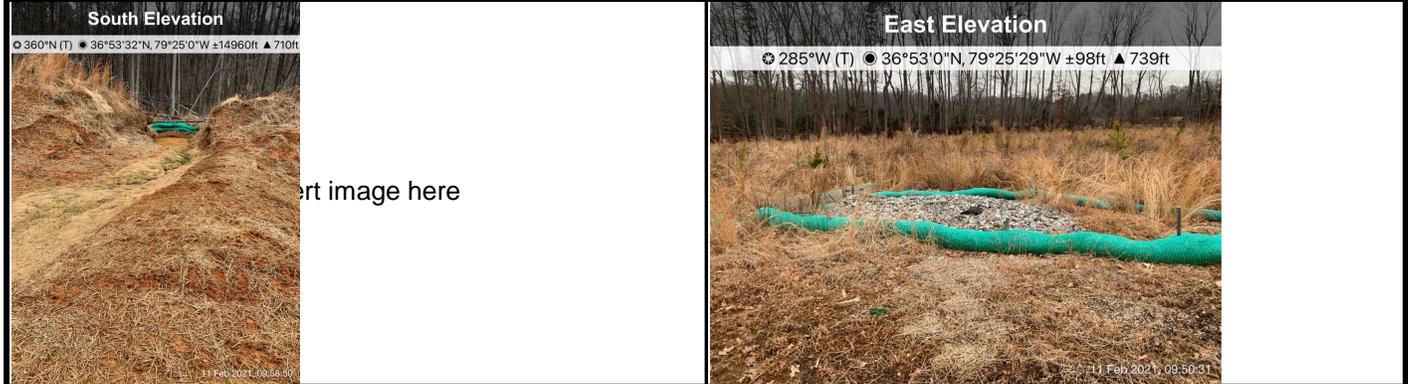
Pic 13 Desc.	Observing water bar, erosion control blanket, sump and end treatment	Pic 14 Desc.	Observing temporary vegetation CWD outlet and ECD's
---------------------	--	---------------------	---

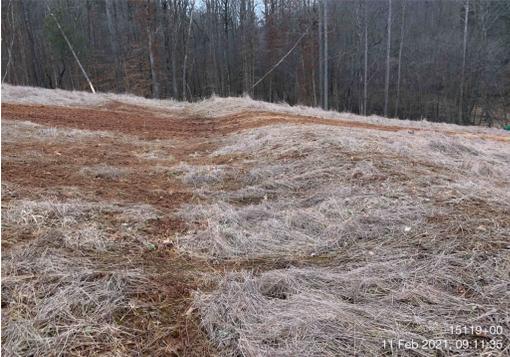
GPS Location	0	GPS Location	0
Field Station#	15119+00	Field Station#	15119+00
Pic 1 Desc.	Waterbar in acceptable condition	Pic 2 Desc.	Waterbar end treatment in acceptable condition
Ⓞ 285°W (M) ● 36°58'12"N, 79°39'5"W ±29ft ▲ 888ft

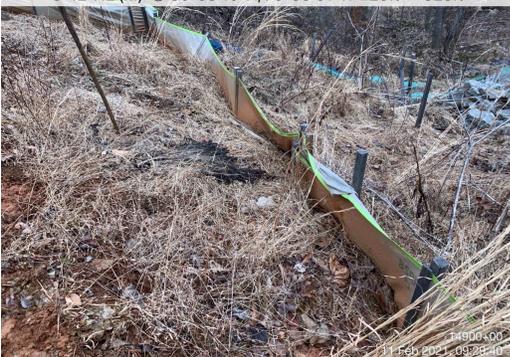
GPS Location	0	GPS Location	0
Field Station#	14900+00	Field Station#	14851+50
Pic 5 Desc.	P1 silt fence requiring maintenance	Pic 6 Desc.	P1 silt fence requiring replacement from 14851+20 to 14851+70

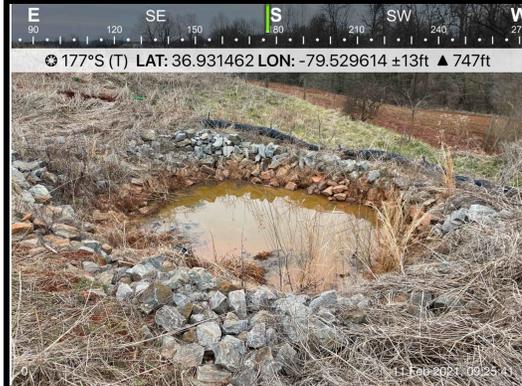
GPS Location	See photo	GPS Location	See photo
Field Station#	15302+00	Field Station#	15313+00
Pic 7 Desc.	CWDs are functioning as intended.	Pic 8 Desc.	Equipment bridge ECDs are in place at all stream and wetland crossings.

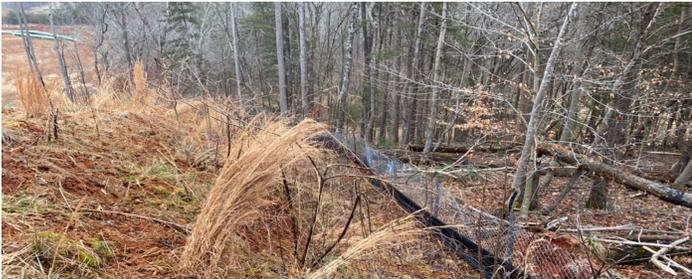
<p>37°33'7" N 79°52'49" W 116°SE COURSE 217' GPS 02.11.2021 12:11:53 110 Three Brooks Ln, Rocky Mount, VA 24151, United States Accur +/-23.0 Ft ALT 1109 Ft</p>			<p>37°33'8" N 79°52'48" W 124°SE COURSE 194' GPS 02.11.2021 12:13:34 209 Three Brooks Ln, Rocky Mount, VA 24151, United States Accur +/-53.9 Ft ALT 1077 Ft</p>		
GPS Location 1		GPS Location 2			
Field Station# 14032+00		Field Station# 14034+00			
Pic 1 Desc. Routine maintenance. SSF down along perimeter. Reattach geotech to fencing.		Pic 2 Desc. Routine maintenance. SSF down along perimeter. Reattach geotech to fencing.

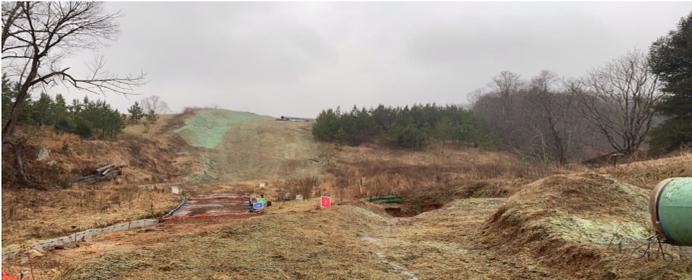
GPS Location 3		GPS Location 4			
Field Station# 13988+00		Field Station# 13998+25			
Pic 3 Desc. View of recently hydroseeded ROW. No issues observed.		Pic 4 Desc. Resource buffer GAS S-KL36. CFS in area continues to undermine at stream.

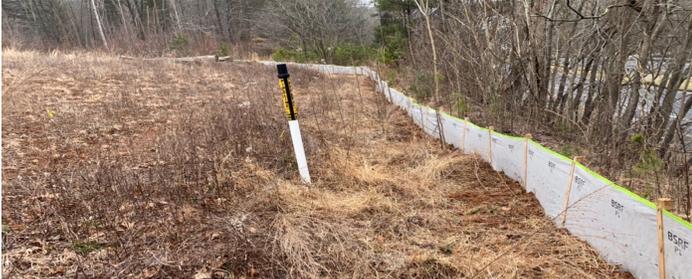
<p>37°3'21" N 79°52'56" W 201°S COURSE 255' GPS 02.11.2021 11:59:05 160 Bonbrook Mill Rd, Rocky Mount, VA 24151, United States Accur +/-22742.8 Ft ALT 1096 Ft</p>			<p>37°3'16" N 79°52'58" W 241°SW COURSE 28' GPS 02.11.2021 12:30:54 18701-18767 Virgil H Goode Hwy, Rocky Mount, VA 24151, United States Accur +/-82.4 Ft ALT 1006 Ft</p>		
GPS Location 5		GPS Location 6			
Field Station# 14011+00		Field Station# 13996+96			
Pic 5 Desc. Contractor replaced P1 silt fence per punch list item.		Pic 6 Desc. Contractor repaired access road MVP-FR-306.02 by adding rock along road.

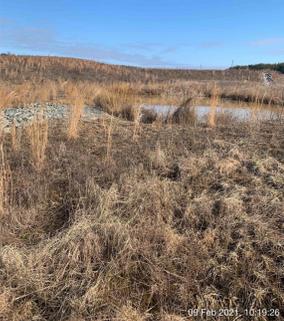
<p>09 Feb 2021, 10:18:19</p>	
GPS Location ○		GPS Location ○			
Field Station# 00+00		Field Station# 00+00			
Pic 1 Desc. Observing temporary vegetation, sediment basin and rock overflow		Pic 2 Desc. Observing emergency overflow at the storm water pond			
<p>South Elevation</p> <p>⊙ 351°N (T) ● 36°49'52"N, 79°20'38"W ±19ft ▲ 642ft</p>

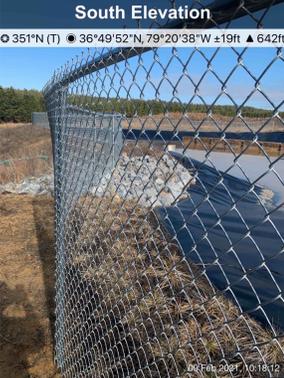
<p>09 Feb 2021, 10:17:25</p>	
GPS Location ○		GPS Location ○			
Field Station# 00+00		Field Station# 00+00			
Pic 3 Desc. Observing emergency overflow at the storm water pond		Pic 4 Desc. Observing temporary vegetation, storm water pond and ECD's
