Visual Site Inspection Report

Project Name H-600 Pipeline Spread I		AFE 124300139	Spread H-600 Pipeline Spread I
Contractor Precision		Report # 20532	
Inspector Justin Burch		Date/Time 3/1/2021 8:52 AM	
Permit # TBD	Inspection Type VA SWPP	Station Begin 14802+19	
State VA	Inspection Area Full	Station End 14928+52	
County Franklin	Ground Wet	Temperature (°F) 53.00	
Municipality N/A	Weather Light Rain	Rain Gauge (in) 1.00	
			Rain Accumulation Time (days) 6.00

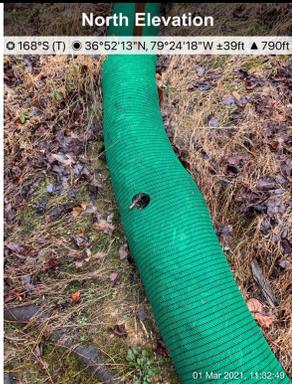
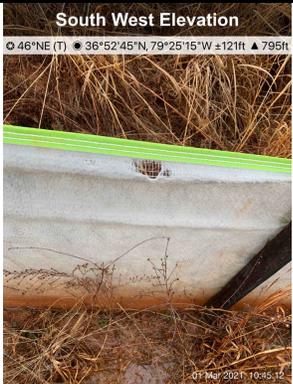
<p>South West Elevation <small>46°NE (T) 36°52'45"N, 79°25'15"W ±121ft ▲ 795ft</small> <small>01 Mar 2021, 10:35:02</small></p>	GPS Location	O	GPS Location	O
Field Station#	15756+46	Field Station#	15696+00	Pic 1 Desc.	Observing CFS that requires maintenance	Pic 2 Desc.	Observing p1 that requires maintenance

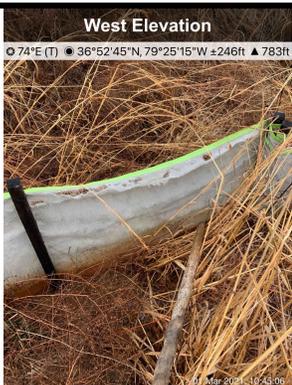
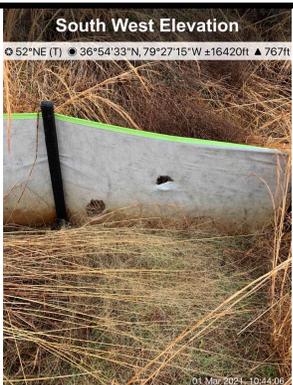
<p>South West Elevation <small>52°NE (T) 36°54'33"N, 79°27'15"W ±1642ft ▲ 767ft</small> <small>01 Mar 2021, 10:44:06</small></p>	GPS Location	O	GPS Location	O
Field Station#	15697+00	Field Station#	15697+00	Pic 3 Desc.	Observing p1 that requires maintenance	Pic 4 Desc.	Observing p1 that requires maintenance

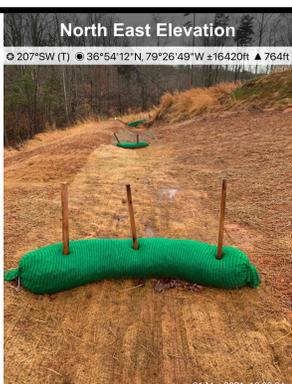
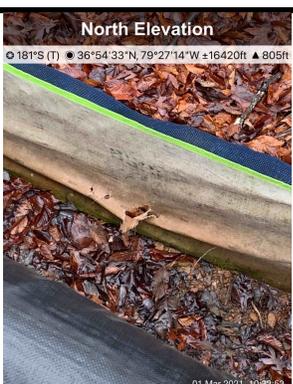
<p>North Elevation <small>181°S (T) 36°54'33"N, 79°27'14"W ±1642ft ▲ 805ft</small> <small>01 Mar 2021, 10:38:54</small></p>	GPS Location	O	GPS Location	O
Field Station#	15710+00	Field Station#	15713+35	Pic 5 Desc.	Observing water bar, erosion control blanket and cfs checks	Pic 6 Desc.	Observing p1 that requires maintenance

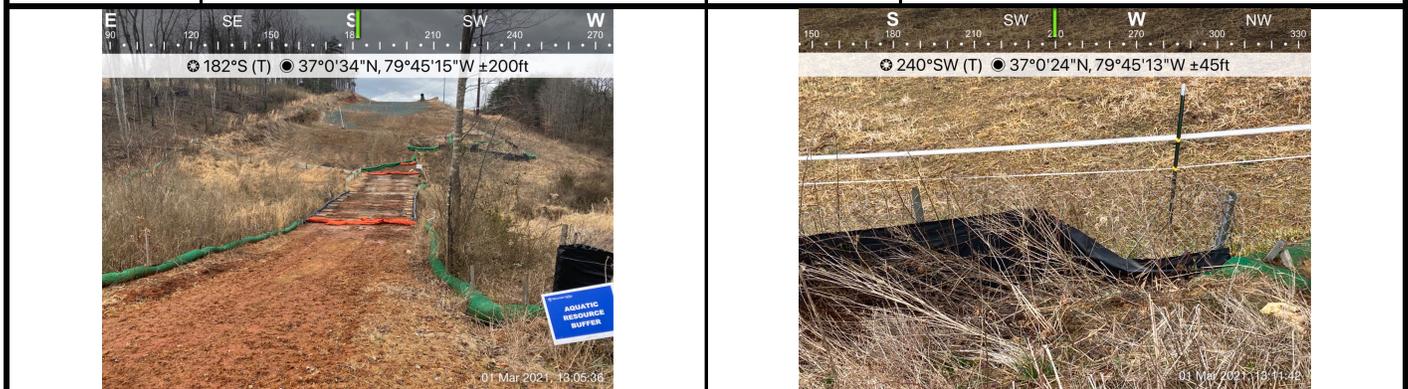
GPS Location	0	GPS Location	0
Field Station#	14531+58	Field Station#	14540+00
Pic 5 Desc.	Approximately 14531+58. Overview of stream crossing, equipment bridge and ECDs at stream S-G18.	Pic 6 Desc.	Approximately 14540+00. SSF requires maintenance.

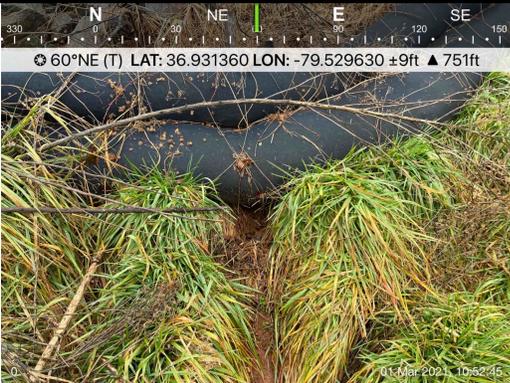
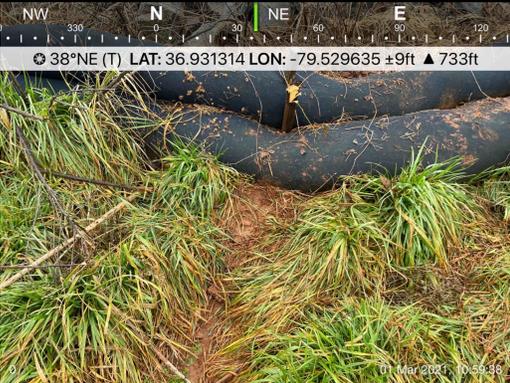
GPS Location	See photo		GPS Location	See photo	
Field Station#	15301+00		Field Station#	15301+00	
Pic 5 Desc.	CWD outlet is undermined and needs to be keyed in.		Pic 6 Desc.	Environmental crew has corrected this issue.

- EI began inspection at Oxford Rd.
- RCEs are in good condition throughout this section.
- CWD inlet at 15300+00 needs to be keyed into topsoil berm. Environmental crew has corrected this issue.
- CWD outlet is undermined at 15301+00. Environmental crew has corrected this issue.
- Rills between the topsoil berm and perimeter P1 at 15335+00 need to be stabilized. Environmental crew has corrected this issue.
- Safety fence is damaged and needs to be repaired in multiple areas. Environmental crew has corrected this issue.
- P1 is in good condition throughout this area.
- Equipment bridge ECDs are in place at all stream and wetland crossings.
- Slip repair at 15338+00 is in good condition after recent rain event.

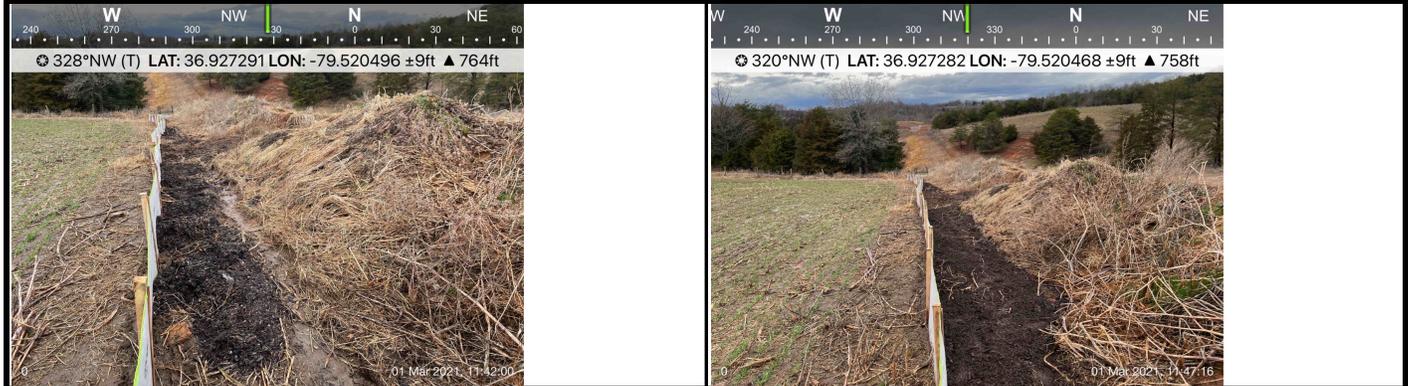
GPS Location	See photo	GPS Location	See photo
Field Station#	15335+00	Field Station#	15335+00
Pic 7 Desc.	Rills between P1 and topsoil berm need to be stabilized.	Pic 8 Desc.	Environmental crew has corrected this issue.

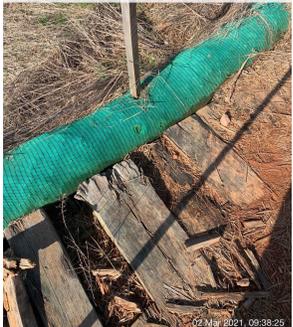
GPS Location	O		GPS Location	O	
Field Station#	15785+00		Field Station#	15836+50	
Pic 5 Desc.	Observing sump and end treatment		Pic 6 Desc.	Observing CFS that received maintenance

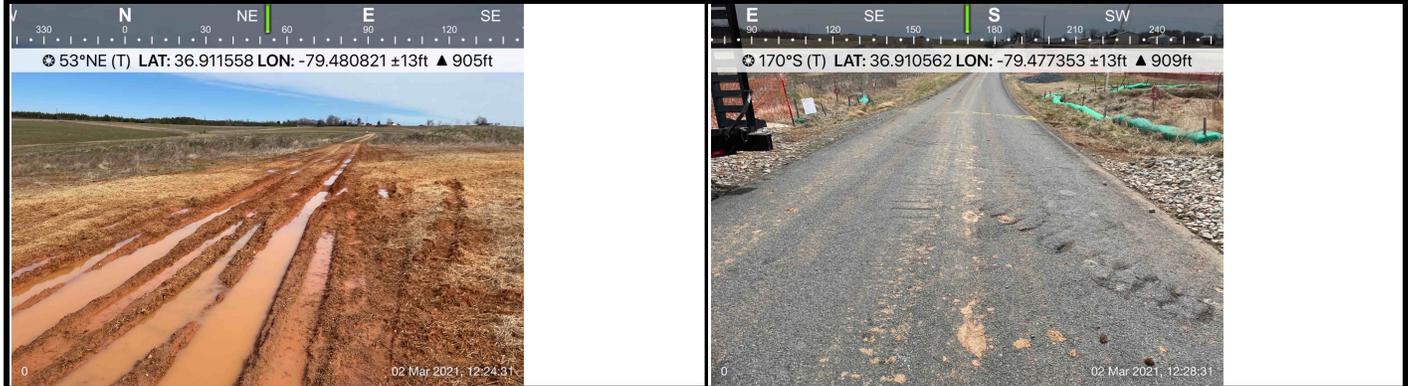
Pic 7 Desc.	MVP-PI-332.01 remains rutted from 3rd party traffic.	Pic 8 Desc.	3rd party contractor tracking along Toshes Rd. from 3rd party RCE.
--------------------	--	--------------------	--

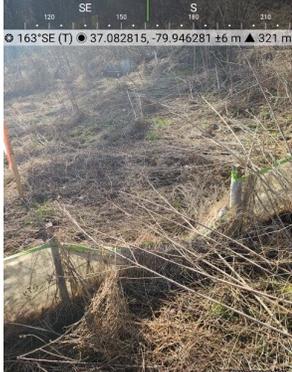
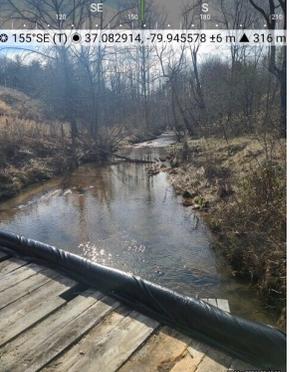
GPS Location	00000	GPS Location	00000		
Field Station#	13702+78	Field Station#	13704+90		
Pic 3 Desc.	P1 requires maintenance at wetland area , documented and added to the punch list.		Pic 4 Desc.	Stream observation photo facing downstream during routine inspection today, no environmental issues observed at the time of inspection.

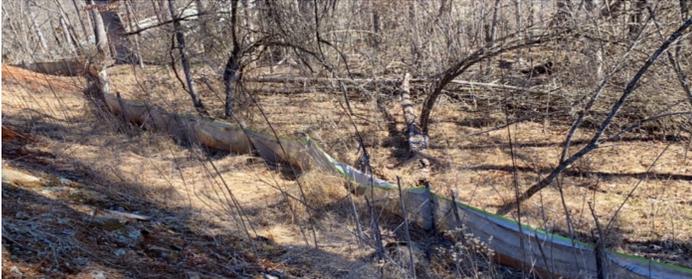
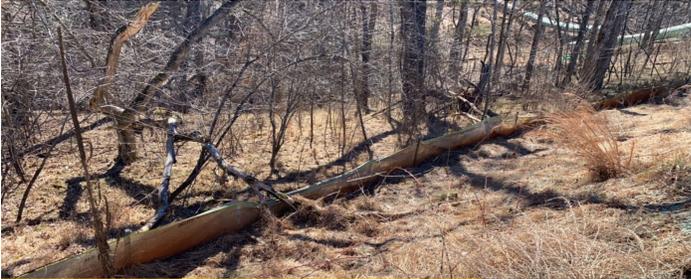
<small>37°3'26" N 79°50'9" W 103°E COURSE -1° GPS 3175 Booker T Washington Hwy, Rocky Mount, VA 24151, United States Accur +/-21.7 Ft ALT 915 Ft</small>		<small>03.03.2021 10:58:42</small>		<small>37°3'25" N 79°50'9" W 95°E COURSE 87° GPS 3175 Booker T Washington Hwy, Rocky Mount, VA 24151, United States Accur +/-109.0 Ft ALT 1016 Ft</small>	
GPS Location 1			GPS Location 2		
Field Station# 14211+00			Field Station# 14212+00		
Pic 1 Desc. Routine maintenance. Repair/replace damaged panels of P1 silt fence along perimeter of ROW.			Pic 2 Desc. Routine maintenance. Repair/replace damaged panels of P1 silt fence along perimeter of ROW.

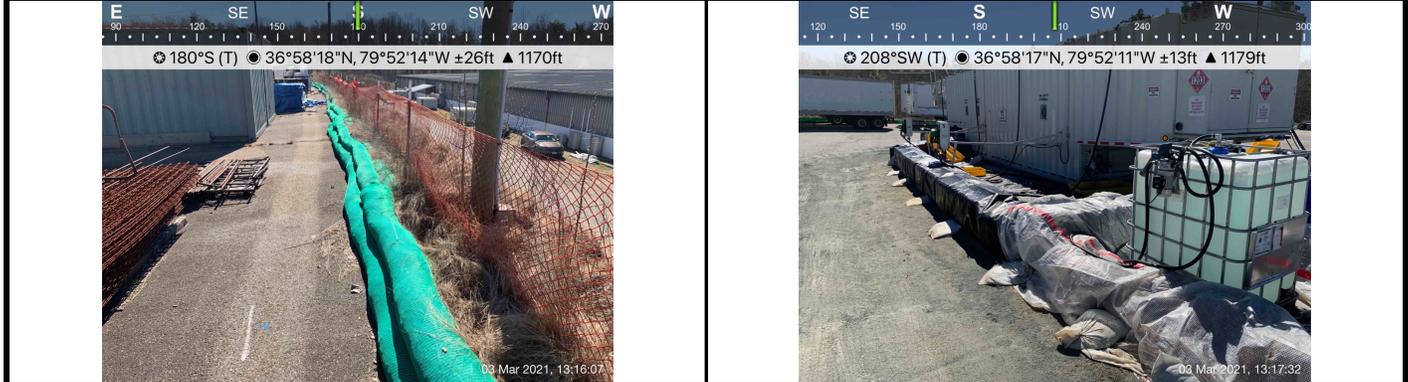
GPS Location	000000000000	GPS Location	000000000000
Field Station#	0000+00	Field Station#	0000+00
Pic 1 Desc.	Perimeter ECD's on west side of MVP-LY-046 in good condition.	Pic 2 Desc.	Secondary containment structure for fuel cell at MVP-LY-046 in good condition.

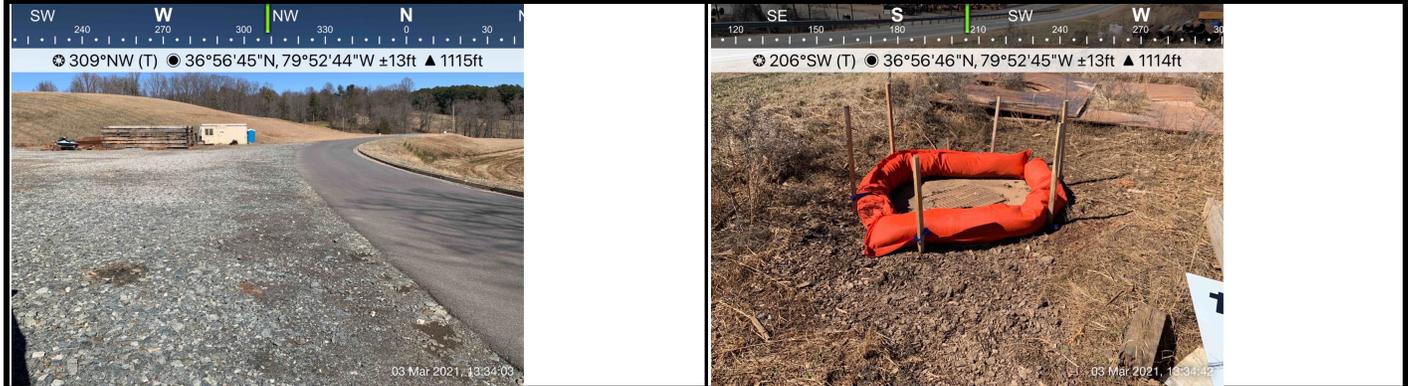
GPS Location	000000000000	GPS Location	000000000000
Field Station#	0000+00	Field Station#	0000+00
Pic 7 Desc.	RCE at MVP-LY-033 in good condition.	Pic 8 Desc.	Inlet protection for catch basin at MVP-LY-033 in acceptable condition.

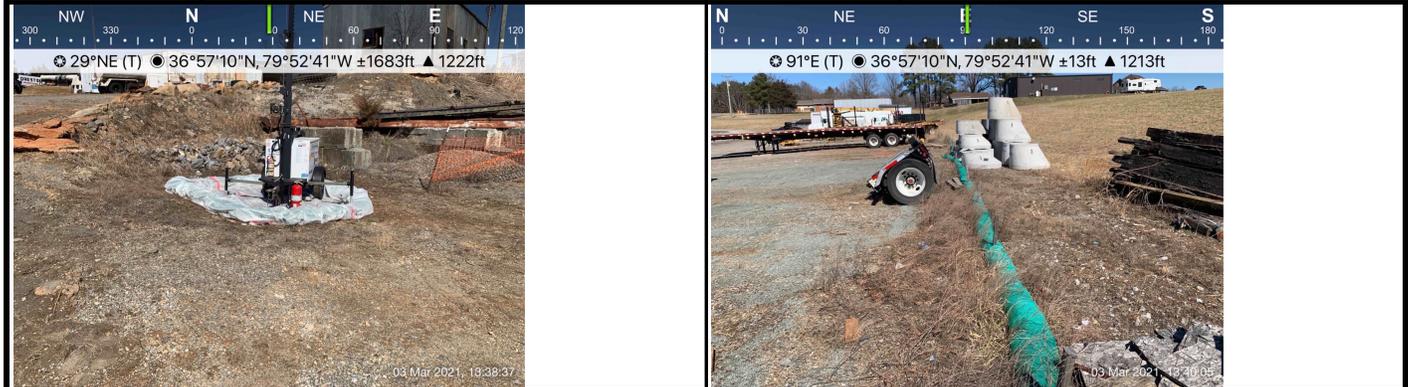
GPS Location	000000000000	GPS Location	000000000000
Field Station#	0000+00	Field Station#	0000+00
Pic 9 Desc.	Secondary containment structure for light plant at MVP-ANC-006 liner issue identified during the previous inspection addressed.	Pic 10 Desc.	Perimeter ECD's at MVP-ANC-006 in good condition.

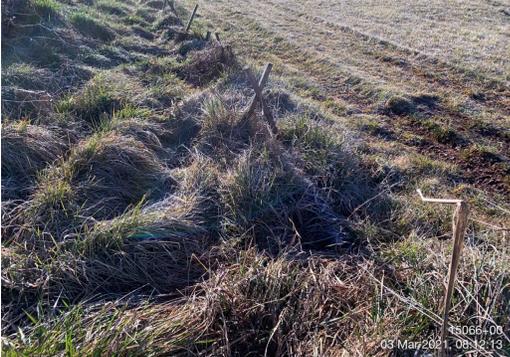
<p>181°S (M) 36°57'45"N, 79°35'36"W ±26ft ▲ 912ft 15066+00 03 Mar 2021, 08:12:13</p>

<p>195°S (M) 36°57'46"N, 79°35'37"W ±167ft ▲ 929ft 15064+00 03 Mar 2021, 13:48:58</p>	
GPS Location	0	GPS Location	0
Field Station#	15066+00	Field Station#	15064+00
Pic 1 Desc.	Perimeter CFS around MVP-ATWS-382 from 15064+00 to 15068+00 is deteriorated. Contractor replaced it immediately.	Pic 2 Desc.	Perimeter CFS around MVP-ATWS-382 from 15064+00 to 15068+00 after replacement

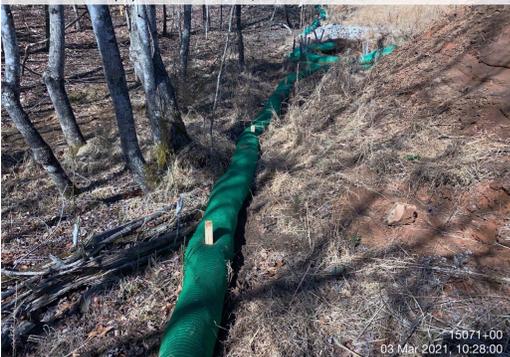
<p>297°NW (M) 36°57'47"N, 79°35'26"W ±11220ft ▲ 884ft 15071+00 03 Mar 2021, 10:28:00</p>

<p>309°NW (M) 36°57'31"N, 79°35'5"W ±82ft ▲ 890ft 15099+00 03 Mar 2021, 09:06:32</p>	
GPS Location	0	GPS Location	0
Field Station#	15071+00	Field Station#	15099+00
Pic 3 Desc.	Perimeter CFS after replacement from 15071+00 to 15072+00. Deteriorated CFS was removed before picture could be taken.	Pic 4 Desc.	Permanent vegetative stabilization in acceptable condition

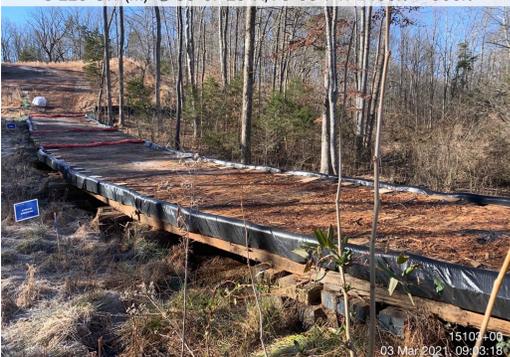
<p>229°SW (M) 36°57'29"N, 79°35'1"W ±400ft ▲ 900ft 15103+00 03 Mar 2021, 09:13:18</p>

<p>177°S (M) 36°56'58"N, 79°34'47"W ±314ft ▲ 901ft 15136+00 03 Mar 2021, 08:14:46</p>	
GPS Location	0	GPS Location	0
Field Station#	15103+00	Field Station#	15136+00
Pic 5 Desc.	Equipment bridge in acceptable condition	Pic 6 Desc.	Waterbar end treatment in acceptable condition

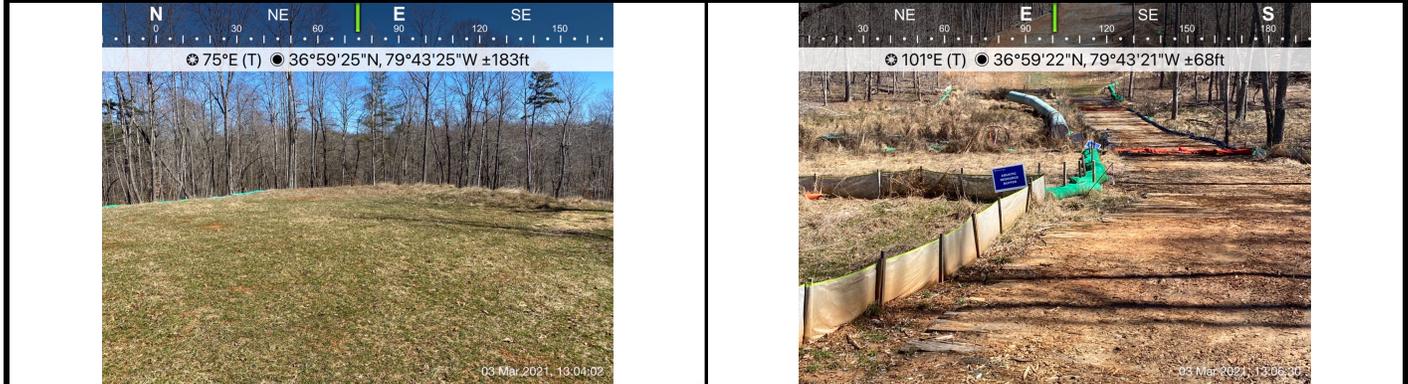
GPS Location	0	GPS Location	0
Field Station#	14651+75	Field Station#	14656+90
Pic 1 Desc.	Approximately 14651+75. Overview of ROW.	Pic 2 Desc.	Approximately 24656+90. Overview of stream crossing, equipment bridge and ECDs at stream S-H38.

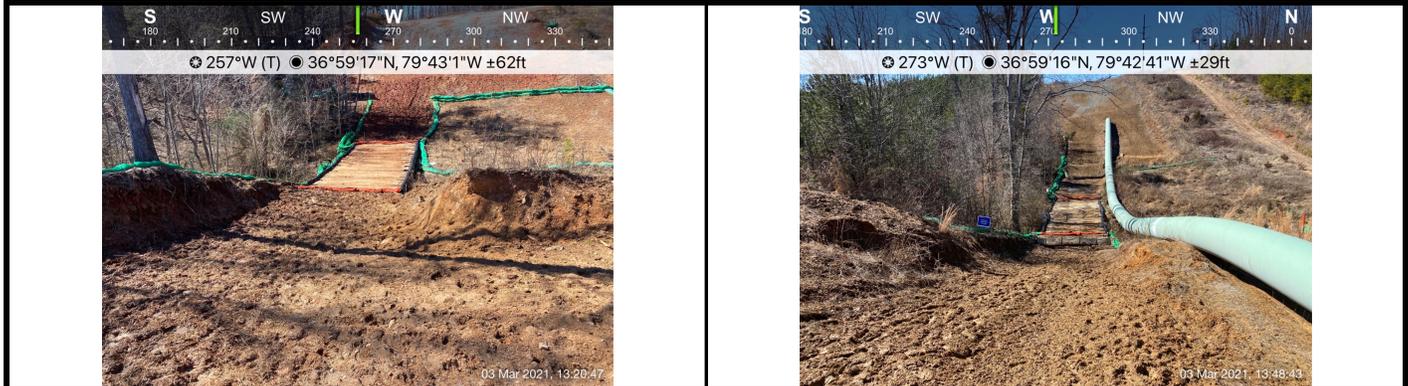
GPS Location	0	GPS Location	0
Field Station#	14673+10	Field Station#	14689+36
Pic 3 Desc.	Approximately 14673+10. Overview of stream crossing, equipment bridge and ECDs at stream S-H37.	Pic 4 Desc.	Approximately 14689+36. Overview of stream crossing, equipment bridge and ECDs at stream S-H34.

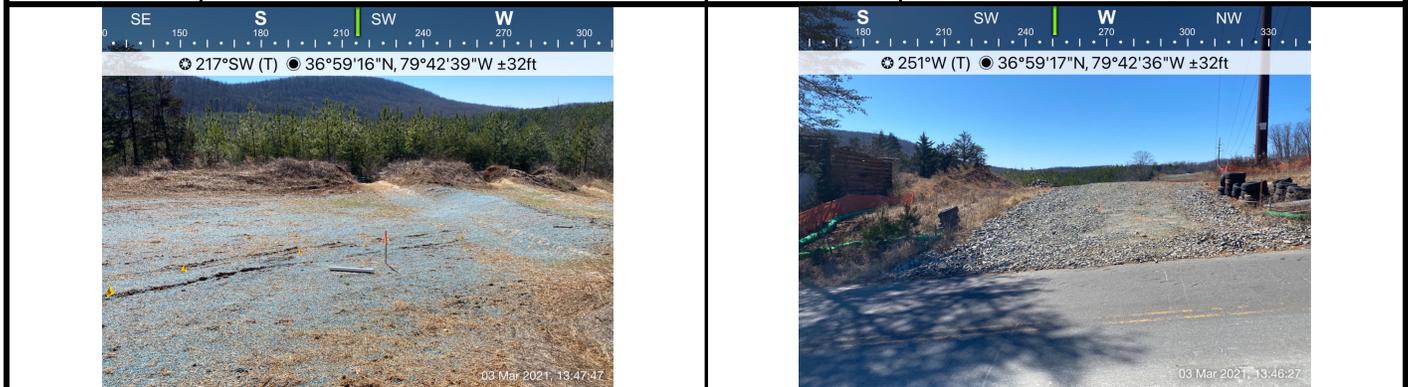
GPS Location	0	GPS Location	0
Field Station#	14691+00	Field Station#	14694+50
Pic 5 Desc.	Approximately 14691+00. Overview of ROW.	Pic 6 Desc.	Approximately 14694+50. Overview of road crossing and RCE.

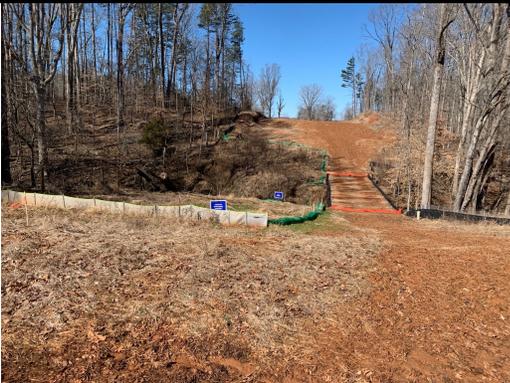
GPS Location O		GPS Location O			
Field Station# 15987+31		Field Station# 15976+50			
Pic 5 Desc. Observing temporary stabilization, signage, buffer, equipment crossing and ECD's		Pic 6 Desc. Observing CFS that requires maintenance

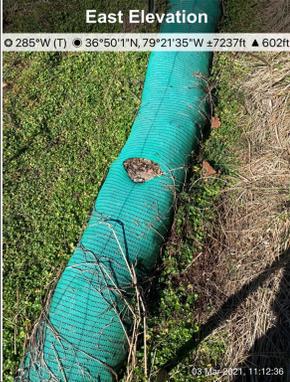
<p>East Elevation <small>285°W (T) ● 36°50'11"N, 79°21'35"W ±7237ft ▲ 602ft</small></p>

<p>North East Elevation <small>220°SW (T) ● 36°50'9"N, 79°21'38"W ±65ft ▲ 607ft</small></p>		<p>ert image here</p>	
GPS Location ○		GPS Location ○			
Field Station# 15961+00		Field Station# 15951+80			
Pic 7 Desc. Observing CFS that requires maintenance		Pic 8 Desc. Observing CFS that requires maintenance

Performed SWPPP Inspection on this section. There were issues identified and added to the punch list. The Contractor is working on repairing the issues. Other than that there were no issues to report at the time of Inspection

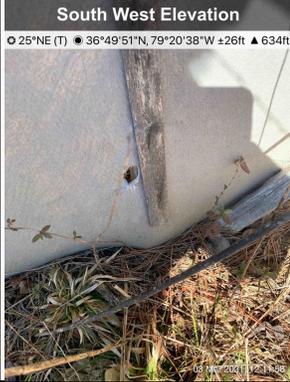
<p>South West Elevation <small>25°NE (T) ● 36°49'51"N, 79°20'38"W ±26ft ▲ 634ft</small></p>

<p>North East Elevation <small>224°SW (T) ● 36°50'11"N, 79°21'39"W ±3320ft ▲ 606ft</small></p>		<p>ert image here</p>	
GPS Location ○		GPS Location ○			
Field Station# 16023+70		Field Station# 15951+00			
Pic 9 Desc. Observing p1 that requires maintenance		Pic 10 Desc. Observing CFS that requires maintenance			
Insert image here			Insert image here

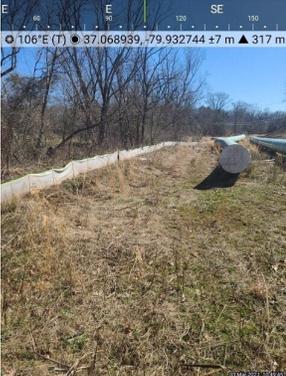
GPS Location	00000	GPS Location	0000	
Field Station#	13756+50	Field Station#	13787+30	
Pic 1 Desc.	The EI observed ECDs on row edge while monitoring row conditions during routine inspection today.		Pic 2 Desc.	Row photo above stream crossing showing so, EI new vegetation growth, slope breakers in place and functioning. No environmental issues observed at the time of inspection.

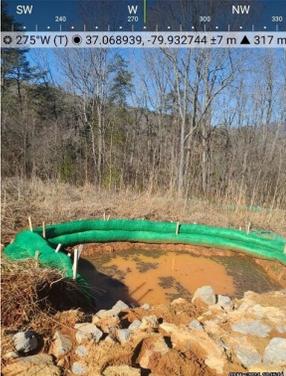
GPS Location	0000	GPS Location	00000	
Field Station#	13784+44	Field Station#	13784+70	
Pic 3 Desc.	Monitored sump end treatment during routine inspection today. No issues observed at the time of inspection.		Pic 4 Desc.	Observed large sump pit and ECDs while checking row conditions today. No environmental issues observed at time of inspection.

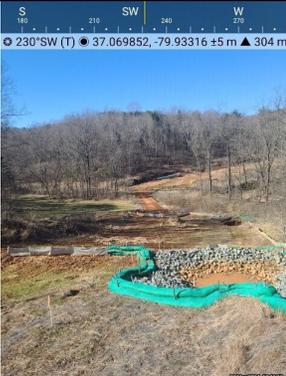
Pic 5 Desc.	EI monitored plunge pool and ECDs functioning, no environmental issues observed at time of inspection.		Pic 6 Desc.	Row photo showing stabilization and slope breakers in place and functioning. No issues observed at the time of inspection.

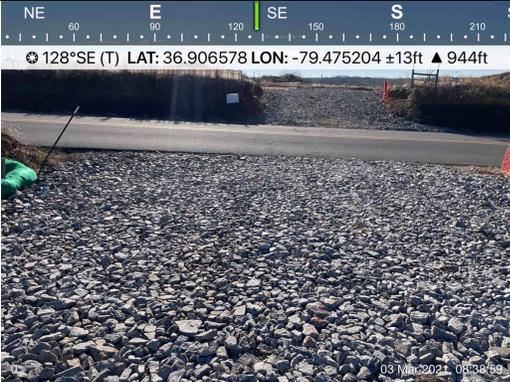
GPS Location See photo		GPS Location See photo			
Field Station# 15496+70		Field Station# 15515+00			
Pic 1 Desc. RCEs are in good condition throughout this section.		Pic 2 Desc. CWDs are functioning as intended.

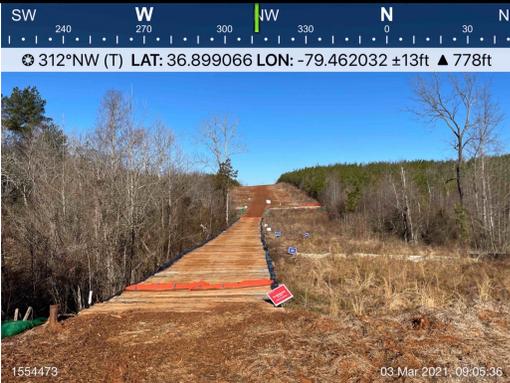
GPS Location See photo		GPS Location See photo			
Field Station# 15544+73		Field Station# 15545+11			
Pic 5 Desc. Equipment bridge ECDs are in place and functioning.		Pic 6 Desc. Waterbars and end treatments are functioning.

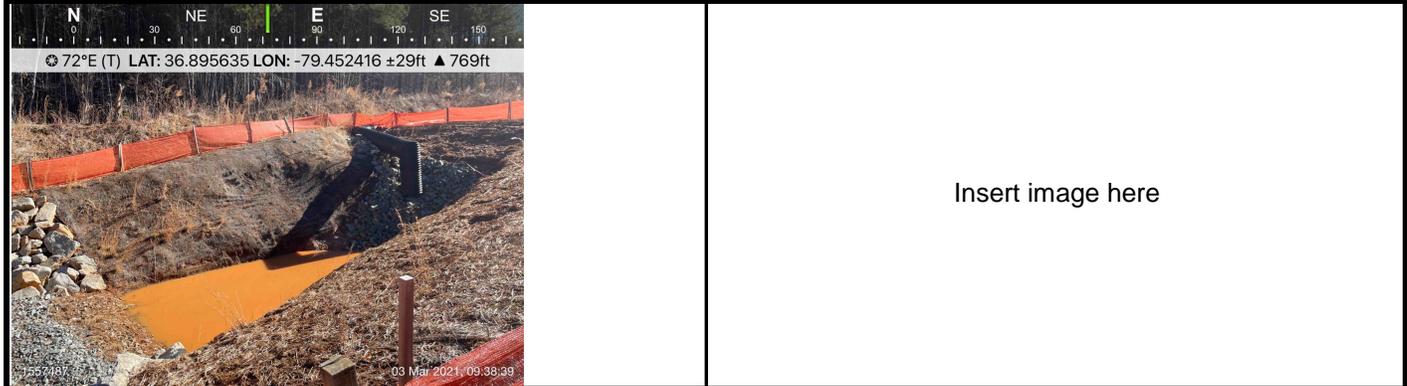
Pic 7 Desc.	Slope drain is in good condition and functioning.	Pic 8 Desc.	
--------------------	---	--------------------	--

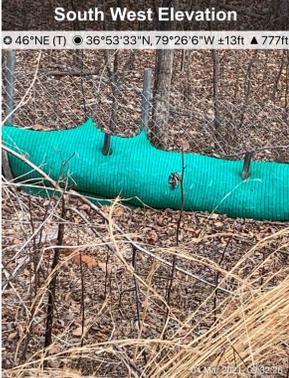
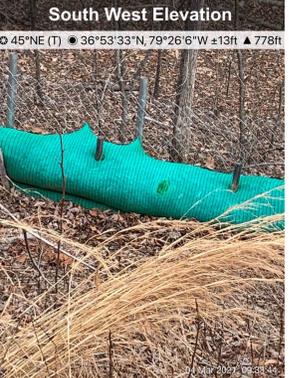
GPS Location	O	GPS Location	O		
Field Station#	15632+50	Field Station#	15632+50		
Pic 3 Desc.	Observing CFS that required maintenance		Pic 4 Desc.	Observing CFS that received maintenance.

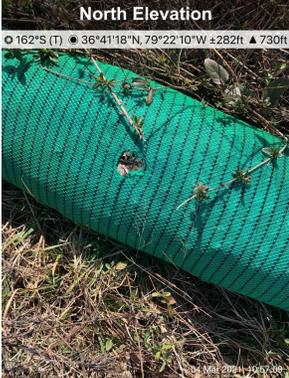
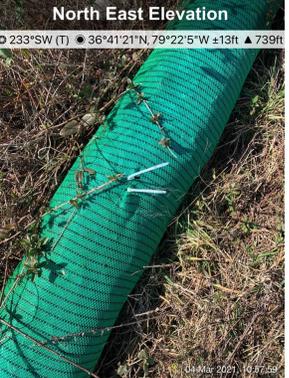
<p>North East Elevation <small>233°SW (T) ● 36°41'21"N, 79°22'5"W ±13ft ▲ 739ft</small></p>	GPS Location	O
GPS Location	O		GPS Location	O	
Field Station#	00+00		Field Station#	00+00	
Pic 1 Desc.	Observing CFS that required maintenance.		Pic 2 Desc.	Observing CFS that received maintenance

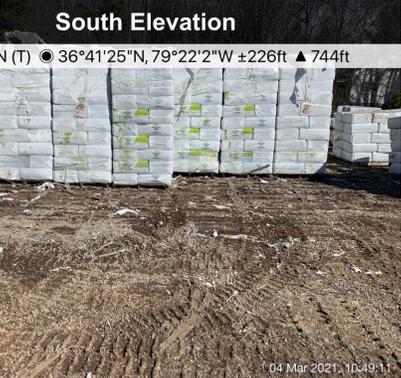
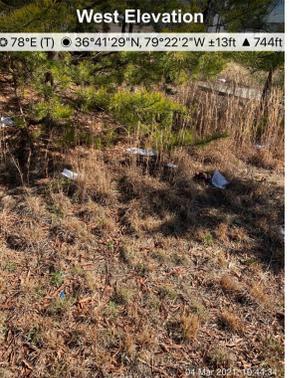
<p>West Elevation <small>78°E (T) ● 36°41'29"N, 79°22'2"W ±13ft ▲ 744ft</small></p>	GPS Location	O
GPS Location	O		GPS Location	O	
Field Station#	00+00		Field Station#	00+00	
Pic 3 Desc.	Observing trash that needs to be removed		Pic 4 Desc.	Observing trash that needs to be removed

E&S BMPs	Compliance Level	Corrective Action	Corrective Time Frame	Date Repaired
Compost Filter Sock	Communication	Contractor repaired upon discovery		3/4/2021
Housekeeping	Communication	Remove trash from yard

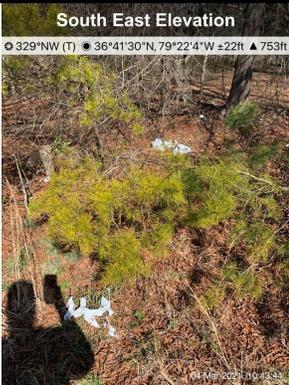
GPS Location	O		GPS Location	O	
Field Station#	00+00		Field Station#	00+00	
Pic 5 Desc.	Observing trash that needs to be removed		Pic 6 Desc.

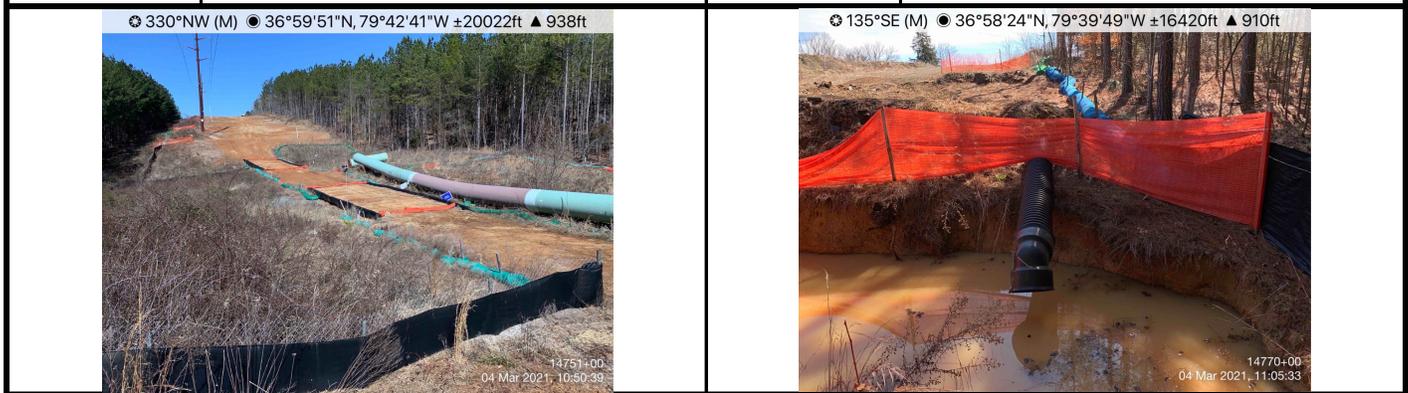
GPS Location	0	GPS Location	0
Field Station#	14751+00	Field Station#	14770+00
Pic 5 Desc.	Equipment bridge in acceptable condition	Pic 6 Desc.	Slope drain in acceptable condition

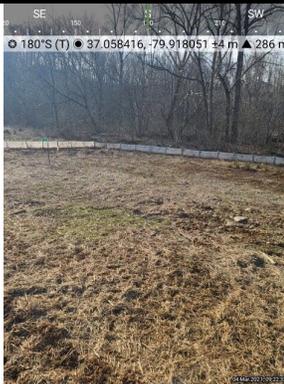
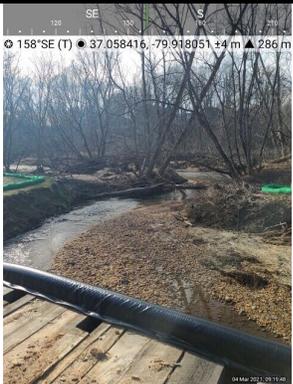
GPS Location	0000		GPS Location	00000	
Field Station#	13864+88		Field Station#	13863+01	
Pic 3 Desc.	El monitored perimeter P1, no issues observed at the time of inspection.		Pic 4 Desc.	Stream observation photo facing downstream during routine inspection, no environmental issues observed at the time of inspection.

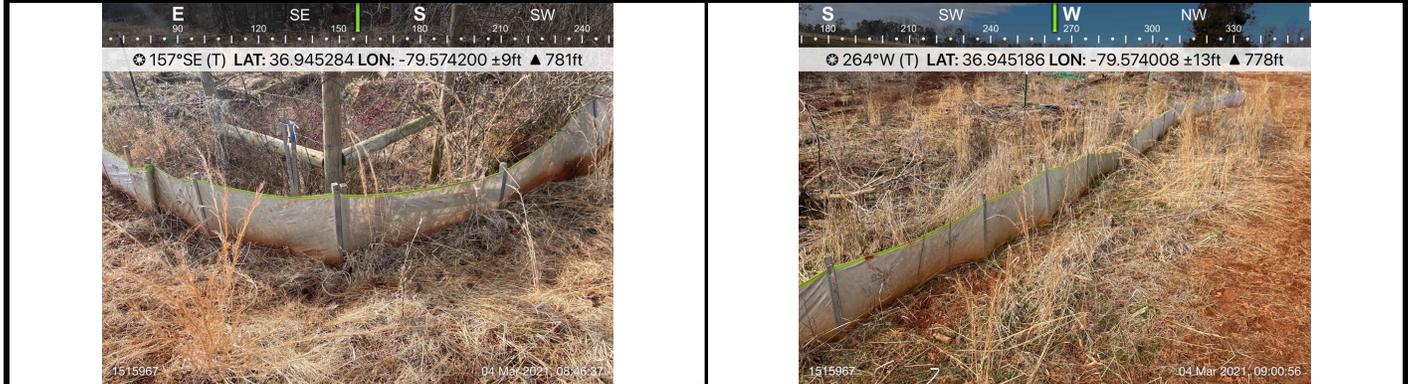
Field Station#	15159+67	Field Station#	15159+67
-----------------------	----------	-----------------------	----------

Pic 1 Desc.	P1 is degraded and needs to be replaced	Pic 2 Desc.	P1 is degraded and needs to be replaced.
--------------------	---	--------------------	--

- EI began inspection at Rockcreek Rd.
- RCE is in good condition at Rockcreek Rd.
- P1 needs to be replaced at 15159+67.
- Equipment bridge ECDs are in place at all stream and wetland crossings.
- Buffer zone P1 is in good condition.
- Slope drain is functioning as intended at 15170+00
- Temporary/permanent waterbars are in good condition and functioning.
- Drainage ECDs require maintenance/improvements at 15195+00. Maintenance to occur when ROW conditions allow.
- Rill erosion at 15214+97 needs to be regraded and stabilized.

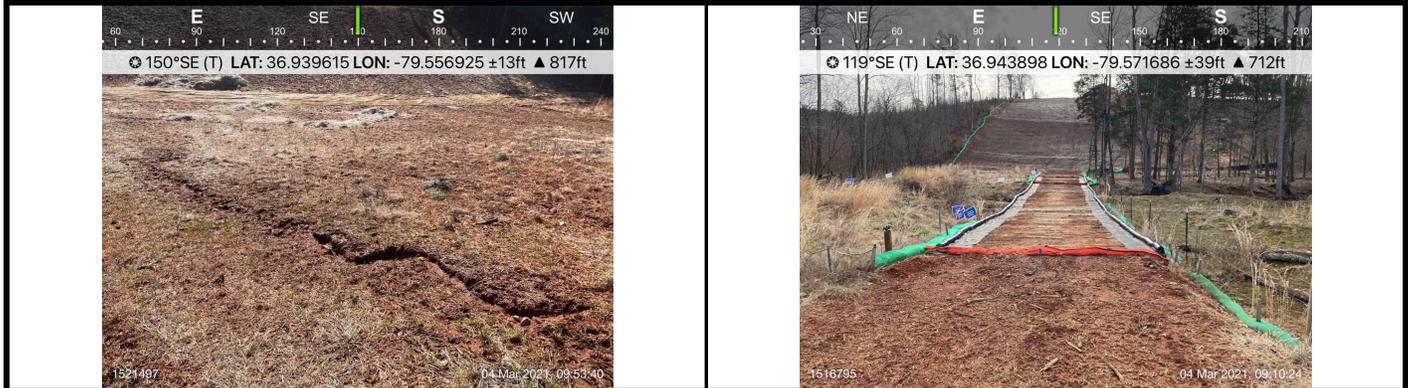
Field Station#	15214+97	Field Station#	15167+95
-----------------------	----------	-----------------------	----------

Pic 3 Desc.	Rill erosion needs to be regraded and stabilized.	Pic 4 Desc.	Equipment bridge ECDs are in place and functioning.
--------------------	---	--------------------	---

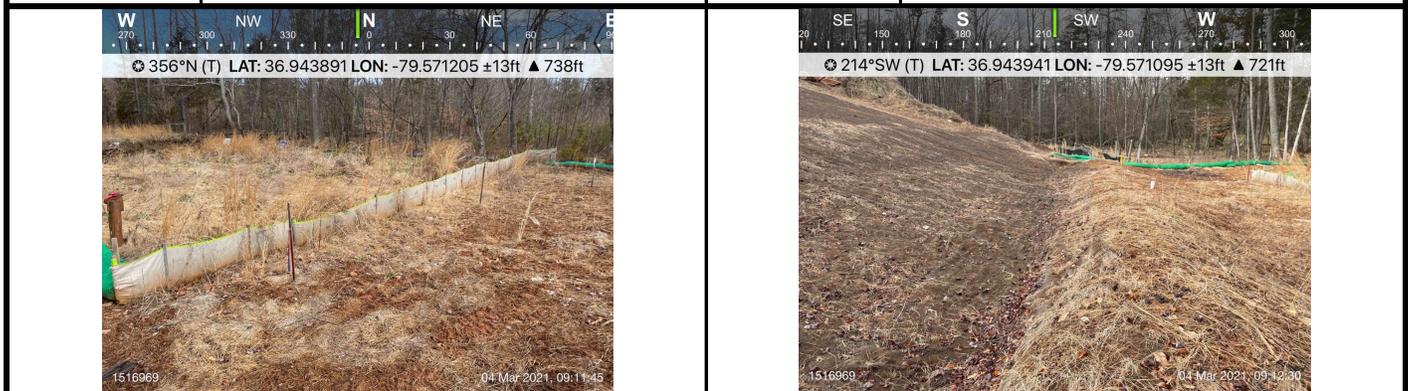
Field Station#	15169+69	Field Station#	15169+69
-----------------------	----------	-----------------------	----------

Pic 5 Desc.	Buffer area P1 is in good condition.	Pic 6 Desc.	Waterbars are in good condition and functioning.
--------------------	--------------------------------------	--------------------	--

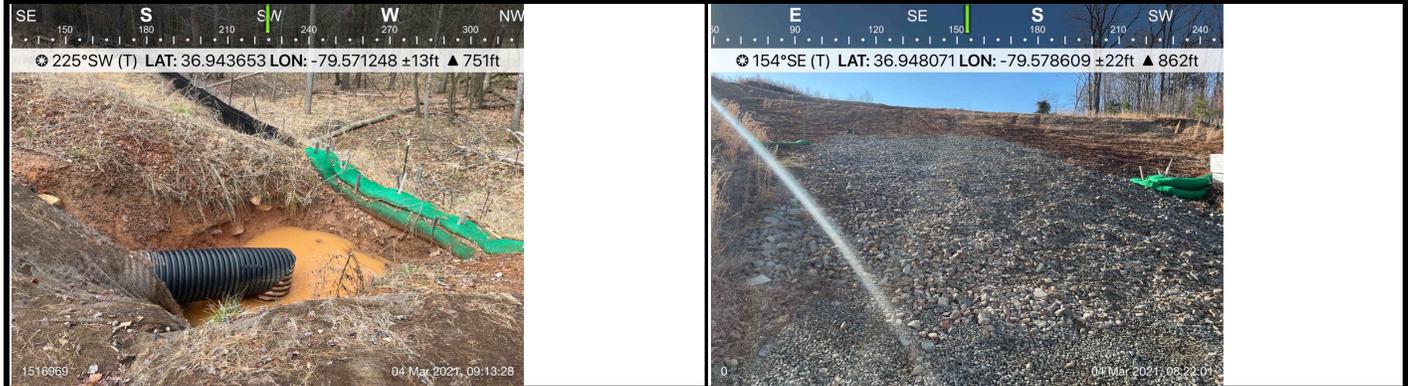
Field Station#	15169+69	Field Station#	15147+22
-----------------------	----------	-----------------------	----------

Pic 7 Desc.	Slope drain is functioning as intended.	Pic 8 Desc.	RCE at Rockcreek Rd. is in good condition.
--------------------	---	--------------------	--

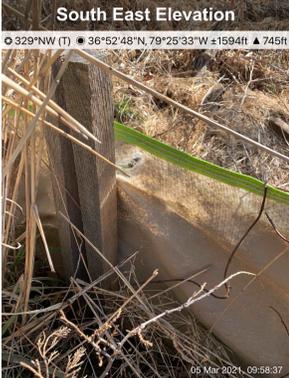
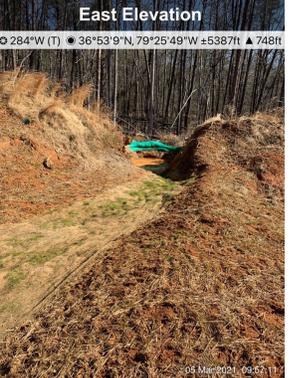
Field Station#	15672+00		Field Station#	15662+00	
Pic 3 Desc.	Observing p1 that requires maintenance		Pic 4 Desc.	Observing water bar, erosion control blanket, sump and end treatment

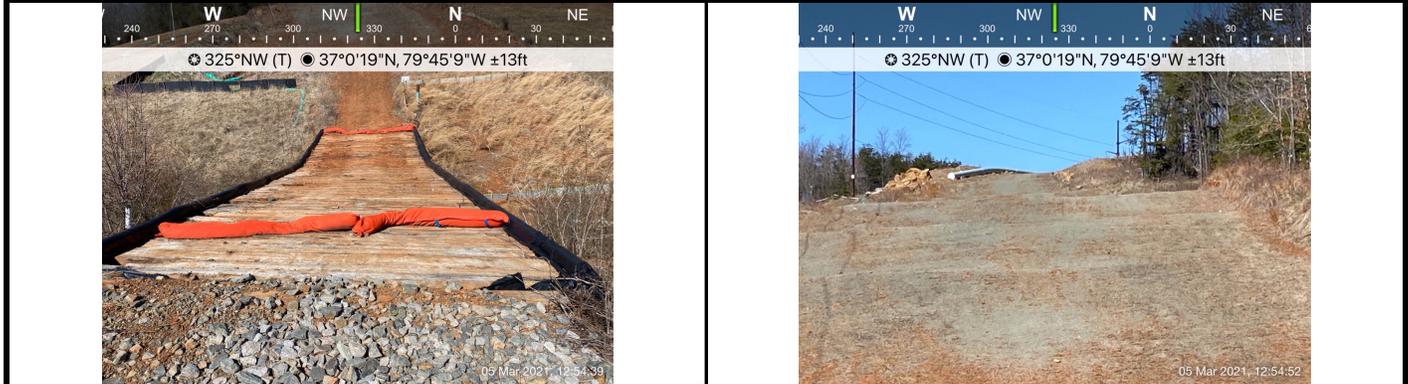
Field Station#	14546+75	Field Station#	14540+00
-----------------------	----------	-----------------------	----------

Pic 1 Desc.	Approximately 14546+75. Overview of stream crossing, equipment bridge and ECDs at stream S-G17.	Pic 2 Desc.	Approximately 14540+00. Overview of ROW.
--------------------	---	--------------------	--

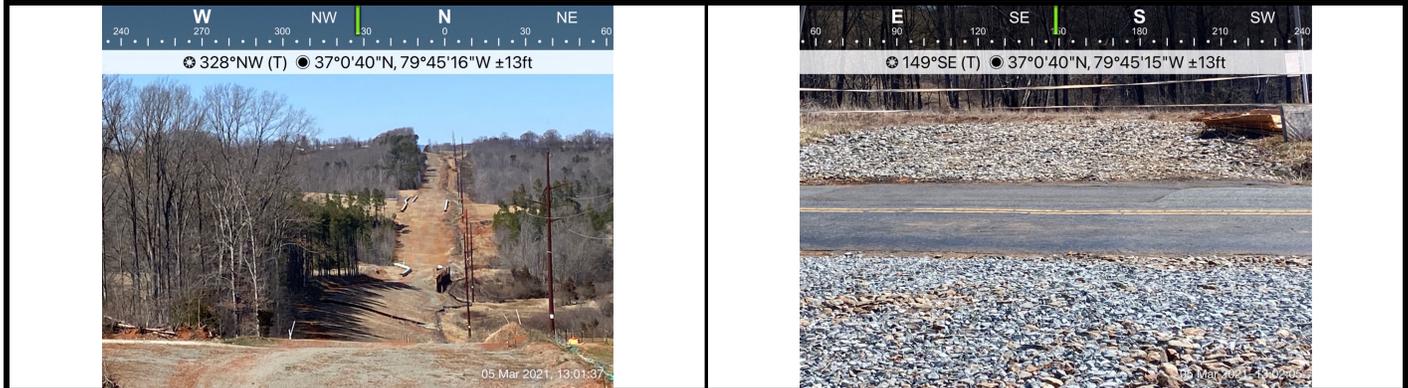
Field Station#	14510+00	Field Station#	14524+75
-----------------------	----------	-----------------------	----------

Pic 3 Desc.	Approximately 14510+00. Overview of ROW.	Pic 4 Desc.	Approximately 14524+75. Overview of road crossing and RCEs.
--------------------	--	--------------------	---

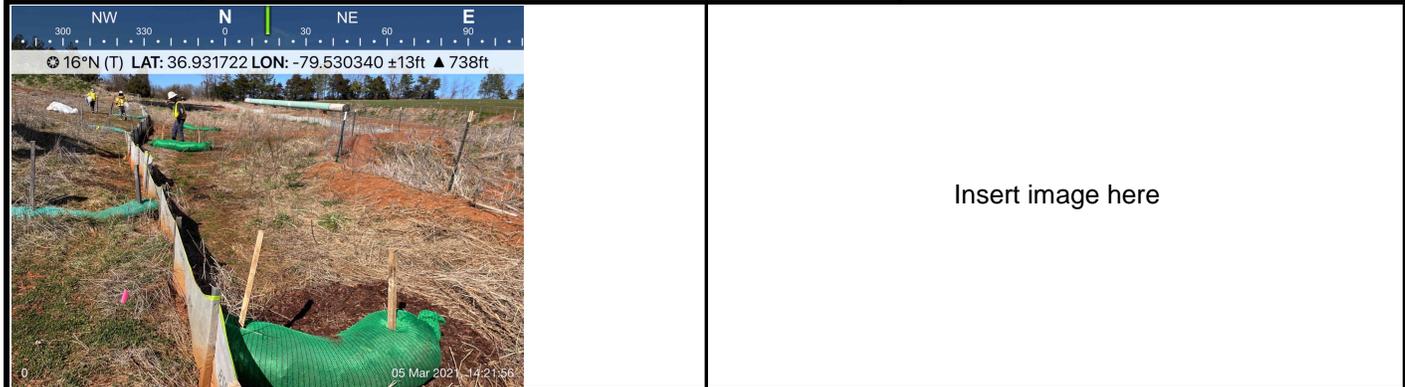
GPS Location	See photo	GPS Location	
Field Station#	15299+75	Field Station#	
Pic 15 Desc.	CFS check dams have been installed to drainage channel.	Pic 16 Desc.

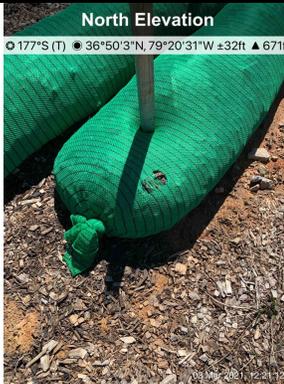
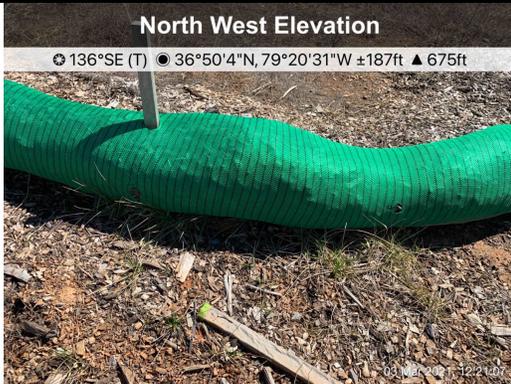
<p>North West Elevation <small>136°SE (T) ● 36°50'4"N, 79°20'31"W ±187ft ▲ 675ft</small></p>	
GPS Location	O		GPS Location	O	
Field Station#	00+00		Field Station#	00+00	
Pic 1 Desc.	Observing CFS that requires maintenance		Pic 2 Desc.	Observing CFS that requires maintenance

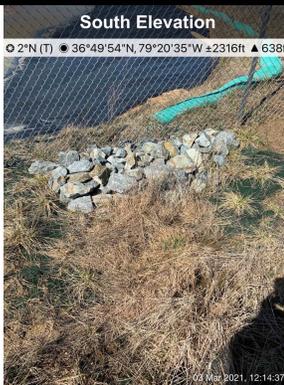
GPS Location	O		GPS Location	O	
Field Station#	00+00		Field Station#	00+00	
Pic 5 Desc.	Observing rock check dam and ECD's		Pic 6 Desc.	Observing emergency overflow at the storm water pond
