# Visual Site Inspection Report

<b>Project Name</b> H-600 Pipeline Spread I		<b>AFE</b> 124300139	<b>Spread</b> H-600 Pipeline Spread I
<b>Contractor</b> Precision		<b>Report #</b> 21606	
<b>Inspector</b> Ben Davenport		<b>Date/Time</b> 3/29/2021 9:41 AM	
<b>Permit #</b> TBD	<b>Inspection Type</b> VA SWPP	<b>Station Begin</b> 13958+31	
<b>State</b> VA	<b>Inspection Area</b> Partial	<b>Station End</b> 14062+17	
<b>County</b> Franklin	<b>Ground</b> Muddy	<b>Temperature (°F)</b> 60.00	
<b>Municipality</b> N/A	<b>Weather</b> Sunny	<b>Rain Gauge (in)</b> 0.50	
			<b>Rain Accumulation Time (days)</b> 1.00

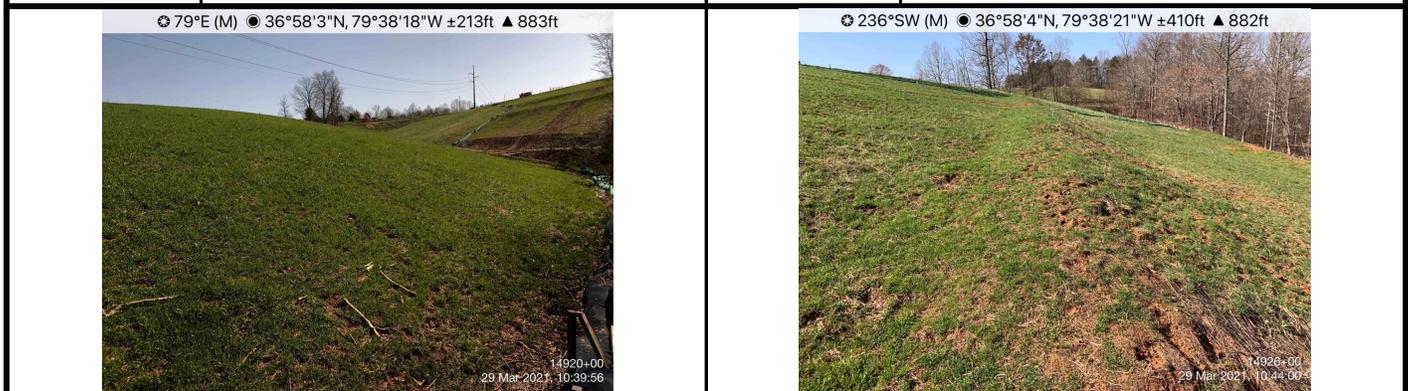
<b>GPS Location</b>	0	<b>GPS Location</b>	0
<b>Field Station#</b>	14833+00	<b>Field Station#</b>	14923+00
<b>Pic 3 Desc.</b>	Equipment bridge in acceptable condition	<b>Pic 4 Desc.</b>	Holes in P1 silt fence (2 panels)

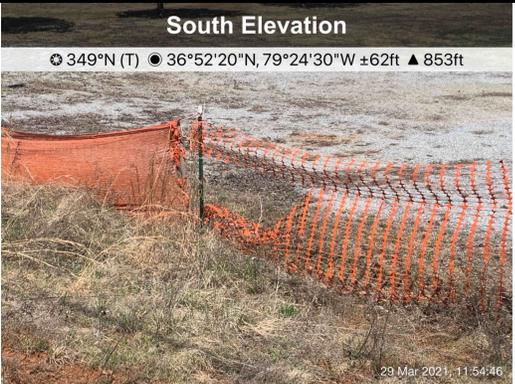
<p>South Elevation            351°N (T) ● 36°52'12"N, 79°24'9"W ±1112ft ▲ 807ft            29 Mar 2021, 11:53:59</p>	
GPS Location	O		GPS Location	O	
Field Station#	15746+00		Field Station#	15766+00	
Pic 1 Desc.	Observing barcade fencing that requires maintenance		Pic 2 Desc.	Observing CFS that required maintenance

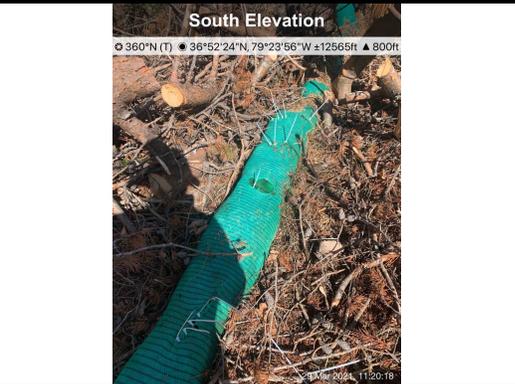
<p>South Elevation            359°N (T) ● 36°52'15"N, 79°24'4"W ±6988ft ▲ 807ft            29 Mar 2021, 11:16:00</p>	
GPS Location	O		GPS Location	O	
Field Station#	15766+00		Field Station#	15765+00	
Pic 3 Desc.	Observing CFS that received maintenance		Pic 4 Desc.	Observing p1 that requires maintenance

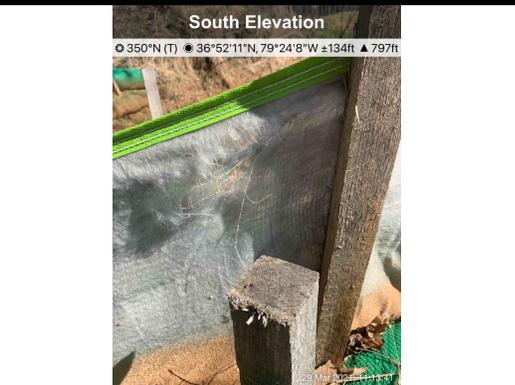
<p>South East Elevation            296°NW (T) ● 36°52'43"N, 79°25'12"W ±1870ft ▲ 760ft            29 Mar 2021, 10:49:16</p>	
GPS Location	O		GPS Location	O	
Field Station#	15767+00		Field Station#	15701+50	
Pic 5 Desc.	Observing p1 that requires maintenance		Pic 6 Desc.	Observing SSF that required maintenance

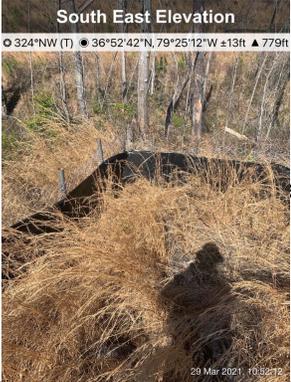
<p>South East Elevation 299°NW (T) 36°53'35"N, 79°23'36"W ±16187ft ▲ 762ft</p>	
GPS Location	O	GPS Location	O
Field Station#	15701+50	Field Station#	15708+02
Pic 7 Desc.	Observing SSF that received maintenance	Pic 8 Desc.	Observing temporary stabilization, signage, buffer, equipment crossing and ECD's

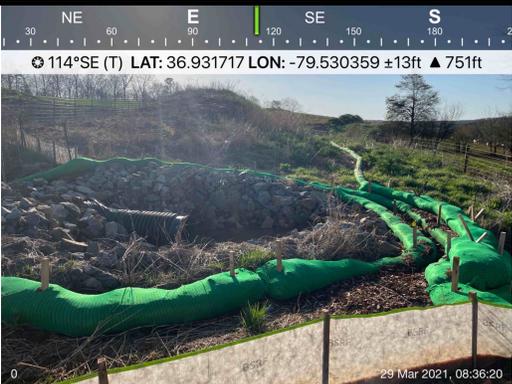
<b>GPS Location</b>	See photo	<b>GPS Location</b>	See photo		
<b>Field Station#</b>	15299+00	<b>Field Station#</b>	15313+00		
<b>Pic 3 Desc.</b>	CWDs are in good condition throughout this section.	<b>Pic 4 Desc.</b>	Equipment bridge ECDs are in place and functioning.

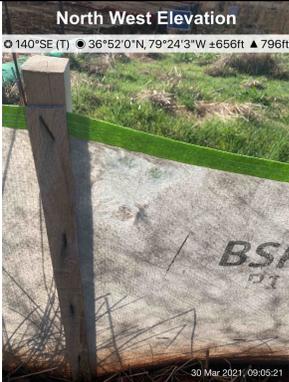
<p>North West Elevation        140°SE (T) ● 36°52'0"N, 79°24'3"W ±656ft ▲ 796ft  <small>30 Mar 2021, 09:05:21</small></p>		ert image here	
GPS Location ○		GPS Location ○			
Field Station# 15884+00		Field Station# 15780+50			
Pic 11 Desc. Observing temporary stabilization, CWD outlet and ECD's		Pic 12 Desc. Observing p1 that requires maintenance

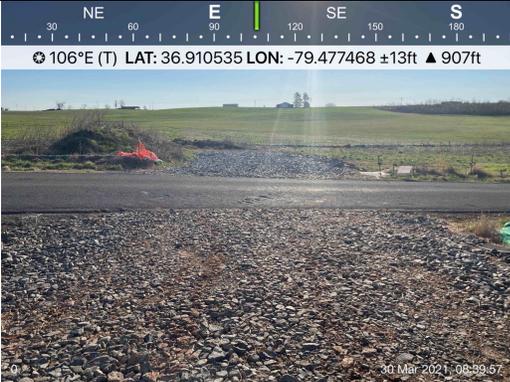
- EI began inspection at Toshes Rd.
- RCEs are in good condition at all road crossings.
- Drainage outlet in good condition at 15475+00.
- 3rd party disturbance upslope from rock outlet at 15465+00. Area will continue to be monitored during rain events to ensure runoff/sediment does not enter/overwhelm MVP ECDs.
- CWDs are in good condition and functioning.
- Equipment bridge ECDs are in place and functioning.
- Waterbars are in good condition and functioning.
- CFS is in good condition along drainage at 15375+00.
- Area remains temporarily stabilized.

<b>GPS Location</b> See photo		<b>GPS Location</b> See photo			
<b>Field Station#</b> 15480+67		<b>Field Station#</b> 15475+00			
<b>Pic 1 Desc.</b> RCEs are in good condition at all road crossings.		<b>Pic 2 Desc.</b> Rock outlet in good condition.

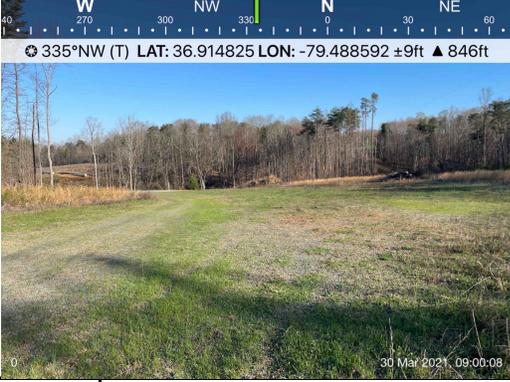
<b>GPS Location</b> See photo		<b>GPS Location</b> See photo			
<b>Field Station#</b> 15440+00		<b>Field Station#</b> 15427+00			
<b>Pic 5 Desc.</b> Area remains temporarily stabilized.		<b>Pic 6 Desc.</b> Equipment bridge ECDs are in good condition and functioning.

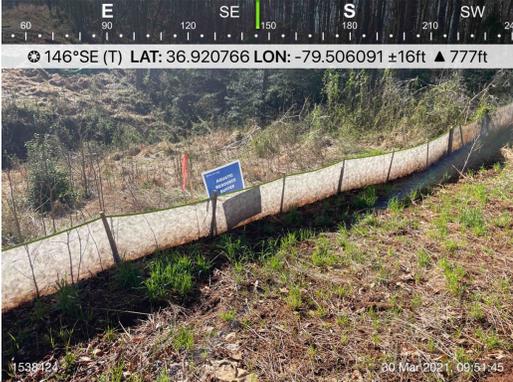
<b>GPS Location</b>	See photo	<b>GPS Location</b>	See photo		
<b>Field Station#</b>	15384+24	<b>Field Station#</b>	15383+80		
<b>Pic 7 Desc.</b>	P1 is in good condition at all stream and wetland buffers.	<b>Pic 8 Desc.</b>	Waterbars are in good condition throughout this section.

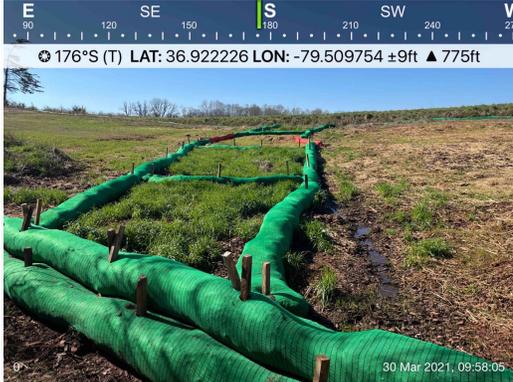
Insert image here			
<b>GPS Location</b>	See photo	<b>GPS Location</b>			
<b>Field Station#</b>	15375+00	<b>Field Station#</b>			
<b>Pic 9 Desc.</b>	CFS along this drainage is in good condition.	<b>Pic 10 Desc.</b>			
Insert image here		Insert image here			
<b>GPS Location</b>		<b>GPS Location</b>			
<b>Field Station#</b>		<b>Field Station#</b>			
<b>Pic 11 Desc.</b>		<b>Pic 12 Desc.</b>

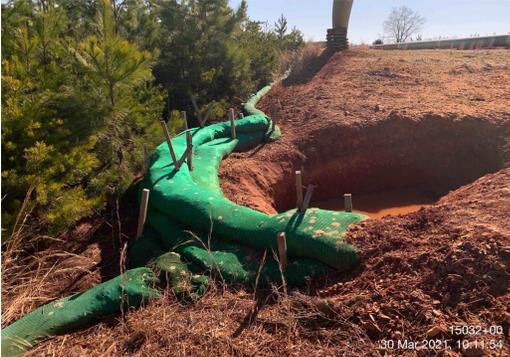
<p>102°E (M) 36°57'55"N, 79°36'12"W ±39ft ▲ 828ft 15032+00 30 Mar 2021, 10:11:34</p>

<p>228°SW (M) 36°58'19"N, 79°37'39"W ±6541ft ▲ 864ft 15047+00 30 Mar 2021, 03:52:42</p>		
<b>GPS Location</b>	0		<b>GPS Location</b>	0	
<b>Field Station#</b>	15032+00		<b>Field Station#</b>	15047+00	
<b>Pic 1 Desc.</b>	Waterbar end treatment in acceptable condition		<b>Pic 2 Desc.</b>	P1 silt fence in acceptable condition

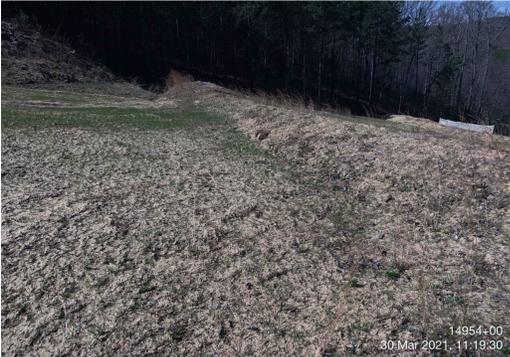
<p>230°SW (M) 36°58'0"N, 79°37'46"W ±213ft ▲ 901ft 14954+00 30 Mar 2021, 11:19:30</p>

<p>121°SE (M) 36°58'2"N, 79°38'7"W ±45ft ▲ 821ft 14936+00 30 Mar 2021, 11:29:43</p>		
<b>GPS Location</b>	0		<b>GPS Location</b>	0	
<b>Field Station#</b>	14954+00		<b>Field Station#</b>	14936+00	
<b>Pic 3 Desc.</b>	Waterbar in acceptable condition		<b>Pic 4 Desc.</b>	Clean water diversion pipe in acceptable condition

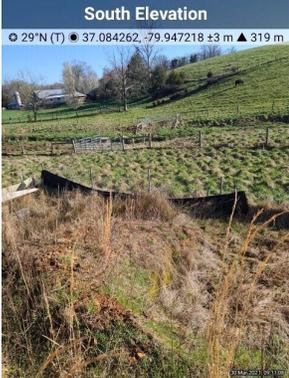
Throughout today's inspections the EI noticed a section of silt fence that required maintenance, the contractor made repairs while traveling row with the EI.

<b>GPS Location</b>	00000		<b>GPS Location</b>	00000	
<b>Field Station#</b>	13696+20		<b>Field Station#</b>	13696+20	
<b>Pic 1 Desc.</b>	Silt fence requires maintenance, contractor in the area and working to make repair.		<b>Pic 2 Desc.</b>	Photo showing repair made by the contractor to silt fence that required maintenance.

E&S BMPs	Compliance Level	Corrective Action	Corrective Time Frame	Date Repaired
Silt Fence (Reinforce Filter Fence)	Acceptable	Repaired silt fence	Addressed	3/30/2021
Vegetative Stabilization (Permanent)	Acceptable			
Equipment Bridge	Acceptable

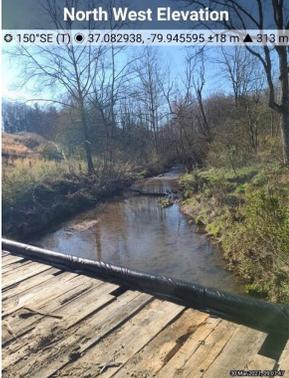
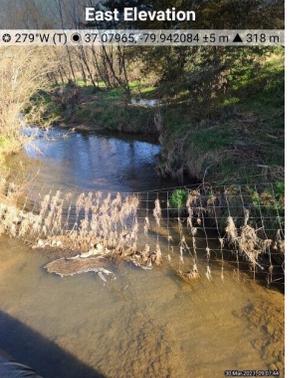
<b>GPS Location</b>	00000		<b>GPS Location</b>	00000	
<b>Field Station#</b>	13705+07		<b>Field Station#</b>	13705+07	
<b>Pic 3 Desc.</b>	Stream observation photo facing downstream during routine inspection today, no issues observed at the time of inspection.		<b>Pic 4 Desc.</b>	Stream observation photo facing upstream during routine inspection today, no issues observed at the time of inspection.

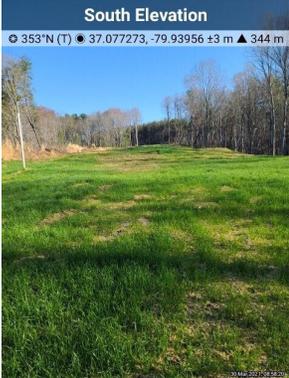
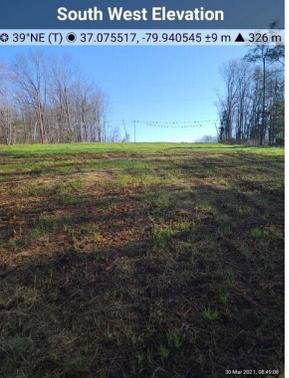
<b>Pic 5 Desc.</b>	Vegetation observation showing good coverage of new vegetation after recent hydro seed activities		<b>Pic 6 Desc.</b>	Vegetation photo showing new vegetation growing ,no issues observed at the time of inspection.

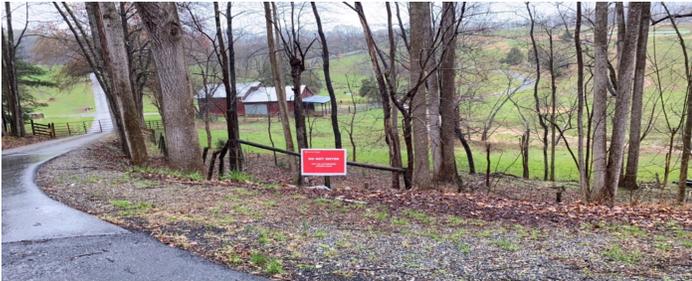
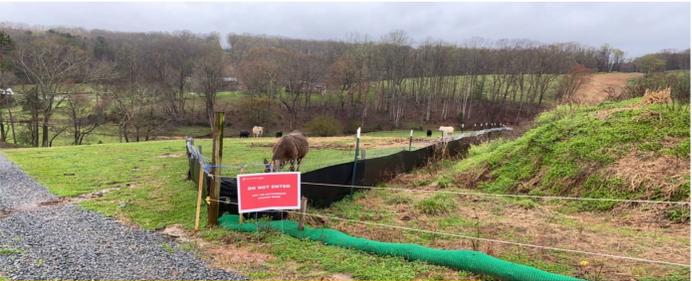
<b>GPS Location</b>	1	<b>GPS Location</b>	2
<b>Field Station#</b>	13196+90	<b>Field Station#</b>	14196+90
<b>Pic 1 Desc.</b>	Signage placed at Hwy 122 entrance to MVP-FR-310 which is being turned back over to landowner	<b>Pic 2 Desc.</b>	Signage placed at ROW entrance to MVP-FR-310 which is being turned back over to landowner

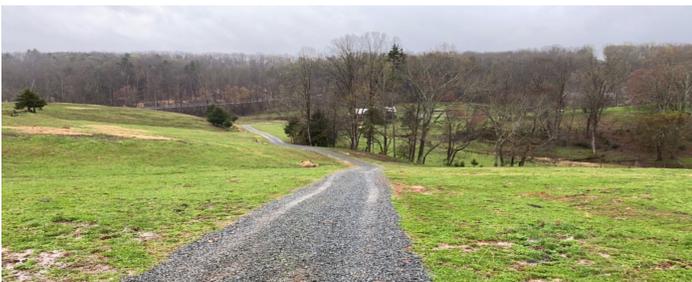
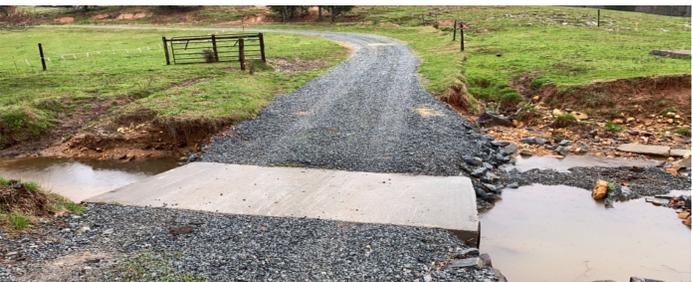
<b>GPS Location</b>	3	<b>GPS Location</b>	4
<b>Field Station#</b>	14196+90	<b>Field Station#</b>	14196+90
<b>Pic 3 Desc.</b>	Condition of MVP-FR-310 upon being turned back over to landowner	<b>Pic 4 Desc.</b>	Condition of MVP-FR-310 upon being turned back over to landowner

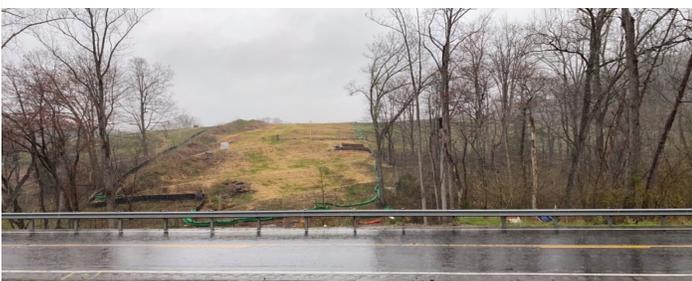
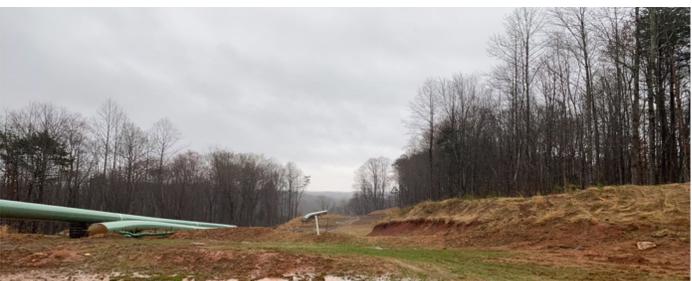
<b>GPS Location</b>	5	<b>GPS Location</b>	6
<b>Field Station#</b>	14209+75	<b>Field Station#</b>	14224+00
<b>Pic 5 Desc.</b>	View of ROW from Hwy 122 crossing. No issues identified.	<b>Pic 6 Desc.</b>	Vegetation growing along ROW in recently seeded and stabilized area.

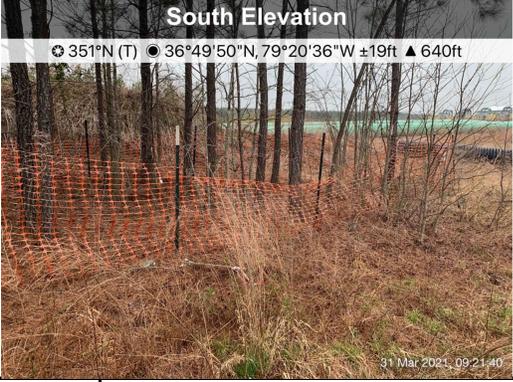
Performed SWPPP Inspection on this line. There was one issue identified and repaired upon discovery by the Contractor.(the item that was repaired was baracade fencing) Other than that there were no issues to report at the time of Inspection.

<p>South Elevation        351°N (T) ● 36°49'50"N, 79°20'36"W ±164ft ▲ 641ft  <small>31 Mar 2021 09:23:18</small></p>			
GPS Location O		GPS Location O			
Field Station# 3+00		Field Station# 3+00			
Pic 5 Desc. Observing barcade fencing that required maintenance		Pic 6 Desc. Observing barcade fencing that received maintenance

E&S BMPs	Compliance Level	Corrective Action	Corrective Time Frame	Date Repaired
Compost Filter Sock	Acceptable			
Equipment Bridge	Acceptable			
Other - Explain in Comments	Communication	Repair safety fence	Addressed	3/31/2021
Sediment Filter Log	Acceptable			
Sensitive Resource Buffer	Acceptable			
Sensitive Resource Signage	Acceptable			
Silt Fence (Filter Fabric Fence)	Acceptable			
Sump Pit	Acceptable			
Vegetative Stabilization (Temporary)	Acceptable

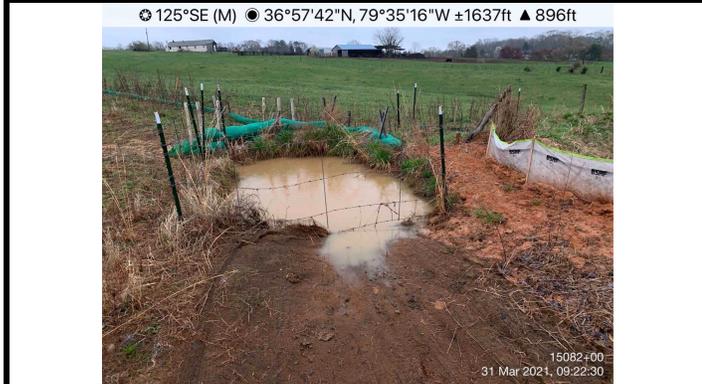
<b>Pic 1 Desc.</b>	Waterbar end treatment in acceptable condition
--------------------	--

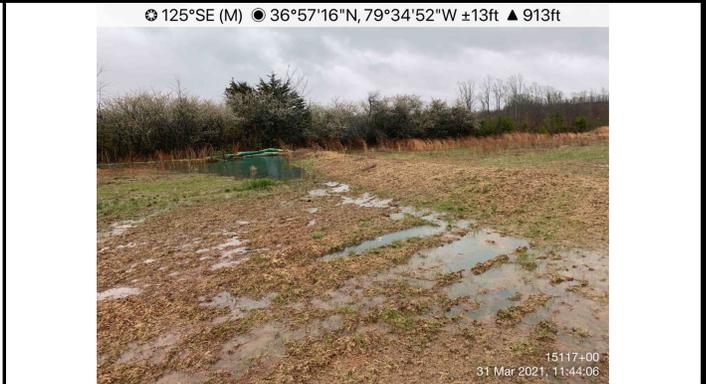
<b>Pic 2 Desc.</b>	Waterbar in acceptable condition
--------------------	----------------------------------

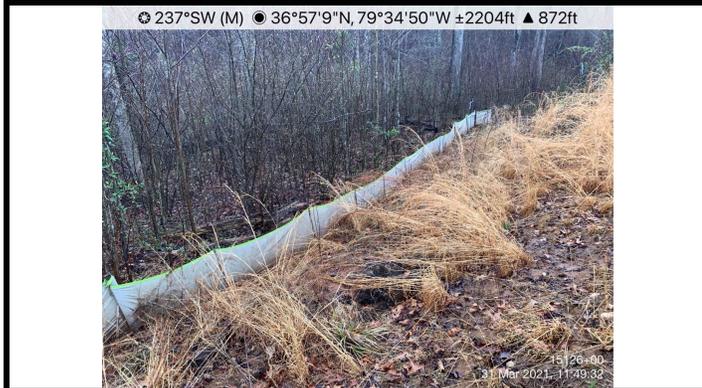
<b>Pic 3 Desc.</b>	P1 silt fence in acceptable condition
--------------------	---------------------------------------

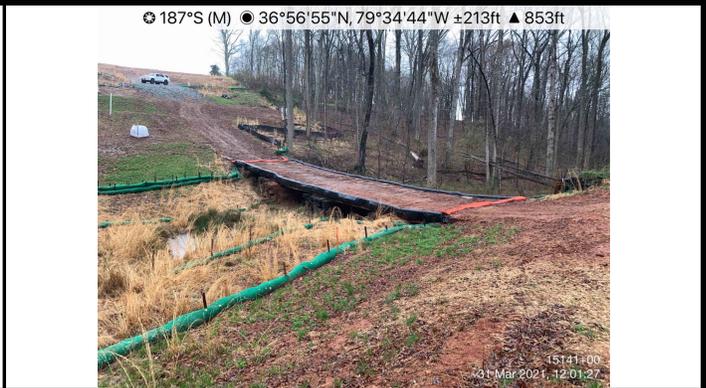
<b>Pic 4 Desc.</b>	Equipment bridge in acceptable condition
--------------------	--

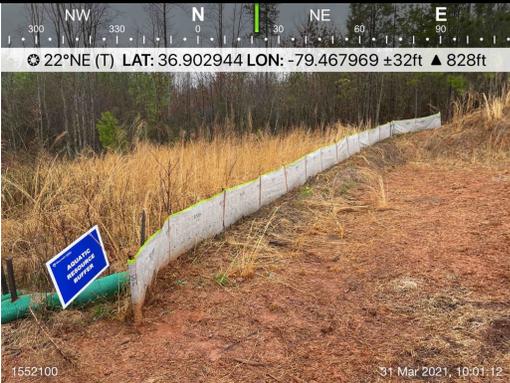
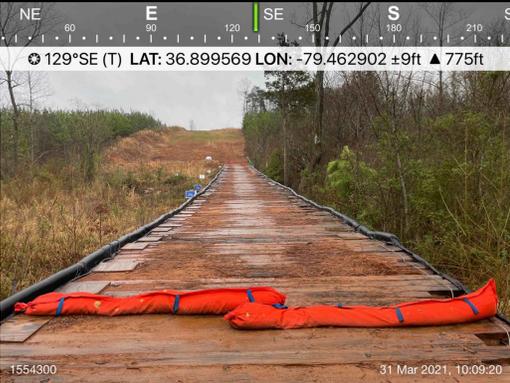
<b>GPS Location</b> See photo		<b>GPS Location</b> See photo			
<b>Field Station#</b> 15521+00		<b>Field Station#</b> 15543+00			
<b>Pic 5 Desc.</b> P1 is in good condition at all stream and wetland buffers.		<b>Pic 6 Desc.</b> Equipment bridge ECDs are in place and functioning.

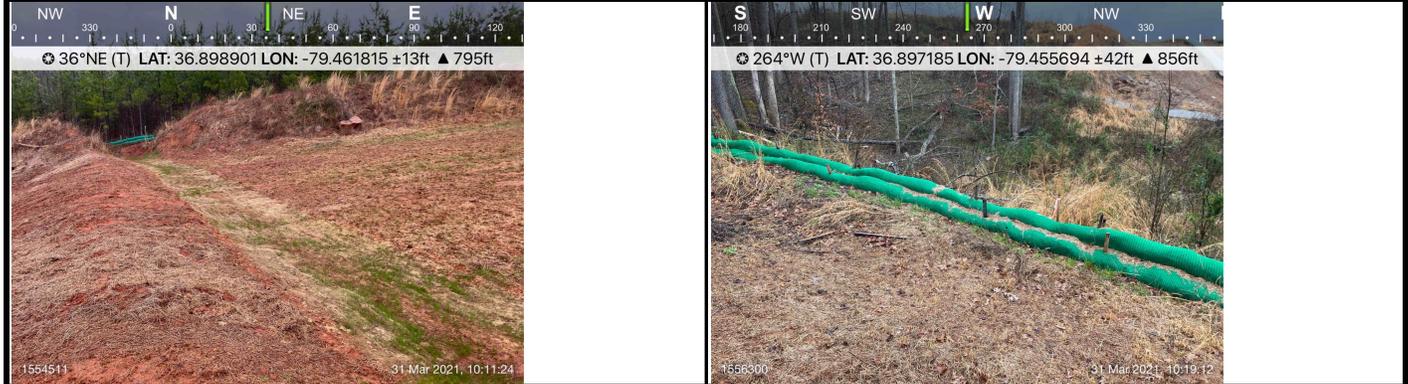
<b>GPS Location</b>	See photo	<b>GPS Location</b>	See photo
<b>Field Station#</b>	15545+11	<b>Field Station#</b>	15563+00
<b>Pic 7 Desc.</b>	Waterbars are functioning as intended.	<b>Pic 8 Desc.</b>	CFS is in good condition throughout this section.

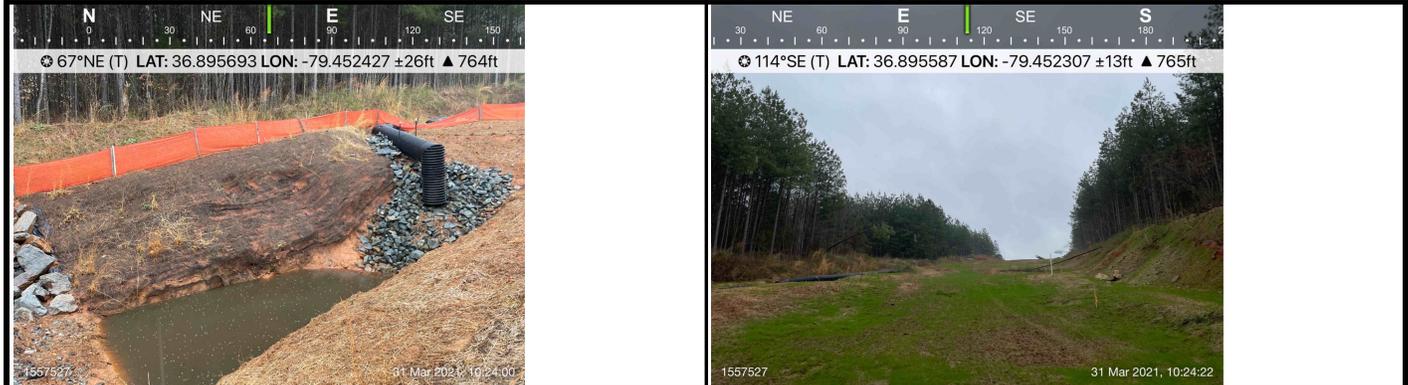
<b>GPS Location</b>	See photo	<b>GPS Location</b>	See photo
<b>Field Station#</b>	15575+27	<b>Field Station#</b>	15575+27
<b>Pic 9 Desc.</b>	Slope drain is functioning as intended.	<b>Pic 10 Desc.</b>	This area remains temporarily stabilized.

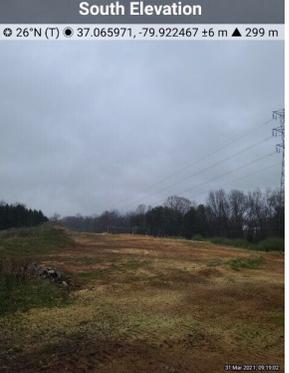
<p>South Elevation  <small>26°N (T) • 37.065971, -79.922467 ±6 m ▲ 299 m</small></p>	
GPS Location	00000		GPS Location	0000	
Field Station#	13812+12		Field Station#	13826+99	
Pic 1 Desc.	Row photo taken during rain events. No issues observed at the time of inspection.		Pic 2 Desc.	Row photo showing saturated row conditions during rain events today.

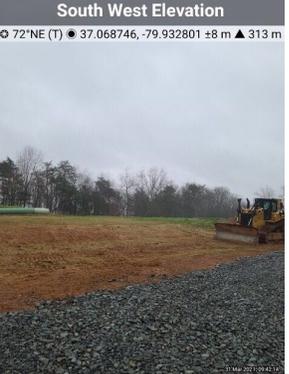
<p>South West Elevation  <small>72°NE (T) • 37.068746, -79.932801 ±8 m ▲ 313 m</small></p>	
GPS Location	0000		GPS Location	00000	
Field Station#	13784+35		Field Station#	13784+35	
Pic 3 Desc.	Row photo taken during rain events today , no issues were observed at the time inspection		Pic 4 Desc.	Row photo taken during light rain events today. Row conditions were saturated

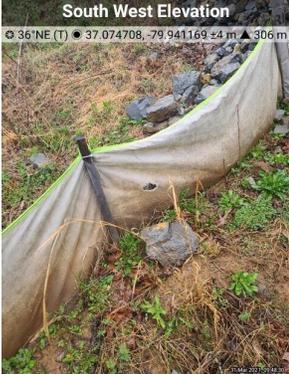
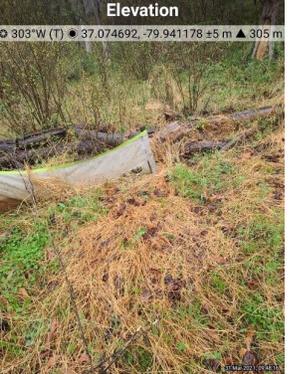
During the EI's travel the EI noticed holes in the P1 at S-EF7 due to being weathered and torn, documented and sent in to be added to the punch list. Discussed with the contractor of the location and repairs needed.

<p>Elevation  <small>303°W (T) • 37.074692, -79.941178 ±5 m ▲ 305 m</small></p>	
GPS Location	00000		GPS Location	00000	
Field Station#	13748+97		Field Station#	13748+97	
Pic 5 Desc.	P1 requires maintenance due to being weathered and torn.		Pic 6 Desc.	P1 requires maintenance due to being weathered and torn, documented and sent in to be added to the punch list

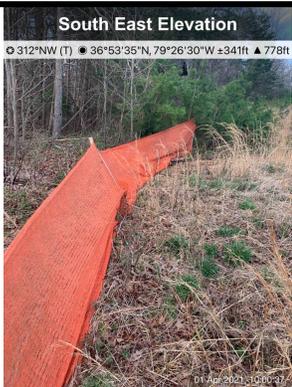
<p><b>South Elevation</b>  <small>343°N (T) ● 36°53'38"N, 79°26'42"W ±13ft ▲ 740ft</small></p>		
<b>GPS Location</b>	O		<b>GPS Location</b>	O	
<b>Field Station#</b>	15609+00		<b>Field Station#</b>	15598+50	
<b>Pic 5 Desc.</b>	Observing safety fence that requires maintenance		<b>Pic 6 Desc.</b>	Observing p1 that received maintenance

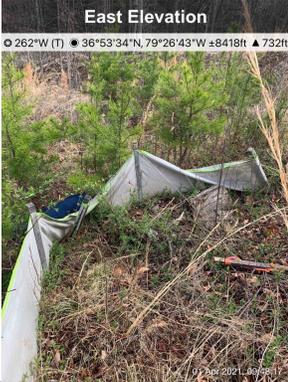
<p style="text-align: center;">Insert image here</p>	
<b>GPS Location</b>	O	<b>GPS Location</b>	O		
<b>Field Station#</b>	15598+50	<b>Field Station#</b>	15594+50		
<b>Pic 7 Desc.</b>	Observing p1 that required maintenance		<b>Pic 8 Desc.</b>	Observing water bar, temporary stabilization and erosion control blanket	
<b>South West Elevation</b> <small>57°NE (T) ● 36°53'38"N, 79°26'49"W ±656ft ▲ 805ft</small>

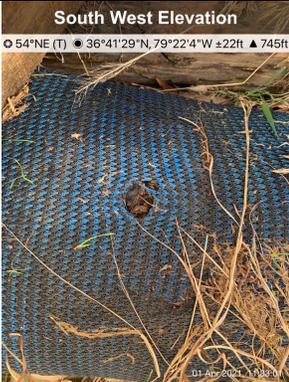
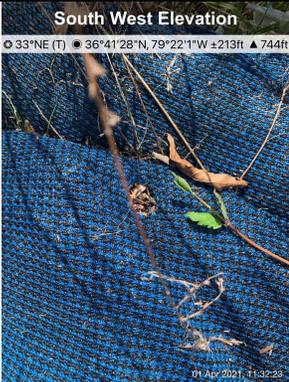
<p>West Elevation  <small>99°E (T) • 36°41'29"N, 79°22'4"W ±13ft ▲ 728ft</small></p>	
GPS Location		O		GPS Location		O	
Field Station#		00+00		Field Station#		00+00	
Pic 1 Desc.		Observing CFS that required maintenance		Pic 2 Desc.		Observing CFS that received maintenance

<p>South West Elevation  <small>29°NE (T) • 36°41'29"N, 79°22'4"W ±213ft ▲ 742ft</small></p>	
GPS Location		O		GPS Location		O	
Field Station#		00+00		Field Station#		00+00	
Pic 3 Desc.		Observing CFS that required maintenance		Pic 4 Desc.		Observing CFS that received maintenance	
Insert image here				Insert image here			
GPS Location				GPS Location

E&S BMPs	Compliance Level	Corrective Action	Corrective Time Frame	Date Repaired
Compost Filter Sock	Communication	Contractor repaired upon discovery		4/1/2021

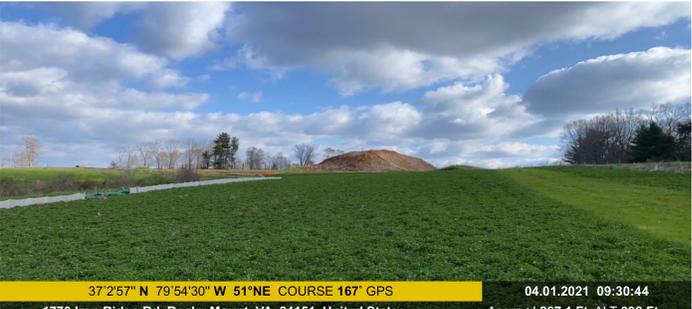
<b>GPS Location</b>	3		<b>GPS Location</b>	4	
<b>Field Station#</b>	13875+16		<b>Field Station#</b>	13901+00	
<b>Pic 3 Desc.</b>	Ditch subsidence CIS S-CD6. Issue continues to worsen.		<b>Pic 4 Desc.</b>	Final cleanup area GAS Iron Ridge Rd.

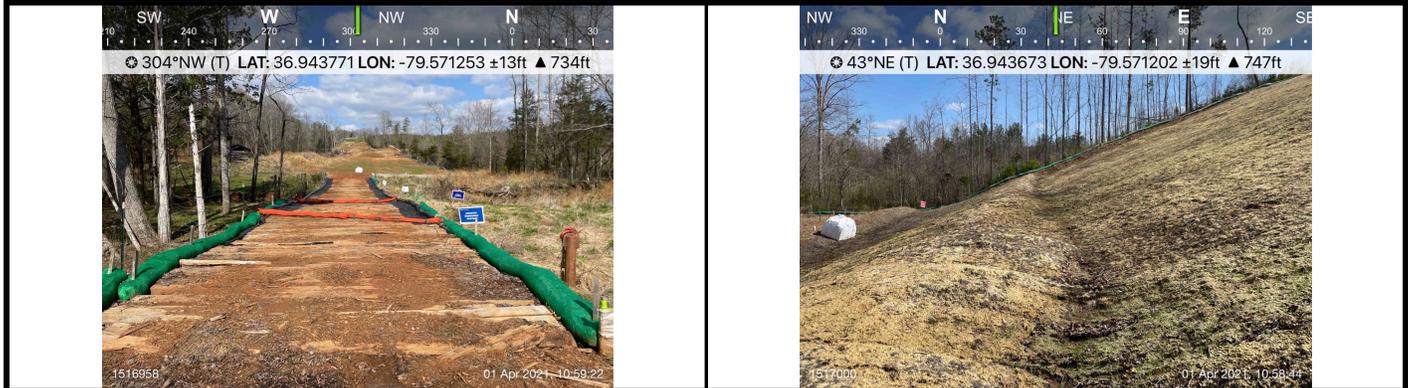
<b>GPS Location</b>	See photo	<b>GPS Location</b>	See photo
<b>Field Station#</b>	15169+58	<b>Field Station#</b>	15170+00
<b>Pic 3 Desc.</b>	Equipment bridge ECDs are in place and functioning.	<b>Pic 4 Desc.</b>	Waterbars are in good condition and functioning.

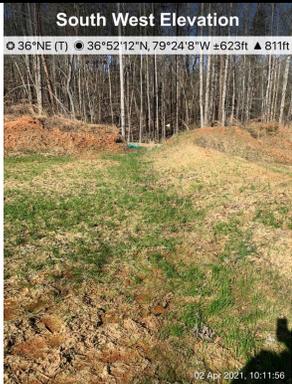
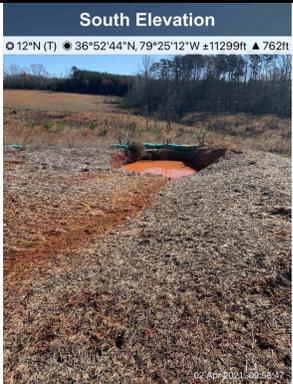
GPS Location	O		GPS Location	O	
Field Station#	15768+00		Field Station#	15697+00	
Pic 1 Desc.	Observing temporary stabilization, water bar and end treatment		Pic 2 Desc.	Observing temporary stabilization, water bar, sump and end treatment

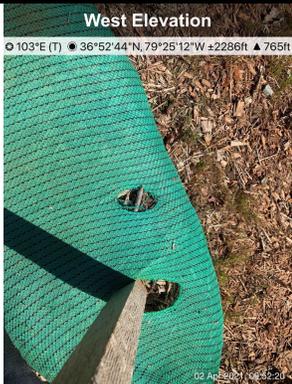
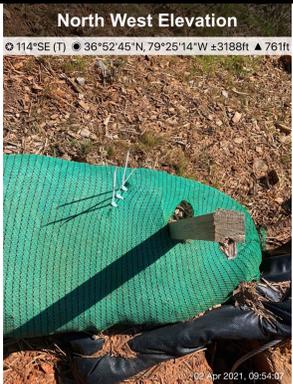
GPS Location	O		GPS Location	O	
Field Station#	15699+00		Field Station#	15699+00	
Pic 3 Desc.	Observing CFS that required maintenance		Pic 4 Desc.	Observing CFS that received maintenance

E&S BMPs	Compliance Level	Corrective Action	Corrective Time Frame	Date Repaired
Cleanwater Diversion Pipe	Acceptable			
Compost Filter Sock	Communication	Contractor repaired upon discovery		4/2/2021
Equipment Bridge	Acceptable			
Erosion Control Blanket	Acceptable			
Housekeeping	Acceptable			
Rock Filter Outlet	Acceptable			
Sensitive Resource Buffer	Acceptable			
Sensitive Resource Signage	Acceptable			
Sump Pit	Acceptable

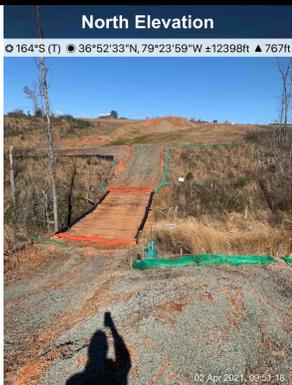
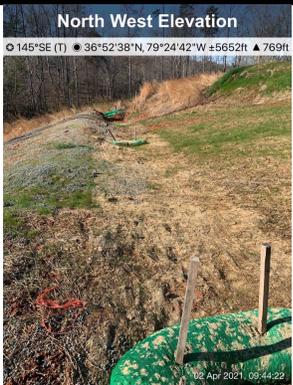
GPS Location	O		GPS Location	O	
Field Station#	15700+46		Field Station#	15768+00	
Pic 5 Desc.	Observing temporary stabilization, signage, buffer, equipment crossing and ECD's		Pic 6 Desc.	Observing temporary stabilization, water bar, erosion control blanket and cfs checks

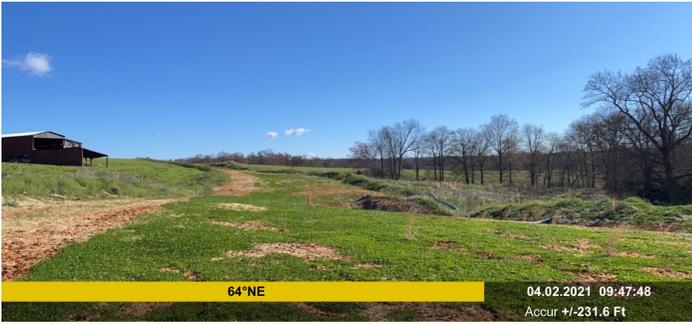
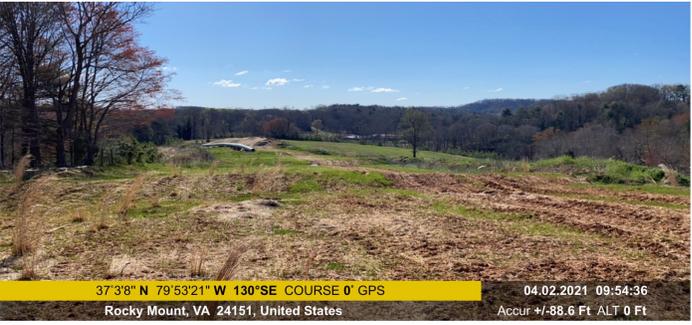
<p>37°38' N 79°53'21" W 130°SE COURSE 0' GPS 04.02.2021 09:54:36 Rocky Mount, VA 24151, United States Accur +/-88.6 Ft ALT 0 Ft</p>		
<b>GPS Location</b>		1		<b>GPS Location</b>	
<b>Field Station#</b>		13972+00		<b>Field Station#</b>	
<b>Pic 1 Desc.</b>		Vegetation observed growing in recently seeded and stabilized area		<b>Pic 2 Desc.</b>	
				Vegetation observed growing in recently seeded and stabilized area

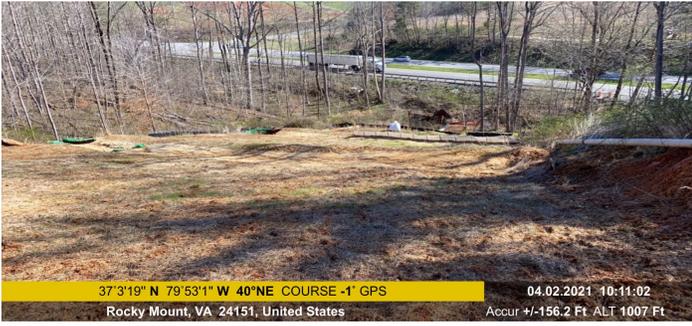
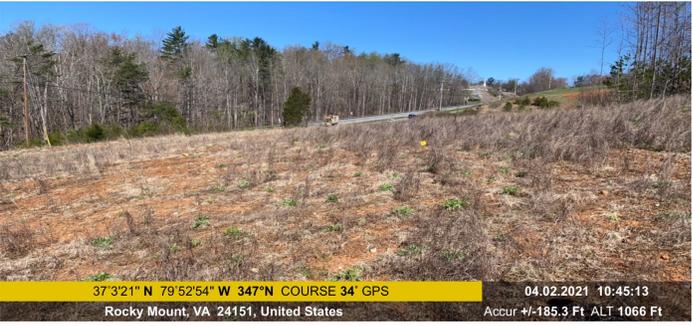
<b>Pic 3 Desc.</b>		Vegetation observed growing in recently seeded and stabilized area		<b>Pic 4 Desc.</b>	
				Sparse vegetation observed in final cleanup area between Hwy 220 and Bonbrook Mill RC1

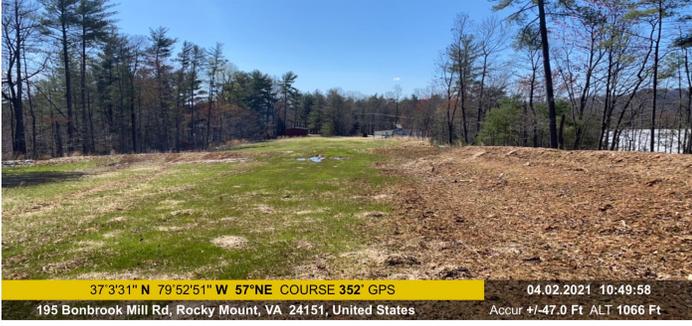
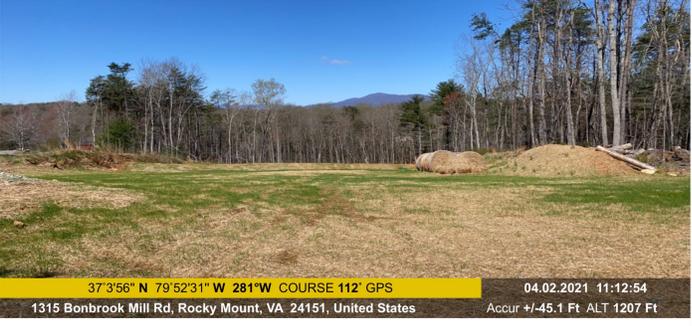
<p>37°3'56" N 79°52'31" W 281°W COURSE 112' GPS 04.02.2021 11:12:54 1315 Bonbrook Mill Rd, Rocky Mount, VA 24151, United States Accur +/-45.1 Ft ALT 1207 Ft</p>		
<b>GPS Location</b>		5		<b>GPS Location</b>	
<b>Field Station#</b>		14022+00		<b>Field Station#</b>	
<b>Pic 5 Desc.</b>		Vegetation observed growing in recently seeded and stabilized area		<b>Pic 6 Desc.</b>	
				Vegetation observed growing in recently seeded and stabilized area

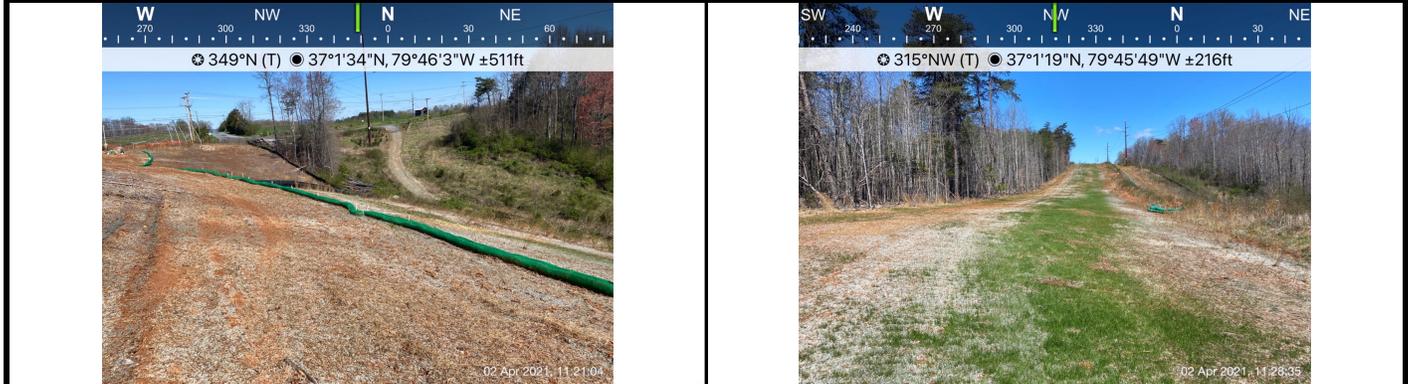
<b>GPS Location</b>	0	<b>GPS Location</b>	0
<b>Field Station#</b>	14457+00	<b>Field Station#</b>	14476+00
<b>Pic 1 Desc.</b>	Approximately 14457+00. Overview of ROW.	<b>Pic 2 Desc.</b>	Approximately 14476+00. Overview of ROW.

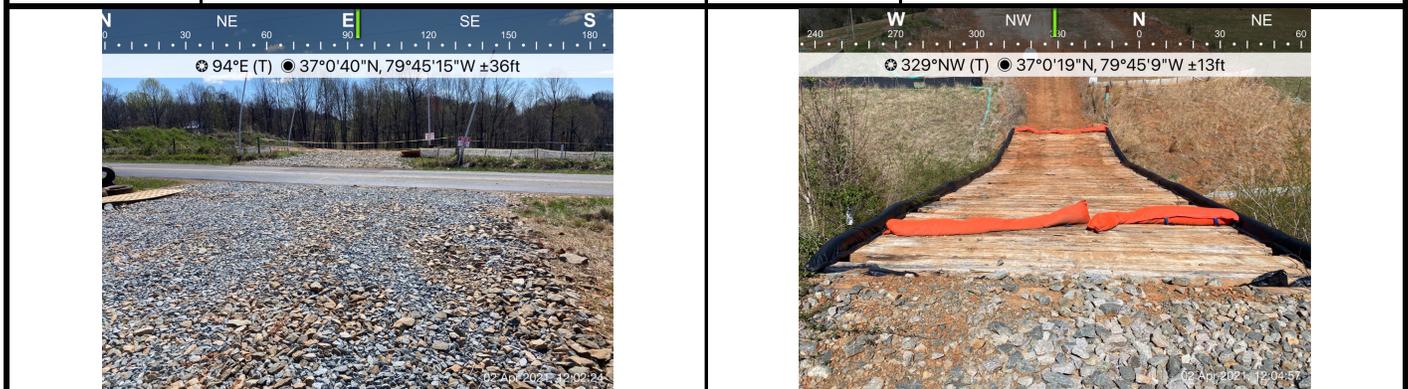
<b>GPS Location</b>	0	<b>GPS Location</b>	0
<b>Field Station#</b>	14524+50	<b>Field Station#</b>	14546+33
<b>Pic 5 Desc.</b>	Approximately 14524+50. Overview of road crossing and RCEs.	<b>Pic 6 Desc.</b>	Approximately 14546+33. Overview of stream crossing, equipment bridge and ECDs at stream S-G17.

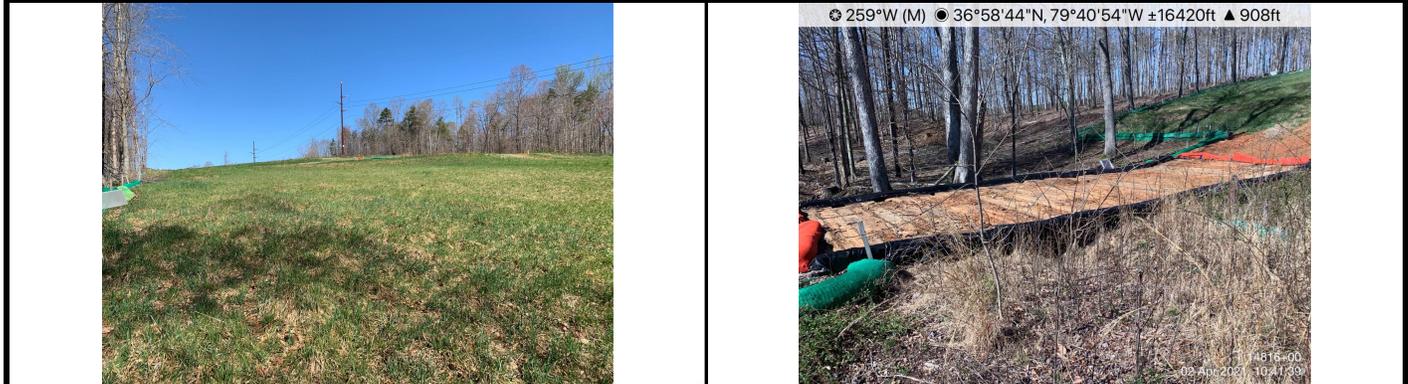
<b>GPS Location</b>	0	<b>GPS Location</b>	0
<b>Field Station#</b>	14815+00	<b>Field Station#</b>	14816+00
<b>Pic 1 Desc.</b>	Permanent vegetative stabilization in acceptable condition	<b>Pic 2 Desc.</b>	Equipment bridge in acceptable condition

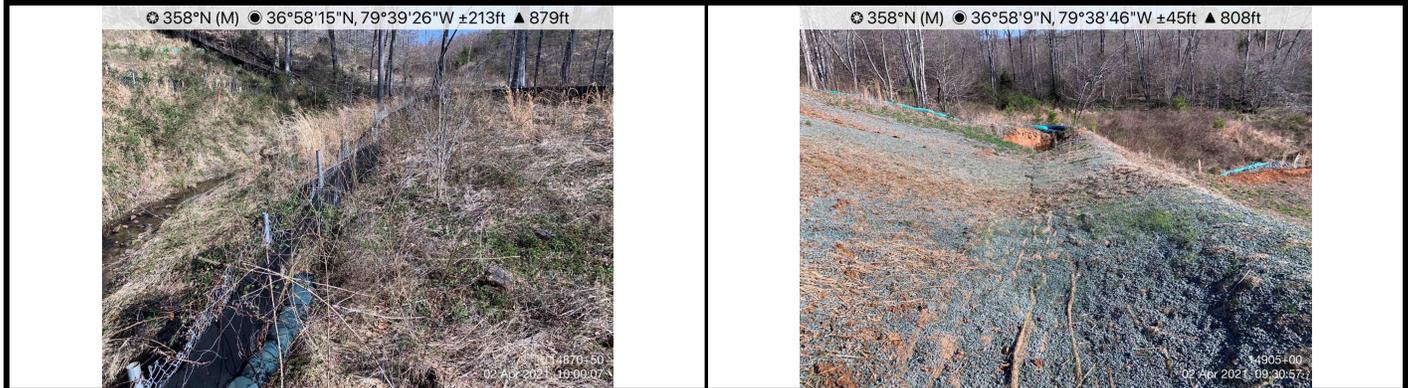
<b>GPS Location</b>	0	<b>GPS Location</b>	0
<b>Field Station#</b>	14870+50	<b>Field Station#</b>	14905+00
<b>Pic 3 Desc.</b>	Super silt fence in acceptable condition	<b>Pic 4 Desc.</b>	Waterbar in acceptable condition

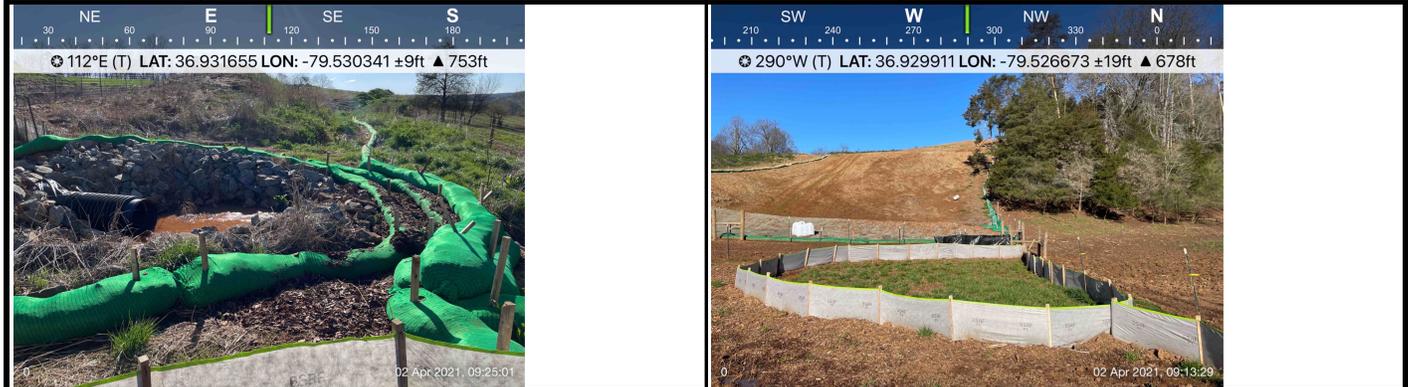
<b>GPS Location</b>	See photo	<b>GPS Location</b>	See photo
<b>Field Station#</b>	15300+00	<b>Field Station#</b>	15311+78
<b>Pic 9 Desc.</b>	CWD is in good condition.	<b>Pic 10 Desc.</b>	Wetland buffer ECDs are in good condition.

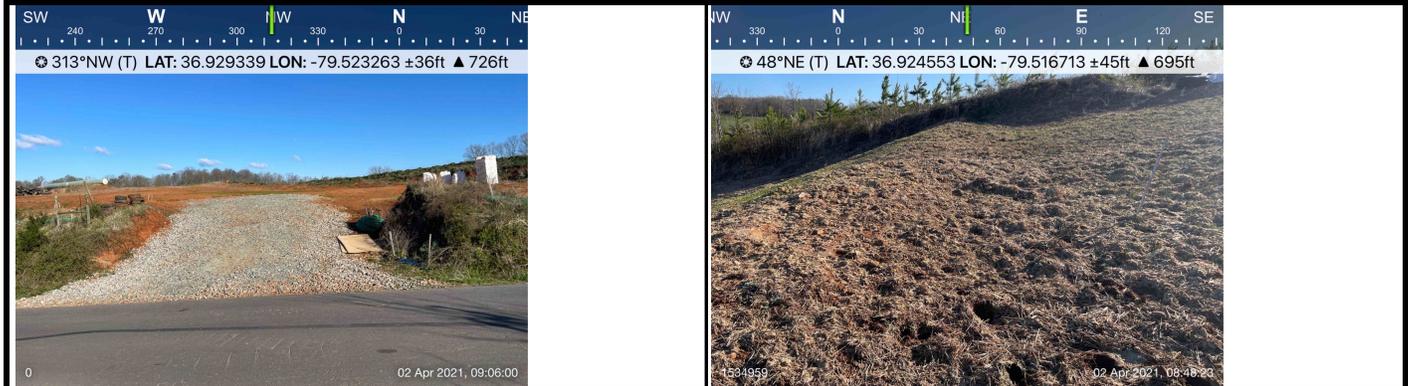
<b>GPS Location</b>	See photo	<b>GPS Location</b>	See photo
<b>Field Station#</b>	15323+24	<b>Field Station#</b>	15349+59
<b>Pic 11 Desc.</b>	RCEs are in good condition at all road crossings.	<b>Pic 12 Desc.</b>	Waverbars are in good condition and functioning.

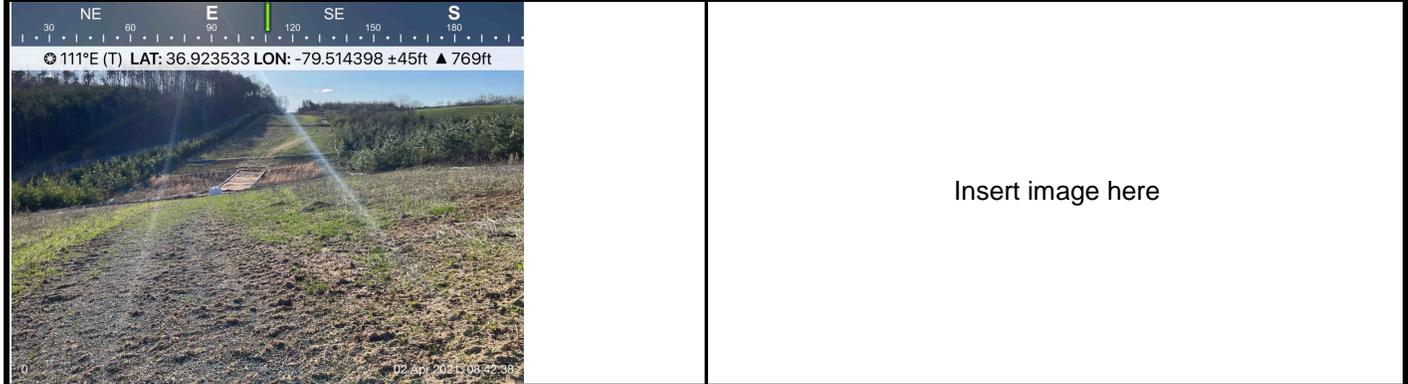
<b>Pic 13 Desc.</b>	Area remains temporarily stabilized.	<b>Pic 14 Desc.</b>	
---------------------	--------------------------------------	---------------------	--

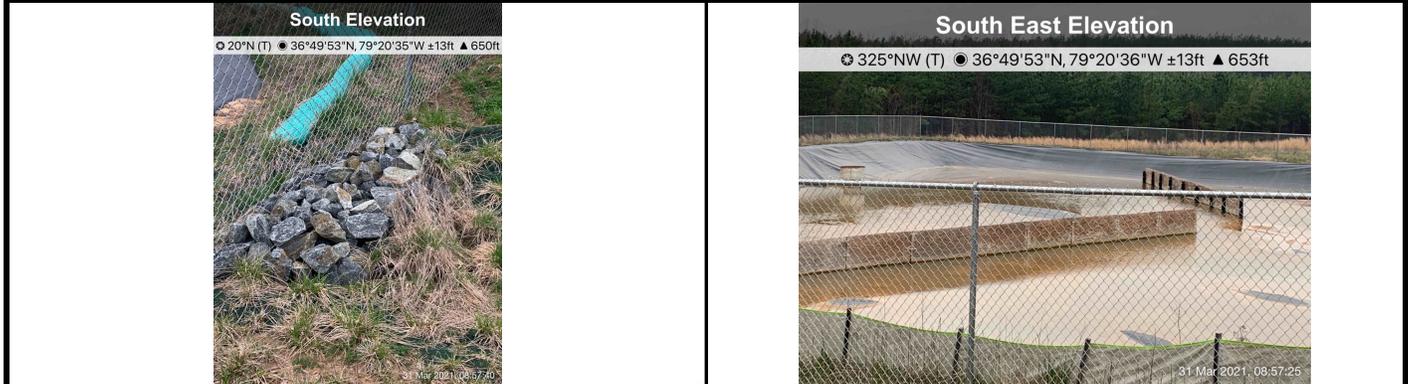
<b>Pic 1 Desc.</b>	Observing temporary stabilization, rock check dam and ECD's	<b>Pic 2 Desc.</b>	Observing storm water pond and ECD's
--------------------	---	--------------------	--------------------------------------
