Visual Site Inspection Report

Project Name H-600 Pipeline Spread G		AFE 124300137	Spread H-600 Pipeline Spread G
Contractor Precision		Report # 19361	
Inspector Chris Burns		Date/Time 1/25/2021 12:30 PM	
Permit # TBD	Inspection Type VA SWPP	Station Begin 11023+80	
State VA	Inspection Area Partial	Station End 11064+53	
County Giles	Ground Wet	Temperature (°F) 39.00	
Municipality N/A	Weather Heavy Rain	Rain Gauge (in) 0.10	
			Rain Accumulation Time (days) 1.00

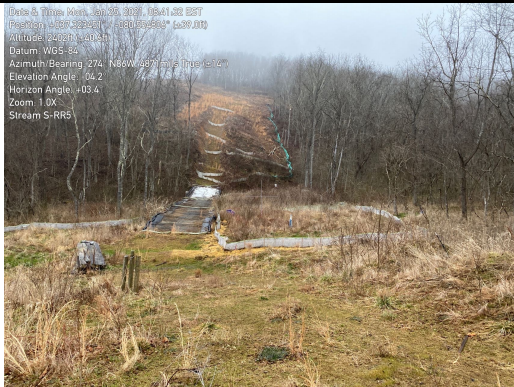
<p><small>Date & Time Mon, Jan 25, 2021, 08:41:38 EST Position: +037.225714° / +080.630880° (+57.2) Altitude: 2115ft (+210.8m) Datum: WGS-84 Azimuth/Bearing: 274.886W 3071mils True (+1.0) Elevation Angle: -06.2 Horizon Angle: +03.4 Zoom: 1.0X Stream: S-RR5</small></p>			
GPS Location	See photo GPS	GPS Location	See photo GPS		
Field Station#	11023+88	Field Station#	11019+00		
Pic 1 Desc.	Stream S- IJ18, equipment bridge and ECD's	Pic 2 Desc.	Stream S- RR5

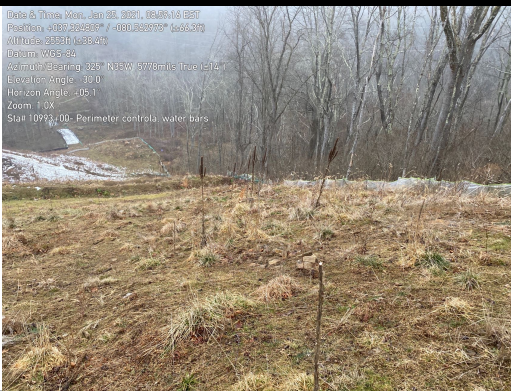
<p><small>Date & Time Mon, Jan 25, 2021, 09:45:16 EST Position: +037.225714° / +080.630880° (+57.2) Altitude: 2332ft (+228.4m) Datum: WGS-84 Azimuth/Bearing: 325.103W 5776mils True (+1.4) Elevation Angle: -12.0 Horizon Angle: +05.1 Zoom: 1.0X Site: 10993.100- Perimeter controls, water bars</small></p>

GPS Location	See photo GPS	GPS Location	See photo GPS		
Field Station#	10993+00	Field Station#	10986+00		
Pic 3 Desc.	Perimeter controls and water bars on slope.	Pic 4 Desc.	Stream S- E25- Equipment bridge and ECD's

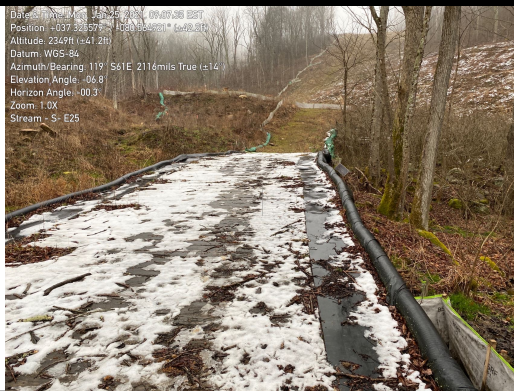
<p><small>Date & Time Mon, Jan 25, 2021, 09:49:38 EST Position: +037.225714° / +080.630880° (+57.2) Altitude: 2249ft (+217.2m) Datum: WGS-84 Azimuth/Bearing: 119.561E 2116mils True (+1.6) Elevation Angle: -06.8 Horizon Angle: -00.3 Zoom: 1.0X Stream: S- E25</small></p>

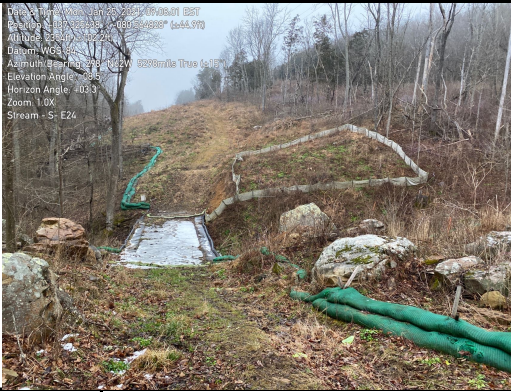
<p><small>Date & Time Mon, Jan 25, 2021, 09:52:17 EST Position: +037.225714° / +080.630880° (+57.2) Altitude: 2340ft (+228.4m) Datum: WGS-84 Azimuth/Bearing: 320.822W 5681mils True (+1.5) Elevation Angle: -08.5 Horizon Angle: +03.4 Zoom: 1.0X Stream: S- E24</small></p>

Pic 5 Desc.	Stream S- E24- Equipment bridge and ECD's	Pic 6 Desc.	Sensitive resource area and bat habitat

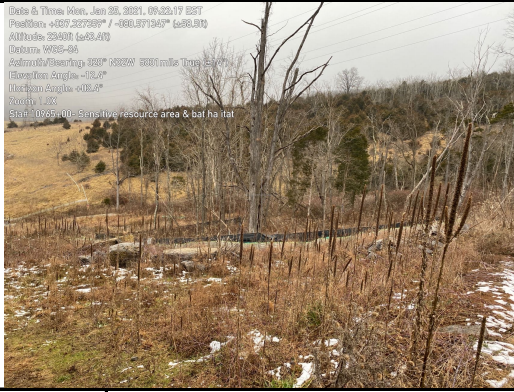
<p><small>Date & Time Mon, Jan 25, 2021, 09:52:17 EST Position: +037.225714° / +080.630880° (+57.2) Altitude: 2340ft (+228.4m) Datum: WGS-84 Azimuth/Bearing: 320.822W 5681mils True (+1.5) Elevation Angle: -08.5 Horizon Angle: +03.4 Zoom: 1.0X Site: 10965.100- Sensitive resource area & bat habitat</small></p>			
GPS Location	See photo GPS	GPS Location	See photo GPS		
Field Station#	10985+00	Field Station#	10965+00

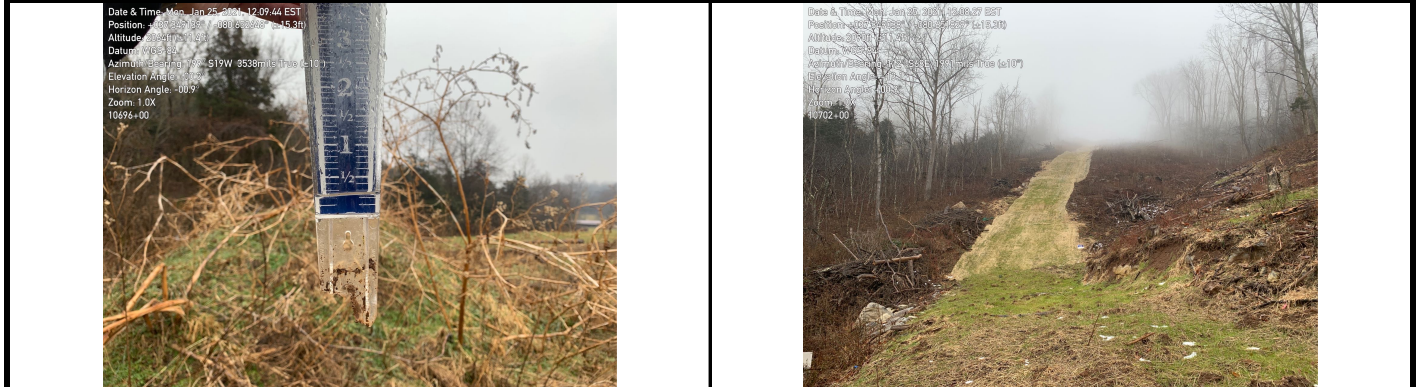
Field Station#	10696+00	Field Station#	10702+00
-----------------------	----------	-----------------------	----------

Pic 1 Desc.	Rain gauge at Buffalo Anklets Road reads 0.3 inches.	Pic 2 Desc.	Steep slope stabilized with ECB.
--------------------	--	--------------------	----------------------------------

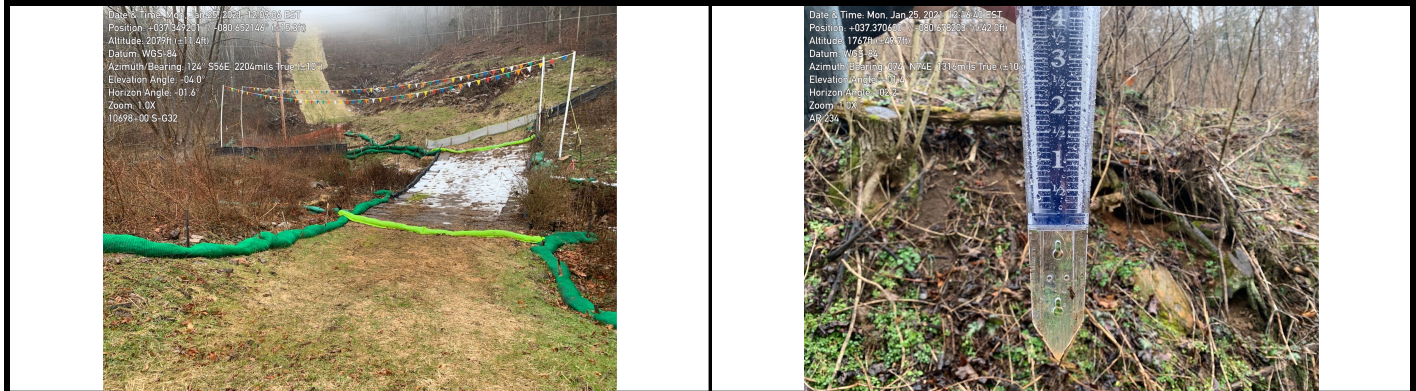
Field Station#	10696+00	Field Station#	12005+00
-----------------------	----------	-----------------------	----------

Pic 3 Desc.	Sensitive resource buffer in place at stream S-G32.	Pic 4 Desc.	Rain gauge at AR 234 reads 0.1 inches.
--------------------	---	--------------------	--

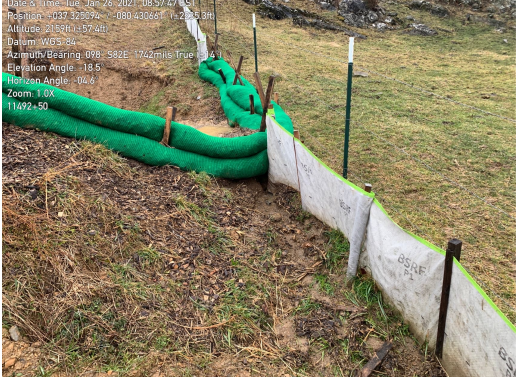
Conducted VA SWPPP inspection from MP 215 to MP 218.3.
 Since last inspection Precision Pipeline has conducted ECD maintenance and ECD upgrades where needed.
 No forward progress has been completed due to FERC shut down.
 Right of way has been stabilized using seed, mulch, and natural vegetation.
 Deficiencies located at station numbers;
 11475+50 - Sloughing on two-tone. Re-stabilize with new ECB
 11492+50 - undermined CFS end treatment.
 11512+58 - Hole and broken stake in priority one silt fence.

GPS Location See photo for GPS location.	GPS Location See photo for GPS location.			
Field Station# 11492+50	Field Station# 11506+00			
Pic 3 Desc. CFS end treatment undermined.	Pic 4 Desc. Clean water diversion pipe and plunge pool in place.

E&S BMPs	Compliance Level	Corrective Action	Corrective Time Frame	Date Repaired
Broad-Based Dip	Acceptable			
Cleanwater Diversion Berm	Acceptable			
Cleanwater Diversion Pipe	Acceptable			
Compost Filter Sock	Communication	Repair undermining	24 Hours	
Equipment Bridge	Acceptable			
Erosion Control Blanket	Communication	Replace ECB	48 Hours	
Rock Construction Entrance	Acceptable			
Silt Fence (Filter Fabric Fence)	Communication	Replace fence.	24 Hours	
Sensitive Resource Buffer	Acceptable

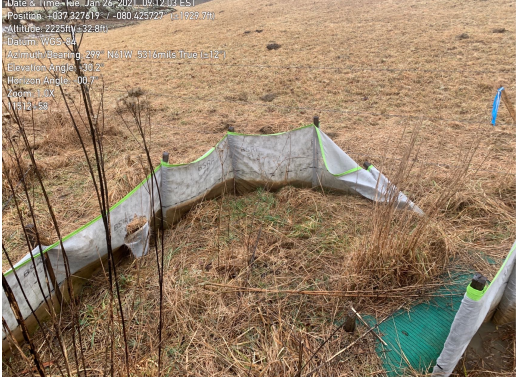
Pic 5 Desc. Priority one silt fence has broken stakes and holes.	Pic 6 Desc. Rain gauge at Mount Tabor Road reads 2.25 inches.

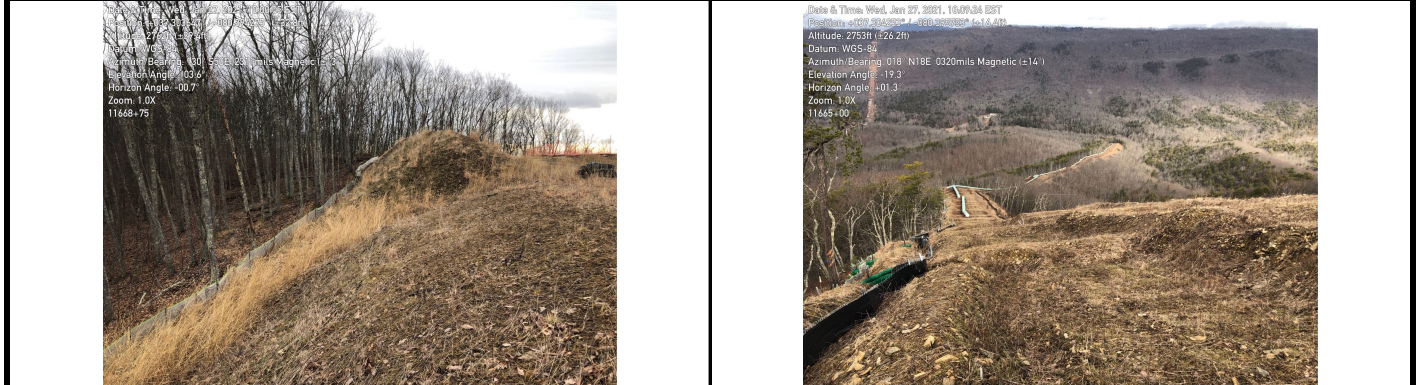
GPS Location	On photo	GPS Location	On photo
Field Station#	11668+75	Field Station#	11665+00
Pic 1 Desc.	ROW stable. Perimeter controls in place.	Pic 2 Desc.	ROW stable with slope breakers in place.

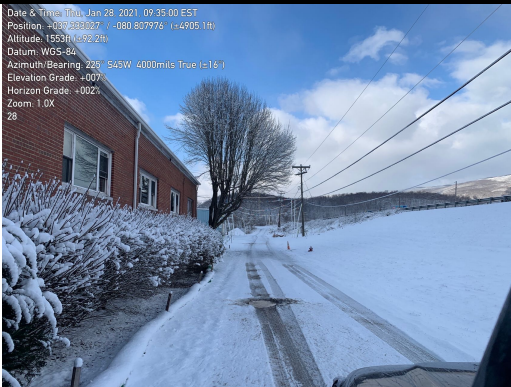
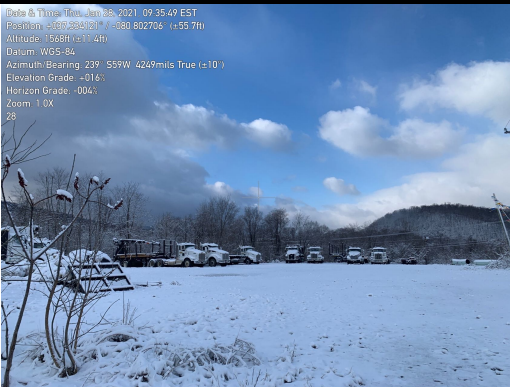
<p><small>Date & Time: Thu, Jan 28, 2021, 09:28:38 EST Position: +48.929333° N, -88.833333° W (+48.929333, -88.833333) Altitude: 1833ft (+559.4m) Datum: WGS-84 Azimuth Bearing: 381° N29W 4926mils True (+381) Elevation Grade: +001ft Horizon Grade: +001ft Zoom: 1.0X 28</small></p>		
GPS Location	See picture above for GPS coordinates	GPS Location	See picture above for GPS coordinates	
Field Station#	12005+00	Field Station#	12005+00	
Pic 1 Desc.	ECD's and row conditions	Pic 2 Desc.	ECD's and row conditions

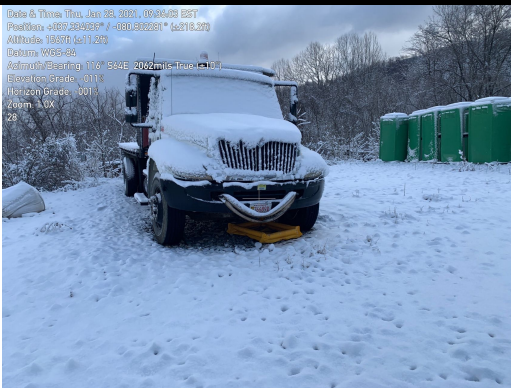
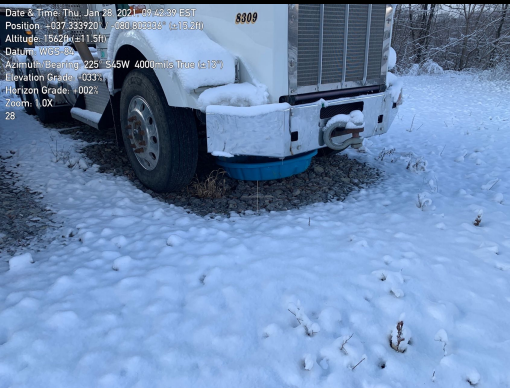
GPS Location	See picture above for GPS coordinates	GPS Location	See picture above for GPS coordinates	
Field Station#	12005+00	Field Station#	12005+00	
Pic 3 Desc.	ECD's and row conditions	Pic 4 Desc.	ECD's and row conditions

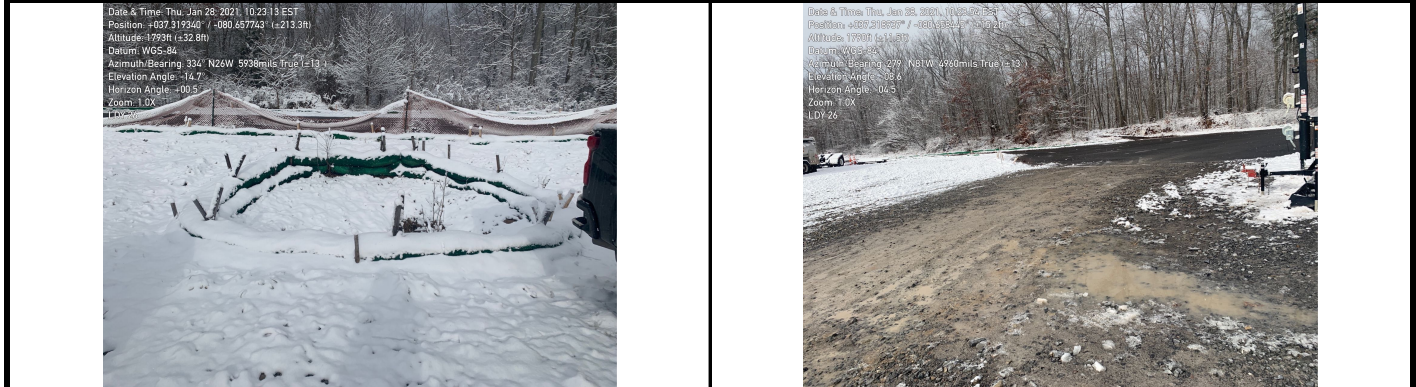
Pic 1 Desc.	Triple stack compost filter sock in place around drainage.	Pic 2 Desc.	RCE in place at LDY 26 entrance.
--------------------	--	--------------------	----------------------------------

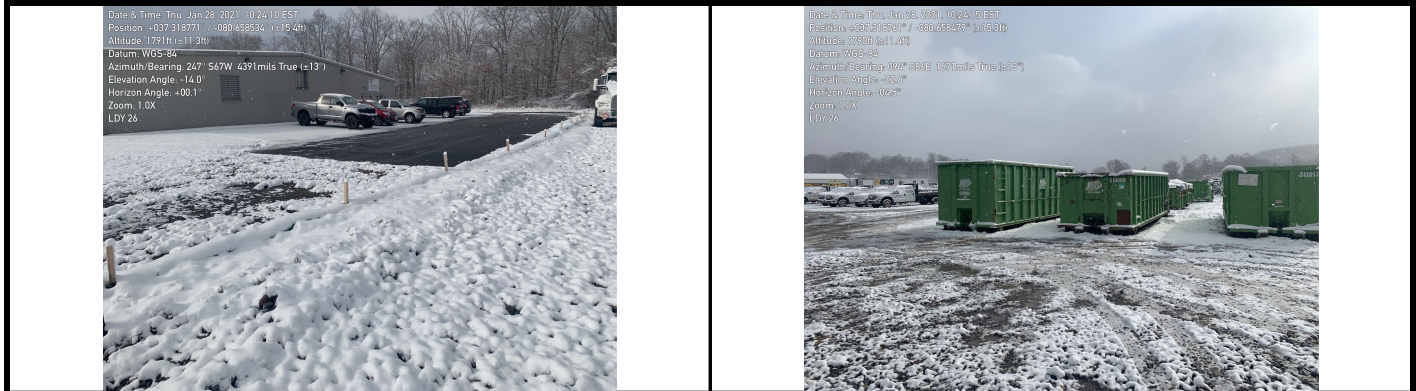
Pic 3 Desc.	18 inch compost filter sock in place along LOD.	Pic 4 Desc.	Dumpsters being utilized for trash management.
--------------------	---	--------------------	--

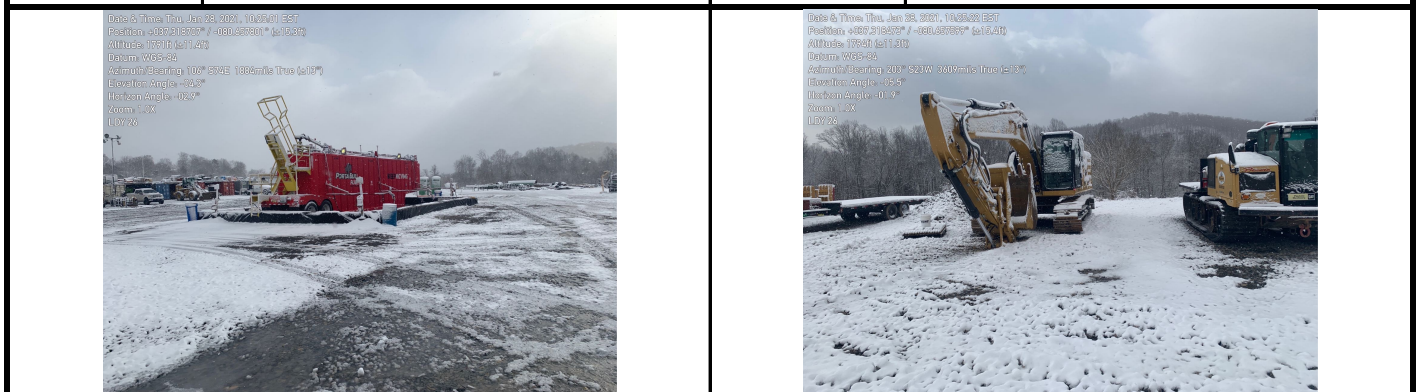
Pic 5 Desc.	Secondary containment in place under fuel cell.	Pic 6 Desc.	Checked staged equipment for leaks.
--------------------	---	--------------------	-------------------------------------

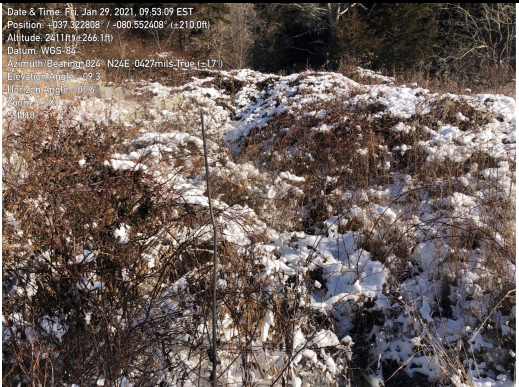
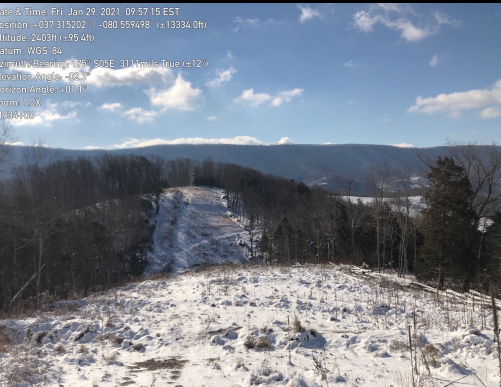
GPS Location	1	GPS Location	2		
Field Station#	11025+50	Field Station#	11034+00		
Pic 1 Desc.	S-IJ18.		Pic 2 Desc.	Section of RoW showing conditions and controls.	
<p>Date & Time: Fri, Jan 29, 2021, 10:10:24 EST Position: +037.311317 / -080.561402 (±13334.0ft) Altitude: 2274ft (±195.8ft) Datum: WGS-84 Azimuth/Bearing: 286° N74W 5084mils True (±12°) Elevation Angle: +27.0° Horizon Angle: +01.9° Zoom: 1.0X 11049+00</p>

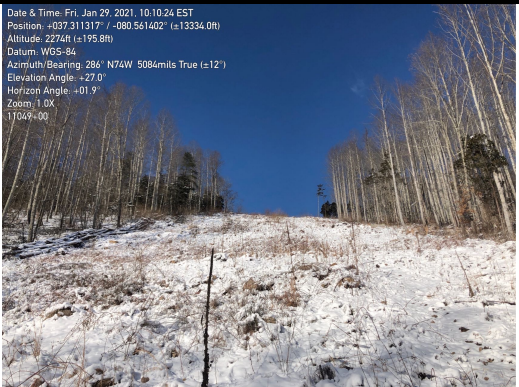
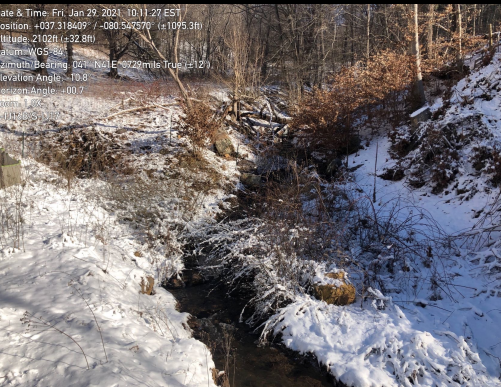
GPS Location	3	GPS Location	4		
Field Station#	11049+00	Field Station#	11050+10		
Pic 3 Desc.	Section of RoW showing conditions and controls.		Pic 4 Desc.	S-IJ16B/S-IJ17.	
<p>Date & Time: Fri, Jan 29, 2021, 10:22:57 EST Position: +037.310112 / -080.546158 (±13334.0ft) Altitude: 2022ft (±104.6ft) Datum: WGS-84 Azimuth/Bearing: 136° S54E 2418mils True (±12°) Elevation Angle: -04.9° Horizon Angle: +00.0° Zoom: 1.0X 11055+00</p>

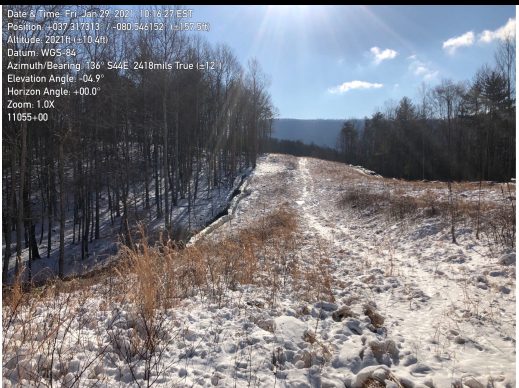
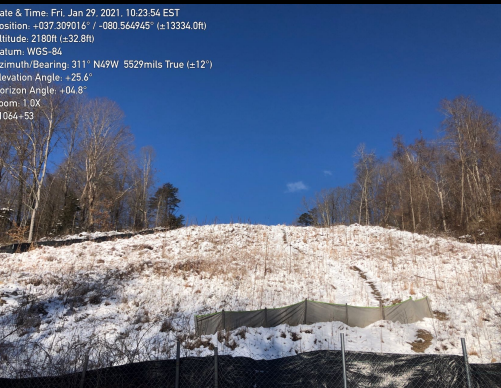
GPS Location	5	GPS Location	6		
Field Station#	11055+00	Field Station#	11064+53		
Pic 5 Desc.	Section of RoW showing conditions and controls.		Pic 6 Desc.	Section of RoW showing conditions and controls.

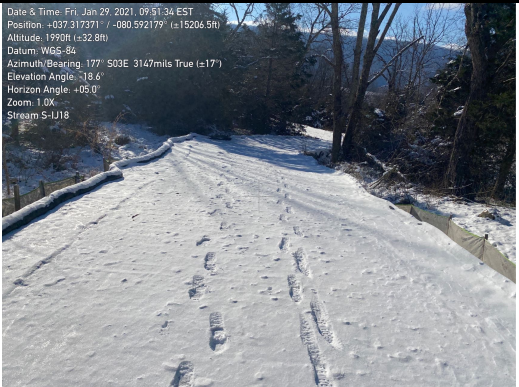
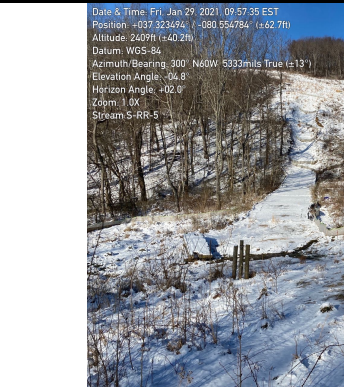
GPS Location	See photo GPS		GPS Location	See photo GPS	
Field Station#	11023+88		Field Station#	11018+00	
Pic 1 Desc.	Stream S- IJ18, bridge and ECD's.		Pic 2 Desc.	Stream S- RR5, bridge and ECD's

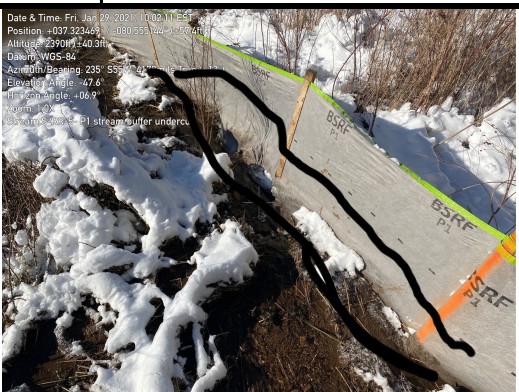
GPS Location	See photo GPS		GPS Location	See photo GPS	
Field Station#	11017+00		Field Station#	10986+00	
Pic 3 Desc.	P1 stream buffer under cut, contractor notified and items added to the punch list.		Pic 4 Desc.	Stream S- E25

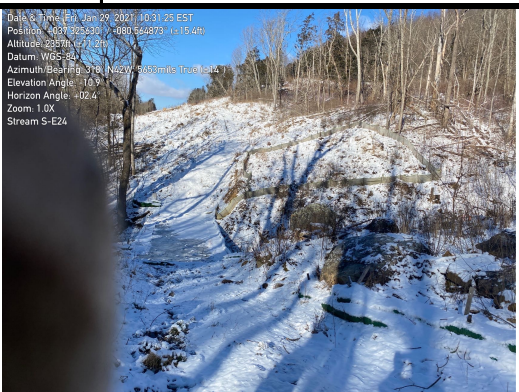
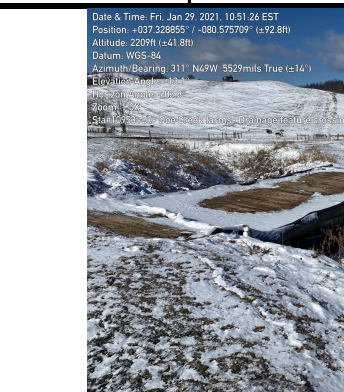
GPS Location	See photo GPS		GPS Location	See photo GPS	
Field Station#	10985+00		Field Station#	10953+00	
Pic 5 Desc.	Stream S- E24, bridge and ECD's		Pic 6 Desc.	Doe Creek Farms drainage feature and bridge.

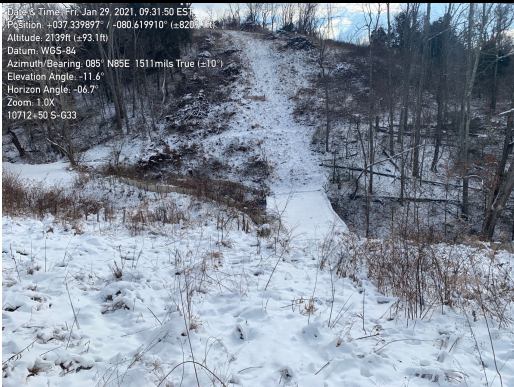
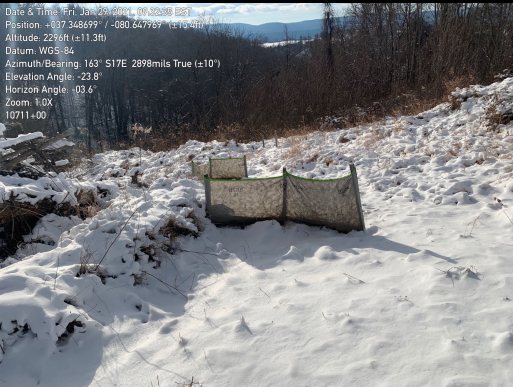
<p><small>Date & Time: Fri, Jan 29, 2021, 09:32:08 EST Position: +037.34699° / -080.64799° (+64ft) Altitude: 2266ft (+11.3ft) Datum: WGS 84 Azimuth/Bearing: 163° S17E 2898mils True (±10°) Elevation Angle: -23.8° Horizon Angle: -03.6° Zoom: 1.0X 10711+00</small></p>		
GPS Location	See photo for GPS location.	GPS Location	See photo for GPS location.	
Field Station#	10712+50	Field Station#	10711+00	
Pic 1 Desc.	Sensitive resource buffer in place at stream S-G33.	Pic 2 Desc.	Priority one silt fence checks in place.

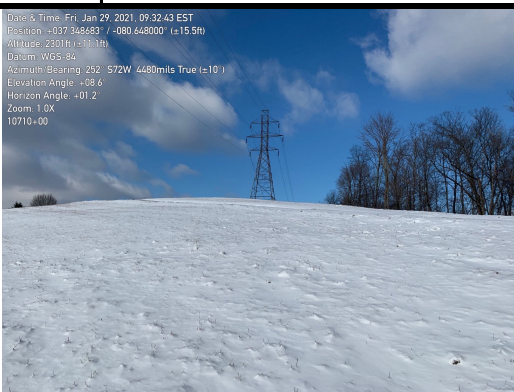
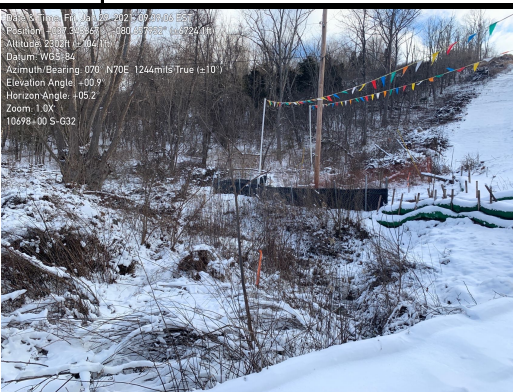
GPS Location	See photo for GPS location.	GPS Location	See photo for GPS location.	
Field Station#	10710+00	Field Station#	10698+00	
Pic 3 Desc.	ROW frozen and snow covered.	Pic 4 Desc.	Sensitive resource buffer in place at stream S-G32.

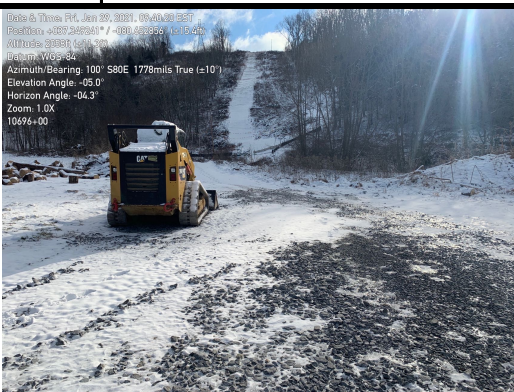
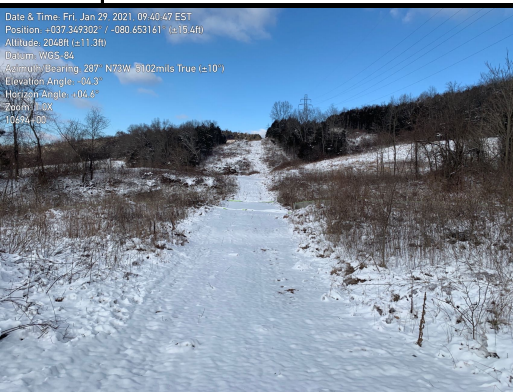
Pic 5 Desc.	RCE in place at Buffalo Anklets Road.	Pic 6 Desc.	Clean water drainage feature in place.

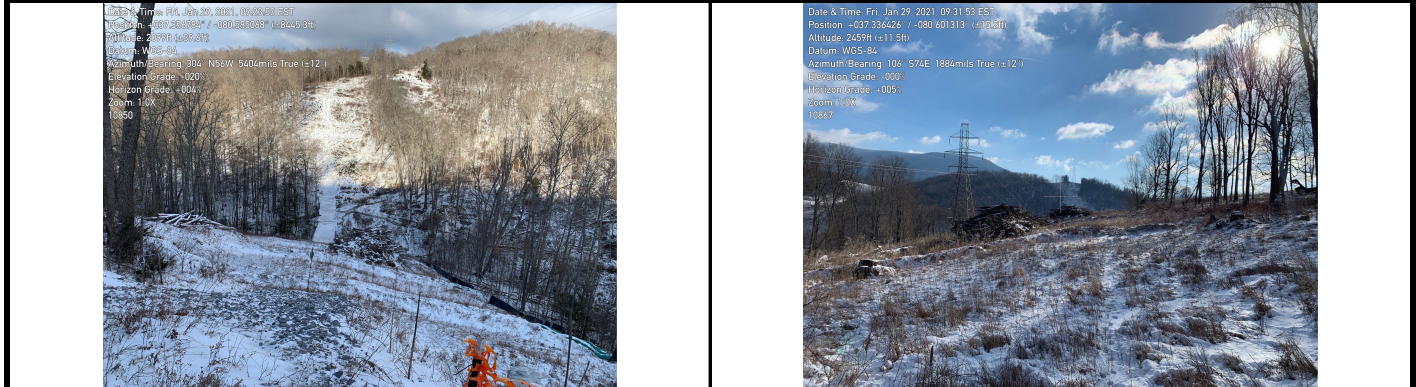
Pic 1 Desc.	ECD's and row conditions	Pic 2 Desc.	ECD's and row conditions
--------------------	--------------------------	--------------------	--------------------------

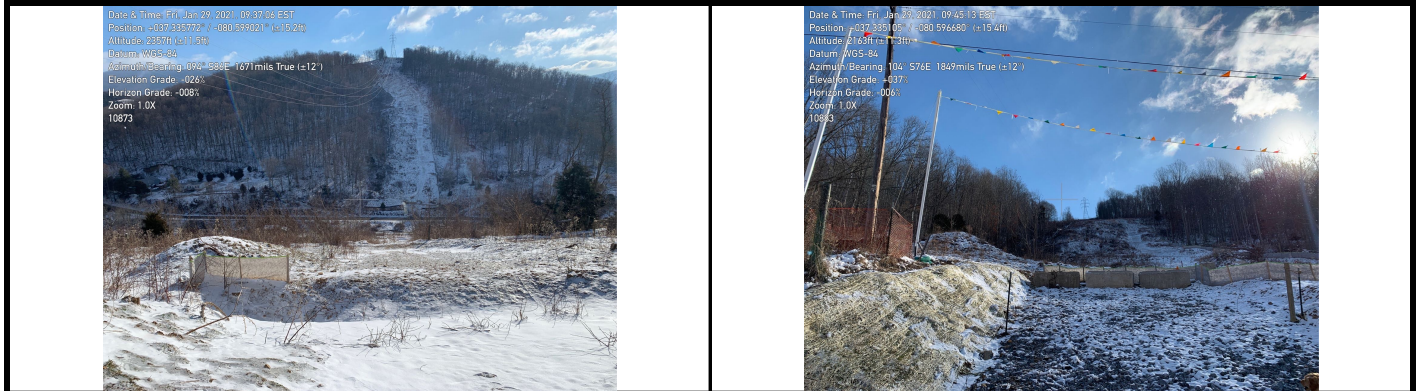
Pic 3 Desc.	ECD's and row conditions	Pic 4 Desc.	ECD's and row conditions
--------------------	--------------------------	--------------------	--------------------------

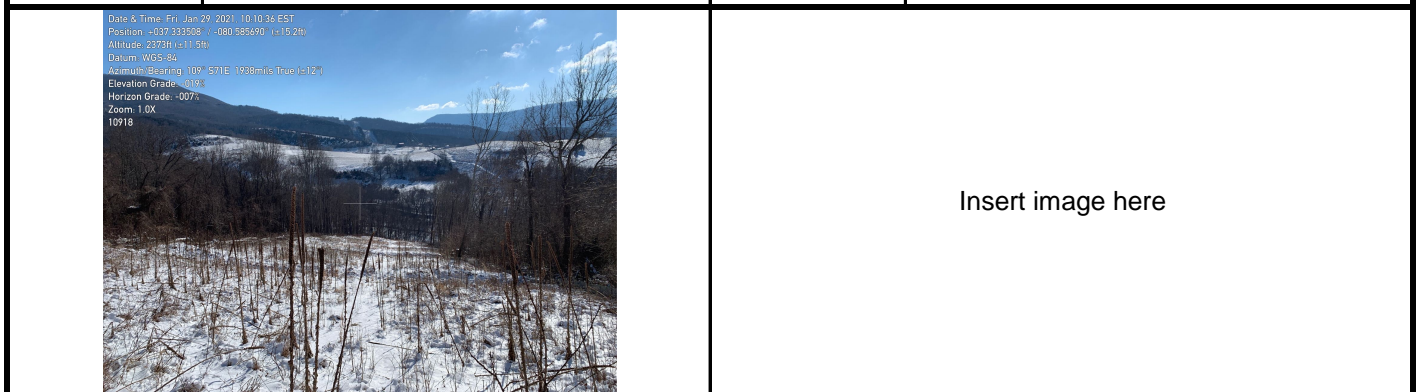
Pic 5 Desc.	ECD's and row conditions	Pic 6 Desc.	
--------------------	--------------------------	--------------------	--
