# Visual Site Inspection Report

<b>Project Name</b> H-600 Pipeline Spread G		<b>AFE</b> 124300137	<b>Spread</b> H-600 Pipeline Spread G
<b>Contractor</b> Precision		<b>Report #</b> 20551	
<b>Inspector</b> Len Kruizenga		<b>Date/Time</b> 3/1/2021 2:34 PM	
<b>Permit #</b> TBD	<b>Inspection Type</b> VA SWPP	<b>Station Begin</b> 11254+99	
<b>State</b> VA	<b>Inspection Area</b> Full	<b>Station End</b> 11158+27	
<b>County</b> Giles	<b>Ground</b> Muddy	<b>Temperature (°F)</b> 51.00	
<b>Municipality</b> N/A	<b>Weather</b> Light Rain	<b>Rain Gauge (in)</b> 1.95	
<b>Rain Accumulation Time (days)</b>			3.00

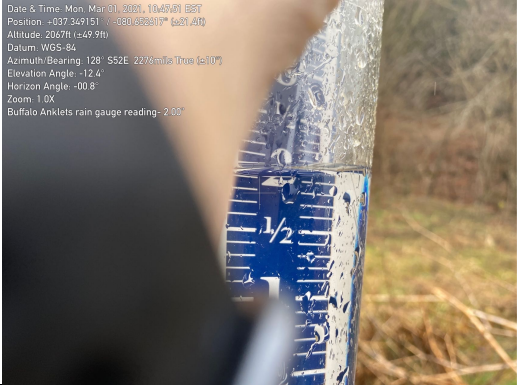
AFE 124300137		Date/Time 3/1/2021 2:34 PM		Report #	
Pictures					
<small>Date &amp; Time: Mon, March 01, 2021 13:45:09 EST            Position: +037.349151, -080.683519, 6261.410            Altitude: 2067ft (=629ft)            Datum: WGS-84            Azimuth/Bearing: 128.852E 22°/mils True (±10°)            Elevation Angle: -12.4            Horizon Angle: -00.8            Zoom: 1.0X            Buffalo Anklets rain gauge reading- 2.00"</small>

<b>Pic 7 Desc.</b>	Buffalo Anklets rain gauge reading- 2.00"	<b>Pic 8 Desc.</b>	AR-234.00 rain gauge reading- 1.80"		
Insert image here			Insert image here		
<b>GPS Location</b>		<b>GPS Location</b>			
<b>Field Station#</b>		<b>Field Station#</b>			
<b>Pic 9 Desc.</b>		<b>Pic 10 Desc.</b>			
Insert image here			Insert image here		
<b>GPS Location</b>		<b>GPS Location</b>			
<b>Field Station#</b>		<b>Field Station#</b>			
<b>Pic 11 Desc.</b>		<b>Pic 12 Desc.</b>

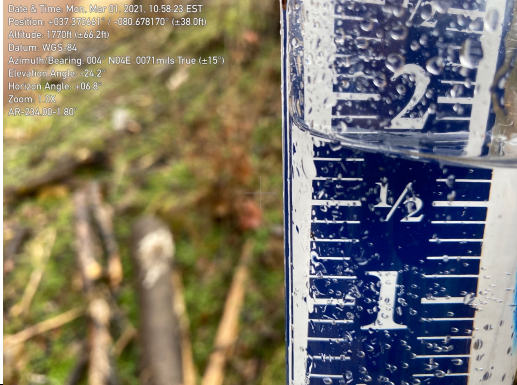
<small>Date &amp; Time: Mon, March 01, 2021 10:58:23 EST            Position: +037.378637, -080.678170, 638.01ft            Altitude: 1770ft (=539ft)            Datum: WGS-84            Azimuth/Bearing: 004. N04E 0071mils True (±15°)            Elevation Angle: -26.2            Horizon Angle: -06.3            Zoom: 1.0X            AR-234.00-1.80"</small>

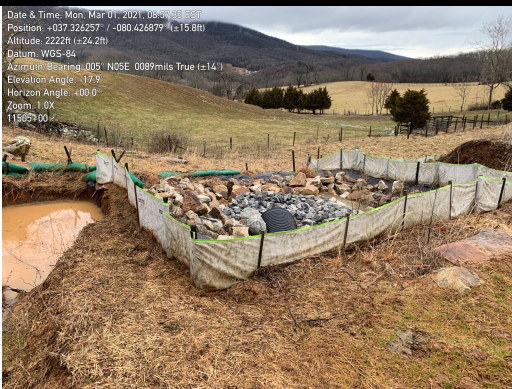
<p><small>Date &amp; Time: Mon, Mar 01, 2021, 08:44:02 EST Position: +037.326147 / -080.426841 (±19.4ft) Altitude: 2200ft (±68.0ft) Datum: WGS-84 Azimuth/Bearing: 29° N22W 529mils True (±2°) Elevation Angle: +6.9° Horizon Angle: -01.3° Zoom: 1.0X 11484+00</small></p>			
<b>GPS Location</b>	See photo for GPS location.	<b>GPS Location</b>	See photo for GPS location.	
<b>Field Station#</b>	11474+00	<b>Field Station#</b>	11484+00	
<b>Pic 1 Desc.</b>	Two-tone stabilized with ECB and slope drains in place.	<b>Pic 2 Desc.</b>	Waterbar end treatment in undermined.

E&S BMPs	Compliance Level	Corrective Action	Corrective Time Frame	Date Repaired
Cleanwater Diversion Berm	Acceptable			
Cleanwater Diversion Pipe	Acceptable			
Compost Filter Sock	Acceptable			
Housekeeping	Acceptable			
Sensitive Resource Buffer	Acceptable			
Silt Fence (Filter Fabric Fence)	Communication	Repair damaged silt fence	24 Hours	
Silt Fence (Reinforced Filter Fabric Fence)	Problem Area			
Vegetative Stabilization (Temporary)	Acceptable			
Waterbar End Treatment	Communication	Repair end treatment	24 Hours

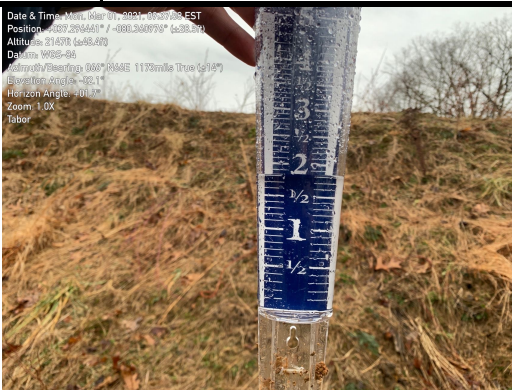
<p><small>Date &amp; Time: Mon, Mar 01, 2021, 09:07:22 EST Position: +037.326481 / -080.346979 (±38.3ft) Altitude: 2147ft (±65.8ft) Datum: WGS-84 Azimuth/Bearing: 066° N66E 117mils True (±1.4°) Elevation Angle: -16.1° Horizon Angle: -01.1° Zoom: 1.0X Tabor</small></p>

<b>GPS Location</b>	See photo for GPS location.	<b>GPS Location</b>	See photo for GPS location.	
<b>Field Station#</b>	11788+00	<b>Field Station#</b>	11980+00	
<b>Pic 5 Desc.</b>	Rain gauge at Mount Tabor Road reads 1.8 inches.	<b>Pic 6 Desc.</b>	Rain gauge at Catawba Road reads 1.8 inches.

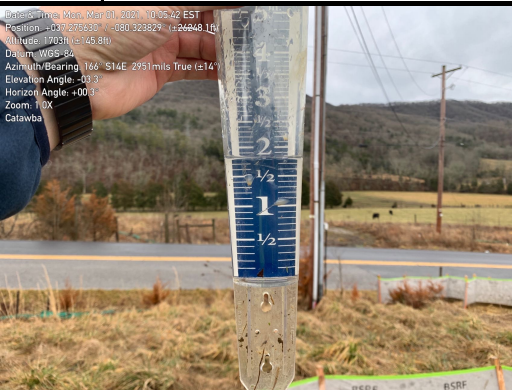
<p><small>Date &amp; Time: Mon, Mar 01, 2021, 09:08:22 EST Position: +037.326231 / -080.323627 (±36.6ft) Altitude: 1703ft (±51.8ft) Datum: WGS-84 Azimuth/Bearing: 166° S14E 2951mils True (±1.4°) Elevation Angle: -01.3° Horizon Angle: +00.0° Zoom: 1.0X Catawba</small></p>

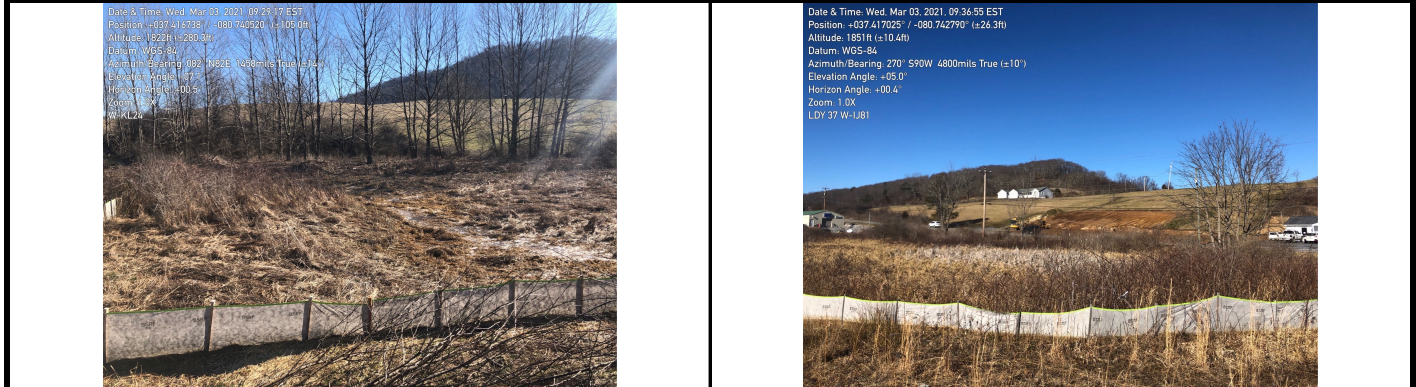
<b>Pic 1 Desc.</b>	W-KL24 and controls.	<b>Pic 2 Desc.</b>	W-IJ81 and controls.
--------------------	----------------------	--------------------	----------------------

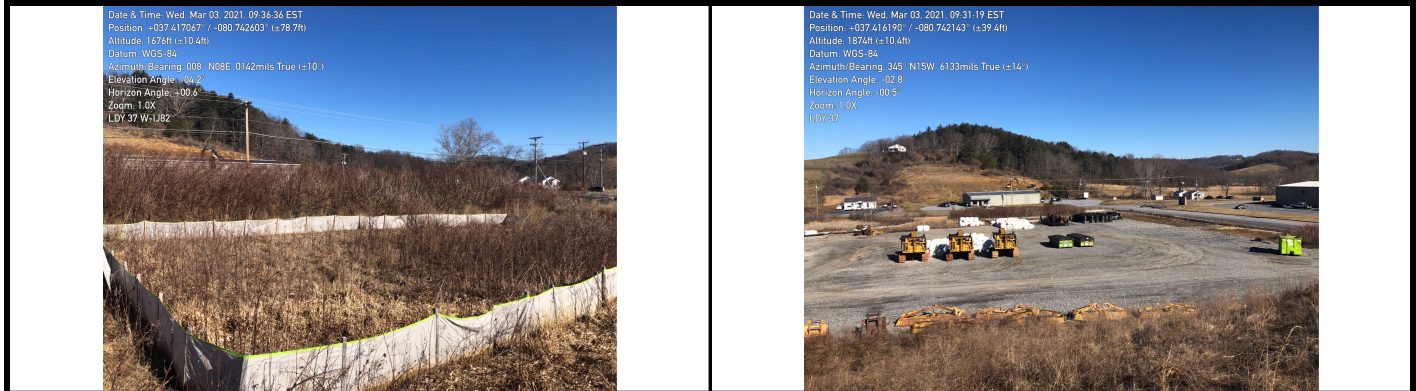
<b>Pic 3 Desc.</b>	W-IJ82 and controls.	<b>Pic 4 Desc.</b>	Overview of the lower section of LDY 37 (#1).
--------------------	----------------------	--------------------	---

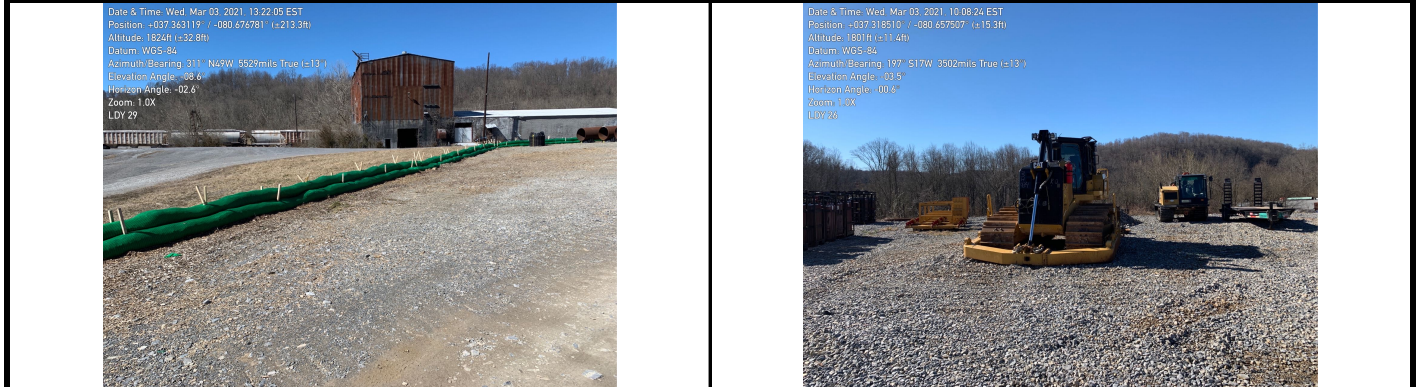
<b>GPS Location</b>	See photo for GPS location.	<b>GPS Location</b>	See photo for GPS location.
<b>Field Station#</b>	12005+00	<b>Field Station#</b>	12005+00
<b>Pic 1 Desc.</b>	Triple stack compost filter sock in place along LOD.	<b>Pic 2 Desc.</b>	Checked staged equipment for leaks.

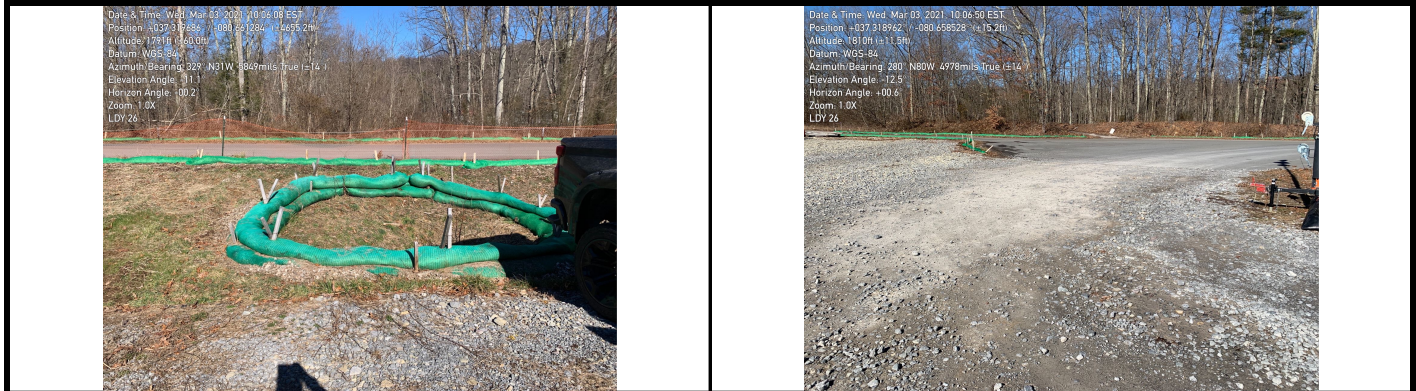
<b>GPS Location</b>	See photo for GPS location.	<b>GPS Location</b>	See photo for GPS location.
<b>Field Station#</b>	12005+00	<b>Field Station#</b>	12005+00
<b>Pic 3 Desc.</b>	Triple stack compost filter sock in place around drainage.	<b>Pic 4 Desc.</b>	RCE in place at LDY 26 entrance.

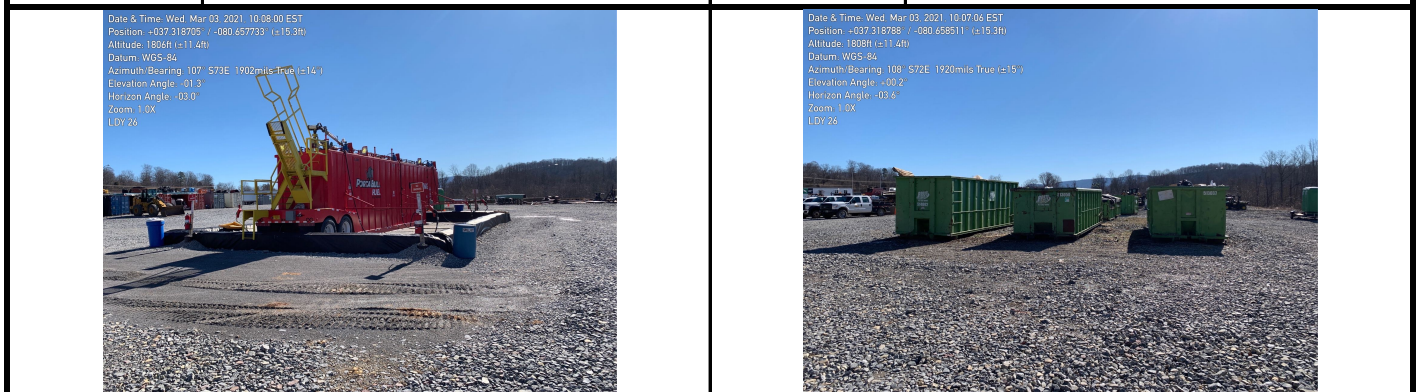
<b>GPS Location</b>	See photo for GPS location.	<b>GPS Location</b>	See photo for GPS location.
<b>Field Station#</b>	12005+00	<b>Field Station#</b>	12005+00
<b>Pic 5 Desc.</b>	Secondary containment in place under fuel cell.	<b>Pic 6 Desc.</b>	Dumpsters being utilized for trash management.

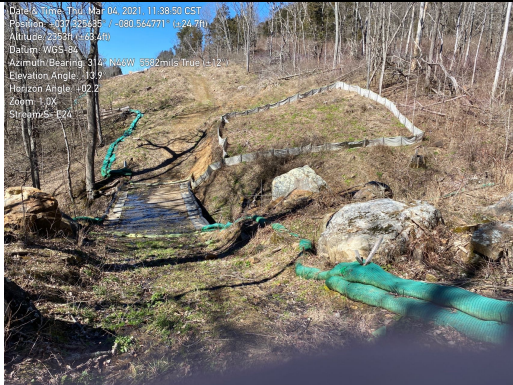
<p>Date &amp; Time: Thu, Mar 04, 2021 11:38:59 CST Position: 327323228, -880338387, 106.670 Altitude: 238.511 (+55.4m) Datum: WGS 84 Azimuth Bearing: 311.824W 3592mils True (+12.1) Elevation Angle: -11.2 Horizon Angle: +02.2 Zoom: 1.0X Stream S: E24</p>		<p><b>GPS Location</b> See photo GPS</p> <p><b>Field Station#</b> 10986+00</p> <p><b>Pic 3 Desc.</b> Stream S- E25</p>		<p><b>GPS Location</b> See photo GPS</p> <p><b>Field Station#</b> 10985+00</p> <p><b>Pic 4 Desc.</b> Stream S- E24</p>

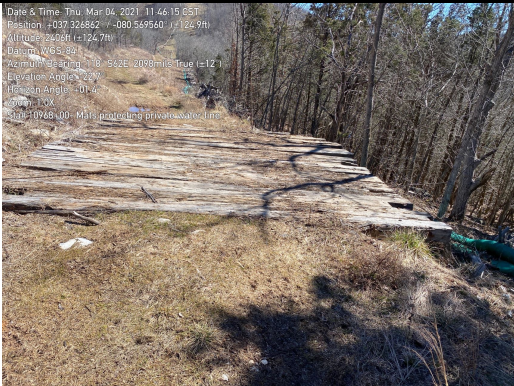
<p>Date &amp; Time: Thu, Mar 04, 2021 11:46:15 CST Position: 327323228, -880338387, 106.670 Altitude: 246.011 (+55.4m) Datum: WGS 84 Azimuth Bearing: 118.552E 2098mils True (+12.1) Elevation Angle: -22.7 Horizon Angle: +01.4 Zoom: 1.0X Site: 10968-00- Mats protecting private water line</p>

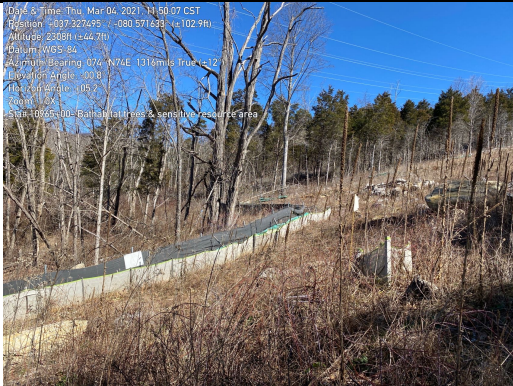
<p>Date &amp; Time: Thu, Mar 04, 2021 11:50:07 CST Position: 327323228, -880338387, 106.670 Altitude: 238.511 (+55.4m) Datum: WGS 84 Azimuth Bearing: 076.124E 1316mils True (+12.1) Elevation Angle: -30.8 Horizon Angle: +05.7 Zoom: 1.0X Site: 10965-00- Sensitive resource area</p>		<p><b>GPS Location</b> See photo GPS</p> <p><b>Field Station#</b> 10968+00</p> <p><b>Pic 5 Desc.</b> Mats protecting private water line</p>		<p><b>GPS Location</b> See photo GPS</p> <p><b>Field Station#</b> 10965+00</p> <p><b>Pic 6 Desc.</b> Sensitive resource area</p>

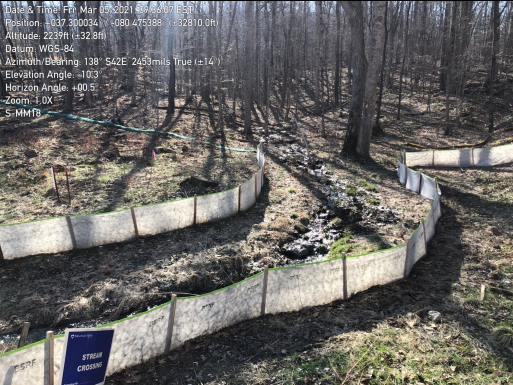
<p>Date &amp; Time: Fri, Mar 05, 2021, 08:03:07 EST Position: -037.300244 / -080.475358 (+32810.0ft) Altitude: 2239ft (+32.8ft) Datum: WGS-84 Azimuth/Bearing: 138° S42E 2453mils True (+1.4°) Elevation Angle: +10.3° Horizon Angle: +00.5° Zoom: 1.0X S-MM18</p>		<p><b>GPS Location</b> 1</p> <p><b>Field Station#</b> 11265+00</p> <p><b>Pic 1 Desc.</b> Perimeter controls functional.</p>		<p><b>GPS Location</b> 2</p> <p><b>Field Station#</b> 11292+80</p> <p><b>Pic 2 Desc.</b> S-MM18 and controls.</p>

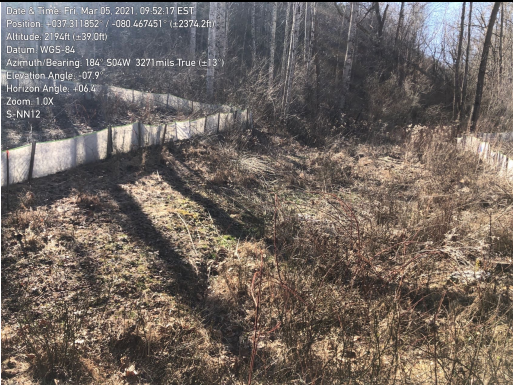
<p>Date &amp; Time: Fri, Mar 05, 2021, 09:52:17 EST Position: -037.311852 / -080.467451 (+2374.2ft) Altitude: 2194ft (+39.0ft) Datum: WGS-84 Azimuth/Bearing: 186° S84W 3271mils True (+1.3°) Elevation Angle: +07.9° Horizon Angle: +06.4° Zoom: 1.0X S-NN12</p>		<p><b>GPS Location</b> 3</p> <p><b>Field Station#</b> 11300+00</p> <p><b>Pic 3 Desc.</b> Section of RoW showing conditions and controls.</p>		<p><b>GPS Location</b> 4</p> <p><b>Field Station#</b> 11327+85</p> <p><b>Pic 4 Desc.</b> S-NN12 and controls.</p>

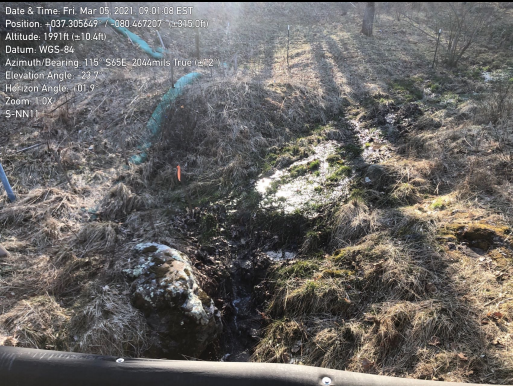
<p>Date &amp; Time: Fri, Mar 05, 2021, 09:01:08 EST Position: -037.305449 / -080.467207 (+2945.0ft) Altitude: 1991ft (+10.4ft) Datum: WGS-84 Azimuth/Bearing: 115° S69E 2042mils True (+0.2°) Elevation Angle: +21.2° Horizon Angle: +01.9° Zoom: 1.0X S-NN11</p>		<p><b>GPS Location</b> 5</p> <p><b>Field Station#</b> 11340+00</p> <p><b>Pic 5 Desc.</b> PPL crews replacing P-1.</p>		<p><b>GPS Location</b> 6</p> <p><b>Field Station#</b> 11352+97</p> <p><b>Pic 6 Desc.</b> S-NN11.</p>

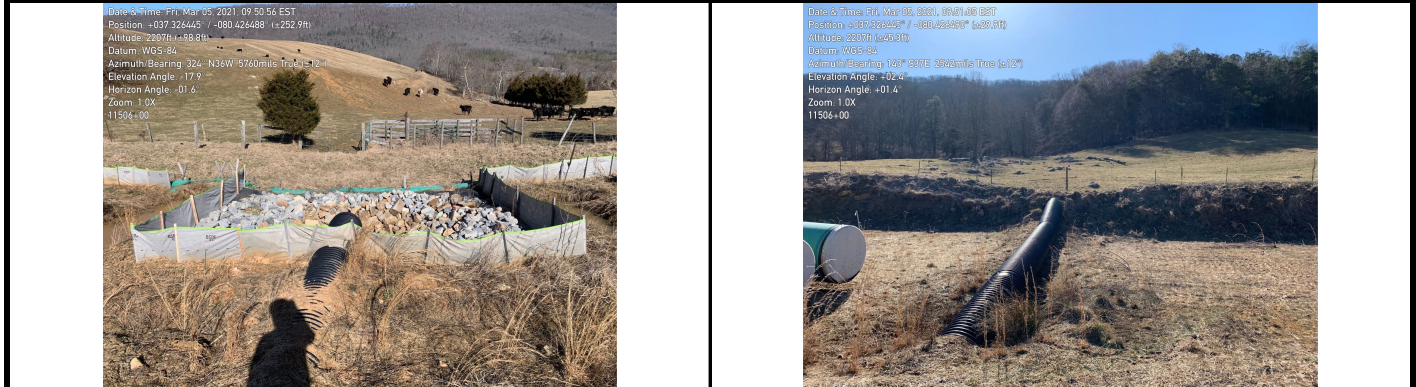
<b>GPS Location</b>	See photo for GPS location.	<b>GPS Location</b>	See photo for GPS location.
<b>Field Station#</b>	11506+00	<b>Field Station#</b>	11506+00
<b>Pic 1 Desc.</b>	Clean water diversion pipe and plunge pool in place.	<b>Pic 2 Desc.</b>	Clean water diversion pipe inlet and clean water diversion berm in place.

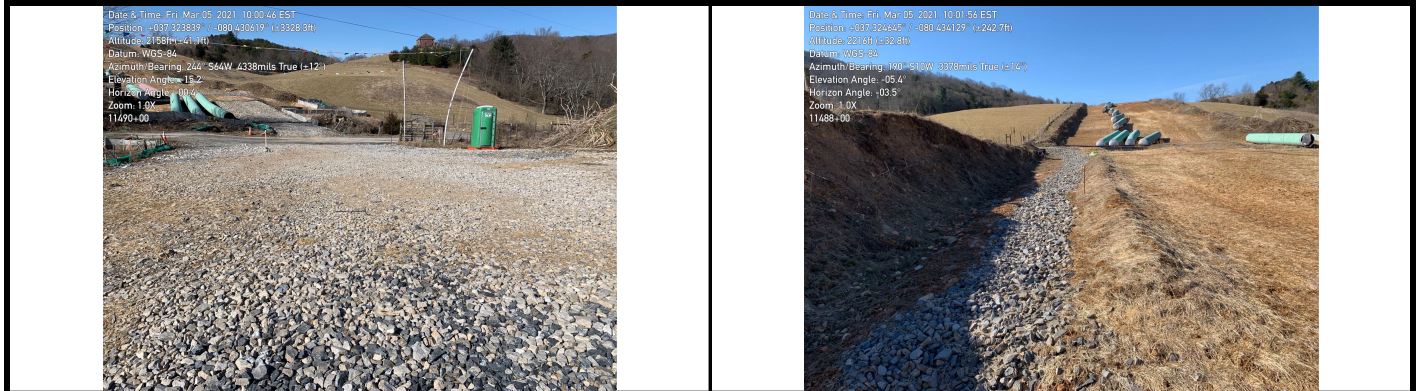
<b>GPS Location</b>	See photo for GPS location.	<b>GPS Location</b>	See photo for GPS location.
<b>Field Station#</b>	11490+00	<b>Field Station#</b>	11488+00
<b>Pic 3 Desc.</b>	RCE in place at Stevers Gap Road.	<b>Pic 4 Desc.</b>	Rock lined channel in place.

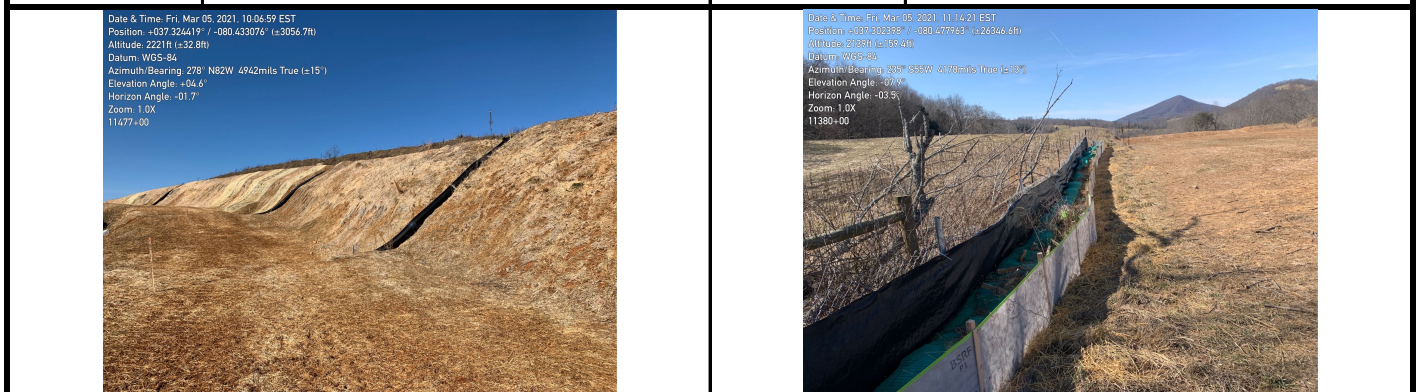
<b>GPS Location</b>	See photo for GPS location.	<b>GPS Location</b>	See photo for GPS location.
<b>Field Station#</b>	11477+00	<b>Field Station#</b>	11380+00
<b>Pic 5 Desc.</b>	Two tone stabilized with ECB and slope drain pipe in place.	<b>Pic 6 Desc.</b>	Triple barrier ECDs in place at off ROW karst feature.

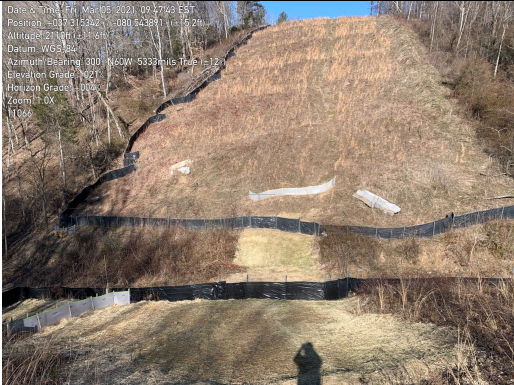
<b>GPS Location</b>		See picture above for GPS coordinates		<b>GPS Location</b>	
				See picture above for GPS coordinates	
<b>Field Station#</b>		110660+00		<b>Field Station#</b>	
				11080+00	
<b>Pic 1 Desc.</b>		ECD's and row conditions		<b>Pic 2 Desc.</b>	
				ECD's and row conditions
