# Visual Site Inspection Report

<b>Project Name</b> H-600 Pipeline Spread G		<b>AFE</b> 124300137	<b>Spread</b> H-600 Pipeline Spread G
<b>Contractor</b> Precision		<b>Report #</b> 21081	
<b>Inspector</b> Len Kruizenga		<b>Date/Time</b> 3/15/2021 8:39 AM	
<b>Permit #</b> TBD	<b>Inspection Type</b> VA SWPP	<b>Station Begin</b>	12005+00
<b>State</b> VA	<b>Inspection Area</b> Full	<b>Station End</b>	12005+00
<b>County</b> Giles	<b>Ground</b> Dry	<b>Temperature (°F)</b>	45.00
<b>Municipality</b> N/A	<b>Weather</b> Cloudy	<b>Rain Gauge (in)</b>	0.00
			<b>Rain Accumulation Time (days)</b> 1.00

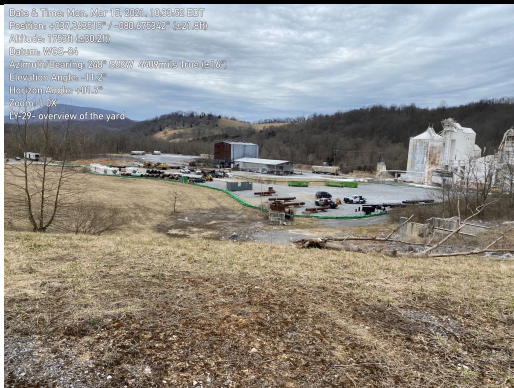
<p>Date &amp; Time Wed, Mar 10, 2021, 11:59:52 EDT  Position: +38.933357° / +80.57138° (-10.00)  Altitude: 1750 ft (533.21)  Datum: WGS-84  Azimuth Bearing: 201° S42W 441mils True (±0.1°)  Elevation Angle: +11.2°  Horizon Angle: +0.0°  Zoom: 1.0X  LY29- overview of the yard</p>

<b>Pic 5 Desc.</b>	LY29- Equipment and welding materials are being brought into the yard.		<b>Pic 6 Desc.</b>	LY29- Overview of the yard.

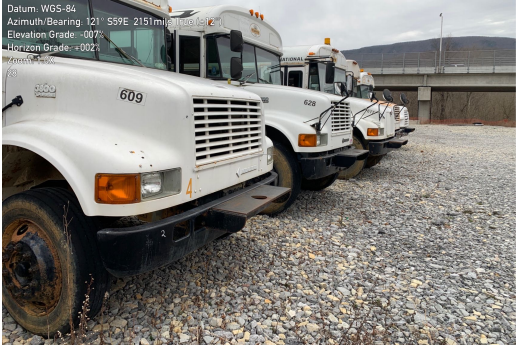
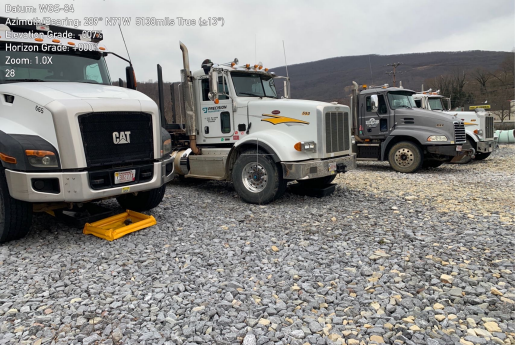
Arrived at LDY 26 for morning meeting  
 Performed SWPPP for LDY 28  
 No damaged ECD's observed during inspection  
 ROW conditions are stable and showing minimal signs of erosion  
 No items added to the punch list  
 Leak discovered due to improper placement of secondary containment, had crews clean spill and upgrade secondary containment

<b>GPS Location</b>	See picture above for GPS coordinates	<b>GPS Location</b>	See picture above for GPS coordinates	
<b>Field Station#</b>	12005+00	<b>Field Station#</b>	12005+00	
<b>Pic 1 Desc.</b>	ECD's and row conditions	<b>Pic 2 Desc.</b>	ECD's and row conditions

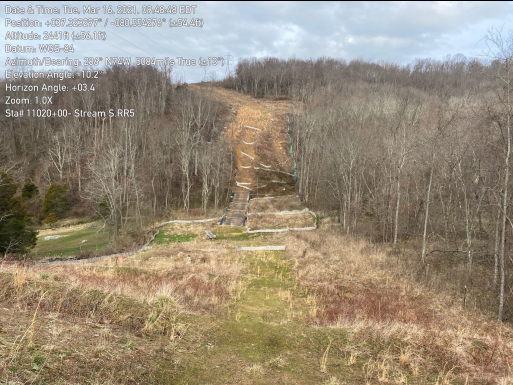
<p>Date &amp; Time: Tue, Mar 16, 2021 09:24:05 EDT  Position: +037.322264 / -080.533110 (+41.8m)  Altitude: 2271ft (+69.1m)  Datum: WGS-84  Azimuth/Bearing: 171.509E 304.0mils True (+13.1)  Elevation Angle: +25.1  Horizon Angle: +03.1  Zoom: 1.0X  Sta# 11024+00 - Stream S- IJ18</p>

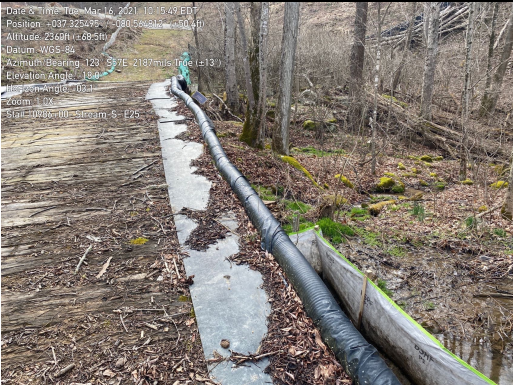
<p>Date &amp; Time: Tue, Mar 16, 2021 10:09:12 EDT  Position: +037.325283 / -080.533104 (+45.8m)  Altitude: 2331ft (+71.3m)  Datum: WGS-84  Azimuth/Bearing: 122.4183W 374.0mils True (+13.1)  Elevation Angle: +35.2  Horizon Angle: +00.8  Zoom: 1.0X  Sta# 10992+00 - Water bars, end treatments, perimeter controls</p>

<b>GPS Location</b>		See photo GPS		<b>GPS Location</b>	
<b>Field Station#</b>		10992+00		<b>Field Station#</b>	
<b>Pic 3 Desc.</b>		Water bars, end treatments, perimeter controls.		<b>Pic 4 Desc.</b>	
				Stream S- E25

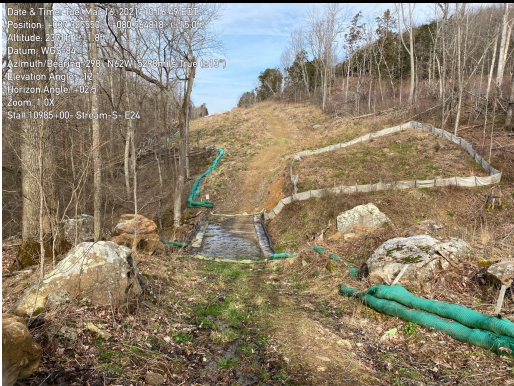
<p>Date &amp; Time: Wed, Mar 17, 2021 08:03:05 EDT  Position: +037.325511 / -080.533110 (+45.8m)  Altitude: 2375ft (+72.4m)  Datum: WGS-84  Azimuth/Bearing: 213.812W 338.0mils True (+13.1)  Elevation Angle: +11.2  Horizon Angle: +02.2  Zoom: 1.0X  Sta# 10985+00 - Stream S- E24</p>

<b>Pic 5 Desc.</b>		Stream S- E24		<b>Pic 6 Desc.</b>	
				Sensitive resource ECD's.

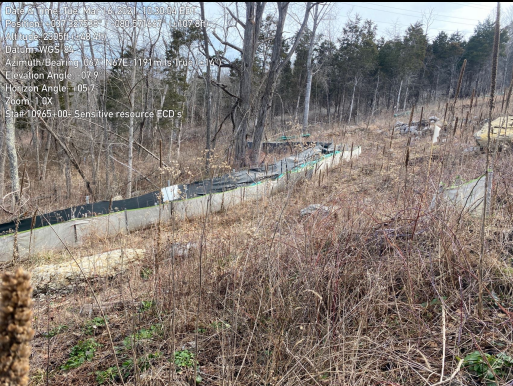
<p>Date &amp; Time: Wed, Mar 17, 2021 08:03:05 EDT  Position: +037.325511 / -080.533110 (+45.8m)  Altitude: 2375ft (+72.4m)  Datum: WGS-84  Azimuth/Bearing: 103.821E 112.1mils True (+13.1)  Elevation Angle: +07.9  Horizon Angle: +05.7  Zoom: 1.0X  Sta# 10965+00 - Sensitive resource ECD's</p>			
<b>GPS Location</b>		See photo GPS		<b>GPS Location</b>	
<b>Field Station#</b>		10985+00		<b>Field Station#</b>

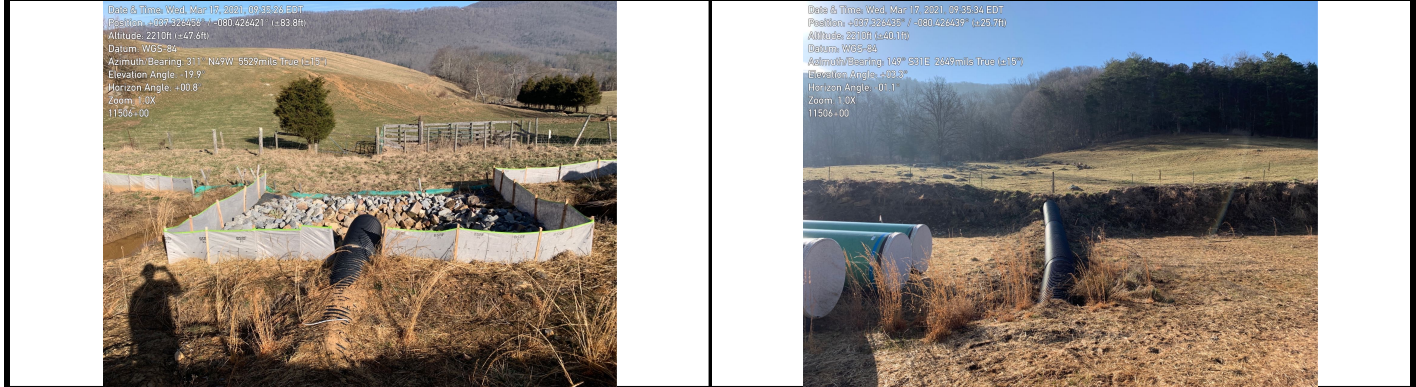
<b>Pic 1 Desc.</b>	Clean water diversion pipe and plunge pool in place.	<b>Pic 2 Desc.</b>	Clean water diversion pipe and clean water diversion berm in place.
--------------------	--	--------------------	---

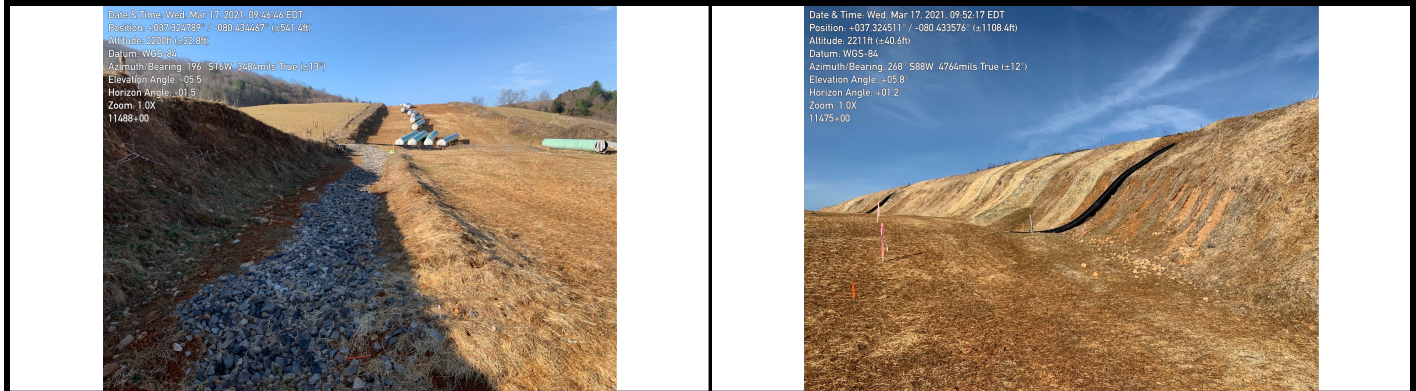
<b>Pic 3 Desc.</b>	Rock lined channel in place.	<b>Pic 4 Desc.</b>	Two-tone stabilized with ECB and slope drains in place.
--------------------	------------------------------	--------------------	---

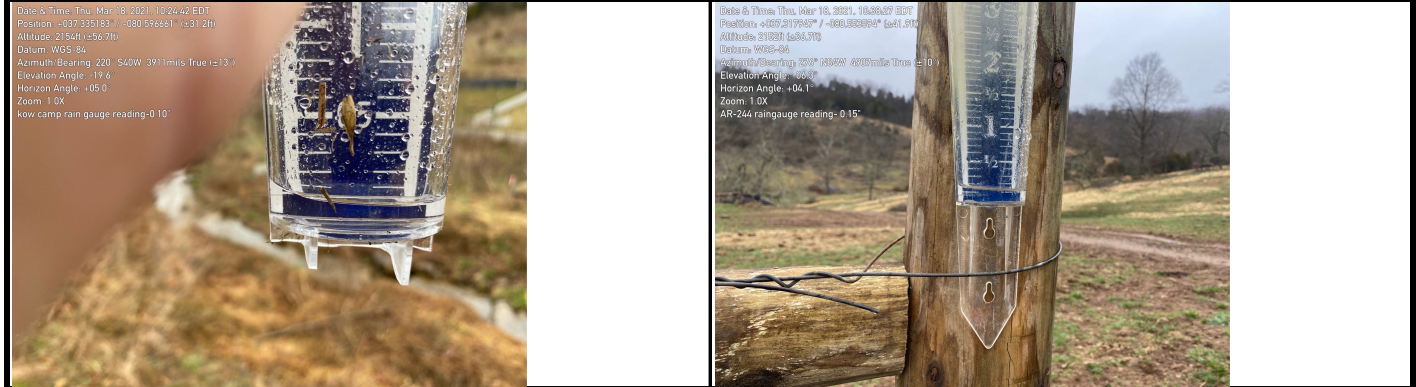
<b>Pic 7 Desc.</b>	Kow Camp rain gauge reading- 0.10"	<b>Pic 8 Desc.</b>	AR-244.00 rain gauge reading- 0.15"
--------------------	------------------------------------	--------------------	-------------------------------------

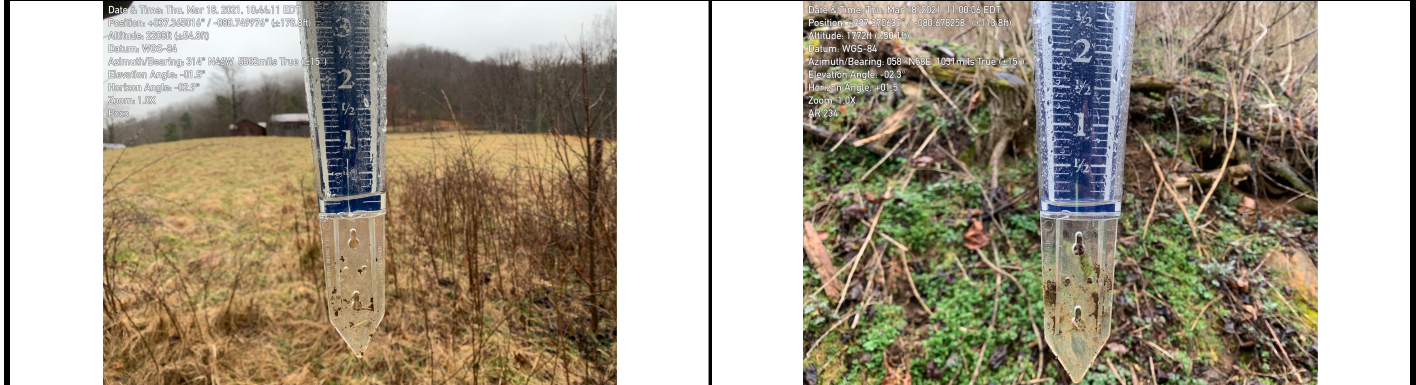
<b>Pic 1 Desc.</b>	Rain gauge at Pocahontas Road read 0.2 inches.	<b>Pic 2 Desc.</b>	Rain gauge at Access Road 234 reads 0.1 inches.
--------------------	--	--------------------	---

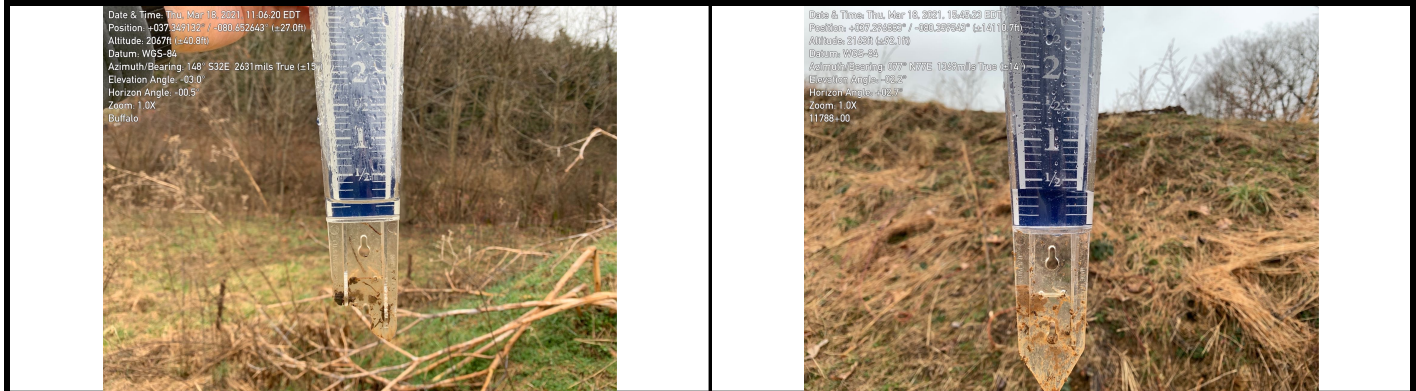
<b>Pic 3 Desc.</b>	Rain gauge at Buffalo Anklets Road reads 0.2 inches.	<b>Pic 4 Desc.</b>	Rain gauge at Mount Tabor Road reads 0.4 inches.
--------------------	--	--------------------	--

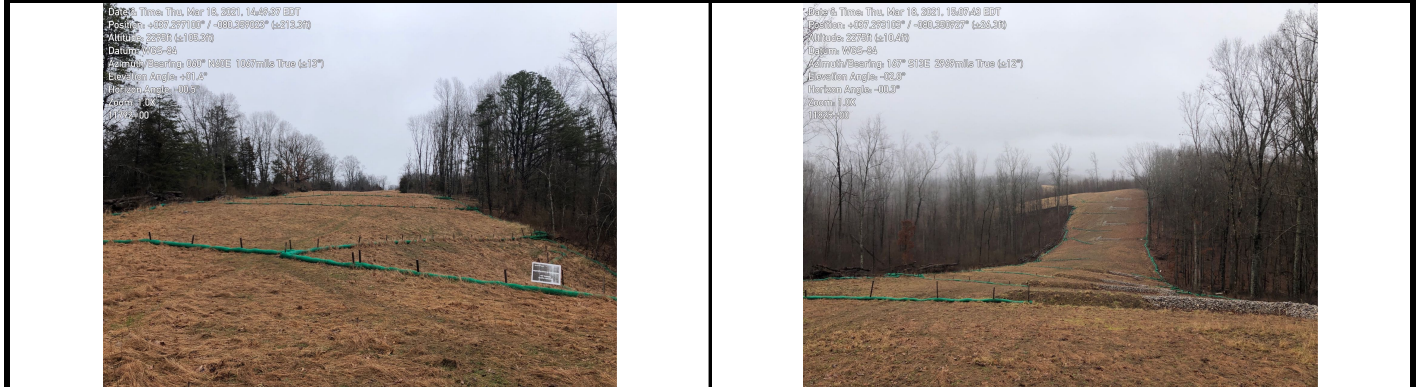
<b>Field Station#</b>	11792+00	<b>Field Station#</b>	11825+00
-----------------------	----------	-----------------------	----------

<b>Pic 1 Desc.</b>	Section of restored RoW showing conditions and controls.	<b>Pic 2 Desc.</b>	Section of restored RoW showing conditions and controls.
--------------------	--	--------------------	--

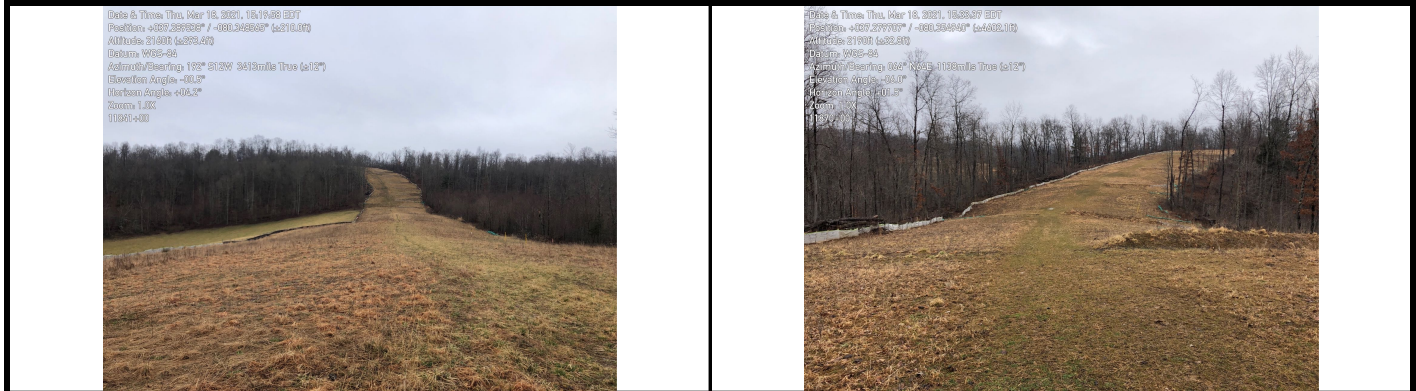
<b>Field Station#</b>	11841+00	<b>Field Station#</b>	11870+00
-----------------------	----------	-----------------------	----------

<b>Pic 3 Desc.</b>	Section of restored RoW showing conditions and controls.	<b>Pic 4 Desc.</b>	Section of restored RoW showing conditions and controls.
--------------------	--	--------------------	--

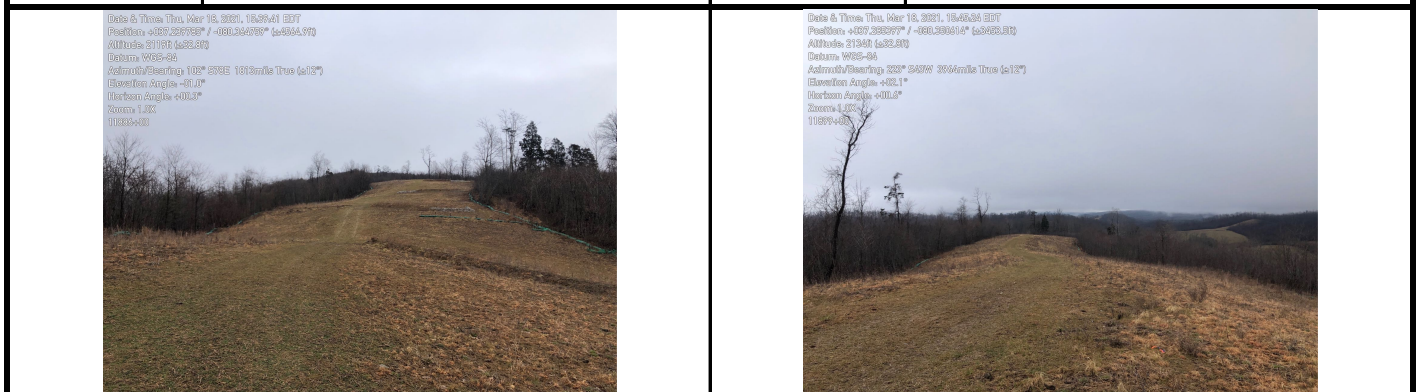
<b>Field Station#</b>	11886+00	<b>Field Station#</b>	11899+00
-----------------------	----------	-----------------------	----------

<b>Pic 5 Desc.</b>	Section of restored RoW showing conditions and controls.	<b>Pic 6 Desc.</b>	Section of restored RoW showing conditions and controls.
--------------------	--	--------------------	--

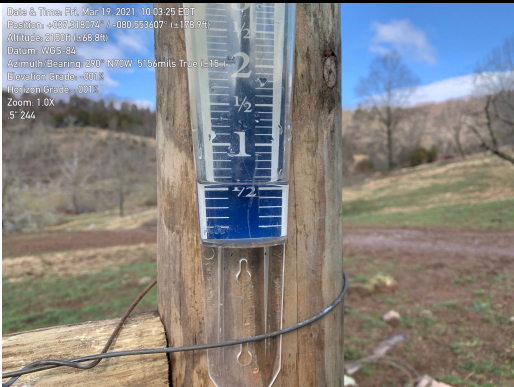
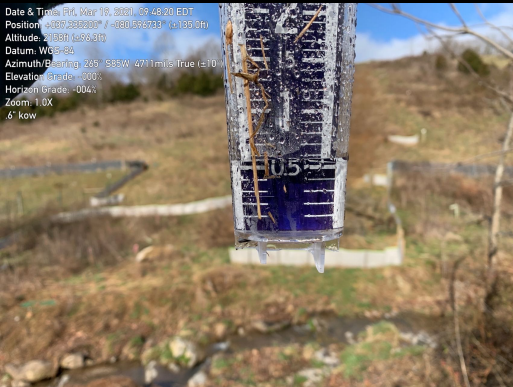
<b>GPS Location</b>	See picture above for GPS coordinates	<b>GPS Location</b>	See picture above for GPS coordinates		
<b>Field Station#</b>	+1	<b>Field Station#</b>	+1		
<b>Pic 1 Desc.</b>	.5" of rain recorded	<b>Pic 2 Desc.</b>	.5" of rain recorded

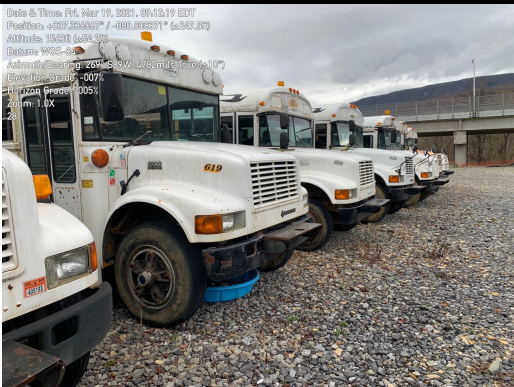
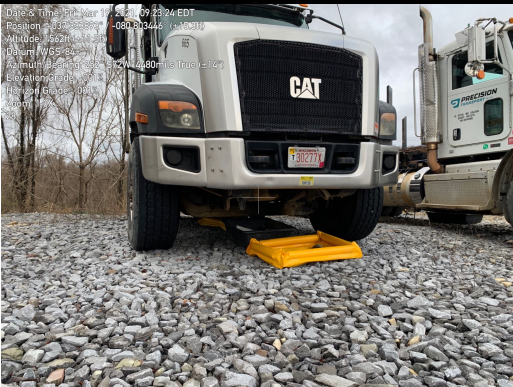
<b>GPS Location</b>	See picture above for GPS coordinates	<b>GPS Location</b>	See picture above for GPS coordinates		
<b>Field Station#</b>	12005+00	<b>Field Station#</b>	12005+00		
<b>Pic 3 Desc.</b>	ECD's and row conditions	<b>Pic 4 Desc.</b>	Secondary containment

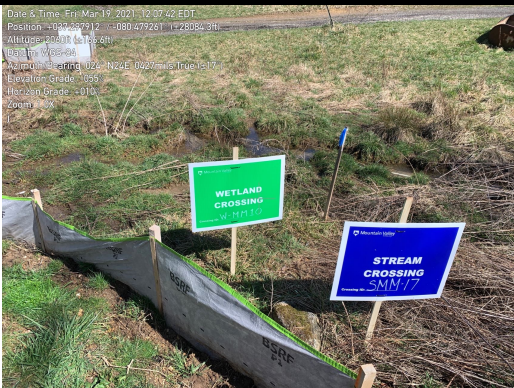
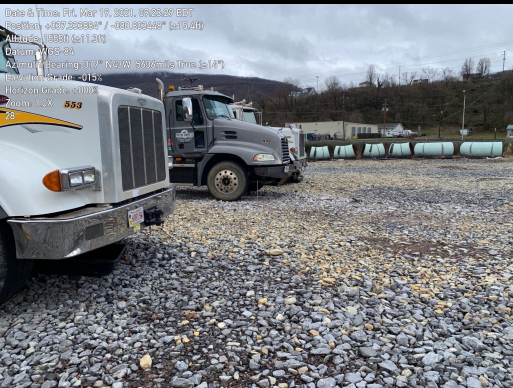
<b>GPS Location</b>	See picture above for GPS coordinates	<b>GPS Location</b>	See picture above for GPS coordinates		
<b>Field Station#</b>	11298+00	<b>Field Station#</b>	12005+00		
<b>Pic 5 Desc.</b>	Signage for sensitive resources	<b>Pic 6 Desc.</b>	ECD's and row conditions

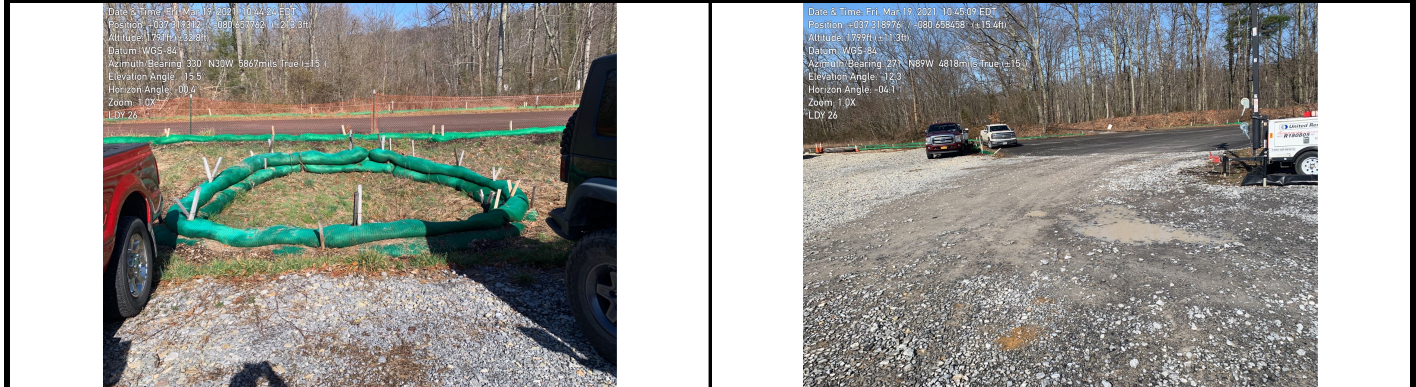
<b>Field Station#</b>	12005+00	<b>Field Station#</b>	12005+00
-----------------------	----------	-----------------------	----------

<b>Pic 1 Desc.</b>	Triple stack compost filter sock in place around drainage.	<b>Pic 2 Desc.</b>	RCE in place at LDY 26 entrance.
--------------------	--	--------------------	----------------------------------

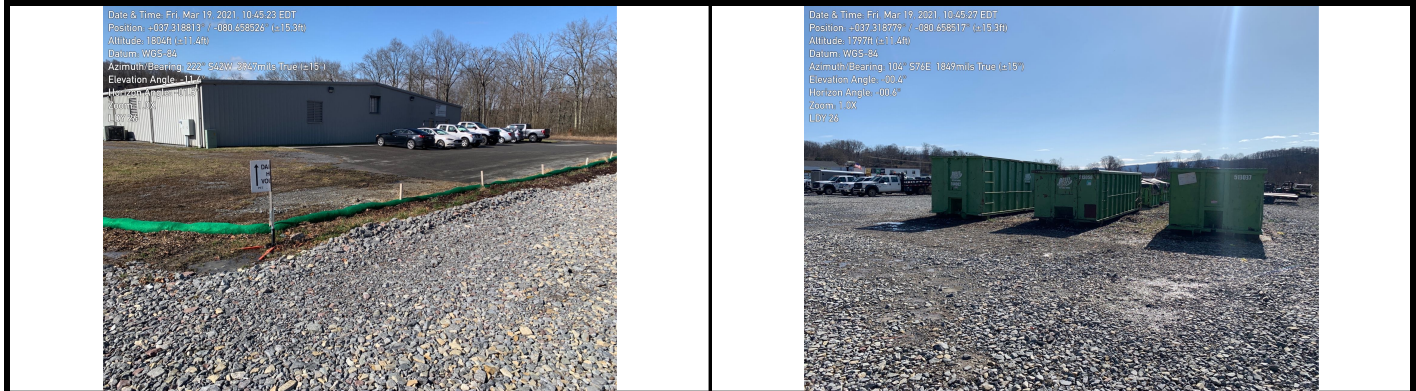
<b>Field Station#</b>	12005+00	<b>Field Station#</b>	12005+00
-----------------------	----------	-----------------------	----------

<b>Pic 3 Desc.</b>	18 inch compost filter sock in place along LOD.	<b>Pic 4 Desc.</b>	Dumpster being utilized for trash management.
--------------------	---	--------------------	---

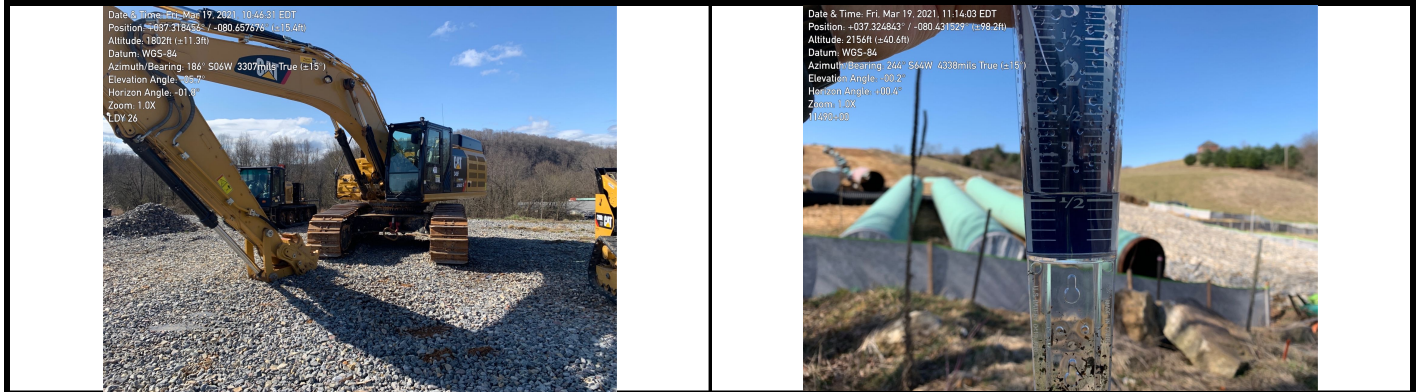
<b>Field Station#</b>	12005+00	<b>Field Station#</b>	11490+00
-----------------------	----------	-----------------------	----------

<b>Pic 5 Desc.</b>	Checked stages equipment for leaks.	<b>Pic 6 Desc.</b>	Rain gauge at Steve's Gap Road reads 0.55 inches.
--------------------	-------------------------------------	--------------------	---
