Visual Site Inspection Report

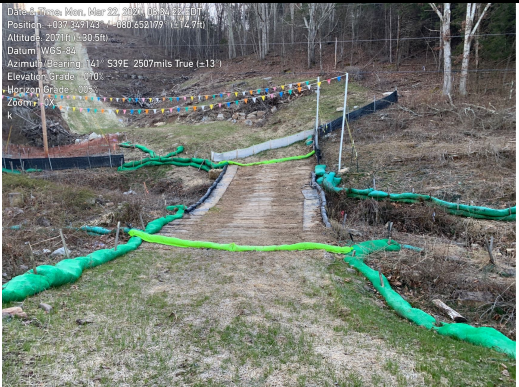
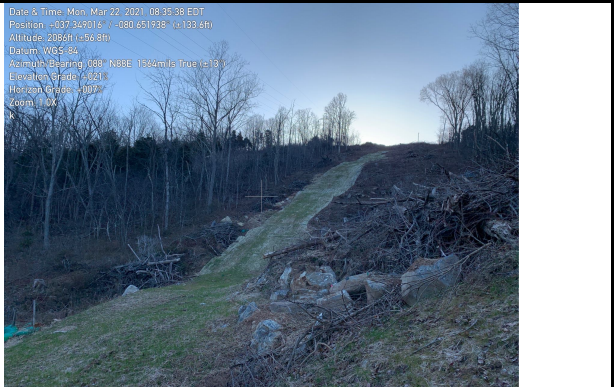
GPS Location	See pictures above for GPS coordinates		GPS Location	See pictures above for GPS coordinates	
Field Station#	+1		Field Station#	+1	
Pic 1 Desc.	ECD's and row conditions		Pic 2 Desc.	ECD's and row conditions	
<p>Date & Time: Mon, Mar 22, 2021, 09:24:00 EDT Position: +037.335857 / +080.638112 (±4.94.370) Altitude: 2123ft (±2.2m) Datum: WGS 84 Azimuth Bearing: 106.593E 1938mils True (±13°) Elevation Grade: -015 Horizon Grade: -0013 Zoom: 1.0X 10839</p>

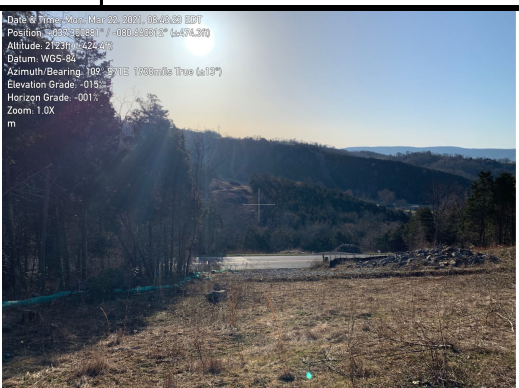
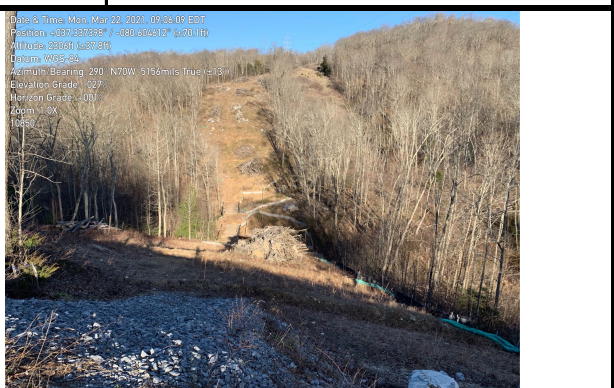
GPS Location	See pictures above for GPS coordinates		GPS Location	See pictures above for GPS coordinates	
Field Station#	+1		Field Station#	10850+00	
Pic 3 Desc.	ECD's and row conditions		Pic 4 Desc.	ECD's and row conditions	
<p>Date & Time: Mon, Mar 22, 2021, 09:11:49 EDT Position: +037.332449 / +080.601668 (±15.1ft) Altitude: 2455ft (±11.6ft) Datum: WGS 84 Azimuth Bearing: 113.547E 2009mils True (±13°) Elevation Grade: -003 Horizon Grade: -0111 Zoom: 1.0X 10839</p>

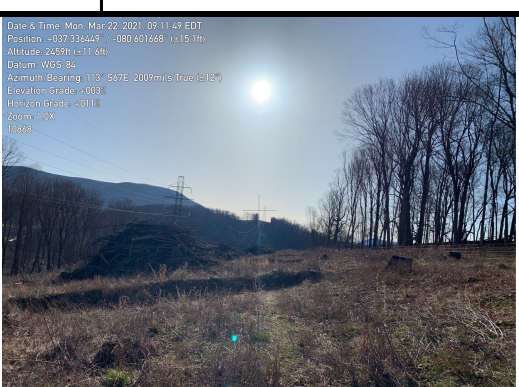
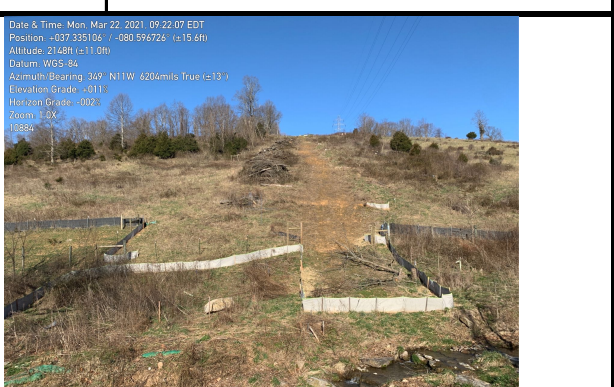
GPS Location	See pictures above for GPS coordinates		GPS Location	See pictures above for GPS coordinates	
Field Station#	10868+00		Field Station#	10884+00	
Pic 5 Desc.	ECD's and row conditions		Pic 6 Desc.	ECD's and row conditions

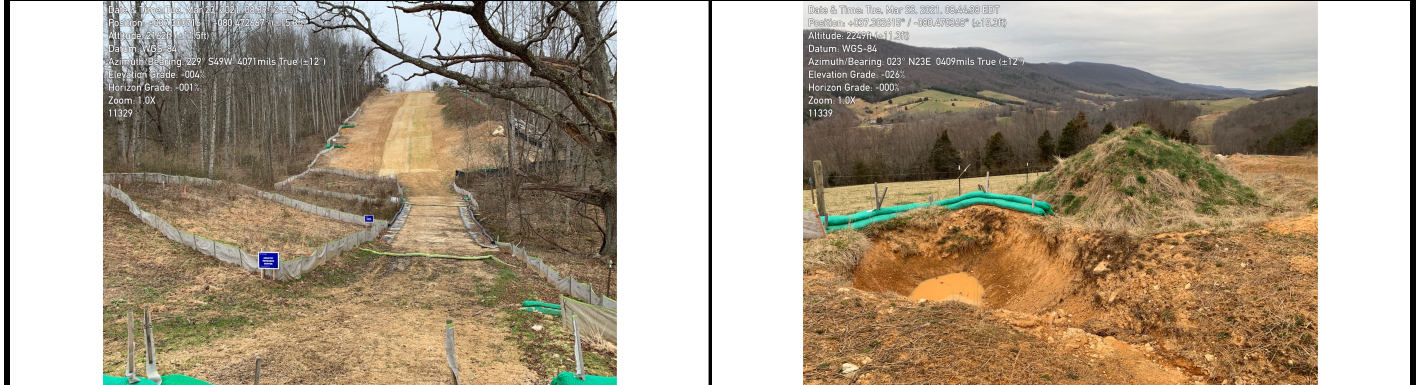
Field Station#	11329+00	Field Station#	1133+90
-----------------------	----------	-----------------------	---------

Pic 1 Desc.	ECD's and row conditions	Pic 2 Desc.	ECD's and row conditions
--------------------	--------------------------	--------------------	--------------------------

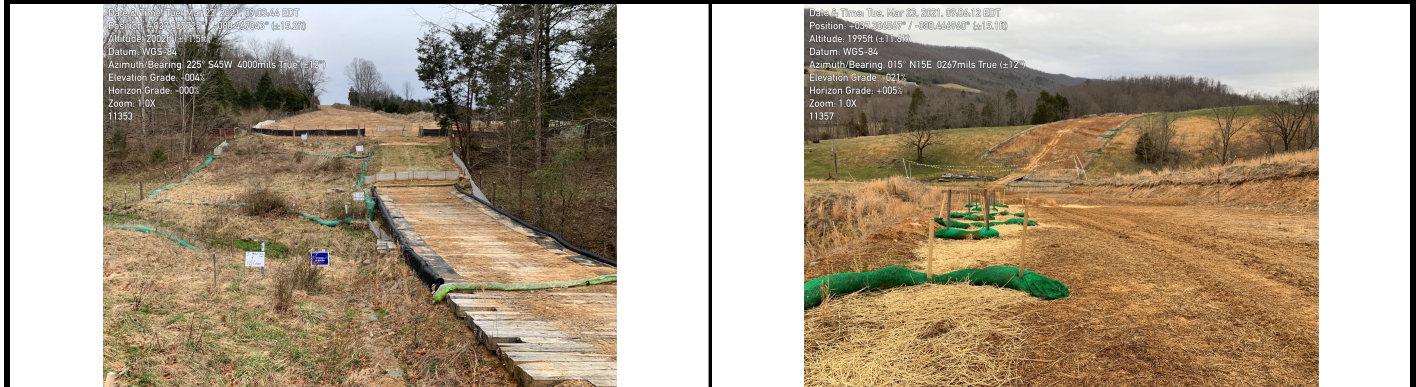
Field Station#	11353+00	Field Station#	11357+00
-----------------------	----------	-----------------------	----------

Pic 3 Desc.	ECD's and row conditions	Pic 4 Desc.	ECD's and row conditions
--------------------	--------------------------	--------------------	--------------------------

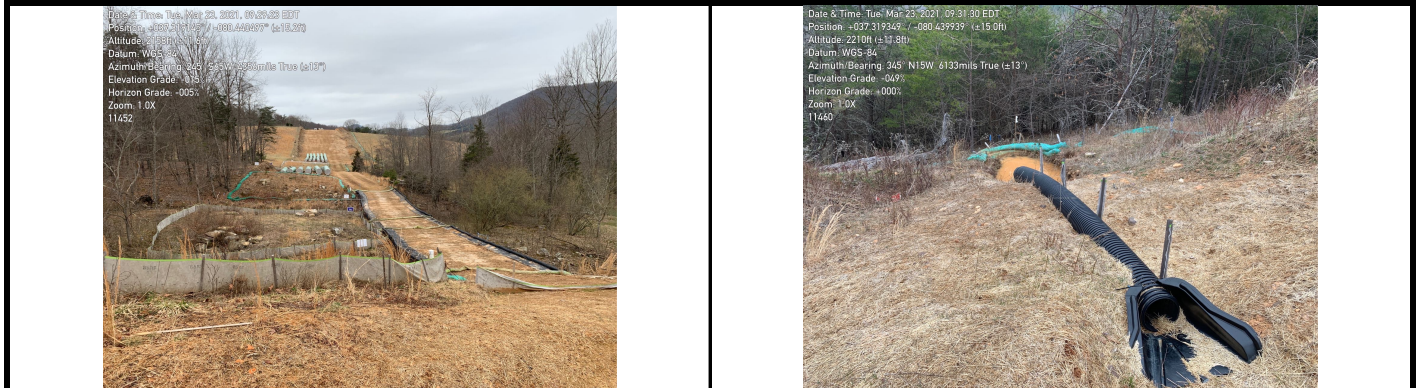
Field Station#	11452+00	Field Station#	11460+00
-----------------------	----------	-----------------------	----------

Pic 5 Desc.	ECD's and row conditions	Pic 6 Desc.	ECD's and row conditions
--------------------	--------------------------	--------------------	--------------------------

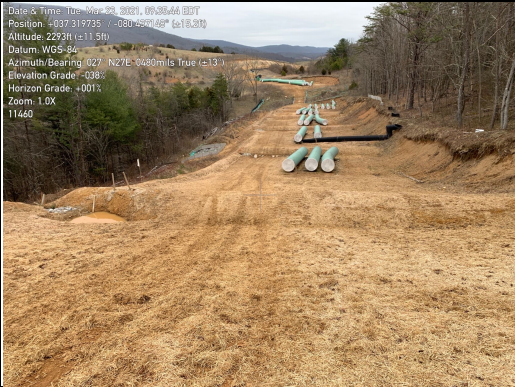
Pic 7 Desc.	ECD's and row conditions
--------------------	--------------------------

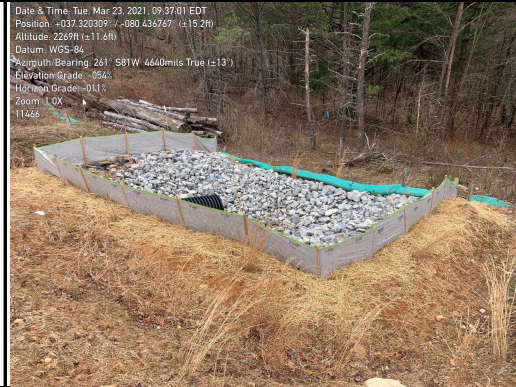
Pic 8 Desc.	ECD's and row conditions
--------------------	--------------------------

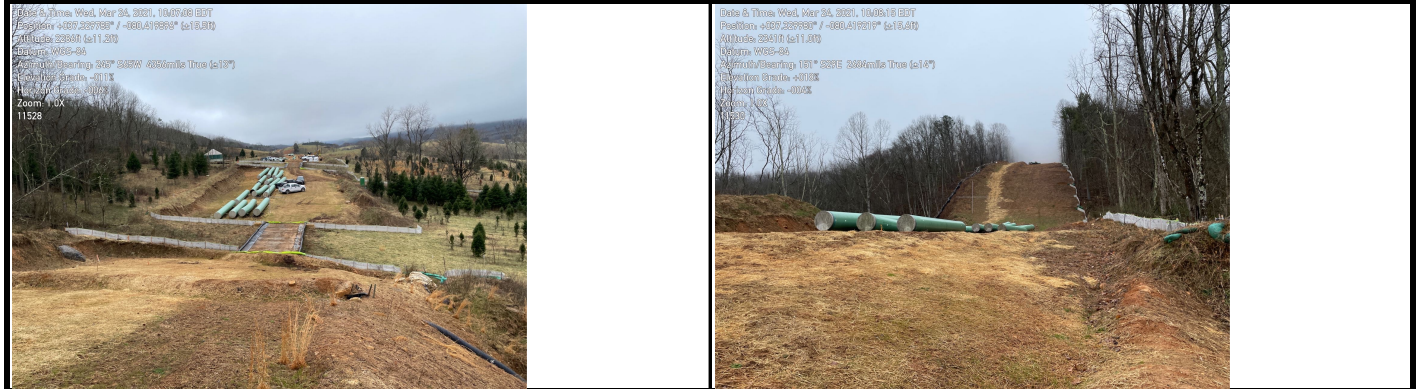
GPS Location	See pictures above for GPS coordinates	GPS Location	See pictures above for GPS coordinates
Field Station#	11528+00	Field Station#	11530+00
Pic 7 Desc.	ECD's and Row Conditions	Pic 8 Desc.	ECD's and Row Conditions

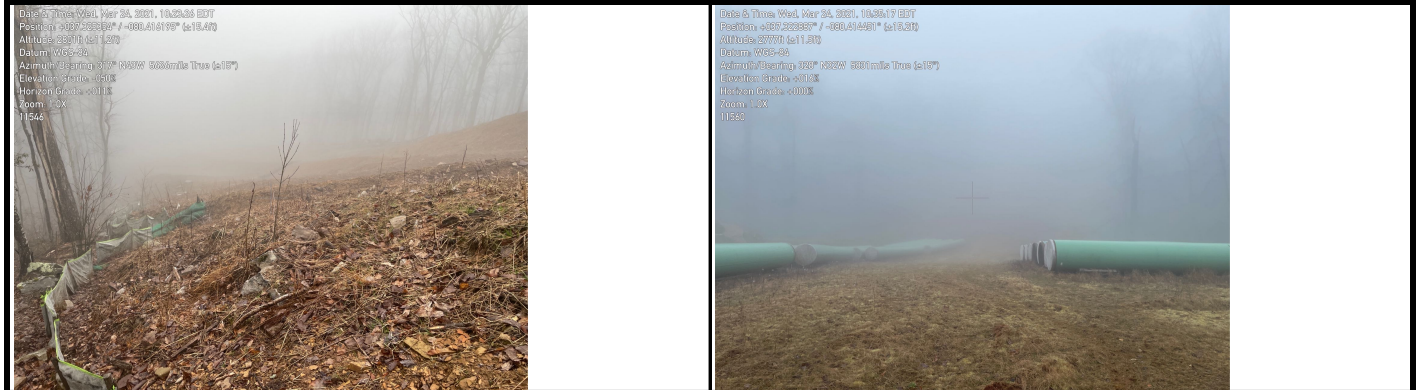
GPS Location	See pictures above for GPS coordinates	GPS Location	See pictures above for GPS coordinates
Field Station#	11546+00	Field Station#	11560+00
Pic 9 Desc.	ECD's and Row Conditions	Pic 10 Desc.	ECD's and Row Conditions

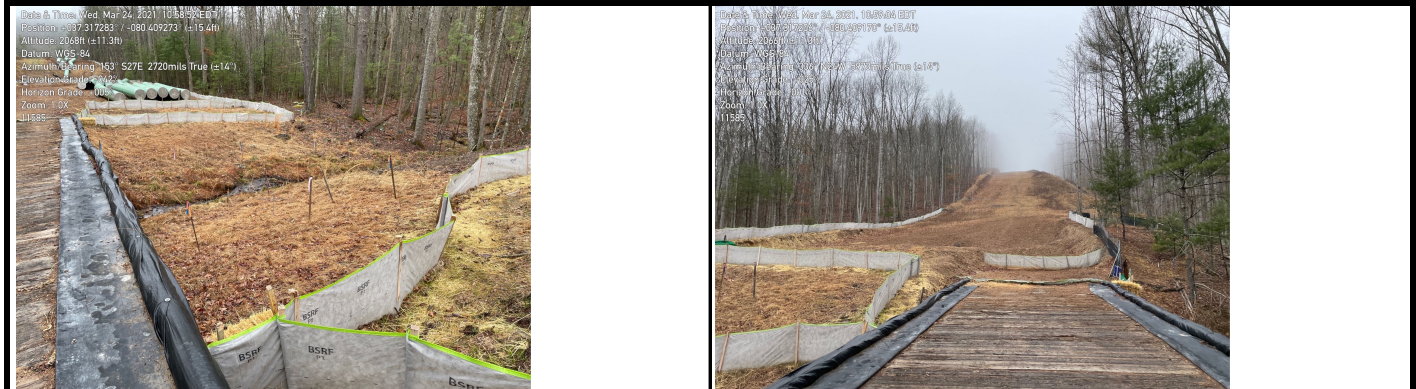
GPS Location	See pictures above for GPS coordinates	GPS Location	See pictures above for GPS coordinates
Field Station#	11585+00	Field Station#	11585+00
Pic 11 Desc.	ECD's and Row Conditions	Pic 12 Desc.	ECD's and Row Conditions

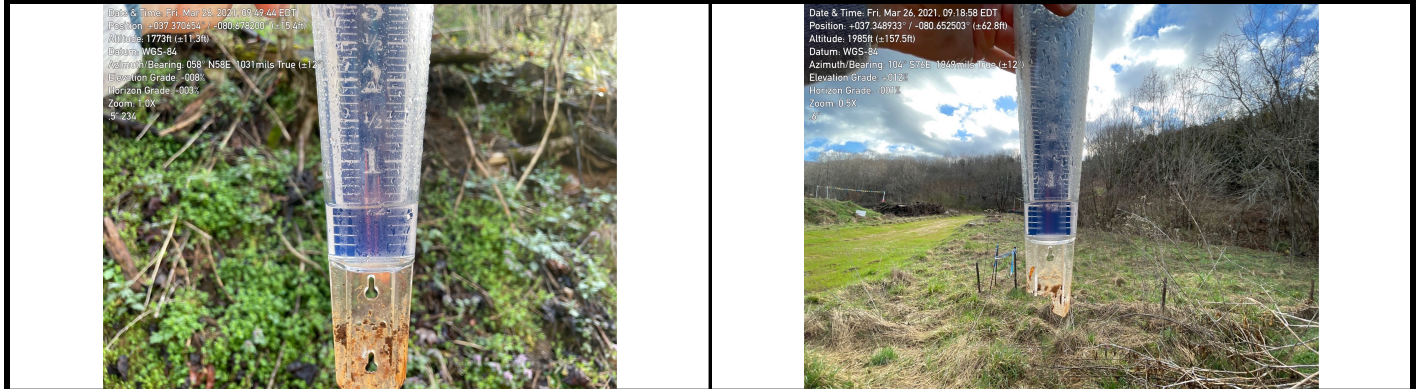
Field Station#	+1	Field Station#	+1
-----------------------	----	-----------------------	----

Pic 3 Desc.	ECD's and row conditions	Pic 4 Desc.	ECD's and row conditions
--------------------	--------------------------	--------------------	--------------------------

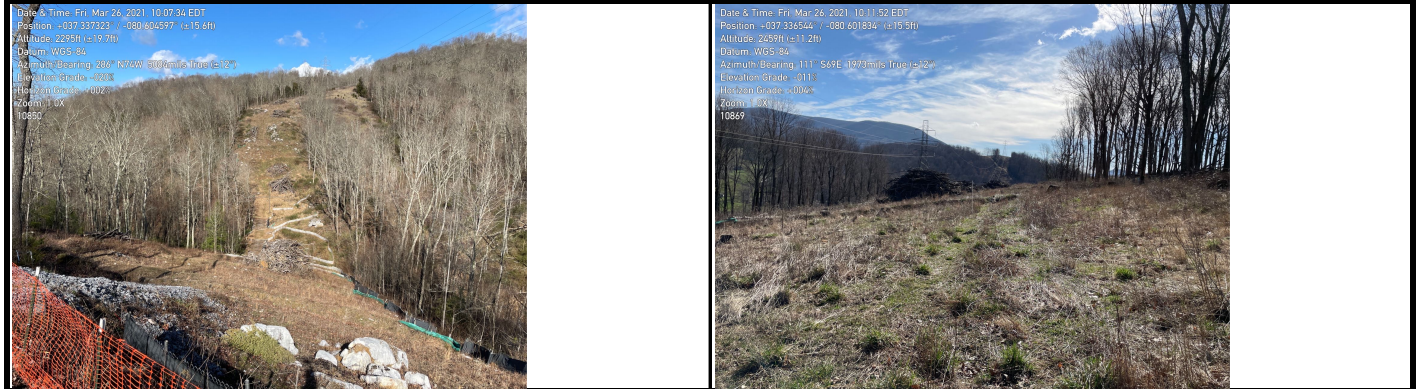
GPS Location	See picture above for GPS coordinates	GPS Location	See picture above for GPS coordinates
Field Station#	10850+00	Field Station#	10869+00
Pic 7 Desc.	ECD's and row conditions	Pic 8 Desc.	ECD's and row conditions

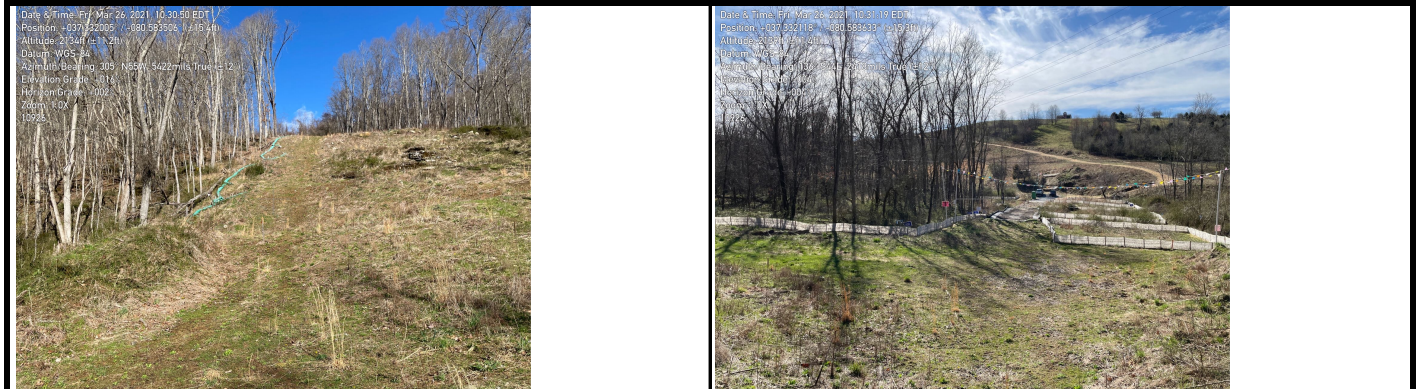
GPS Location	See picture above for GPS coordinates	GPS Location	See picture above for GPS coordinates
Field Station#	10883+00	Field Station#	10888+00
Pic 9 Desc.	ECD's and row conditions	Pic 10 Desc.	ECD's and row conditions
