Visual Site Inspection Report

| Project Name H-600 Pipeline Spread G | | AFE 124300137 | Spread H-600 Pipeline Spread G |
| Permit # TBD | Inspection Type VA SWPP | Station Begin 11064+55 | |

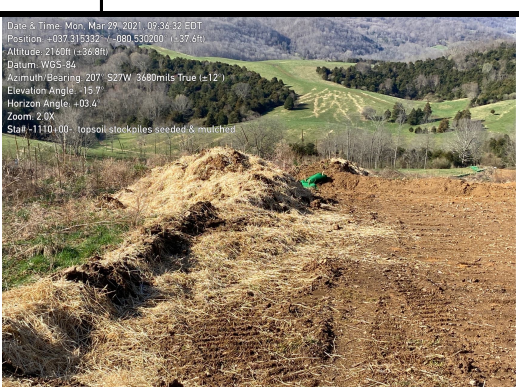
| AFE | 124300137 | Date/Time | 3/29/2021 7:38 AM | Report # | |
|---|---|---|---|---|--|
| <p>Date & Time: Mon, Mar 29, 2021, 09:38:32 EDT Position: -080.313333, -080.532200, 4537.5ft Altitude: 5140ft (=5140ft) Datum: WGS-84 Azimuth Bearing: 207.527W, 3680mils True (=12) Elevation Angle: -15.7 Horizon Angle: +03.4 Zoom: 2.0X Station: 11110+00- topsoil stockpiles seeded & mulched.</p> | | | <p>Date & Time: Mon, Mar 29, 2021, 09:40:31 EDT Position: -080.313583, -080.528833, 4504.0ft Altitude: 4931ft (=4931ft) Datum: WGS-84 Azimuth Bearing: 113.806E, 2009mils True (=13) Elevation Angle: -21.8 Horizon Angle: -06.9 Zoom: 2.0X Station: 11114+00- water bars on steep slope.</p> | | |

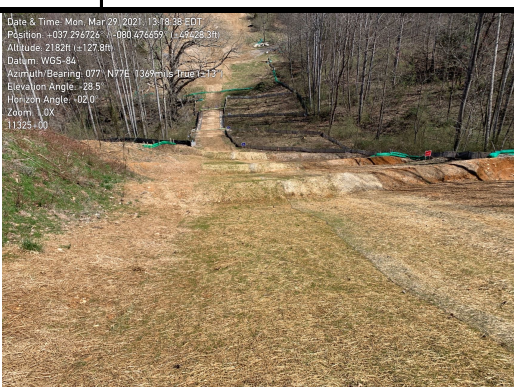
| AFE | 124300137 | Date/Time | 3/29/2021 8:14 PM | Report # | | |
|---|---|---|---|---|---|--|
| Field Station# | 11325+00 | | Field Station# | 11287+00 | | |

| AFE | 124300137 | Date/Time | 3/29/2021 8:14 PM | Report # | | |
|---|---|---|---|---|---|--|
| Pic 3 Desc. | Clean water drainage pipe and plunge pool in place. | | Pic 4 Desc. | Clean water drainage pipe inlet and berm in place. Clean water currently entering pipe. | | |

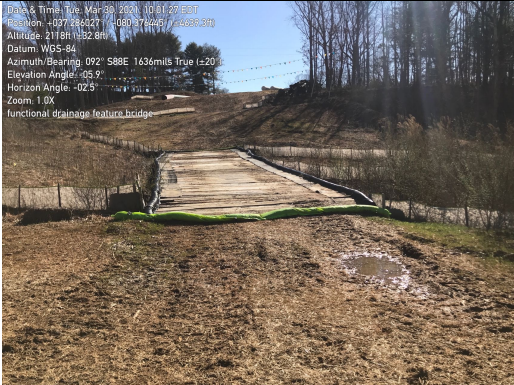
| AFE 124300137 | | Date/Time 3/30/2021 11:36 AM | | Report # | | | |
|---|---|---|---|---|---|---|--|
| <p>Data & Time: Tue, Mar 30, 2021, 10:51:20 EDT Position: 117723221, 1688371427, 143663301 Altitude: 2118m (6949ft) Datum: WGS-84 Azimuth/Bearing: 092.588E 1636mils True (±20) Elevation Angle: -05.7° Horizon Angle: -02.5° Zoom: 1.0x 11780+00 functional drainage feature bridge</p> | | <p>Data & Time: Tue, Mar 30, 2021, 09:02:49 EDT Position: 1173727356, 1688401125, 152436481 Altitude: 2248m (7391ft) Datum: WGS-84 Azimuth/Bearing: 202.522W 3591mils True (±13) Elevation Angle: -24.2° Horizon Angle: -00.1° Zoom: 1.0x 11728+50 waterbar and treatment falling into sump</p> | | <p>Data & Time: Tue, Mar 30, 2021, 09:46:20 EDT Position: 1173439581, 1688177036, 1510216841 Altitude: 2265m (7431ft) Datum: WGS-84 Azimuth/Bearing: 135.185W 6911mils True (±3) Elevation Angle: -6.5° Horizon Angle: -02.3° Zoom: 1.0x 11734+00 super silt fence and end treatment in need of maintenance</p> | | <p>Data & Time: Tue, Mar 30, 2021, 09:48:34 EDT Position: 1173239358, 1688377735, 1510216841 Altitude: 2186m (7188ft) Datum: WGS-84 Azimuth/Bearing: 190.510W 3378mils True (±8) Elevation Angle: -16.6° Horizon Angle: -02.7° Zoom: 1.0x 11735+00 waterbar and treatment</p> | |
| Pic 1 Desc. | Mat bridge in good working condition | Pic 2 Desc. | CFS falling into sump. | Pic 3 Desc. | Super silt fence and end treatment in need of maintenance. | | |

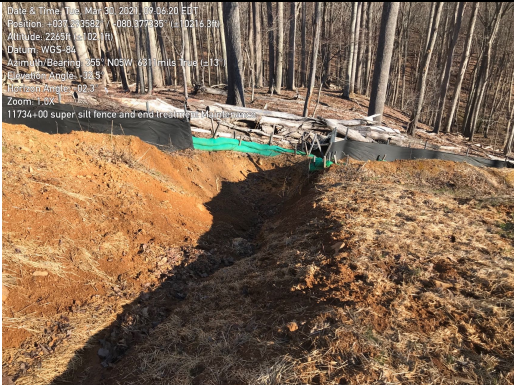
VA SWPPP inspection MP 221.02 to MP 223.37
 Maintenance items identified and added to punch list.
 -11725+50-CFS falling into sump.
 -11734+00-super siltfence and end treatment in need of maintenance
 -11735+00-sump full of sediment.
 -11727+00-CFS falling into sump
 Communication was given to Precision on listed items.
 No impacts to sensitive resources observed.

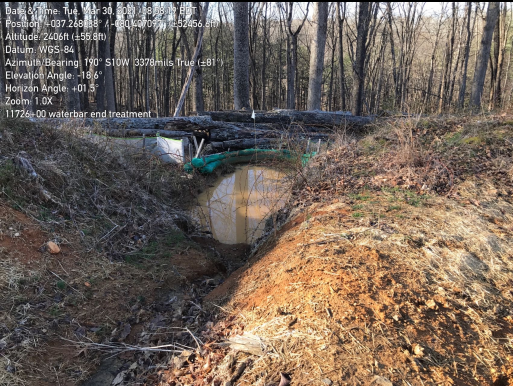
| AFE 124300137 | | Date/Time 3/30/2021 11:36 AM | | Report # | | | |
|---|---|---|---|---|---|---|--|
| <p>Data & Time: Tue, Mar 30, 2021, 08:59:57 EDT Position: 1172722491, 1688088201, 153281611 Altitude: 2248m (7391ft) Datum: WGS-84 Azimuth/Bearing: 192.512W 3415mils True (±15) Elevation Angle: -21.8° Horizon Angle: -00.9° Zoom: 1.0x 11727+00 waterbar and treatment falling in sump</p> | | <p>Data & Time: Tue, Mar 30, 2021, 08:59:57 EDT Position: 1172722491, 1688088201, 153281611 Altitude: 2248m (7391ft) Datum: WGS-84 Azimuth/Bearing: 190.510W 3378mils True (±8) Elevation Angle: -16.6° Horizon Angle: -01.5° Zoom: 1.0x 11726+00 waterbar and treatment</p> | | <p>Data & Time: Tue, Mar 30, 2021, 08:59:57 EDT Position: 1172722491, 1688088201, 153281611 Altitude: 2248m (7391ft) Datum: WGS-84 Azimuth/Bearing: 190.510W 3378mils True (±8) Elevation Angle: -16.6° Horizon Angle: -01.5° Zoom: 1.0x 11726+00 waterbar and treatment</p> | | | |
| Pic 5 Desc. | CFS falling into sump. | Pic 6 Desc. | End treatment in good working condition | Pic 5 Desc. | End treatment in good working condition | | |

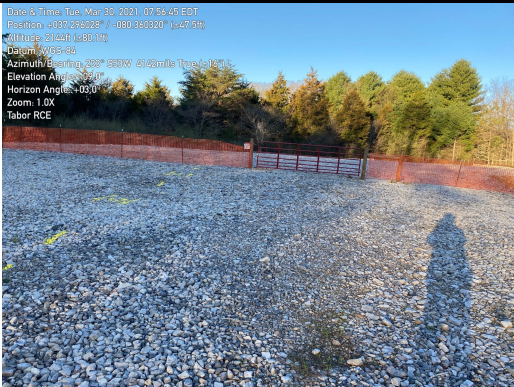
| AFE | 124300137 | Date/Time | 3/30/2021 3:45 PM | Report # |
|---|---|---|---|---|
| Field Station# | 11790+00 | Field Station# | 11797+00 | |

| AFE | 124300137 | Date/Time | 3/30/2021 3:45 PM | Report # |
|---|---|---|---|---|
| Pic 1 Desc. | Tabor RCE | | Pic 2 Desc. | Level spreaders |

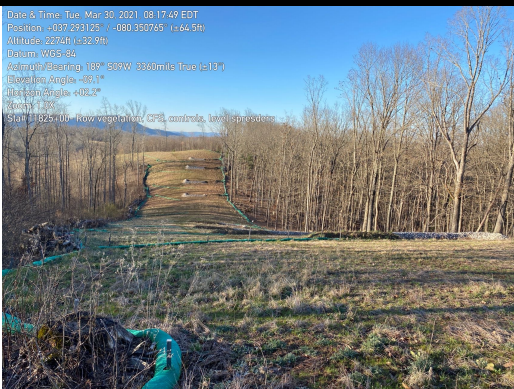
| AFE | 124300137 | Date/Time | 3/30/2021 3:45 PM | Report # |
|---|---|---|---|---|
| Field Station# | 11825+00 | | Field Station# | 11838+00 |

| AFE | 124300137 | Date/Time | 3/30/2021 3:45 PM | Report # |
|---|---|---|---|---|
| Pic 3 Desc. | Row vegetation, CFS controls, level spreaders. | | Pic 4 Desc. | SSF & CFS perimeter controls. |

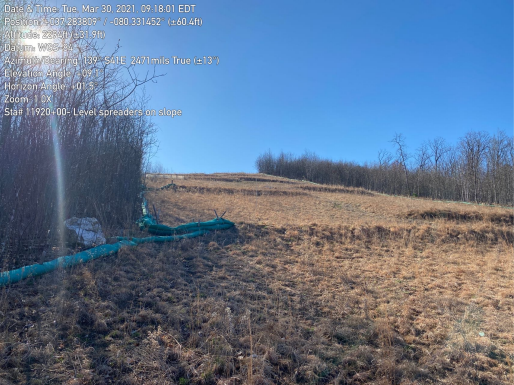
| Field Station# | 11920+00 | Field Station# | 11942+00 |

| <p><small>Date & Time: Tue, Mar 30, 2021, 09:18:01 EDT Position: +037 279130, -080 331432, +60 4ft Altitude: 2238ft (+62 9ft) Datum: WGS 84 Azimuth/Bearing: 169° S11E, 3004mils True (+14.1) Elevation Angle: -13.0° Horizon Angle: +03.3° Zoom: 1.0X Staff: 11920+00- Level spreaders on slope</small></p> | | <p><small>Date & Time: Tue, Mar 30, 2021, 09:24:01 EDT Position: +037 279130, -080 327739, +80 1ft Altitude: 2238ft (+62 9ft) Datum: WGS 84 Azimuth/Bearing: 169° S11E, 3218mils True (+14.1) Elevation Angle: -13.0° Horizon Angle: +03.3° Zoom: 1.0X Staff: 11942+00- Karst ECD's</small></p> | |
| Pic 7 Desc. | Level spreaders on slope. | Pic 8 Desc. | Karst ECD's. |

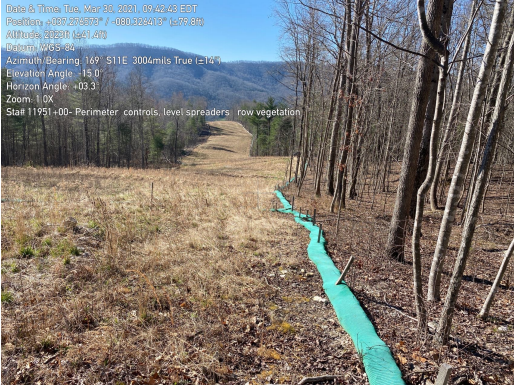
| Field Station# | 11951+00 | Field Station# | 11971+00 |

| <p><small>Date & Time: Tue, Mar 30, 2021, 09:42:28 EDT Position: +037 271280, -080 326134, +95 0ft Altitude: 3020ft (+92 2ft) Datum: WGS 84 Azimuth/Bearing: 169° S11E, 3004mils True (+14.1) Elevation Angle: -13.0° Horizon Angle: +03.3° Zoom: 1.0X Staff: 11951+00- Perimeter controls, level spreaders, row vegetation</small></p> | | <p><small>Date & Time: Tue, Mar 30, 2021, 09:56:40 EDT Position: +037 271280, -080 326134, +95 0ft Altitude: 3020ft (+92 2ft) Datum: WGS 84 Azimuth/Bearing: 169° S11E, 3004mils True (+14.1) Elevation Angle: -13.0° Horizon Angle: +03.3° Zoom: 1.0X Staff: 11971+00- water bars on slope</small></p> | |
| Pic 9 Desc. | Perimeter controls, level spreaders, row vegetation. | Pic 10 Desc. | Water bars on slope. |

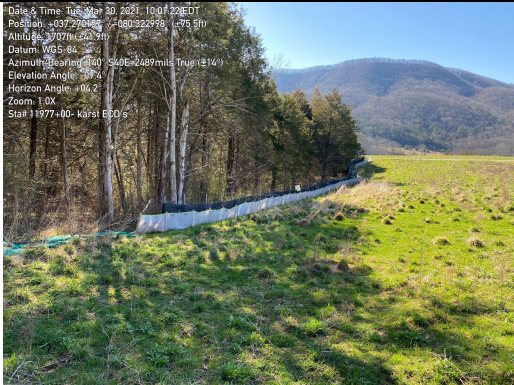
| <p><small>Date & Time: Tue, Mar 30, 2021, 10:04:26 EDT Position: +037 270785, -080 322398, +75 5ft Altitude: 1707ft (+42 3ft) Datum: WGS 84 Azimuth/Bearing: 010° N13E, 0231mils True (+14.1) Elevation Angle: +02.4° Horizon Angle: +00.8° Zoom: 1.0X Staff: 11977+00- Karst ECD's</small></p> | | <p><small>Date & Time: Tue, Mar 30, 2021, 10:07:22 EDT Position: +037 248355, -080 320530, +87 2ft Altitude: 1636ft (+39 2ft) Datum: WGS 84 Azimuth/Bearing: 010° N13E, 0231mils True (+14.1) Elevation Angle: +02.4° Horizon Angle: +00.8° Zoom: 1.0X AR-266.00- Access rd, rock check dams n bar ditch</small></p> | |

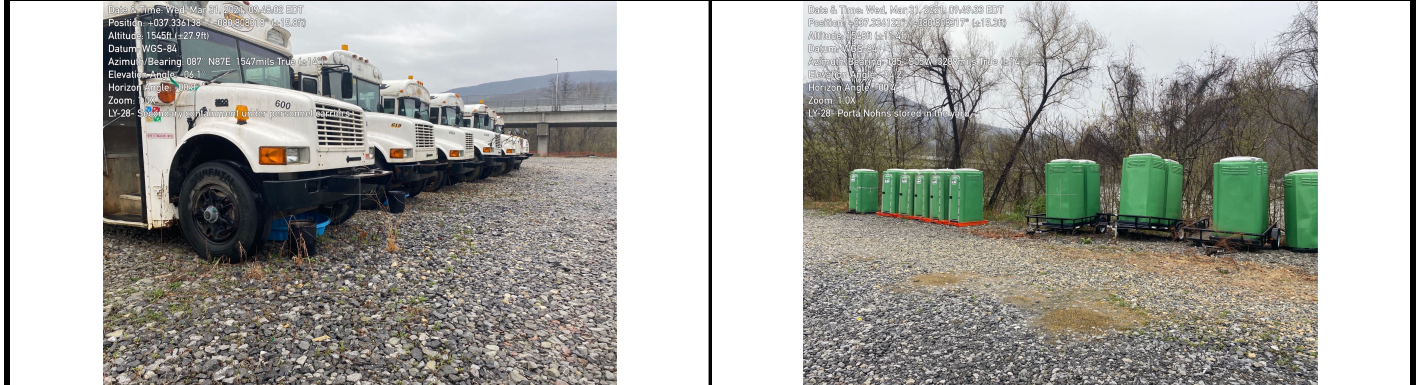
| Pic 1 Desc. | LY28- West portion of the yard, school buses used for employees transport. | Pic 2 Desc. | LY28- Porta Johns stored |

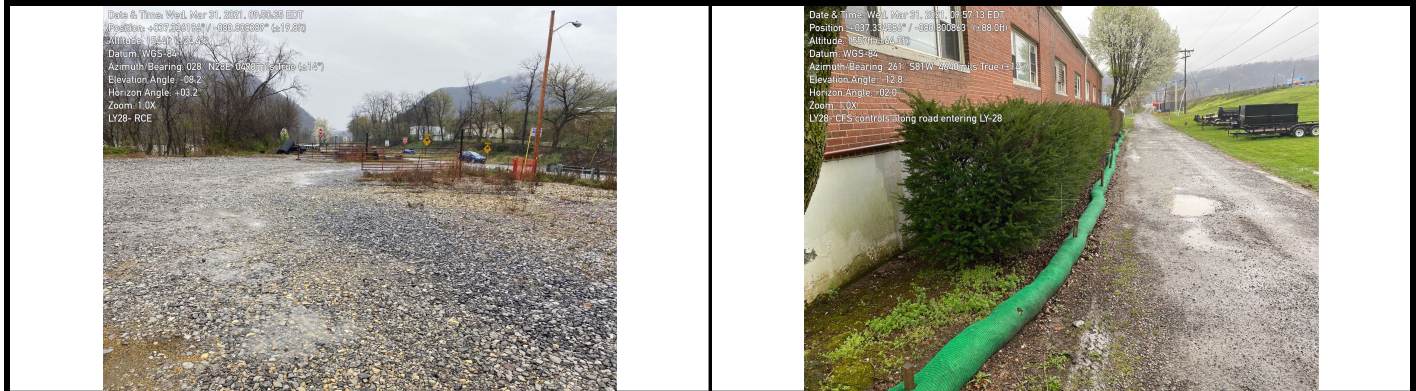
| Pic 3 Desc. | LY28 west portion of the yard- LY28 RCE | Pic 4 Desc. | LY28, east portion of the yard- CFS perimeter controls |

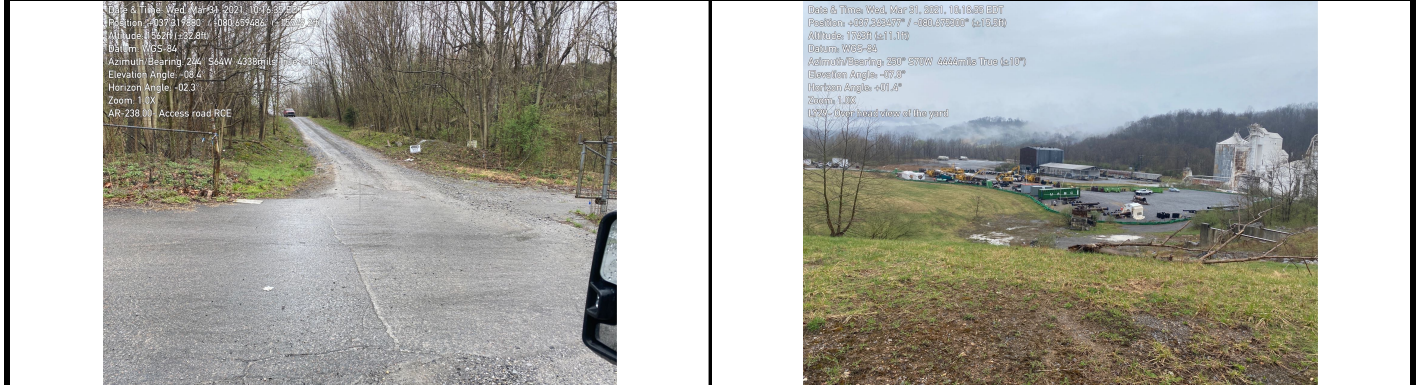
| Pic 1 Desc. LY29- AR-238.00, RCE | Pic 2 Desc. LY29- Overhead view of the yard. |

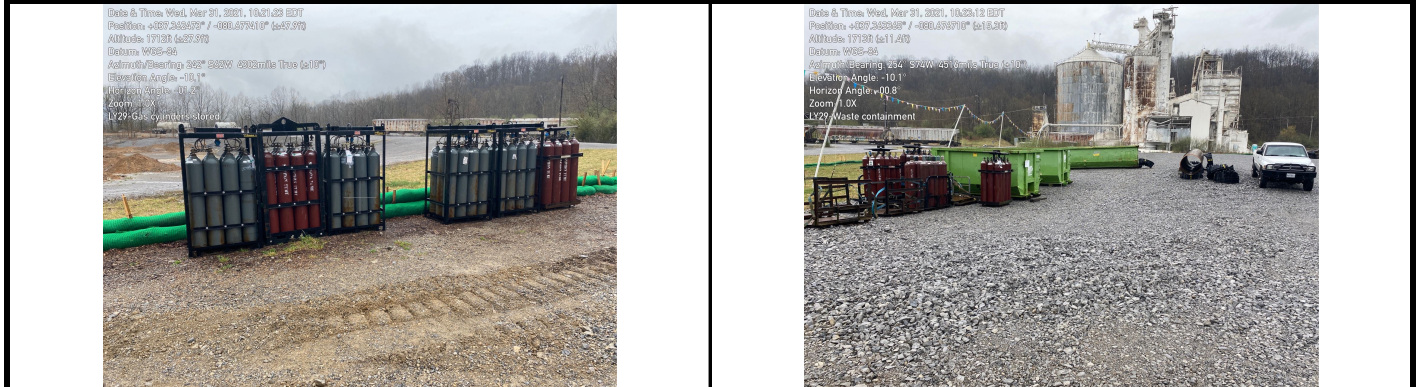
| Pic 3 Desc. LY29- Gas cylinder's storage. | Pic 4 Desc. LY29- Waste containers |

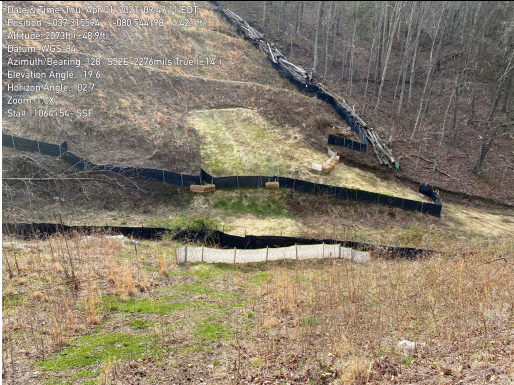
| AFE 124300137 | | Date/Time 4/1/2021 7:44 AM | | Report # | |
|---|--|---|--|---|--|
| Field Station# | | 11064+00 | | Field Station# | |

| AFE 124300137 | | Date/Time 4/1/2021 7:44 AM | | Report # | |
|---|--|---|--|---|--|
| Pic 1 Desc. | | AR-245.01 - SSF | | Pic 2 Desc. | |

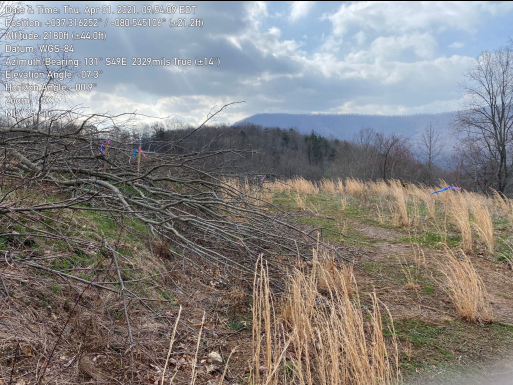
| AFE 124300137 | | Date/Time 4/1/2021 7:44 AM | | Report # | |
|---|--|---|--|---|--|
| | | | | Site for MLV 25 | |

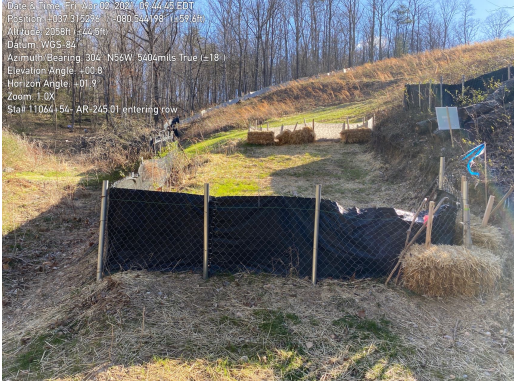
| AFE | 124300137 | Date/Time | 4/2/2021 7:50 AM | Report # | |
|---|---|---|---|---|--|
| Field Station# | 11064+54 | Field Station# | 11070+00 | | |

| AFE | 124300137 | Date/Time | 4/2/2021 7:50 AM | Report # | |
|---|---|---|---|---|--|
| Pic 1 Desc. | Row at AR-245.01- ECD's | Pic 2 Desc. | Steep slope controls. | | |

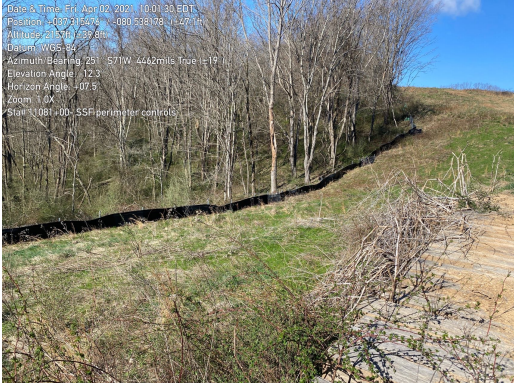
| AFE | 124300137 | Date/Time | 4/2/2021 7:50 AM | Report # | |
|---|---|---|---|---|--|
| Field Station# | 11081+00 | Field Station# | 11098+00 | | |

| AFE | 124300137 | Date/Time | 4/2/2021 7:50 AM | Report # | |
|---|---|---|---|---|--|
| Pic 3 Desc. | SSF perimeter controls | Pic 4 Desc. | Drainage feature, bridge, ECD's | | |

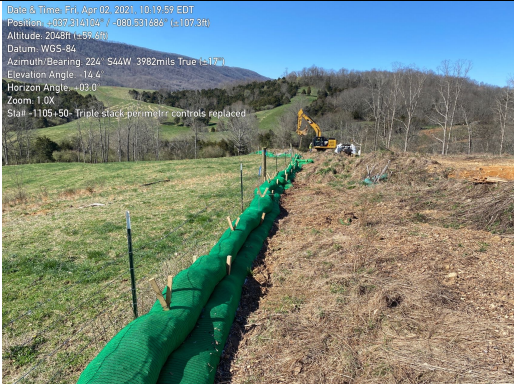
| AFE | 124300137 | Date/Time | 4/2/2021 7:50 AM | Report # | |
|---|---|---|---|---|--|
| Field Station# | 11105+00 | Field Station# | 11131+00 | | |

| AFE | 124300137 | Date/Time | 4/2/2021 7:50 AM | Report # | |
|---|---|---|---|---|--|
| <p><small>Date & Time: Fri Apr 02 2021 10:19:57 EDT Position: +037314924, -080531888, 11105.00 Altitude: 2045ft (623.5m) Datum: WGS-84 Azimuth/Bearing: 224, S44W, 398.2mils True (±16) Elevation Angle: -14.4 Horizon Angle: -03.0 Zoom: 1.0X Stall: 11105+50- Triple strip perimeter controls replaced</small></p> | | <p><small>Date & Time: Fri Apr 02 2021 10:38:36 EDT Position: +037314924, -080532914, 11131.00 Altitude: 1999ft (609.7m) Datum: WGS-84 Azimuth/Bearing: 128, S52E, 227.6mils True (±16) Elevation Angle: -12.2 Horizon Angle: +06.7 Zoom: 1.0X Stall: 11131+00- karst ECD's replaced with new materials</small></p> | | | |

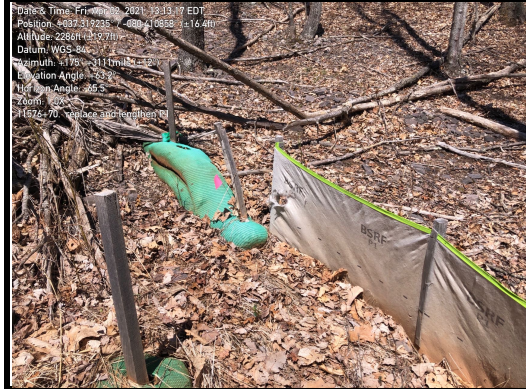
| GPS Location | On photo |

| Pic 7 Desc. | Silt fence to be replaced and lengthened. |

| E&S BMPs | Compliance Level | Corrective Action | Corrective Time Frame | Date Repaired |
|---|---|---|---|---|
| Silt Fence (Filter Fabric Fence) | Communication | Silt fence repair needed 3 locations | | |

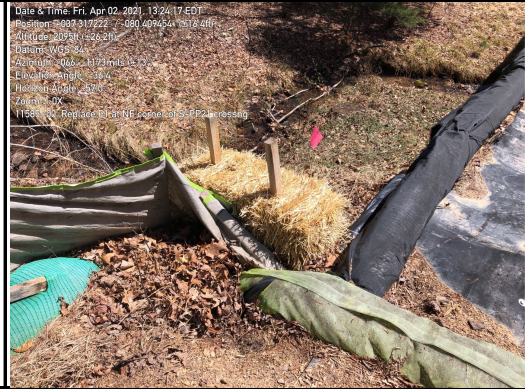
| GPS Location | On photo |

| Pic 8 Desc. | Silt fence to be repaired. |

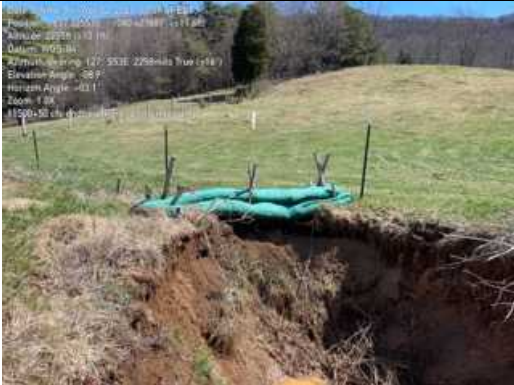
| AFE 124300137 | | Date/Time 4/2/2021 10:57 PM | | Report # | |
|---|--|---|--|---|--|
| Field Station# 11500+50 | | Field Station# 11405+00 | | | |

- ST#11305+00 end treatment needs to properly installed
- ST#11312+20 replace orange safety fence
- ST#11325+50 end treatment not functional
- ST#11512+58 end treatment needed
- ST#11500+50 CFS end treatment falling into sump
- ST#11450+94 soil overtopping CFS
- ST#11405+00 hole in P1 end treatment
- ST#11415+00 broken P1 stakes

All items have been communicated to the contractor and added to the punchlist.
 areas where crews have not yet worked have acceptable temporary stabilization.
 Bridge over stream s-kl43 is slated for repair
