Visual Site Inspection Report

Project Name H-600 Pipeline Spread H		AFE 124300138	Spread H-600 Pipeline Spread H
Contractor Precision		Report # 20048	
Inspector John Brcic		Date/Time 2/15/2021 3:58 PM	
Permit # TBD	Inspection Type VA SWPP	Station Begin 12284+75	
State VA	Inspection Area Partial	Station End 12443+75	
County Montgomery	Ground Wet	Temperature (°F) 35.00	
Municipality N/A	Weather Light Rain	Rain Gauge (in) 0.60	
Rain Accumulation Time (days)			3.00

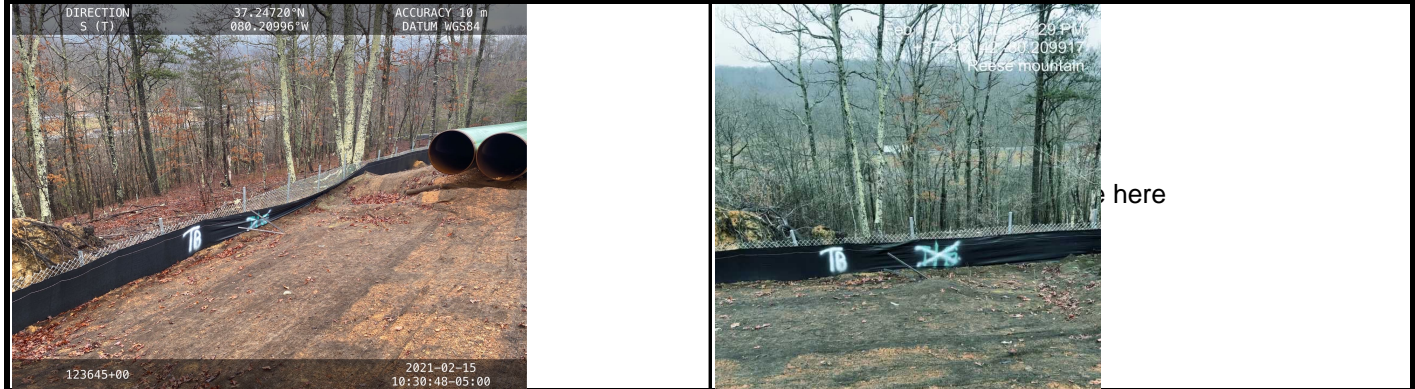
GPS Location	See photo	GPS Location	See photo
Field Station#	12365+00	Field Station#	12365+00
Pic 7 Desc.	Fabric has detached from the chain link on this super silt fence.	Pic 8 Desc.	Fabric was reattached to the chain link on this super silt fence.

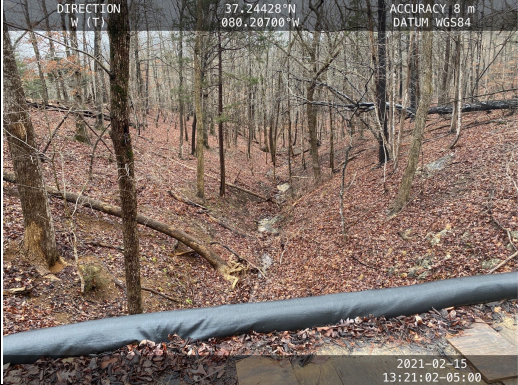
<p>DIRECTION S (T) 37.24382°N 080.20652°W ACCURACY 10 m DATUM WGS84 2021-02-15 13:23:03-05:00</p>	
GPS Location	See photo	GPS Location	See photo
Field Station#	12380+04	Field Station#	12383+00
Pic 13 Desc.	Stream S-NN19, facing west, downstream	Pic 14 Desc.	Clean water diversion channel remains stable.

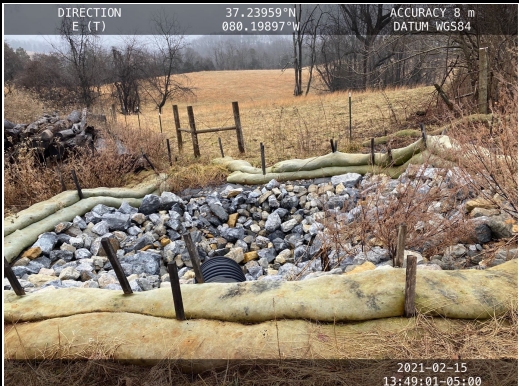
<p>DIRECTION E (T) 37.23959°N 080.19897°W ACCURACY 8 m DATUM WGS84 2021-02-15 13:49:01-05:00</p>	
GPS Location	See photo	GPS Location	See photo
Field Station#	12409+00	Field Station#	12410+50
Pic 15 Desc.	Clean water diversion pipe inlet remains in satisfactory condition.	Pic 16 Desc.	Clean water diversion pipe outlet plunge pool in good repair.

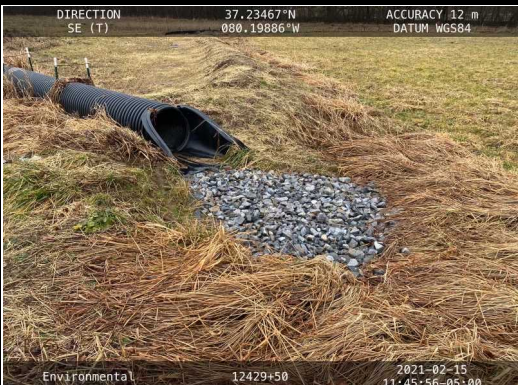
<p>DIRECTION NE (T) 37.23330°N 080.19818°W ACCURACY 5 m DATUM WGS84 Environmental 12435+50 2021-02-15 11:26:46-05:00</p>	
GPS Location	See photo	GPS Location	See photo
Field Station#	12429+50	Field Station#	12435+50
Pic 17 Desc.	This clean water diversion pipe inlet is free of sediment and functioning properly.	Pic 18 Desc.	Stream S-NN16, Roanoke River, facing northeast from Lafayette Road

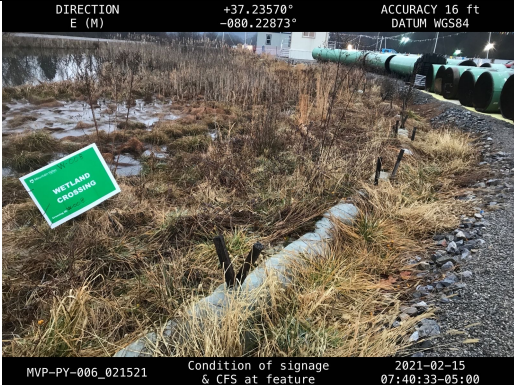
GPS Location		MVP-PY-006 See photo for gps data		GPS Location			
Field Station#		+0		Field Station#			
Pic 1 Desc.		Condition of signage and compost filter sock along south edge of feature W-008. Looking E.		Pic 2 Desc.

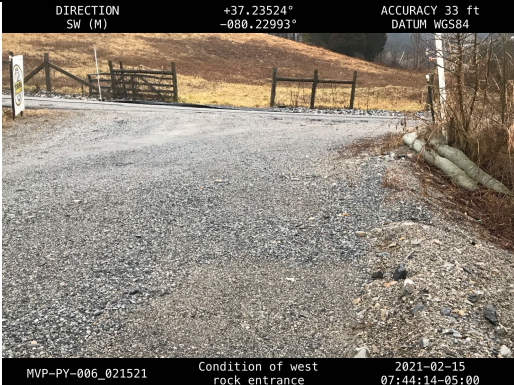
GPS Location		MVP-PY-006 See photo for gps data0		GPS Location			
Field Station#		+0		Field Station#			
Pic 3 Desc.		Condition of west rock entrance. No stone on roadway. Looking SW.		Pic 4 Desc.

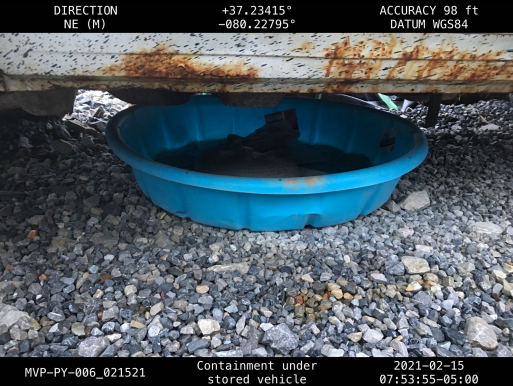
GPS Location		MVP-PY-006 See photo for gps data		GPS Location			
Field Station#		+0		Field Station#			
Pic 5 Desc.		Condition of compost filter sock along south LOD. Looking E.		Pic 6 Desc.			
				Condition of containment under stored vehicle. Looking NE.

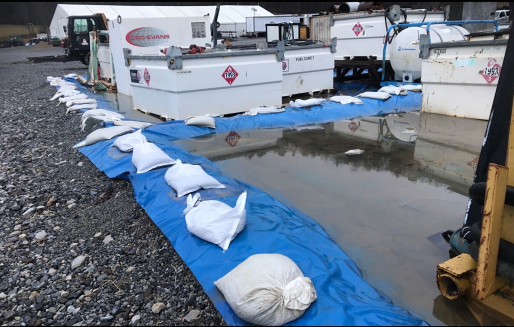
<p style="font-size: x-small;">MVP-PY-006_021521 Condition of poly containments 2021-02-15 07:57:23-05:00</p>
GPS Location MVP-PY-006 See photo for gps data	GPS Location MVP-PY-006 See photo for gps data
Field Station# +0	Field Station# +0
Pic 7 Desc. No deposits of fluids around hazardous waste dumpsters west of the mechanics building. Looking NE.	Pic 8 Desc. Condition of poly lined containments. Holding stormwater. Looking SE.
<p style="font-size: small;">DIRECTION N (M) +37.23543° ACCURACY 16 ft -080.22857° DATUM WGS84</p>

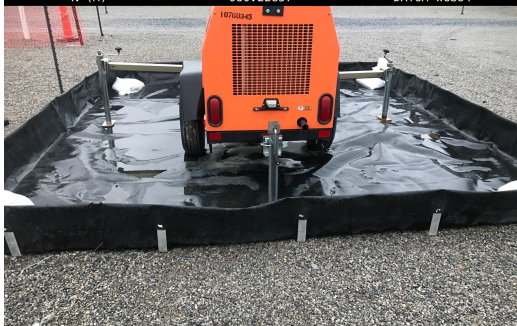
<p style="font-size: x-small;">MVP-PY-006_021521 Condition of containment 2021-02-15 07:59:20-05:00</p>	<p style="font-size: small;">DIRECTION NE (M) +37.23588° ACCURACY 213 ft -080.22721° DATUM WGS84</p>

GPS Location MVP-PY-006 See photo for gps data	GPS Location MVP-PY-006 See photo for gps data
Field Station# +0	Field Station# +0
Pic 9 Desc. Condition of containment under light plant. Looking N.	Pic 10 Desc. No fuel spills south of the Blue Bulk fuel tanks. Looking NE.
<p style="font-size: small;">DIRECTION N (M) +37.23560° ACCURACY 33 ft -080.22694° DATUM WGS84</p>

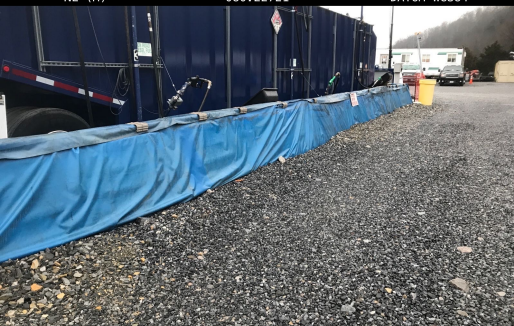
<p style="font-size: x-small;">MVP-PY-006_021521 No fuel spills south of tanks 2021-02-15 08:05:33-05:00</p>

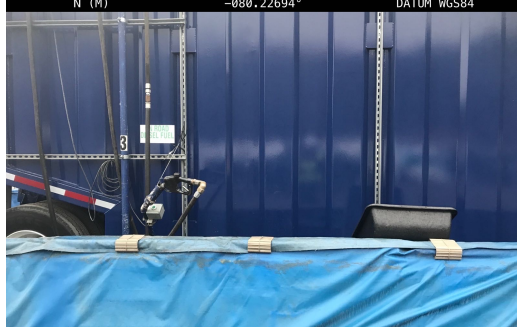
<p style="font-size: x-small;">MVP-PY-006_021521 No leaky fittings or nozzles 2021-02-15 08:05:49-05:00</p>	<p style="font-size: small;">DIRECTION SW (M) +37.23610° ACCURACY 355 ft -080.22704° DATUM WGS84</p>

<p style="font-size: x-small;">MVP-PY-006_021521 Condition of containment 2021-02-15 08:06:24-05:00</p>
GPS Location MVP-PY-006 See photo for gps data	GPS Location MVP-PY-006 See photo for gps data
Field Station# +0	Field Station# +0
Pic 11 Desc. Blue Bulk Fuel tanks no leaky fittings or nozzles. Drip pans in place. Looking N.	Pic 12 Desc. Condition of containment under DEF container. Free of stormwater. Looking SW.

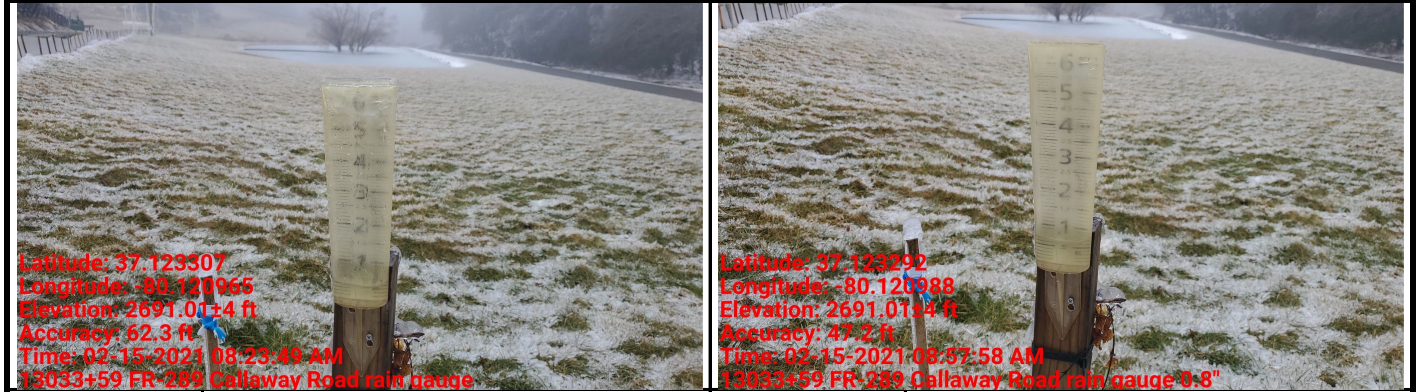
GPS Location	See pic for GPS location	GPS Location	See pic for GPS location
Field Station#	13033+59	Field Station#	13033+59
Pic 1 Desc.	Callaway Road rain gauge before melting snow and ice.	Pic 2 Desc.	Callaway Road rain gauge after melting snow and ice. 0.8"

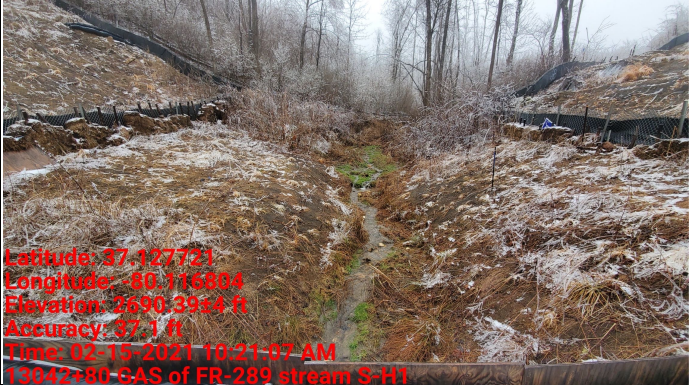
<p>Latitude: 37.127721 Longitude: -80.116804 Elevation: 2690.39±4 ft Accuracy: 37.1 ft Time: 02-15-2021 10:21:07 AM 13042+80 GAS of FR-289 stream S-H1</p>

<p>Latitude: 37.127726 Longitude: -80.116772 Elevation: 2690.39±4 ft Accuracy: 30.5 ft Time: 02-15-2021 10:23:26 AM 13043+60 GAS of FR-289 stream S-H1</p>	
GPS Location	See pic for GPS location	GPS Location	See pic for GPS location
Field Station#	13042+80	Field Station#	13043+00
Pic 7 Desc.	Upstream side of stream S-H1.	Pic 8 Desc.	Slope on the CIS of S-H1.

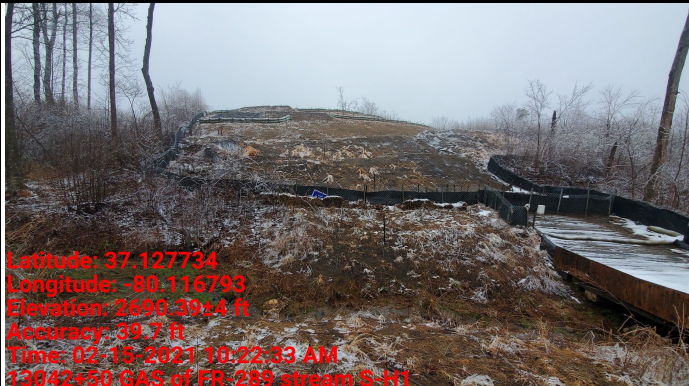
<p>Latitude: 37.127734 Longitude: -80.116793 Elevation: 2690.39±4 ft Accuracy: 39.7 ft Time: 02-15-2021 10:22:33 AM 13042+50 GAS of FR-289 stream S-H1</p>

Field Station#	13042+50	Field Station#	13027+00
Pic 9 Desc.	Slope on the GAS of S-H1.	Pic 10 Desc.	Waterbars and curlexed slope on the GAS of streams S-G24 and S-G25.

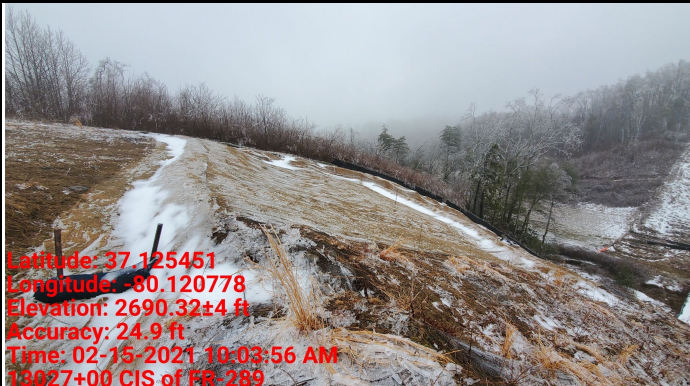
<p>Latitude: 37.125451 Longitude: -80.120778 Elevation: 2690.32±4 ft Accuracy: 24.9 ft Time: 02-15-2021 10:03:56 AM 13027+00 CIS of FR-289</p>	
GPS Location	See pic for GPS location	GPS Location	See pic for GPS location

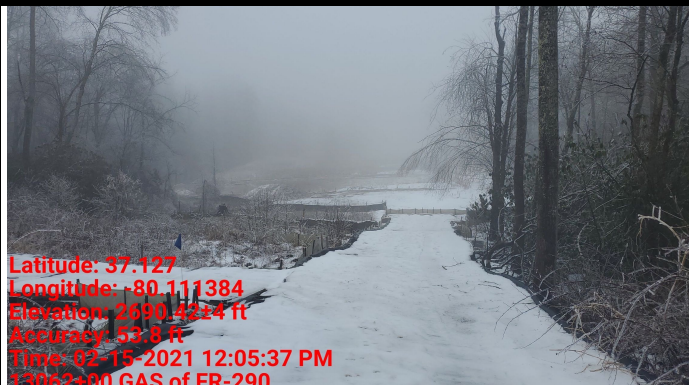
<p>Latitude: 37.127 Longitude: -80.111384 Elevation: 2690.42±4 ft Accuracy: 53.8 ft Time: 02-15-2021 12:05:37 PM 13062+80 GAS of FR-290</p>

<p>Latitude: 37.126972 Longitude: -80.111729 Elevation: 2690.42±4 ft Accuracy: 43.6 ft Time: 02-15-2021 12:06:25 PM 13063+00 GAS of FR-290</p>	
GPS Location	See pic for GPS location	GPS Location	See pic for GPS location
Field Station#	13062+00	Field Station#	13063+00
Pic 11 Desc.	Equipment bridge and the GAS of FR-290.	Pic 12 Desc.	Equipment bridge and the CIS of FR-290.

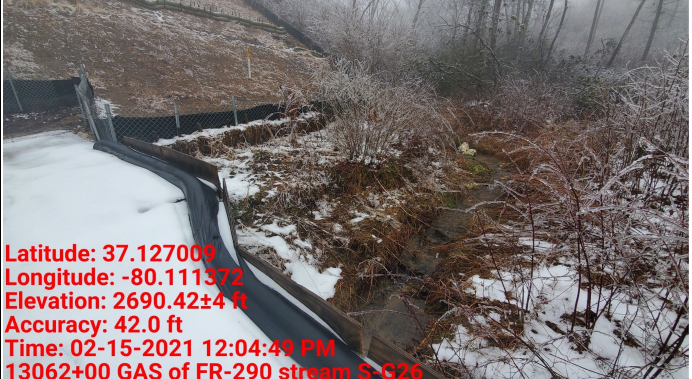
<p>Latitude: 37.127009 Longitude: -80.111372 Elevation: 2690.42±4 ft Accuracy: 42.0 ft Time: 02-15-2021 12:04:49 PM 13062+00 GAS of FR-290 stream S-G26</p>

<p>Latitude: 37.126983 Longitude: -80.111348 Elevation: 2690.42±4 ft Accuracy: 34.8 ft Time: 02-15-2021 12:06:52 PM 13063+00 GAS of FR-290 stream S-G27</p>		
GPS Location	See pic for GPS location		GPS Location	See pic for GPS location	
Field Station#	13062+00		Field Station#	13063+00	
Pic 13 Desc.	Upstream side of stream S-G26.		Pic 14 Desc.	Upstream side of stream S-G27.

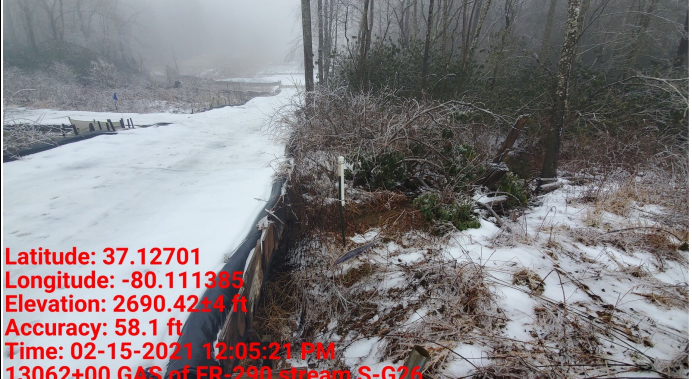
<p>Latitude: 37.12701 Longitude: -80.111385 Elevation: 2690.42±4 ft Accuracy: 58.1 ft Time: 02-15-2021 12:05:21 PM 13062+00 GAS of FR-290 stream S-G26</p>

GPS Location	See pic for GPS location		GPS Location	See pic for GPS location	
Field Station#	13062+00		Field Station#	13063+00	
Pic 15 Desc.	Downstream side of stream S-G26.		Pic 16 Desc.	Downstream side of stream S-G27.

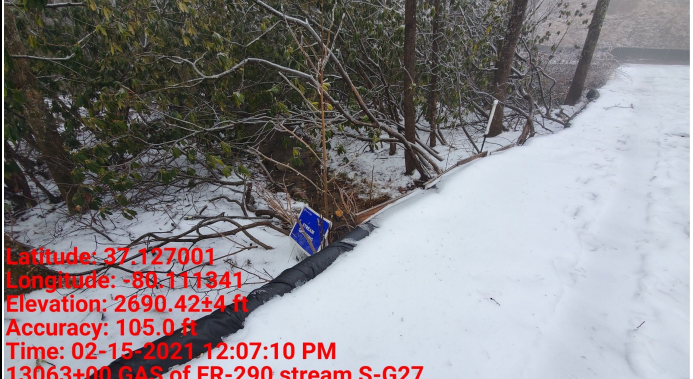
<p>Latitude: 37.127001 Longitude: -80.111341 Elevation: 2690.42±4 ft Accuracy: 105.0 ft Time: 02-15-2021 12:07:10 PM 13063+00 GAS of FR-290 stream S-G27</p>

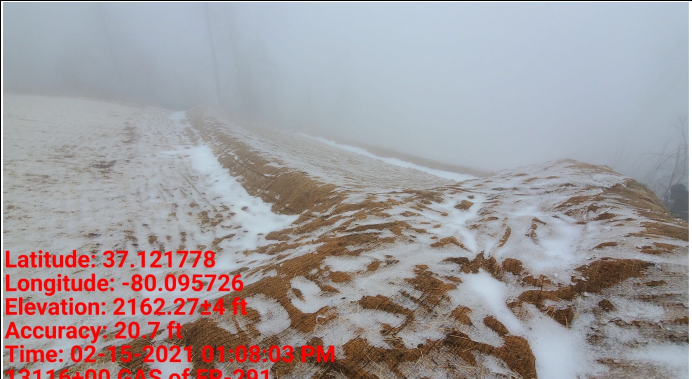
<p>Latitude: 37.121778 Longitude: -80.095726 Elevation: 2162.27±4 ft Accuracy: 20.7 ft Time: 02-15-2021 01:08:03 PM 13116+00 GAS of FR-291</p>

<p>Latitude: 37.121792 Longitude: -80.0957 Elevation: 2162.27±4 ft Accuracy: 67.6 ft Time: 02-15-2021 01:08:29 PM 13116+00 GAS of FR-291</p>		
GPS Location	See pic for GPS location		GPS Location	See pic for GPS location	
Field Station#	13116+00		Field Station#	13116+00	
Pic 17 Desc.	Curlexed ROW on the GAS of FR-291.		Pic 18 Desc.	CIS of FR-291.

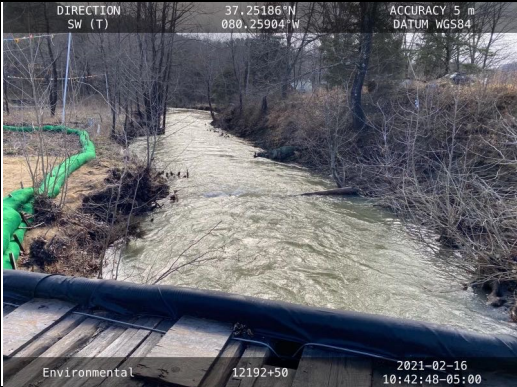
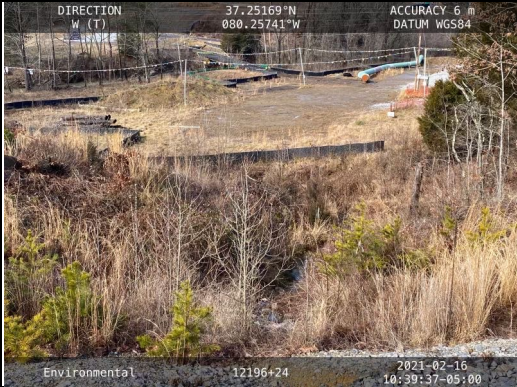
GPS Location	See photo	GPS Location	See photo
Field Station#	12192+50	Field Station#	12196+24
Pic 13 Desc.	Stream S-C21, Bradshaw Creek, facing southwest, downstream	Pic 14 Desc.	Stream S-OO11, facing west, downstream

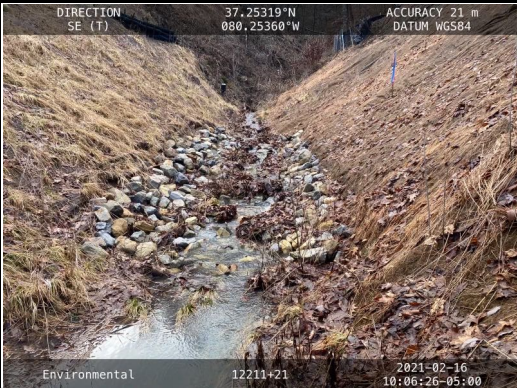
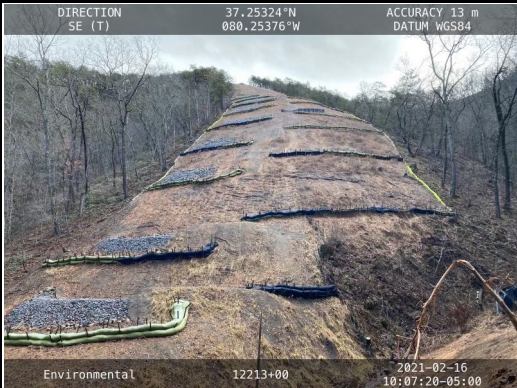
GPS Location	See photo	GPS Location	See photo
Field Station#	12211+21	Field Station#	12213+00
Pic 15 Desc.	Rock lined channel at the bottom of the ravine between Bradshaw Road and Reese Mt effectively preventing scour in drainage.	Pic 16 Desc.	The permanent restoration between Bradshaw Road and the switchback on Reese Mt remains stable.

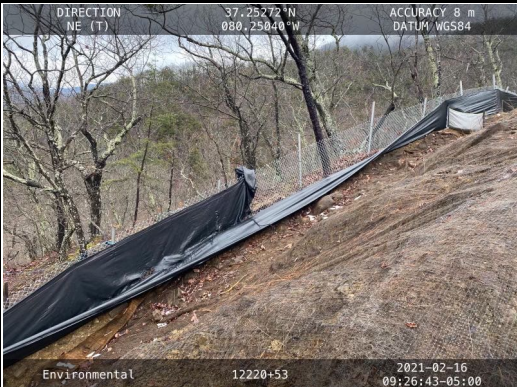
GPS Location	See photo	GPS Location	See photo
Field Station#	12220+53	Field Station#	12220+53
Pic 17 Desc.	Fabric detached from chain link on SSF.	Pic 18 Desc.	Fabric reattached to chain link on SSF.

E&S BMPs	Compliance Level	Corrective Action	Corrective Time Frame	Date Repaired
Silt Fence (Reinforced Filter Fabric Fence)	Communication	12220+53: reattach fabric on SSF	Addressed	2/16/2021
Silt Fence (Reinforced Filter Fabric Fence)	Communication	12132+00: reattach fabric on SSF	Addressed	2/16/2021
Compost Filter Sock	Acceptable			
Silt Fence (Filter Fabric Fence)	Acceptable			
Sensitive Resource Buffer	Acceptable			
Equipment Bridge	Acceptable			
Waterbar	Acceptable			
Sediment Trap	Acceptable			
Cleanwater Diversion Pipe	Acceptable

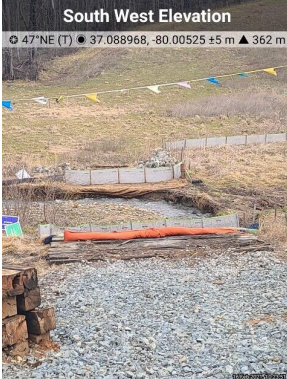
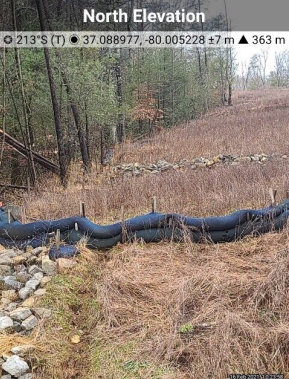
<p>North Elevation 213°S (T) ● 37.088977, -80.005228 +7 m ▲ 363 m</p>	
GPS Location	00000		GPS Location	00000	
Field Station#	13498+00		Field Station#	13496+76	
Pic 1 Desc.	Observed stream crossing where mats were removed during maintenance repairs where bridge had to be removed , ECDs functioning , no environmental issues observed at the time		Pic 2 Desc.	Monitored ECDs and rock lined channel at road crossing , all ECDs functioning after recent rain events. No environmental issues observed at the time of inspection

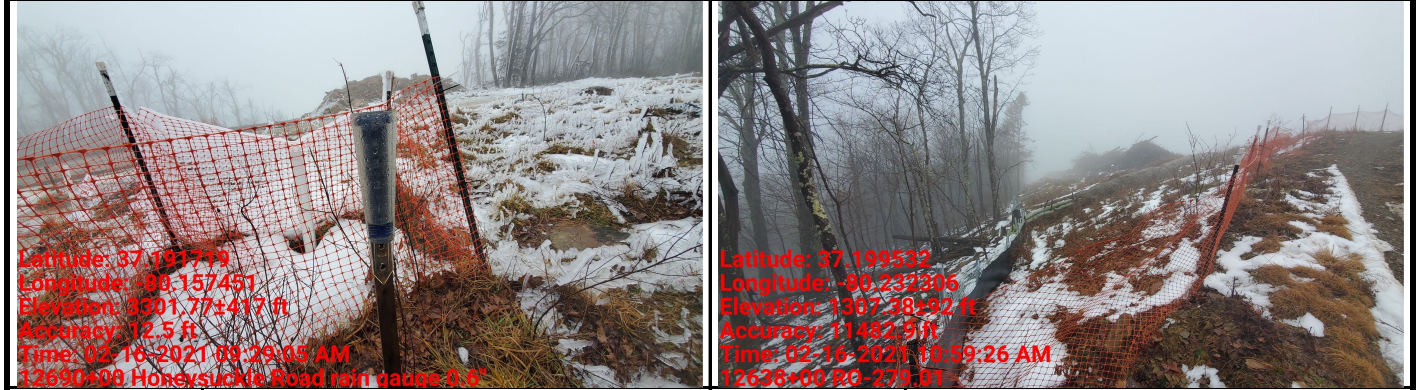
GPS Location	See pic for GPS location	GPS Location	See pic for GPS location
Field Station#	12690+00	Field Station#	12638+00
Pic 1 Desc.	0.6" total precipitation at Honeysuckle Road.	Pic 2 Desc.	GAS of access RO-279.01

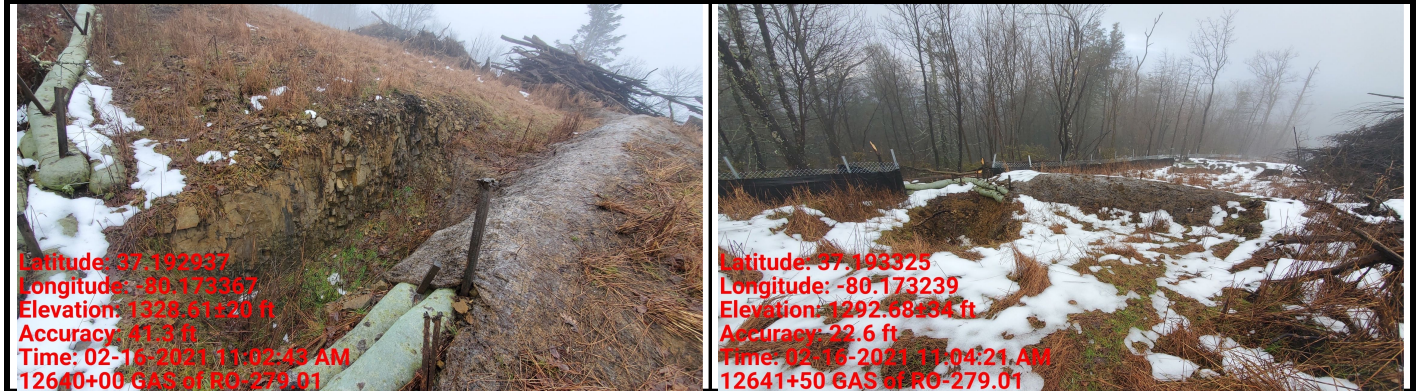
GPS Location	See pic for GPS location	GPS Location	See pic for GPS location
Field Station#	12640+00	Field Station#	12641+50
Pic 3 Desc.	Waterbars, sumps and end treatments remain in compliance.	Pic 4 Desc.	Waterbars, sumps and end treatments remain in compliance.

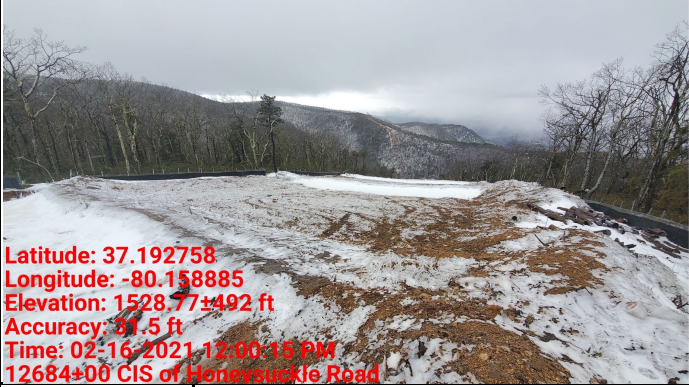
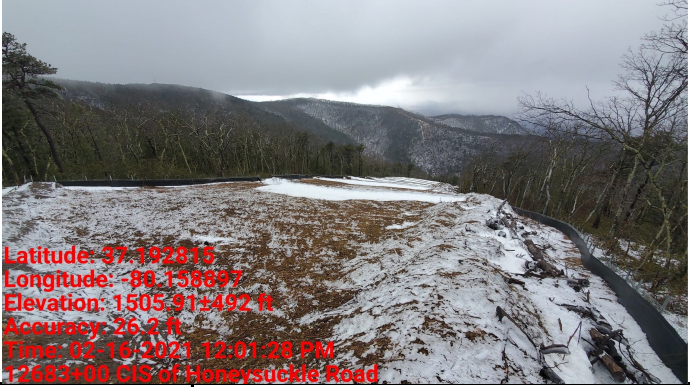
<p>Latitude: 37.192816 Longitude: -80.158897 Elevation: 1505.91±492 ft Accuracy: 26.2 ft Time: 02-16-2021 12:01:28 PM 12683+00 CIS of Honeysuckle Road</p>	
GPS Location	See pic for GPS location	GPS Location	See pic for GPS location
Field Station#	12684+00	Field Station#	12683+00
Pic 7 Desc.	Current ROW conditions on the CIS of Honeysuckle Road.	Pic 8 Desc.	Current ROW conditions on the GAS of RO-279.01.

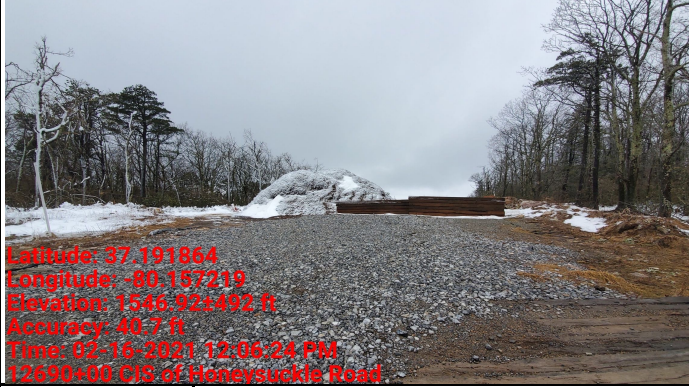
GPS Location	See pic for GPS location	GPS Location	See pic for GPS location
Field Station#	12690+00	Field Station#	12691+00
Pic 9 Desc.	RCE on the CIS of Honeysuckle Road.	Pic 10 Desc.	GAS of the Honeysuckle Road crossing.

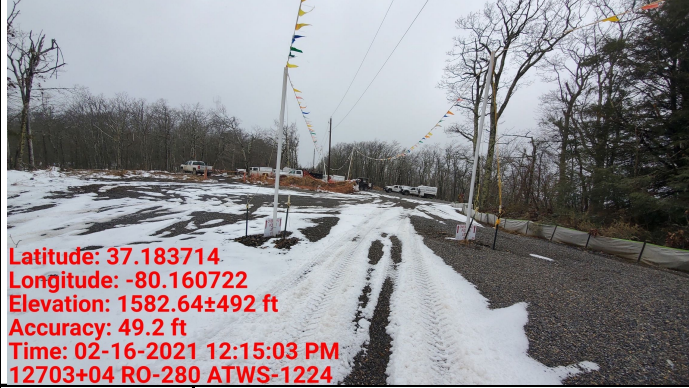
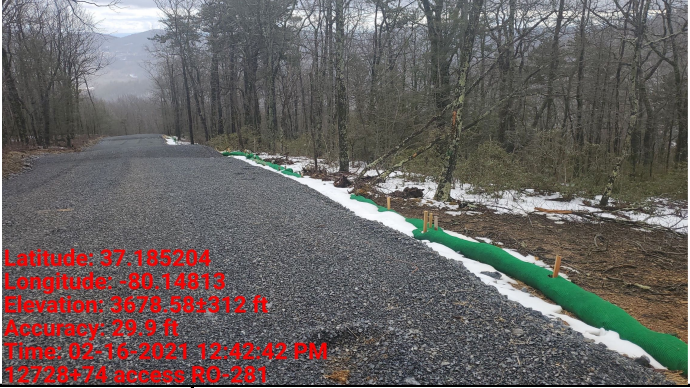
<p>Latitude: 37.185204 Longitude: -80.14813 Elevation: 3678.58±312 ft Accuracy: 29.9 ft Time: 02-16-2021 12:42:43 PM 12728+74 access RO-281</p>	
GPS Location	See pic for GPS location	GPS Location	See pic for GPS location
Field Station#	12703+04	Field Station#	12728+74
Pic 11 Desc.	ATWS at RO-280 remains in acceptable condition.	Pic 12 Desc.	Access road RO-281 current condition.

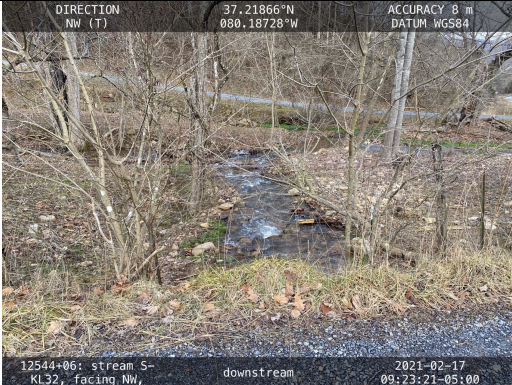
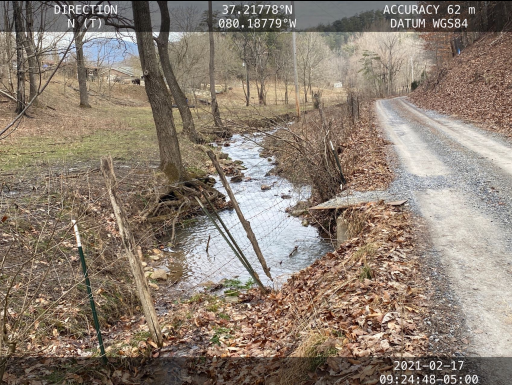
GPS Location See photo		GPS Location See photo			
Field Station# 12544+06		Field Station# 12544+06			
Pic 1 Desc. Stream S-KL32, facing northwest, downstream from Yellow Finch Lane		Pic 2 Desc. Stream S-EF20b, facing north, downstream from Yellow Finch Lane

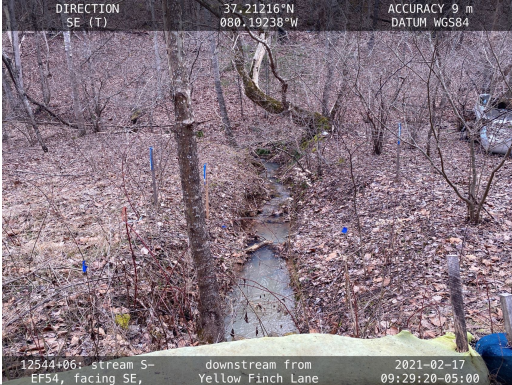
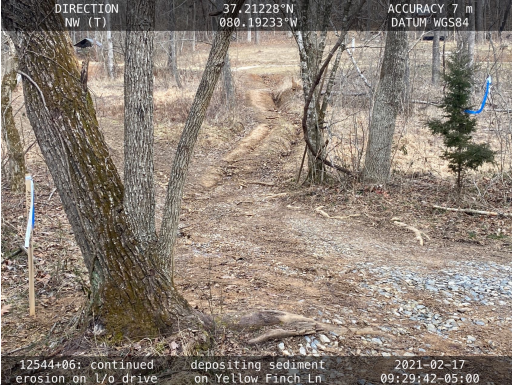
GPS Location See photo		GPS Location See photo			
Field Station# 12544+06		Field Station# 12544+06			
Pic 3 Desc. Stream S-EF54, facing southeast, downstream from Yellow Finch Lane.		Pic 4 Desc. Significant erosion observed in landowner driveway uphill from Yellow Finch Lane.

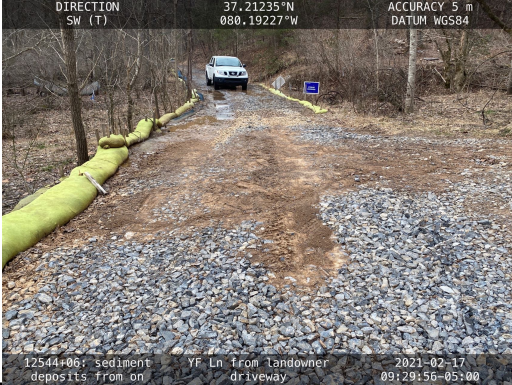
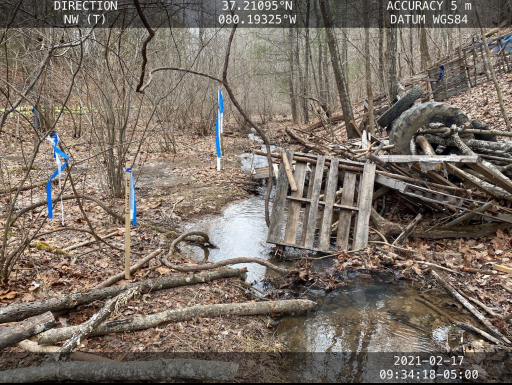
GPS Location See photo		GPS Location See photo			
Field Station# 12544+06		Field Station# 12544+54			
Pic 5 Desc. Sediment deposits in Yellow Finch Lane where it has washed out of landowner's driveway.		Pic 6 Desc. Stream S-EF20a, facing northwest, downstream

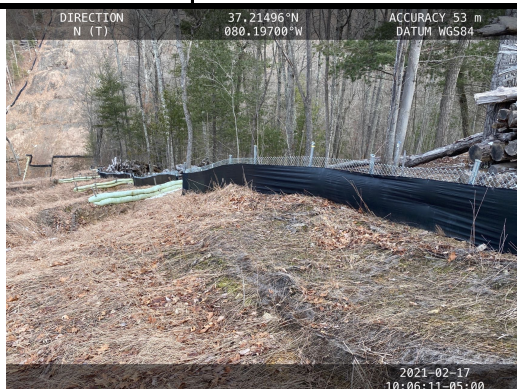
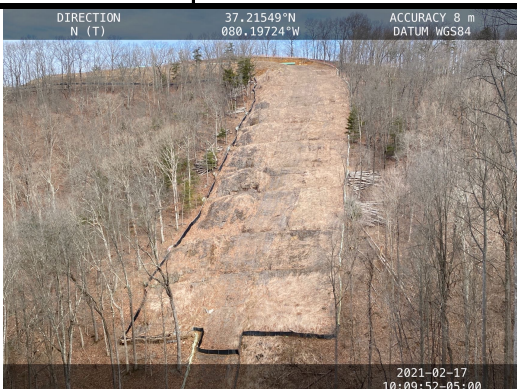
<p>DIRECTION N (T) 37.21549°N 080.19724°W ACCURACY 8 m DATUM WGS84</p> <p>2021-02-17 10:09:52-05:00</p>	
GPS Location	See photo	GPS Location	See photo
Field Station#	12524+00	Field Station#	12517+00
Pic 11 Desc.	Perimeter controls in satisfactory condition on slopes on both sides of stream S-EF19.	Pic 12 Desc.	Slope stable on coming in side of stream S-EF19.

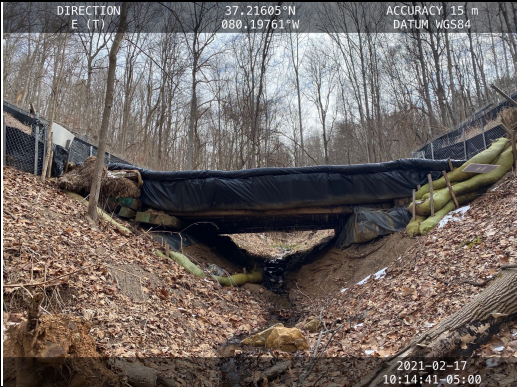
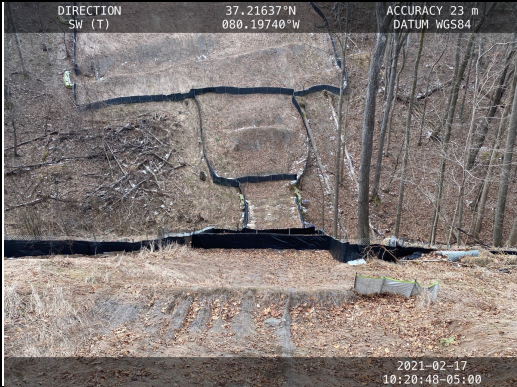
<p>DIRECTION SW (T) 37.21637°N 080.19740°W ACCURACY 23 m DATUM WGS84 2021-02-17 10:20:48-05:00</p>	
GPS Location	See photo	GPS Location	See photo
Field Station#	12119+41	Field Station#	12519+41
Pic 13 Desc.	Stream S-EF19, facing east, upstream	Pic 14 Desc.	Bridge, buffer zone and ECDs in satisfactory condition at stream S-EF19.

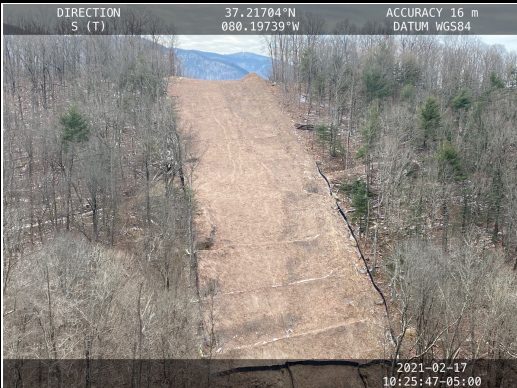
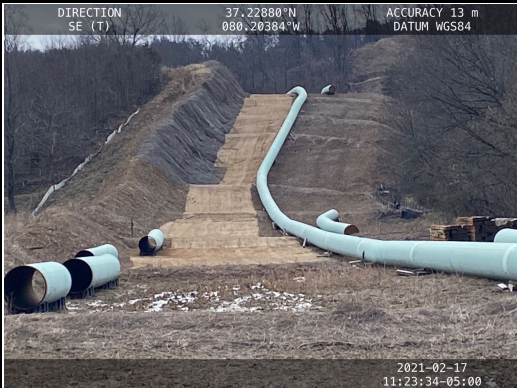
<p>DIRECTION SE (T) 37.22880°N 080.20384°W ACCURACY 13 m DATUM WGS84 2021-02-17 11:23:34-05:00</p>	
GPS Location	See photo	GPS Location	See photo
Field Station#	12523+00	Field Station#	12470+00
Pic 15 Desc.	Slope stable on going away side of stream S-EF19.	Pic 16 Desc.	ROW and stockpiles stable.

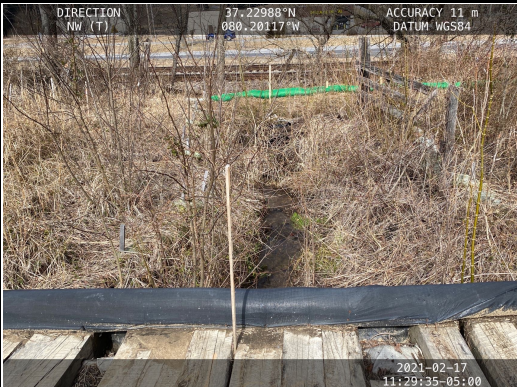
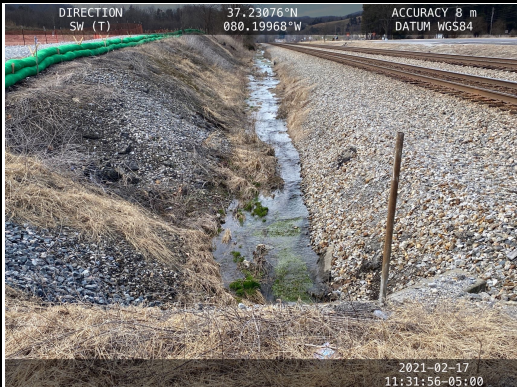
GPS Location	See photo	GPS Location	See photo
Field Station#	12455+21	Field Station#	12444+94
Pic 17 Desc.	Stream S-CD12, facing northwest, downstream	Pic 18 Desc.	Stream S-I1, facing southwest, upstream

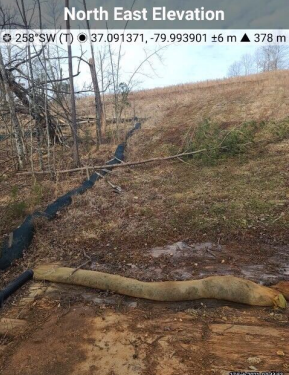
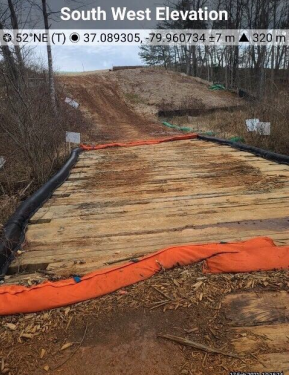
Throughout today's inspections the EI noticed a downed tree across the CFS , damage was done to the CFS , documented and sent in to be addressed by the contractor with time limit for removal.

<p>South West Elevation 52°NE (T) ● 37.089305, -79.960734 ±7 m ▲ 320 m</p>		
GPS Location	0000		GPS Location	0000	
Field Station#	13533+00		Field Station#	13659+00	
Pic 1 Desc.	Throughout the EI's travel today the EI noticed a downed tree across the CFS , Documented to add to the punch list to be removed, no damage, no time limit for removal.		Pic 2 Desc.	Monitored equipment bridge and protection as well as ECDs at stream crossing, o environmental issues observed at the time of inspection.

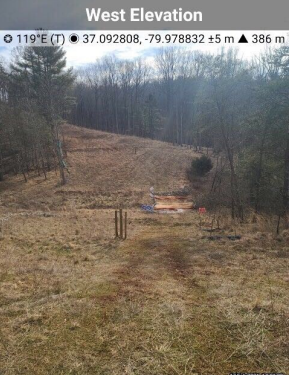
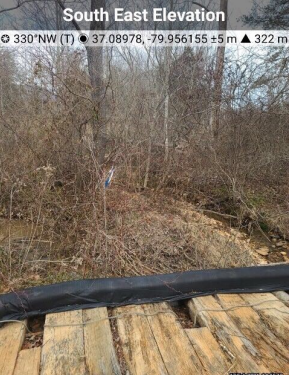
<p>South East Elevation 330°NW (T) ● 37.08978, -79.956155 ±5 m ▲ 322 m</p>		
GPS Location	0000		GPS Location	00000	
Field Station#	13579+25		Field Station#	13659+03	
Pic 3 Desc.	Row photo taken by the EI showing vegetation. Good stabilization at time of inspection.		Pic 4 Desc.	Stream observation photo facing upstream during routine inspection today.

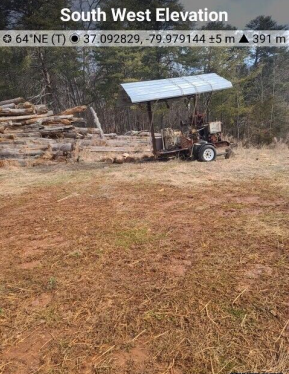
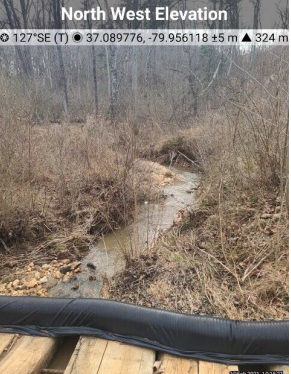
<p>North West Elevation 127°SE (T) ● 37.089776, -79.956118 ±5 m ▲ 324 m</p>		
GPS Location	00000		GPS Location	0000	
Field Station#	13576+25		Field Station#	13659+03	
Pic 5 Desc.	EI noticed where a land owner set up a wood splitter on row , checked for Amy any environmental issues, no issues observed at the time of inspection. will continue to monitor		Pic 6 Desc.	Stream observation photo facing downstream during routine inspection today, no environmental issues observed.

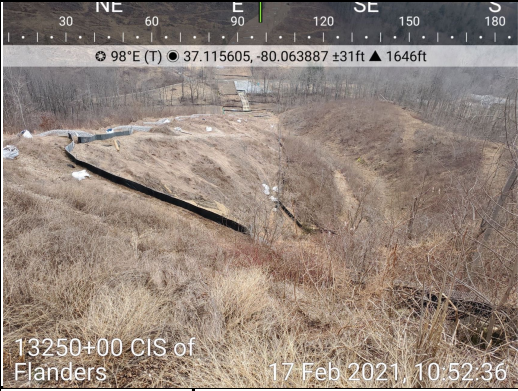
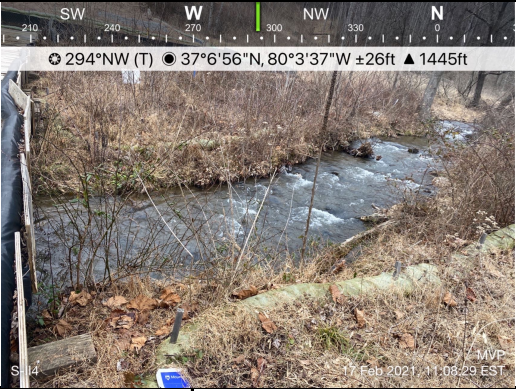
GPS Location	See photo for coordinates.		GPS Location	See photo for coordinates.	
Field Station#	13250+00		Field Station#	13260+60	
Pic 13 Desc.	ROW stable with acceptable vegetative coverage and curlex along steep slope.		Pic 14 Desc.	S-II4, upstream, water level up, slight turbidity noted, no ROW impacts observed.

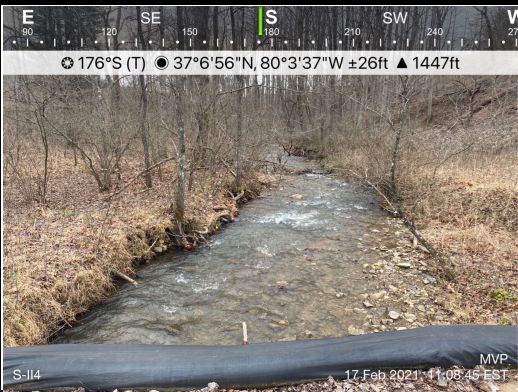
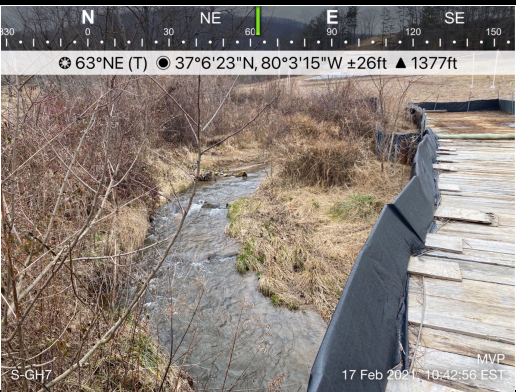
GPS Location	See photo for coordinates.		GPS Location	See photo for coordinates.	
Field Station#	13260+60		Field Station#	13309+09	
Pic 15 Desc.	S-II4, downstream, no changes noted to stream bed or banks, water moving swiftly.		Pic 16 Desc.	S-GH7, upstream, water level up, slight turbidity observed, no ROW impacts observed.

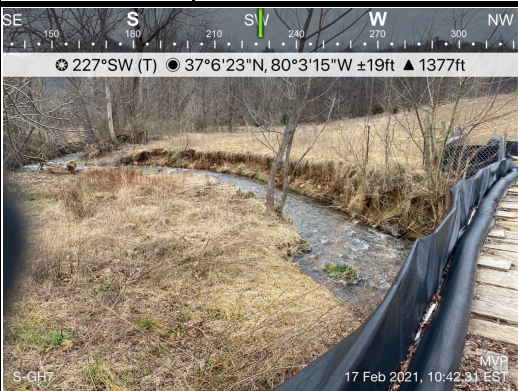
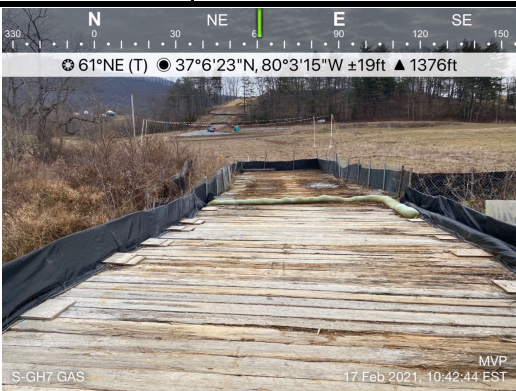
GPS Location	See photo for coordinates.		GPS Location	See photo for coordinates.	
Field Station#	13309+09		Field Station#	13309+09	
Pic 17 Desc.	S-GH7, downstream, no changes noted to stream bed or banks.		Pic 18 Desc.	Bridge across S-GH7 in good condition, perimeter ECDs functioning acceptably.

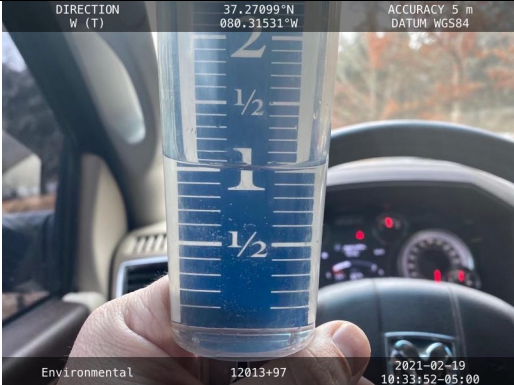
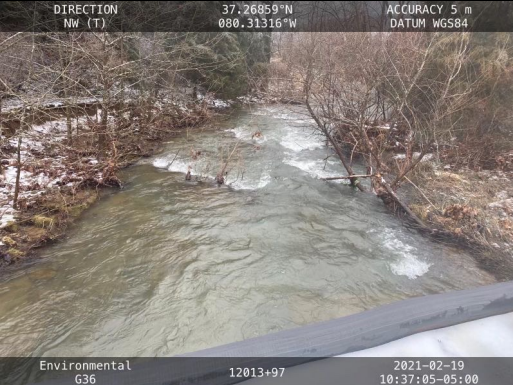
GPS Location See photo Field Station# 12013+97 Pic 1 Desc. 1.0 inches of precipitation at Catawba.			GPS Location See photo Field Station# 12013+97 Pic 2 Desc. Stream S-G36 on access road MVP-MN-268.01, facing northwest, downstream

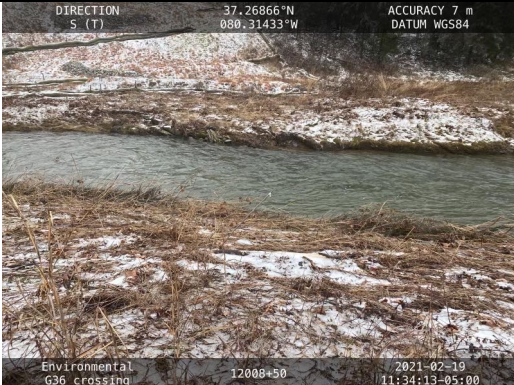
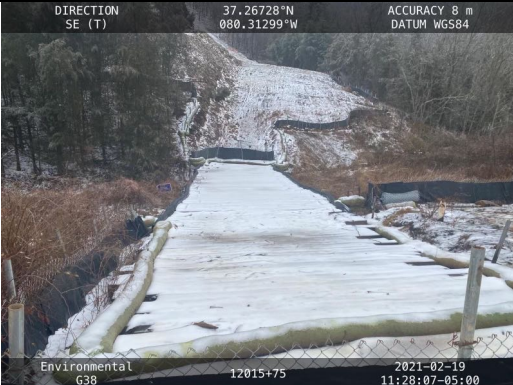
GPS Location See photo Field Station# 12008+50 Pic 3 Desc. Stream S-G36, facing south			GPS Location See photo Field Station# 12015+75 Pic 4 Desc. Stream S-G38, facing southeast

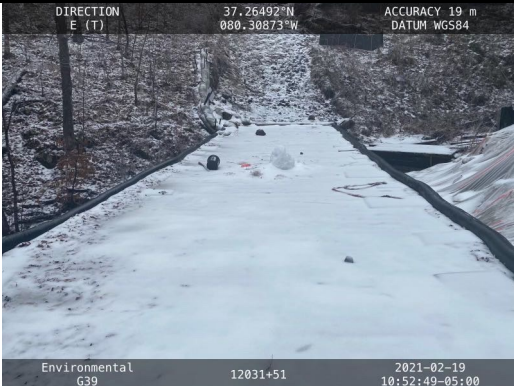
GPS Location See photo Field Station# 12031+51 Pic 5 Desc. Bridge in satisfactory condition over stream S-G38.			GPS Location See photo Field Station# 12069+00 Pic 6 Desc. Slope on coming in side of access road MVP-MN-270 remains stable.

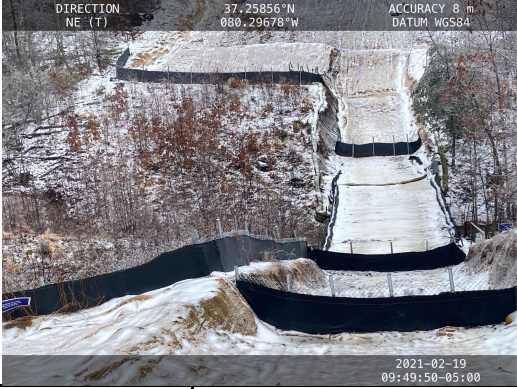
<p>DIRECTION NE (T) 37.25878°N 080.29342°W ACCURACY 11 m DATUM WGS84 2021-02-19 10:04:34-05:00</p>	
GPS Location	See photo	GPS Location	See photo
Field Station#	12076+95	Field Station#	12086+56
Pic 7 Desc.	Bridge, buffer zone, and ECDs in satisfactory condition at stream S-MM15.	Pic 8 Desc.	Bridge, buffer zone and ECDs in satisfactory condition at stream S-MM14.

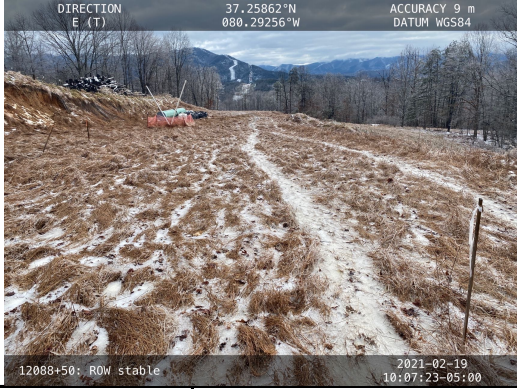
<p>DIRECTION S (T) 37.25830°N 080.29110°W ACCURACY 8 m DATUM WGS84 2021-02-19 10:10:30-05:00</p>	
GPS Location	See photo	GPS Location	See photo
Field Station#	12088+50	Field Station#	12193+00
Pic 9 Desc.	ROW stable.	Pic 10 Desc.	Clean water diversion pipe and outlet in satisfactory condition.

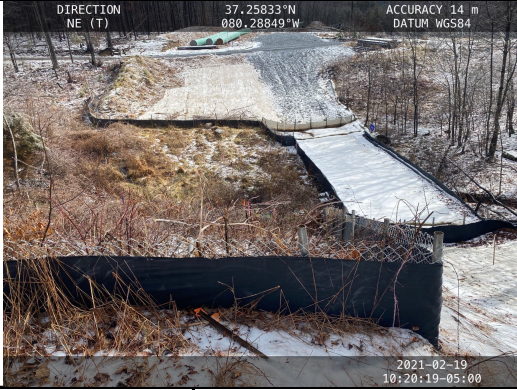
<p>DIRECTION NE (T) 37.25833°N 080.28849°W ACCURACY 14 m DATUM WGS84 2021-02-19 10:20:19-05:00</p>	
GPS Location	See photo	GPS Location	See photo
Field Station#	12098+44	Field Station#	12101+57
Pic 11 Desc.	Stream S-MM13, facing southeast, downstream	Pic 12 Desc.	Bridge, buffer zone and ECDs in satisfactory condition at stream S-MM11.

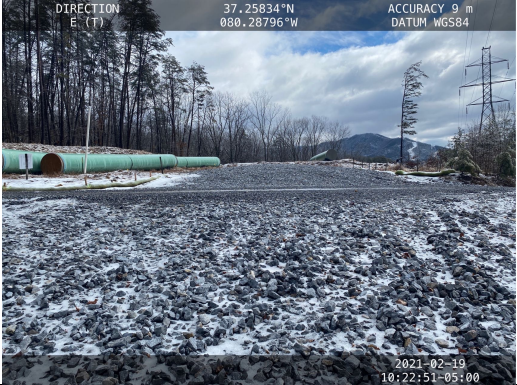
<p>DIRECTION E (T) 37.25834°N 080.28796°W ACCURACY 9 m DATUM WGS84 2021-02-19 10:22:51-05:00</p>	
GPS Location	See photo	GPS Location	See photo
Field Station#	12101+57	Field Station#	12102+69
Pic 13 Desc.	Stream S-MM11, facing south, downstream	Pic 14 Desc.	RCEs in good repair on both sides of Half Acre Rock Road, MVP-MN-270.01.

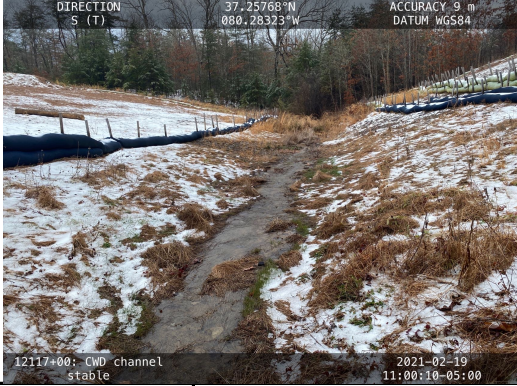
<p>DIRECTION S (T) 37.25768°N 080.28323°W ACCURACY 9 m DATUM WGS84 12117+00: CWD channel stable 2021-02-19 11:00:10-05:00</p>	
GPS Location	See photo	GPS Location	See photo
Field Station#	12112+13	Field Station#	12117+00
Pic 17 Desc.	Stream S-F16, facing south, downstream	Pic 18 Desc.	Clean water diversion channel remains stable on coming in side of Flatwoods Road.

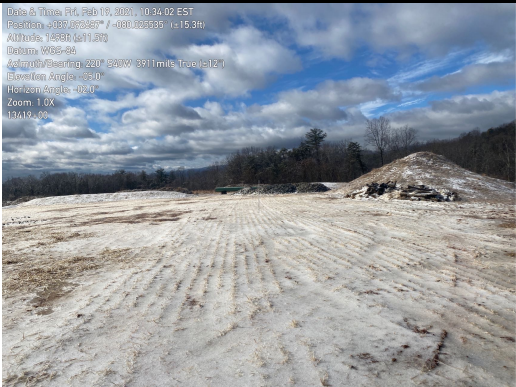
GPS Location	See photo for coordinates.	GPS Location	See photo for coordinates.
Field Station#	13419+00	Field Station#	13422+00	Pic 1 Desc.	ATWS-1351, workspace and ROW stable.	Pic 2 Desc.	Sump walls repaired, new outlet protection installed, additional checks added in drainage areas.

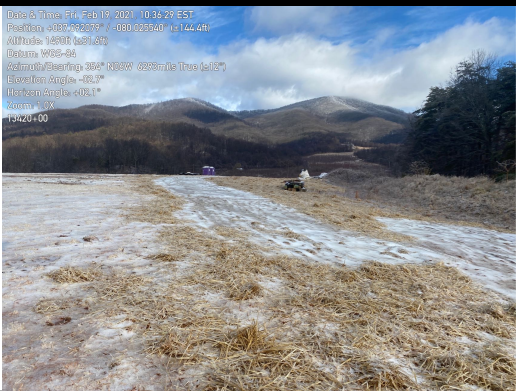
GPS Location	See photo for coordinates.	GPS Location	See photo for coordinates.
Field Station#	13421+00	Field Station#	13317+02	Pic 3 Desc.	ATWS-1351, workspace stabilized.	Pic 4 Desc.	Private driveway on the GAS of Wades Gap road crossing, no environmental concerns noted.

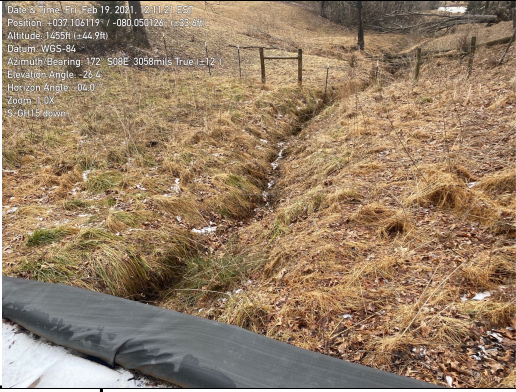
GPS Location	See photo for coordinates.	GPS Location	See photo for coordinates.
Field Station#	13321+47	Field Station#	13321+47	Pic 5 Desc.	S-GH15, downstream of equipment bridge, banks well vegetated and appeared stable, water flowing clear.	Pic 6 Desc.	S-GH15, upstream of equipment bridge, banks appeared stable, perimeter ECDs in acceptable condition.

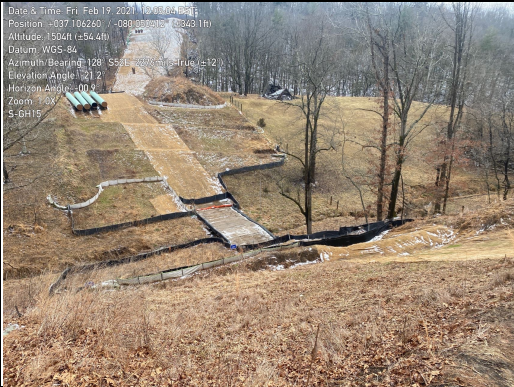
Pic 7 Desc. S-GH15, ROW stable, perimeter controls in acceptable condition, waterbars functioning acceptably.

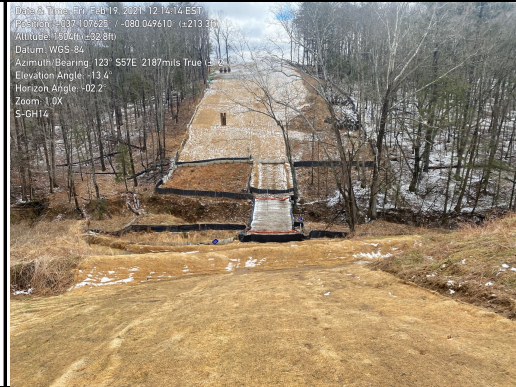
Pic 8 Desc. S-GH14, ROW stable, perimeter controls in acceptable condition, waterbars functioning acceptably.

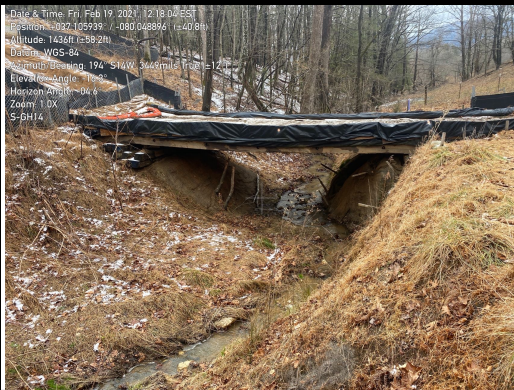
Pic 9 Desc. S-GH14, looking downstream upstream of equipment bridge, banks appeared stable, no changes noted at crossing.

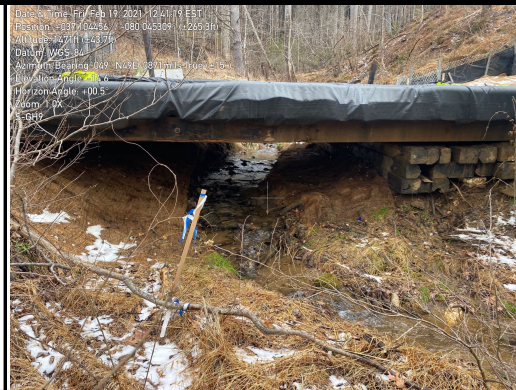
Pic 10 Desc. S-GH9, downstream of equipment bridge, stream banks stable and no observable turbidity noted in water.

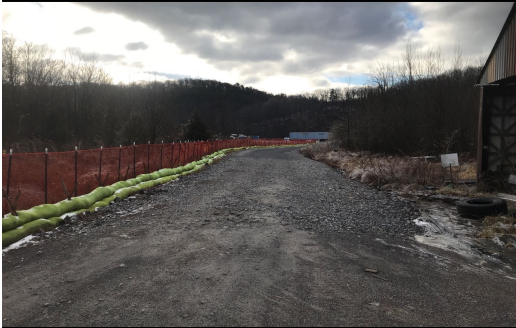
<p>DIRECTION S (M) +37.27542° -080.11675° ACCURACY 0.96 mi DATUM WGS84</p> <p>MVP-LY-049_021921 Condition of rock entrance 2021-02-19 08:45:21-05:00</p>

<p>DIRECTION S (M) +37.27095° -080.12218° ACCURACY 16 ft DATUM WGS84</p> <p>MVP-LY-049_021921 Condition of containment 2021-02-19 08:52:56-05:00</p>		
	GPS Location MVP-LY-049 See photo for gps data		GPS Location MVP-LY-049 See photo for gps data		
Field Station# +0	Field Station# +0				
Pic 1 Desc. Condition of rock entrance on center drive. Looking S.	Pic 2 Desc. Condition of containment under light plant. Looking S.
