Visual Site Inspection Report

Project Name H-600 Pipeline Spread H		AFE 124300138	Spread H-600 Pipeline Spread H
Contractor Precision		Report # 20048	
Inspector John Brcic		Date/Time 2/15/2021 3:58 PM	
Permit # TBD	Inspection Type VA SWPP	Station Begin 12284+75	
State VA	Inspection Area Partial	Station End 12443+75	
County Montgomery	Ground Wet	Temperature (°F) 35.00	
Municipality N/A	Weather Light Rain	Rain Gauge (in) 0.60	
Rain Accumulation Time (days)			3.00

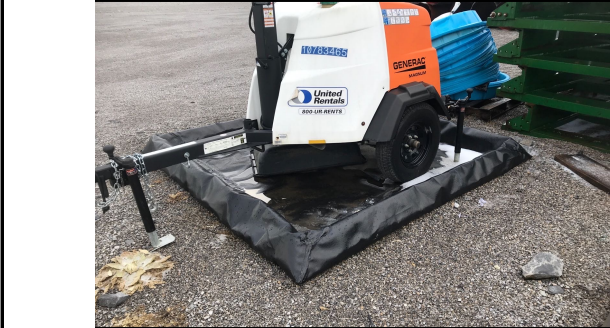
<p>DIRECTION S (M) +37.27095° -080.12218° ACCURACY 16 ft DATUM WGS84</p> <p>MVP-LY-049_021921 Condition of containment 2021-02-19 08:52:56-05:00</p>		
	GPS Location MVP-LY-049 See photo for gps data		GPS Location MVP-LY-049 See photo for gps data		
Field Station# +0	Field Station# +0				
Pic 1 Desc. Condition of rock entrance on center drive. Looking S.	Pic 2 Desc. Condition of containment under light plant. Looking S.

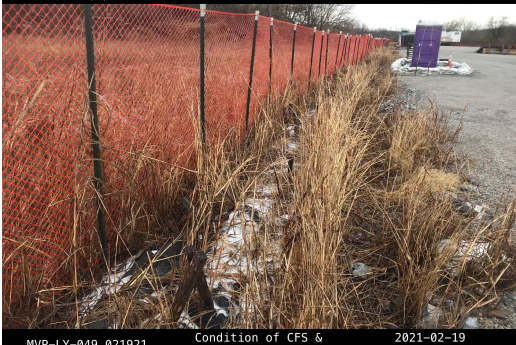
<p>DIRECTION NE (M) +37.27114° -080.12192° ACCURACY 16 ft DATUM WGS84</p> <p>MVP-LY-049_021921 Condition of CFS & safety fence 2021-02-19 08:58:00-05:00</p>

GPS Location MVP-LY-049 See photo for gps data		GPS Location MVP-LY-049 See photo for gps data		
Field Station# +0	Field Station# +0				
Pic 3 Desc. Condition of compost filter sock and safety fence along north LOD. Looking NE.	Pic 4 Desc. Condition of containment under barrel of toilet chemical. Holding stormwater and ice. Looking SE.

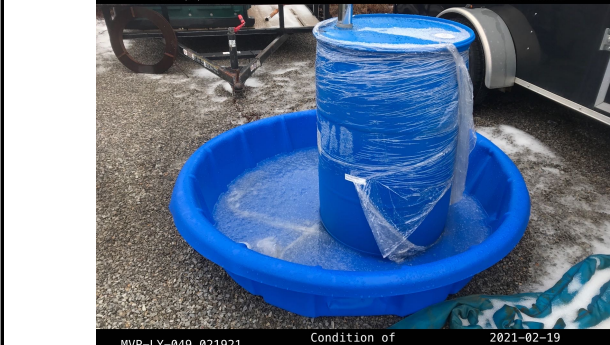
<p>DIRECTION SE (M) +37.27105° -080.12011° ACCURACY 33 ft DATUM WGS84</p> <p>MVP-LY-049_021921 Condition of containment 2021-02-19 08:59:47-05:00</p>

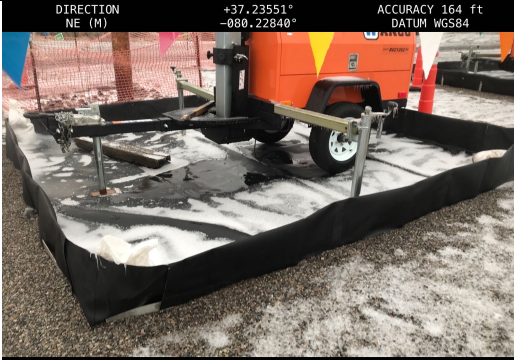
<p>DIRECTION NE (M) +37.23551° -080.22848° ACCURACY 164 ft DATUM WGS84</p> <p>MVP-PY-006_021921 Condition of containment 2021-02-19 07:25:22-05:00</p>

<p>DIRECTION W (M) +37.23517° -080.22995° ACCURACY 33 ft DATUM WGS84</p> <p>MVP-PY-006_021921 Condition of west rock entrance 2021-02-19 07:33:16-05:00</p>			
GPS Location MVP-PY-006 See photo for gps data		GPS Location MVP-PY-006 See photo for gps data			
Field Station# +0		Field Station# +0			
Pic 1 Desc. Condition of containment under light plant. Holding ice. Looking NE		Pic 2 Desc. Condition of west rock entrance. No stone on roadway. Looking W.

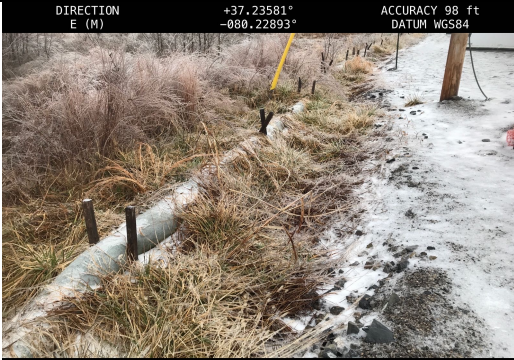
GPS Location MVP-PY-006 See photo for gps data		GPS Location MVP-PY-006 See photo for gps data			
Field Station# +0		Field Station# +0			
Pic 3 Desc. Condition of compost filter sock along north LOD. Looking E.		Pic 4 Desc. Condition of compost filter sock along east LOD. Looking S.

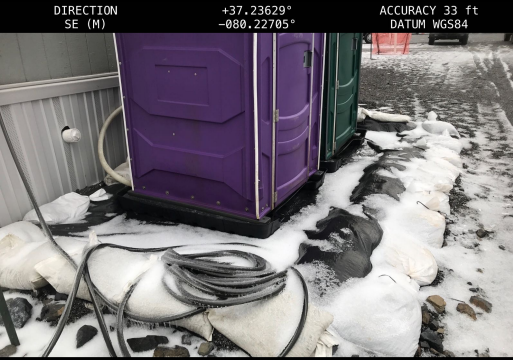
<p>DIRECTION SE (M) +37.23629° -080.22705° ACCURACY 33 ft DATUM WGS84</p> <p>MVP-PY-006_021921 Condition of trays & containment 2021-02-19 07:40:11-05:00</p>			
GPS Location MVP-PY-006 See photo for gps data		GPS Location MVP-PY-006 See photo for gps data			
Field Station# +0		Field Station# +0			
Pic 5 Desc. Condition of compost filter sock and signage for feature W-008. Looking E.		Pic 6 Desc. Condition of trays and containment under toilets. Holding ice. Looking SE.

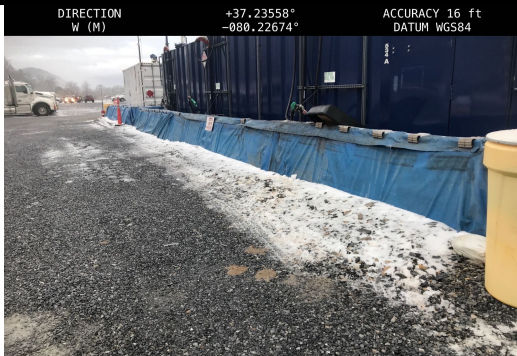
GPS Location	MVP-PY-006 See photo for gps data	GPS Location	MVP-PY-006 See photo for gps data
Field Station#	+0	Field Station#	+0
Pic 9 Desc.	No fuel spills south of the Blue Bulk fuel tanks. Looking W.	Pic 10 Desc.	Blue Bulk Fuel tanks no leaky internal fittings. Looking W.
DIRECTION S (M) +37.23563° -080.22684° ACCURACY 16 ft DATUM WGS84

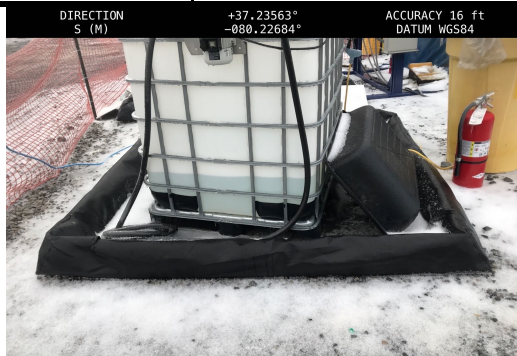
MVP-PY-006_021921 Condition of containment 2021-02-19 07:45:36-05:00		MVP-PY-006_021921 Secondary containment on site for tankers ... 2021-02-19 07:45:43-05:00	
GPS Location	MVP-PY-006 See photo for gps data	GPS Location	MVP-PY-006 See photo for gps data
Field Station#	+0	Field Station#	+0
Pic 11 Desc.	Condition of containment under DEF container. Holding ice. Looking S.	Pic 12 Desc.	Secondary containment on site for tankers offloading fuel. Looking W.

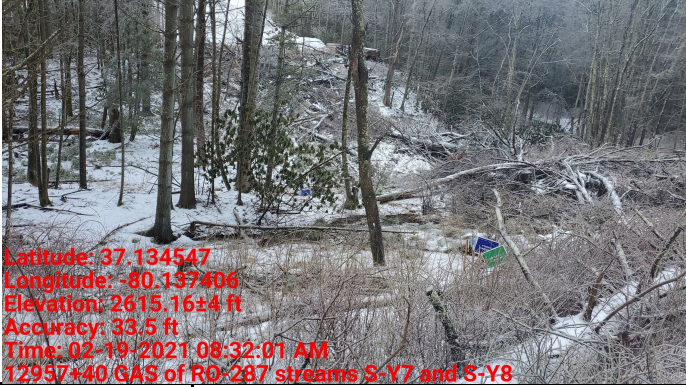
<p>Latitude: 37.134547 Longitude: -80.137406 Elevation: 2615.16±4 ft Accuracy: 33.5 ft Time: 02-19-2021 08:32:01 AM 12957+40 CIS of RO-287 streams S-Y7 and S-Y8</p>

<p>Latitude: 37.134682 Longitude: -80.137531 Elevation: 2615.16±4 ft Accuracy: 42.0 ft Time: 02-19-2021 08:33:21 AM 12956+80 CIS of RO-287 landowner's spring box and streams S-Y7</p>	
GPS Location	See pic for GPS location	GPS Location	See pic for GPS location
Field Station#	12957+40	Field Station#	12956+80
Pic 7 Desc.	Downstream side of streams S-Y7 and S-Y8.	Pic 8 Desc.	Sump end treatment and landowner's spring box in the background.

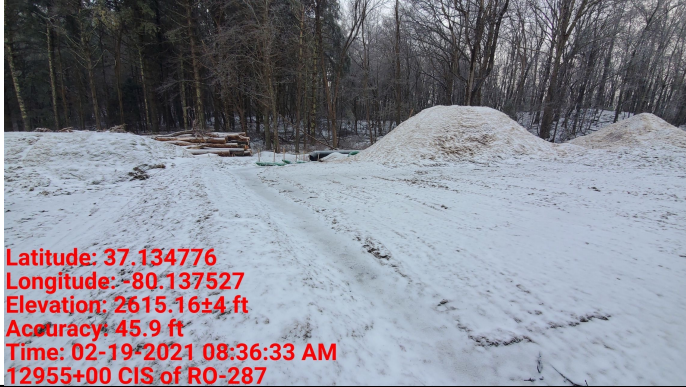
<p>Latitude: 37.134776 Longitude: -80.137527 Elevation: 2615.16±4 ft Accuracy: 45.9 ft Time: 02-19-2021 08:36:33 AM 12955+00 CIS of RO-287</p>

GPS Location	See pic for GPS location	GPS Location	See pic for GPS location
Field Station#	12955+00	Field Station#	12951+50
Pic 9 Desc.	Waterbars, sumps and end treatments remain in acceptable condition on the CIS of RO-287.	Pic 10 Desc.	Current ROW conditions on the CIS of RO-287.

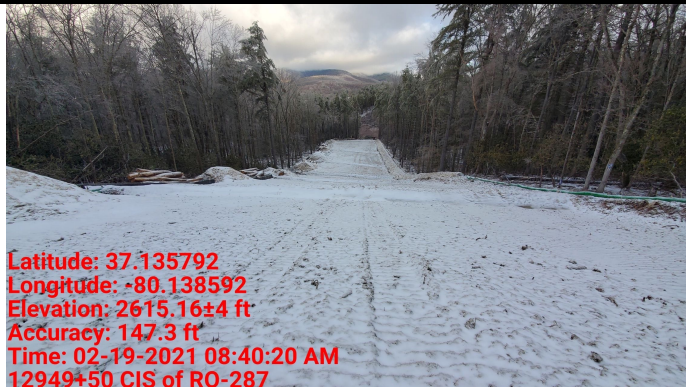
<p>Latitude: 37.135792 Longitude: -80.138592 Elevation: 2615.16±4 ft Accuracy: 147.3 ft Time: 02-19-2021 08:40:20 AM 12949+50 CIS of RO-287</p>

<p>Latitude: 37.137378 Longitude: -80.138351 Elevation: 2615.16±4 ft Accuracy: 77.4 ft Time: 02-19-2021 08:43:27 AM 12947+00 CIS of RO-287</p>	
GPS Location	See pic for GPS location	GPS Location	See pic for GPS location
Field Station#	12949+50	Field Station#	12947+00
Pic 11 Desc.	Current ROW conditions on the CIS of RO-287.	Pic 12 Desc.	Waterbars, sumps and end treatments remain in acceptable condition on the CIS of RO-287.

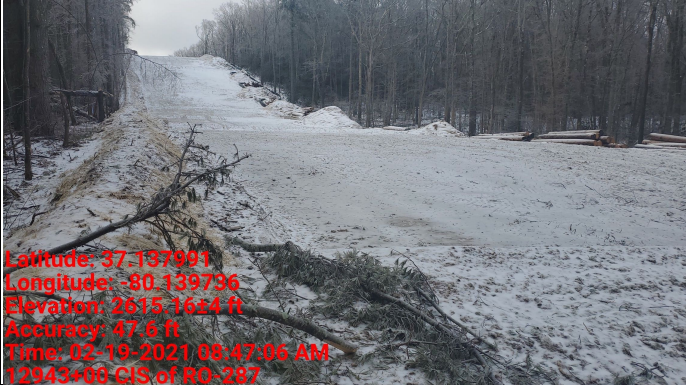
<p>Latitude: 37.137991 Longitude: -80.139736 Elevation: 2615.16±4 ft Accuracy: 47.6 ft Time: 02-19-2021 08:47:06 AM 12943+00 CIS of RO-287</p>

<p>Latitude: 37.138031 Longitude: -80.139587 Elevation: 2615.16±4 ft Accuracy: 41.0 ft Time: 02-19-2021 08:49:35 AM 12945+00 CIS of RO-287</p>	
GPS Location	See pic for GPS location	GPS Location	See pic for GPS location
Field Station#	12943+00	Field Station#	12945+00
Pic 13 Desc.	Current ROW conditions on the CIS of RO-287.	Pic 14 Desc.	Waterbars, sumps and end treatments remain in acceptable condition on the CIS of RO-287.

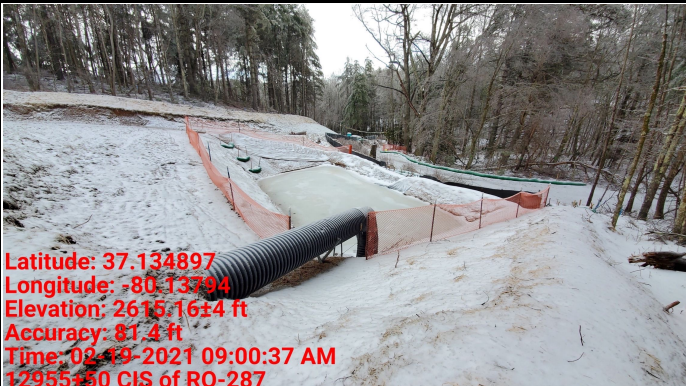
<p>Latitude: 37.134897 Longitude: -80.13794 Elevation: 2615.16±4 ft Accuracy: 81.4 ft Time: 02-19-2021 09:00:37 AM 12955+50 CIS of RO-287</p>

Field Station#	12955+50	Field Station#	12956+50
Pic 15 Desc.	Sediment trap on the the CIS of RO-287.	Pic 16 Desc.	ECD's along landowners access driveway.

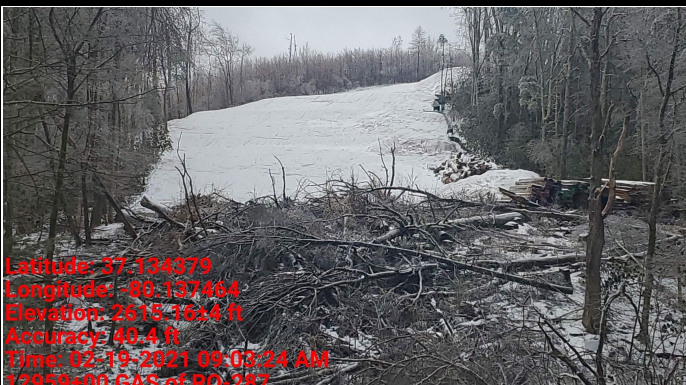
<p>Latitude: 37.134379 Longitude: -80.137464 Elevation: 2615.16±4 ft Accuracy: 40.4 ft Time: 02-19-2021 09:03:24 AM 12959+00 GAS of RO-287</p>

<p>Latitude: 37.135421 Longitude: -80.13405 Elevation: 2615.16±4 ft Accuracy: 45.4 ft Time: 02-19-2021 09:10:33 AM 12957+30 Access Road RO-287 stream S-Z17</p>	
GPS Location	See pic for GPS location	GPS Location	See pic for GPS location
Field Station#	12959+00	Field Station#	12957+30
Pic 17 Desc.	No maintenance issues or impacts observed on the GAS of RO-287.	Pic 18 Desc.	Stream S-Z17 along access RO-287.
