Visual Site Inspection Report

Project Name H-600 Pipeline Spread H		AFE 124300138	Spread H-600 Pipeline Spread H
Contractor Precision		Report # 20247	
Inspector John Brcic		Date/Time 2/20/2021 1:37 PM	
Permit # TBD	Inspection Type VA SWPP	Station Begin 12284+75	
State VA	Inspection Area Partial	Station End 12443+75	
County Montgomery	Ground Frozen	Temperature (°F) 30.00	
Municipality N/A	Weather Sunny	Rain Gauge (in) 0.00	
			Rain Accumulation Time (days) 1.00

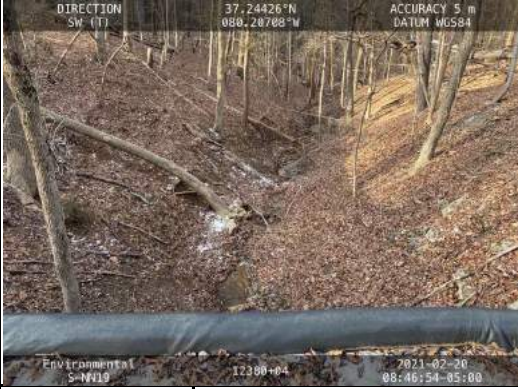
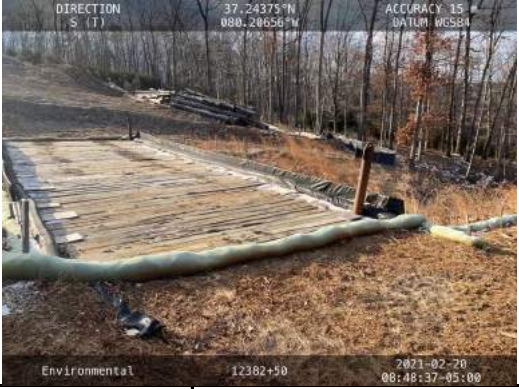
GPS Location	See photo	GPS Location	See photo
Field Station#	12380+04	Field Station#	12382+50
Pic 7 Desc.	Stream S-NN19, facing southwest, downstream	Pic 8 Desc.	Clean water diversion channel stable, ECDs in satisfactory condition.

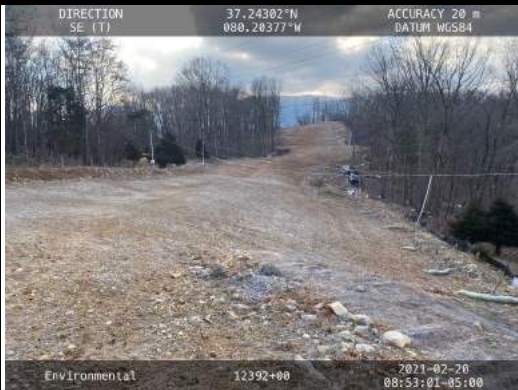
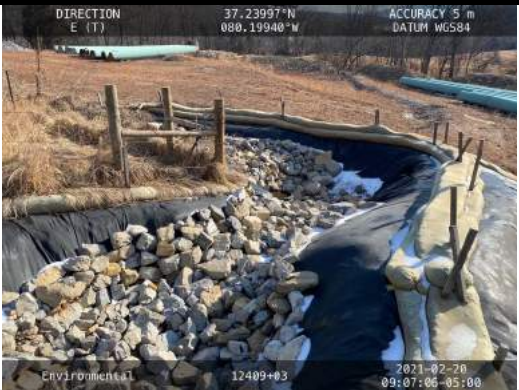
GPS Location	See photo	GPS Location	See photo
Field Station#	12392+50	Field Station#	12409+03
Pic 9 Desc.	ROW stable between I-81 and MLV-27.	Pic 10 Desc.	Clean water diversion pipe inlet free of sediment.

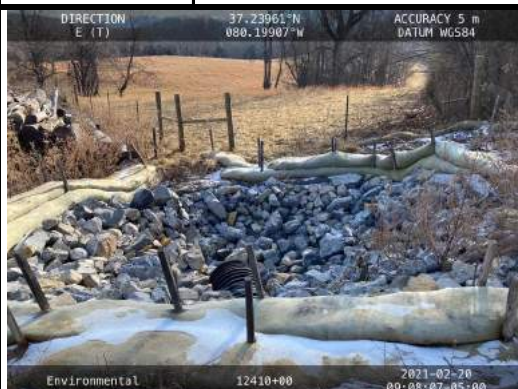
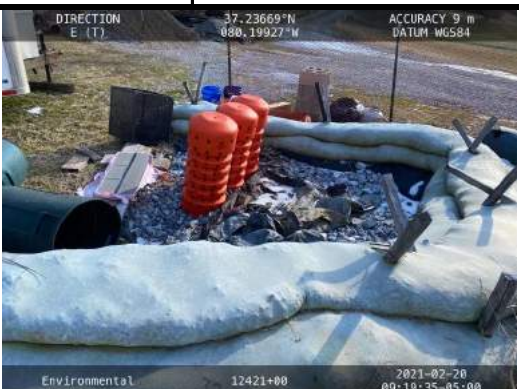
GPS Location	See photo	GPS Location	See photo
Field Station#	12410+00	Field Station#	12421+00
Pic 11 Desc.	Clean water diversion pipe outlet below MLV-27 in satisfactory condition.	Pic 12 Desc.	Clean water diversion pipe inlet on coming in side of access road MVP-MN-279 is free of sediment and functioning properly.

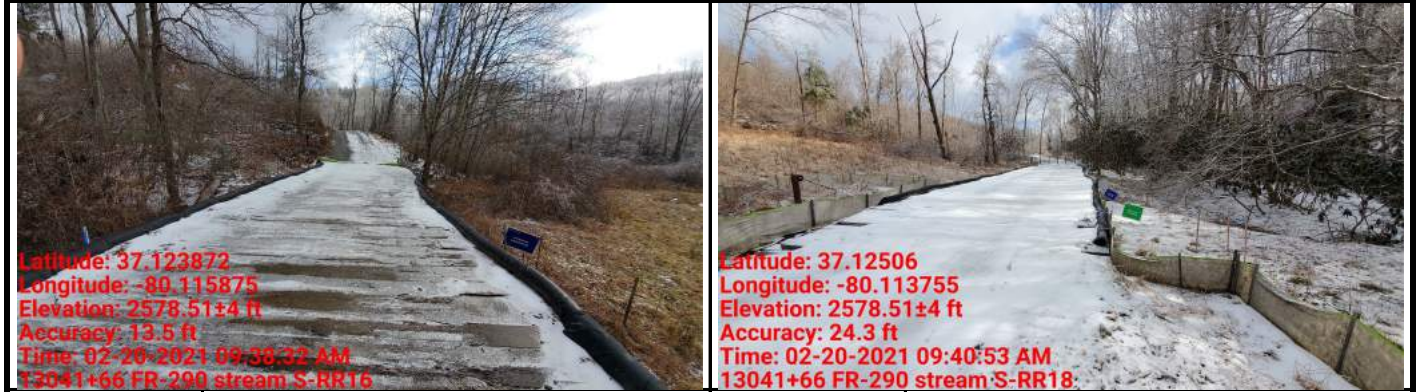
GPS Location	See pic for GPS location	GPS Location	See pic for GPS location
Field Station#	13061+44	Field Station#	13061+44
Pic 1 Desc.	Access road FR-290 at stream crossing S-RR16.	Pic 2 Desc.	Access road FR-290 at stream crossing S-RR18.

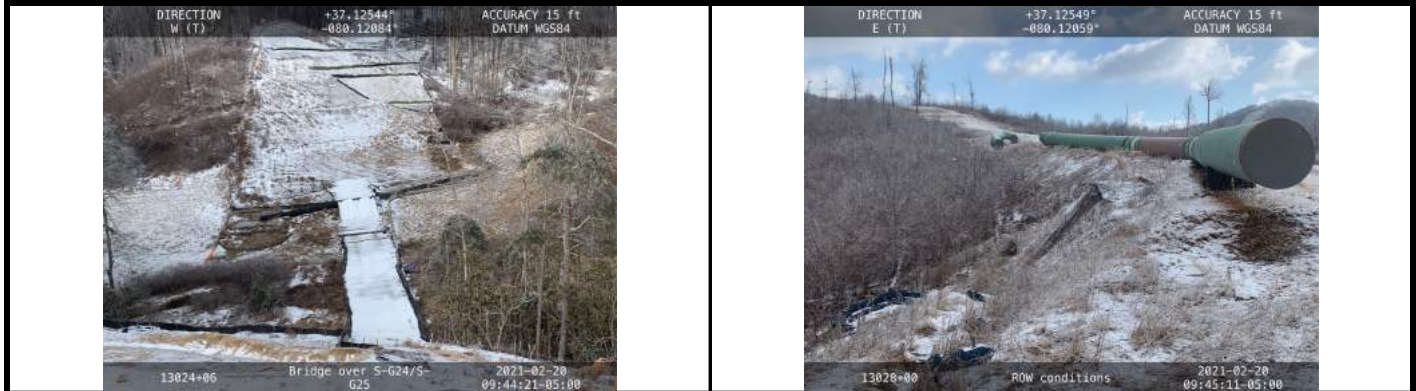
GPS Location	See pic for GPS location	GPS Location	See pic for GPS location
Field Station#	13026+00	Field Station#	13027+00
Pic 3 Desc.	Streams S-G24 and S-G25 on the GAS of the BRP.	Pic 4 Desc.	Current ROW conditions on the CIS of FR-289.

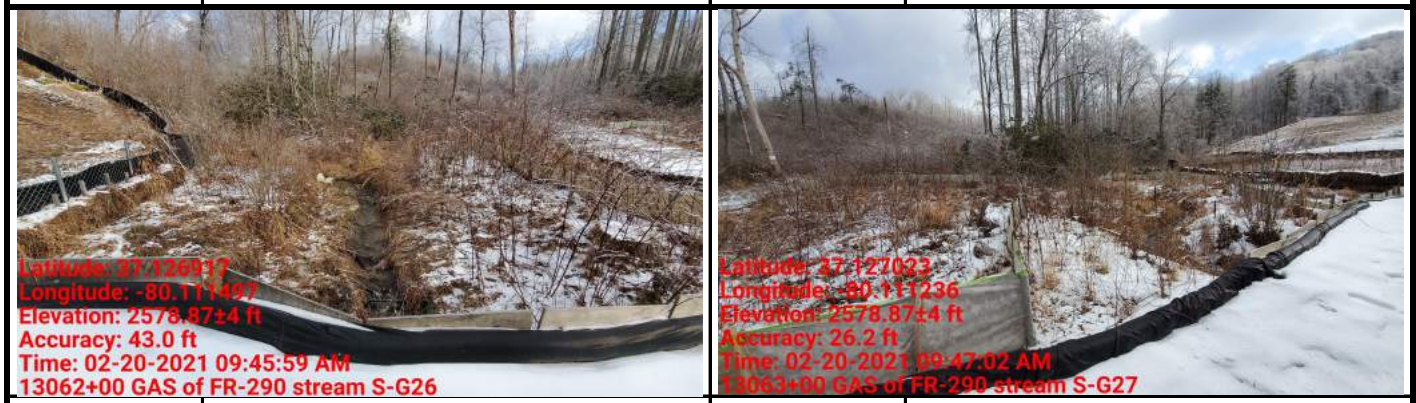
GPS Location	See pic for GPS location	GPS Location	See pic for GPS location
Field Station#	13062+00	Field Station#	13063+00
Pic 5 Desc.	Upstream side of stream S-G26.	Pic 6 Desc.	Upstream side of stream S-G27.

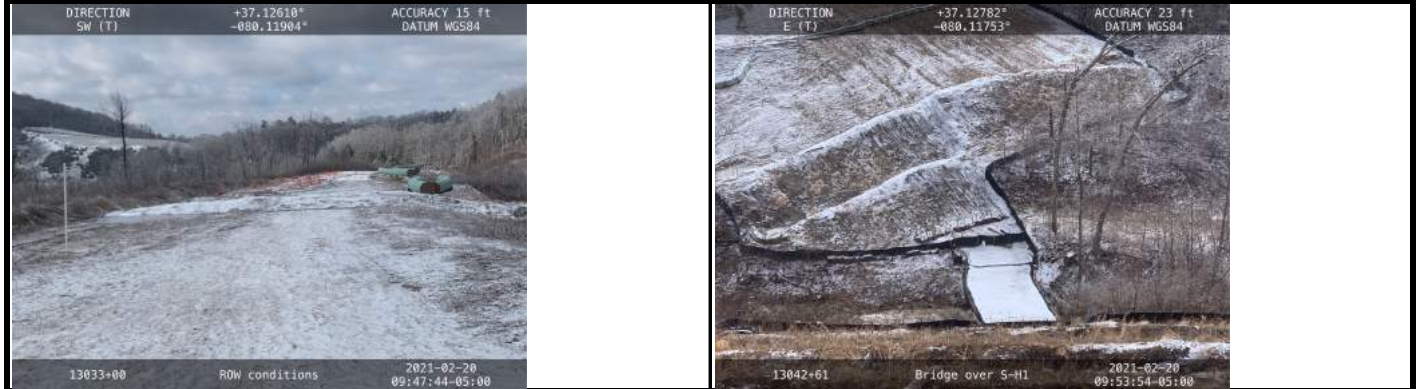
GPS Location	See pic for GPS location	GPS Location	See pic for GPS location
Field Station#	13033+00	Field Station#	13041+00
Pic 7 Desc.	Current ROW conditions on the CIS of FR-289.	Pic 8 Desc.	Stream S-H1 on the GAS of FR-289.

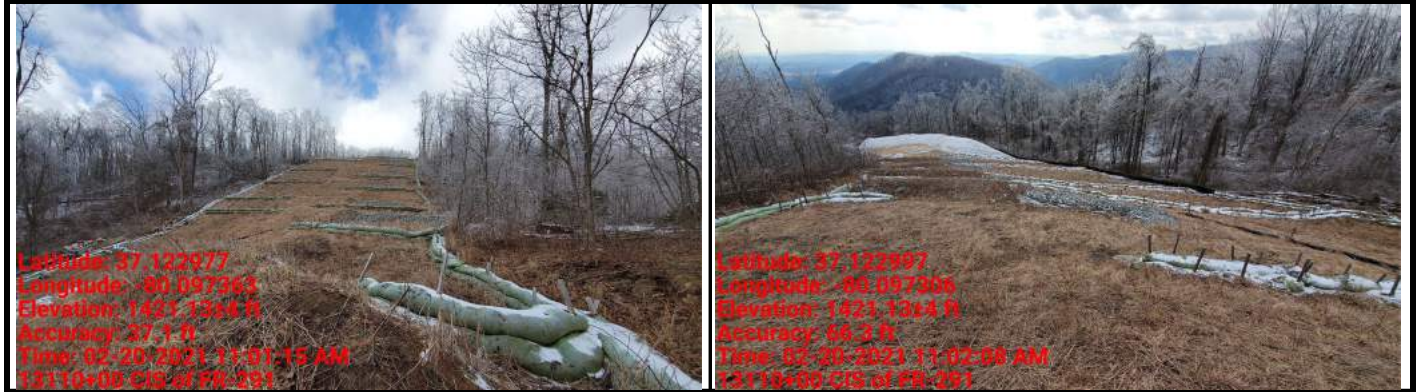
GPS Location	See pic for GPS location	GPS Location	See pic for GPS location
Field Station#	13110+00	Field Station#	13110+00
Pic 11 Desc.	Current ROW conditions on the CIS of FR-291.	Pic 12 Desc.	Current ROW conditions on the CIS of FR-291.

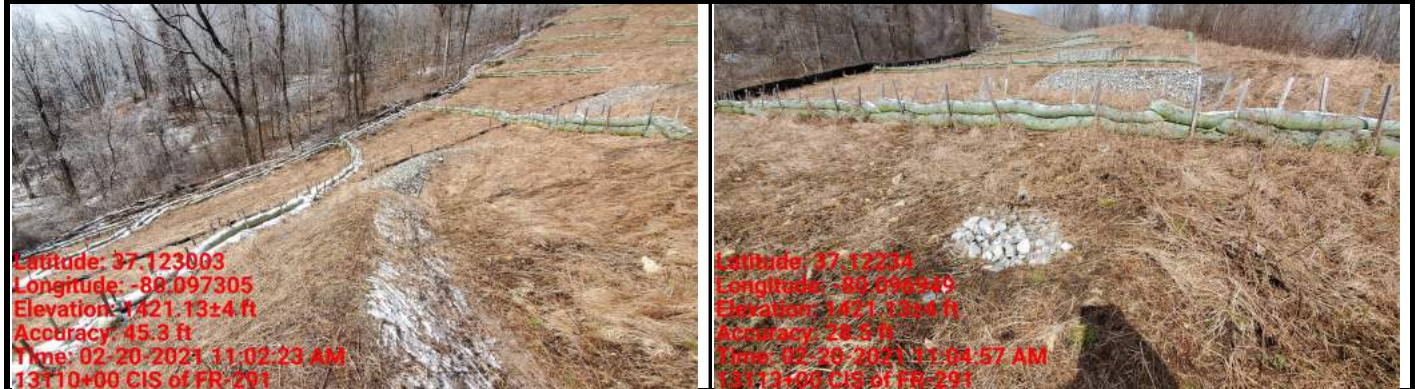
GPS Location	See pic for GPS location	GPS Location	See pic for GPS location
Field Station#	13110+00	Field Station#	13112+00
Pic 13 Desc.	Current ROW conditions on the CIS of FR-291.	Pic 14 Desc.	Current ROW conditions on the CIS of FR-291.

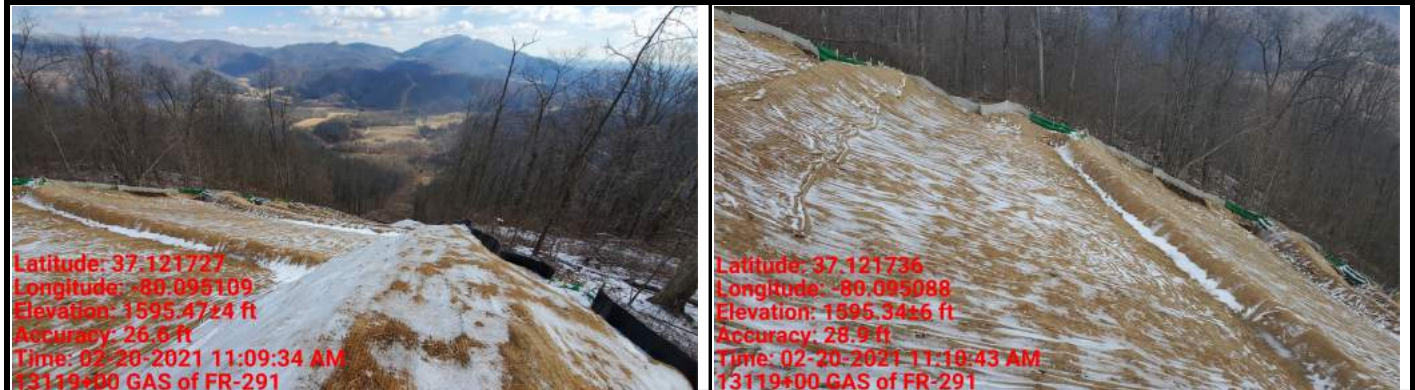
GPS Location	See pic for GPS location	GPS Location	See pic for GPS location
Field Station#	13119+00	Field Station#	13119+00
Pic 15 Desc.	Current ROW conditions on the GAS of FR-291.	Pic 16 Desc.	Current ROW conditions on the GAS of FR-291.

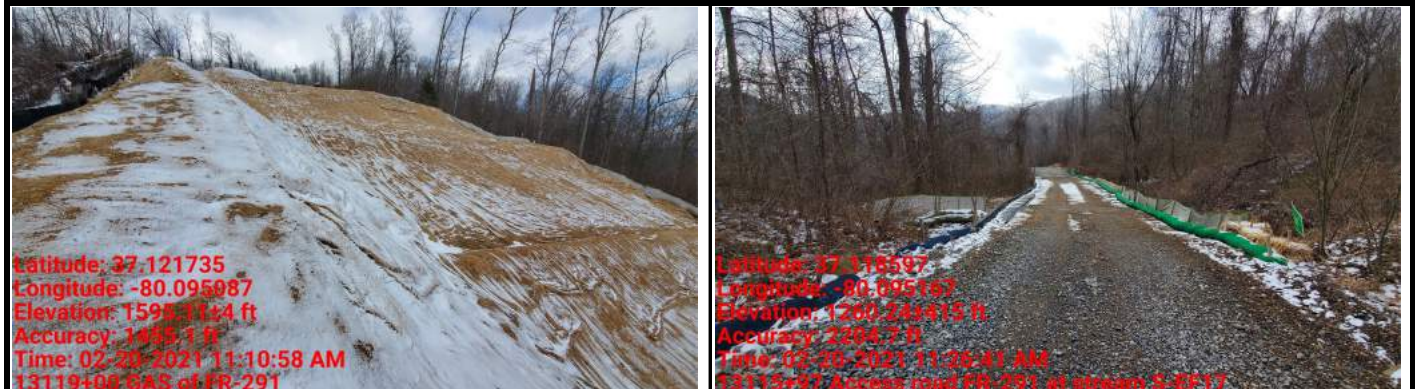
GPS Location	See pic for GPS location	GPS Location	See pic for GPS location
Field Station#	13119+00	Field Station#	13115+97
Pic 17 Desc.	Current ROW conditions on the GAS of FR-291.	Pic 18 Desc.	Access road FR-291 at stream S-EF17.

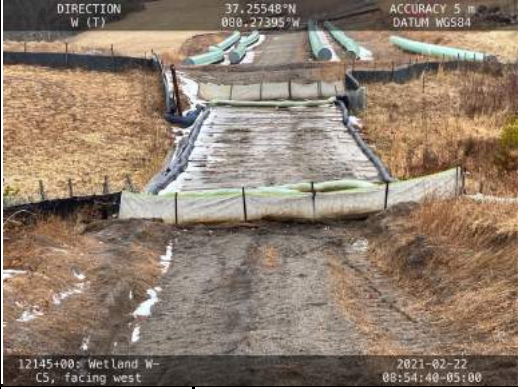
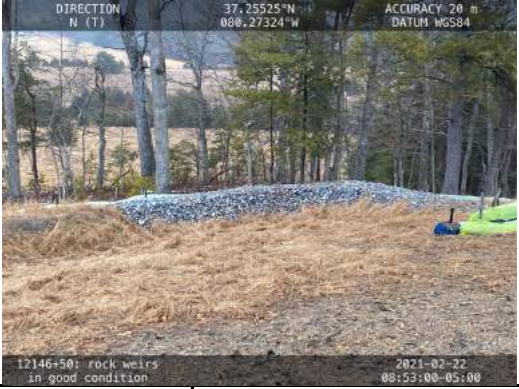
GPS Location	See photo	GPS Location	See photo
Field Station#	12145+00	Field Station#	12146+50
Pic 7 Desc.	Wetland W-C5, facing west	Pic 8 Desc.	Rock weir in satisfactory condition.

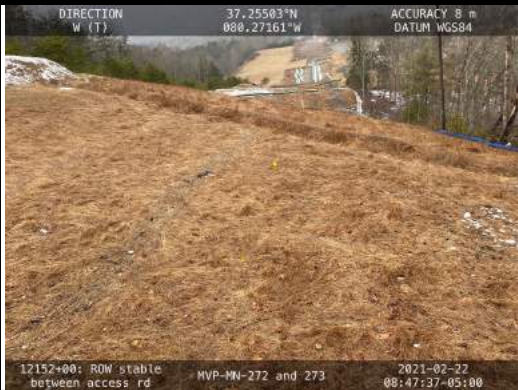
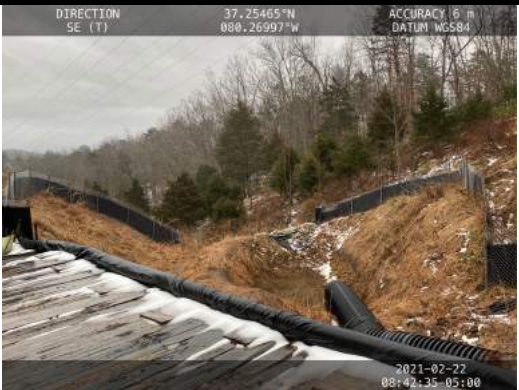
GPS Location	See photo	GPS Location	See photo
Field Station#	12152+00	Field Station#	12157+00
Pic 9 Desc.	ROW stable between access roads MVP-MN-272 and 273.	Pic 10 Desc.	Clean water diversion channel and temporary sediment trap are stable and functioning properly.

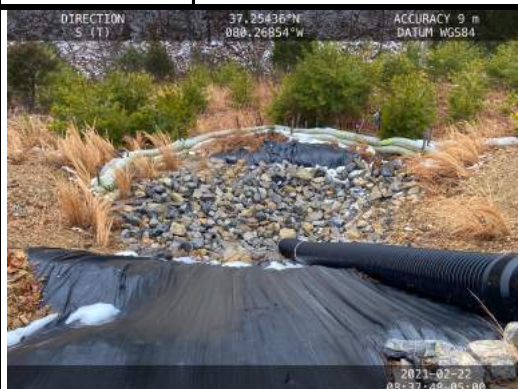
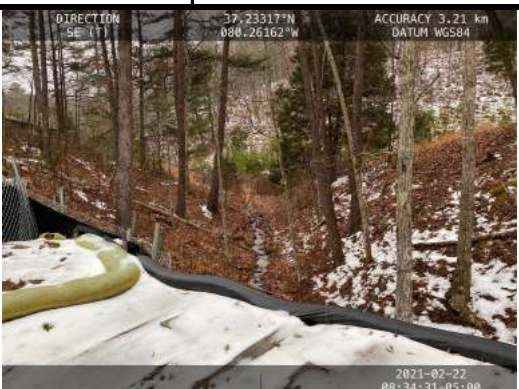
GPS Location	See photo	GPS Location	See photo
Field Station#	12160+00	Field Station#	12163+05
Pic 11 Desc.	Slope drain in good condition.	Pic 12 Desc.	Stream S-C25, facing southeast, downstream

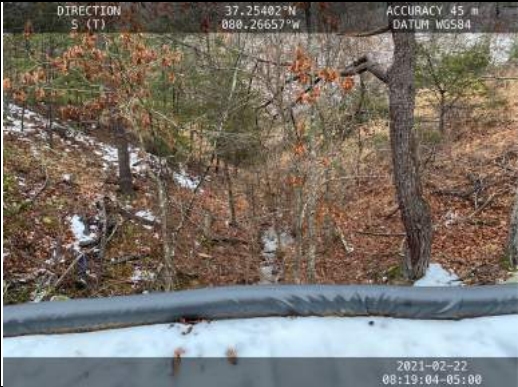
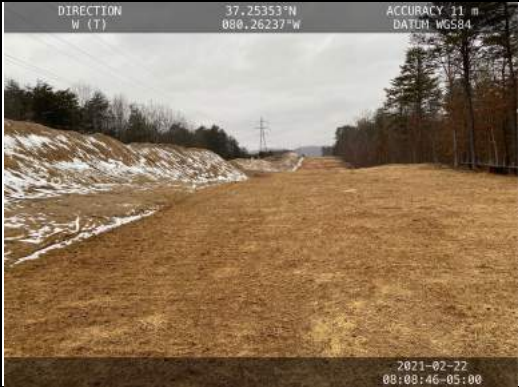
GPS Location	See photo	GPS Location	See photo
Field Station#	12166+47	Field Station#	12179+00
Pic 13 Desc.	Stream S-C24, facing south, downstream	Pic 14 Desc.	ROW and stockpiles stable.

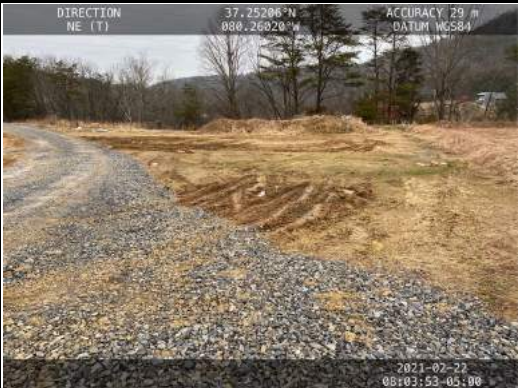
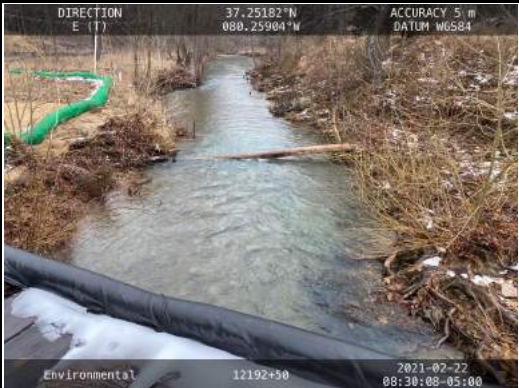
GPS Location	See photo	GPS Location	See photo
Field Station#	12188+40	Field Station#	12192+50
Pic 15 Desc.	Area next to MVP-MN-274 rutted by AEP contractor activity.	Pic 16 Desc.	Stream S-C21, Bradshaw Creek, facing east, downstream

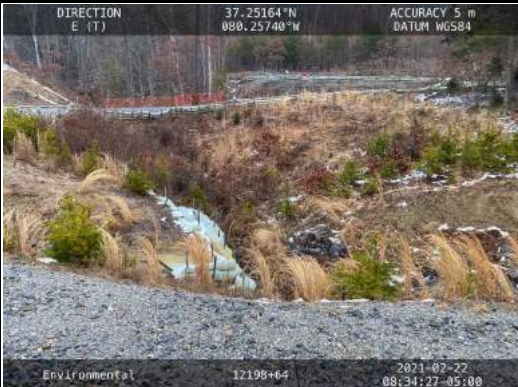
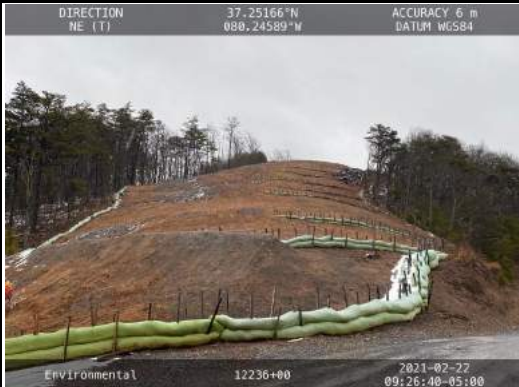
GPS Location	See photo	GPS Location	See photo
Field Station#	12198+64	Field Station#	12236+00
Pic 17 Desc.	Stream S-0011, facing east	Pic 18 Desc.	Permanent restoration remains stable over the top of Reese Mountain.

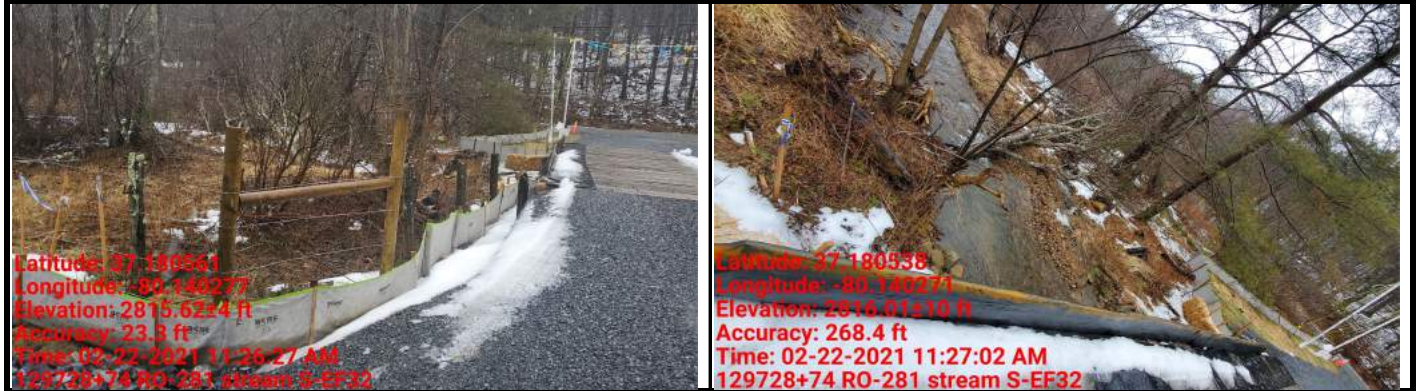
GPS Location	See pic for GPS location	GPS Location	See pic for GPS location
Field Station#	12728+74	Field Station#	12728+74
Pic 13 Desc.	Stream S-EF32 on access road RO-281 near Poor Mountain Road.	Pic 14 Desc.	Downstream side of stream S-EF32 on access road RO-281 near Poor Mountain Road.

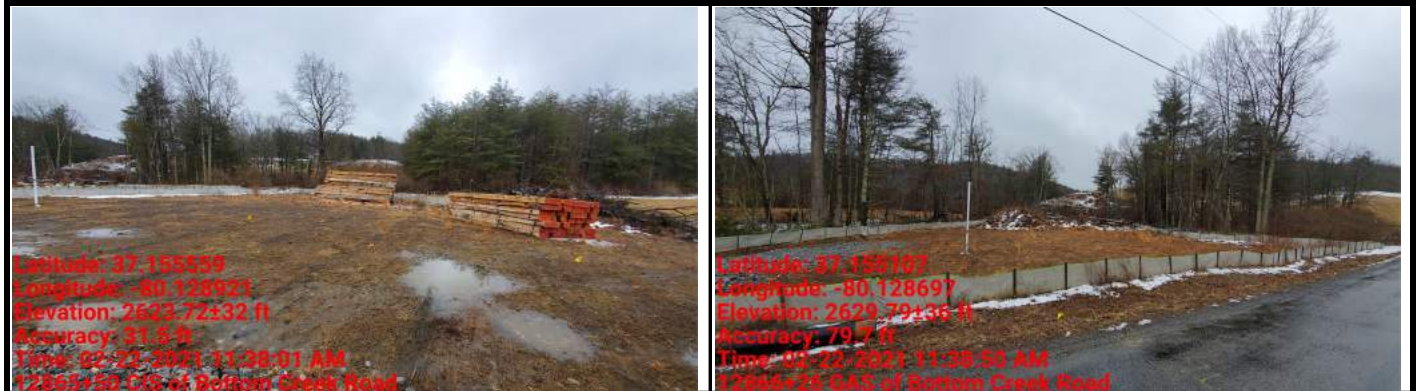
GPS Location	See pic for GPS location	GPS Location	See pic for GPS location
Field Station#	12865+50	Field Station#	12866+26
Pic 17 Desc.	Current ROW conditions on the CIS of Bottom Creek Road.	Pic 18 Desc.	GAS of Bottom Creek Road crossing.

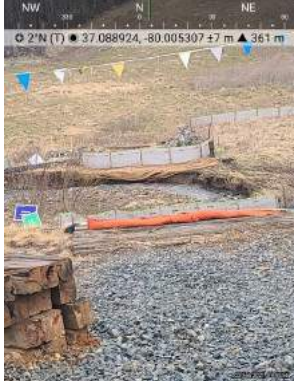
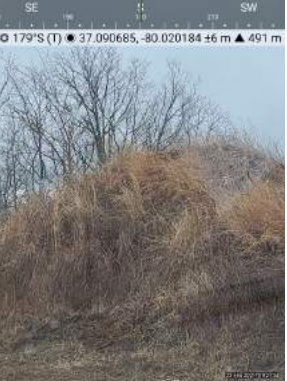
GPS Location	00000	GPS Location	0000	
Field Station#	13497+12	Field Station#	13437+72	
Pic 1 Desc.	The EI monitored stream crossing on problem land owner area, no environmental issues observed at the time of inspection today.		Pic 2 Desc.	The EI monitored stabilization on spoil piles while checking row conditions during light rain showers .

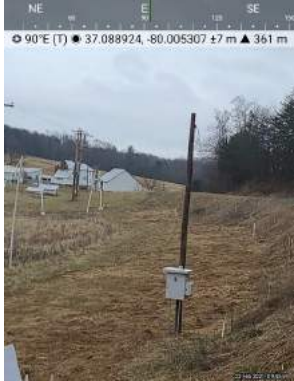
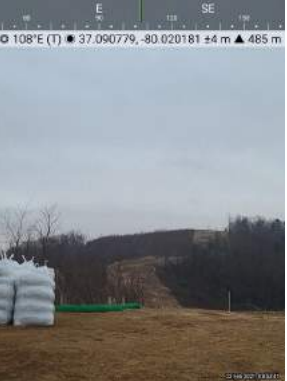
GPS Location	00000	GPS Location	0000	
Field Station#	13497+00	Field Station#	13436+67	
Pic 3 Desc.	Vegetation observation photo in anode bed location showing good growth and no environmental issues observed at the time of inspection.		Pic 4 Desc.	Row photo taken during light rain events today.

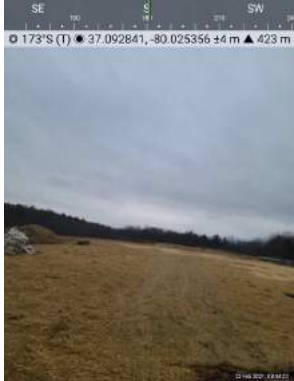
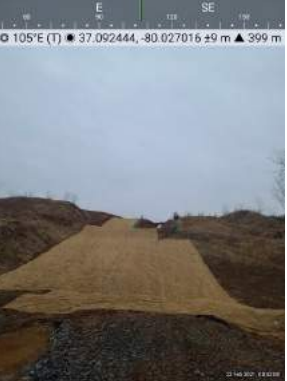
GPS Location	00000	GPS Location	00000	
Field Station#	13420+00	Field Station#	13416+23	
Pic 5 Desc.	EI monitored recently stabilized work space that was done by spread H contractor.		Pic 6 Desc.	EI monitored ECDs on hill side at CAHAS #1 rd crossing during light rain events, no environmental issues observed at the time of inspection.

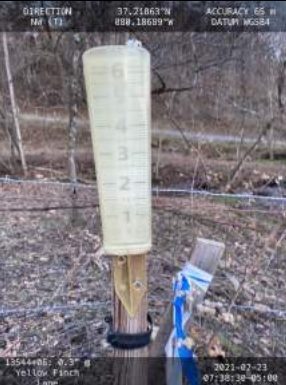
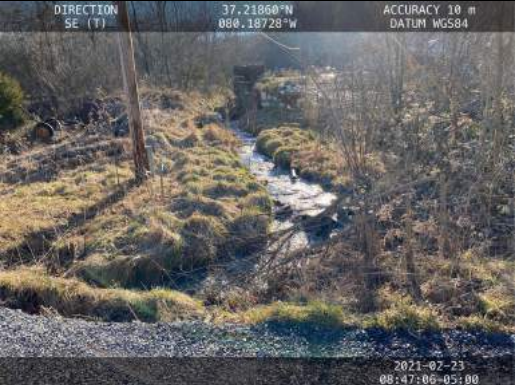
GPS Location	See photo		GPS Location	See photo	
Field Station#	12544+06		Field Station#	12544+06	
Pic 1 Desc.	0.3 inches of precipitation at Yellow Finch Lane.		Pic 2 Desc.	Stream S-KL32, facing southeast, upstream from Yellow Finch Lane

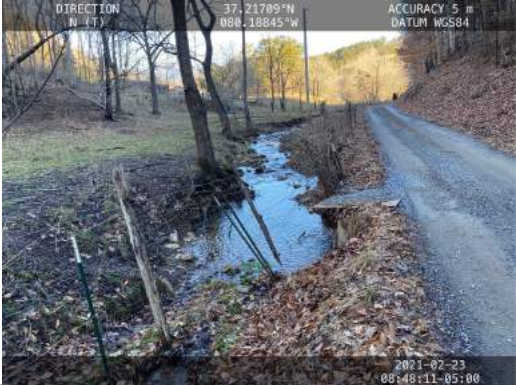
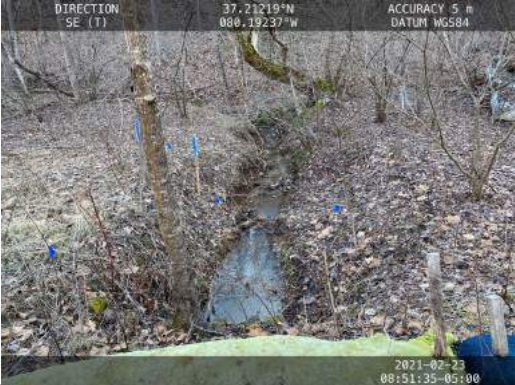
GPS Location	See photo		GPS Location	See photo	
Field Station#	12544+06		Field Station#	12544+06	
Pic 3 Desc.	Stream S-EF20b, facing north, downstream from Yellow Finch Lane		Pic 4 Desc.	Stream S-EF20a, facing southeast, downstream from Yellow Finch Lane

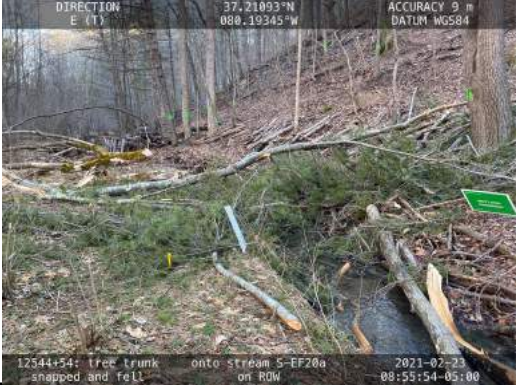
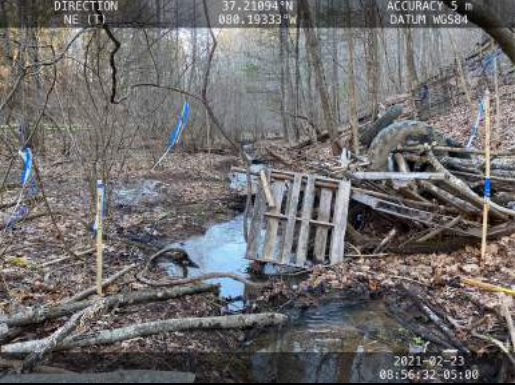
GPS Location	See photo		GPS Location	See photo	
Field Station#	12544+54		Field Station#	12544+54	
Pic 5 Desc.	A pine tree trunk snapped off near the top and landed over stream S-EF20a within the LOD.		Pic 6 Desc.	Stream S-EF20a, facing northeast, downstream

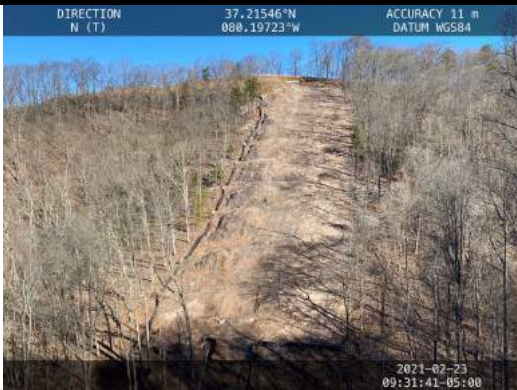
GPS Location	See photo	GPS Location	See photo
Field Station#	12535+00	Field Station#	12517+00
Pic 9 Desc.	Denuded logging road adjacent to MVP ROW exhibiting some gully erosion.	Pic 10 Desc.	The slope on the coming in side of stream S-EF19 remains stable.

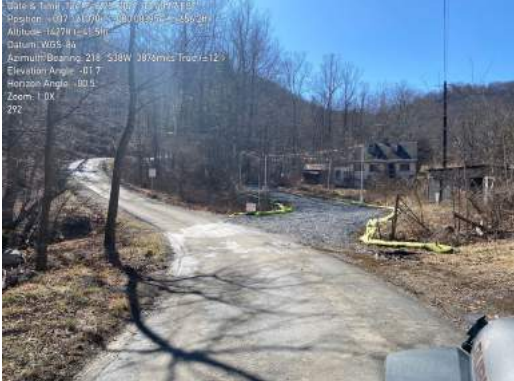
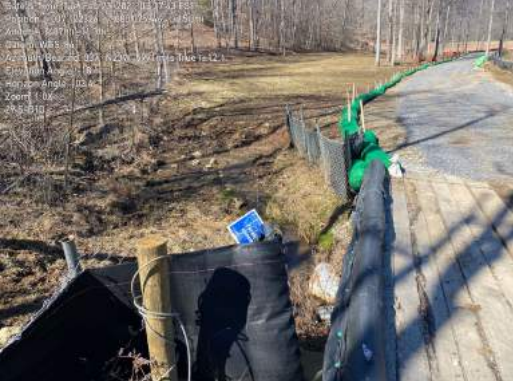
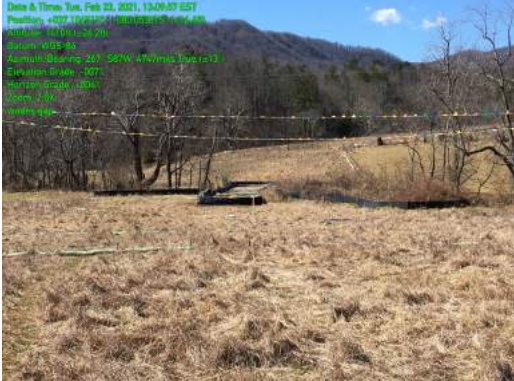
<p><small>Date & Time: Tue, Feb 23, 2021, 13:11:58 Position: +027 124300138, +080 0561877 Altitude: 1427M (4385.26) Datum: WGS 84 Azimuth Bearing: 214.538W 3975mAz True (+12.7) Elevation Angle: -01.7 Horizon Angle: -02.5 Zoom: 1.0X 292</small></p>			
GPS Location See photo for coordinates.		GPS Location See photo for coordinates.			
Field Station# 13148+00		Field Station# 13190+00			
Pic 1 Desc. MVP-FR-292, RCE and ECDs along access road in acceptable condition.		Pic 2 Desc. D-D10, upstream, MVP-AR-29, typical cattle disturbance noted along stream banks and bed, cattle in field.

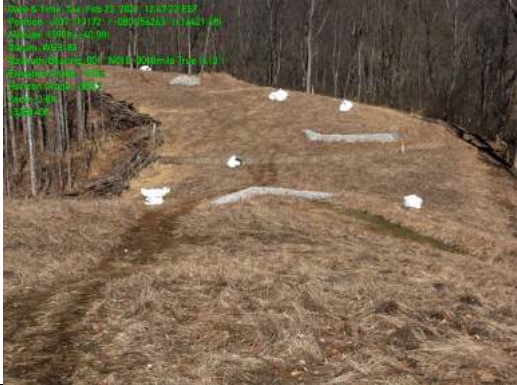
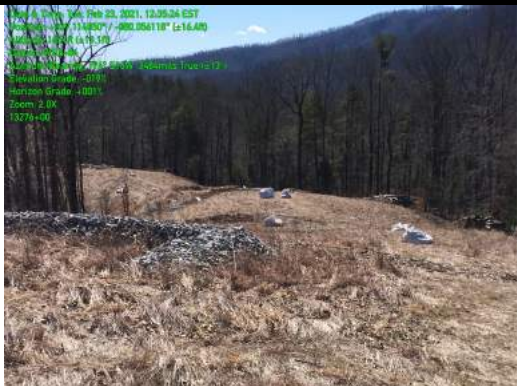
GPS Location	See photo for coordinates.		GPS Location	See photo for coordinates.	
Field Station#	13300+00		Field Station#	13288+00	
Pic 7 Desc.	ROW stable, vegetative cover noted across LOD, ATV trail noted.		Pic 8 Desc.	ROW stable, vegetative cover noted across LOD, ATV trail noted.

GPS Location	See photo for coordinates.		GPS Location	See photo for coordinates.	
Field Station#	13276+00		Field Station#	13268+00	
Pic 9 Desc.	ROW stable, vegetative cover noted across LOD.		Pic 10 Desc.	ROW stable, vegetative cover noted across LOD.

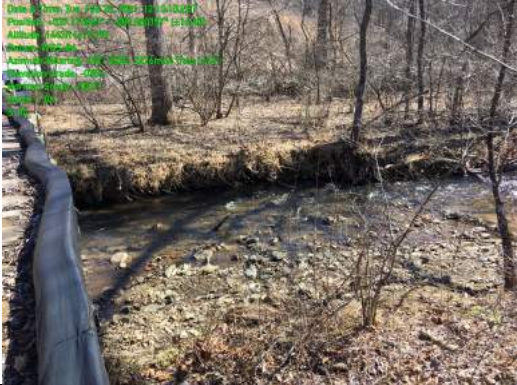
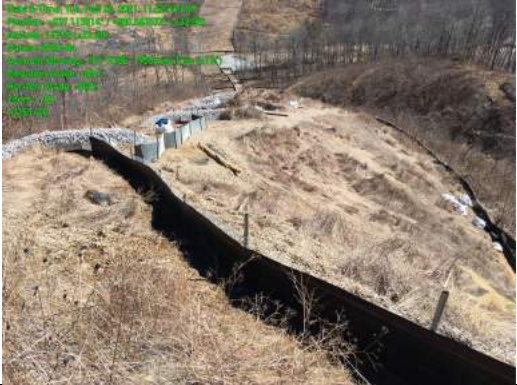
GPS Location	See photo for coordinates.	GPS Location	See photo for coordinates.		
Field Station#	13260+60	Field Station#	13253+00		
Pic 13 Desc.	S-II4, downstream, no changes observed at stream crossing, no environmental concerns.	Pic 14 Desc.	ROW stable, no notable movement or erosion noted in area above slip.

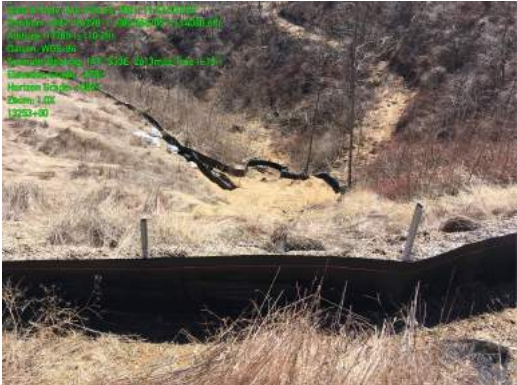
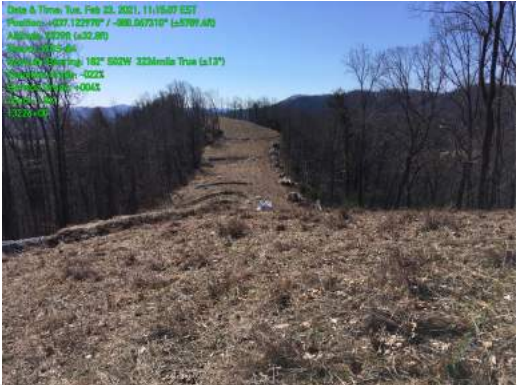
GPS Location	See photo for coordinates.	GPS Location	See photo for coordinates.		
Field Station#	13253+00	Field Station#	13226+00		
Pic 15 Desc.	No changes observed at previously documented slip, no sediment accumulation in perimeter controls.	Pic 16 Desc.	ROW stable, acceptable vegetative cover noted across LOD.

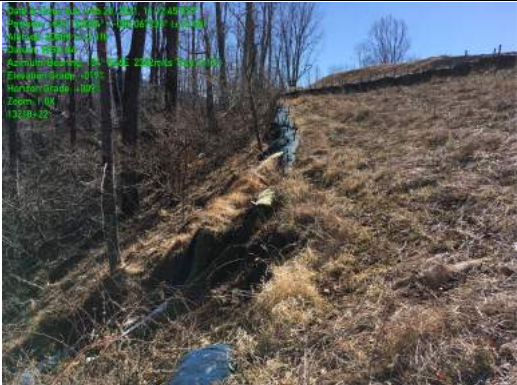
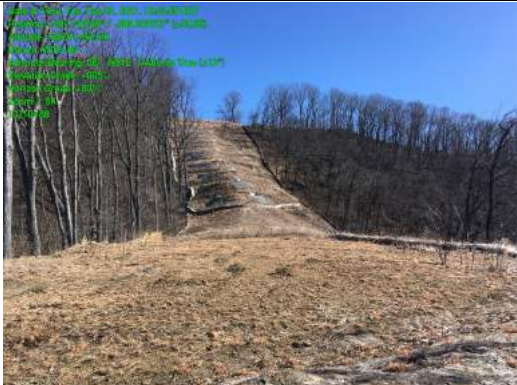
GPS Location	See photo for coordinates.	GPS Location	See photo for coordinates.		
Field Station#	13222+00	Field Station#	13210+88		
Pic 17 Desc.	Previously documented slip along LOD, no notable changes observed.	Pic 18 Desc.	ROW stable, acceptable vegetative cover noted across LOD.

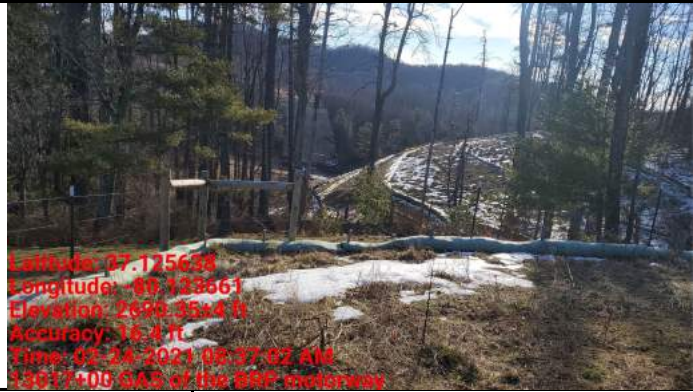
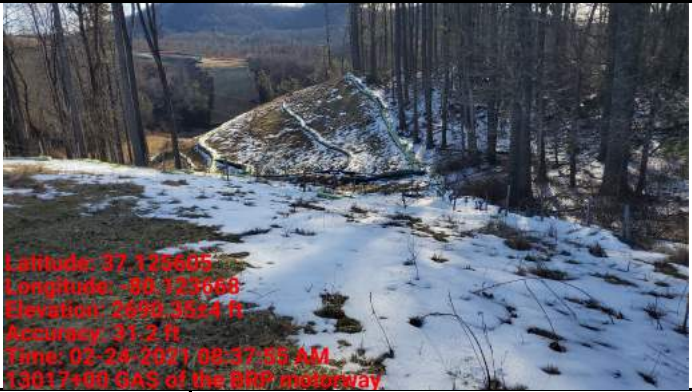
<p>Latitude: 37.125635 Longitude: -80.123668 Elevation: 2699.3554 ft Accuracy: 31.2 ft Time: 02-24-2021 08:37:55 AM 13017+00 GAS of the BRP motorway</p>			
GPS Location	See pic for GPS location		GPS Location	See pic for GPS location	
Field Station#	13017+00		Field Station#	13017+00	
Pic 1 Desc.	Wooded portion of the BRP on the GAS of the motorway.		Pic 2 Desc.	Wooded portion of the BRP on the GAS of the motorway.

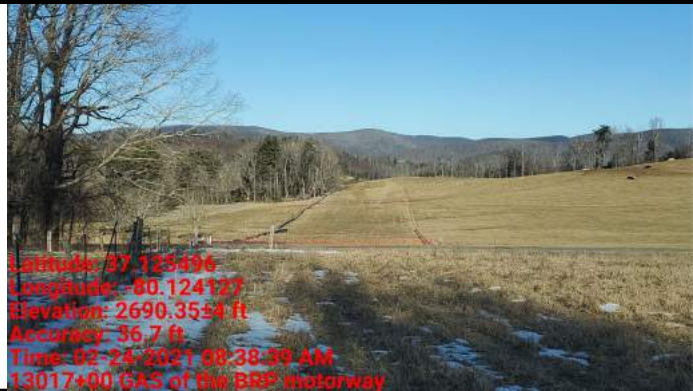
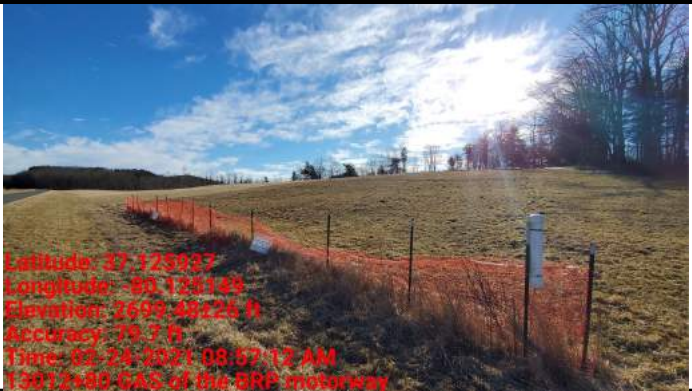
GPS Location	See pic for GPS location		GPS Location	See pic for GPS location	
Field Station#	13017+00		Field Station#	13012+80	
Pic 3 Desc.	BRP from the top of the hill on the GAS of the motorway.		Pic 4 Desc.	GAS of the BRP motorway.

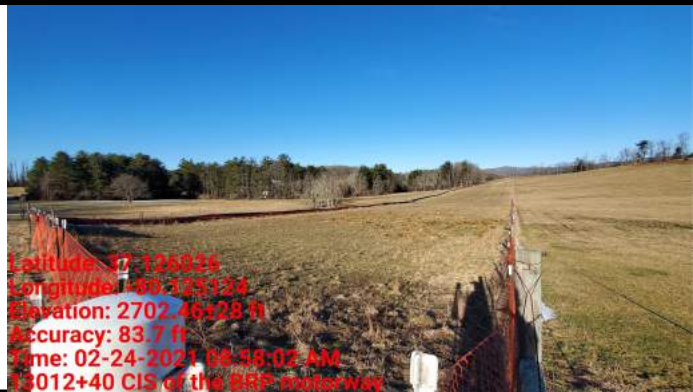
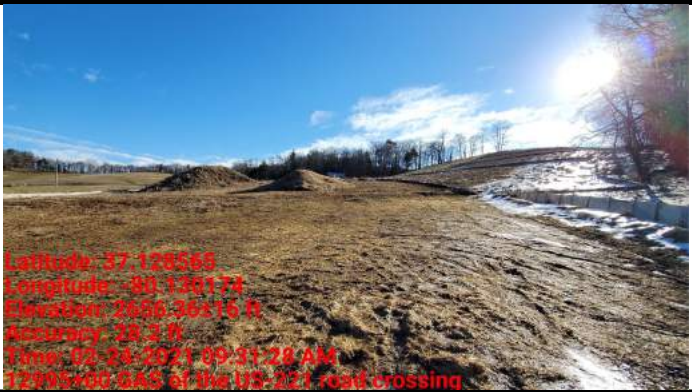
<p>Latitude: 37.126565 Longitude: -80.126174 Elevation: 2626.76215 ft Accuracy: 78.3 ft Time: 02-24-2021 09:11:28 AM 12995+00 GAS of the US-221 road crossing</p>			
GPS Location	See pic for GPS location		GPS Location	See pic for GPS location	
Field Station#	13012+40		Field Station#	12995+00	
Pic 5 Desc.	CIS of the BRP motorway.		Pic 6 Desc.	GAS of the US-221 road crossing.

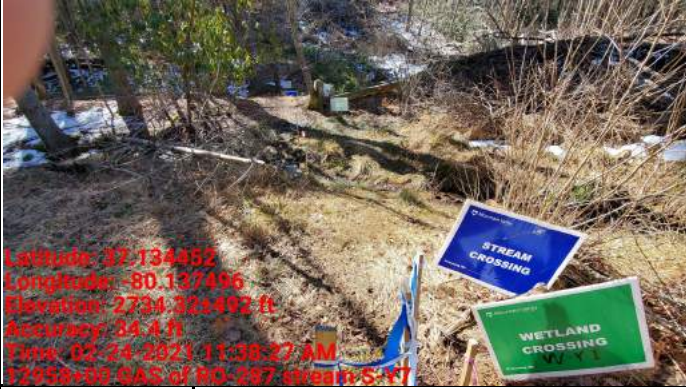
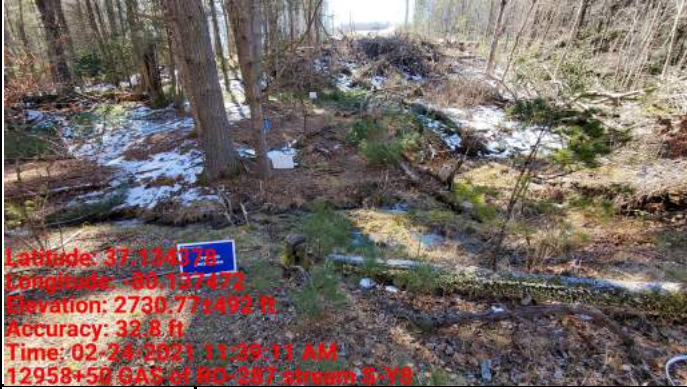
GPS Location	See pic for GPS location	GPS Location	See pic for GPS location
Field Station#	12958+00	Field Station#	12958+50
Pic 13 Desc.	Downstream side of stream S-Y7.	Pic 14 Desc.	Downstream side of stream S-Y8.

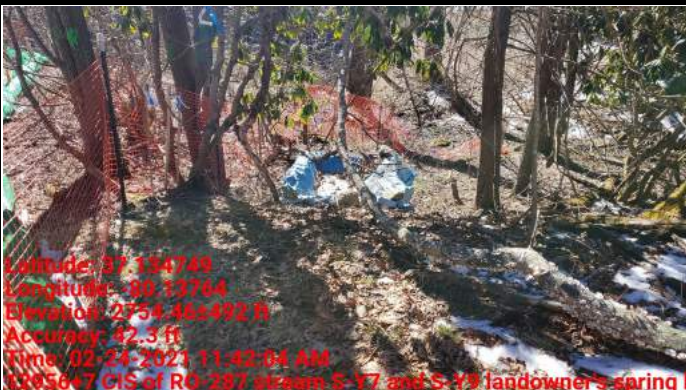
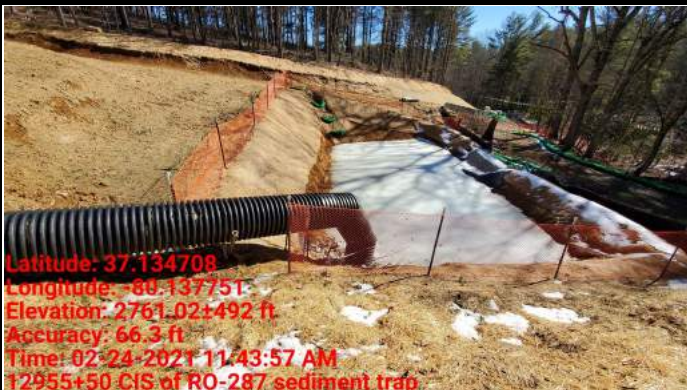
GPS Location	See pic for GPS location	GPS Location	See pic for GPS location
Field Station#	12956+75	Field Station#	12955+50
Pic 15 Desc.	Landowner's spring box at access RO-287.	Pic 16 Desc.	Sediment trap on the CIS of RO-287.

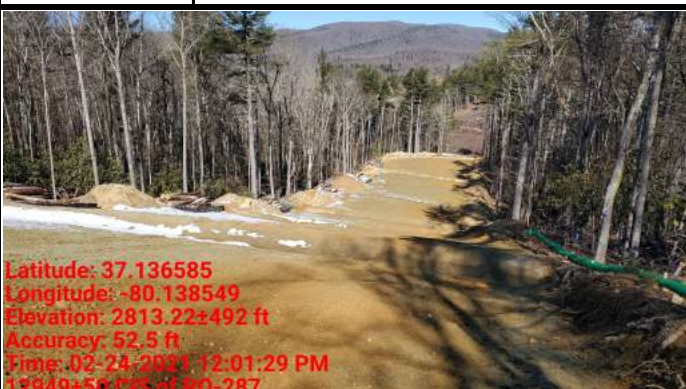
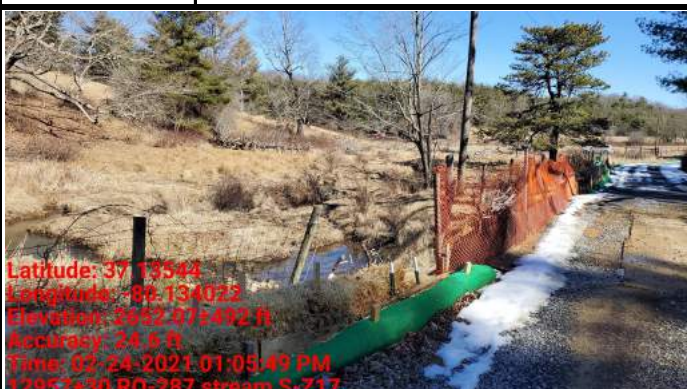
GPS Location	See pic for GPS location	GPS Location	See pic for GPS location
Field Station#	129495+50	Field Station#	12957+30
Pic 17 Desc.	Current ROW conditions on the GAS of stream S-IJ43.	Pic 18 Desc.	Access road RO-287 at stream S-Z17.

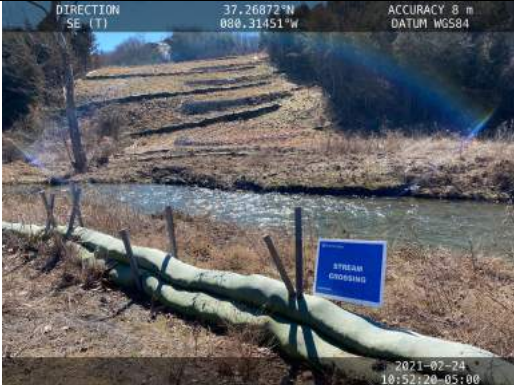
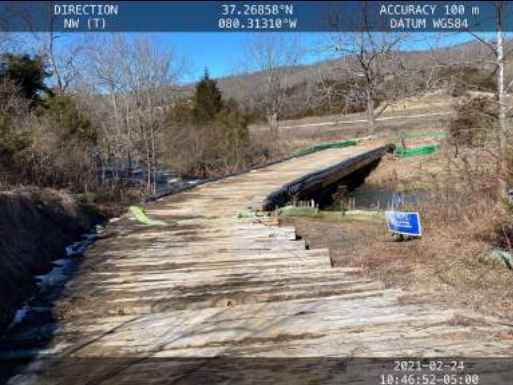
GPS Location	See photo	GPS Location	See photo		
Field Station#	12008+64	Field Station#	12013+97		
Pic 1 Desc.	Stream S-G36, facing southeast	Pic 2 Desc.	Bridge and ECDs in satisfactory condition at the stream crossing on access road MVP-MN-268.01.

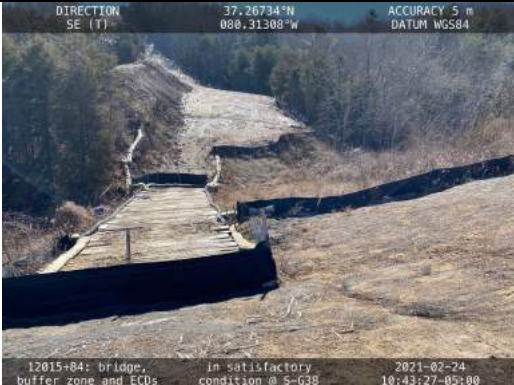
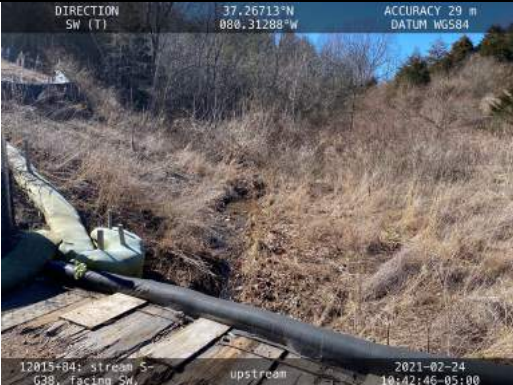
GPS Location	See photo	GPS Location	See photo		
Field Station#	12015+84	Field Station#	12015+84		
Pic 3 Desc.	Bridge, buffer zone and ECDs in satisfactory condition at stream S-G38.	Pic 4 Desc.	Stream S-G38, facing southwest, upstream

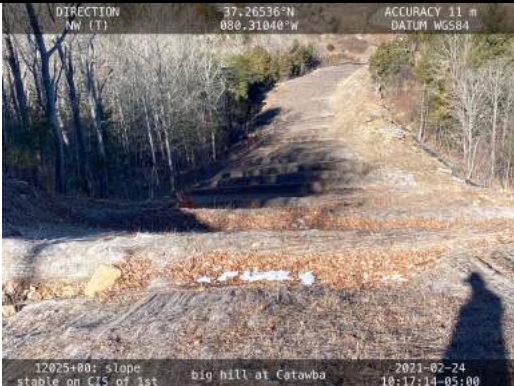
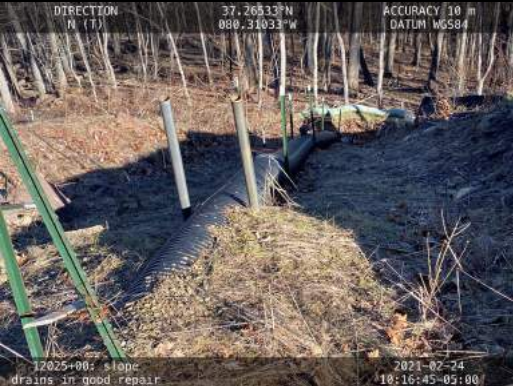
GPS Location	See photo	GPS Location	See photo		
Field Station#	12025+00	Field Station#	12025+00		
Pic 5 Desc.	Slope stable on coming in side of first significant hill at Catawba.	Pic 6 Desc.	Slope drains intact and functioning properly.

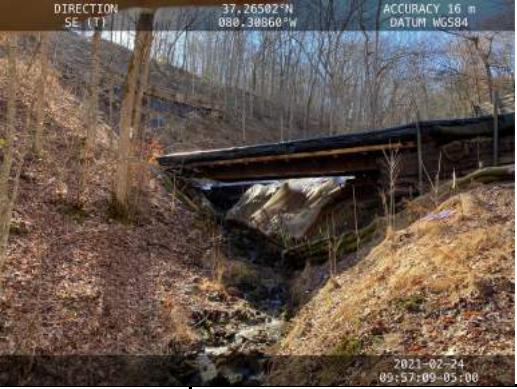
<p>DIRECTION SE (T) 37.26502°N 088.38868°W ACCURACY 16 m DATUM WGS84 12031+51: stream S-G39, facing southeast, upstream 2021-02-24 09:57:09-05:00</p>	
GPS Location	See photo	GPS Location	See photo
Field Station#	12031+51	Field Station#	12031+51
Pic 7 Desc.	Bridge, buffer zone, ECDs, and retaining walls in satisfactory condition at stream S-G39.	Pic 8 Desc.	Stream S-G39, facing southeast, upstream

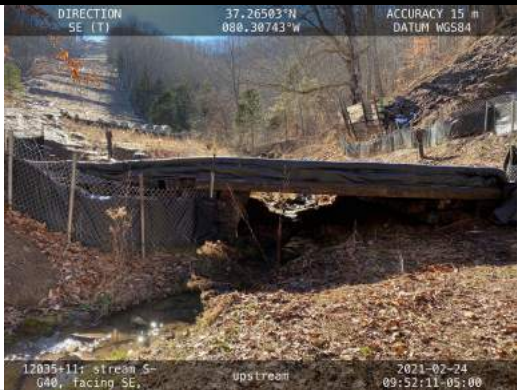
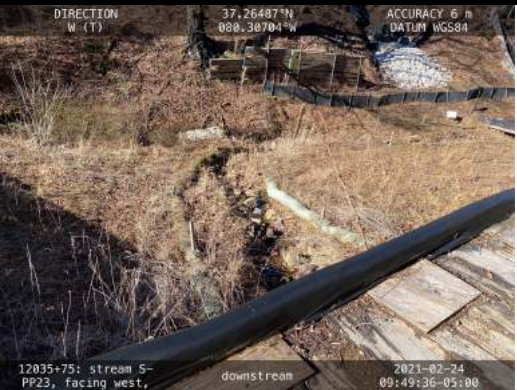
<p>DIRECTION SE (T) 37.26503°N 088.38743°W ACCURACY 15 m DATUM WGS84 12035+11: stream S-G40, facing SE, upstream 2021-02-24 09:52:11-05:00</p>

<p>DIRECTION W (T) 37.26487°N 088.38784°W ACCURACY 6 m DATUM WGS84 12035+75: stream S-PP23, facing west, downstream 2021-02-24 09:49:36-05:00</p>

GPS Location	See photo	GPS Location	See photo
Field Station#	12035+11	Field Station#	12035+75
Pic 9 Desc.	Stream S-G40, facing southeast, upstream	Pic 10 Desc.	Stream S-PP23, facing west, downstream

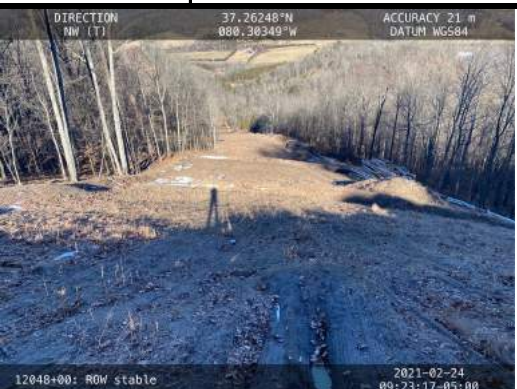
<p>DIRECTION NW (T) 37.26248°N 088.38349°W ACCURACY 21 m DATUM WGS84 12048+00: ROW stable 2021-02-24 09:23:17-05:00</p>	
GPS Location	See photo	GPS Location	See photo
Field Station#	12038+00	Field Station#	12048+00
Pic 11 Desc.	Plunge pool outlets remain in good condition on the clean water diversion pipe on the going away side of stream S-G40.	Pic 12 Desc.	ROW stable

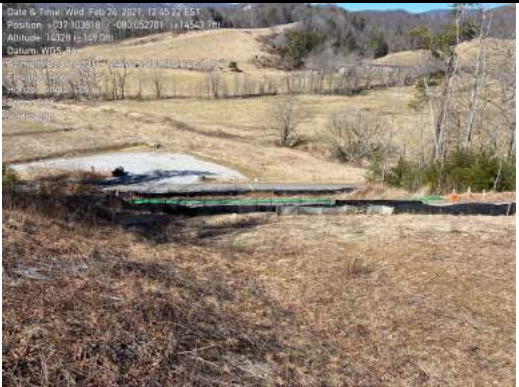
GPS Location	See photo for coordinates.		GPS Location	See photo for coordinates.	
Field Station#	13318+00		Field Station#	13320+00	
Pic 1 Desc.	Wades Gap road crossing, private driveway in acceptable condition.		Pic 2 Desc.	ROW stabilized, ECDs functioning acceptably along S-GH15.

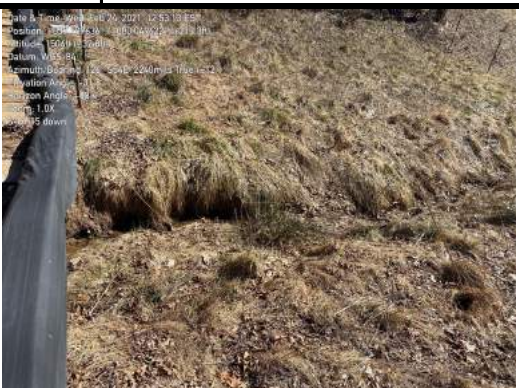
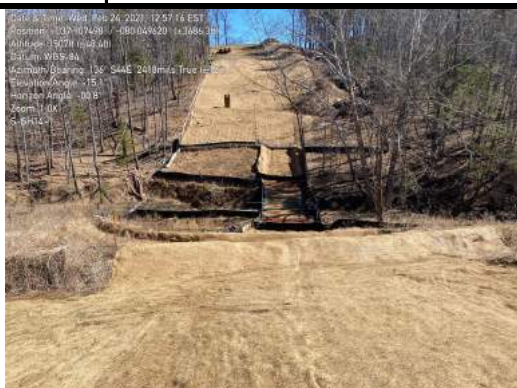
GPS Location	See photo for coordinates.		GPS Location	See photo for coordinates.	
Field Station#	13321+47		Field Station#	13324+00	
Pic 3 Desc.	S-GH15, downstream, banks well vegetated and appeared stable.		Pic 4 Desc.	S-GH14, ROW stabilized on both sides of stream crossing, ECDs in acceptable condition.
