Visual Site Inspection Report

Project Name H-600 Pipeline Spread H		AFE 124300138	Spread H-600 Pipeline Spread H
Contractor Precision		Report # 20247	
Inspector John Brcic		Date/Time 2/20/2021 1:37 PM	
Permit # TBD	Inspection Type VA SWPP	Station Begin 12284+75	
State VA	Inspection Area Partial	Station End 12443+75	
County Montgomery	Ground Frozen	Temperature (°F) 30.00	
Municipality N/A	Weather Sunny	Rain Gauge (in) 0.00	
			Rain Accumulation Time (days) 1.00

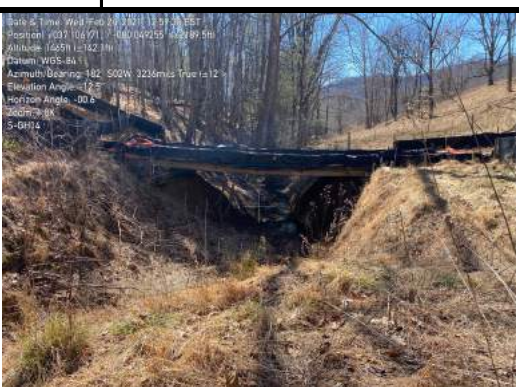
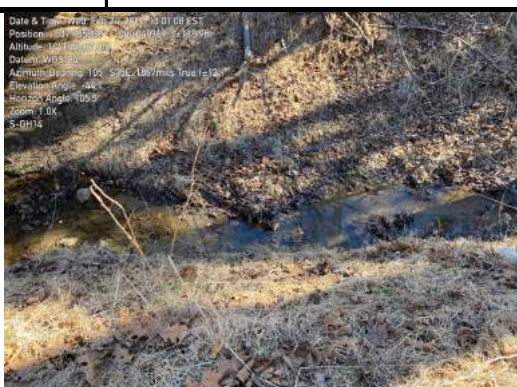
Field Station#	13325+30		Field Station#	13325+30	
Pic 5 Desc.	S-GH14, upstream side of bridge, bridge in acceptable condition, stream banks appeared stable.		Pic 6 Desc.	S-GH14, water flowing clear downstream of equipment bridge.

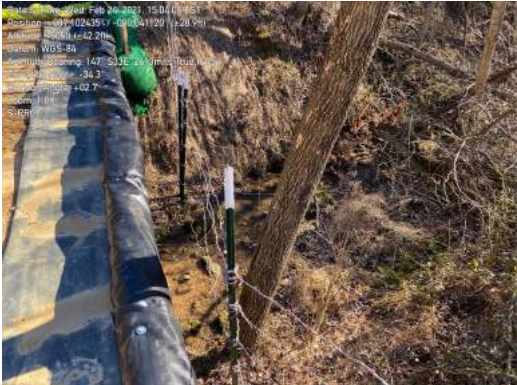
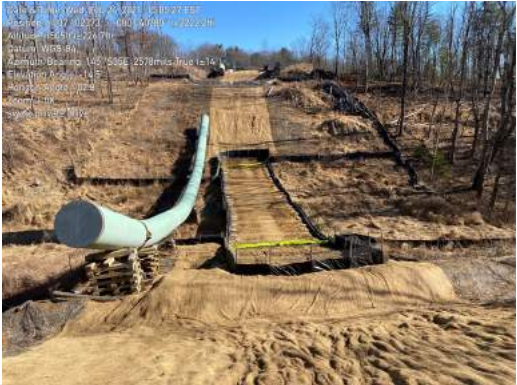
GPS Location	See photo for coordinates.	GPS Location	See photo for coordinates.
Field Station#	13352+23	Field Station#	13355+00
Pic 15 Desc.	S-RR09, downstream, no ROW impacts noted at stream crossing, banks appeared stable.	Pic 16 Desc.	ROW stable, ECDs in acceptable condition, waterbars functioning acceptably.

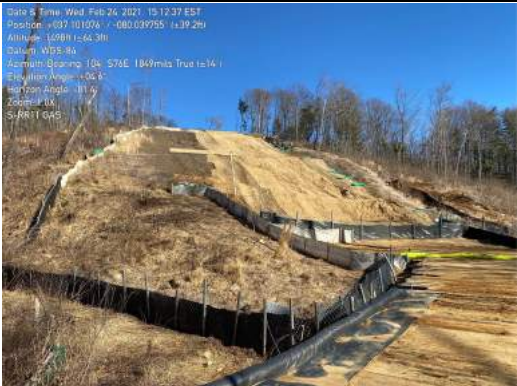
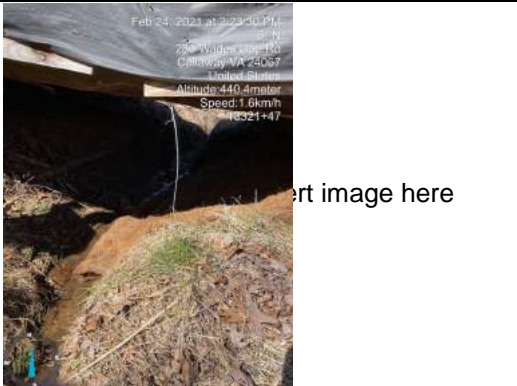
GPS Location	See photo for coordinates.	GPS Location	See photo for coordinates.
Field Station#	13359+00	Field Station#	13321+47
Pic 17 Desc.	ROW stabilized, ECDs in acceptable condition along S-RR11 stream crossing.	Pic 18 Desc.	Right descending bank of S-GH15 stabilized.

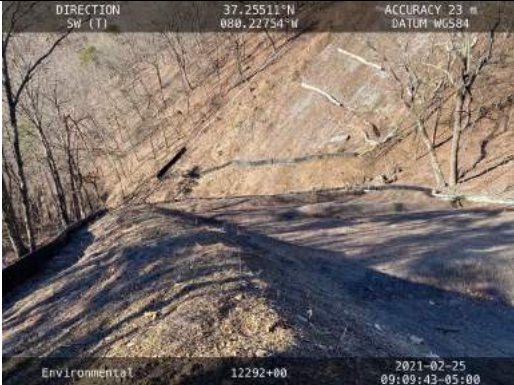
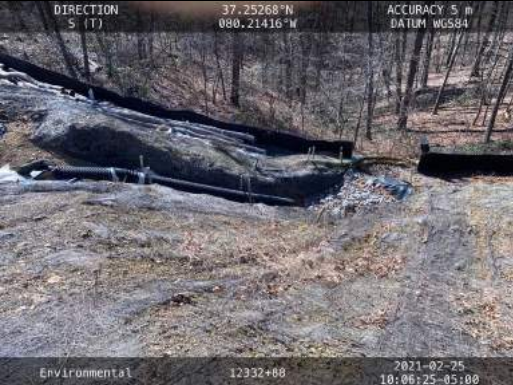
GPS Location	See photo		GPS Location	See photo	
Field Station#	12292+00		Field Station#	12332+88	
Pic 1 Desc.	The drainage feature in the bottom of the "Big V" remains stable.		Pic 2 Desc.	Slope drains in good repair and functioning properly between Reese Mountain and I-81.

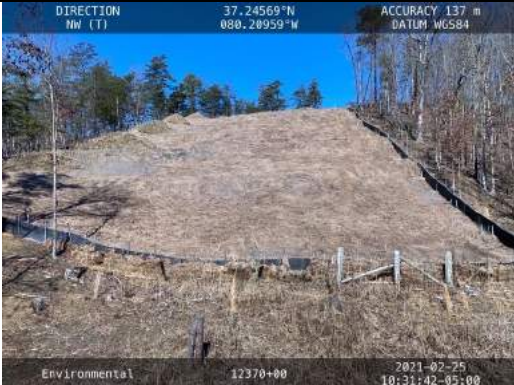
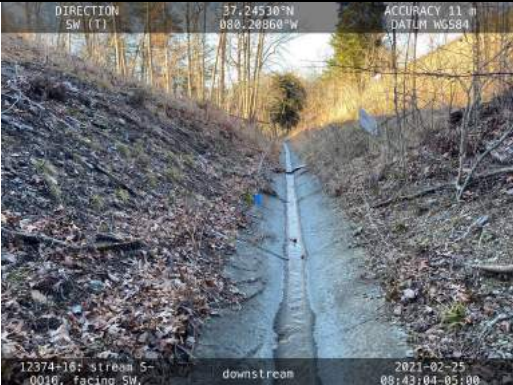
GPS Location	See photo		GPS Location	See photo	
Field Station#	12370+00		Field Station#	12374+16	
Pic 3 Desc.	Slope stable on coming in side of I-81.		Pic 4 Desc.	Stream S-0016, facing southwest, downstream

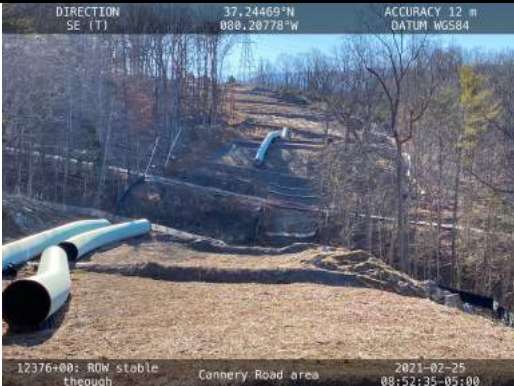
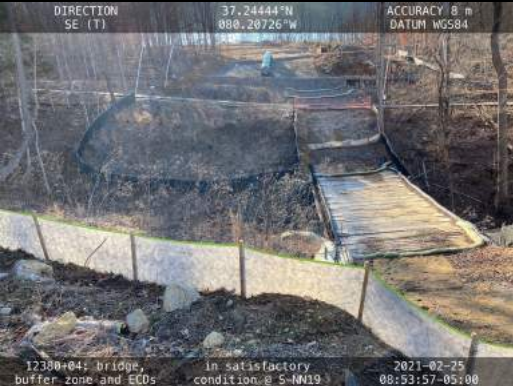
GPS Location	See photo		GPS Location	See photo	
Field Station#	12376+00		Field Station#	12380+04	
Pic 5 Desc.	ROW stable through Cannery Road area.		Pic 6 Desc.	Bridge, buffer zone and ECDs in satisfactory condition at stream S-NN16.

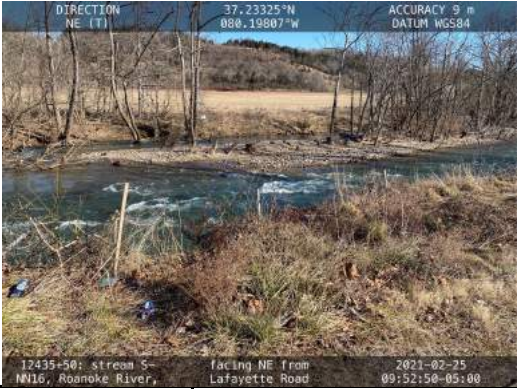
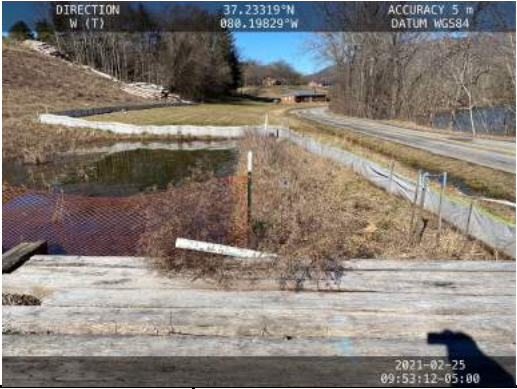
Pic 15 Desc.	Stream S-NN16, facing northeast from Lafayette Road.	Pic 16 Desc.	ECDs in satisfactory condition on going away side of Lafayette Road.

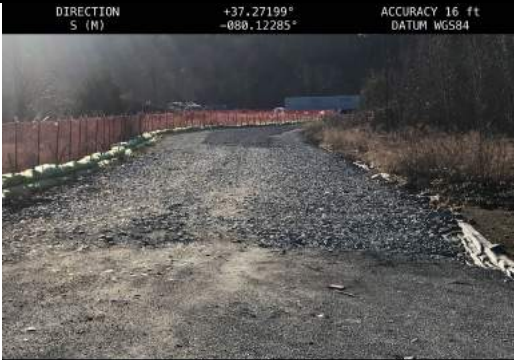
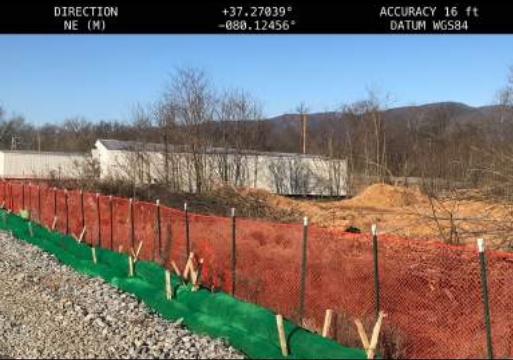
<p>DIRECTION NE (N) +37.27039° -080.12456° ACCURACY 16 ft DATUM WGS84</p> <p>MVP-LY-049_0225215 Landowner disturbance along feature 2021-02-25 08:56:02-05:00</p>			
GPS Location MVP-LY-049 See photo for gps data		GPS Location MVP-LY-049 See photo for gps data			
Field Station# +0		Field Station# +0			
Pic 1 Desc. Condition of rock entrance on center drive. No sediment on stone. Looking S.		Pic 2 Desc. Landowner soil disturbance along north edge of feature W-CV21A. Looking NE.

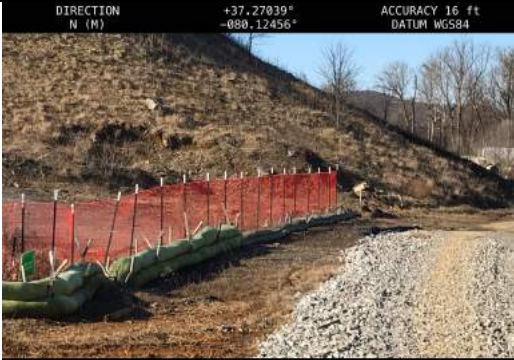
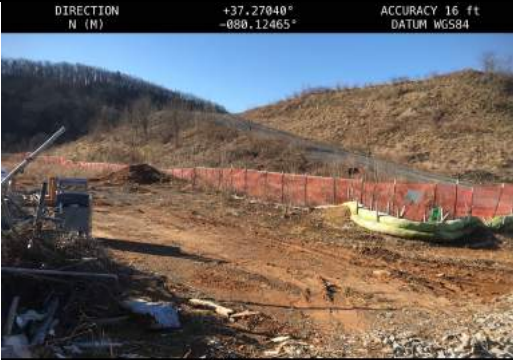
GPS Location MVP-LY-049 See photo for gps data		GPS Location MVP-LY-049 See photo for gps data			
Field Station# +0		Field Station# +0			
Pic 3 Desc. Landowner soil disturbance within 66' and 120' west of feature. Areas not stabilized. Looking W.		Pic 4 Desc. Landowner soil disturbance along compost filter sock and feature W-CV21B. Area not stabilized. No impacts. Looking SW.

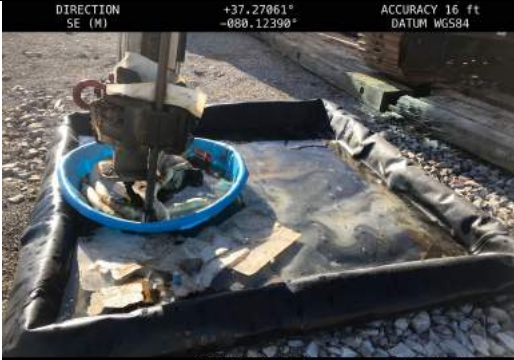
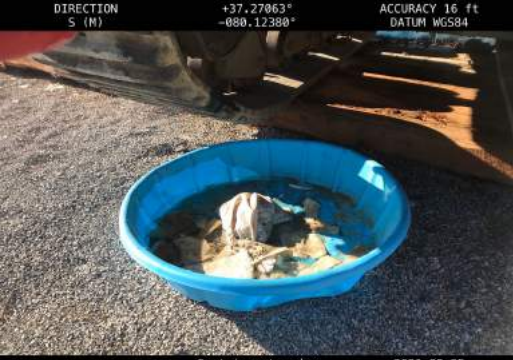
<p>DIRECTION S (N) +37.27063° -080.12380° ACCURACY 16 ft DATUM WGS84</p> <p>MVP-LY-049_022521 Containment under stored equipment 2021-02-25 08:58:04-05:00</p>			
GPS Location MVP-LY-049 See photo for gps data		GPS Location MVP-LY-049 See photo for gps data			
Field Station# +0		Field Station# +0			
Pic 5 Desc. Condition of containment under stored equipment. Looking SE.		Pic 6 Desc. Condition of containment under stored equipment. Looking S.

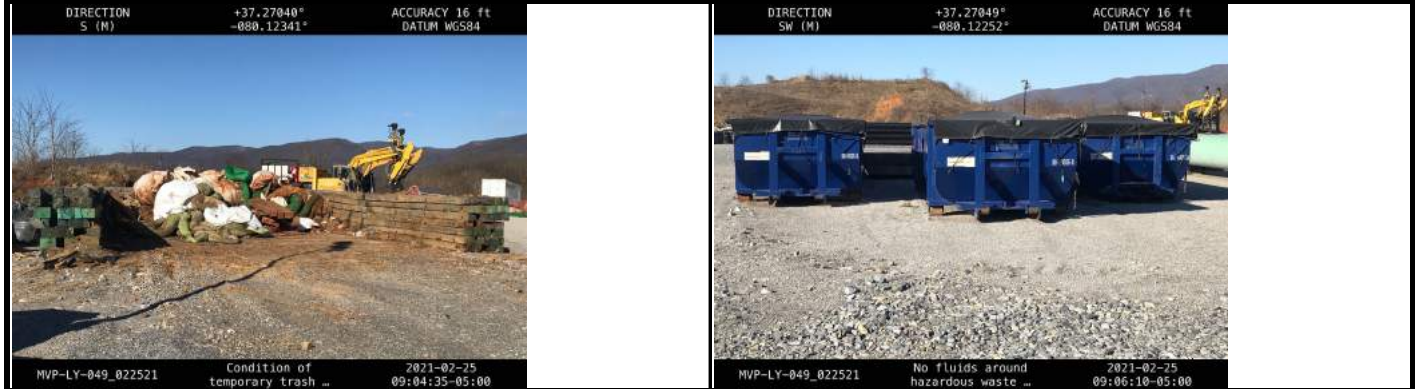
GPS Location	MVP-LY-049 See photo for gps data	GPS Location	MVP-LY-049 See photo for gps data
Field Station#	+0	Field Station#	+0
Pic 13 Desc.	Condition of temporary trash transfer pit. Debris inside boundary of pit. Looking NW.	Pic 14 Desc.	No fluids or deposits around hazardous waste dumpsters. Looking NW.

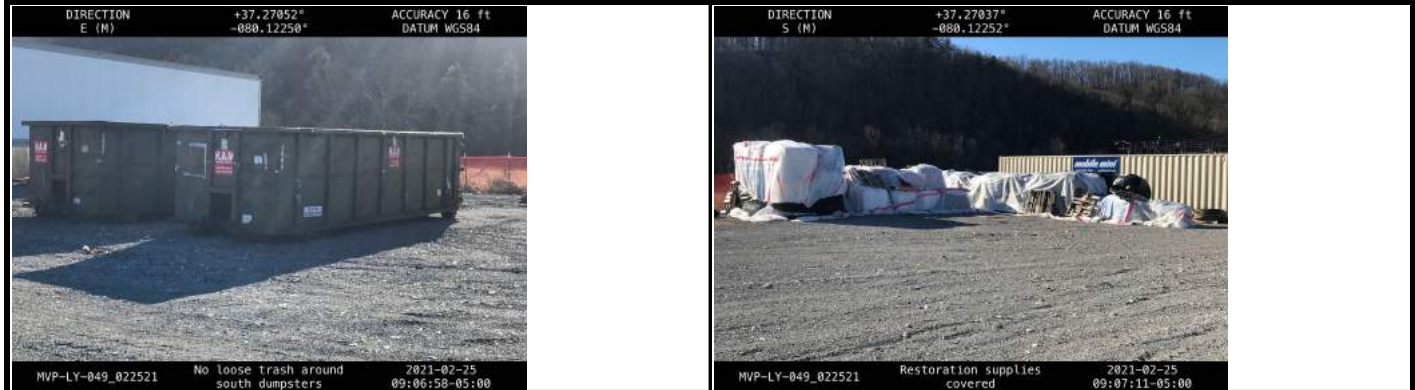
GPS Location	MVP-LY-049 See photo for gps data	GPS Location	MVP-LY-049 See photo for gps data
Field Station#	+0	Field Station#	+0
Pic 15 Desc.	No loose trash around south dumpsters or in yard. Looking S.	Pic 16 Desc.	Restoration supplies covered and protected from the elements. Looking SW.

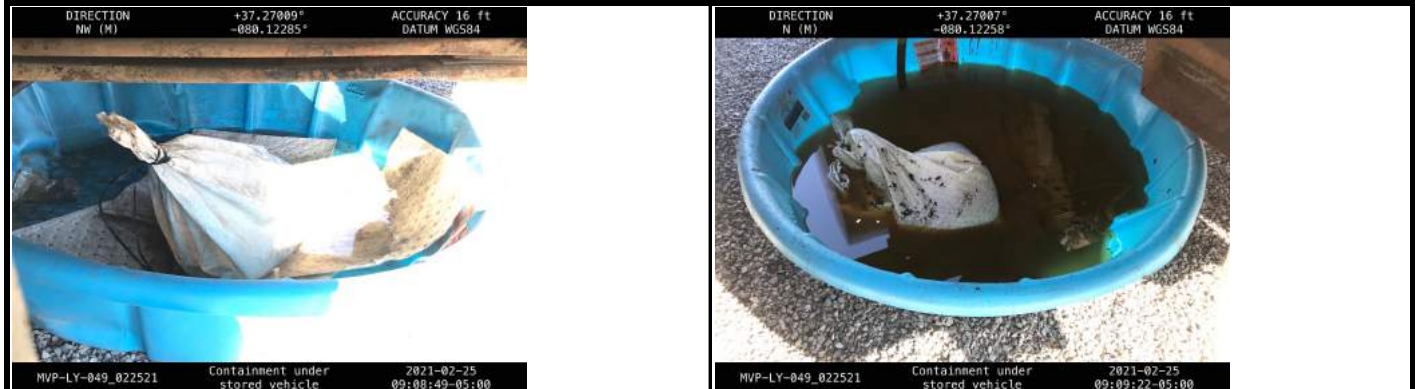
GPS Location	MVP-LY-049 See photo for gps data	GPS Location	MVP-LY-049 See photo for gps data
Field Station#	+0	Field Station#	+0
Pic 17 Desc.	Condition of containment under stored vehicle. Looking N.	Pic 18 Desc.	Condition of containment under stored vehicle. Looking N.

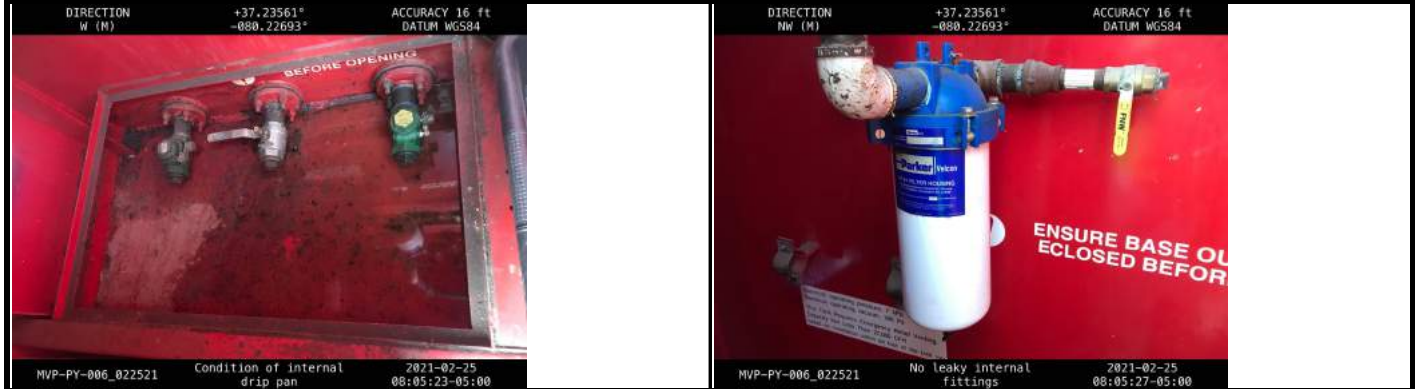
GPS Location MVP-PY-006 See photo for gps data	GPS Location MVP-PY-006 See photo for gps data
Field Station# +0	Field Station# +0
Pic 13 Desc. Off Road Fuel unit condition of internal drip pan. Looking W.	Pic 14 Desc. Off Road Fuel unit no leaky internal fittings. Looking NW.

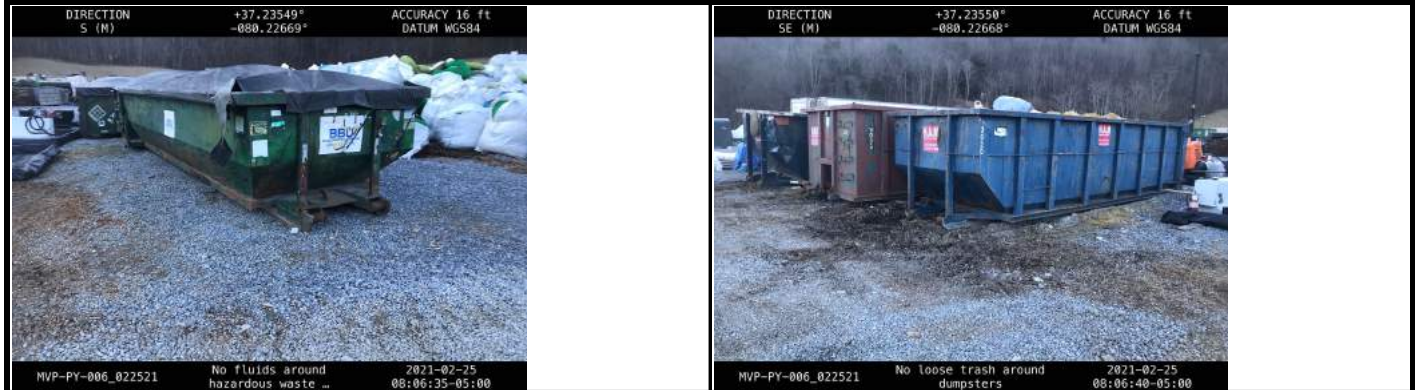
GPS Location MVP-PY-006 See photo for gps data	GPS Location MVP-PY-006 See photo for gps data
Field Station# +0	Field Station# +0
Pic 15 Desc. No fluids or deposits around hazardous waste dumpsters. Looking S.	Pic 16 Desc. No loose trash around dumpsters or in the yard. Looking SE.

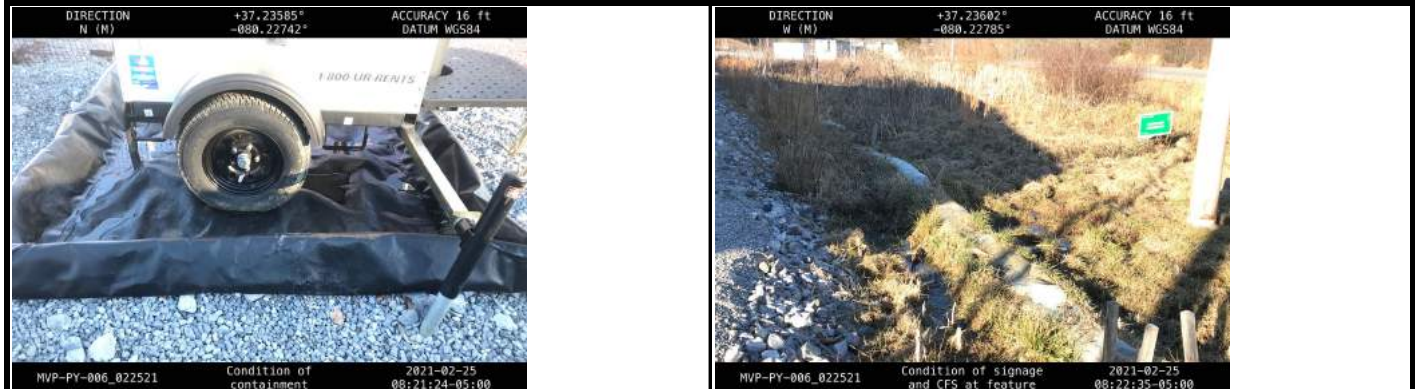
GPS Location MVP-PY-006 See photo for gps data	GPS Location MVP-PY-006 See photo for gps data
Field Station# +0	Field Station# +0
Pic 17 Desc. Condition of containment under light plant. Free of stormwater. Looking N.	Pic 18 Desc. Condition of signage and compost filter sock along feature W-008. Looking W.

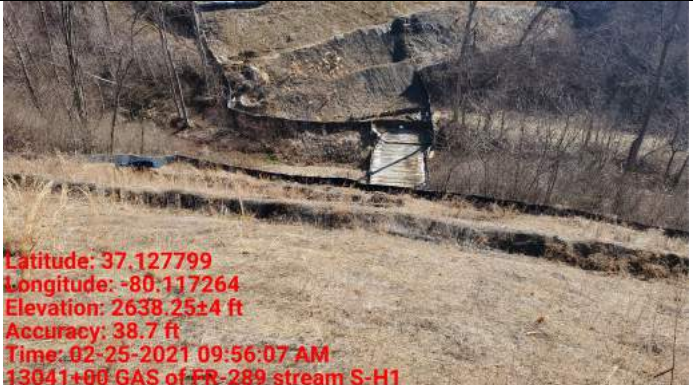
GPS Location	See pic for GPS location	GPS Location	See pic for GPS location
Field Station#	13025+50	Field Station#	13041+00
Pic 1 Desc.	Streams S-G24 and S-G25 on the GAS of the BRP.	Pic 2 Desc.	Stream S-H1 on the GAS of FR-289.

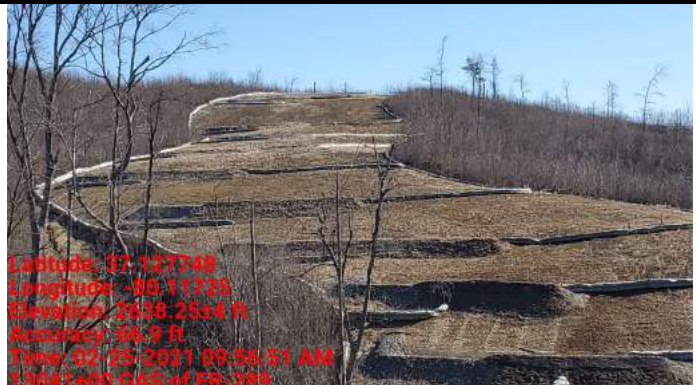
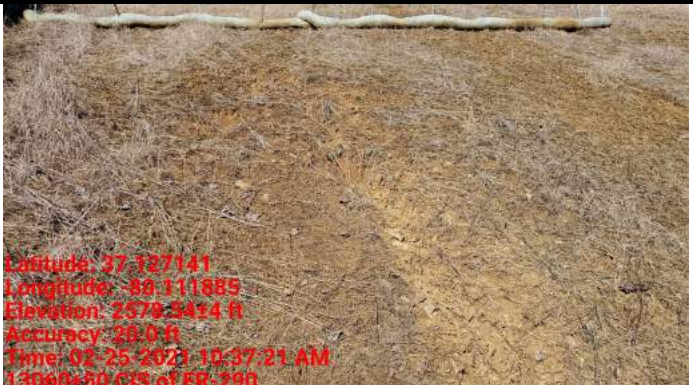
GPS Location	See pic for GPS location	GPS Location	See pic for GPS location
Field Station#	13041+00	Field Station#	13060+50
Pic 3 Desc.	Restored ROW on the GAS of stream S-H1.	Pic 4 Desc.	Erosion rills on the CIS of FR-290 added to the Punch List to be corrected by the contractor.

E&S BMPs	Compliance Level	Corrective Action	Corrective Time Frame	Date Repaired
Vegetative Stabilization (Permanent)	Communication	Repair erosion rills and curlex	Addressed	2/25/2021
Waterbar	Acceptable			
Waterbar End Treatment	Acceptable			
Sump Pit	Acceptable			
Compost Filter Sock	Acceptable			
Silt Fence (Filter Fabric Fence)	Acceptable			
Silt Fence (Reinforced Filter Fabric Fence)	Acceptable			
Rock Construction Entrance	Acceptable			
Equipment Bridge	Acceptable

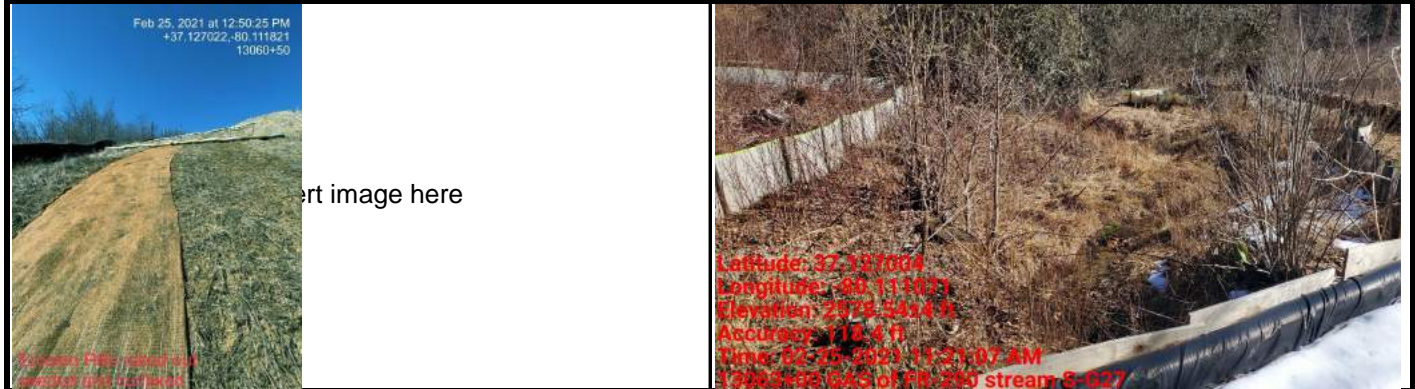
GPS Location	See pic for GPS location	GPS Location	See pic for GPS location
Field Station#	13060+50	Field Station#	13063+00
Pic 7 Desc.	Erosion rills on the CIS of FR-290 raked out, seeded and stabilized with Erosion Control Blanket by the contractor.	Pic 8 Desc.	Upstream side of stream S-G27.

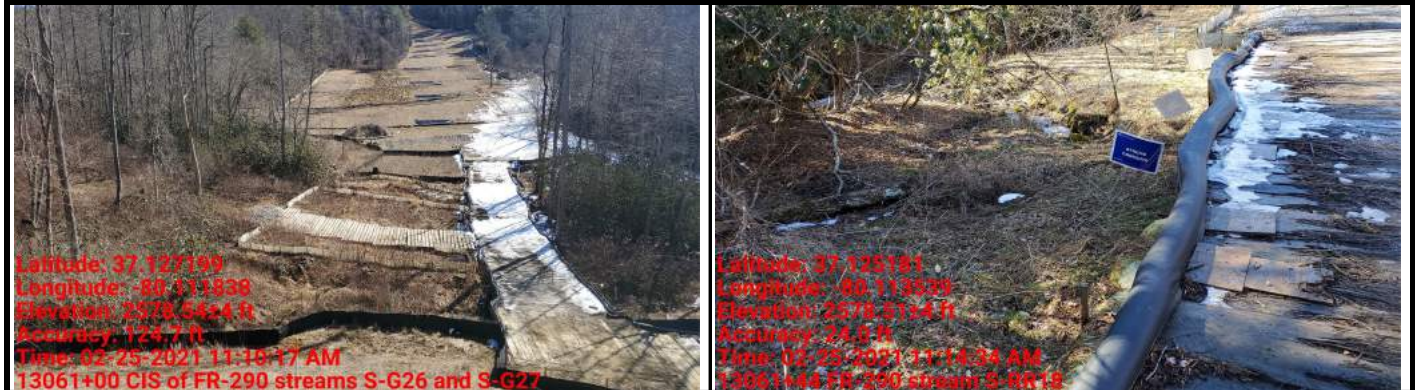
GPS Location	See pic for GPS location	GPS Location	See pic for GPS location
Field Station#	13061+00	Field Station#	13061+44
Pic 9 Desc.	Streams S-G26 and S-G27 from the CIS of FR-290.	Pic 10 Desc.	Downstream side of Stream S-RR18 on access road FR-290

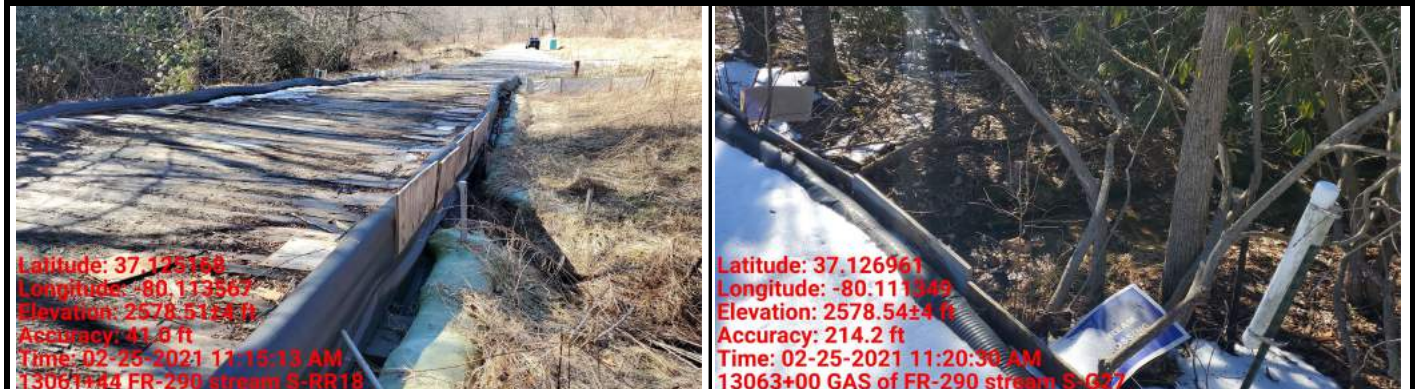
GPS Location	See pic for GPS location	GPS Location	See pic for GPS location
Field Station#	13061+44	Field Station#	13063+00
Pic 11 Desc.	Upstream side of stream S-RR18 on access road FR-290.	Pic 12 Desc.	Downstream side of stream S-G27.

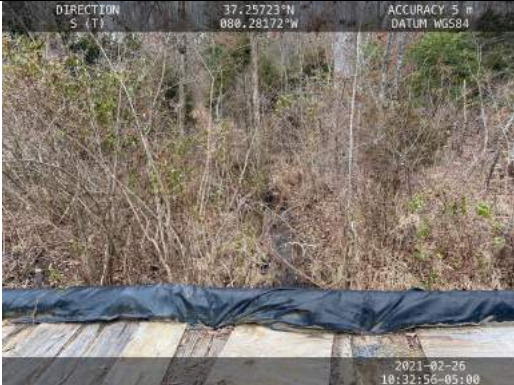
GPS Location See photo		GPS Location See photo			
Field Station# 12121+33		Field Station# 12121+83			
Pic 1 Desc. Stream S-C33, facing south, downstream		Pic 2 Desc. Stream S-C36, facing south, downstream

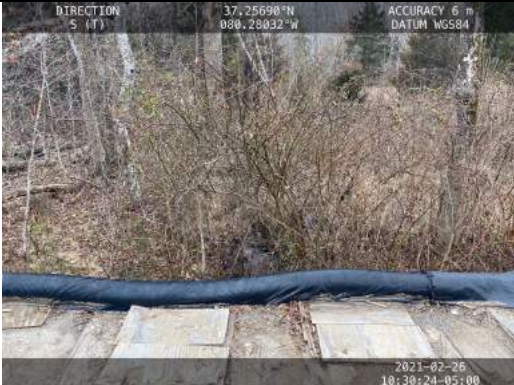
GPS Location See photo		GPS Location See photo			
Field Station# 12125+65		Field Station# 12132+73			
Pic 3 Desc. Stream S-MM31, facing south, downstream		Pic 4 Desc. Bridge, buffer zone and ECDs in satisfactory condition at stream S-C29.

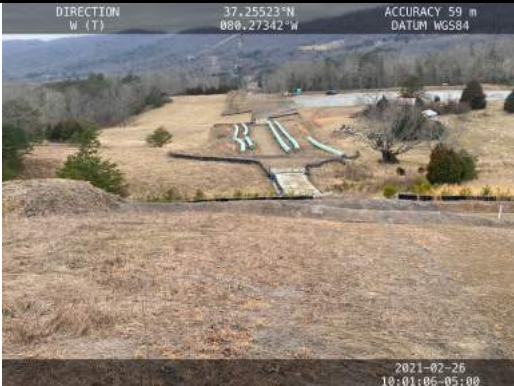
GPS Location See photo		GPS Location See photo			
Field Station# 12146+00		Field Station# 12148+00			
Pic 5 Desc. ROW stable.		Pic 6 Desc. Ravine stable between access roads MVP-MN-272 & 273.

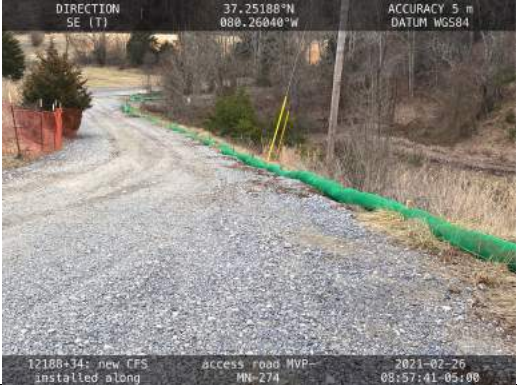
<p>DIRECTION SE (T) 37.25188°N 880.26040°W ACCURACY 5 m DATUM WGS84 12188+34: new CFS installed along access road MVP-MN-274 2021-02-26 08:57:41-09:00</p>	
GPS Location	See photo	GPS Location	See photo
Field Station#	12188+45	Field Station#	12188+34
Pic 13 Desc.	Area rutted by AEP contractor next to where access road MVP-MN-274 crosses the ROW was seeded and mulched.	Pic 14 Desc.	Old CFS was replaced with new CFS alongside access road MVP-MN-274.

Stations 12119+17 to 12284+75.....Activity since last SWPPP inspection. An environmental crew replaced old 12 inch CFS between stations 12184+00 and 12188+00, next to the AEP access road. They also replaced CFS alongside access road MVP-MN-274. An area that was rutted by the AEP contractor next to access road MVP-MN-274 where it crosses the ROW was seeded and mulched. CFS was replaced on the turnout on access road MVP-MN-276.03 approximately 500 feet past the gate.

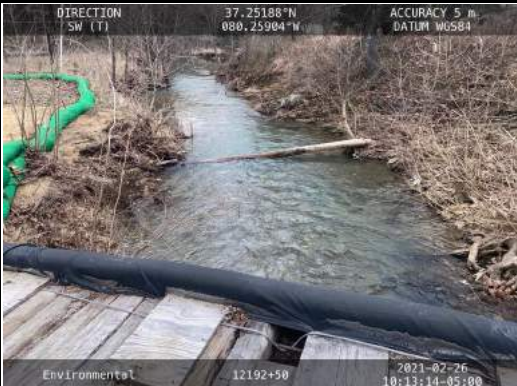
GPS Location	See photo	GPS Location	See photo
Field Station#	12192+50	Field Station#	12196+24
Pic 15 Desc.	Stream S-C21, Bradshaw Creek, facing southwest, downstream	Pic 16 Desc.	Stream S-0011, facing west, downstream

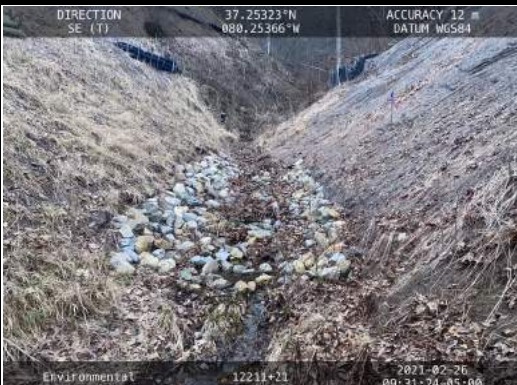
<p>DIRECTION E (T) 37.25309°N 880.25380°W ACCURACY 11 m DATUM WGS84 Environmental 12213+50 2021-02-26 09:32:34-05:00</p>	
GPS Location	See photo	GPS Location	See photo
Field Station#	12211+21	Field Station#	12213+50
Pic 17 Desc.	Drainage feature in bottom of the ravine between Bradshaw Road and Reese Mountain remains stable where it was armored with rock	Pic 18 Desc.	Permanent restoration remains stable between Bradshaw Road and the switchback on Reese Mountain.

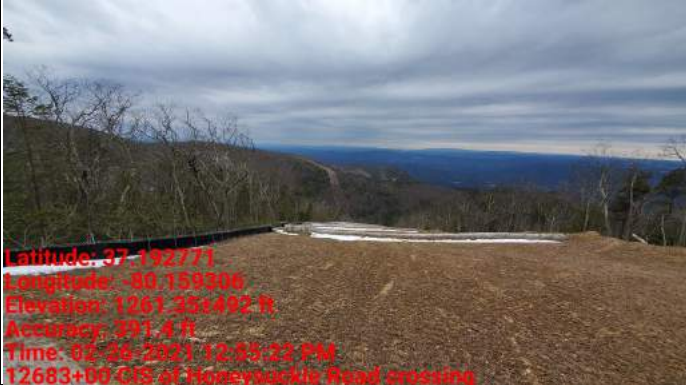
<p>Latitude: 37.185465 Longitude: -80.148387 Elevation: 796.89±492 ft Accuracy: 12.5 ft Time: 02-26-2021 02:24:50 PM 12728+74 RO-281 ATWS-1536</p>		
GPS Location	See pic for GPS location		GPS Location	See pic for GPS location	
Field Station#	12683+00		Field Station#	12728+74	
Pic 13 Desc.	Current ROW conditions on the CIS of Honeysuckle Road.		Pic 14 Desc.	No maintenance issues or impacts observed on RO-281 at the ROW.

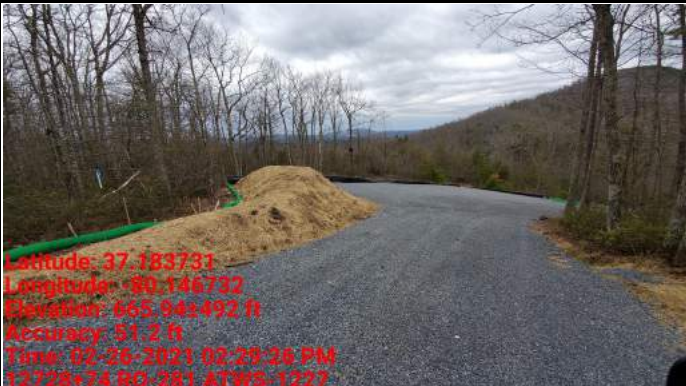
GPS Location	See pic for GPS location		GPS Location	See pic for GPS location	
Field Station#	12728+74		Field Station#	12728+74	
Pic 15 Desc.	ECD's and BMP's remain in compliance along RO-281.		Pic 16 Desc.	No stream impacts observed at S-EF32.

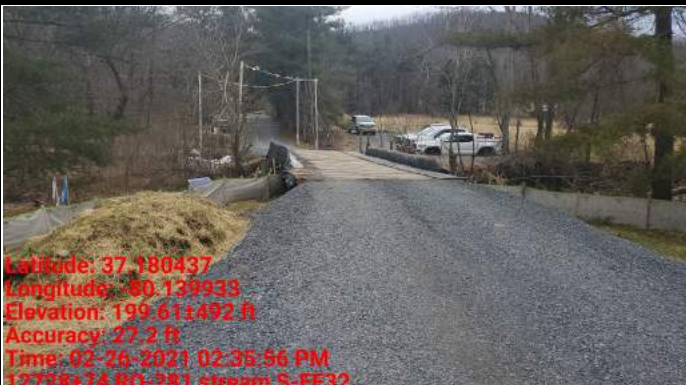
<p>Latitude: 37.155324 Longitude: -80.128849 Elevation: 2530.09±10 ft Accuracy: 38.5 ft Time: 02-26-2021 02:47:26 PM 12866+26 GAS of Bottom Creek Road</p>		
GPS Location	See pic for GPS location		GPS Location	See pic for GPS location	
Field Station#	12728+74		Field Station#	12866+26	
Pic 17 Desc.	Access road RO-281 at Poor Mountain Road.		Pic 18 Desc.	GAS of the Bottom Creek Road crossing.
