Visual Site Inspection Report

Project Name H-600 Pipeline Spread H		AFE 124300138	Spread H-600 Pipeline Spread H
Contractor Precision		Report # 19823	
Inspector Jason Nielsen		Date/Time 2/8/2021 4:11 PM	
Permit # TBD	Inspection Type VA SWPP	Station Begin	12005+00
State VA	Inspection Area Partial	Station End	12119+17
County Montgomery	Ground Wet	Temperature (°F)	40.00
Municipality N/A	Weather Sunny	Rain Gauge (in)	0.30
			Rain Accumulation Time (days) 1.00

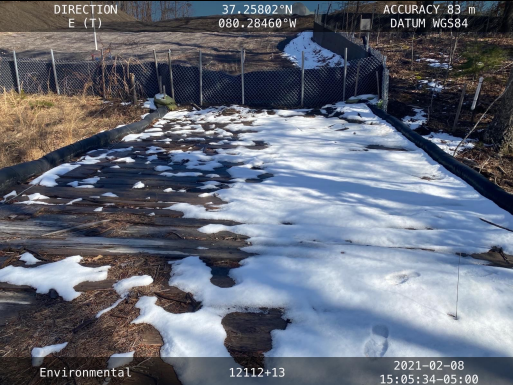
AFE 124300138		Date/Time 2/8/2021 4:11 PM		Report #	
Pictures					
  <p>DIRECTION SE (T) 37.25766°N 080.28352°W ACCURACY 35 m DATUM WGS84</p> <p>Environmental 12117+00 2021-02-08 15:07:37-05:00</p>

<p>DIRECTION E (T) 37.25802°N 080.28460°W ACCURACY 83 m DATUM WGS84</p> <p>Environmental 12112+13 2021-02-08 15:05:34-05:00</p>	
GPS Location See photo		GPS Location See photo			
Field Station# 12117+00		Field Station# 12112+13			
Pic 1 Desc. Stabilized drainage feature		Pic 2 Desc. Bridge and ECDs at S-F16ab

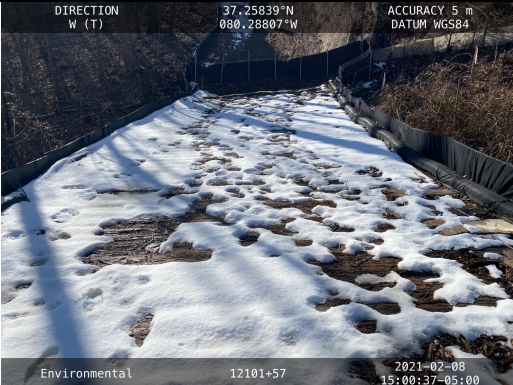
<p>DIRECTION E (T) 37.23496°N 080.27036°W ACCURACY 2.06 km DATUM WGS84</p> <p>Environmental 12108+41 2021-02-08 15:03:45-05:00</p>

<p>DIRECTION W (T) 37.25839°N 080.28807°W ACCURACY 5 m DATUM WGS84</p> <p>Environmental 12101+57 2021-02-08 15:00:37-05:00</p>			
GPS Location See photo		GPS Location See photo			
Field Station# 12108+41		Field Station# 12101+57			
Pic 3 Desc. Bridge and ECDs at S-F15		Pic 4 Desc. Bridge and ECDs at stream crossing S-MM11

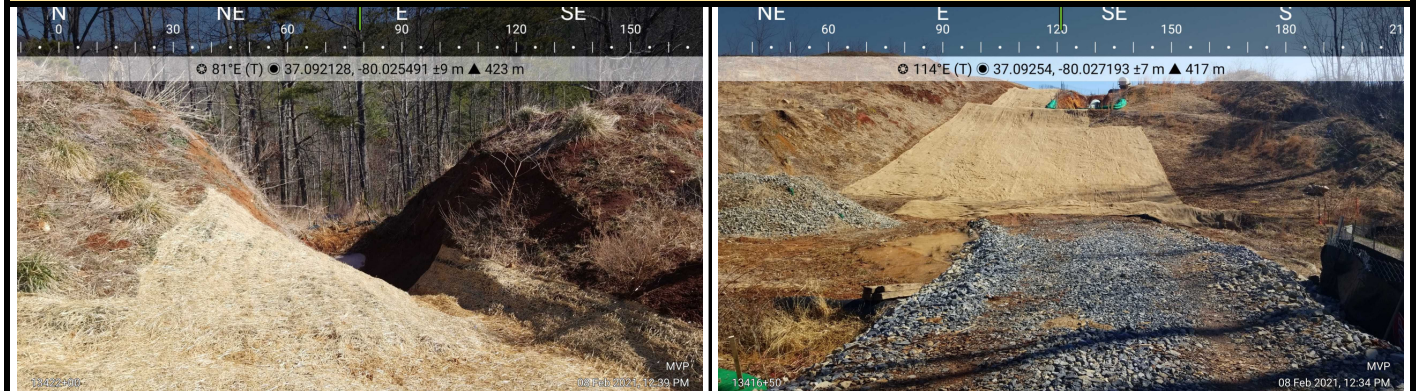
Field Station#	13422+00	Field Station#	13416+50
-----------------------	----------	-----------------------	----------

Pic 1 Desc.	ROW Overview. ECDs are functional and ROW is stable.	Pic 2 Desc.	ROW Overview. ECDs are functional and ROW is stable.
--------------------	--	--------------------	--

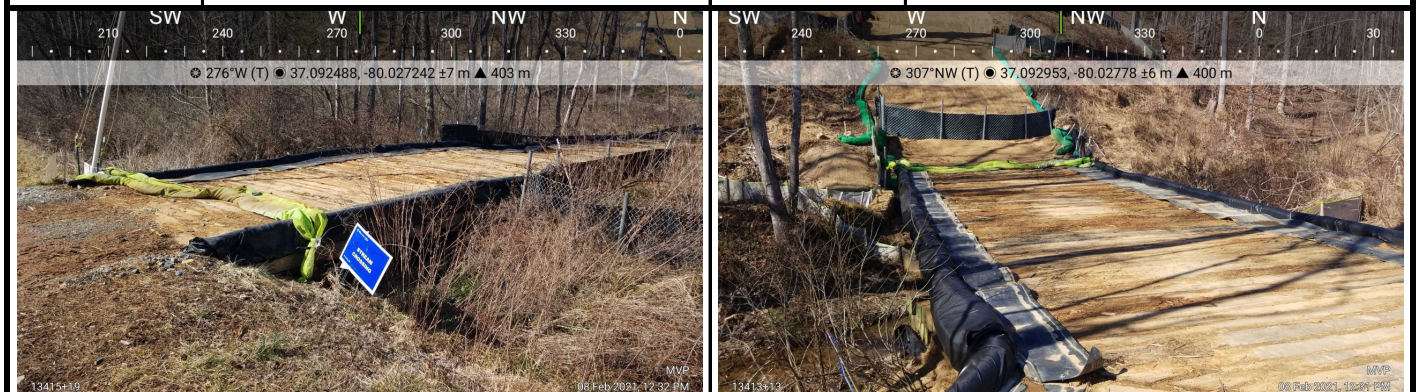
Field Station#	13415+19	Field Station#	13413+13
-----------------------	----------	-----------------------	----------

Pic 3 Desc.	Overview of Waterbody S-IJ3. ECDs are functional and ROW is stable.	Pic 4 Desc.	Overview of Waterbody S-IJ1. ECDs are functional and ROW is stable.
--------------------	---	--------------------	---

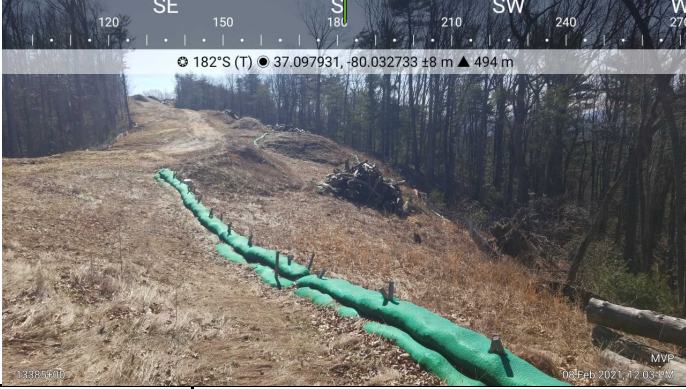
GPS Location	See Above	GPS Location	See Above
Field Station#	13385+00	Field Station#	13367+00
Pic 7 Desc.	ROW Overview. ECDs are functional and ROW is stable.	Pic 8 Desc.	ROW Overview. ECDs are functional and ROW is stable.

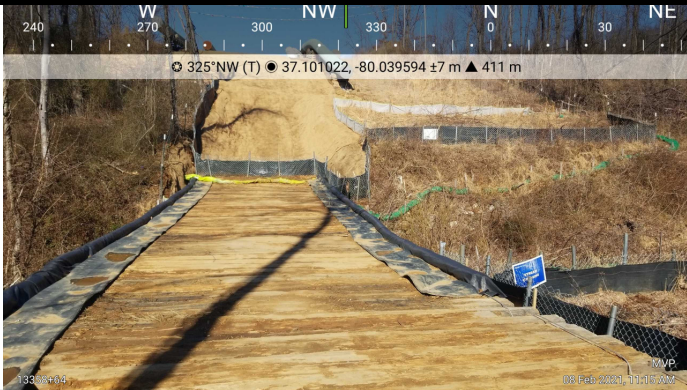
This section of right of way received 0.3" precipitation in the last 24 hours and has received 0.3" precipitation for the week thus far. One new 72 hour internal punchlist item was added today (see photo below). All other observed erosion control devices (ECDs) and best management practices (BMPS) are in satisfactory condition and continue to function properly. ROW remains stable throughout the inspection area.

GPS Location	See Above	GPS Location	See Above
Field Station#	13363+00	Field Station#	13358+64
Pic 9 Desc.	Punchlist item: Repair super silt fence.	Pic 10 Desc.	Overview of Waterbody S-RR11. ECDs are functional and ROW is stable.

E&S BMPs	Compliance Level	Corrective Action	Corrective Time Frame	Date Repaired
Compost Filter Sock	Acceptable			
Silt Fence (Filter Fabric Fence)	Acceptable			
Silt Fence (Reinforce Filter Fence)	Communication	ST 13363+00 repair super silt fence		
Sump Pit	Acceptable			
Waterbar	Acceptable			
Waterbar End Treatment	Acceptable			
Equipment Bridge	Acceptable			
Cleanwater Diversion Pipe	Acceptable			
Rock Construction Entrance	Acceptable

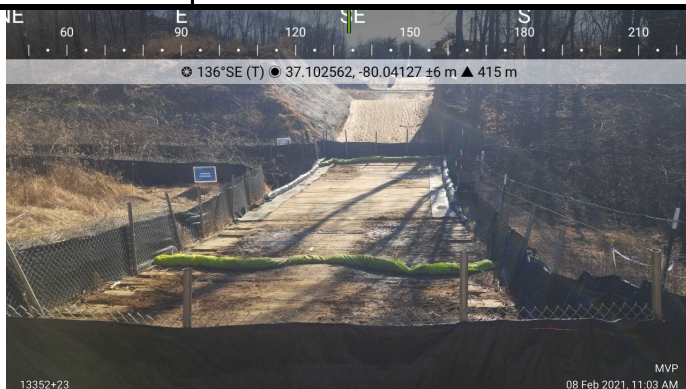
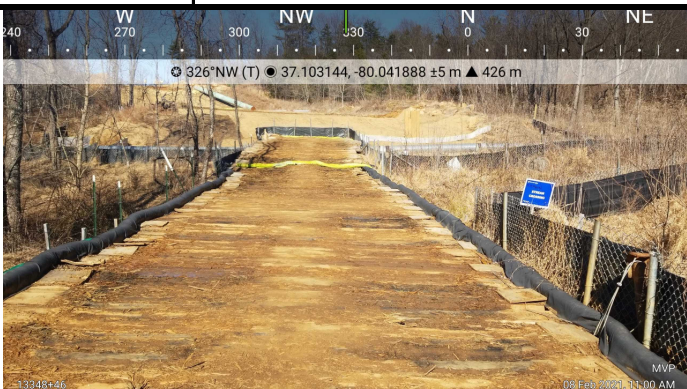
GPS Location	See Above	GPS Location	See Above
Field Station#	13352+23	Field Station#	13348+46
Pic 11 Desc.	Overview of Waterbody S-RR09. ECDs are functional and ROW is stable.	Pic 12 Desc.	Overview of Waterbody S-RR08. ECDs are functional and ROW is stable.

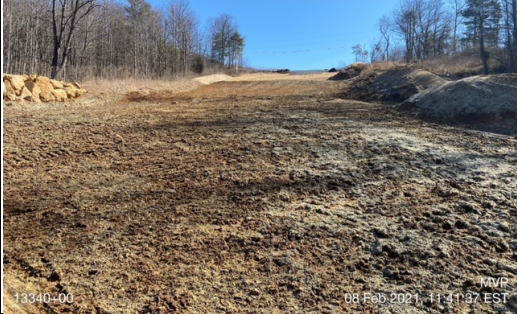
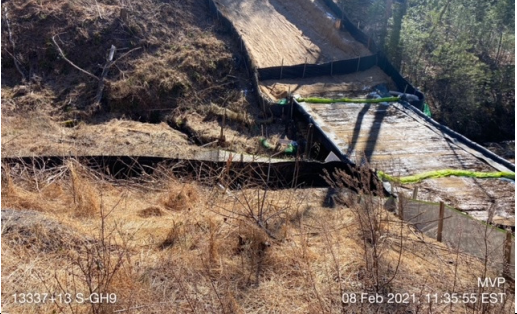
GPS Location		See Above		GPS Location	
Field Station#		13340+00		Field Station#	
Pic 13 Desc.		ROW Overview. ECDs are functional and ROW is stable.		Pic 14 Desc.	
				Overview of Waterbody S-GH9. ECDs are functional and ROW is stable.	
North West Elevation 127°SE (T) 37°6'17"N, 80°2'46"W ±19ft ▲ 1485ft

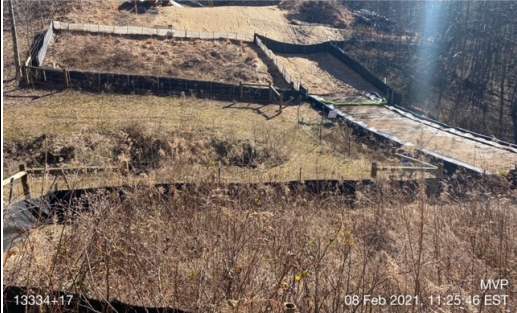
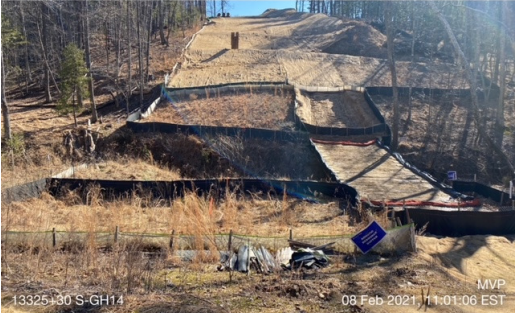
GPS Location		See Above		GPS Location	
Field Station#		13334+17		Field Station#	
Pic 15 Desc.		Overview of Waterbody S-GH11. ECDs are functional and ROW is stable.		Pic 16 Desc.	
				Overview of Waterbody S-GH14. ECDs are functional and ROW is stable.	
North Elevation 190°S (T) 37°6'21"N, 80°3'0"W ±13ft ▲ 1440ft

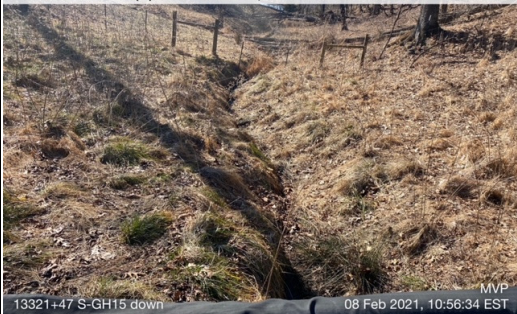
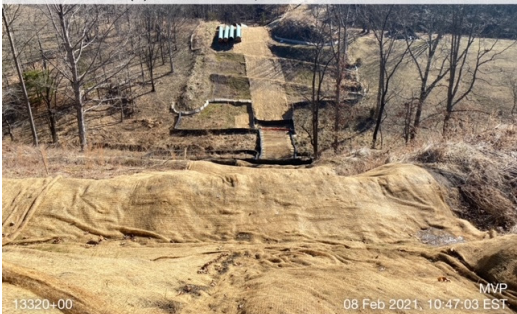
GPS Location		See Above		GPS Location	
Field Station#		13321+47		Field Station#	
Pic 17 Desc.		Downstream view of Waterbody S-GH15. ECDs are functional and ROW is stable.		Pic 18 Desc.	
				ROW Overview. ECDs are functional and ROW is stable.

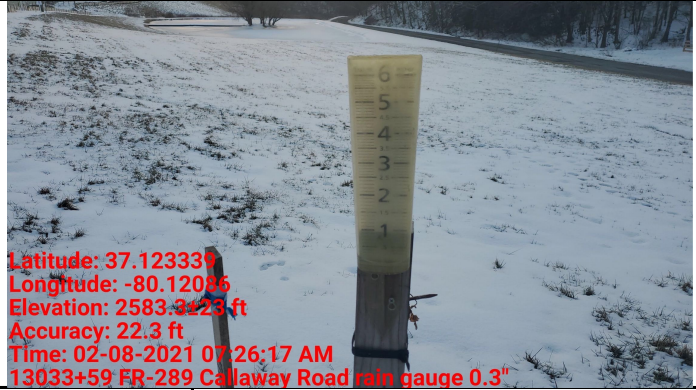
Latitude: 37.123339 Longitude: -80.12085 Elevation: 2583.3±23 ft Accuracy: 22.3 ft Time: 02-08-2021 07:26:17 AM 13033+59 FR-289 Callaway Road rain gauge 0.3"

Latitude: 37.125534 Longitude: -80.123477 Elevation: 2805.77±27 ft Accuracy: 29.9 ft Time: 02-08-2021 07:42:46 AM 13018+00 GAS of the BRP
GPS Location See pic for GPS location	GPS Location See pic for GPS location
Field Station# 13033+59	Field Station# 13018+00
Pic 1 Desc. 0.3" total precipitation after melting ice in the rain gauge.	Pic 2 Desc. Wooded portion of the BRP on the GAS of the motorway.

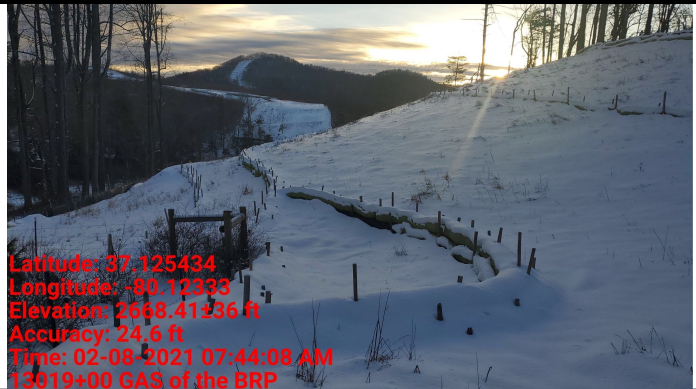
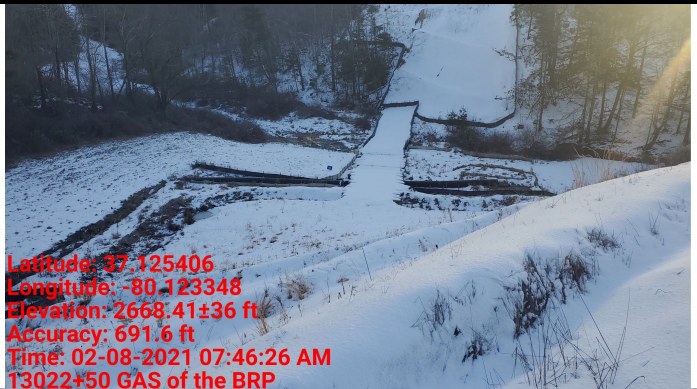
Field Station# 13019+00	Field Station# 13022+50
Pic 3 Desc. Permanent restoration has been performed.	Pic 4 Desc. Streams S-G24 and S-G25 on the GAS of the BRP property.

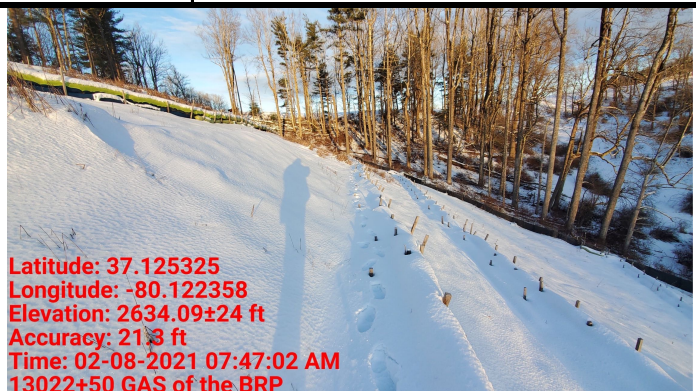
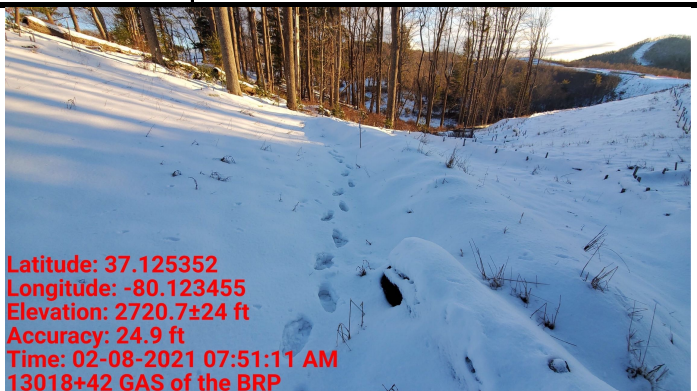
Latitude: 37.125352 Longitude: -80.123455 Elevation: 2720.7±24 ft Accuracy: 24.9 ft Time: 02-08-2021 07:51:11 AM 13018+42 GAS of the BRP
GPS Location See pic for GPS location	GPS Location See pic for GPS location
Field Station# 13022+50	Field Station# 13018+42
Pic 5 Desc. Snow cover remains over CFS and other ECD's in the area.	Pic 6 Desc. Permanent Slope Breaker and Rock Level Spreaders remain in good condition.

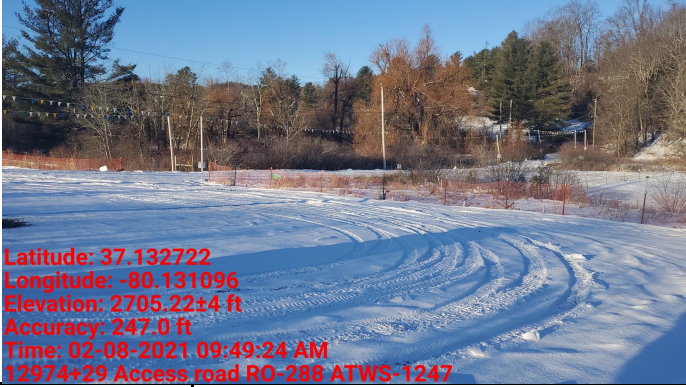
GPS Location	See pic for GPS location		GPS Location	See pic for GPS location	
Field Station#	12974+29		Field Station#	12974+29	
Pic 9 Desc.	Access road RO-288 at stream S-Q20.		Pic 10 Desc.	Access road RO-288 at stream S-KL4.

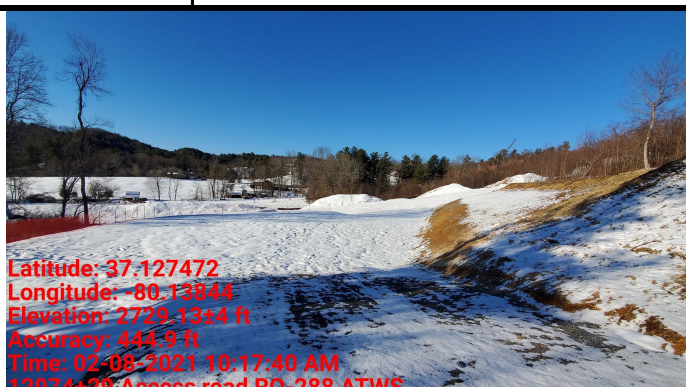
<p>Latitude: 37.127472 Longitude: -80.13844 Elevation: 2729.13±4 ft Accuracy: 444.9 ft Time: 02-08-2021 10:17:40 AM 12974+29 Access road RO-288 ATWS</p>			  <p>Latitude: 37.120284 Longitude: -80.136419 Elevation: 2692.39±4 ft Accuracy: 12.5 ft Time: 02-08-2021 10:30:17 AM 12975+00 GAS of RO-288</p>		
GPS Location	See pic for GPS location		GPS Location	See pic for GPS location	
Field Station#	12974+29		Field Station#	12975+00	
Pic 11 Desc.	ATWS-1309 and 1310 at RO-288 and the ROW.		Pic 12 Desc.	CWDB and CWDP on the GAS of RO-288.

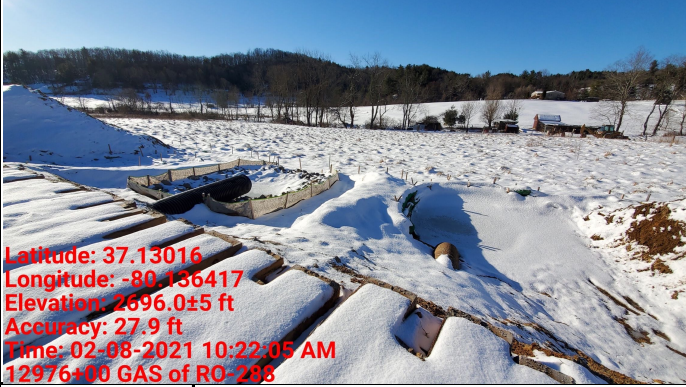
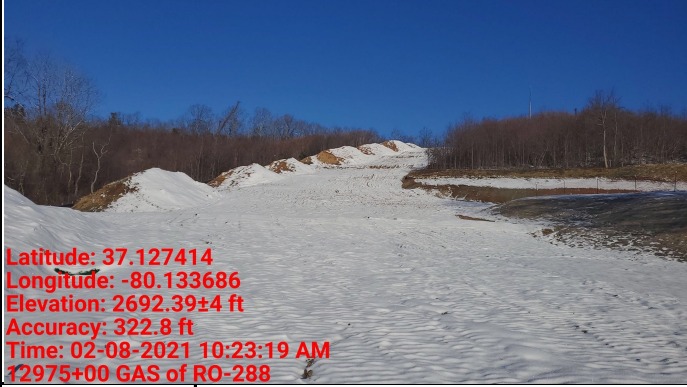
<p>Latitude: 37.127414 Longitude: -80.133686 Elevation: 2692.39±4 ft Accuracy: 322.8 ft Time: 02-08-2021 10:23:19 AM 12975+00 GAS of RO-288</p>	
GPS Location	See pic for GPS location	GPS Location	See pic for GPS location
Field Station#	12976+00	Field Station#	12975+00
Pic 13 Desc.	CWDP and plunge pool on the GAS of RO-288.	Pic 14 Desc.	Stabilized ROW on the CIS of RO-288.

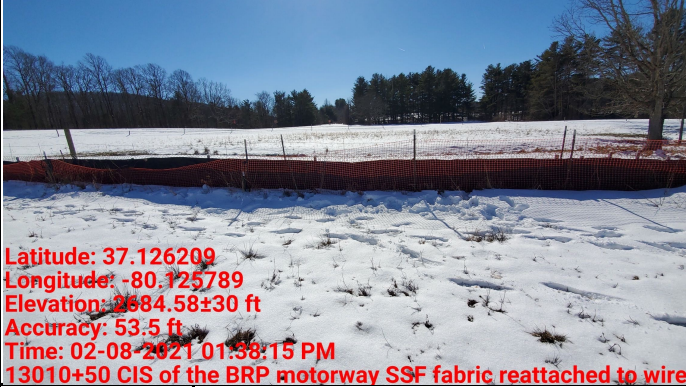
<p>Latitude: 37.126209 Longitude: -80.125789 Elevation: 2684.58±30 ft Accuracy: 53.5 ft Time: 02-08-2021 01:38:15 PM 13010+50 CIS of the BRP motorway SSF fabric reattached to wire</p>

Field Station#	13010+50	Field Station#	12958+00
Pic 15 Desc.	SSF fabric reattached to the wire fence on the CIS of the BRP motorway.	Pic 16 Desc.	Stream S-Y7 on the GAS of RO-287.

E&S BMPs	Compliance Level	Corrective Action	Corrective Time Frame	Date Repaired
Waterbar	Acceptable			
Waterbar End Treatment	Acceptable			
Sump Pit	Acceptable			
Silt Fence (Reinforced Filter Fabric Fence)	Communication	Reattach fabric to wire fence	Addressed	2/8/2021
Silt Fence (Filter Fabric Fence)	Acceptable			
Compost Filter Sock	Acceptable			
Cleanwater Diversion Pipe	Acceptable			
Cleanwater Diversion Berm	Acceptable			
Plunge Pool	Acceptable

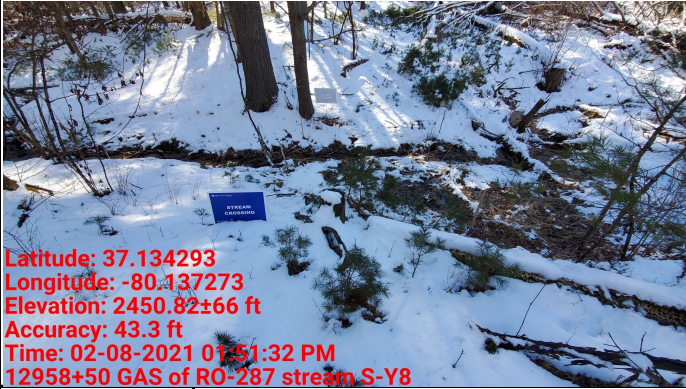
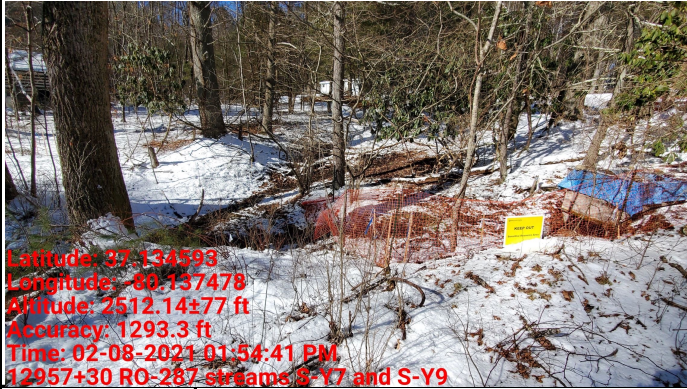
<p>Latitude: 37.134593 Longitude: -80.137478 Elevation: 2512.14±77 ft Accuracy: 1293.3 ft Time: 02-08-2021 01:54:41 PM 12957+30 RO-287 streams S-Y7 and S-Y9</p>	
GPS Location	See pic for GPS location	GPS Location	See pic for GPS location
Field Station#	12958+50	Field Station#	12957+30
Pic 17 Desc.	Stream S-Y8 on the GAS of RO-287.	Pic 18 Desc.	Streams S-Y7 and S-Y9(landowner's spring box at RO-287.

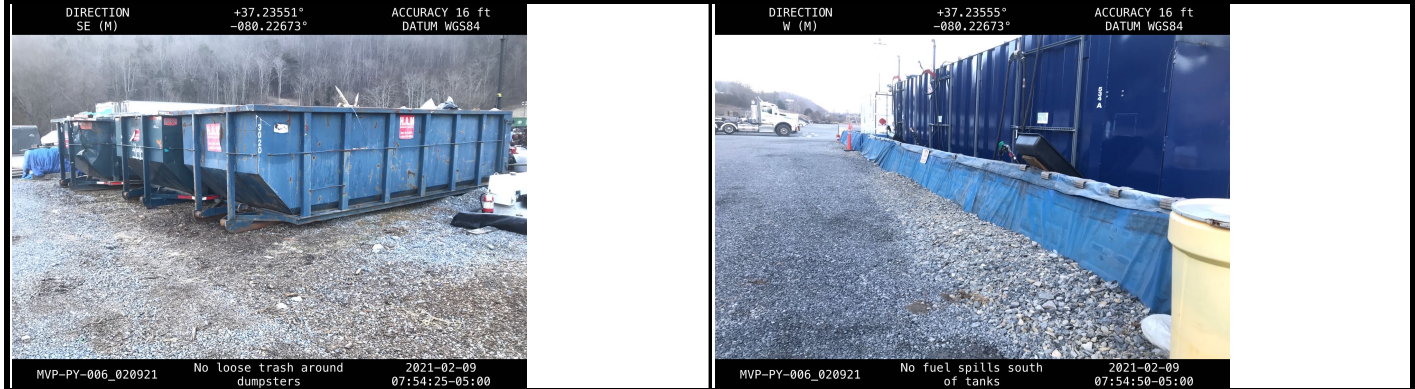
GPS Location MVP-PY-006 See photo for gps data	GPS Location MVP-PY-006 See photo for gps data
Field Station# +0	Field Station# +0
Pic 7 Desc. No loose trash around dumpsters. Looking SE.	Pic 8 Desc. No fuel spills south of the Blue Bulk fuel tanks. Looking W.

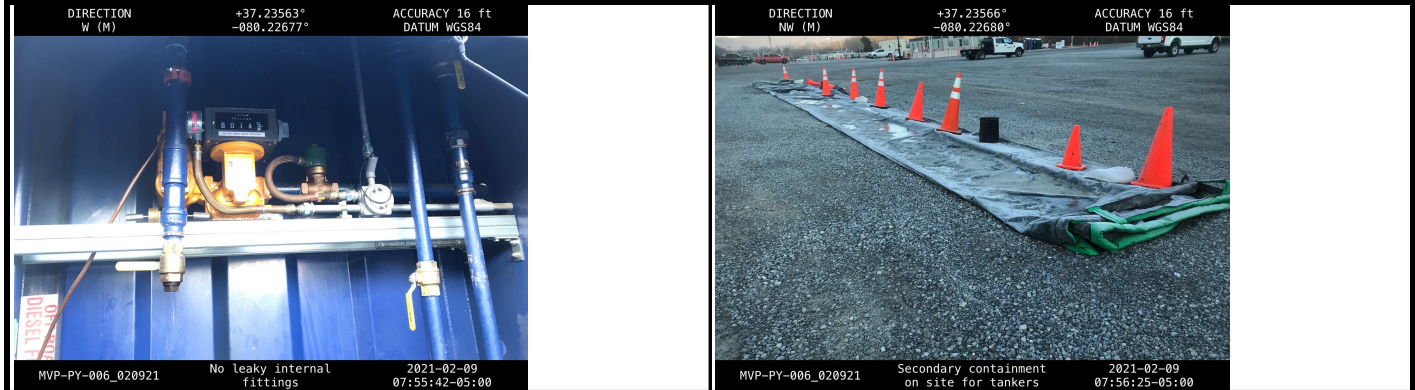
GPS Location MVP-PY-006 See photo for gps data	GPS Location MVP-PY-006 See photo for gps data
Field Station# +0	Field Station# +0
Pic 9 Desc. Blue Bulk Fuel tanks no leaky internal fittings. Looking W.	Pic 10 Desc. Secondary containment on site for tankers offloading fuel. Looking NW.

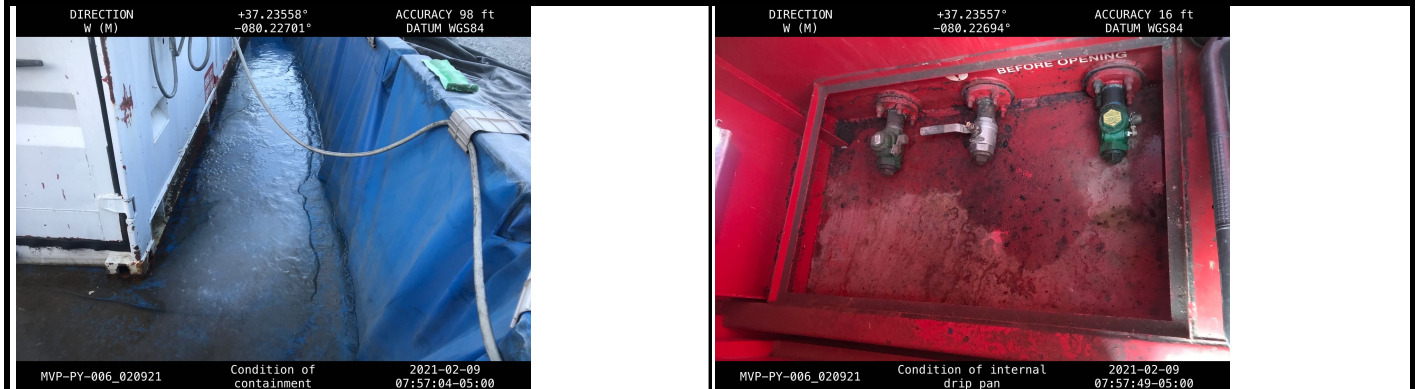
GPS Location MVP-PY-006 See photo for gps data	GPS Location MVP-PY-006 See photo for gps data
Field Station# +0	Field Station# +0
Pic 11 Desc. Off Road Fuel unit containment holding stormwater and ice. Looking W.	Pic 12 Desc. Off Road Fuel unit Condition of internal drip pan. Looking W.

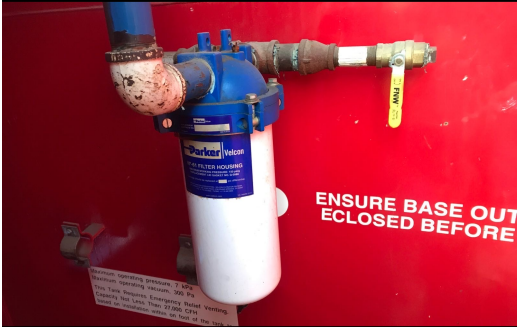
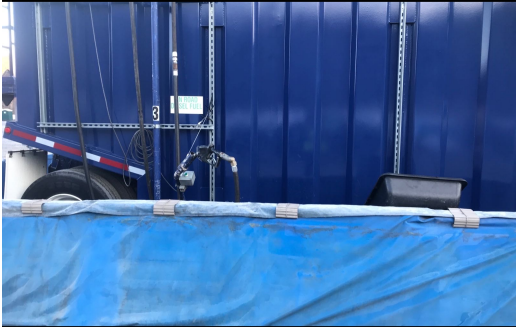
<p style="font-size: x-small; margin-top: 5px;">MVP-PY-006_020921 No leaky internal fittings 2021-02-09 07:57:51-05:00</p>	<p style="font-size: small;">DIRECTION N (M) +37.23557° ACCURACY 16 ft -080.22697° DATUM WGS84</p>

<p style="font-size: x-small; margin-top: 5px;">MVP-PY-006_020921 No leaky fittings or nozzles 2021-02-09 07:58:42-05:00</p>
GPS Location MVP-PY-006 See photo for gps data	GPS Location MVP-PY-006 See photo for gps data
Field Station# +0	Field Station# +0
Pic 13 Desc. Off Road Fuel unit no leaky internal fittings. Looking NW.	Pic 14 Desc. Blue Bulk Fuel tanks no leaky fittings or nozzles. Looking N.
<p style="font-size: small;">DIRECTION E (M) +37.23552° ACCURACY 16 ft -080.22630° DATUM WGS84</p>

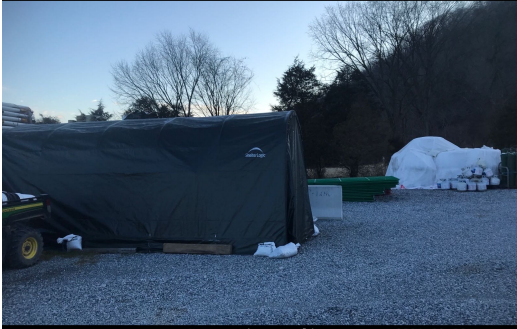
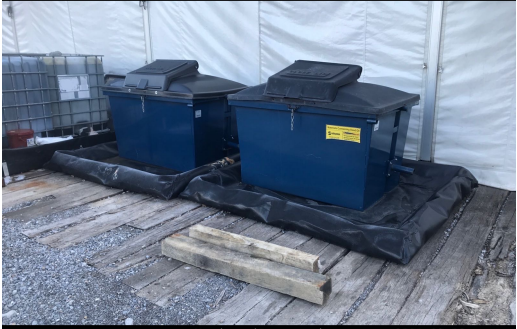
<p style="font-size: x-small; margin-top: 5px;">MVP-PY-006_020921 Restoration supplies covered 2021-02-09 08:01:03-05:00</p>	<p style="font-size: small;">DIRECTION NE (M) +37.23421° ACCURACY 16 ft -080.22708° DATUM WGS84</p>

<p style="font-size: x-small; margin-top: 5px;">MVP-PY-006_020921 No deposits around hazardous waste 2021-02-09 08:03:20-05:00</p>

GPS Location MVP-PY-006 See photo for gps data	GPS Location MVP-PY-006 See photo for gps data
Field Station# +0	Field Station# +0
Pic 15 Desc. Restoration supplies covered and protected from the weather. Looking E.	Pic 16 Desc. No deposits or fluids around hazardous waste dumpsters west of the mechanics building. Looking NE.
<p style="font-size: small;">DIRECTION SE (M) +37.23451° ACCURACY 33 ft -080.22791° DATUM WGS84</p>

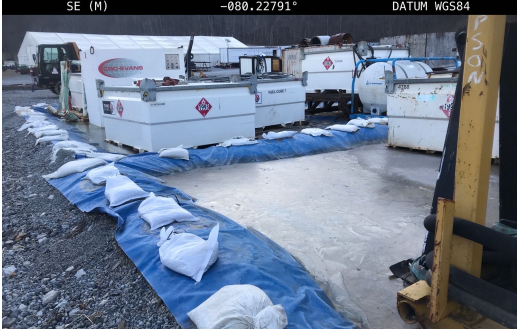
<p style="font-size: x-small; margin-top: 5px;">MVP-PY-006_020921 Condition of poly containments 2021-02-09 08:04:46-05:00</p>	<p style="font-size: small;">DIRECTION NE (M) +37.23463° ACCURACY 16 ft -080.22810° DATUM WGS84</p>

Pic 17 Desc. Condition of poly lined containments. Holding stormwater and ice. Looking SE.	Pic 18 Desc. Condition of trays and containment under toilets. Looking NE.

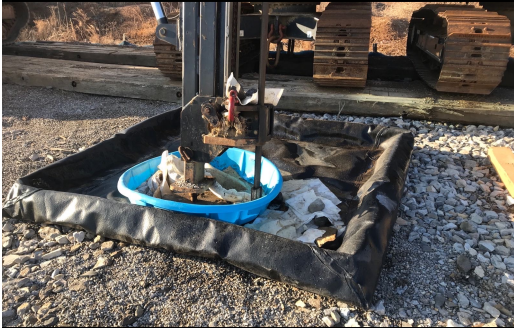
<p>MVP-LY-049_020921 Containment under stored equipment 2021-02-09 08:41:40-05:00</p>		<p>DIRECTION S (M) +37.27056° -080.12381° ACCURACY 16 ft DATUM WGS84</p>   <p>MVP-LY-049_020921 Containment under stored equipment 2021-02-09 08:41:51-05:00</p>			
GPS Location MVP-LY-049 See photo for gps data		GPS Location MVP-LY-049 See photo for gps data			
Field Station# +0		Field Station# +0			
Pic 5 Desc. Condition of containment under stored equipment. Looking S.		Pic 6 Desc. Condition of containment under stored equipment. Looking S.

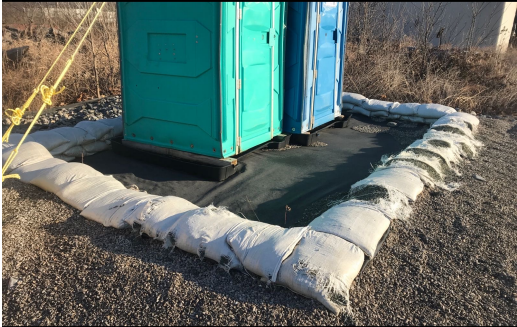
<p>MVP-LY-049_020921 Condition of trays and containment 2021-02-09 08:42:45-05:00</p>			
GPS Location MVP-LY-049 See photo for gps data		GPS Location MVP-LY-049 See photo for gps data	
Field Station# +0		Field Station# +0	
Pic 7 Desc. Condition of trays and containment under toilets. Looking NE.		Pic 8 Desc. Condition of temporary trash transfer pit. Debris inside boundary of pit. Looking SW.	
<p>DIRECTION SW (M) +37.27041° ACCURACY 16 ft -080.12343° DATUM WGS84</p>

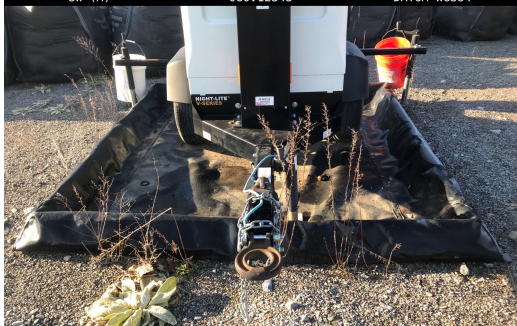
<p>MVP-LY-049_020921 Condition of containment 2021-02-09 08:43:28-05:00</p>		<p>DIRECTION SW (M) +37.27010° ACCURACY 16 ft -080.12254° DATUM WGS84</p>

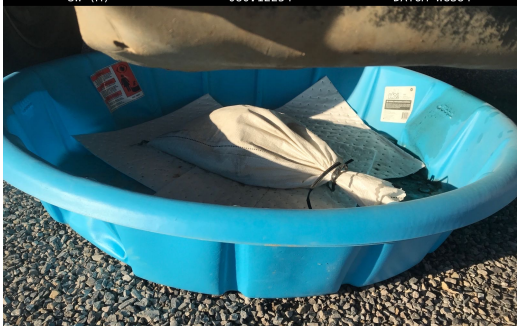
<p>MVP-LY-049_020921 Containment under stored vehicle 2021-02-09 08:45:09-05:00</p>	
GPS Location MVP-LY-049 See photo for gps data		GPS Location MVP-LY-049 See photo for gps data

Field Station# +0		Field Station# +0	
Pic 9 Desc. Condition of containment under light plant. Free of stormwater and ice. Looking SW.		Pic 10 Desc. Condition of containment under stored vehicle. Looking SW.	
<p>DIRECTION NE (M) +37.27013° ACCURACY 16 ft -080.12262° DATUM WGS84</p>

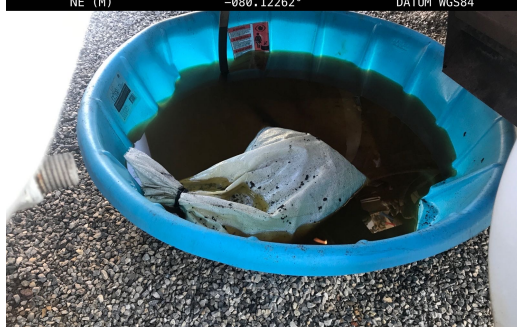
<p>MVP-LY-049_020921 Containment under stored vehicle 2021-02-09 08:45:20-05:00</p>		<p>DIRECTION N (M) +37.27020° ACCURACY 16 ft -080.12298° DATUM WGS84</p>

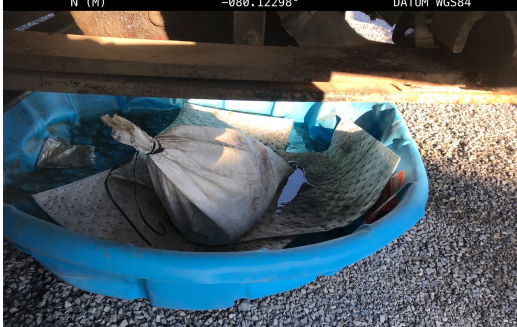
<p>MVP-LY-049_020921 Containment under stored vehicle 2021-02-09 08:45:54-05:00</p>	
GPS Location MVP-LY-049 See photo for gps data		GPS Location MVP-LY-049 See photo for gps data	
Field Station# +0		Field Station# +0	
Pic 11 Desc. Condition of containment under stored vehicle. Looking NE.		Pic 12 Desc. Condition of containment under stored vehicle. Looking N.

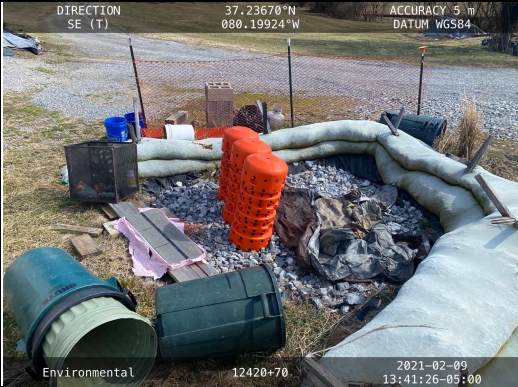
GPS Location	See photo	GPS Location	See photo
Field Station#	12420+70	Field Station#	12420+73
Pic 7 Desc.	Clean water crossing inlet in acceptable condition	Pic 8 Desc.	RCE in acceptable condition

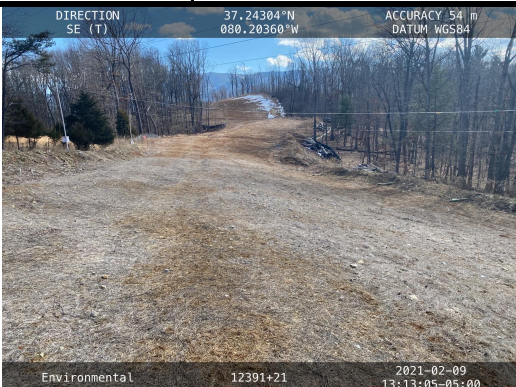
GPS Location	See photo	GPS Location	See photo
Field Station#	12405+00	Field Station#	12391+21
Pic 11 Desc.	Stabilized Slope in acceptable condition	Pic 12 Desc.	Stabilized ROW in acceptable condition

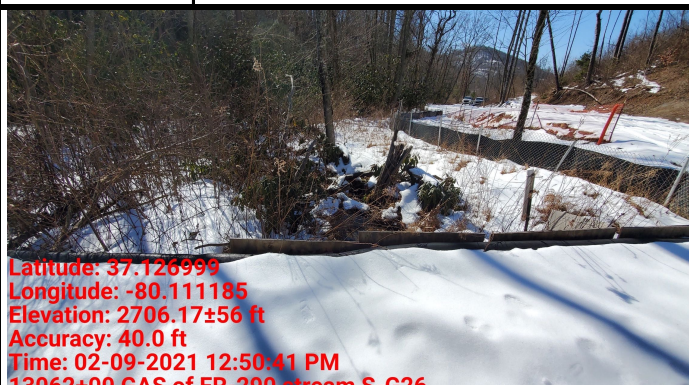
Field Station#	13064+50	Field Station#	13063+00
Pic 9 Desc.	SSF repaired by environmental crew.	Pic 10 Desc.	Stream S-G27 on the GAS of FR-290.

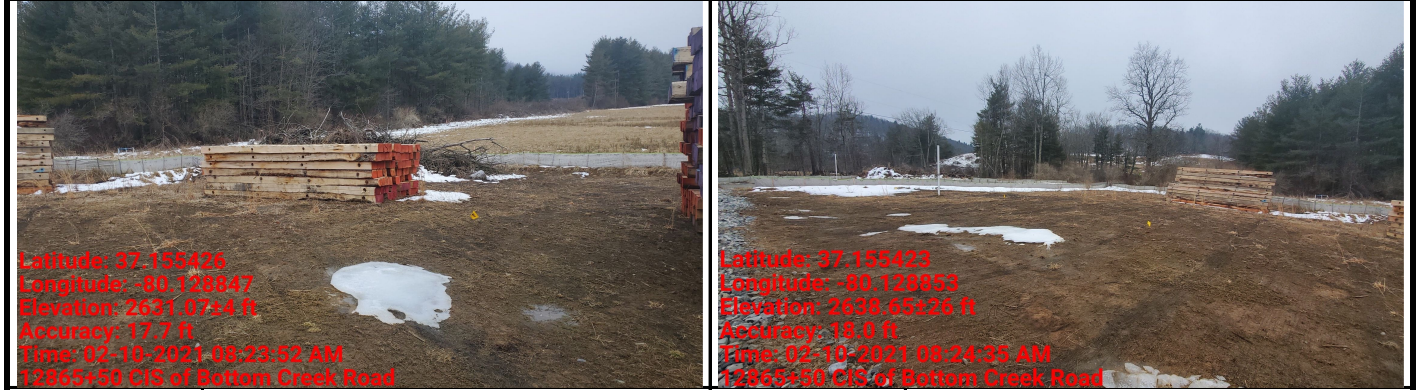
GPS Location	See pic for GPS location	GPS Location	See pic for GPS location
Field Station#	12865+50	Field Station#	12865+50
Pic 1 Desc.	CIS of the Bottom Creek Road crossing.	Pic 2 Desc.	Stabilized ROW on the CIS of Bottom Creek Road.

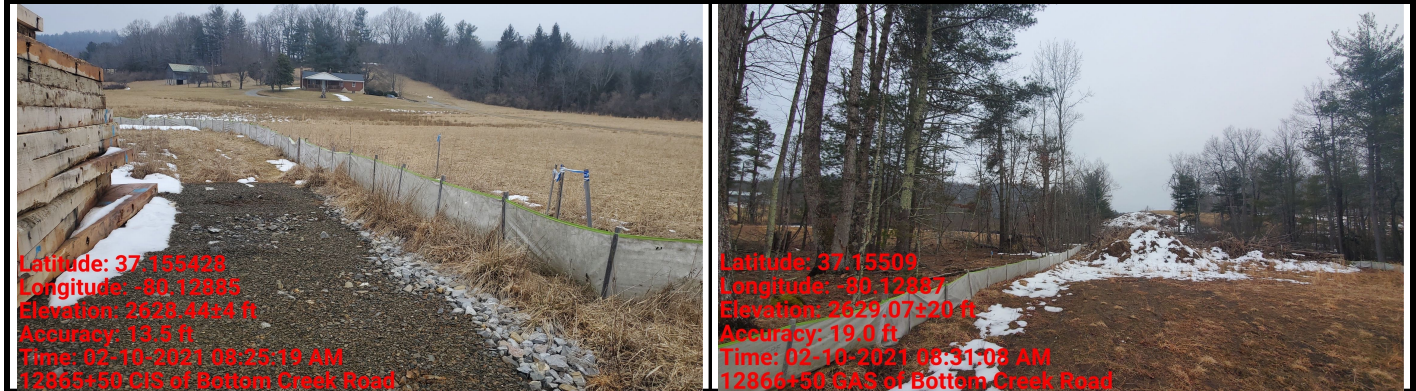
GPS Location	See pic for GPS location	GPS Location	See pic for GPS location
Field Station#	12865+50	Field Station#	12866+50
Pic 3 Desc.	CIS of the Bottom Creek Road crossing.	Pic 4 Desc.	GAS of the Bottom Creek Road crossing.

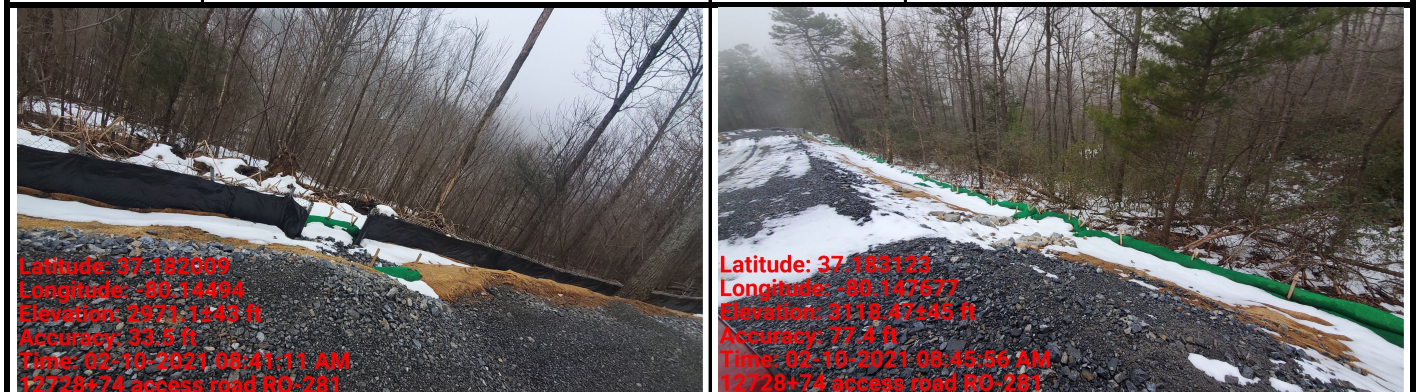
GPS Location	See pic for GPS location	GPS Location	See pic for GPS location
Field Station#	12728+74	Field Station#	12728+74
Pic 5 Desc.	Outlet in the SSF along access road RO-281.	Pic 6 Desc.	ECD's along access road RO-281.

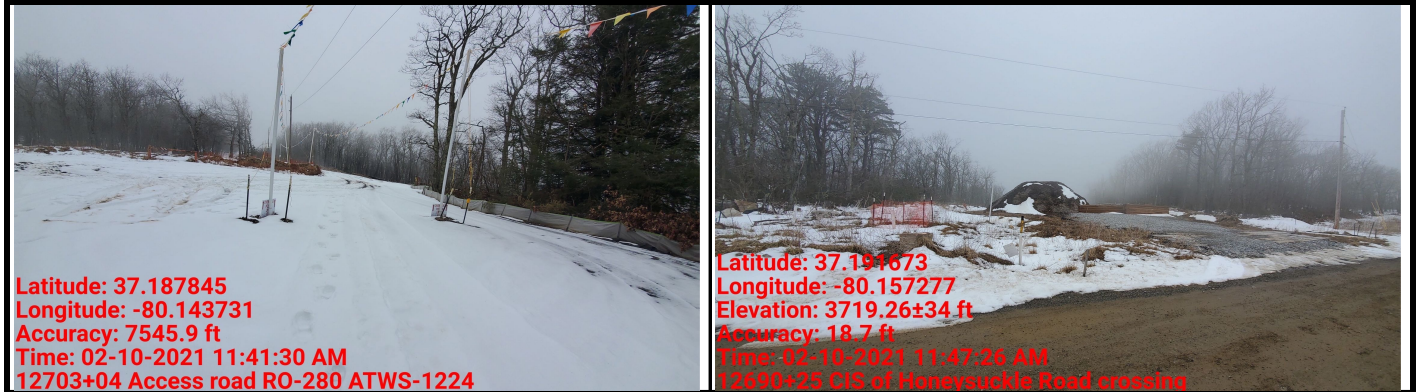
GPS Location	See pic for GPS location	GPS Location	See pic for GPS location
Field Station#	12703+04	Field Station#	12690+25
Pic 9 Desc.	No maintenance issues or impacts observed at the ATWS RO-288 and Honeysuckle Road.	Pic 10 Desc.	CIS of the Honeysuckle Road crossing.

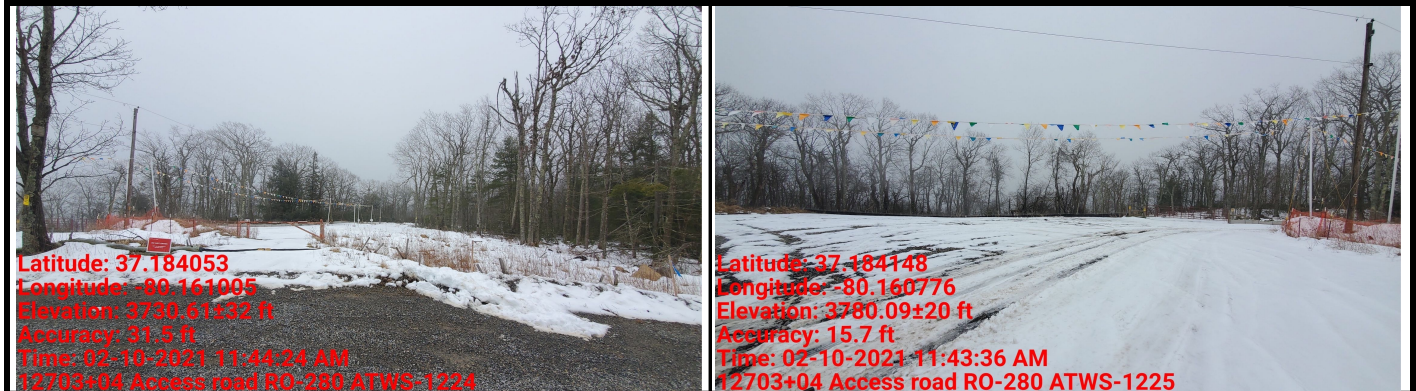
GPS Location	See pic for GPS location	GPS Location	See pic for GPS location
Field Station#	12703+04	Field Station#	12703+04
Pic 11 Desc.	ATWS from Honeysuckle Road at RO-288.	Pic 12 Desc.	No maintenance issues or impacts observed at the ATWS RO-288 and Honeysuckle Road.

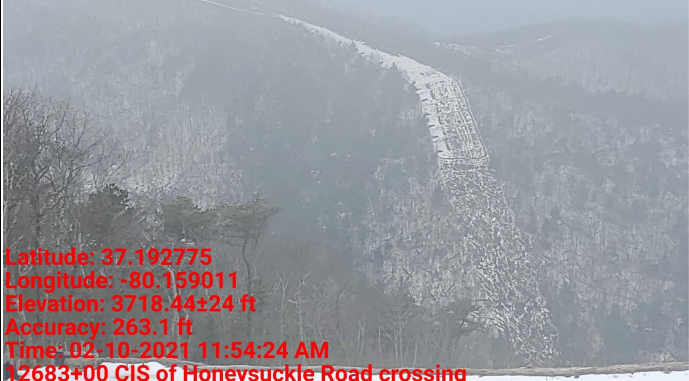
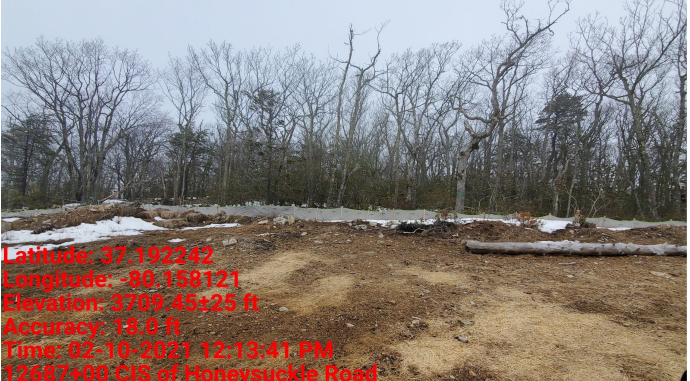
<p>Latitude: 37.192242 Longitude: -80.159121 Elevation: 3700.45±25 ft Accuracy: 13.0 ft Time: 02-10-2021 12:13:41 PM 12687+00 CIS of Honeysuckle Road</p>	
GPS Location	See pic for GPS location	GPS Location	See pic for GPS location
Field Station#	12683+00	Field Station#	12687+00
Pic 13 Desc.	GAS of access road RO-279.01 from the CIS of Honeysuckle Road.	Pic 14 Desc.	Current ROW conditions on the CIS of Honeysuckle Road.

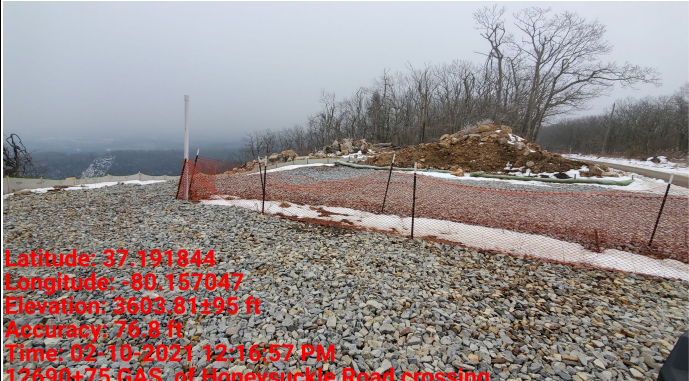
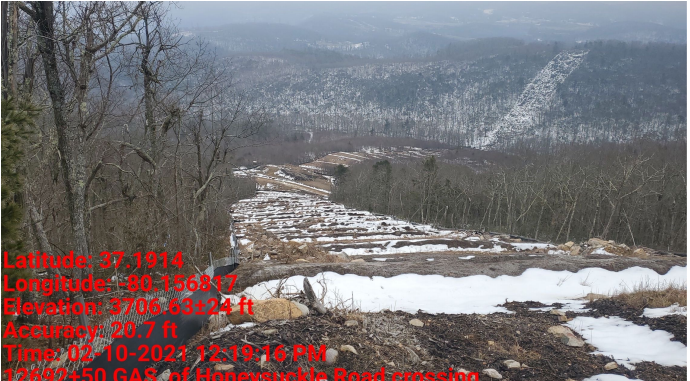
GPS Location	See pic for GPS location	GPS Location	See pic for GPS location
Field Station#	12690+75	Field Station#	12692+50
Pic 15 Desc.	GAS of the Honeysuckle Road crossing.	Pic 16 Desc.	Current ROW conditions on the GAS of Honeysuckle Road.

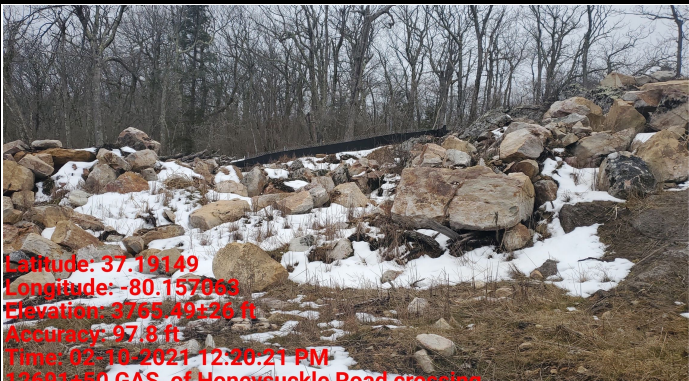
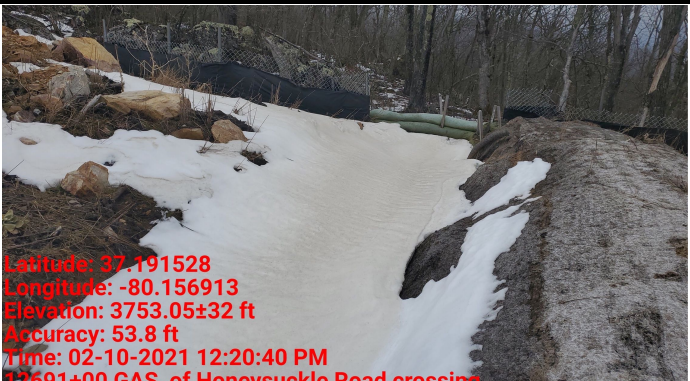
<p>Latitude: 37.191528 Longitude: -80.156913 Elevation: 3753.05±32 ft Accuracy: 53.8 ft Time: 02-10-2021 12:20:40 PM 12691+00 GAS of Honeysuckle Road crossing</p>	
GPS Location	See pic for GPS location	GPS Location	See pic for GPS location
Field Station#	12691+50	Field Station#	12691+00
Pic 17 Desc.	No maintenance issues or impacts were observed in the area.	Pic 18 Desc.	Considerable amount of snow remains on the ROW.

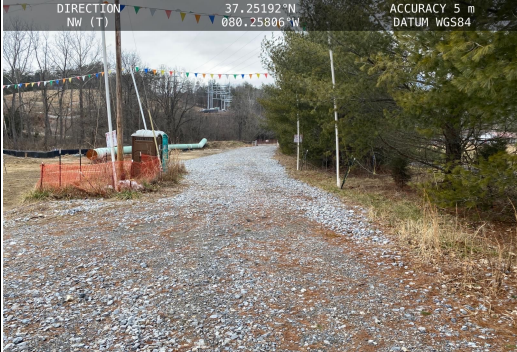
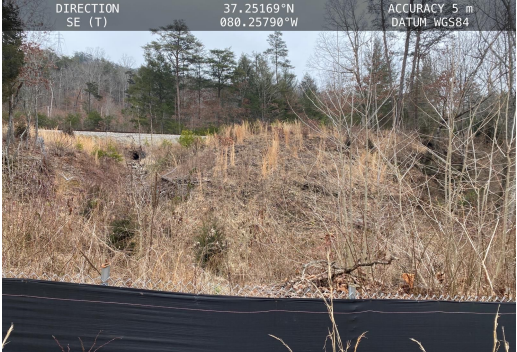
GPS Location	See photo	GPS Location	See photo
Field Station#	12198+90	Field Station#	12196+24
Pic 15 Desc.	Access Road MVP-MN-275 in acceptable condition	Pic 16 Desc.	Stream crossing S-0011 in acceptable condition

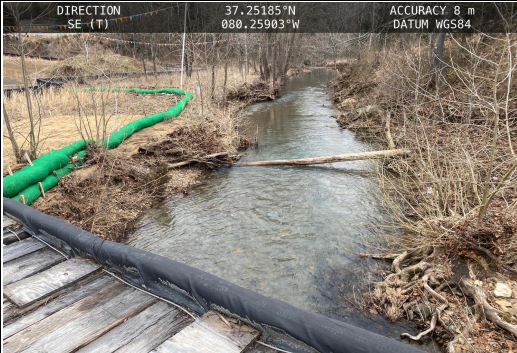
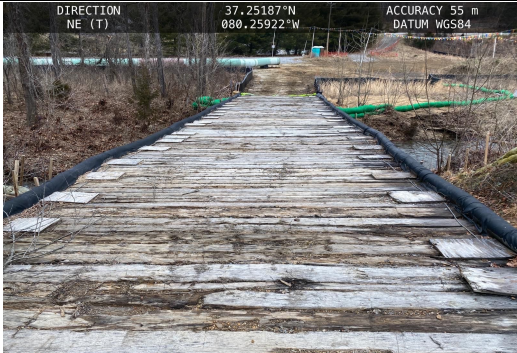
GPS Location	See photo	GPS Location	See photo
Field Station#	12192+50	Field Station#	12192+50
Pic 17 Desc.	S-C21 down stream with no signs of impact	Pic 18 Desc.	Bridge and ECDs at stream crossing S-C21 in acceptable condition

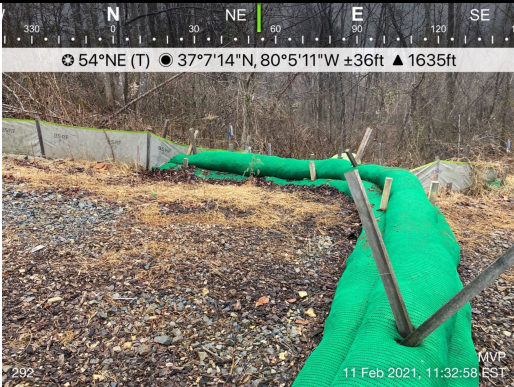
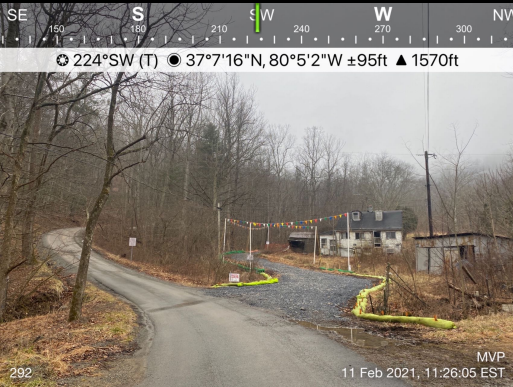
<p>GPS: 224°SW (T) 37°7'16"N, 80°5'2"W ±95ft ▲1570ft 11 Feb 2021, 11:28:05 EST</p>			
GPS Location	See photo for coordinates.		GPS Location	See photo for coordinates.	
Field Station#	13143+00		Field Station#	13148+00	
Pic 1 Desc.	Drainage area from S-D14 dry.		Pic 2 Desc.	MVP-FR-292, RCE and access road in acceptable condition.

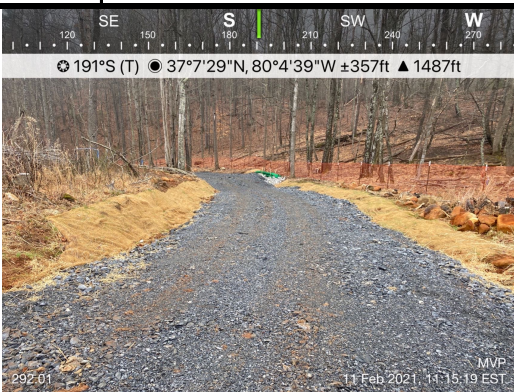
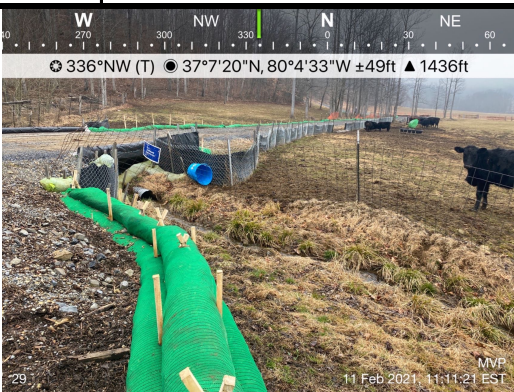
<p>GPS: 329°NW (T) 37°7'20"N, 80°4'33"W ±59ft ▲1436ft 11 Feb 2021, 11:11:50 EST</p>			
GPS Location	See photo for coordinates.		GPS Location	See photo for coordinates.	
Field Station#	13189+00		Field Station#	13190+00	
Pic 3 Desc.	MVP-FR-292.01, access road in acceptable condition, banks stabilized and broad based dips and rock lined channel outlets acceptable.		Pic 4 Desc.	S-D10, upstream of equipment air bridge, typical cattle disturbance noted along banks and in stream bed.

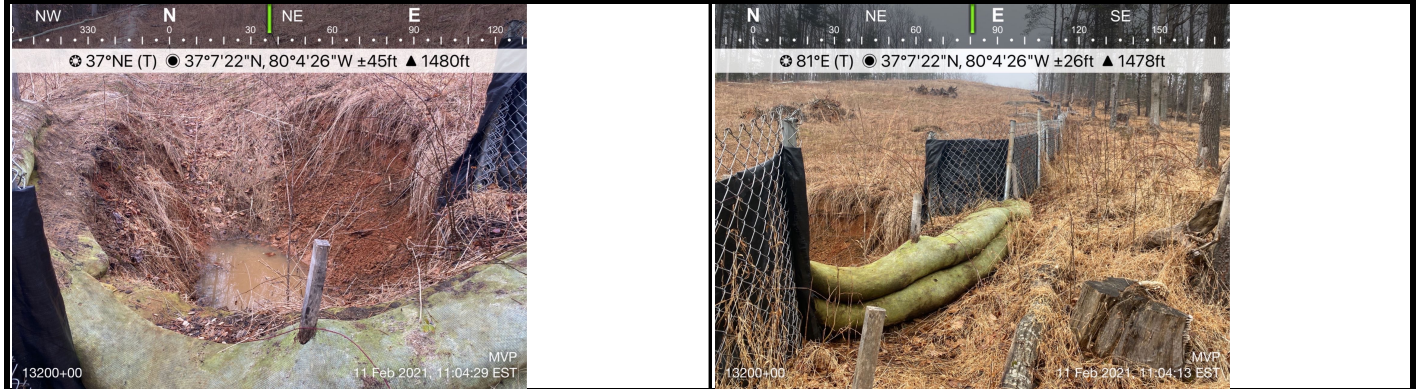
GPS Location	See photo for coordinates.	GPS Location	See photo for coordinates.
Field Station#	13200+00	Field Station#	13200+00
Pic 7 Desc.	Sump walls showing signs of age.	Pic 8 Desc.	Waterbar and sump outlet protection functioning acceptably.

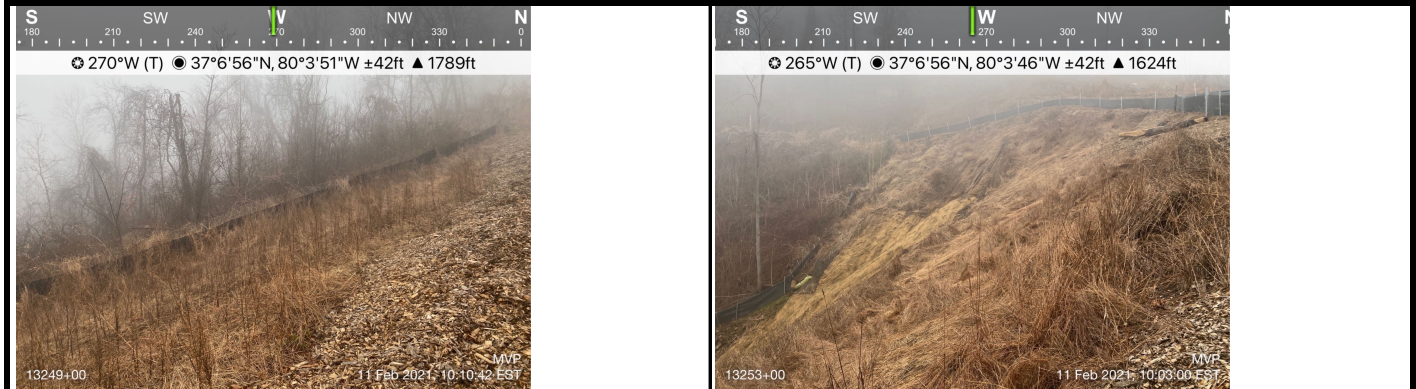
GPS Location	See photo for coordinates.	GPS Location	See photo for coordinates.
Field Station#	13249+00	Field Station#	13253+00
Pic 11 Desc.	Super silt fence in acceptable condition along LOD perimeter.	Pic 12 Desc.	Previously documented slip appeared stable, no observable movement of curlex noted, no sediment build up along SSF at toe.
