Visual Site Inspection Report

Project Name H-600 Pipeline Spread H		AFE 124300138	Spread H-600 Pipeline Spread H
Contractor Precision		Report # 19823	
Inspector Jason Nielsen		Date/Time 2/8/2021 4:11 PM	
Permit # TBD	Inspection Type VA SWPP	Station Begin	12005+00
State VA	Inspection Area Partial	Station End	12119+17
County Montgomery	Ground Wet	Temperature (°F)	40.00
Municipality N/A	Weather Sunny	Rain Gauge (in)	0.30
			Rain Accumulation Time (days) 1.00

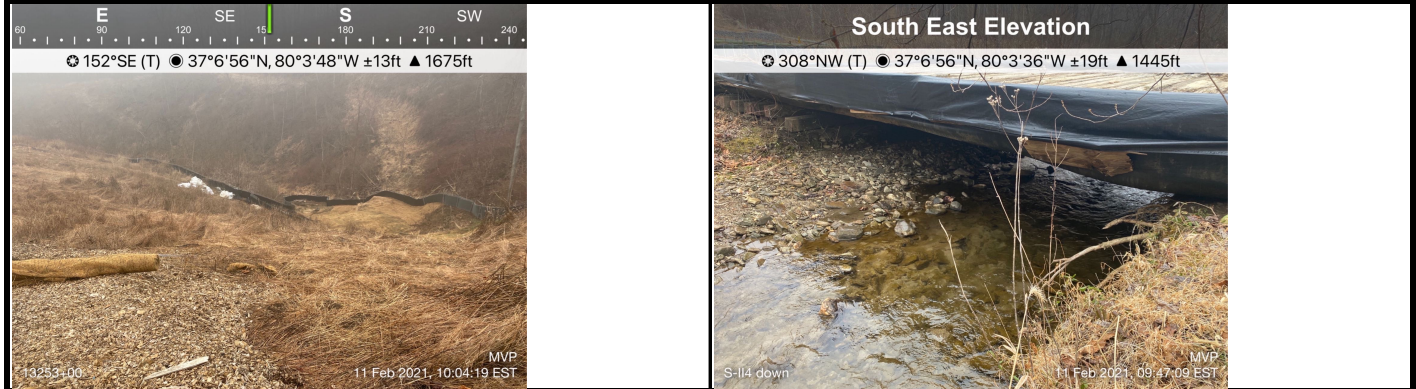
GPS Location	See photo for coordinates.	GPS Location	See photo for coordinates.
Field Station#	13253+00	Field Station#	13260+60
Pic 13 Desc.	Previously documented slip stable, perimeter controls functioning acceptably.	Pic 14 Desc.	S-II4, downstream side of equipment bridge, bridge in acceptable condition, no observable turbidity noted.

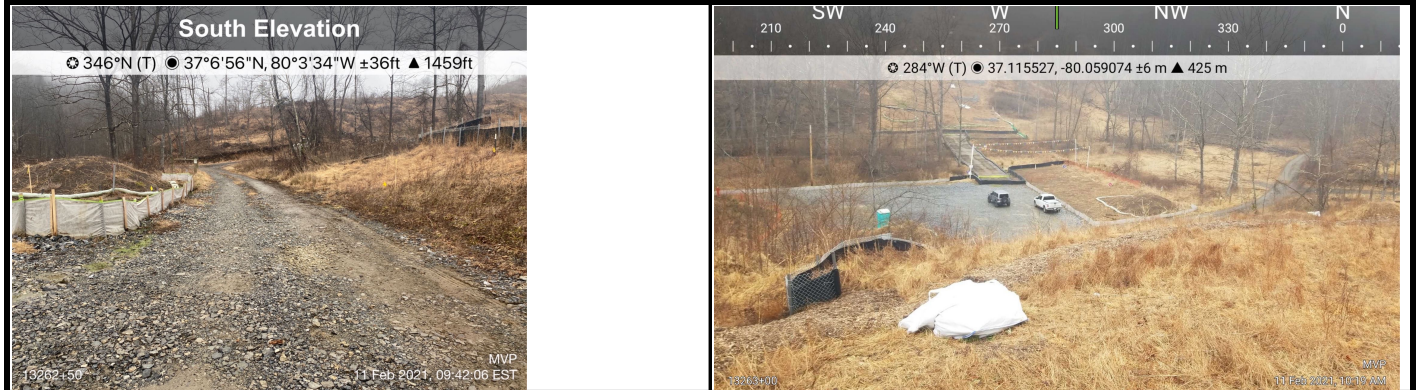
GPS Location	See photo for coordinates.	GPS Location	See photo for coordinates.
Field Station#	13262+50	Field Station#	13263+00
Pic 15 Desc.	MVP-FR-293.01, Flanders Road, access road in acceptable condition, logging truck parked off ROW.	Pic 16 Desc.	Going away side of Flanders Road stable with good vegetative cover across LOD.

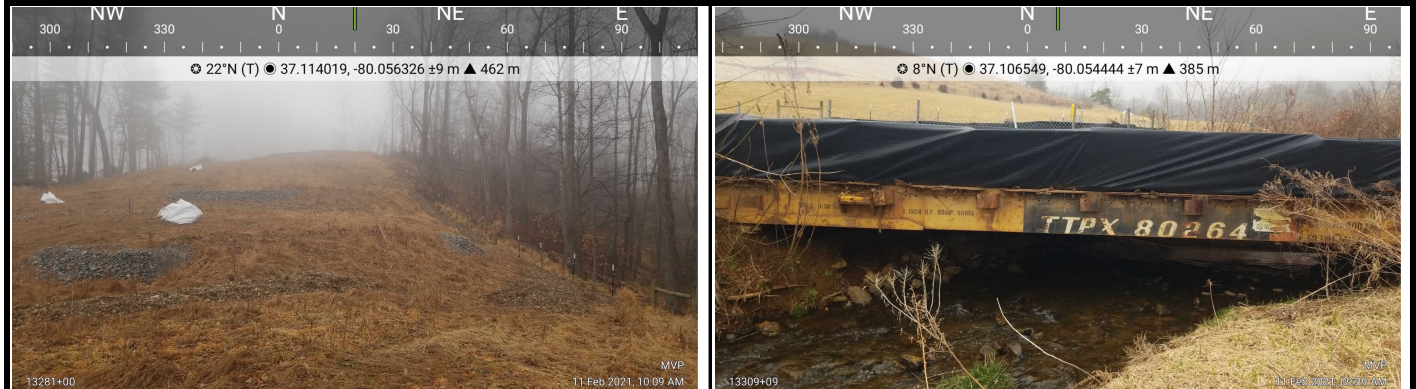
GPS Location	See photo for coordinates.	GPS Location	See photo for coordinates.
Field Station#	13281+00	Field Station#	13309+09
Pic 17 Desc.	ROW and permanent waterbars stable with good vegetative cover across LOD.	Pic 18 Desc.	S-GH7, downstream side of equipment bridge, rail car bridge in good condition, no additional erosion noted under bridge on CIS.

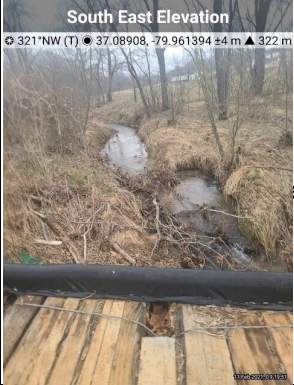
<p>South East Elevation <small>321°NW (T) • 37.08908, -79.961394 ±4 m ▲ 322 m</small></p>		Insert image here		Insert image here	
GPS Location	00000	GPS Location			
Field Station#	13643+67	Field Station#			
Pic 7 Desc.	Stream observation photo facing upstream during routine inspection today, no issues observed as light rain events began .		Pic 8 Desc.		
Insert image here		Insert image here		Insert image here	
GPS Location		GPS Location			
Field Station#		Field Station#			
Pic 9 Desc.		Pic 10 Desc.			
Insert image here		Insert image here		Insert image here	
GPS Location		GPS Location			
Field Station#		Field Station#			
Pic 11 Desc.		Pic 12 Desc.

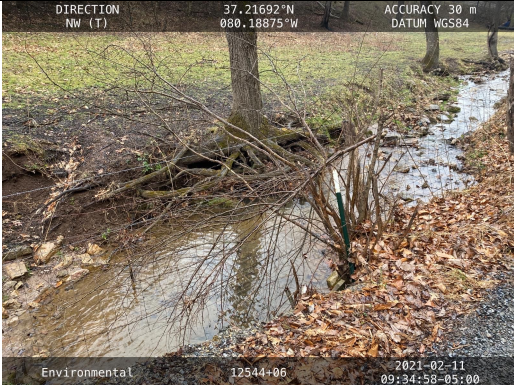
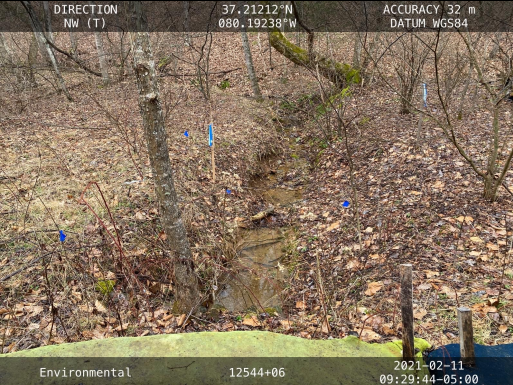
<p>DIRECTION: NW (T) 37.21212°N 080.19238°W ACCURACY 32 m DATUM WGS84</p> <p>Environmental 12544+06 2021-02-11 09:29:44-05:00</p>			
GPS Location See photo		GPS Location See photo			
Field Station# 12544+06		Field Station# 12544+06			
Pic 1 Desc. S-EF20b down stream from yellow finch road crossing in acceptable condition		Pic 2 Desc. S-EF54 down stream in acceptable condition

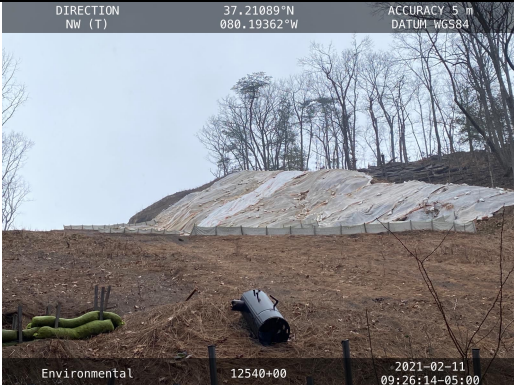
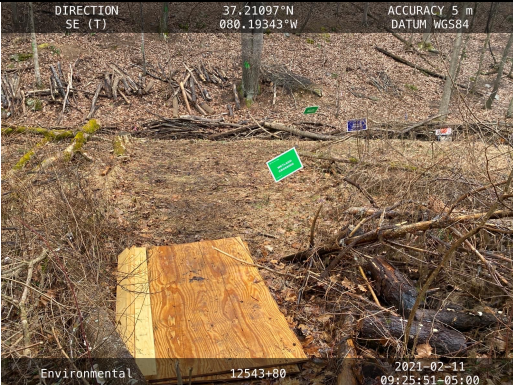
Field Station# 12540+00		Field Station# 12543+80			
Pic 3 Desc. Plastic used for stabilization of the spoil pile in acceptable condition and stable		Pic 4 Desc. S-EF20a stream crossing in acceptable condition with no signs of impact

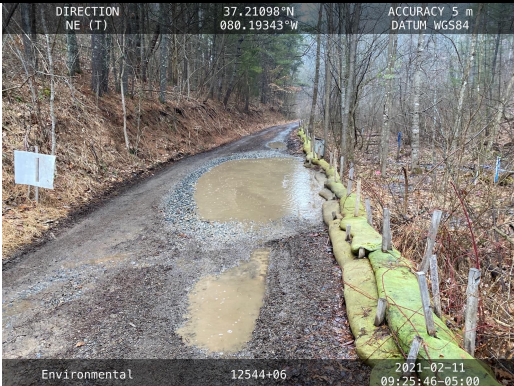
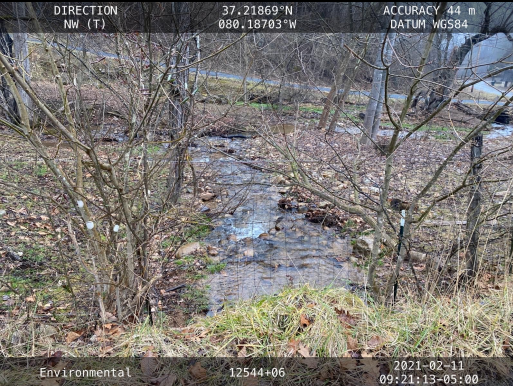
<p>DIRECTION: NW (T) 37.21869°N 080.18703°W ACCURACY 44 m DATUM WGS84</p> <p>Environmental 12544+06 2021-02-11 09:21:13-05:00</p>			
GPS Location See photo		GPS Location See photo			
Field Station# 12544+06		Field Station# 12544+06			
Pic 5 Desc. Low point in yellow finch road that holds water.		Pic 6 Desc. S-KL32 in acceptable condition looking down stream

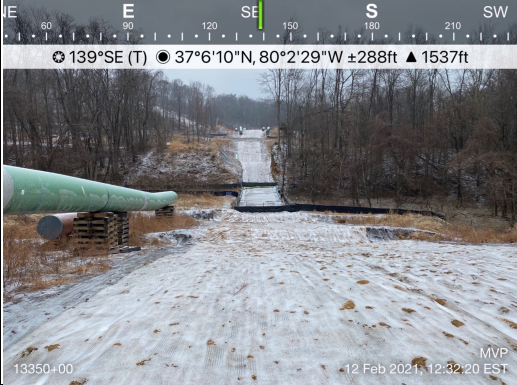
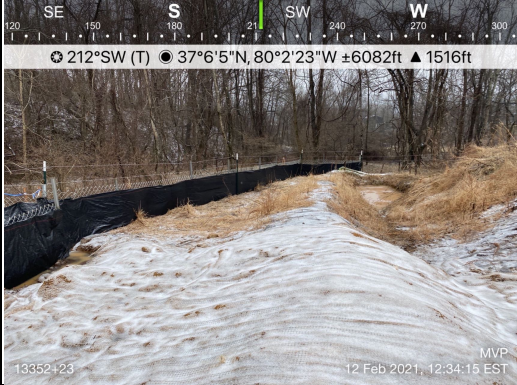
<p>13352+23 12 Feb 2021, 12:34:15 EST</p>	
GPS Location	See photo for coordinates.	GPS Location	See photo for coordinates.
Field Station#	13350+00	Field Station#	13352+23
Pic 13 Desc.	ROW stable with layer of ice across on top of curlexed ROW.	Pic 14 Desc.	Waterbar, sump, outlet protection, and perimeter controls along stream crossing in acceptable condition.

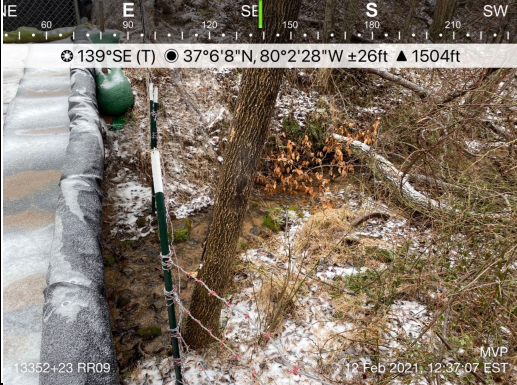
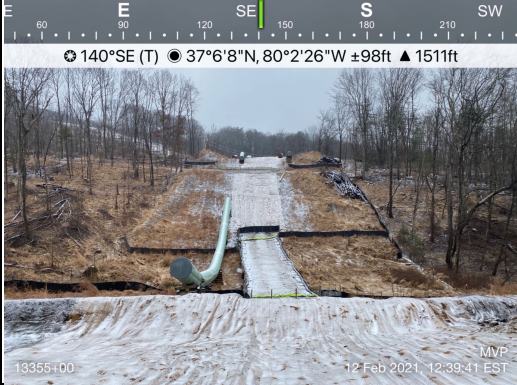
<p>13355+00 12 Feb 2021, 12:39:41 EST</p>	
GPS Location	See photo for coordinates.	GPS Location	See photo for coordinates.
Field Station#	13352+23	Field Station#	13355+00
Pic 15 Desc.	S-RR09, downstream of equipment bridge, no observable turbidity noted in stream channel, banks stable.	Pic 16 Desc.	ROW stable, ECDs in acceptable condition, private drive in acceptable condition.

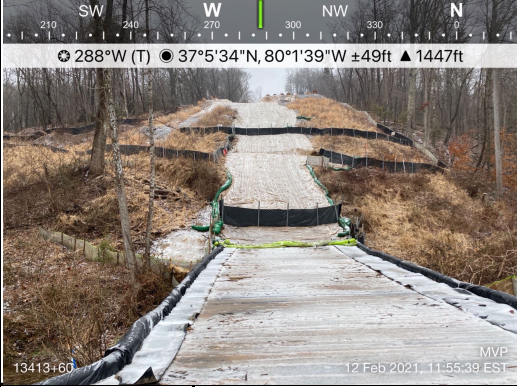
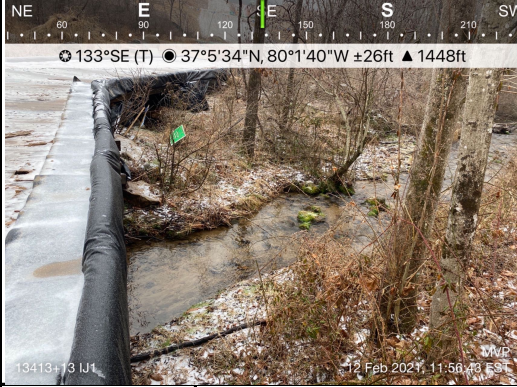
GPS Location	See photo for coordinates.	GPS Location	See photo for coordinates.
Field Station#	13413+60	Field Station#	13413+13
Pic 17 Desc.	ROW stable and covered in frost, bridge iced over, no environmental concerns for the CIS of S-IJ1.	Pic 18 Desc.	S-IJ2 and S-IJ1, downstream sides of equipment bridge, no turbidity observed in streams, banks appeared stable.

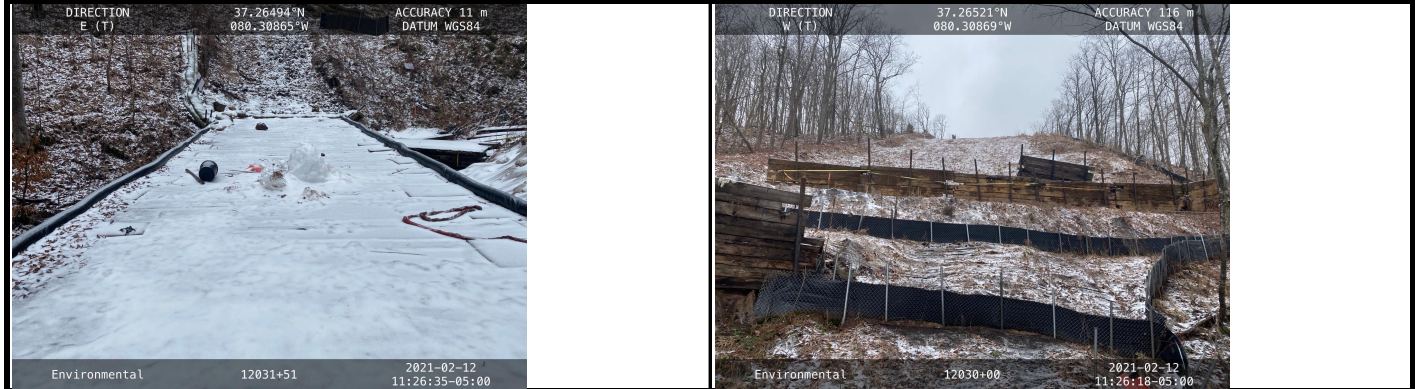
GPS Location	See photo for GPS coordinates	GPS Location	See photo for GPS coordinates
Field Station#	12031+51	Field Station#	12030+00
Pic 7 Desc.	Bridge and ECDs at S-G39 in acceptable condition	Pic 8 Desc.	Stabilized ROW with layer of ice covering ground

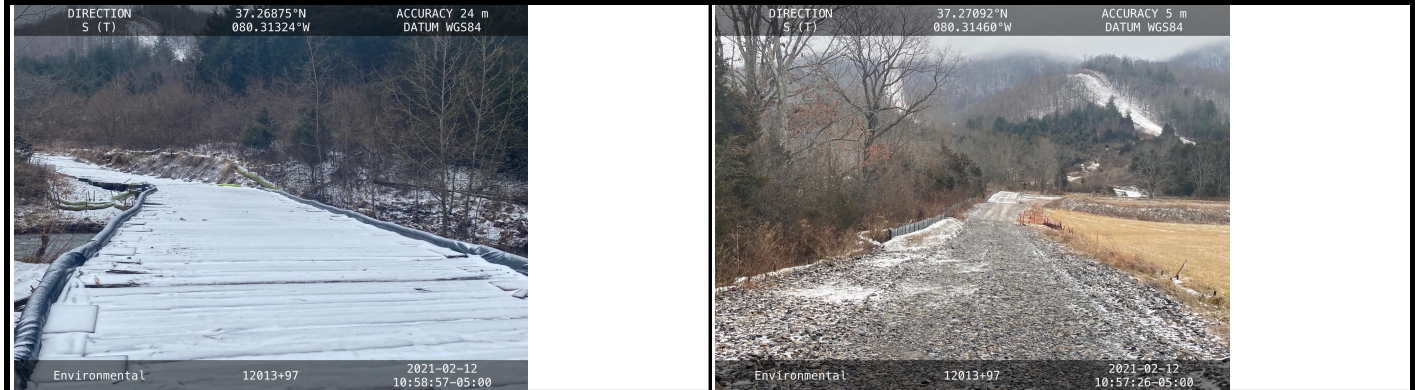
GPS Location	See photo for GPS coordinates	GPS Location	See photo for GPS coordinates
Field Station#	12013+97	Field Station#	12013+97
Pic 9 Desc.	Bridge and ECDs at stream crossing S-G36 on access road MVP-MN-268	Pic 10 Desc.	Access Road MVP-MN-268 in acceptable condition

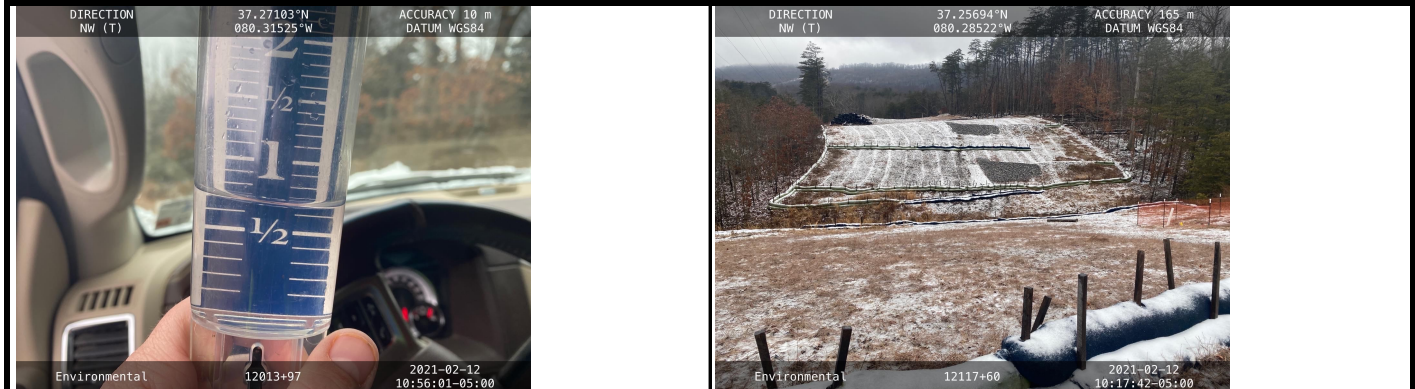
GPS Location	See photo for GPS coordinates	GPS Location	See photo for GPS coordinates
Field Station#	12013+97	Field Station#	12117+60
Pic 11 Desc.	Catawba rain gauge totals after melting the ice.	Pic 12 Desc.	Stabilized ROW

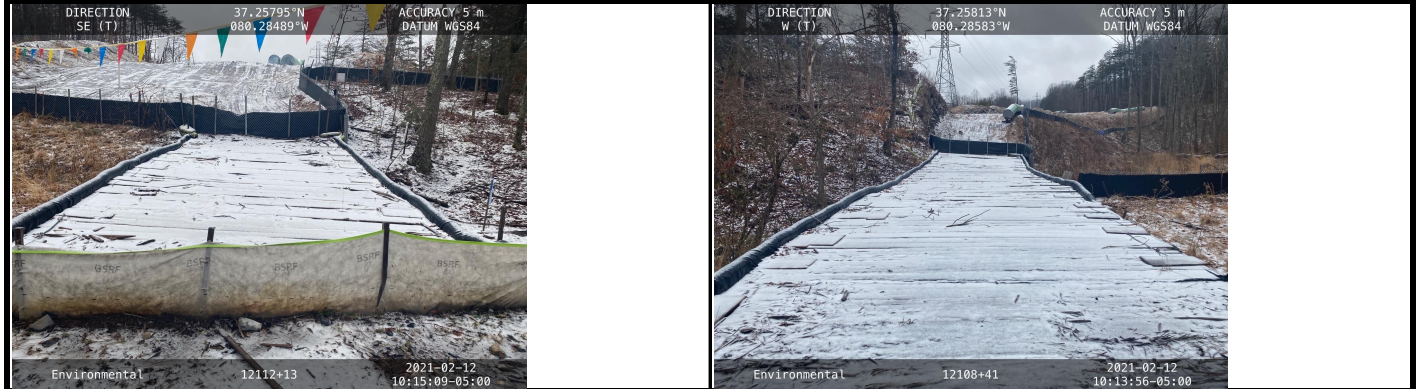
GPS Location	See photo for GPS coordinates	GPS Location	See photo for GPS coordinates
Field Station#	12112+13	Field Station#	12108+41
Pic 13 Desc.	Bridge and ECDs at stream S-F16A/B in acceptable condition	Pic 14 Desc.	Bridge and ECDs at stream S-F15 in acceptable condition

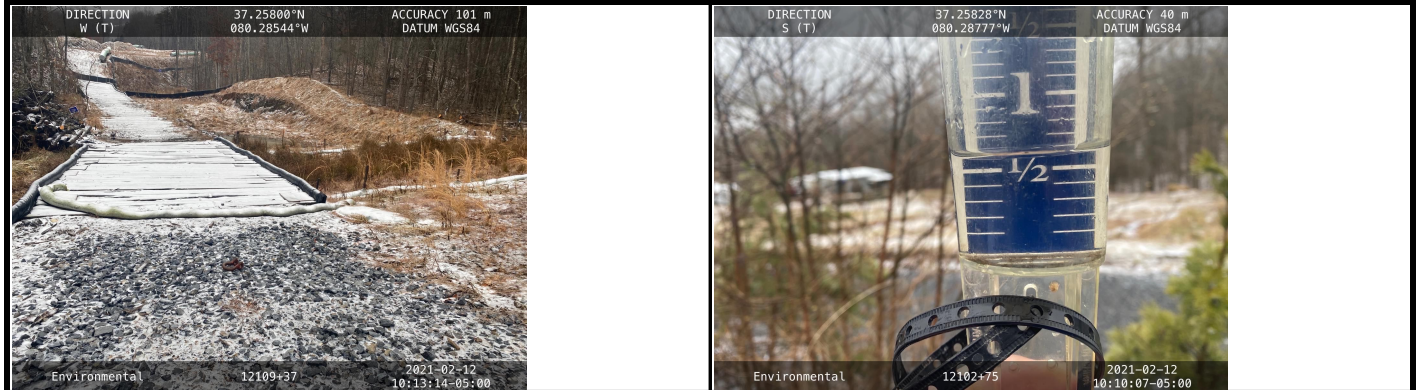
GPS Location	See photo for GPS coordinates	GPS Location	See photo for GPS coordinates
Field Station#	12109+37	Field Station#	12102+75
Pic 15 Desc.	Clean water crossing in acceptable condition	Pic 16 Desc.	Half acre of rock rain gauge totals after melting the ice.

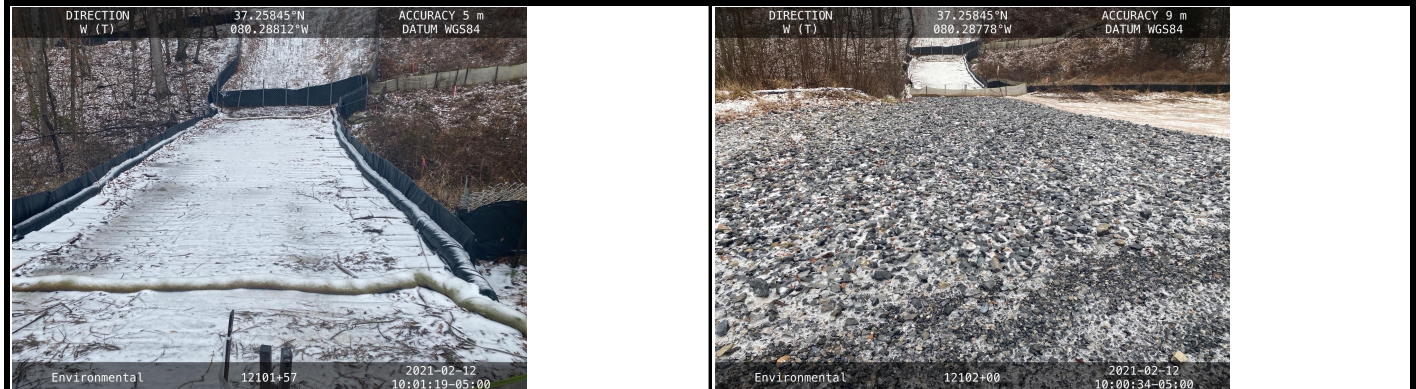
GPS Location	See photo for GPS coordinates	GPS Location	See photo for GPS coordinates
Field Station#	12101+57	Field Station#	12102+00
Pic 17 Desc.	Bridge and ECDs at S-MM11 in acceptable condition	Pic 18 Desc.	RCE on the CIS of half acre of rock road in acceptable condition
