Visual Site Inspection Report

Project Name H-600 Pipeline Spread H		AFE 124300138	Spread H-600 Pipeline Spread H
Contractor Precision		Report # 21607	
Inspector Logan Box		Date/Time 3/29/2021 3:36 PM	
Permit # TBD	Inspection Type VA SWPP	Station Begin 13525+99	
State VA	Inspection Area Partial	Station End 13670+00	
County Franklin	Ground Damp	Temperature (°F) 61.00	
Municipality N/A	Weather Sunny	Rain Gauge (in) 0.50	
			Rain Accumulation Time (days) 2.00

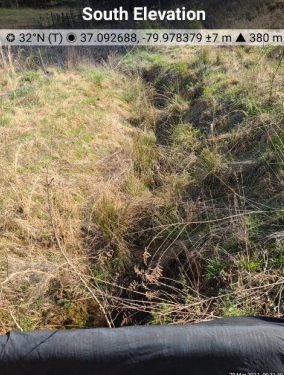
<p>South Elevation 32°N (T) ● 37.092688, -79.978379 ±7 m ▲ 380 m</p>

<p>North Elevation 186°S (T) ● 37.092698, -79.978408 ±6 m ▲ 377 m</p>	
GPS Location	00000		GPS Location	00000	
Field Station#	13579+93		Field Station#	13579+93	
Pic 1 Desc.	Stream observation photo facing upstream during routine inspection today, no issues observed at the time of inspection.		Pic 2 Desc.	Stream observation photo facing downstream during routine inspection today. No issues observed at the time inspection.

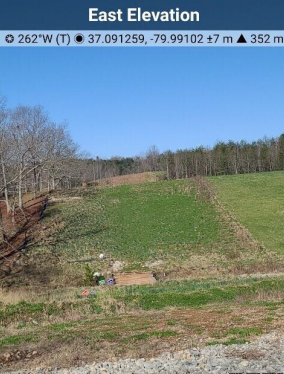
<p>East Elevation 262°W (T) ● 37.091259, -79.99102 ±7 m ▲ 352 m</p>

<p>North East Elevation 246°SW (T) ● 37.089997, -79.974039 ±3 m ▲ 453 m</p>	
GPS Location	0000000		GPS Location	00000	
Field Station#	13540+00		Field Station#	13587+34	
Pic 5 Desc.	Row photo showing permanent vegetation area with good coverage.		Pic 6 Desc.	Row photo showing vegetation in permanent area with good stabilization.

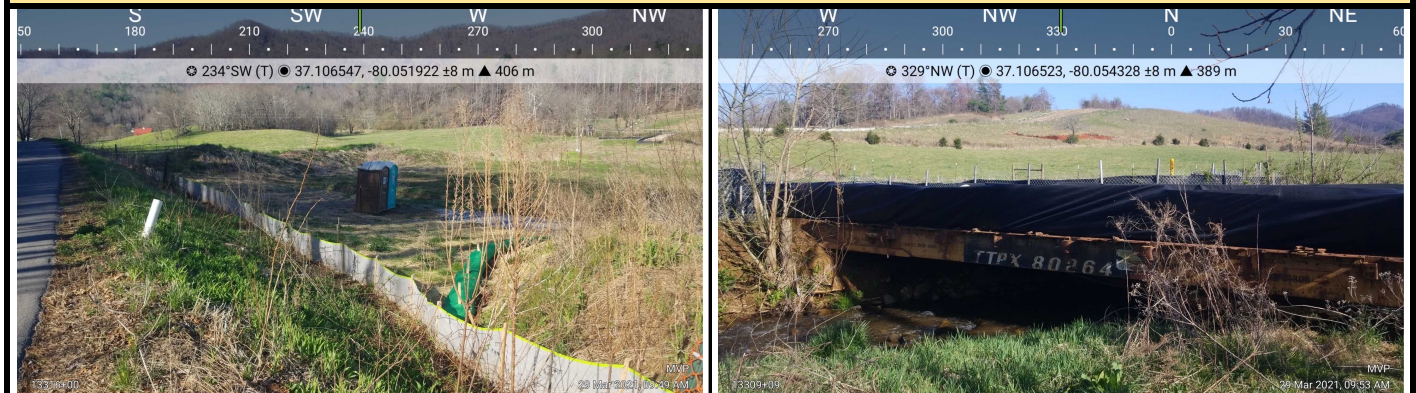
GPS Location See photo coordinates.	GPS Location See photo coordinates.
Field Station# 13316+00	Field Station# 13309+00
Pic 1 Desc. CIS of Wades Gap, perimeter controls in acceptable condition along road crossing.	Pic 2 Desc. S-GH7, upstream, bridge in good condition, no changes noted at stream crossing.

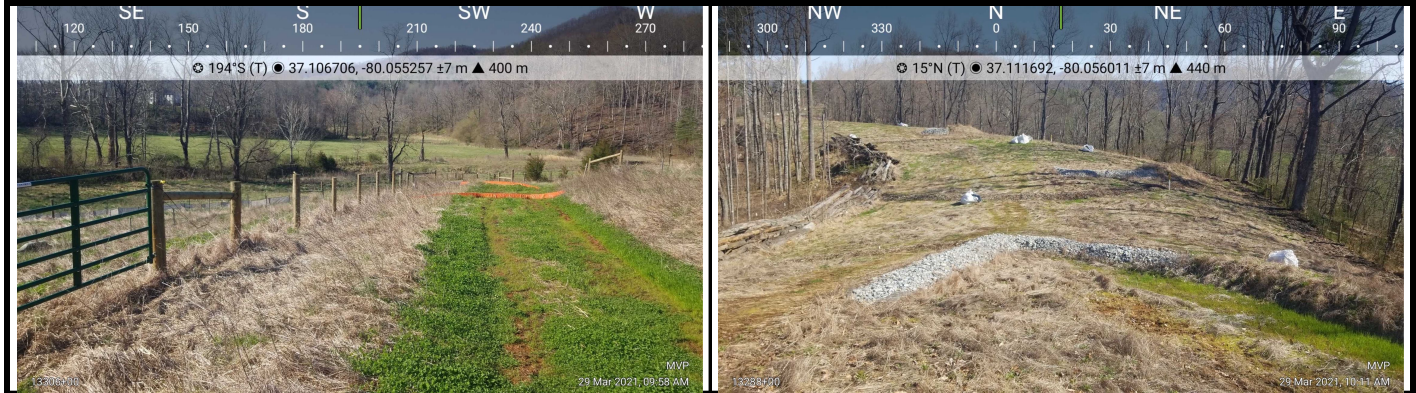
GPS Location See photo coordinates.	GPS Location See photo coordinates.
Field Station# 13306+00	Field Station# 13288+00
Pic 3 Desc. ROW stable with vegetative cover across LOD.	Pic 4 Desc. ROW stable with vegetative cover across LOD.

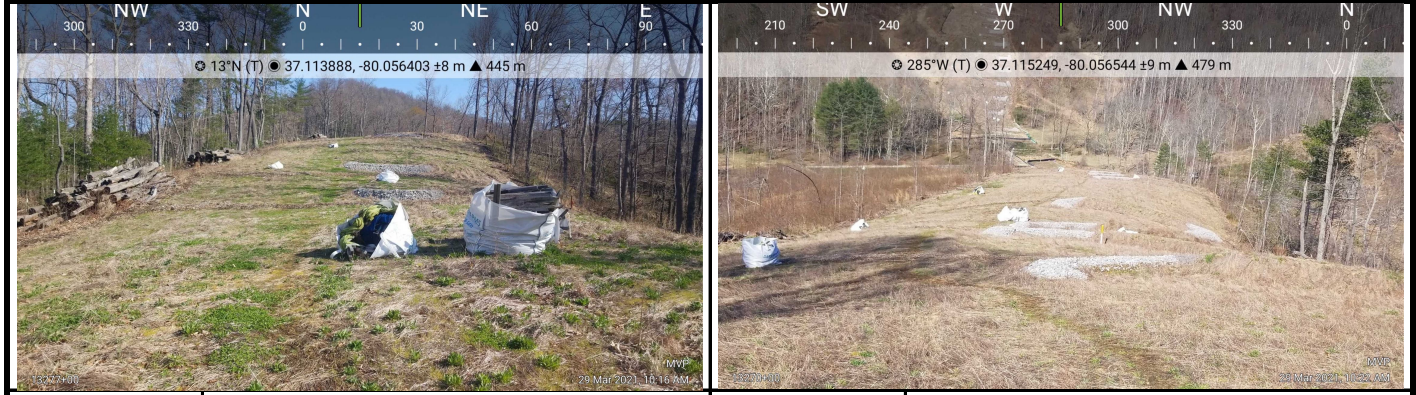
GPS Location See photo coordinates.	GPS Location See photo coordinates.
Field Station# 13277+00	Field Station# 13270+00
Pic 5 Desc. ROW stable with vegetative cover across LOD.	Pic 6 Desc. ROW stable with vegetative cover across LOD.

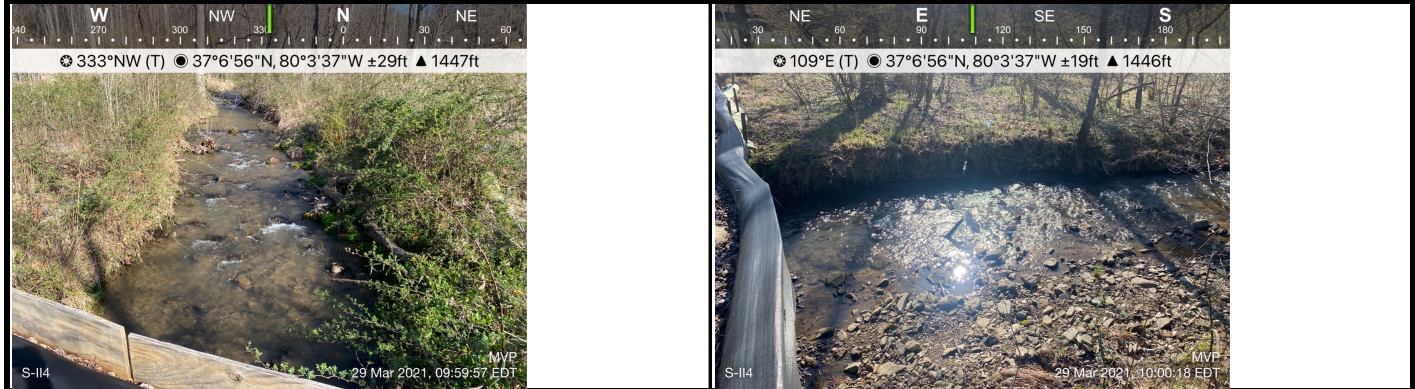
GPS Location	See photo coordinates.	GPS Location	See photo coordinates.
Field Station#	13260+60	Field Station#	13260+60
Pic 7 Desc.	S-II4, upstream, banks stable and well vegetated, no changes noted.	Pic 8 Desc.	S-II4, downstream, banks appeared stable, no changes noted.

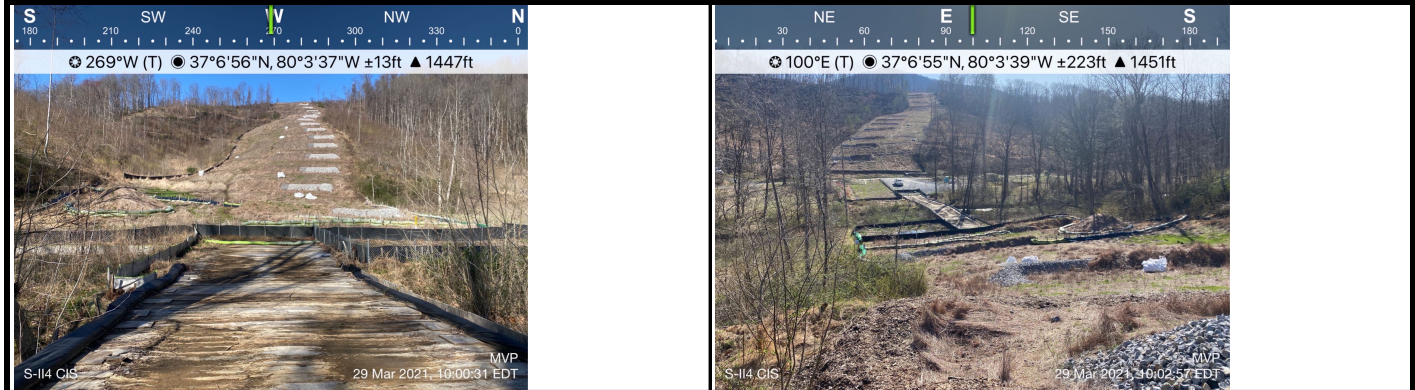
GPS Location	See photo coordinates.	GPS Location	See photo coordinates.
Field Station#	13260+60	Field Station#	13257+00
Pic 9 Desc.	CIS S-II4, bridge in acceptable condition at stream crossing, ROW stable and perimeter controls in acceptable condition.	Pic 10 Desc.	ROW stable with vegetative cover across LOD.

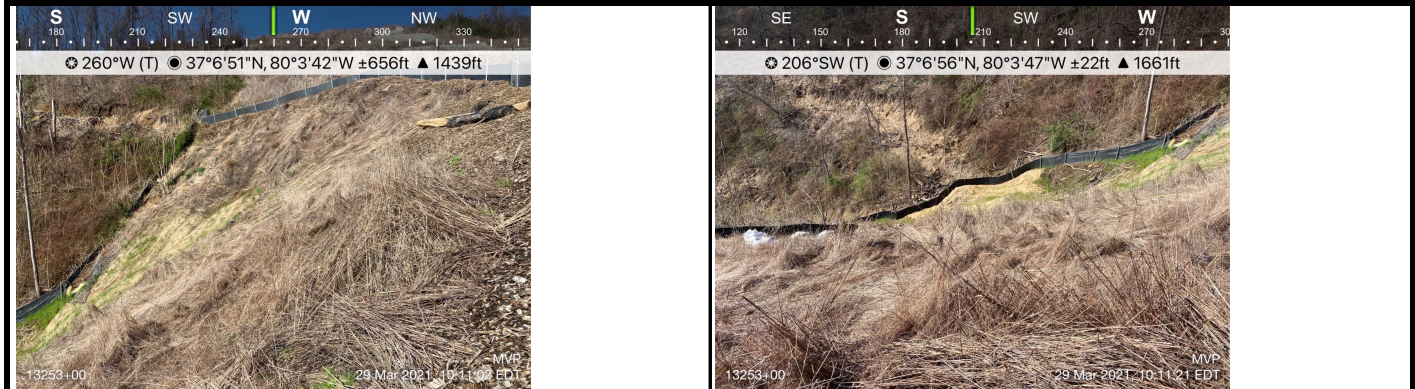
GPS Location	See photo coordinates.	GPS Location	See photo coordinates.
Field Station#	13253+00	Field Station#	13253+00
Pic 11 Desc.	No changes noted at slip location, area appeared stable with erosion control blanket and vegetative cover.	Pic 12 Desc.	No changes noted at slip location, area appeared stable with erosion control blanket and vegetative cover.

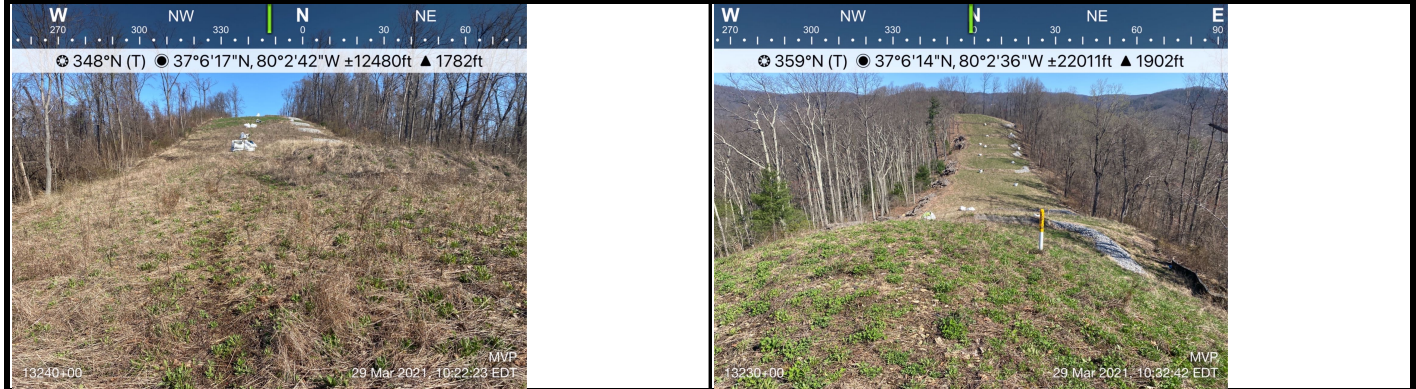
GPS Location	See photo coordinates.	GPS Location	See photo coordinates.
Field Station#	13240+00	Field Station#	13230+00
Pic 13 Desc.	ROW stable with vegetative cover across LOD.	Pic 14 Desc.	ROW stable with vegetative cover across LOD.

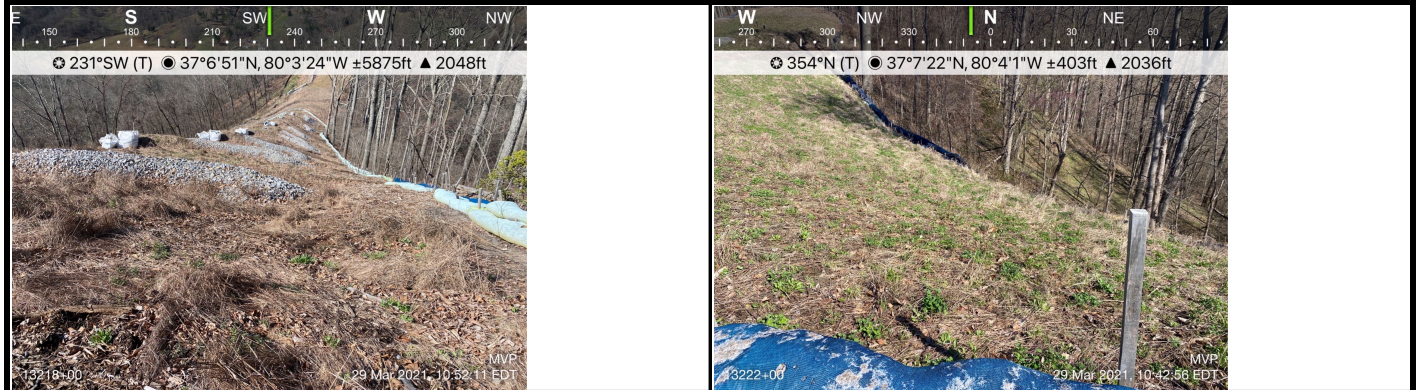
GPS Location	See photo coordinates.	GPS Location	See photo coordinates.
Field Station#	13218+00	Field Station#	13222+00
Pic 15 Desc.	ROW stable with vegetative cover across LOD.	Pic 16 Desc.	ROW stable with vegetative cover across LOD.

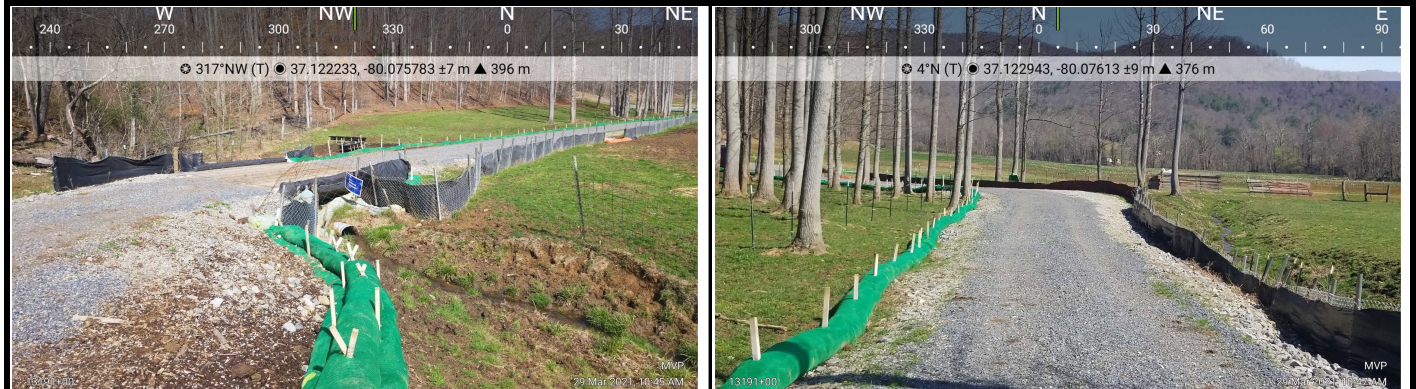
GPS Location	See photo coordinates.	GPS Location	See photo coordinates.
Field Station#	13191+00	Field Station#	13191+00
Pic 17 Desc.	MVP-MLV-AR-29, S-D10, typical cattle disturbance noted at stream.	Pic 18 Desc.	MVP-MLV-AR-29, access road in acceptable condition, ECDs functioning acceptably.

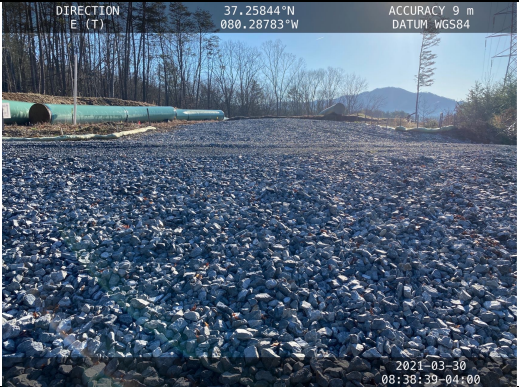
<p>DIRECTION E (T) 37.25844°N 080.28783°W ACCURACY 9 m DATUM WGS84 2021-03-30 08:30:39-04:00</p>	
GPS Location	See photo	GPS Location	See photo
Field Station#	12101+57	Field Station#	12102+69
Pic 7 Desc.	Bridge, buffer zone and ECDs in satisfactory condition at stream S-MM11.	Pic 8 Desc.	RCEs on both sides of Half Acre Rock Road in satisfactory condition.
  <p>DIRECTION E (T) 37.25829°N 080.28643°W ACCURACY 13 m DATUM WGS84 12108+41: bridge, buffer zone and ECDs in satisfactory condition @ S-F15 2021-03-30 08:41:29-04:00</p>		  <p>DIRECTION SW (T) 37.25792°N 080.28485°W ACCURACY 5 m DATUM WGS84 2021-03-30 08:44:49-04:00</p>	
GPS Location	See photo	GPS Location	See photo
Field Station#	12108+41	Field Station#	12112+13
Pic 9 Desc.	Bridge, buffer zone and ECDs in satisfactory condition at stream S-F15.	Pic 10 Desc.	Stream S-F16, facing southwest, downstream

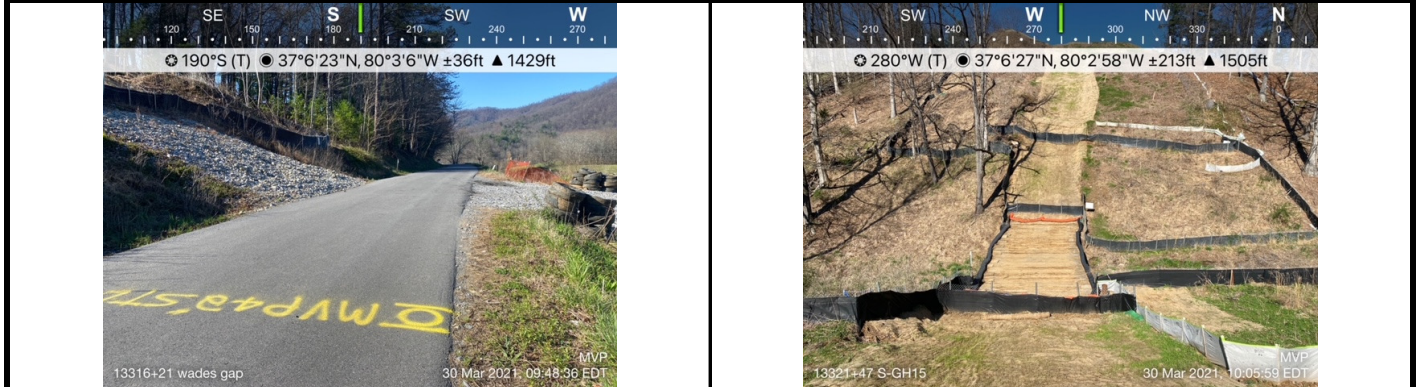
GPS Location	See Above	GPS Location	See Above
Field Station#	13316+21	Field Station#	13321+47
Pic 1 Desc.	Overview of Wades Gap Road ROW crossing. ECDs are functional and ROW is stable.	Pic 2 Desc.	Overview of Waterbody S-GH15. ECDs are functional and ROW is stable.

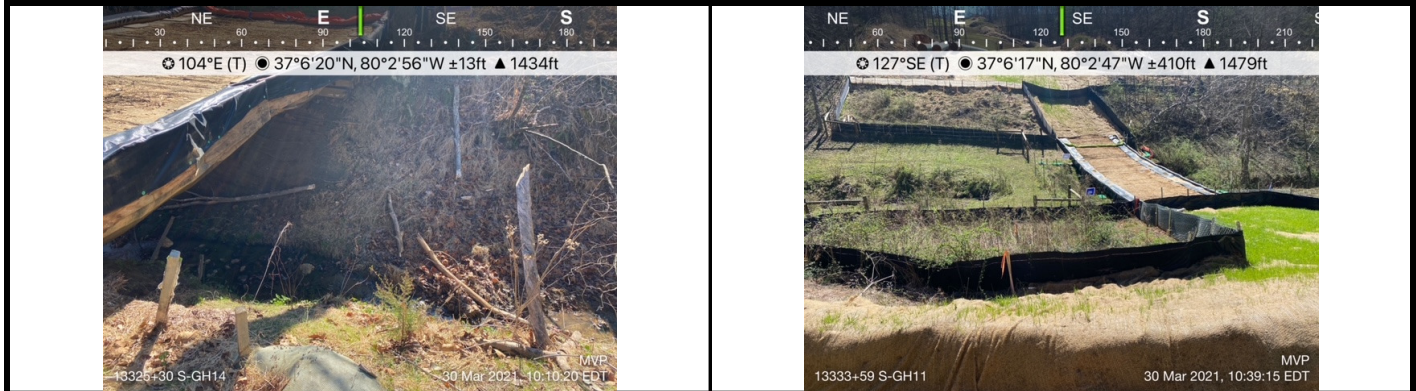
GPS Location	See Above	GPS Location	See Above
Field Station#	13325+30	Field Station#	13333+59
Pic 3 Desc.	Waterbody S-GH14. ECDs are functional and ROW is stable.	Pic 4 Desc.	Overview of Waterbody S-GH11. ECDs are functional and ROW is stable.

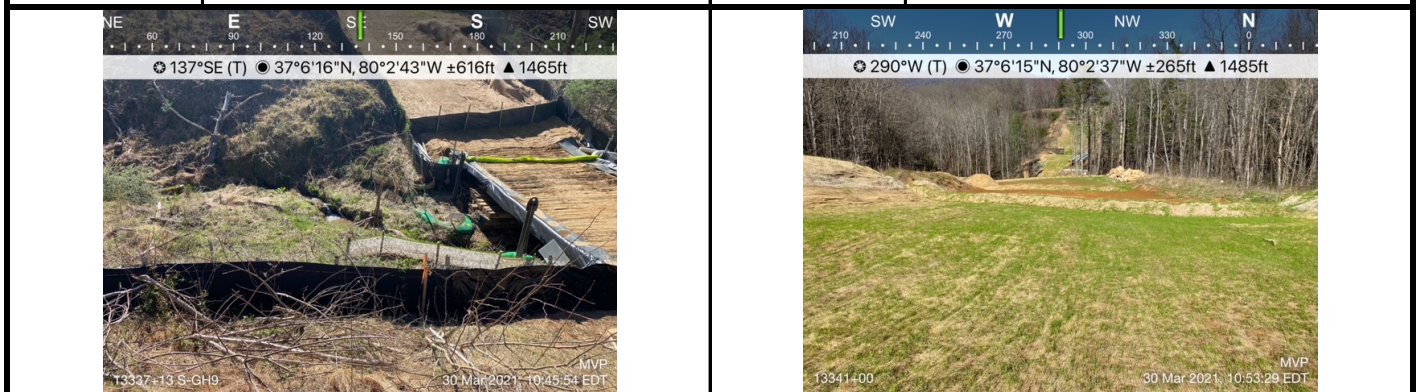
GPS Location	See Above	GPS Location	See Above
Field Station#	13337+13	Field Station#	13341+00
Pic 5 Desc.	Overview of Waterbody S-GH9. ECDs are functional and ROW is stable.	Pic 6 Desc.	ROW Overview. ECDs are functional and ROW is stable.

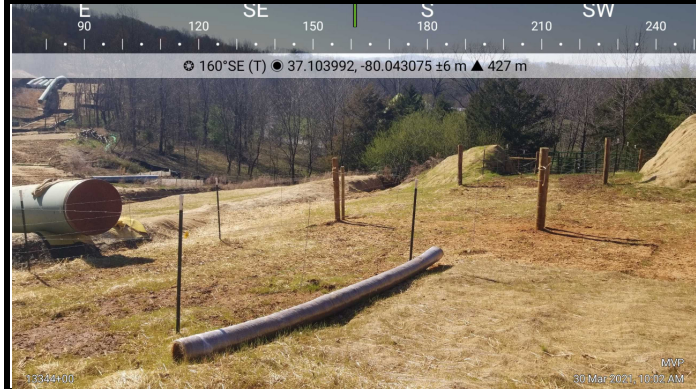
GPS Location	See Above
Field Station#	13344+00
Pic 7 Desc.	ROW Overview. ECDs are functional and ROW is stable.

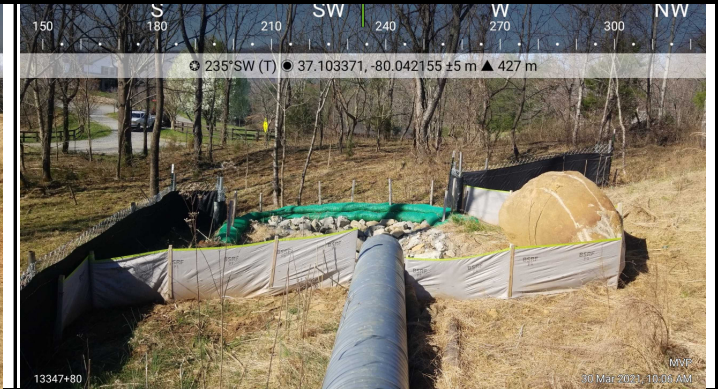
GPS Location	See Above
Field Station#	13347+80
Pic 8 Desc.	ROW Overview. Cleanwater diversion pipe. ECDs are functional and ROW is stable.

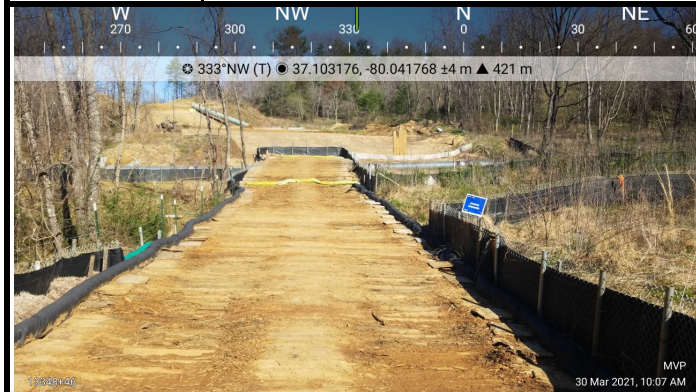
GPS Location	See Above
Field Station#	13348+46
Pic 9 Desc.	Overview of Waterbody S-RR08. ECDs are functional and ROW is stable.

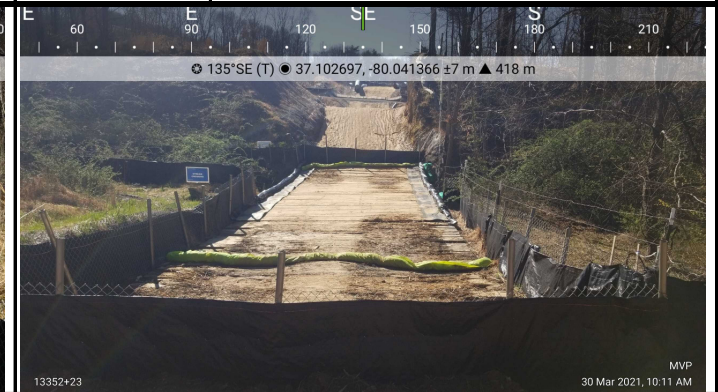
GPS Location	See Above
Field Station#	13352+23
Pic 10 Desc.	Overview of Waterbody S-RR09. ECDs are functional and ROW is stable.

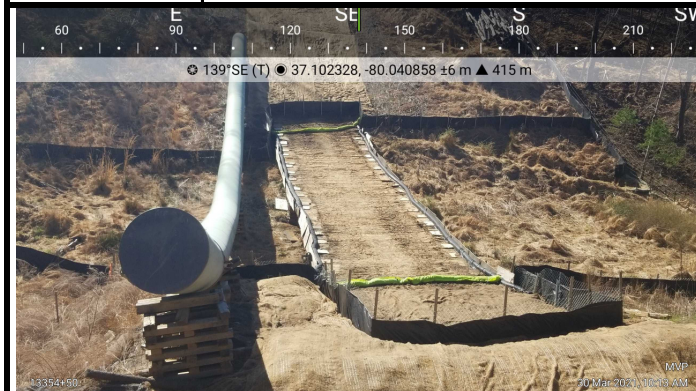
GPS Location	See Above
Field Station#	13354+50
Pic 11 Desc.	ROW Overview. Bridge of "grassy swale". ECDs are functional and ROW is stable.

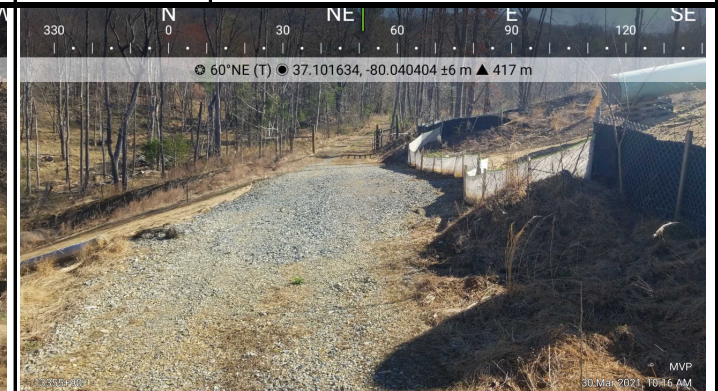
GPS Location	See Above
Field Station#	13355+90
Pic 12 Desc.	Overview of private road crossing ROW. ECDs are functional and ROW is stable.

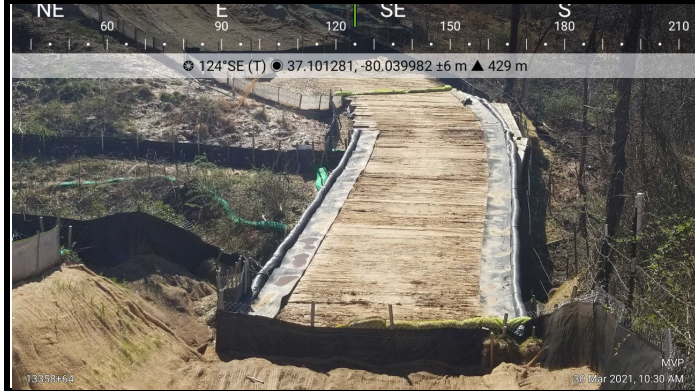
GPS Location	See Above
Field Station#	13358+64
Pic 13 Desc.	Overview of Waterbody S-RR11. ECDs are functional and ROW is stable.

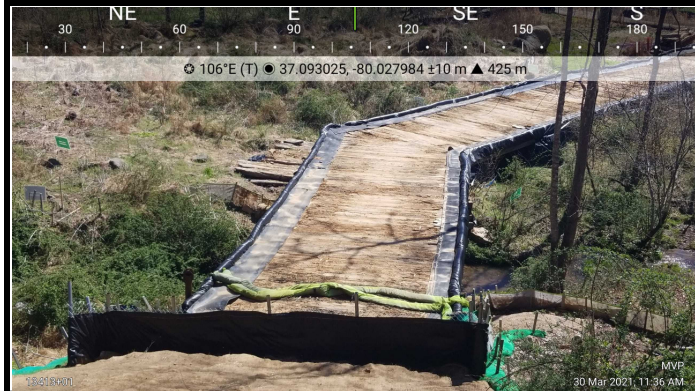
GPS Location	See Above
Field Station#	13413+01
Pic 17 Desc.	Overview of Waterbody S-IJ1. ECDs are functional and ROW is stable

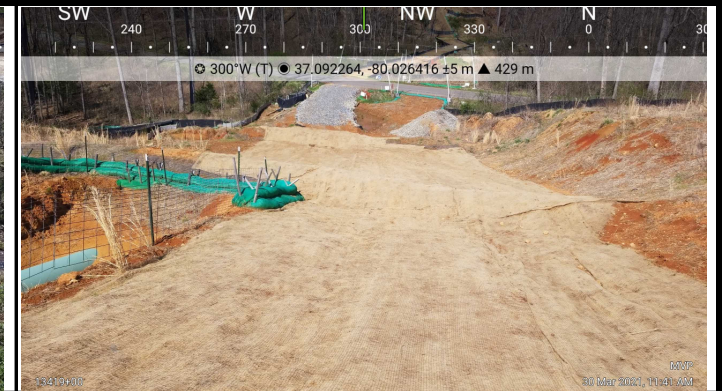
GPS Location	See Above
Field Station#	13419+00
Pic 18 Desc.	ROW Overview. ECDs are functional and ROW is stable.

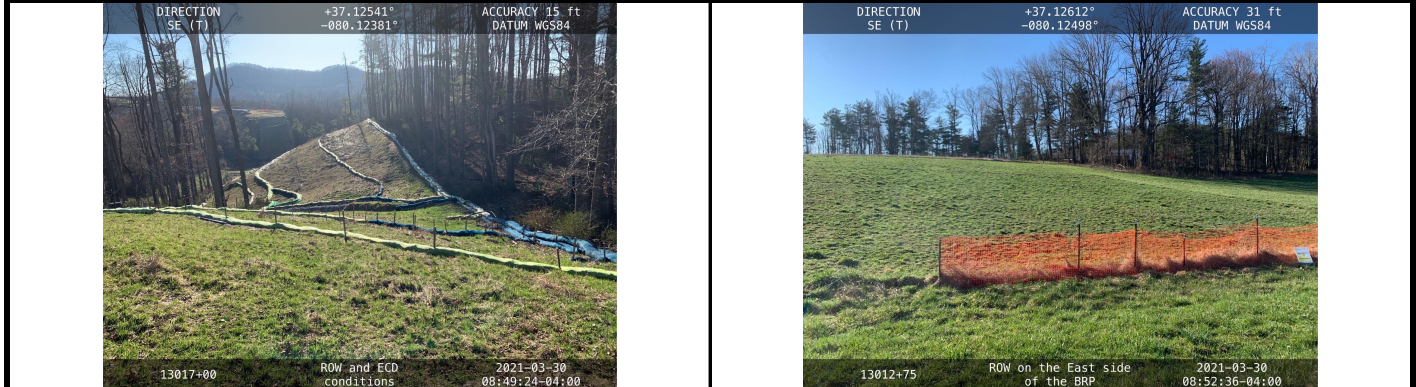
Pic 1 Desc.	Current conditions of the wooded portion of the BRP.	Pic 2 Desc.	GAS of the BRP motorway.
--------------------	--	--------------------	--------------------------

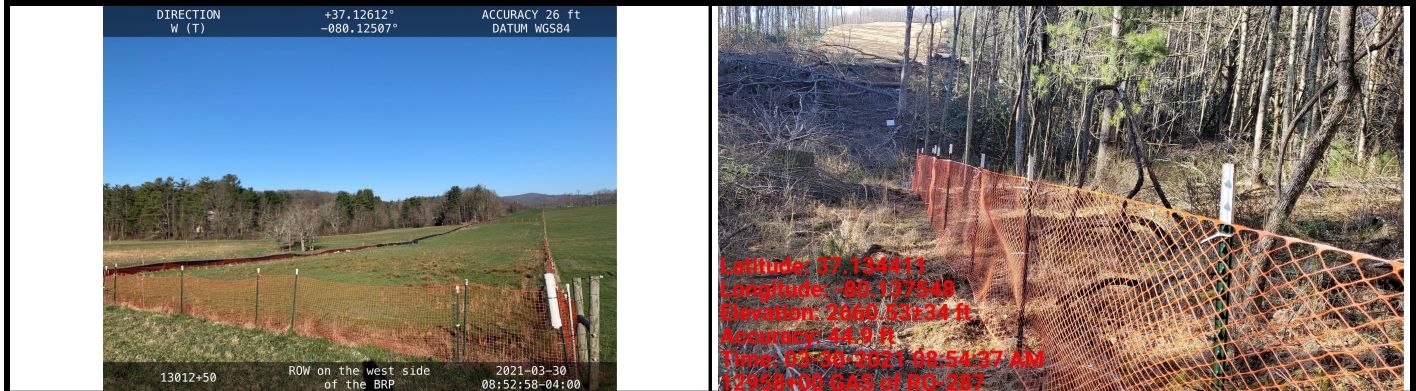
Pic 3 Desc.	CIS of the BRP motorway.	Pic 4 Desc.	Additional orange safety fence installed on the GAS of RO-287.
--------------------	--------------------------	--------------------	--

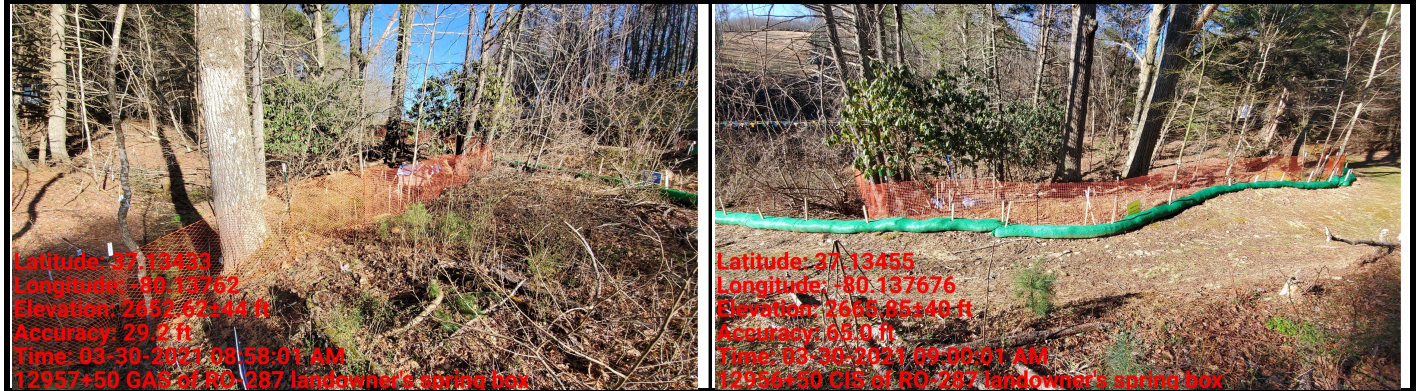
GPS Location	See pic for GPS location	GPS Location	See pic for GPS location
Field Station#	12957+50	Field Station#	12956+50
Pic 7 Desc.	Landowner's spring box at access RO-287.	Pic 8 Desc.	Additional orange safety fence installed around the spring box and along the driveway.

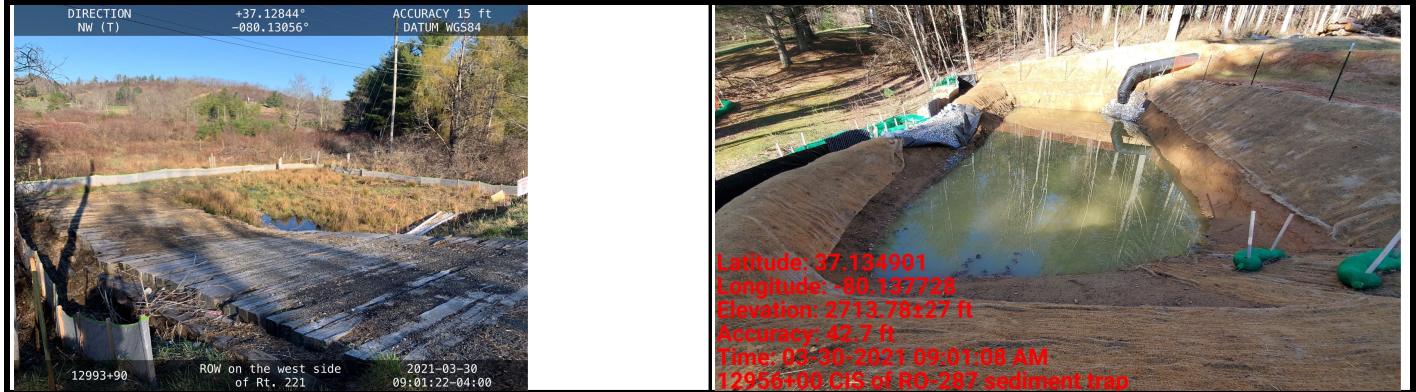
GPS Location	See pic for GPS location	GPS Location	See pic for GPS location
Field Station#	12993+00	Field Station#	12956+00
Pic 9 Desc.	Current conditions of the ROW on the CIS of US-221.	Pic 10 Desc.	Large sediment trap on the CIS of RO-287.

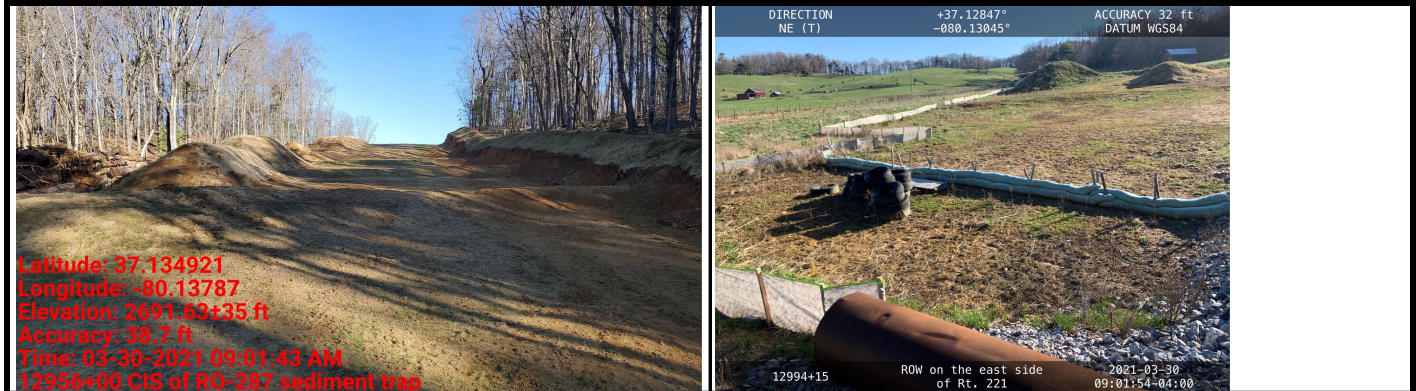
GPS Location	See pic for GPS location	GPS Location	See pic for GPS location
Field Station#	12956+00	Field Station#	12994+25
Pic 11 Desc.	Current ROW conditions on the CIS of RO-287.	Pic 12 Desc.	GAS of the US-221 road crossing.

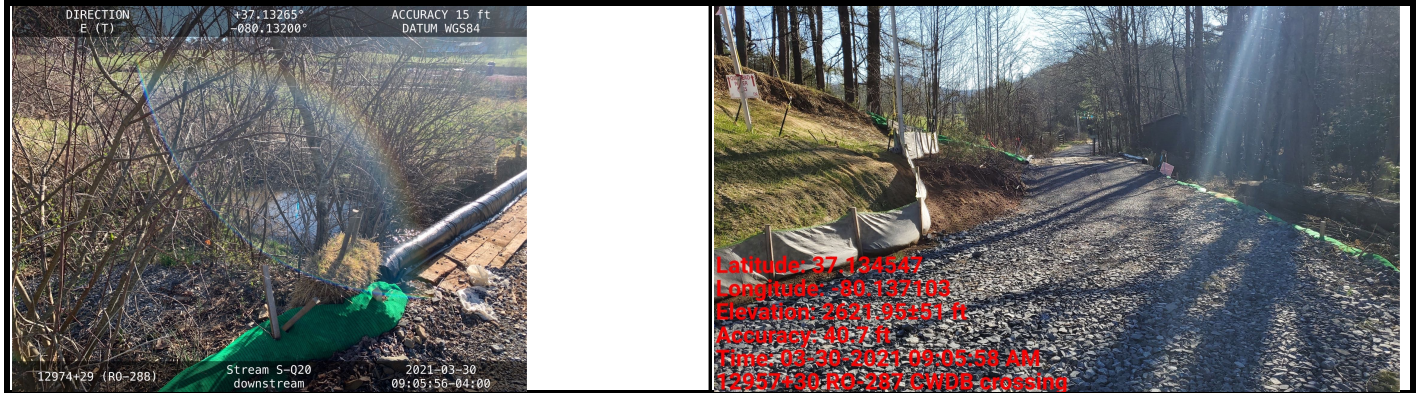
GPS Location	See pic for GPS location	GPS Location	See pic for GPS location
Field Station#	12974+29	Field Station#	12957+30
Pic 13 Desc.	Downstream side of stream S-Q20 on RO-288.	Pic 14 Desc.	CWDB crossing on RO-287.

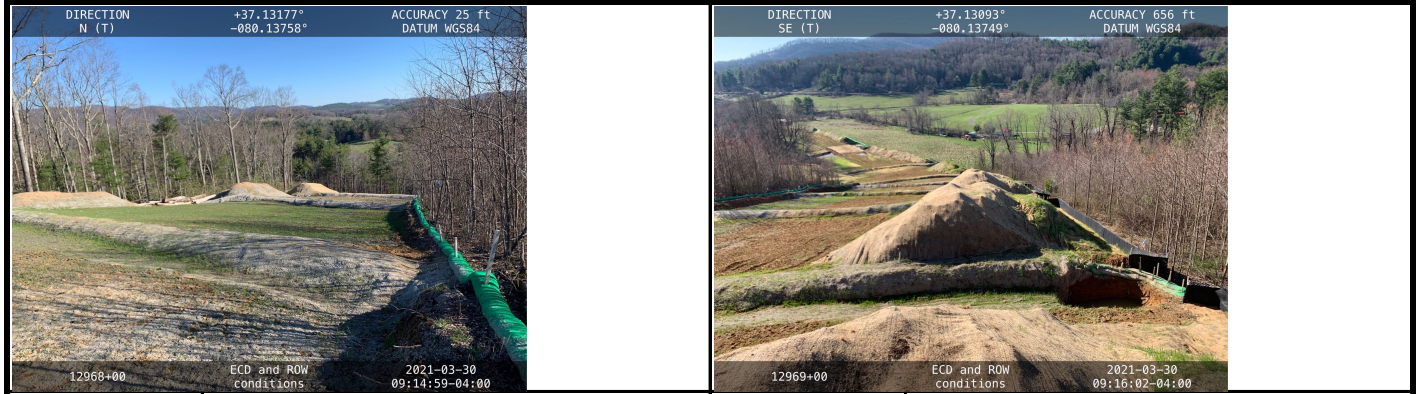
GPS Location	See pic for GPS location	GPS Location	See pic for GPS location
Field Station#	12968+00	Field Station#	12969+00
Pic 15 Desc.	Current ROW conditions on the GAS of RO-287.	Pic 16 Desc.	Current ROW conditions on the CIS of RO-288.

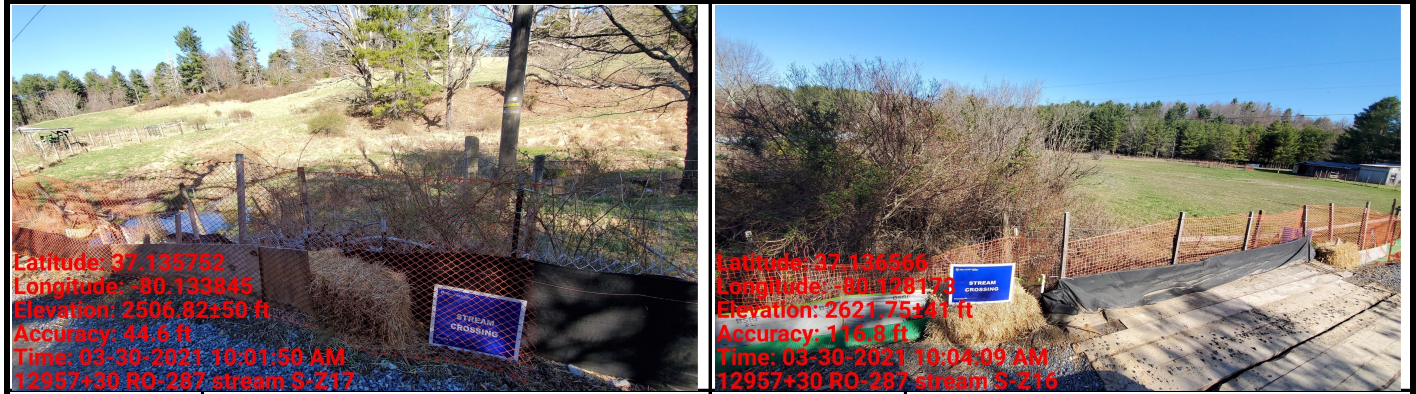
GPS Location	See pic for GPS location	GPS Location	See pic for GPS location
Field Station#	12957+30	Field Station#	12957+30
Pic 17 Desc.	Stream S-Z17.	Pic 18 Desc.	Stream S-Z16.

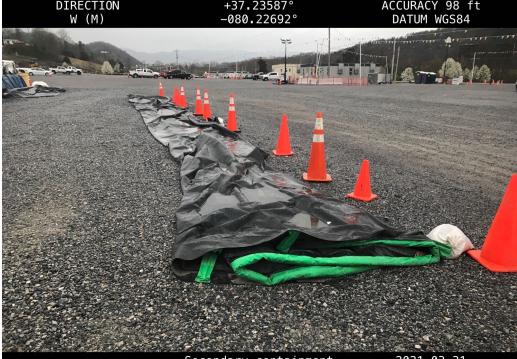
<p>DIRECTION W (M) +37.23587° -080.22692° ACCURACY 98 ft DATUM WGS84</p> <p>MVP-PY-006_033121 Secondary containment on site for tankers 2021-03-31 07:43:04-04:00</p>

GPS Location	MVP-PY-006 See photo for gps data	GPS Location	MVP-PY-006 See photo for gps data
Field Station#	+0	Field Station#	+0
Pic 7 Desc.	Secondary containment on site for tankers offloading fuel. Looking W.	Pic 8 Desc.	Blue Bulk Fuel tanks no leaky internal fittings. Looking W.

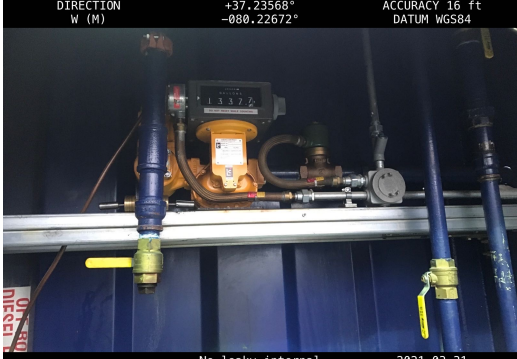
<p>DIRECTION W (M) +37.23568° -080.22672° ACCURACY 16 ft DATUM WGS84</p> <p>MVP-PY-006_033121 No leaky internal fittings 2021-03-31 07:43:43-04:00</p>
---	---

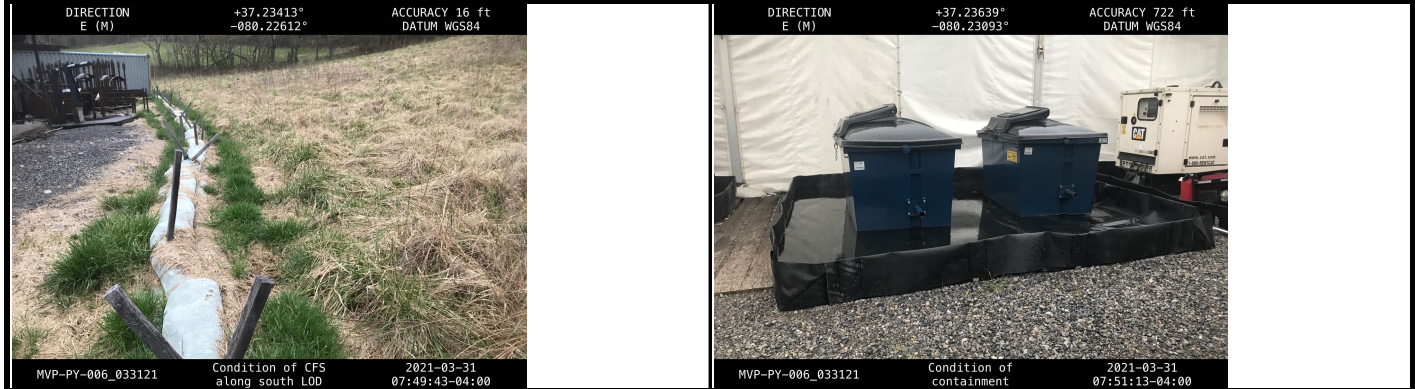
GPS Location MVP-PY-006 See photo for gps data	GPS Location MVP-PY-006 See photo for gps data
Field Station# +0	Field Station# +0
Pic 13 Desc. Condition of compost filter sock along south LOD. Looking E.	Pic 14 Desc. Condition of containment containing hazardous waste dumpsters. Holding stormwater. Looking E.

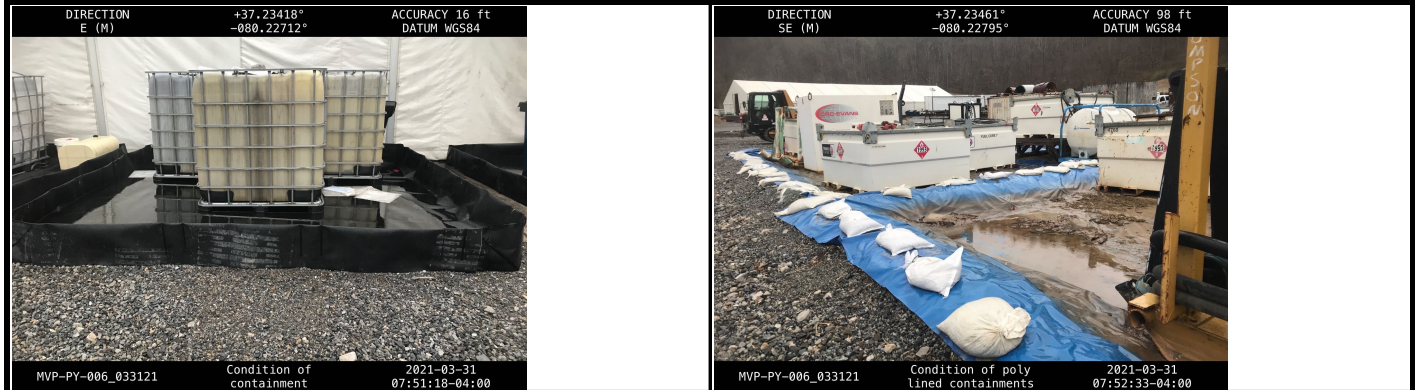
GPS Location MVP-PY-006 See photo for gps data	GPS Location MVP-PY-006 See photo for gps data
Field Station# +0	Field Station# +0
Pic 15 Desc. Condition of containment under used oil containers. Holding stormwater. Looking E.	Pic 16 Desc. Condition of poly lined rock berm containments. Holding stormwater. Looking SE.

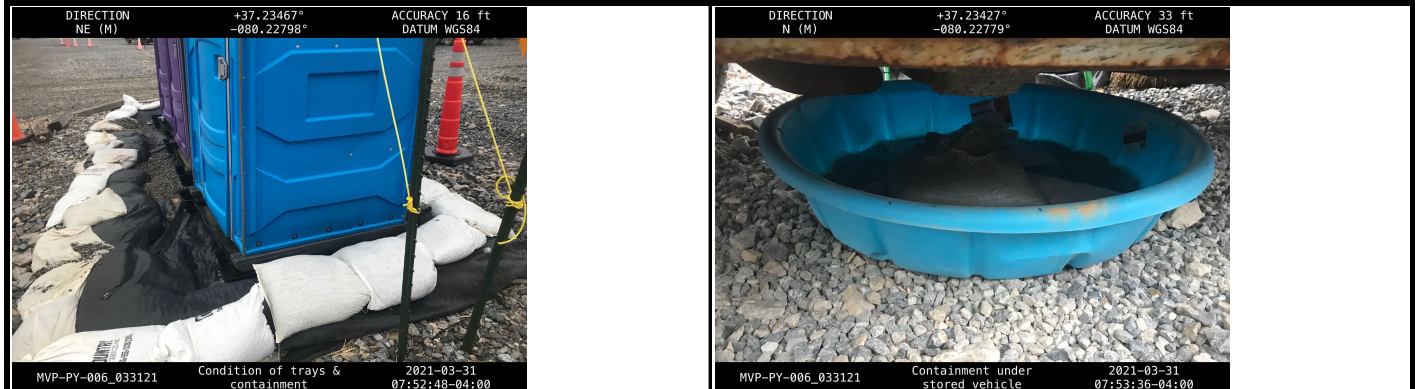
GPS Location MVP-PY-006 See photo for gps data	GPS Location MVP-PY-006 See photo for gps data
Field Station# +0	Field Station# +0
Pic 17 Desc. Condition of trays and containment under toilets. Looking NE.	Pic 18 Desc. Condition of containment under stored vehicle. Looking N.

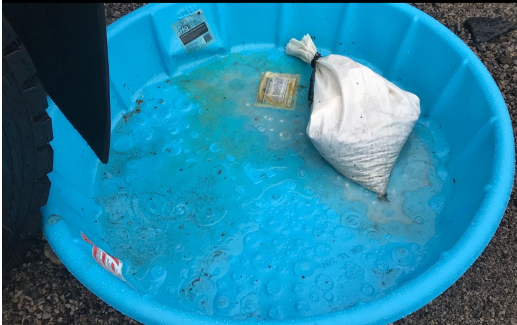
<p>MVP-LY-049_033121 Containment under stored trailer 2021-03-31 09:32:02-04:00</p>	<p>DIRECTION N (M) +37.27015° -080.12286° ACCURACY 16 ft DATUM WGS84</p>   <p>MVP-LY-049_033121 Containment under stored vehicle 2021-03-31 09:32:10-04:00</p>
---	---

GPS Location MVP-LY-049 See photo for gps data	GPS Location MVP-LY-049 See photo for gps data
Field Station# +0	Field Station# +0
Pic 17 Desc. Condition of containment under stored trailer. Looking SW.	Pic 18 Desc. Condition of containment under stored vehicle. Looking N.

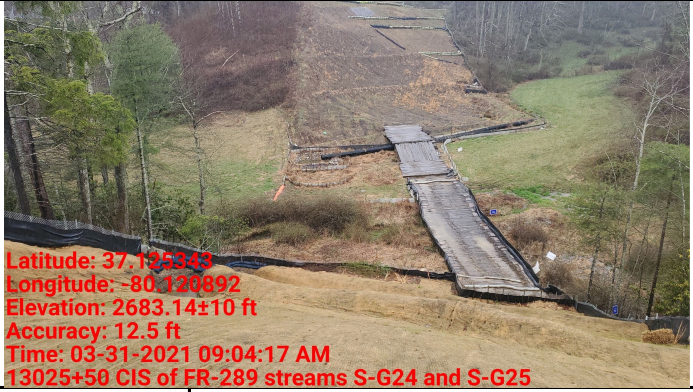
<p>Latitude: 37.125343 Longitude: -80.130892 Elevation: 2683.14±10 ft Accuracy: 12.5 ft Time: 03-31-2021 09:04:17 AM 13025+50 CIS of FR-289 streams S-G24 and S-G25</p>

<p>Latitude: 37.125547 Longitude: -80.119823 Elevation: 2690.13±10 ft Accuracy: 11.8 ft Time: 03-31-2021 09:09:45 AM 13028+50 CIS of FR-289</p>	
GPS Location	See pic for GPS location	GPS Location	See pic for GPS location
Field Station#	13025+50	Field Station#	13028+50
Pic 1 Desc.	Streams S-G24 and S-G25 from the GAS.	Pic 2 Desc.	Current ROW conditions on the CIS of FR-289.

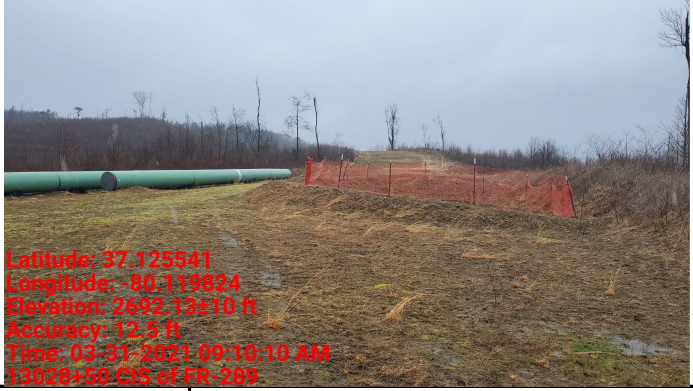
<p>Latitude: 37.125541 Longitude: -80.119824 Elevation: 2692.13±10 ft Accuracy: 12.5 ft Time: 03-31-2021 09:10:10 AM 13028+50 CIS of FR-289</p>

Field Station#	13028+50	Field Station#	13040+50
Pic 3 Desc.	Current ROW conditions on the CIS of FR-289.	Pic 4 Desc.	Stream S-H1 from the CIS.

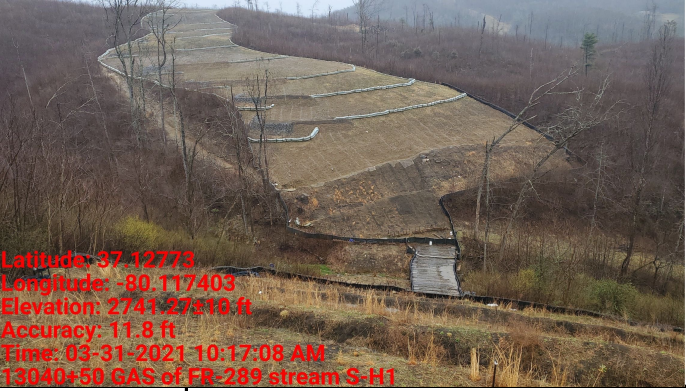
<p>Latitude: 37.12773 Longitude: -80.117403 Elevation: 2741.27±10 ft Accuracy: 11.8 ft Time: 03-31-2021 10:17:08 AM 13040+50 GAS of FR-289 stream S-H1</p>	
GPS Location	See pic for GPS location	GPS Location	See pic for GPS location

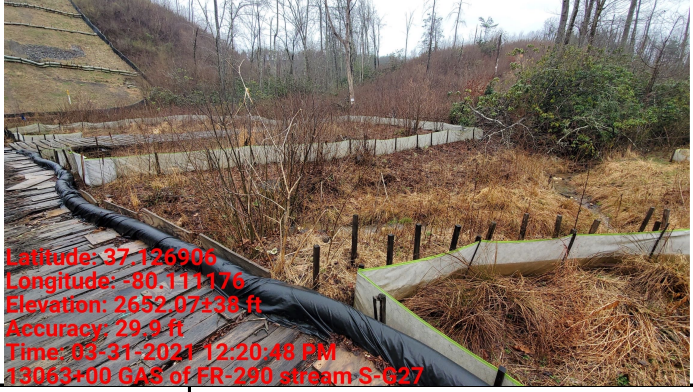
<p>Latitude: 37.126906 Longitude: -80.111176 Elevation: 2652.07±38 ft Accuracy: 29.9 ft Time: 03-31-2021 12:20:48 PM 13063+00 GAS of FR-290 stream S-G27</p>

<p>Latitude: 37.126973 Longitude: -80.111058 Elevation: 2642.56±37 ft Accuracy: 27.9 ft Time: 03-31-2021 12:31:12 PM 13063+00 GAS of FR-290 stream S-G27</p>	
GPS Location	See pic for GPS location	GPS Location	See pic for GPS location
Field Station#	13063+00	Field Station#	13063+00
Pic 5 Desc.	Upstream side of stream S-G27.	Pic 6 Desc.	Downstream side of stream S-G27.

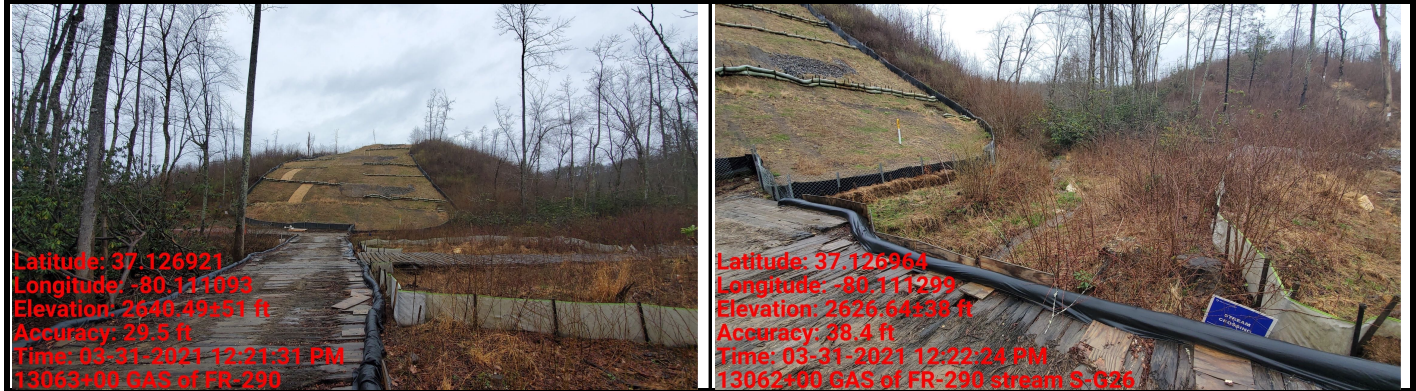
GPS Location	See pic for GPS location	GPS Location	See pic for GPS location
Field Station#	13063+00	Field Station#	13062+00
Pic 7 Desc.	CIS of FR-290 from equipment bridge.	Pic 8 Desc.	Upstream side of stream S-G26.

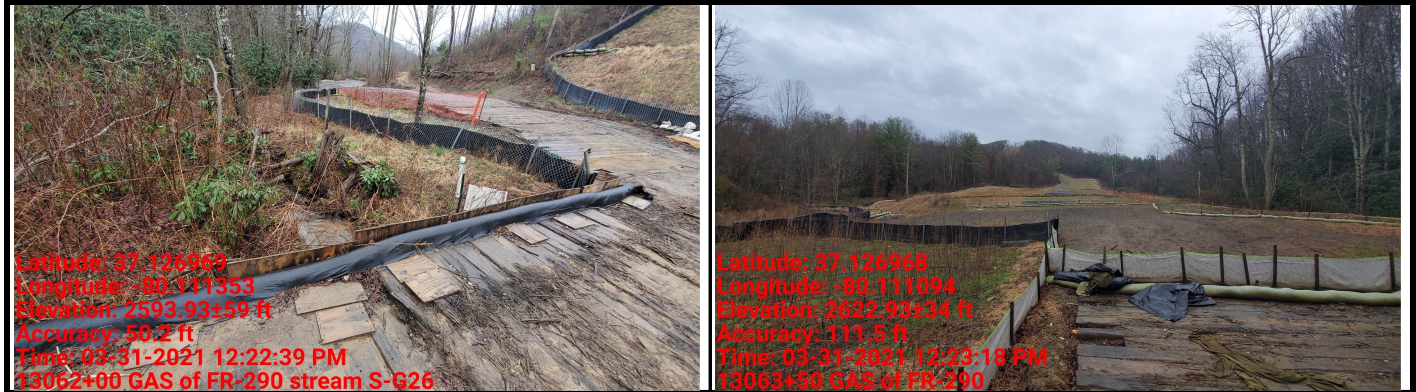
GPS Location	See pic for GPS location	GPS Location	See pic for GPS location
Field Station#	13062+00	Field Station#	13063+50
Pic 9 Desc.	Downstream side of stream S-G26.	Pic 10 Desc.	GAS of streams S-G26 and S-G27.

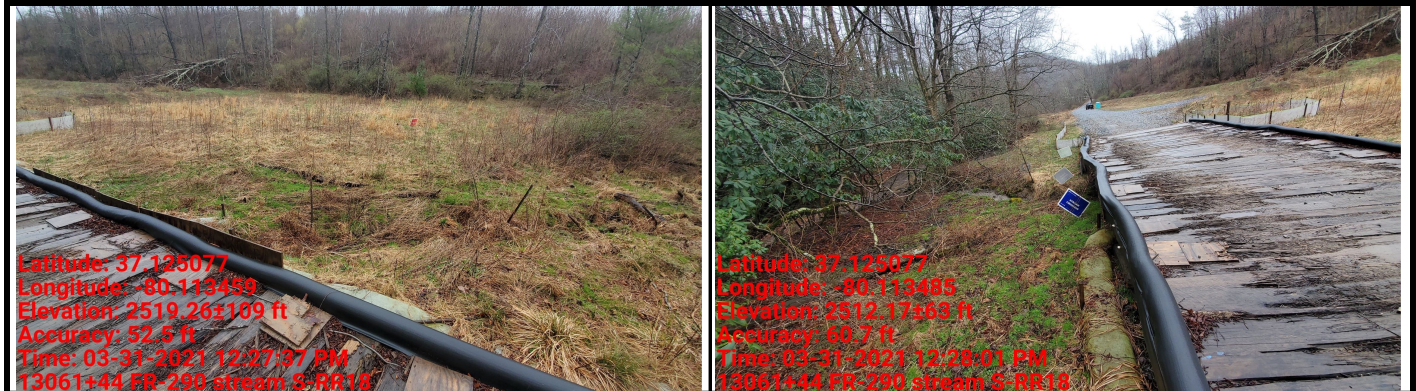
GPS Location	See pic for GPS location	GPS Location	See pic for GPS location
Field Station#	13061+44	Field Station#	13061+44
Pic 11 Desc.	Upstream side of stream S-RR18.	Pic 12 Desc.	Downstream side of stream S-RR18.

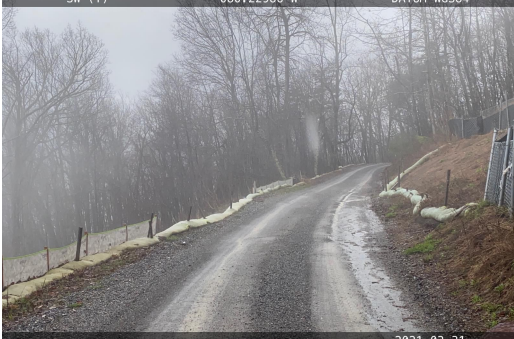
<p>DIRECTION NE (T) 37.23334°N 080.19809°W ACCURACY 9 m DATUM WGS84</p> <p>Environmental 12435+50 2021-03-31 13:21:43-04:00</p>			
GPS Location See photo		GPS Location See photo			
Field Station# 12284+75		Field Station# 12435+50			
Pic 1 Desc. ROW crossing on access road MVP-MN-276.03 in acceptable condition		Pic 2 Desc. Stream crossing S-NN16 in acceptable condition

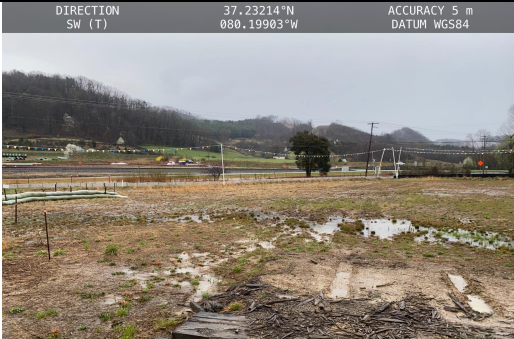
Field Station# 12442+00		Field Station# 12437+70			
Pic 3 Desc. Stabilized ROW in acceptable condition		Pic 4 Desc. CFS crossing mats ran over and needs repaired.
