Visual Site Inspection Report

Project Name H-600 Pipeline Spread H		AFE 124300138	Spread H-600 Pipeline Spread H
Contractor Precision		Report # 21607	
Inspector Logan Box		Date/Time 3/29/2021 3:36 PM	
Permit # TBD	Inspection Type VA SWPP	Station Begin 13525+99	
State VA	Inspection Area Partial	Station End 13670+00	
County Franklin	Ground Damp	Temperature (°F) 61.00	
Municipality N/A	Weather Sunny	Rain Gauge (in) 0.50	
			Rain Accumulation Time (days) 2.00

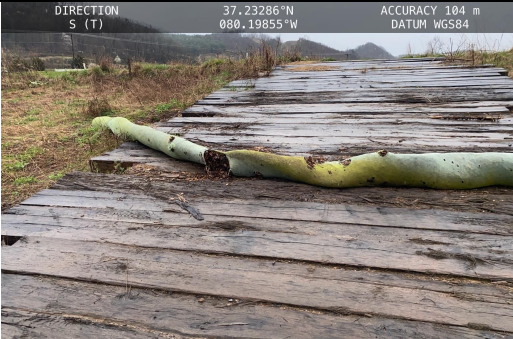
Field Station# 12442+00		Field Station# 12437+70			
Pic 3 Desc. Stabilized ROW in acceptable condition		Pic 4 Desc. CFS crossing mats ran over and needs repaired.

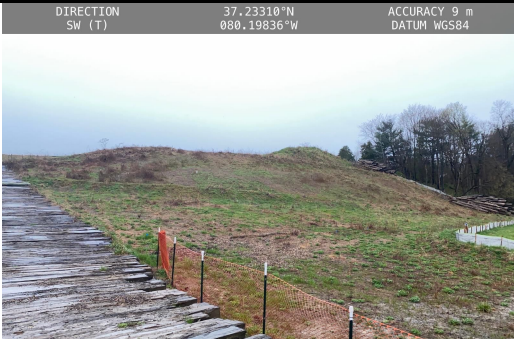
<p>DIRECTION Nw (T) 37.23636°N 080.19859°W ACCURACY 165 m DATUM WGS84</p> <p>Environmental 12426+00 2021-03-31 13:00:20-04:00</p>			
GPS Location See photo		GPS Location see photo			
Field Station# 12437+70		Field Station# 12426+00			
Pic 5 Desc. Stabilized ROW in acceptable condition		Pic 6 Desc. Stabilized diversion berm in acceptable condition

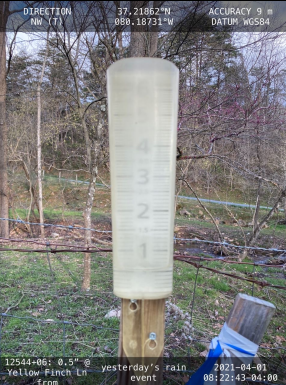
GPS Location	See photo	GPS Location	See photo		
Field Station#	12544+06	Field Station#	12544+06		
Pic 1 Desc.	0.5" of precipitation at Yellow Finch Lane from yesterday's rain event.	Pic 2 Desc.	Stream S-KL32, facing northwest, downstream from Yellow Finch Lane

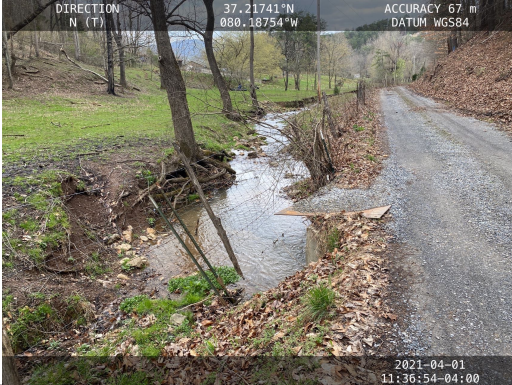
GPS Location	See photo	GPS Location	See photo		
Field Station#	12544+06	Field Station#	12544+06		
Pic 3 Desc.	Stream S-EF20b, facing north, downstream from Yellow Finch Lane	Pic 4 Desc.	Sediment washing out of landowner's driveway and depositing on Yellow Finch Lane.

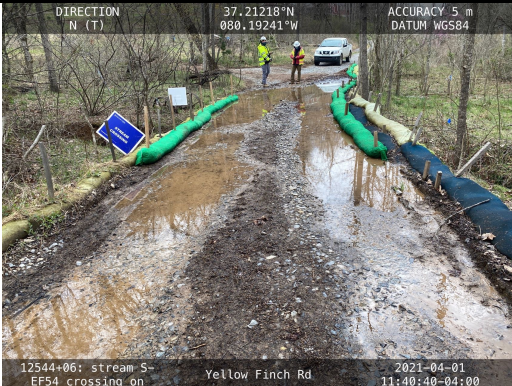
GPS Location	See photo	GPS Location	See photo		
Field Station#	12544+06	Field Station#	12544+06		
Pic 5 Desc.	Water pooled on Yellow Finch Lane where stream S-EF54 crosses beneath the road.	Pic 6 Desc.	ECDs in satisfactory condition along edge of Yellow Finch Lane at the ROW crossing.

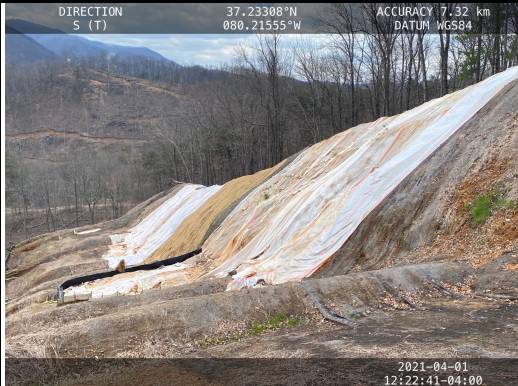
GPS Location	See photo	GPS Location	See photo
Field Station#	12529+00	Field Station#	12519+41
Pic 9 Desc.	Stockpiles remain stable.	Pic 10 Desc.	Bridge, buffer zone and ECDs in satisfactory condition at stream S-EF19.

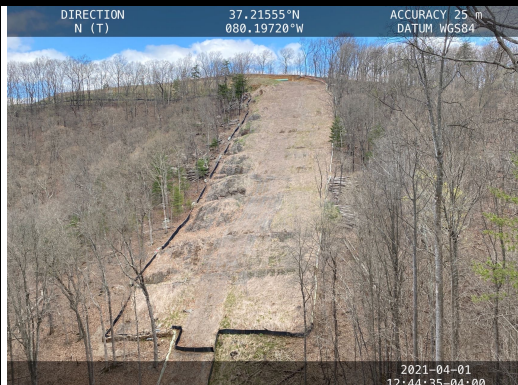
GPS Location	See photo	GPS Location	See photo
Field Station#	12517+00	Field Station#	12519+41
Pic 11 Desc.	Slope remains stable on the coming in side of stream S-EF19.	Pic 12 Desc.	Stream S-EF19, facing west, downstream

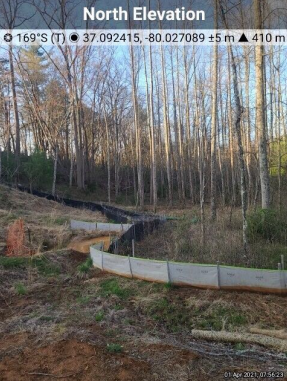
GPS Location 000000		GPS Location 0000			
Field Station# 13496+76		Field Station# 13417+20			
Pic 1 Desc. Monitored permanent vegetation, inspected ECDs at road crossing, no environmental issues observed at the time of inspection.		Pic 2 Desc. Monitored ECDs along side row , no environmental issues observed at the time of inspection.

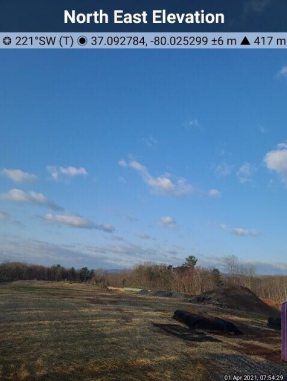
GPS Location 0000		GPS Location 0000			
Field Station# 13497+87		Field Station# 13420+00			
Pic 3 Desc. Monitored ECDs and vegetation growth, permanent vegetation was good up row from stream crossing.		Pic 4 Desc. Additional photo showing stabilization in work space . No issues observed at the time of inspection.

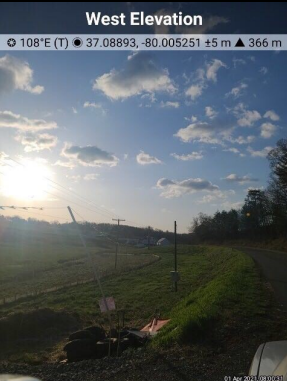
GPS Location 0000		GPS Location 0000			
Field Station# 13420+00		Field Station# 13496+84			
Pic 5 Desc. Monitored work space area at CAHAS#1 , new vegetation growing , ECDs in place and functioning.		Pic 6 Desc. Monitored ECDs and vegetation growth in Anode bed area. No environmental issues observed at the time of inspection.

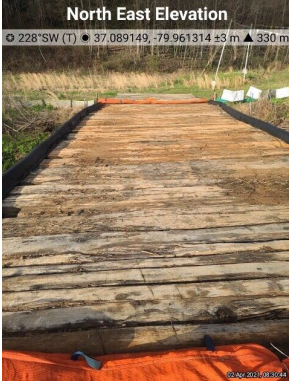
<p>East Elevation 303°W (T) ● 37.08907, -79.96156 ±5 m ▲ 328 m</p>		
GPS Location	00000	GPS Location	0000		
Field Station#	13643+54	Field Station#	13643+00		
Pic 1 Desc.	Monitored equipment bridge and protection during inspection today.		Pic 2 Desc.	Saturated row photo showing vegetation in area recently hydro seeded with new growth coming up.

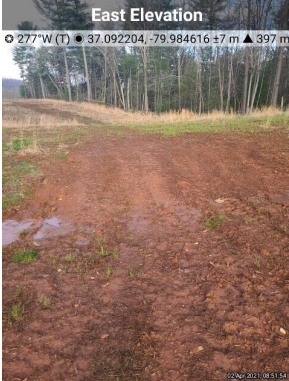
<p>South East Elevation 315°NW (T) ● 37.089064, -79.961376 ±3 m ▲ 331 m</p>		
GPS Location	00000	GPS Location	00000		
Field Station#	13562+10	Field Station#	13643+54		
Pic 3 Desc.	Row photo showing vegetation growth, sparse vegetation with some new growth in travel lane, will continue to monitor the area.		Pic 4 Desc.	Stream observation photo facing upstream during routine inspection today, no environmental issues observed at the time of inspection.

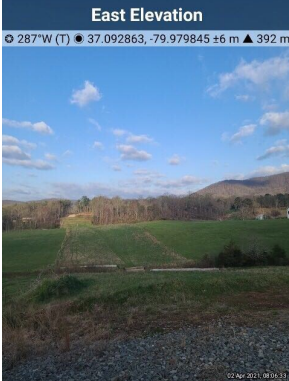
<p>North West Elevation 159°SE (T) ● 37.089049, -79.961313 ±3 m ▲ 331 m</p>		
GPS Location	00000	GPS Location	00000		
Field Station#	13563+63	Field Station#	13643+54		
Pic 5 Desc.	Row photo showing permanent vegetation growth with good coverage.		Pic 6 Desc.	Stream observation photo facing downstream during routine inspection today, no environmental issues observed at the time of inspection.

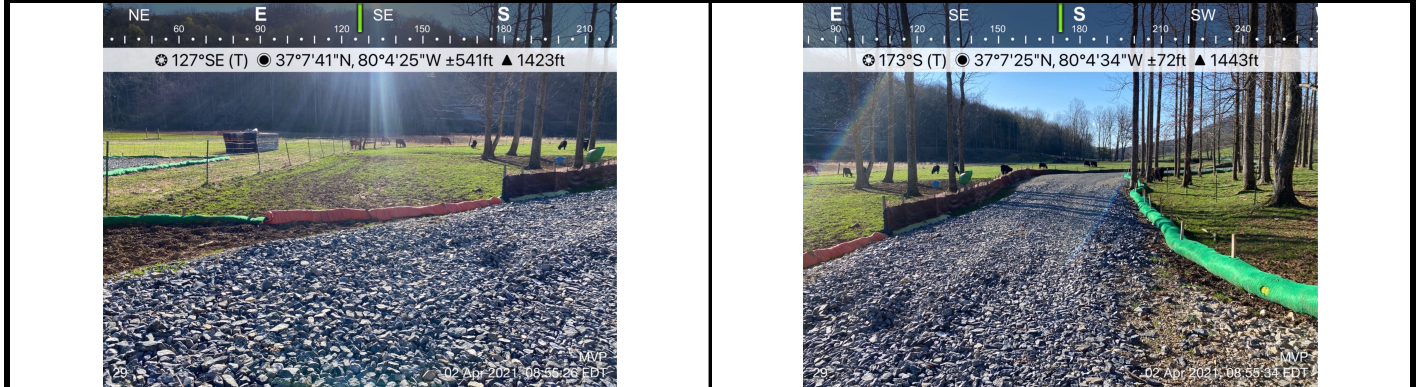
GPS Location	See photo for coordinates.
Field Station#	13190+00
Pic 1 Desc.	MVP-MLV-AR-29, access road and perimeter controls in acceptable condition.
GPS Location	See photo for coordinates.
Field Station#	13190+00
Pic 2 Desc.	MVP-MLV-AR-29, access road and perimeter controls in acceptable condition.

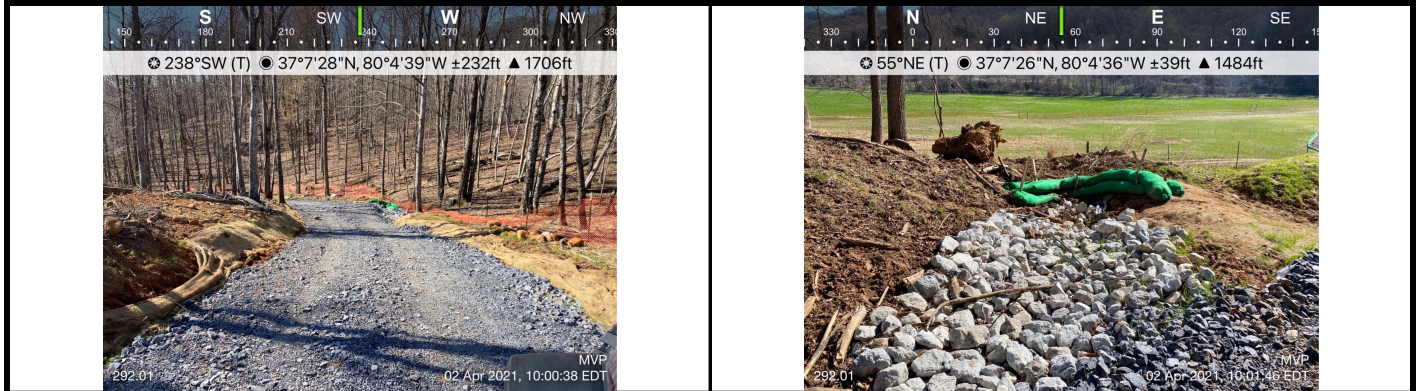
GPS Location	See photo for coordinates.
Field Station#	13186+00
Pic 3 Desc.	MVP-FR-292.01, access road in acceptable condition.
GPS Location	See photo for coordinates.
Field Station#	13188+00
Pic 4 Desc.	MVP-FR-292.01, access road in acceptable condition.

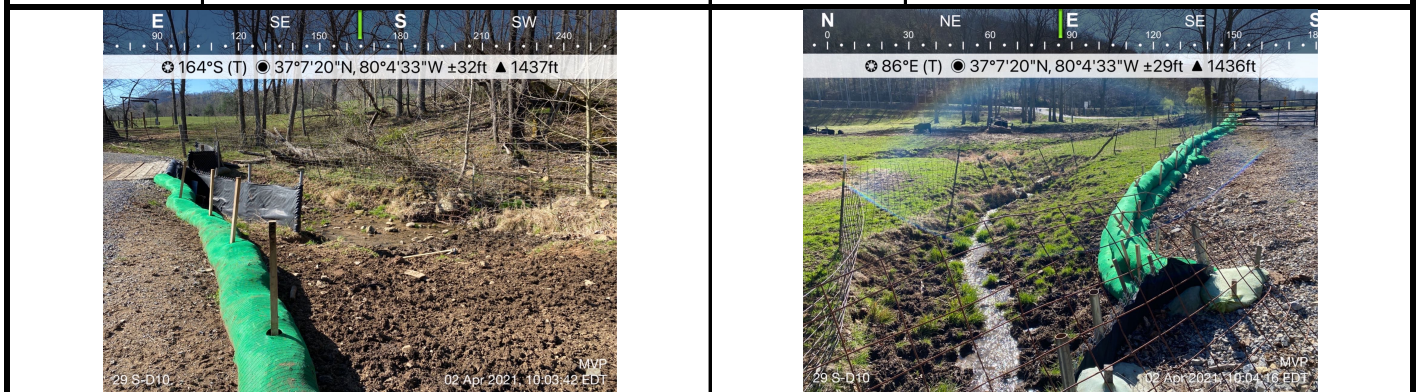
GPS Location	See photo for coordinates.
Field Station#	13190+00
Pic 5 Desc.	MVP-MLV-AR-29, S-D10, perimeter controls in acceptable condition, typical cattle disturbance noted in in stream and along banks.
GPS Location	See photo for coordinates.
Field Station#	13190+00
Pic 6 Desc.	MVP-MLV-AR-29, S-D10, perimeter controls in acceptable condition, typical cattle disturbance noted in in stream and along banks.

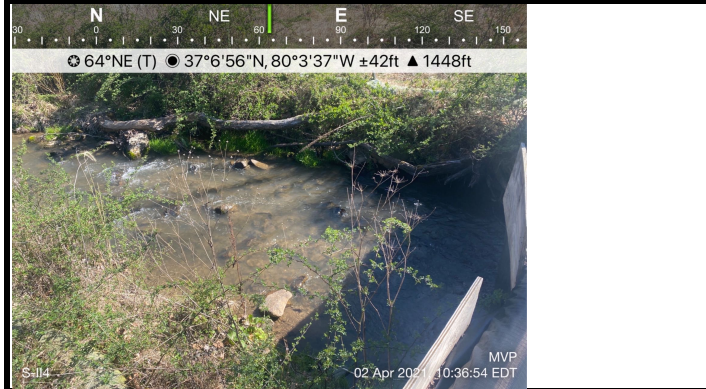
Pic 13 Desc. S-II4, upstream, slight turbidity noted in stream, bed and banks appeared stable.

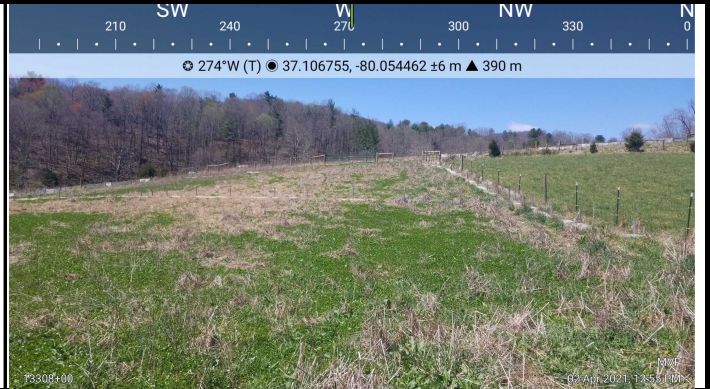
Pic 14 Desc. ROW stable with vegetative cover across LOD.

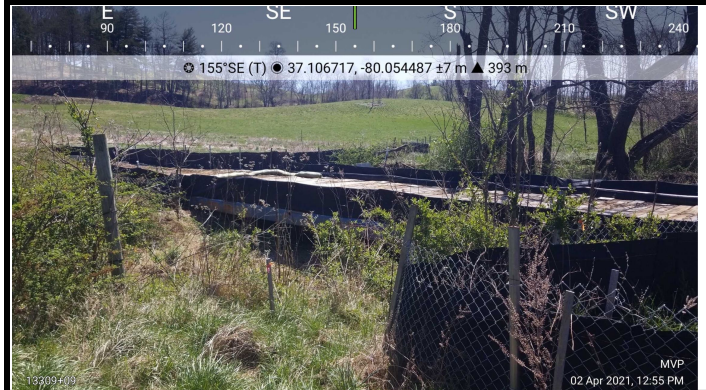
Pic 15 Desc. S-GH7, bridge in acceptable condition over stream crossing.
