# Visual Site Inspection Report

<b>Project Name</b>	H-600 Pipeline Spread H	<b>AFE</b>	124300138	<b>Spread</b>	H-600 Pipeline Spread H
<b>Contractor</b>	Precision			<b>Report #</b>	22418
<b>Inspector</b>	Logan Box			<b>Date/Time</b>	4/19/2021 3:18 PM
<b>Permit #</b>	TBD	<b>Inspection Type</b>	VA SWPP	<b>Station Begin</b>	13415+51
<b>State</b>	VA	<b>Inspection Area</b>	Partial	<b>Station End</b>	13525+99
<b>County</b>	Franklin	<b>Ground</b>	Wet	<b>Temperature (°F)</b>	64.00
<b>Municipality</b>	N/A	<b>Weather</b>	Light Rain	<b>Rain Gauge (in)</b>	0.30
				<b>Rain Accumulation Time (days)</b>	1.00

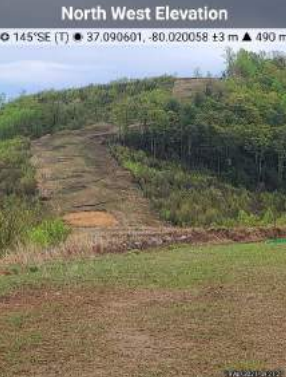
<b>AFE</b>	124300138	<b>Date/Time</b>	4/19/2021 3:18 PM	<b>Report #</b>	
<b>Pictures</b>					
	<b>North Elevation</b> <small>185°S (T) 37.092491, -80.027069 ±7 m ▲ 396 m</small>  			<b>East Elevation</b> <small>264°W (T) 37.090416, -80.020382 ±4 m ▲ 479 m</small>  	
<b>GPS Location</b>	00000	<b>GPS Location</b>	00000		
<b>Field Station#</b>	13416+44	<b>Field Station#</b>	13436+33		
<b>Pic 1 Desc.</b>	Monitored erosion control blanket on hill side , o environmental issues observed at the time of inspection.		<b>Pic 2 Desc.</b>	Monitored ECDs and vegetation growth during light rain events .	
	<b>North West Elevation</b> <small>145°SE (T) 37.090601, -80.020058 ±3 m ▲ 490 m</small>

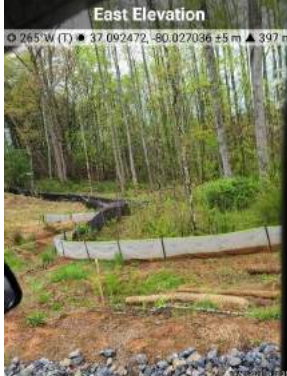
<b>GPS Location</b>	0000	<b>GPS Location</b>	0000		
<b>Field Station#</b>	13497+87	<b>Field Station#</b>	13415+90		
<b>Pic 5 Desc.</b>	Observed ECDs on stream bank where equipment mats were removed during maintenance repairs.		<b>Pic 6 Desc.</b>	Monitored ECDs during light rain events .

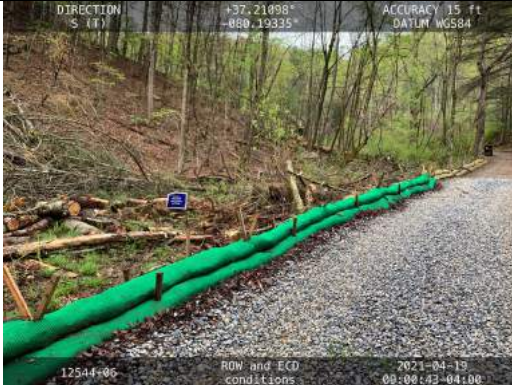
<b>GPS Location</b>	See photo for gps location data.		<b>GPS Location</b>	See photo for gps location data.	
<b>Field Station#</b>	12544+06		<b>Field Station#</b>	12544+06	
<b>Pic 1 Desc.</b>	Photo shows the condition of the access road and ECDs.		<b>Pic 2 Desc.</b>	Photo shows the condition of the access road and ECDs.

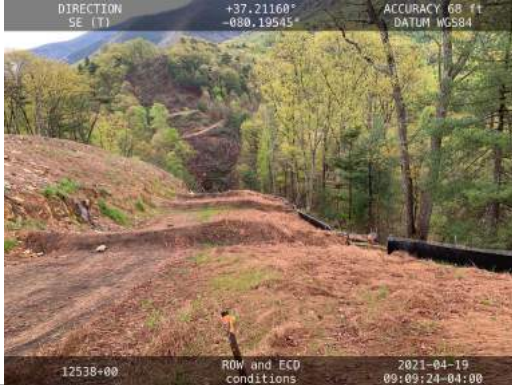
<b>GPS Location</b>	See photo for gps location data.		<b>GPS Location</b>	See photo for gps location data.	
<b>Field Station#</b>	12543+00		<b>Field Station#</b>	12538+00	
<b>Pic 3 Desc.</b>	Photo shows the soil slope stabilized with Visqueen.		<b>Pic 4 Desc.</b>	Photo shows the ROW and ECD conditions from about 12538+00 to 12543+00.

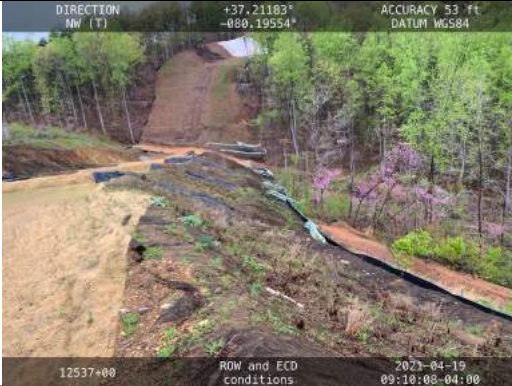
<b>Pic 5 Desc.</b>	Photo shows the ROW and ECD conditions from about 12533+00 to 12537+00.		<b>Pic 6 Desc.</b>	Photo shows the soil slopes stabilized with Visqueen.

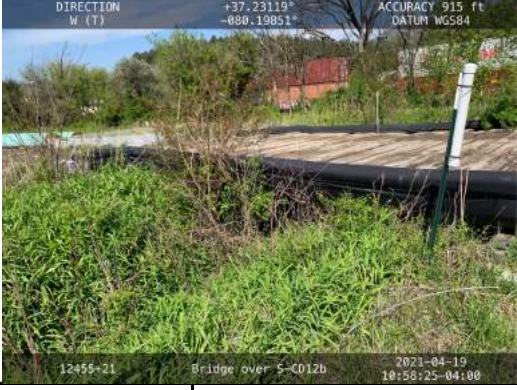
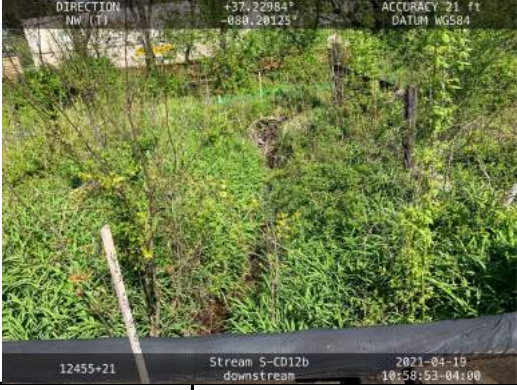
<b>Field Station#</b>	12455+21		<b>Field Station#</b>	12455+21	
<b>Pic 17 Desc.</b>	Photo shows the bridge over stream S-CD12b		<b>Pic 18 Desc.</b>	Photo shows stream S-CD12b downstream from the bridge.

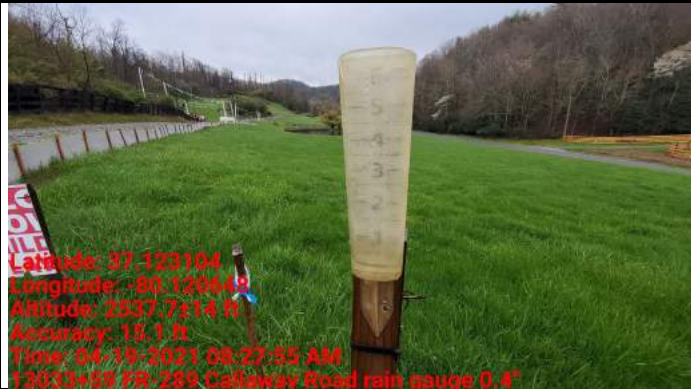
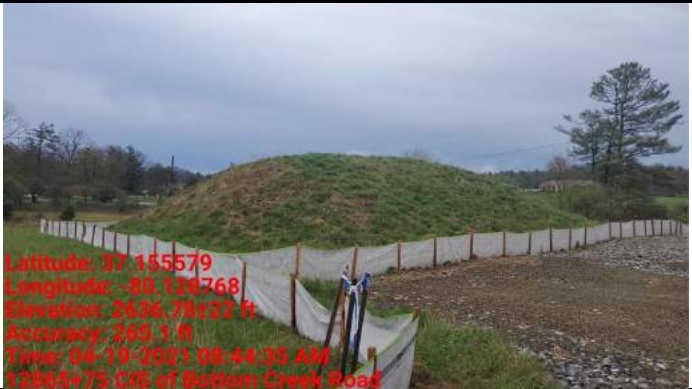
<p>Latitude: 37.155579 Longitude: -80.128768 Elevation: 2436.78±22 ft Accuracy: 285.1 ft Time: 04-19-2021 08:44:35 AM 12865+75 CIS of Bottom Creek Road</p>		
<b>GPS Location</b>	See pic for GPS location		<b>GPS Location</b>	See pic for GPS location	
<b>Field Station#</b>	13033+59		<b>Field Station#</b>	12865+75	
<b>Pic 1 Desc.</b>	0.4" total precipitation.		<b>Pic 2 Desc.</b>	P1 perimeter at Bottom Creek Road remains in compliance.

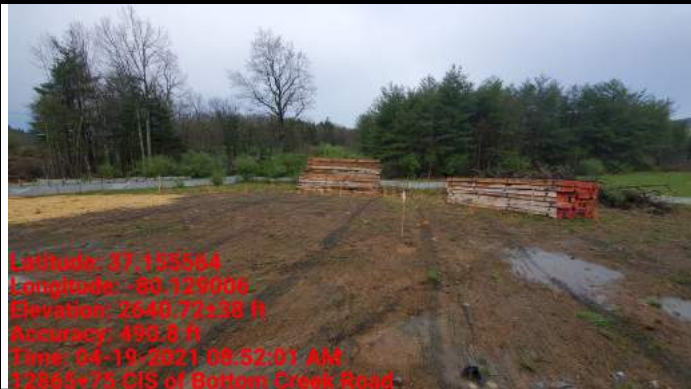
<b>GPS Location</b>	See pic for GPS location		<b>GPS Location</b>	See pic for GPS location	
<b>Field Station#</b>	12865+75		<b>Field Station#</b>	12866+26	
<b>Pic 3 Desc.</b>	Current ROW conditions on the CIS of Bottom Creek Road.		<b>Pic 4 Desc.</b>	GAS of Bottom Creek Road crossing.

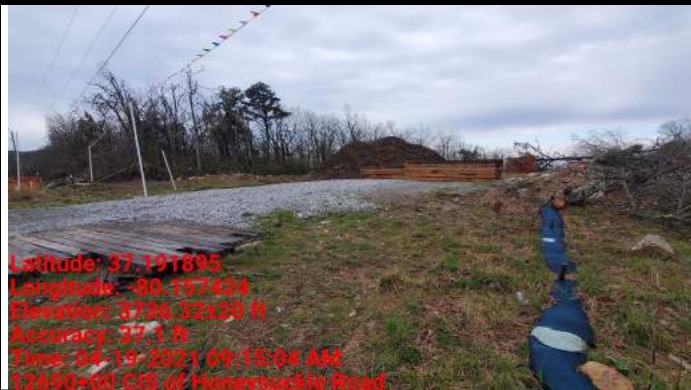
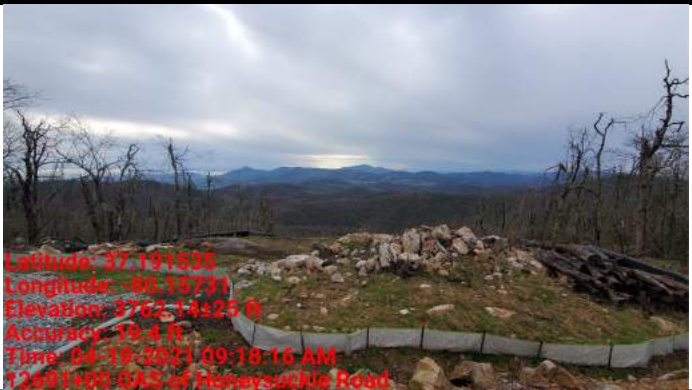
<p>Latitude: 37.191535 Longitude: -80.15731 Elevation: 3162.14±25 ft Accuracy: 19.4 ft Time: 04-19-2021 09:18:16 AM 12691+00 GAS of Honeysuckle Road</p>		
<b>GPS Location</b>	See pic for GPS location		<b>GPS Location</b>	See pic for GPS location	
<b>Field Station#</b>	12690+00		<b>Field Station#</b>	12691+00	
<b>Pic 5 Desc.</b>	RCE on the CIS of Honeysuckle Road.		<b>Pic 6 Desc.</b>	GAS of Honeysuckle Road crossing.

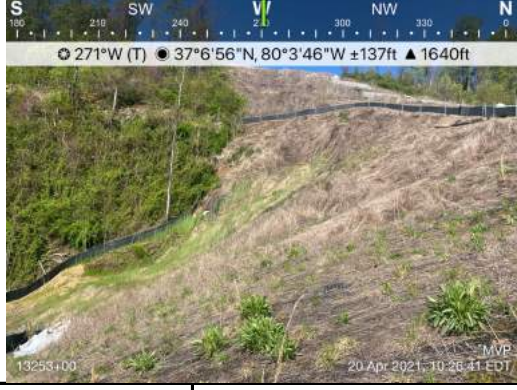
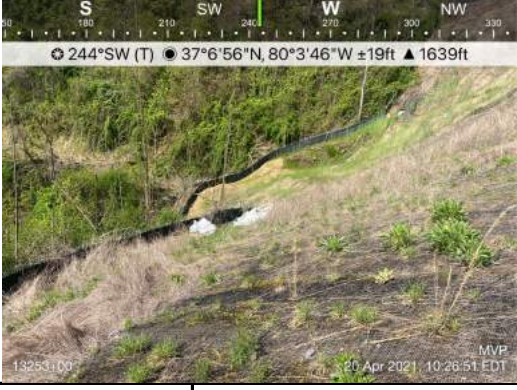
<b>Pic 11 Desc.</b>	Documented slip area appeared stable with vegetation establishing.		<b>Pic 12 Desc.</b>	Documented slip area appeared stable with vegetation establishing.

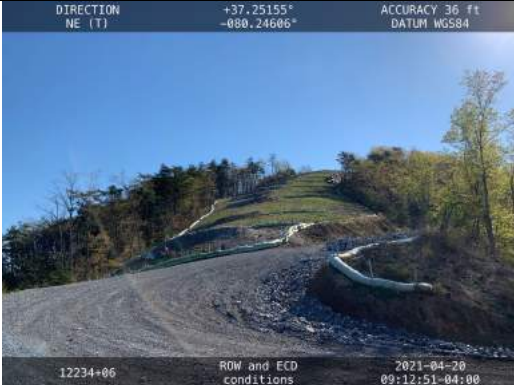
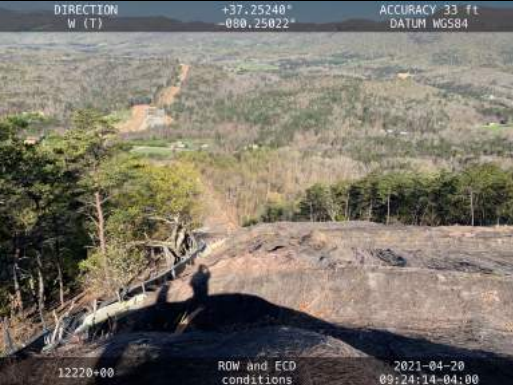
<b>GPS Location</b>	See photo for gps location data.		<b>GPS Location</b>	See photo for gps location data.	
<b>Field Station#</b>	12234+06		<b>Field Station#</b>	12220+00	
<b>Pic 1 Desc.</b>	Photo shows the ROW and ECD conditions.		<b>Pic 2 Desc.</b>	Photo shows the ROW and ECD conditions.

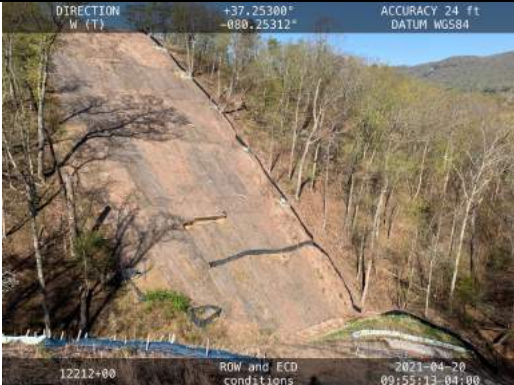
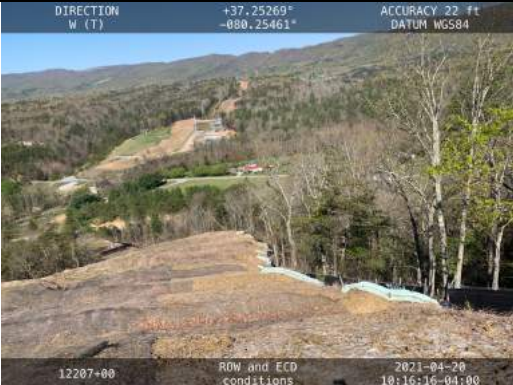
<b>GPS Location</b>	See photo for gps location data.		<b>GPS Location</b>	See photo for gps location data.	
<b>Field Station#</b>	12212+00		<b>Field Station#</b>	12207+00	
<b>Pic 3 Desc.</b>	Photo shows the ROW and ECD conditions.		<b>Pic 4 Desc.</b>	Photo shows the ROW and ECD conditions.

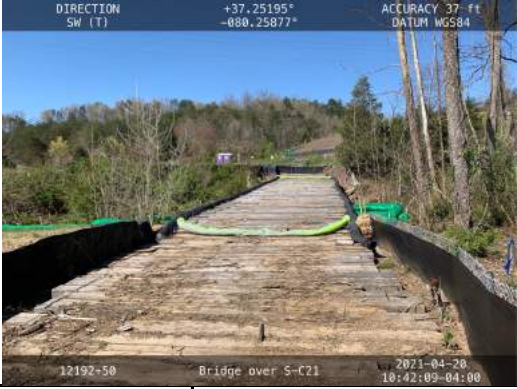
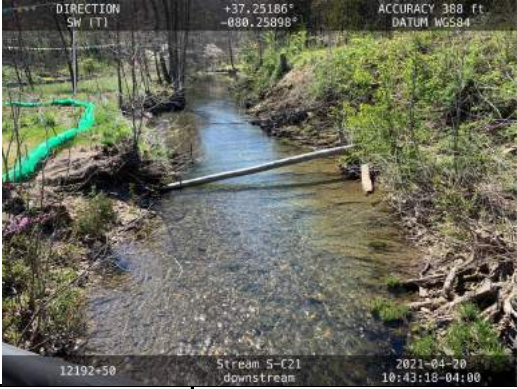
<b>GPS Location</b>	See photo for gps location data.		<b>GPS Location</b>	See photo for gps location data.	
<b>Field Station#</b>	12192+50		<b>Field Station#</b>	12192+50	
<b>Pic 7 Desc.</b>	Photo shows the bridge over stream S-C21.		<b>Pic 8 Desc.</b>	Photo shows stream S-C21 downstream from the bridge.

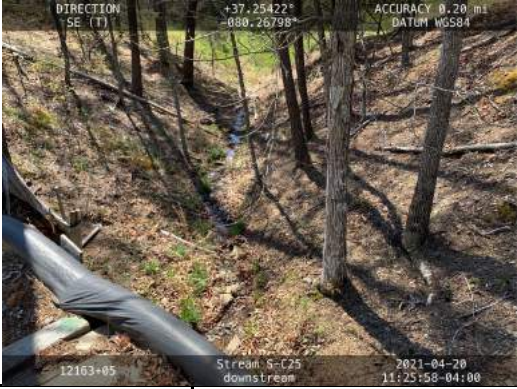
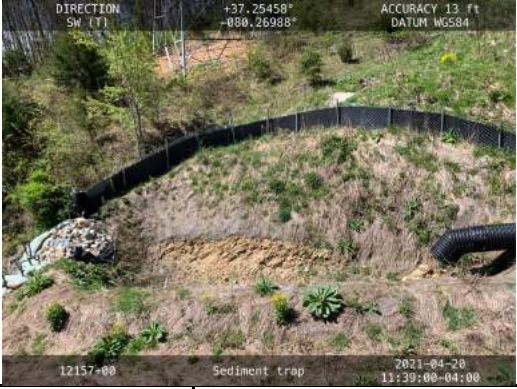
<b>GPS Location</b>	See photo for gps location data.		<b>GPS Location</b>	See photo for gps location data.	
<b>Field Station#</b>	12163+05		<b>Field Station#</b>	12157+00	
<b>Pic 13 Desc.</b>	Photo shows stream S-C25 downstream from the bridge.		<b>Pic 14 Desc.</b>	Photo shows the sediment trap.

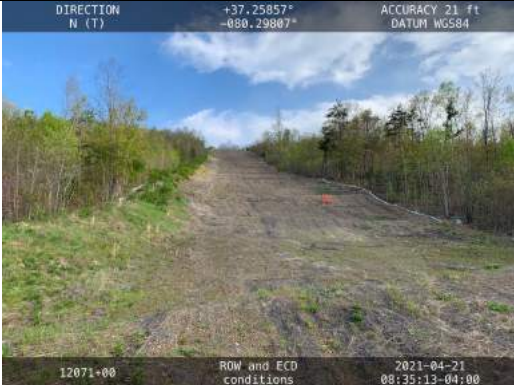
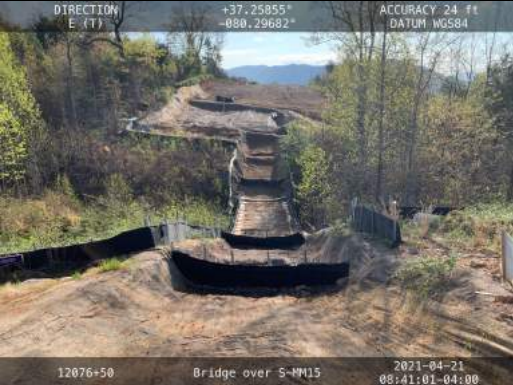
<b>GPS Location</b>	See photo for gps location data.		<b>GPS Location</b>	See photo for gps location data.	
<b>Field Station#</b>	12071+00		<b>Field Station#</b>	12076+50	
<b>Pic 1 Desc.</b>	Photo shows the ROW and ECD conditions from about 12065+00 to 12071+00.		<b>Pic 2 Desc.</b>	Photo shows the bridge over stream S-MM15.

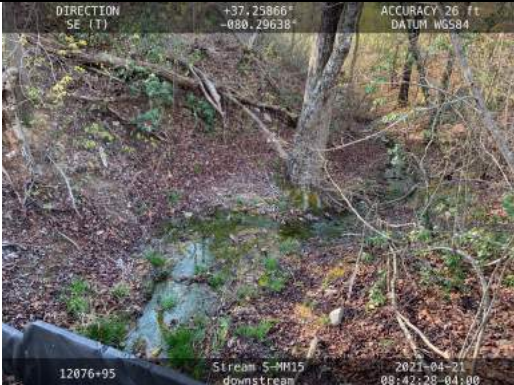
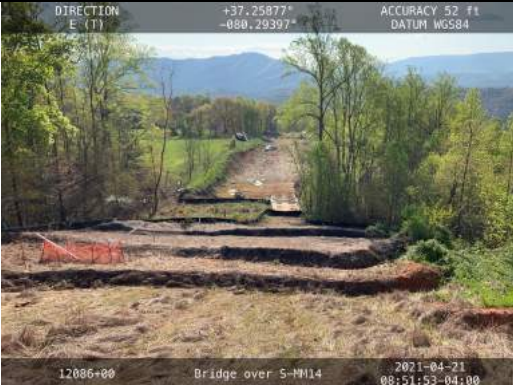
<b>GPS Location</b>	See photo for gps location data.		<b>GPS Location</b>	See photo for gps location data.	
<b>Field Station#</b>	12076+95		<b>Field Station#</b>	12086+00	
<b>Pic 3 Desc.</b>	Photo shows stream S-MM15 downstream from the bridge.		<b>Pic 4 Desc.</b>	Photo shows the slope on the CIS of the bridge over S-MM14.

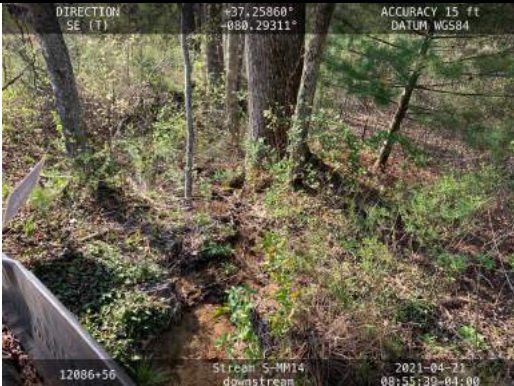
<b>Pic 5 Desc.</b>	Photo shows stream S-MM14 downstream from the bridge.		<b>Pic 6 Desc.</b>	Photo shows stream S-MM13 downstream from the bridge.

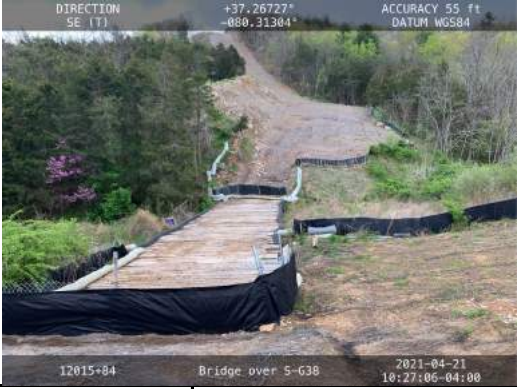
<b>GPS Location</b>	See photo for gps location data.		<b>GPS Location</b>	See photo for gps location data.	
<b>Field Station#</b>	12015+84		<b>Field Station#</b>	12035+11	
<b>Pic 13 Desc.</b>	Photo shows the bridge over stream S-G38.		<b>Pic 14 Desc.</b>	Photo shows the bridge over stream S-G40.

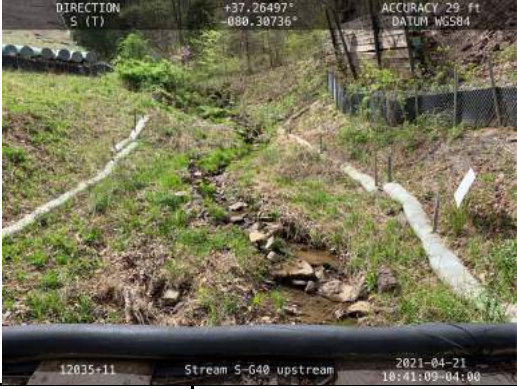
<b>GPS Location</b>	See photo for gps location data.		<b>GPS Location</b>	See photo for gps location data.	
<b>Field Station#</b>	12035+11		<b>Field Station#</b>	12035+75	
<b>Pic 15 Desc.</b>	Photo shows stream S-G40 upstream from the bridge.		<b>Pic 16 Desc.</b>	Photo shows the bridge over stream S-PP23.

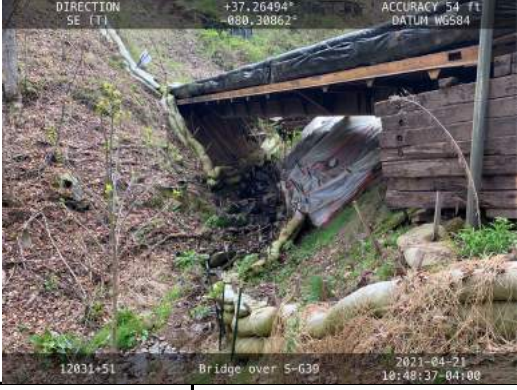
<b>Pic 17 Desc.</b>	Photo shows the bridge over stream S-G39.		<b>Pic 18 Desc.</b>	Photo shows stream S-G39 downstream from the bridge.

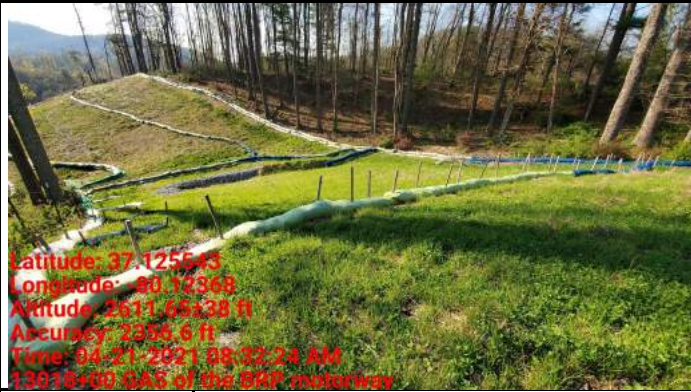
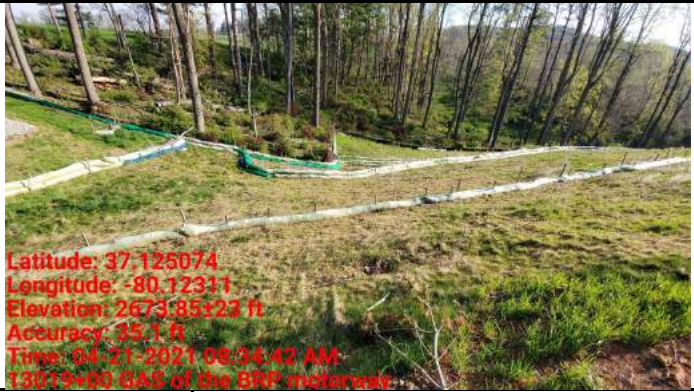
Latitude: 37.125543 Longitude: -80.12368 Elevation: 2611.54±38 ft Accuracy: 23.6 ft Time: 04-21-2021 08:32:24 AM 13018+00 GAS of the BRP motorway			Latitude: 37.125074 Longitude: -80.12311 Elevation: 2673.85±23 ft Accuracy: 35.1 ft Time: 04-21-2021 08:34:42 AM 13019+00 GAS of the BRP motorway		
GPS Location	See pic for GPS location		GPS Location	See pic for GPS location	
Field Station#	13018+00		Field Station#	13019+00	
Pic 1 Desc.	Necked down area of the BRP.		Pic 2 Desc.	Permanent restoration in the wooded portion of the BRP.

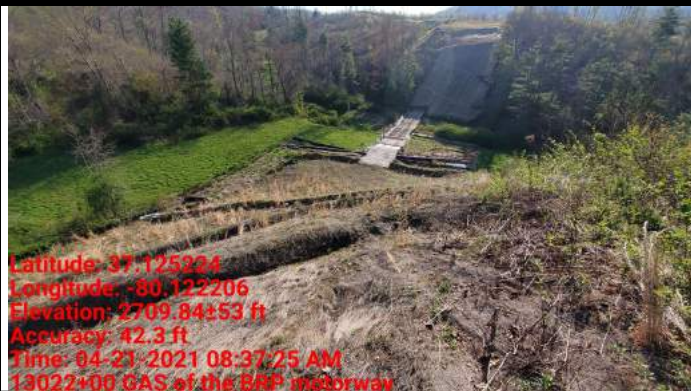
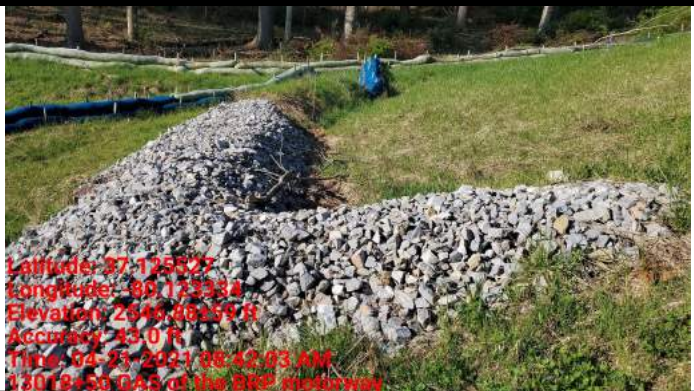
GPS Location	See pic for GPS location		GPS Location	See pic for GPS location	
Field Station#	13022+00		Field Station#	13018+50	
Pic 3 Desc.	Temporarily stabilized portion on the GAS of the BRP boundary.		Pic 4 Desc.	Permanent Slope Breaker and Rock Level Spreader.

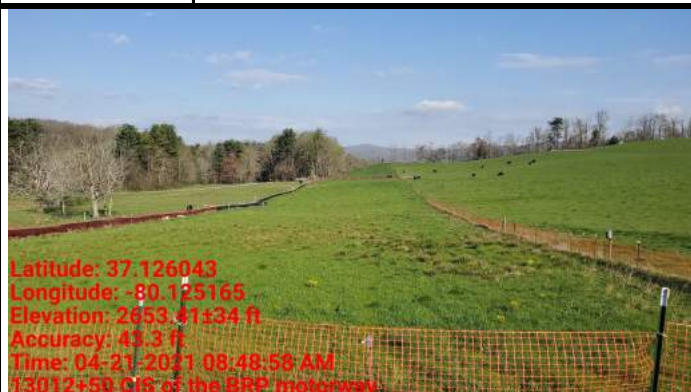
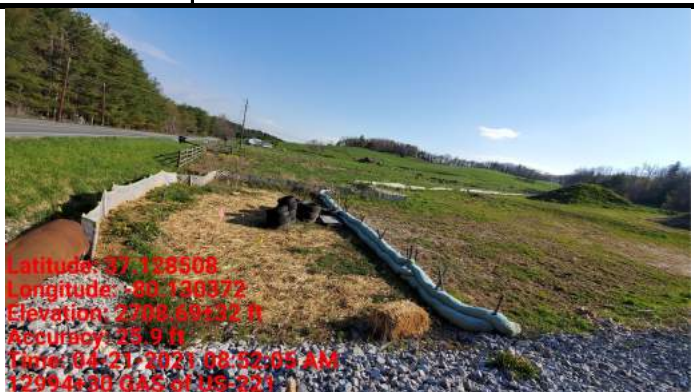
Latitude: 37.126043 Longitude: -80.125165 Elevation: 2653.41±34 ft Accuracy: 43.3 ft Time: 04-21-2021 08:48:58 AM 13012+50 CIS of the BRP motorway			Latitude: 37.126508 Longitude: -80.126872 Elevation: 2708.48±32 ft Accuracy: 33.9 ft Time: 04-21-2021 08:52:05 AM 12994+00 GAS of US-221		
GPS Location	See pic for GPS location		GPS Location	See pic for GPS location	
Field Station#	13012+50		Field Station#	12994+30	
Pic 5 Desc.	CIS of the BRP motorway.		Pic 6 Desc.	GAS of the US-221 road crossing.

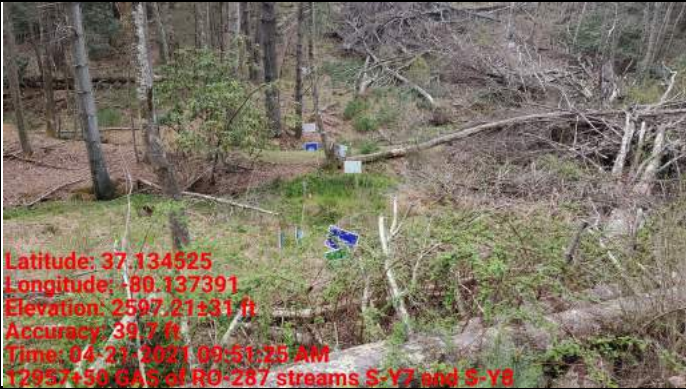
Latitude: 37.134525 Longitude: -80.137391 Elevation: 2597.21±31 ft Accuracy: 39.7 ft Time: 04-21-2021 09:51:25 AM 12957+50 GAS of RO-287 streams S-Y7 and S-Y8			Latitude: 37.134586 Longitude: -80.137642 Elevation: 2617.72±46 ft Accuracy: 64.6 ft Time: 04-21-2021 09:53:08 AM 12957+20 CIS of RO-287 landowner's spring box		
<b>GPS Location</b>	See pic for GPS location		<b>GPS Location</b>	See pic for GPS location	
<b>Field Station#</b>	12957+50		<b>Field Station#</b>	12957+20	
<b>Pic 13 Desc.</b>	Streams S-Y7 and S-Y8 on the downstream side of the ROW.		<b>Pic 14 Desc.</b>	Landowner's spring box at RO-287.

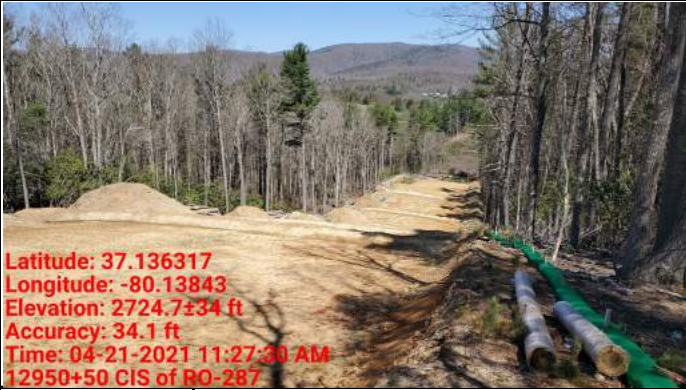
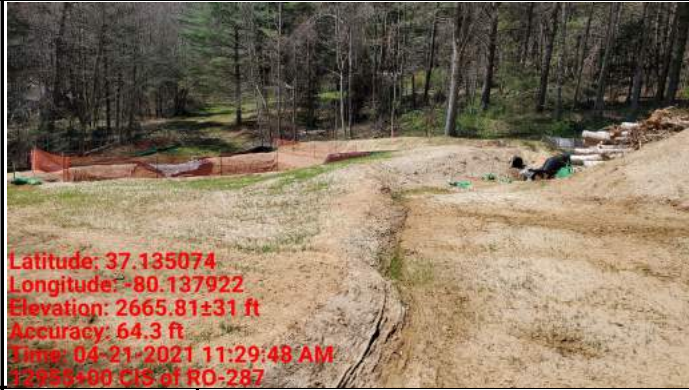
Latitude: 37.136317 Longitude: -80.13843 Elevation: 2724.7±34 ft Accuracy: 34.1 ft Time: 04-21-2021 11:27:30 AM 12950+50 CIS of RO-287			Latitude: 37.135074 Longitude: -80.137922 Elevation: 2665.81±31 ft Accuracy: 64.3 ft Time: 04-21-2021 11:29:48 AM 12955+00 CIS of RO-287		
<b>GPS Location</b>	See pic for GPS location		<b>GPS Location</b>	See pic for GPS location	
<b>Field Station#</b>	12950+50		<b>Field Station#</b>	12955+00	
<b>Pic 17 Desc.</b>	Current conditions of the ROW on the CIS of RO-287.		<b>Pic 18 Desc.</b>	Waterbars, sumps and end treatments remain in compliance throughout the area.

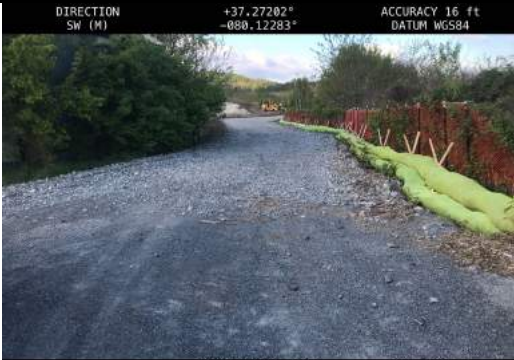
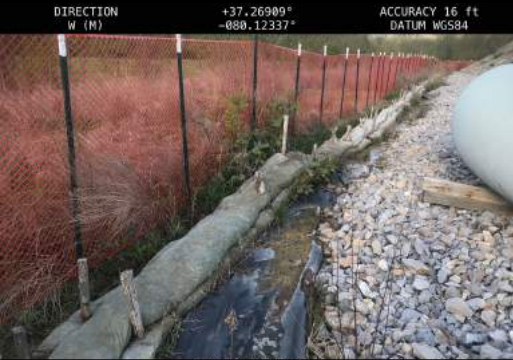
<p>DIRECTION W (M) +37.26909° -080.12337° ACCURACY 16 ft DATUM WGS84</p> <p>MVP-LY-049_042221 Condition of CFS &amp; safety fence LOD 2021-04-22 08:10:58-04:00</p>			
<b>GPS Location</b>	MVP-LY-049 See photo for gps data	<b>GPS Location</b>	MVP-LY-049 See photo for gps data		
<b>Field Station#</b>	+0	<b>Field Station#</b>	+0		
<b>Pic 1 Desc.</b>	Condition of rock entrance on north drive. No sediment on stone. Looking SW.	<b>Pic 2 Desc.</b>	Condition of compost filter sock and safety fence along south LOD. Looking W.

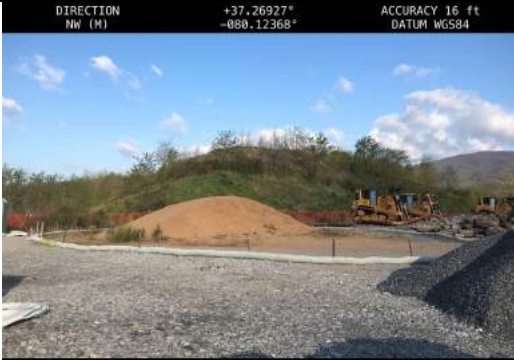
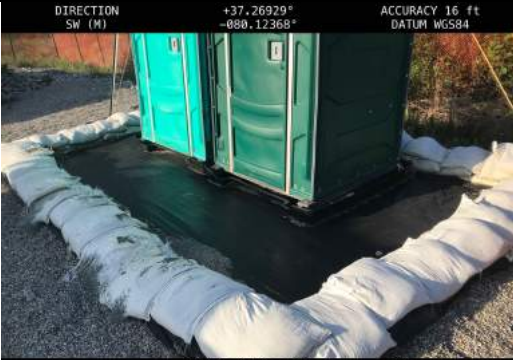
<b>GPS Location</b>	MVP-LY-049 See photo for gps data	<b>GPS Location</b>	MVP-LY-049 See photo for gps data		
<b>Field Station#</b>	+0	<b>Field Station#</b>	+0		
<b>Pic 3 Desc.</b>	Condition of compost filter sock around sand pile. In place and functioning. Looking NW.	<b>Pic 4 Desc.</b>	Condition of trays and containment under toilets. Looking SW.

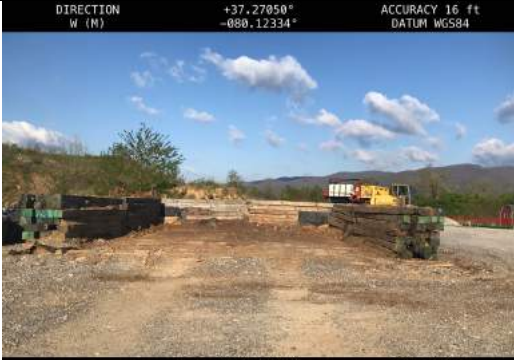
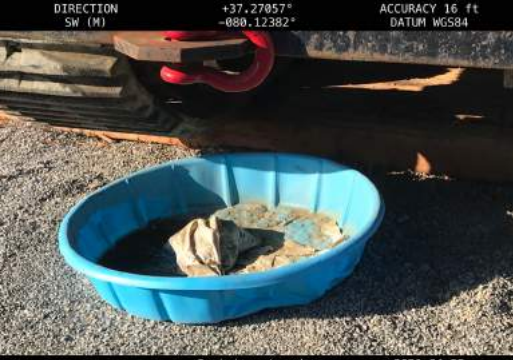
<p>DIRECTION SW (M) +37.27057° -080.12382° ACCURACY 16 ft DATUM WGS84</p> <p>MVP-LY-049_042221 Containment under stored equipment 2021-04-22 08:26:45-04:00</p>			
<b>GPS Location</b>	MVP-LY-049 See photo for gps data	<b>GPS Location</b>	MVP-LY-049 See photo for gps data		
<b>Field Station#</b>	+0	<b>Field Station#</b>	+0		
<b>Pic 5 Desc.</b>	Condition of temporary trash transfer pit. Pit empty. Looking W.	<b>Pic 6 Desc.</b>	Condition of containment under stored equipment. Looking SW.

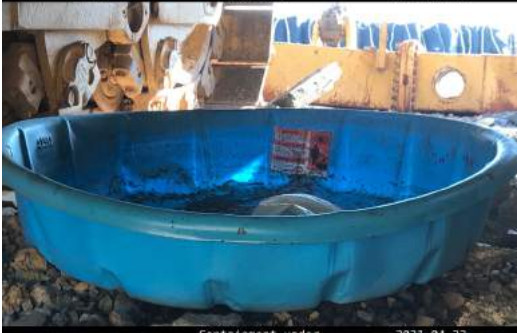
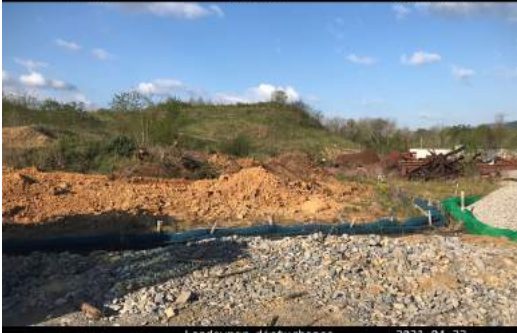
MVP-LY-049_042221 Landowner disturbance along CFS 2021-04-22 08:26:56-04:00			
<b>GPS Location</b>	MVP-LY-049 See photo for gps data		<b>GPS Location</b>	MVP-LY-049 See photo for gps data	
<b>Field Station#</b>	+0		<b>Field Station#</b>	+0	
<b>Pic 7 Desc.</b>	Condition of containment under stored equipment. Looking E.		<b>Pic 8 Desc.</b>	Landowner soil disturbance along compost filter sock. No new damage to ECD's. Looking W.	
DIRECTION SW (N) +37.27046° -080.12447° ACCURACY 16 ft DATUM WGS84

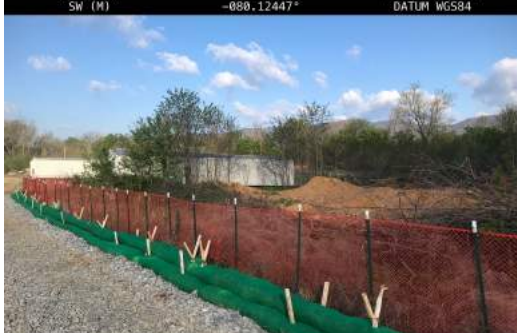
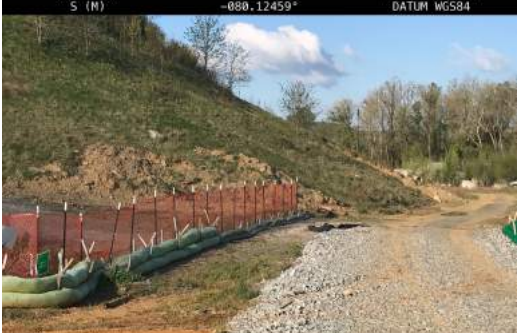
<b>GPS Location</b>	MVP-LY-049 See photo for gps data		<b>GPS Location</b>	MVP-LY-049 See photo for gps data	
<b>Field Station#</b>	+0		<b>Field Station#</b>	+0	
<b>Pic 9 Desc.</b>	Landowner soil disturbance along north edge of feature W-CV21A. Area not stabilized. Looking NW.		<b>Pic 10 Desc.</b>	Landowner soil disturbance within 66' and 120' west of feature W-CV21B. Areas not stabilized. Looking SW.	
DIRECTION S (N) +37.27045° -080.12472° ACCURACY 16 ft DATUM WGS84

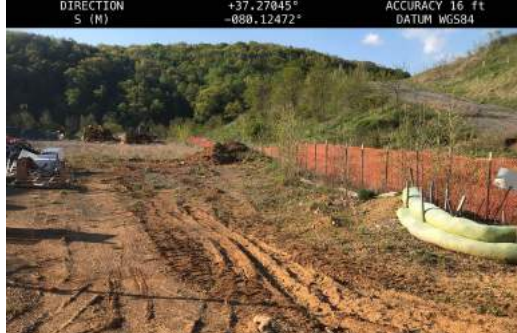
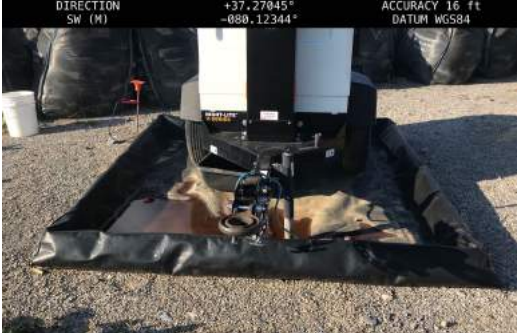
MVP-LY-049_042221 Condition of containment 2021-04-22 08:30:40-04:00			
<b>GPS Location</b>	MVP-LY-049 See photo for gps data		<b>GPS Location</b>	MVP-LY-049 See photo for gps data	
<b>Field Station#</b>	+0		<b>Field Station#</b>	+0	
<b>Pic 11 Desc.</b>	Landowner soil disturbance along compost filter sock and feature W-CV21B. Area not stabilized. Looking S.		<b>Pic 12 Desc.</b>	Condition of containment under light plan. Looking SW.

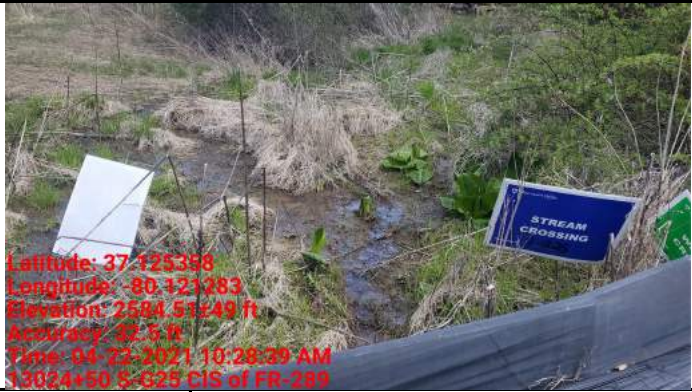
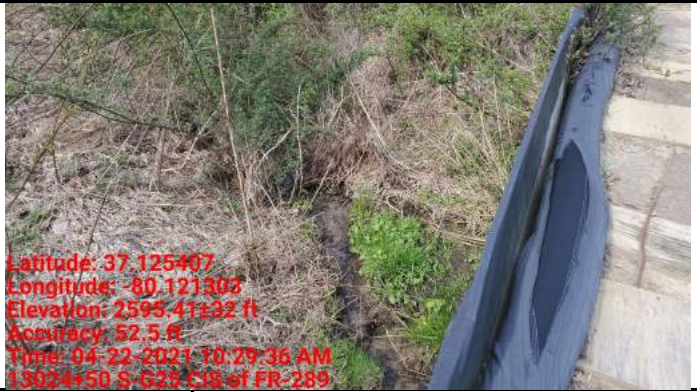
Latitude: 37.125398 Longitude: -80.121283 Elevation: 2584.51±49 ft Accuracy: 42.5 ft Time: 04-22-2021 10:29:39 AM 13024+50 S-G25 CIS of FR-289			Latitude: 37.125407 Longitude: -80.121303 Elevation: 2595.41±32 ft Accuracy: 52.5 ft Time: 04-22-2021 10:29:36 AM 13024+50 S-G25 CIS of FR-289		
GPS Location	See pic for GPS location		GPS Location	See pic for GPS location	
Field Station#	13024+50		Field Station#	13024+50	
Pic 1 Desc.	Stream S-G25 on the upstream side of the equipment bridge.		Pic 2 Desc.	Stream S-G25 on the downstream side of the equipment bridge.

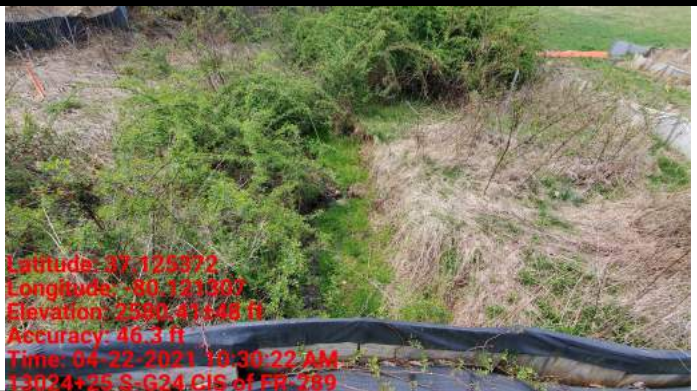
GPS Location	See pic for GPS location		GPS Location	See pic for GPS location	
Field Station#	13024+25		Field Station#	13024+25	
Pic 3 Desc.	Stream S-G24 on the upstream side of the equipment bridge.		Pic 4 Desc.	Stream S-G24 on the downstream side of the equipment bridge.

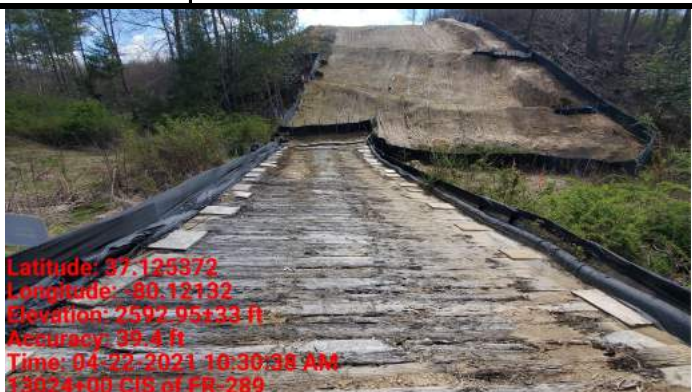
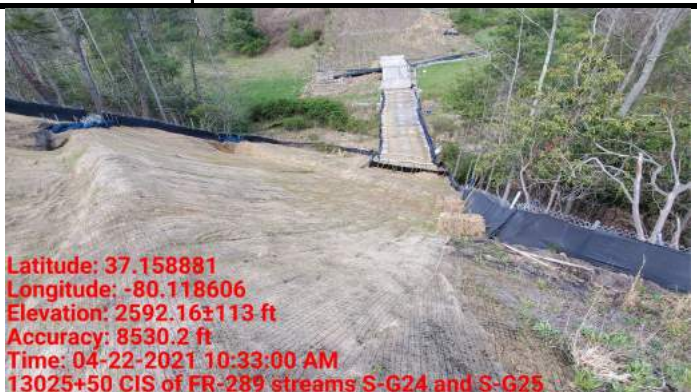
Latitude: 37.125372 Longitude: -80.121302 Elevation: 2592.95±33 ft Accuracy: 39.4 ft Time: 04-22-2021 10:30:38 AM 13024+00 CIS of FR-289			Latitude: 37.158881 Longitude: -80.118606 Elevation: 2592.16±113 ft Accuracy: 8530.2 ft Time: 04-22-2021 10:33:00 AM 13025+50 CIS of FR-289 streams S-G24 and S-G25		
GPS Location	See pic for GPS location		GPS Location	See pic for GPS location	
Field Station#	13024+00		Field Station#	13025+50	
Pic 5 Desc.	Equipment bridge over streams S-G24 and S-G25.		Pic 6 Desc.	Streams S-G24 and S-G25 from GAS.

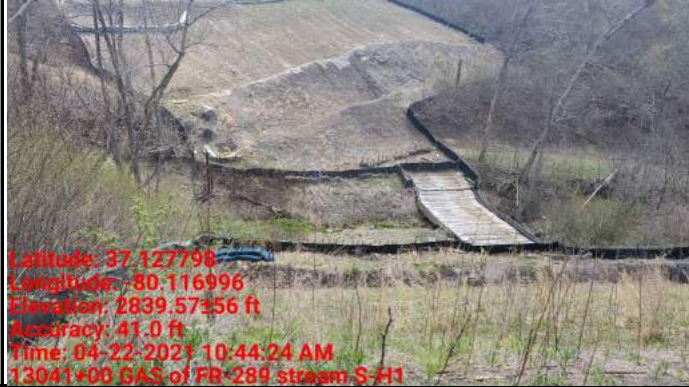
<p>Latitude: 37.127798 Longitude: -80.116996 Elevation: 2839.57356 ft Accuracy: 41.0 ft Time: 04-22-2021 10:44:24 AM 13041+00 GAS of FR-289 stream S-H1</p>		
GPS Location	See pic for GPS location		GPS Location	See pic for GPS location	
Field Station#	13035+00		Field Station#	13041+00	
Pic 7 Desc.	Waterbars, sumps and end treatments remain in compliance throughout the area.		Pic 8 Desc.	Stream S-H1 on the GAS of FR-289.

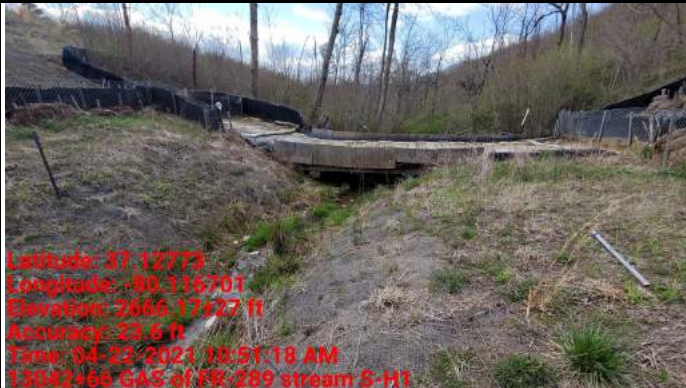
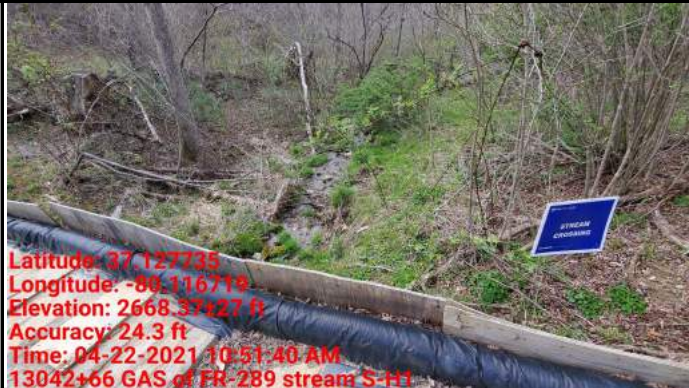
GPS Location	See pic for GPS location		GPS Location	See pic for GPS location	
Field Station#	13042+66		Field Station#	13042+66	
Pic 9 Desc.	Stream S-H1 on the upstream side of the equipment bridge.		Pic 10 Desc.	Stream S-H1 on the downstream side of the equipment bridge.

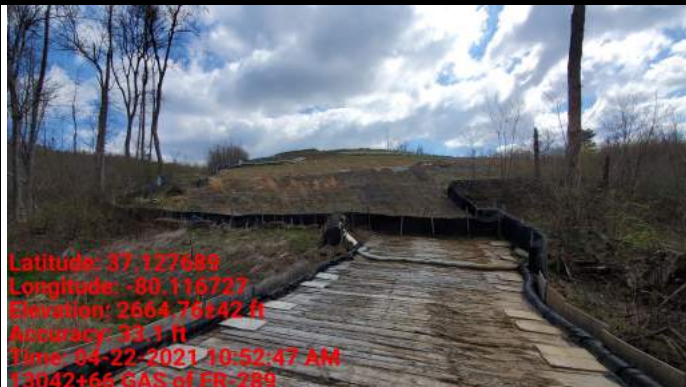
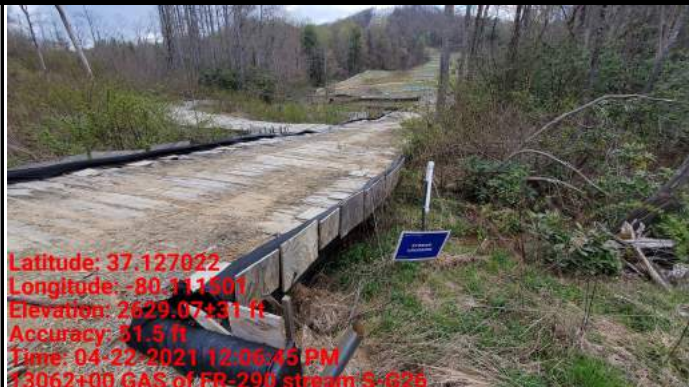
<p>Latitude: 37.127022 Longitude: -80.111507 Elevation: 2629.07431 ft Accuracy: 31.5 ft Time: 04-22-2021 12:06:45 PM 13062+00 GAS of FR-299 stream S-G26</p>		
GPS Location	See pic for GPS location		GPS Location	See pic for GPS location	
Field Station#	13042+66		Field Station#	13062+00	
Pic 11 Desc.	GAS of stream S-H1.		Pic 12 Desc.	Stream S-G26 on the downstream side of the equipment bridge.

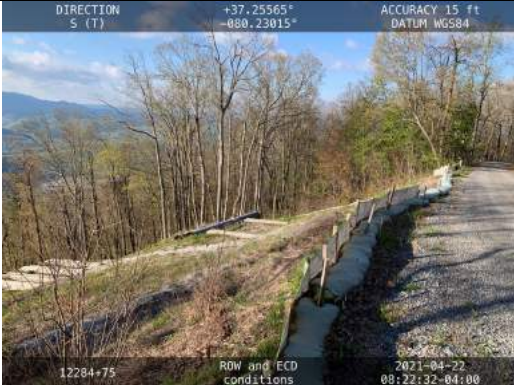
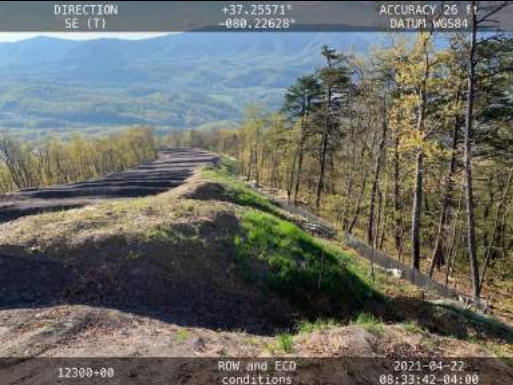
<b>GPS Location</b>	See photo for gps location data.		<b>GPS Location</b>	See photo for gps location data.	
<b>Field Station#</b>	12284+75		<b>Field Station#</b>	12300+00	
<b>Pic 1 Desc.</b>	Photo shows ECDs along access road MN-276.03 at the ROW crossing.		<b>Pic 2 Desc.</b>	Photo shows the ROW and ECD conditions.

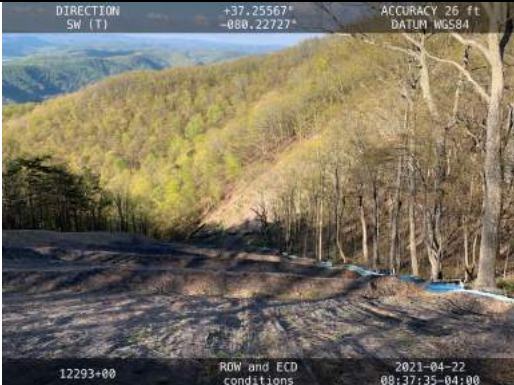
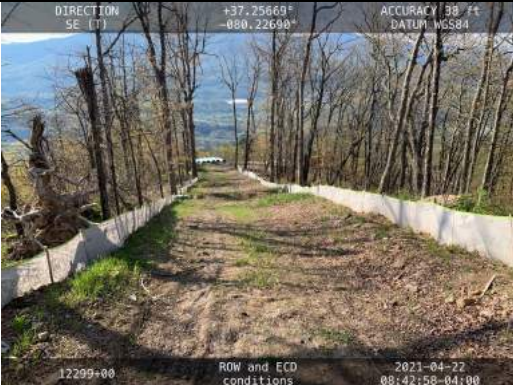
<b>GPS Location</b>	See photo for gps location data.		<b>GPS Location</b>	See photo for gps location data.	
<b>Field Station#</b>	12293+00		<b>Field Station#</b>	12299+00	
<b>Pic 3 Desc.</b>	Photo shows the ROW and ECD conditions.		<b>Pic 4 Desc.</b>	Photo shows the ROW and ECD conditions.

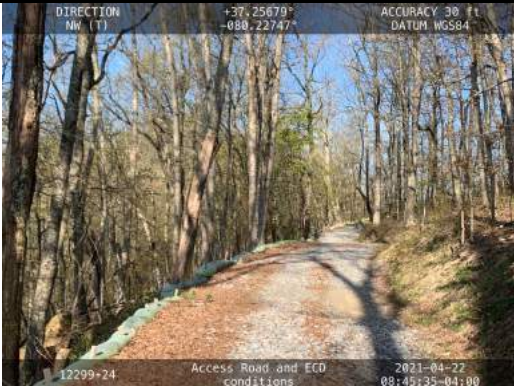
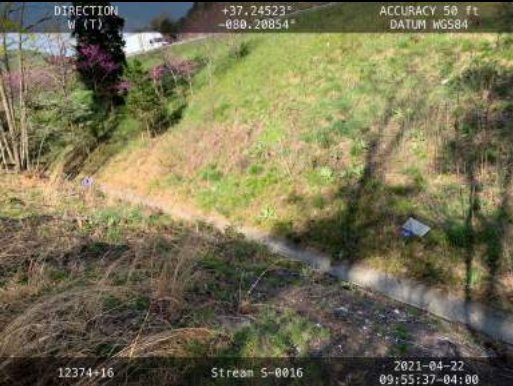
<b>Pic 5 Desc.</b>	Photo shows the ECDs along MN-276.03.		<b>Pic 6 Desc.</b>	Photo shows stream S-0016.

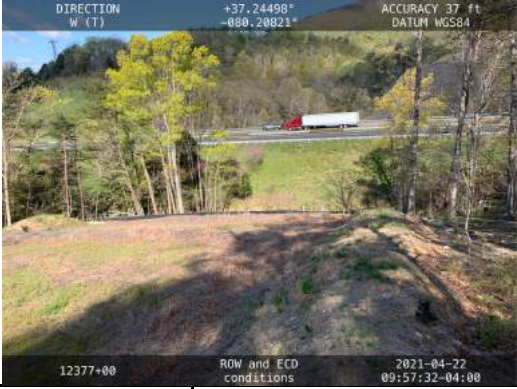
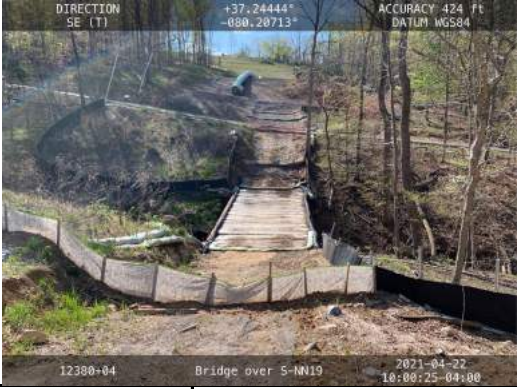
<b>GPS Location</b>	See photo for gps location data.		<b>GPS Location</b>	See photo for gps location data.	
<b>Field Station#</b>	12377+00		<b>Field Station#</b>	12380+04	
<b>Pic 7 Desc.</b>	Photo shows the ROW and ECD conditions.		<b>Pic 8 Desc.</b>	Photo shows the bridge over stream S-NN19.

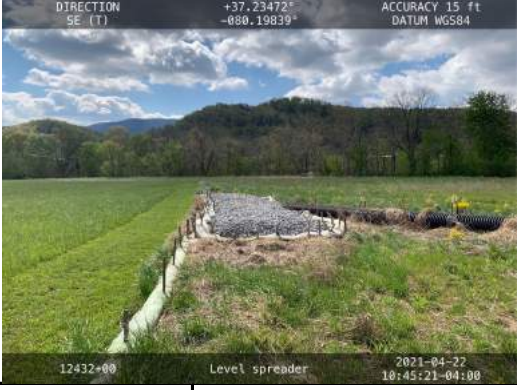
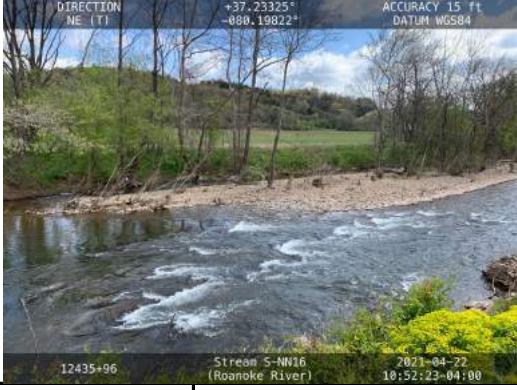
<b>Pic 17 Desc.</b>	Photo shows the level spreader.		<b>Pic 18 Desc.</b>	Photo shows stream S-NN16 (Roanoke River)

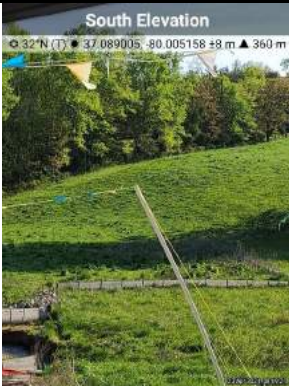
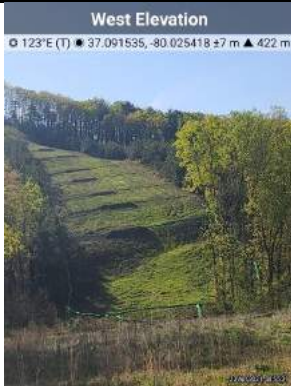
<p>West Elevation 123°E (T) 37.091535, -80.025418 ±7 m ▲ 422 m</p>	
<b>GPS Location</b>	000000	<b>GPS Location</b>	000000	<b>Field Station#</b>	13497+87
<b>Field Station#</b>	13497+87	<b>Field Station#</b>	13424+16	<b>Pic 5 Desc.</b>	Permanent vegetation photo showing good coverage and growth.
				<b>Pic 6 Desc.</b>	Row photo showing good vegetation growth, monitored ECDs while checking row conditions. No environmental issues observed at the time of inspection.

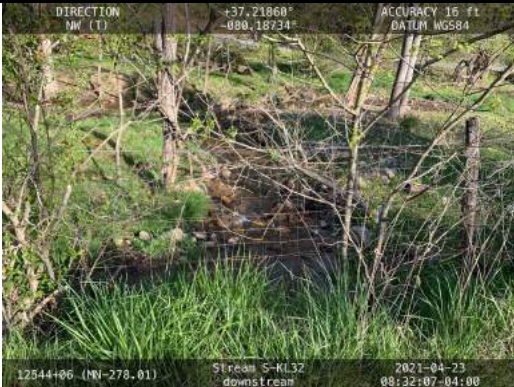
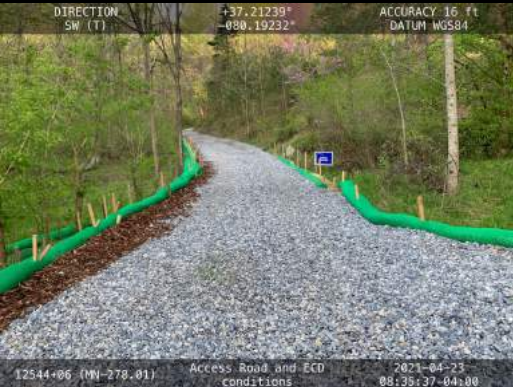
<b>GPS Location</b>	See photo for gps location data.		<b>GPS Location</b>	See photo for gps location data.	
<b>Field Station#</b>	12544+06		<b>Field Station#</b>	12544+06	
<b>Pic 1 Desc.</b>	Photo shows stream S-KL32 downstream from the access road.		<b>Pic 2 Desc.</b>	Photo shows the access road and ECD conditions.

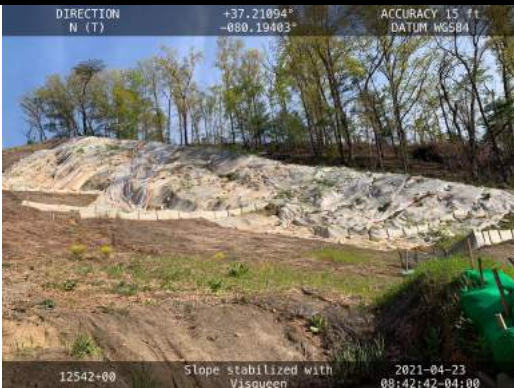
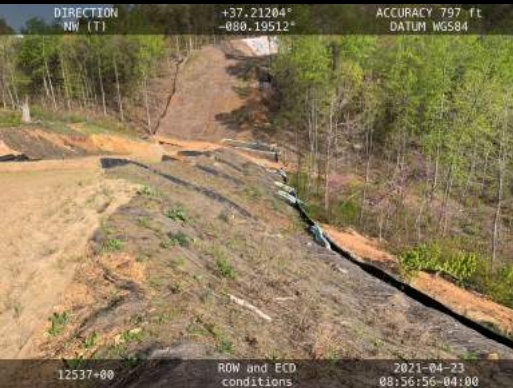
<b>Pic 5 Desc.</b>	Photo shows the slope stabilized with Visqueen.		<b>Pic 6 Desc.</b>	Photo shows the ROW and ECD conditions.

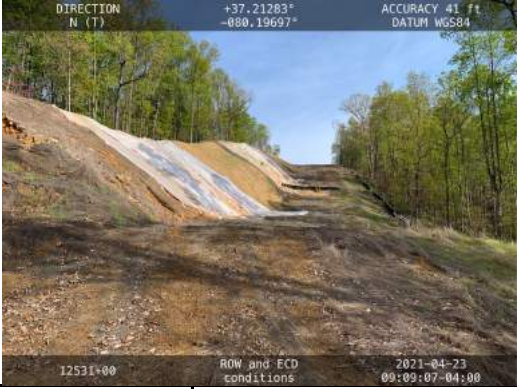
<b>GPS Location</b>	See photo for gps location data.		<b>GPS Location</b>	See photo for gps location data.	
<b>Field Station#</b>	12531+00		<b>Field Station#</b>	12519+75	
<b>Pic 7 Desc.</b>	Photo shows the slope stabilized with Visqueen.		<b>Pic 8 Desc.</b>	Photo shows the bridge over stream S-EF19.

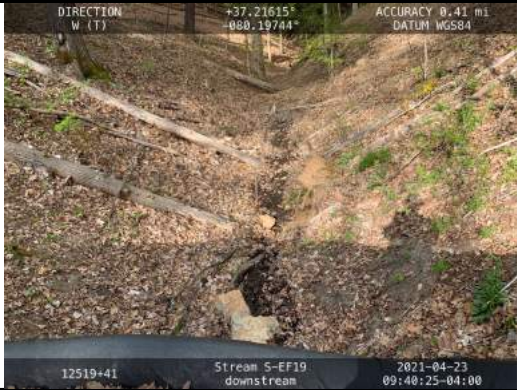
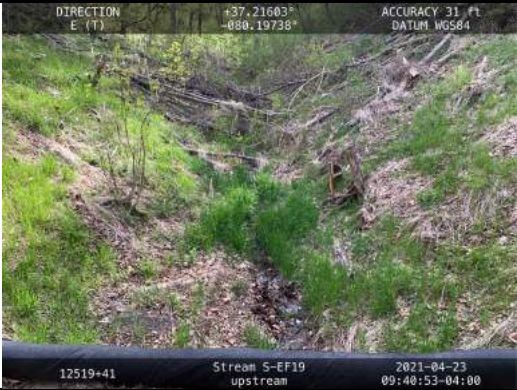
<b>GPS Location</b>	See photo for gps location data.		<b>GPS Location</b>	See photo for gps location data.	
<b>Field Station#</b>	12519+41		<b>Field Station#</b>	12519+41	
<b>Pic 9 Desc.</b>	Photo shows stream S-EF19 downstream from the ROW.		<b>Pic 10 Desc.</b>	Photo shows stream S-EF19 upstream from the ROW.

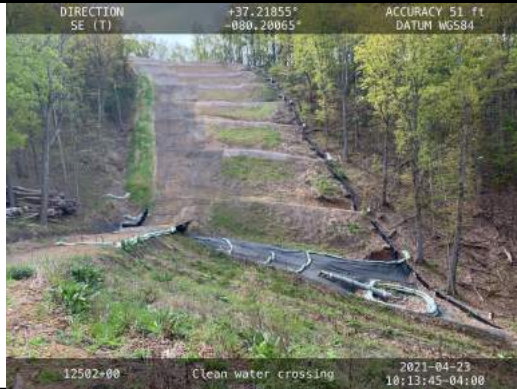
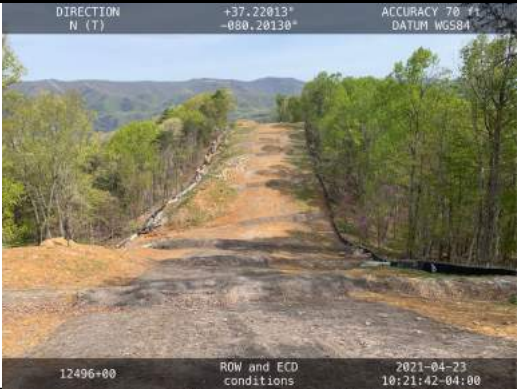
<b>Pic 11 Desc.</b>	Photo shows the ROW and clean water crossing.		<b>Pic 12 Desc.</b>	Photo shows the ROW and ECD conditions.

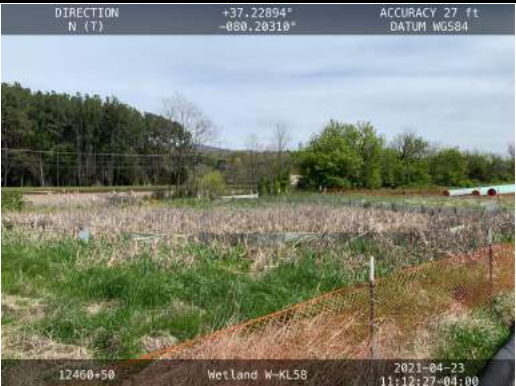
<p>Insert image here</p>	
<b>GPS Location</b>	See photo for gps location data.		<b>GPS Location</b>	See photo for gps location data.	
<b>Field Station#</b>	12468+00		<b>Field Station#</b>	12460+50	
<b>Pic 15 Desc.</b>	Photo shows the replaced P1 silt fence.		<b>Pic 16 Desc.</b>	Photo shows wetland W-KL58.
