# Visual Site Inspection Report

<b>Project Name</b>	H-600 Pipeline Spread H	<b>AFE</b>	124300138	<b>Spread</b>	H-600 Pipeline Spread H
<b>Contractor</b>	Precision			<b>Report #</b>	22418
<b>Inspector</b>	Logan Box			<b>Date/Time</b>	4/19/2021 3:18 PM
<b>Permit #</b>	TBD	<b>Inspection Type</b>	VA SWPP	<b>Station Begin</b>	13415+51
<b>State</b>	VA	<b>Inspection Area</b>	Partial	<b>Station End</b>	13525+99
<b>County</b>	Franklin	<b>Ground</b>	Wet	<b>Temperature (°F)</b>	64.00
<b>Municipality</b>	N/A	<b>Weather</b>	Light Rain	<b>Rain Gauge (in)</b>	0.30
				<b>Rain Accumulation Time (days)</b>	1.00

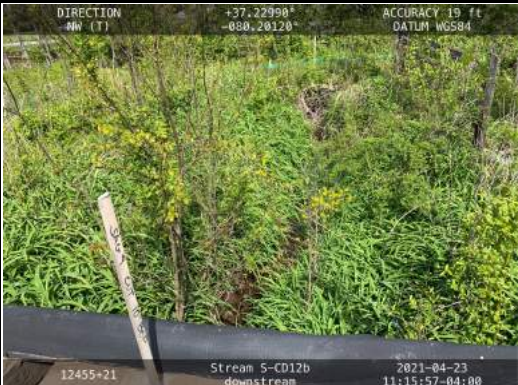
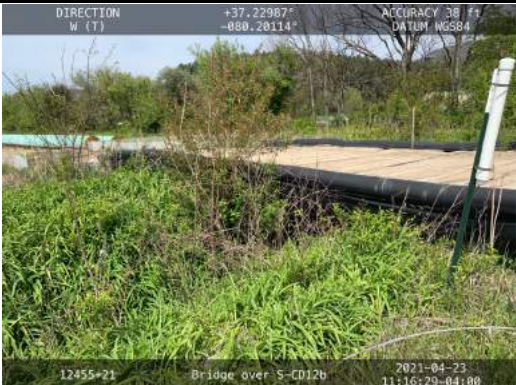
<b>Pic 17 Desc.</b>	Photo shows stream S-CD12b downstream from the ROW.		<b>Pic 18 Desc.</b>	Photo shows the bridge over stream S-CD12b.
