Visual Site Inspection Report

| Project Name | H-600 Pipeline Spread H | AFE | 124300138 | Spread | H-600 Pipeline Spread H |
| Permit # | TBD | Inspection Type | VA SWPP | Station Begin | 12942+00 |

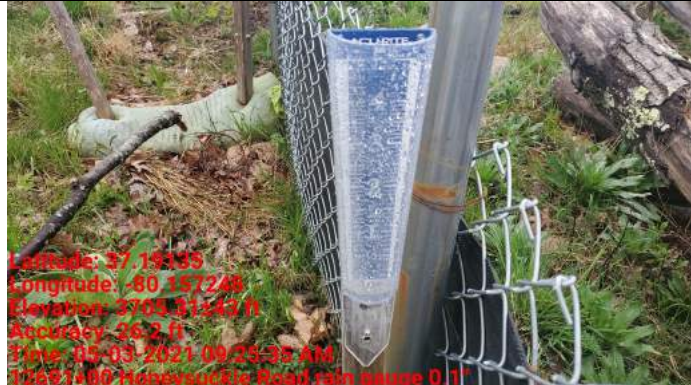
| Pic 1 Desc. | Honeysuckle Road rain gauge. 0.1" total precipitation. | | Pic 2 Desc. | Callaway Road rain gauge. 0.2" total precipitation. | |

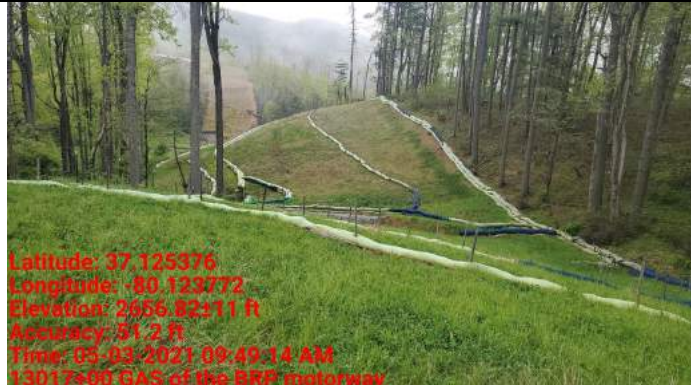
| Pic 3 Desc. | Wooded portion of the BRP on the GAS of the motorway. | | Pic 4 Desc. | Ag portion of the BRP on the GAS of the motorway. | |

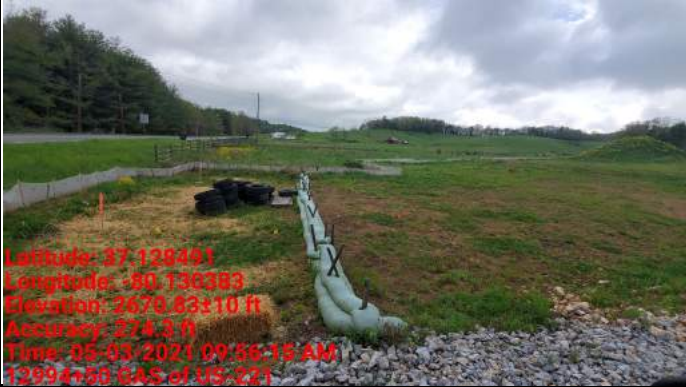
| Pic 7 Desc. | GAS of the US-221 road crossing. | | Pic 8 Desc. | Cattle crossing on the CIS of the BRP motorway. | |

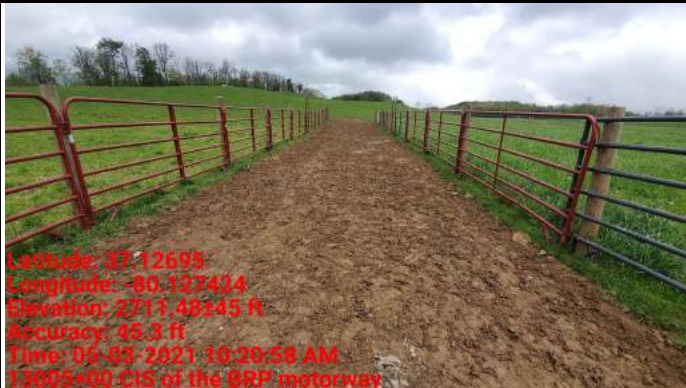
| Pic 9 Desc. | Cattle crossing on the CIS of the BRP motorway. | | Pic 10 Desc. | Access road RO-288 at stream S-Q20. | |

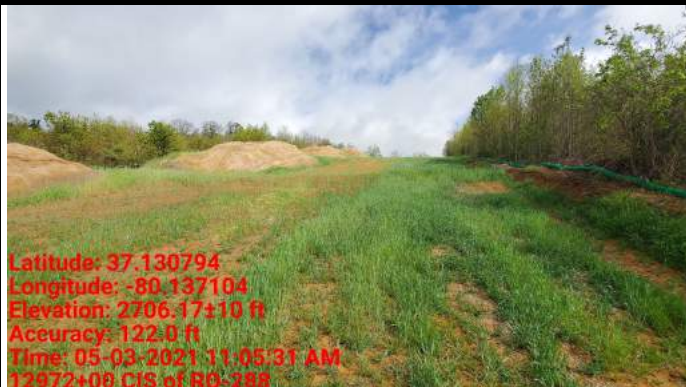
| Pic 11 Desc. | Slope on the CIS of RO-288. | | Pic 12 Desc. | Current ROW conditions at RO-288. | |

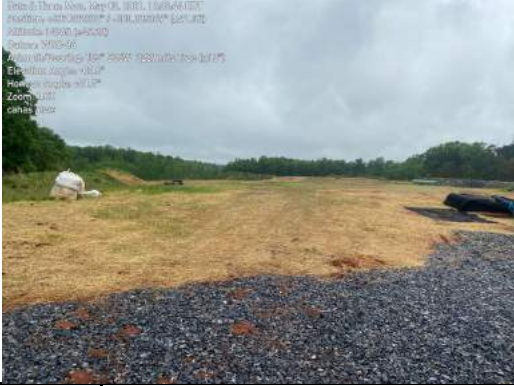
| Pic 1 Desc. | ATWS-1351 workspace stabilized with vegetation establishing. | | Pic 2 Desc. | S-IJ1, downstream, no ROW impacts, banks well vegetated, slight turbidity noted. | |

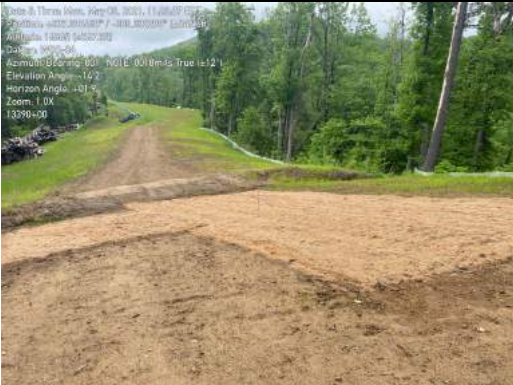
| Pic 3 Desc. | ROW stable with vegetation establishing across LOD, waterbars functioning acceptably. | | Pic 4 Desc. | ROW stable, sparse vegetation noted in travel lane with the exception of the newly stabilized area. | |

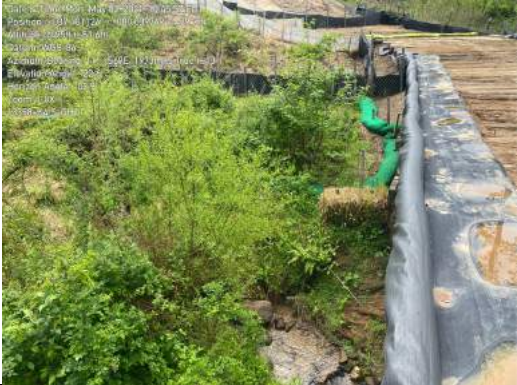
| Pic 7 Desc. | S-RR11, upstream, no ROW impacts noted, ECDs functioning acceptably along stream buffer. | | Pic 8 Desc. | S-RR11, downstream, no ROW impacts noted, slight turbidity noted in stream. | |

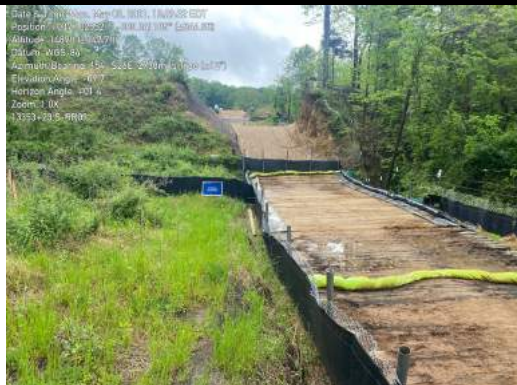
| Pic 11 Desc. | S-RR09, equipment bridge and perimeter ECDs in acceptable condition. | | Pic 12 Desc. | S-RR08, downstream, no impacts noted, little to no turbidity noted. | |

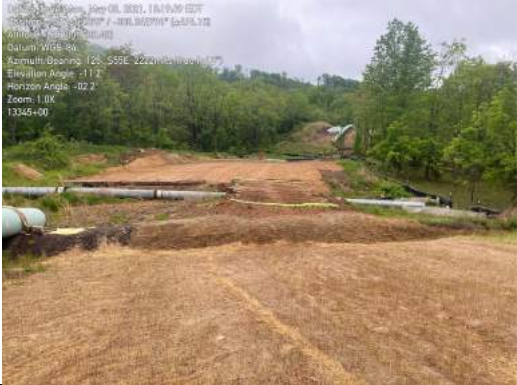
| Pic 13 Desc. | ROW stable with sparse vegetation noted in areas with erosion control blanket installed. | | Pic 14 Desc. | S-GH9, ECDs along stream buffer and ROW perimeters in acceptable condition, ROW stable on both sides of stream crossing. | |

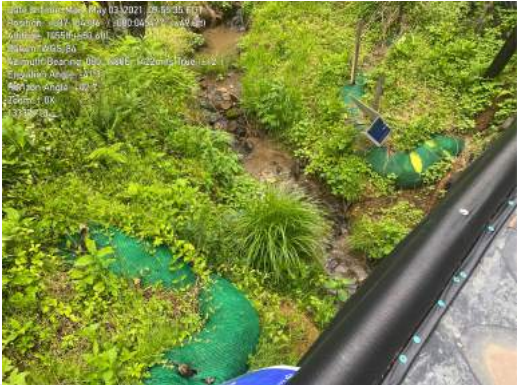
| Pic 15 Desc. | S-GH9, upstream, no ROW releases noted, slight turbidity noted in stream, banks well vegetated. | | Pic 16 Desc. | S-GH11, downstream of equipment bridge looking upstream, banks stabilized with erosion control blanket, small log in stream. | |

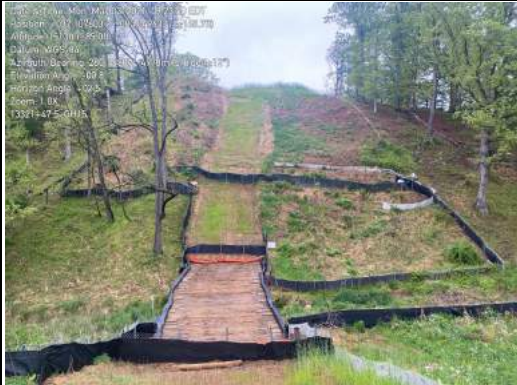
| Pic 17 Desc. | S-GH14, downstream of equipment bridge, banks appeared stable, no impacts observed, little to no turbidity noted in stream. | | Pic 18 Desc. | S-GH15, ROW stable on both sides of stream crossing, perimeter controls in acceptable condition, vegetation establishing across LOD. | |

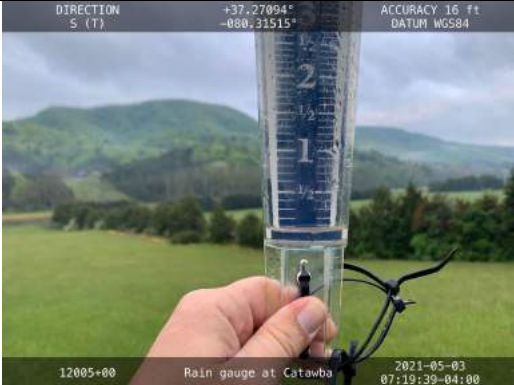
| Pic 1 Desc. | Catawba rain gauge totals | | Pic 2 Desc. | Stream S-G36 down stream. | |

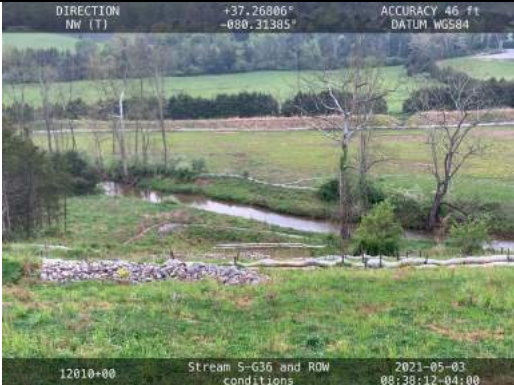
| Pic 3 Desc. | Stream S-G36 and ROW conditions | | Pic 4 Desc. | Bridge and ECDs at stream crossing S-G38 in acceptable condition | |

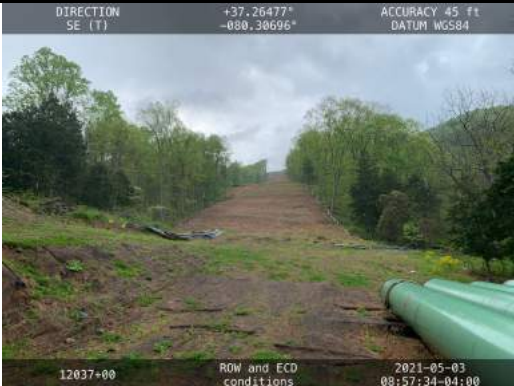
| Pic 5 Desc. | Stabilized ROW in acceptable condition | | Pic 6 Desc. | Clean water crossing outlet in acceptable condition | |

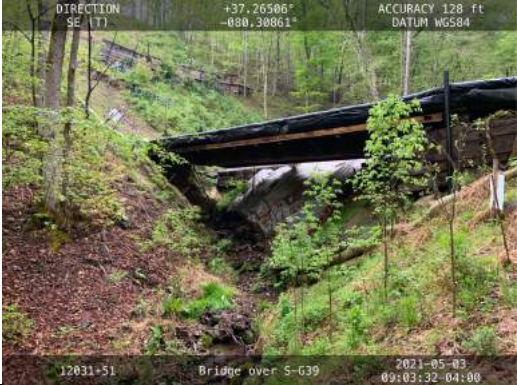
| Pic 7 Desc. | Bridge and ECDs crossing S-G39 in acceptable condition | | Pic 8 Desc. | Stabilized ROW in acceptable condition | |

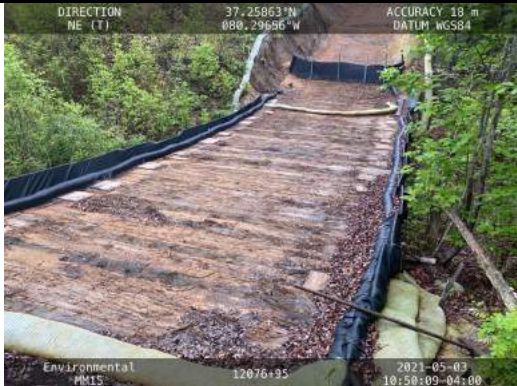
| Pic 9 Desc. | Bridge and ECDs crossing stream S-MM15 in acceptable condition | | Pic 10 Desc. | Bridge crossing S-MM14 in acceptable condition | |

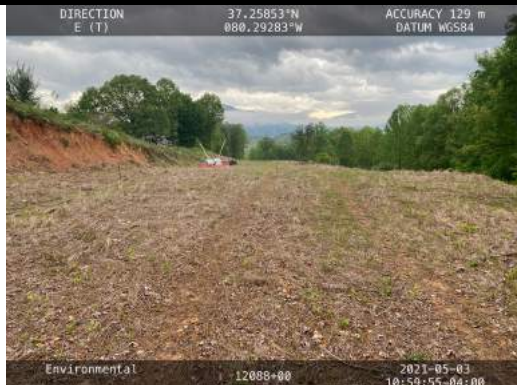
| Pic 11 Desc. | Stabilized ROW in acceptable condition | | Pic 12 Desc. | Clean water crossing pipe crossing stabilized ROW | |

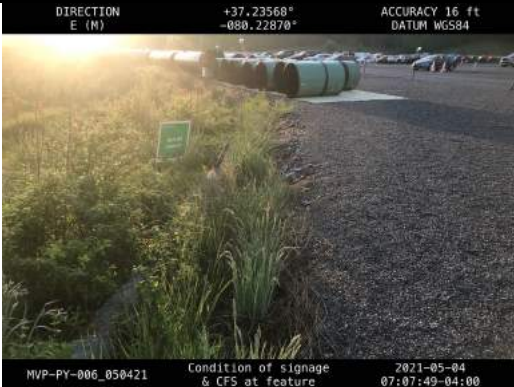
| Pic 1 Desc. | Condition of signage and compost filter sock along feature W-008. Looking E | | Pic 2 Desc. | Condition of non stabilized soil pile adjacent to LOD on VDOT property. Looking S. | |

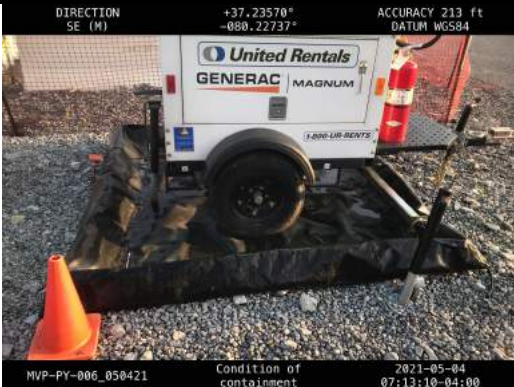
| Pic 3 Desc. | Condition of containment under light plant. Free of stormwater. Looking SE. | | Pic 4 Desc. | No fuel spills south of the Blue Bulk fuel tank. Looking NW. | |

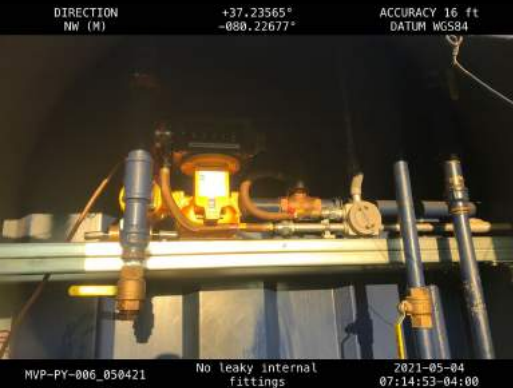
| Pic 5 Desc. | Blue Bulk Fuel tanks containment holding stormwater. Looking N. | | Pic 6 Desc. | Blue Bulk Fuel tanks no leaky internal fittings. Looking NW. | |

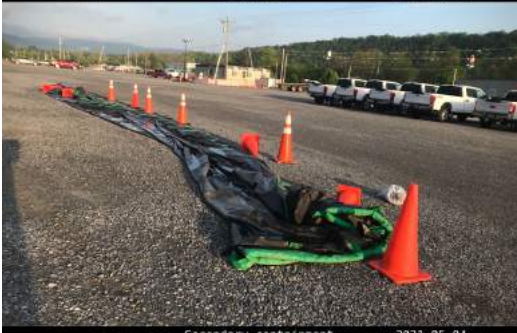
| MVP-PY-006_050421 Secondary containment on site for tankers 2021-05-04 07:15:36-04:00 | | MVP-PY-006_050421 No leaky fittings or nozzles 2021-05-04 07:15:50-04:00 | | | |
| Pic 7 Desc. | Secondary containment on site for tankers offloading fuel. Looking NW. | | Pic 8 Desc. | Blue Bulk Fuel tanks no leaky fittings or nozzles. Looking S. | |

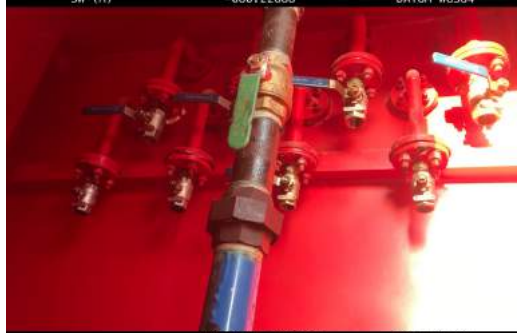
| Pic 9 Desc. | Off Road Fuel unit containment holding stormwater. Looking N. | | Pic 10 Desc. | Off Road Fuel unit condition of internal drip pan. Looking S. | |

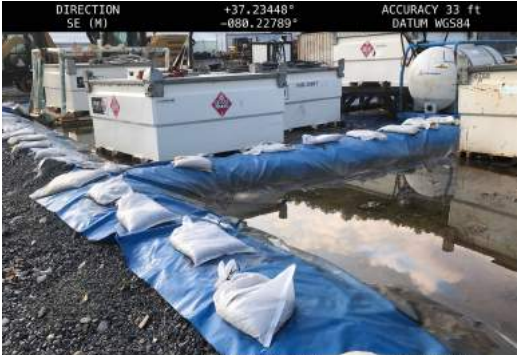
| Pic 15 Desc. | Condition of poly lined rock berm containments. Holding stormwater. Looking SE. | | Pic 16 Desc. | Condition of containment under stored vehicle. Looking NE. | |

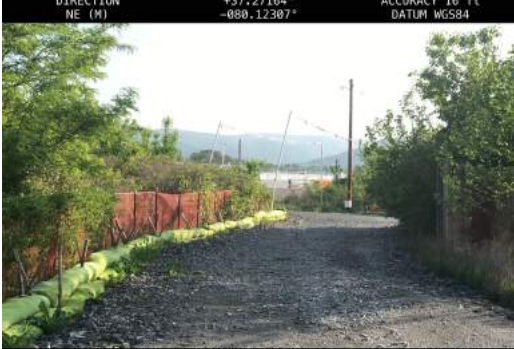
| Pic 1 Desc. | Condition of rock entrance on north drive. No sediment on stone. Looking NE. | Pic 2 Desc. | Condition of containment under light plant. Holding stormwater. Looking S. | | |

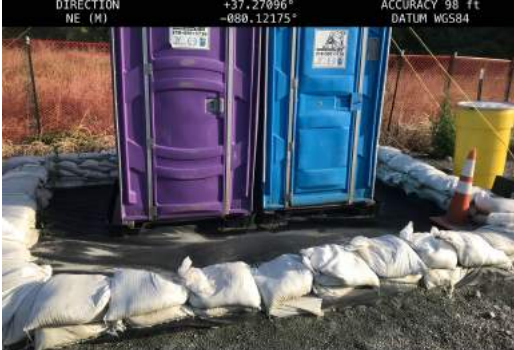
| Pic 3 Desc. | Condition of trays and containment under toilets. Looking NE. | Pic 4 Desc. | No loose trash around south dumpsters or in the yard. Looking SW. | | |

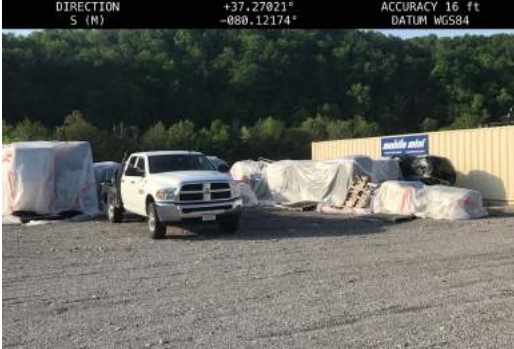
| Pic 5 Desc. | Restoration supplies covered and protected from the elements. Looking S. | Pic 6 Desc. | Condition of containment under stored equipment. Looking S. | | |

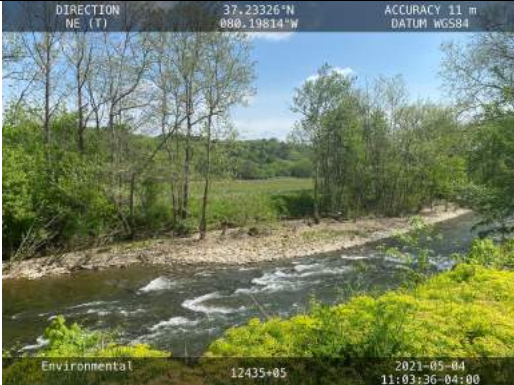
| Pic 1 Desc. | Stream crossing S-NN16 in acceptable condition | | Pic 2 Desc. | Access Road MV0-MN-291 is in acceptable condition | |

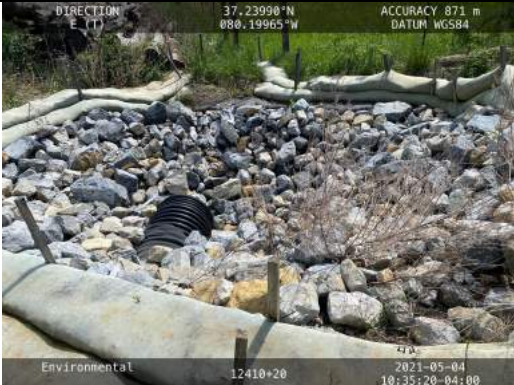
| Pic 3 Desc. | Clean water crossing outlet in acceptable condition | | Pic 4 Desc. | Clean water crossing inlet in acceptable condition | |

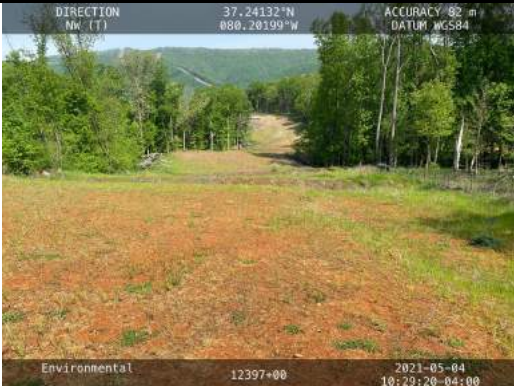
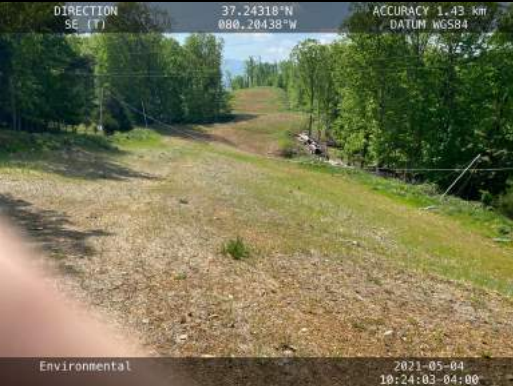
| Pic 5 Desc. | Stabilized ROW in acceptable condition | | Pic 6 Desc. | Stabilized ROW In Acceptable condition | |

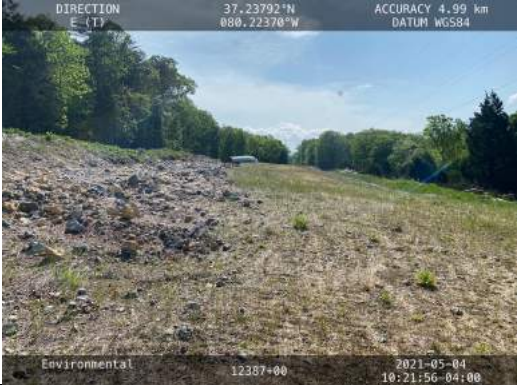
| Pic 7 Desc. | Stabilized ROW in acceptable condition | | Pic 8 Desc. | Clean water crossing in acceptable condition | |

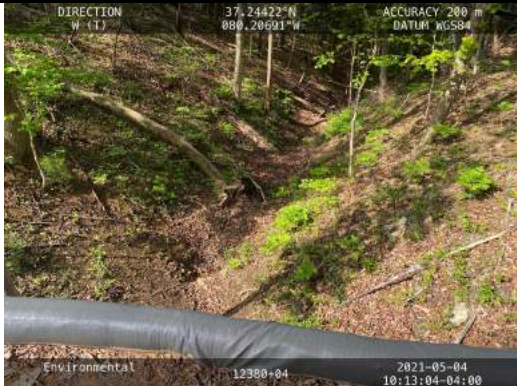
| Pic 9 Desc. | Stream crossing S-NN19 down stream in acceptable condition | | Pic 10 Desc. | Bridge and ECDs crossing S-NN19 in acceptable condition | |

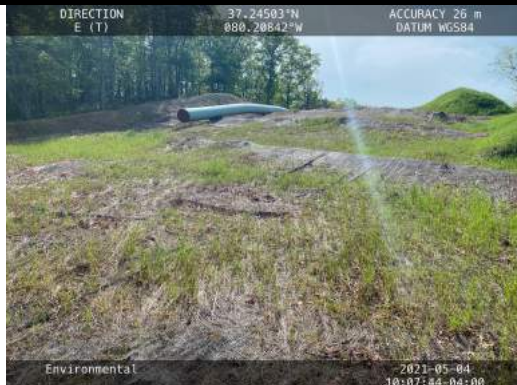
| Pic 11 Desc. | Stabilized slope in acceptable condition | | Pic 12 Desc. | Stream crossing S-OO16 in acceptable condition | |

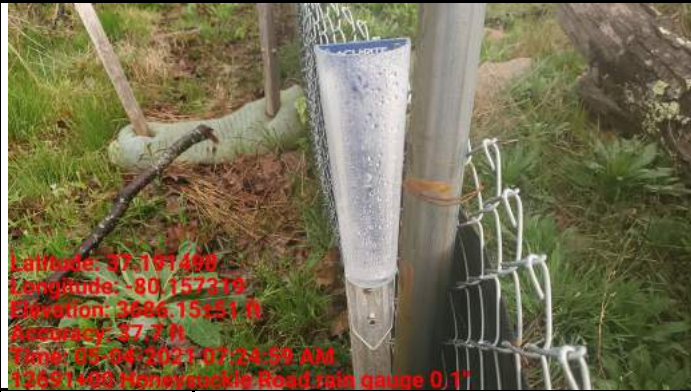
| Pic 1 Desc. | Honeysuckle Road rain gauge. 0.1" total precipitation | | Pic 2 Desc. | Callaway Road rain gauge. 0.0" total precipitation. | |

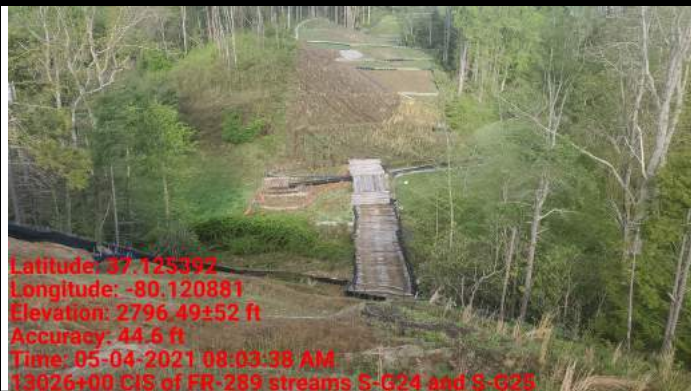
| Pic 3 Desc. | GAS of the BRP, streams S-G24 and S-G25. | | Pic 4 Desc. | Stream crossing S-H1 on the GAS of FR-289. | |

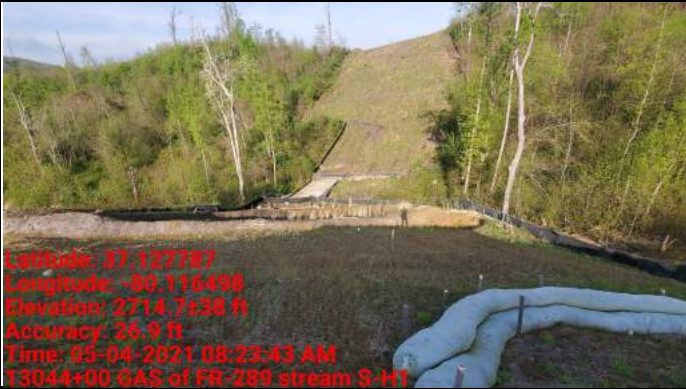
| Pic 7 Desc. | GAS of S-H1 looking back upstream. | | Pic 8 Desc. | Current ROW conditions on the CIS of FR-290. | |

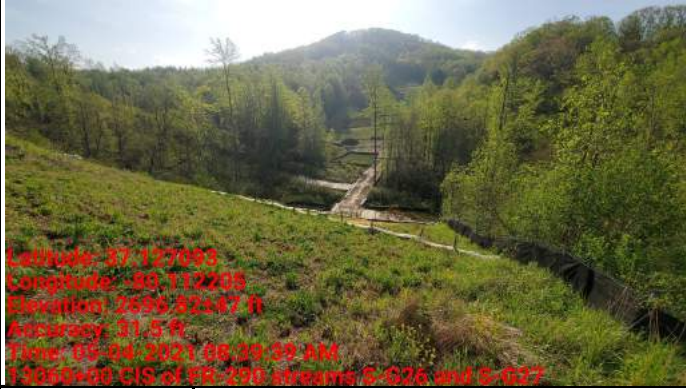
| Pic 9 Desc. | Streams S-G26 and S-G27 from the CIS. | | Pic 10 Desc. | Streams S-G26 and S-G27 from the GAS. | |

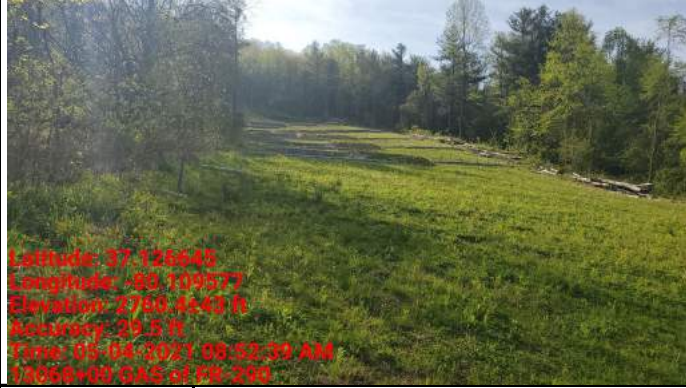
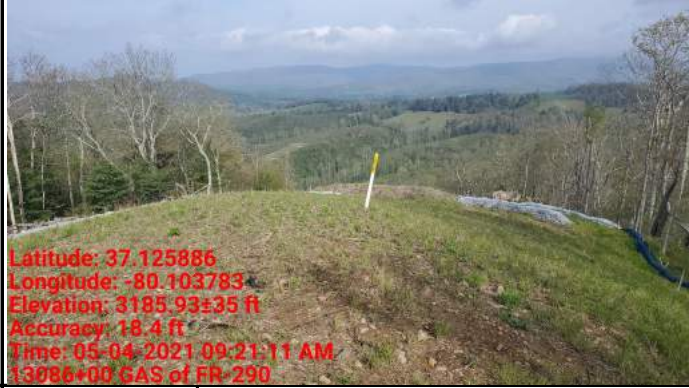
| Pic 11 Desc. | Current ROW conditions on the GAS of FR-290. | | Pic 12 Desc. | Current ROW conditions on the GAS of FR-290. | |

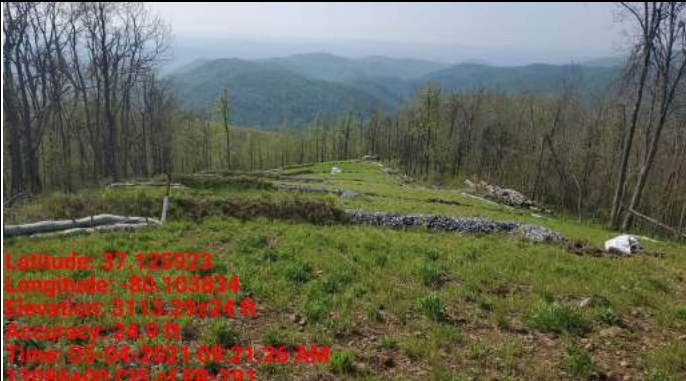
| Pic 13 Desc. | Current ROW conditions on the CIS of FR-291 | | Pic 14 Desc. | Current ROW conditions on the CIS of FR-291. | |

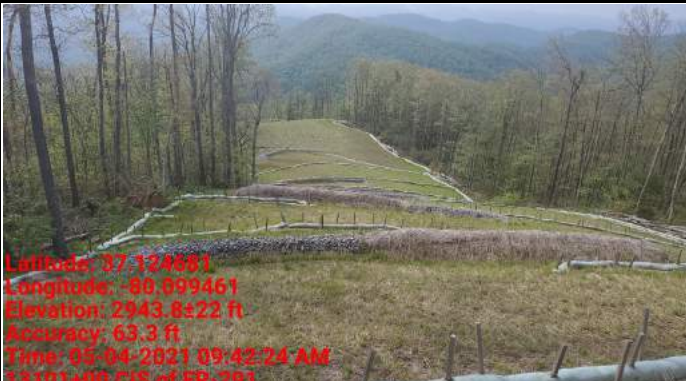
| Pic 15 Desc. | Permanent Slope Breakers and Rock Level Spreaders remain in compliance throughout the area. | | Pic 16 Desc. | Current ROW conditions on the CIS of FR-291 | |

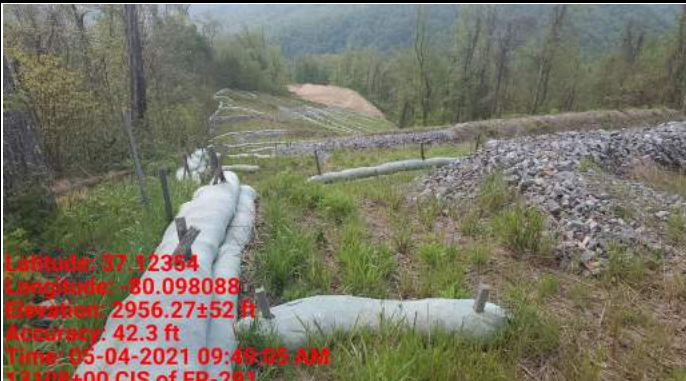
| Pic 17 Desc. | Temporary CFS controls remain in acceptable condition throughout the area. | | Pic 18 Desc. | Current ROW conditions on the CIS of FR-291. | |

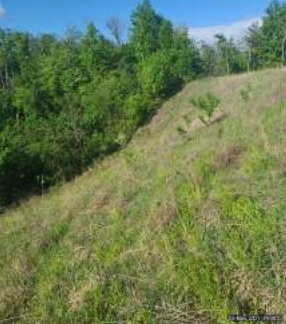
| Pic 1 Desc. | Row photo showing vegetation on side slope. Good coverage noted. | | Pic 2 Desc. | Monitored CFS on row boundary during vegetation observation. No issues observed at the time of inspection. All ECDs up to date and functioning. | |

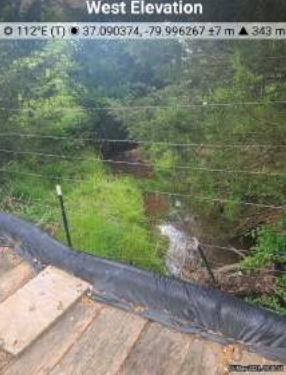
| Pic 3 Desc. | Stream observation photo facing upstream during routine inspection today. No issues noticed at the time of inspection. | | Pic 4 Desc. | Monitored row perimeter ECDs while checking vegetation growth in permanent area. No issues observed at the time of inspection | |

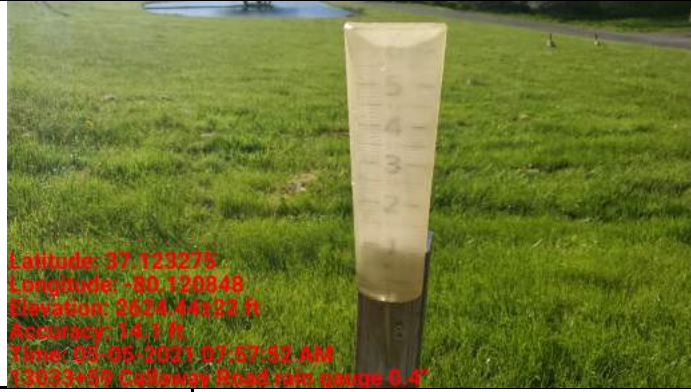
| Field Station# | 13033+59 | | Field Station# | 12691+00 | |

| Pic 1 Desc. | Callaway Road rain gauge. 0.4" | | Pic 2 Desc. | Honeysuckle Road rain gauge. 0.5" | |

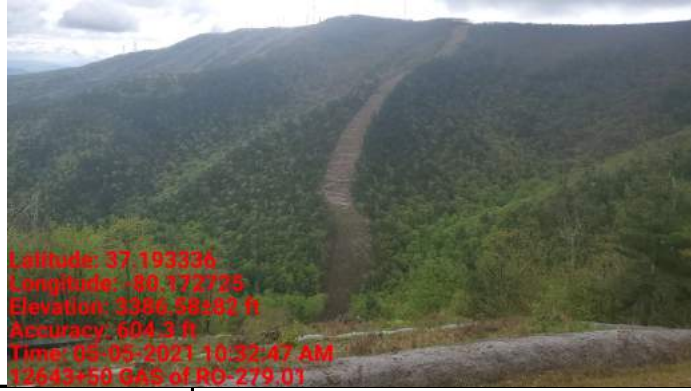
| Field Station# | 12643+50 | | Field Station# | 12642+50 | |

| Pic 3 Desc. | View of the GAS of S-IJ50 and the CIS stabilized ROW from the GAS of RO-279.01. . | | Pic 4 Desc. | Waterbars, sumps and end treatments remain in compliance throughout the area. | |

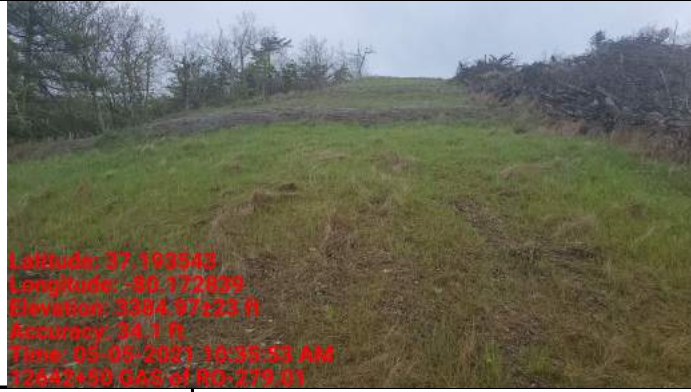
| Field Station# | 12642+50 | | Field Station# | 12641+00 | |

| Pic 5 Desc. | Good vegetative stabilization growing throughout the inspected area. | | Pic 6 Desc. | No maintenance issues or impacts were observed in the area. | |

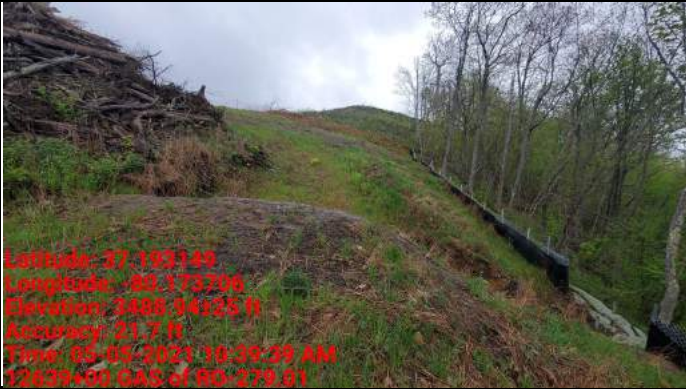
| Field Station# | 12639+00 | | Field Station# | 12684+00 | |

| Pic 7 Desc. | Current conditions of the ROW on the GAS of RO-279.01. | | Pic 8 Desc. | Current ROW conditions on the CIS of Honeysuckle Road. | |

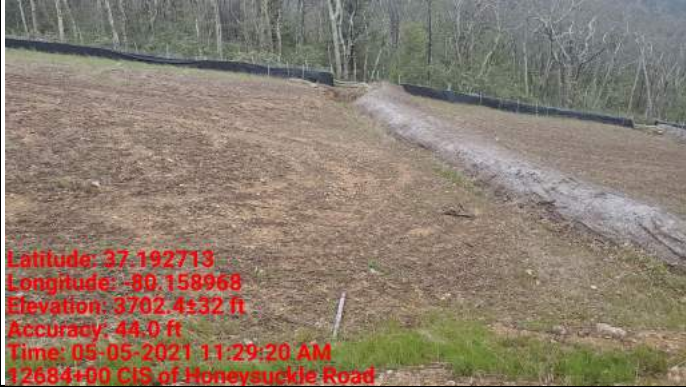
| Field Station# | 12684+00 | | Field Station# | 12684+00 | |

| Pic 9 Desc. | Waterbars, sumps and end treatments remain in compliance throughout the area. | | Pic 10 Desc. | No maintenance issues or impacts were found in the area. | |

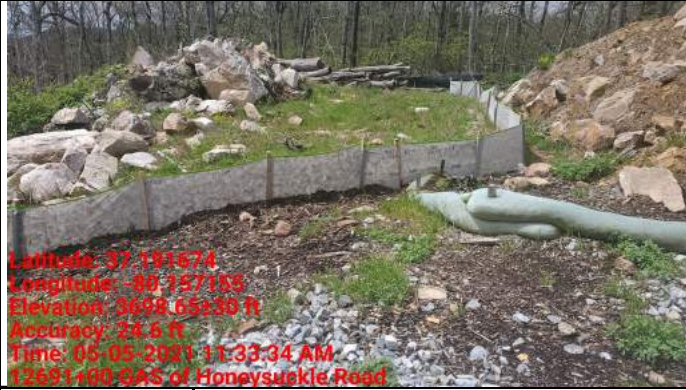
| Pic 11 Desc. | P1 silt fence in acceptable condition. | | Pic 12 Desc. | Current ROW conditions on the GAS of Honeysuckle Road crossing. | |

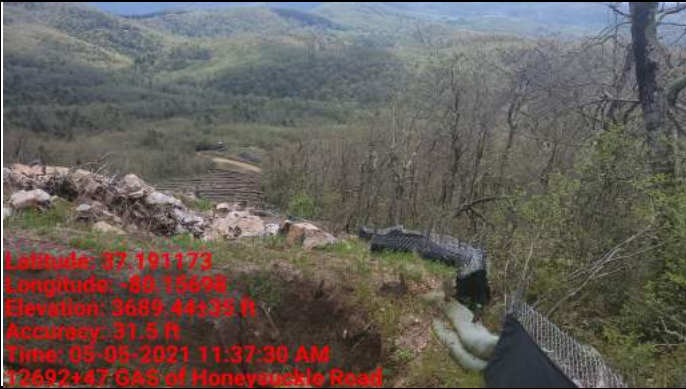
| Field Station# | 12692+47 | | Field Station# | 12728+74 | |

| Pic 13 Desc. | Waterbars, sumps and end treatments remain in compliance. | | Pic 14 Desc. | Current condition of the ATWS at the top of access road RO=281. | |

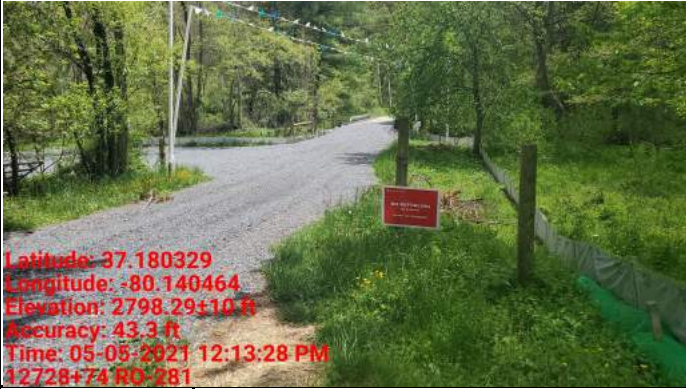
| Field Station# | 12728+74 | | Field Station# | 12728+74 | |

| Pic 15 Desc. | No maintenance issues or impacts were found at RO-281. | | Pic 16 Desc. | Upstream side of stream S-EF32 on RO-281. | |

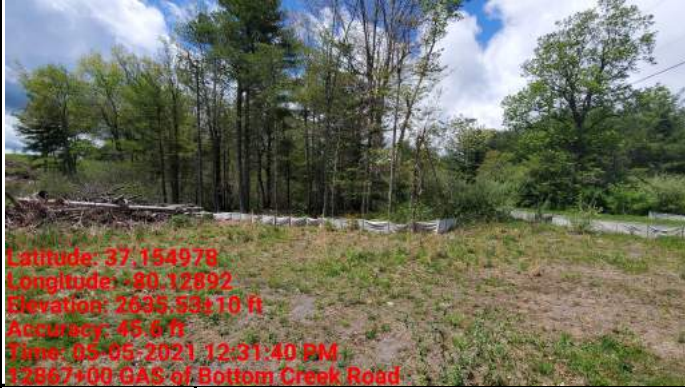
| Field Station# | 12865+80 | | Field Station# | 12867+00 | |

| Pic 17 Desc. | Current conditions at the CIS of Bottom Creek Road. | | Pic 18 Desc. | Current conditions at the GAS of Bottom Creek Road. | |

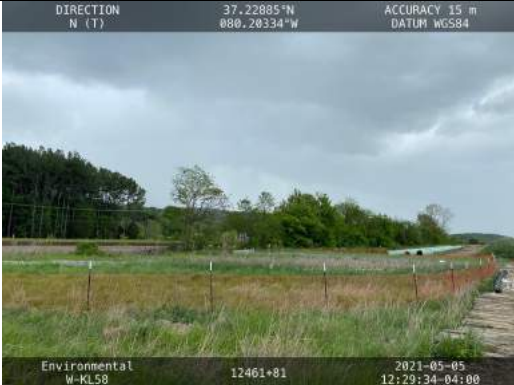
| Field Station# | 12461+81 | | Field Station# | 12485+00 | |

| Pic 1 Desc. | ECDS protecting wetland W-KL58 in acceptable condition | | Pic 2 Desc. | Stabilized slope in acceptable condition | |

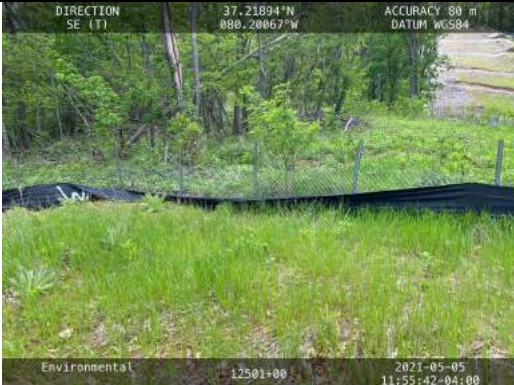
| Field Station# | 12501+00 | | Field Station# | 12506+00 | |

| Pic 3 Desc. | Fabric pulled away from chain link | | Pic 4 Desc. | Stabilized slope in acceptable condition | |

| <p>A SWPPP inspection was performed between Highway 11 and Yellow Finch Road, stations 12443+75 to 12544+06. The streams included in today's inspection were S-KL32, S-EF20b, S-EF54, S-EF20a, S-EF19, S-CD12, and S-I1. There was no impacts recorded to any of the streams or their corresponding buffer zones. The access roads observed included MLV-28, and MN-278.01. During the inspection there were several spots of SSF that needs repaired due to the weather, between STA#12520+00-12524+00 the fabric needs reattached to the chain link, at STA#12504+00 a tree top has fallen on to the SSF damaging the fence, and at STA# 12501+00 the fabric needs reattached to the chain link. All other ECDs along the access roads and ROW are in acceptable condition and functioning properly. The ROW remains in a stable condition. PPL had an environmental crew repairing the damaged fence as soon as the issues were found.</p> | | | | | |

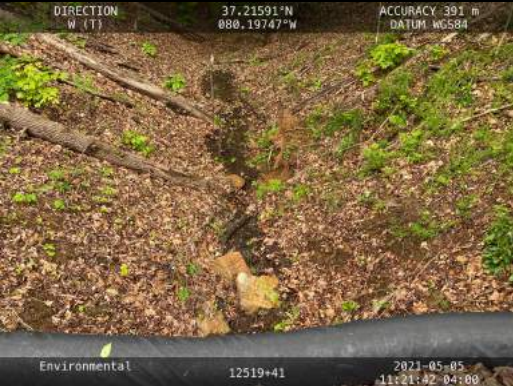
| Pic 5 Desc. | Downed tree top laying on SSF | | Pic 6 Desc. | Downstream of S-EF19 in acceptable condition | |

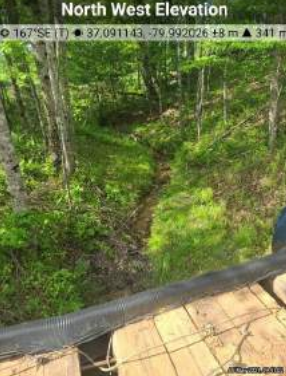
| Field Station# | 13533+32 | Field Station# | 13533+32 | | |

| Pic 1 Desc. | Stream observation photo facing downstream during routine inspection today. No issues observed at the time of inspection. | | Pic 2 Desc. | Stream observation photo facing upstream during routine inspection today. | |

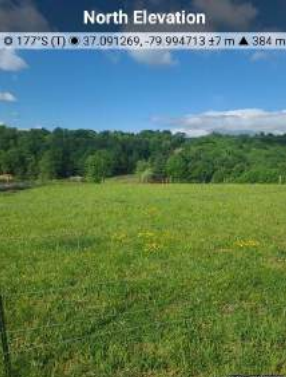
| Field Station# | 13530+78 | Field Station# | 13539+30 | | |

| Pic 3 Desc. | Vegetation observation photo showing good covering . | | Pic 4 Desc. | P1 requires maintenance due to being weathered and torn, documented and added to the punch list for repair. | |

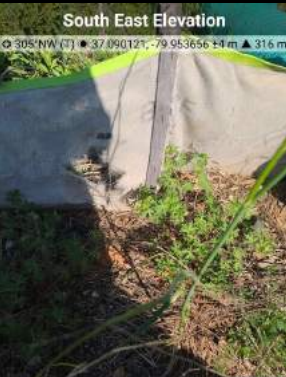
| Field Station# | 13667+02 | Field Station# | 13574+98 | | |

| Pic 5 Desc. | P1 at stream buffer requires maintenance due to being weathered and torn. Documented and added to the punch list | | Pic 6 Desc. | Photo showing vegetation while checking newly installed ECDs , no environmental issues observed at the time of inspection. | |

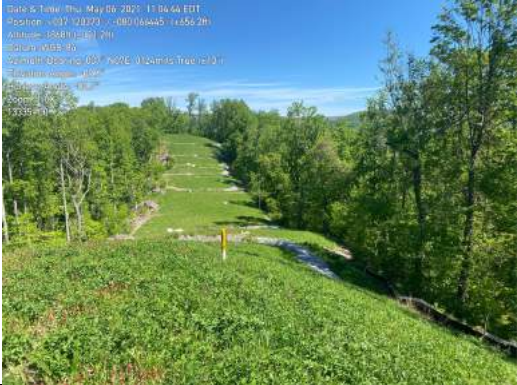
| Field Station# | 13235+00 | | Field Station# | 13251+50 | |

| Pic 7 Desc. | ROW stable with vegetation establishing well across LOD. | | Pic 8 Desc. | ROW stable with vegetation establishing across LOD. | |

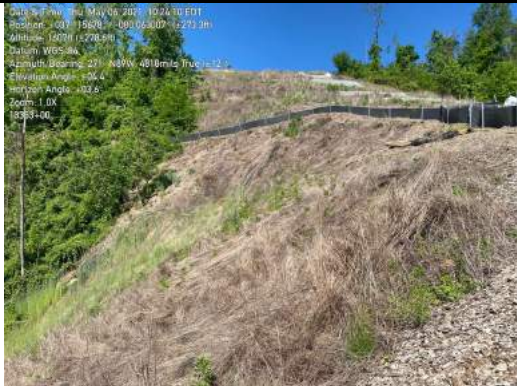
| Field Station# | 13253+00 | | Field Station# | 13253+00 | |

| Pic 9 Desc. | Slip appeared to be stable, no notable changes, vegetation establishing. | | Pic 10 Desc. | Perimeter controls below slip in acceptable condition. | |

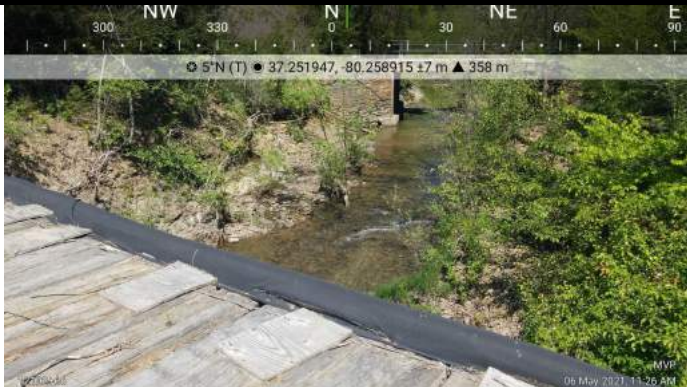
| Field Station# | 12192+66 | | Field Station# | 12196+24 | |

| Pic 1 Desc. | Up stream of S-C21 in acceptable condition | | Pic 2 Desc. | Stream crossing S-OO11 in acceptable condition | |

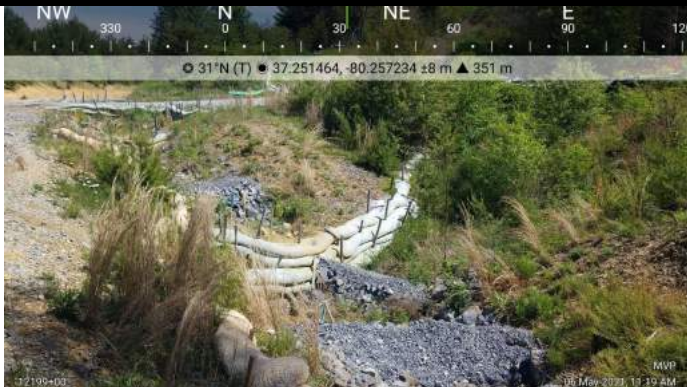
| Field Station# | 12199+00 | | Field Station# | 12121+50 | |

| Pic 3 Desc. | ECDs w/itching the drainage area protecting S-OO11 in acceptable condition | | Pic 4 Desc. | Bridge crossing S-C33 in acceptable condition | |

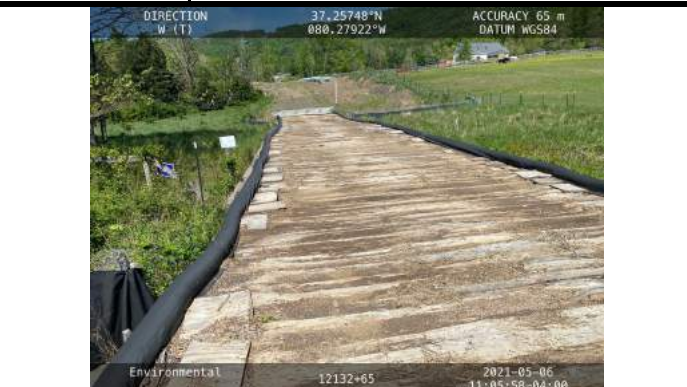
| Pic 5 Desc. | Bridge and ECDs crossing S-C29 in acceptable condition | | Pic 6 Desc. | Stabilized slope in acceptable condition | |

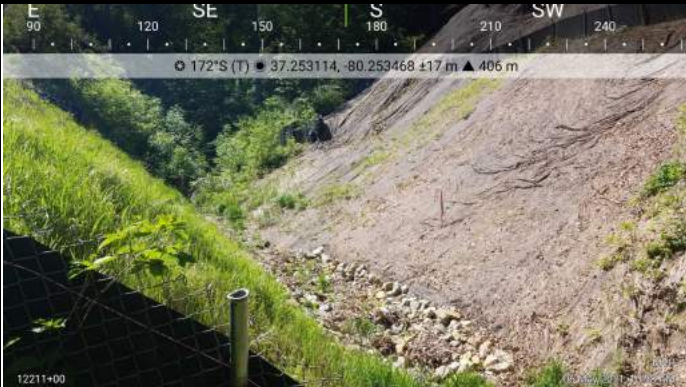
| Pic 7 Desc. | Stabilized drainage feature in acceptable condition | | Pic 8 Desc. | Stabilized slope in acceptable condition | |

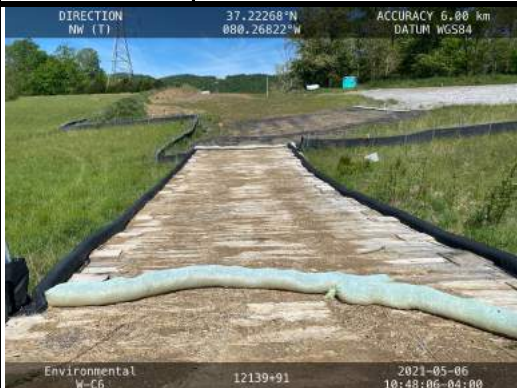
| Pic 9 Desc. | Bridge and ECDs at wetland crossing W-C6 in acceptable condition | | Pic 10 Desc. | Bridge and ECDs at wetland W-C5 in acceptable condition | |

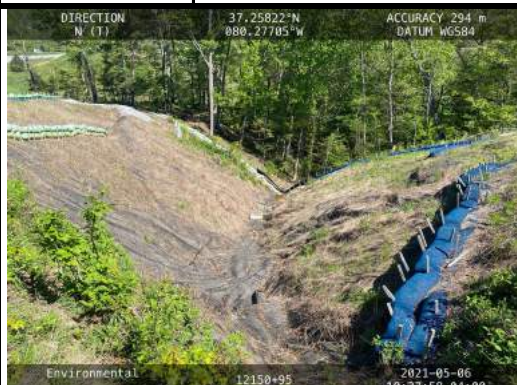
| Pic 11 Desc. | Stabilized drainage feature in acceptable condition | | Pic 12 Desc. | Stabilized ROW in acceptable condition | |

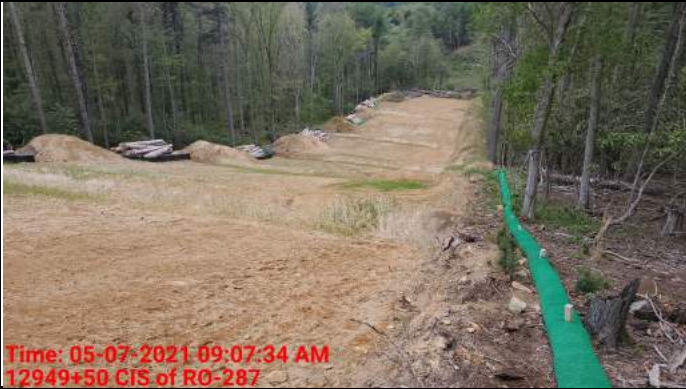
| Pic 7 Desc. | Current ROW conditions on the GAS of stream S-IJ43. | | Pic 8 Desc. | Current ROW conditions on the GAS of stream S-IJ43. | |

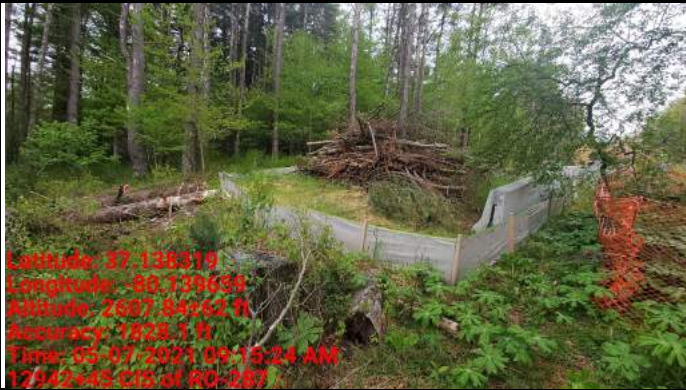
| Pic 9 Desc. | Edge of disturbed area on GAS of stream S-IJ43. | | Pic 10 Desc. | Stream S-Z17 where it crosses RO-287. | |

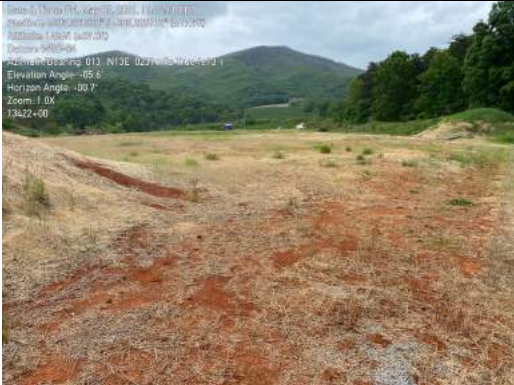
| Pic 1 Desc. | ATWS-1351, extra workspace stabilized with vegetation beginning to establish. | | Pic 2 Desc. | S-IJ1, downstream, slight turbidity noted, no ROW impacts, banks vegetated and stable. | |

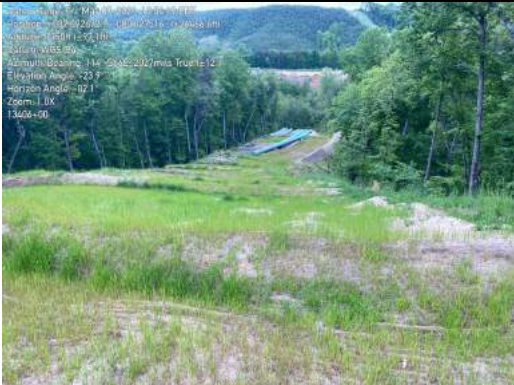
| Pic 3 Desc. | ROW stable with vegetation establishing across LOD. | | Pic 4 Desc. | ROW stable with vegetation establishing across LOD. | |

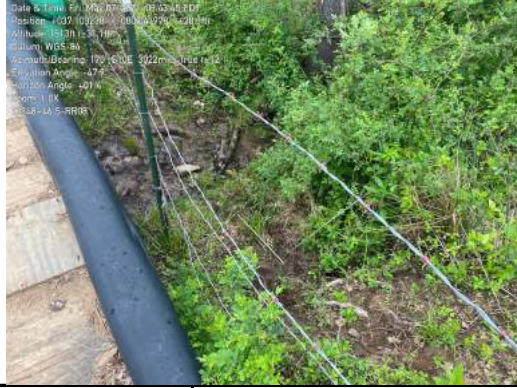
| Pic 11 Desc. | S-RR08, downstream, evidence of livestock in stream, water flowing clear, no ROW impacts noted. | | Pic 12 Desc. | ROW stable with vegetation establishing across LOD. | |

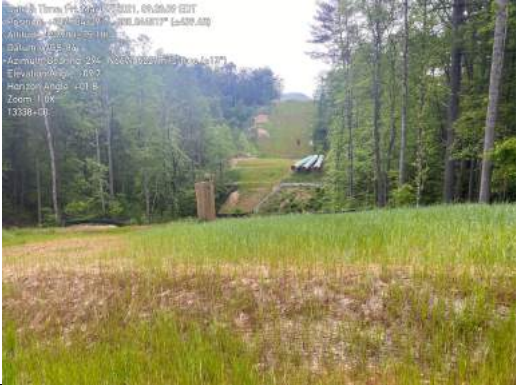
| Pic 13 Desc. | ROW stable with vegetation establishing across LOD. | | Pic 14 Desc. | S-GH9, downstream, no ROW impacts noted at crossing, banks well vegetated, water clear. | |

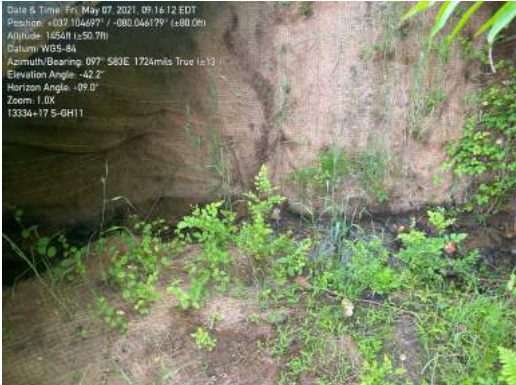
| Pic 15 Desc. | S-GH11, downstream, banks stabilized, water flowing clear, small log under equipment bridge in channel. | | Pic 16 Desc. | ROW stable with vegetation establishing across LOD. | |

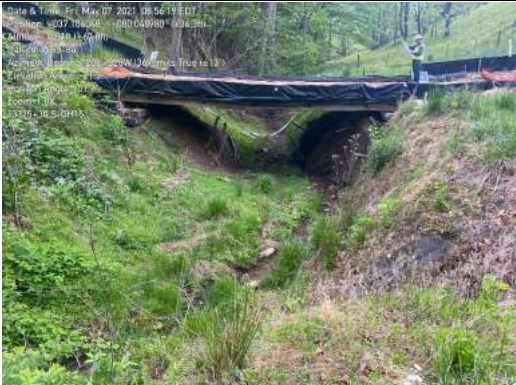
| Pic 17 Desc. | S-GH15, upstream looking downstream, banks appeared stable, no turbidity noted in stream, bridge in acceptable condition. | | Pic 18 Desc. | S-GH14, downstream, banks well vegetation, no ROW impacts observed, cattle noted in pond off ROW. | |
