Visual Site Inspection Report

Project Name H-600 Pipeline Spread I		AFE 124300139	Spread H-600 Pipeline Spread I
Contractor Precision		Report # 20027	
Inspector Justin Burch		Date/Time 2/15/2021 11:07 AM	
Permit # TBD	Inspection Type VA SWPP	Station Begin 15063+85	
State VA	Inspection Area Full	Station End 15142+66	
County Pittsylvania	Ground Wet	Temperature (°F) 38.00	
Municipality Chatham	Weather Light Rain	Rain Gauge (in) 0.30	
			Rain Accumulation Time (days) 6.00

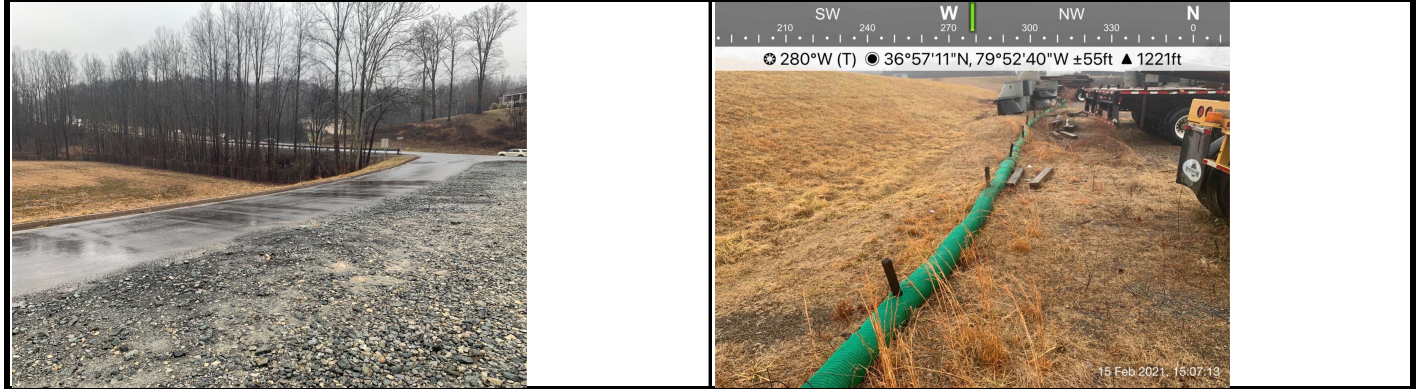
Pic 7 Desc.	RCE at MVP- LY-033 in good condition	Pic 8 Desc.	Perimeter ECD's at MVP-ANC-006 in good condition.
--------------------	--------------------------------------	--------------------	---

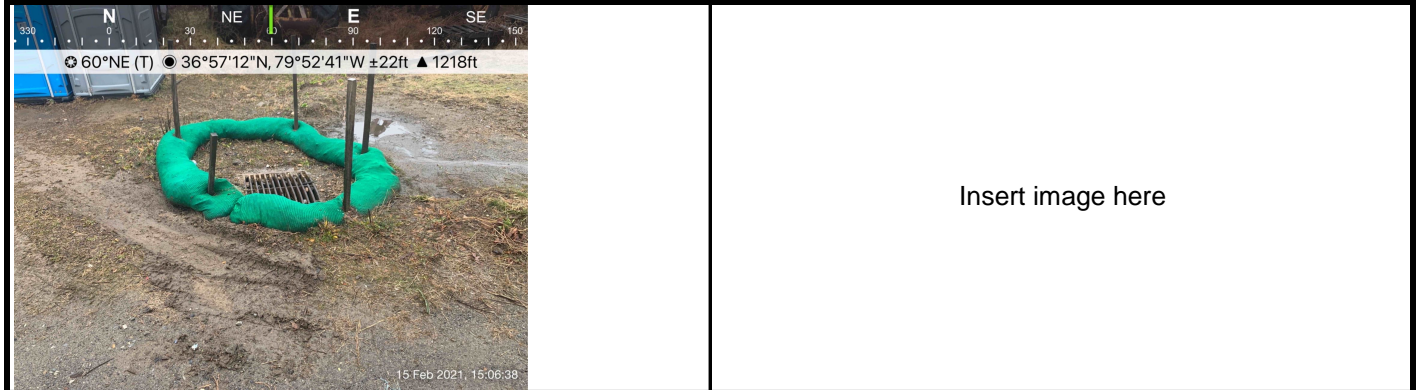
Pic 9 Desc.	Inlet protection for catch basin at MVP-ANC-066 maintenance issue from previous inspection addressed by contractor.	Pic 10 Desc.	
--------------------	---	---------------------	--

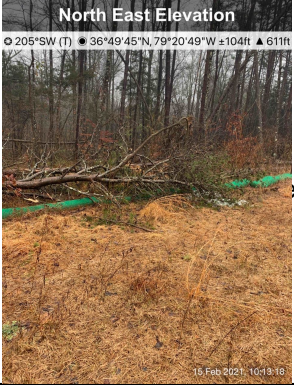
ert image here	
GPS Location ○		GPS Location ○			
Field Station# 16008+00		Field Station# 16009+00			
Pic 9 Desc. Observing tree that needs to be removed		Pic 10 Desc. Observing tree that needs to be removed			
North West Elevation <small>151°SE (T) ● 36°49'46"N, 79°20'48"W ±19ft ▲ 613ft</small>  		North East Elevation <small>225°SW (T) ● 36°49'48"N, 79°20'43"W ±586ft ▲ 604ft</small>

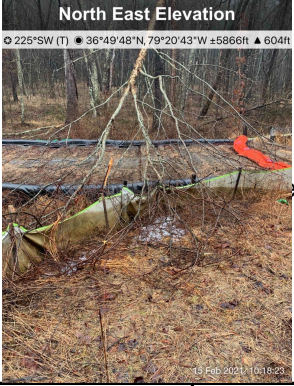
GPS Location ○		GPS Location ○			
Field Station# 16014+00		Field Station# 16016+36			
Pic 11 Desc. Observing several trees that need to be removed		Pic 12 Desc. Observing tree that needs to be removed from the P1

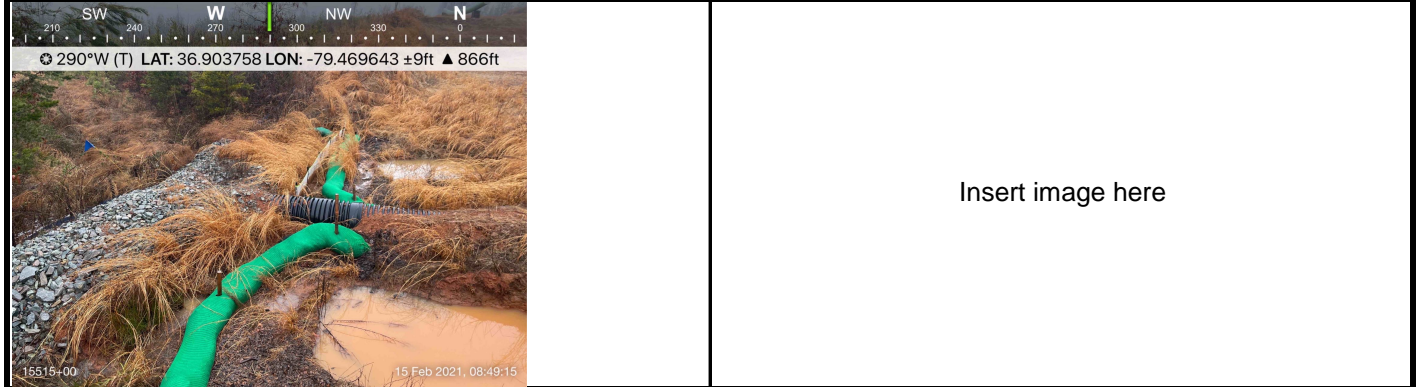
Pic 7 Desc.	CWDs are functioning throughout this section.	Pic 8 Desc.	
--------------------	---	--------------------	--

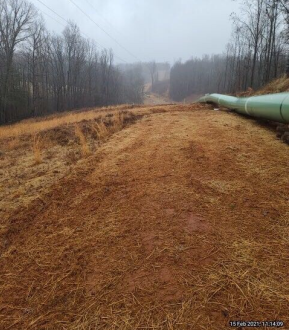
GPS Location	00000	GPS Location	00000
Field Station#	13830+00	Field Station#	13783+90	Pic 1 Desc.	Row photo showing saturated row conditions as light rain events continue.	Pic 2 Desc.	EI monitored row conditions , checking ECDs and stabilization on hill sides above stream crossing, o environmental issues observed at the time of inspection
	<p data-bbox="365 789 527 810">South West Elevation</p> <p data-bbox="305 814 592 835">☉ 51°NE (T) ● 37.06989, -79.933037 ±6 m ▲ 299 m</p>  		<p data-bbox="1063 789 1226 810">North West Elevation</p> <p data-bbox="1003 814 1291 835">☉ 164°SE (T) ● 37.065918, -79.922213 ±3 m ▲ 316 m</p>

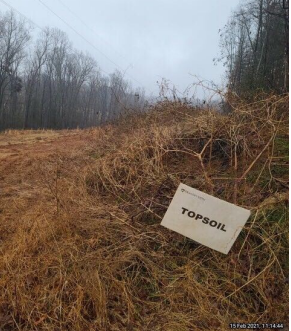
Field Station#	13784+35	Field Station#	13827+19	Pic 3 Desc.	Observed large sump pit at Brick Church access road, no environmental issues observed at the time of inspection	Pic 4 Desc.	EI monitored top soil piles and stabilization. No issues observed at the time of inspection
	<p data-bbox="389 1369 503 1390">West Elevation</p> <p data-bbox="305 1394 592 1415">☉ 115°E (T) ● 37.069948, -79.932307 ±4 m ▲ 313 m</p>  		<p data-bbox="1079 1369 1209 1390">South Elevation</p> <p data-bbox="1003 1394 1291 1415">☉ 13°N (T) ● 37.065964, -79.922264 ±4 m ▲ 316 m</p>

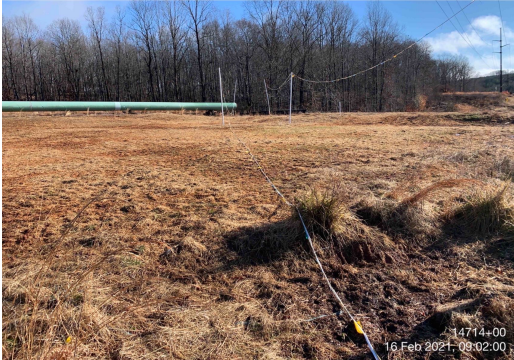
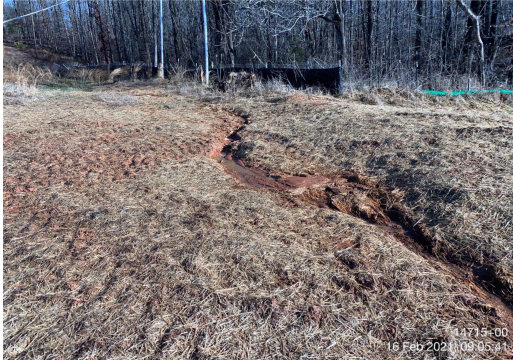
<p>14715+00 16 Feb 2021, 09:03:41</p>	
GPS Location	0	GPS Location	0
Field Station#	14714+00	Field Station#	14715+00
Pic 1 Desc.	Goal post requiring maintenance	Pic 2 Desc.	Erosion in waterbar flow line
<p>133°SE (M) 36°59'20"N, 79°42'11"W ±793ft ▲ 929ft</p>

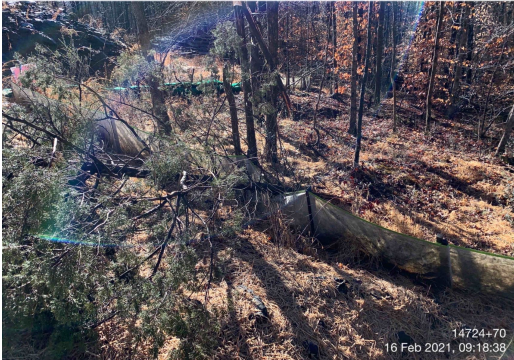
<p>14766+00 16 Feb 2021, 10:03:50</p>	
GPS Location	0	GPS Location	0
Field Station#	14724+70	Field Station#	14766+00
Pic 3 Desc.	P1 silt fence damaged by a fallen tree	Pic 4 Desc.	Sediment on equipment bridge
<p>174°S (M) 36°58'41"N, 79°40'53"W ±3070ft ▲ 859ft</p>

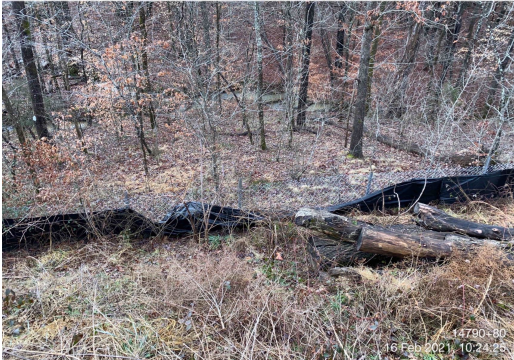
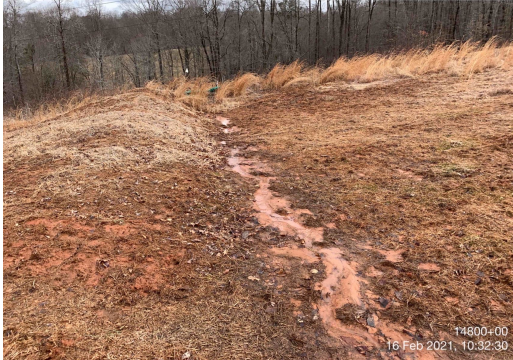
GPS Location	0	GPS Location	0
Field Station#	14790+80	Field Station#	14800+00
Pic 5 Desc.	Super silt fence requiring maintenance	Pic 6 Desc.	Waterbar in acceptable condition

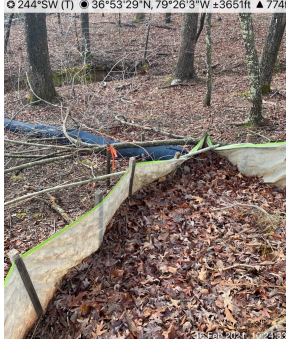
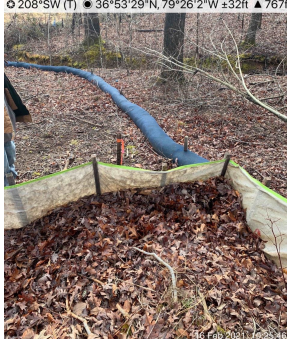
GPS Location	O		GPS Location	O	
Field Station#	15635+00		Field Station#	15635+00	
Pic 1 Desc.	Observing limbs that needed to be removed from ECD,s.		Pic 2 Desc.	Observing ECD,S free of limbs	
	<p style="text-align: center;">East Elevation</p> <p style="font-size: small;">◉ 286°W (T) ● 36°53'33"N, 79°26'9"W ±45ft ▲ 810ft</p>

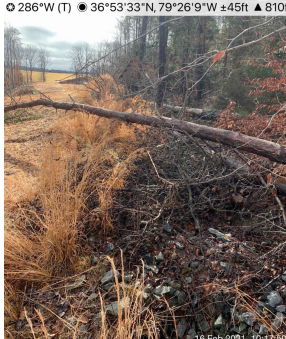
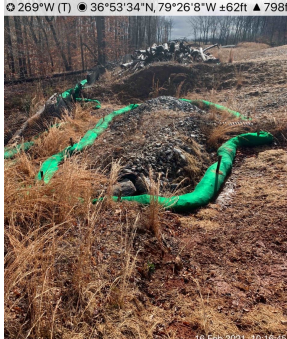
Pic 3 Desc.	Observing trees that need to be removed		Pic 4 Desc.	Observing temporary stabilization,CWD outlet and ECD's	
	<p style="text-align: center;">North East Elevation</p> <p style="font-size: small;">◉ 205°SW (T) ● 36°53'34"N, 79°26'9"W ±52ft ▲ 796ft</p>

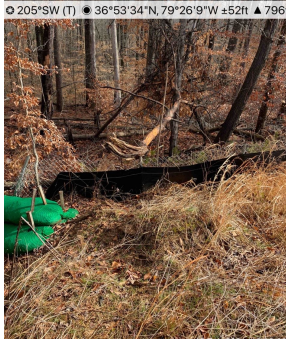
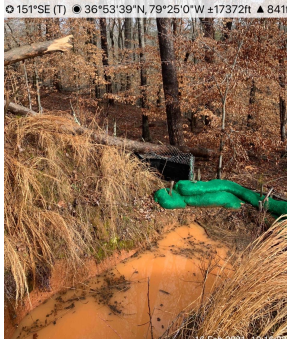
GPS Location	O		GPS Location	O	
Field Station#	15628+00		Field Station#	15628+00	
Pic 5 Desc.	Observing limb that needs to be removed from SSF		Pic 6 Desc.	Observing tree that needs to be removed from SSF

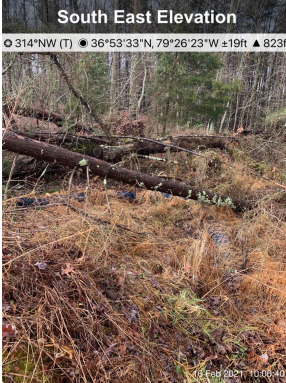
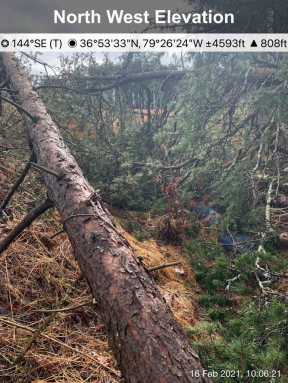
<p>North West Elevation <small>144°SE (T) ● 36°53'33"N, 79°26'24"W ±4593ft ▲ 608ft</small></p>	ert image here		
GPS Location	O	GPS Location	O		
Field Station#	15616+00	Field Station#	15616+00		
Pic 7 Desc.	Observing trees that need to be removed from the CFS		Pic 8 Desc.	Observing trees that need to be removed from CFS

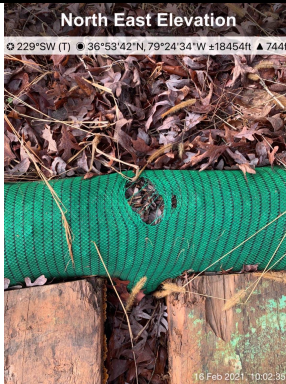
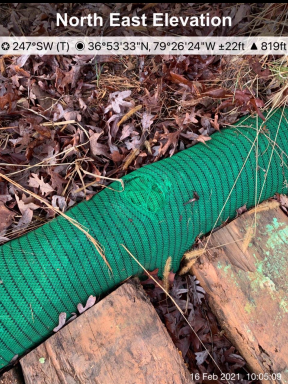
<p>North East Elevation <small>247°SW (T) ● 36°53'33"N, 79°26'24"W ±22ft ▲ 619ft</small></p>	ert image here		
GPS Location	O	GPS Location	O		
Field Station#	15615+00	Field Station#	15615+00		
Pic 9 Desc.	Observing CFS that required maintenance		Pic 10 Desc.	Observing CFS that received maintenance

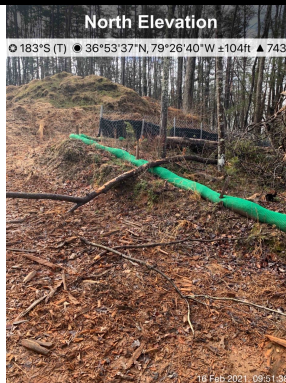
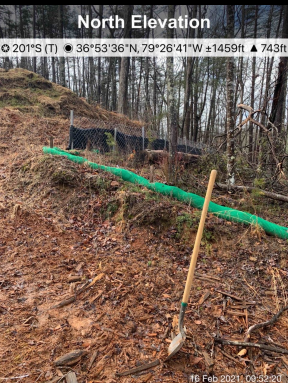
<p>North Elevation <small>201°S (T) ● 36°53'36"N, 79°26'41"W ±1459ft ▲ 743ft</small></p>	ert image here		
GPS Location	O	GPS Location	O		
Field Station#	15600+50	Field Station#	15600+50		
Pic 11 Desc.	Observing limb that needed to be removed		Pic 12 Desc.	Observing CFS free of limbs

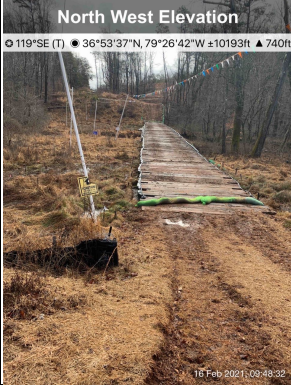
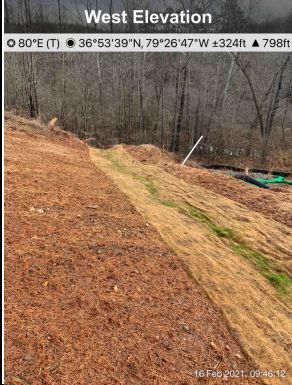
<p>ert image here</p>	
GPS Location ○		GPS Location ○			
Field Station# 15595+60		Field Station# 15593+50			
Pic 13 Desc. Observing buffer, equipment crossing and ECD's		Pic 14 Desc. Observing temporary stabilization, water bar and erosion control blanket

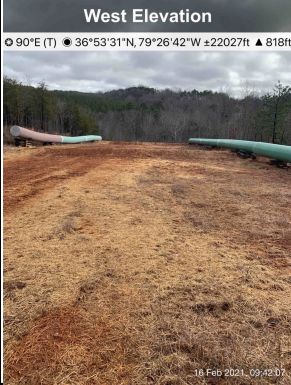
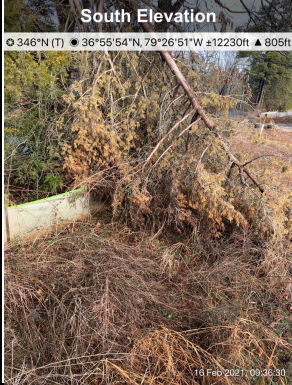
<p>ert image here</p>	
GPS Location ○		GPS Location ○			
Field Station# 15590+00		Field Station# 15584+70			
Pic 15 Desc. Observing temporary stabilization and water bar		Pic 16 Desc. Observing tree that needs to be removed from the p1			
<p>Insert image here</p>			<p>Insert image here</p>		
GPS Location		GPS Location			
Field Station#		Field Station#			
Pic 17 Desc.		Pic 18 Desc.

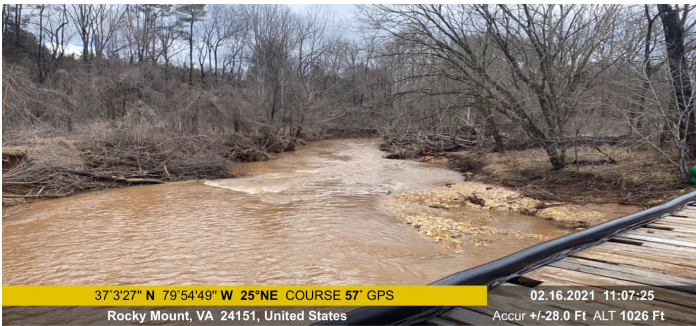
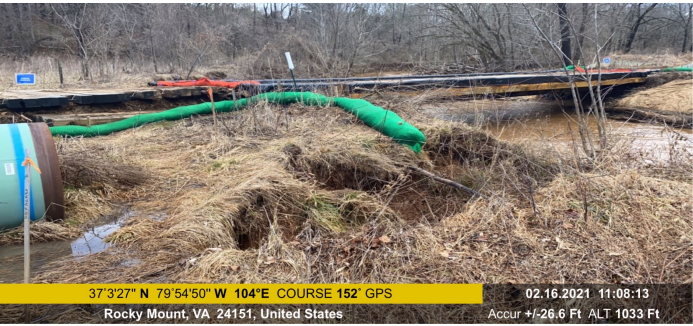
GPS Location	5	GPS Location	6
Field Station#	13875+73	Field Station#	13875+00
Pic 5 Desc.	Downstream view of S-CD6 at ROW crossing	Pic 6 Desc.	Ditch subsidence CIS S-CD6 updated picture

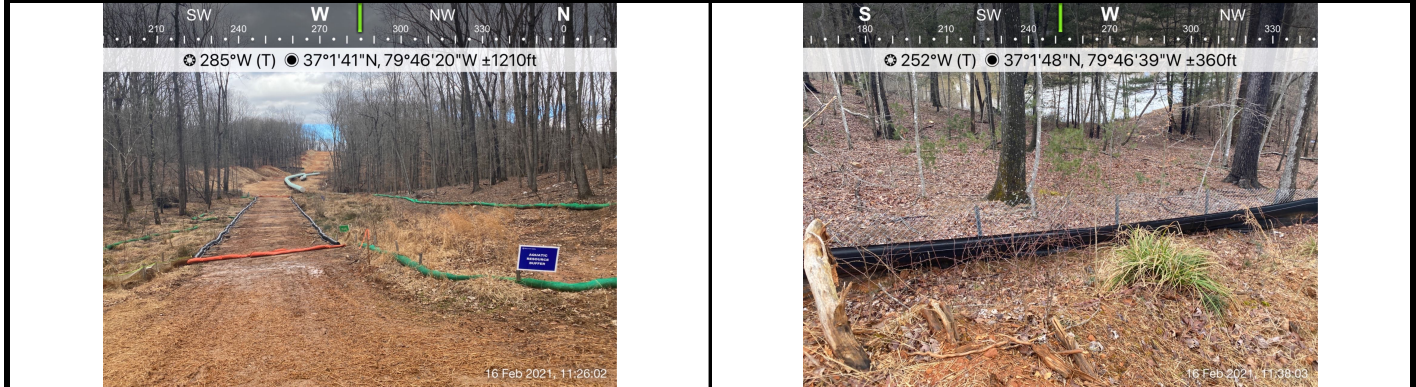
GPS Location	0	GPS Location	0
Field Station#	14438+49	Field Station#	14424+00
Pic 1 Desc.	Approximately 14438+49. Overview of stream crossing, equipment bridge and ECDs at stream S-IJ47.	Pic 2 Desc.	Approximately 14424+00. SSF requires maintenance.

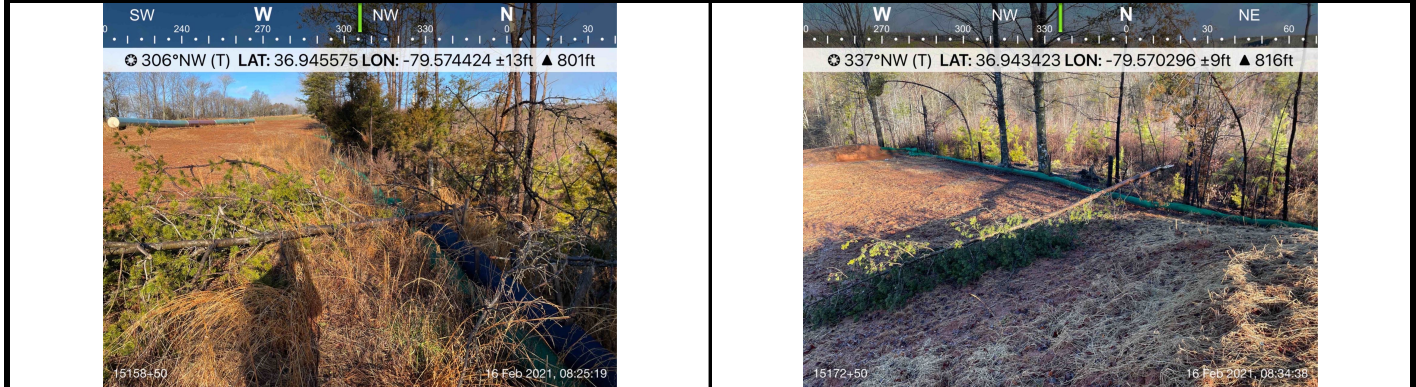
GPS Location	See photo	GPS Location	See photo
Field Station#	15158+50	Field Station#	15172+50
Pic 1 Desc.	Tree has fallen onto the ROW and needs to be removed.	Pic 2 Desc.	Tree has fallen onto the ROW and needs to be removed.

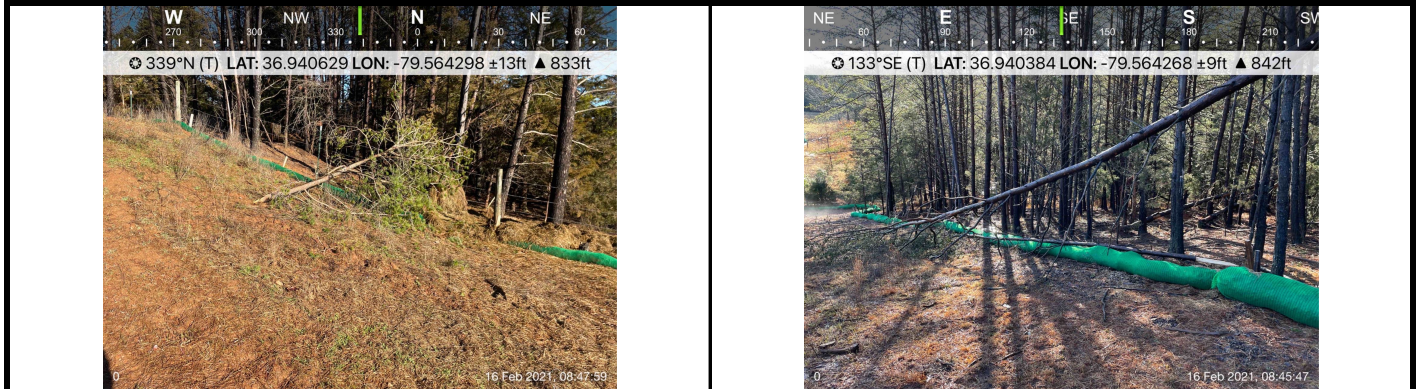
GPS Location	See photo	GPS Location	See photo
Field Station#	15192+75	Field Station#	15193+00
Pic 3 Desc.	Tree has fallen onto the ROW and needs to be removed.	Pic 4 Desc.	Tree has fallen onto the ROW and needs to be removed.

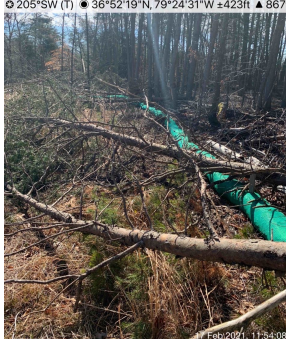
GPS Location	O		GPS Location	O	
Field Station#	15745+00		Field Station#	15749+00	
Pic 1 Desc.	Observing trees that need to be removed and maintenance performed		Pic 2 Desc.	Observing trees that need to be removed and maintenance performed	
	<p>North Elevation <small>⊙ 172°S (T) ● 36°52'18"N, 79°24'21"W ±314ft ▲ 878ft</small></p>

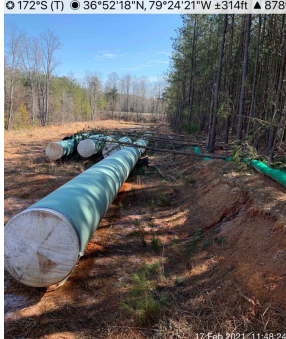
<p>South West Elevation <small>⊙ 64°NE (T) ● 36°52'13"N, 79°24'8"W ±19ft ▲ 793ft</small></p>  	
GPS Location	O		GPS Location	O	
Field Station#	15752+00		Field Station#	15766+00	
Pic 3 Desc.	Observing trees that need to be removed and maintenance performed		Pic 4 Desc.	Observing CFS that requires maintenance

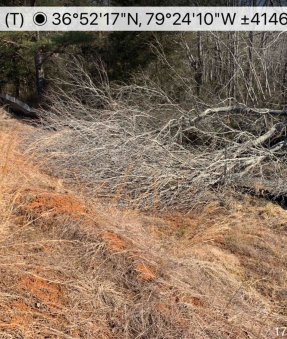
GPS Location	O		GPS Location	O	
Field Station#	15766+00		Field Station#	15762+00	
Pic 5 Desc.	Observing CFS that requires maintenance		Pic 6 Desc.	Observing trees that need to be removed and maintenance performed

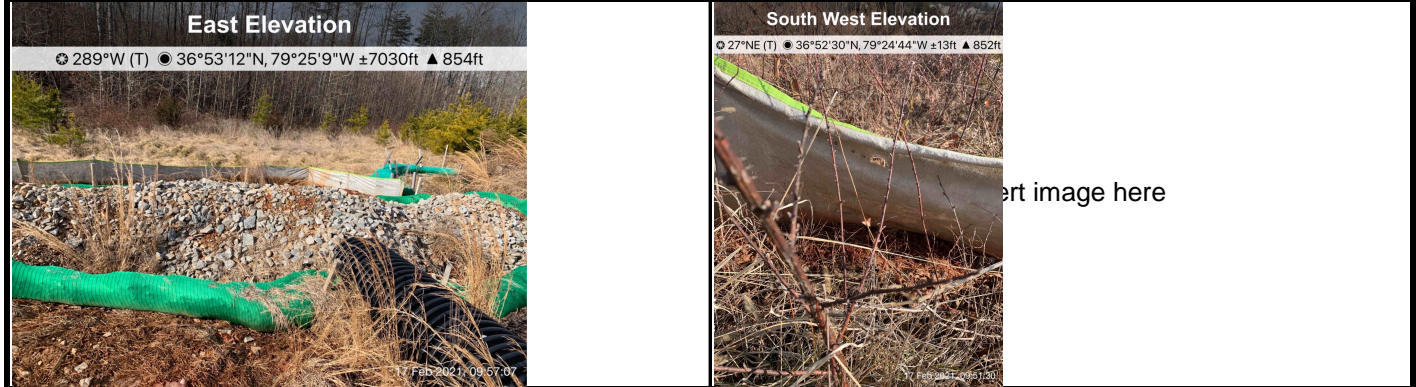
GPS Location	○	GPS Location	○
Field Station#	15723+00	Field Station#	15730+00
Pic 13 Desc.	Observing CWD outlet and ECD's	Pic 14 Desc.	Observing p1 that requires maintenance

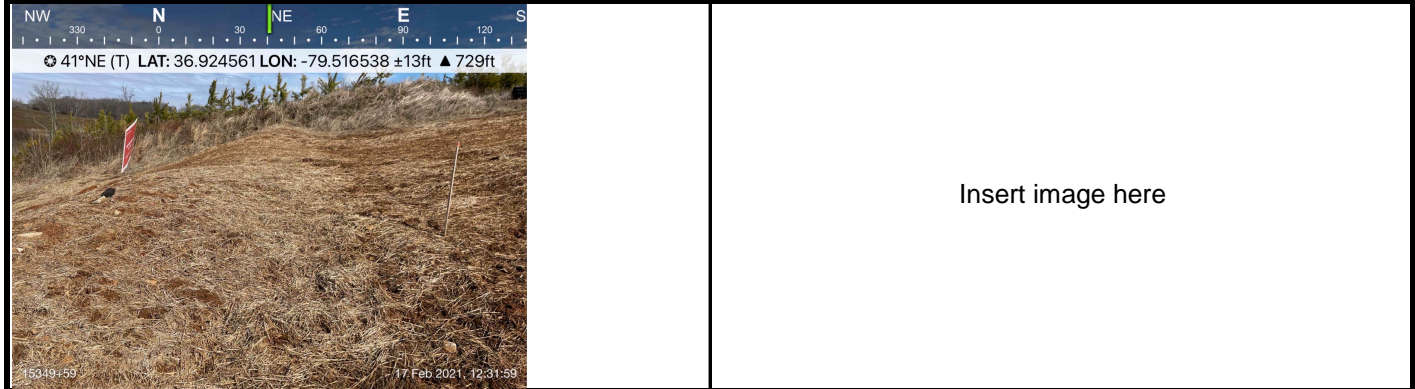
Pic 7 Desc.	Waterbars are functioning as intended.	Pic 8 Desc.	
--------------------	--	--------------------	--

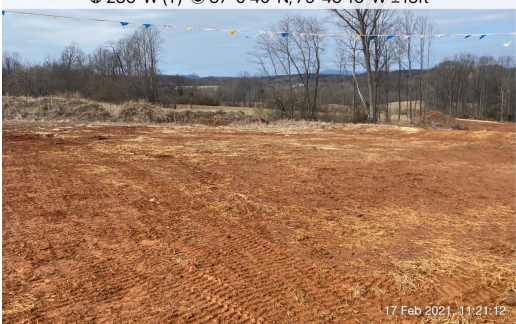
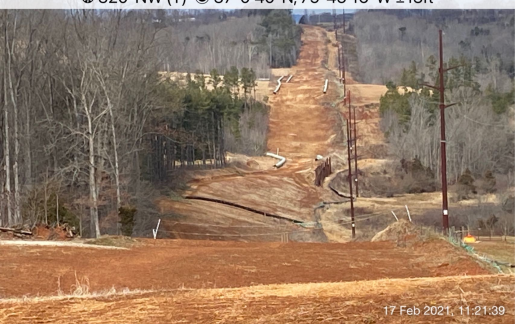
GPS Location	0	GPS Location	0	
Field Station#	14522+50	Field Station#	14510+00	
Pic 1 Desc.	Approximately 14522+50. Overview of ROW.	Pic 2 Desc.	Approximately 14510+00. Overview of ROW.

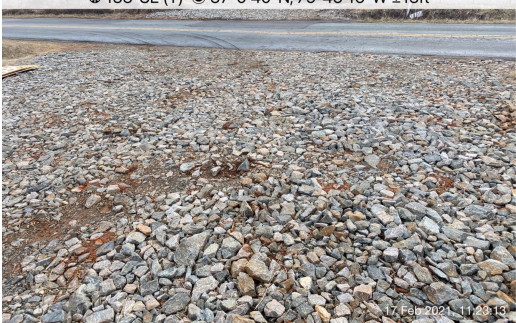
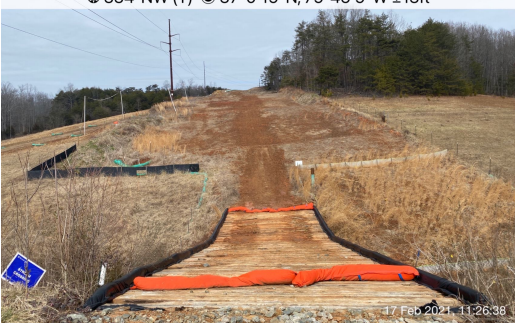
GPS Location	0	GPS Location	0	
Field Station#	14524+50	Field Station#	14546+33	
Pic 3 Desc.	Approximately 14524+50. Overview of road crossing and RCEs.	Pic 4 Desc.	Approximately 14546+33. Overview of stream crossing, equipment bridge and ECDs at stream S-G17.

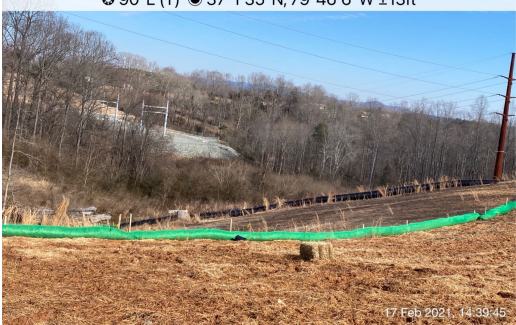
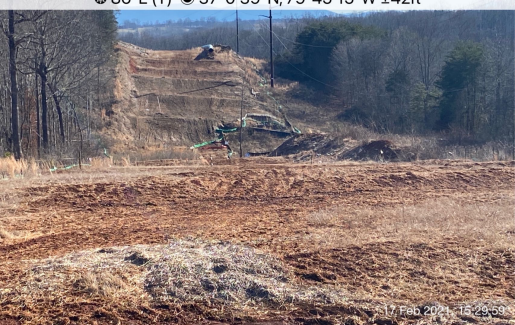
GPS Location	0	GPS Location	0	
Field Station#	14457+00	Field Station#	14529+00	
Pic 5 Desc.	Approximately 14457+00. Overview of ROW.	Pic 6 Desc.	Approximately 14529+00. Overview of ROW.

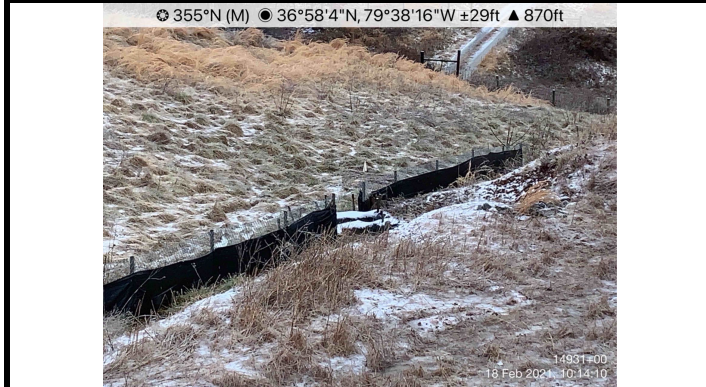
Pic 1 Desc. Super silt fence in acceptable condition

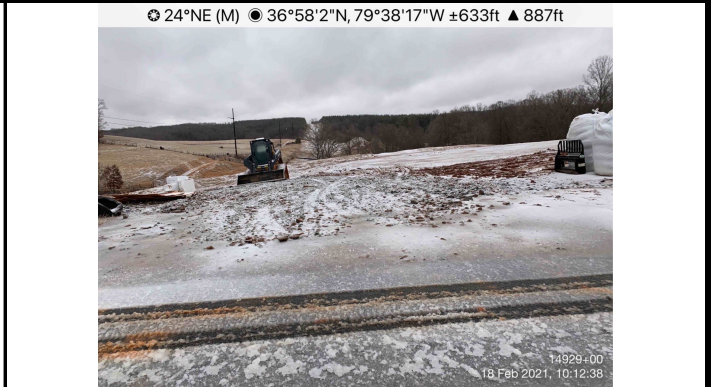
Pic 2 Desc. RCE in acceptable condition

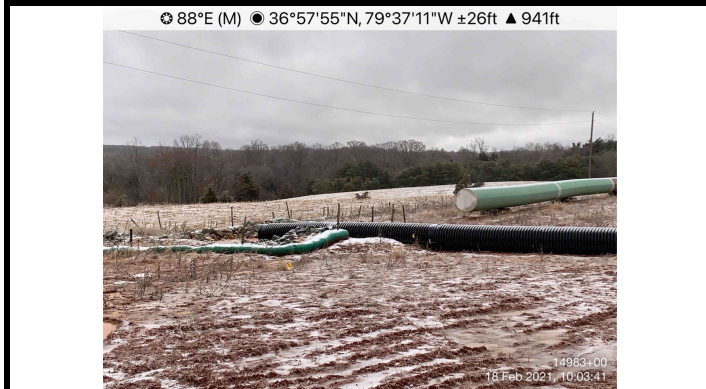
Pic 3 Desc. Clean water diversion pipe in acceptable condition

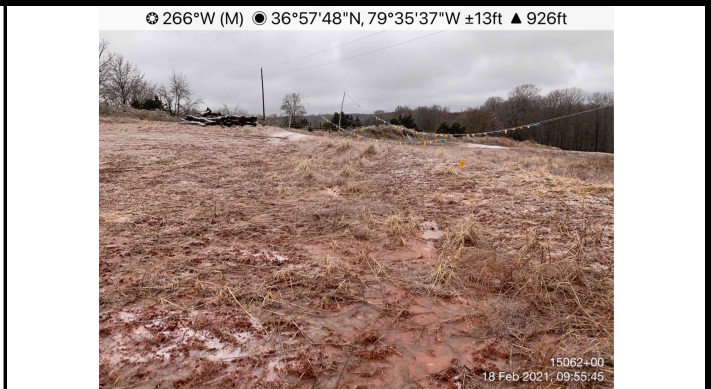
Pic 4 Desc. Waterbar in acceptable condition

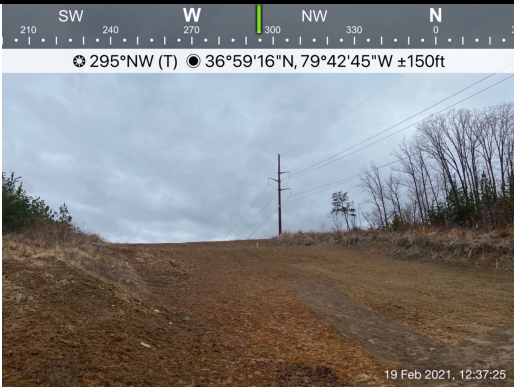
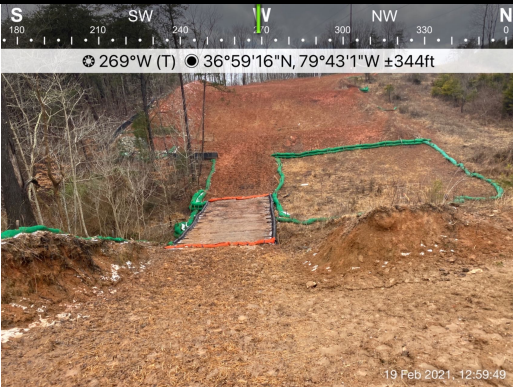
GPS Location 0		GPS Location 0			
Field Station# 14685+00		Field Station# 14673+10			
Pic 3 Desc. Approximately 14685+00. Overview of ROW.		Pic 4 Desc. Approximately 14673+10. Overview of stream crossing, equipment bridge and ECDs at stream S-H37.

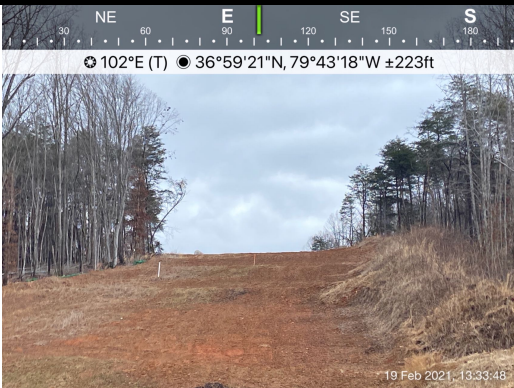
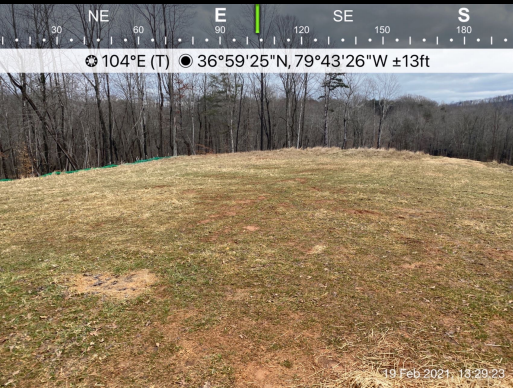
GPS Location 0		GPS Location 0			
Field Station# 14661+00		Field Station# 14651+50			
Pic 5 Desc. Approximately 14661+00. Overview of ROW.		Pic 6 Desc. Approximately 14651+50. Overview of ROW.

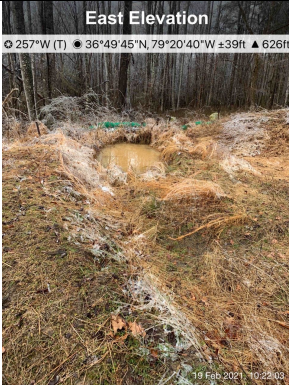
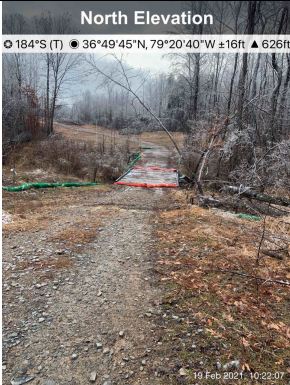
<p>North Elevation <small>184°S (T) • 36°49'45"N, 79°20'40"W ±16ft ▲ 626ft</small> <small>19 Feb 2021 10:22:07</small></p>	
GPS Location		O		GPS Location		O	
Field Station#		11+00		Field Station#		12+65	
Pic 1 Desc.		Observing temporary vegetation, sump and end treatment		Pic 2 Desc.		Observing equipment crossing and ECD's

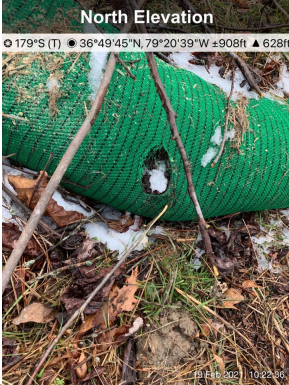
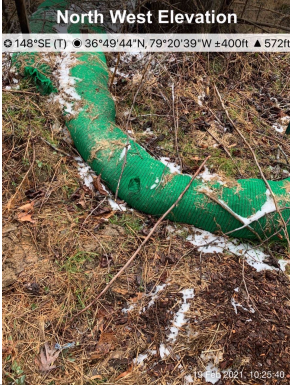
<p>North West Elevation <small>148°SE (T) • 36°49'44"N, 79°20'39"W ±400ft ▲ 572ft</small> <small>19 Feb 2021 10:25:40</small></p>	
GPS Location		O		GPS Location		O	
Field Station#		12+45		Field Station#		12+45	
Pic 3 Desc.		Observing CFS that required maintenance		Pic 4 Desc.		Observing CFS that received maintenance

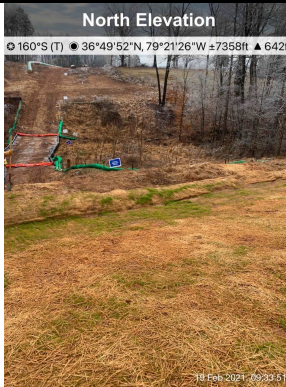
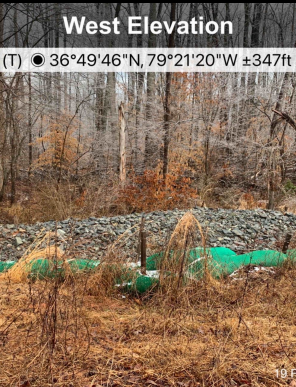
<p>West Elevation <small>112°E (T) ● 36°49'46"N, 79°21'20"W ±347ft ▲ 635ft</small></p>	
GPS Location	O		GPS Location	O	
Field Station#	15977+00		Field Station#	15984+00	
Pic 1 Desc.	Observing water bar, temporary stabilization, signage, buffer, equipment crossing and ECD's		Pic 2 Desc.	Observing temporary stabilization, CWD outlet and ECD's

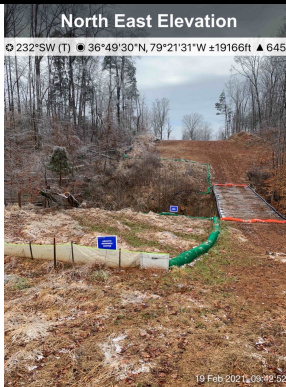
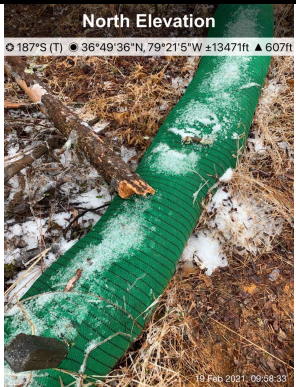
<p>North Elevation <small>187°S (T) ● 36°49'36"N, 79°21'5"W ±1347ft ▲ 607ft</small></p>	
GPS Location	O		GPS Location	O	
Field Station#	15987+31		Field Station#	16019+00	
Pic 3 Desc.	Observing temporary stabilization, signage, buffer, equipment crossing and ECD's		Pic 4 Desc.	Observing limb that needs to be removed from CFS.

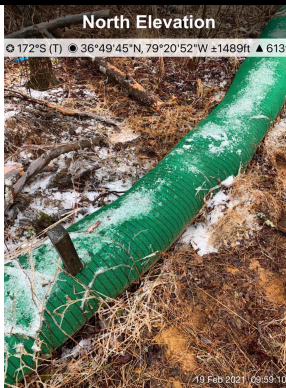
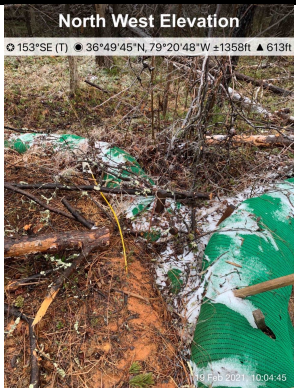
<p>North West Elevation <small>153°SE (T) ● 36°49'45"N, 79°20'48"W ±1358ft ▲ 613ft</small></p>	
GPS Location	O		GPS Location	O	
Field Station#	16019+00		Field Station#	16011+00	
Pic 5 Desc.	Observing CFS free of limbs		Pic 6 Desc.	Observing limbs that need to be removed from CFS

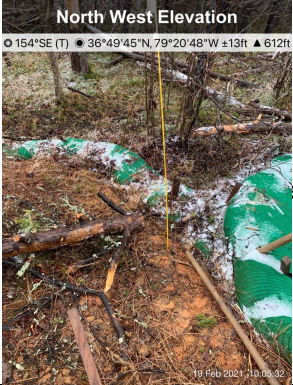
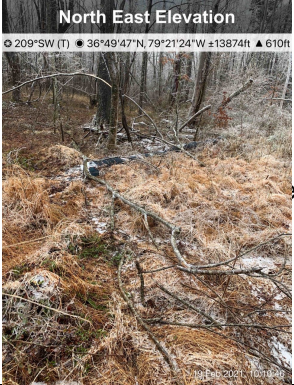
<p>North East Elevation <small>209°SW (T) 36°49'47"N, 79°21'24"W ±13874ft ▲ 610ft</small></p>		<p>Insert image here</p>	
GPS Location O		GPS Location O			
Field Station# 16011+00		Field Station# 16012+00			
Pic 7 Desc. Observing CFS free of limbs		Pic 8 Desc. Observing limbs that need to be removed from CFS

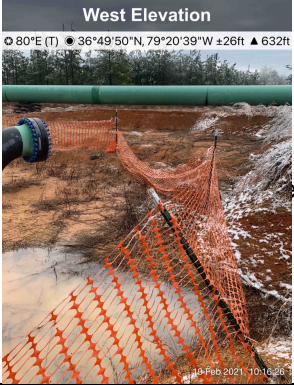
<p>West Elevation <small>80°E (T) 36°49'50"N, 79°20'39"W ±26ft ▲ 632ft</small></p>		<p>Insert image here</p>	
GPS Location O		GPS Location O			
Field Station# 16021+00		Field Station# 16026+05			
Pic 9 Desc. Observing trees that need to be removed		Pic 10 Desc. Observing safety fence that required maintenance

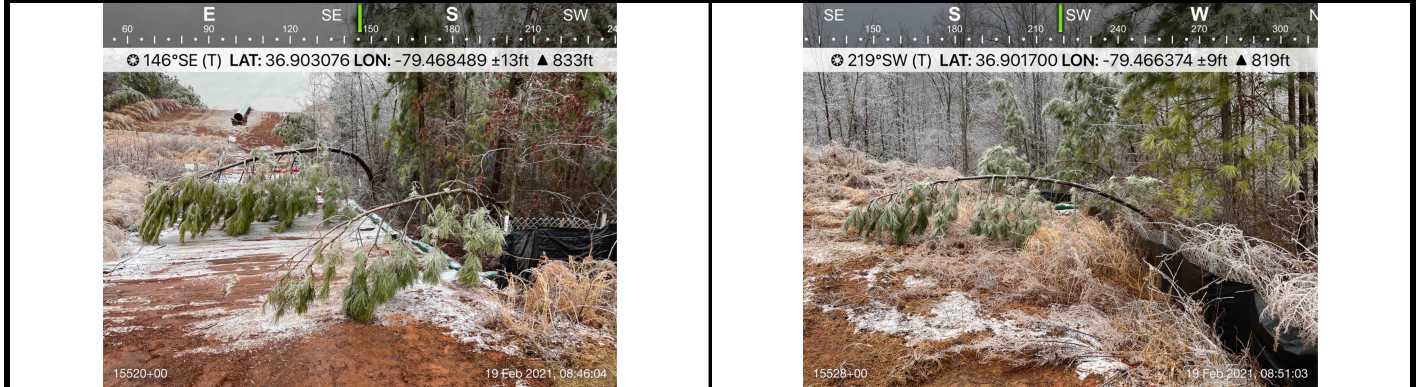
Field Station#	15520+00	Field Station#	15528+00
-----------------------	----------	-----------------------	----------

- EI began inspection at Toshes Rd.
- RCEs are in good condition at all road crossings.
- Multiple trees are down and hanging over ROW ECDs. These trees need to be removed. (See photos)
- Equipment bridge ECDs in place and functioning at all stream/wetland crossings.
- Temporary waterbars and end treatments are in good condition and functioning.
- P1 is in good condition and functioning at all stream and wetland buffers.
- CWDs are in good condition and functioning throughout this section.

Pic 1 Desc.	Multiple trees are down and need to be removed.	Pic 2 Desc.	Multiplayer trees are down across ECDs and need to be removed.
--------------------	---	--------------------	--

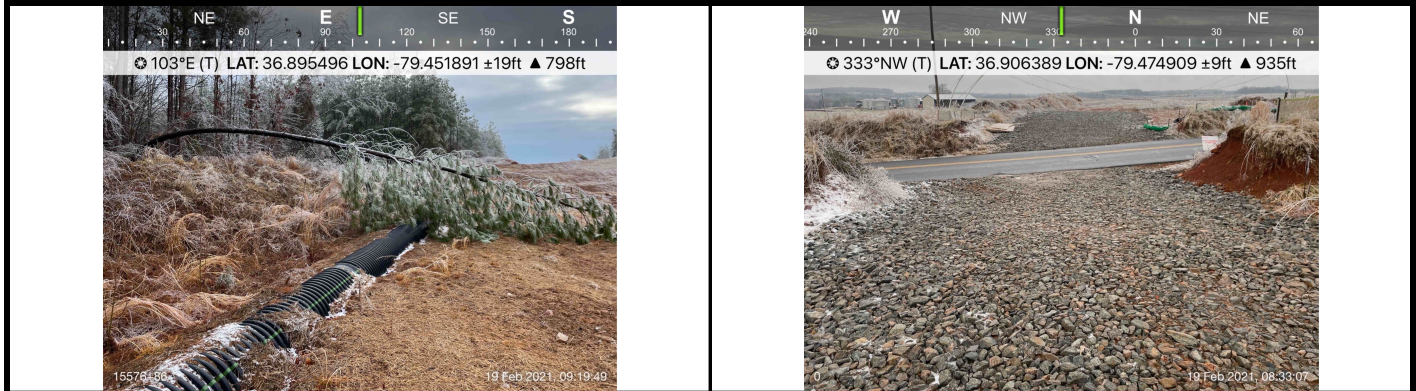
Field Station#	15576+86	Field Station#	15496+70
-----------------------	----------	-----------------------	----------

Pic 3 Desc.	Tree has fallen across slope drain pipe and needs to be removed. (Slope drain pipe remains in good condition).	Pic 4 Desc.	RCEs are in good condition at all road crossings.
--------------------	--	--------------------	---

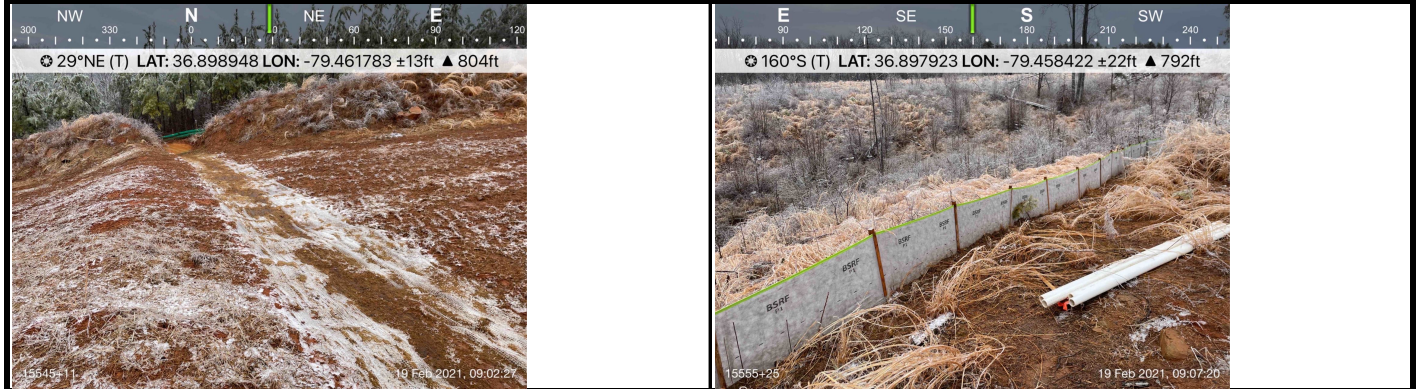
Field Station#	15545+11	Field Station#	15555+25
-----------------------	----------	-----------------------	----------

Pic 7 Desc.	Waterbars are functioning as intended.	Pic 8 Desc.	P1 is in good condition at all stream and wetland buffers.
--------------------	--	--------------------	--

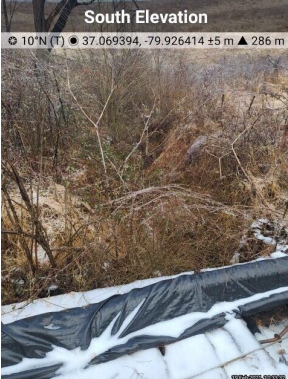
<p>South West Elevation <small>54°NE (T) • 37.068133, -79.932653 ±4 m ▲ 315 m</small></p>	
GPS Location	00000		GPS Location	00000	
Field Station#	13805+69		Field Station#	13784+35	
Pic 3 Desc.	Stream observation photo facing upstream during routine inspection today, no issues observed at time of inspection.		Pic 4 Desc.	EI noticed safety fence was down after recent ice event , documented and sent in to be added to the punch list.

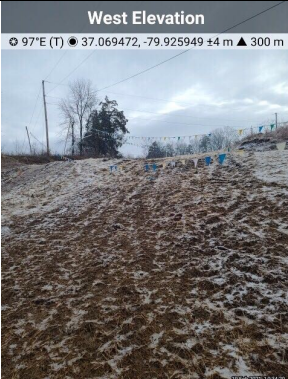
Throughout the EI's travel today the EI noticed several overhead power line ribbons that was sagging due to recent ice events, the EI talked with the contractor and they were aware and will be making repairs .

<p>West Elevation <small>108°E (T) • 37.069005, -79.924093 ±7 m ▲ 307 m</small></p>	
GPS Location	000000		GPS Location	00000	
Field Station#	13087+48		Field Station#	13814+23	
Pic 5 Desc.	Row photo showing ice on row , over head power ribbon was down, talked with the contractor and they were aware and will be replacing it today.		Pic 6 Desc.	While traveling row during routine inspection today the EI monitored the seeding contractor hydro seeding the row with a helicopter, no environmental issues observed at the time of

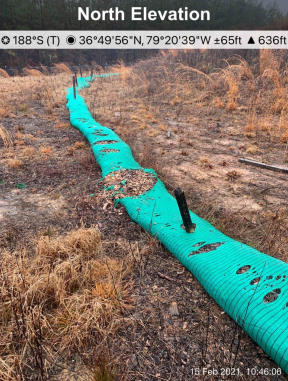
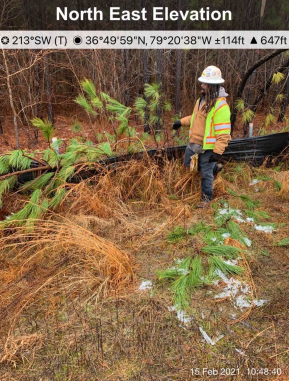
<p>North East Elevation <small>213°SW (T) 36°49'59"N, 79°20'38"W ±114ft ▲ 647ft</small> <small>15 Feb 2021, 10:48:08</small></p>	
GPS Location O		GPS Location O			
Field Station# 00+00		Field Station# 00+00			
Pic 1 Desc. Observing cfs that requires maintenance		Pic 2 Desc. Observing Contractor removing tree from SSF.

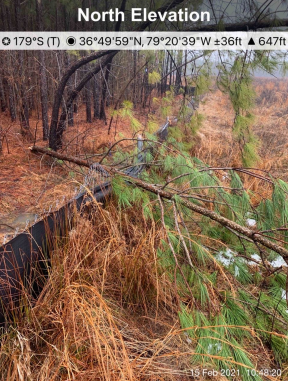
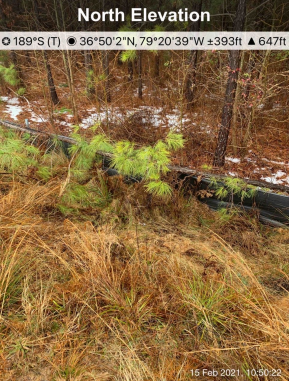
<p>North Elevation <small>189°S (T) 36°50'2"N, 79°20'39"W ±393ft ▲ 647ft</small> <small>15 Feb 2021, 10:50:22</small></p>	
GPS Location P		GPS Location O			
Field Station# 00+00		Field Station# 00+00			
Pic 3 Desc. Observing tree that needs to be removed from SSF		Pic 4 Desc. Observing tree that needs to be removed from SSF.

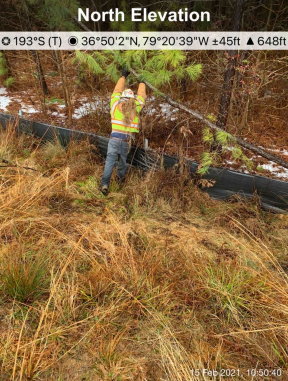
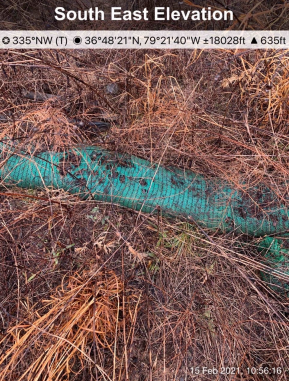
<p>South East Elevation <small>335°NW (T) 36°48'21"N, 79°21'40"W ±18028ft ▲ 635ft</small> <small>15 Feb 2021, 10:50:39</small></p>	
GPS Location O		GPS Location O			
Field Station# 00+00		Field Station# 00+00			
Pic 5 Desc. Observing the Contractor removing tree from the SSF.		Pic 6 Desc. Observing CFS that requires maintenance.

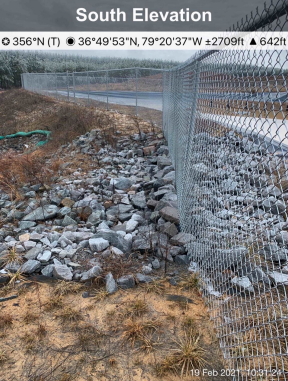
<p>South Elevation <small>356°N (T) ● 36°49'53"N, 79°20'37"W ±2709ft ▲ 642ft</small></p>		  <p>East Elevation <small>277°W (T) ● 36°49'55"N, 79°20'40"W ±387ft ▲ 572ft</small></p>			
GPS Location		O		GPS Location	
Field Station#		00+00		Field Station#	
Pic 3 Desc.		Observing emergency overflow at the storm water pond		Pic 4 Desc.	
Pic 3 Desc.				Observing temporary vegetation, rock check dam and SSF	
Insert image here			Insert image here		
GPS Location				GPS Location	
Field Station#				Field Station#	
Pic 5 Desc.				Pic 6 Desc.
