Visual Site Inspection Report

Project Name H-600 Pipeline Spread I		AFE 124300139	Spread H-600 Pipeline Spread I
Contractor Precision		Report # 20252	
Inspector Ben Davenport		Date/Time 2/21/2021 1:12 PM	
Permit # TBD	Inspection Type VA SWPP	Station Begin 13853+45	
State VA	Inspection Area Partial	Station End 14311+57	
County Franklin	Ground Muddy	Temperature (°F) 40.00	
Municipality N/A	Weather Sunny	Rain Gauge (in) 0.00	
Rain Accumulation Time (days)			0.00

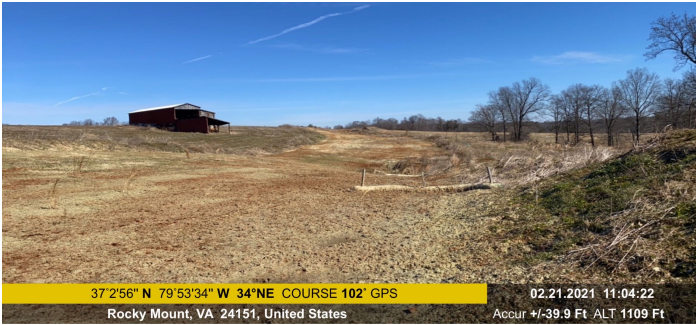
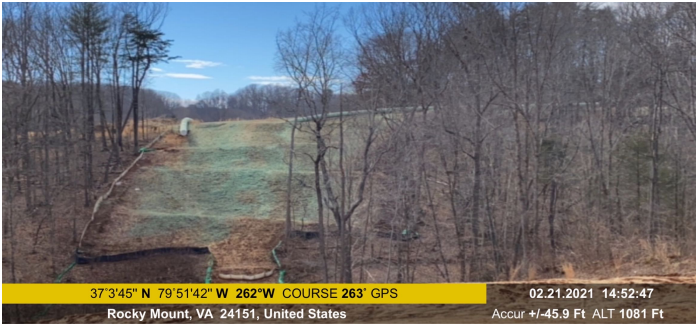
GPS Location	3	GPS Location	4		
Field Station#	13963+00	Field Station#	14103+00		
Pic 3 Desc.	View of stabilized ROW applied aerially after mix has dried		Pic 4 Desc.	View of freshly applied hydroseed mix applied aerially	
Insert image here			Insert image here		
GPS Location		GPS Location			
Field Station#		Field Station#			
Pic 5 Desc.		Pic 6 Desc.

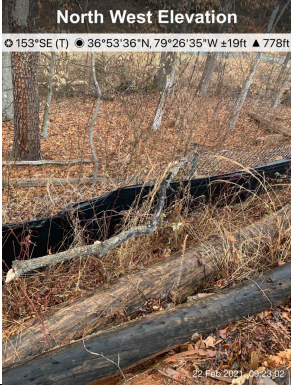
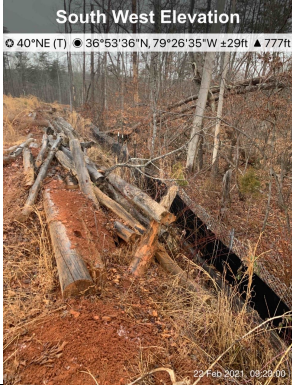
<p>South West Elevation <small>© 40°NE (T) ● 36°53'36"N, 79°26'35"W ±29ft ▲ 777ft</small></p>		<p>ert image here</p>	
GPS Location ○		GPS Location ○			
Field Station# 15606+00		Field Station# 15606+20			
Pic 7 Desc. Observing limbs that need to be removed from the SSF		Pic 8 Desc. Observing limbs that need to be removed from the SSF

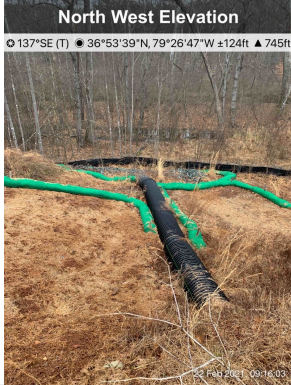
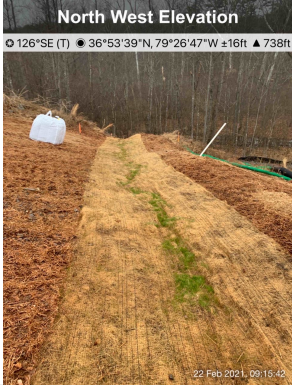
<p>North West Elevation <small>© 126°SE (T) ● 36°53'39"N, 79°26'47"W ±16ft ▲ 738ft</small></p>		<p>ert image here</p>	
GPS Location ○		GPS Location ○			
Field Station# 15595+00		Field Station# 15594+00			
Pic 9 Desc. Observing temporary stabilization CWD pipe, outlet and ECD's		Pic 10 Desc. Observing temporary stabilization, water bar and erosion control blanket

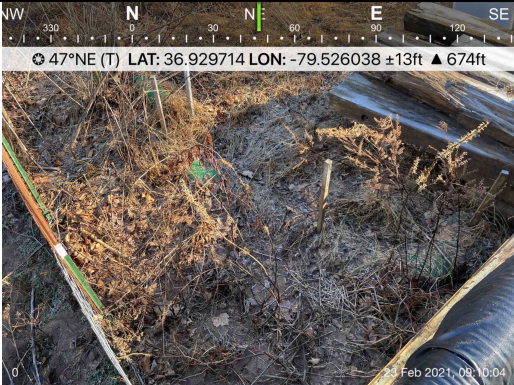
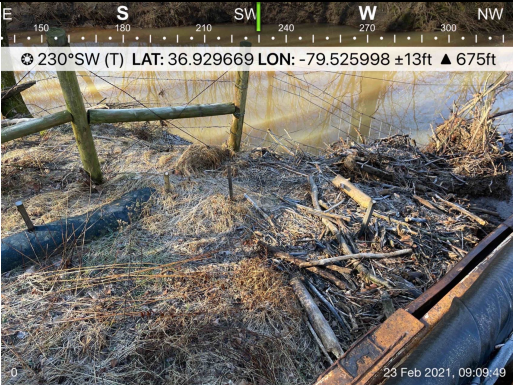
GPS Location See photo		GPS Location See photo			
Field Station# 15315+00		Field Station# 15315+00			
Pic 3 Desc. CFS requires maintenance at this stream buffer.		Pic 4 Desc. CFS requires maintenance at this stream buffer.

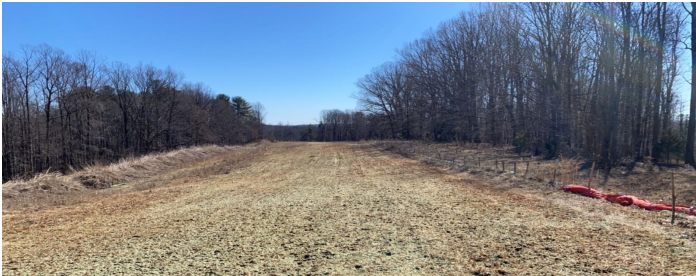
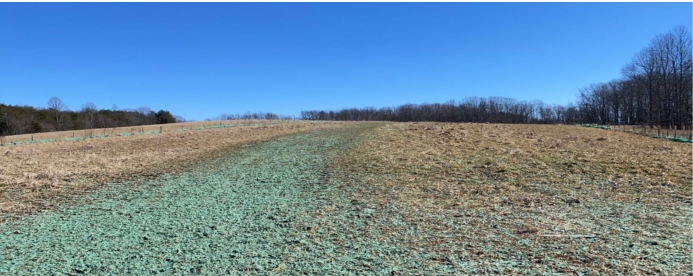
<small>37°35'2" N 79°52'7" W 133°SE COURSE 205° GPS Wirtz, VA 24184, United States</small>			<small>37°34'8" N 79°51'37" W 94°E COURSE 39° GPS 1321 Angle Plantation Rd, Rocky Mount, VA 24151, United States</small>		
<small>02.24.2021 10:55:22 Accur +/-78.5 Ft ALT 1169 Ft</small>			<small>02.24.2021 11:08:23 Accur +/-126.3 Ft ALT 1029 Ft</small>		
GPS Location	1		GPS Location	2	
Field Station#	14092+00		Field Station#	14112+00	
Pic 1 Desc.	View of recently stabilized ROW		Pic 2 Desc.	Contractor aerially seeded and stabilized travel lane through permanent section of ROW

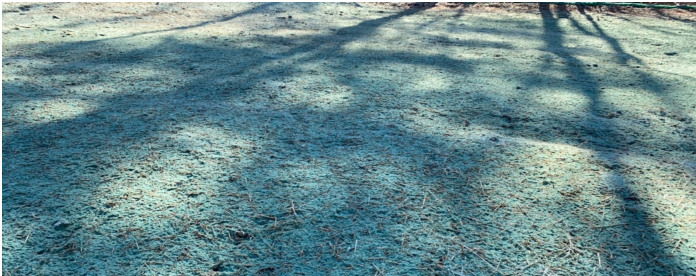
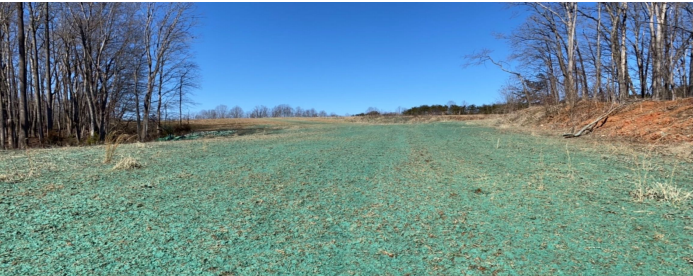
GPS Location	3		GPS Location	4	
Field Station#	14109+00		Field Station#	14123+00	
Pic 3 Desc.	View of area of ROW recently aerially seeded and stabilized		Pic 4 Desc.	View of area of ROW recently aerially seeded and stabilized

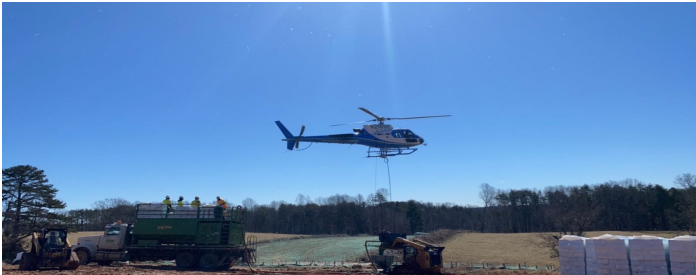
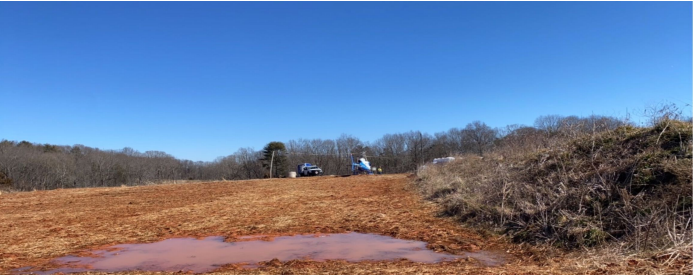
<small>37°34'2" N 79°51'18" W 123°SE COURSE -1° GPS 180 Jonesmill Ln, Rocky Mount, VA 24151, United States</small>			<small>37°32'4" N 79°50'48" W 92°E COURSE 310° GPS Rocky Mount, VA 24151, United States</small>		
<small>02.24.2021 11:15:57 Accur +/-15.8 Ft ALT 1082 Ft</small>			<small>02.24.2021 11:35:54 Accur +/-36.2 Ft ALT 1042 Ft</small>		
GPS Location	5		GPS Location	6	
Field Station#	14131+28		Field Station#	14171+36	
Pic 5 Desc.	Helicopter aerially seeding and stabilizing ROW		Pic 6 Desc.	Helicopter refueling at Angle Plantation Rd

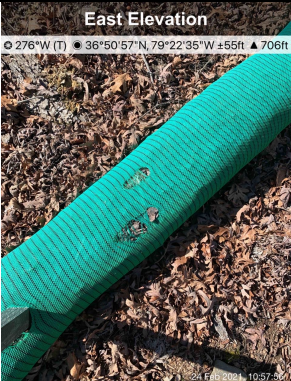
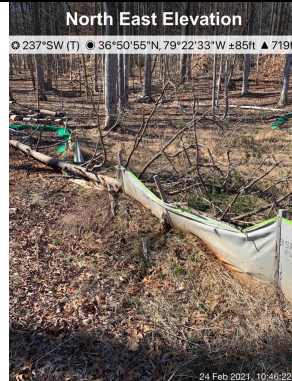
GPS Location	O		GPS Location	O	
Field Station#	15862+30		Field Station#	15866+50	
Pic 3 Desc.	Observing CFS that required maintenance		Pic 4 Desc.	Observing tree that needs to be removed and ECD maintenance performed

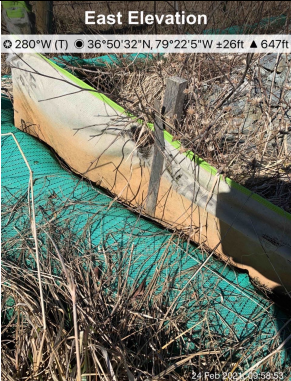
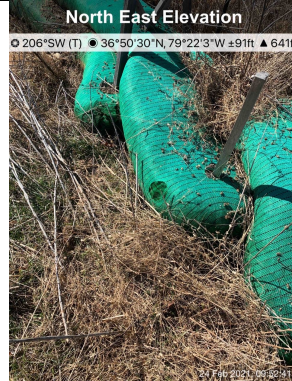
GPS Location	O		GPS Location	O	
Field Station#	15920+00		Field Station#	15924+00	
Pic 5 Desc.	Observing p1 that requires maintenance		Pic 6 Desc.	Observing CFS that received maintenance

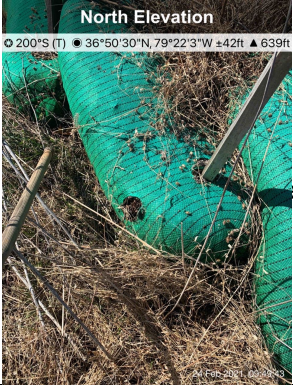
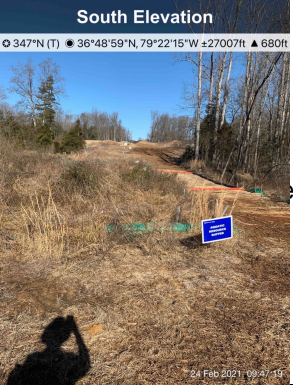
<p>South Elevation <small>347°N (T) ● 36°48'59"N, 79°22'15"W ±27007ft ▲ 680ft</small></p>		<p>Insert image here</p>	
GPS Location ○		GPS Location ○			
Field Station# 15924+00		Field Station# 15923+49			
Pic 7 Desc. Observing CFS that required maintenance		Pic 8 Desc. Observing signage, buffer, equipment crossing and ECD's

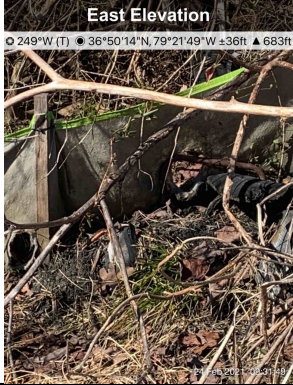
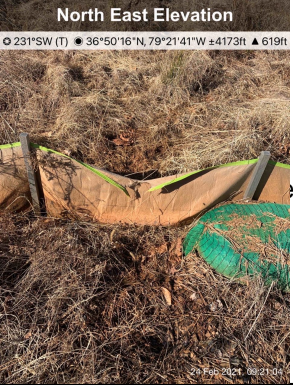
<p>North East Elevation <small>231°SW (T) ● 36°50'16"N, 79°21'41"W ±4173ft ▲ 619ft</small></p>		<p>Insert image here</p>	
GPS Location ○		GPS Location ○			
Field Station# 15941+00		Field Station# 15946+00			
Pic 9 Desc. Observing p1 that requires		Pic 10 Desc. Observing p1 that requires maintenance/damaged by wildlife.

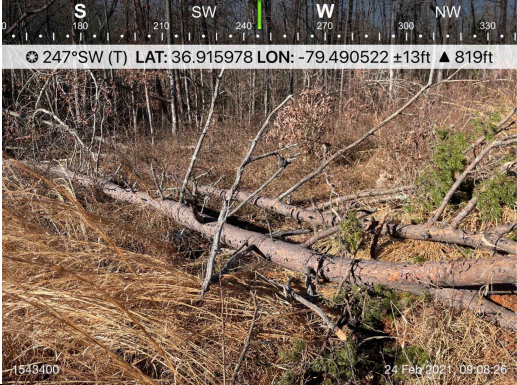
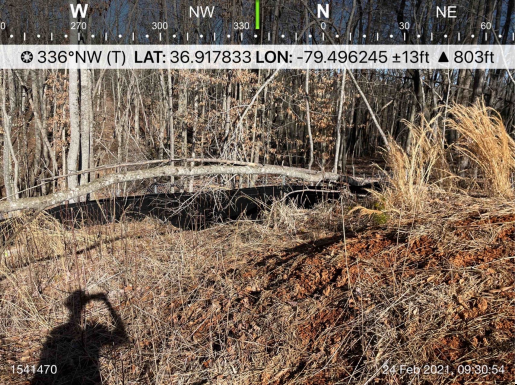
GPS Location	See photo	GPS Location	See photo		
Field Station#	15434+00	Field Station#	15414+70		
Pic 7 Desc.	Tree has fallen across CFS and needs to be removed.	Pic 8 Desc.	Tree has fallen across SSF and needs to be removed.

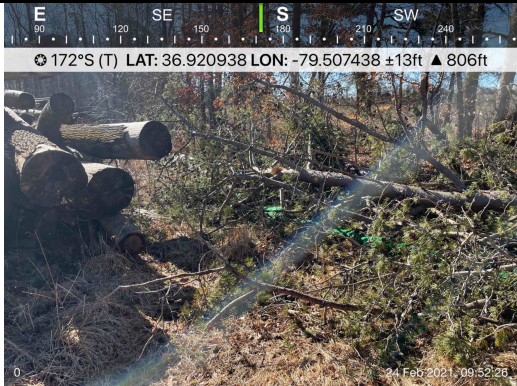
Insert image here			
GPS Location	See photo	GPS Location			
Field Station#	15381+00	Field Station#			
Pic 9 Desc.	Tree has fallen across CFS/P1 and needs to be removed.	Pic 10 Desc.			
Insert image here			Insert image here		
GPS Location		GPS Location			
Field Station#		Field Station#			
Pic 11 Desc.		Pic 12 Desc.

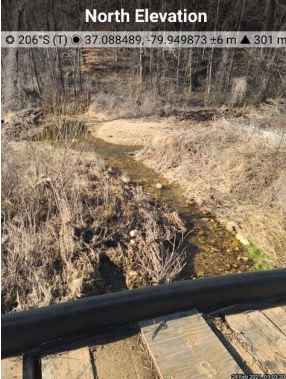
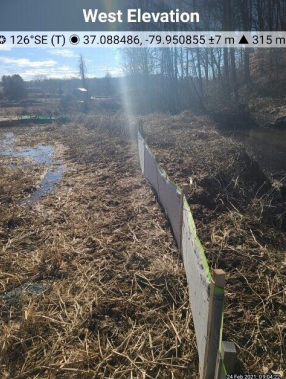
<p>West Elevation 126°SE (T) • 37.088486, -79.950855 +7 m ▲ 315 m</p>	
GPS Location	0000		GPS Location	0000	
Field Station#	13678+71		Field Station#	13676+70	
Pic 1 Desc.	Stream observation photo facing downstream during routine inspection today. No issues observed at the time of inspection today.		Pic 2 Desc.	The EI monitored ECDs on problem land owner track . No environmental issues observed

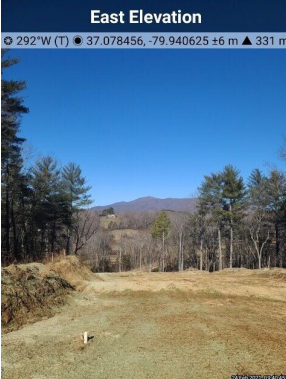
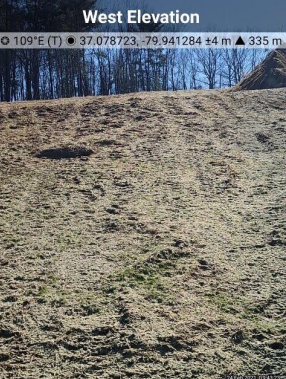
<p>West Elevation 109°E (T) • 37.078723, -79.941284 +4 m ▲ 335 m</p>	
GPS Location	0000		GPS Location	0000	
Field Station#	13732+42		Field Station#	13730+00	
Pic 3 Desc.	Row photo showing stabilized row . No environmental issues observed by the EI at time of inspection.		Pic 4 Desc.	Photo showing area of row recently hydro seeded in efforts to stabilize the row. No issues observed at the time of inspection.

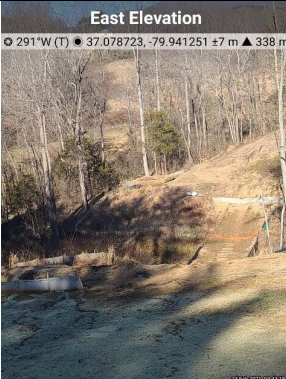
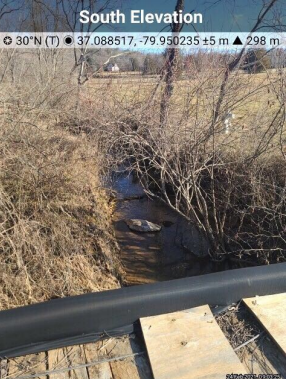
<p>South Elevation 30°N (T) • 37.088517, -79.950235 +5 m ▲ 298 m</p>	
GPS Location	0000		GPS Location	0000	
Field Station#	13728+42		Field Station#	13678+71	
Pic 5 Desc.	Row photo taken by the EI showing stabilization on hill side above stream crossing, no environmental issues observed at the time of inspection		Pic 6 Desc.	Stream observation photo facing upstream during routine inspection today. No issues observed at the time of inspection today.

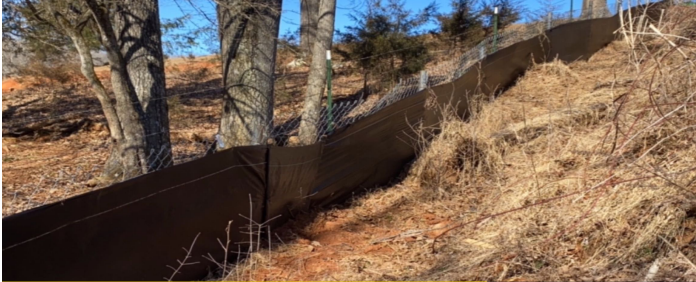
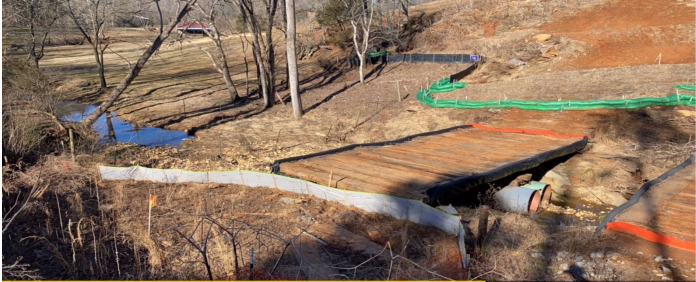
<small>37°3'28" N 79°50'12" W 283°W COURSE 151° GPS 02.25.2021 10:31:30 3175 Booker T Washington Hwy, Rocky Mount, VA 24151, United States Accur +/-138.8 Ft ALT 972 Ft</small>			<small>37°3'27" N 79°50'10" W 37°NE COURSE 314° GPS 02.25.2021 09:40:06 3175 Booker T Washington Hwy, Rocky Mount, VA 24151, United States Accur +/-41.1 Ft ALT 894 Ft</small>		
GPS Location	1		GPS Location	2	
Field Station#	14208+00		Field Station#	14208+75	
Pic 1 Desc.	Contractor repaired SSF per punch list item.		Pic 2 Desc.	Contractor replaced P1 silt fence per punch list item.

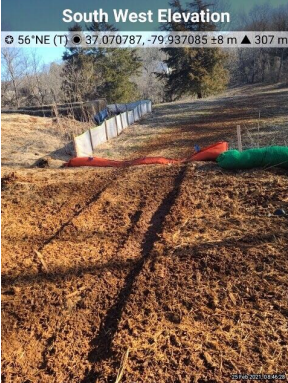
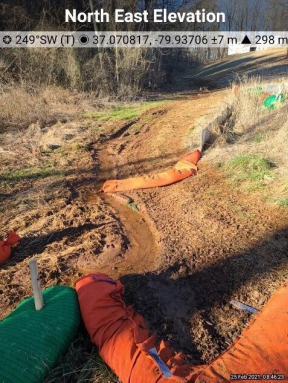
<p>North East Elevation <small>249°SW (T) 37.070817, -79.93706 ±7 m ▲ 298 m</small></p>		
GPS Location	00000		GPS Location	00000	
Field Station#	13770+63		Field Station#	13770+63	
Pic 1 Desc.	During the EI's travel the EI monitored area where a land owner continues to travel over ECDs and cross the row with a ATV , the I will continue to monitor the area		Pic 2 Desc.	During the EI's travel the EI monitored area where a land owner continues to travel over ECDs and cross the row with a ATV , the I will continue to monitor the area

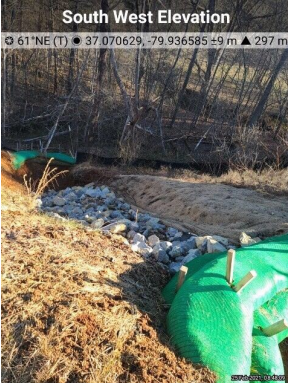
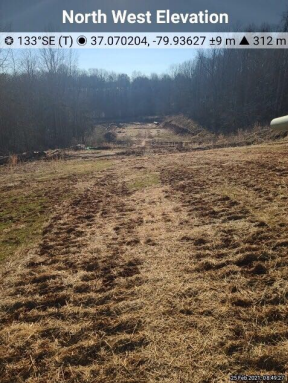
Field Station#	13772+50		Field Station#	13777+75	
Pic 3 Desc.	The EI monitored rock lined channel and end treatment.no issues observed		Pic 4 Desc.	Row photo showing some vegetation and stabilization, no environmental issues observed

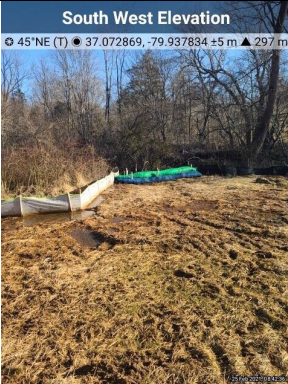
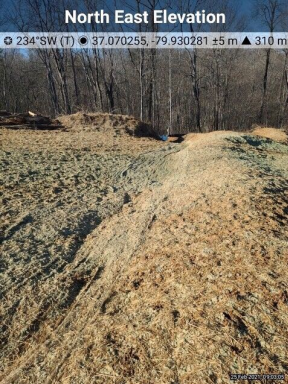
<p>North East Elevation <small>234°SW (T) 37.070255, -79.930281 ±5 m ▲ 310 m</small></p>		
GPS Location	00000		GPS Location	00000	
Field Station#	13760+50		Field Station#	13800+00	
Pic 5 Desc.	EI monitored ECDs near stream on edge of row , no environmental issues observed at the time of inspection.		Pic 6 Desc.	Throughout the EI's travel today the EI monitored area recently stabilized and observed erosion control blanket installed in the mouth of slope breakers, no environmental

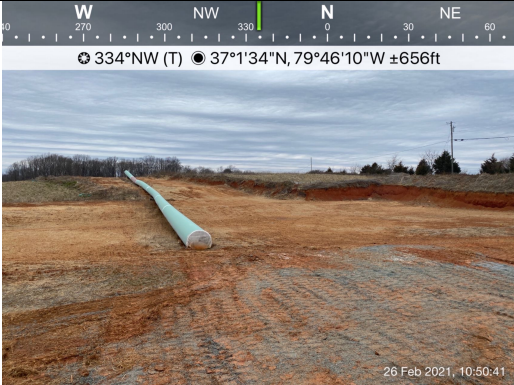
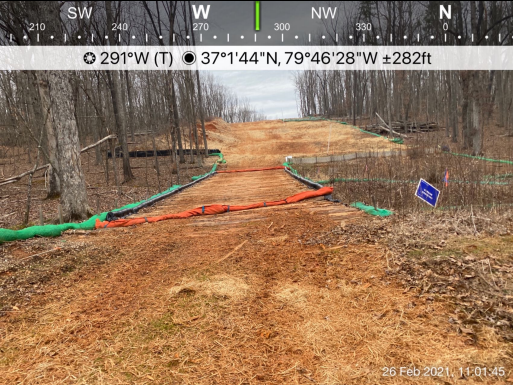
<p>GPS: 291°W (T) ● 37°1'44"N, 79°46'28"W ±282ft 26 Feb 2021, 11:01:45</p>	
GPS Location	0	GPS Location	0
Field Station#	14451+00	Field Station#	14434+01
Pic 1 Desc.	Approximately 14451+00. Overview of ROW.	Pic 2 Desc.	Approximately 14434+01. Overview of stream crossing, equipment bridge and ECDs at stream S-GH40.

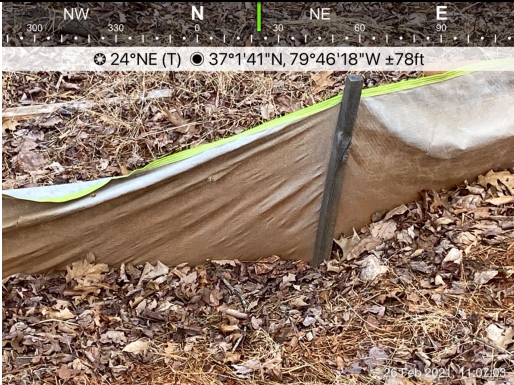
<p>GPS: 342°N (T) ● 37°2'20"N, 79°48'19"W ±22ft 26 Feb 2021, 11:54:17</p>	
GPS Location	0	GPS Location	0
Field Station#	14442+00	Field Station#	14433+00
Pic 3 Desc.	Approximately 14442+00. P-1 requires maintenance. Damage appears to be caused by wildlife.	Pic 4 Desc.	Approximately 14433+00. Overview of road crossing and RCE.

E&S BMPs	Compliance Level	Corrective Action	Corrective Time Frame	Date Repaired
3rd Party Damages	Communication	Replace damaged P-1		
Compost Filter Sock	Acceptable			
Equipment Bridge	Acceptable			
Rock Construction Entrance	Acceptable			
Sensitive Resource Buffer	Acceptable			
Sensitive Resource Signage	Acceptable			
Silt Fence (Filter Fabric Fence)	Communication	Replace fence damaged by wildlife		
Silt Fence (Reinforce Filter Fence)	Acceptable

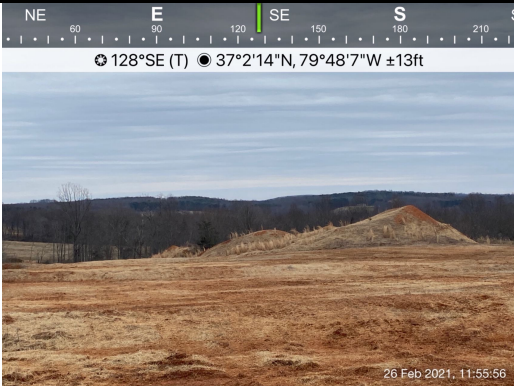
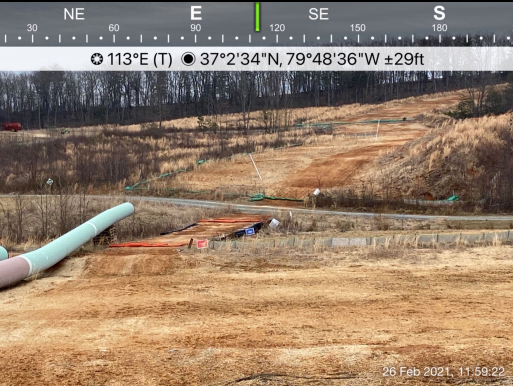
GPS Location	0	GPS Location	0
Field Station#	14347+00	Field Station#	14313+00
Pic 5 Desc.	Approximately 14347+00. Overview of ROW.	Pic 6 Desc.	Approximately 14313+00. Overview of ROW.

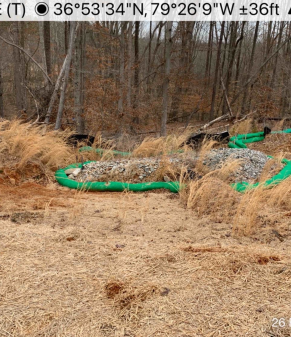
GPS Location	O	GPS Location	O	Field Station#	15632+00
Field Station#	15632+00	Field Station#	15616+00	Pic 5 Desc.	Observing temporary stabilization, CWD outlet and ECD's
Pic 5 Desc.	Observing temporary stabilization, CWD outlet and ECD's	Pic 6 Desc.	Observing temporary stabilization, water bar, sump and end treatment

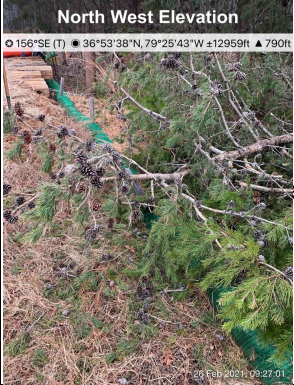
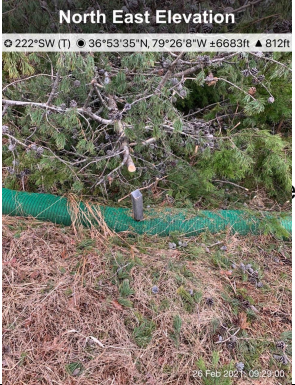
<p>North East Elevation <small>222°SW (T) ● 36°53'35"N, 79°26'8"W ±6683ft ▲ 812ft</small> <small>26 Feb 2021 09:27:00</small></p>		<p>Insert image here</p>	
GPS Location ○		GPS Location ○			
Field Station# 15614+00		Field Station# 15614+00			
Pic 7 Desc. Observing tree that needed to be removed from the CFS.		Pic 8 Desc. Observing CFS that is no longer impacted by the tree.			
  <p>South West Elevation <small>67°NE (T) ● 36°53'35"N, 79°26'31"W ±291ft ▲ 786ft</small> <small>26 Feb 2021 09:28:51</small></p>		  <p>South West Elevation <small>52°NE (T) ● 36°53'39"N, 79°26'47"W ±29ft ▲ 745ft</small> <small>26 Feb 2021 09:10:18</small></p>		<p>Insert image here</p>	
GPS Location ○		GPS Location ○

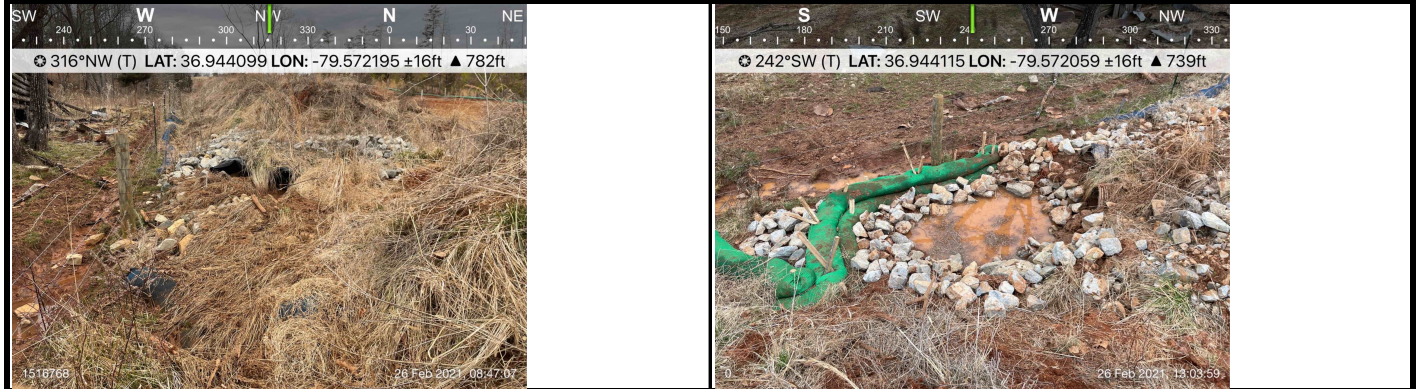
Field Station#	15167+68	Field Station#	15167+68
-----------------------	----------	-----------------------	----------

Pic 7 Desc.	CWD plunge pool needs to be reestablished and spill way CFS needs to be replaced.	Pic 8 Desc.	Environmental crew has corrected this issue.
--------------------	---	--------------------	--

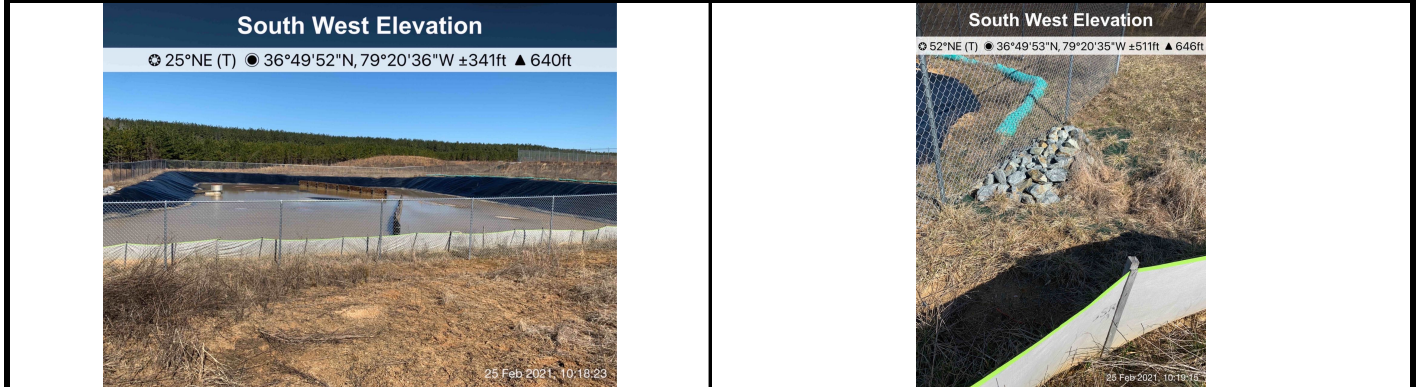
Field Station#	00+00	Field Station#	00+00
-----------------------	-------	-----------------------	-------

Pic 1 Desc.	Observing temporary stabilization, storm water pond and ECD's	Pic 2 Desc.	Observing temporary vegetation, rock check dam and ECD's
--------------------	---	--------------------	--

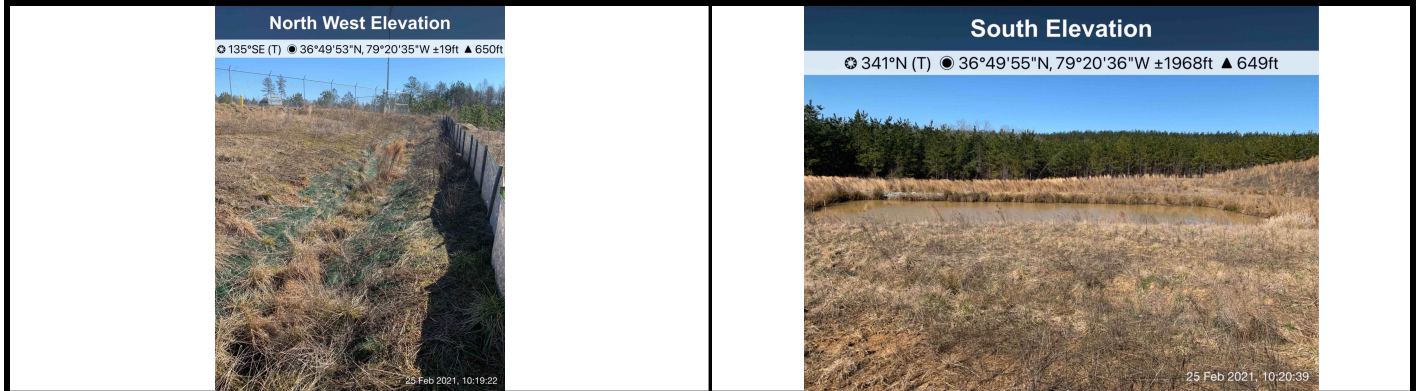
Field Station#	00+00	Field Station#	00+00
-----------------------	-------	-----------------------	-------

Pic 3 Desc.	Observing temporary vegetation, erosion control blanket and p1.	Pic 4 Desc.	Observing sediment basin
--------------------	---	--------------------	--------------------------
