Visual Site Inspection Report

Project Name H-600 Pipeline Spread I		AFE 124300139	Spread H-600 Pipeline Spread I
Contractor Precision		Report # 21078	
Inspector Ben Davenport		Date/Time 3/15/2021 8:07 AM	
Permit # TBD	Inspection Type VA SWPP	Station Begin 14171+36	
State VA	Inspection Area Partial	Station End 14358+11	
County Franklin	Ground Dry	Temperature (°F) 50.00	
Municipality N/A	Weather Cloudy	Rain Gauge (in) 0.00	
Rain Accumulation Time (days)			0.00

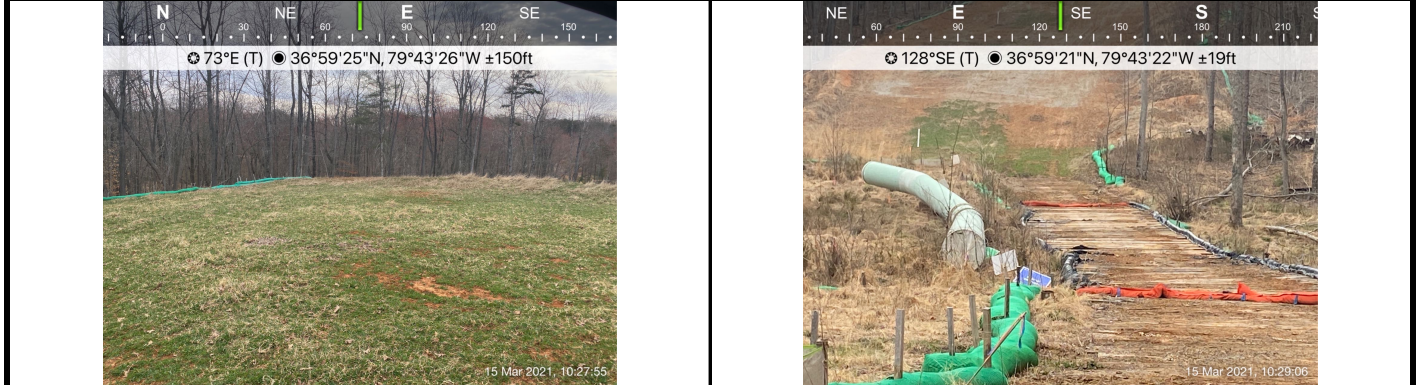
GPS Location 0	GPS Location 0
Field Station# 14652+00	Field Station# 14656+90
Pic 1 Desc. Approximately 14652+00. Overview of ROW.	Pic 2 Desc. Approximately 14656+90. Overview of stream crossing, equipment bridge and ECDs at stream S-H38.

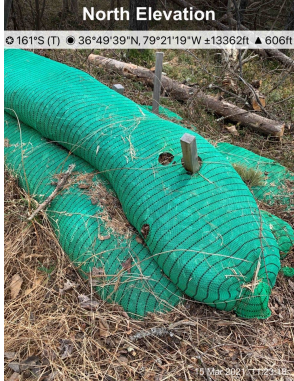
GPS Location O	
Field Station#	16012+00	Field Station#	16012+00	Pic 2 Desc. Observing CFS that received maintenance	
Pic 1 Desc.	Observing CFS that required maintenance		Pic 2 Desc.	Observing CFS that received maintenance	
 	GPS Location O	 	GPS Location O		
Field Station#	16016+36	Field Station#	15999+00	Pic 4 Desc. Observing temporary stabilization, erosion control blanket and cfs checks	
Pic 3 Desc.	Observing temporary stabilization, signage, buffer, equipment crossing and ECD's		Pic 4 Desc.	Observing temporary stabilization, erosion control blanket and cfs checks

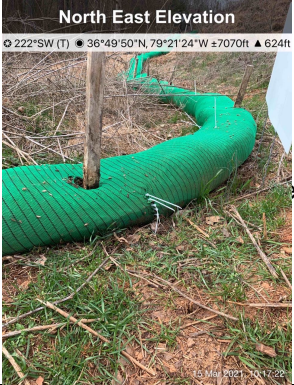
<p>North East Elevation <small>222°SW (T) ● 36°49'50"N, 79°21'24"W ±7070ft ▲ 624ft</small></p>		<p>ert image here</p>	
GPS Location		O		GPS Location	
Field Station#		15976+85		Field Station#	
Pic 7 Desc.		Observing CFS that required maintenance		Pic 8 Desc.	
				Observing CFS that received maintenance

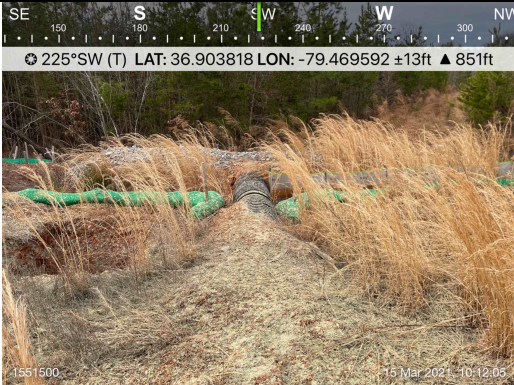
<p>GPS Location See photo</p> <p>Field Station# 15515+00</p> <p>Pic 3 Desc. CWDs are in good condition throughout this section.</p>		<p>GPS Location See photo</p> <p>Field Station# 15536+00</p> <p>Pic 4 Desc. This section of ROW is now stabilized.</p>

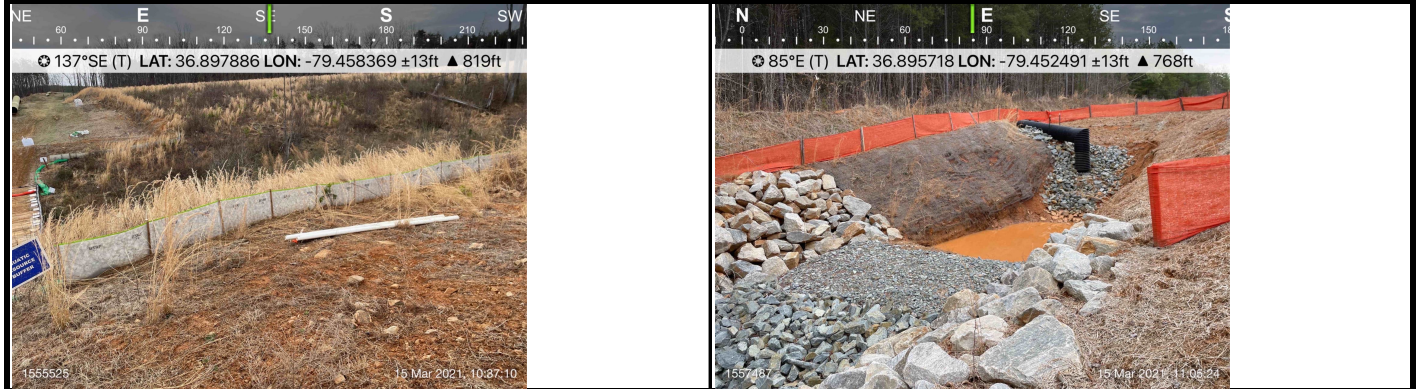
Pic 7 Desc.	P1 is in good condition at all stream and wetland buffers.	Pic 8 Desc.	Slope drain remains in good condition.
--------------------	--	--------------------	--

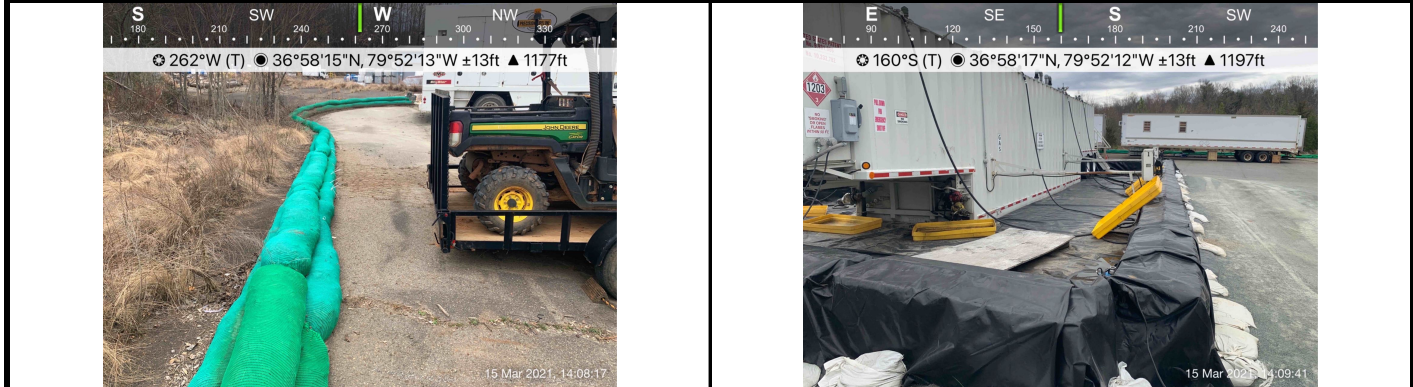
GPS Location	000000000000	GPS Location	000000000000
Field Station#	0000+00	Field Station#	0000+00
Pic 1 Desc.	Perimeter ECD's on south end of MVP-LY-046 in good condition.	Pic 2 Desc.	Secondary containment structure for fuel cell at MVP-LY-046 in good condition.

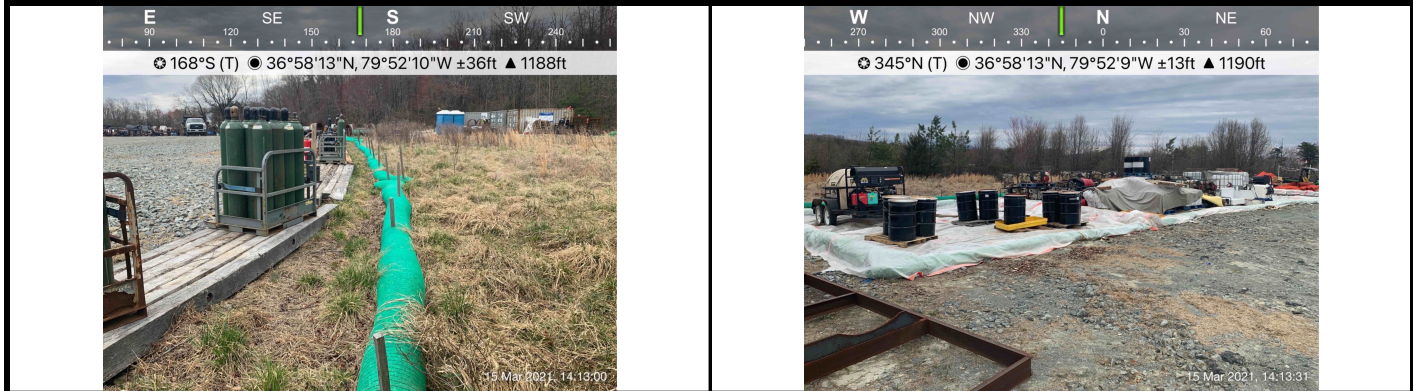
GPS Location	000000000000	GPS Location	000000000000
Field Station#	0000+00	Field Station#	0000+00
Pic 3 Desc.	Perimeter ECD's on north end of MVP-LY-045 in good condition.	Pic 4 Desc.	Secondary containment structure at north end of MVP-LY-045 in good condition.

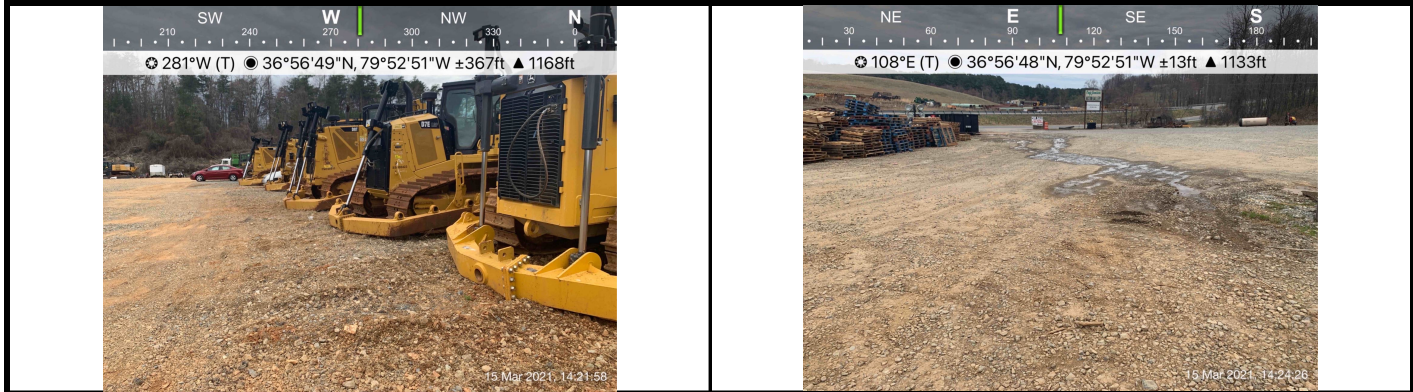
GPS Location	000000000000	GPS Location	000000000000
Field Station#	0000+00	Field Station#	0000+00
Pic 5 Desc.	Inspected all equipment no leaks observed during inspection at MVP-LY-032	Pic 6 Desc.	Monitoring surface water flow at MVP- LY-032 no issues were observed.

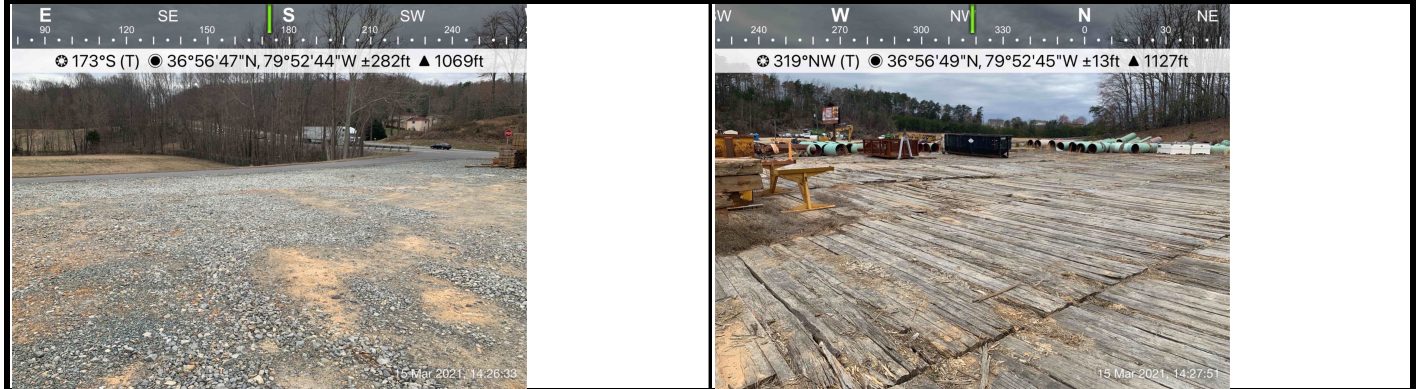
GPS Location	000000000000	GPS Location	000000000000
Field Station#	0000+00	Field Station#	0000+00
Pic 7 Desc.	RCE at MVP-LY-033 in good condition.	Pic 8 Desc.	Housekeeping at MVP-LY-033 in order

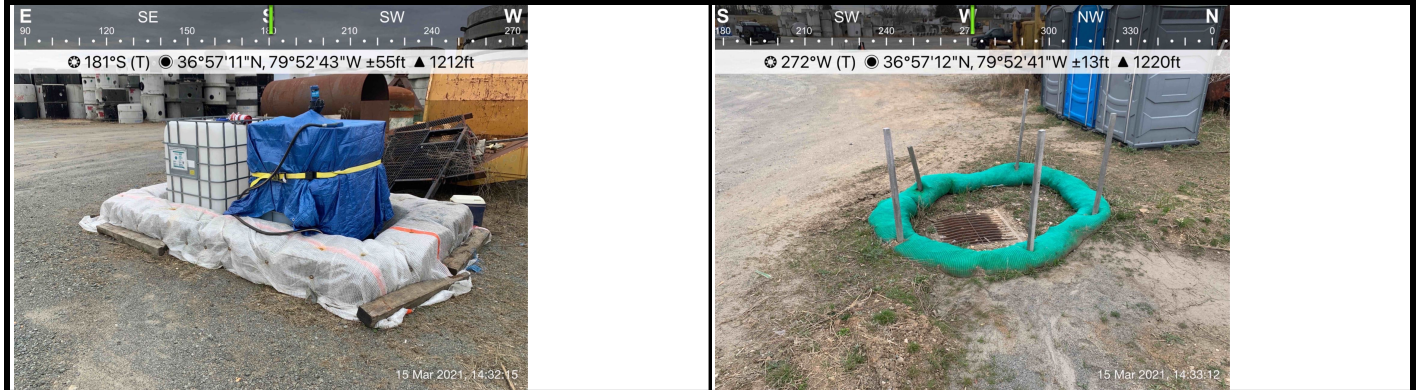
GPS Location	000000000000	GPS Location	000000000000
Field Station#	0000+00	Field Station#	0000+00
Pic 9 Desc.	Secondary containment structure at MVP-ANC-066 in good condition	Pic 10 Desc.	Inlet protection for the catch basin at MVP-ANC-066 in good condition.

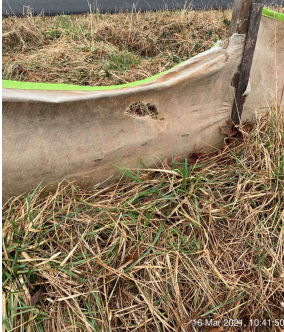
GPS Location	O		GPS Location	O	
Field Station#	15646+50		Field Station#	15646+50	
Pic 1 Desc.	Observing p1 that requires maintenance		Pic 2 Desc.	Observing the Contractor performing ECD maintenance	
	<p>North East Elevation</p> <p>245°SW (T) ● 36°53'22"N, 79°26'4"W ±4406ft ▲ 813ft</p>

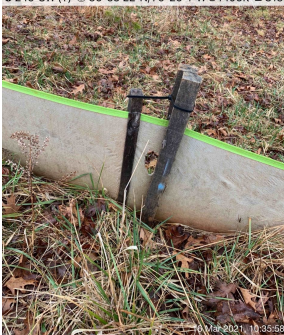
GPS Location	O		GPS Location	O	
Field Station#	15639+00		Field Station#	15636+45	
Pic 3 Desc.	Observing p1 that requires maintenance		Pic 4 Desc.	Observing temporary stabilization, signage, buffer, equipment crossing and ECD's	
	<p>West Elevation</p> <p>99°E (T) ● 36°53'31"N, 79°26'5"W ±13ft ▲ 794ft</p>

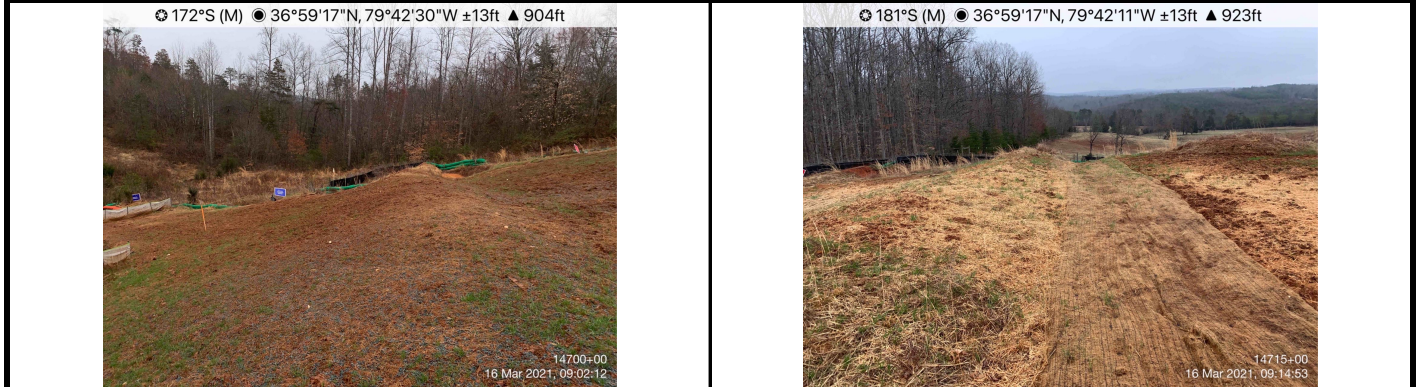
GPS Location	0	GPS Location	0
Field Station#	14700+00	Field Station#	14715+00
Pic 1 Desc.	Waterbar in acceptable condition	Pic 2 Desc.	Waterbar in acceptable condition

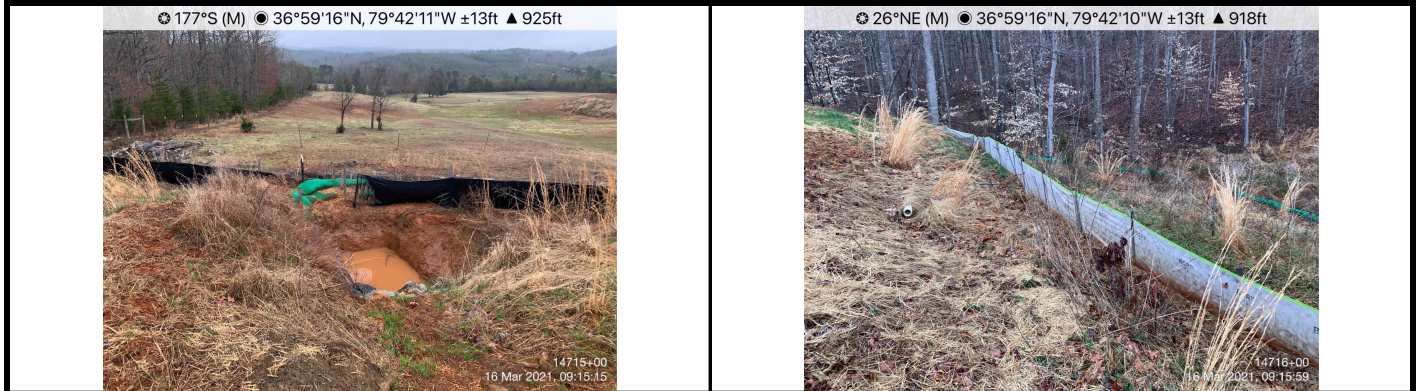
GPS Location	0	GPS Location	0
Field Station#	14715+00	Field Station#	14716+00
Pic 3 Desc.	Waterbar end treatment in acceptable condition	Pic 4 Desc.	P1 silt fence in acceptable condition

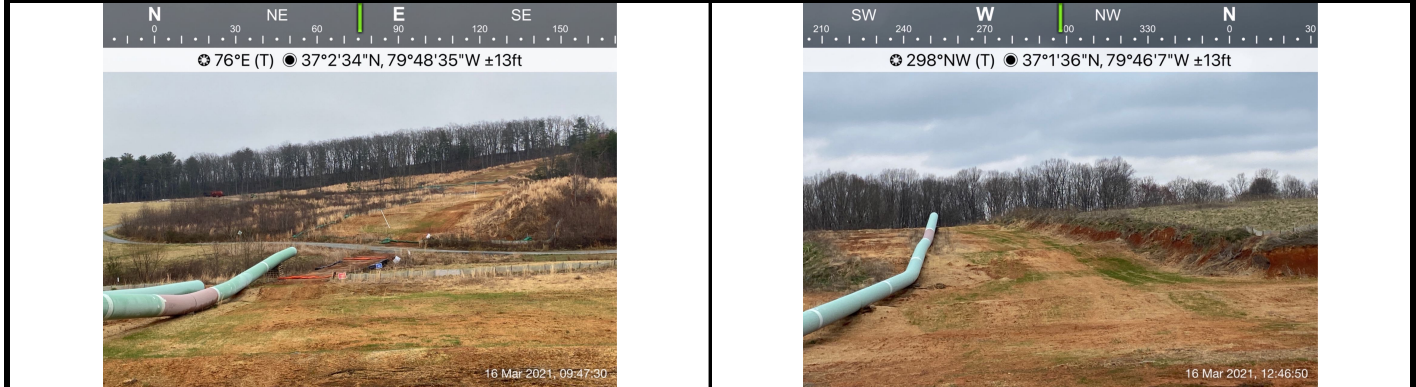
GPS Location	0	GPS Location	0
Field Station#	14313+50	Field Station#	14451+00
Pic 1 Desc.	Approximately 14313+50. Overview of ROW.	Pic 2 Desc.	Approximately 14451+00. Overview of ROW.

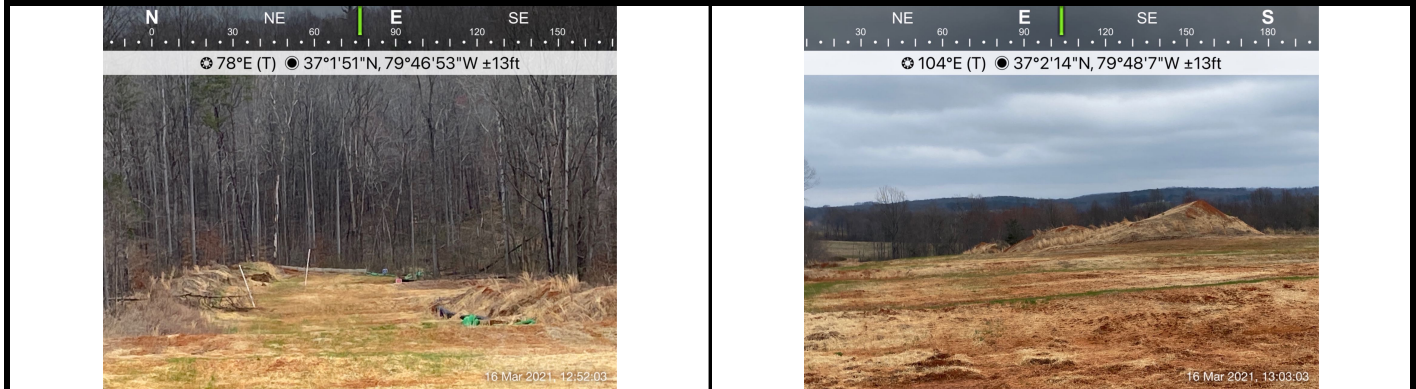
GPS Location	0	GPS Location	0
Field Station#	14415+00	Field Station#	14346+00
Pic 3 Desc.	Approximately 14415+00. Overview of ROW.	Pic 4 Desc.	Approximately 14346+00. Overview of ROW.

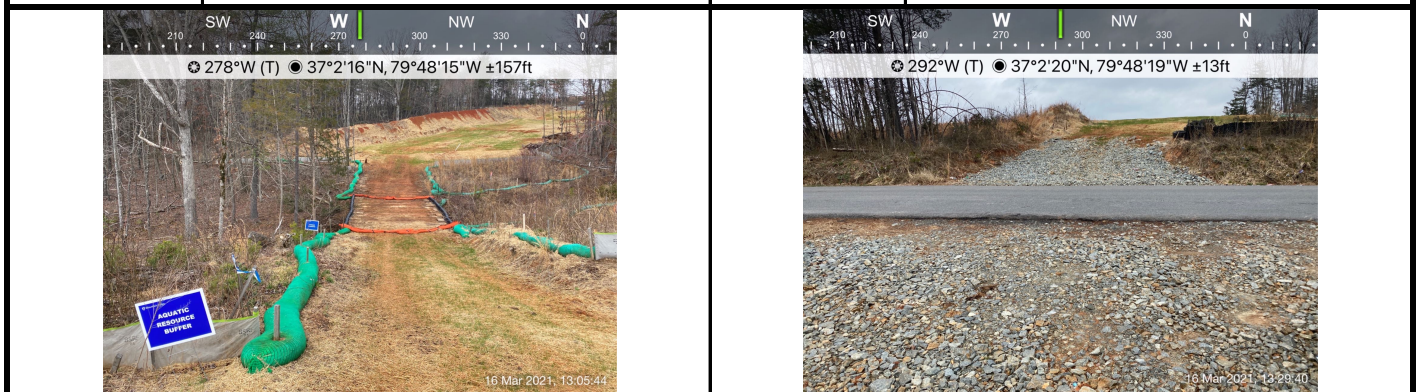
GPS Location	0	GPS Location	0
Field Station#	14338+56	Field Station#	14333+00
Pic 5 Desc.	Approximately 14338+56. Overview of stream crossing, equipment bridge and ECDs at stream S-A36.	Pic 6 Desc.	Approximately 14333+00. Overview of road crossing and RCEs.

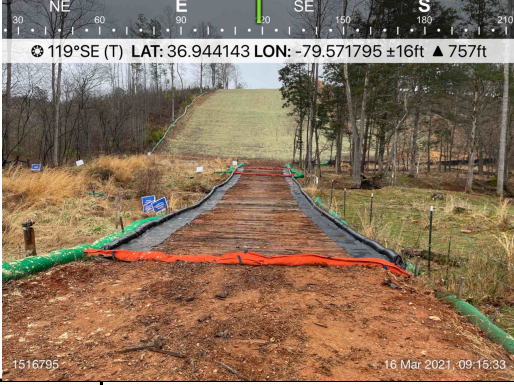
GPS Location See photo		GPS Location See photo			
Field Station# 15167+95		Field Station# 15165+57			
Pic 5 Desc. Equipment bridge ECDs are in good condition.		Pic 6 Desc. This section of ROW has been temporarily stabilized.

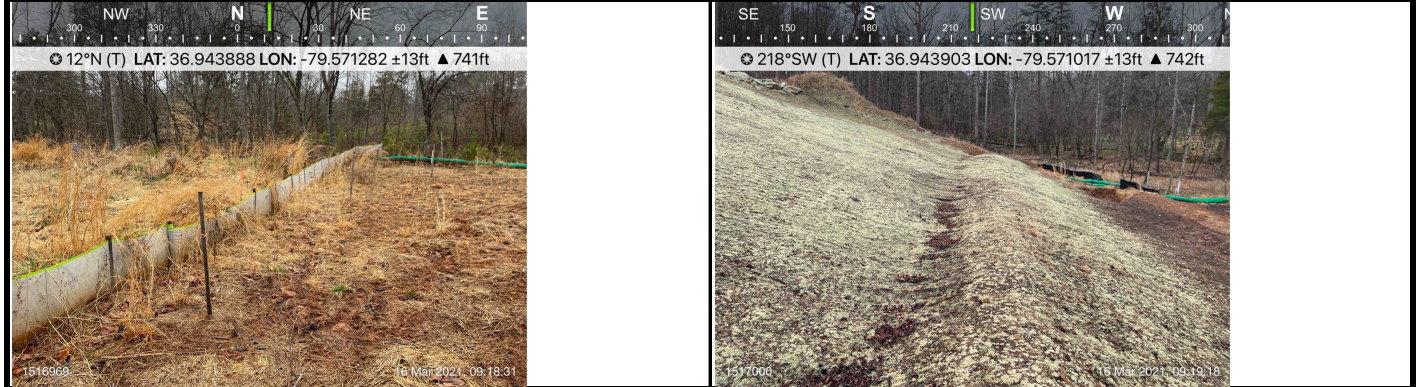
GPS Location	See photo	GPS Location	See photo
Field Station#	15169+69	Field Station#	15170+00
Pic 7 Desc.	P1 is in good condition at this stream buffer.	Pic 8 Desc.	Waterbars are functioning as intended.

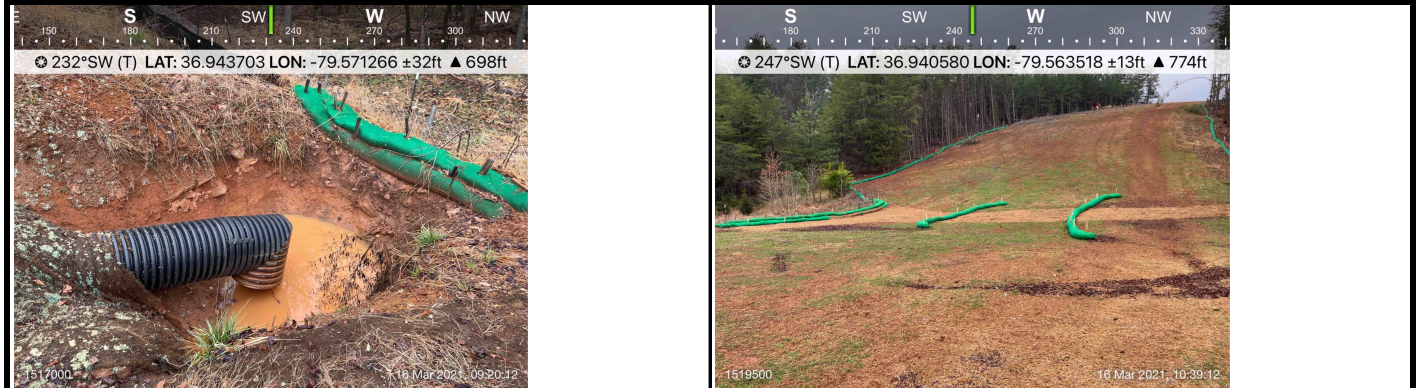
GPS Location	See photo	GPS Location	See photo
Field Station#	15170+00	Field Station#	15195+00
Pic 9 Desc.	Slope drain remains in good condition.	Pic 10 Desc.	Drainage ECDs are in good condition.

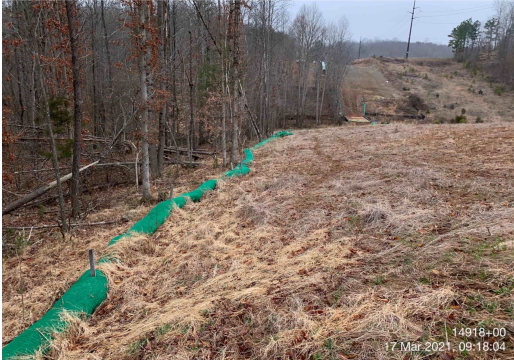
GPS Location	0	GPS Location	0
Field Station#	14918+00	Field Station#	14837+00
Pic 1 Desc.	Perimeter CFS in acceptable condition	Pic 2 Desc.	Plunge pool in acceptable condition
Ⓧ 196°S (M) ● 36°58'8"N, 79°38'48"W ±13244ft ▲ 784ft

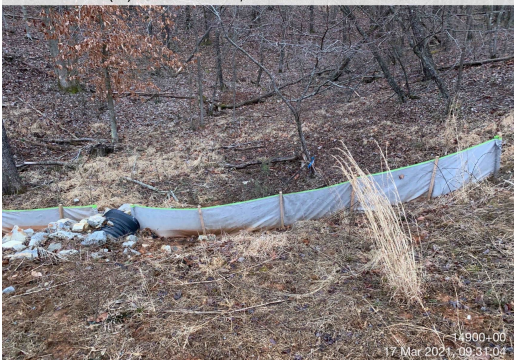
GPS Location	0	GPS Location	0
Field Station#	14900+00	Field Station#	14819+00
Pic 3 Desc.	P1 silt fence in acceptable condition	Pic 4 Desc.	Temporary vegetative stabilization in acceptable condition
Ⓧ 164°S (M) ● 36°58'30"N, 79°40'30"W ±36ft ▲ 929ft

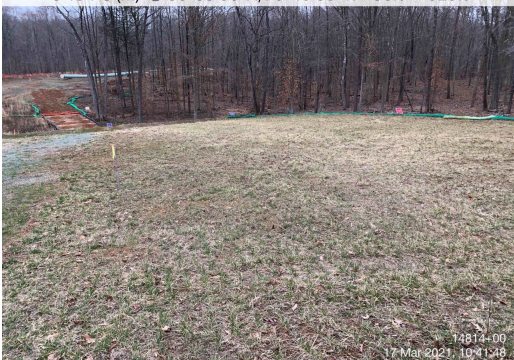
GPS Location	0	GPS Location	0
Field Station#	14814+00	Field Station#	14803+00
Pic 5 Desc.	Permanent vegetative stabilization in acceptable condition	Pic 6 Desc.	Waterbar end treatment in acceptable condition

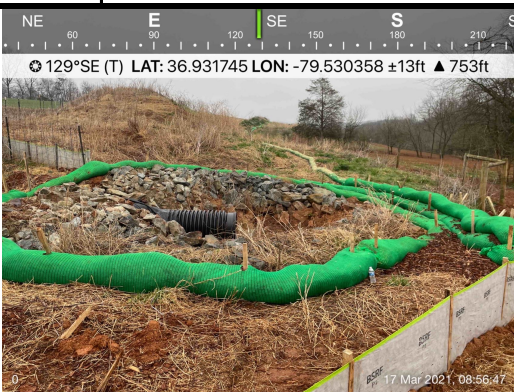
GPS Location	See photo	GPS Location	See photo		
Field Station#	15300+00	Field Station#	15322+00		
Pic 5 Desc.	CWDs are functioning as intended.	Pic 6 Desc.	Waterbars are in good condition.

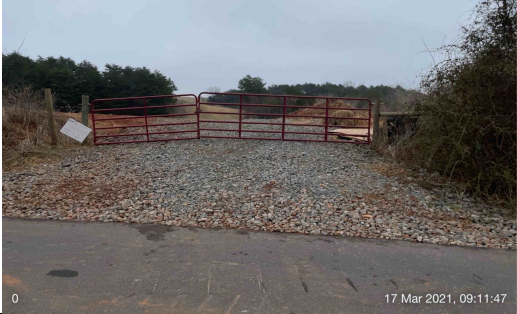
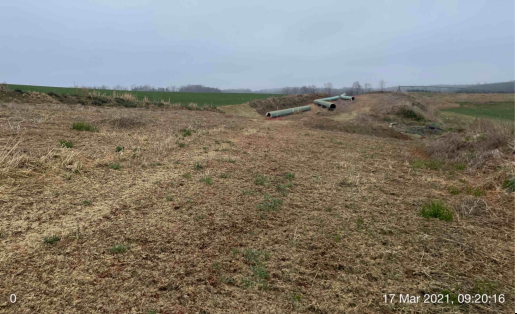
GPS Location	See photo	GPS Location	See photo		
Field Station#	15323+24	Field Station#	15338+00		
Pic 7 Desc.	RCEs are in good condition at all road crossings.		Pic 8 Desc.	This section of ROW remains temporarily stabilized.

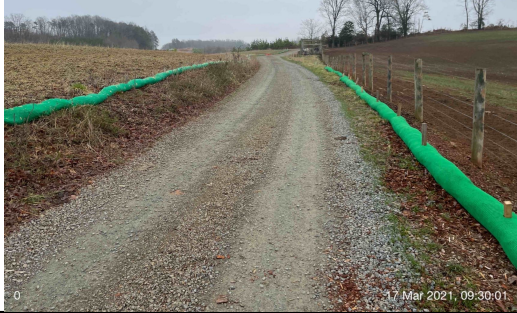
Insert image here			
GPS Location	See photo	GPS Location			
Field Station#	15354+08	Field Station#			
Pic 9 Desc.	MVP-PI-332 is in good condition with controls in place		Pic 10 Desc.		
Insert image here		Insert image here			
GPS Location		GPS Location			
Field Station#		Field Station#			
Pic 11 Desc.		Pic 12 Desc.

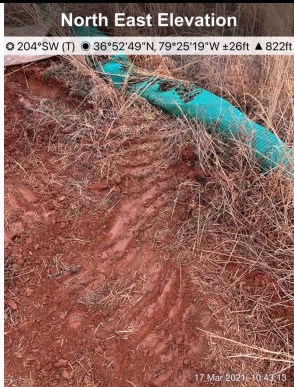
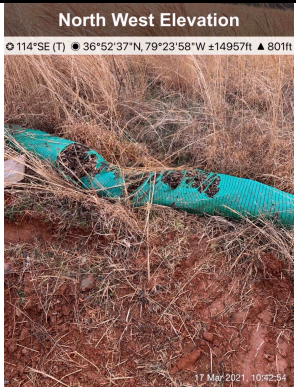
<p>North West Elevation <small>114°SE (T) ● 36°52'37"N, 79°23'58"W ±1495ft ▲ 801ft</small> <small>17 Mar 2021 10:42:51</small></p>	GPS Location	O	GPS Location	O
Field Station#	15693+00		Field Station#		15693+00		
Pic 1 Desc.	Observing CFS that requires maintenance (damaged by Gwinnups)		Pic 2 Desc.	Observing CFS that requires maintenance (damaged by Gwinnups)

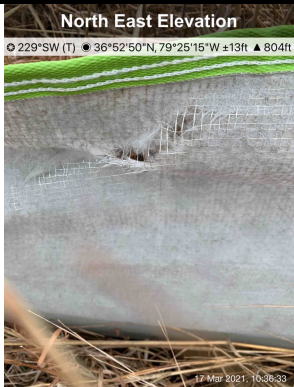
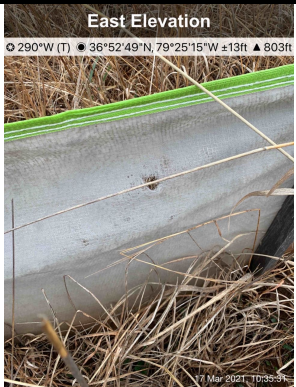
Pic 3 Desc.	Observing p1 that requires maintenance		Pic 4 Desc.	Observing p1 that requires maintenance

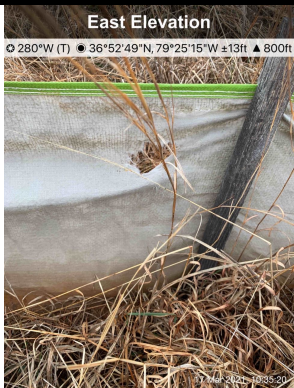
<p>West Elevation <small>81°E (T) ● 36°52'46"N, 79°25'15"W ±160ft ▲ 801ft</small> <small>17 Mar 2021 10:31:49</small></p>	GPS Location	O	GPS Location	O
Field Station#	15695+00		Field Station#		15696+00		
Pic 5 Desc.	Observing P1 that requires maintenance (this panel was damaged by wildlife)		Pic 6 Desc.	Observing water bar, cfs check, temporary stabilization and end treatment

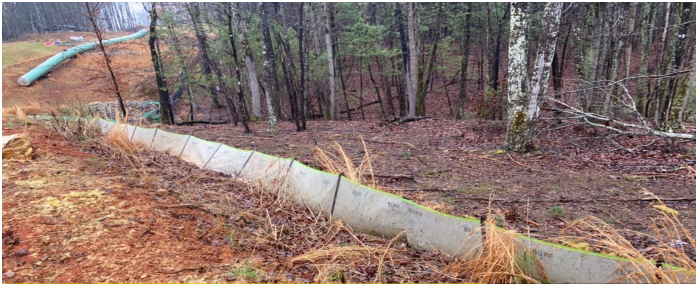
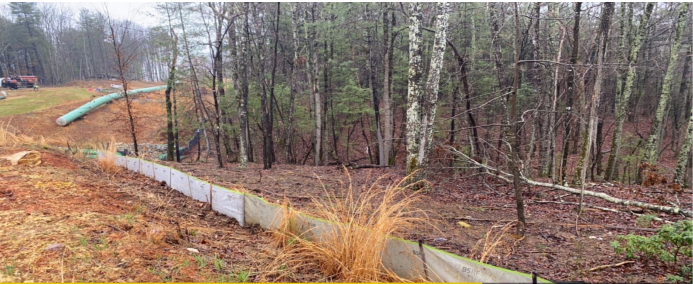
<small>37°3'53" N 79°52'24" W 132°SE COURSE 274' GPS Rocky Mount, VA 24151, United States</small>			<small>03.18.2021 12:43:33 Accur +/-93.9 Ft ALT 1167 Ft</small>		
<small>37°3'54" N 79°52'24" W 115°SE COURSE 109' GPS Rocky Mount, VA 24151, United States</small>			<small>03.18.2021 13:20:43 Accur +/-88.2 Ft ALT 1149 Ft</small>		
GPS Location	1		GPS Location	2	
Field Station#	14071+00		Field Station#	14071+00	
Pic 1 Desc.	Routine maintenance. Multiple broken stakes in perimeter of P1 silt fence. Replace.		Pic 2 Desc.	Contractor replaced P1 silt fence per punch list item.

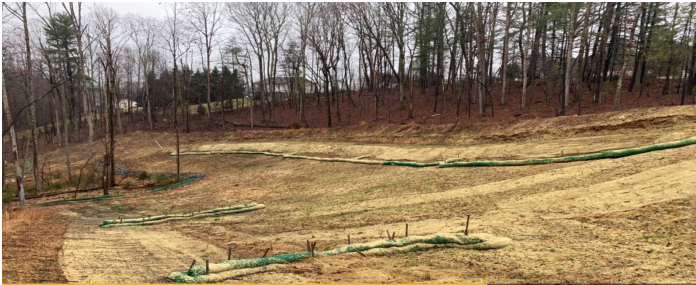
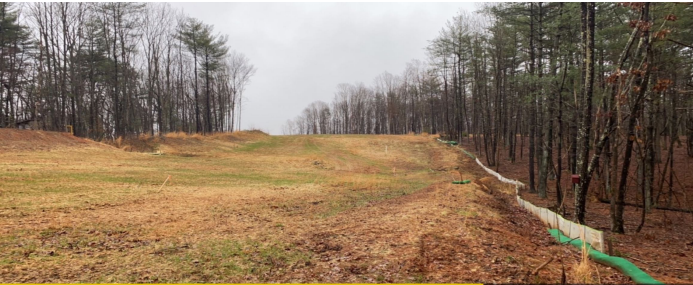
GPS Location	3		GPS Location	4	
Field Station#	14064+00		Field Station#	14081+00	
Pic 3 Desc.	View of recently applied hydroseed mix along ROW		Pic 4 Desc.	View of recently hydroseeded area along ROW. Vegetation beginning to grow.

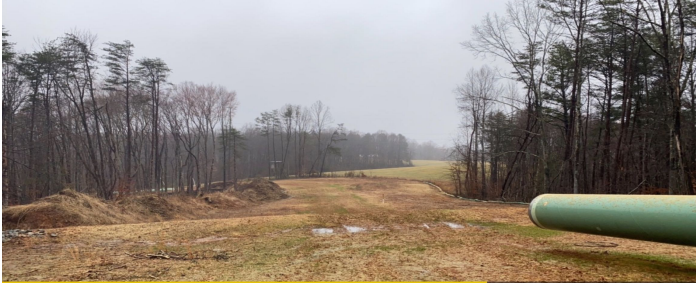
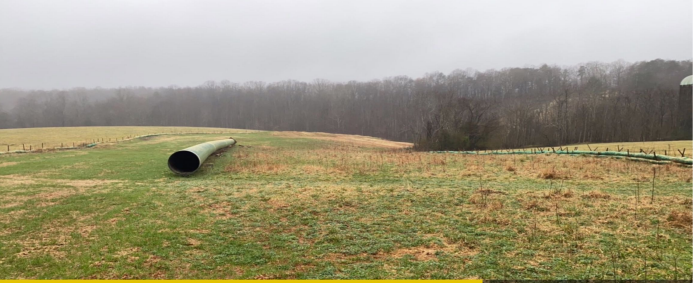
<small>37°3'26" N 79°51'7" W 6°N COURSE 45' GPS Rocky Mount, VA 24151, United States</small>			<small>03.18.2021 10:23:27 Accur +/-44.4 Ft ALT 952 Ft</small>		
<small>37°3'23" N 79°50'51" W 244°SW COURSE 252' GPS 131-429 Angle Plantation Rd, Rocky Mount, VA 24151, United States</small>			<small>03.18.2021 10:14:58 Accur +/-81.7 Ft ALT 1037 Ft</small>		
GPS Location	5		GPS Location	6	
Field Station#	14146+00		Field Station#	14165+00	
Pic 5 Desc.	View of recently hydroseeded area along ROW. Vegetation beginning to grow.		Pic 6 Desc.	View of recently hydroseeded area along ROW. Vegetation beginning to grow.

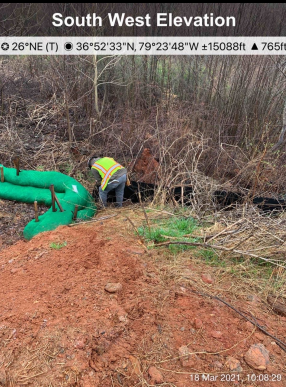
GPS Location	O		GPS Location	O	
Field Station#	15858+00		Field Station#	15858+00	
Pic 1 Desc.	Observing SSF that required maintenance		Pic 2 Desc.	Observing the Contractor performing ECD maintenance.

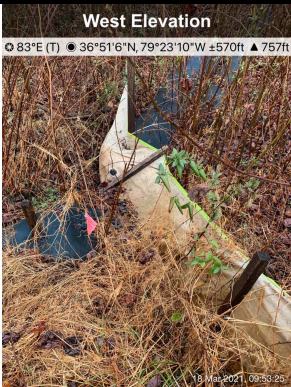
GPS Location	O		GPS Location	O	
Field Station#	15852+90		Field Station#	15852+90	
Pic 3 Desc.	Observing p1 that required maintenance		Pic 4 Desc.	Observing p1 that received maintenance

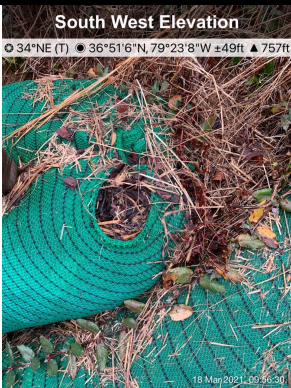
GPS Location	O		GPS Location	O	
Field Station#	15853+00		Field Station#	15853+00	
Pic 5 Desc.	Observing CFS that required maintenance		Pic 6 Desc.	Observing CFS that received maintenance

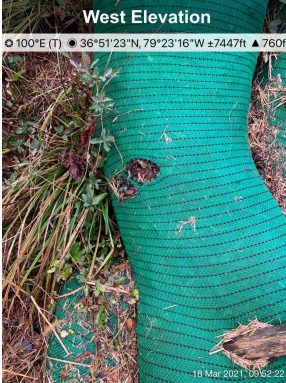
<p>South West Elevation <small>25°NE (T) 36°51'5"N, 79°23'8"W ±29ft ▲759ft</small> <small>18 Mar 2021, 09:55:49</small></p>	ert image here		
GPS Location	O	GPS Location	O		
Field Station#	15853+00	Field Station#	15853+00		
Pic 7 Desc.	Observing CFS that required maintenance		Pic 8 Desc.	Observing CFS that received maintenance

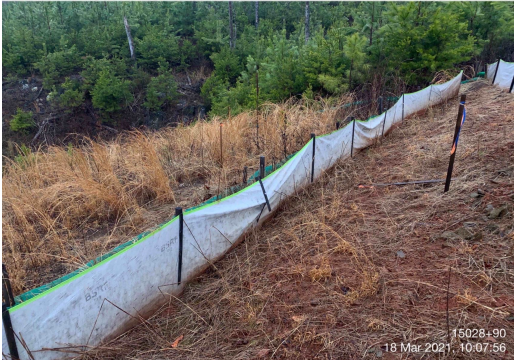
<p>63°NE (M) ● 36°57'55"N, 79°35'56"W ±52ft ▲ 786ft 15045+69 18 Mar 2021, 10:27:38</p>		
GPS Location 0			GPS Location 0		
Field Station# 15028+90			Field Station# 15045+69		
Pic 3 Desc. P1 silt fence fabric detached from stake			Pic 4 Desc. P1 silt fence with holes in it

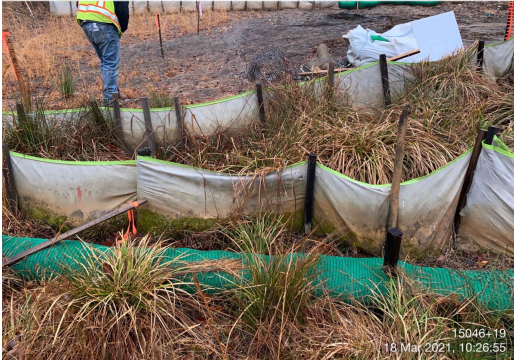
GPS Location 0			GPS Location 0		
Field Station# 15046+19			Field Station# 15054+00		
Pic 5 Desc. P1 silt fence with holes and is degraded			Pic 6 Desc. Plunge pool in acceptable condition

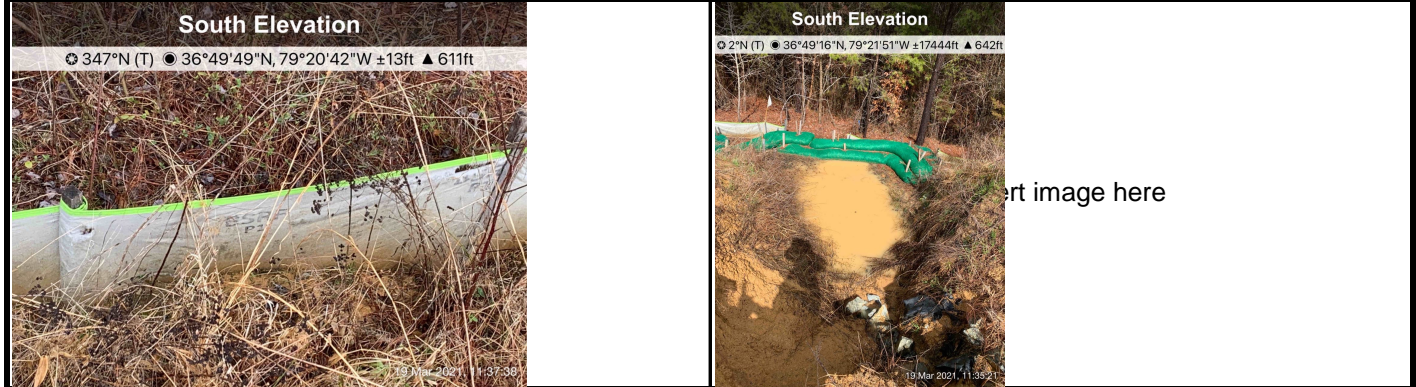
GPS Location	O	GPS Location	O
Field Station#	16020+00	Field Station#	16022+00
Pic 7 Desc.	Observing p1 that requires maintenance	Pic 8 Desc.	Observing sump and end treatment

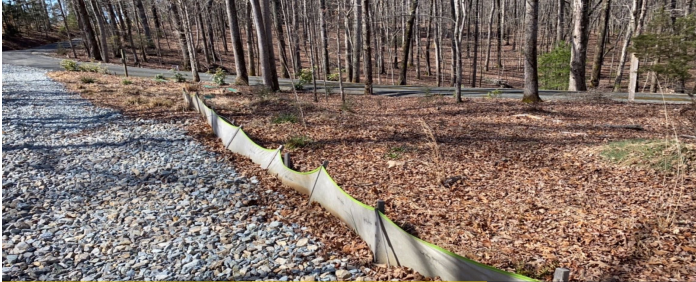
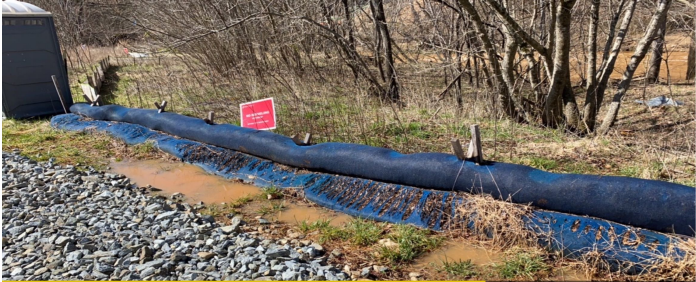
<small>37°3'16" N 79°50'2" W 310°NW COURSE 106° GPS Rocky Mount, VA 24151, United States</small>		<small>37°3'20" N 79°49'47" W 226°SW COURSE -1° GPS Rocky Mount, VA 24151, United States</small>	
<small>03.19.2021 11:34:51 Accur +/-157.1 Ft ALT 1005 Ft</small>		<small>03.19.2021 11:16:34 Accur +/-23.2 Ft ALT 873 Ft</small>	
GPS Location	1	GPS Location	2
Field Station#	1422+17	Field Station#	14235+19
Pic 1 Desc.	Routine maintenance. New rock added to Flint Hill Rd damaged perimeter P1 silt fence. Repair.	Pic 2 Desc.	Routine maintenance. Perimeter CFS triple stack along MVP-MLV-AR-32 damaged and needs replaced.

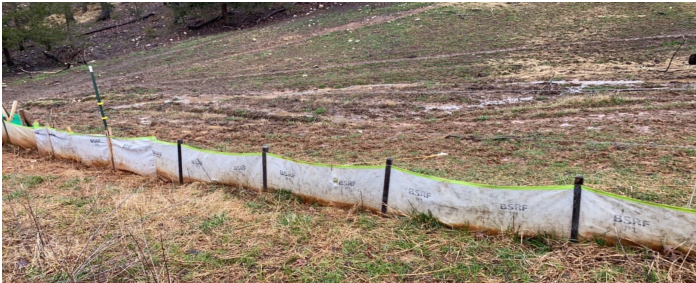
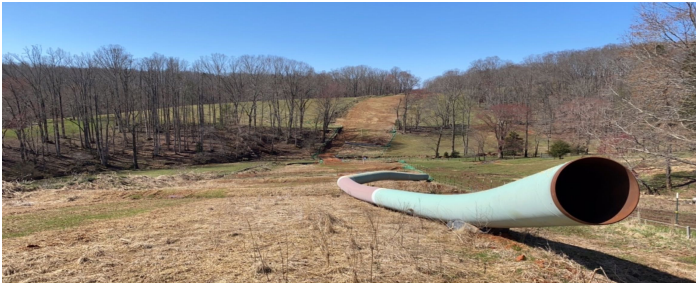
<small>03.19.2021 10:02:11 Accur +/-15.4 Ft ALT 1008 Ft</small>		<small>03.19.2021 11:52:22 Accur +/-147.1 Ft ALT 903 Ft</small>	
GPS Location	3	GPS Location	4
Field Station#	14297+00	Field Station#	14196+00
Pic 3 Desc.	Routine maintenance. P1 silt fence has multiple holes from cattle damage. Replaced damaged panels.	Pic 4 Desc.	View of recently stabilized ROW with vegetation beginning to grow.

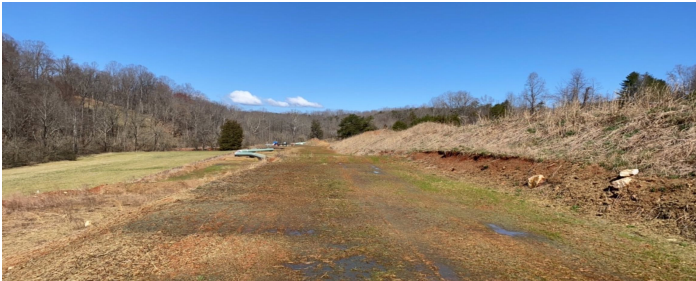
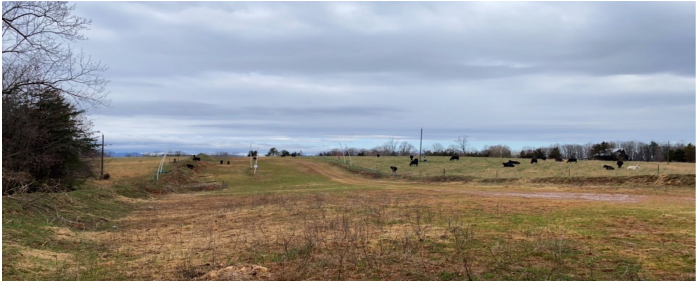
<small>37°3'13" N 79°49'38" W 313°NW COURSE 78° GPS Rocky Mount, VA 24151, United States</small>		<small>37°2'35" N 79°48'37" W 327°NW COURSE 269° GPS 955 Greenway Rd, Glade Hill, VA 24092, United States</small>	
<small>03.19.2021 11:12:28 Accur +/-77.3 Ft ALT 886 Ft</small>		<small>03.19.2021 09:53:43 Accur +/-37.1 Ft ALT 1064 Ft</small>	
GPS Location	5	GPS Location	6
Field Station#	14244+00	Field Station#	14307+00
Pic 5 Desc.	View of recently stabilized ROW with vegetation beginning to grow.	Pic 6 Desc.	View of ROW CIS Farm View Rd. Electric fence is not hot allowing cattle to enter ROW. Will continue to monitor area for cattle damage to FGDs.

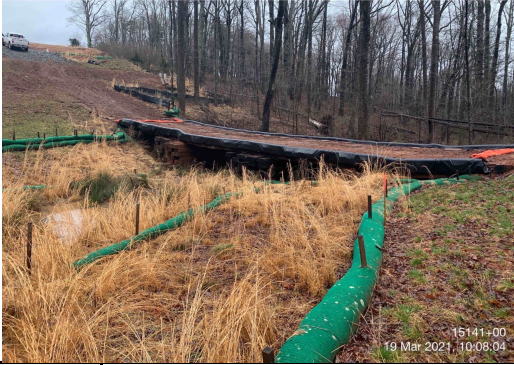
<p>145°SE (M) 36°56'58"N, 79°34'46"W ±5551ft ▲ 878ft 15136+00 19 Mar 2021, 10:14:17</p>		
GPS Location 0			GPS Location 0		
Field Station# 15141+00			Field Station# 15136+00		
Pic 1 Desc. CFS in acceptable condition			Pic 2 Desc. Waterbar end treatment in acceptable condition

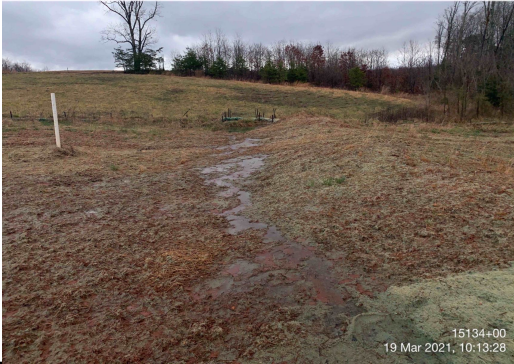
<p>85°E (M) 36°57'7"N, 79°34'50"W ±984ft ▲ 887ft 15127+00 19 Mar 2021, 10:26:11</p>		
GPS Location 0			GPS Location 0		
Field Station# 15134+00			Field Station# 15127+00		
Pic 3 Desc. Waterbar in acceptable condition			Pic 4 Desc. Super silt fence in acceptable condition

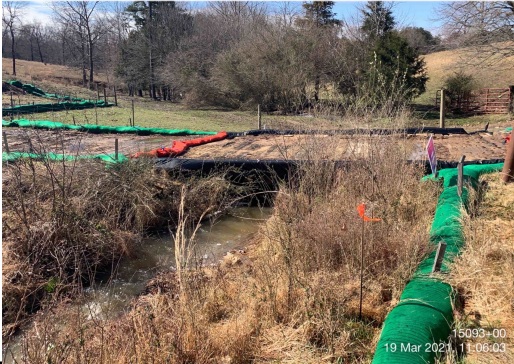
GPS Location 0			GPS Location 0		
Field Station# 15093+00			Field Station# 15074+00		
Pic 5 Desc. Equipment bridge in acceptable condition			Pic 6 Desc. Waterbar in acceptable condition

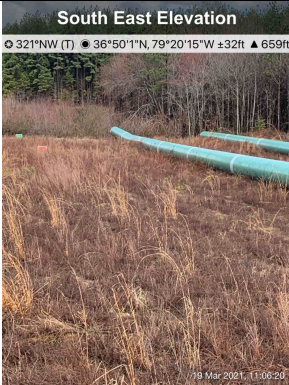
<p>South West Elevation <small>24°NE (T) ● 36°50'7"N, 79°20'23"W ±13ft ▲ 648ft</small></p>			
GPS Location O		GPS Location O			
Field Station# 19+00		Field Station# 14+30			
Pic 1 Desc. Observing temporary vegetation, signage and buffer		Pic 2 Desc. Observing p1 that requires maintenance			
  <p>North Elevation <small>166°S (T) ● 36°50'7"N, 79°20'22"W ±13ft ▲ 643ft</small></p>		  <p>West Elevation <small>75°E (T) ● 36°50'6"N, 79°20'23"W ±26ft ▲ 652ft</small></p>			
GPS Location O		GPS Location O			
Field Station# 14+30		Field Station# 15+73			
Pic 3 Desc. Observing p1 that requires maintenance		Pic 4 Desc. Observing temporary vegetation, signage, buffer and ECD's.			
Insert image here			Insert image here		
GPS Location		GPS Location

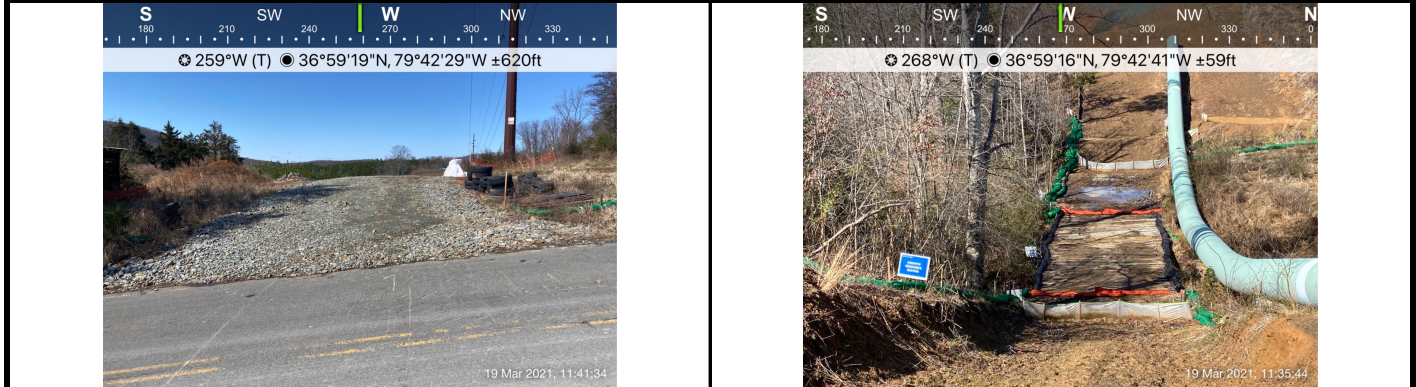
GPS Location	0	GPS Location	0
Field Station#	14694+50	Field Station#	14689+36
Pic 1 Desc.	Approximately 14694+50. Overview of road crossing and RCE.	Pic 2 Desc.	Approximately 14689+36. Overview of stream crossing, equipment bridge and ECDs at stream S-H34.

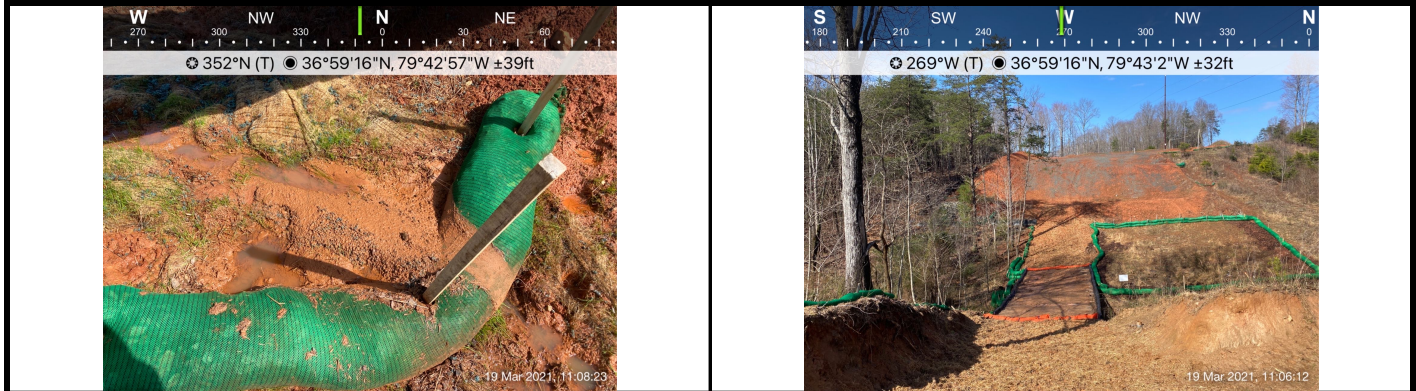
GPS Location	0	GPS Location	0
Field Station#	14676+75	Field Station#	14673+10
Pic 3 Desc.	Approximately 14676+75. CFS requires maintenance.	Pic 4 Desc.	Approximately 14673+10. Overview of stream crossing, equipment bridge and ECDs at stream S-H37.

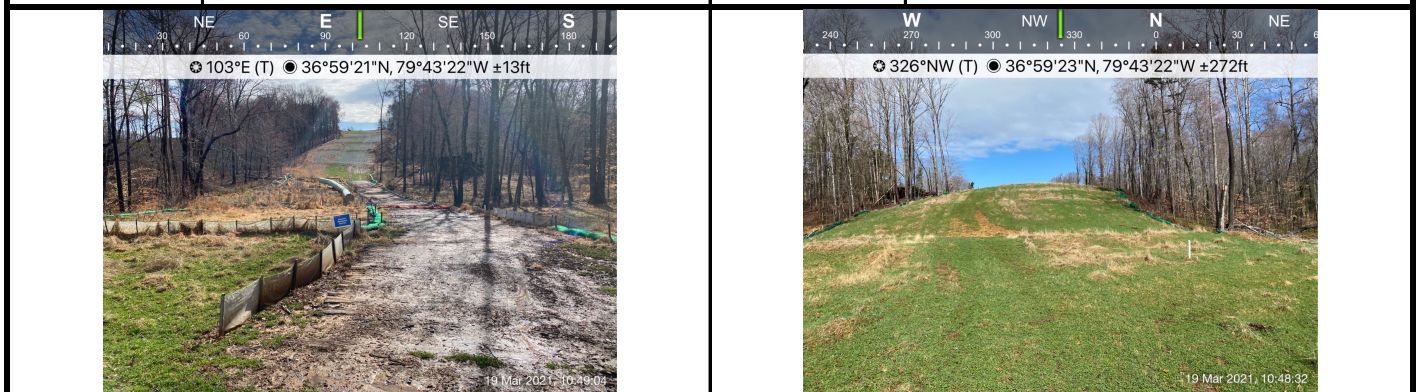
GPS Location	0	GPS Location	0
Field Station#	14656+90	Field Station#	14652+00
Pic 5 Desc.	Approximately 14656+90. Overview of stream crossing, equipment bridge and ECDs at stream S-H38.	Pic 6 Desc.	Approximately 14652+00. Overview of ROW.

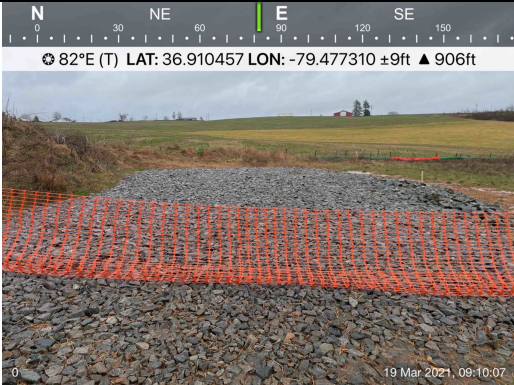
GPS Location See photo		GPS Location See photo			
Field Station# 15480+67		Field Station# 15515+00			
Pic 3 Desc. RCEs are in good condition at all road crossings.		Pic 4 Desc. CWDs are functioning as intended.

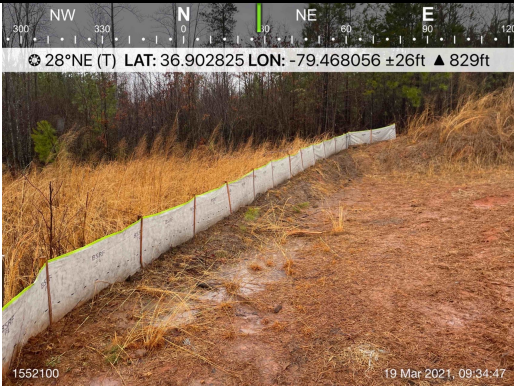
GPS Location See photo		GPS Location See photo			
Field Station# 15521+00		Field Station# 15525+00			
Pic 5 Desc. P1 is in good condition at all stream and wetland buffers.		Pic 6 Desc. Small sink hole at this location remains unchanged since last inspection.

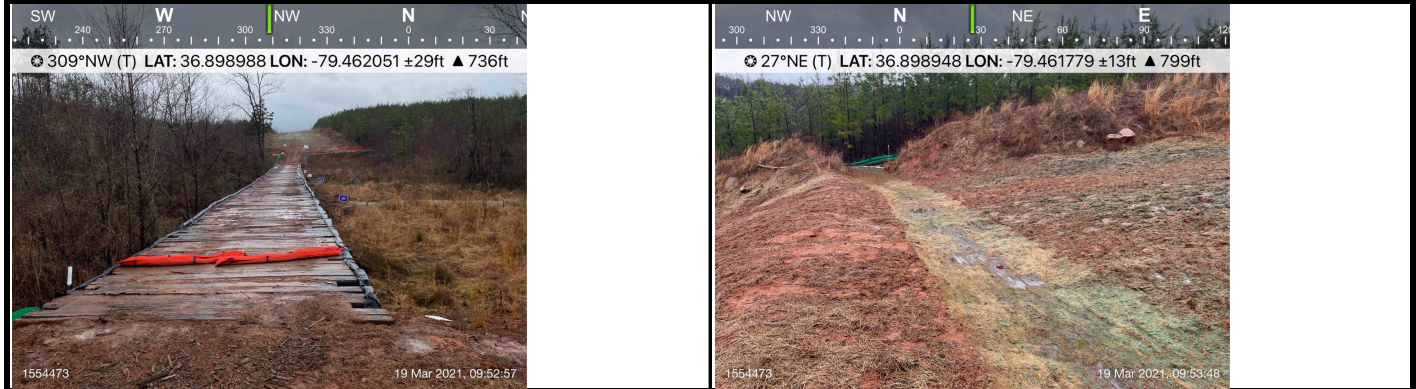
GPS Location	See photo	GPS Location	See photo
Field Station#	15544+73	Field Station#	15544+73
Pic 7 Desc.	Equipment bridge ECDs are in good condition and functioning at all stream and wetland crossings.	Pic 8 Desc.	Waterbars and end treatments are functioning as intended.

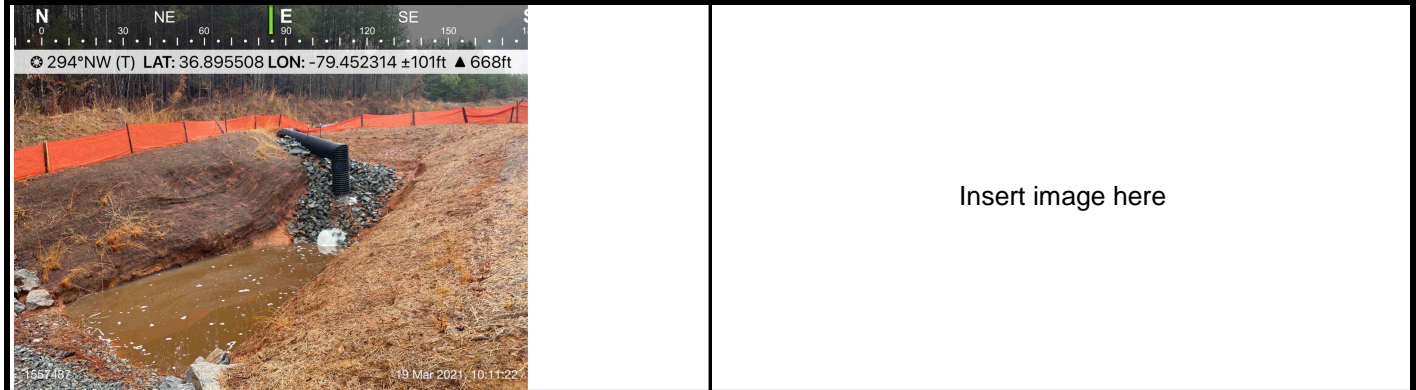
GPS Location	See photo	GPS Location	
Field Station#	15574+87	Field Station#	
Pic 9 Desc.	Slope drain is in good condition and functioning.	Pic 10 Desc.

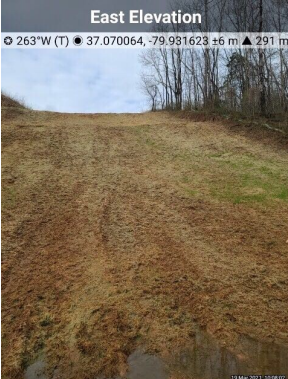
Pic 3 Desc.	Row photo showing stabilization on hill side with some new vegetation growing.		Pic 4 Desc.	During the EI's travel today the EI noticed a section of P1 that required maintenance due to being weathered and torn, documented and added to the punch list for repair.

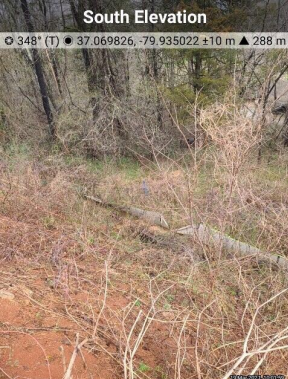
Throughout today's inspections after recent 1.5" rain events over the last 2days the EI noticed a section of P1that required maintenance repairs due to being weathered and torn , documented and sent in to be added to the punch list.
