Visual Site Inspection Report

Project Name H-600 Pipeline Spread I		AFE 124300139	Spread H-600 Pipeline Spread I
Contractor Precision		Report # 20846	
Inspector Ben Davenport		Date/Time 3/8/2021 11:45 AM	
Permit # TBD	Inspection Type VA SWPP	Station Begin 14062+17	
State VA	Inspection Area Partial	Station End 14171+36	
County Franklin	Ground Dry	Temperature (°F) 61.00	
Municipality N/A	Weather Sunny	Rain Gauge (in) 0.00	
			Rain Accumulation Time (days) 0.00

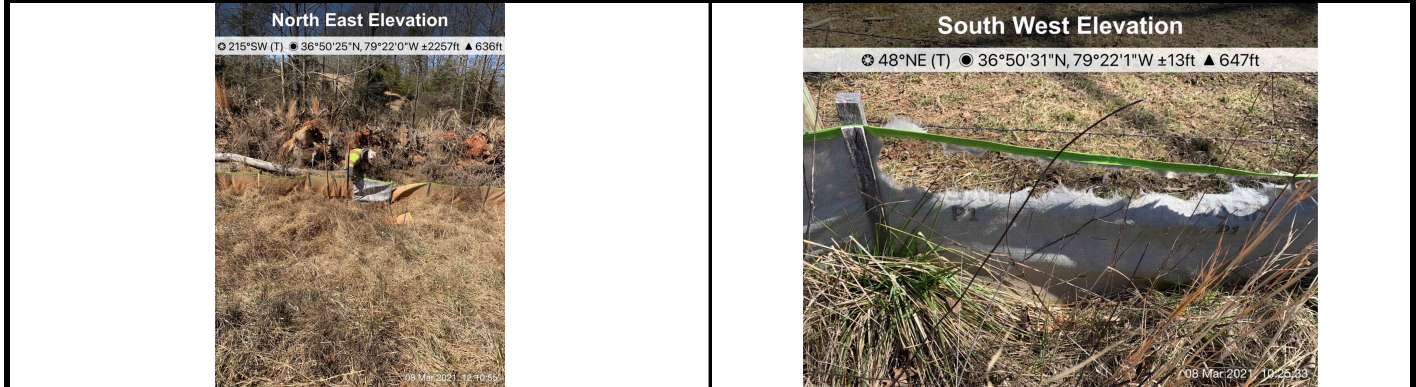
Pic 1 Desc.	Observing the Contractor performing ECD maintenance	Pic 2 Desc.	Observing p1 that requires maintenance
--------------------	---	--------------------	--

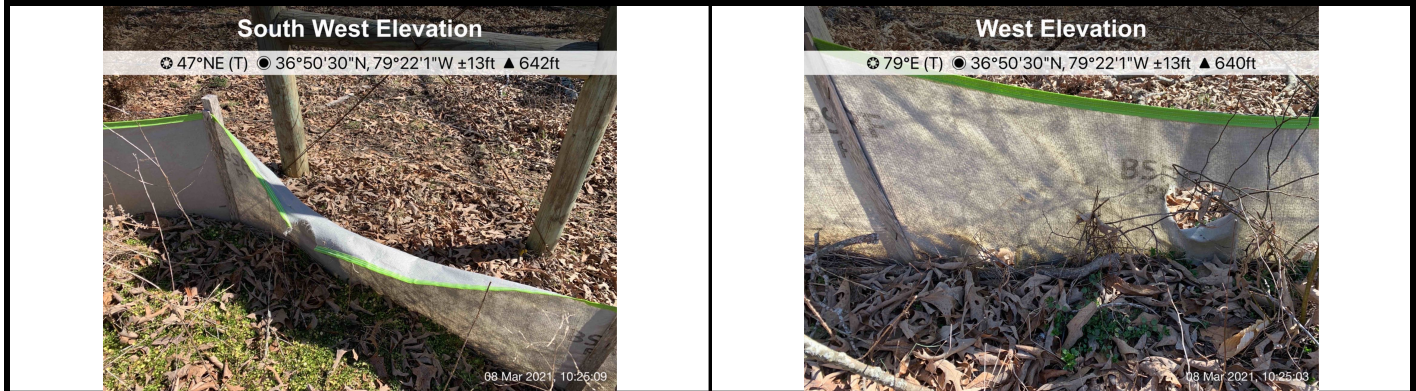
Pic 3 Desc.	Observing p1 that requires maintenance	Pic 4 Desc.	Observing p1 that requires maintenance
--------------------	--	--------------------	--

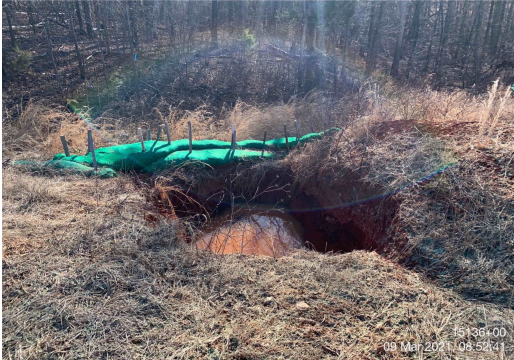
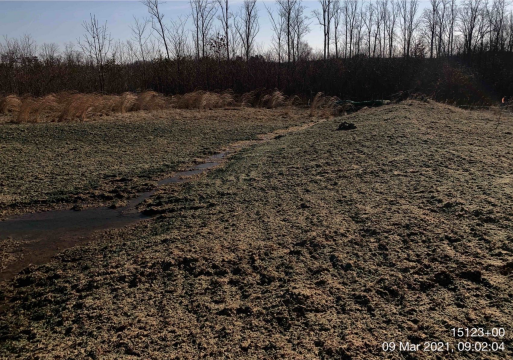
<p>91°E (M) 36°57'19"N, 79°34'54"W ±6482ft ▲ 892ft 15123+00 09 Mar 2021, 08:02:04</p>		
GPS Location 0			GPS Location 0		
Field Station# 15136+00			Field Station# 15123+00		
Pic 1 Desc. Waterbar end treatment in acceptable condition			Pic 2 Desc. Waterbar in acceptable condition

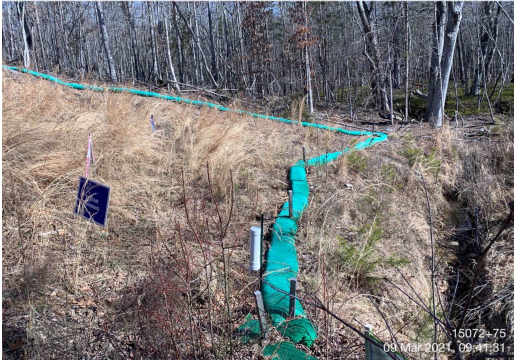
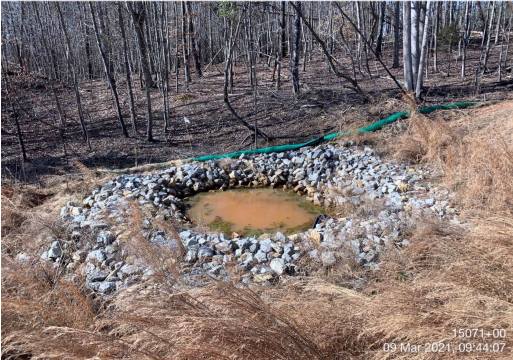
<p>215°SW (M) 36°57'43"N, 79°35'29"W ±5157ft ▲ 870ft 15071+00 09 Mar 2021, 09:44:07</p>		
GPS Location 0			GPS Location 0		
Field Station# 15072+75			Field Station# 15071+00		
Pic 3 Desc. CFS in acceptable condition			Pic 4 Desc. Plunge pool in acceptable condition

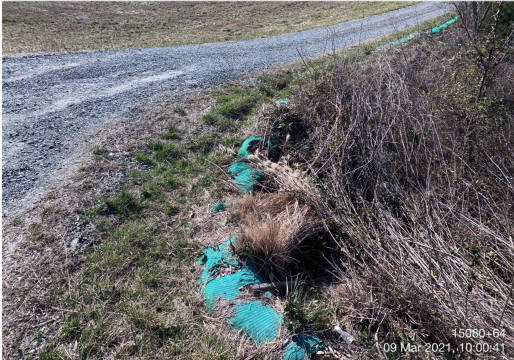
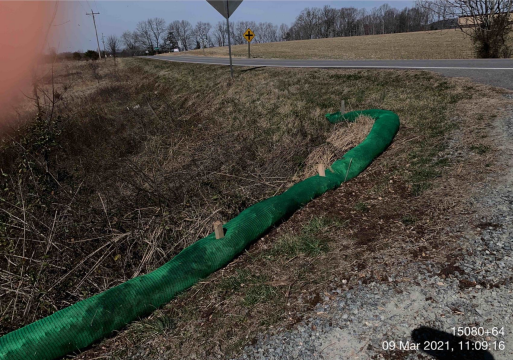
GPS Location 0			GPS Location 0		
Field Station# 15080+64			Field Station# 15080+64		
Pic 5 Desc. CFS missing stakes and with holes on access road MVP-PI-325. Contractor addressed it immediately.			Pic 6 Desc. CFS after replacement on access road MVP-PI-325

E&S BMPs	Compliance Level	Corrective Action	Corrective Time Frame	Date Repaired
Waterbar End Treatment	Acceptable			
Waterbar	Acceptable			
Compost Filter Sock	Acceptable			
Plunge Pool	Acceptable			
Compost Filter Sock	Communication	CFS was replaced	Immediate	3/9/2021

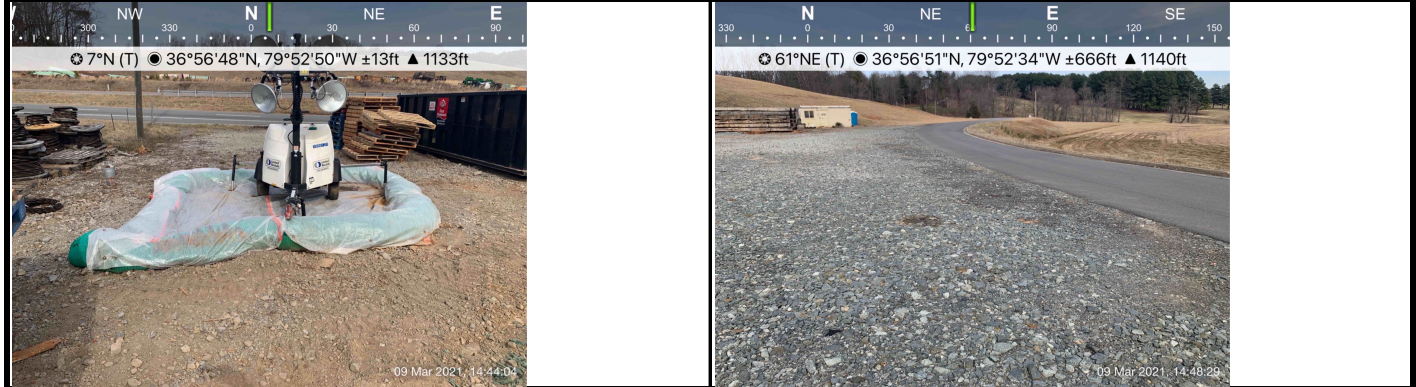
GPS Location	000000000000	GPS Location	000000000000
Field Station#	0000+00	Field Station#	0000+00
Pic 7 Desc.	Secondary containment structure for light plant near entrance of MVP- LY-032 in good condition.	Pic 8 Desc.	RCE at MVP-LY-033 in good condition.

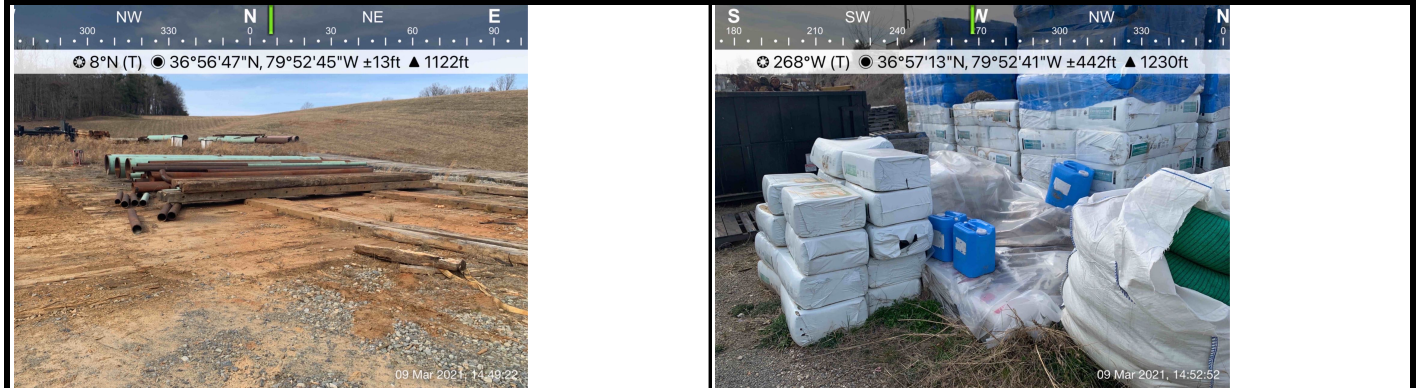
GPS Location	0000000000	GPS Location	0000000000
Field Station#	0000+00	Field Station#	0000+00
Pic 9 Desc.	Housekeeping in order at MVP-LY-033	Pic 10 Desc.	Fertilizer at MVP-ANC-066 covered as required.

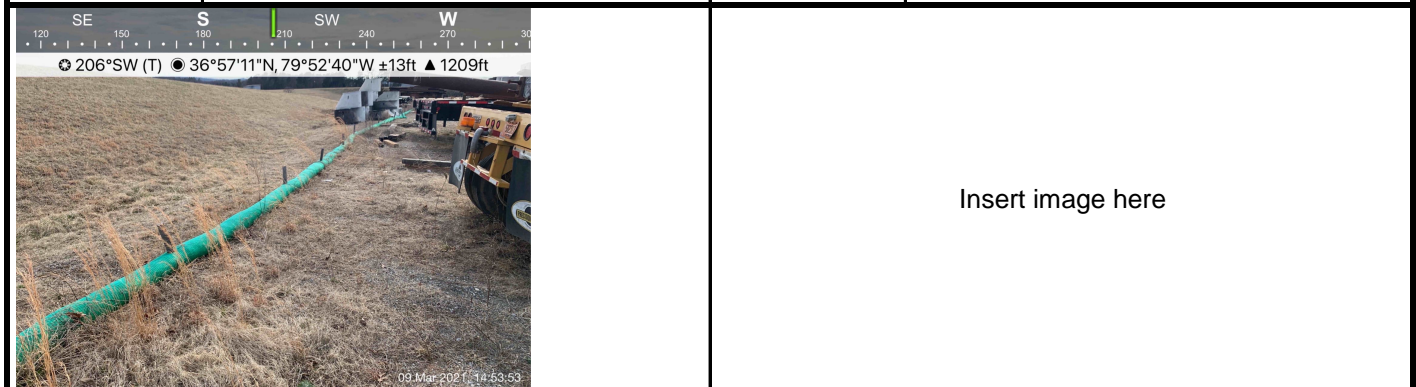
GPS Location	000000000000	GPS Location	
Field Station#	0000+00	Field Station#	
Pic 11 Desc.	Perimeter ECD's at MVP-ANC-066 in good condition.	Pic 12 Desc.

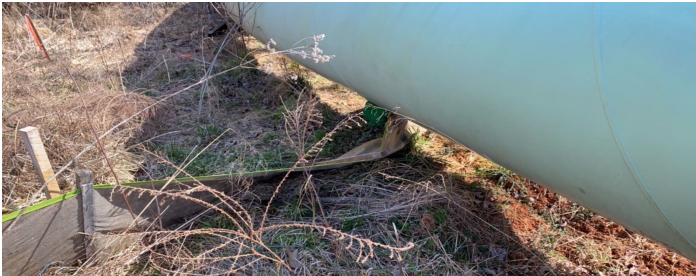
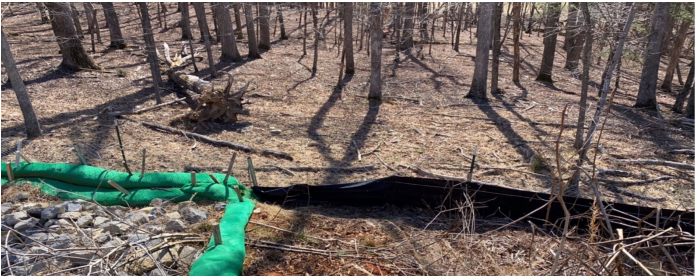
<p>37°3'28" N 79°50'42" W 13°N COURSE 125° GPS Rocky Mount, VA 24151, United States</p>			<p>03.09.2021 10:33:43 Accur +/-72.6 Ft ALT 989 Ft</p>		
<p>37°3'29" N 79°50'42" W 120°SE COURSE 223° GPS Rocky Mount, VA 24151, United States</p>			<p>03.09.2021 10:36:33 Accur +/-838.8 Ft ALT 986 Ft</p>		
GPS Location	1		GPS Location	2	
Field Station#	14175+75		Field Station#	14179+00	
Pic 1 Desc.	Routine maintenance. Replace damaged panels of P1 silt fence.		Pic 2 Desc.	Routine maintenance. SSF down along perimeter. Reattach geotextile fabric to fencing.

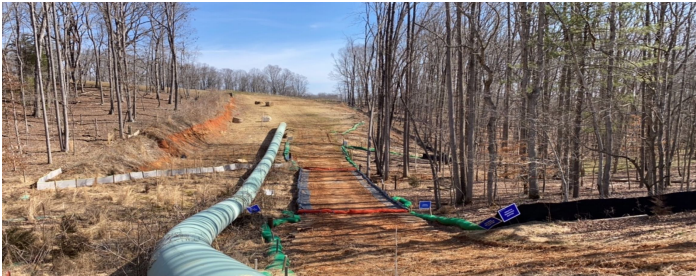
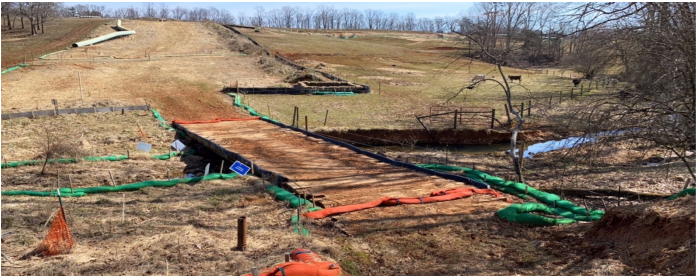
GPS Location	3		GPS Location	4	
Field Station#	14176+09		Field Station#	14190+14	
Pic 3 Desc.	Equipment bridge and surrounding ECDs in place and functional at stream crossing.		Pic 4 Desc.	Equipment bridge and surrounding ECDs in place and functional at stream crossing.

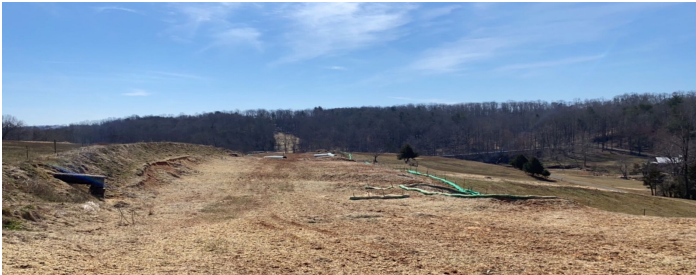
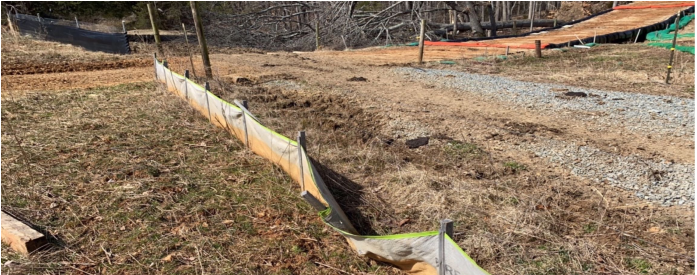
<p>37°3'36" N 79°50'17" W 173°S COURSE 329° GPS 3175 Booker T Washington Hwy, Rocky Mount, VA 24151, United States</p>			<p>03.09.2021 10:47:50 Accur +/-61.5 Ft ALT 971 Ft</p>		
<p>37°2'49" N 79°48'46" W 280°W COURSE 288° GPS 955 Greenway Rd, Glade Hill, VA 24092, United States</p>			<p>03.09.2021 11:33:02 Accur +/-75.9 Ft ALT 1008 Ft</p>		
GPS Location	5		GPS Location	6	
Field Station#	14202+00		Field Station#	14295+00	
Pic 5 Desc.	View of recently applied hydroseed mix along ROW.		Pic 6 Desc.	Routine maintenance. Replace damaged panels of P1 silt fence from cattle damage.

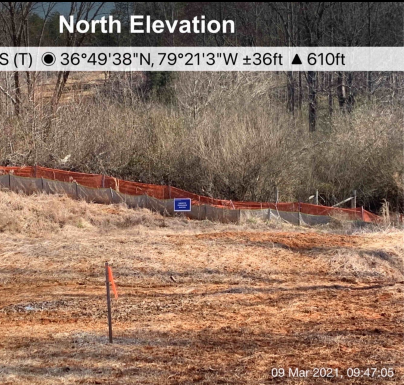
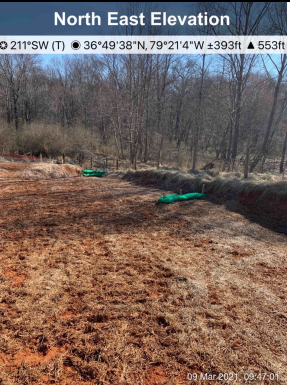
GPS Location	O	GPS Location	O		
Field Station#	15999+50	Field Station#	15998+00		
Pic 3 Desc.	Observing temporary stabilization, signage and ECD's		Pic 4 Desc.	Observing temporary stabilization, erosion control blanket and cfs checks

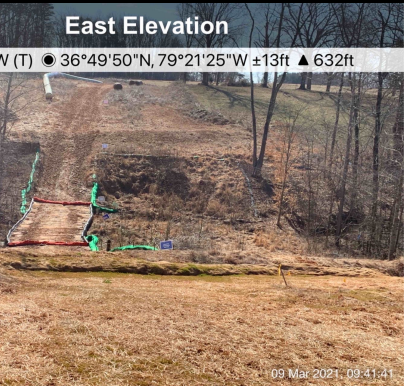
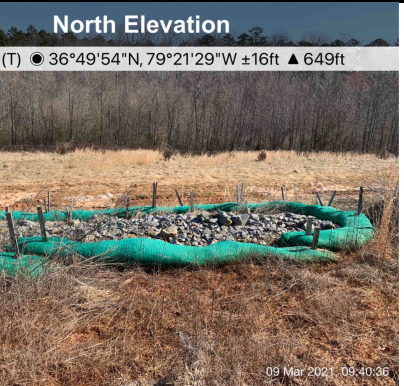
GPS Location	O	GPS Location	O		
Field Station#	15977+35	Field Station#	15967+00		
Pic 5 Desc.	Observing temporary stabilization, water bar, signage, buffer, equipment crossing and ECD's		Pic 6 Desc.	Observing temporary vegetation, CWD outlet and ECD's

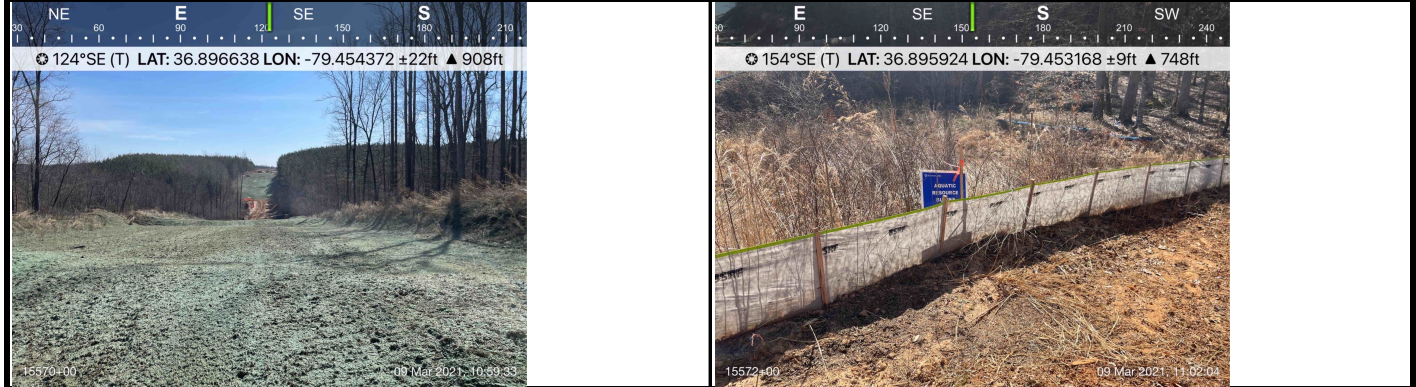
GPS Location	See photo	GPS Location	See photo
Field Station#	15570+00	Field Station#	15572+00
Pic 7 Desc.	ROW is being stabilized.	Pic 8 Desc.	P1 is in good condition at all stream and wetland buffers.

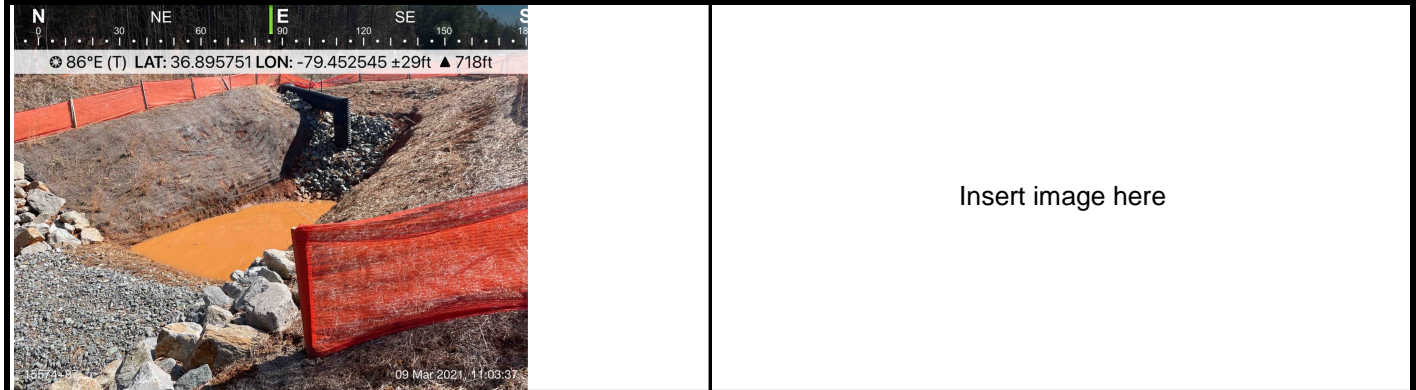
GPS Location	See photo	GPS Location	
Field Station#	15574+87	Field Station#	
Pic 9 Desc.	Slope drain remains in good condition.	Pic 10 Desc.

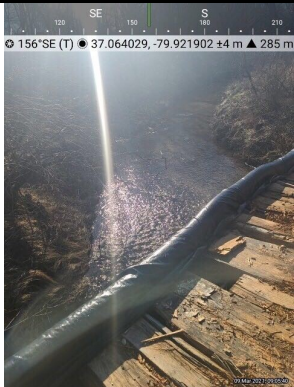
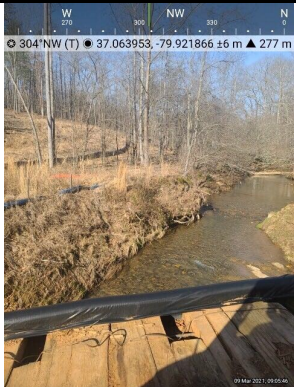
GPS Location	00000	GPS Location	00000		
Field Station#	13834+04	Field Station#	13834+04		
Pic 1 Desc.	Stream observation photo facing upstream during routine inspection today, no issues observed at time of inspection.		Pic 2 Desc.	Stream observation photo facing downstream during routine inspection today. No issues observed at the time of inspection.

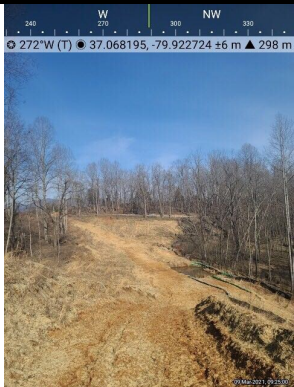
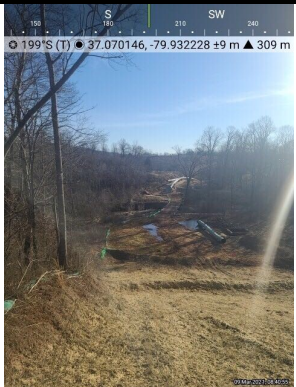
GPS Location	00000	GPS Location	00000		
Field Station#	13819+28	Field Station#	13787+78		
Pic 3 Desc.	Row photo showing stabilization on hill side, ECDs in place at bottom of hill. No issues observed at the time of inspection.		Pic 4 Desc.	Row photo showing stabilization on hill side above stream crossing. No issues observed at the time of inspection.

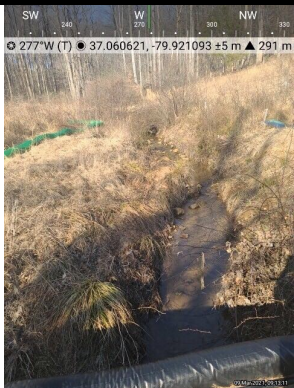
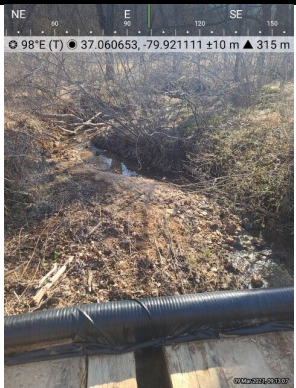
GPS Location	00000	GPS Location	00000		
Field Station#	13846+98	Field Station#	13846+98		
Pic 5 Desc.	Stream observation photo facing downstream during routine inspection today. No issues observed at the time of inspection.		Pic 6 Desc.	Stream observation photo facing upstream during routine inspection today, no issues observed at the time of inspection.

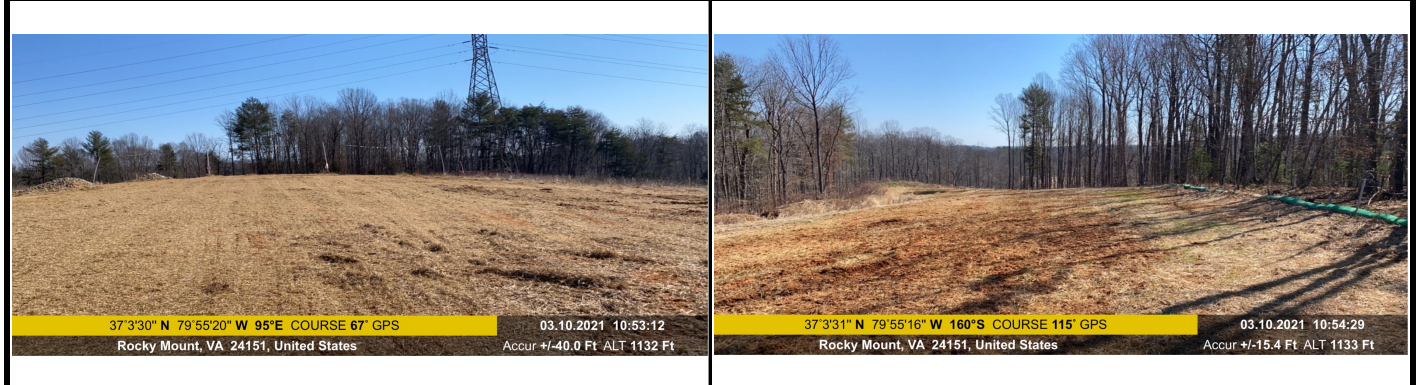
GPS Location	1	GPS Location	2
Field Station#	13853+45	Field Station#	13858+00
Pic 1 Desc.	Workspace at MVP-FR-303.01 hand seeded and mulched when work was completed in area.	Pic 2 Desc.	Some vegetative growth observed in areas aerially seeded and stabilized.

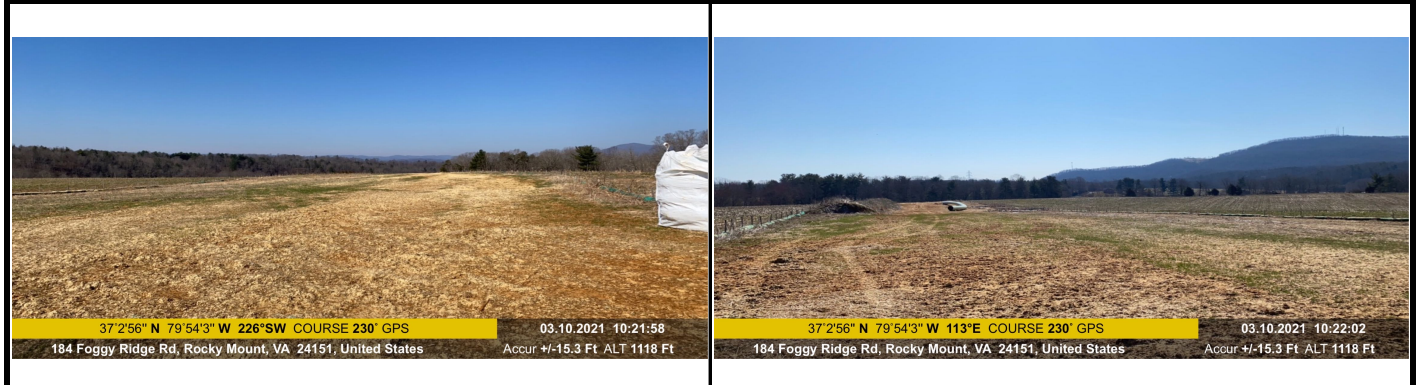
GPS Location	3	GPS Location	4
Field Station#	13932+00	Field Station#	13943+00
Pic 3 Desc.	Some vegetative growth observed in areas aerially seeded and stabilized.	Pic 4 Desc.	Some vegetative growth observed in areas aerially seeded and stabilized.

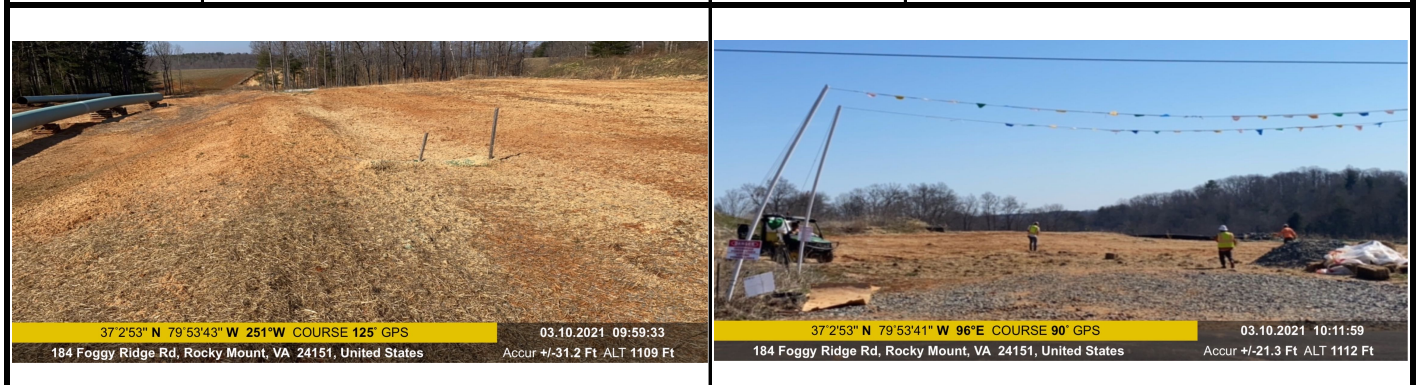
GPS Location	5	GPS Location	6
Field Station#	13955+50	Field Station#	13958+31
Pic 5 Desc.	Area of transition between seed and mulch applied by hand versus aerially. Entire ROW was covered.	Pic 6 Desc.	Contractor hand seeding and mulching workspace near road crossing.

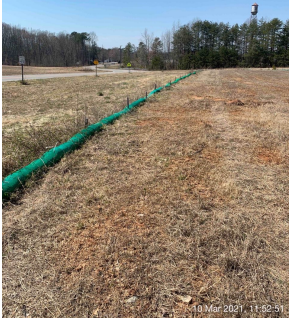
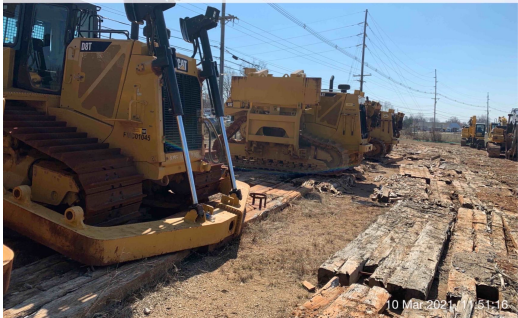
GPS Location		O		GPS Location	
		O			
Field Station#		00+00		Field Station#	
		00+00			
Pic 1 Desc.		Observing temporary vegetation and ECD's		Pic 2 Desc.	
				Observing staged equipment	
		<p>South East Elevation</p> <p>302°NW (T) 36°41'29"N, 79°22'4"W ±22ft ▲ 754ft</p>

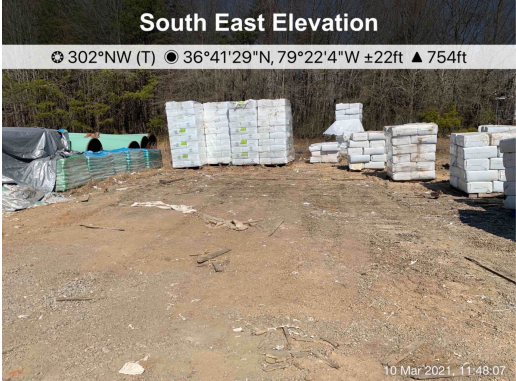
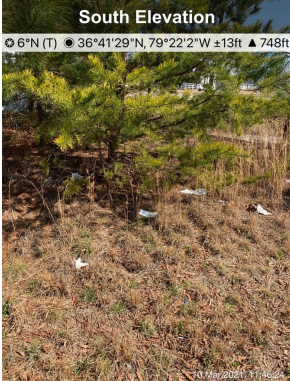
GPS Location		O		GPS Location	
		O			
Field Station#		00+00		Field Station#	
		00+00			
Pic 3 Desc.		Observing trash that needs to be removed.		Pic 4 Desc.	
				Observing trash that needs to be removed	
		<p>South East Elevation</p> <p>295°NW (T) 36°41'30"N, 79°22'3"W ±22ft ▲ 750ft</p>

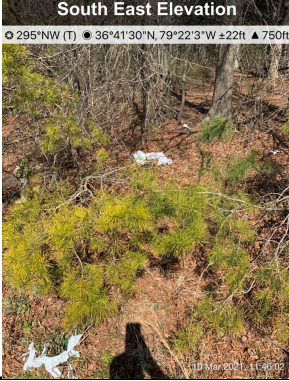
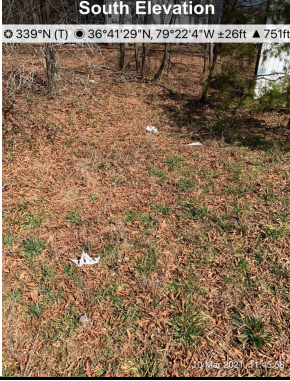
GPS Location		O		GPS Location	
		O			
Field Station#		00+00		Field Station#	
		00+00			
Pic 5 Desc.		Observing trash that needs to be removed		Pic 6 Desc.	
				Observing trash that needs to be removed.

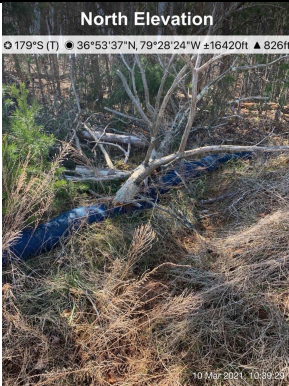
<p>North Elevation <small>179°S (T) ● 36°53'37"N, 79°28'24"W ±16420ft ▲ 826ft</small></p>			
GPS Location O		GPS Location O			
Field Station# 15630+00		Field Station# 15614+00			
Pic 5 Desc. Observing temporary stabilization, CWD outlet and ECD's		Pic 6 Desc. Observing tree that needed to be removed from the CFS.

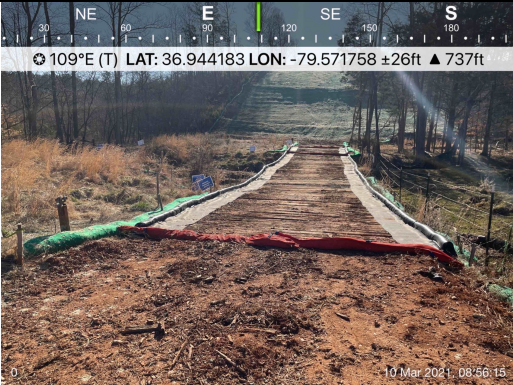
GPS Location See photo		GPS Location See photo			
Field Station# 15161+00		Field Station# 15167+96			
Pic 3 Desc. P1 is damaged and needs to be replaced.		Pic 4 Desc. Equipment bridge ECDs are in place and functioning.

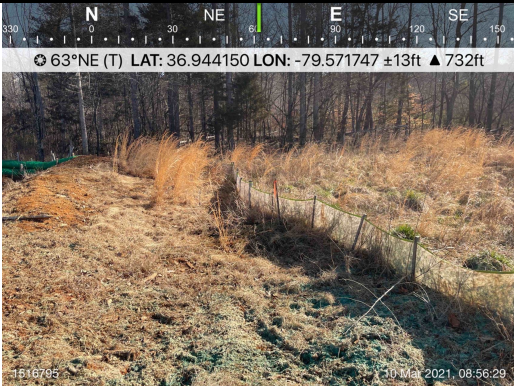
GPS Location See photo		GPS Location See photo			
Field Station# 15167+95		Field Station# 15195+00			
Pic 5 Desc. P1 is in good condition at all stream and wetland crossings.		Pic 6 Desc. Previous drainage repair is in good condition.

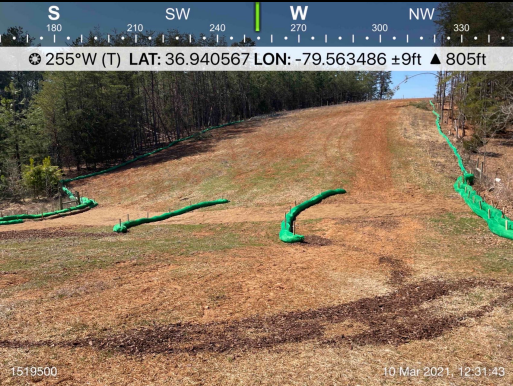
- EI began inspection at Rockcreek Rd.
- RCE is in good condition at Rockcreek Rd.
- Area needs to be stabilized at 15152+84. This location was disturbed during Gwinnups stabilization and was too wet at the time to stabilize.
- Trash needs to be removed from ROW in multiple locations.
- P1 is damaged at 15161+00 and needs to be replaced.
- Equipment bridge ECDs are in place and functioning.
- P1 is in good condition at all stream and wetland buffers.
- Previous drainage repairs at 15195+00, 15201+00 & 15203+00 are in good condition.

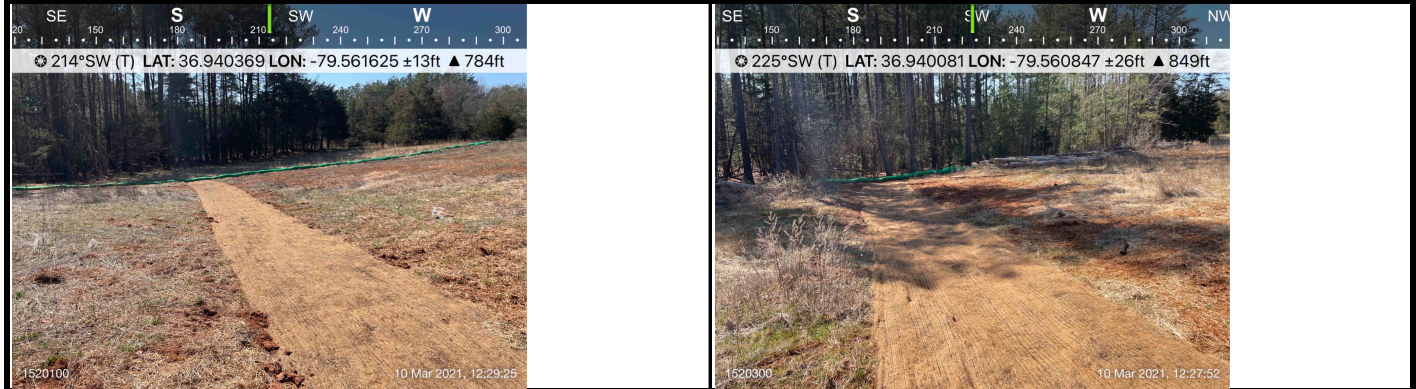
Pic 7 Desc.	Previous drainage repair is in good condition.	Pic 8 Desc.	Previous drainage repair is in good condition.
--------------------	--	--------------------	--

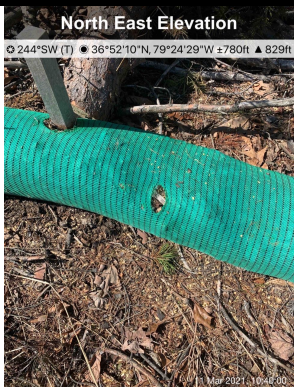
GPS Location	O		GPS Location	O	
Field Station#	15744+88		Field Station#	15744+88	
Pic 3 Desc.	Observing CFS that required maintenance		Pic 4 Desc.	Observing CFS that received maintenance

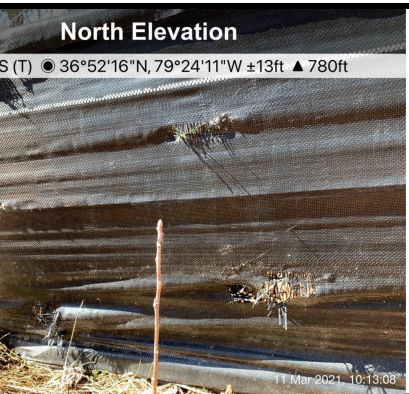
GPS Location	O		GPS Location	O	
Field Station#	15762+00		Field Station#	15762+00	
Pic 5 Desc.	Observing SSF that requires maintenance		Pic 6 Desc.	Observing SSF that requires maintenance

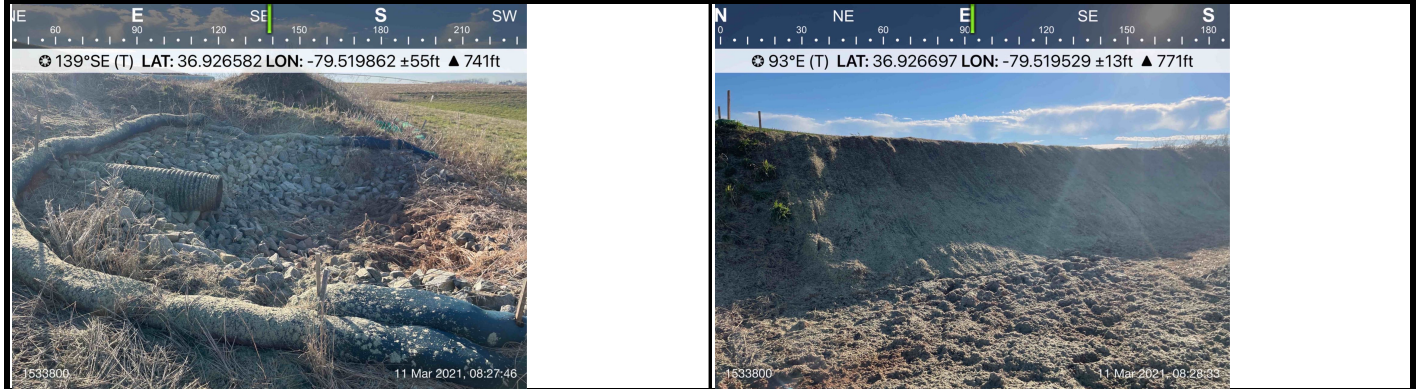
GPS Location	See photo	GPS Location	See photo
Field Station#	15338+00	Field Station#	15338+00
Pic 7 Desc.	CWDs are in good condition throughout this section.	Pic 8 Desc.	Diversion berm repair remains in good condition.

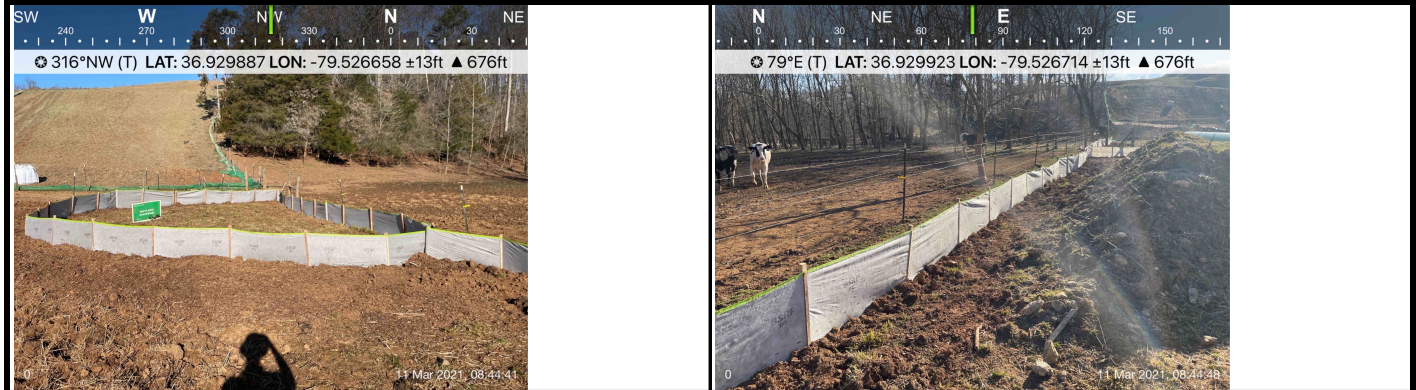
GPS Location	See photo	GPS Location	See photo
Field Station#	15311+78	Field Station#	15311+78
Pic 9 Desc.	Repaired wetland ECDs are in good condition.	Pic 10 Desc.	Perimeter P1 repair is in good condition.

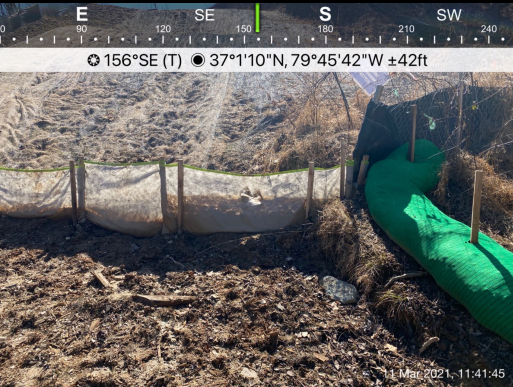
<p>GPS Location: 156°SE (T) 37°1'10"N, 79°45'42"W ±42ft 11 Mar 2021, 11:41:45</p>			
GPS Location	0	GPS Location	0		
Field Station#	14457+00	Field Station#	14486+90		
Pic 1 Desc.	Approximately 14457+00. Overview of ROW.	Pic 2 Desc.	Approximately 14486+90. P-1 requires maintenance. Damaged by livestock.

E&S BMPs	Compliance Level	Corrective Action	Corrective Time Frame	Date Repaired
3rd Party Damages	Communication	Replace P-1 damaged by livestock		
Cleanwater Diversion Pipe	Acceptable			
Compost Filter Sock	Acceptable			
Equipment Bridge	Acceptable			
Rock Construction Entrance	Acceptable			
Sensitive Resource Buffer	Acceptable			
Sensitive Resource Signage	Acceptable			
Silt Fence (Filter Fabric Fence)	Communication	Replace fence damaged by livestock		
Silt Fence (Reinforce Filter Fence)	Acceptable

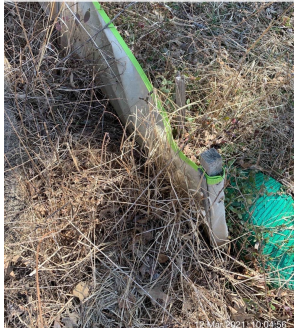
<p>12 Mar 2021 10:09:01</p>	GPS Location	O	GPS Location	O
Field Station#	15928+00	Field Station#	15923+00	Pic 1 Desc.	Observing water bar,temporary stabilization and erosion control blanket	Pic 2 Desc.	Observing p1 that requires maintenance (broken stakes)
	<p>South East Elevation</p> <p>310°NW (T) ● 36°50'28"N, 79°22'1"W ±36ft ▲ 629ft</p>

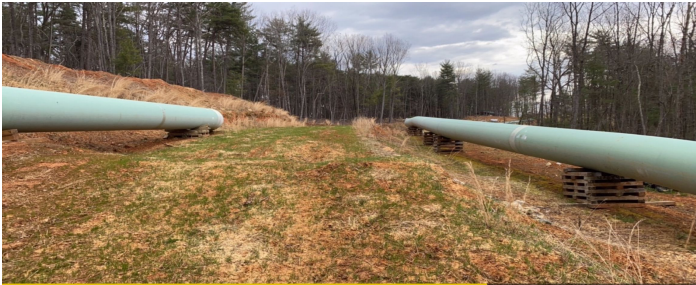
<small>37°3'56" N 79°52'31" W 77°E COURSE 28' GPS 1338 Bonbrook Mill Rd, Rocky Mount, VA 24151, United States 03.12.2021 11:32:10 Accur +/-72.8 Ft ALT 1016 Ft</small>			<small>37°3'53" N 79°52'29" W 27°NE COURSE 37' GPS 1214 Bonbrook Mill Rd, Rocky Mount, VA 24151, United States 03.12.2021 10:35:48 Accur +/-133.8 Ft ALT 865 Ft</small>		
GPS Location	1		GPS Location	2	
Field Station#	14062+17		Field Station#	14065+00	
Pic 1 Desc.	Rutting created by vehicle tracks at Bonbrook Mill RC2 approach		Pic 2 Desc.	Vegetation beginning to grow in areas recently aerially seeded and stabilized

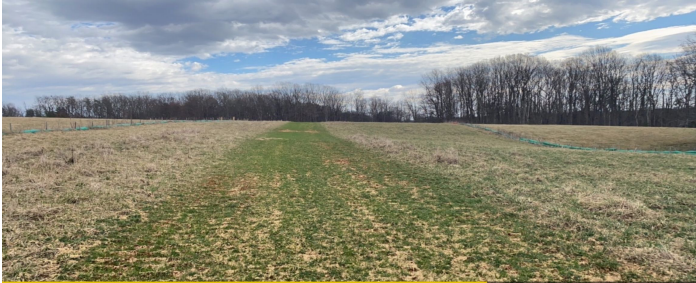
GPS Location	3		GPS Location	4	
Field Station#	14070+00		Field Station#	14094+00	
Pic 3 Desc.	Vegetation beginning to grow in areas recently aerially seeded and stabilized		Pic 4 Desc.	Vegetation beginning to grow in areas recently aerially seeded and stabilized

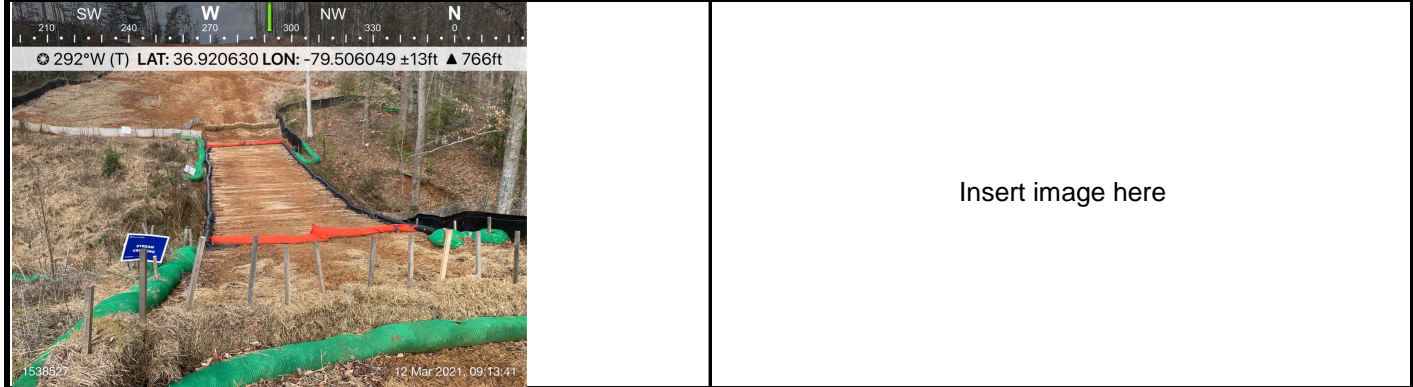
Pic 7 Desc.	Equipment bridge ECDs are in place and in good condition.	Pic 8 Desc.	
--------------------	---	--------------------	--

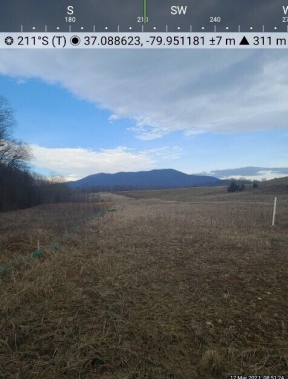
<p>GPS coordinates: 211°S (T) • 37.088623, -79.951181 ±7 m ▲ 311 m</p>	
GPS Location	0000	GPS Location	0000	
Field Station#	13678+71	Field Station#	13677+78	
Pic 3 Desc.	Stream observation photo facing upstream during routine inspection today. No issues observed at the time of inspection.	Pic 4 Desc.	Row photo showing stabilization and new vegetation growing . No environmental issues observed at the time of inspection.

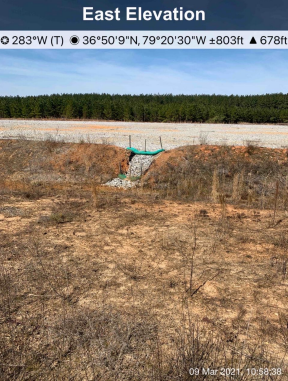
<p>East Elevation <small>283°W (T) ● 36°50'9"N, 79°20'30"W ±803ft ▲ 678ft</small></p>

<p>South Elevation <small>358°N (T) ● 36°49'53"N, 79°20'34"W ±118ft ▲ 654ft</small></p>			
GPS Location O		GPS Location O			
Field Station# 00+00		Field Station# 00+00			
Pic 1 Desc. Observing Lay down yard,temporary stabilization,rock drain and ECD's		Pic 2 Desc. Observing p1 that requires maintenance

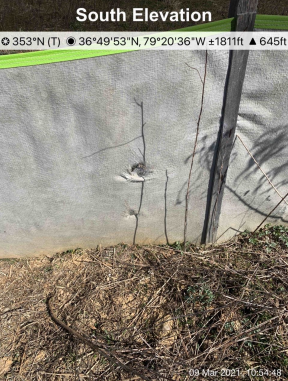
<p>South Elevation <small>353°N (T) ● 36°49'53"N, 79°20'36"W ±181ft ▲ 645ft</small></p>

<p>South East Elevation <small>299°NW (T) ● 36°49'52"N, 79°20'36"W ±85ft ▲ 647ft</small></p>			
GPS Location O		GPS Location O			
Field Station# 00+00		Field Station# 00+00			
Pic 3 Desc. Observing p1 that requires maintenance		Pic 4 Desc. Observing temporary stabilization,storm water pond and ECD's			
Insert image here			Insert image here

Performed SWPPP Inspection on the Transco Facility and Lay down yard. There were issues identified and added to the punch list. The Contractor is working on repairing the identified issues. Other than that there were no issues to report at the time of Inspection.
